2023 Annual Facility Performance Review Summary Report

Tailings Management Facility, Quebrada Blanca 2

WSP Reference N° 8013-TSC-099-RE-1400-C-00133_3

September, 2024

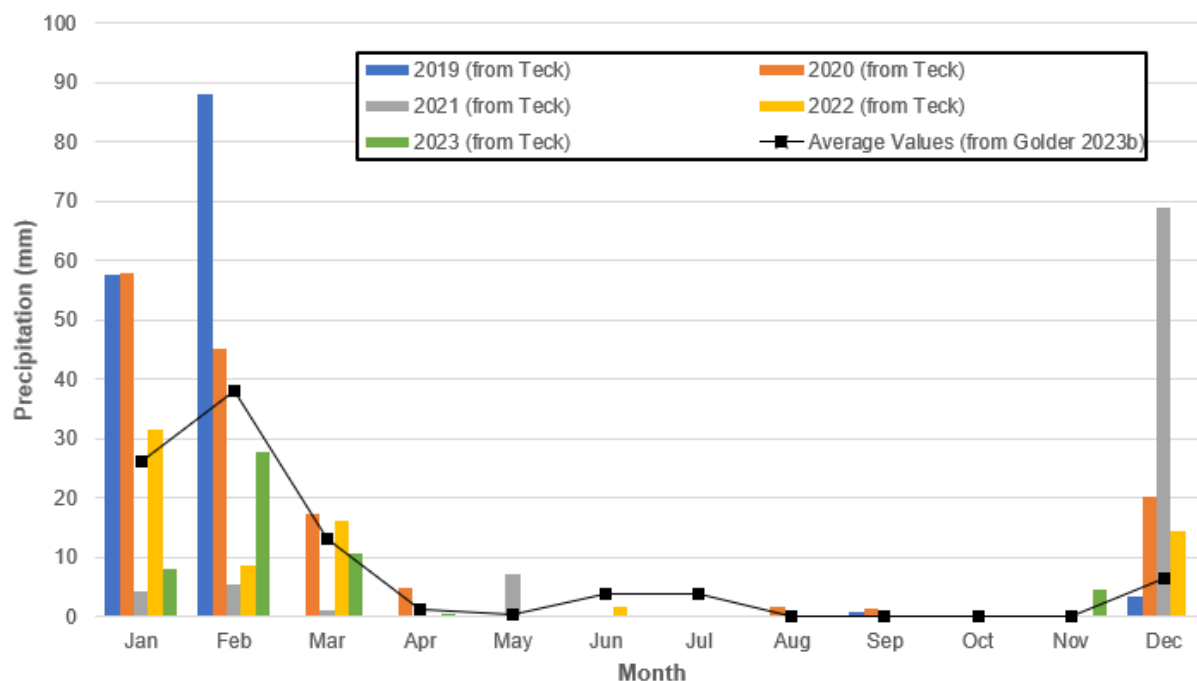
Figure 3: Monthly Precipitation for 2019 to 2023 with Average Values.

The monthly precipitation data collected by Teck on-site for the 2019 to 2023 period are shown in Figure 3 along with the average monthly values from Golder (2023d). The monthly precipitation values shown in the graphic correspond to the average values.

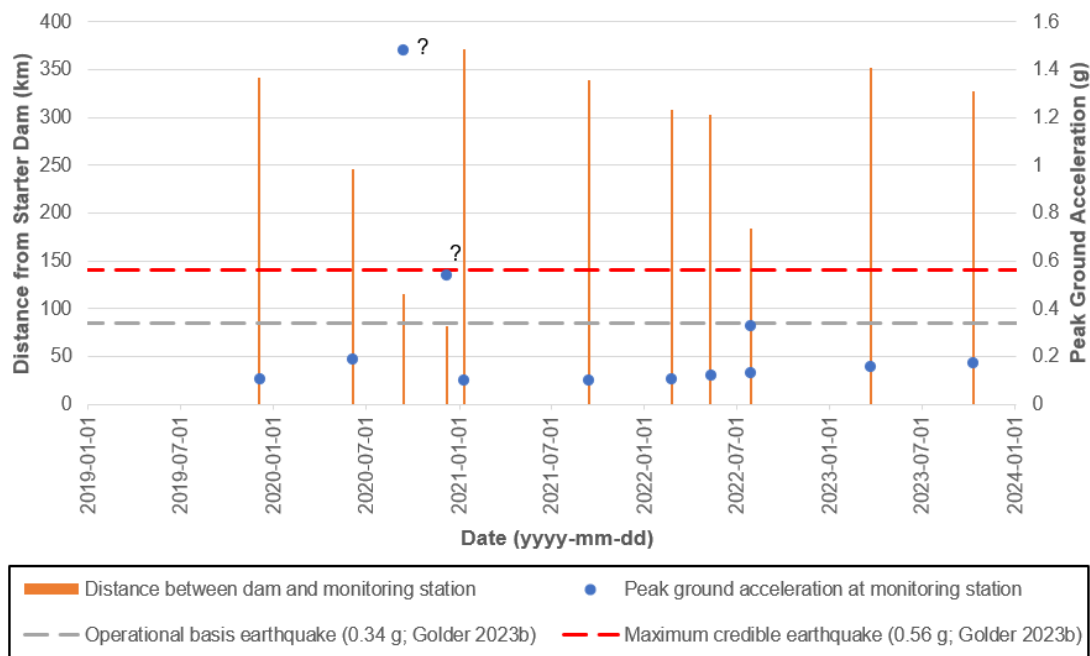
Figure 4: Ground Accelerations near Starter Dam for Period 2019 to 2023.

Figure 4 shows the ground accelerations for these events, and their distance from the sand dam, along with the OBE and MCE ground accelerations. The two higher ground accelerations reported in late 2020 are questioned as no effects were reported at site.

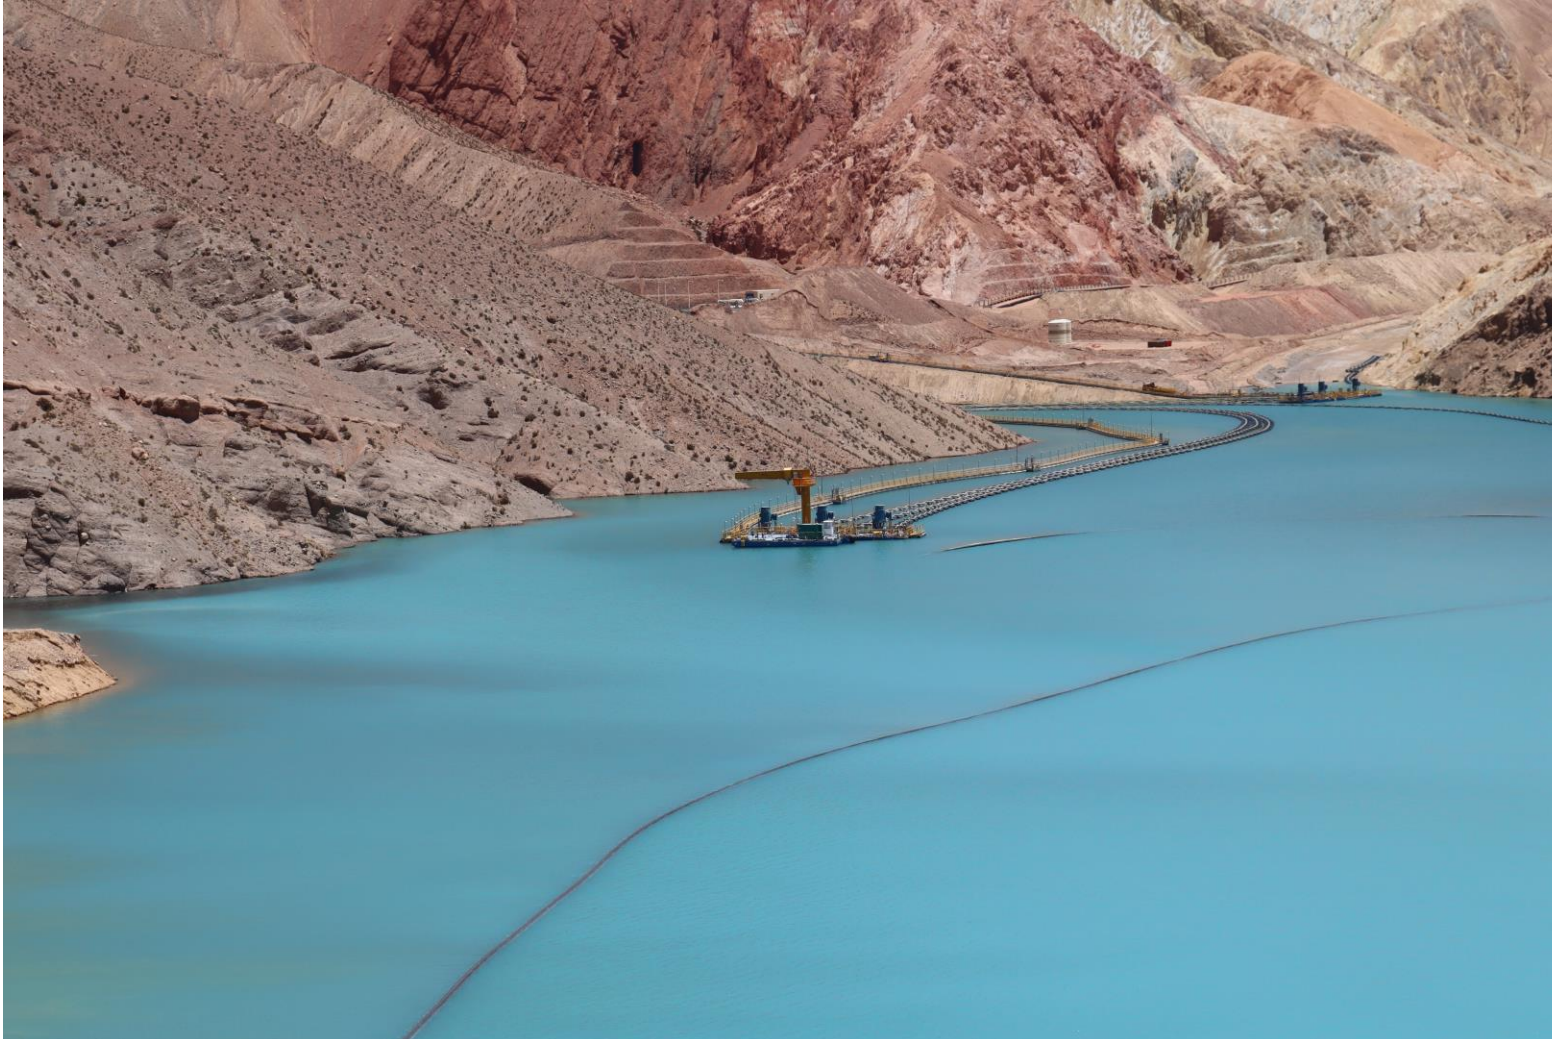
Plate 5: Reclaim Pond (1400)

- Position 2 of the barge pumps was being brought into operation, while position 1 was in the process of being decommissioned. (Plate 5).
- Pond size and location as expected covering all the area of tailings deposition.
- Pond maximum volume measured during the period of 2023 lower than the maximum pond volume defined in the design criteria (1.5 M m³) (Golder, 2023d).
- Pond depth reportedly sufficient for water reclaim process from barges.

- Water quality reportedly good for reclaim and dilution.
- Floating pipelines are scheduled to be removed by CMTQB (Plate 5).

Barge Position 1 (Position 2 in background)

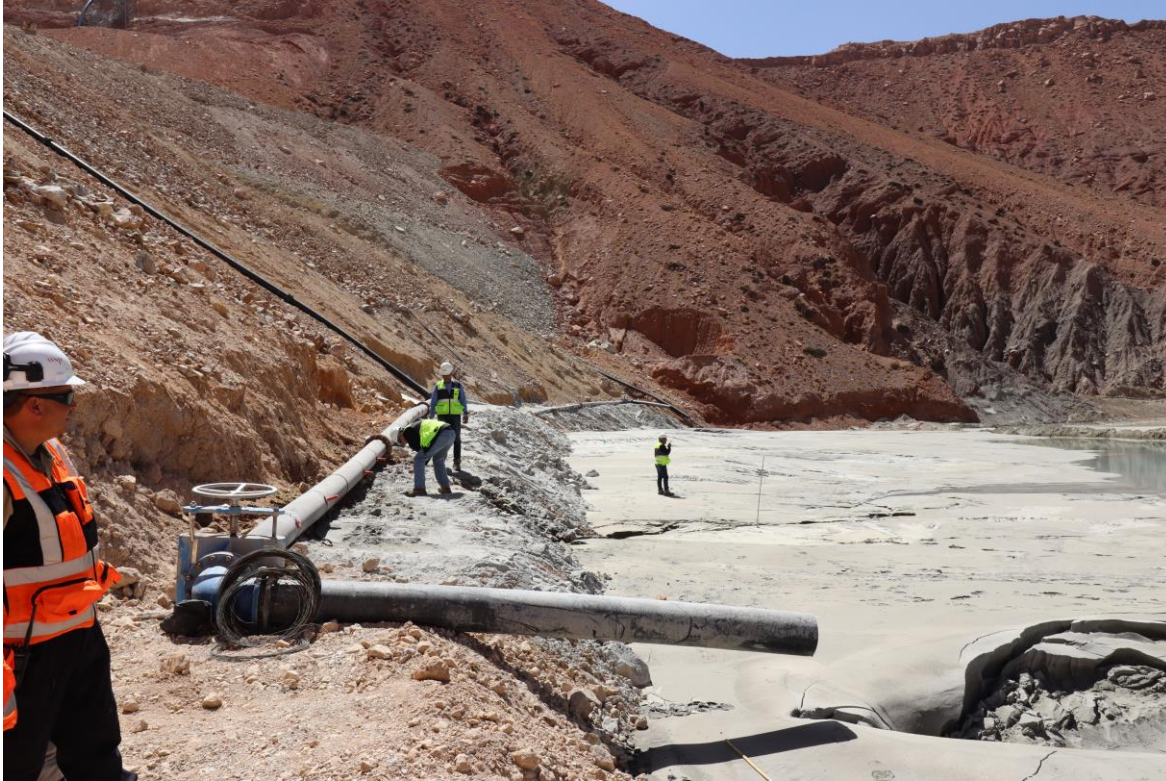
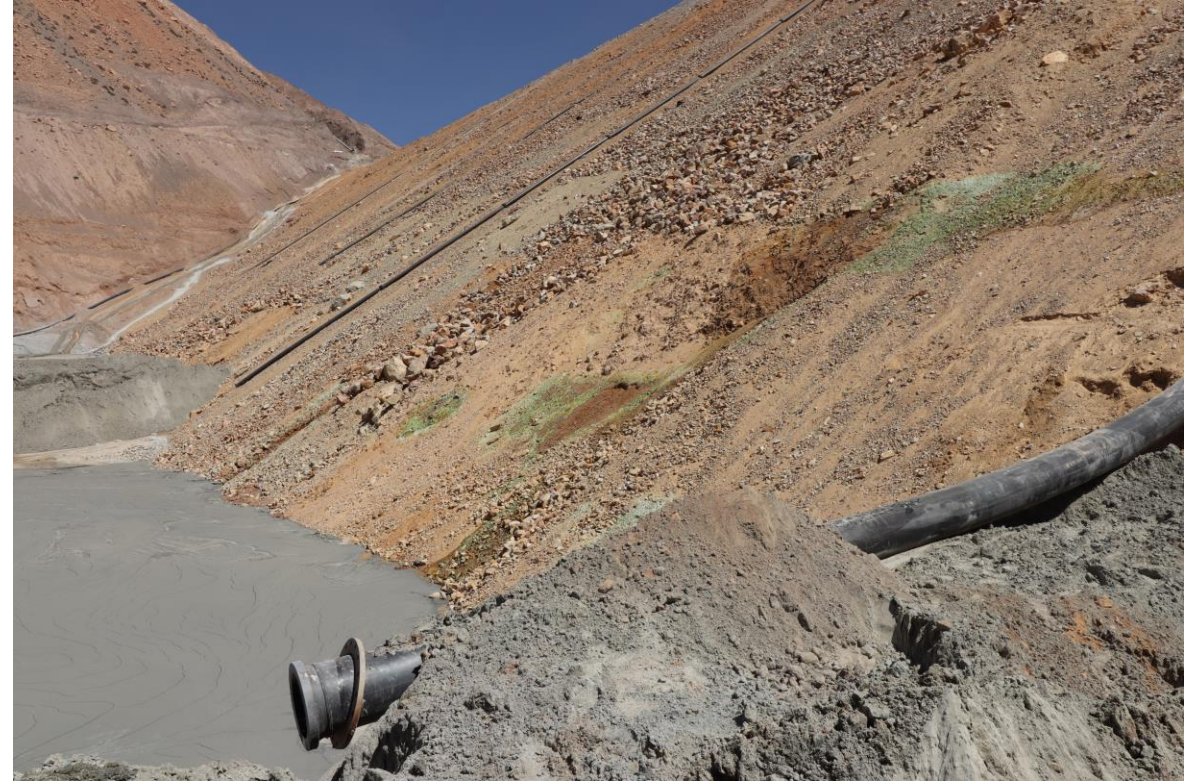
Plate 19: Sand Dam (1465)

- CMTQB to arrange for extension of IN-02.
- Use of portable pumps will assist with management of sand transport water.
- Seepage reporting to Paddock 1 from starter dam is decreasing. Use of sumps and pumps immediately adjacent to starter dam downstream slope will improve water management (Plate 19).

Paddock sand distribution system

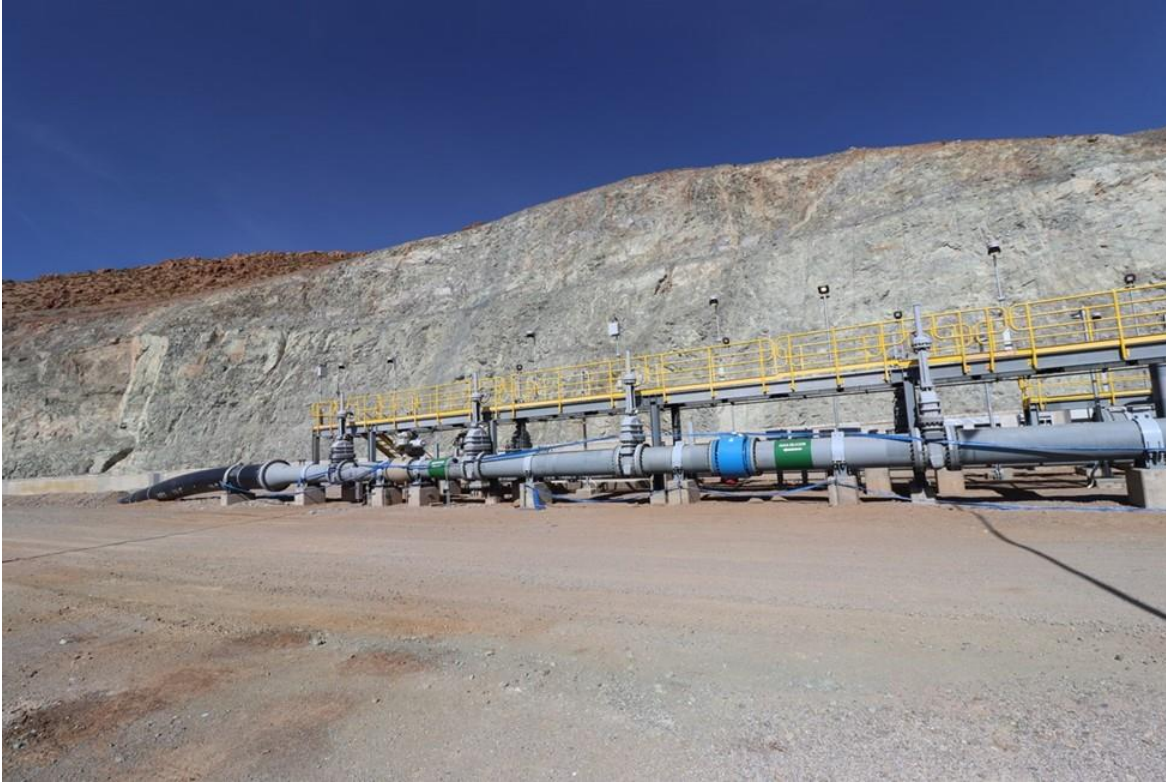
Plate 31: Dilution Water Terminal Station (1644)

- The slope has performed well in 2023, with no evidence of change since the 2022 AFPR site visit.
- Drape mesh installed following 2022 AFPR.
 - Two hanging/loose blocks remain as-observed during the 2022 AFPR; bolting continues to be suggested to protect launder from rockfall hazard. WSP has issued a document outlining the drape mesh and bolting requirements (Plate 31).

Drape mesh installed following 2022 AFPR
