TECK RESOURCES LIMITED BEAVERDELL MINE

Beaverdell Tailings Storage Facilities 2017 Annual Dam Safety Inspection

Reference Number: 1778313-052-R-Rev0-1000

This report presents the 2017 annual dam safety inspection (DSI) for the embankments of the tailings storage facilities (TSF) at the closed Beaverdell Mine. The facilities consist of the South TSF and North TSF.

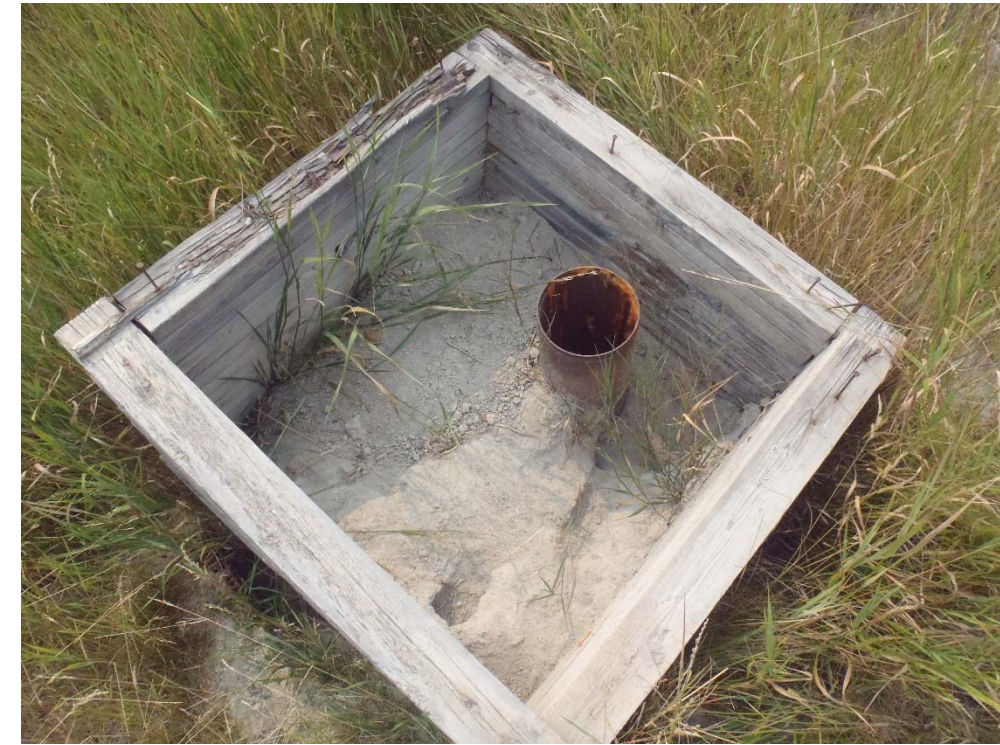
The South TSF contains a decant towers/tunnels in Cell 5 which originally managed pond water. No decant tower has been observed in any of the other South TSF cells. The decant tower in Cell 5 is shown in Photograph 10, Appendix A, and its approximate location is shown in Figure 3. This decant tower was sealed with foam in 2016.

Photograph 10: South TSF, Cell 5, backfilled decant tower, looking east. 8 August 2017.

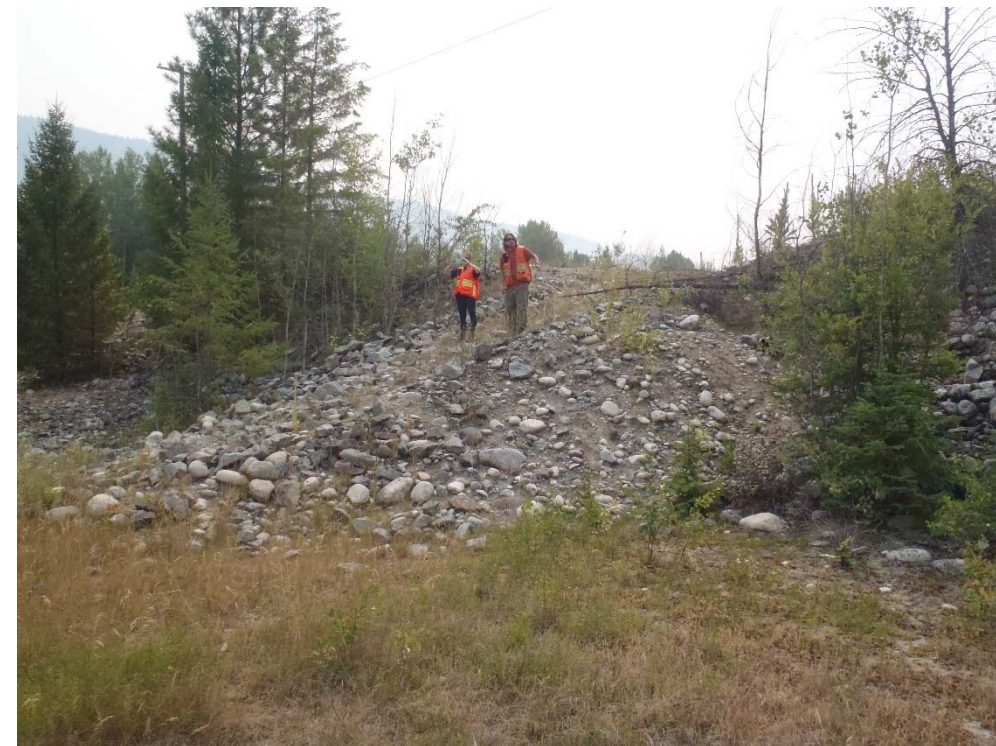
Photograph 23: South TSF, spillway between Cell 4 and Cell 3, looking south. 8 August 2017.

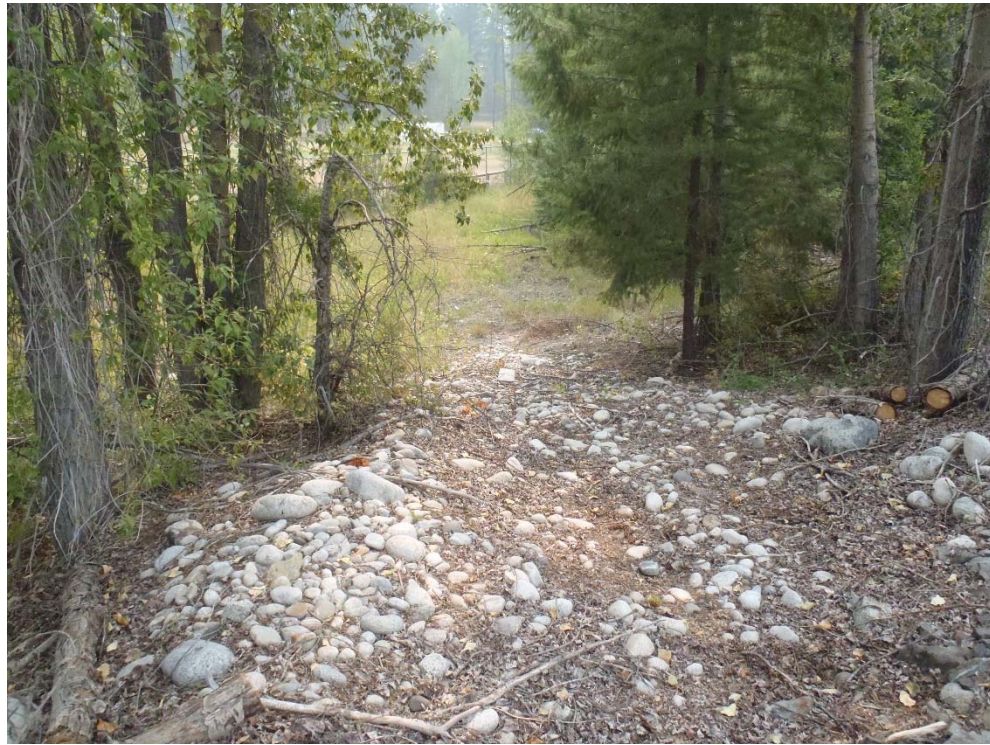
Dimensions of the various spillways through the cells have been determined based on observations made during site inspections. The spillway through the Cell 3/4 divider dike has a bottom width of 3 m, a height of 1 m above the tailings at Cell 4, and lateral slopes of 2H:1V. It is trapezoidal in shape, partially riprap-armoured, and allows the conveyance of surface water from Cell 4 to Cell 3 (Photographs 22 and 23, Appendix A). The small, partially riprap-armoured spillway through the Cell 4/5 divider dike has a bottom width of 1 m and lateral slopes of about 1.5H:1V and allows conveyance of surface water from Cell 5 to Cell 4 (Photographs 16 and 17, Appendix A). There is a spillway exiting Cell 3 (Teck Cominco 2004), but the dimensions for this outlet are unknown. The current status of the Cell 3 spillway is shown in Photographs 27 and 28, Appendix A. There are no construction as-builts for these spillways. Plans are in place to upgrade the capacity of the Cell 3 spillway in 2018.

Photograph 27: South TSF, Cell 3, spillway from Cell 3 crest, looking east from crest. 8 August 2017.

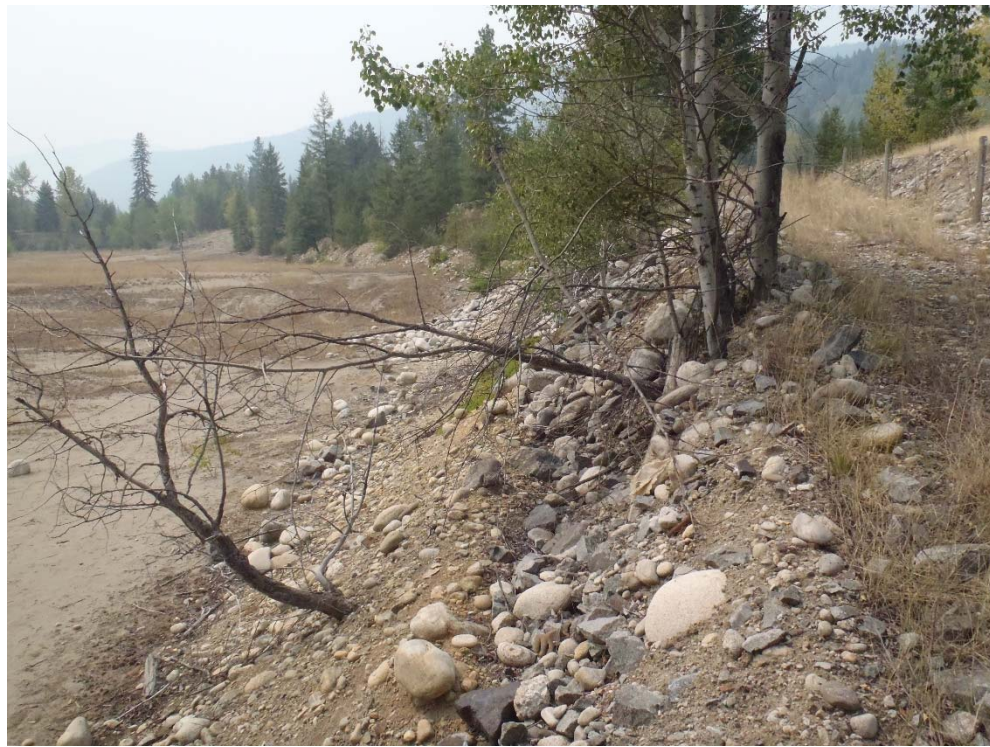
Some dead trees were observed on the west side of Cell 3's upstream slope (Photograph 31, Appendix A). The dead trees are not considered to be a significant risk to the stability of the facility, but should be removed.

Photograph 31: South TSF, Cell 3, west side of facility upstream slope, looking southwest. 8 August 2017.

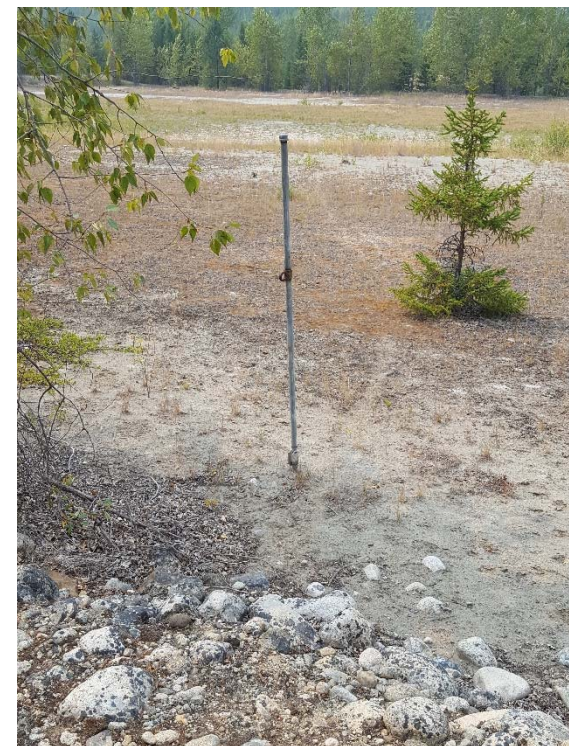
Photograph 36: North TSF, Cell 6, tailings surface and standpipe piezometer 6-3 (not functional), looking west. 8 August 2017.

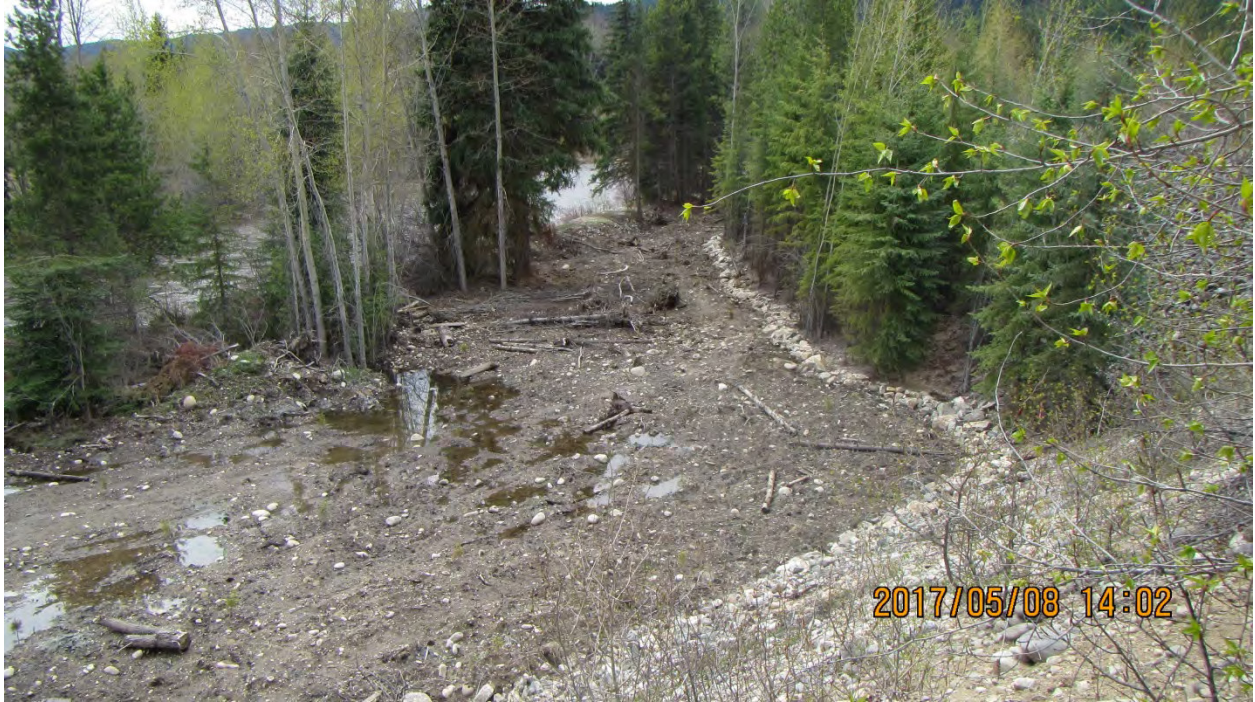
The ponded water just to the east of cell 5 migrated through the sand and gravel material in the berm between the WKR and Cell 5 (photo 4). This area was riprapped in the distant past and in some sections the riprap is deteriorated or missing. There is evidence of deterioration of the riverbank in two locations on west side of the WKR near cell 5 (photos 1 & 2). Once this water reached the top of this low area it flowed south through the area we used to construct the new riprap system in 2016. The flow did not disturb the newly planted trees or old wooden debris we add to this area. There was no indication of an outflow to this water; it's believed to have drained into the sand gravel layer. During the excavation for the riprap installation in 2016 we encountered water in the sand and gravel layers at the same elevation as the WKR.

Photo 5
Exposed riprap along cell 5

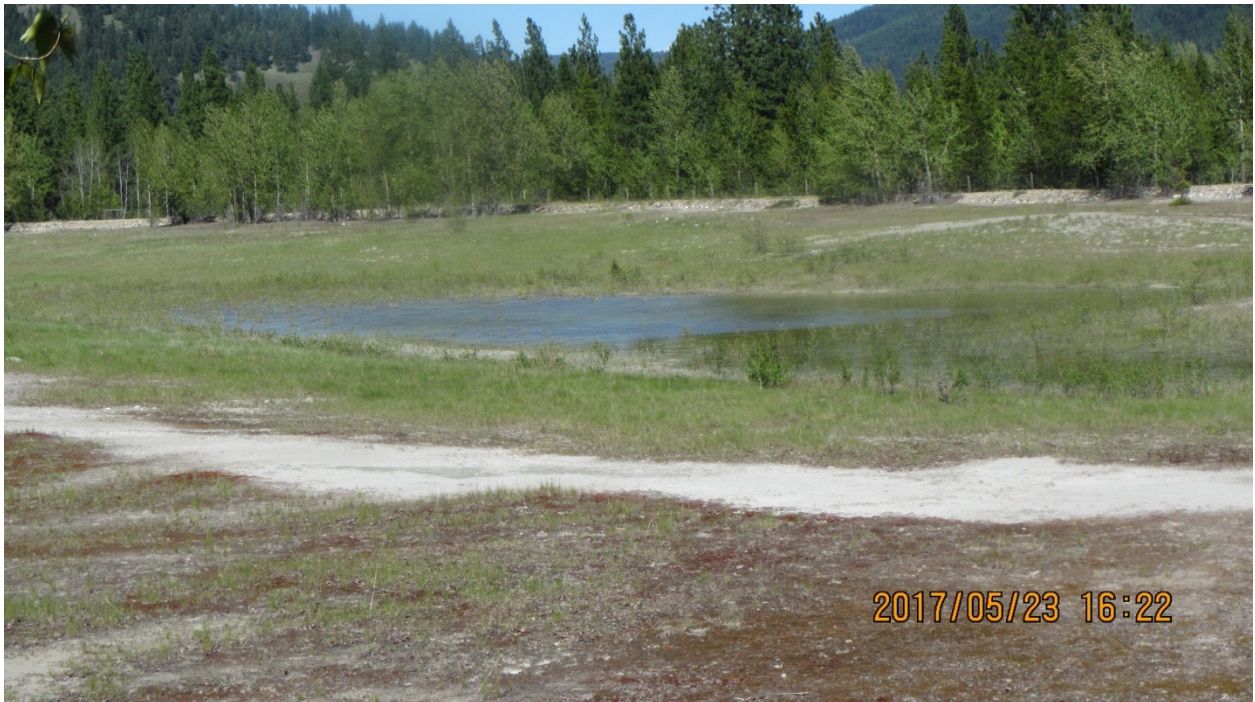
Decant Outlet Cell 7

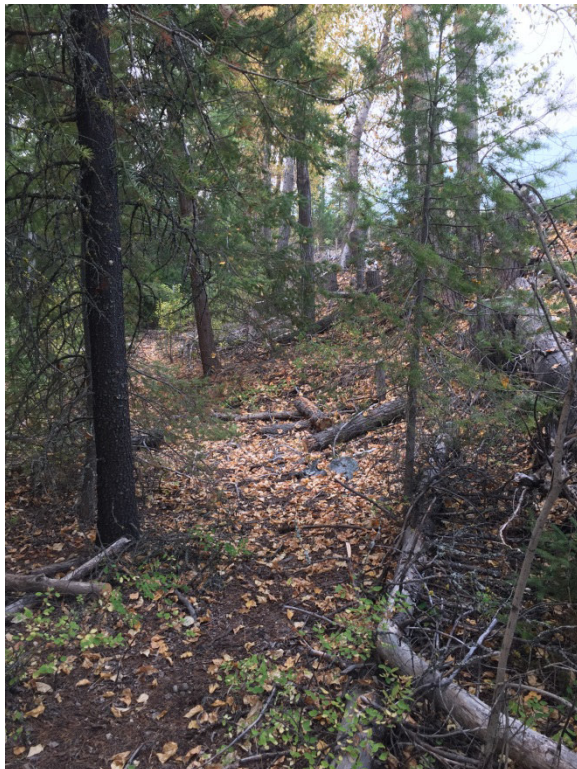
Animal Burrow in Cell 3 Dike Filled In

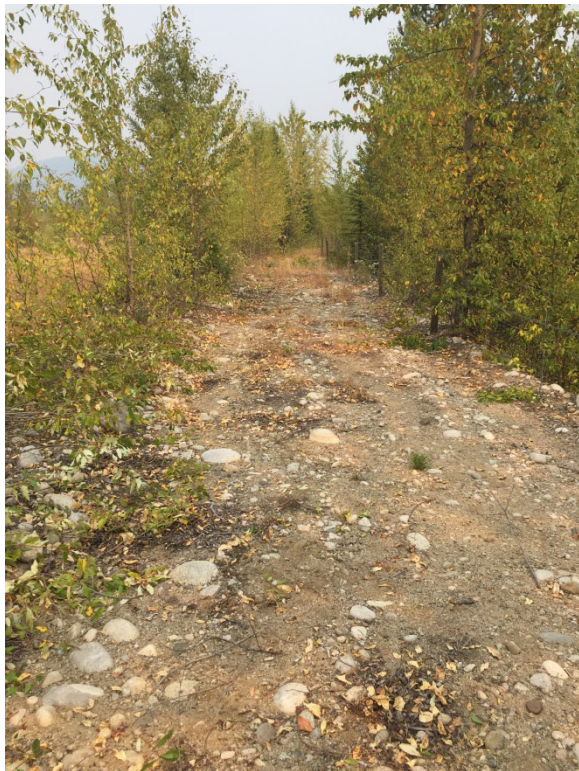
Vegetation on Cell 5 Dike

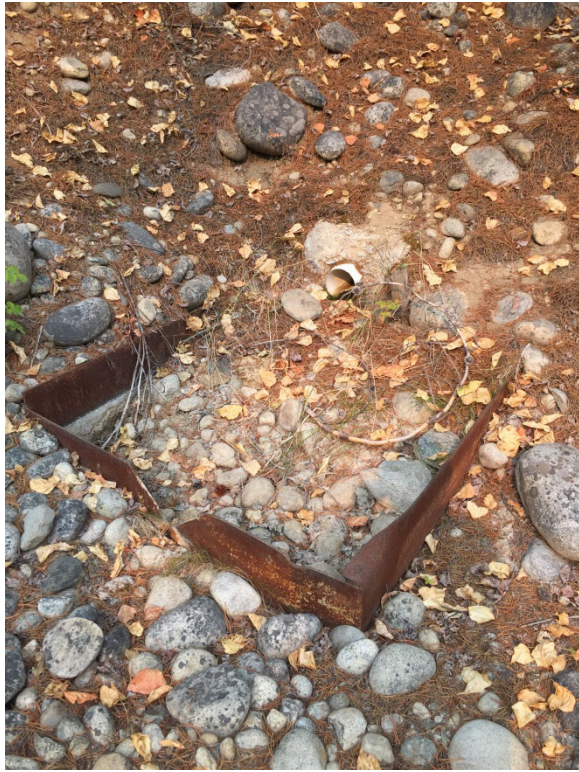
ANIMAL DEN BESIDE DECANT INTAKE IN POND 7

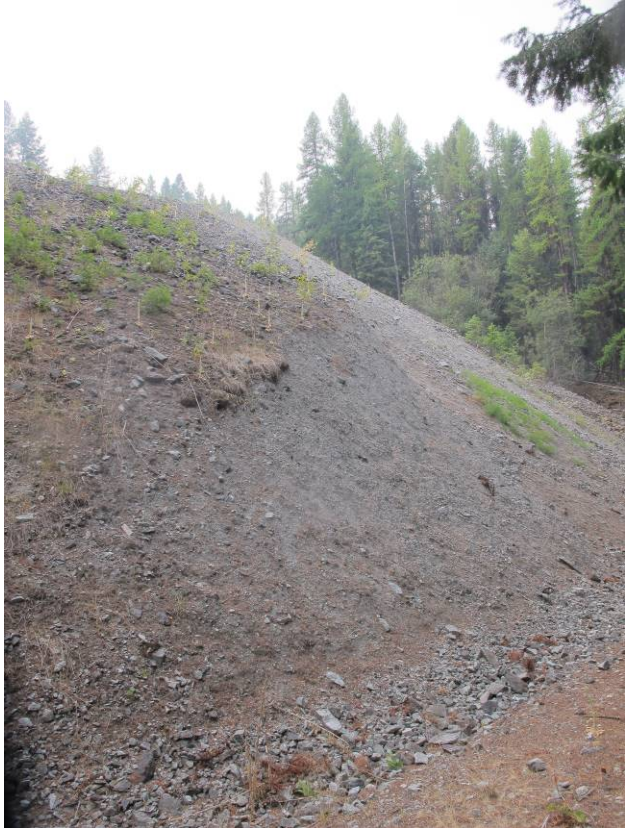
In comparison to the major dumps, Photo 5 shows a typical waste rock dump that is associated with an adit that ‘chased’ a surface exposure. The height was approximately 20 m high and was end dumped from an old mine entrance. The waste rock dumps pose a risk as the construction methods of the dump and volume of the dump is unknown. In addition, waste rock dumps at the main portal sites are within a mountain drainage and erosion of the waste rock dumps were noted (shown in Photo 6).

Photo 5: Typical waste rock dump on property

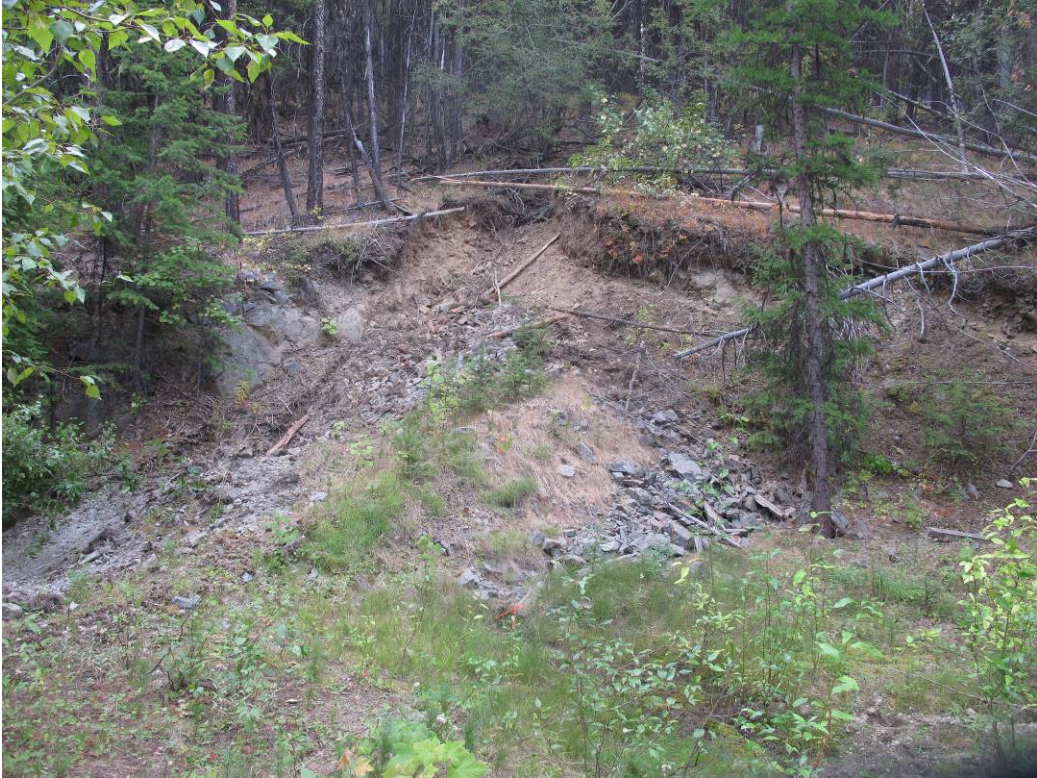
Numerous entries into the underground working exist. Discovery of old portals is through site reconnaissance by mine personnel. Where feasible, the portals are backfilled and the surface is recontoured. Photo 7 shows a recently completed backfilling of the portal. Mine personnel monitor the performance of portal closures and make necessary repairs (placing additional material on portal) to ensure portals are not accessible.

Photo 7: Completed backfill of mine adit

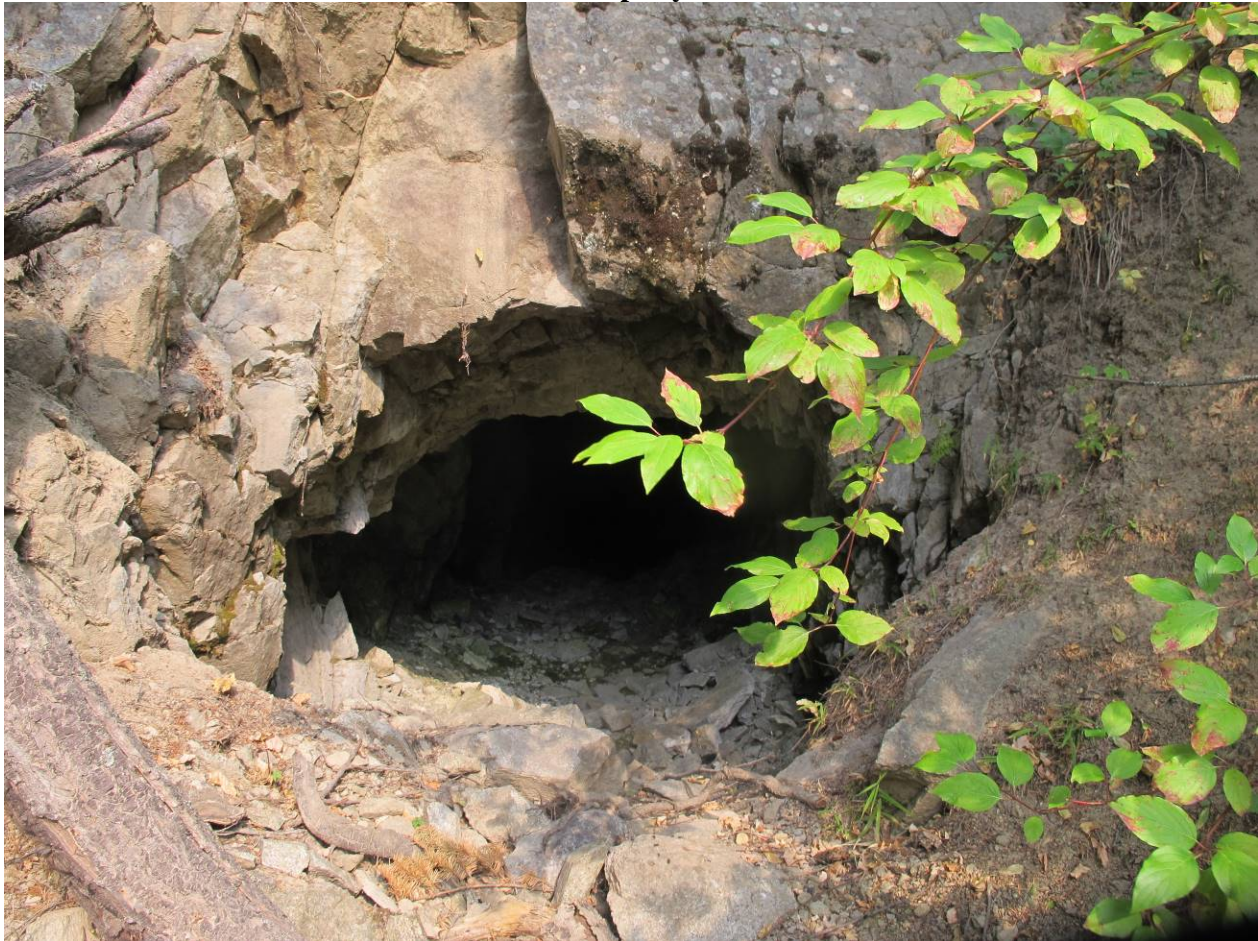
During the inspection, Teck representatives showed the Inspector two portals that are open to the public and no closure has been performed by the Mine Permit holder. Photo 8 and 9 show the

Photo 9: Abandoned adit providing access to underground workings outside of Beaverdell Mine Property
