# **2023 ANNUAL FACILITY PERFORMANCE REPORT - LOUVICOURT**

**TECK RESOURCES LTD.**

**WSP Canada Inc.**

CA0005174.2774 RA-Rev0-TSF Inspection 2023

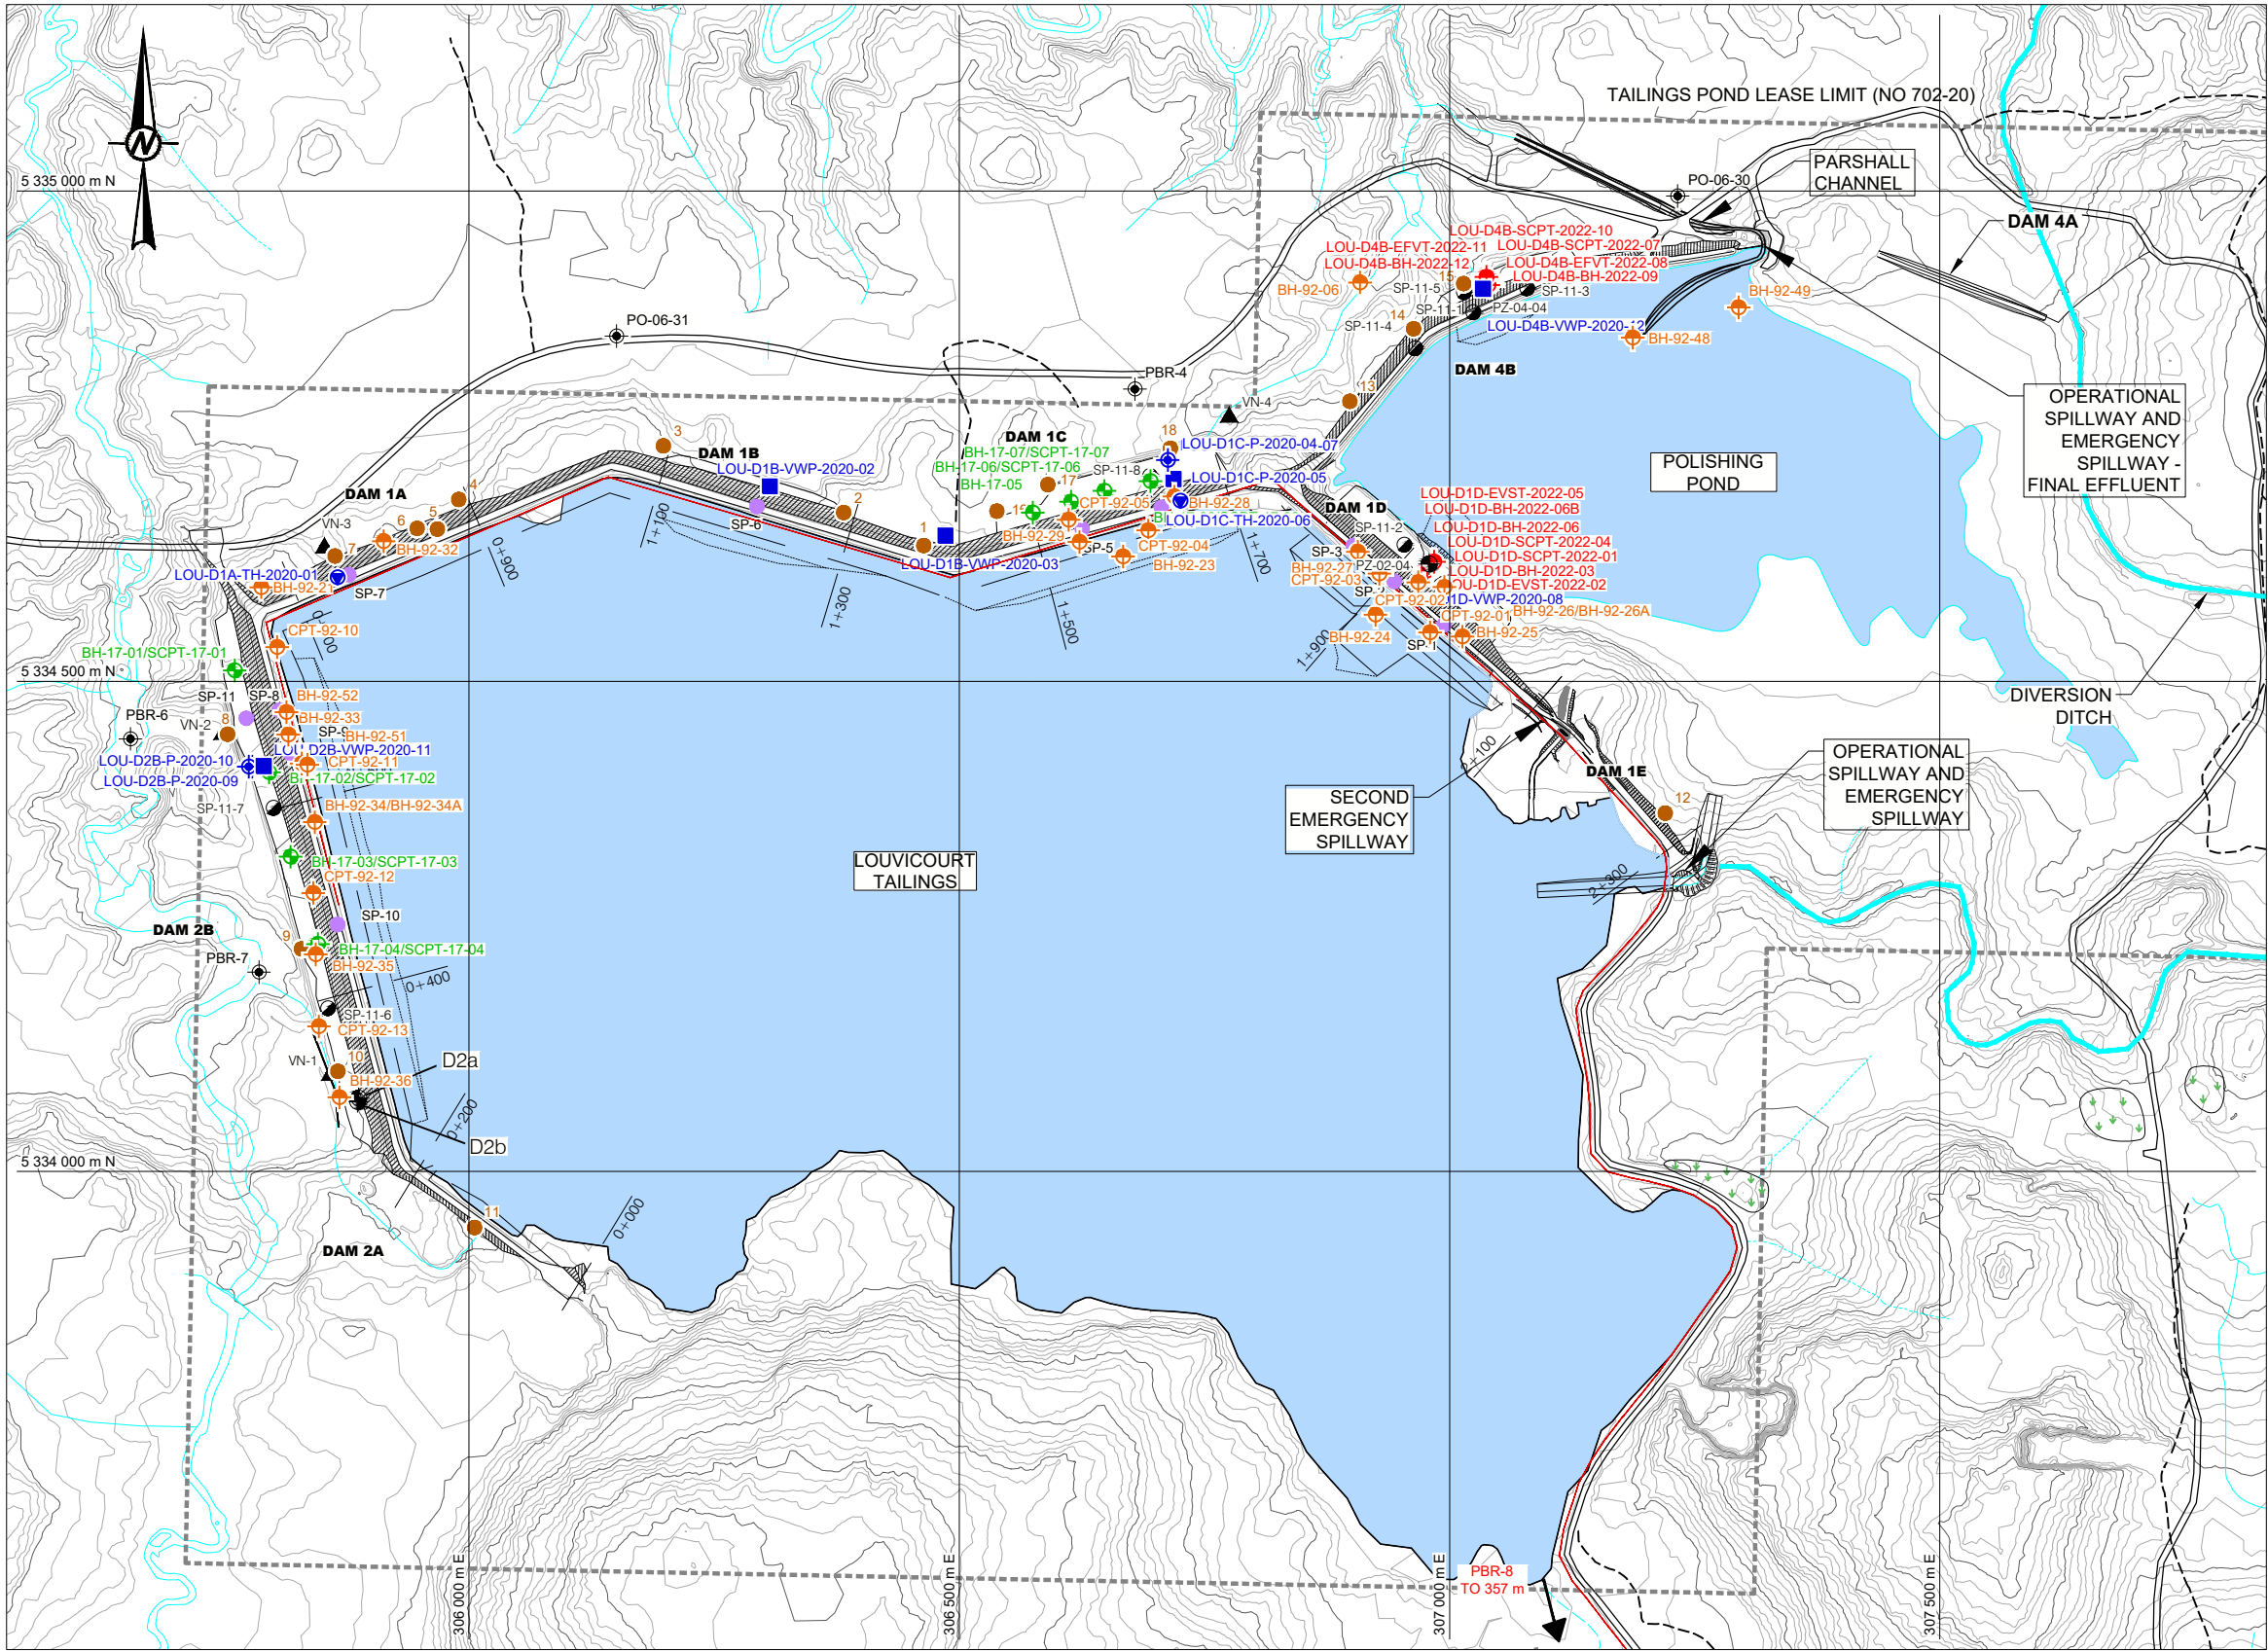
FIGURE  
1

- Ponding water was observed at the toe of Dams 1A to 1E generally at the same locations as last year. Ponded water with little to no observable flow was visible near the toe of Dams 1A to 1C and 2B (Photograph 3). Seepage volumes did not appear significantly different than that under typical conditions; however, disturbance from tree removal equipment during 2022 has resulted in some ponding areas that were not readily visible in the past (Photographs 4 and 5). The locations of current and historic seepage points are presented on Figure 1.

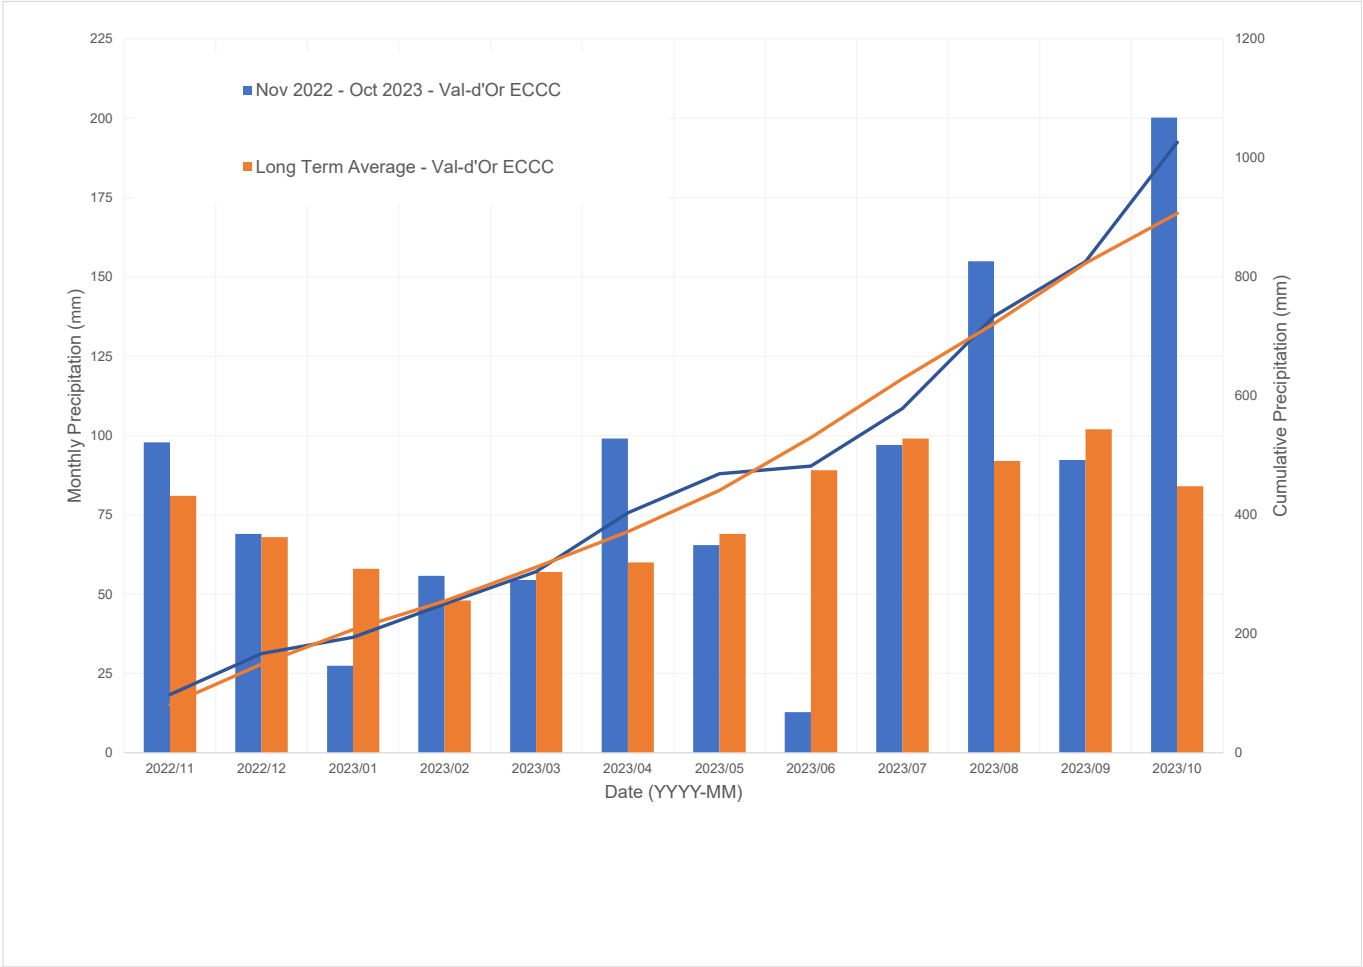
Figure 3: Monthly Precipitation Data from November 2022 to October 2023

Table 2 and Figure 3 summarize the Val-d'Or total monthly precipitation data over the period from November 1, 2022, to October 31, 2023. The data originates from the Environment and Climate Change Canada climate stations (Table 1), which are located about 15 km from the mine site. The available data from the stations presented in Table 1 were combined to form a continuous-time series over the period 1951-2023, which was used for the precipitation analysis and water balance presented in this section.

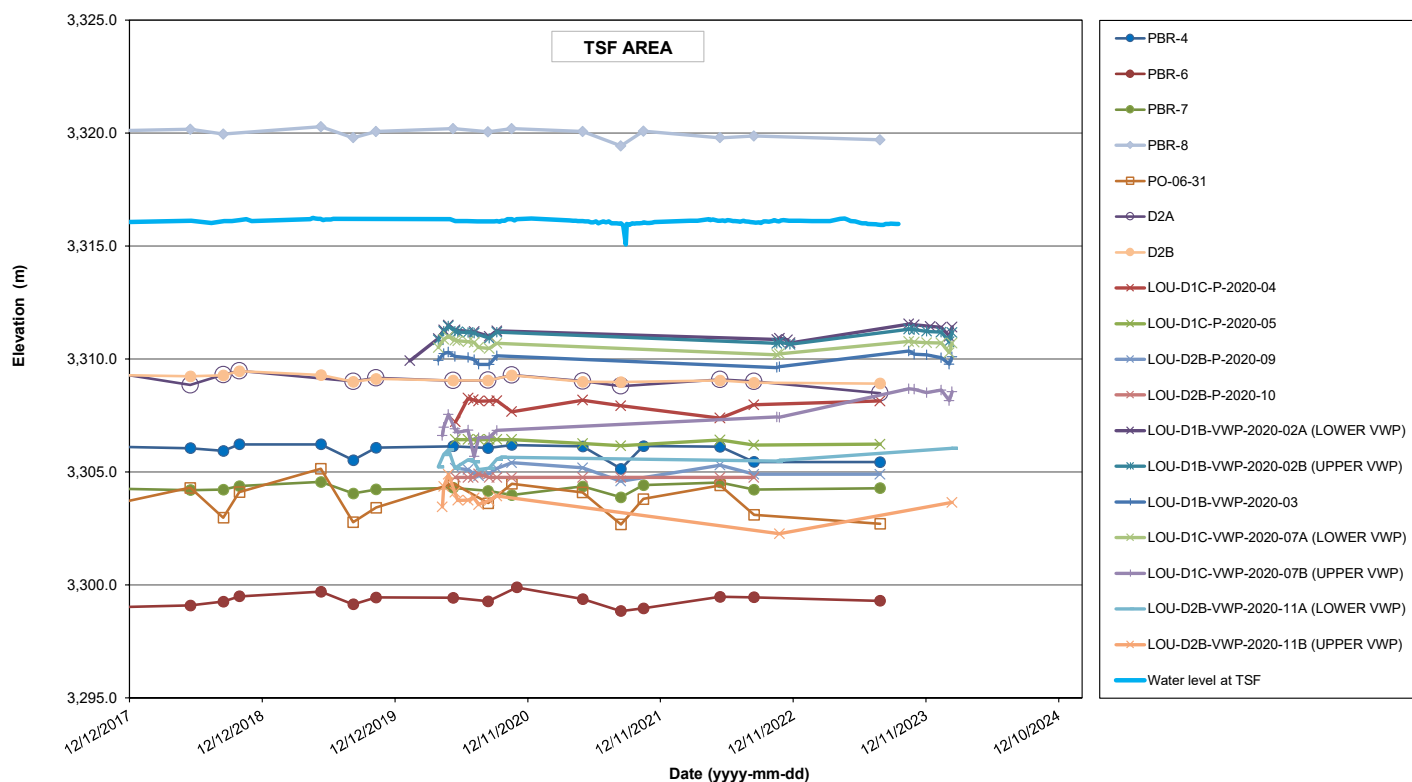
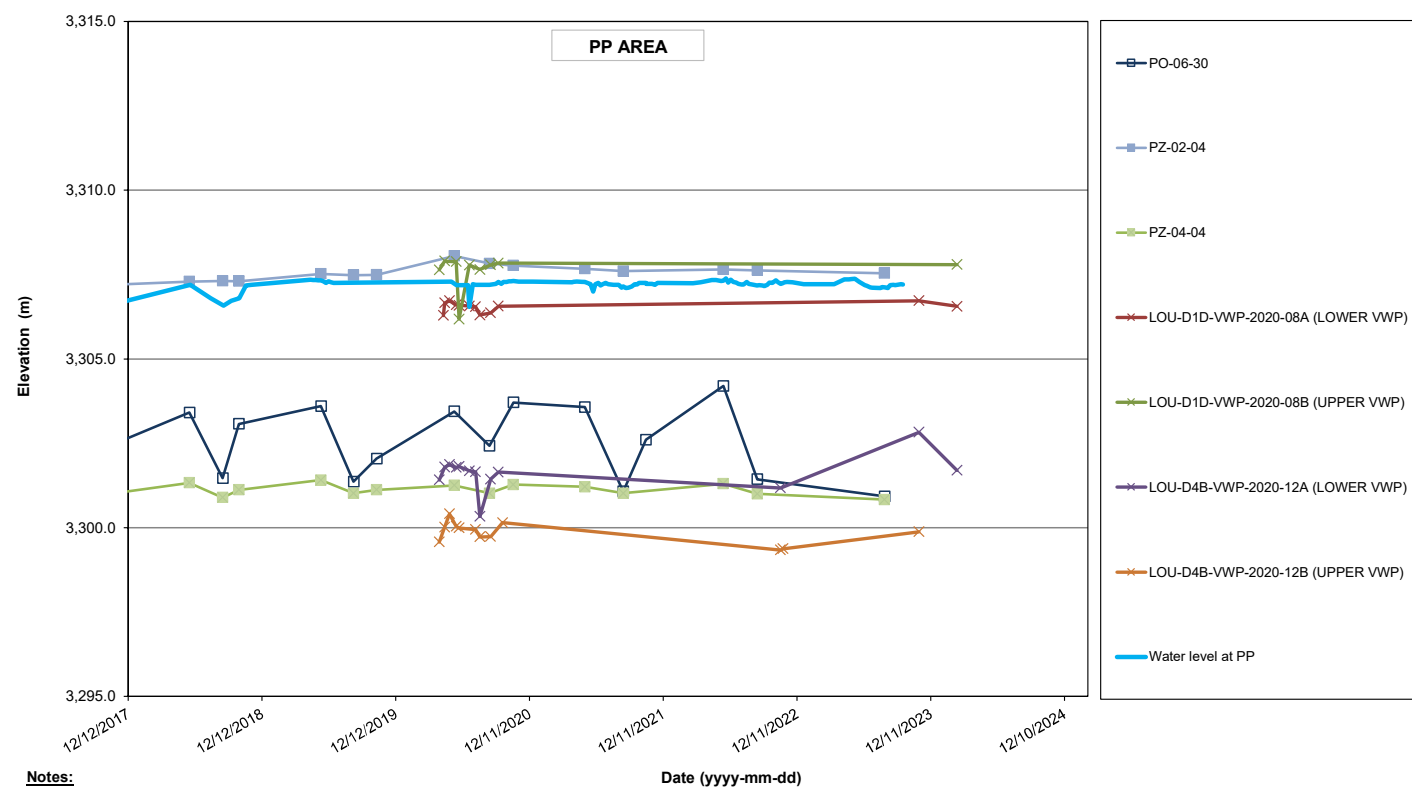
FIGURE 4

Figure 4 presents groundwater levels for the polishing pond and tailings facility embankments for a total of 8 standpipe piezometers and 11 vibrating wire piezometers installed on the berms of the three different embankments (1, 2 and 4). The vibrating wire piezometers installed in 2020 were grouted in place as described in the factual report (Golder 2023b), and any mention of manual readings indicates the use of a handheld wire connection.

Data for 2023 were provided by Teck (Figure 4) and include more frequent manual readings in late 2023. The values included in the WSP data review excluded remote telemetry data due to water-level inconsistencies and a lack of confidence. The reported values are manual reading, direct water levels of the open standpipes, or wire connection of the VWP. Recent values are quite stable for all standpipe piezometers and consistent with previous trends; historical trends for VWPs will be better defined in the coming years with more data collected. Certain instruments show variable readings in 2023, though the provided data includes manual readings that require validation. The data collection issues will be improved when the data acquisition system issues are resolved.

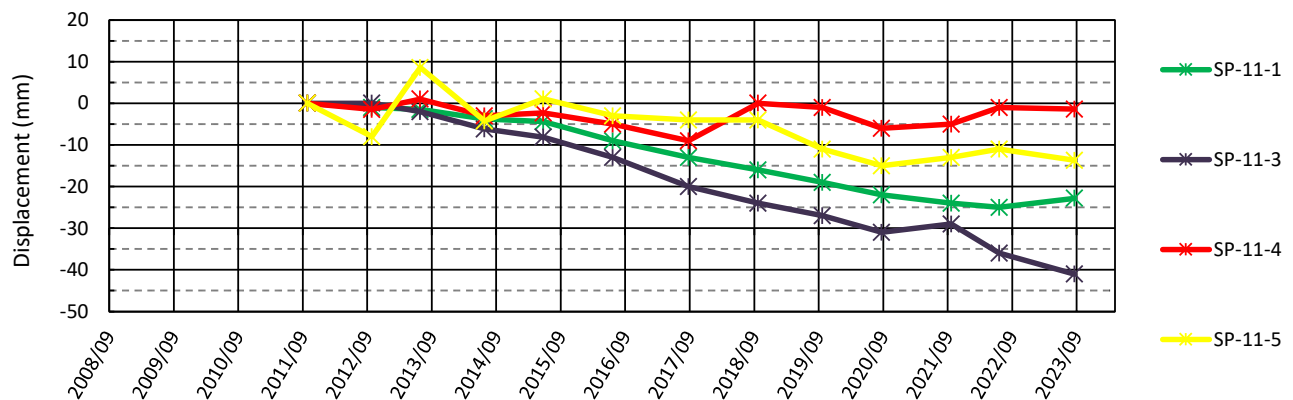
**Figure 7 : Vertical Displacement of the Survey Monuments at Dam 4**

Since the previous year, the vertical survey data of the 19 instruments on site shows that 14 monuments indicated minor vertical movements of  $\leq 1$  mm, 3 monuments had vertical movements  $> 1$  mm and  $\leq 3$  mm (the stated survey accuracy is 2 mm) and 2 monuments had vertical movements  $> 3$  mm and  $\leq 5$  mm. Here vertical movements indicate either positive (settlement), or negative (upward), to filter the movements that are below the survey stated precision of  $\pm 2$  mm. SP-11-3 and SP-11-5 at Dam 4B are the two instruments that show new settlement above the stated accuracy and require more careful monitoring for this period. All monuments show a total settlement since installation of 41 mm or less, although the survey data record suggests a pattern of continuing minor settlement in some instruments. To better assess the settlement data, plots of historical settlement have been prepared as Figures 5 to 7.
