# **Teck Coal Limited**

## **Quintette Coal Operations**

### ***2017 Dam Safety Inspection***

### ***Shikano North Tailings Dam***

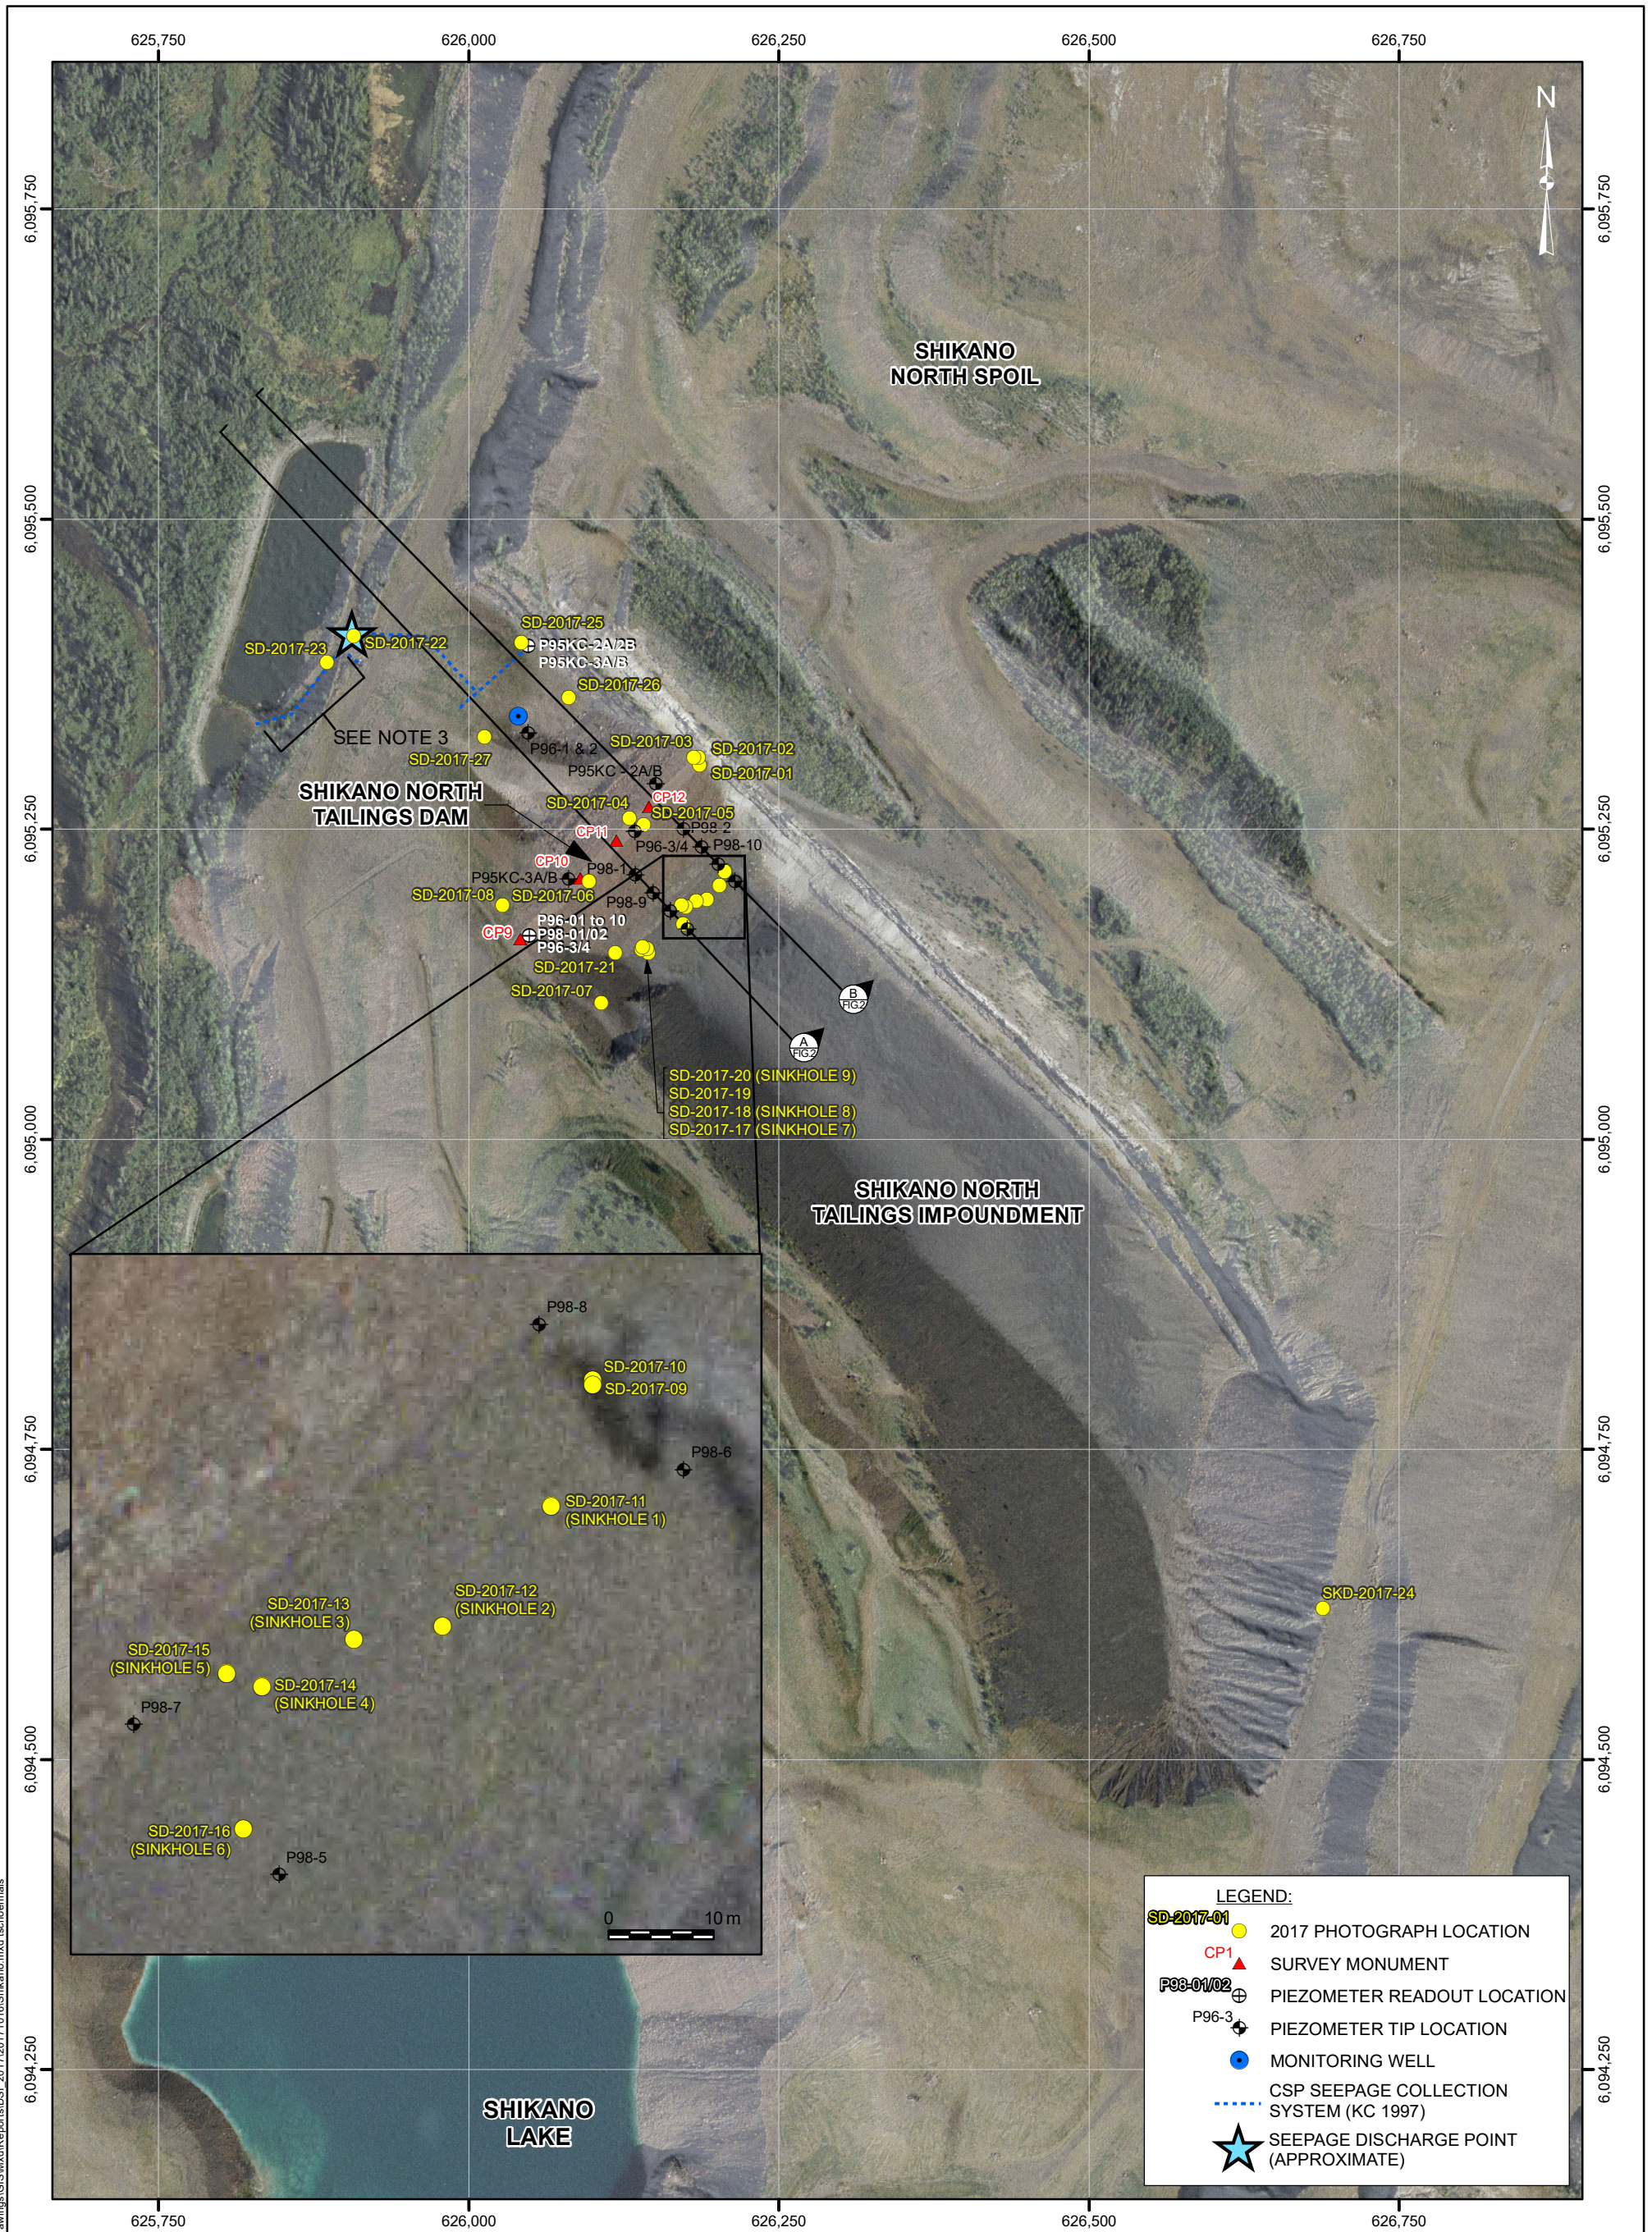
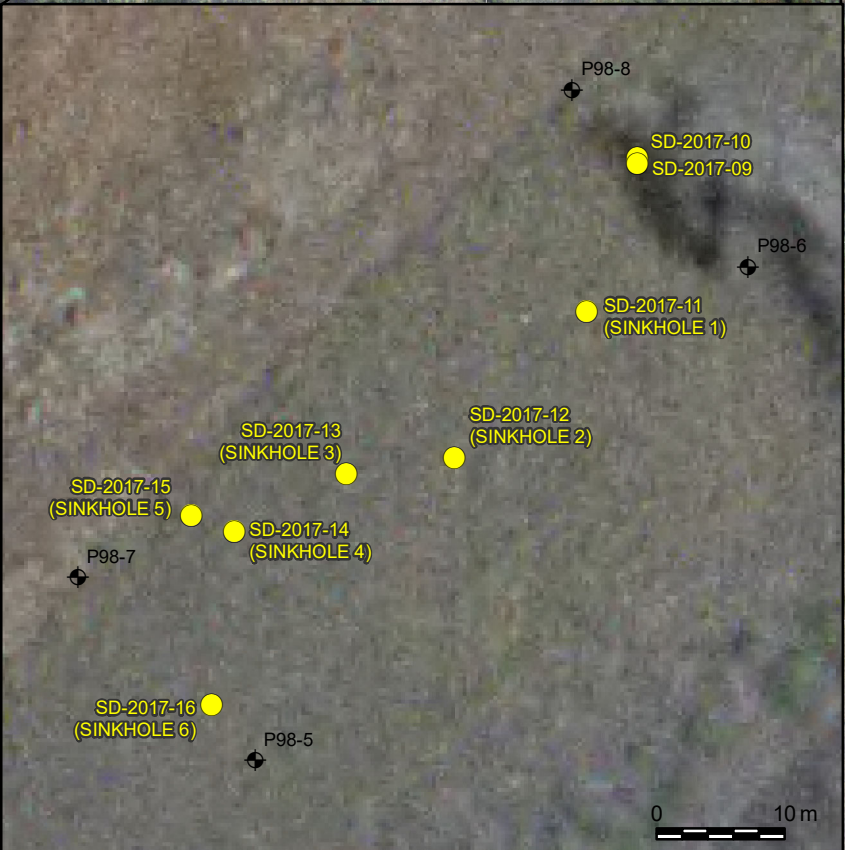
- **Sinkhole Depressions in Tailings Beach (refer for Figure 1 and Photo I-7 for sinkholes general location):** A cluster of sinkholes (Sinkhole 6) were observed on the tailings beach (Photo I-20). The largest of the sinkholes is approximately 7 m by 3.5 m and 2 m deep. These features have been noted since the 2010 DSI but when they started to form is not known. There was a notable increase in size between the 2012 and 2013, and between 2016 and 2017 DSIs but a less significant increase noted between 2014 and 2016. Sinkholes 2 and 3 were observed in 2015 in the tailings beach, which also appears to have slightly increased in size in 2017 (Photos I-16 and I-17). Sinkholes 1 and 9 were observed in 2016 in the tailings beach and only Sinkhole 1 appears to have slightly increased in size in 2017 (Photos I-15 and I-26). Sinkholes 4, 5, 7 and 8 were first observed during the 2017 inspection (Photo I-18, Photos I-19, I-24, and I-25). The cause of these features is most likely the migration of tailings into the upstream coarse rockfill shell and "windows" of high permeability gravel (Figure 2) which are upstream of the filters. Sinkholes are considered a local condition. A sinkhole monitoring program should be established and conducted in conjunction with the routine visual inspections at the SNTD. The sinkholes should be shown on a drawing for future reference.

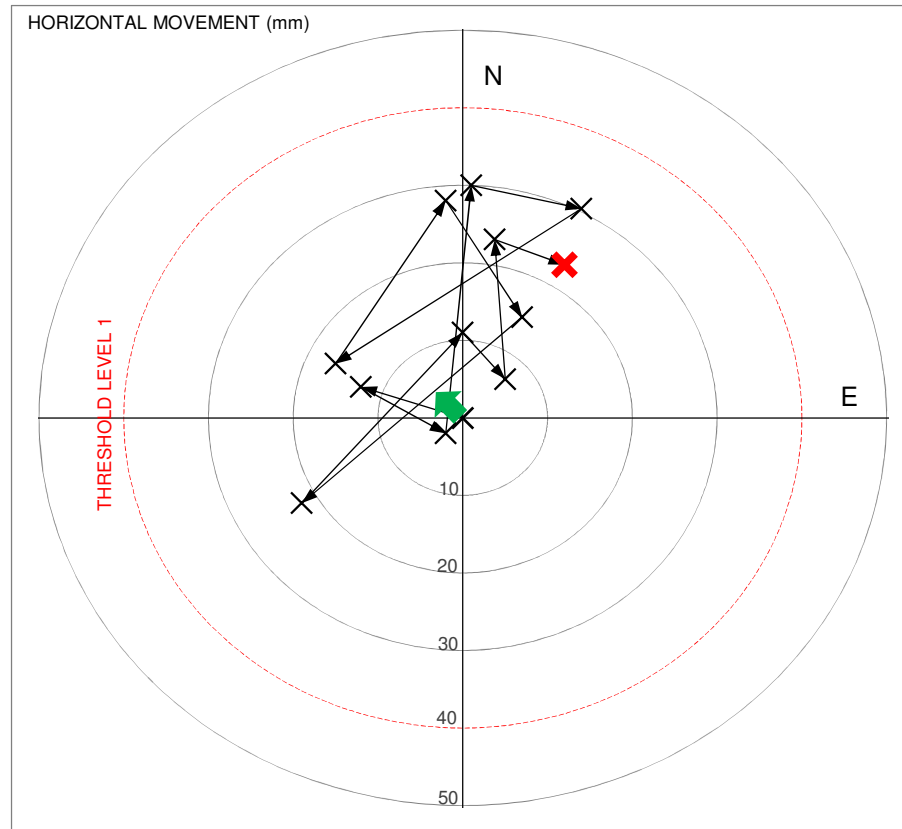
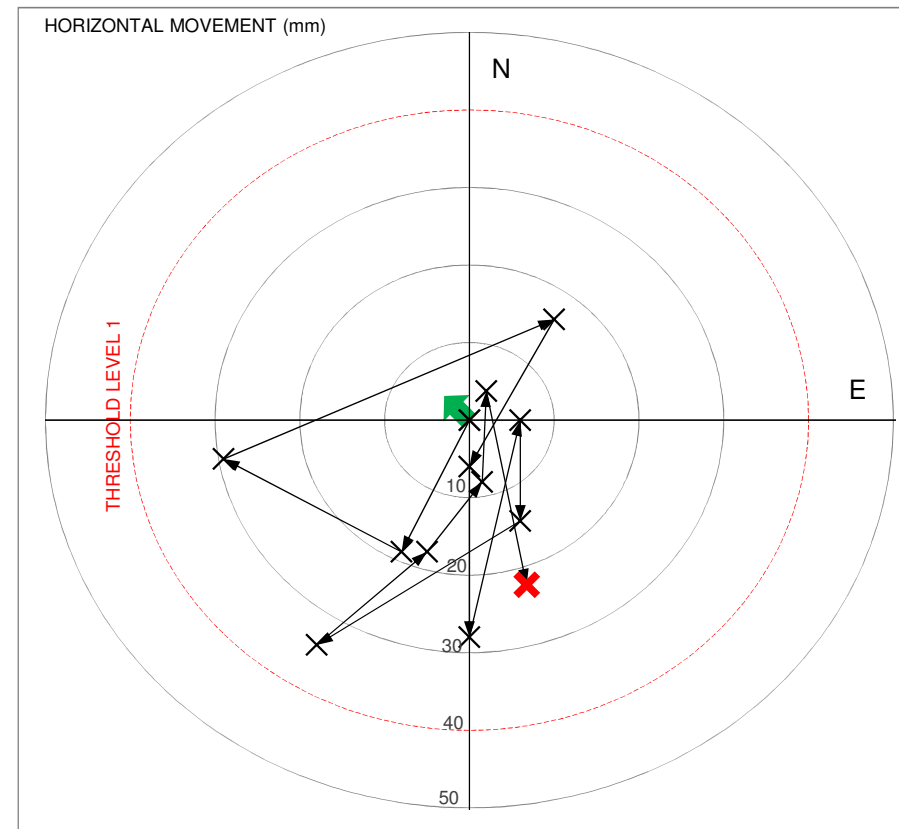
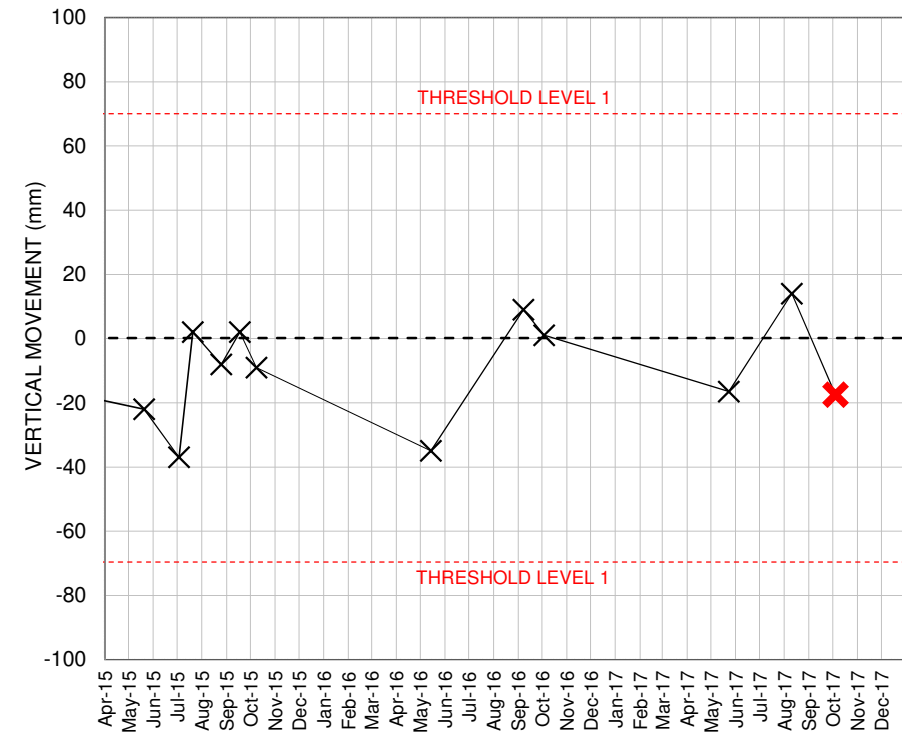
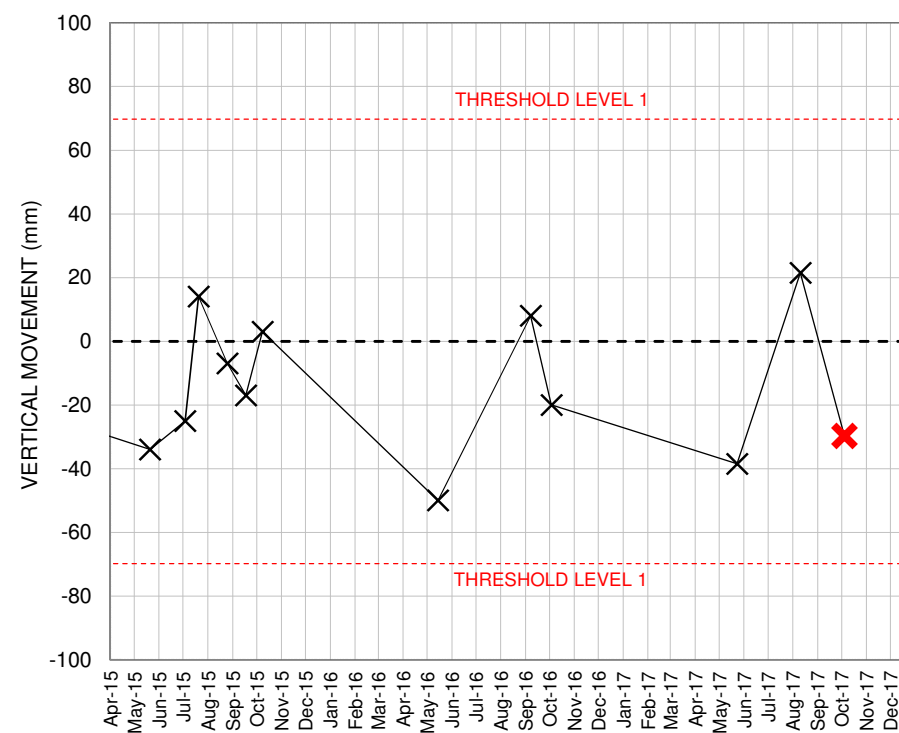
<table><tr> <td style="padding: 2px;"><small>PROJECT</small></td> <td style="padding: 2px;">QUINTETTE COAL OPERATIONS 2017 DAM SAFETY INSPECTION</td> </tr><tr> <td style="padding: 2px;"><small>FIG. No.</small></td> <td style="padding: 2px;">3</td> </tr></table>

A comparison of the October 2016 measurements to the 2017 monitoring records are also summarized in Figure 3. The 2017 surveys were completed using the same method as 2016, using a GPS base station with portable rod mounted survey device and the same operator completed the surveys. The observed movements between readings in 2017 are plotted on Figures 4 and 5.

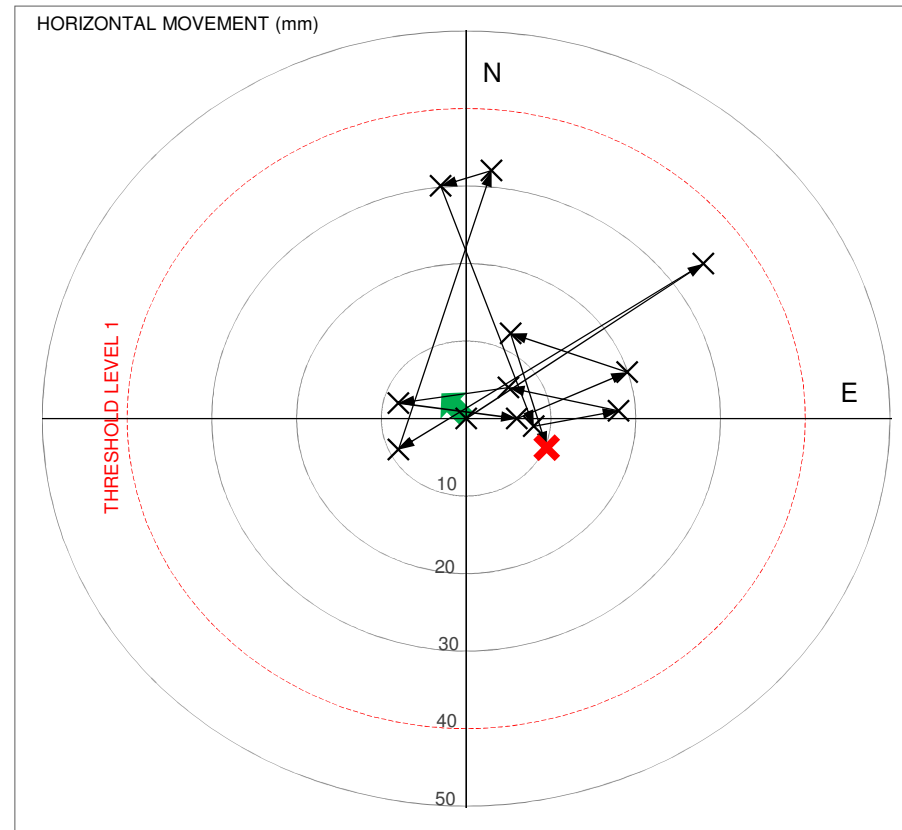
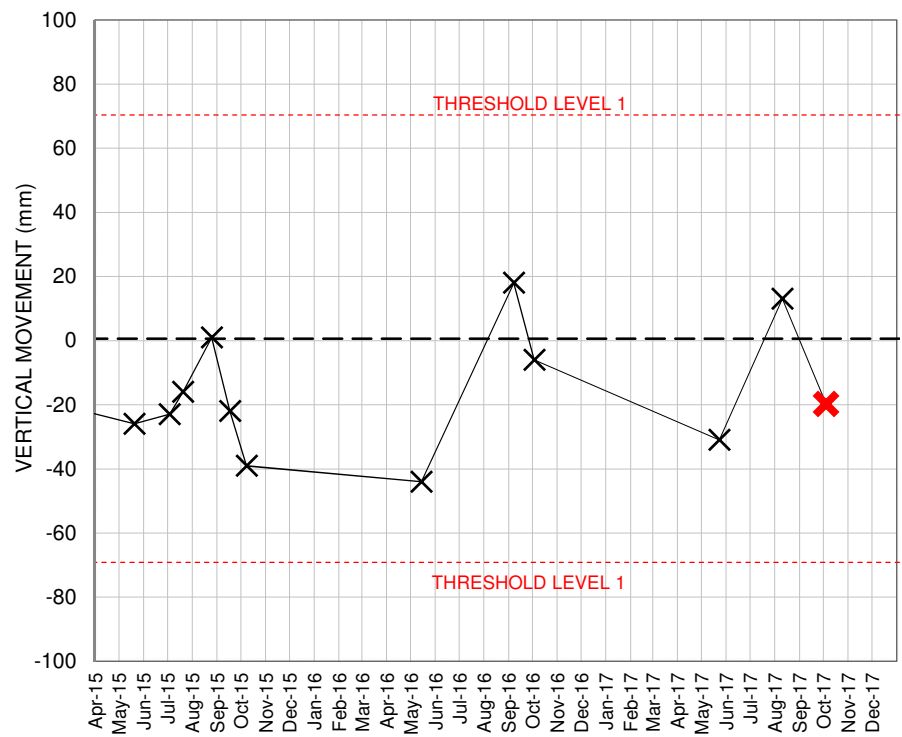
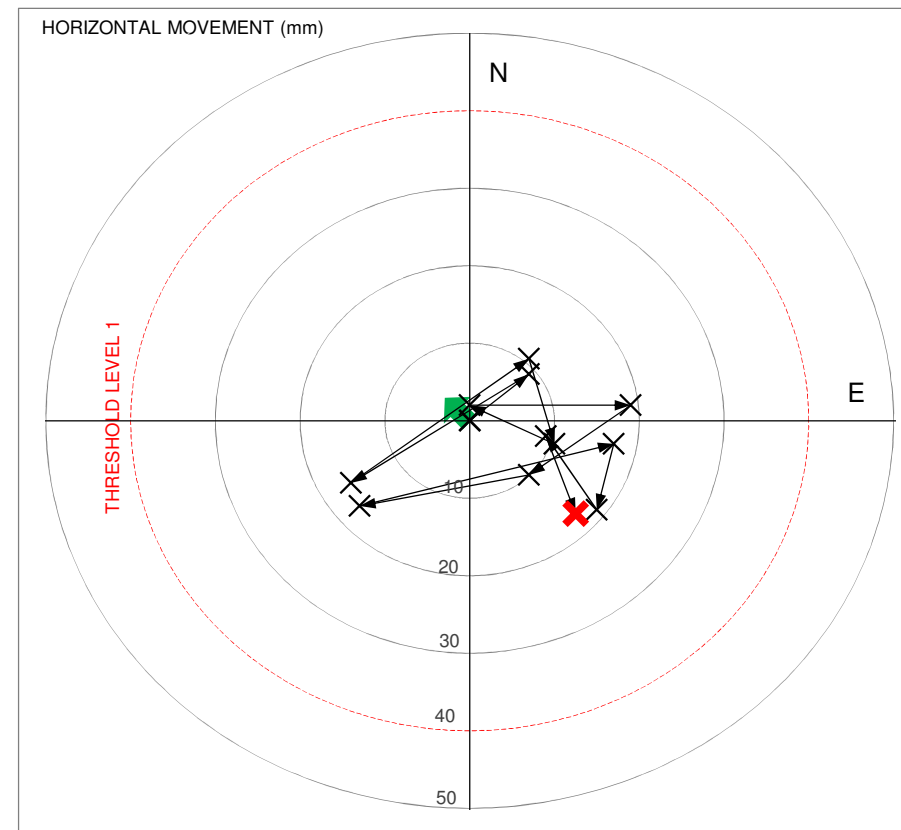
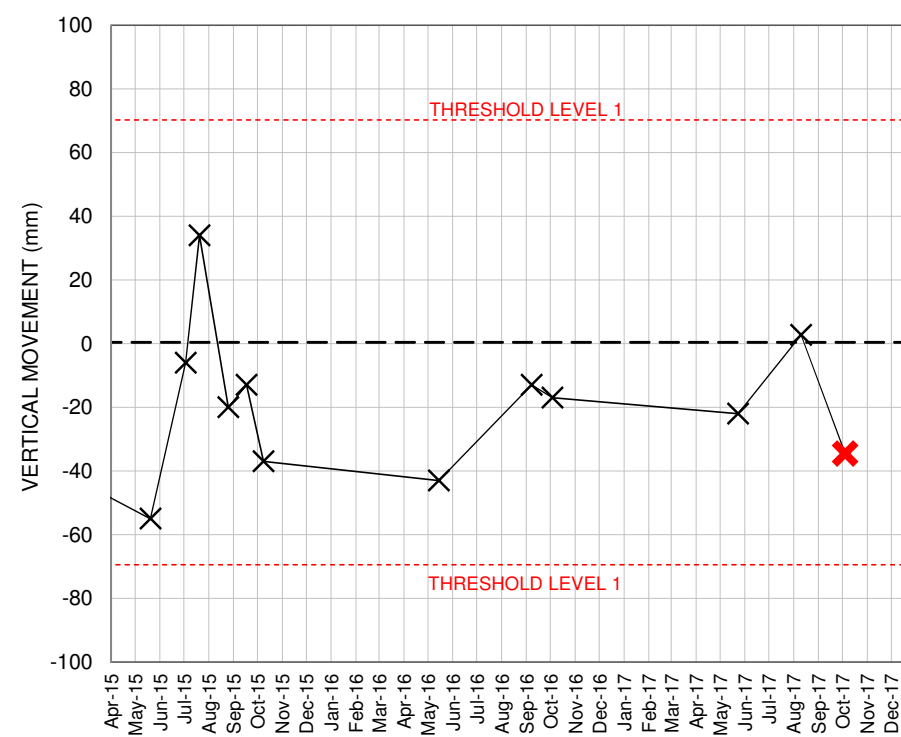
From a review of the available data since 2014, none of the monuments indicates a trend in the downstream direction or significant crest settlement. There was no exceedance of thresholds during 2017 (Figures 4 and 5). Therefore, KCB recommend the survey monuments reading frequency be reduced to once per year. The current OMS has been updated to include the recommended survey reading frequency.
