# **Teck Coal Limited**

## **Quintette Coal Operations**

### ***2017 Dam Safety Inspection***

### ***Plantsite Tailings Dam***

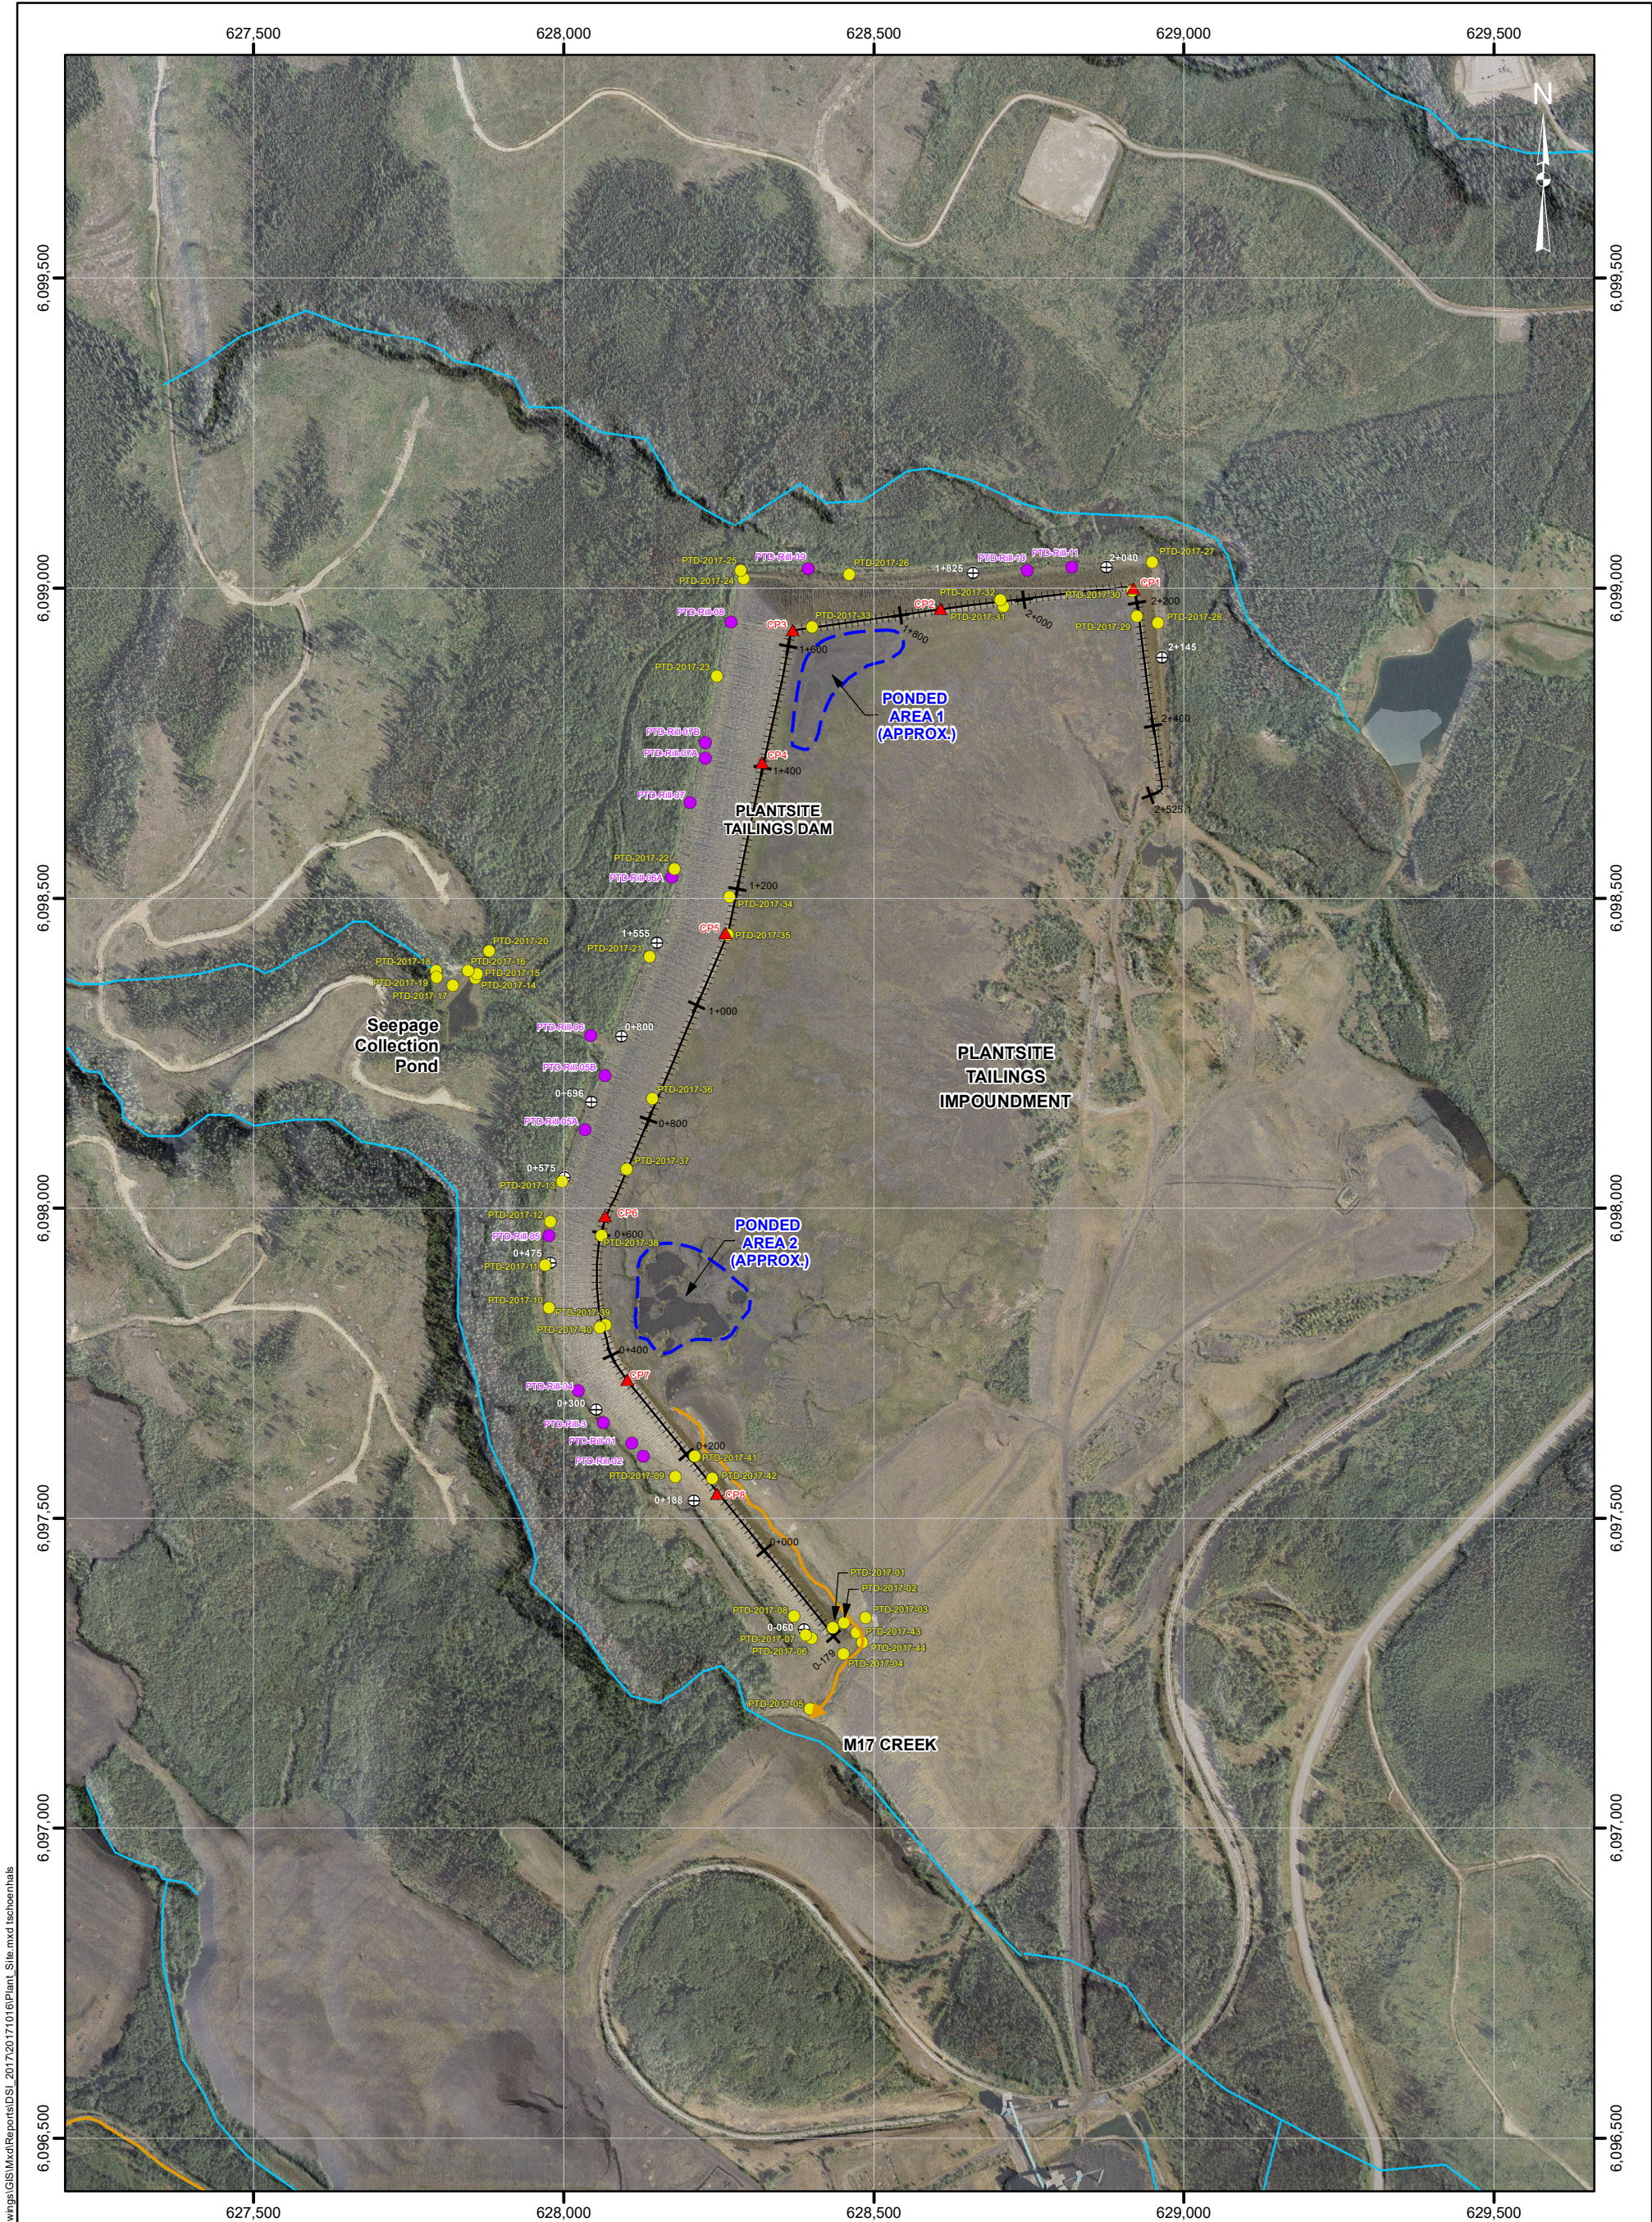
PROJECT	QUINTETTE COAL OPERATIONS 2017 DAM SAFETY INSPECTION	
TITLE	PLANTSITE TAILINGS DAM GENERAL ARRANGEMENT	
PROJECT No.	M09684A14	FIG No. 1

Instrumentation at PTD includes 32 pneumatic piezometers and 8 dam crest survey monuments to monitor dam movement and settlement. Locations of the piezometer readout locations and the survey monuments are shown in Figure 1.

The followings are the recommended freeboard QPOs based on ponded areas at the northwest corner of the impoundment (Ponded Area 1) (see Photo I-41 and Figure 1) and inside tailings depressions (Ponded Area 2) (see Photo I-48 and Figure 1):

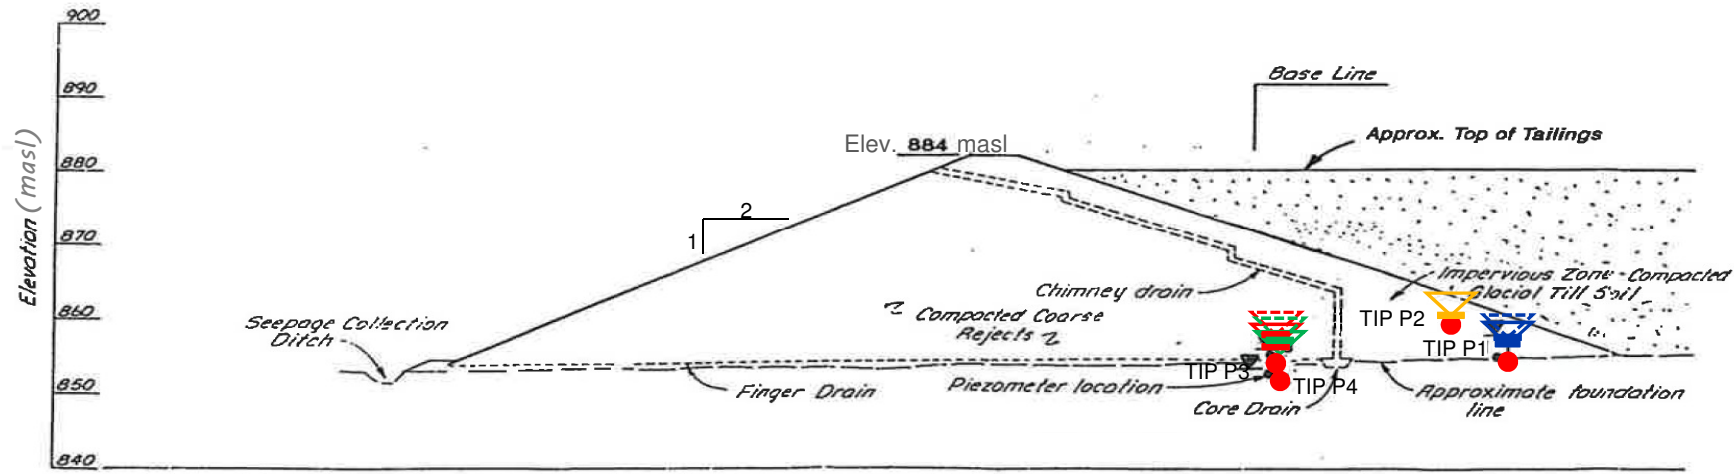
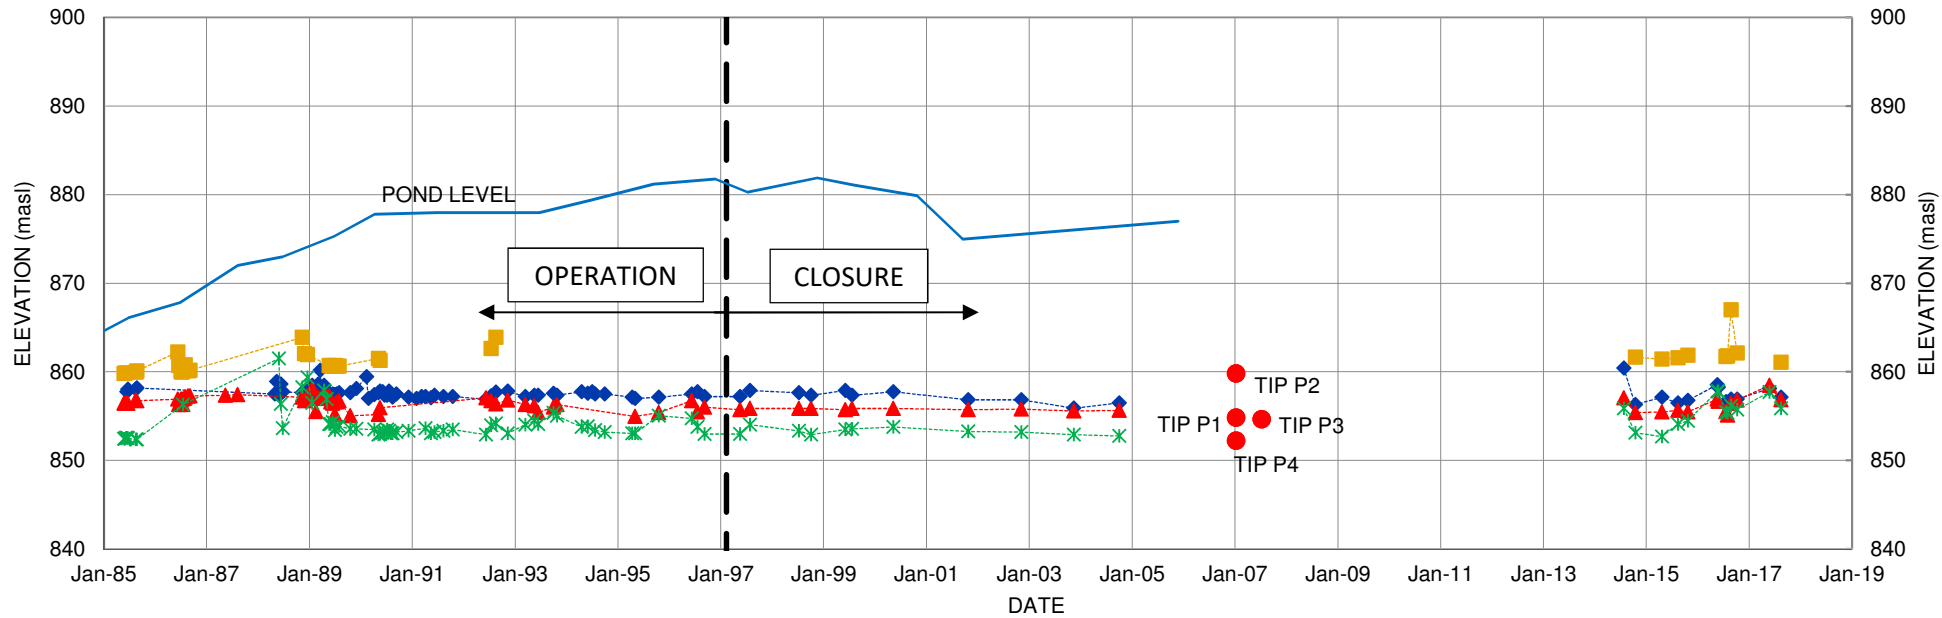
INSTRUMENTATION SECTION STA. 0+300 m

- Sta. 0+300, Sta. 0+475 and Sta. 0+575 are situated near ponded water (Figure 1), which would likely influence the readings and show elevated pore pressures in the warmer wetter months (May to September).

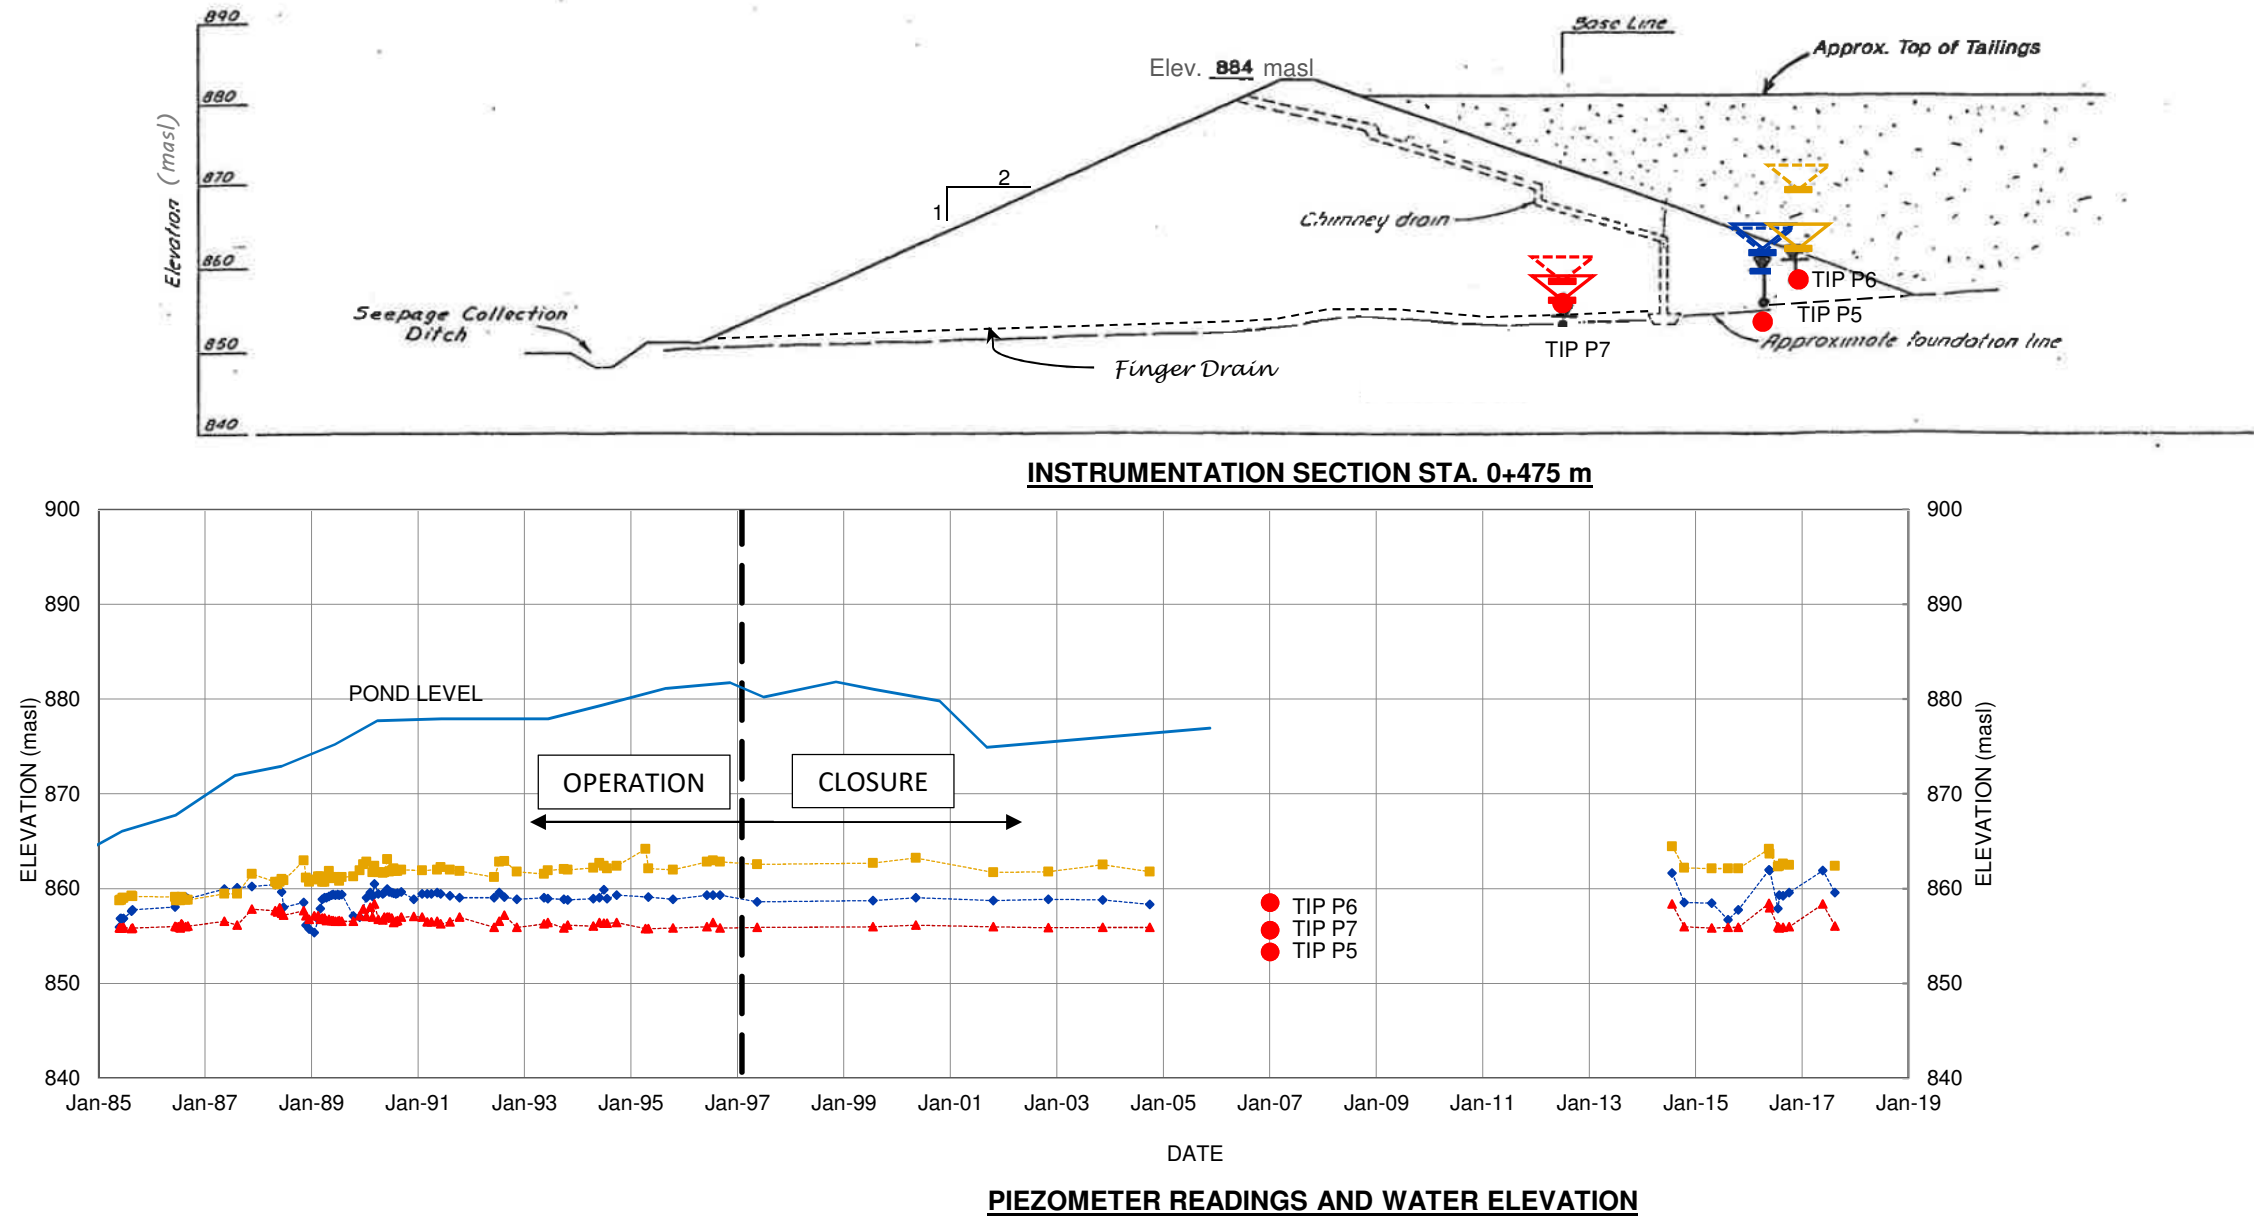
4

interface, upstream of the chimney drain. As a result, labels for P5 and P7 have been revised in Figure 4.

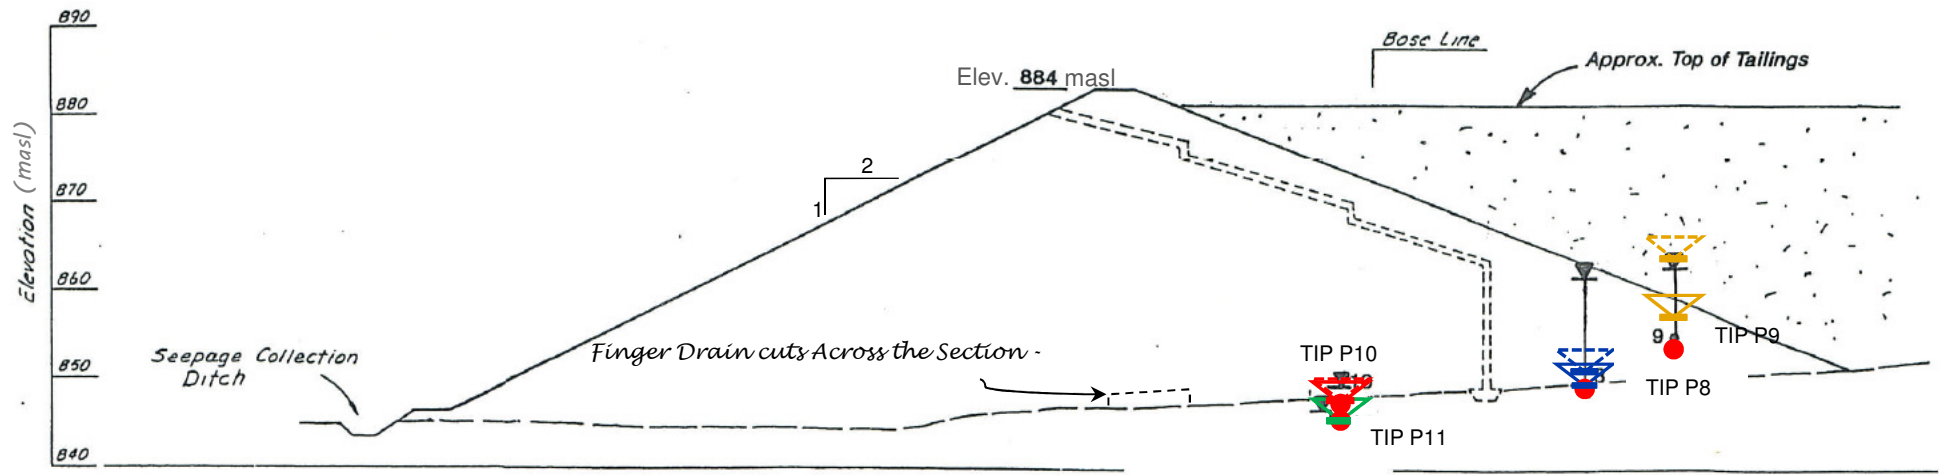
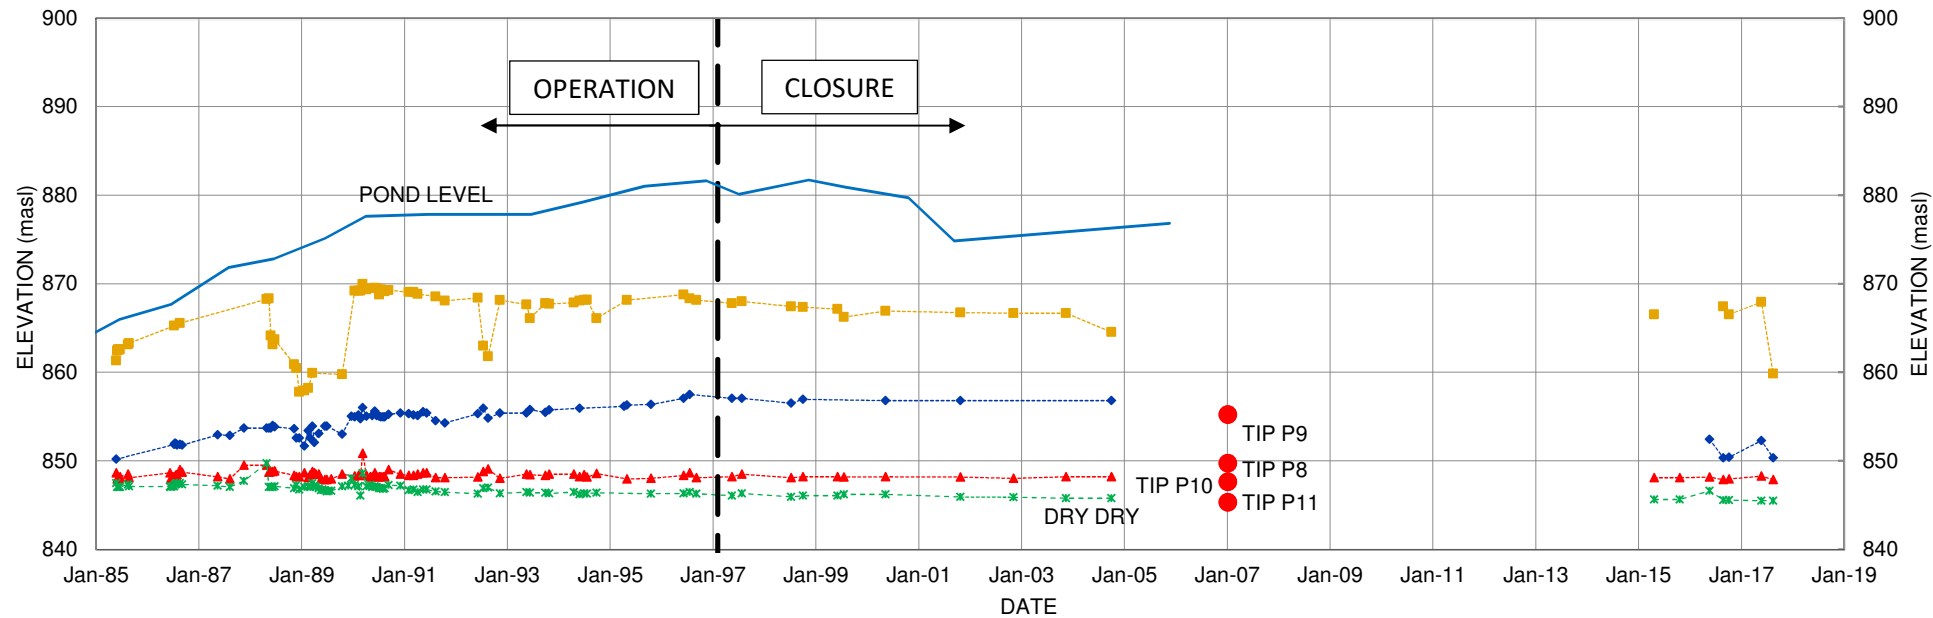
PROJECT		QUINTETTE COAL OPERATIONS 2017 DAM SAFETY INSPECTION	
TITLE		PLANTSITE TAILINGS DAM 2017 PIEZOMETER READINGS STA. 0+575 m	
PROJECT No.	M09684A14	FIG. No.	5

- **Sta. 0+575:** P8 and P9 instrument labels may have been switched in the field during relabeling of the instrument in 2015 (see KCB (2016c) Figure 6 instrumentation plot for reference). The observation was based on lower water level recorded in piezometers installed at the fill/foundation relative to water level measured in piezometers installed in the dam fill. Revised data and piezometer plots for P8 and P9 are shown in Figure 5.

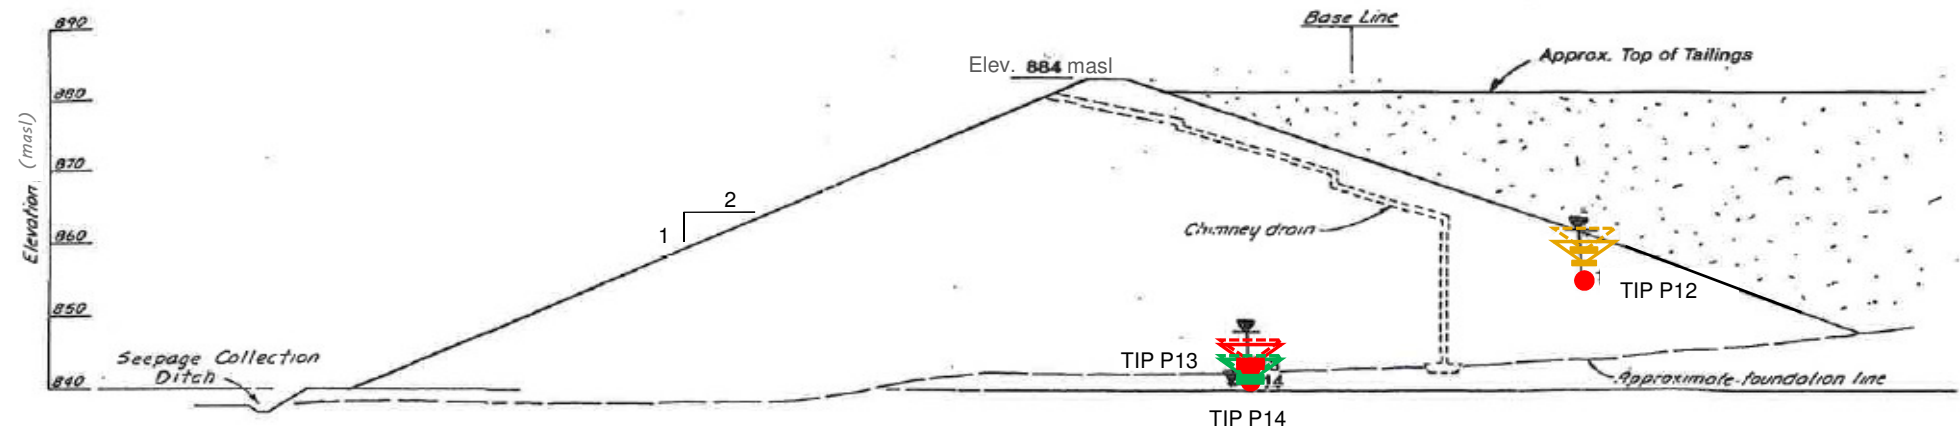
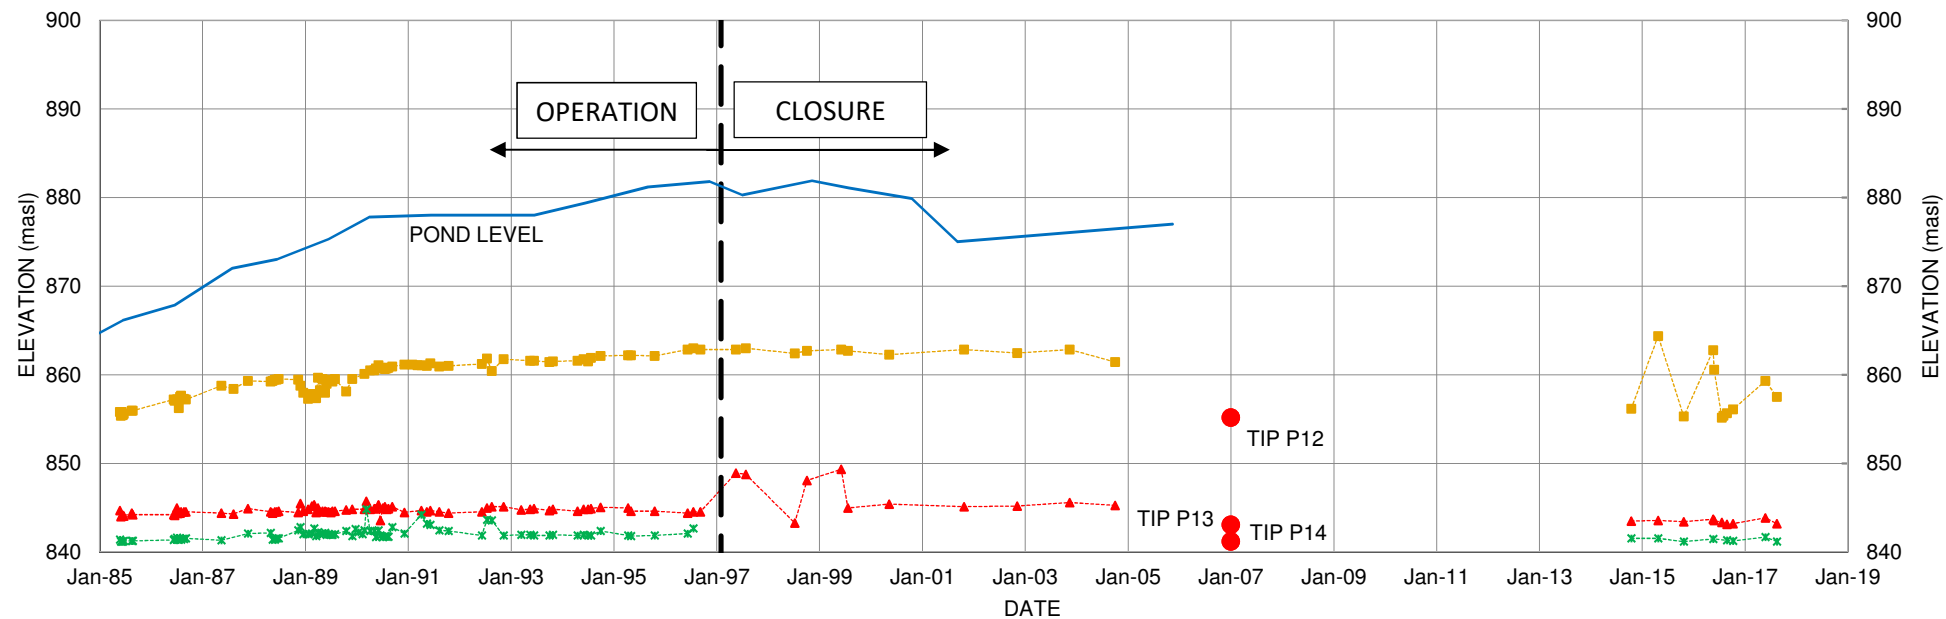
PROJECT	QUINTETTE COAL OPERATIONS 2017 DAM SAFETY INSPECTION	
TITLE	PLANTSITE TAILINGS DAM 2017 PIEZOMETER READINGS STA. 0+696 m	
PROJECT No.	M09684A14	FIG. No. 6

- **Sta. 0+696:** P12 and P13 labels and measurements may have been switched in May 2016 (refer to KCB (2016c) Figure 7 instrumentation plot for reference). P13 is expected to read relatively constant piezometric level as the water table is likely controlled by the upstream chimney drain and by a nearby finger drain at Sta. 0+705 (approximate). Instead, P13 data between May 2016 and May 2017 indicate seasonal fluctuation. Conversely, P12, located upstream of the chimney drain, showed no seasonal fluctuation in 2016, contradicting data from other piezometers installed upstream of the chimney drain. This indicates the labels of the two piezometers may have been switched. Revised P12 and P13 plots are shown in Figure 6.

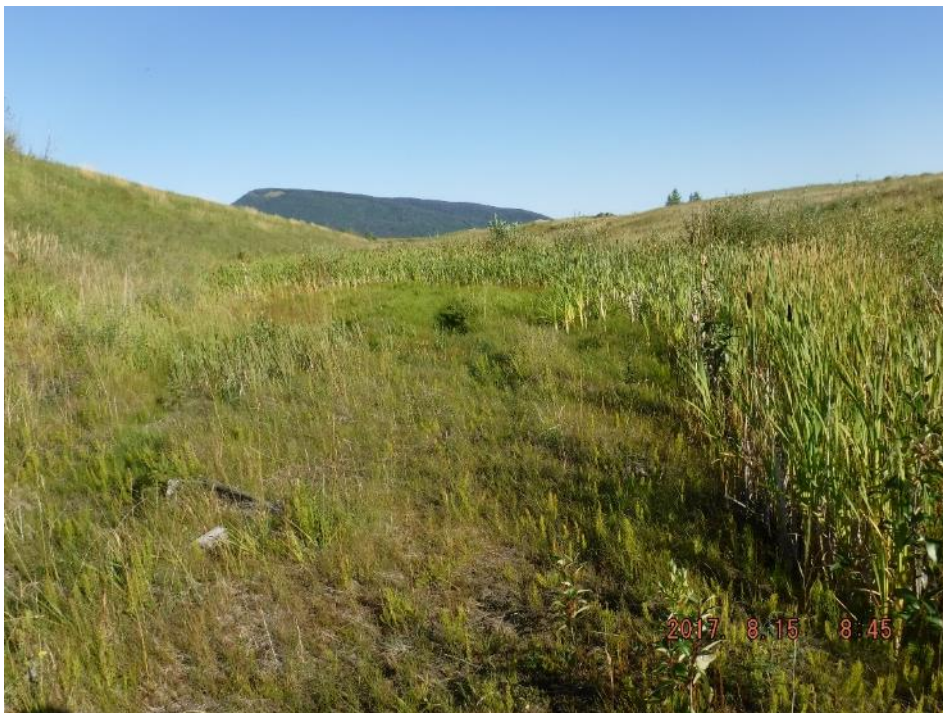
**Photo I-4** Spillway channel – viewed from inside the PTD impoundment looking southwest toward discharge point into M17 Creek (PTD-2017-03)

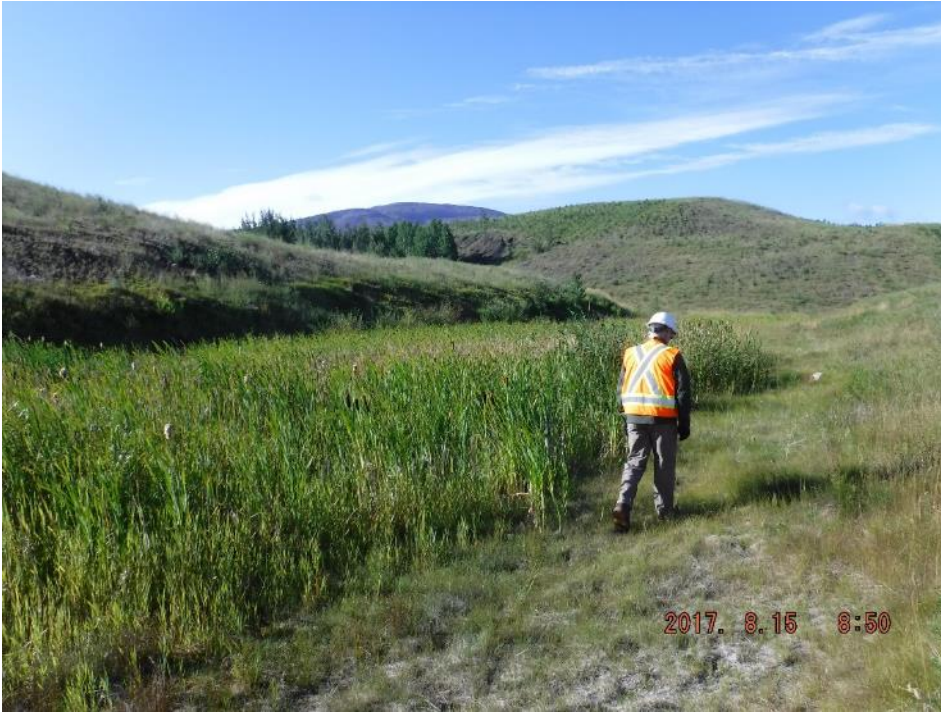
**Photo I-7 Spillway discharge point into M17 Creek (PTD-2017-05)**

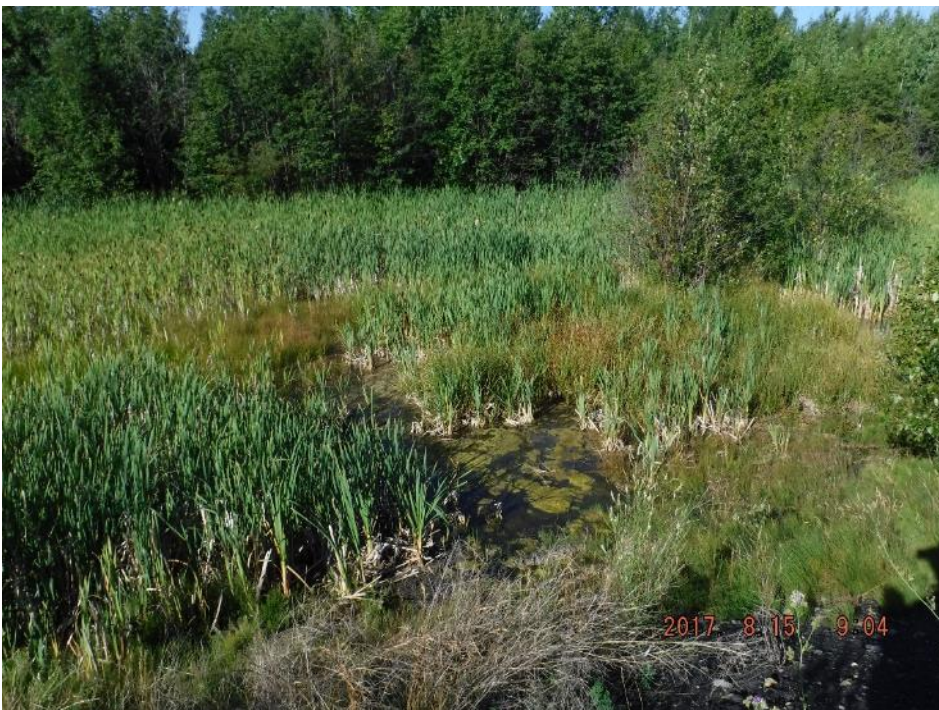
**Photo I-12     PTD downstream slope - looking northeast. No sign of distress (PTD-2017-09)**

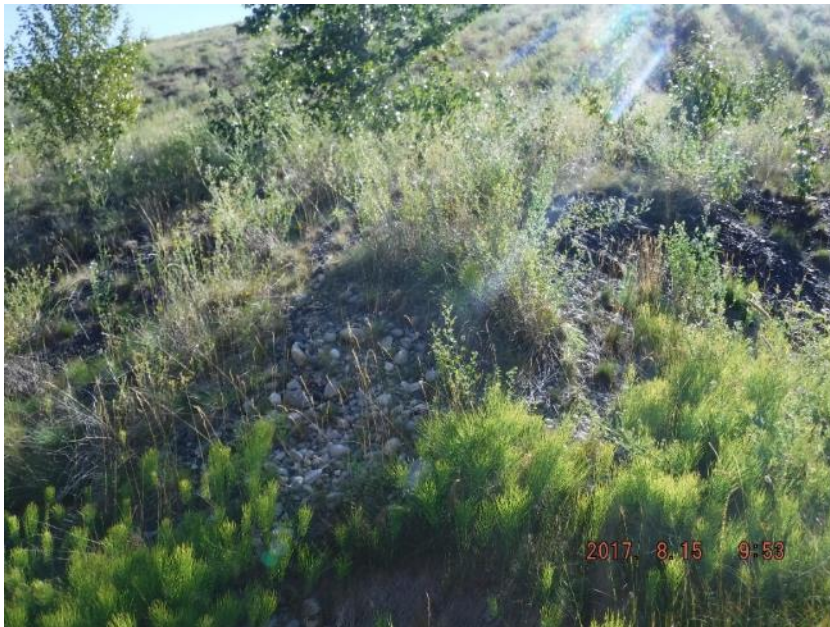
**Photo I-17 Finger drain at the PTD toe – <1 L/min flow (PTD-2017-13)**

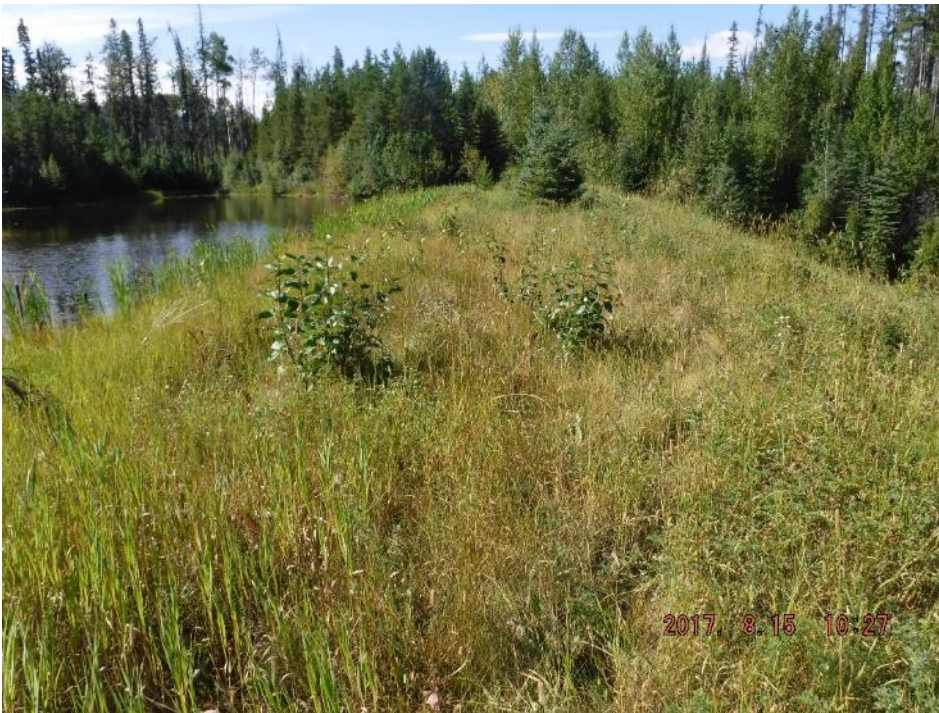
**Photo I-21     Seepage Collection Pond – downstream slope; no sign of erosion or movement. (PTD-2017-17)**

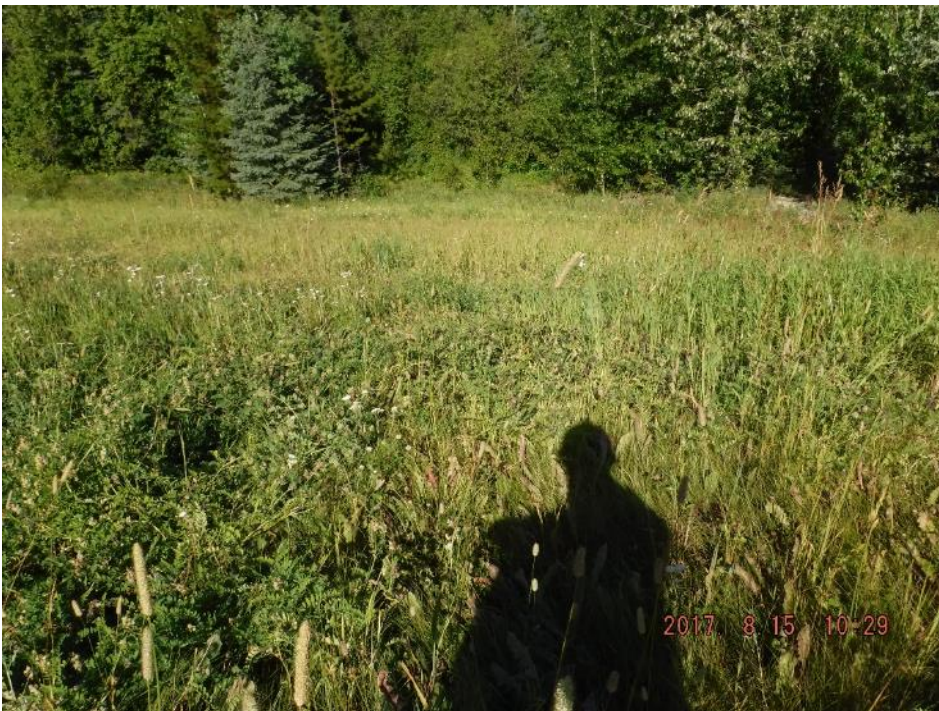
**Photo I-22** Seepage Collection Pond – spillway channel appears to be dry; channel is heavily vegetated (PTD-2017-18)

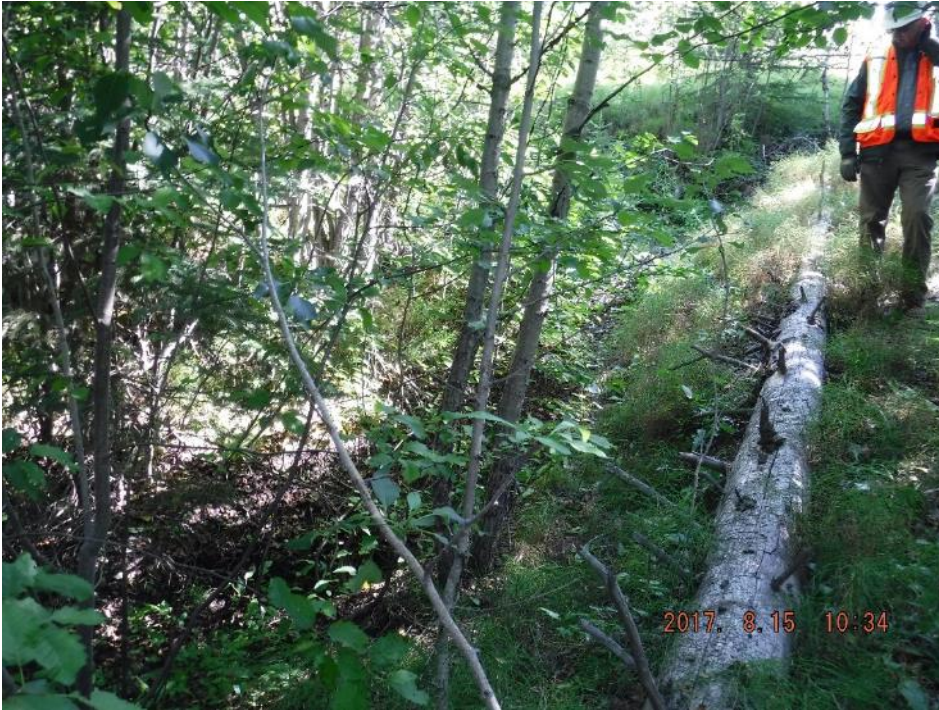
**Photo I-23** Seepage Collection Pond – looking west at the toe; area appears to be dry (PTD-2017-19)

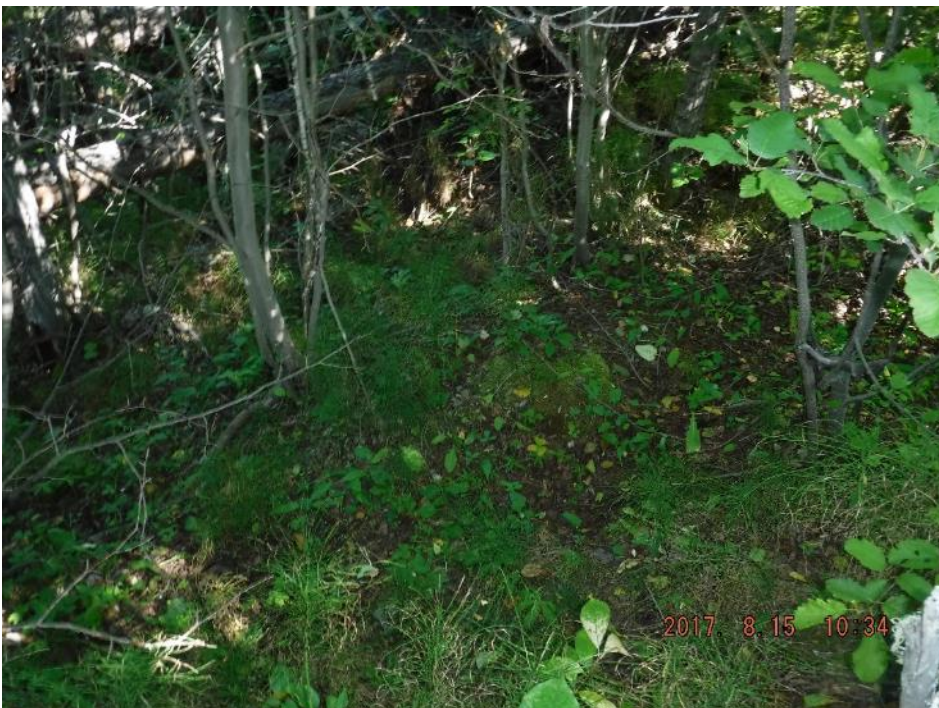
**Photo I-24** Seepage Collection Pond – looking south at the toe; area appears to be dry (PTD-2017-19)

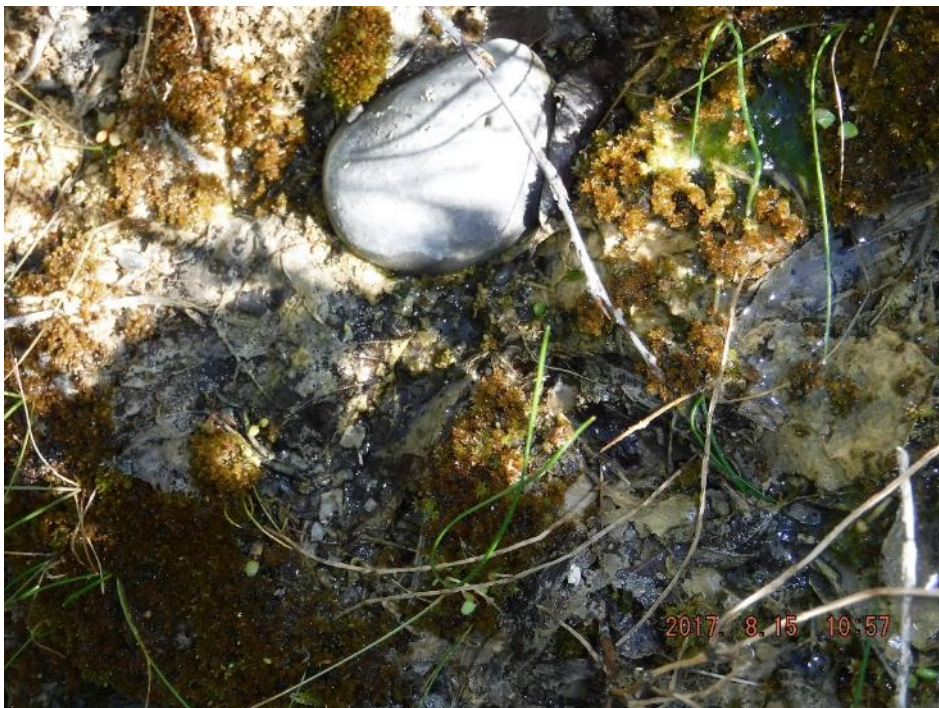
**Photo I-28 Finger drain with flow <1 L/min (PTD-2017-22)**

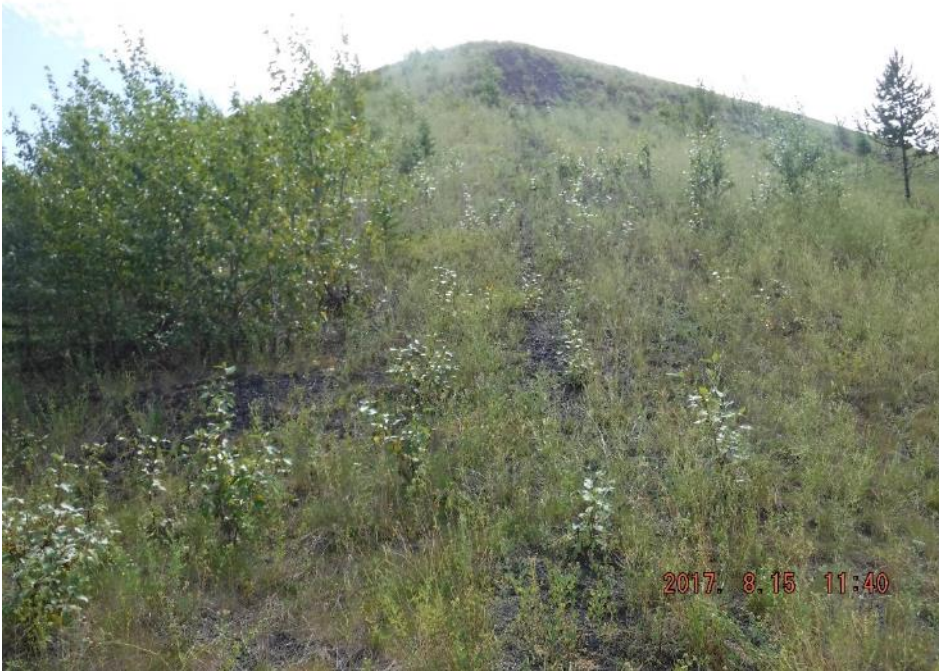
**Photo I-32** Overview of PTD northwest corner - steep scarp near downstream slope ramp – inactive due to the amount of vegetation growth on scarp (PTD-2017-25)

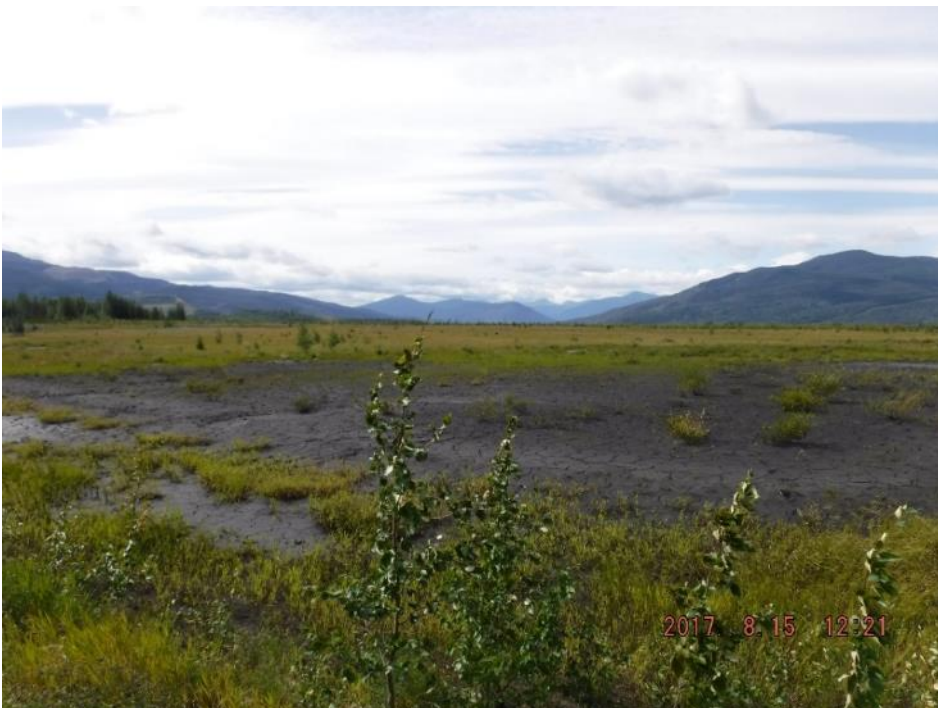
**Photo I-39 Upstream Slope and Tailings beach – no sinkholes or sign of distress (PTD-2017-31)**

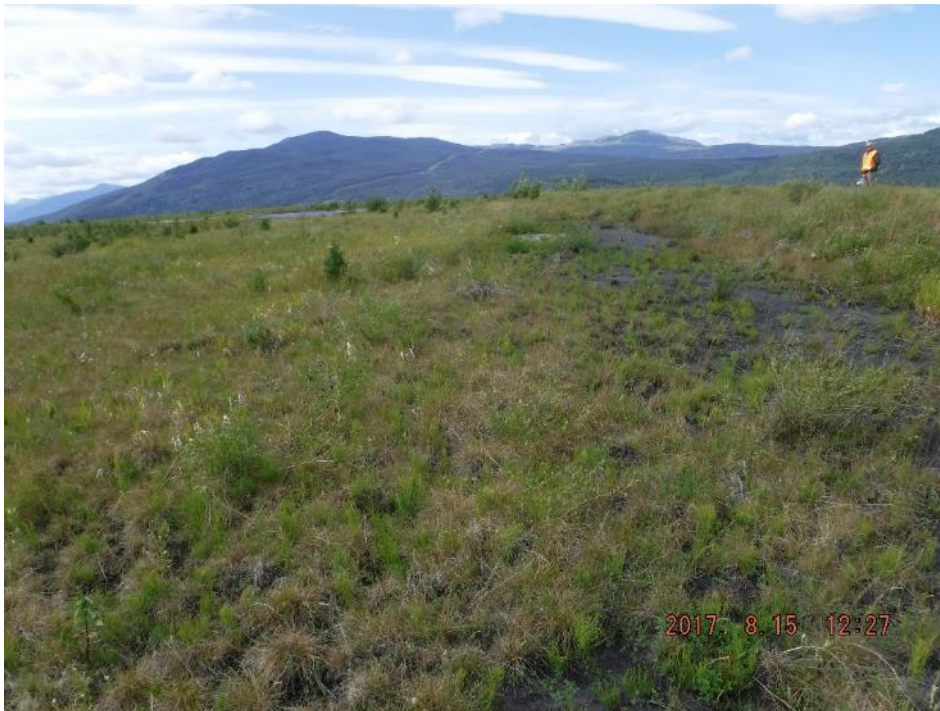
**Photo I-40 PTD crest – no sign of distress. Tailings surface is approximately 2 m lower than dam crest level (PTD-2017-32)**

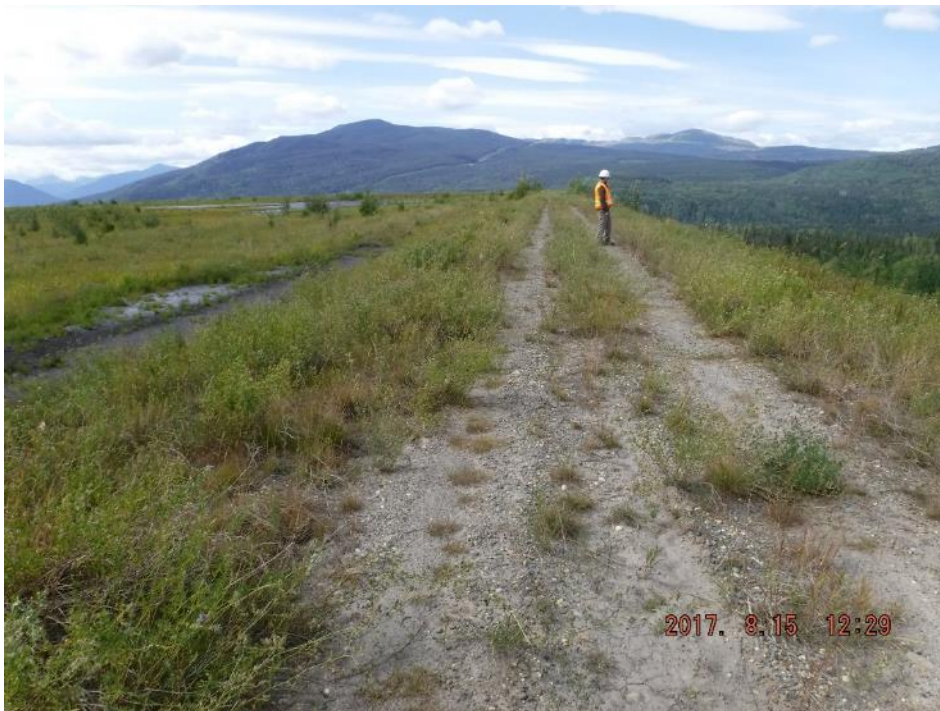
**Photo I-41     Pond estimated as 70 m from dam crest near Sta. 1+550 (PTD-2017-33)**

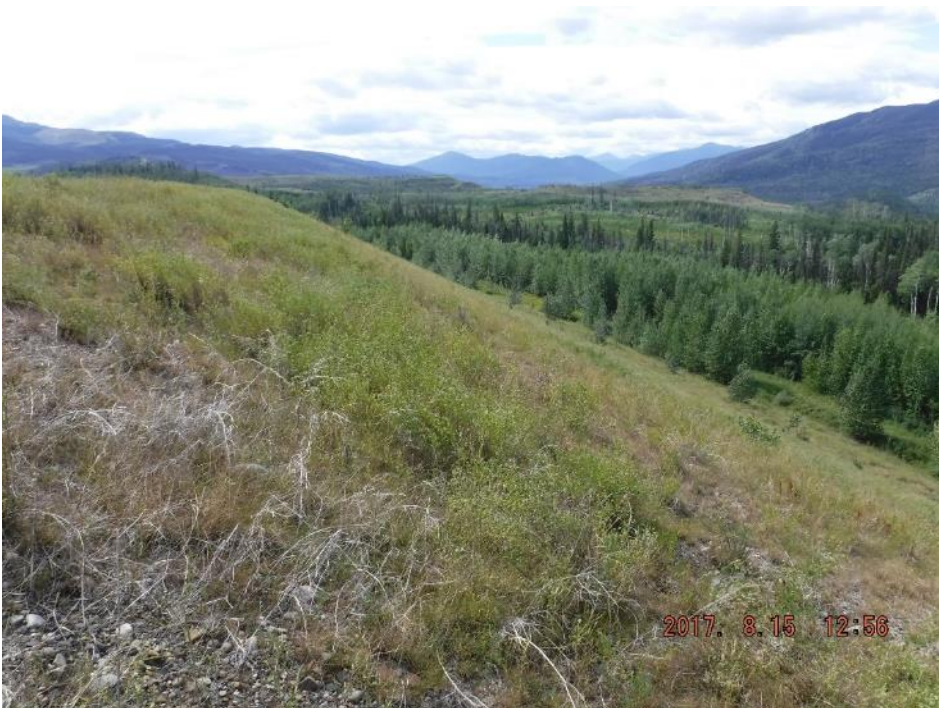
**Photo I-45**     **Whaleback feature – no change from previous year (PTD-2017-37). See Figure I for location of PTD-2017-37.**
