# **Teck Coal Limited**

## **Quintette Coal Operations**

### ***2017 Dam Safety Inspection***

### ***Plantsite Tailings Dam***

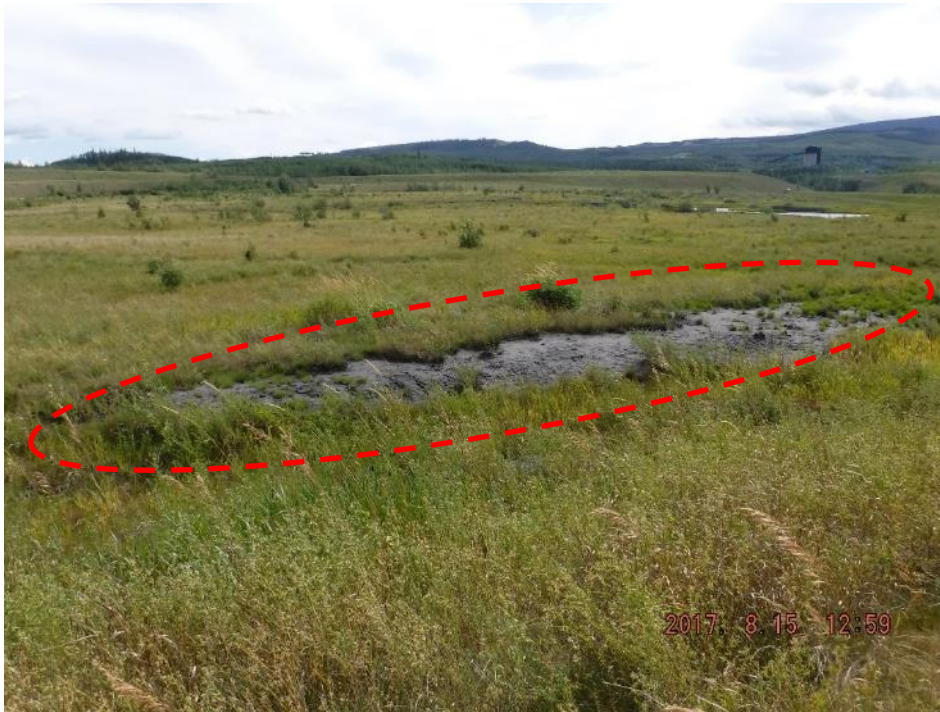
**Photo I-46**     **From dam crest near Sta. 0+600 looking at the ponded area and the tailings beach; no sign of sinkholes or distress (PTD-2017-38)**

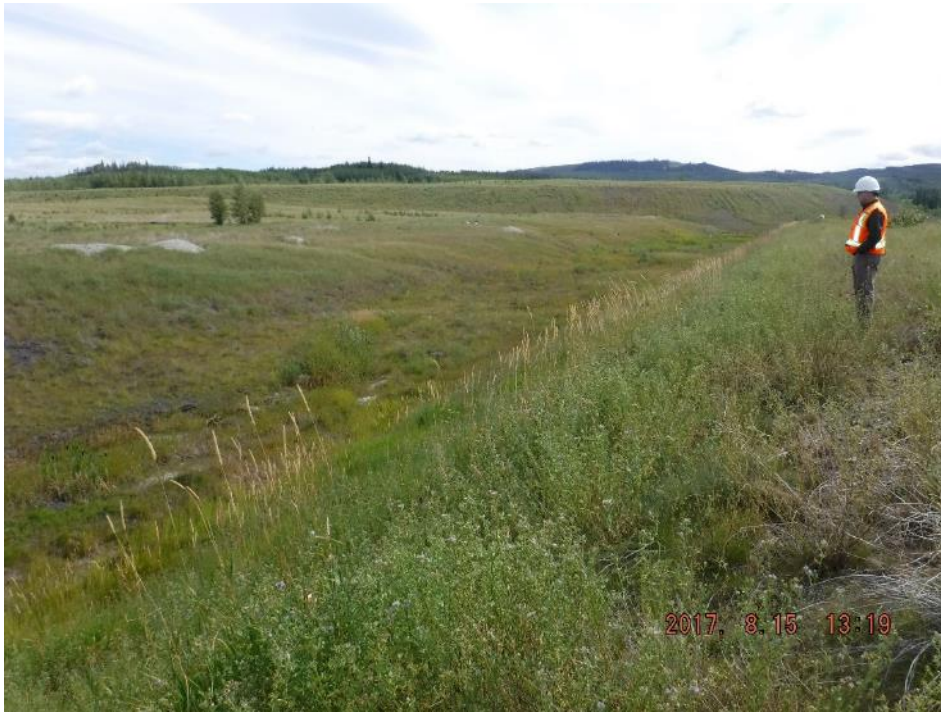
**Photo I-52** From dam crest looking northwest at the spillway low flow channel and downstream slope – no obstruction or sign of distress (PTD-2017-42)

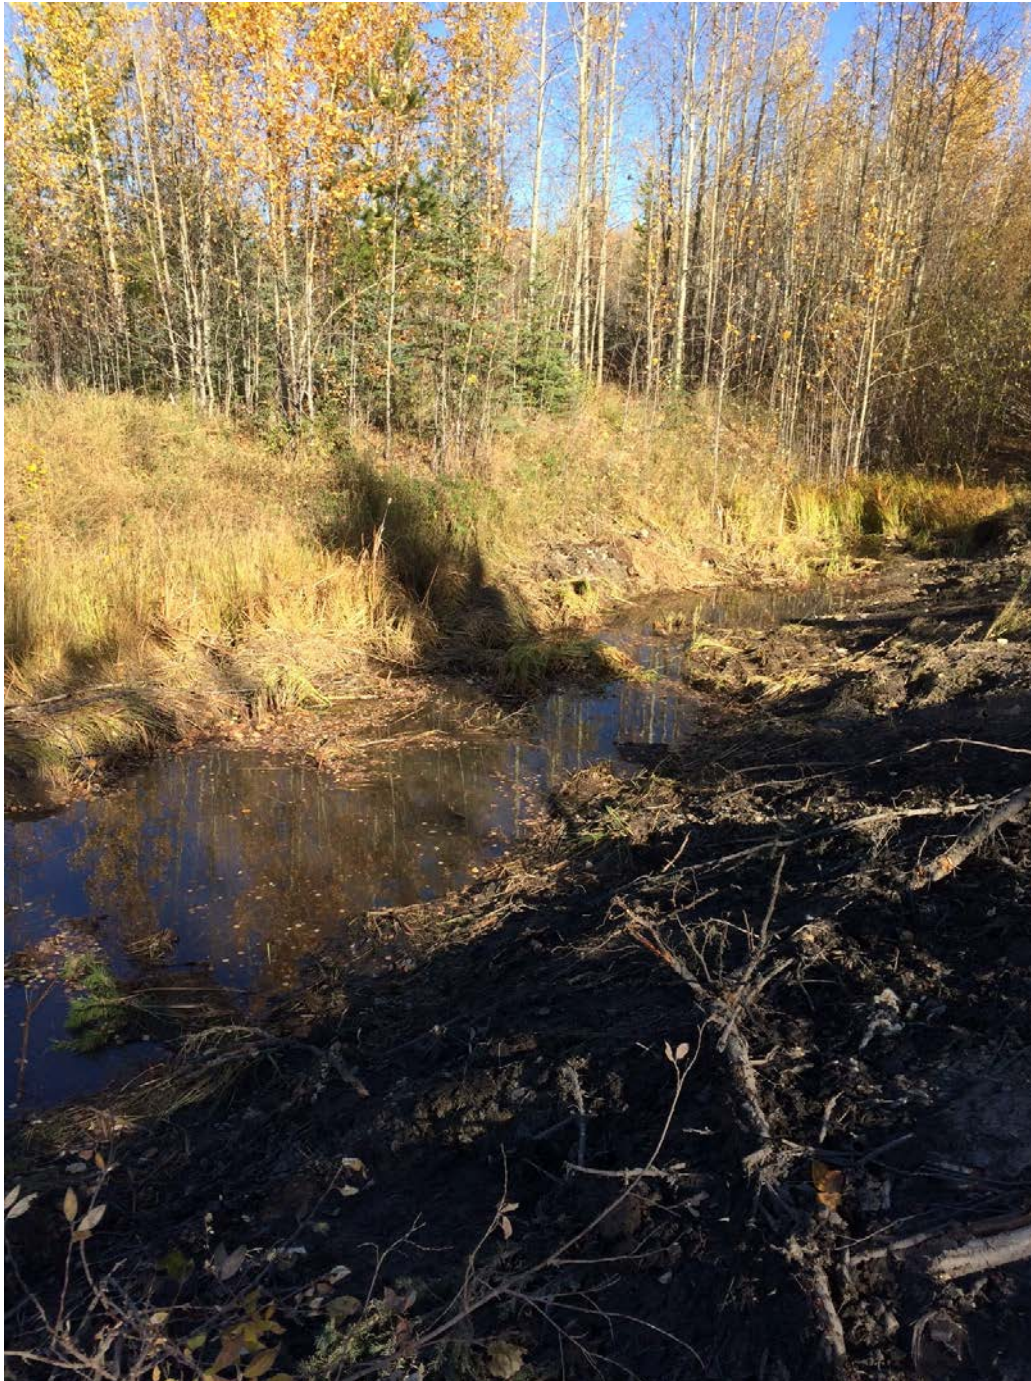
**Photo I-19 PTD Seepage Collection Pond – Beaver Dam noted obstructing the outlet area of the pond (PTD-2017-15)**

**Photo I-58**    **Teck removed beaver dam and vegetation at the Seepage Collection Pond in October 2017 – looking northeast (near waypoint PTD-2017-15)**

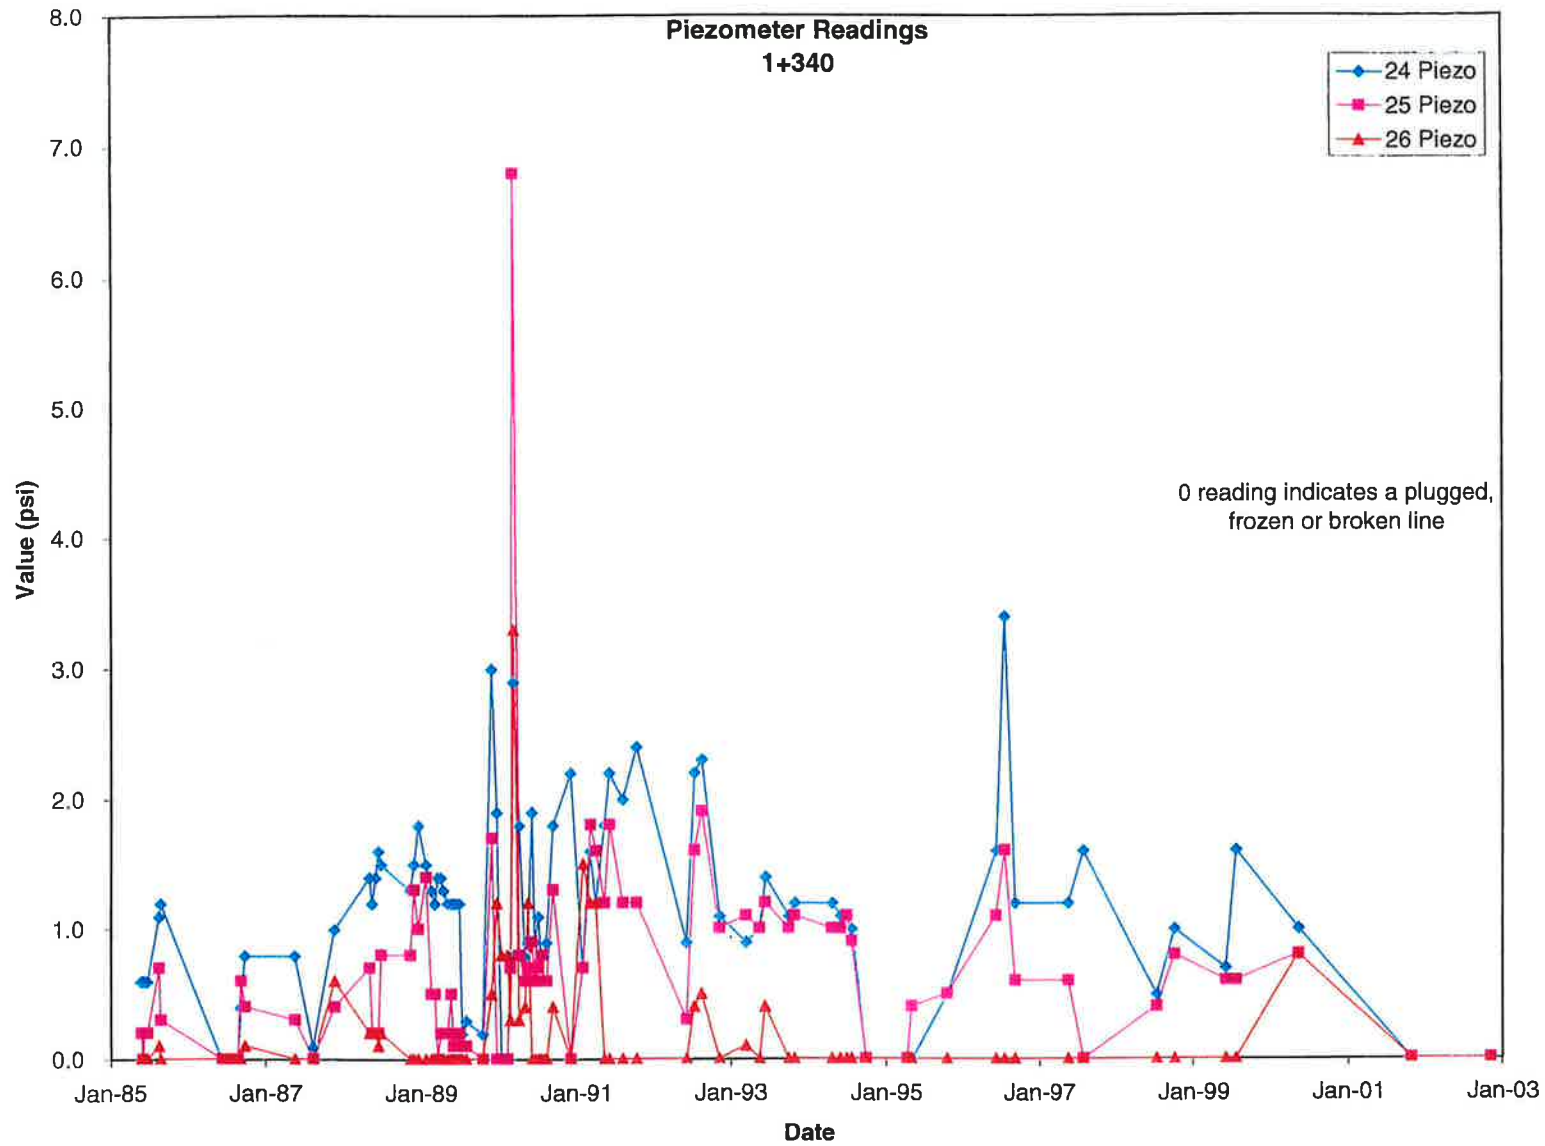
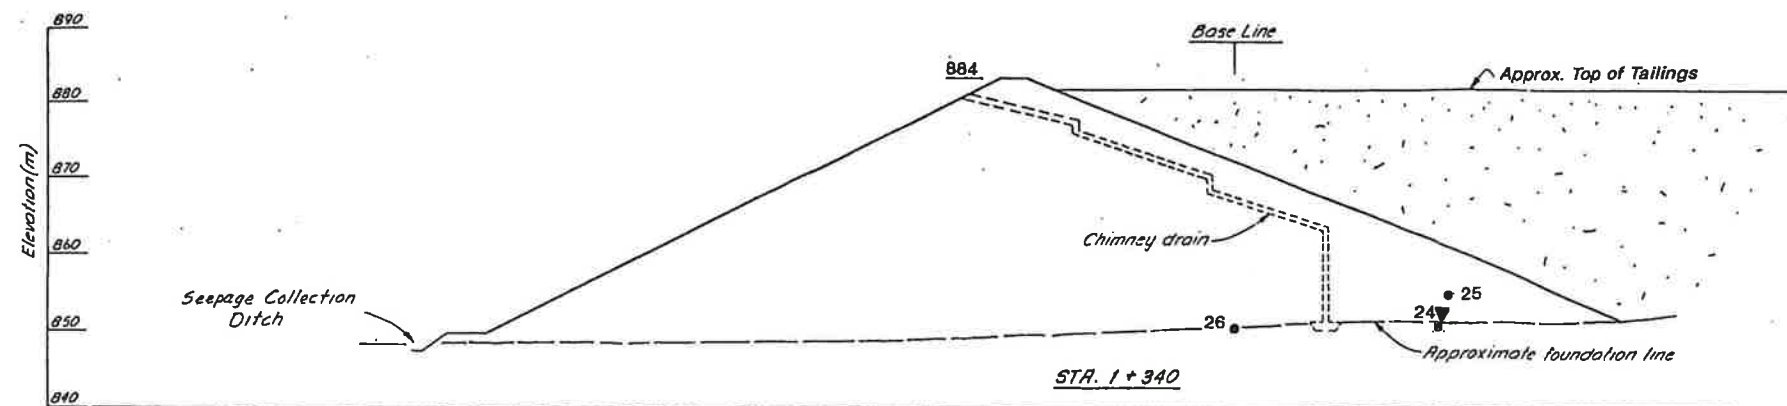
#### STATION 1+340

Piezometer 26 is located shallow depth below the fill/foundation surface of contact, on the downstream side of the core drain. This piezometer has not been functional for several years.
