## Sä Dena Hes Mine, Yukon Territory 2017 Dam Safety Inspection

SRK Consulting (Canada) Inc.  
December 2017

Project No: 1CT008.065

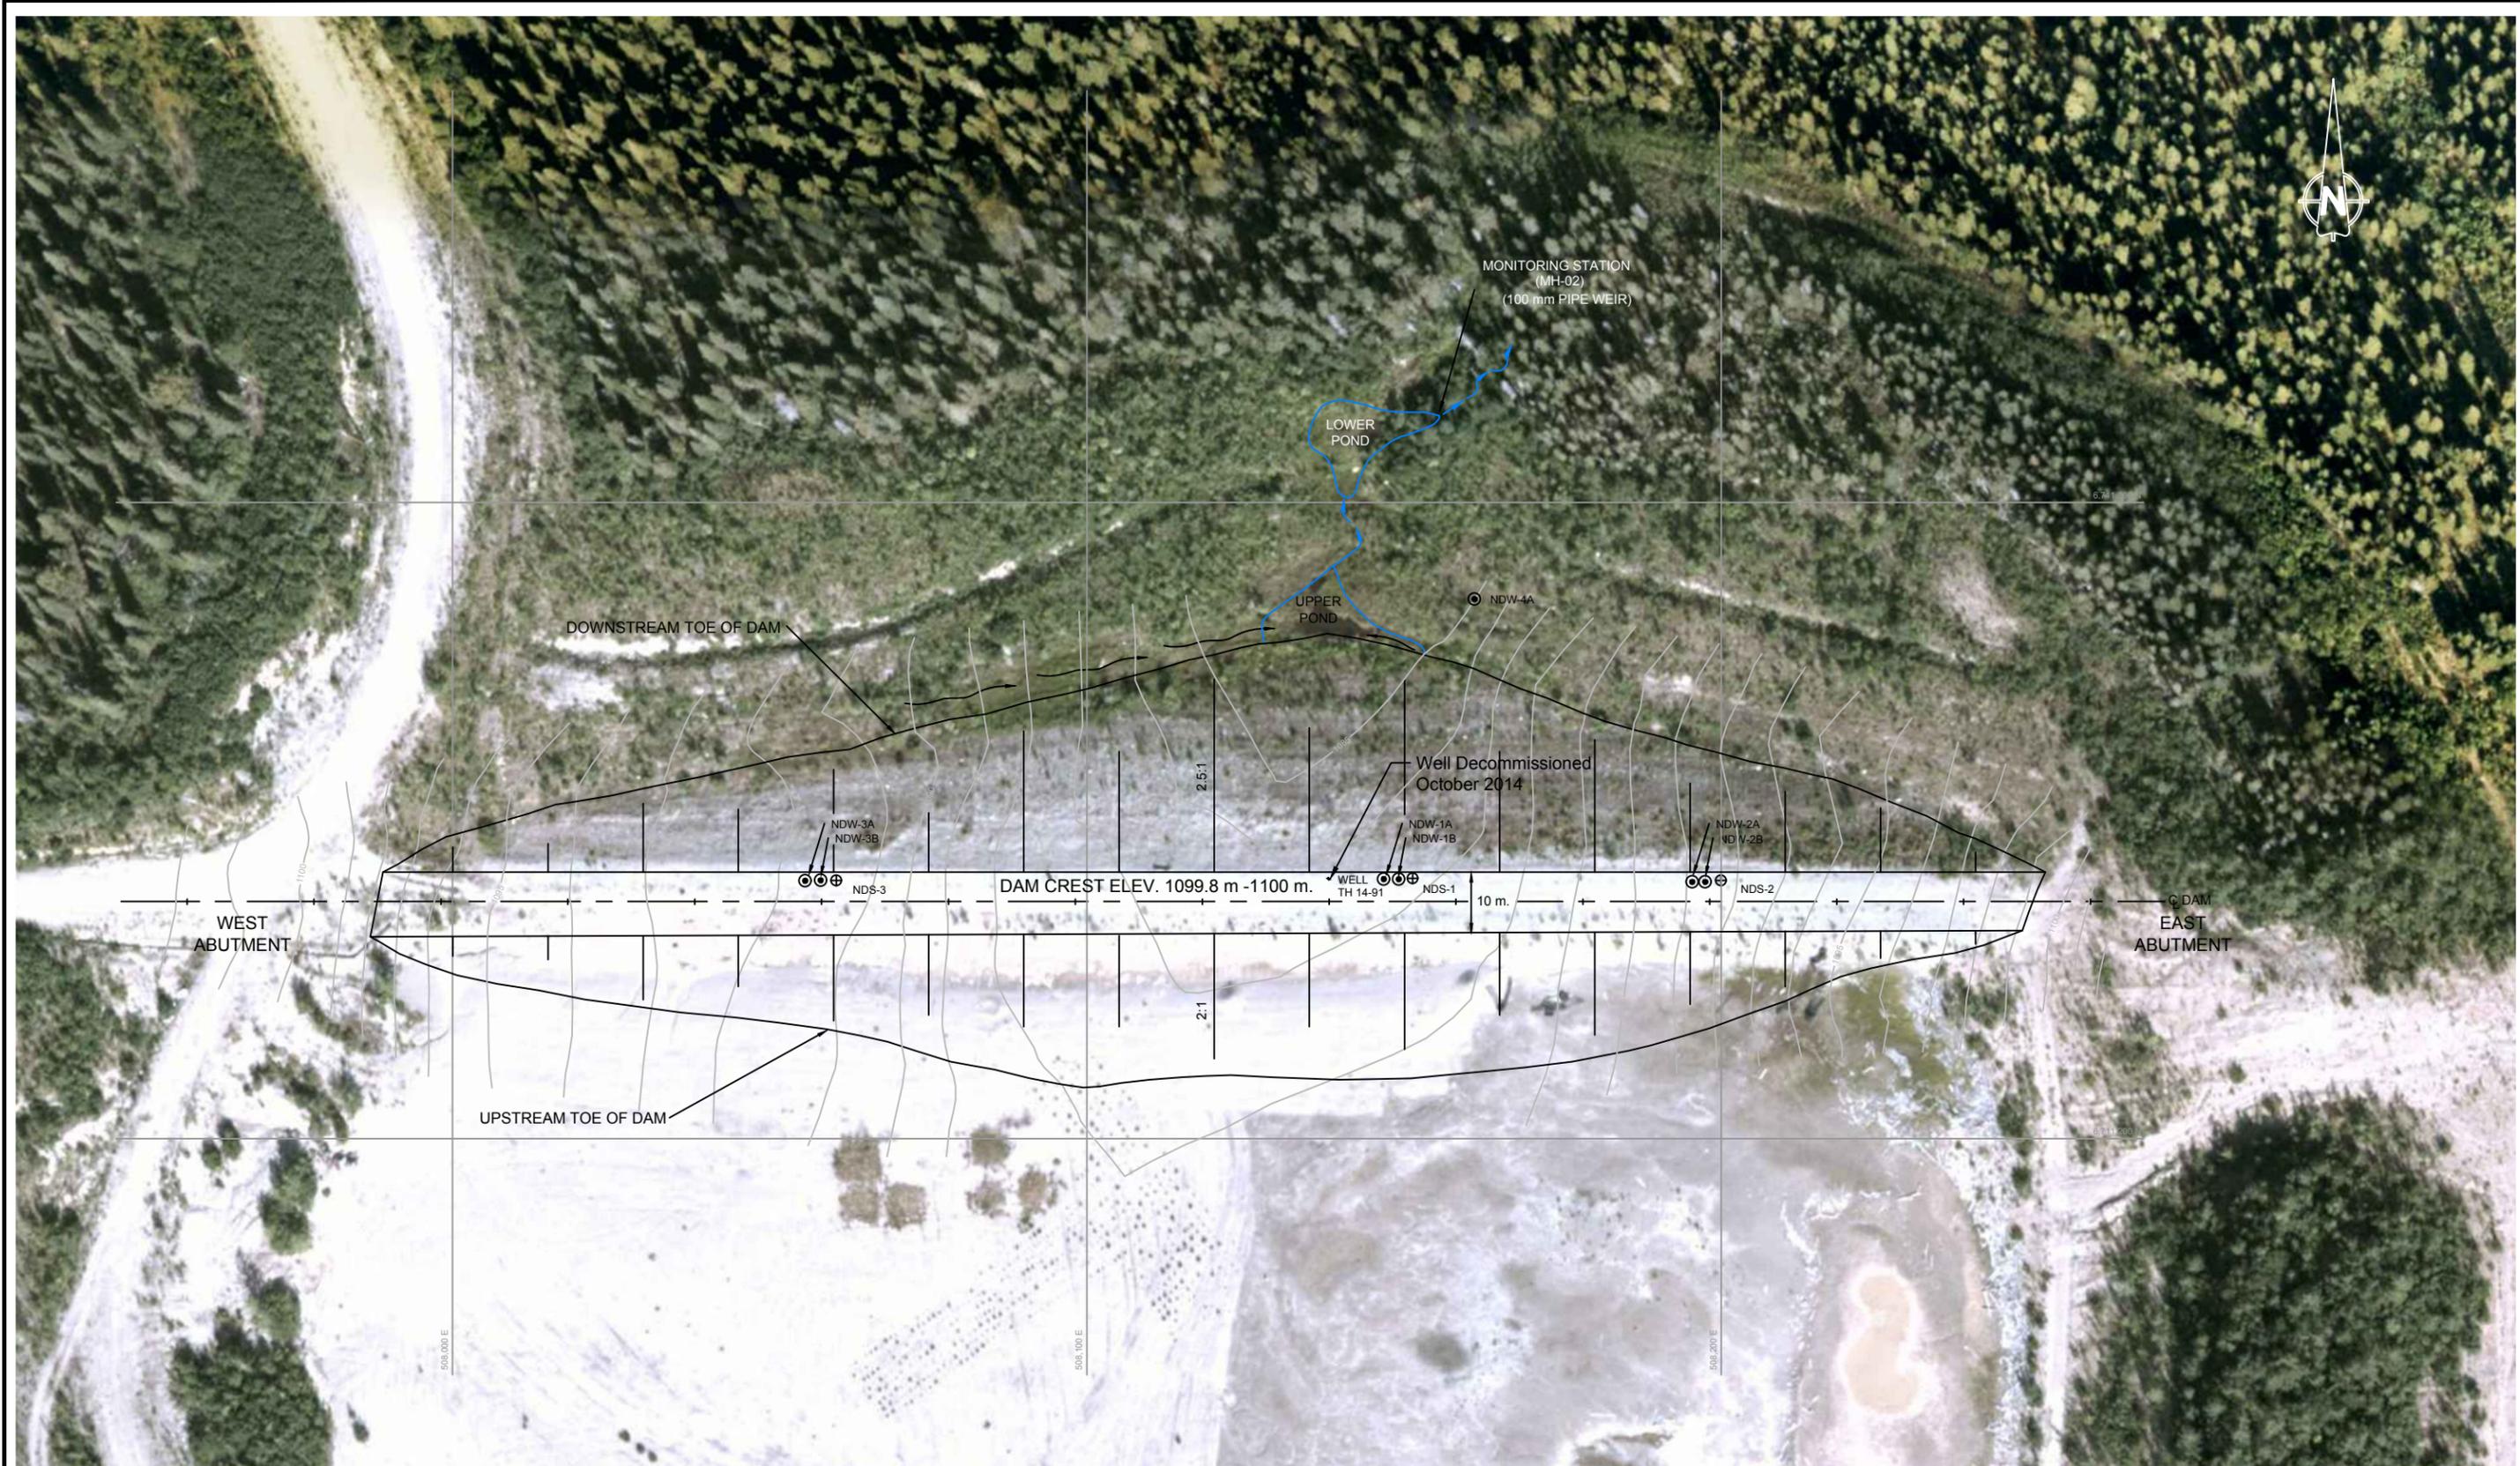
The North Dam is approximately 15 m high with a crest elevation of 1,100 m, a crest length of about 260 m, and a crest width of 10 m. A site plan and section through the dam are shown in Figures 3 and 4. The North Dam for this report is considered a mining dam as it is a barrier constructed for the retention of tailings (CDA 2014).

A site plan and a section of the North Dam are presented on Figures 3 and 4.

The crest of the North Dam (Photo 1), is in good condition. It shows no signs of deformation or abnormal settling. The downstream slope of the dam (Photo 2) shows no signs of surficial movement or erosion nor is there any sign of bulging at the downstream toe. Oversized trees observed during a previous dam safety inspection in 2015 had been removed in accordance with the routine maintenance specified in the OMS manual.

The piezometers and settlement gauges (Photos 3, 4 and 5) on the North Dam are in good condition and continue to function as designed. The orange coloured piezometer caps provide visible identification for the monitoring team. Piezometer 4A at the toe of the dam has not been updated with the new caps, and the steel protective cap has settled over time below the top of the PVC pipe.

Along the downstream toe of the North Dam there is an 80 m long seepage zone (Photo 6). Seepage from this zone is collected at a monitoring station referred to as MH-02 and is a combination of groundwater discharge from the surrounding hillsides to the west and minimal seepage flow from the impoundment. The monitoring station consists of a 6-inch diameter steel pipe (Photo 7) embedded in sandbags. It was noted that the pipe had rotated and was not functioning as designed. Photo 8 shows the redundant slope displacement monitoring pins, which have survived the elements.

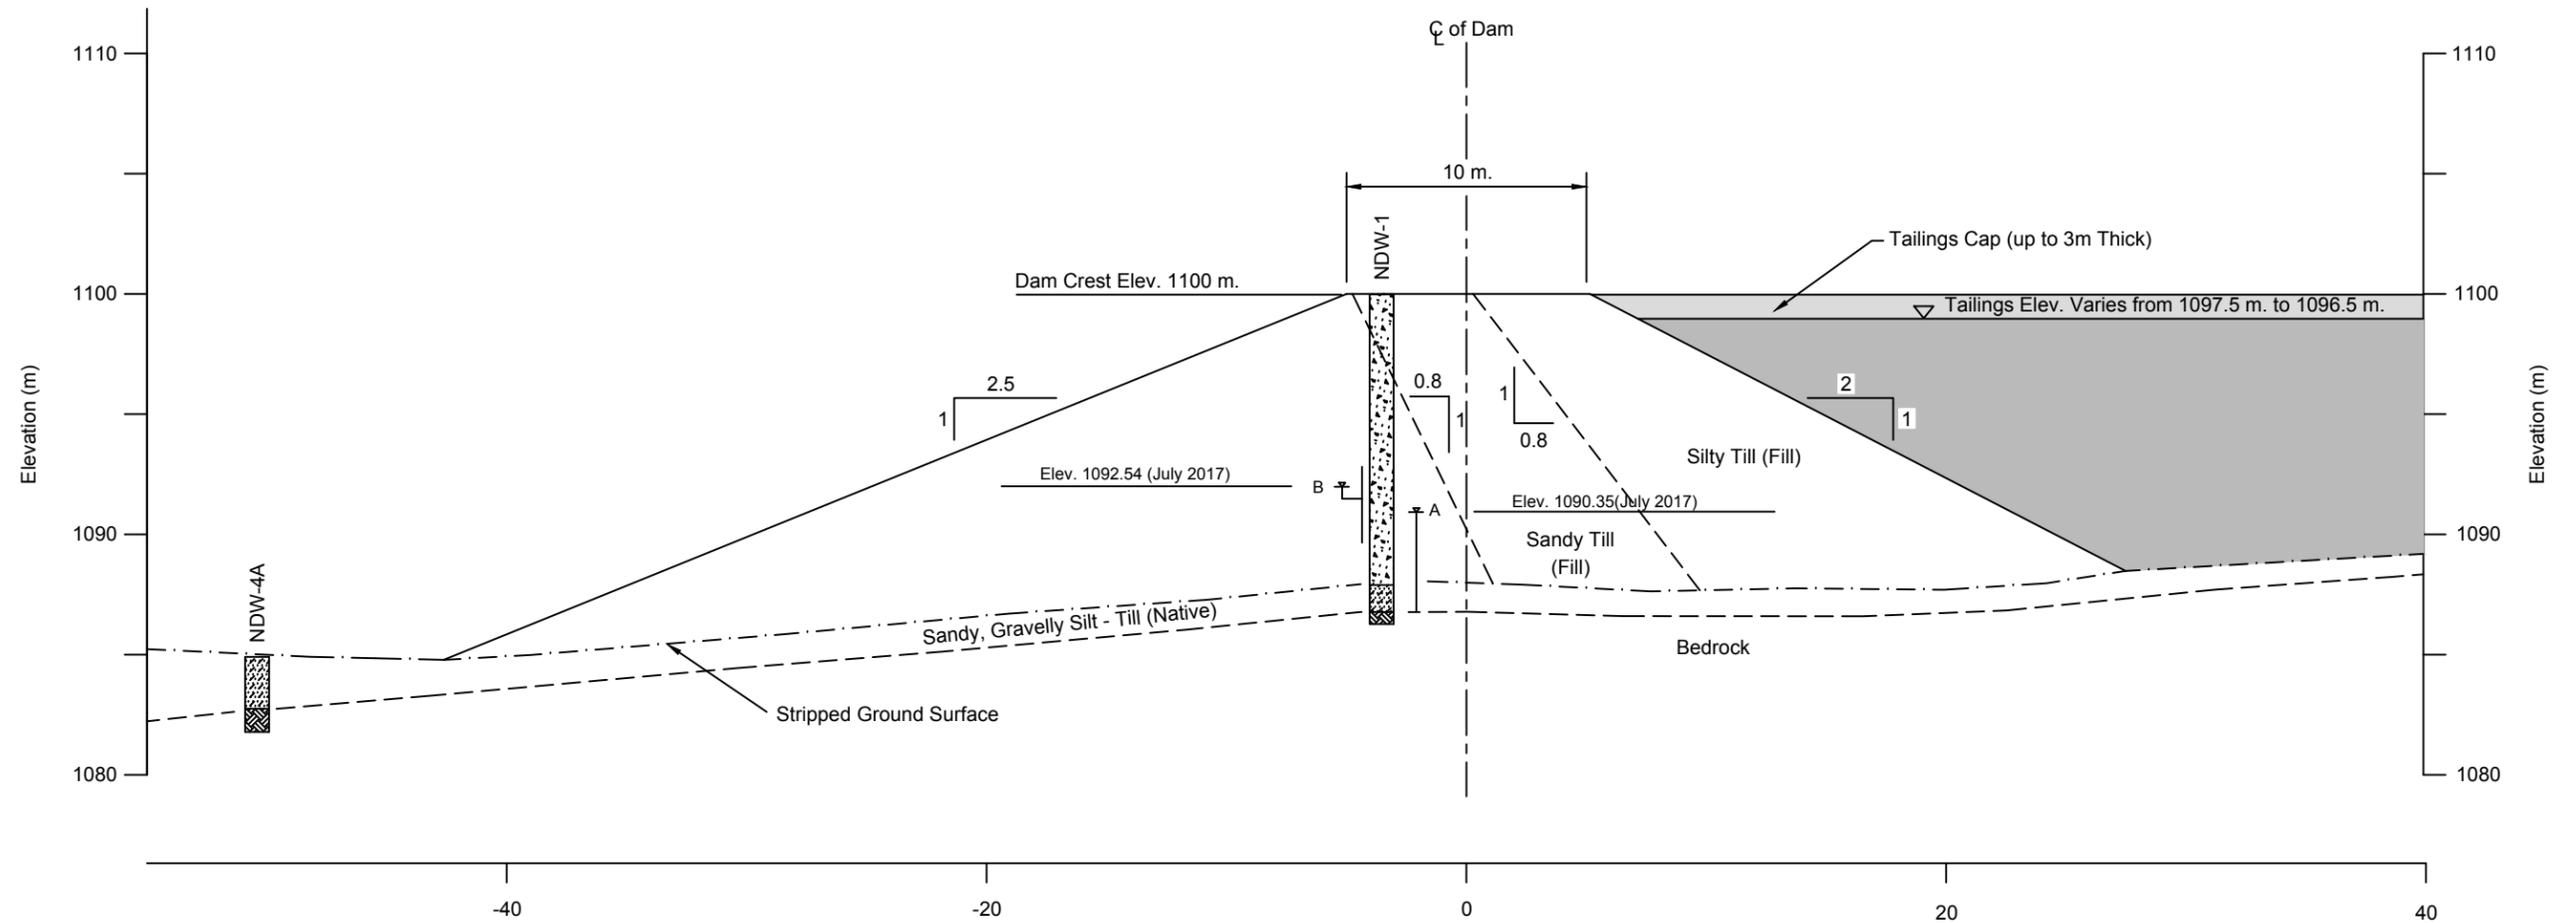
The peak levels recorded in July 2017 are plotted on the dam section shown on Figure 4.

DATE	T.O.P.	READING	ELEV.
NDW-1B	July 2017	1100.57	8.03	1092.54
NDW-1A	July 2017	1100.69	10.34	1090.35

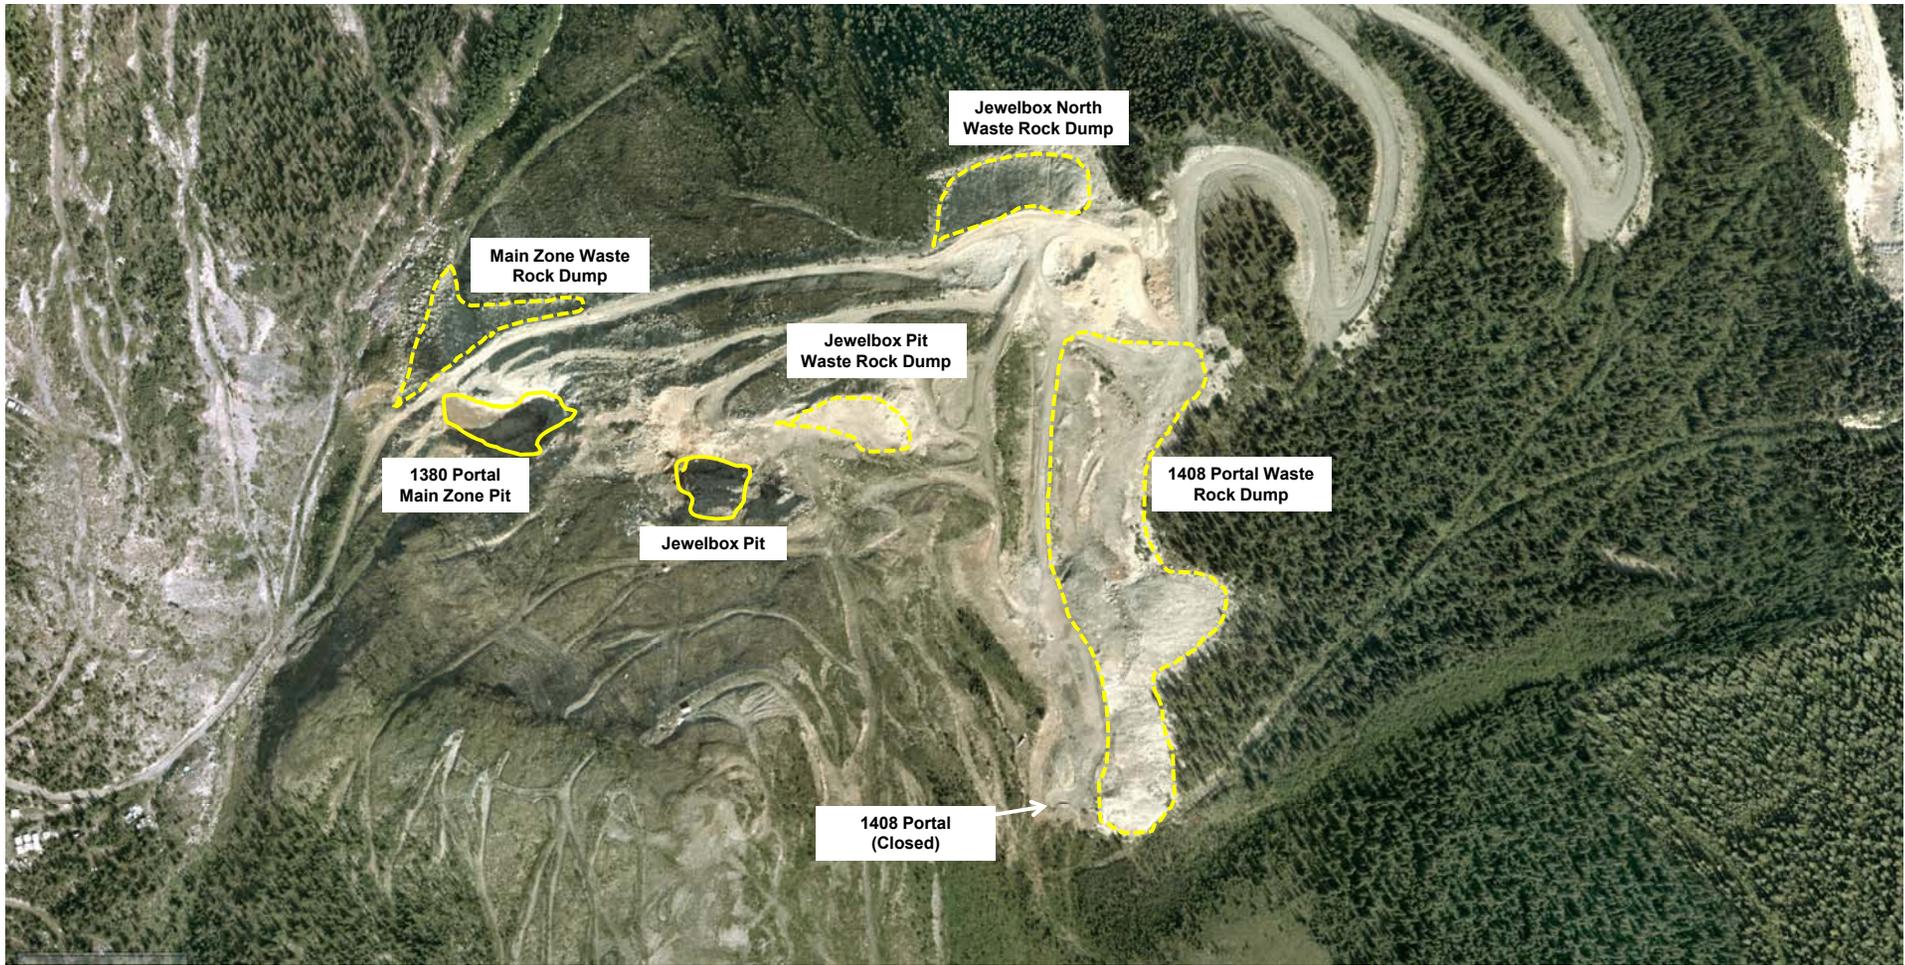
SRK inspected the resloped Main Zone and Jewelbox waste dumps (Photo 24 and Figure 12). It was noted that at the toe of the dumps, there was evidence of some erosion (Photos 25 and 26). While the erosion does not impact the stability of the dumps, SRK recommended that marked stakes be installed at the base of the erosion to monitor the erosion trend over time. Teck has installed the stakes and they will be inspected in 2018.

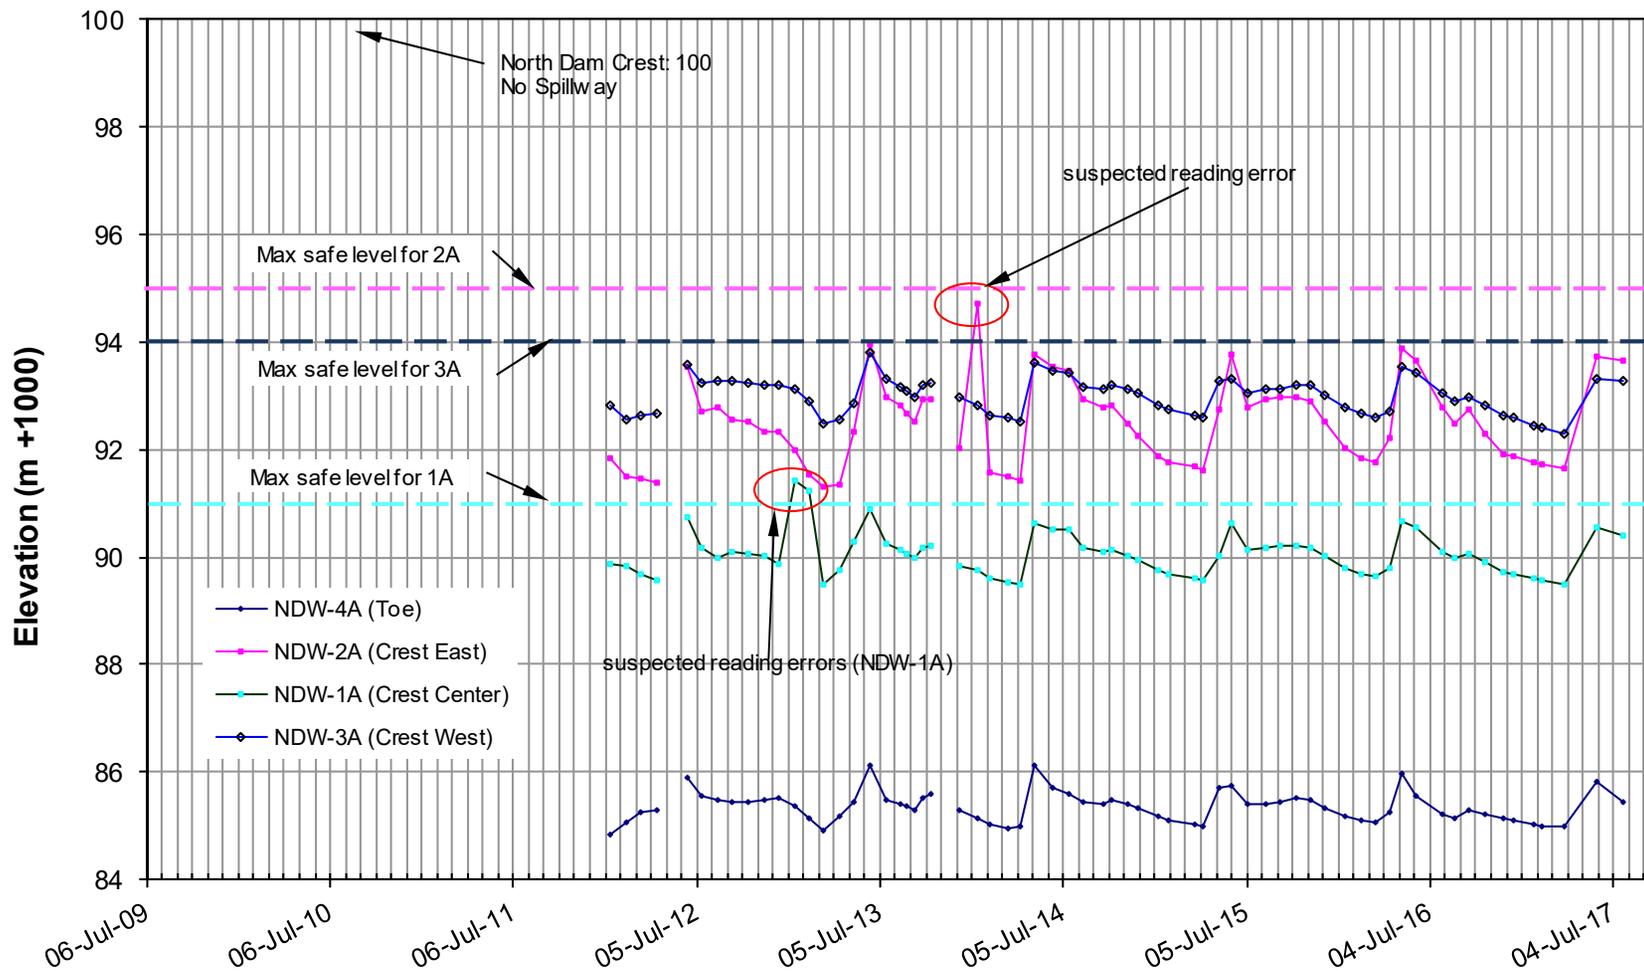
The piezometers and settlement gauges on the North Dam are in good condition and continue to function as designed. The seasonal fluctuations recorded in the latter part of 2016 and most of 2017 in the piezometers are consistent with those observed in previous years.
