## **Tailings Storage Facility Disclosure**

## South Tailings Pond Tailings Storage Facility

July 2023

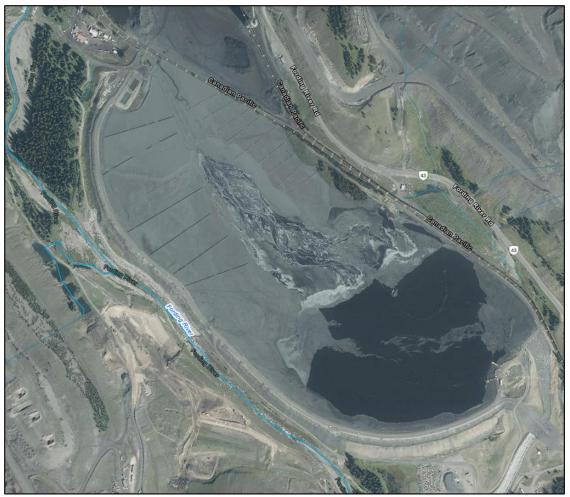
Figure 1: South Tailings Pond TSF Site Plan

| Cor | ntents | 1 |
|---|---|---|
| Fig | ure 1: South Tailings Pond TSF Site Plan | 3 |
