Tailings Storage Facility Disclosure Report

Red Dog Operations, Tailings Storage Facility

July 2023

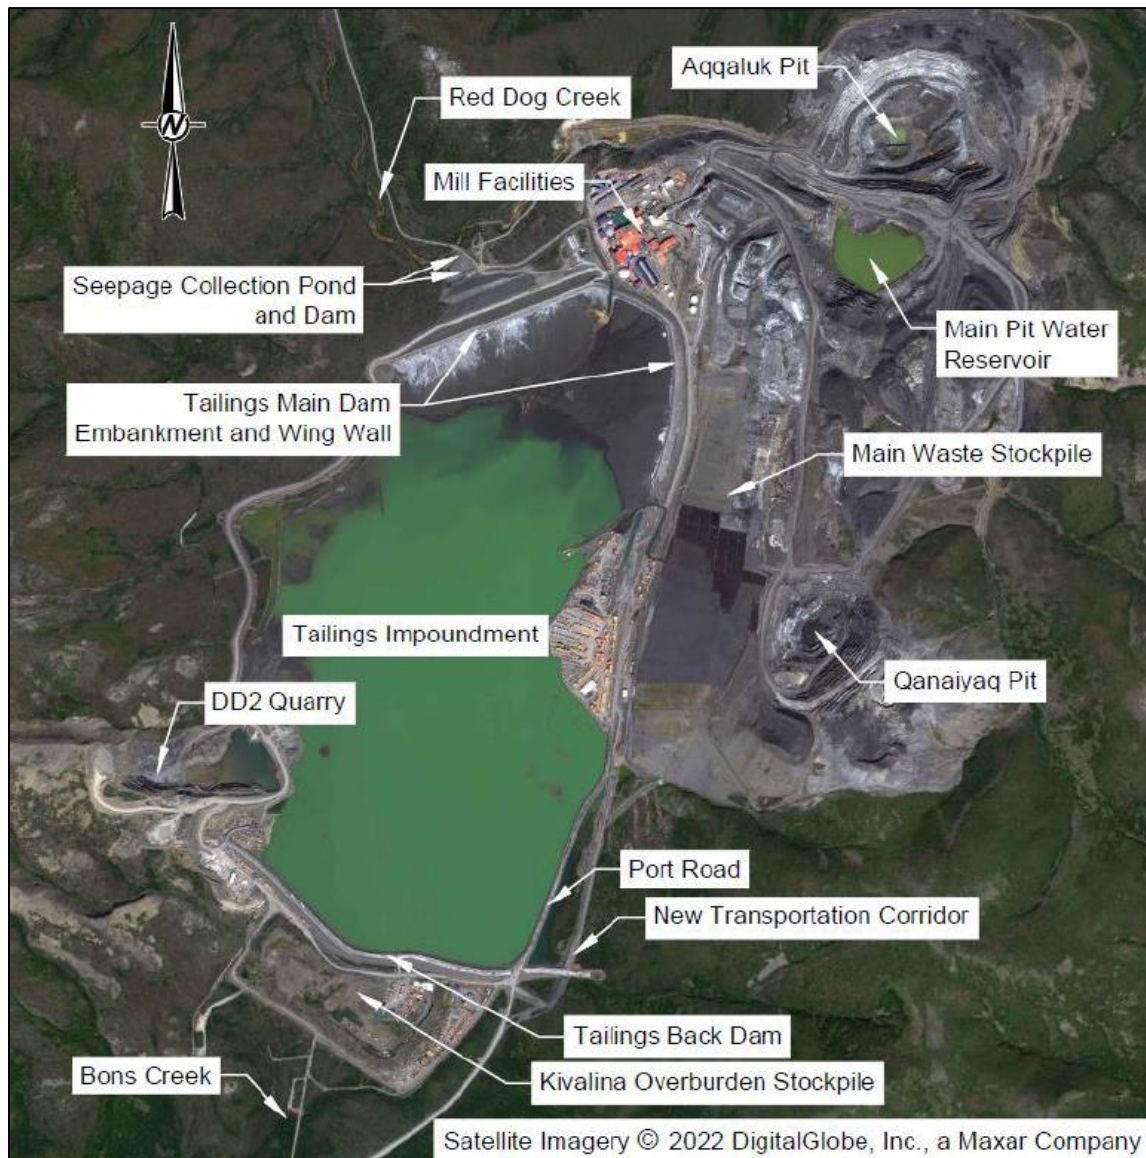
Figure 1: Red Dog Operations TSF Site Plan

Structure	Purpose
Tailings Main Dam TMD) (Embankment and Wing Wall)	Tailings and water retaining structure.
Tailings Back Dam (TBD)	Tailings and water retaining structure.
TMD Seepage Collection Dam	Primary collection pond downstream of the TMD, which collects and pumps water back to the TSF.
