# **Teck Highland Valley Copper Partnership**

## **2021 Annual Facility Performance Report**

*Highmont Tailings Storage Facility*

March 2022

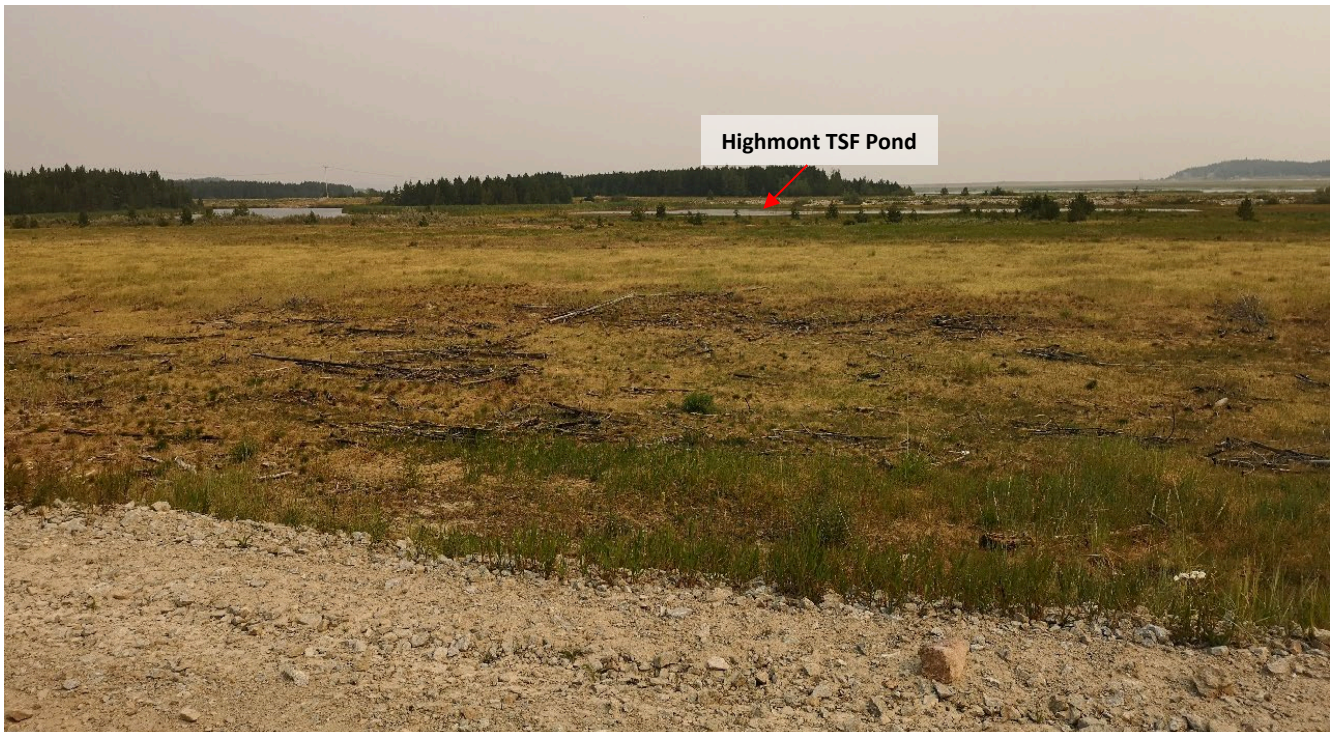
**Photo I-A-3 View of tailings impoundment and beach from South Dam (HGH-2021-03)**

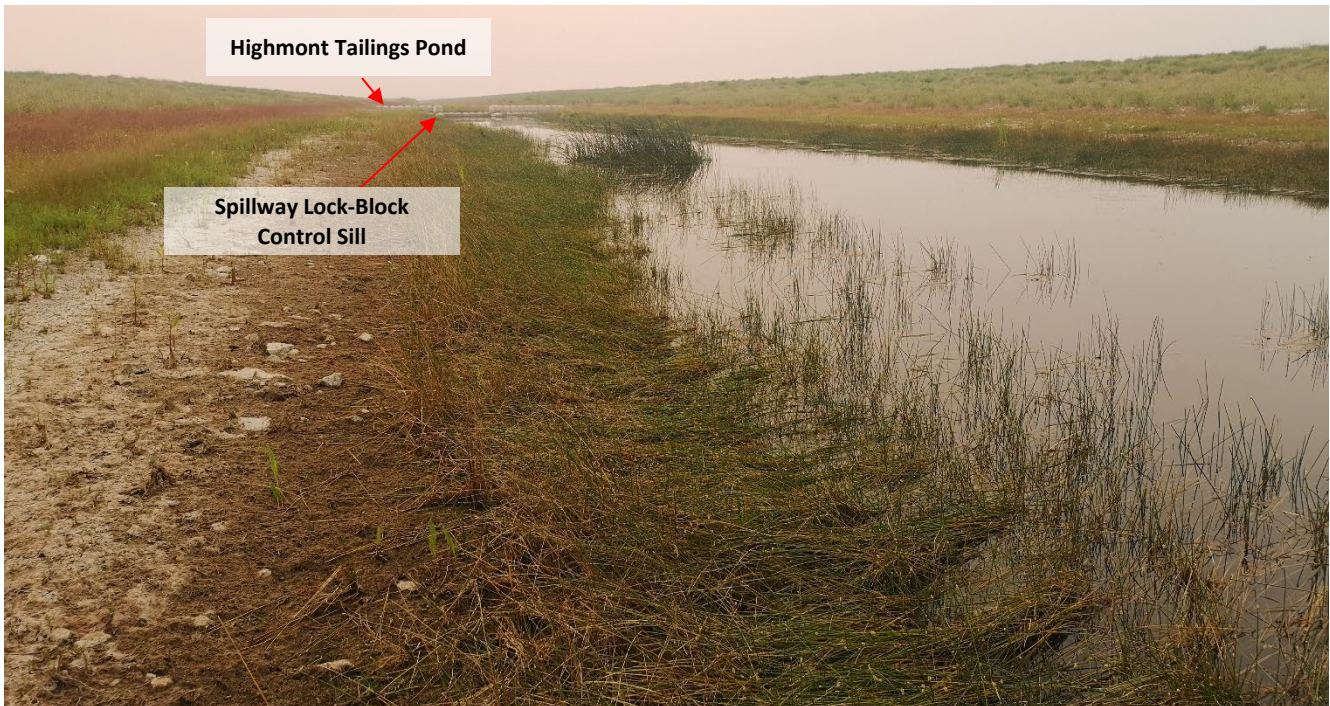
**Photo I-A-18 Highmont Spillway approach channel, concrete lock-block control sill – Spillway was not flowing at the time of the site visit. Water ponded downstream of sill is controlled by level at spillway flow control gate (HGH-2021-10)**

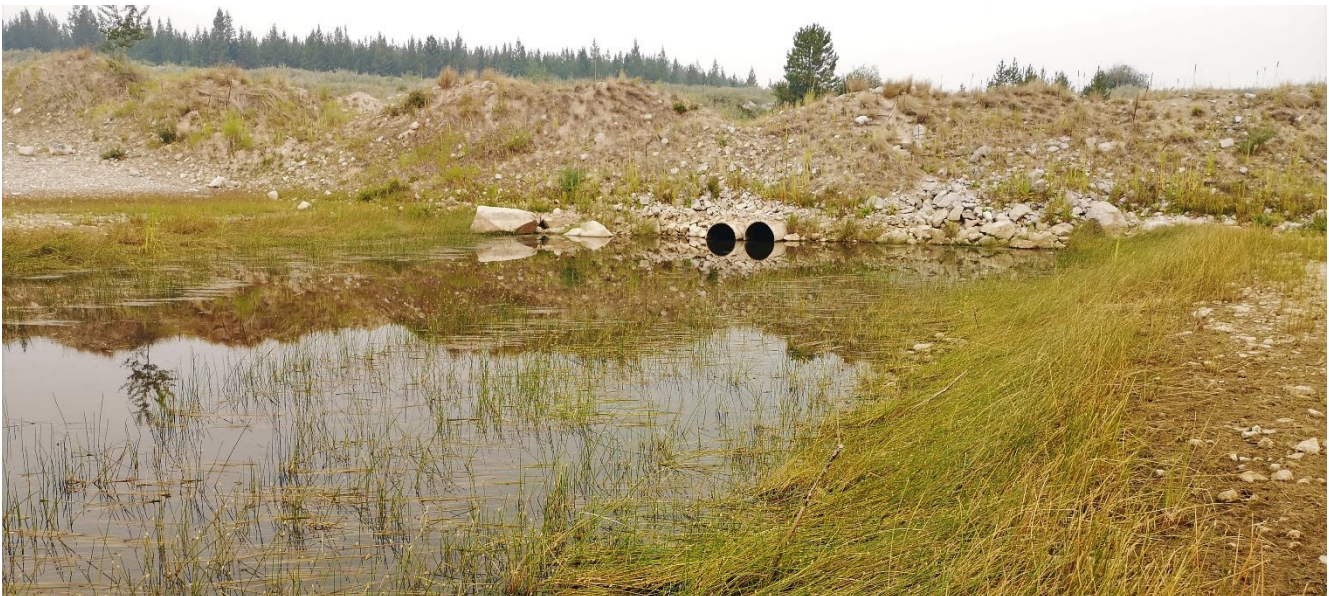
**Photo I-A-19 Approach channel. Road culverts are partially submerged, section upstream of culverts is clear of debris and vegetation (HGH-2021-10)**

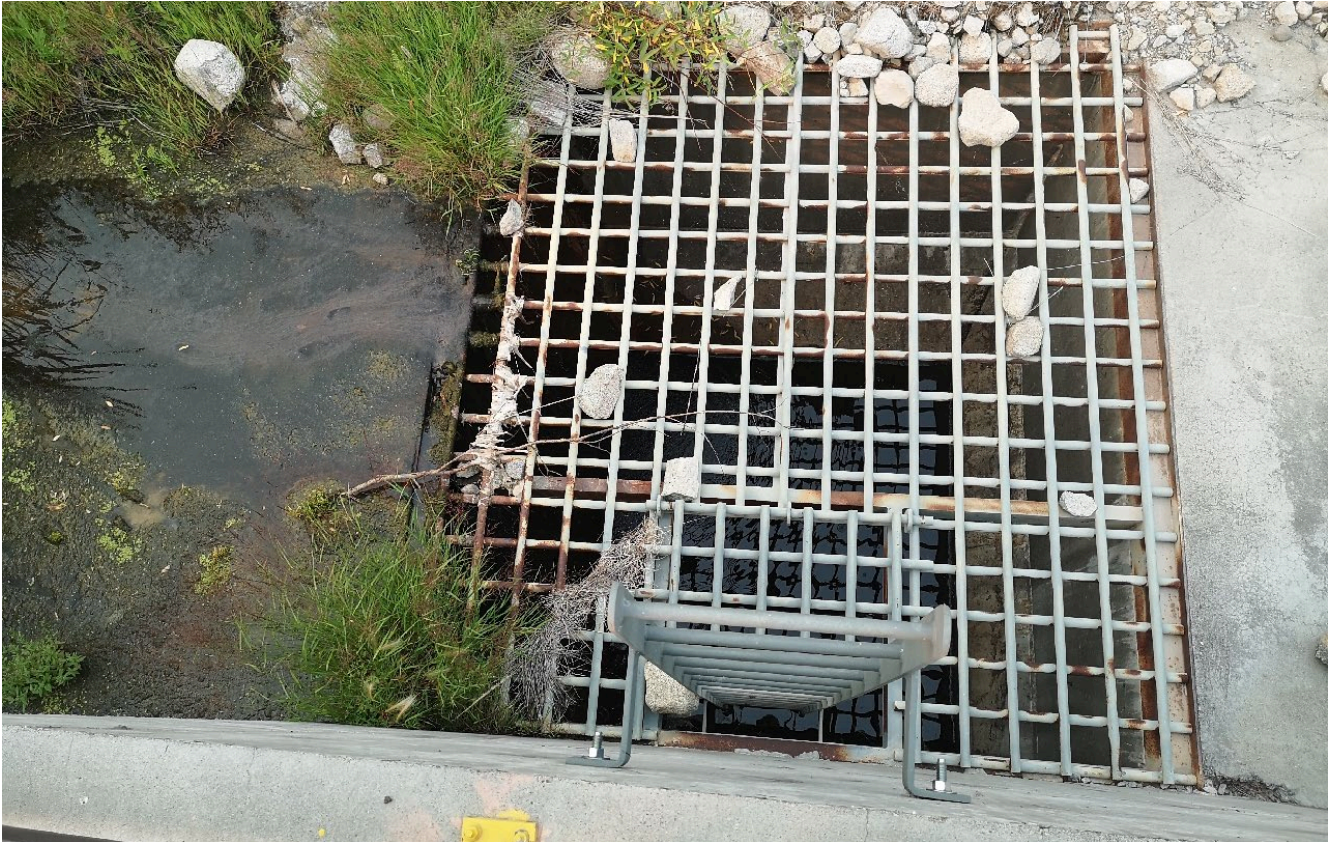
**Photo I-A-23 Highmont Spillway channel, S1 Pond diversion trash rack. Minor flow into the diversion. Trash rack is clear of debris. No flow downstream of diversion (HGH-2021-14)**

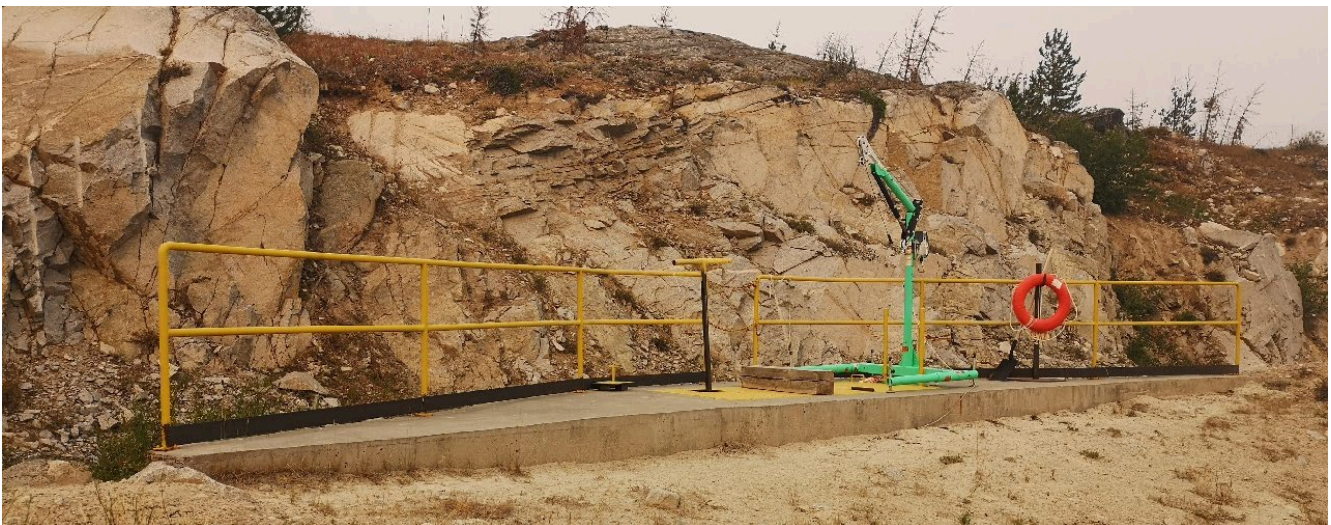
**Photo I-A-24 Highmont Spillway channel, S1 Pond diversion control (HGH-2021-14)**

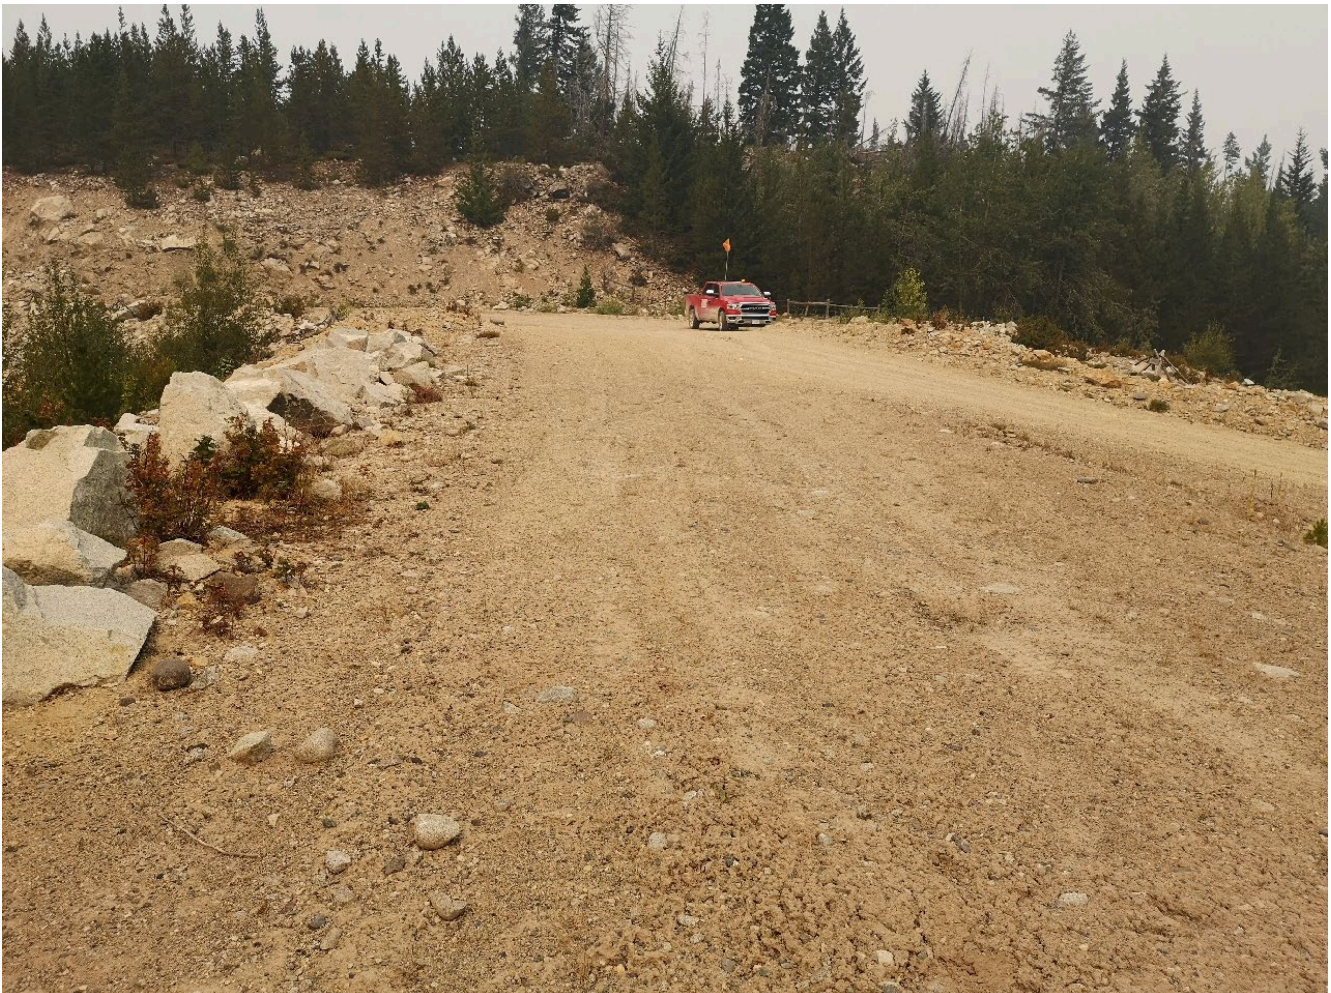
#### Photo I-B-1 S1 Pond: Overview of crest looking west towards left abutment (HGH-2021-18).

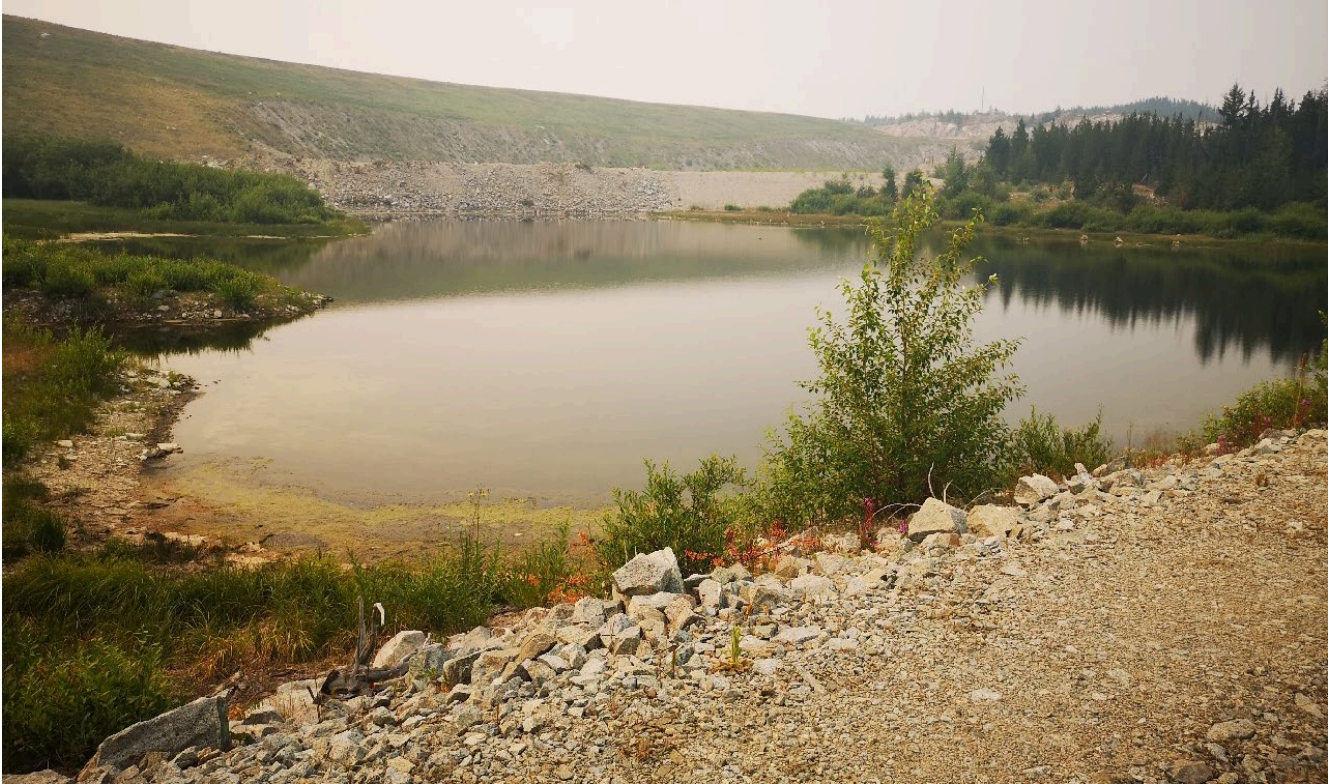
**Photo I-B-11 S2 Pond: S2 Pond with view of downstream slope of Highmont North Dam in the background (HGH-2021-21).**

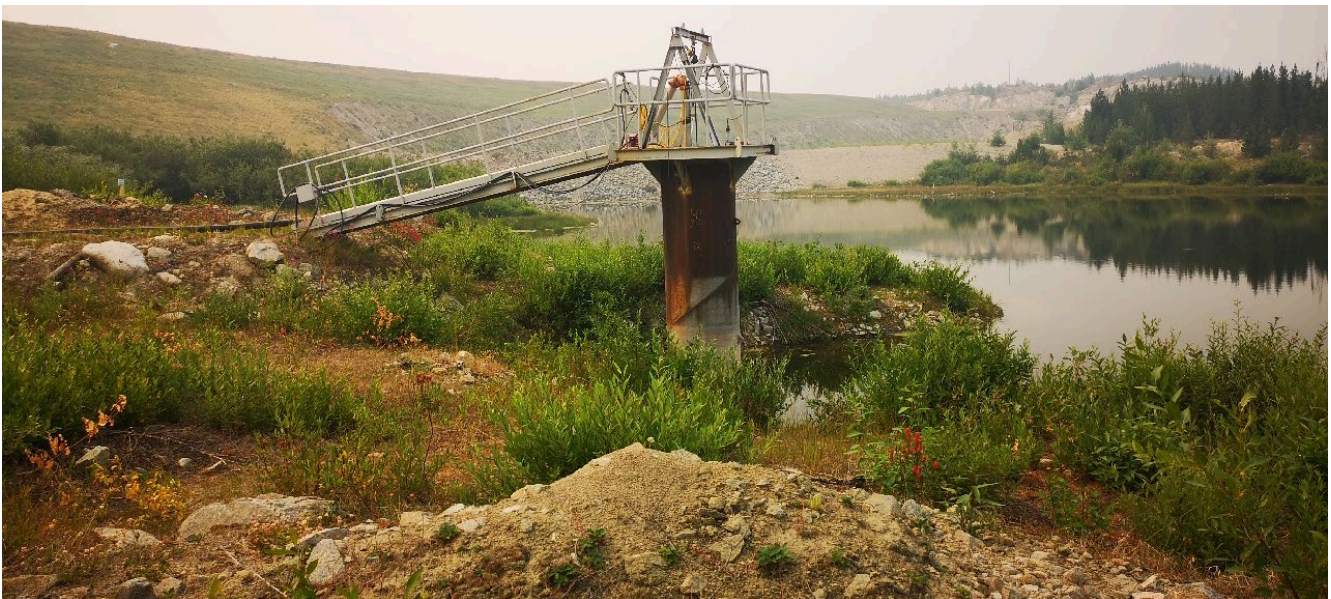
**Photo I-B-12 S2 Pond: Low-Level Outlet (HGH-2021-23).**

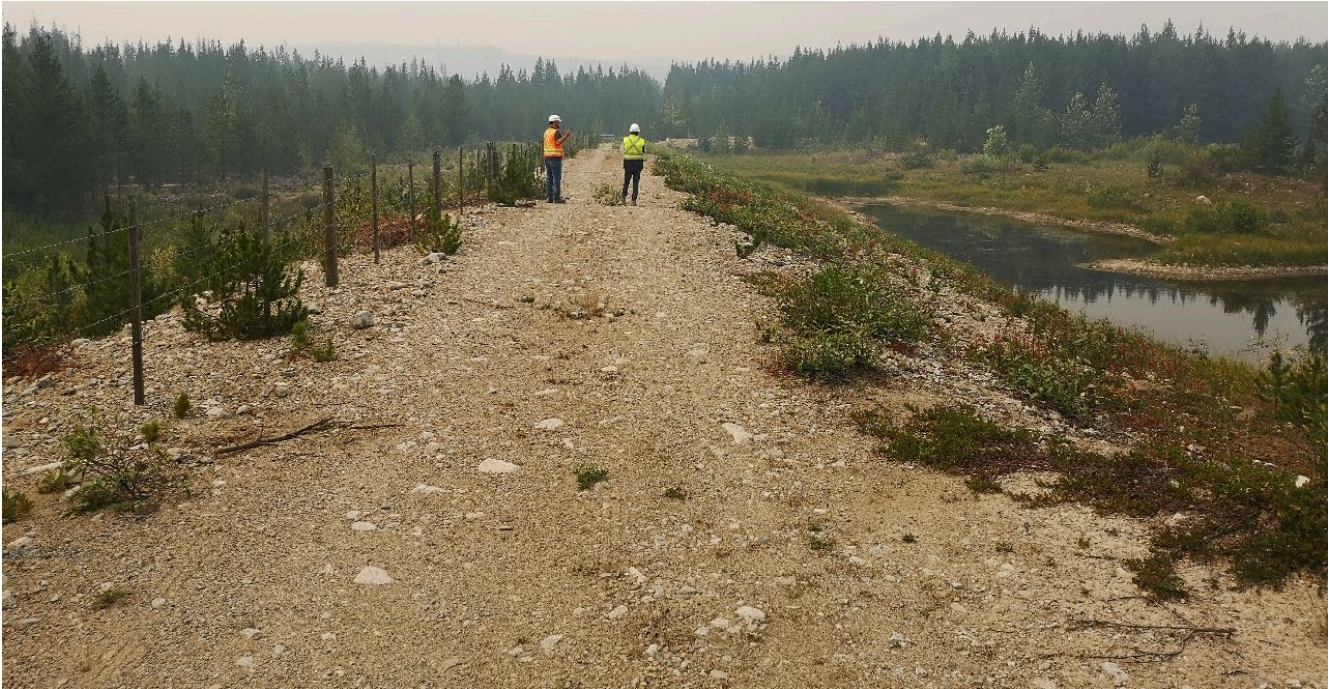
- **Downstream Slope:** Good physical condition. Slope is sparsely vegetated over the layer of gravel which provides adequate erosion protection based on performance over the service life (Photo I-B-20 to Photo I-B-22).

**Photo I-B-20 S3 Pond: Overview of downstream slope from right abutment (HGH-2021-27).**

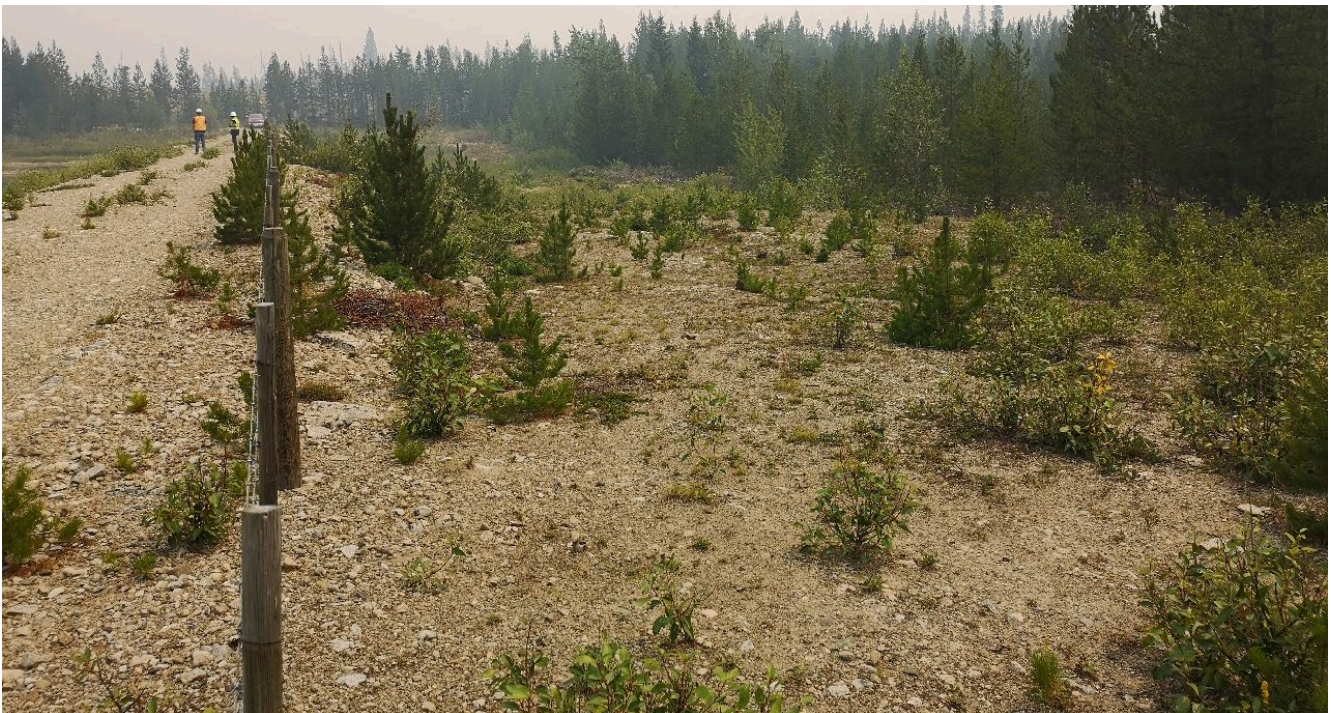
**Photo I-B-21 S3 Pond: Overview of downstream slope with small trees from mid dam (HGH-2021-28).**

S3-004	Significant vegetation (including trees) observed on crest and downstream slope. Continue to remove trees, however grassy vegetation on slopes can be left in place, provided steady-state conditions continue.	3	CLOSED (2021)	Closed after crest maintenance. Given the dam geometry (minimum crest width of 4 m and maximum dam height of 3.4 m), small trees on downstream slope are not considered a stability or seepage concern.

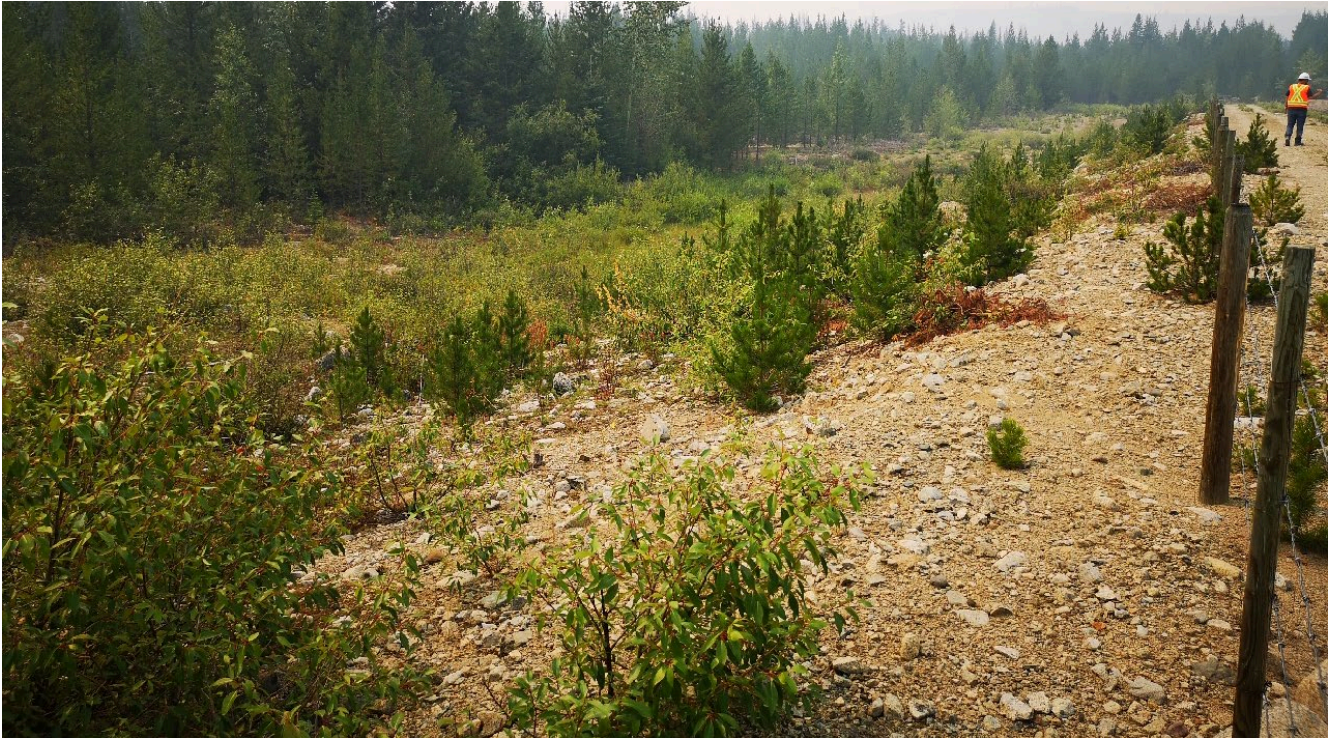
- **Left and Right Abutment:** Good physical condition. No observations of significant scour or other indicators of potential concern (e.g. cracking, slumping, horizontal displacement) (Photo I-B-23).

**Photo I-B-23 S3 Pond: Overview of upstream slope from right abutment (HGH-2021-27).**

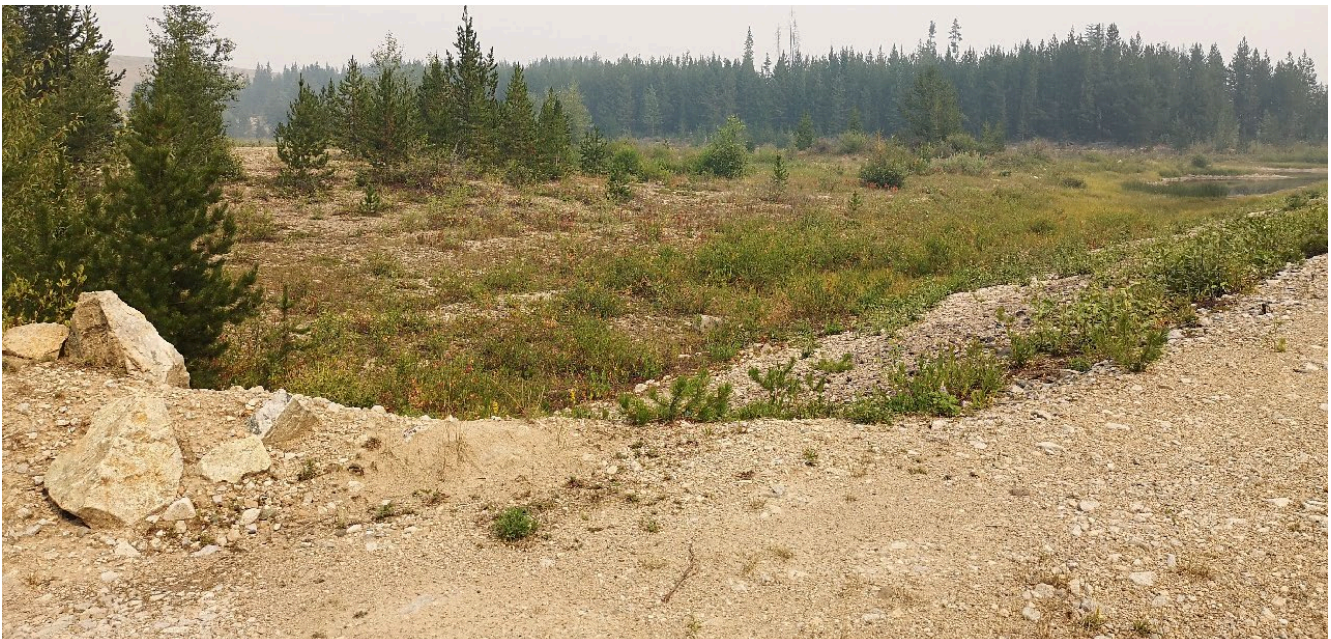
**Photo I-B-24 S3 Pond: Impoundment and Highmont South Dam slope in the background. View from S3 Pond left abutment, looking northwest (HGH-2021-29).**

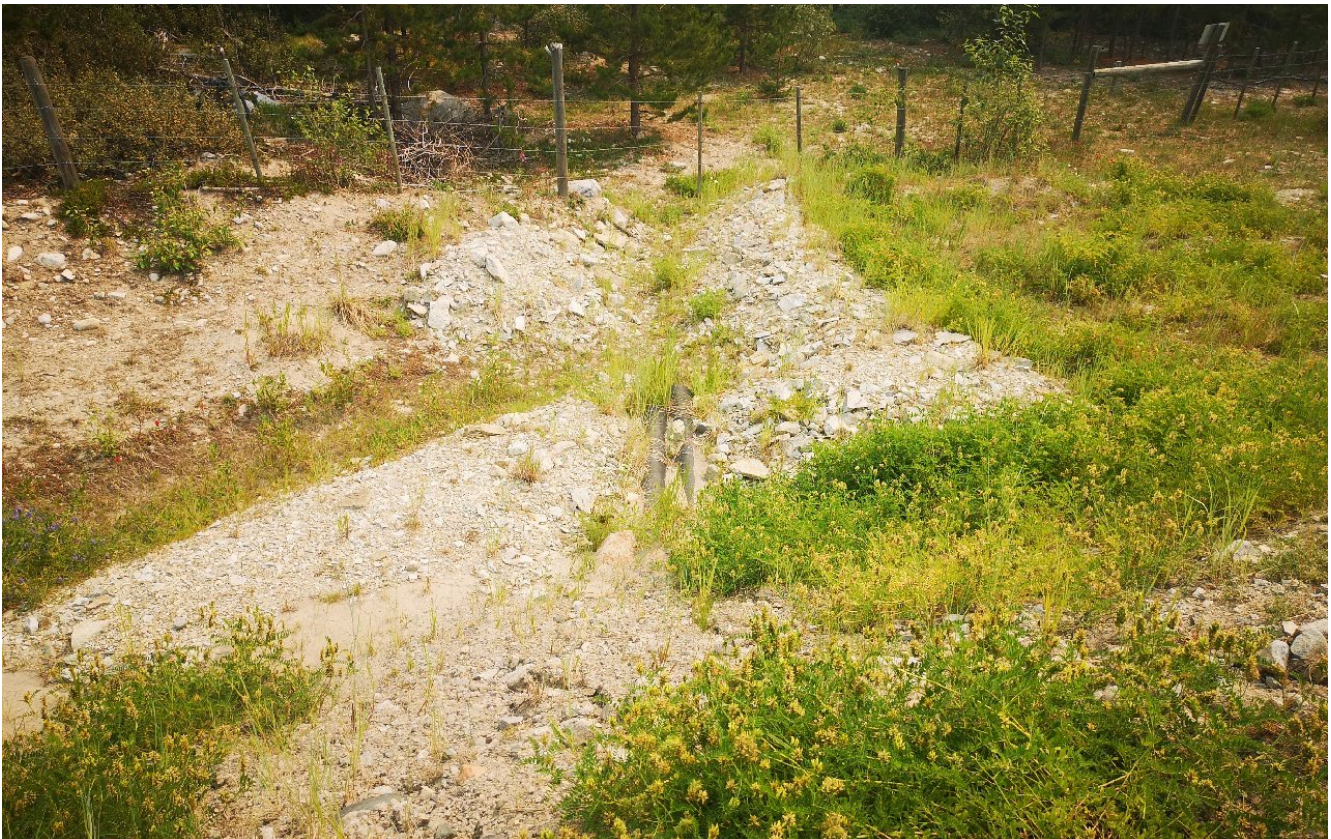
**Photo I-B-30 S5 Pond: Overview of Pumping Sub-cell (HGH-2021-34).**

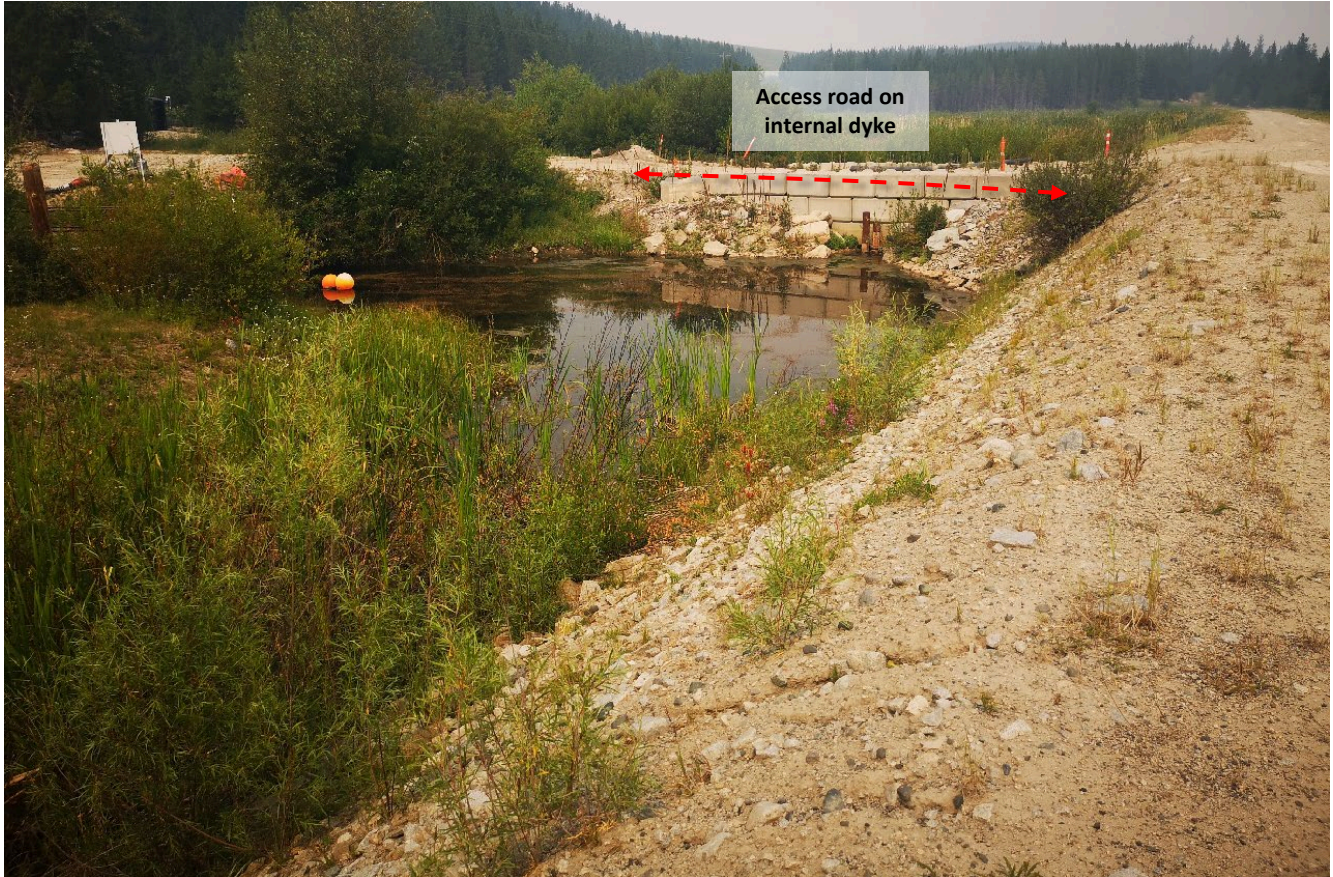
**Photo I-B-31 S5 Pond: Overview of S5 Pond basin (HGH-2021-32).**

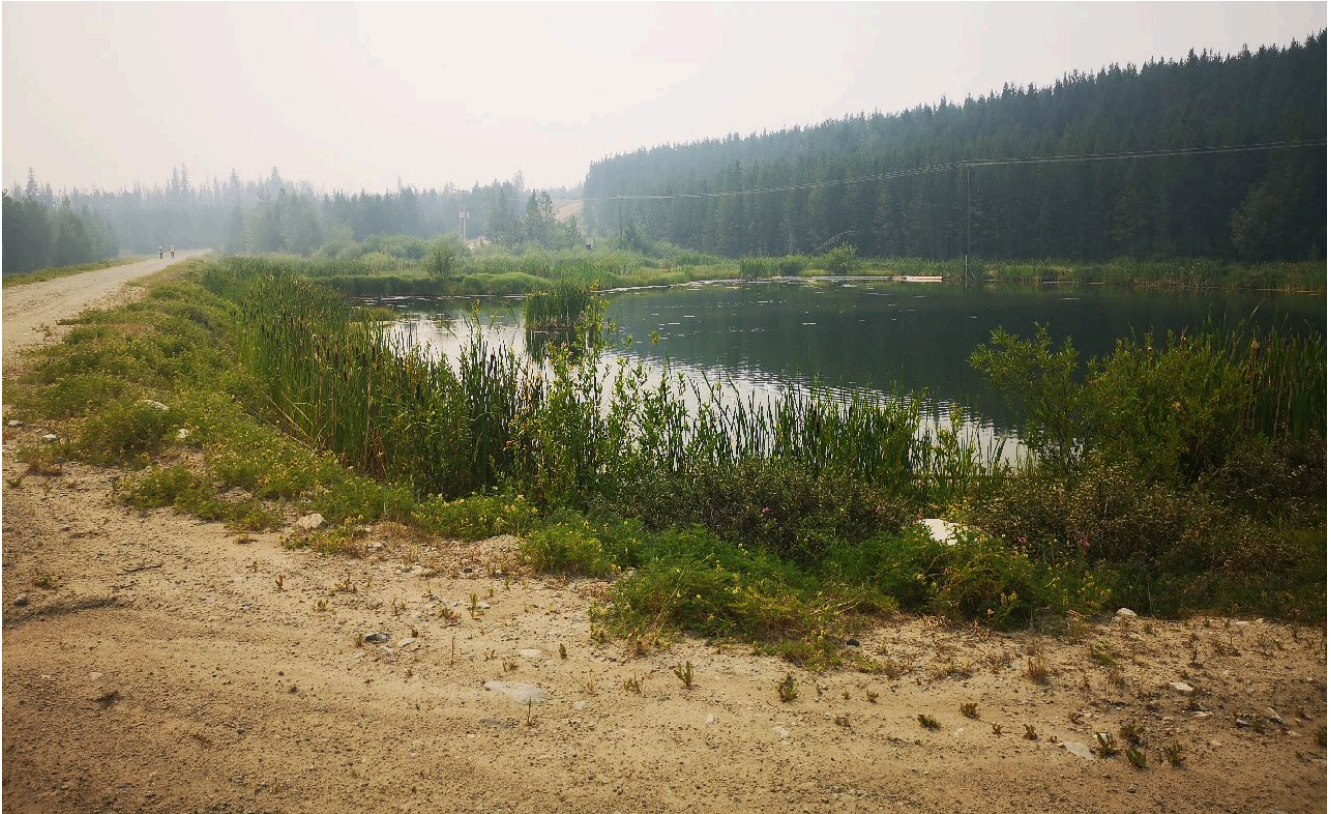
**Photo I-B-32 S5 Pond: Pumping Sub-cell spillway channel (HGH-2021-34).**

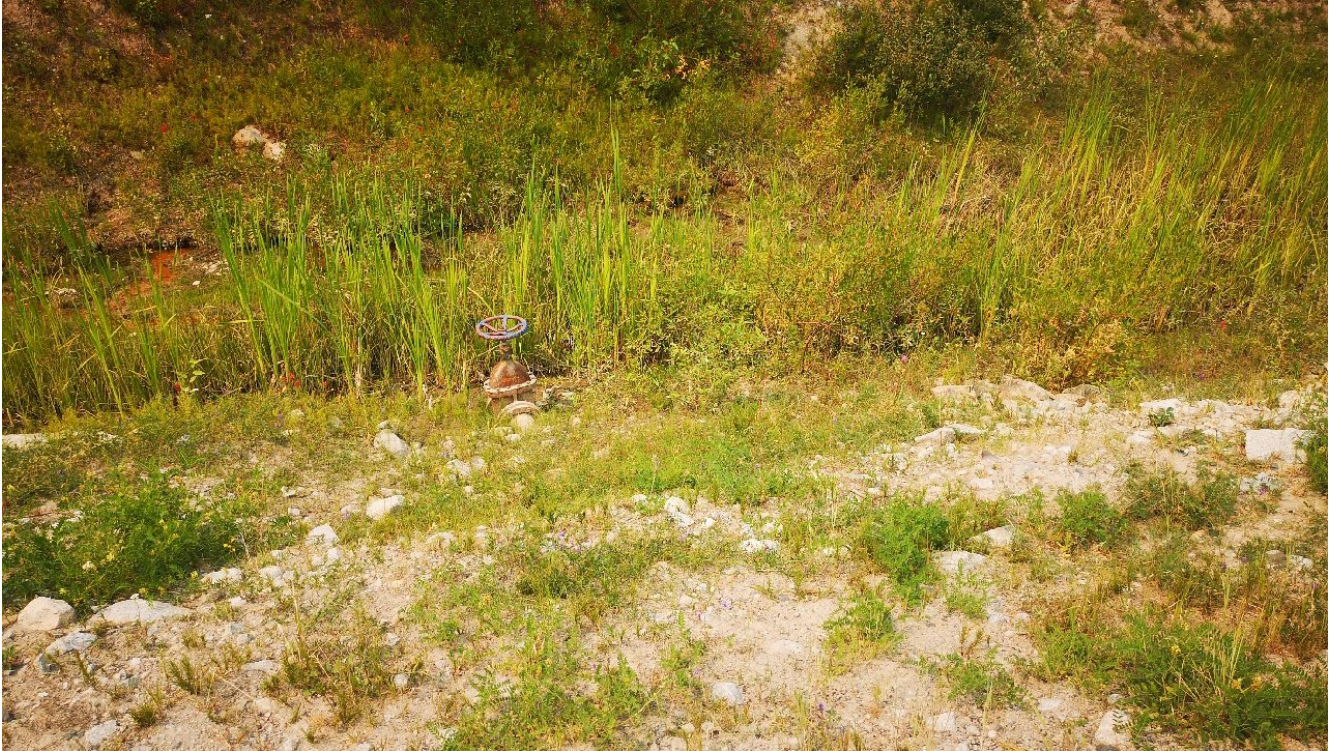
**Photo I-B-34 S5 Pond: Overview of downstream slope and Outlet #2 pipe daylighting at toe, looking east (HGH-2021-35).**

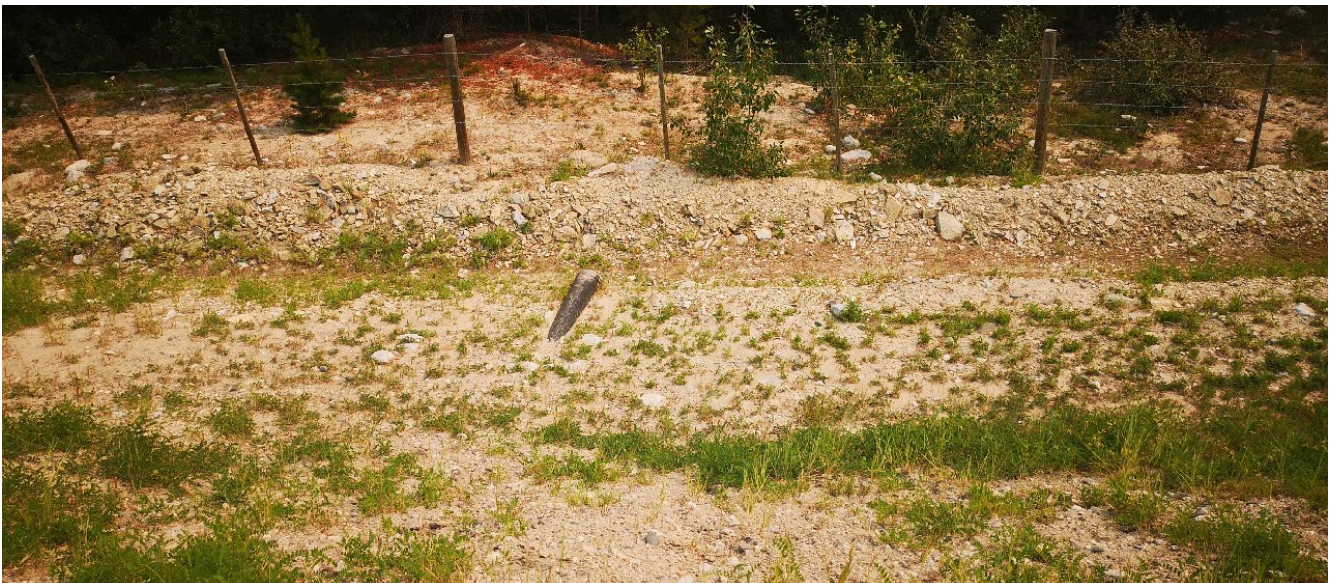
**Photo I-B-35 S5 Pond: Spillway Overflow pipes partially blocked at intake by sand bags. Potential animal burrow identified. KCB suggests clearing out vegetation from spillway channel and backfilling potential animal burrow (HGH-2021-36 and HGH-2021-37).**

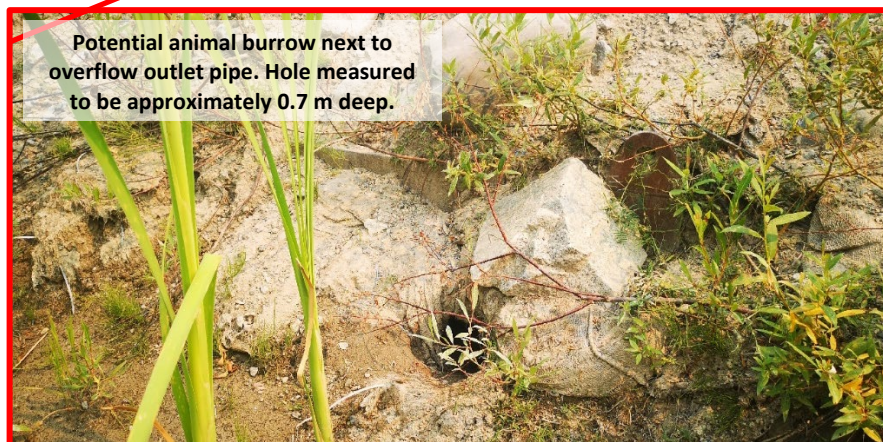
**Photo I-B-36 S5 Pond: Overview of downstream slope and S5 Overflow outlet pipes daylighting at toe, looking east (HGH-2021-36).**

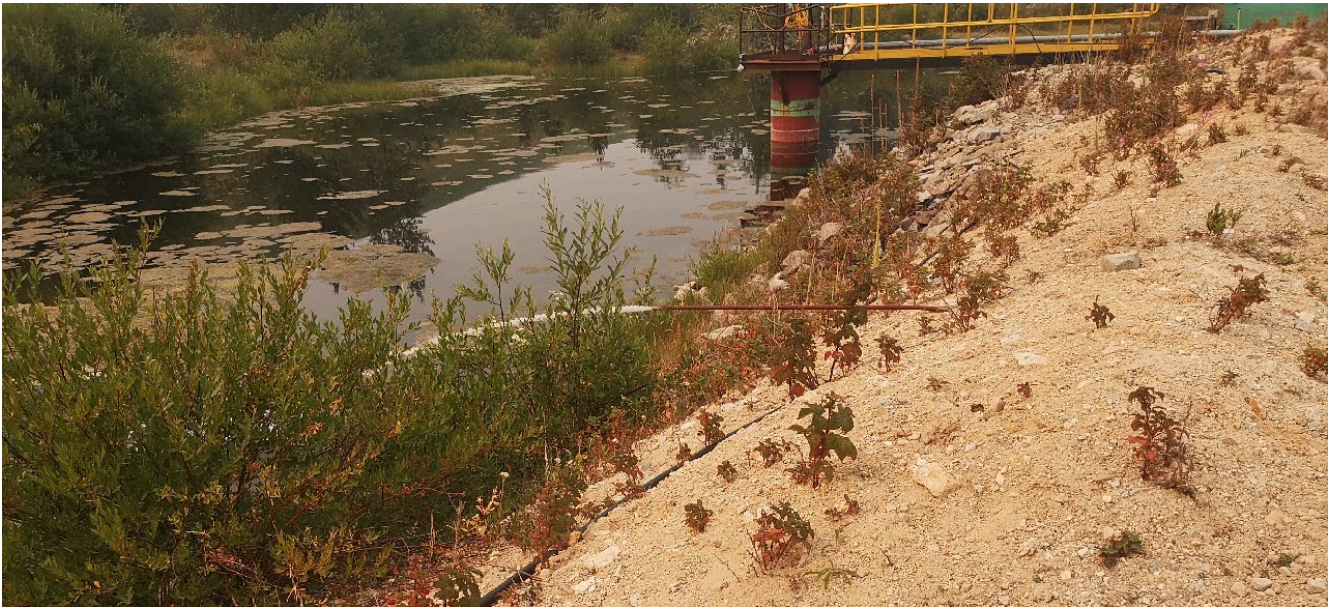
- **Crest:** Good physical condition. No signs of significant erosion, deterioration, displacement, or cracking (Photo I-B-38).
- **Left and Right Abutment:** Good physical condition. No signs of significant erosion, deterioration, displacement, or cracking.
- **Downstream Slope:** Good physical condition. Moderate vegetation throughout slope and large wood debris present. No observed signs of erosion, deterioration, or adverse displacement. (Photo I-B-39).
- **Pond:** At the time of the site visit the pond appeared lower in elevation when compared to the 2020 site visit. Less than 2 m below the crest of the dam (Photo I-B-40 and Photo I-B-41).
- **Spillway:** The outlet pipe was clear of debris (Photo I-B-42).
- **Seepage:** None observed.

**Photo I-B-42 S8 Pond: Overview of overflow pipe trash rack. Rack is clear of debris. Current water level is below the invert (HGH-2021-40).**
