2022 Annual Facility Performance Review

Sä Dena Hes Mine, Yukon Territory
Teck Resources Limited

SRK Consulting (Canada) Inc. ■ CAPR001928 ■ November 2022

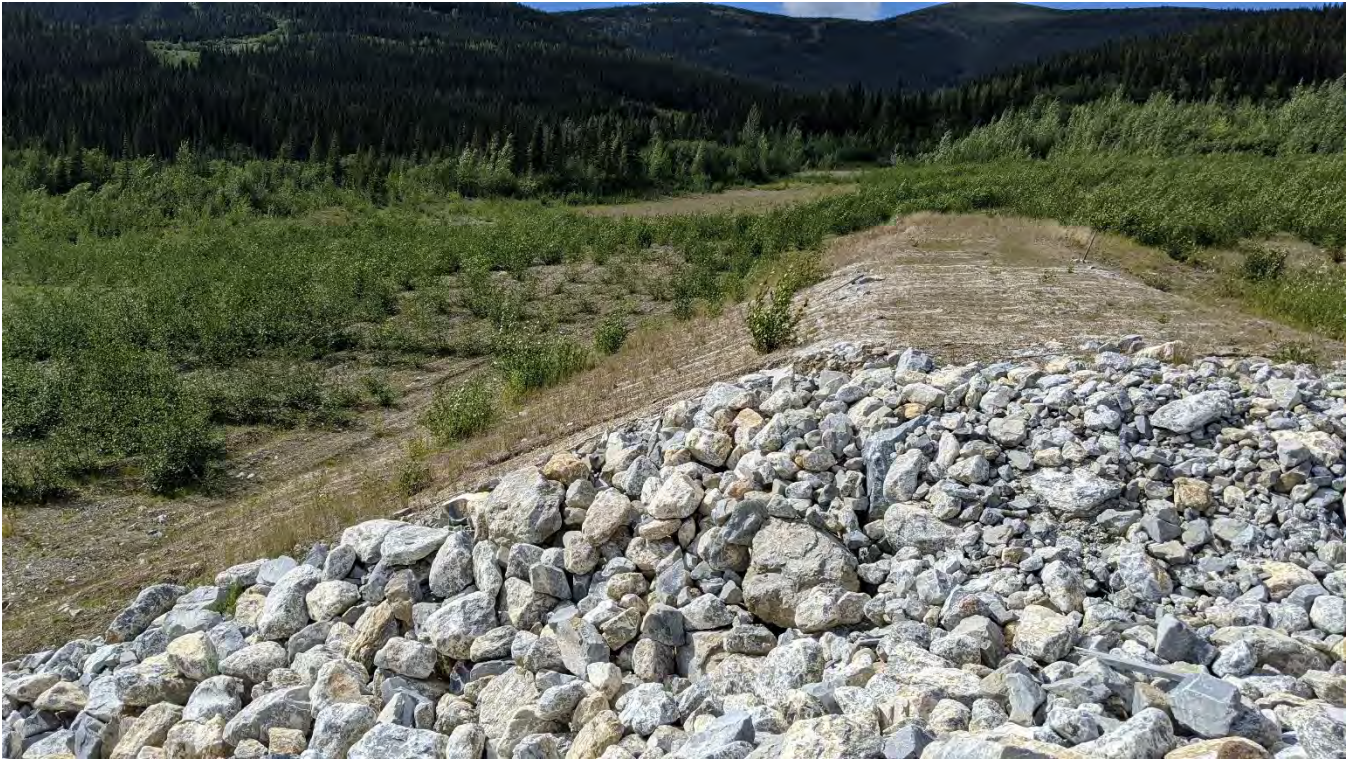
Photo SRS-03: Crest and downstream slope of the SRS looking west from the spillway.

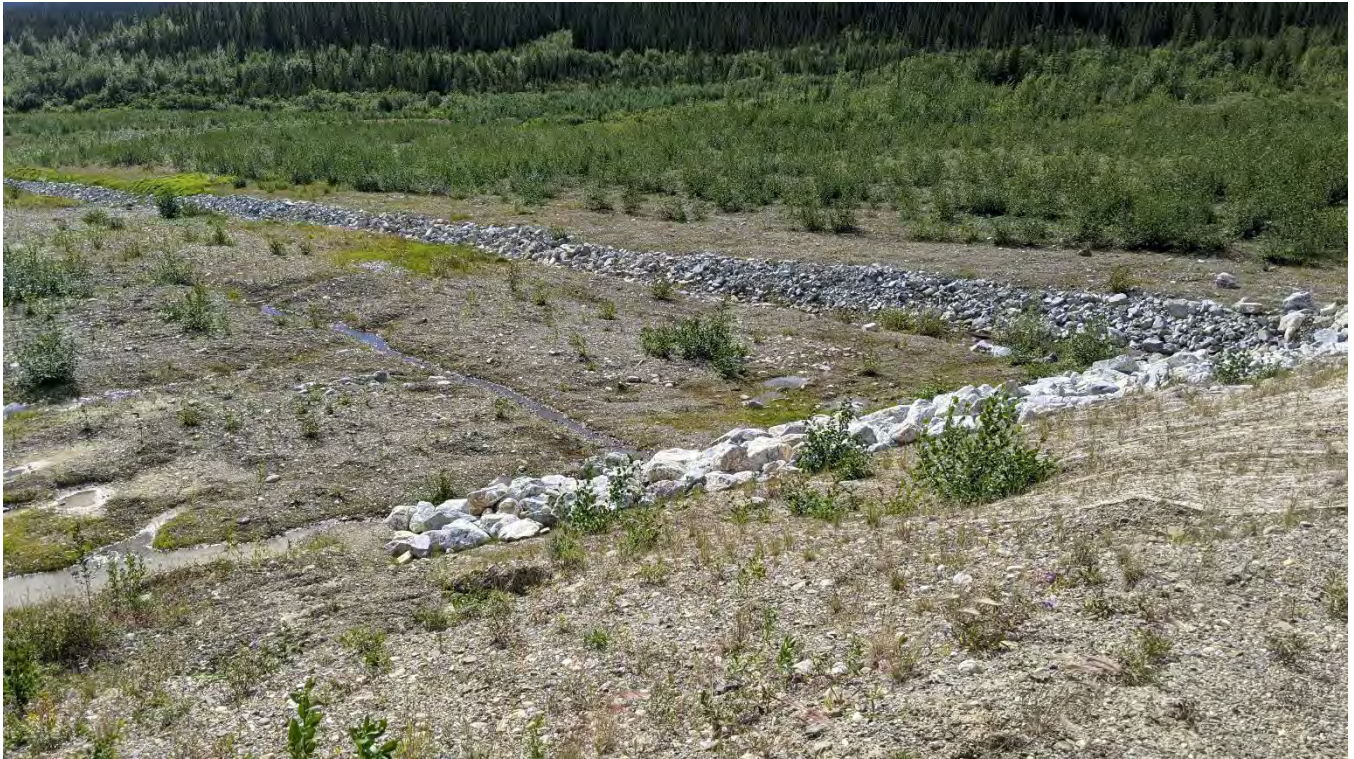
Photo SRS-05: Downstream face of the SRS on the east side of the spillway looking southwest.

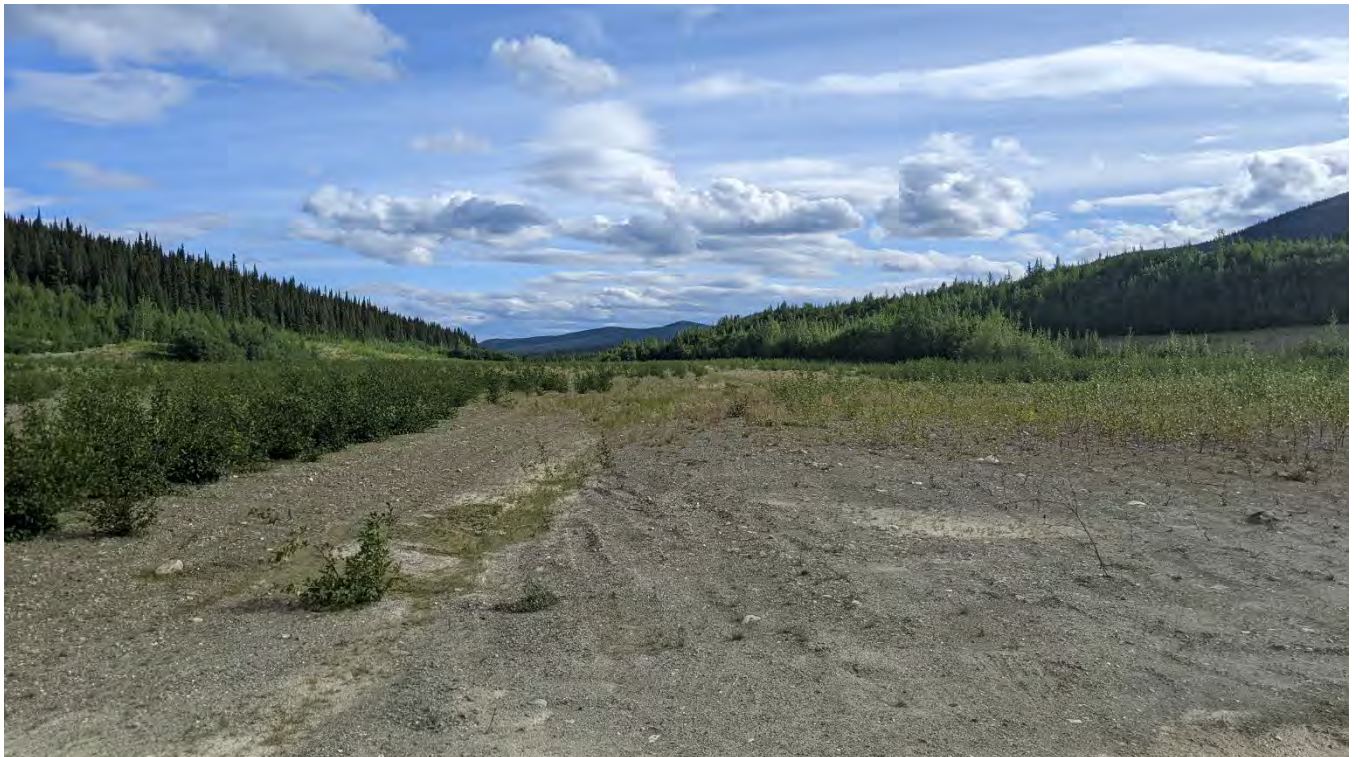
Photo TC-02: Upstream end of the Main drainage swale taken from the North Dam looking south.

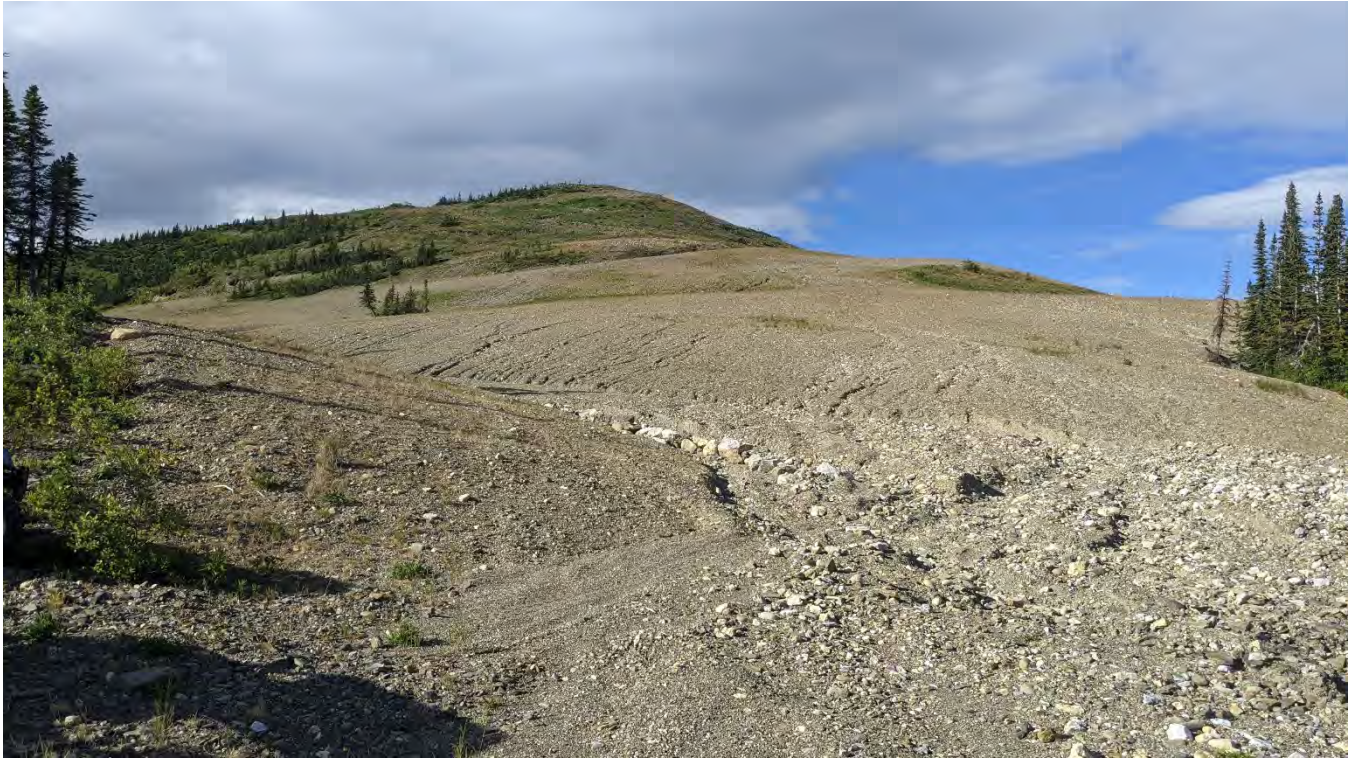
Photo WR-03: Jewelbox Waste Rock Dump looking upstream from the erosion gully (Photo WR-04).

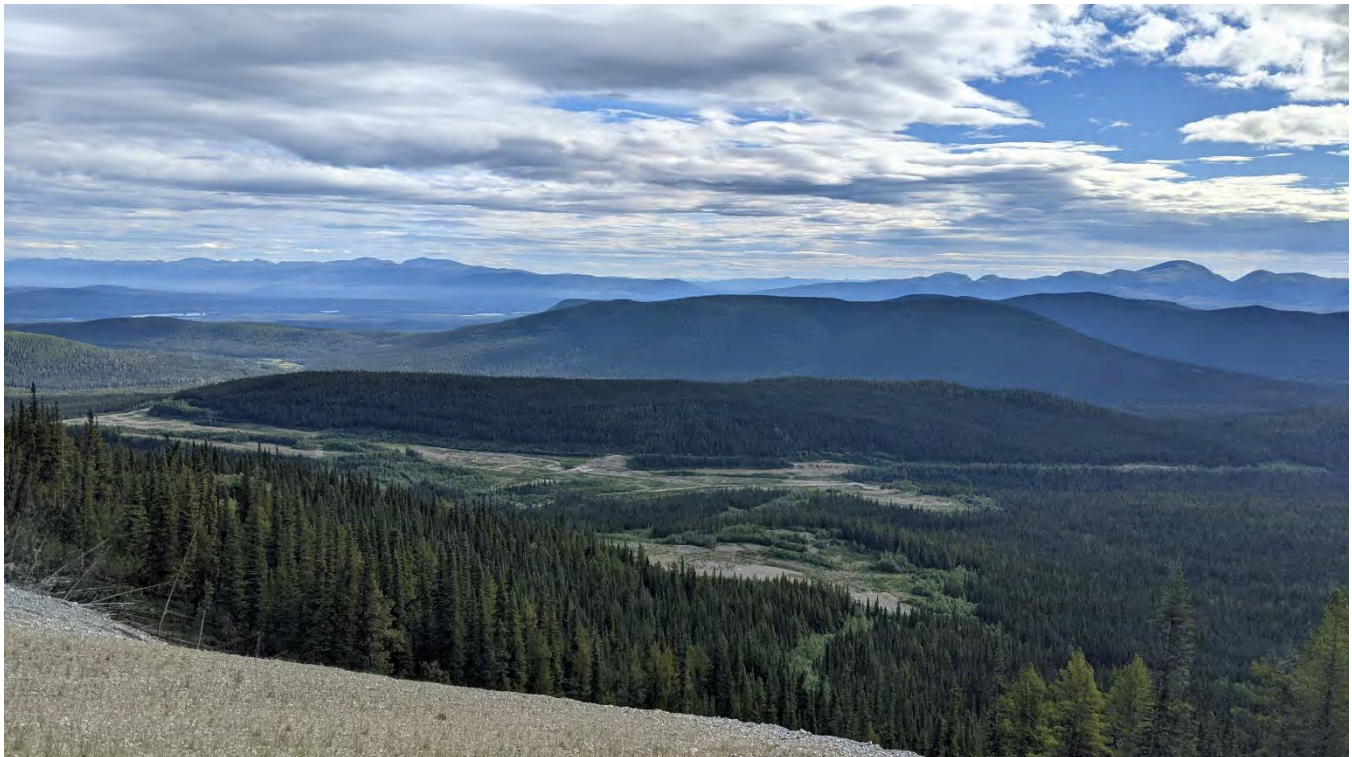
Photo WR-06: Overview of the TMA taken from the 1408 Portal Waste Rock Dump.

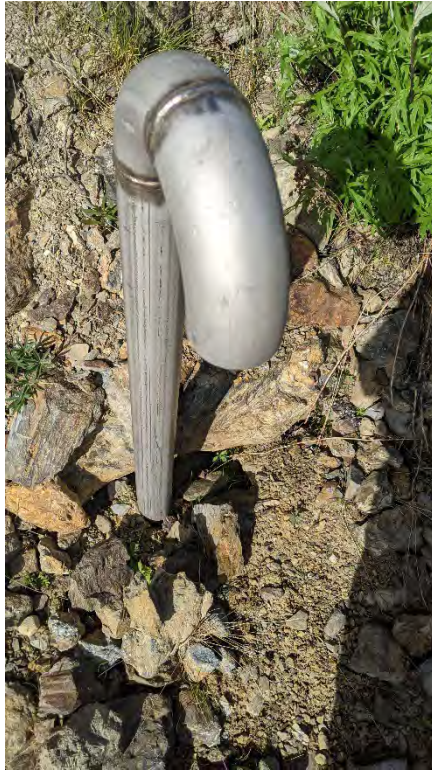
Photo WR-09: Vent pipe from the 1408 portal.

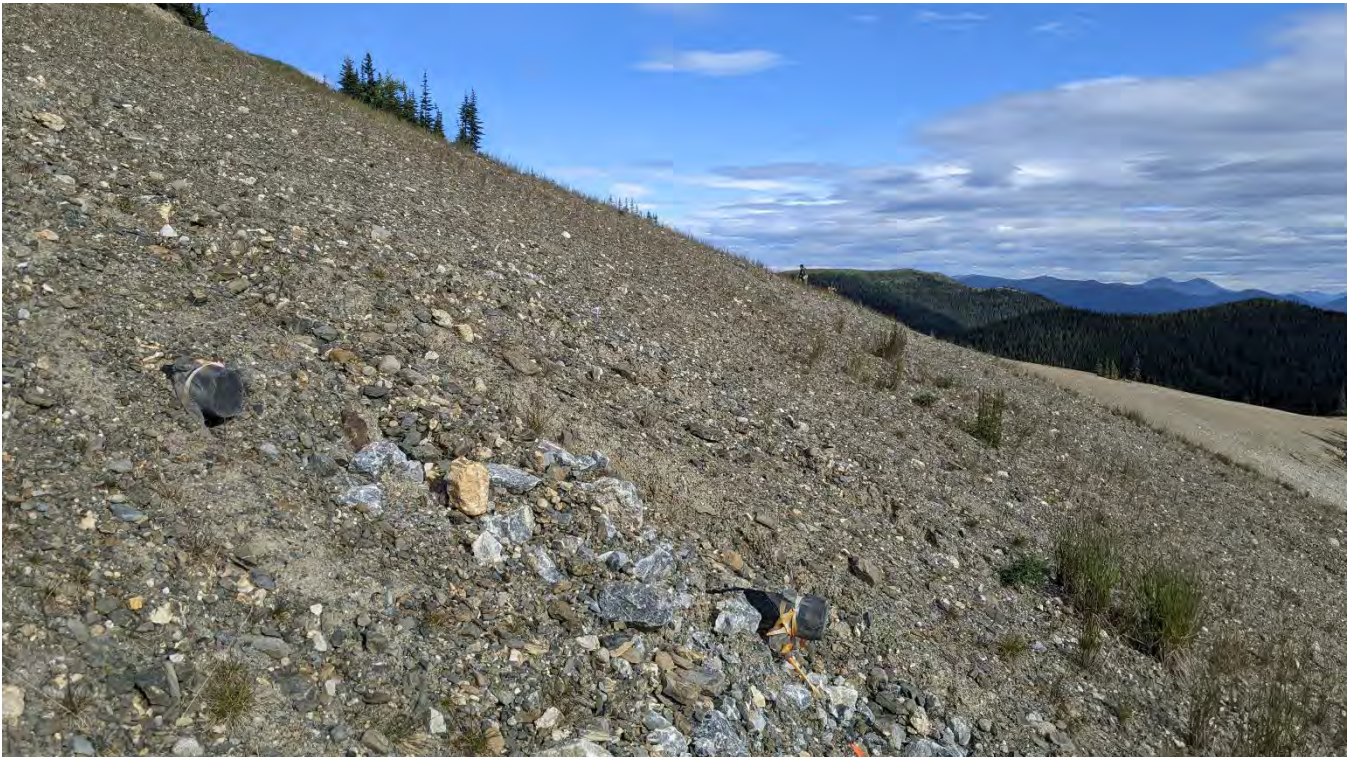
Photo WR-10: Drainpipes from the 1408 Portal.

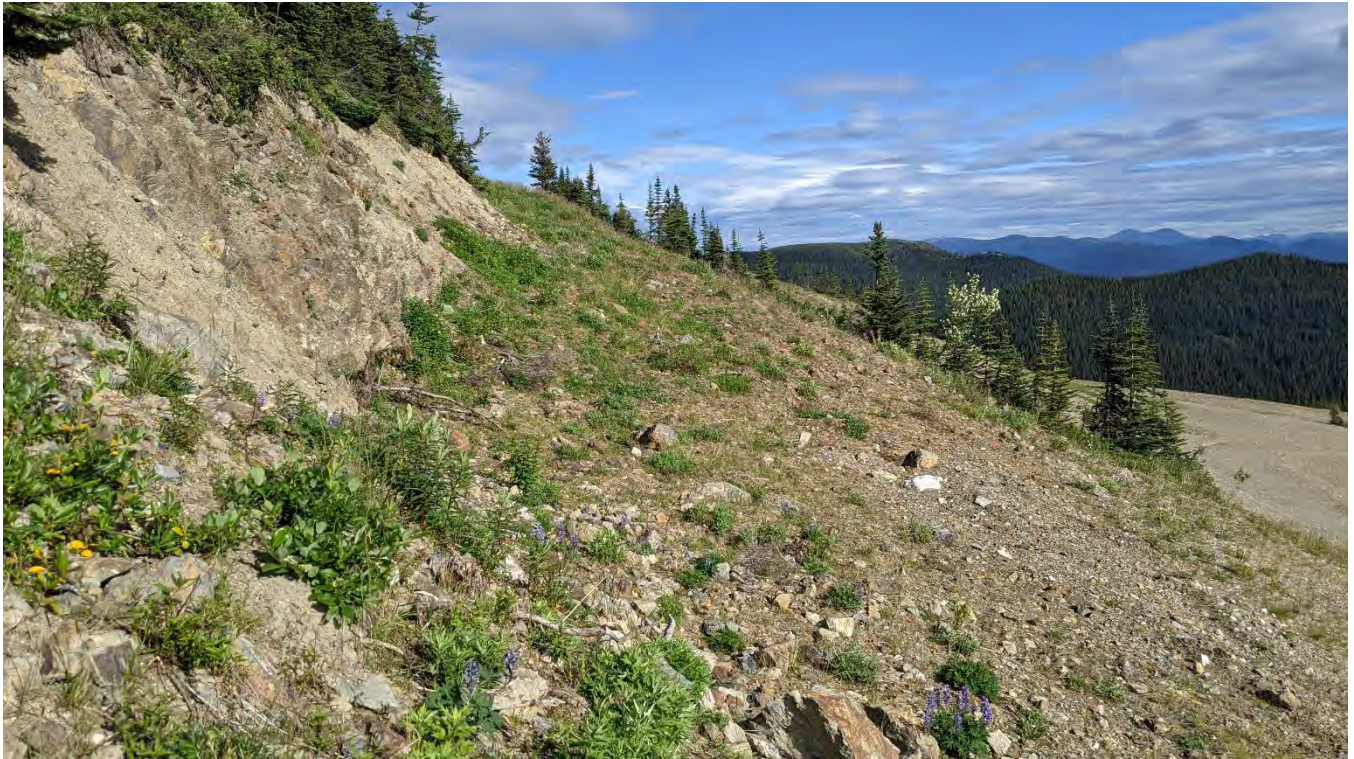
Photo WR-11: Fill placement above the 1408 Portal looking north.

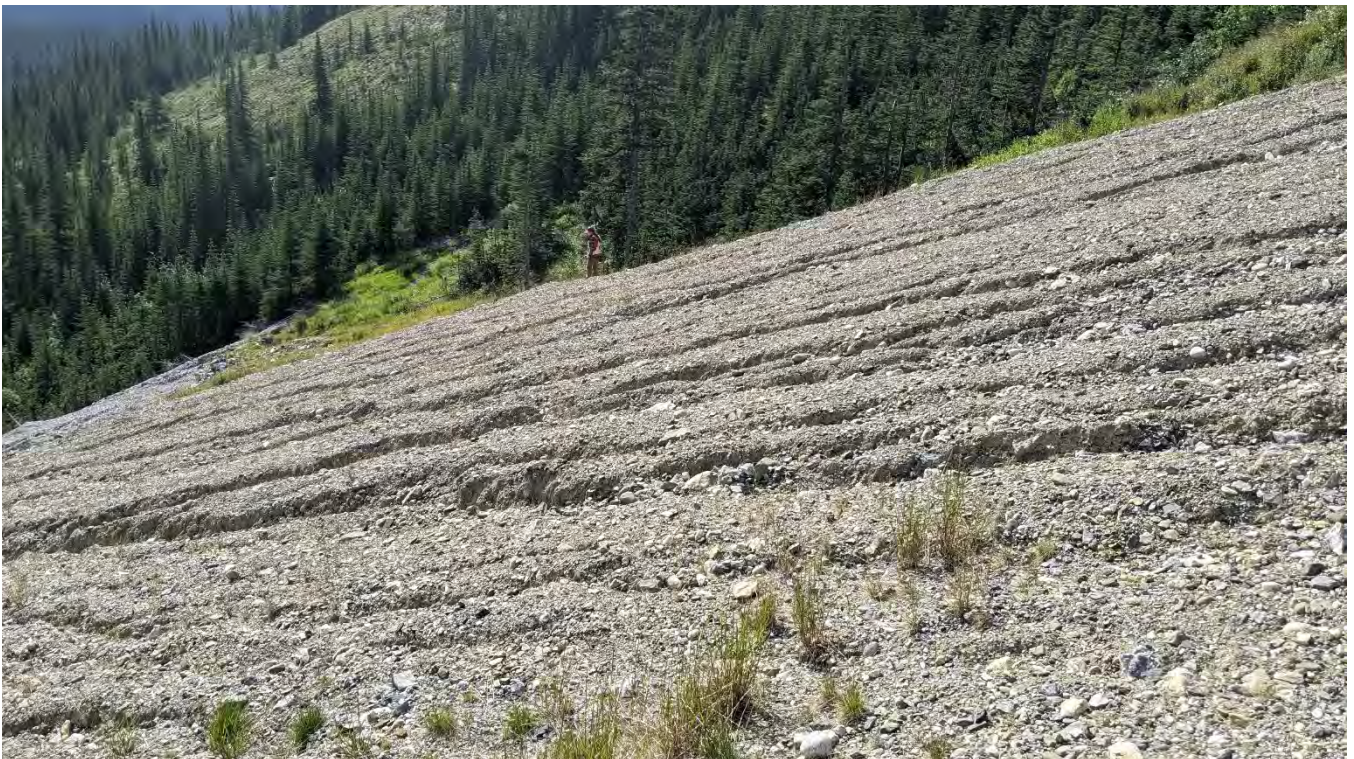
Photo WR-12: Rill erosion at the south end of the 1408 Portal Waste Rock Dump looking southeast.

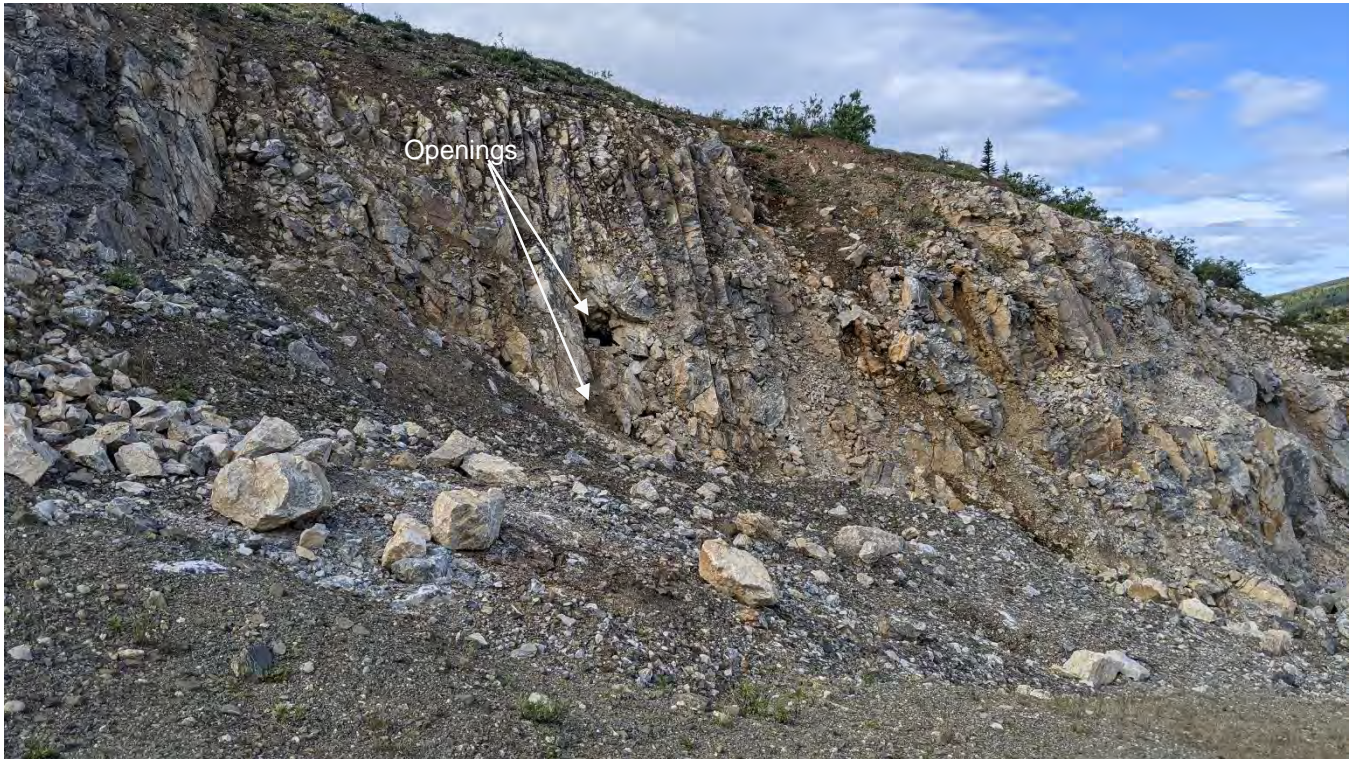
Photo WR-13: Openings in the Jewelbox Pit wall above the Main Zone Waste Rock Dump

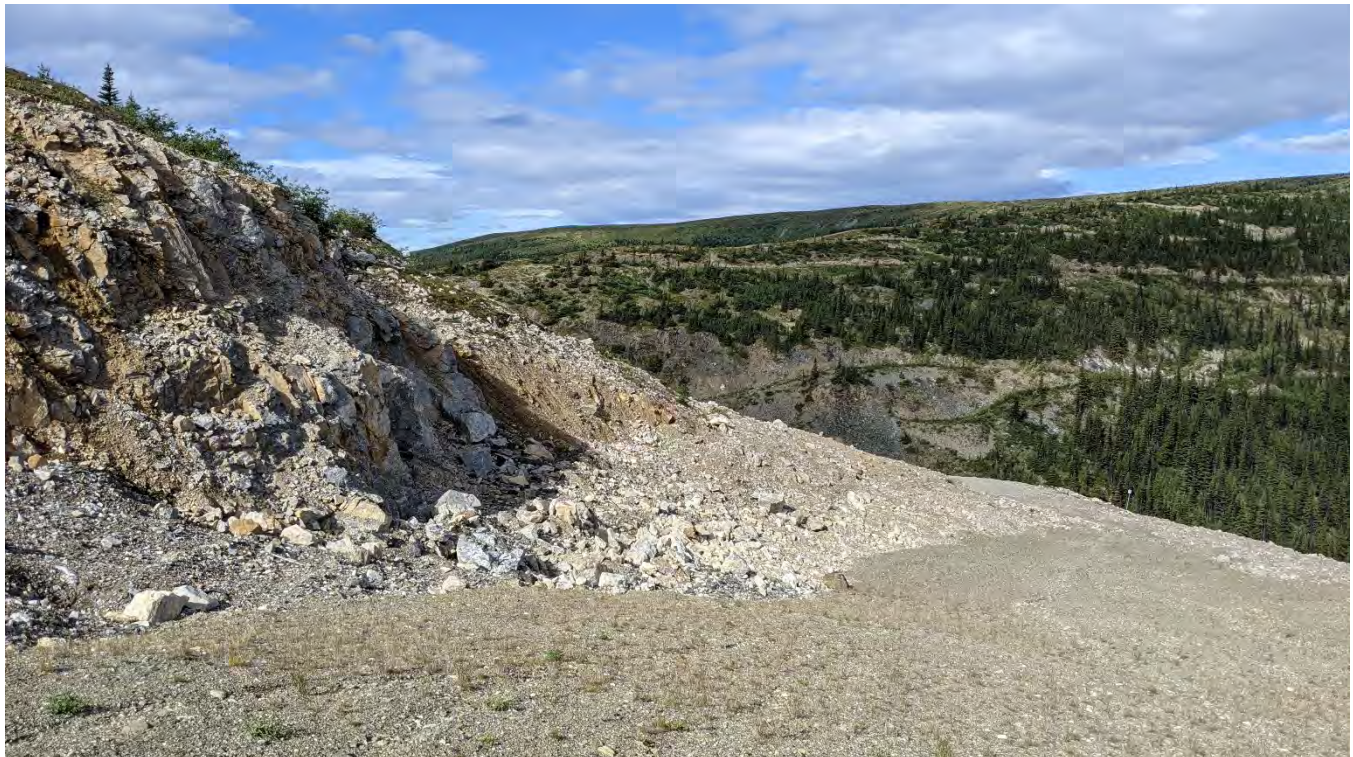
Photo WR-14: Jewelbox Pit wall looking west.

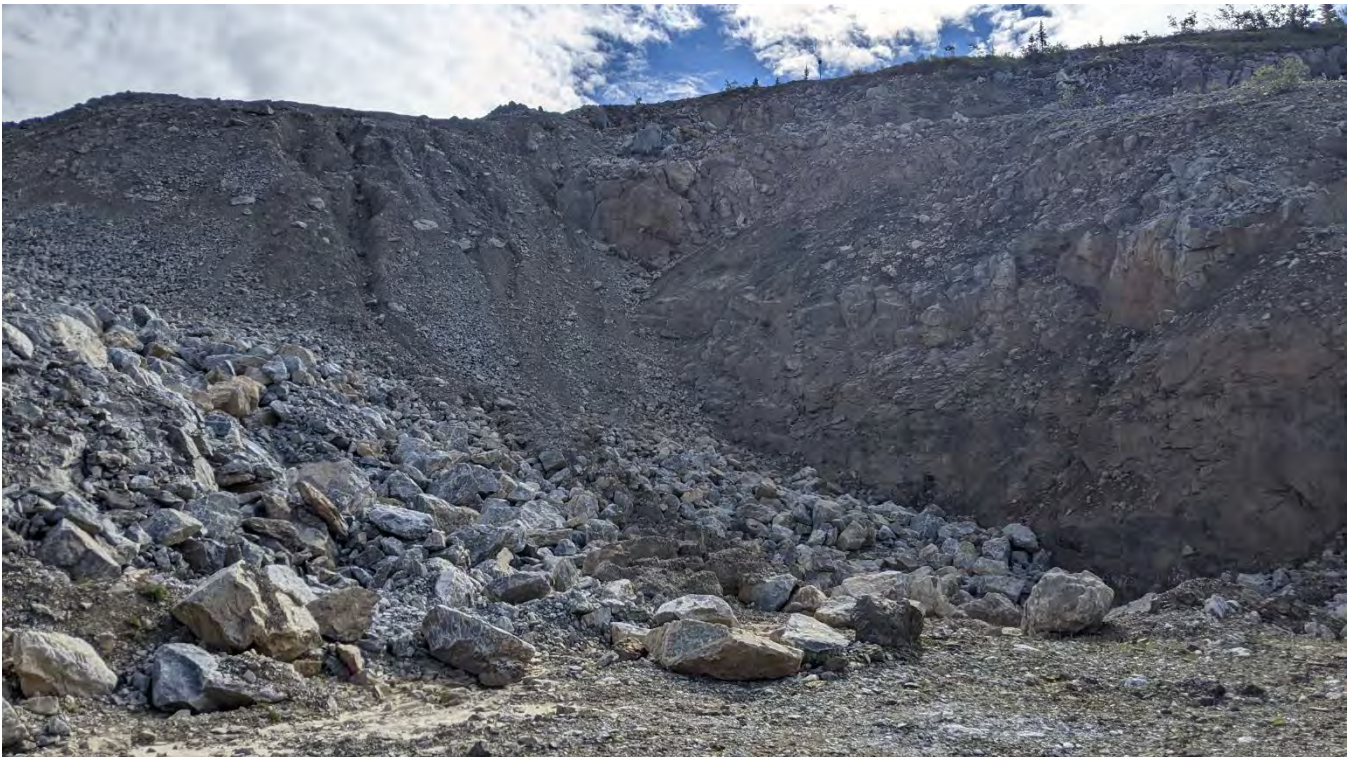
Photo WR-16: Backfill at the 1380 Portal below Main Zone Waste Rock Dump.

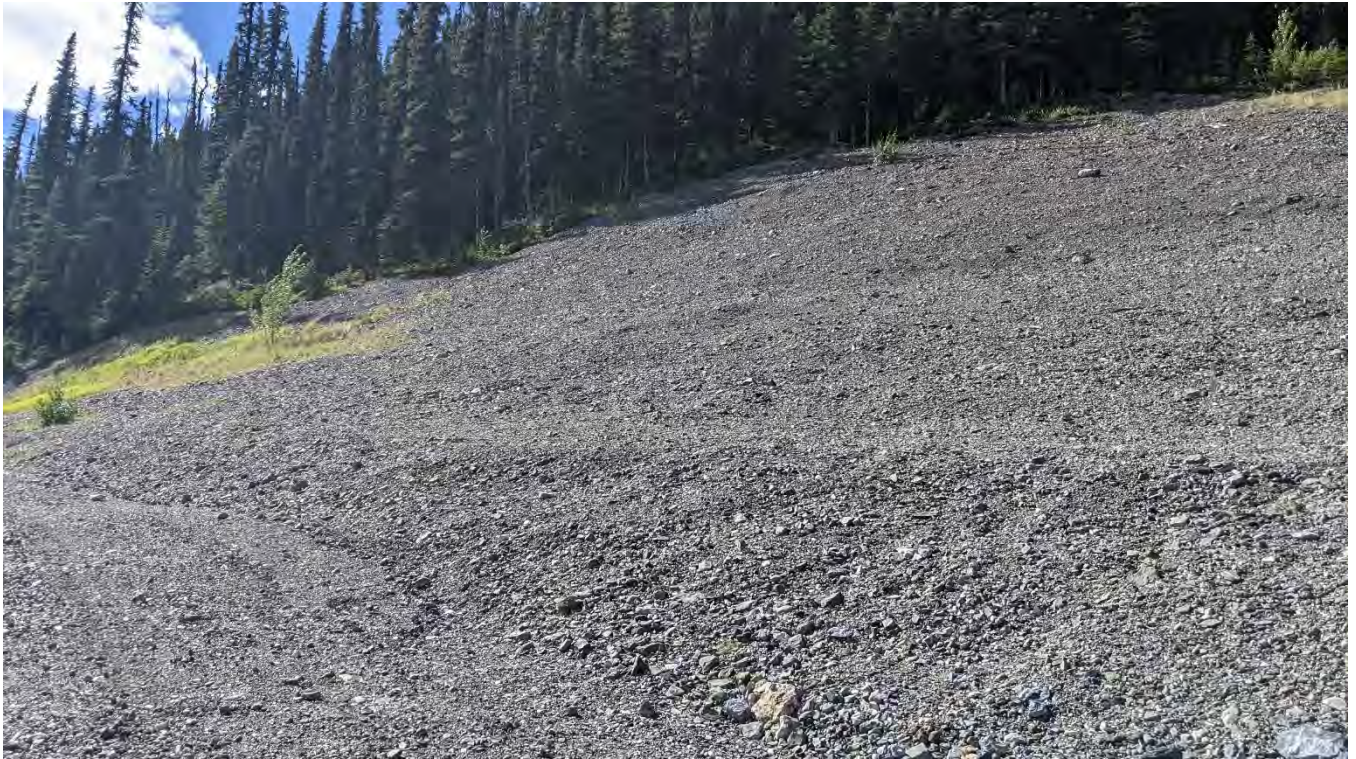
Photo WR-17: Regraded Burnick Waste Rock Dump at the 1200 Portal.

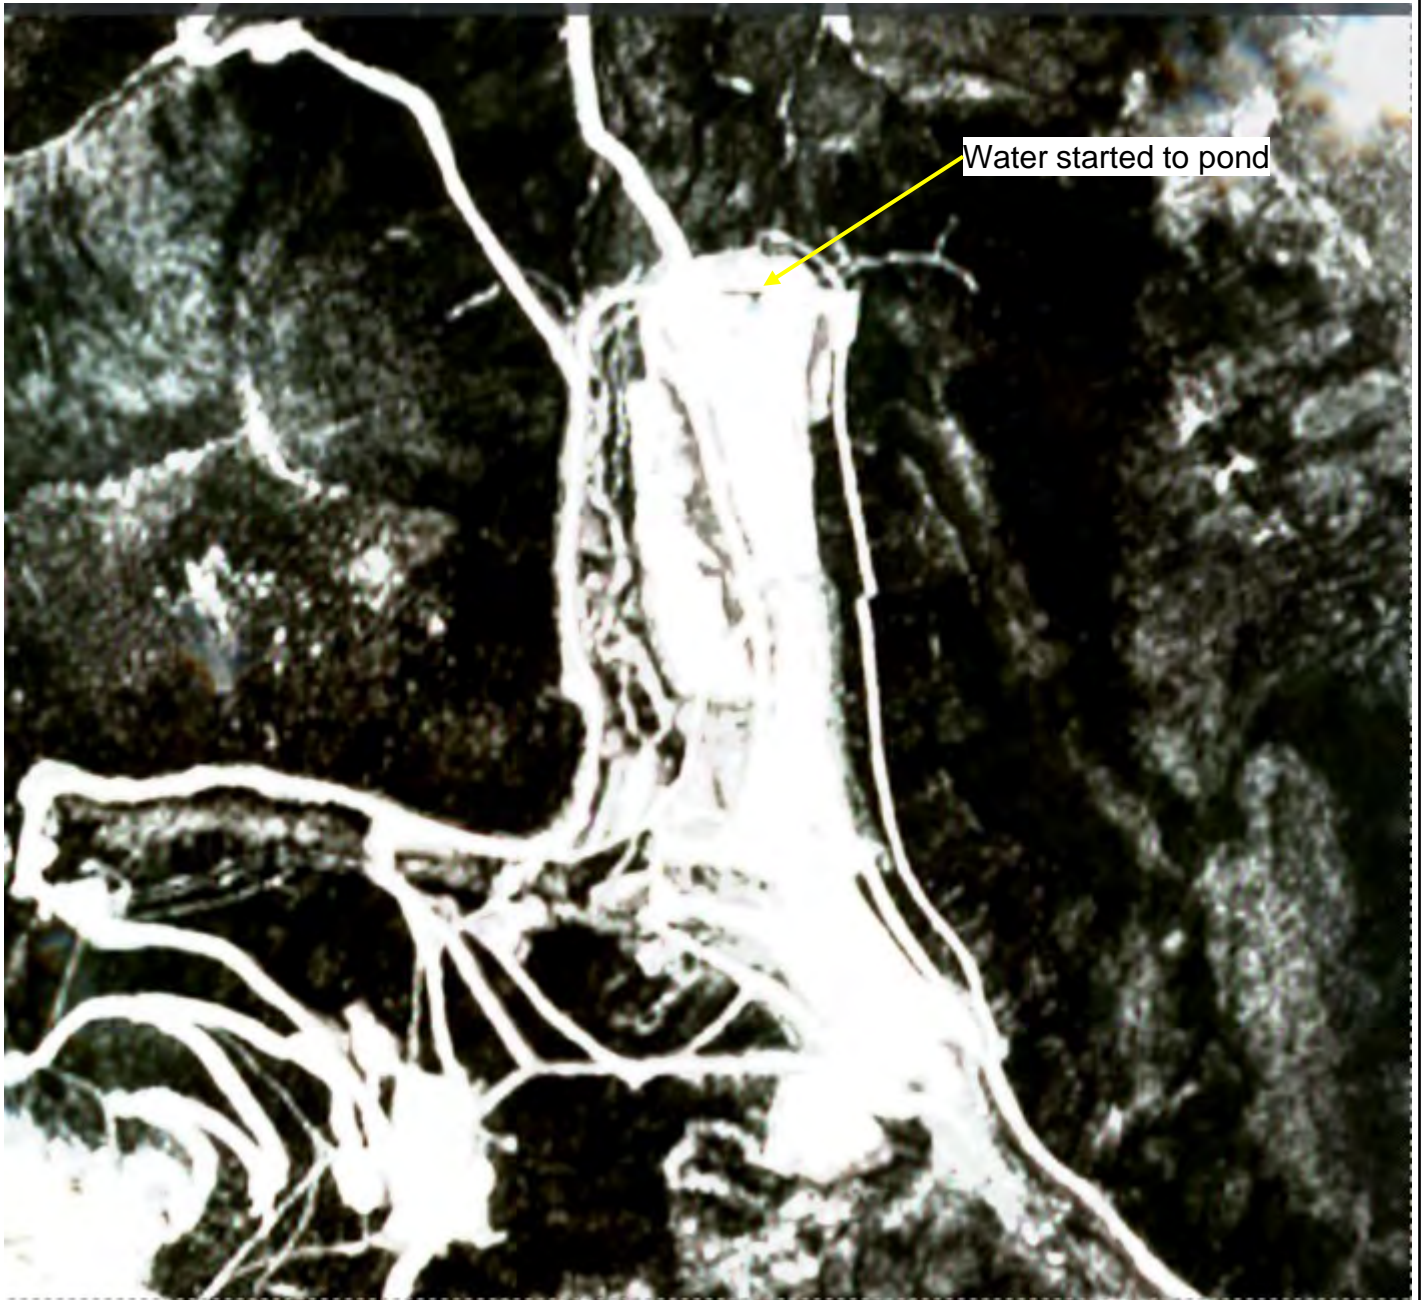
Figure: **B-2**

Water started to pond

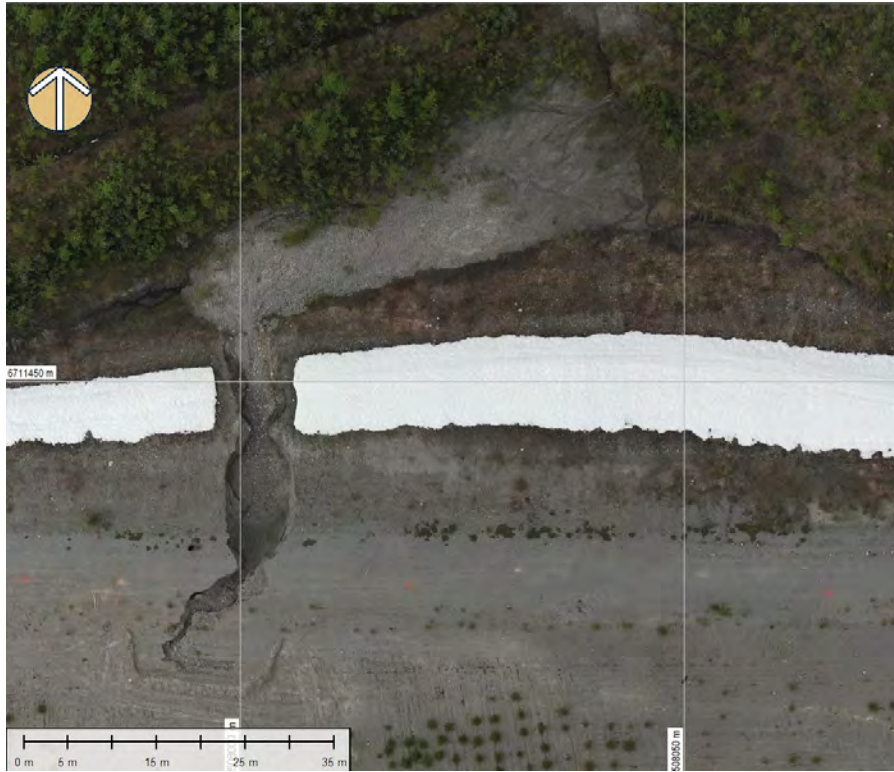
Photo 1: Drone Orthophoto - June 20, 2022

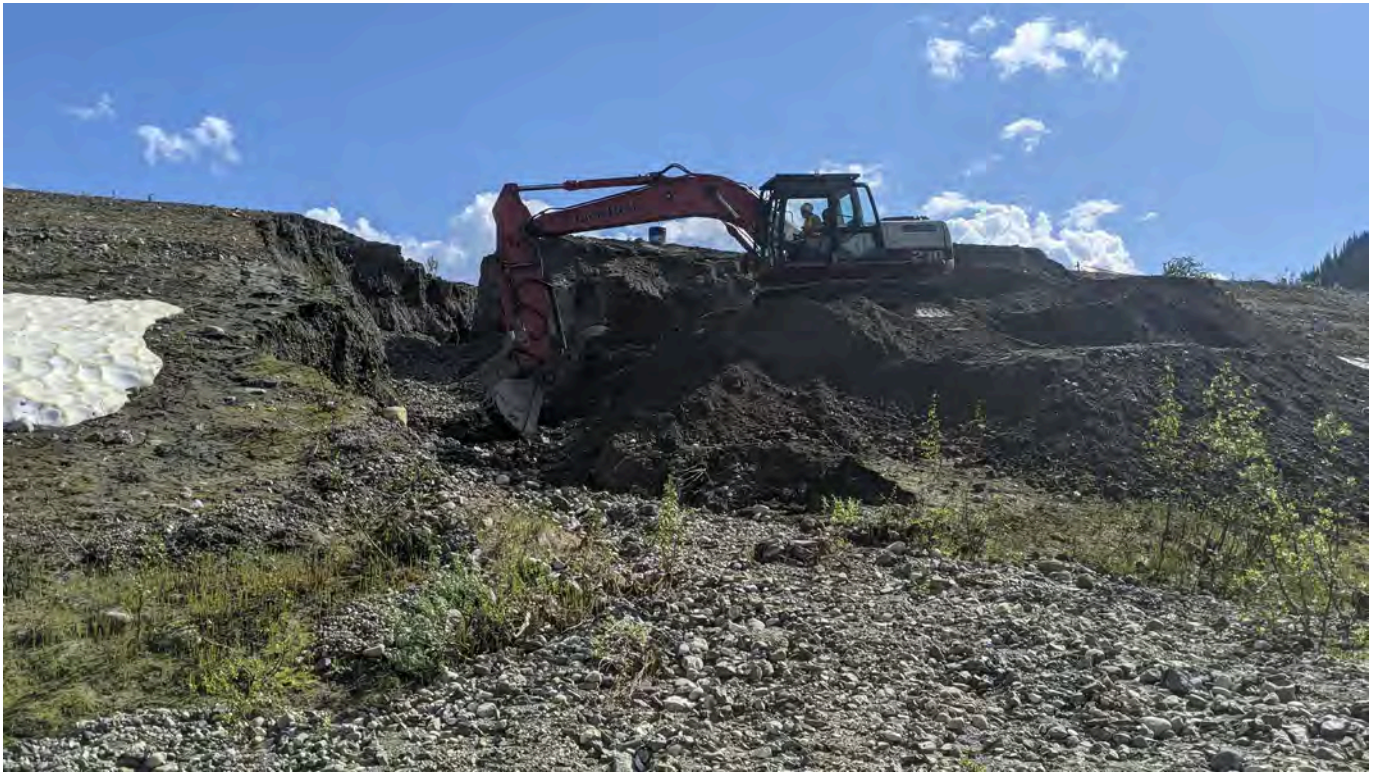
Photo 5: Excavator constructing working platforms down the west side of the gully (June 23, 2022).

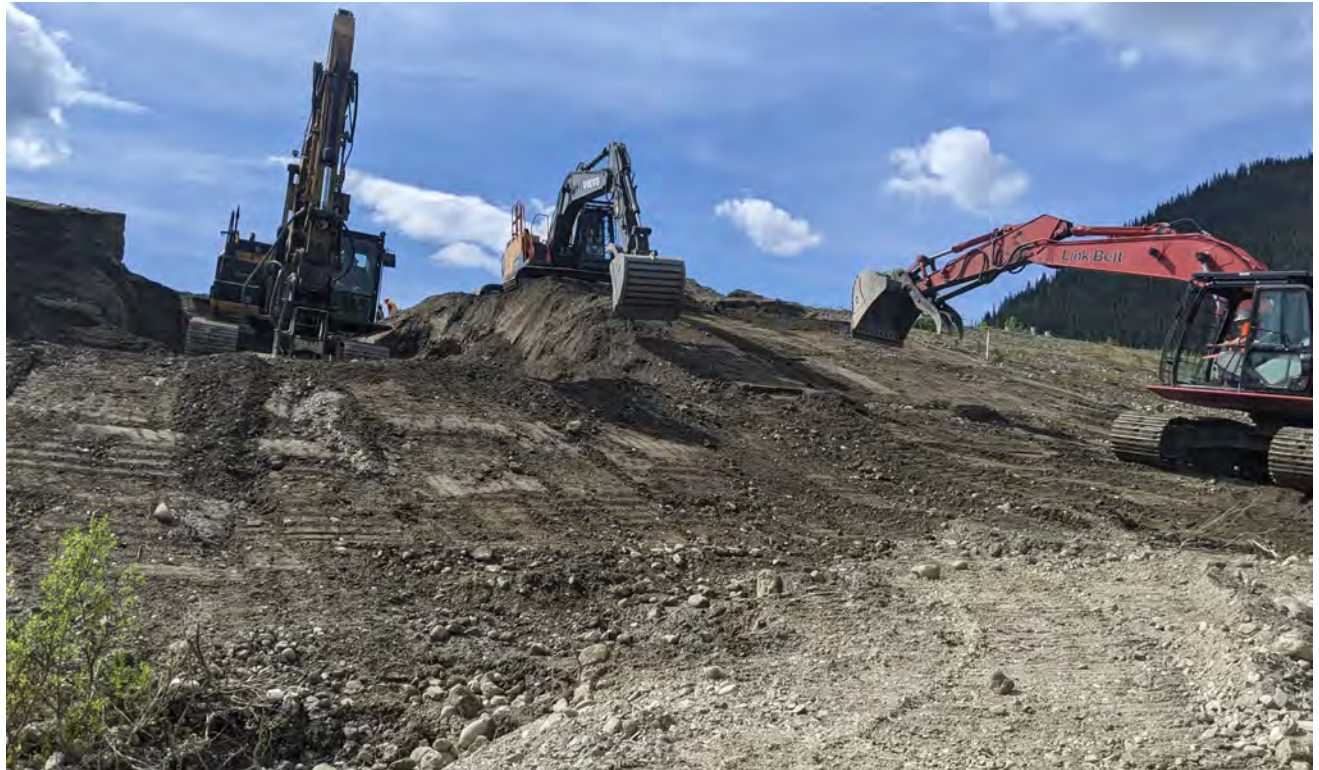
Photo 9: Placement of sand and gravel and trimming of the dam slope (June 25, 2022).

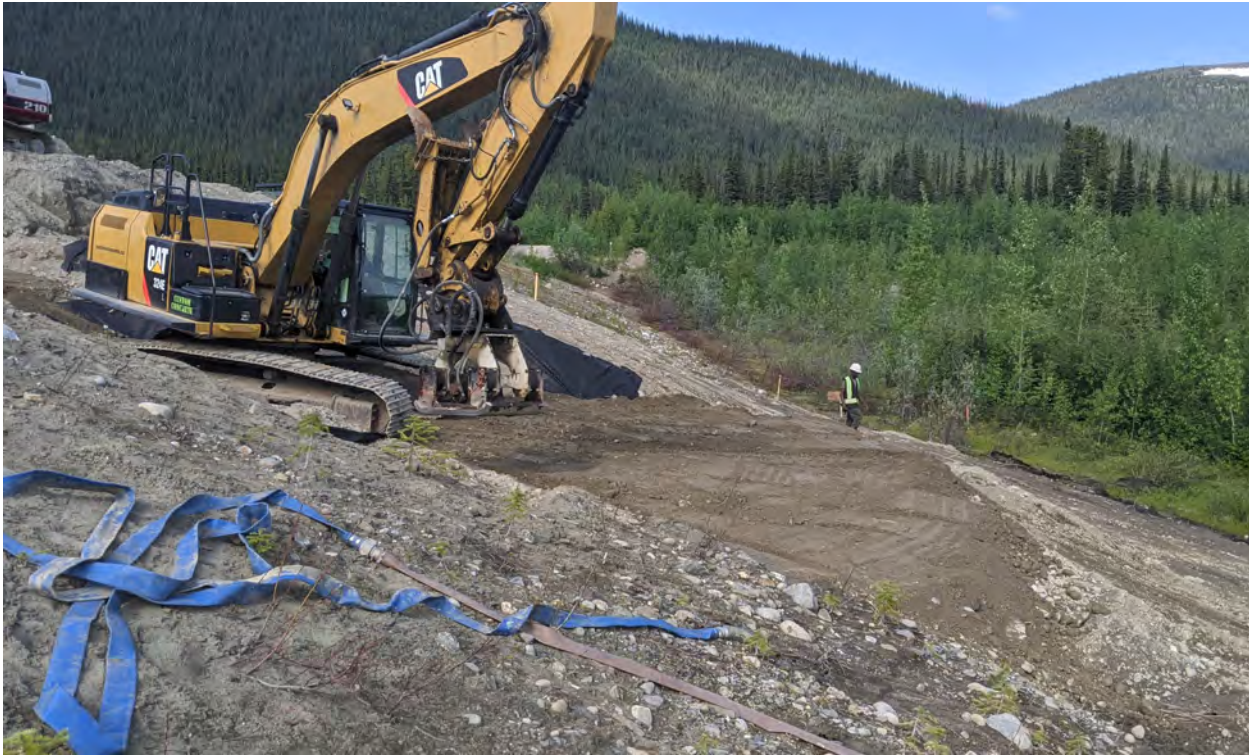
Photo 9: Till placement (June 26, 2022).

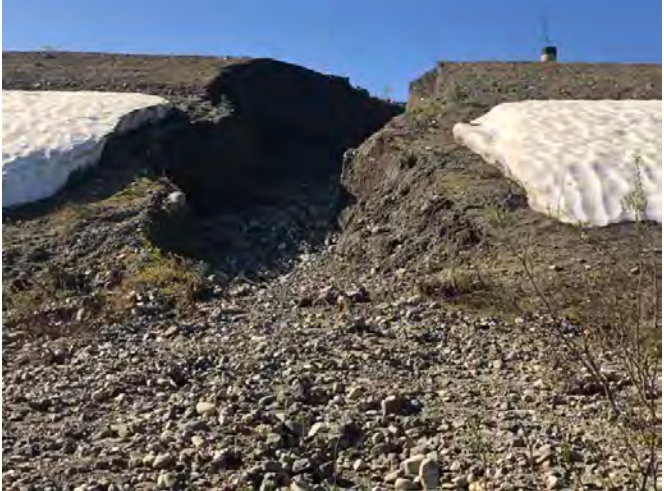
Date:
17/06/2022
Ponded Water
No Issues
Erosion
Major erosion issue , west of center of N. Dam. Large erosion gully washed from tailings cap to almost the toe of downstream face. Contacted appropriate supervisor and repairs were performed.

Photo Discription	Photo	Photo Location
North Dam erosion

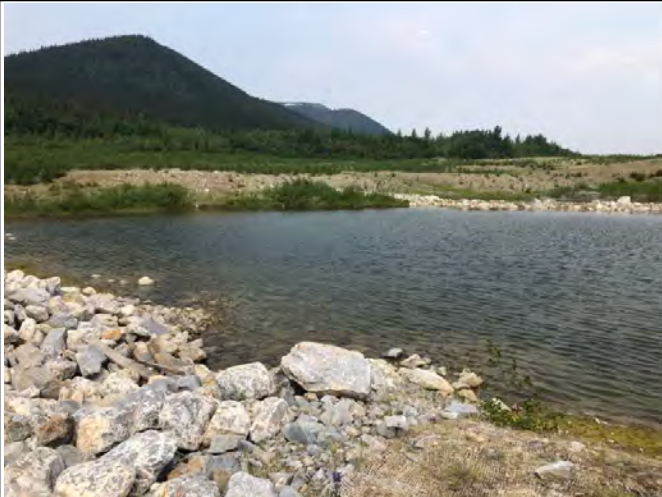
Vertical cracking on downstream face about 30cm from edge of riprap

Photo Discription	Photo	Photo Location
SRS pond
