2022 Annual Facility Performance Review Summary Report

Tailings Management Facility, Quebrada Blanca 2

Compañía Minera Teck Quebrada Blanca S.A.

Golder Associates S.A.

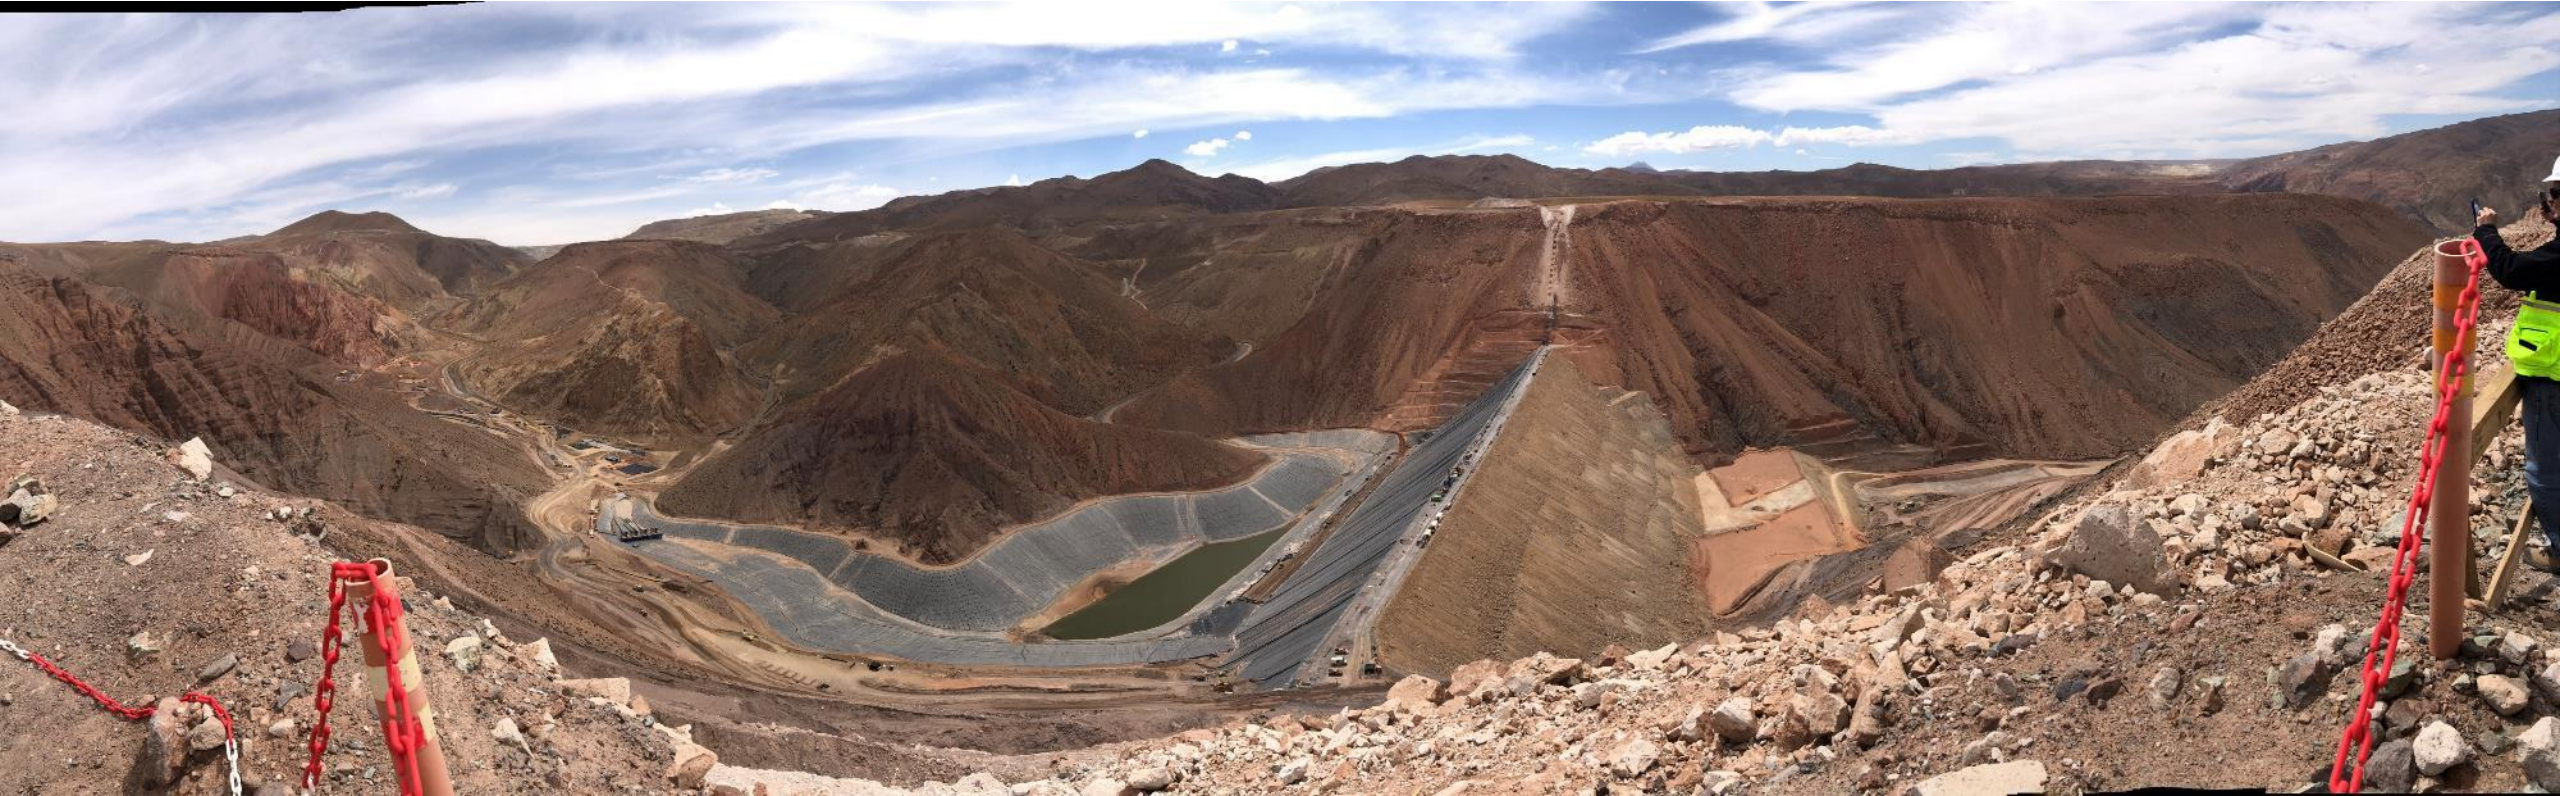
Plate 1: Tailings Management Facility (1400)

View from west abutment looking upstream

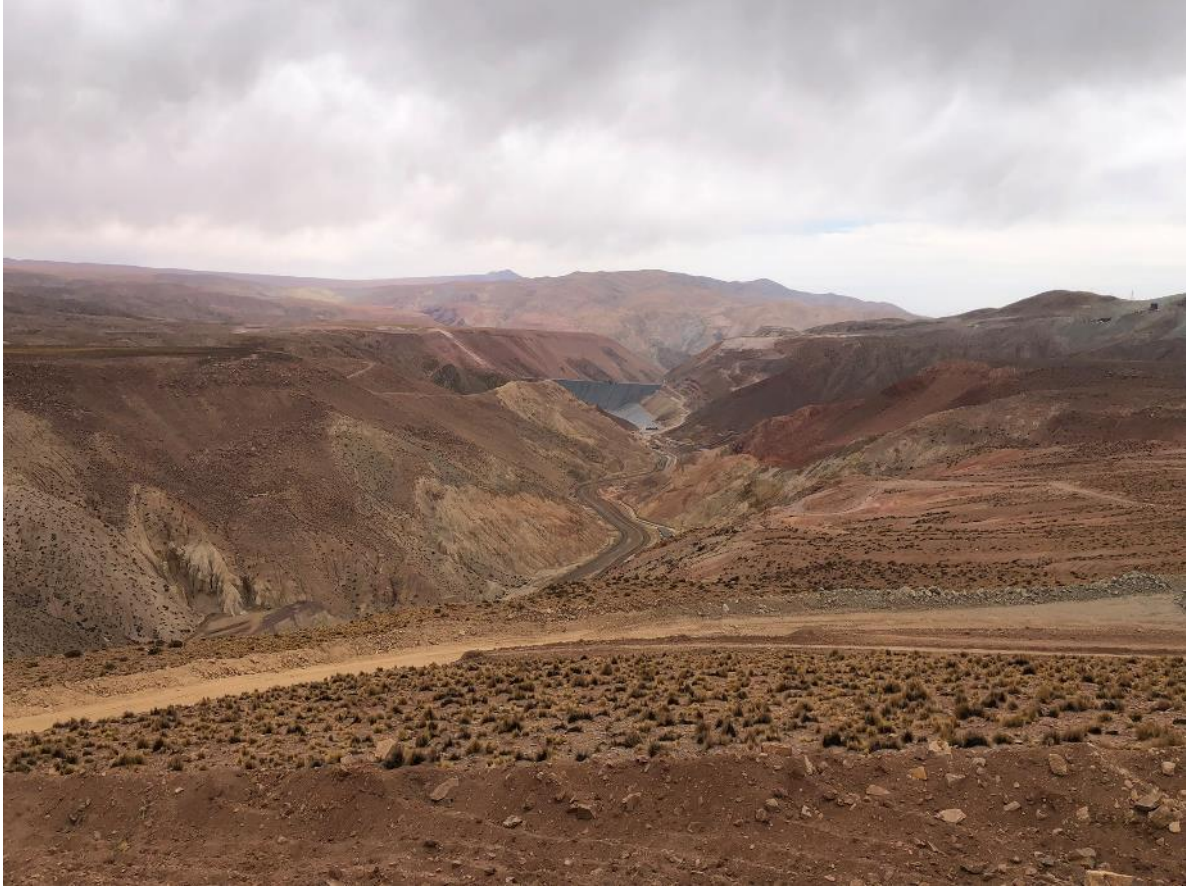
Plate 2: Tailings Management Facility (1400)

Looking south from north end of tailings management facility

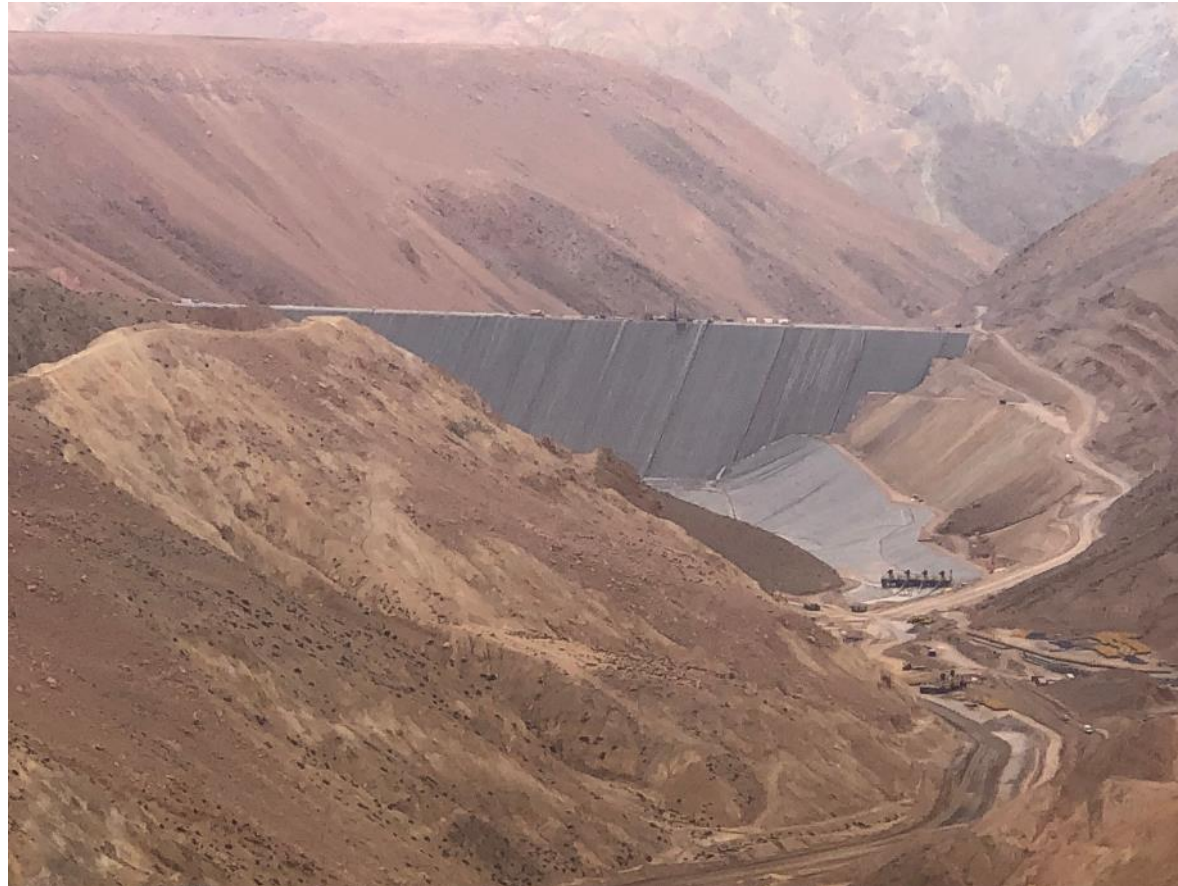
Plate 3: Starter Dam (1452)

Looking south towards upstream face

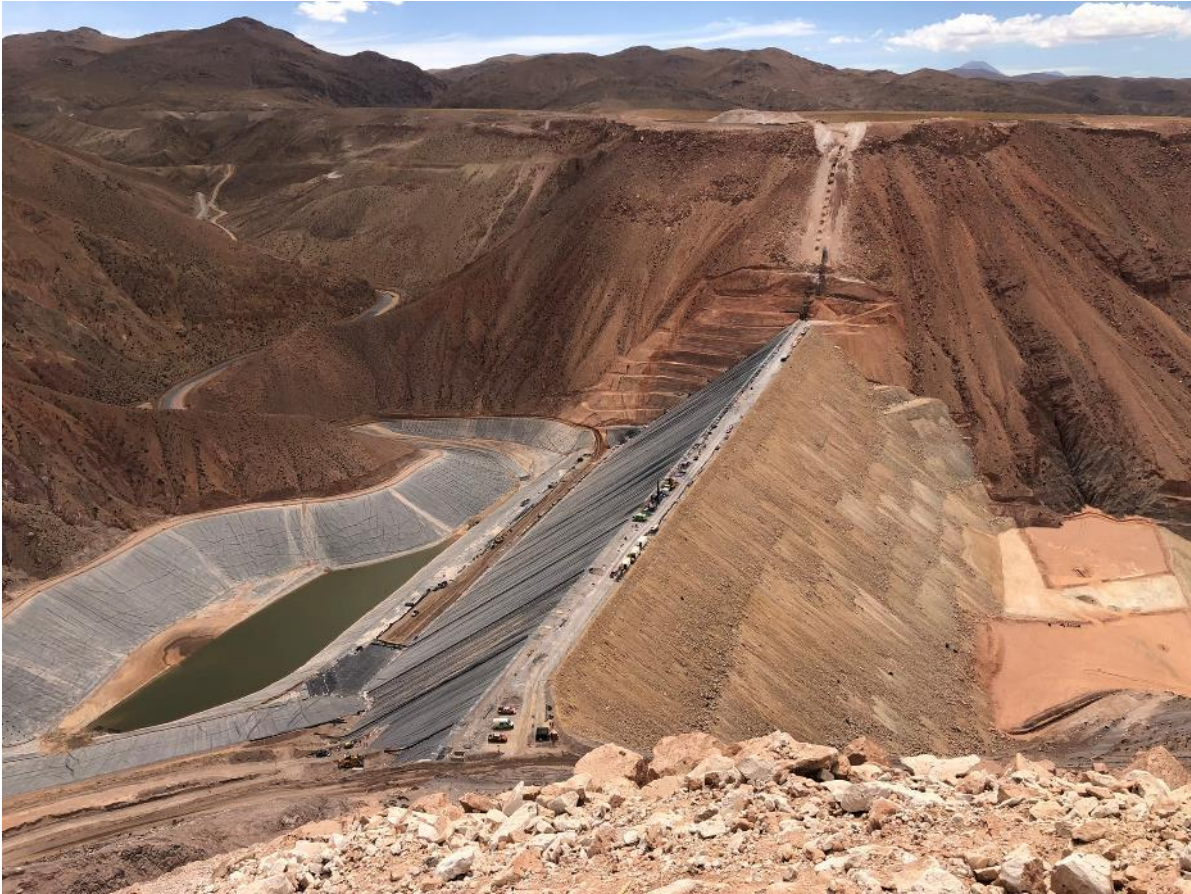
Plate 4: Starter Dam (1452)

Looking east from west abutment

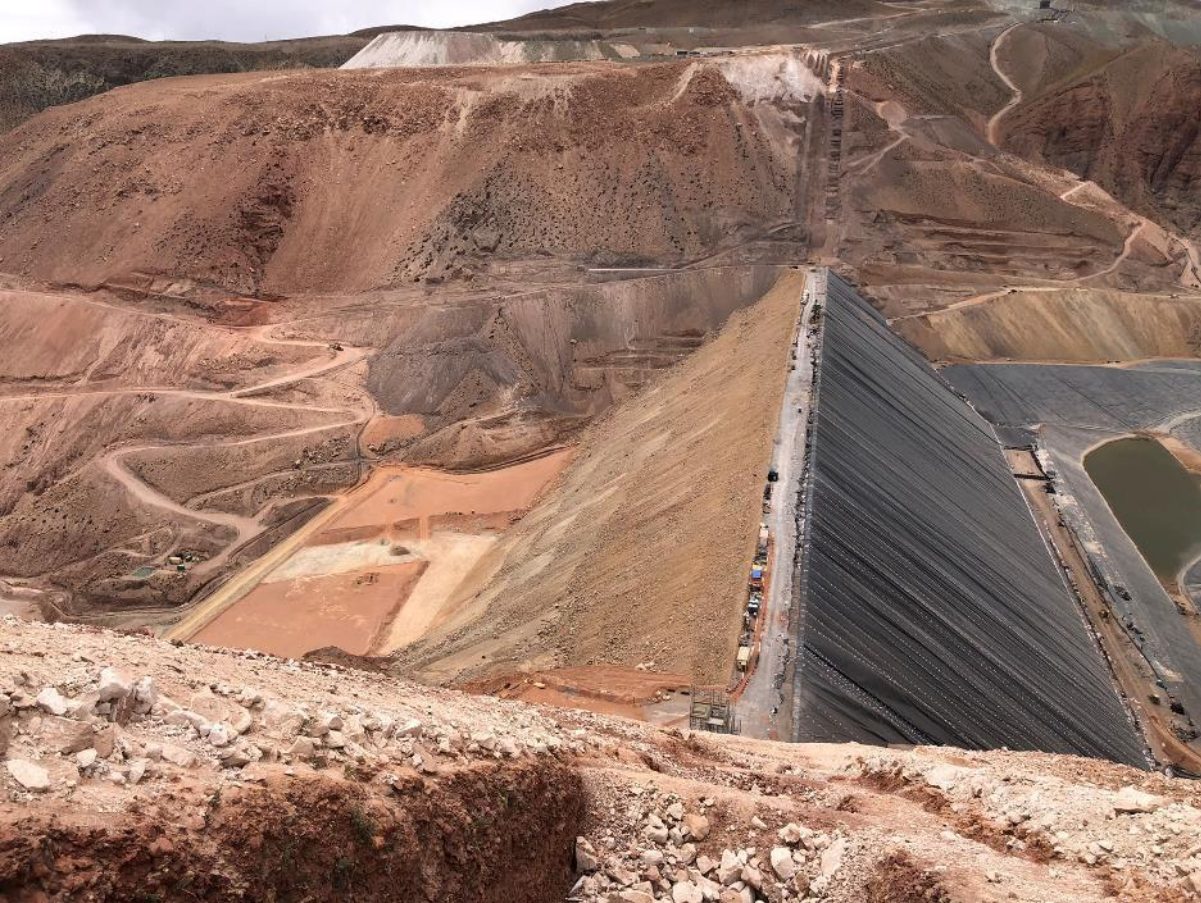
Plate 5: Starter Dam (1452)

Looking west from east abutment

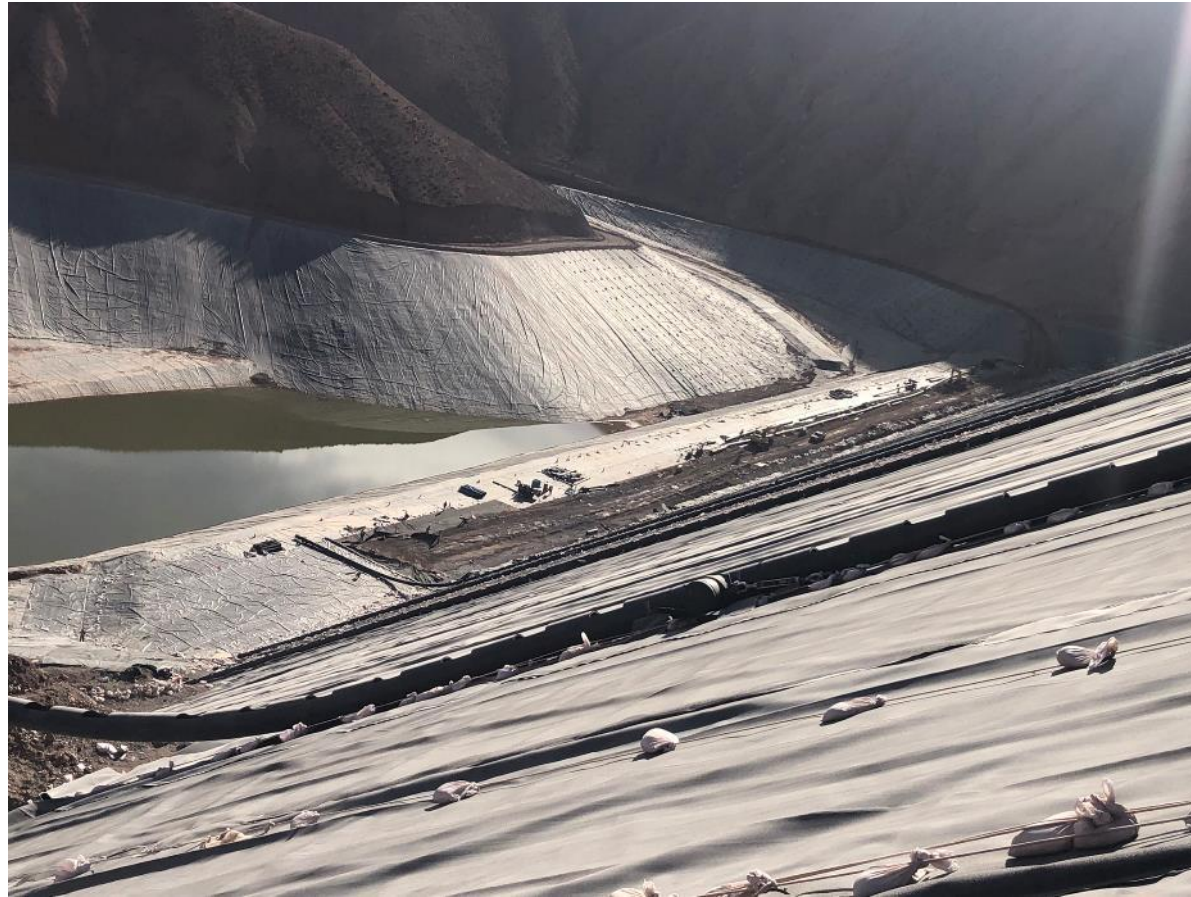
Plate 8: Starter Dam (1452) & Cofferdam (1424)

Looking upstream from starter dam crest

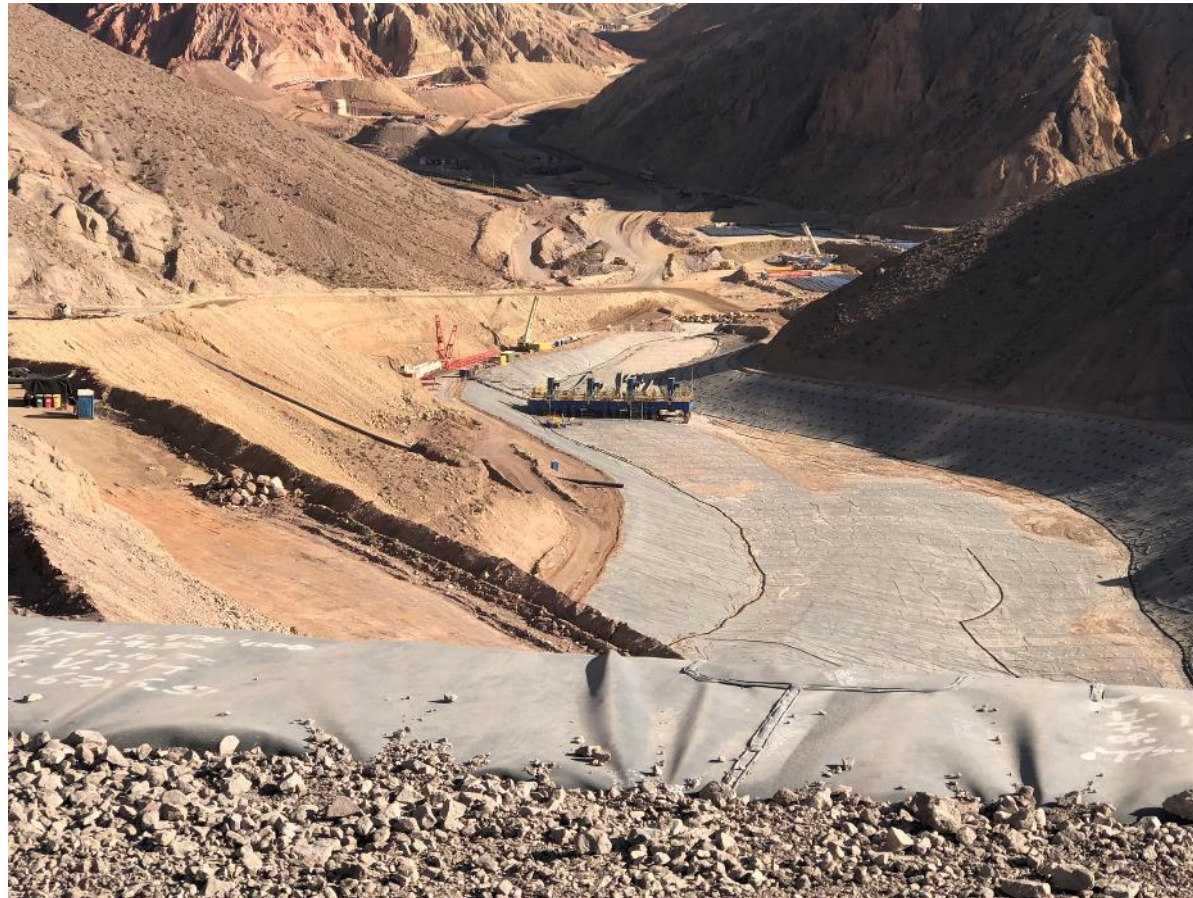
Plate 9: Tailings Management Facility (1400)

Looking up Valley 1 from starter dam crest

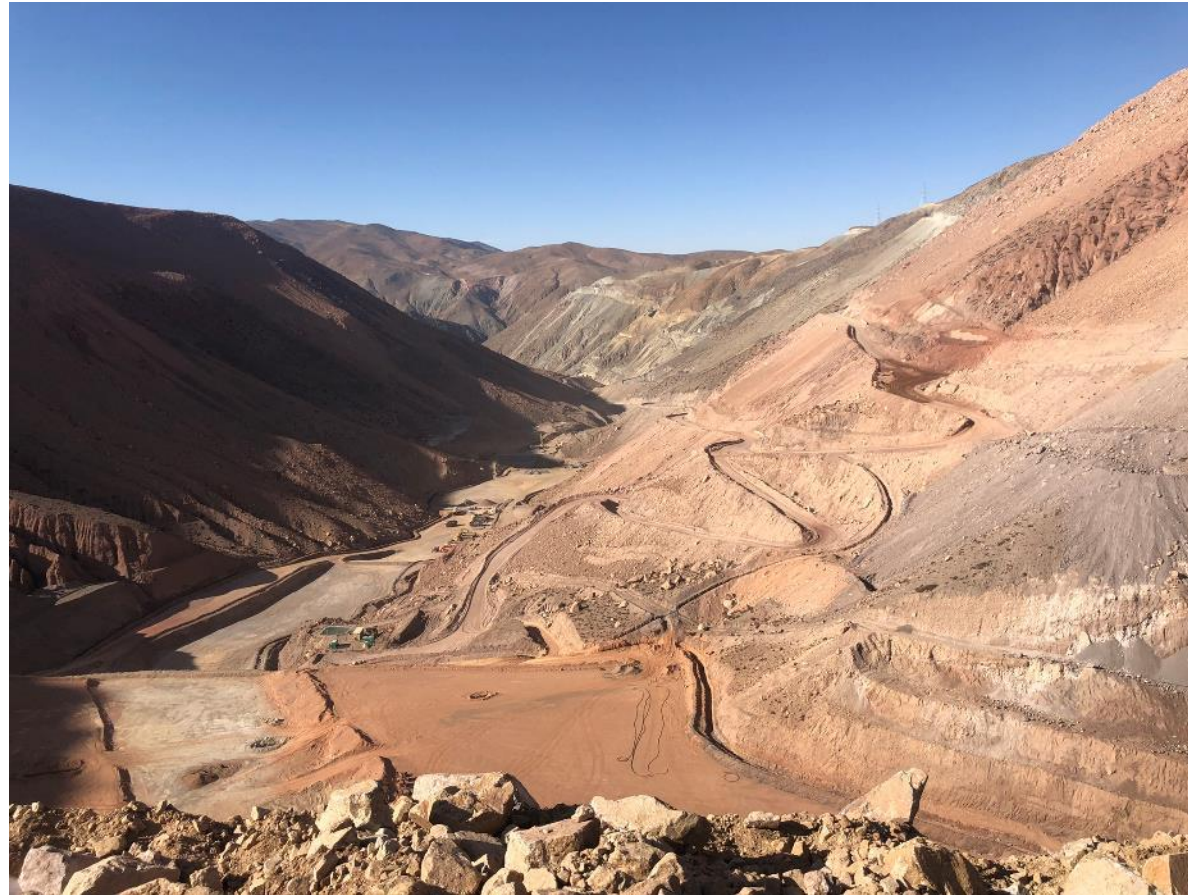
Plate 10: Starter Dam (1452)

Looking downstream from starter dam crest

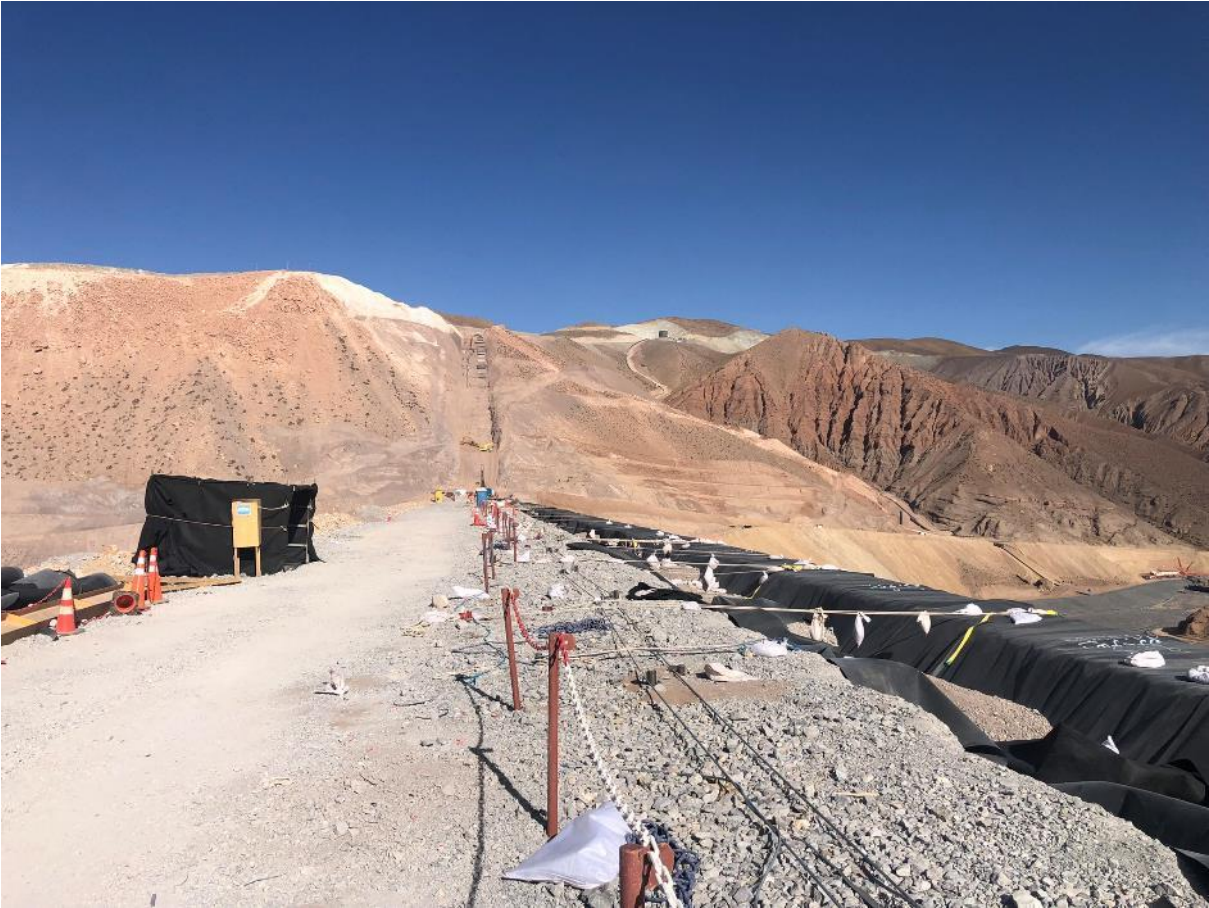
Plate 11: Starter Dam (1452)

Looking east towards cyclone station from starter dam crest

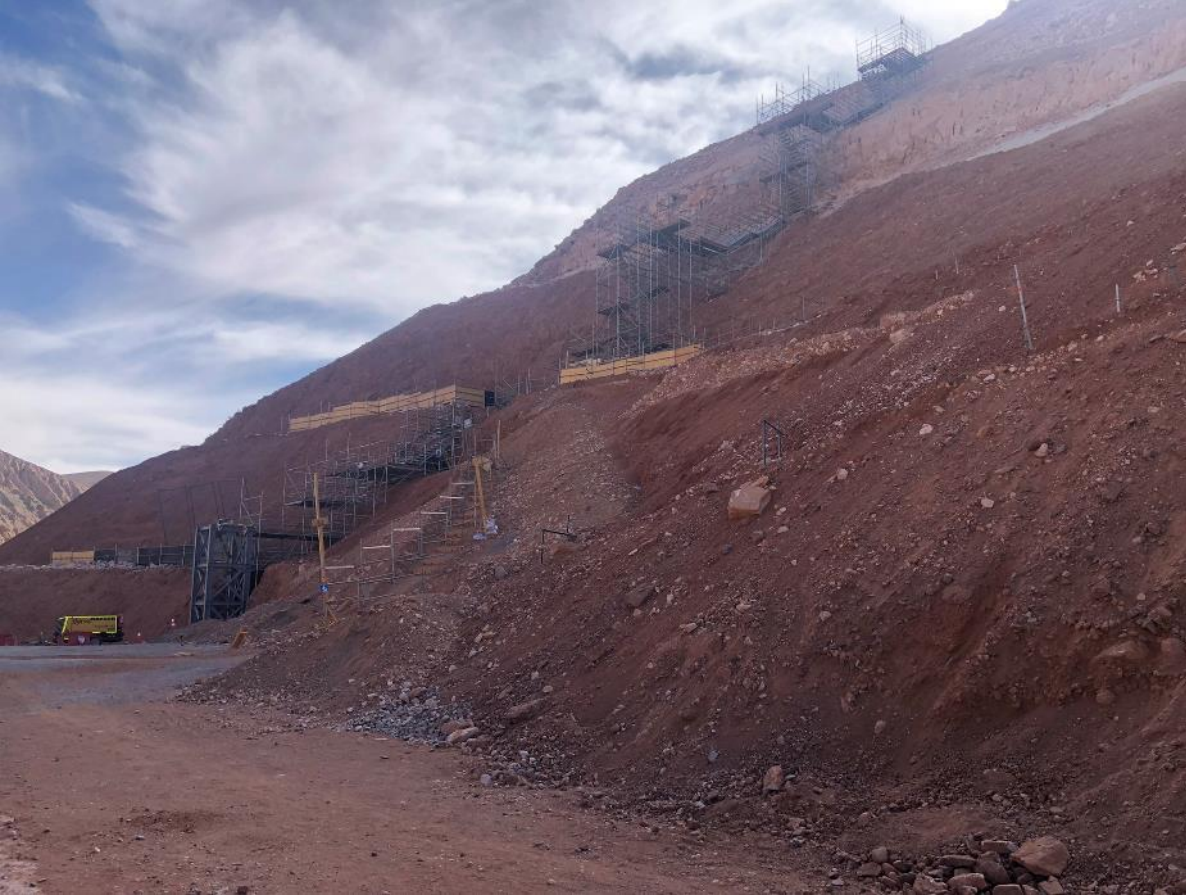
Plate 12: Tailings Distribution System (1442)

- An opportunity was identified for future backfilling of the pipe supports on the east abutment. Rather than placing and compacting sand in the confined space of a pipe support (see Plate 12), the use of lean concrete is to be considered. Use of the bedrock excavation may be made in combination with simple formwork on the outside face. Golder will consider this during the Phase I sand dam detailed design when it begins.

East abutment viewed from starter dam crest

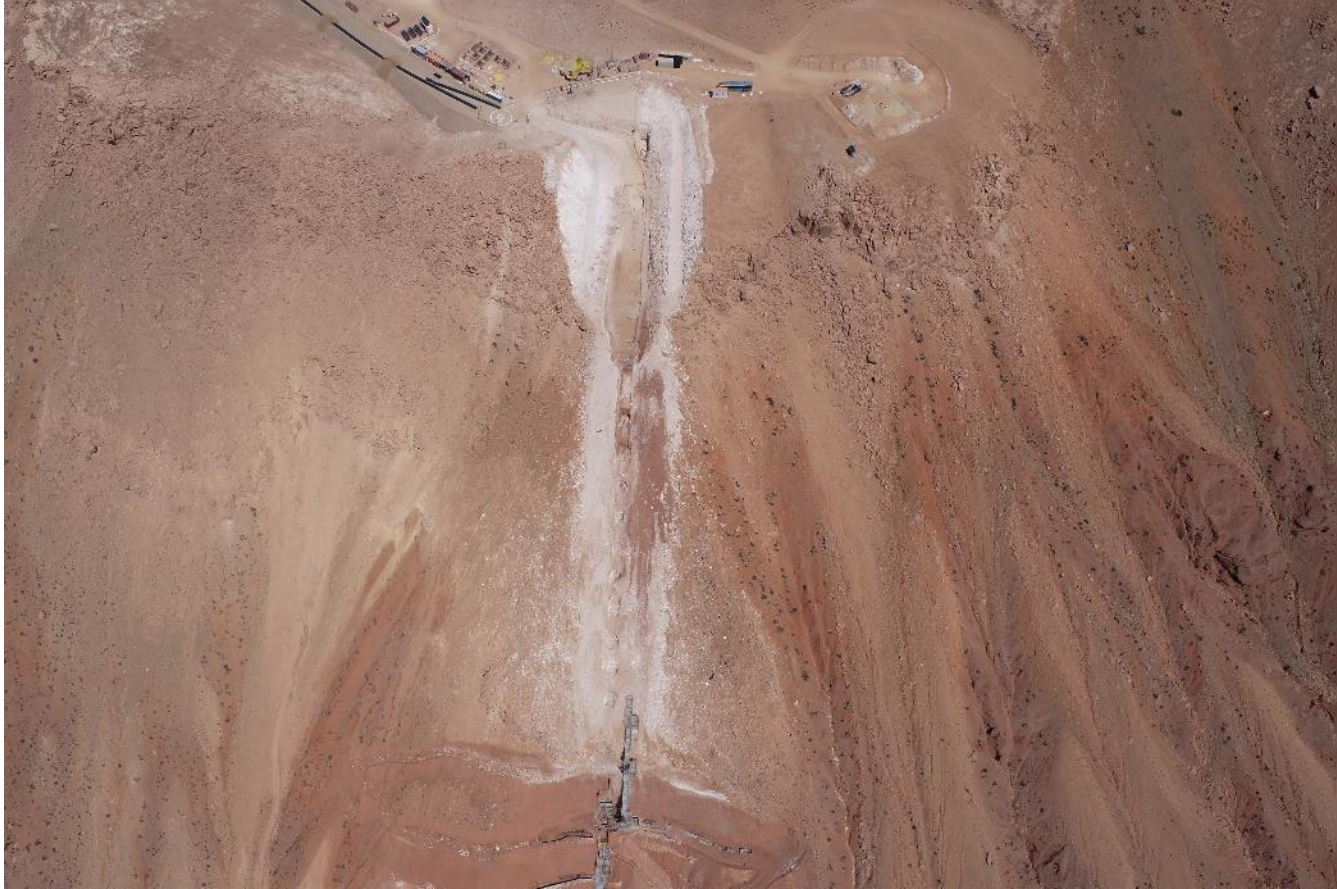
Plate 13: Tailings Distribution System (1442)

East abutment above starter dam crest

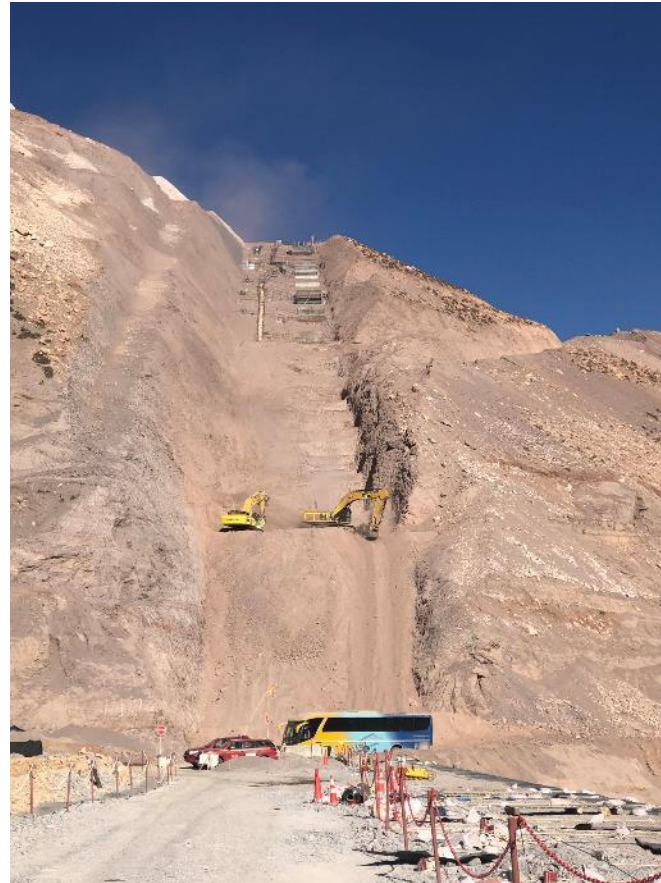
Plate 14: Tailings distribution system

West abutment viewed from starter dam crest

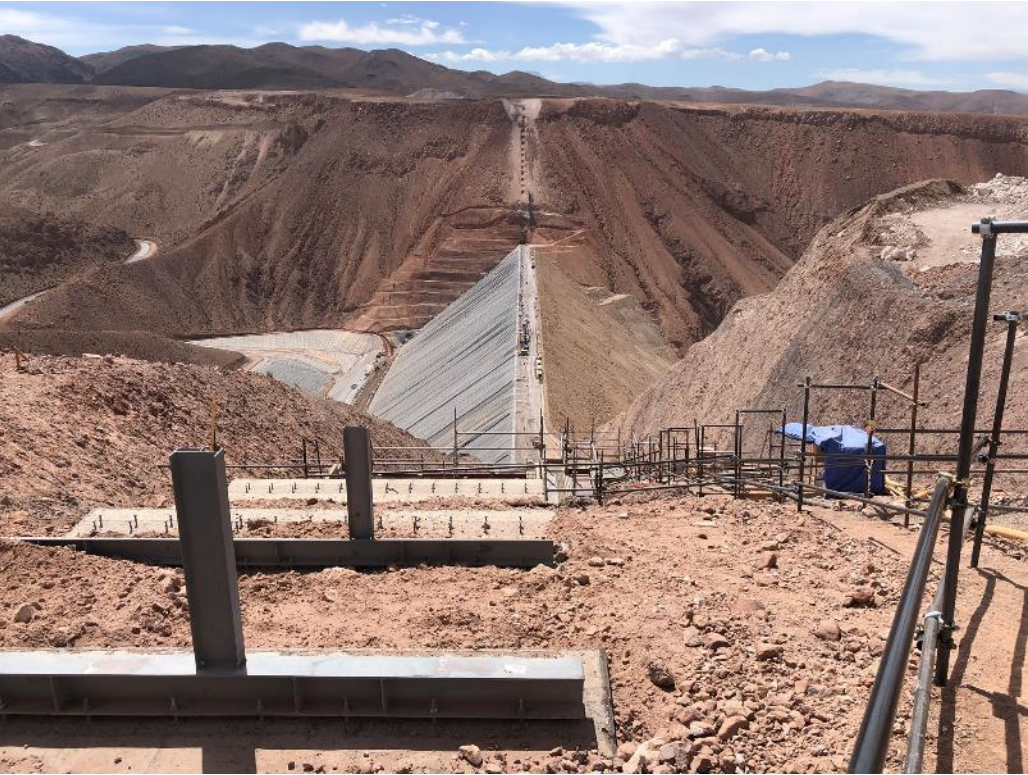
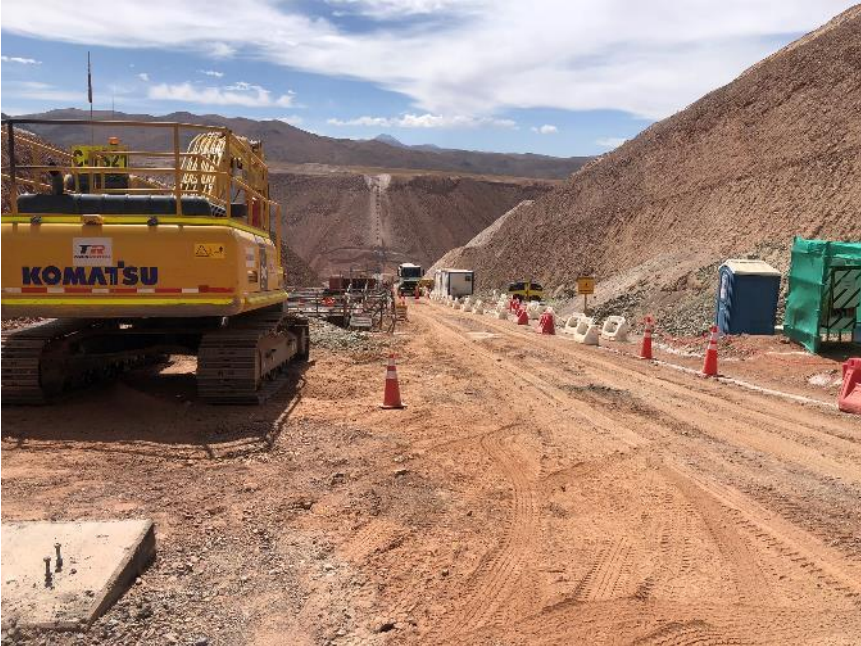
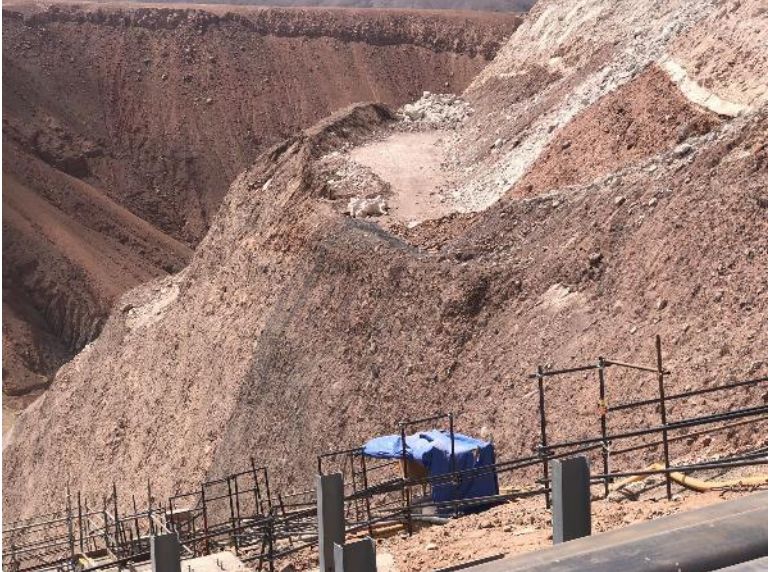
Plate 16: Tailing Distribution System (1442)

Above starter dam crest

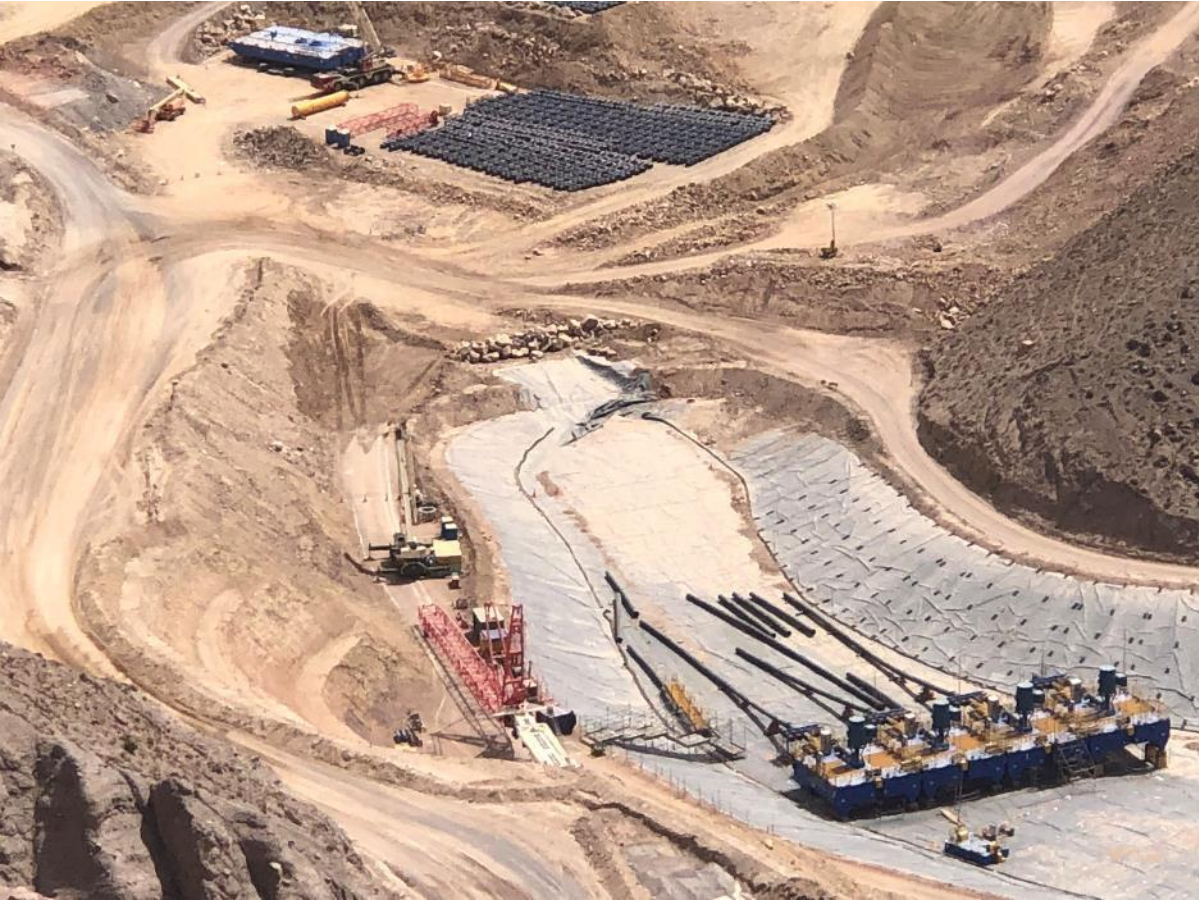
Plate 17: Initial Reclaim Pond (1424)

Initial pump barge installation

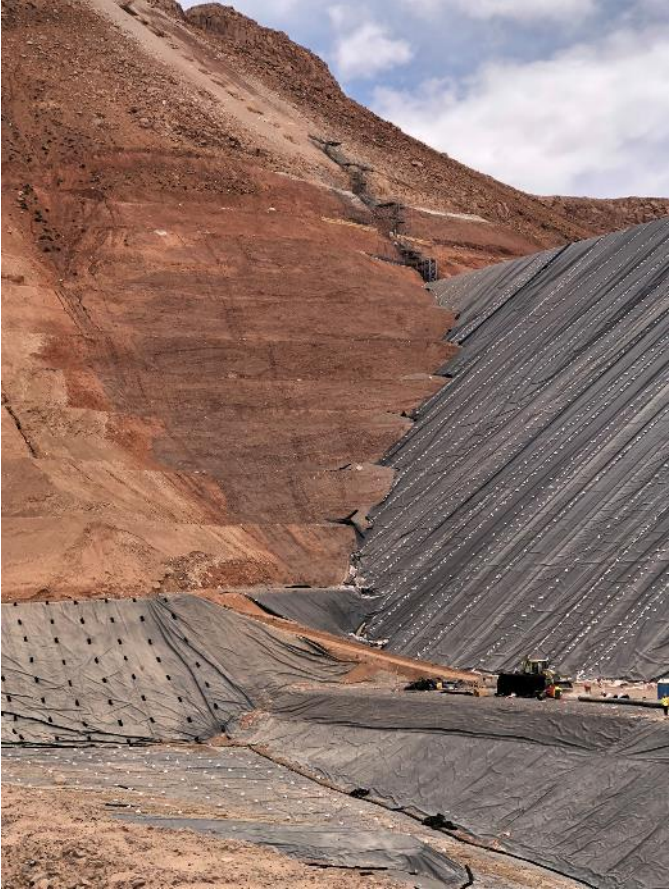
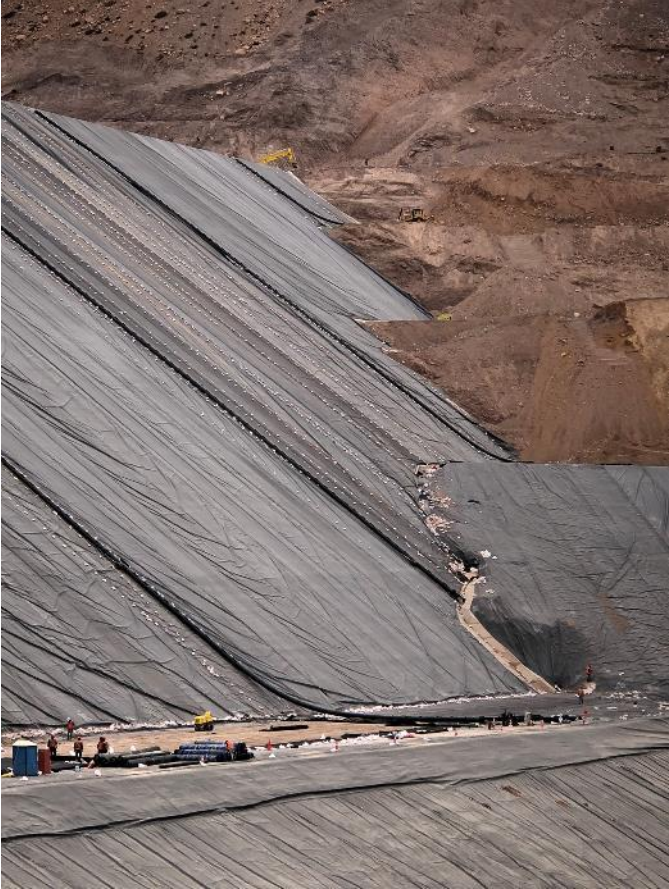
Plate 18: Starter Dam (1452)

Starter dam upstream lining system and abutment tie-ins

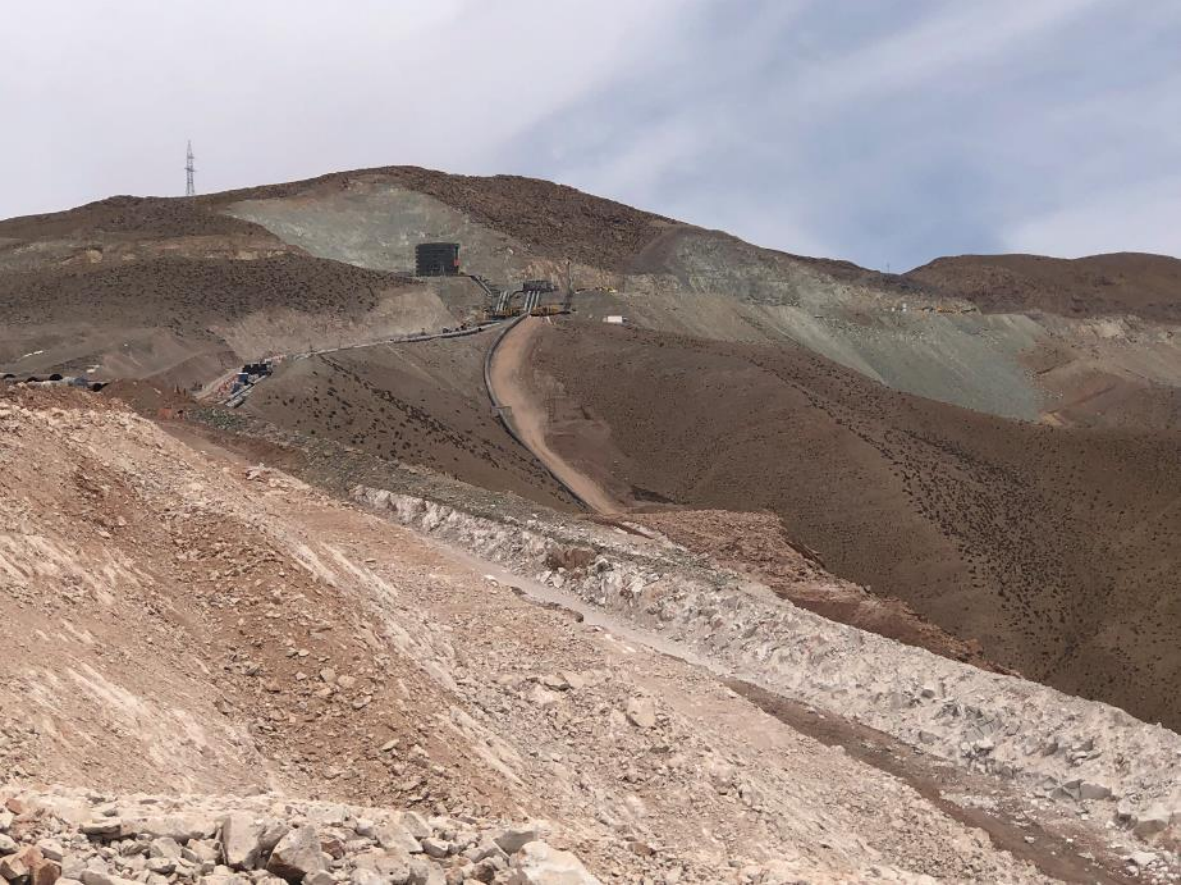
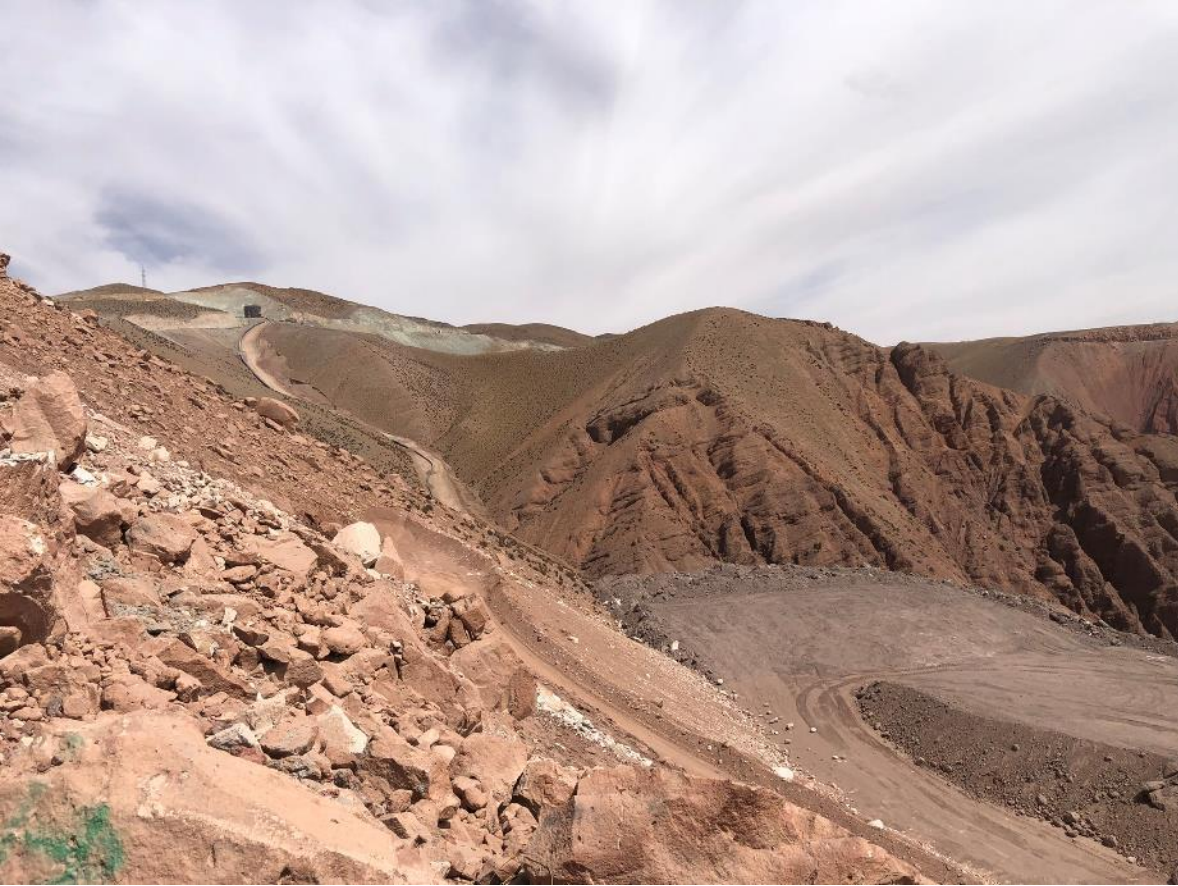
Plate 19: Cyclone Station (1441)

Emergency discharge pipeline

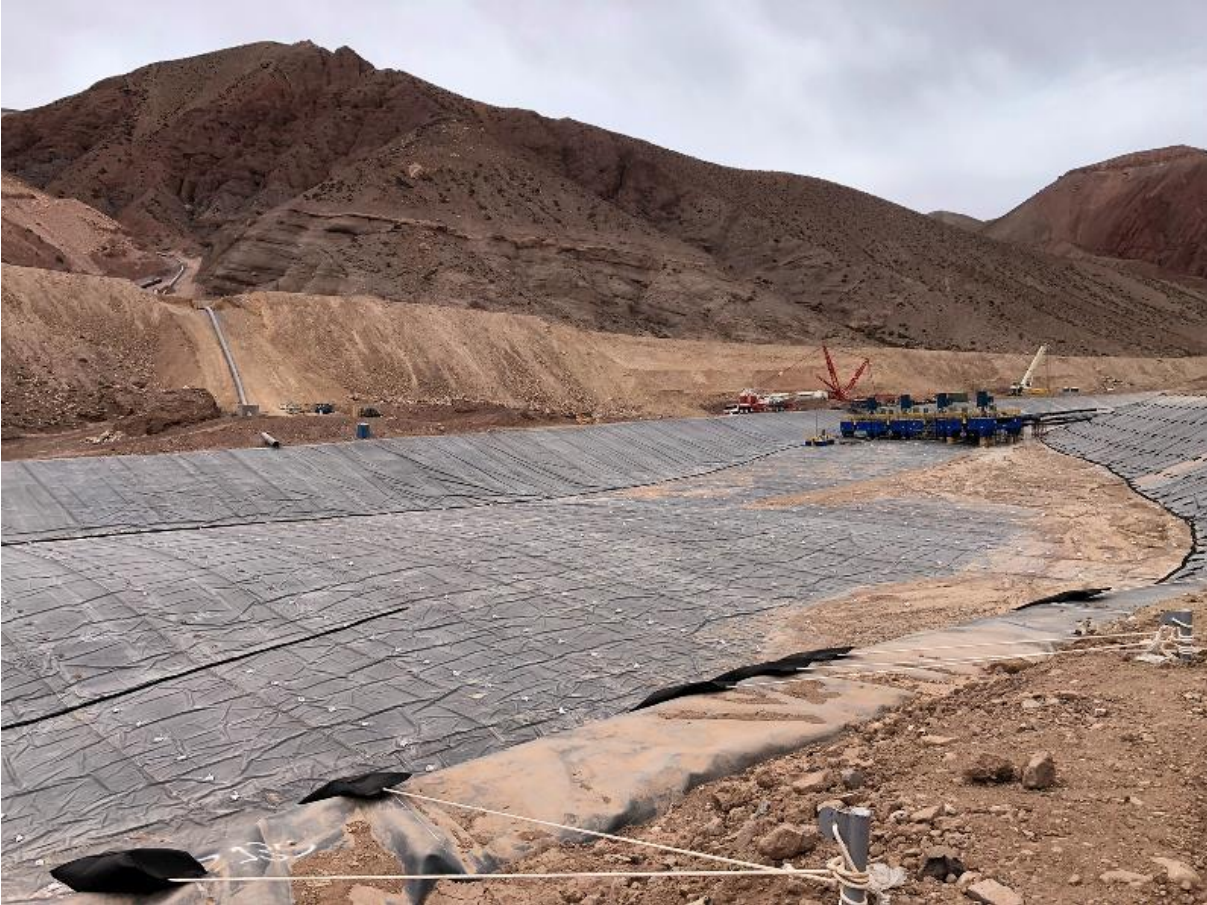
Plate 20: Cyclone Station (1441) & Initial Reclaim Pond (1424)

Outlet of emergency discharge pipeline

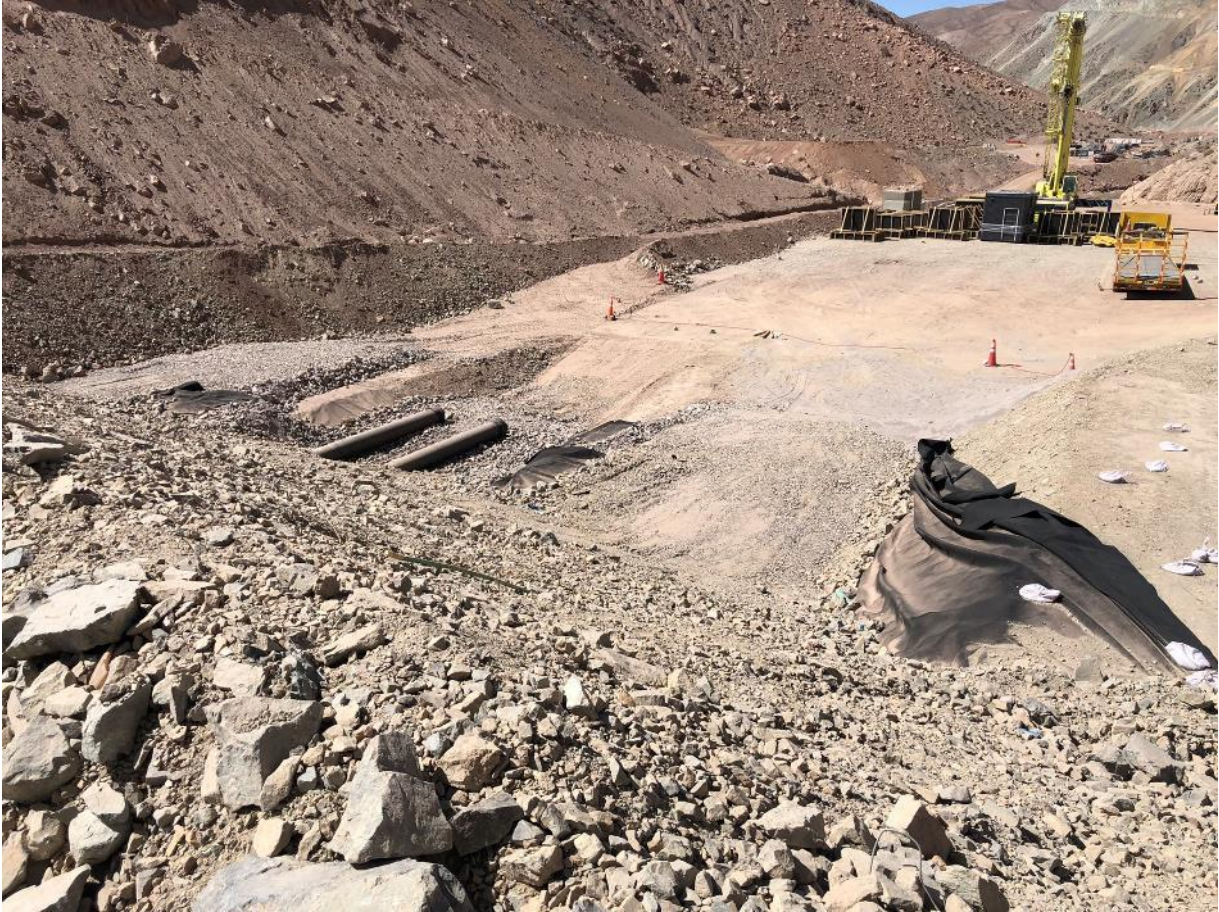
Plate 24: Dam Drainage System (1453)

View downstream from Year 2 sump downstream limit

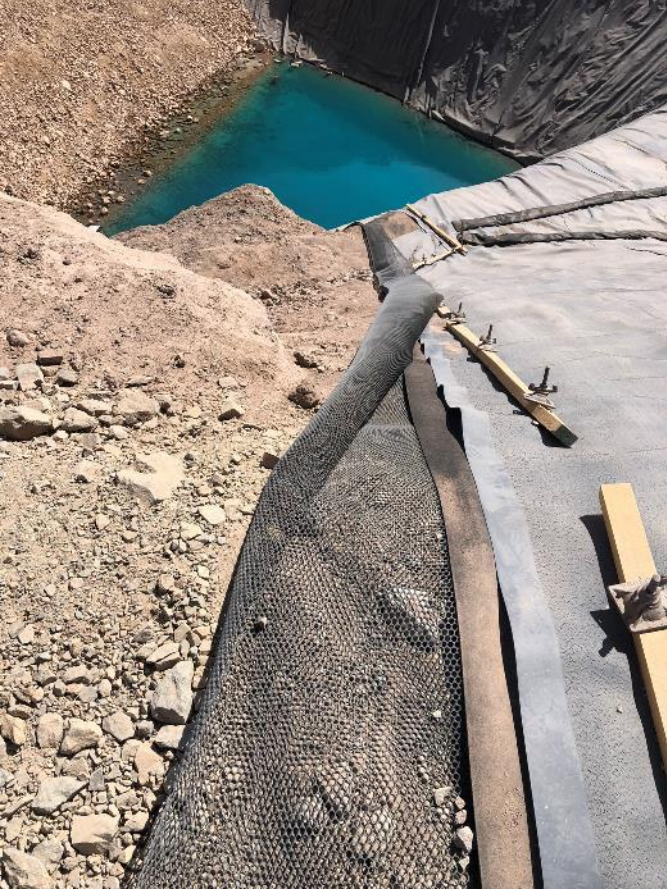
Plate 25: Year 2 Sump

- An opportunity was identified to improve the liner-to-bedrock connection at the Year 2 sump (see Plate 25) to reduce seepage losses. Any seepage bypassing the Year 2 sump will, per the design, report to the seepage collection ponds (1461). In discussions with CMTQB subsequent to the 2022 AFPR inspection, it was decided that any contemplated improvement will be carried out by CMTQB during operations.

Details
