2022 Annual Facility Performance Review Summary Report

Tailings Management Facility, Quebrada Blanca 2

Compañía Minera Teck Quebrada Blanca S.A.

Golder Associates S.A.

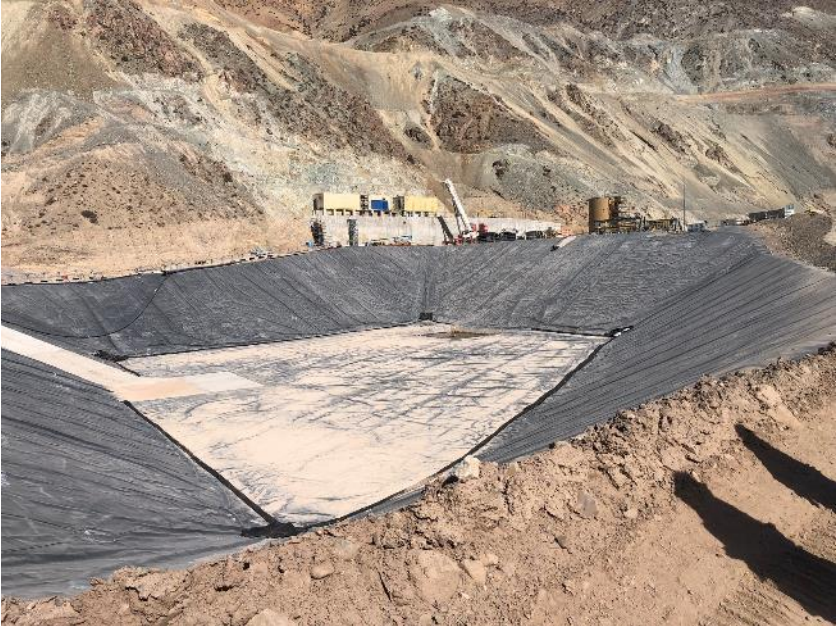
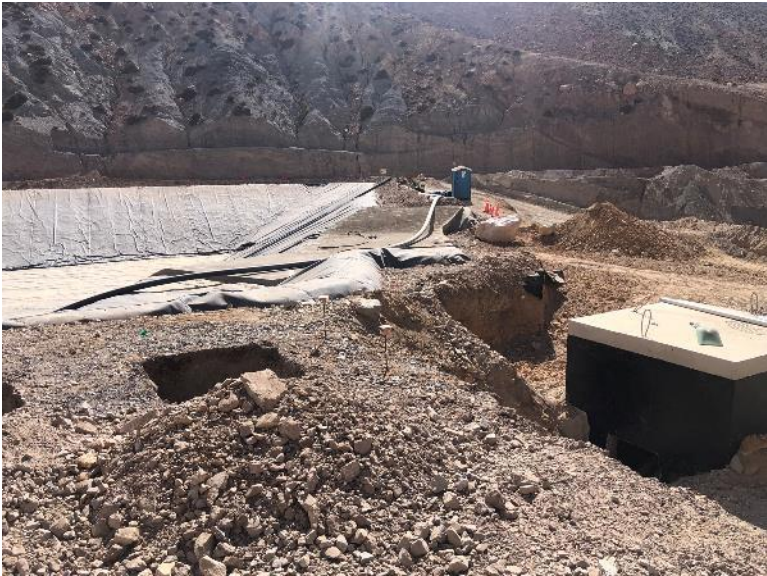
Plate 28: Seepage Collection Ponds (1461)

- Work continues on the non-contact water ditch on the east side of the seepage collection ponds.
- Material graded into Seepage Collection Pond 1 is to be removed and the lining system inspected for damage. This material was graded off of the access road by the contractor following rain events in December 2022 (see Plates 26, 27, and 28).

Seepage Collection Pond 2

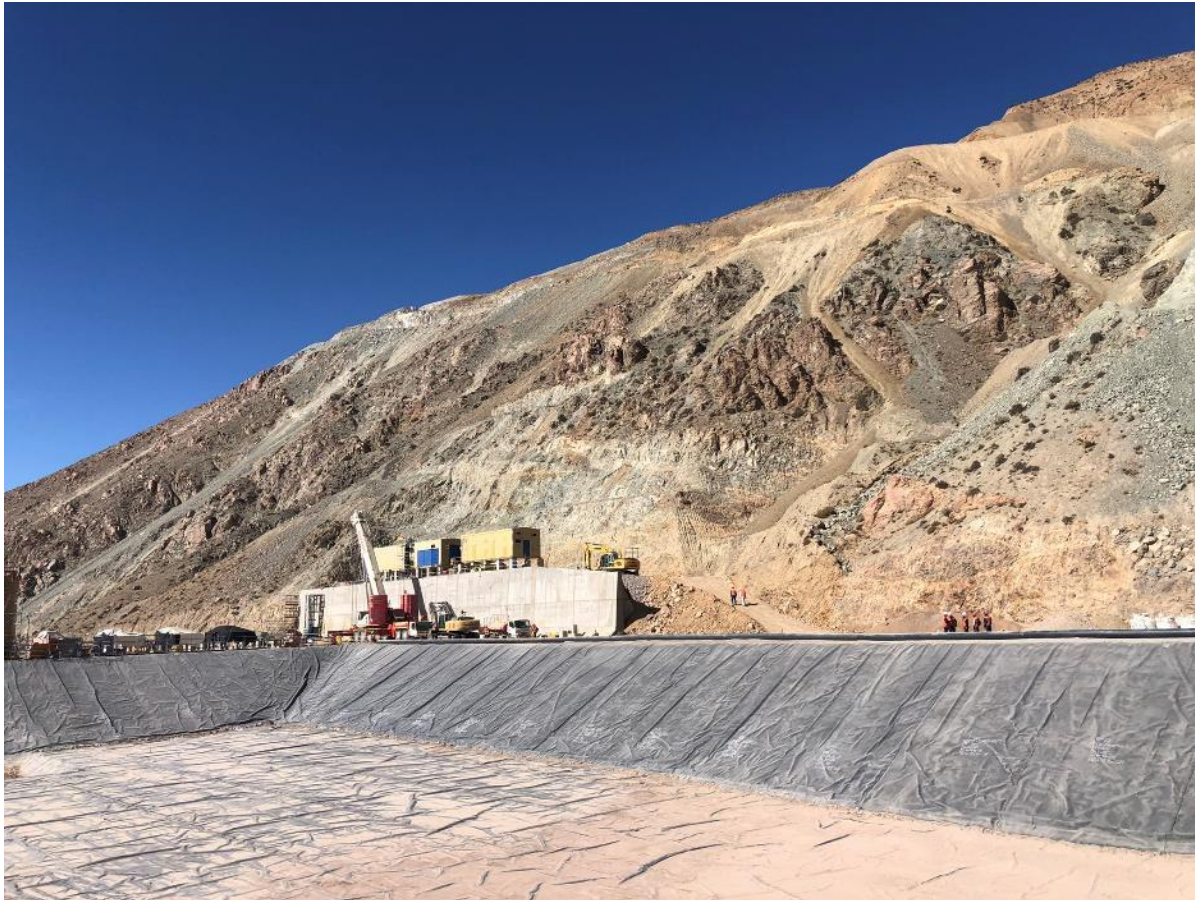
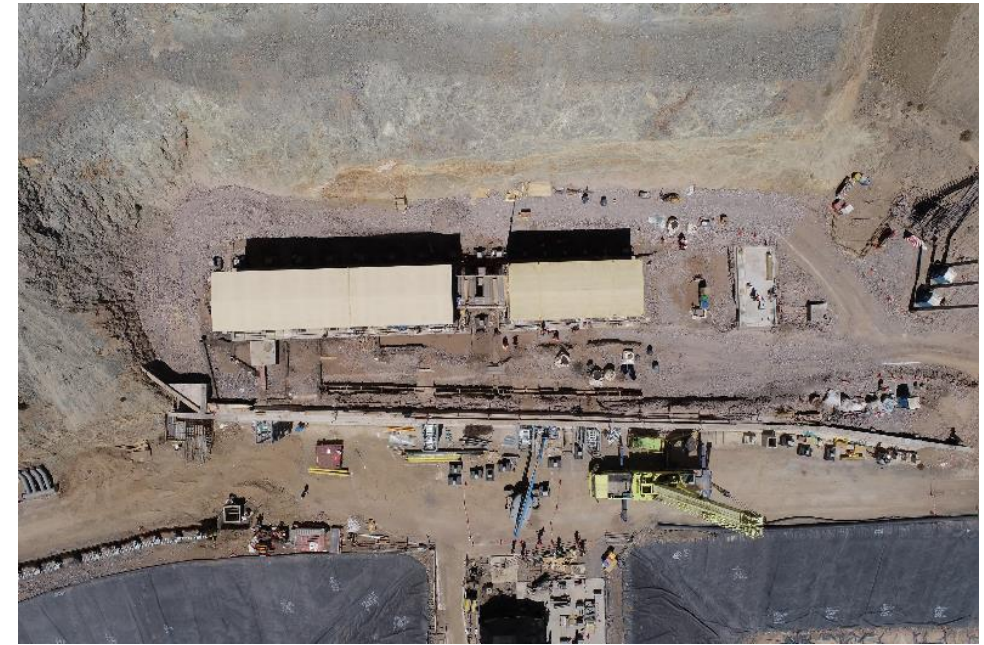
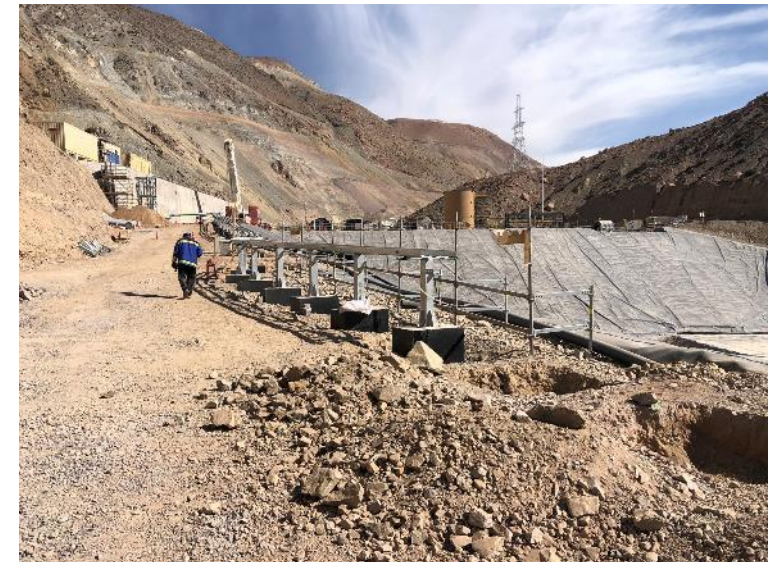
Plate 29: Seepage Collection Ponds (1461)

Retaining wall & electrical rooms

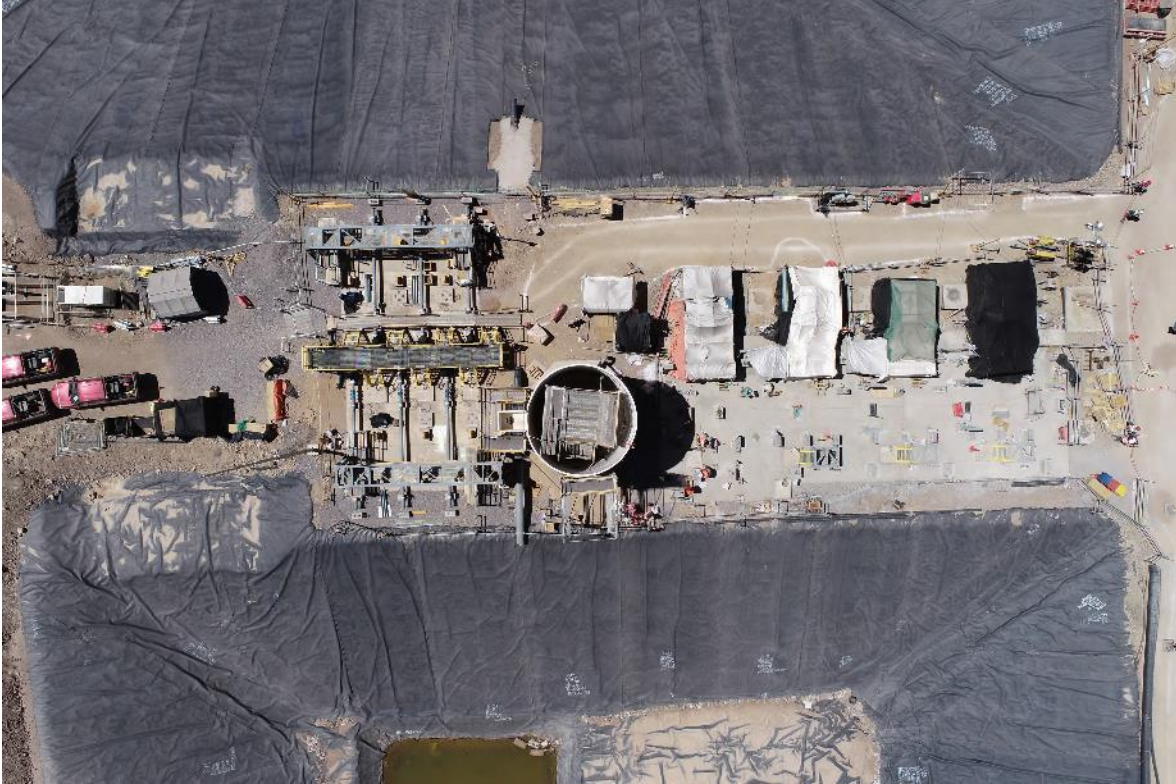
Plate 30: Seepage Collection Ponds (1461)

Central berm & pumping infrastructure

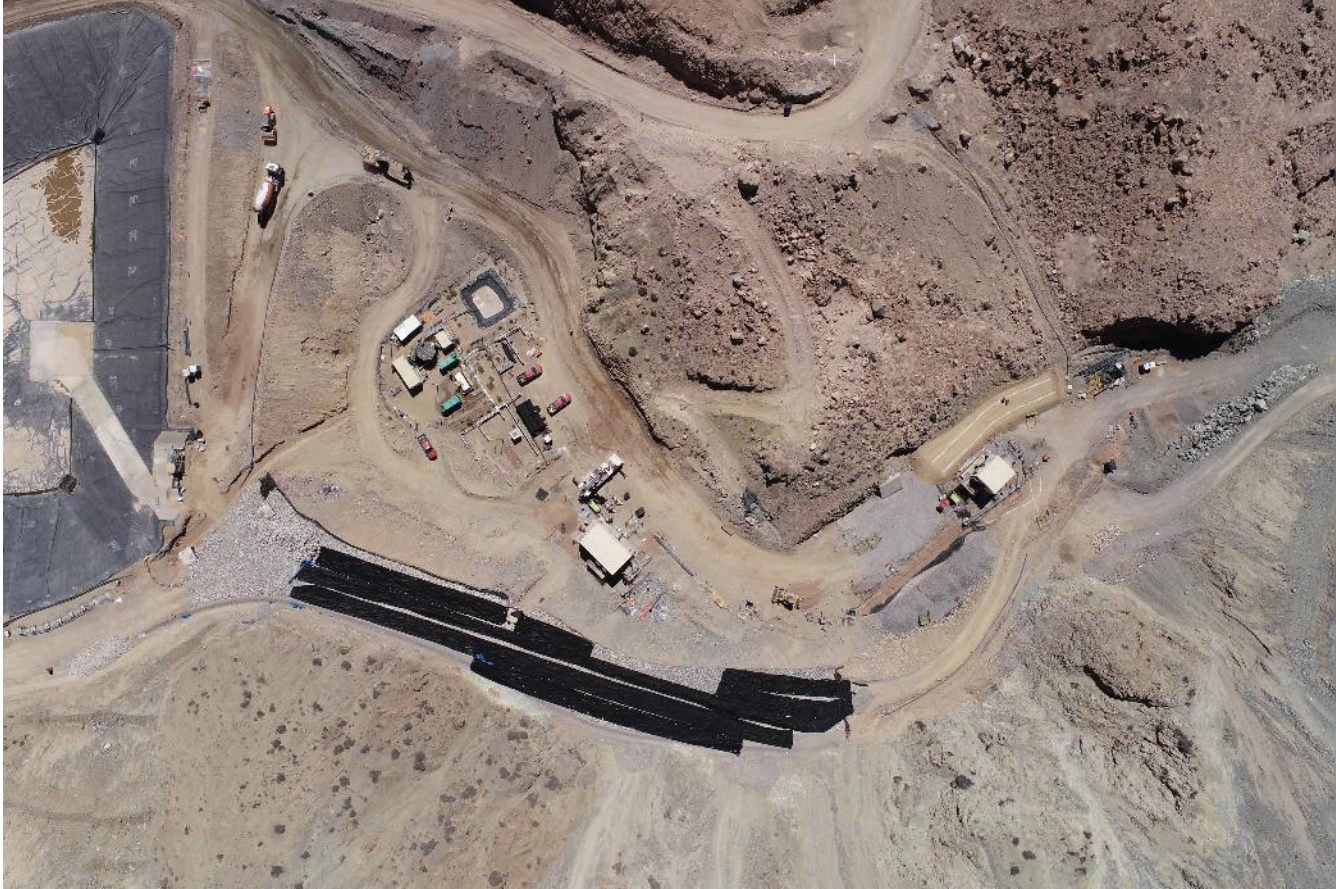
Plate 31: Seepage Cut-Off System (1465)

ID	Observed Features	Yes	No	Plate (Appendix B)	Comments
7.0 Seepage Collection Ponds & Surrounds					
7.1	Concern with Current or Previous Water Level		x	31	Ponds empty. Spillway from Seepage Collection Pond 2 under construction.

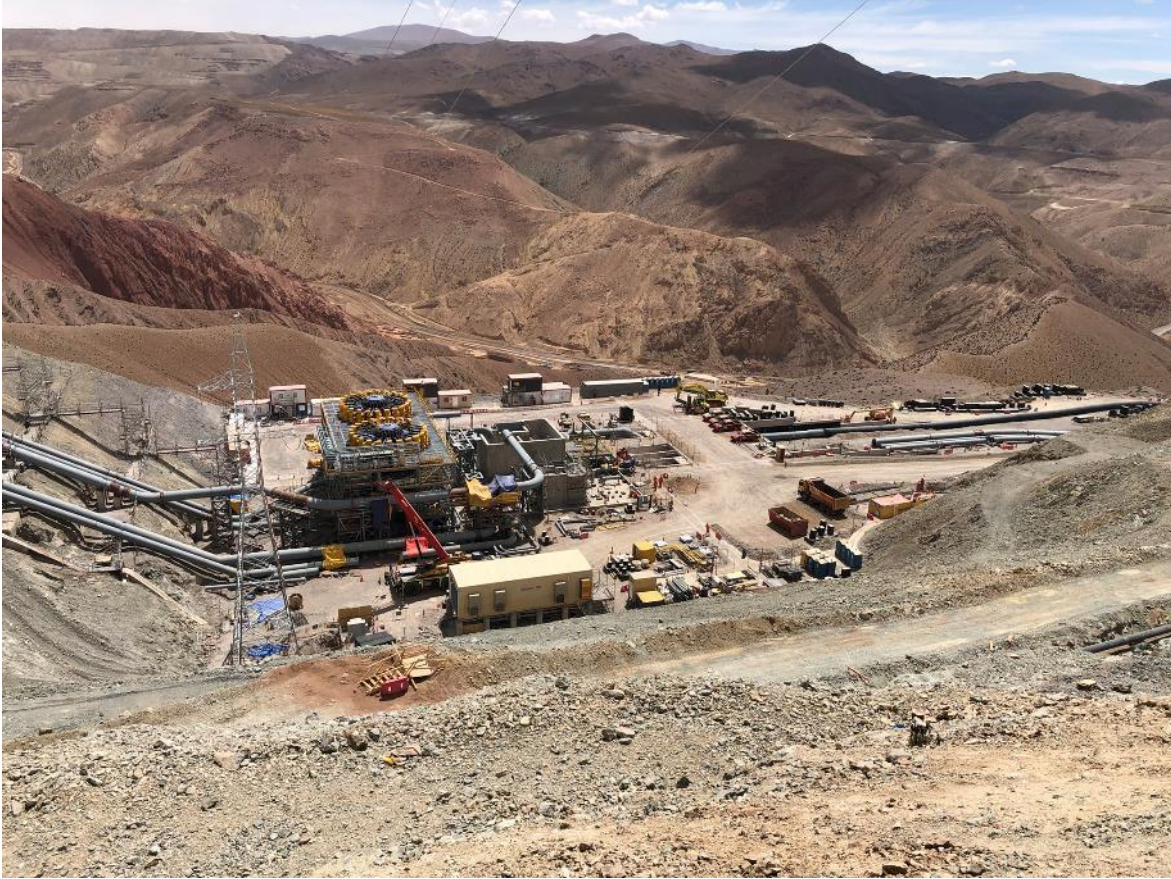
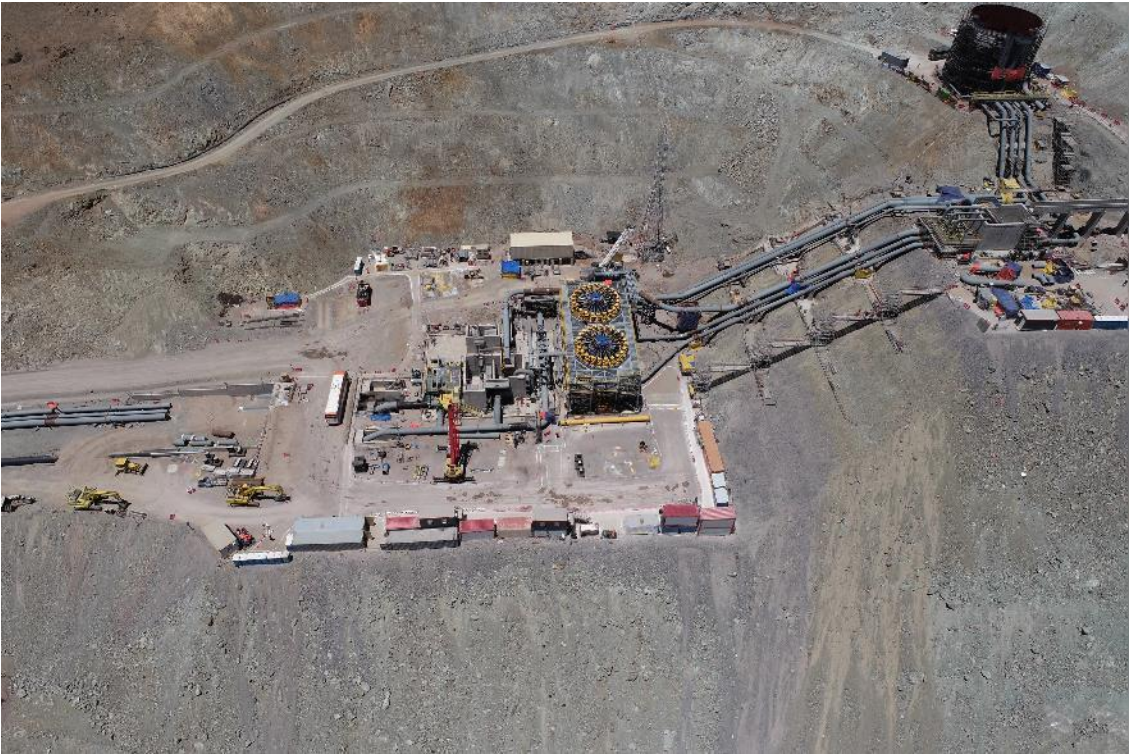
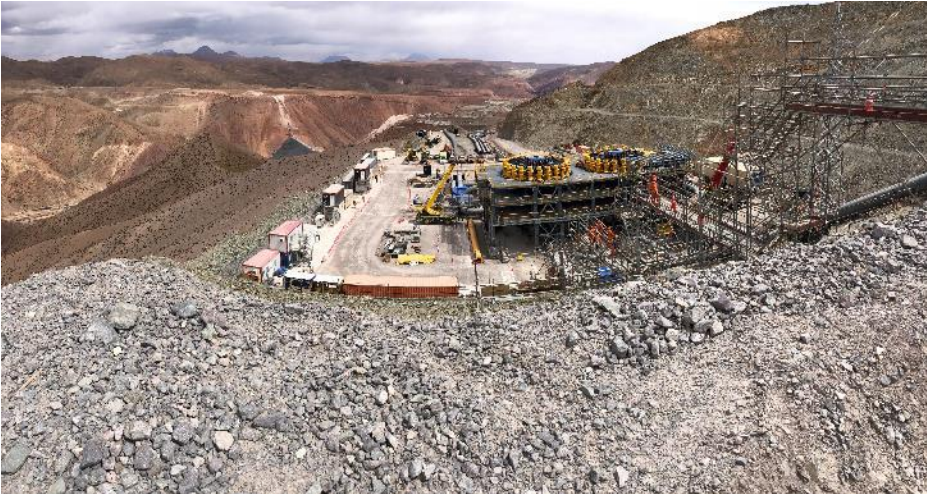
Plate 32: Cyclone Station (1441)

9.5	Other Deformation/Settlement		x		
9.6	Other Unusual Conditions		x		
10.0 Cyclone Station					
10.1	Concern with cut slopes		x	32	Performing well to-date. Installation of drape mesh to be carried out based on performance per design.

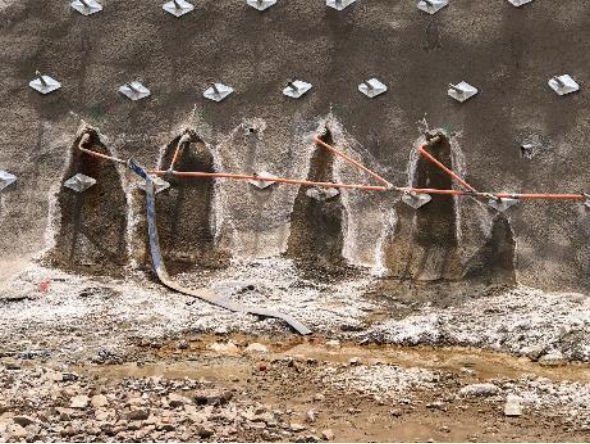
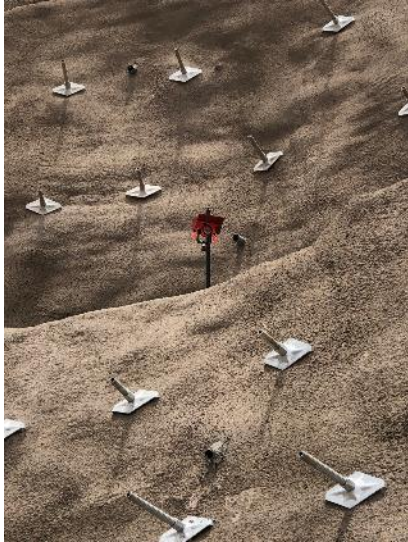
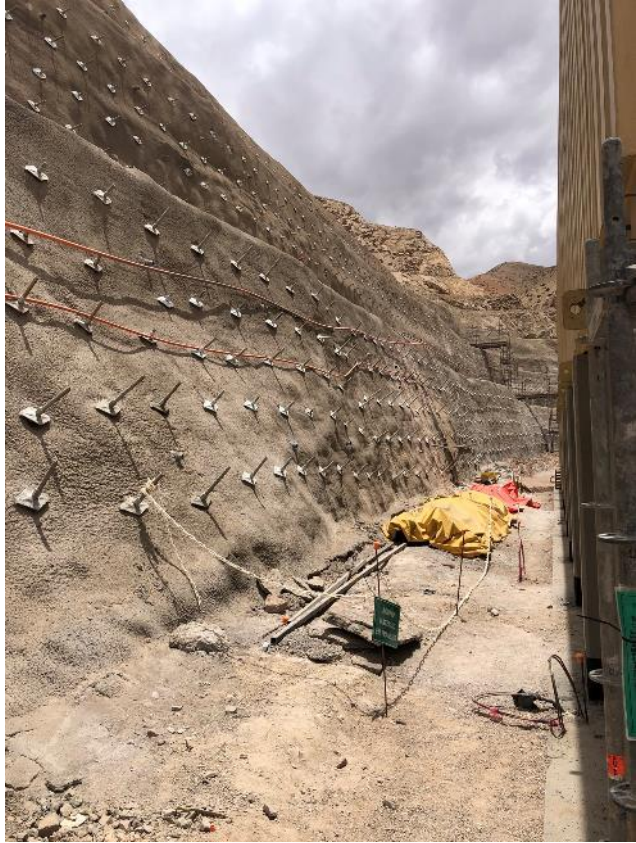
Plate 36: Booster Station No. 2 (1480)

Slope reinforcement measures

12.5	Other Unusual Conditions		x		
13.0 Booster Station No. 2					
13.1	Concern with cut slopes		x	36	Geotechnical instrumentation installation in-progress per design.

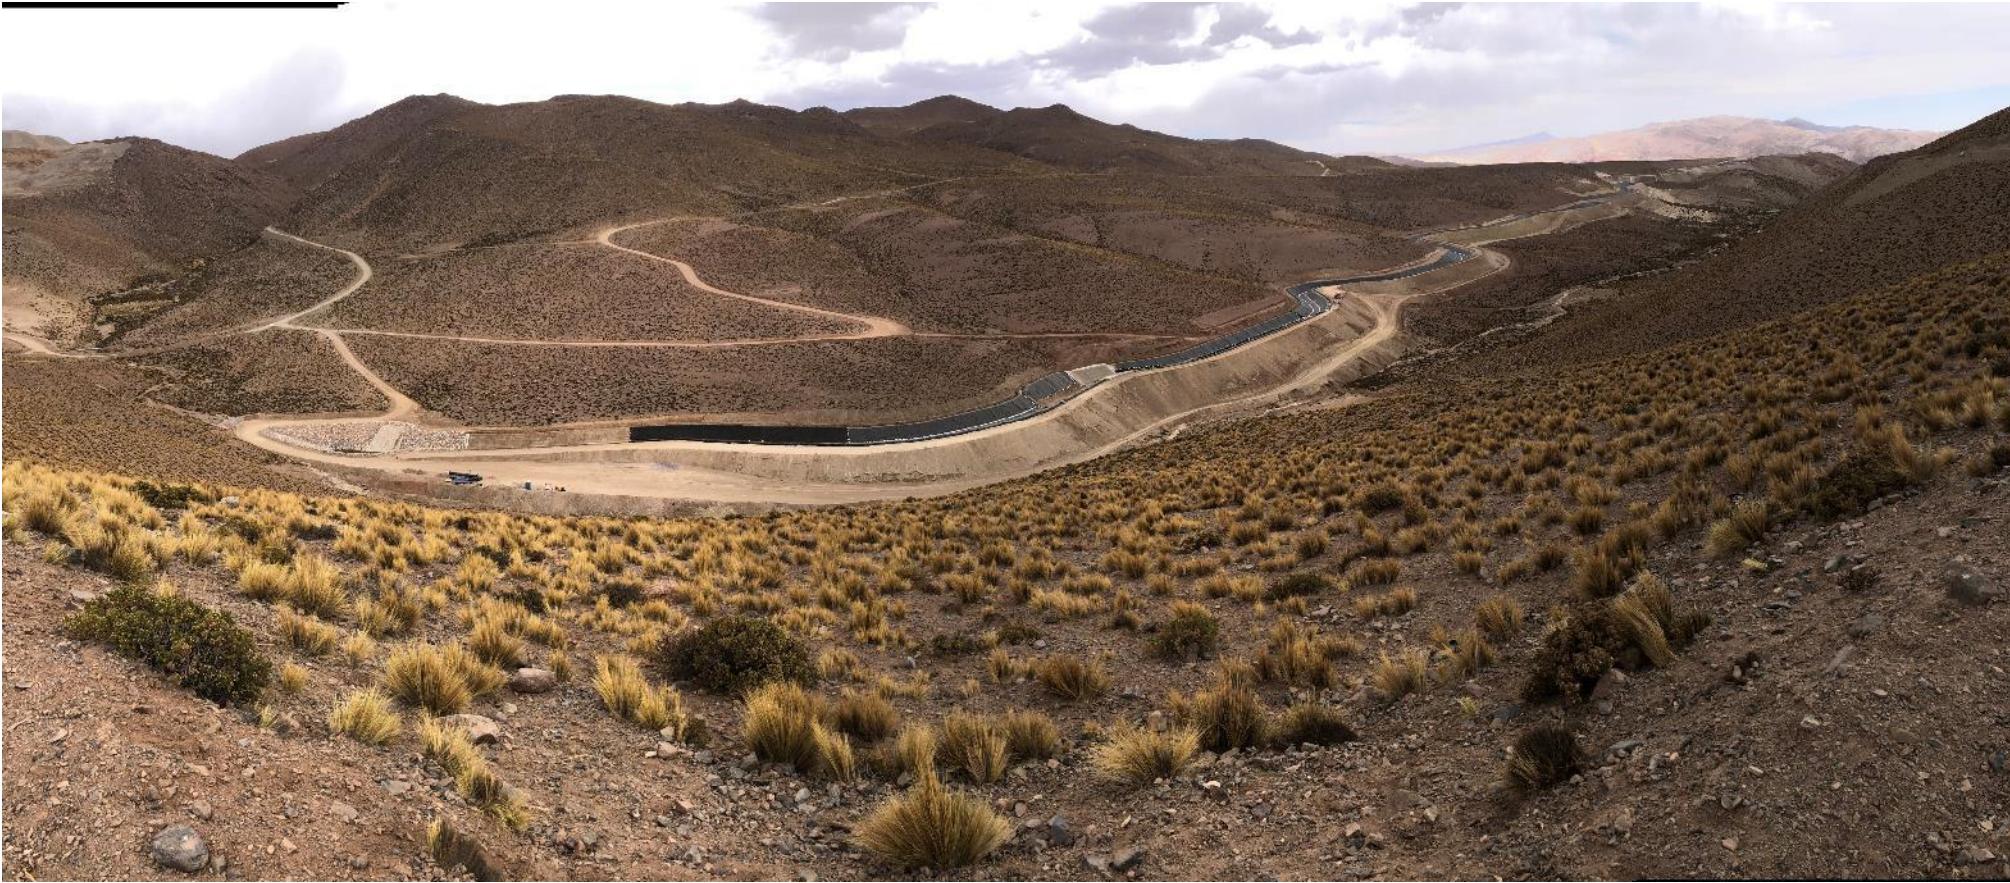
Plate 42: TMF Contour Channel (1422)

8.0 TMF Contour Channel					
8.1	Evidence of Erosion or Obstructions.		x		
8.2	Unusual Intensity of Flow in Channel		x		
8.3	Evidence of Damage to Channel Armouring/Lining		x	42	Liner installation in-progress; near completion.
