# Tailings Storage Facilities - West Fork Tailings Facility and Lagoons A, B, C and D 2018 Dam Safety Inspection

**FINAL REPORT**

Project # TE183022

25-Mar-19

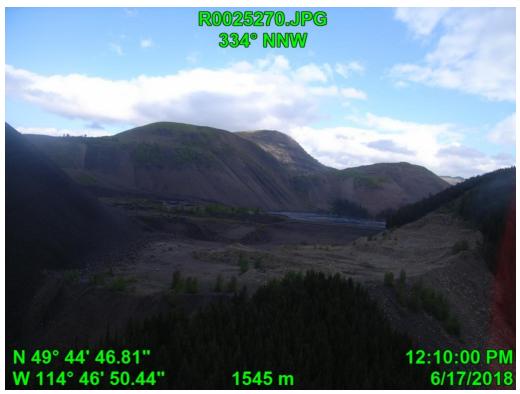
Photograph F - 1: Showing aerial overview of WFTF, looking northwest.

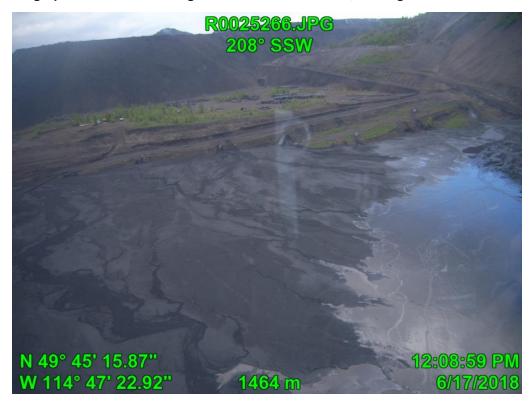
Photograph F - 2: Showing aerial overview of upstream of WFTF, looking south.

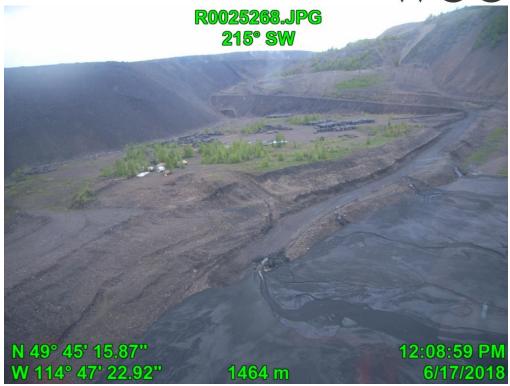
Photograph F - 3: Showing an aerial view of tailings pipelines and tailings beaching at the WTFT, looking west.

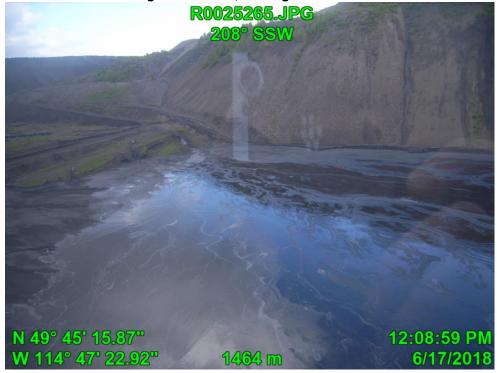
Photograph F - 4: Showing an aerial view of upstream of the WFTF, looking southwest.

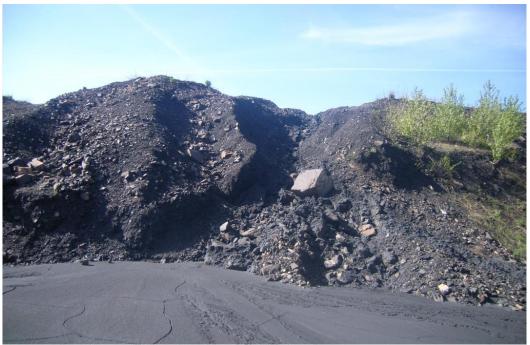
Photograph F - 10: Showing a sinkhole on the west side of the WFTF near the Adit dump. (Photo R0018420, 06/06/2017)

2.3	Other Deformation/Settlement/Sinkholes	Х			Sinkholes at left abutment and along adit dump toe road up to 0.6 m dia.
	Concerns with Low Areas on the Crest		Х		Officiolog at lost abatificiti and along date damp too road up to 0.0 m did.
	Concerning Vegetation Growth		X		
	Other Unusual Conditions	Х	,,		Animal tracks on tailings beach
<u> </u>			<u> </u>	<u> </u>

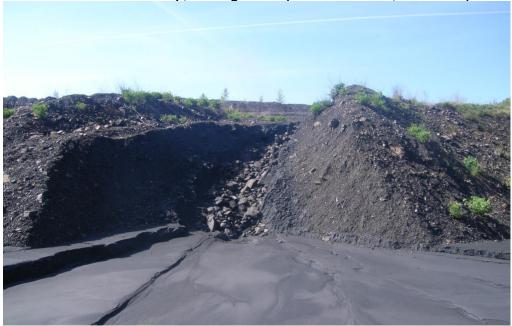
Photograph F - 11: Showing an erosion gully on upstream slope due to tailings discharged from spigot 1 pipe located close to the Adit dump, looking south. (Photo R0018422, 06/06/2017)

ID	Observed Features	Yes	No	N/A	Comments
1.0	Upstream Dam Slope			•	
	Concern with Current or Previous Water Level		Χ		
	Evidence of Wave or Other Erosion	Χ			Significant erosion around spigots 1-3 from tailings
	Deterioration of Erosion Protection	Χ			No erosion protection in place
	Unusual Accumulation of Debris/Logs		X		
	Evidence of Sloughing/Sliding		Χ		
	Evidence of Cracks	Χ	V		Longitudinal cracking around spigot 5 – does not appear recent
	Any Other Deformation		X

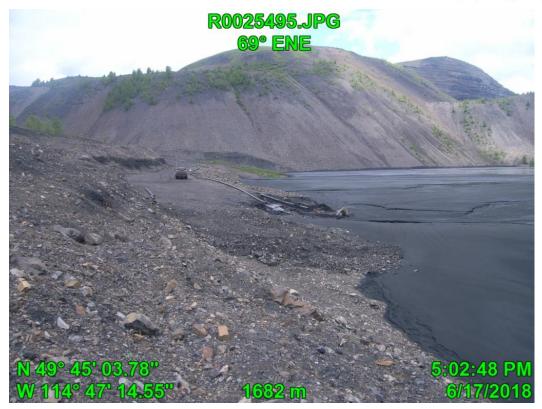
Photograph F - 12: Showing an erosion gully on upstream slope due to tailings. (Photo R0018425, 06/06/2017)

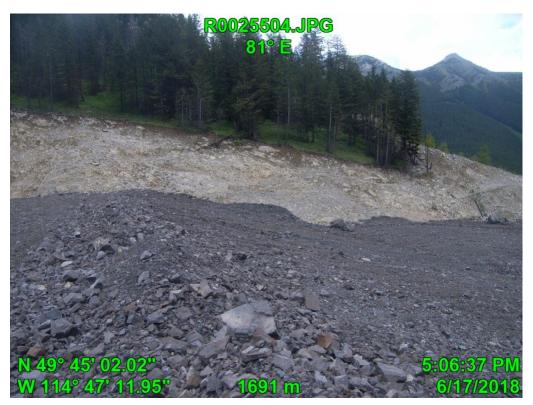
Photograph F - 16: Showing tailings beach at southeast corner of the basin, looking north. Noted seepage track on the tailings beach. (Photo R0018378, 06/06/2017)

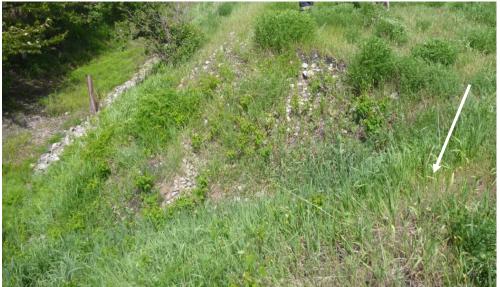
Photograph H - 7: Showing erosion on the slope of west embankment of Lagoon B, looking northeast.

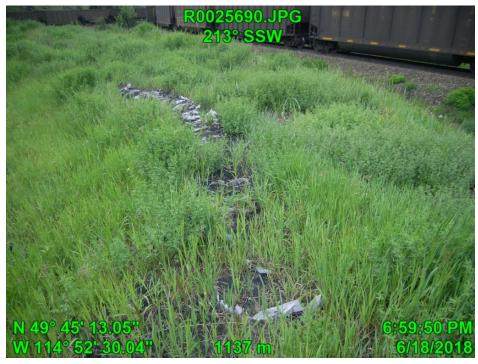
Photograph H - 8: Showing a pipeline at the toe at south end of the west embankment and an erosion gully, looking north. (Photo No. P1100775, 2017/06/07)

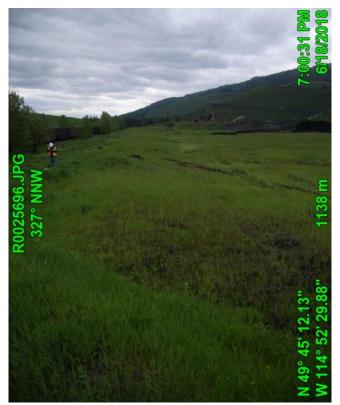
Photograph H - 10: Showing west surface of Lagoon B, view from southwest corner, looking north. [R0025696]

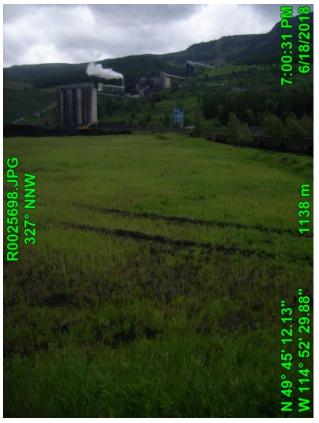
Photograph H - 11: Showing south surface of Lagoon B, view from southwest corner, looking northeast.

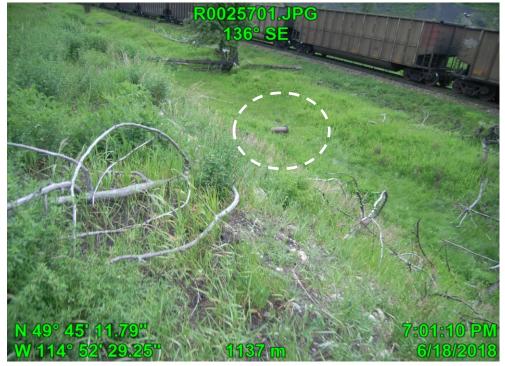
Photograph H - 12: Showing south end of Lagoon B, looking southeast. Noted the outlet steel pipe on the south slope.

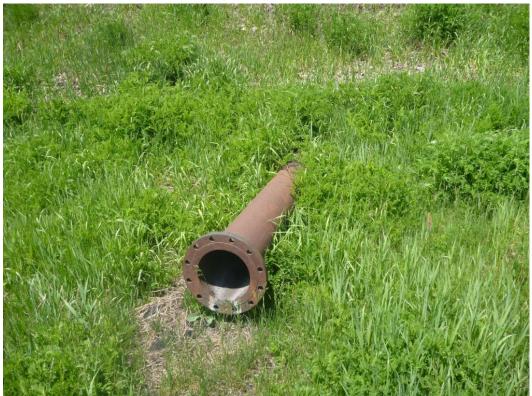
Photograph H - 13: Showing dry outlet at southwest corner of Lagoon B, looking north. (Photo No. P1100766, 2017/06/07)

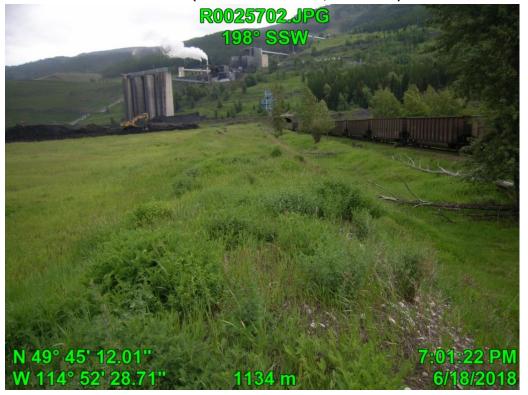
Photograph H - 14: Showing northwest area of Lagoon B, looking northeast.

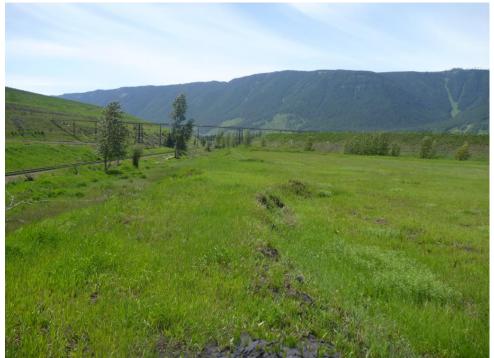
Photograph H - 15: Showing crest and slope on south side of Lagoon B, Looking southwest (Photo No. P1100758, 2017/06/07).

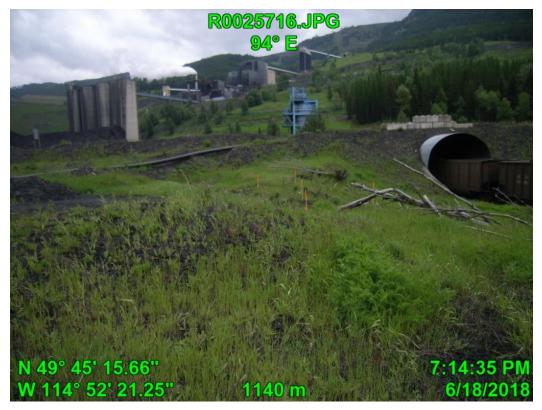
Photograph H - 16: Showing north end of the south side of Lagoon B, looking northeast.

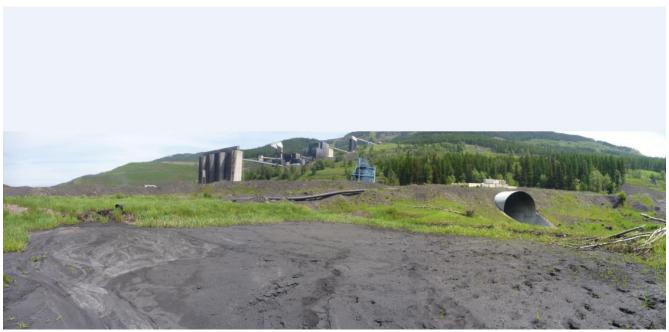
Photograph H - 17: Showing tailings discharge pipe and discharge area located at the southeast corner of Lagoon B, looking northeast. (Panorama Photo, 2017/06/07)

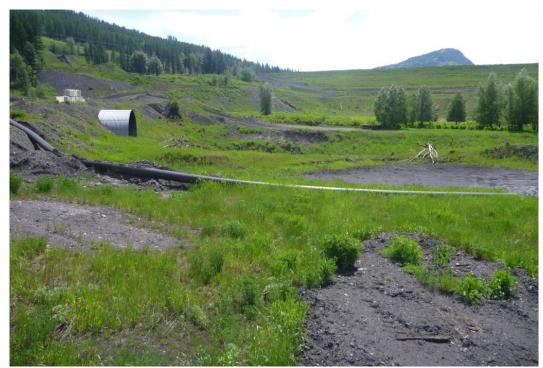
Photograph H - 18: Showing tailings discharge area located at the southeast corner of Lagoon B, looking southeast (Photo No. P1100748, 2017/06/07).

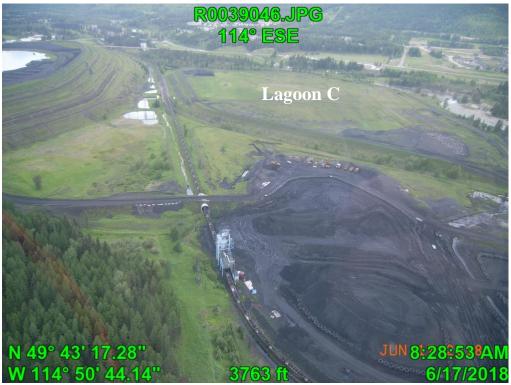
Photograph I - 1: Showing aerial overview of Lagoon C, looking northeast.

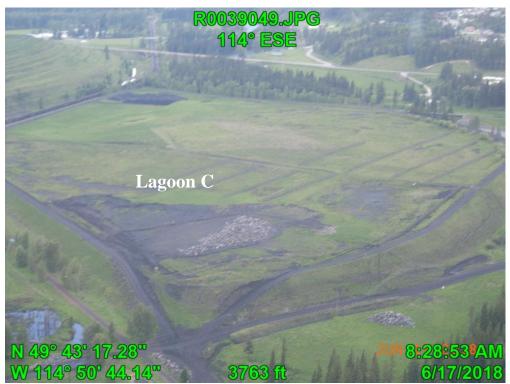
Photograph I - 2: Showing aerial overview of Lagoon C, looking east.

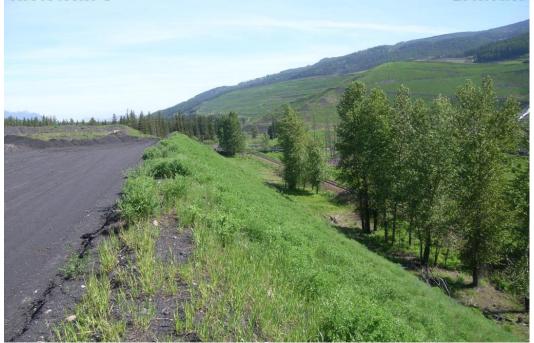
Photograph I - 5: Showing the crest and shoulder of the north end of east slope of Lagoon C, looking north.
(Photo R0018458, 06/07/2017

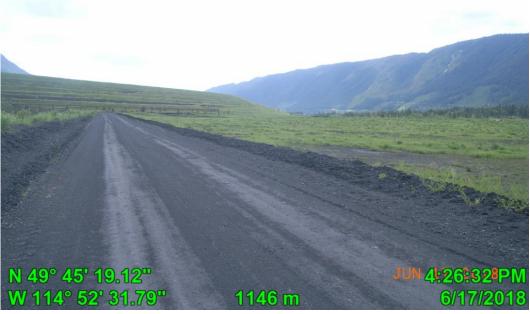
Photograph I - 7: Showing the crest and upstream from the north end of Lagoon C, looking south.

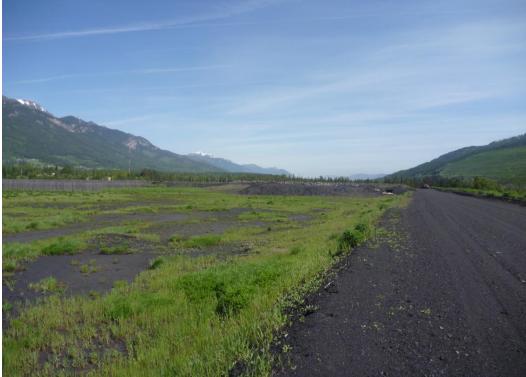
Showing the crest and upstream at the north end of Lagoon C, looking north. (Photo No. P1100615, 2017/06/07) Photograph I - 8:

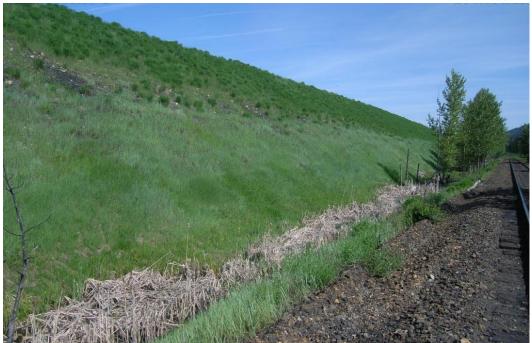
Photograph I - 9: Showing erosion at east slope toe of Lagoon C, looking north. (Photo R0018869, 06/07/2017)

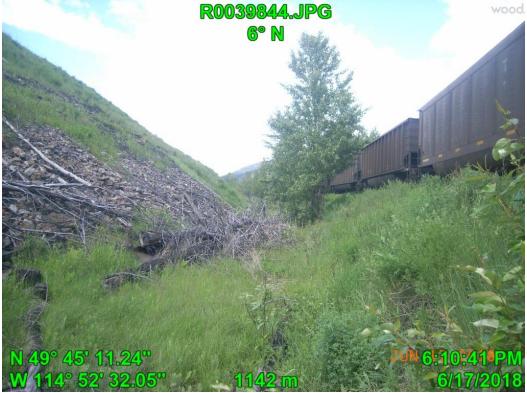
Photograph I - 10: Showing erosion at the south end of the east slope toe of Lagoon C, looking north.

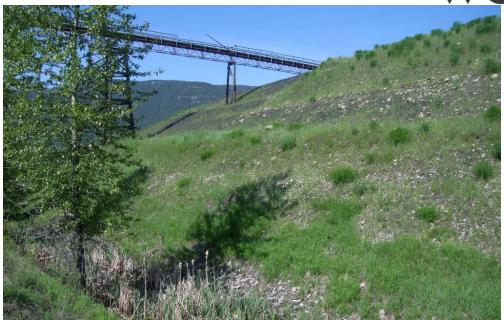
Photograph I - 11: Showing toe and downstream slope at the southeast corner of Lagoon C, looking southwest. (Photo R0018488, 06/07/2017)

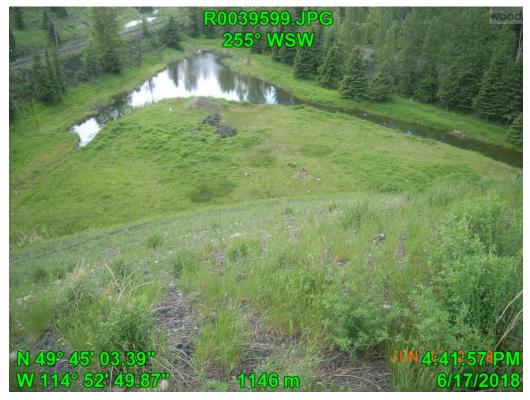
Photograph I - 14: Showing downstream toe at southwest corner of Lagoon C, looking southwest.

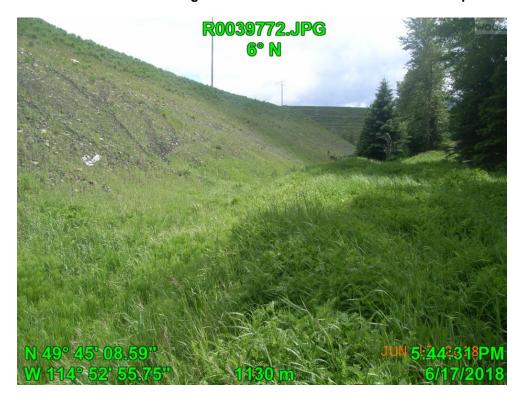
Photograph I - 16: Showing west slope and toe of Lagoon C, looking southeast.

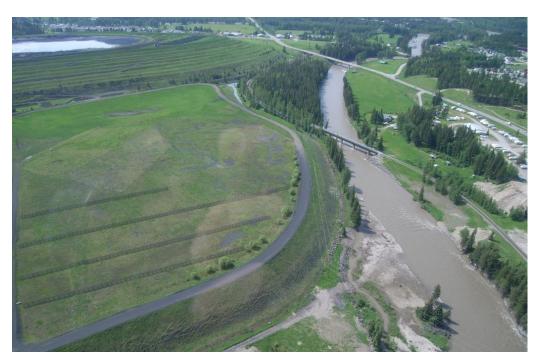
Photograph I - 17: Showing an aerial view of the west slope and toe of Lagoon C, looking south. (Photo R0018038, 06/06/2017)

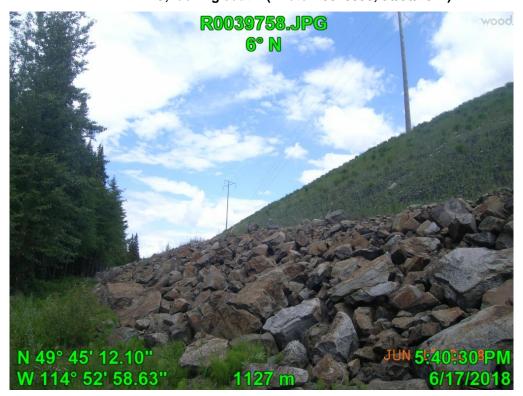
Photograph I- 18: Showing west slope and toe of Lagoon C, showing erosion protection, looking north.

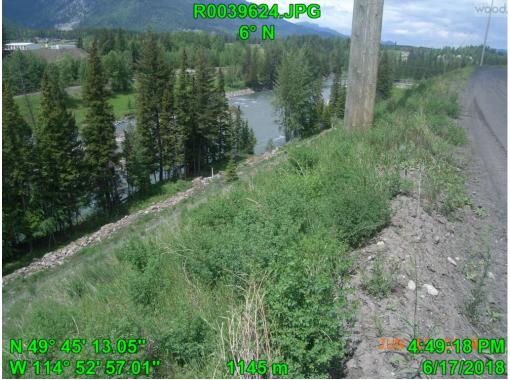
Photograph I - 19: Showing west slope and toe of Lagoon C, looking northwest.

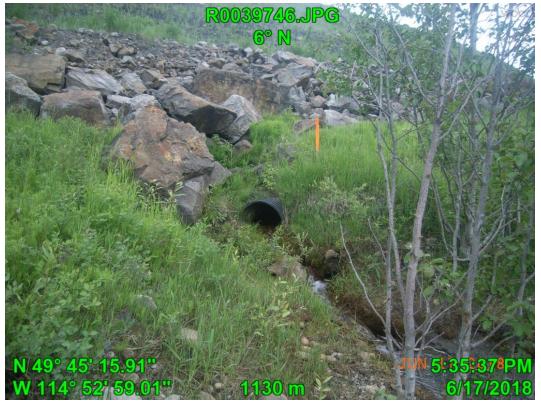
Photograph I- 20: Showing discharge outlet at the west slope toe of Lagoon C.

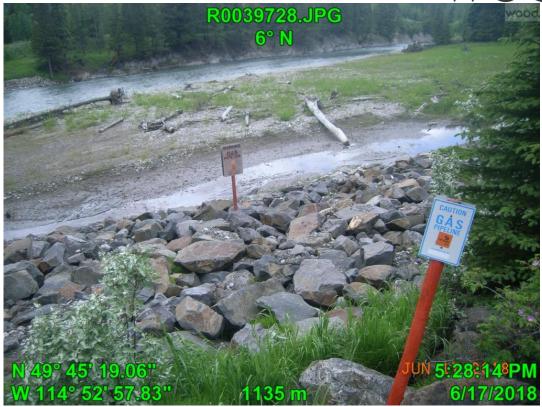
Photograph I - 21: Showing the sign of natural gas line at west slope toe of Lagoon C, looking northwest.

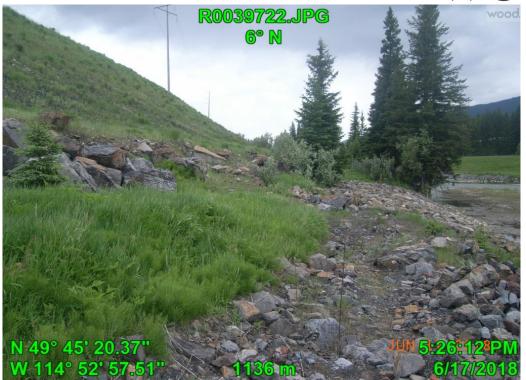
Photograph I - 23: Showing erosion riprap along the shoreline of the Elk River, at the west toe of Lagoon C, looking southwest.

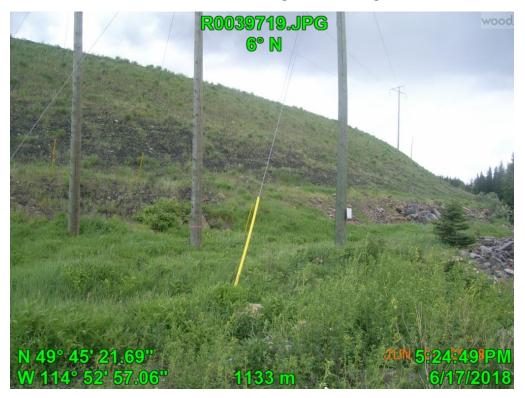
Photograph I - 24: Showing erosion on slope at northwest corner of Lagoon C, looking southeast.

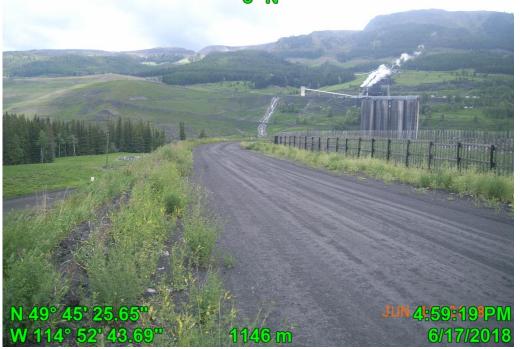
Photograph I - 25: Showing crest and upstream at the northwest corner of Lagoon C, looking northeast.

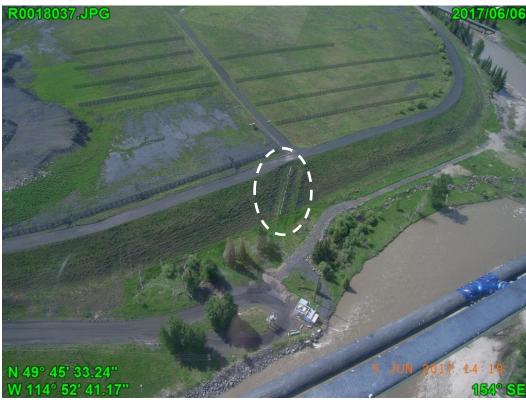
Photograph I - 26: Showing pipeline routed on north slope of Lagoon C, looking Southwest. (Photo R0018037, 06/06/2017)

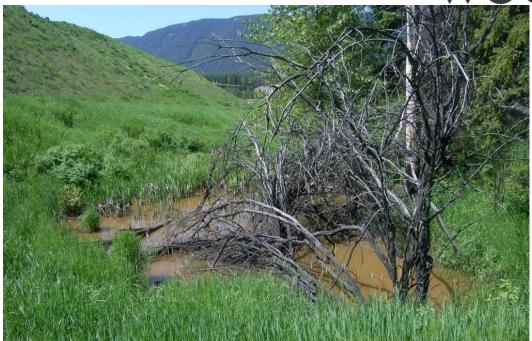
Photograph I - 27: Showing ponded water at toe of north slope of Lagoon C, looking west. (Photo R0018615, 06/07/2017)

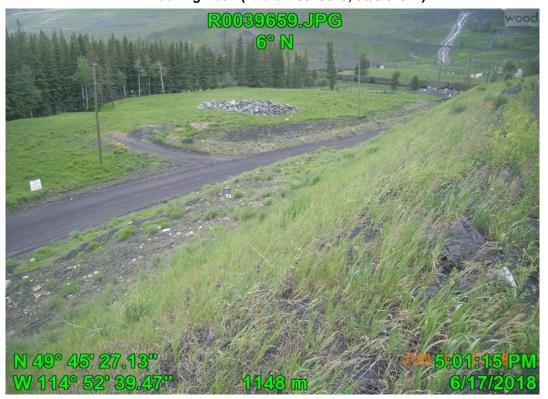
Photograph I - 28: Showing erosion on north slope of Lagoon C, looking east.

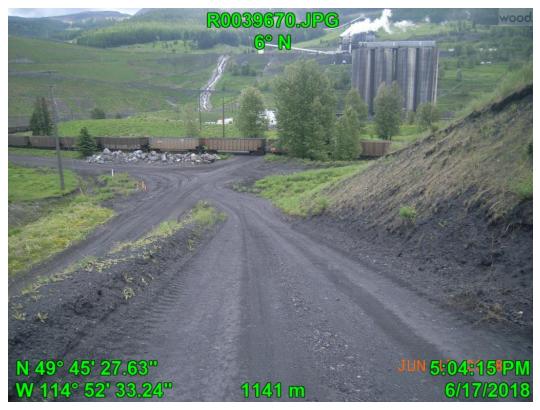
Photograph I - 29: Showing the toe of northeast corner of Lagoon C, looking east.

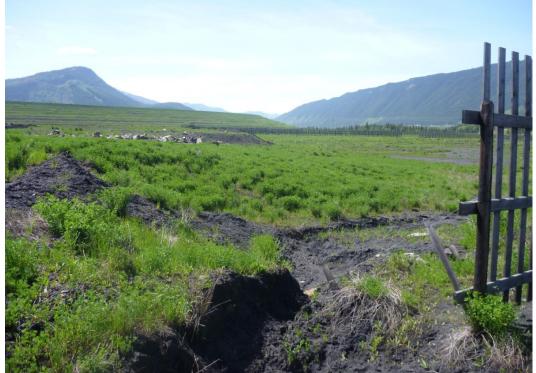
Photograph I - 30: Showing the surface of northwest area of Lagoon C, looking southwest. (Photo No.P1100678, 2017/06/07)

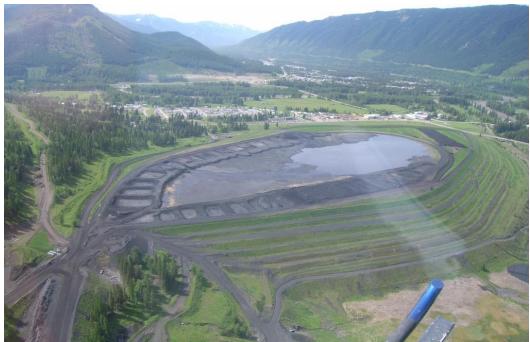
Photograph J - 1: Showing an aerial overview of Lagoon D, looking south. (Photo R0018013, 06/06/2017)

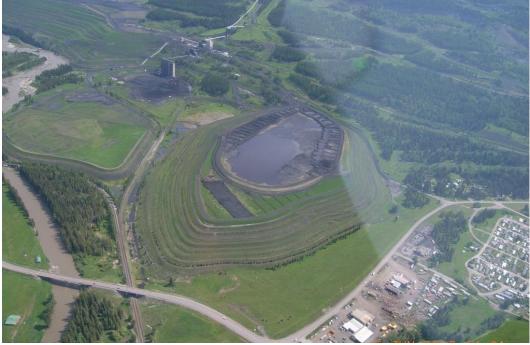
Photograph J - 2: Showing an aerial overview of Lagoon D, looking northeast. (Photo R0018047, 06/06/2017)

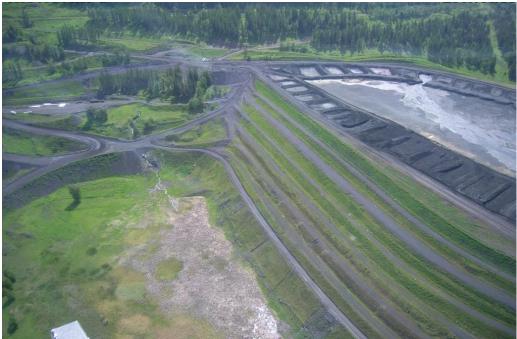
Photograph J - 3: Showing surface of the west corner and east end of the north slope of Lagoon D, looking east. (Photo R0018016, 06/06/2017)

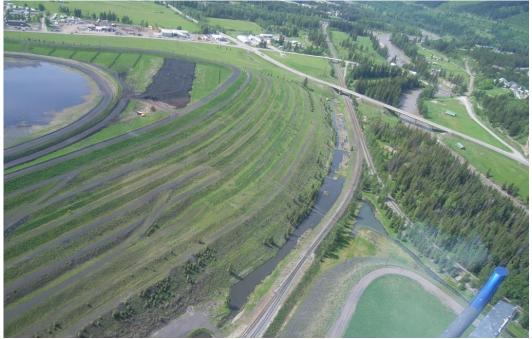
Photograph J - 4: Showing surface of the east corner and west end of the north slope of Lagoon D, looking southwest. (Photo R0018017, 06/06/2017)

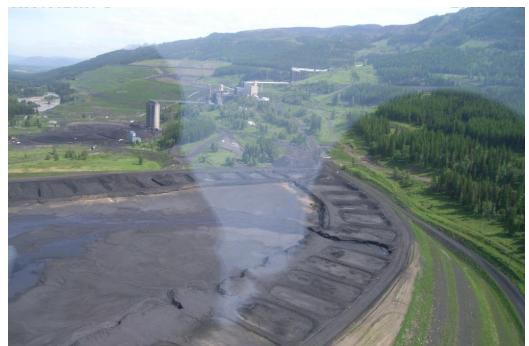
Photograph J - 5: Showing surface of the west corner and west end of the south slope of Lagoon D, looking north. (Photo R0018050, 06/06/2017)

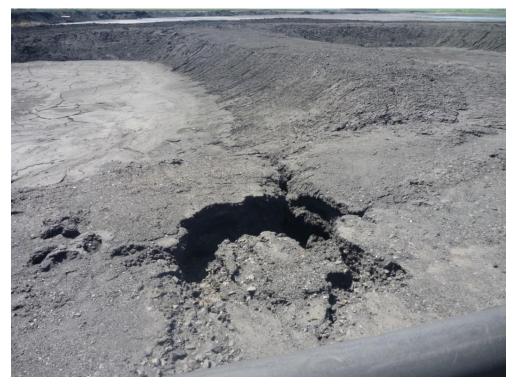
Photograph J - 7: Showing an upstream tailings cells at the northeast corner of Lagoon D, looking west.

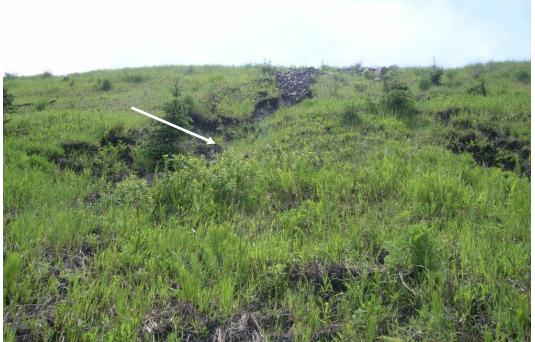
Photograph J - 12: Showing a close-view of the second seep area on the north slope, looking southeast. (Photo R0018803, 06/07/2017)

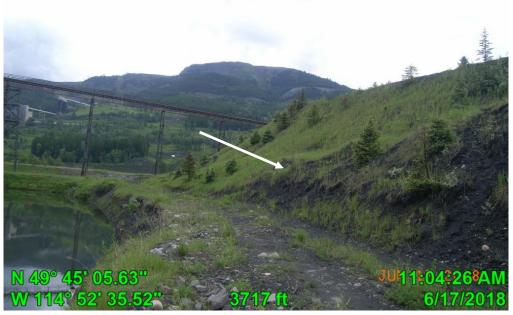
Photograph J - 14: Showing north slope, looking east. Noted the pipe on the lower north slope.

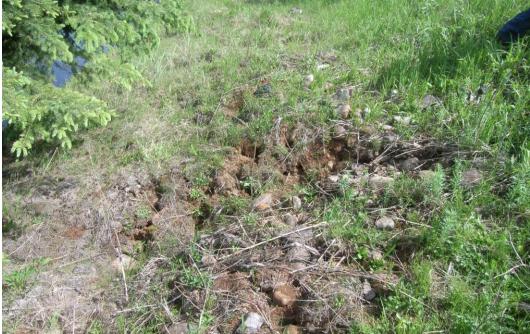
Photograph J - 19: Showing an animal borrow on the toe of north slope of Lagoon D, looking southwest. (Photo R0018721, 06/07/2017)

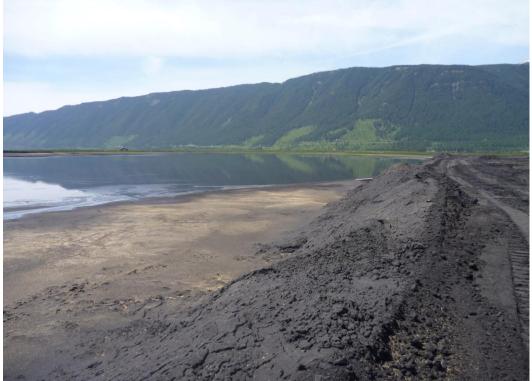
Photograph J - 21: Showing upstream tailings beach at the north section of Lagoon D, looking east. (Photo P1100702, 2017/06/06)

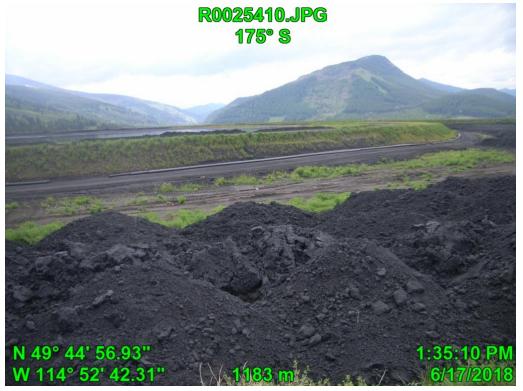
Photograph J - 22: Showing upstream tailings beach at the north section of Lagoon D, looking west. (Photo P1100703, 2017/06/06)

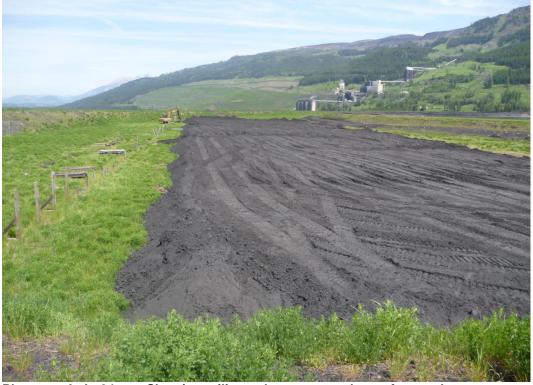
Photograph J - 23: Showing surface of the west corner of Lagoon D, looking south. Noted active tailings deposition on the surface

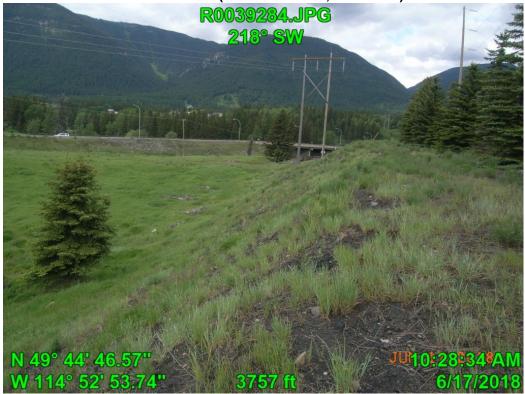
Photograph J - 25: Showing the toe at the west corner of Lagoon D, looking southwest. (Photo R0018531, 06/07/2017)

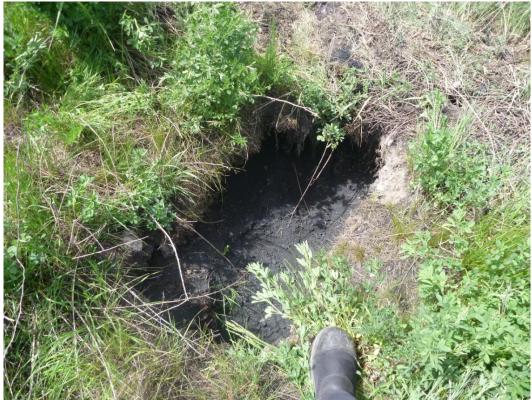
Photograph J - 26: Showing the toe of the dam at west end of Lagoon D, looking northwest.

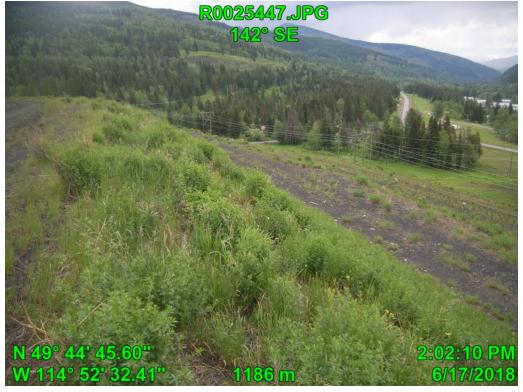
Photograph J - 27: Showing a sinkhole at south west crest of Lagoon D, looking east. (Photo P1100730, 2017/06/06).

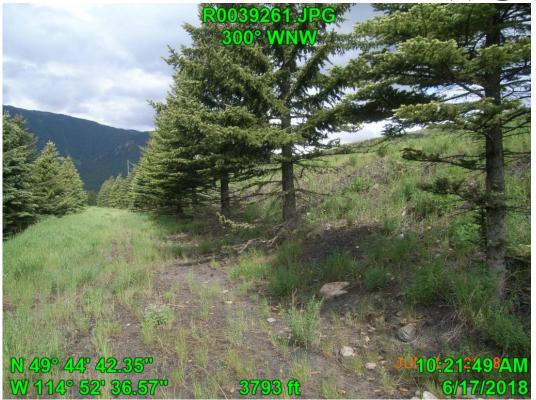
Photograph J - 28: Showing the crest shoulder at the south corner of Lagoon D, looking southeast.

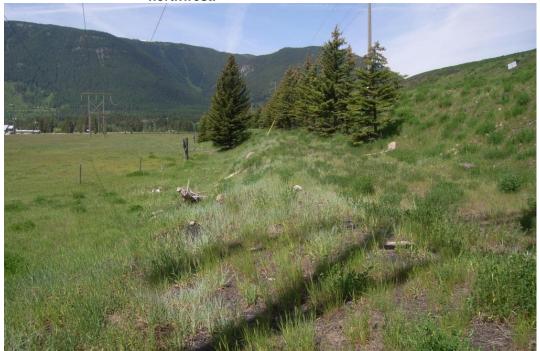
Photograph J - 29: Showing erosion on the south slope of Lagoon D, looking northwest.

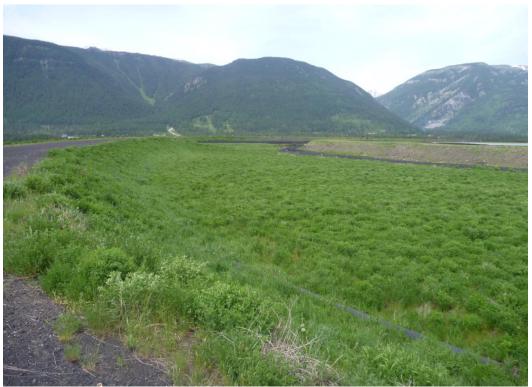
Photograph J - 30: Showing the toe of the south embankment of Lagoon D, looking west. (Photo R0018639, 06/07/2017)

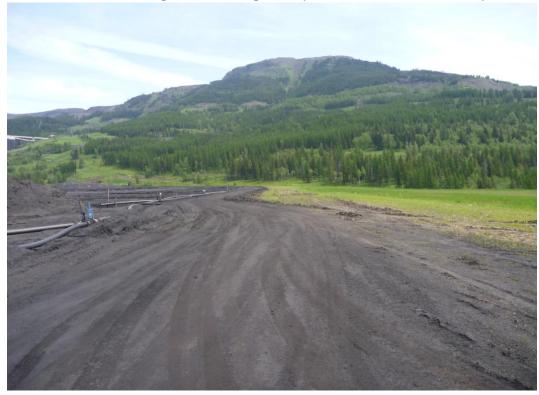
Photograph J - 31: Showing dam crest and upstream surface at the south area of Lagoon D, looking west. (Photo P1100735, 2017/06/07).
