2018 Dam Safety Inspection for North Tailings Pond and South Tailings Pond

Teck Coal Limited, Fording River Operations

Golder Associates Ltd.

29 March 2019

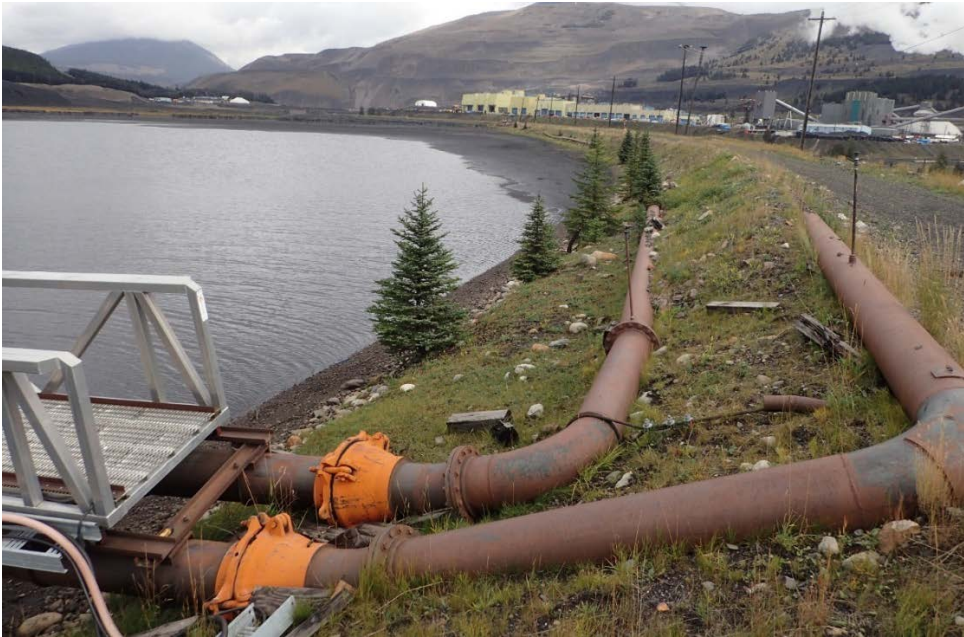
Photograph A-3: NTP dam upstream slope with small tress and vegetation growing, and unused reclaim pipes, looking northeast, 12 September 2018.

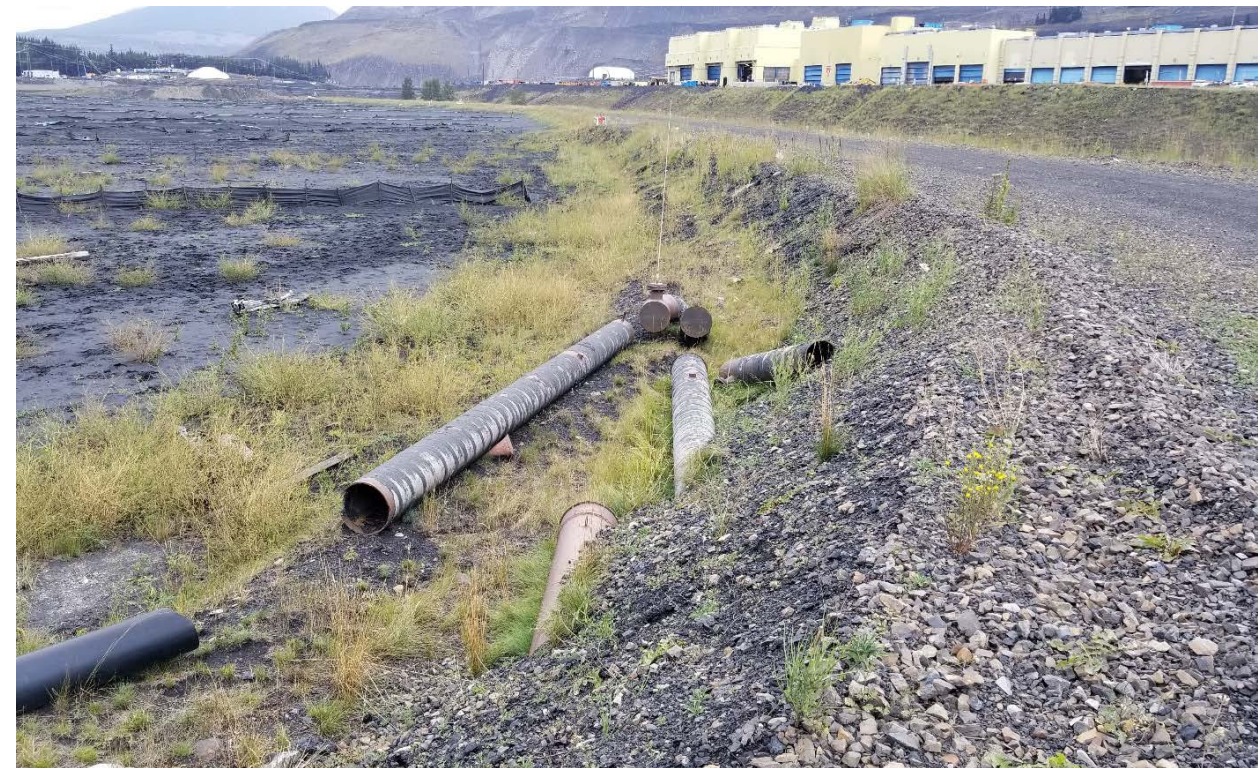
Photograph A-4: NTP unused reclaim pipelines on upstream slope, capped pipelines that go into dam section and crossing under crest, looking north, 12 September 2018.

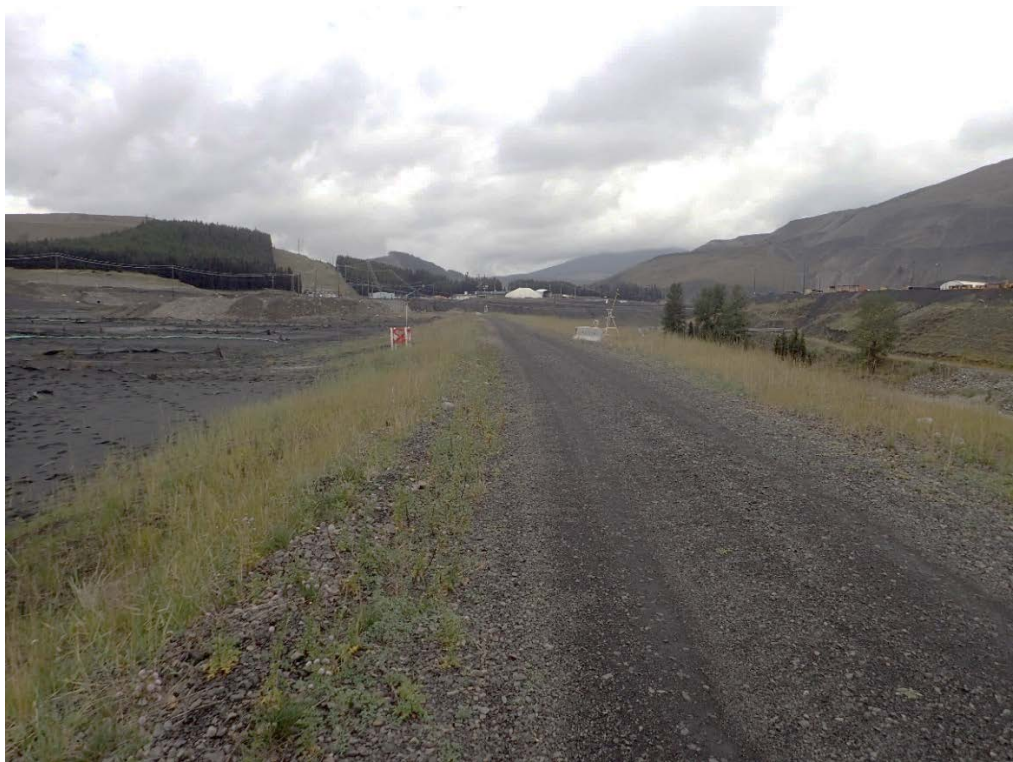
Photograph A-5: NTP crest and upstream slope, looking north, 12 September 2018.

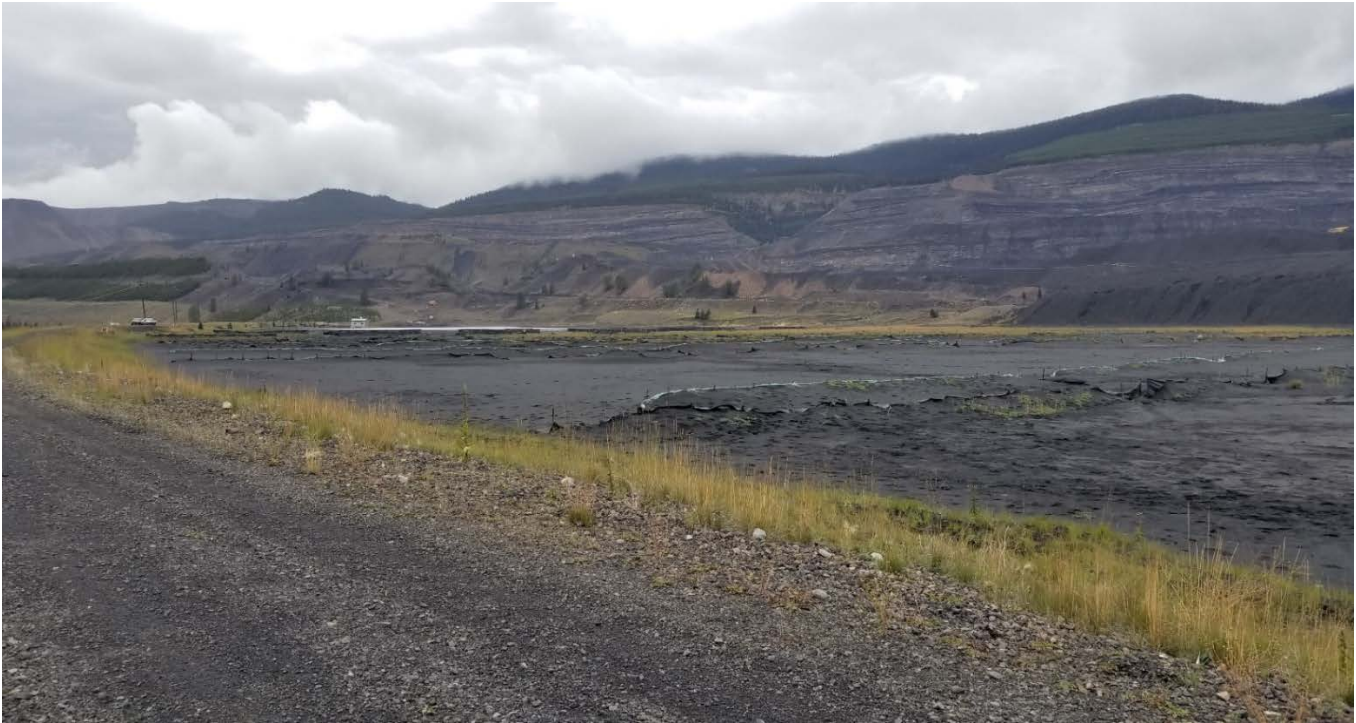
Photograph A-8: NTP, tailings surface with silt fencing for dust control, looking southwest, 12 September 2018.

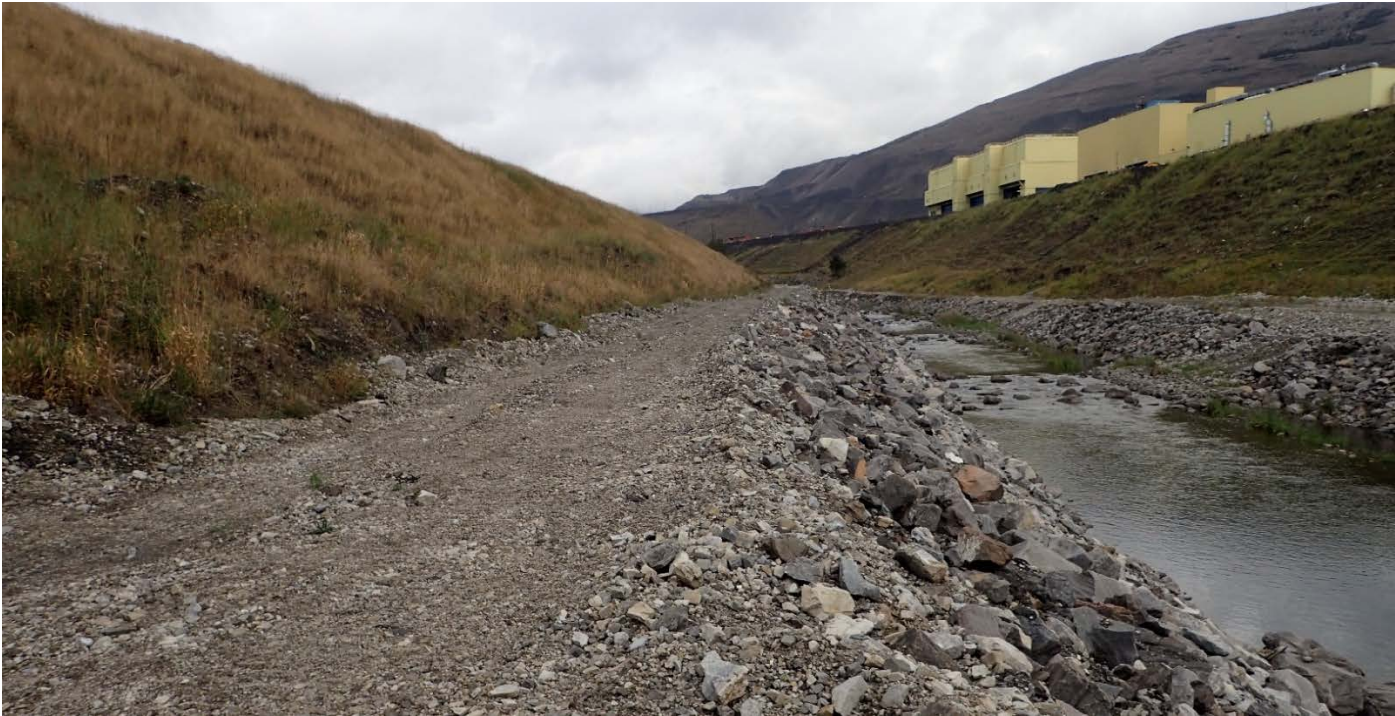
Photograph A-9: NTP downstream slope and toe near Stn 0+700, riprap along Fording River, looking northeast, 12 September 2018.

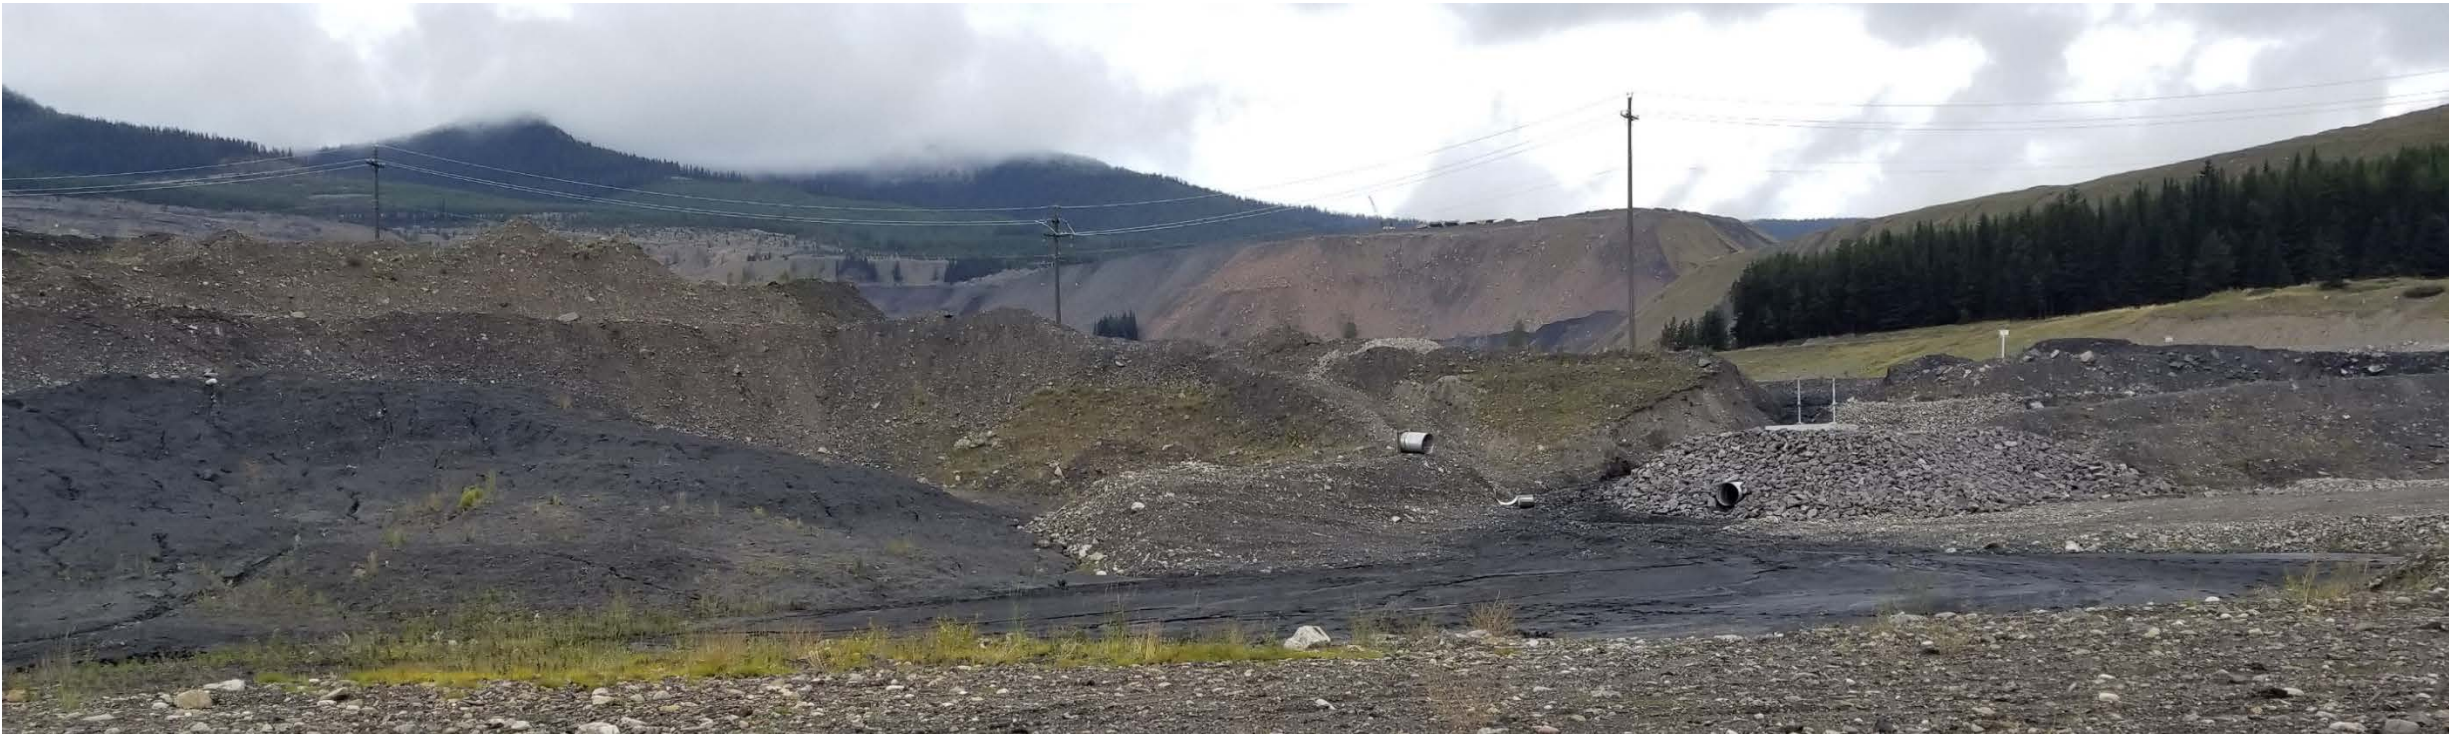
Photograph A-14: At NTP north abutment, stockpile areas to west, surface runoff from haul road and ditch reporting to tailings beach in this area, and emergency overflow from Liverpool pond outlet, looking west, 12 September 2018.

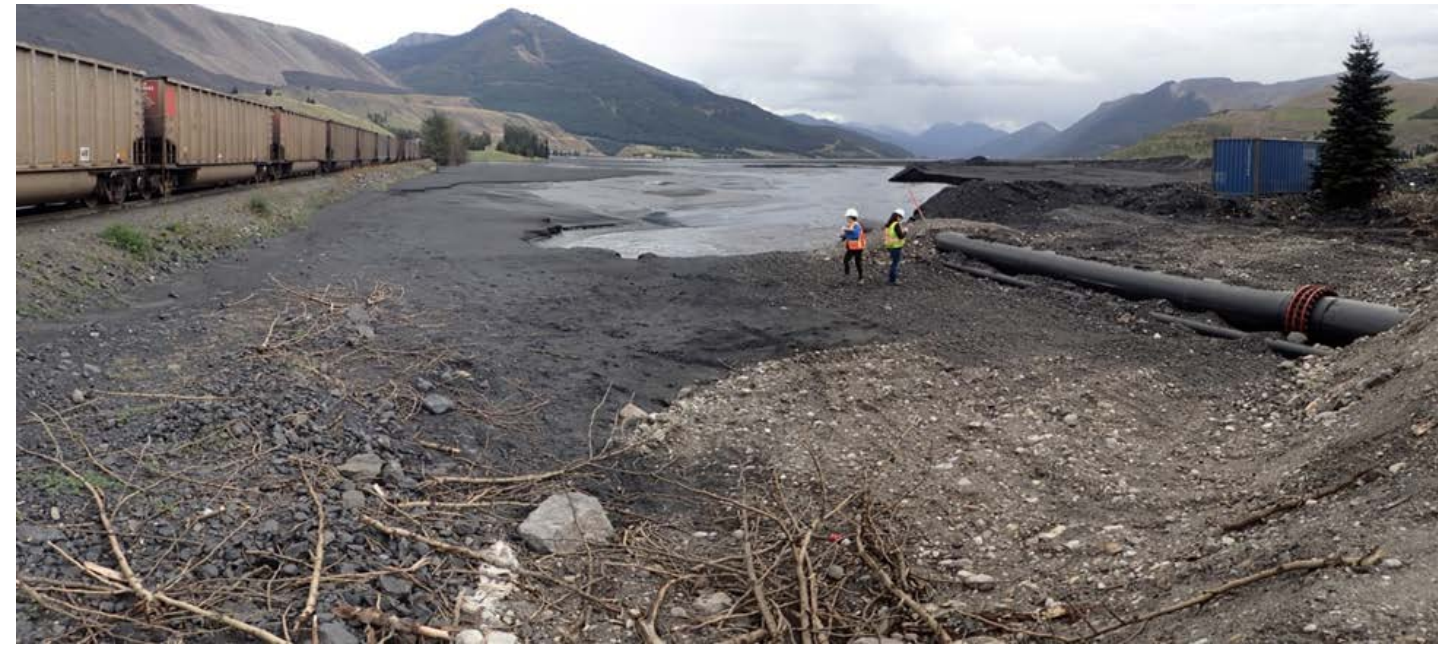
Photograph A-16: STP north single point discharge, which was recently extended and raised, adjacent to railway line, looking south, 11 September 2018.

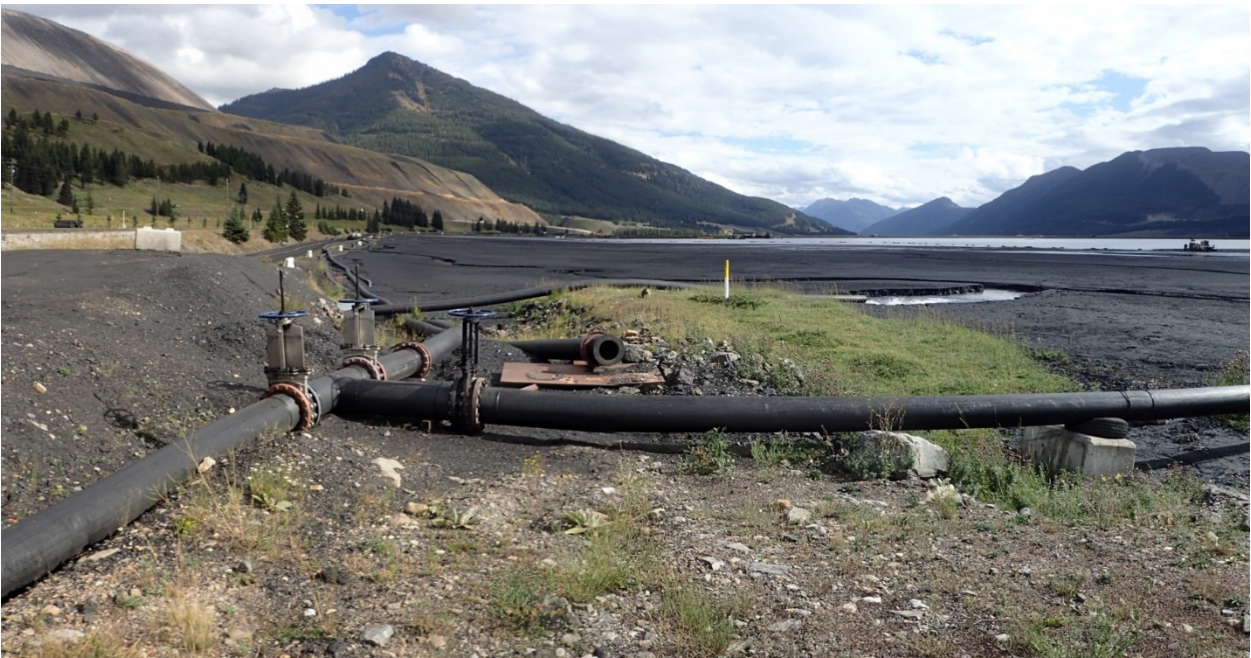
Photograph A-17: Tailings dredge pipeline and emergency bypass in foreground, temporary reclaim pipeline from Turnbull TSF discharging water along with Blackmore creek culverts, looking south, 11 September 2018.

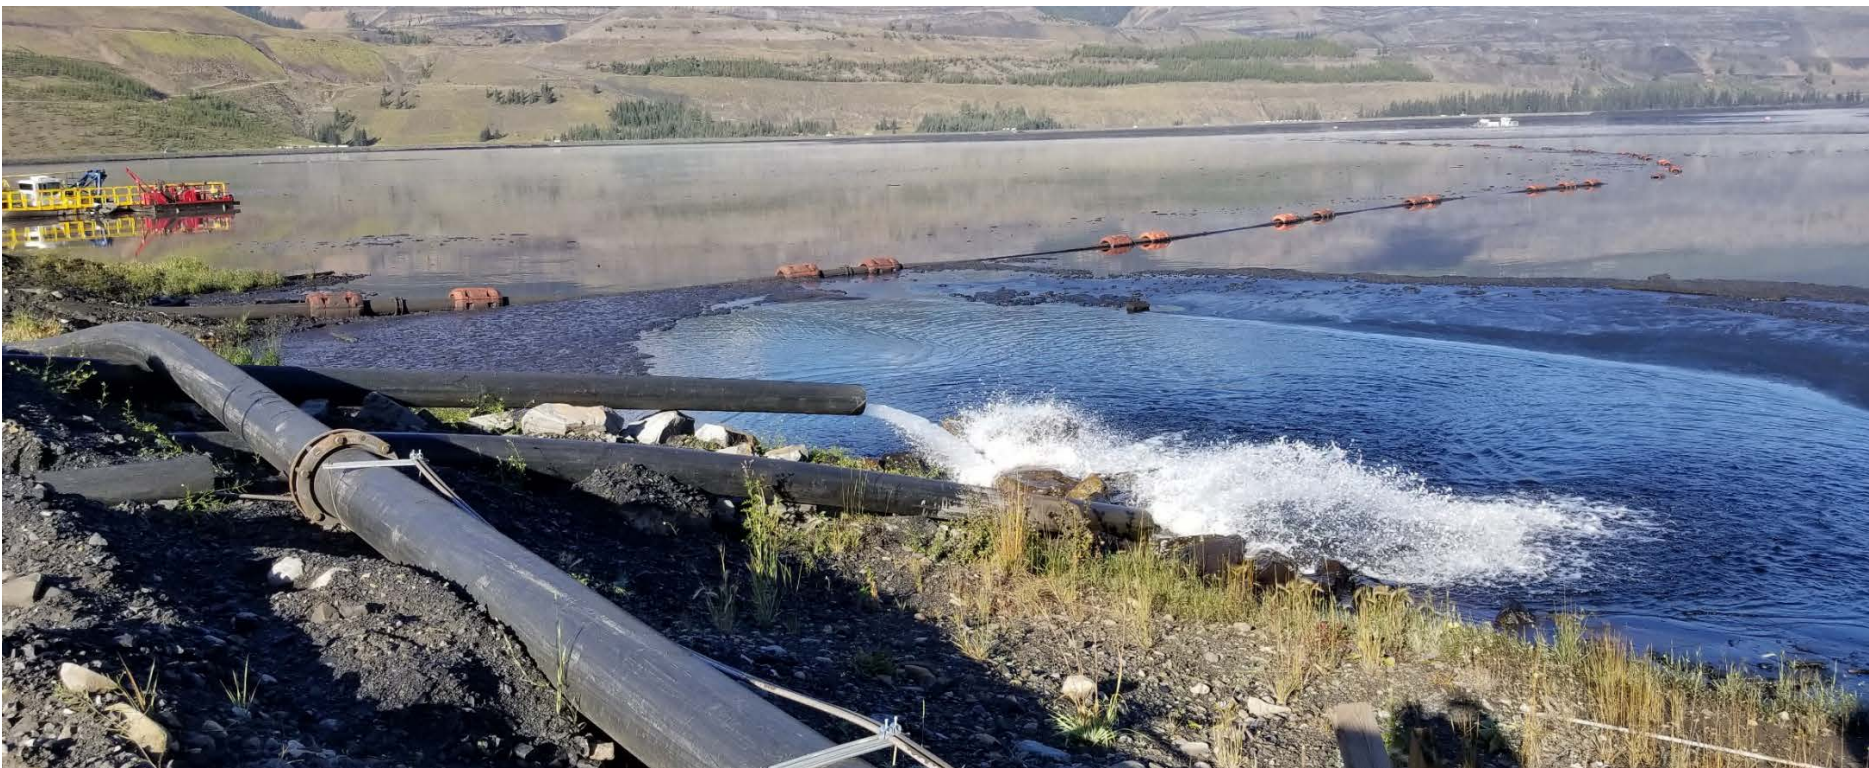
Photograph A-20: STP south abutment till blanket area, makeup waterlines from Kilmarnock Pond with riprap protection on blanket, looking northwest, 11 September 2018.

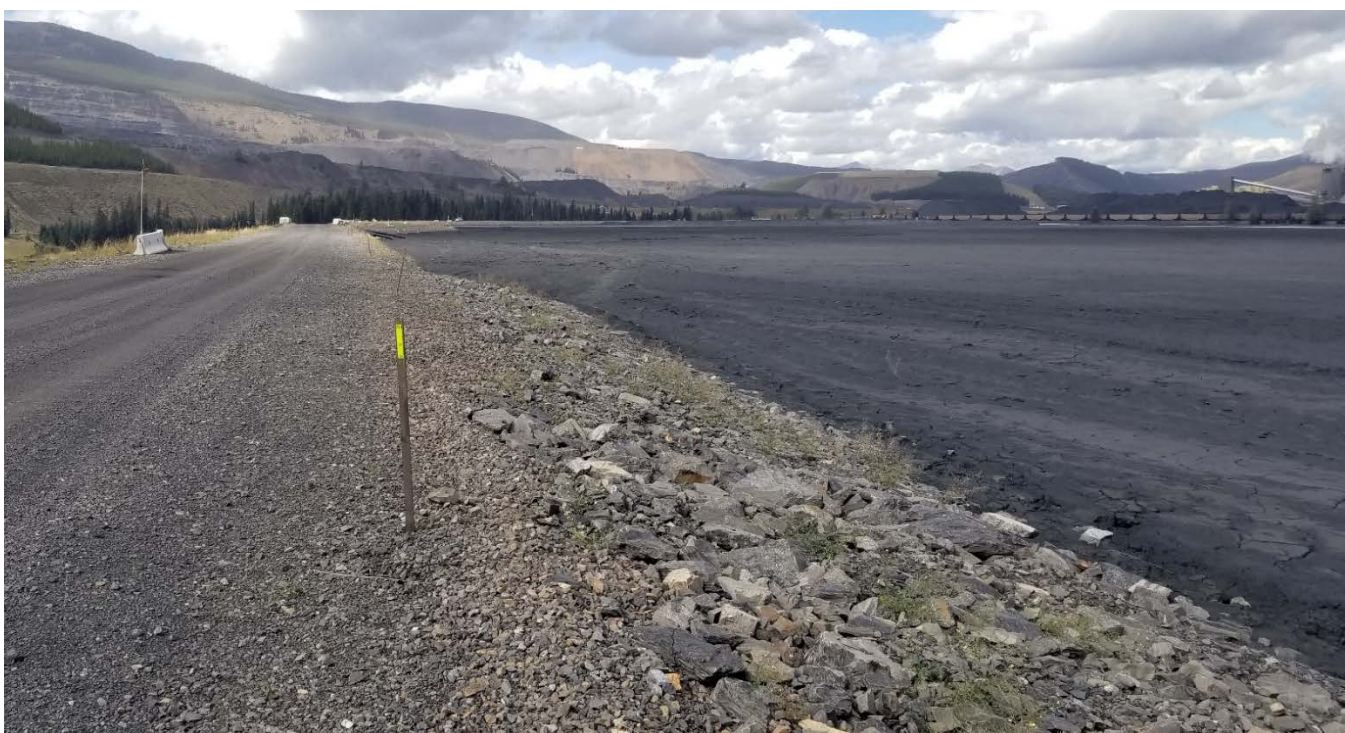
Photograph A-24: STP upstream slope and crest, looking north, 11 September 2018.

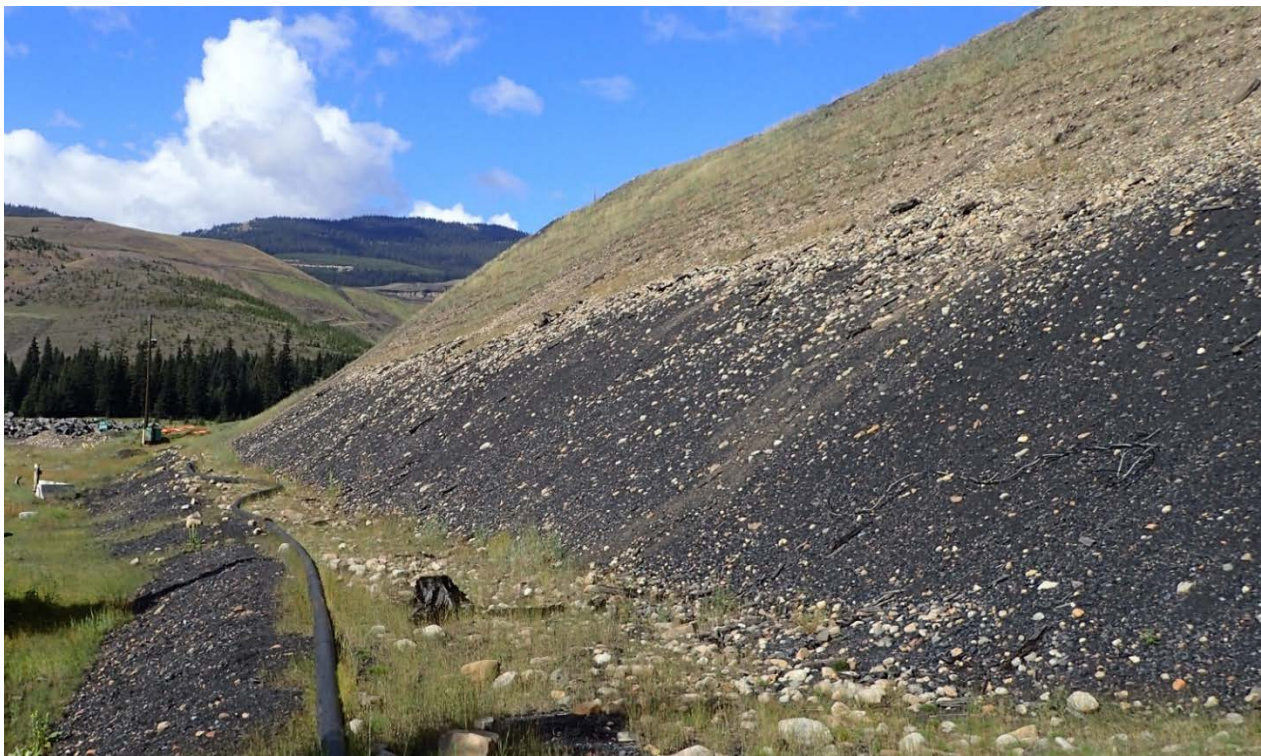
Photograph A-26: STP Main Dam downstream slope and toe at seepage return well, looking west, 11 September 2018.

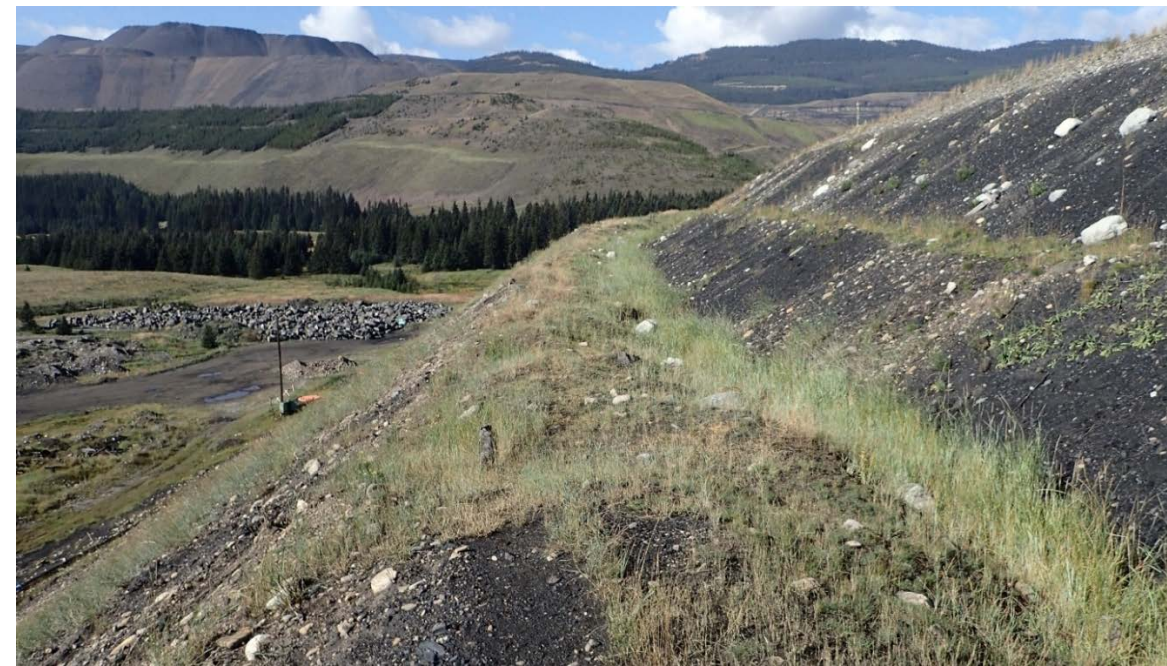
Photograph A-27: STP Main Dam downstream slope at bench (~elev. 1,630 m), looking west, 11 September 2018.

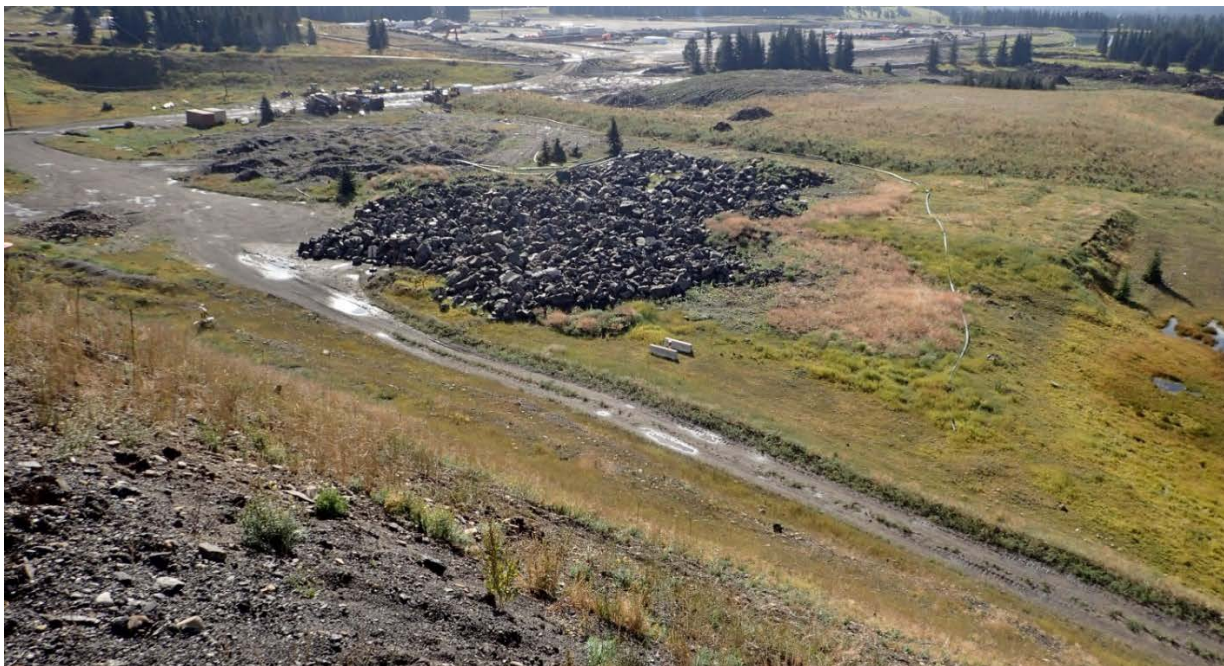
Photograph A-28: STP Main Dam, looking south at riprap emergency stockpile and Fording River flood plain, 11 September 2018.

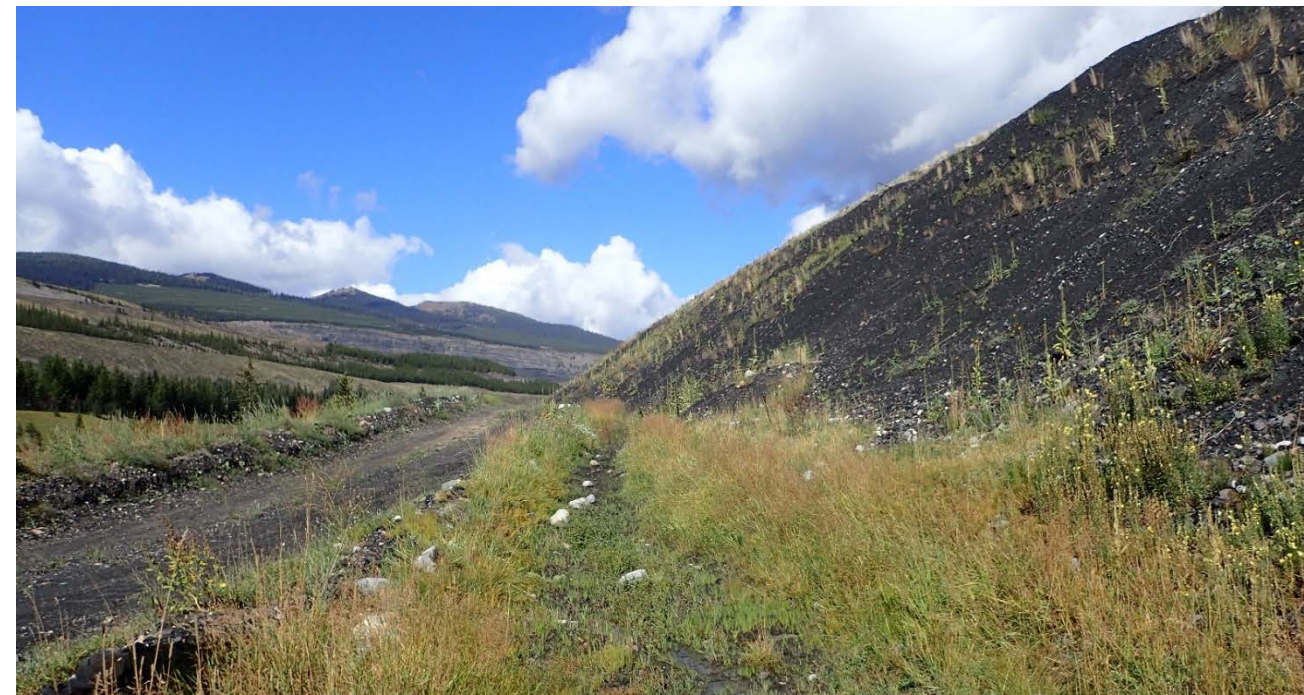
Photograph A-31: On STP West Dam access road, looking north west, 11 September 2018.

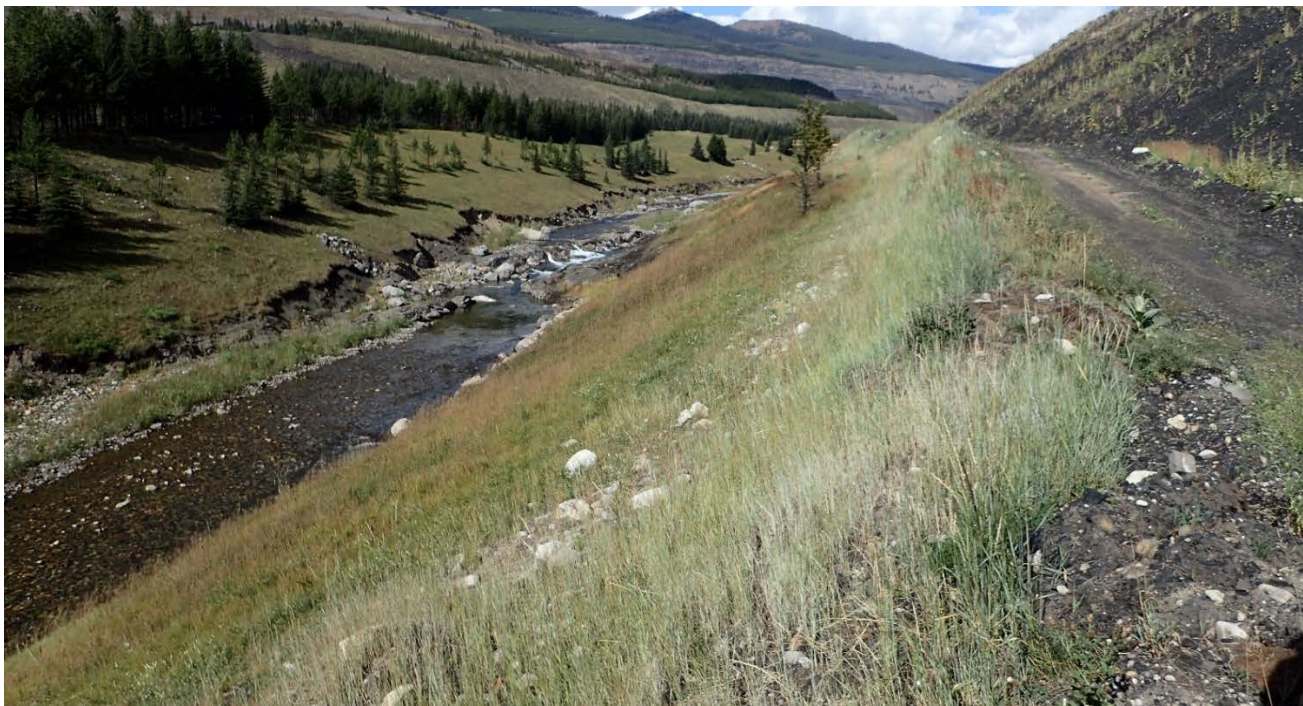
Photograph A-32: On STP West Dam access road, Fording River to the left and STP downstream slope to the right, looking east, 11 September 2018.

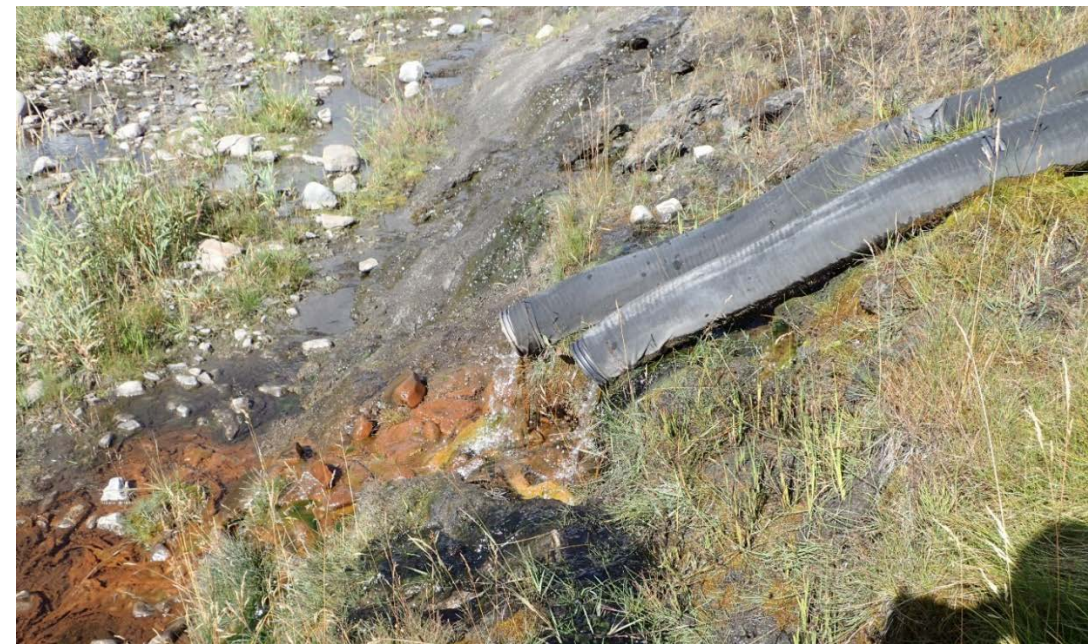
Photograph A 33: On slope of STP West Dam access road, seepage collection point along the downstream slope (Stn. 1+000). Seepage collection points monitor flow. Note discolouration. The flow rate at the time of inspection was approximately 0.21 L/sec from the south pipe (closer to the page) and 0.26 L/sec from the north pipe (further into the page). 11 September 2018.

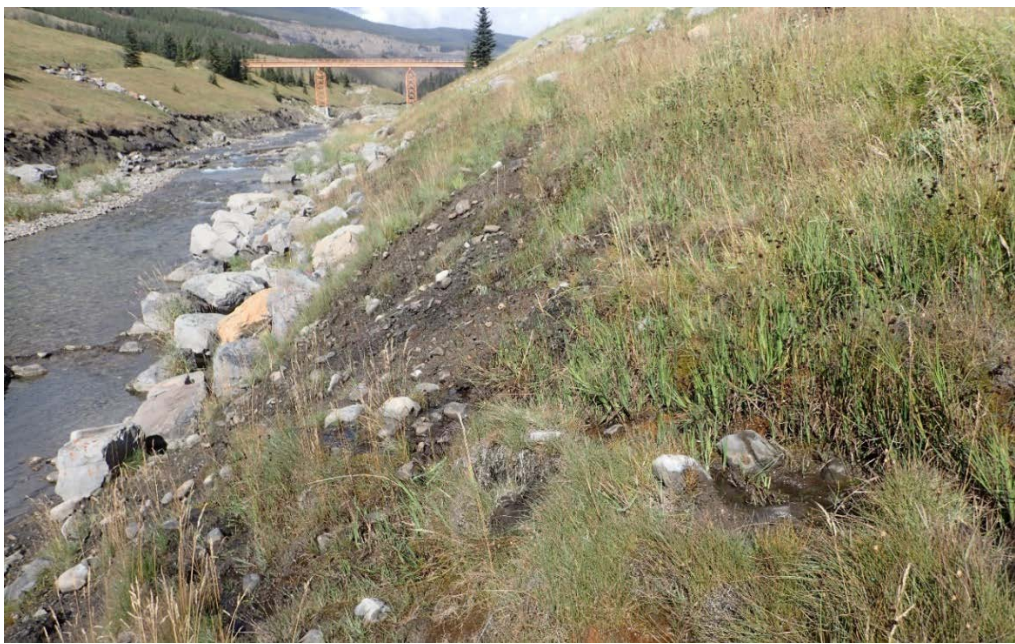
Photograph A-34: On Slope of STP West Dam access road, looking northwest along Fording River, 11 September 2018.

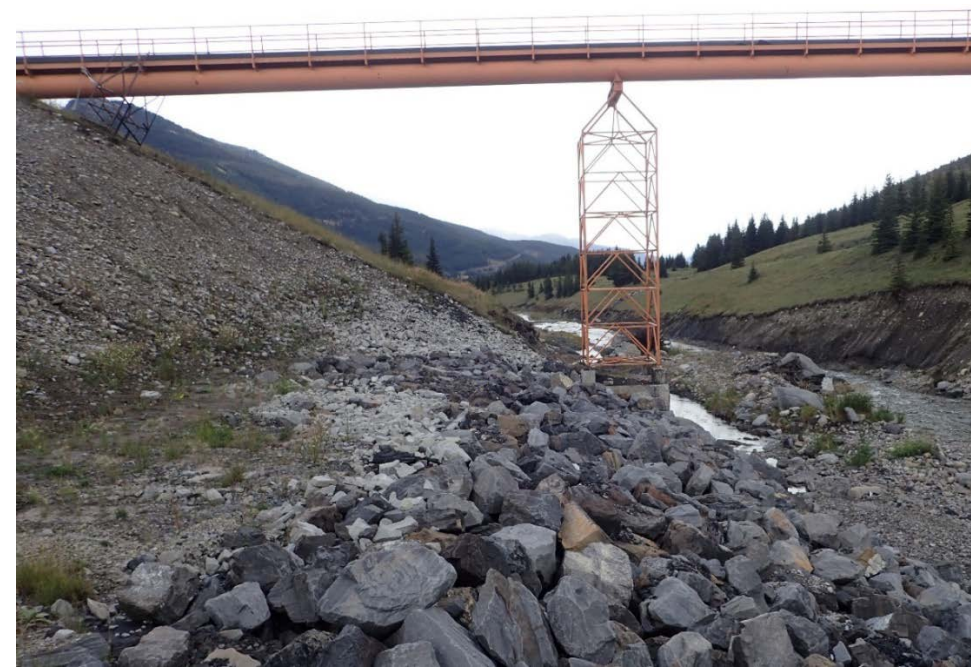
Photograph A-35: STP West Dam, till cut and riprap along downstream toe up to old pipeline bridge, looking southeast, 11 September 2018.

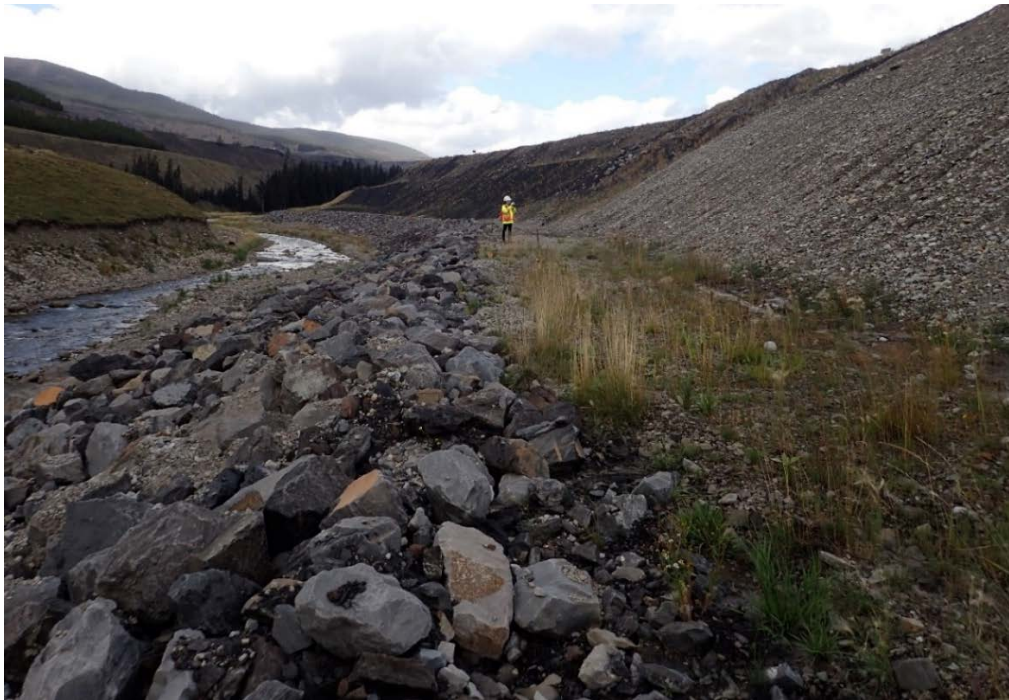
Photograph A-36: STP West Dam, riprap along dam toe, looking northwest, 11 September 2018.

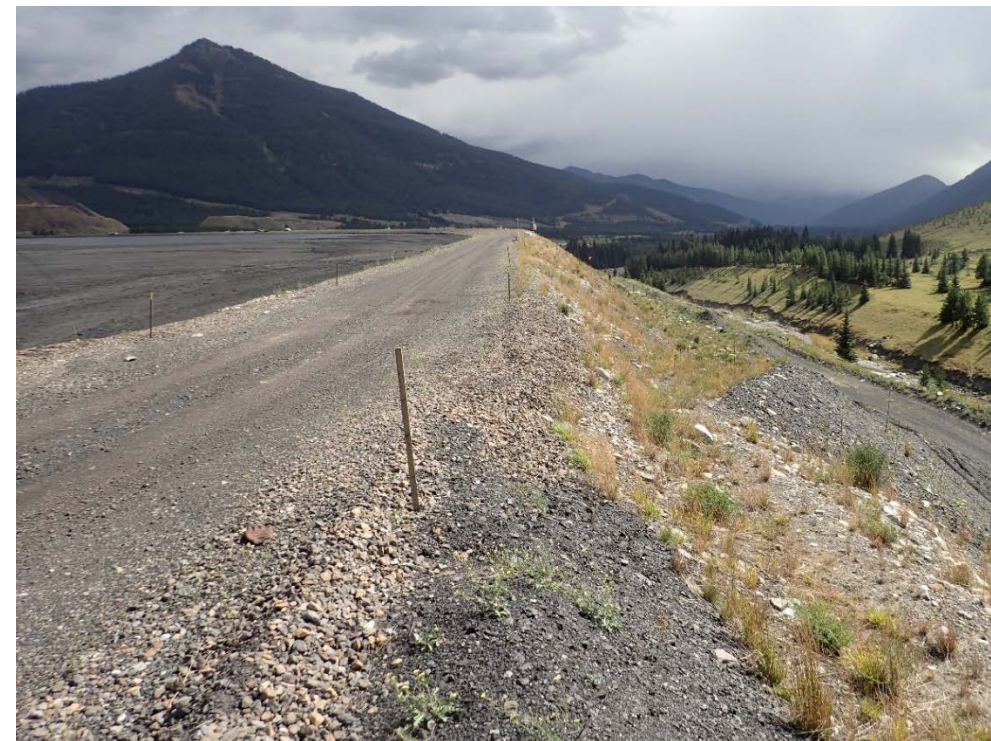
Photograph A-37: STP West Dam crest overview, looking southeast, 11 September 2018

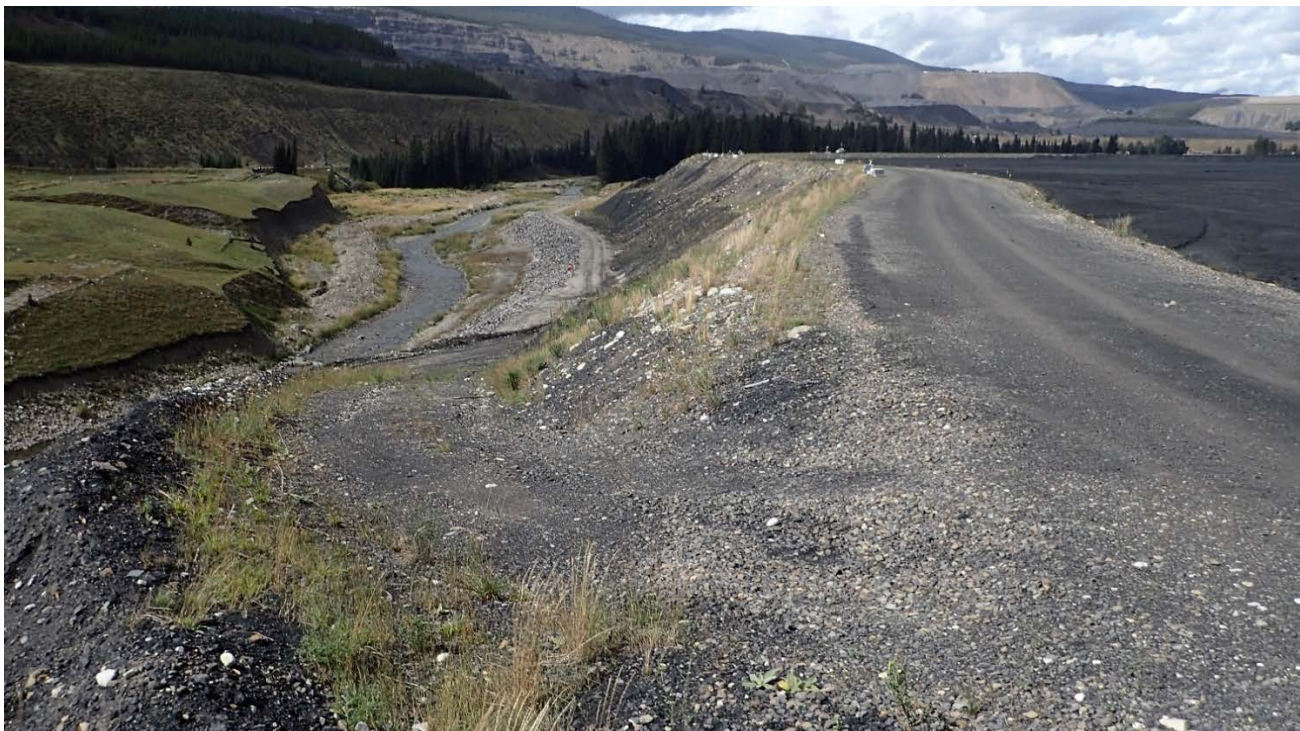
Photograph A-38: STP West Dam, downstream slope overview and Fording River, looking northwest, 11 September 2018.

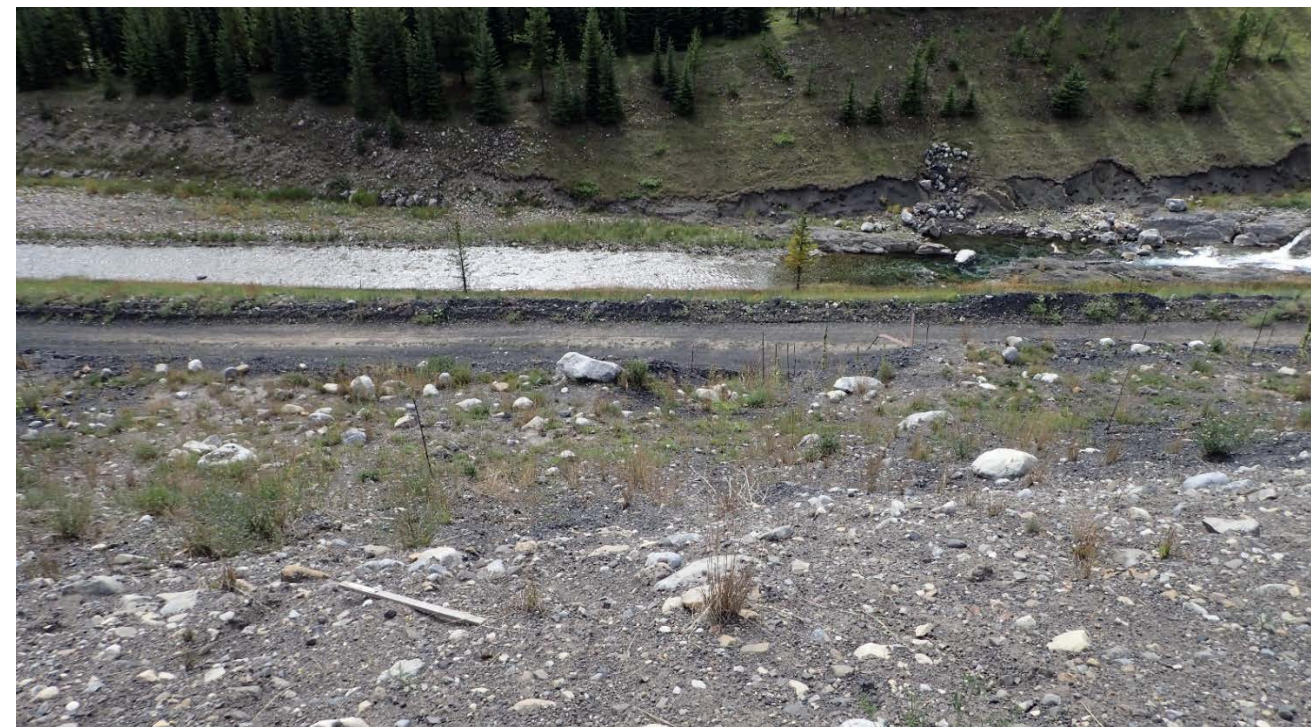
Photograph A-39: On STP West Dam, downstream slope and Fording River, looking southwest, 11 September 2018.

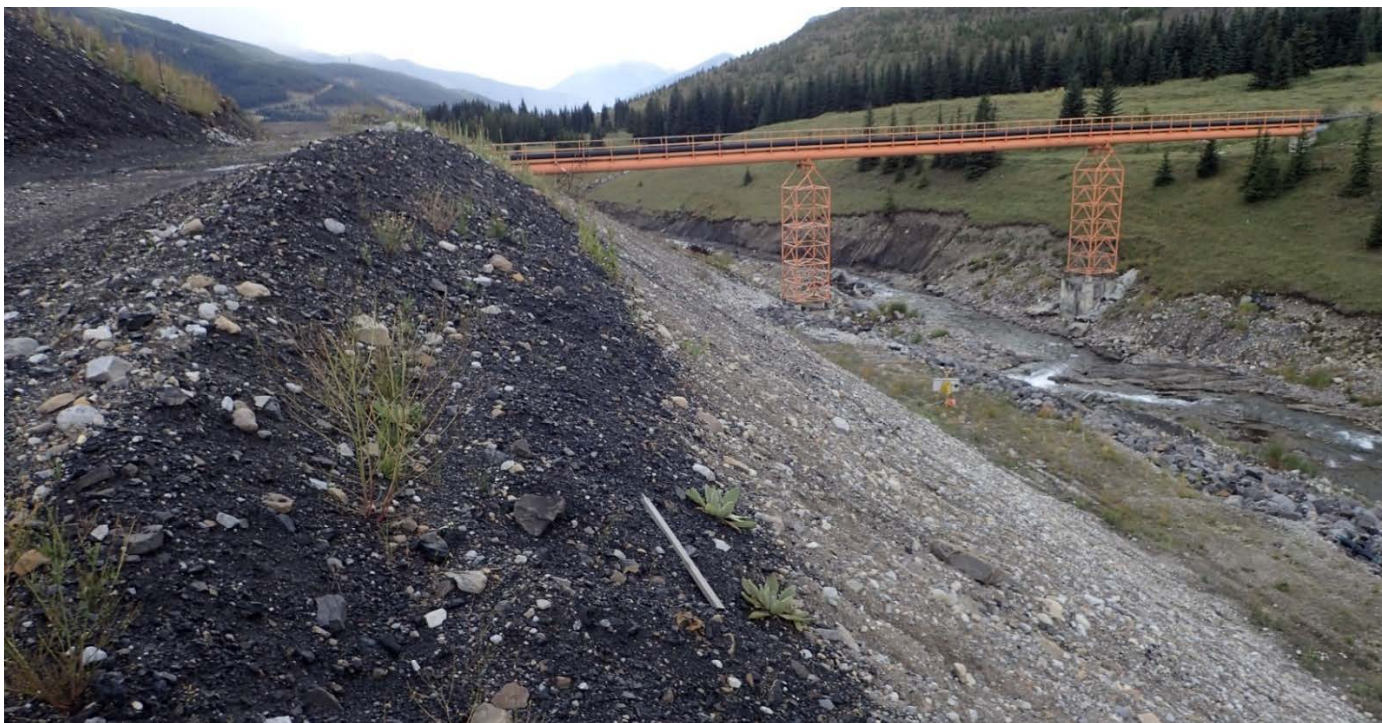
Photograph A-40: STP unused dredge pipeline to 2P-3P TSA on pipe bridge and West Dam access road's downstream slope, looking southeast, 11 September 2018.

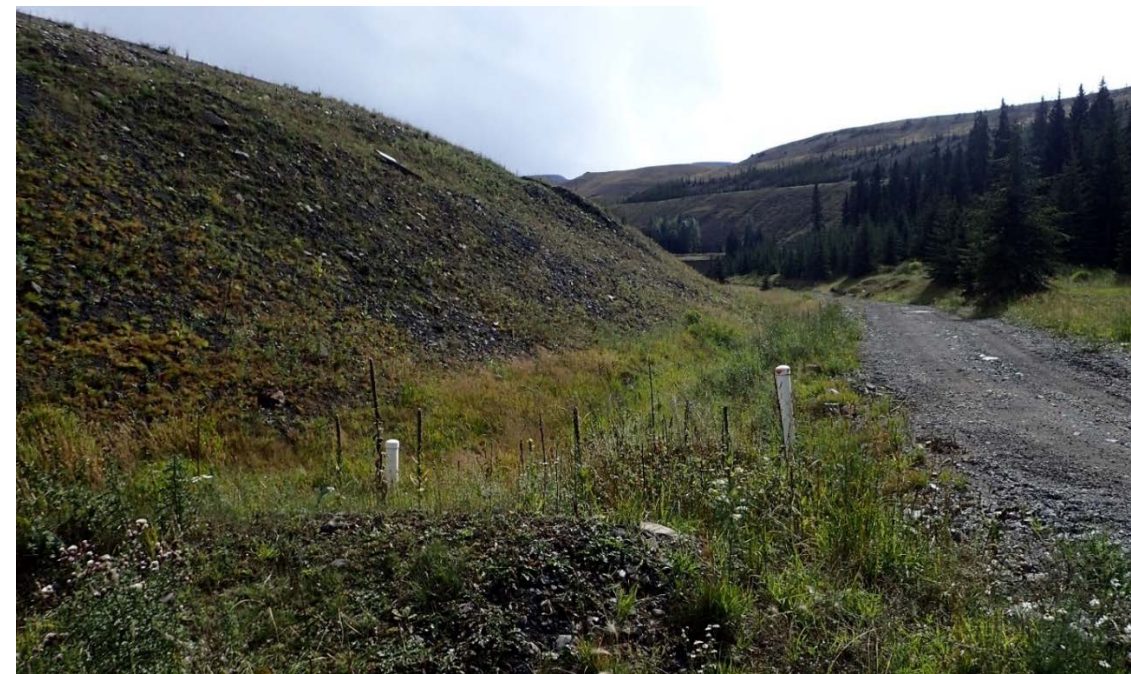
Photograph A-41: STP West Dam downstream slope with vegetation and ditch at downstream toe, looking south, 11 September 2018.
