2018 Dam Safety Inspection for North Tailings Pond and South Tailings Pond

Teck Coal Limited, Fording River Operations

Golder Associates Ltd.

29 March 2019

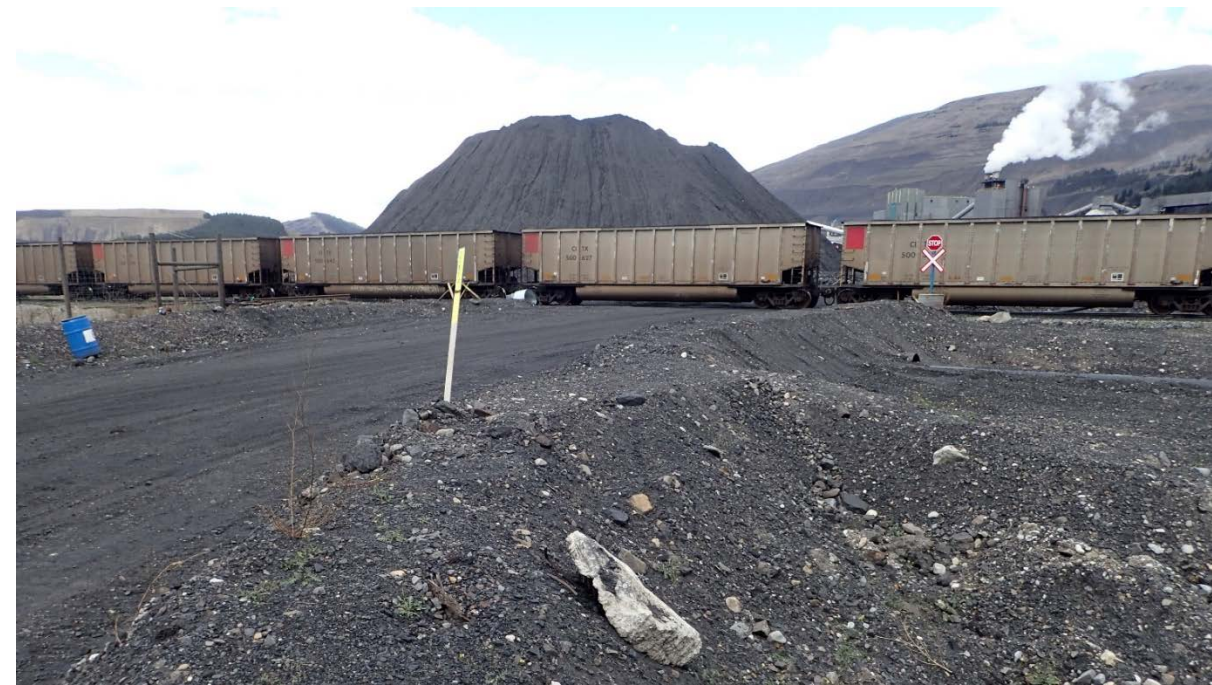
Photograph A-43: STP north abutment, upstream till berm, looking northeast 11 September 2018.

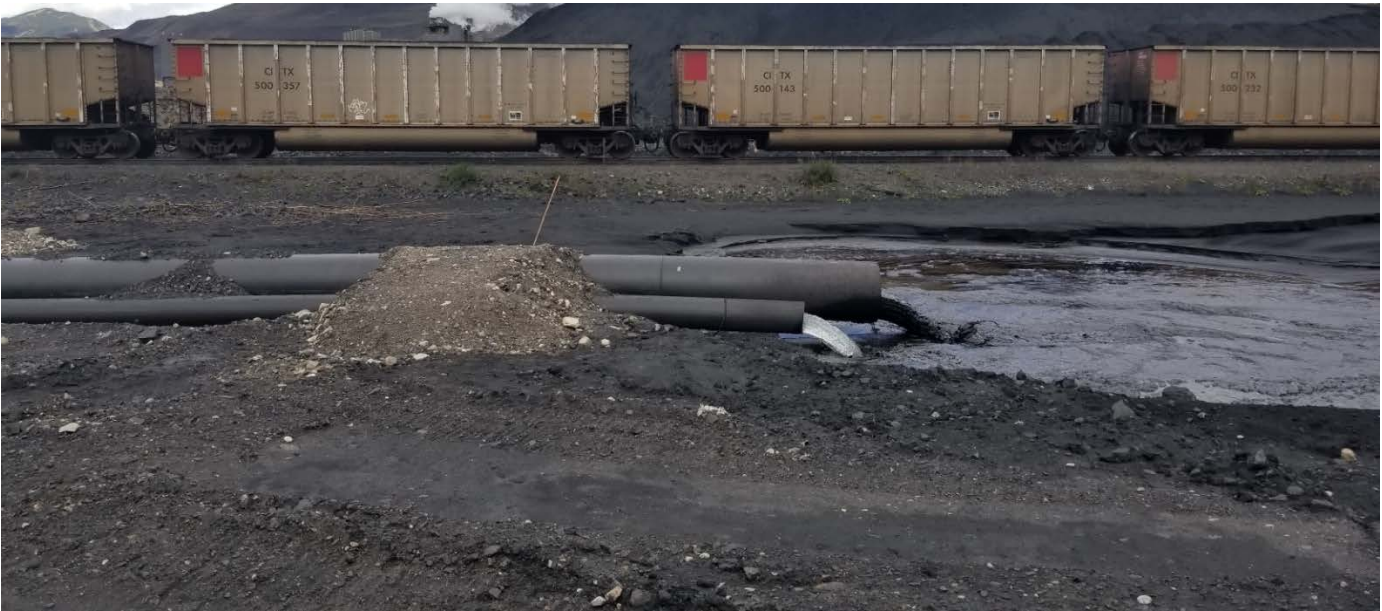
Photograph A-44: At STP north abutment and north single point discharge, outlet of tailings pipe from the processing plant (larger pipe) and discharge from Shandley Pit (smaller pipe), looking east, 11 September 2018.

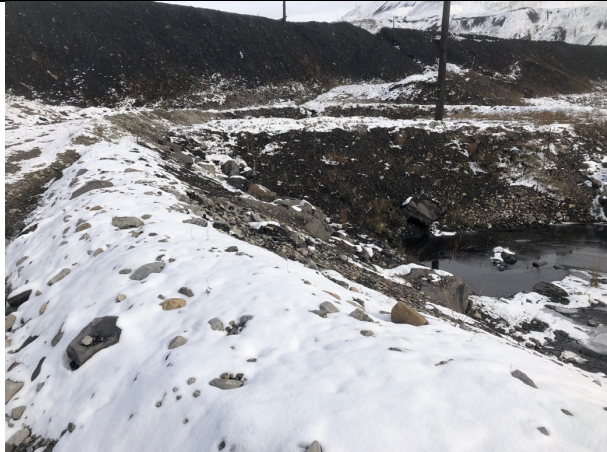
Photo 1: Looking upstream along alignment of NTP riprap that is buried (approx. Sta. 0+100)

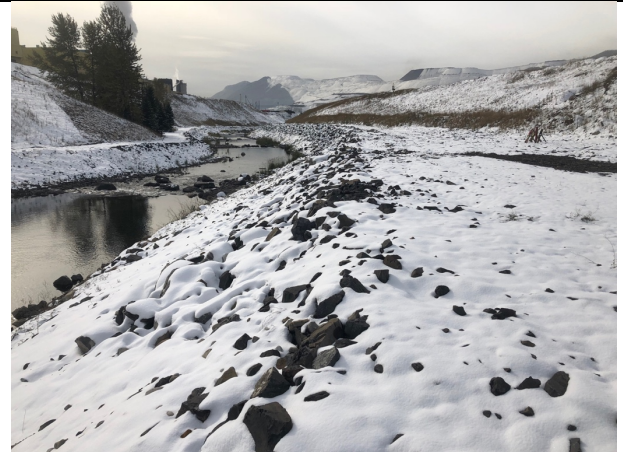
Riprap extends from upstream of the NTP to about Sta. 1+075 of the Golder NTP dam baseline as shown on Figure 1. Visual inspection of the lower riprap slope was impeded by gravel placed over the riprap during 2013 construction. The upper riprap slope placed during 2016/2017 was visible and appears to be well-interlocked. The exposed toe of the revetment was also observed and appears to be in good condition with no visual signs of scour or displacement. Riprap was visible on the entire slope in one short section approximately between Sta. 0+750 and Sta. 0+830. The exposed riprap is in good condition and appears to remain well interlocked. The slope of the exposed riprap is about 1.5H:1V.

Photo 2: Looking downstream at NTP riprap covered by gravel (approx. Sta. 0+175 to 0+350)

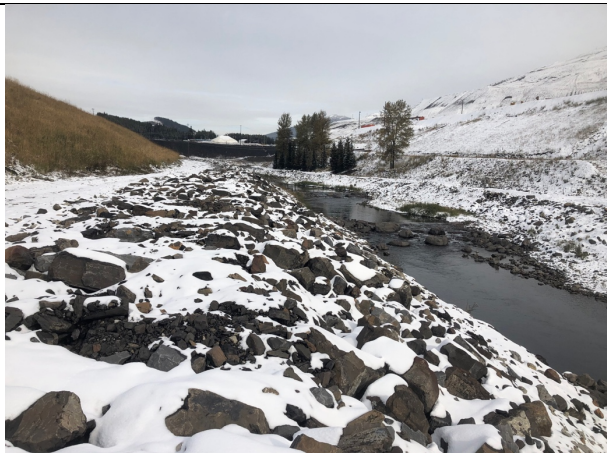
Photo 3: Looking upstream at NTP riprap (approx. Sta. 0+400 to 0+500)

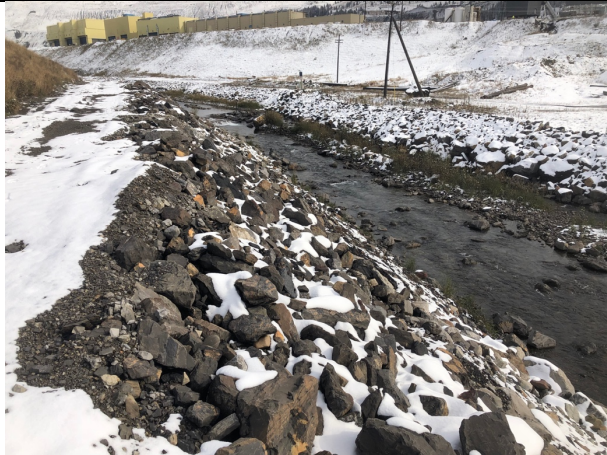
Photo 5: Looking upstream at NTP riprap (approx. Sta. 0+775 to 0+850)

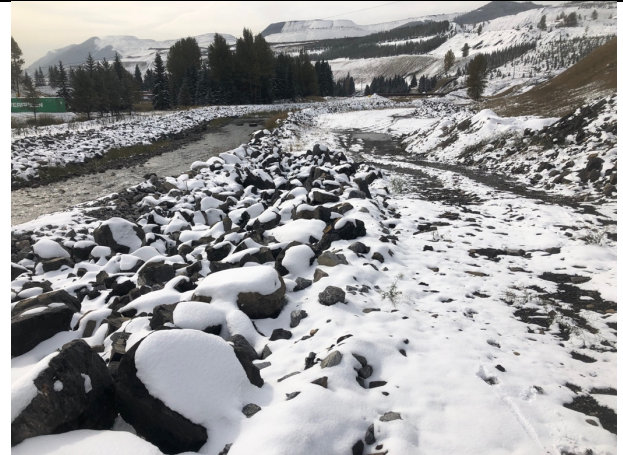
Photo 6: Looking downstream at NTP riprap (approx. Sta. 1+000 to 1+075)

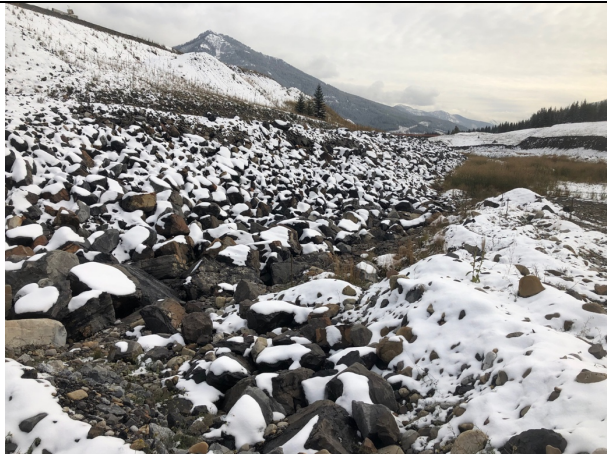
Photo 7: Looking downstream at STP downstream tie-in of raised riprap (approx. Sta. 0+275 to 0+325)

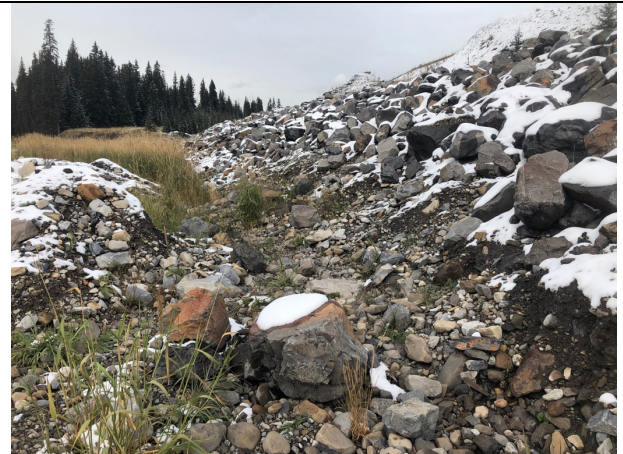
Photo 8: Looking upstream at STP riprap with minor erosion of gravel at the toe of the slope (approx. Sta. 0+300 to 0+325), no impact to riprap stability

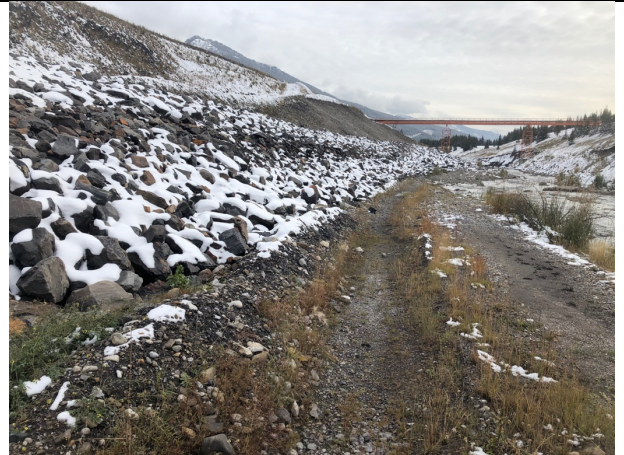
Photo 10: Looking downstream at STP riprap (approx. Sta. 0+550 to 0+660)

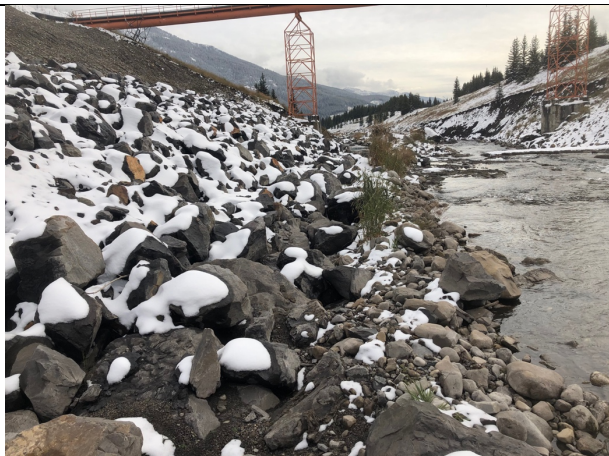
Photo 11: Looking downstream at STP riprap (approx. Sta. 0+620 to 0+660)

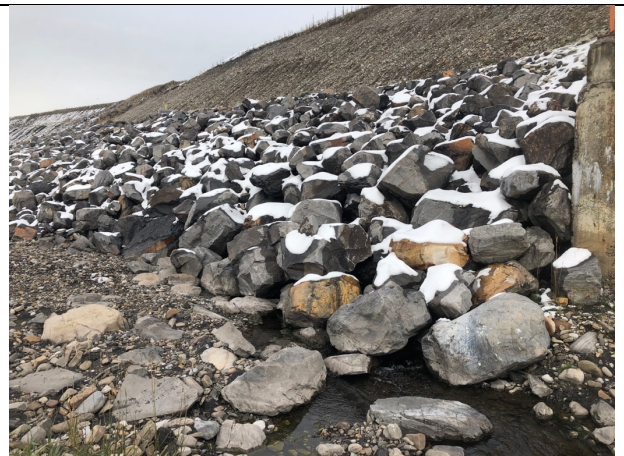
Photo 12: Looking upstream at STP riprap tie-in to pipe bridge abutment (approx. Sta. 0+650 to 0+685)
