REPORT

2018 Dam Safety Inspection for Greenhills Operations, Tailings Storage Facility

Teck Coal Limited, Greenhills Operations

Reference No. 1894290-2018-133-R-Rev0-2000

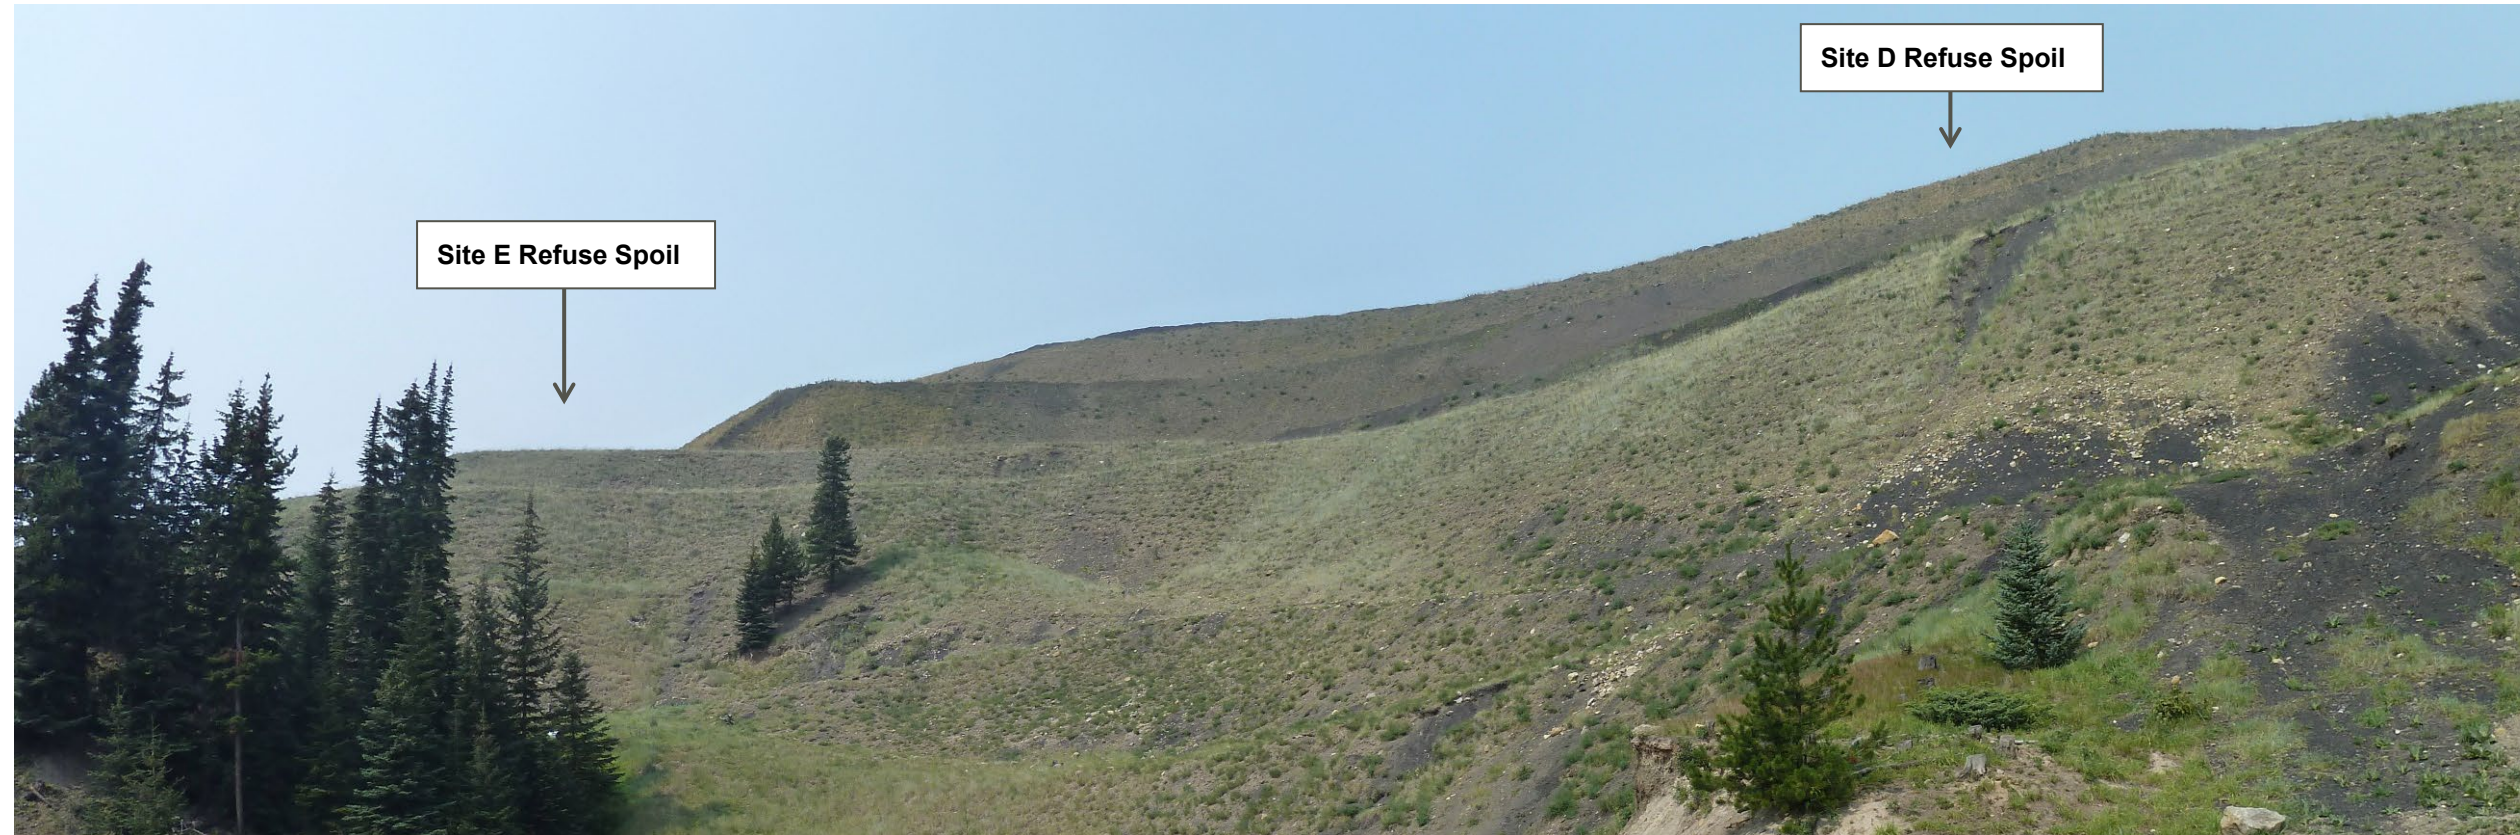
Photograph 10: Site D and E – overview of Site D and Site E coarse coal refuse spoils, looking northwest. 15 August 2018.

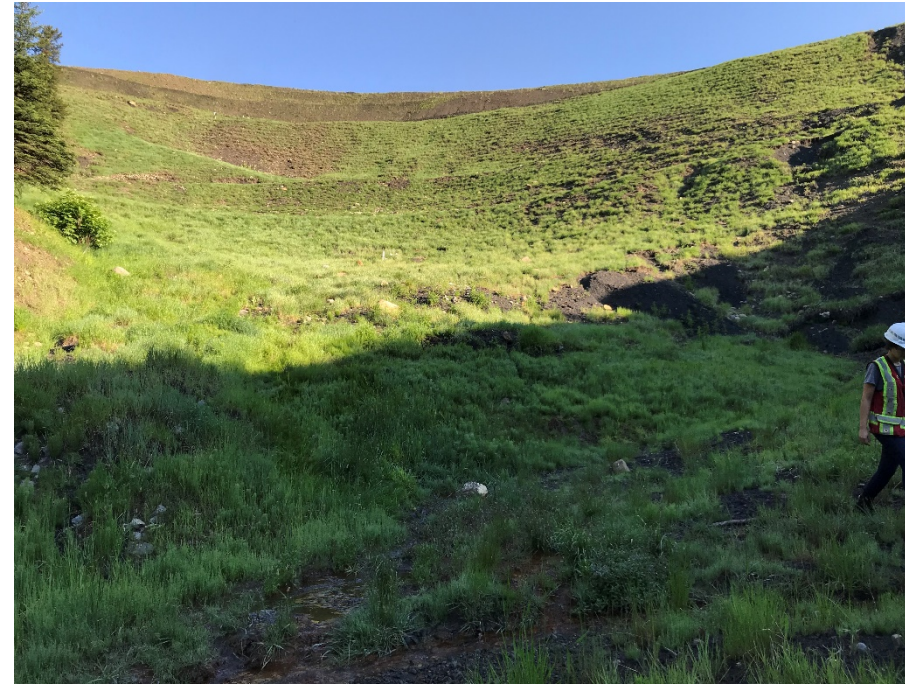
Photograph 14: Creek below Site C, D and E Looking north. 18 June 2018

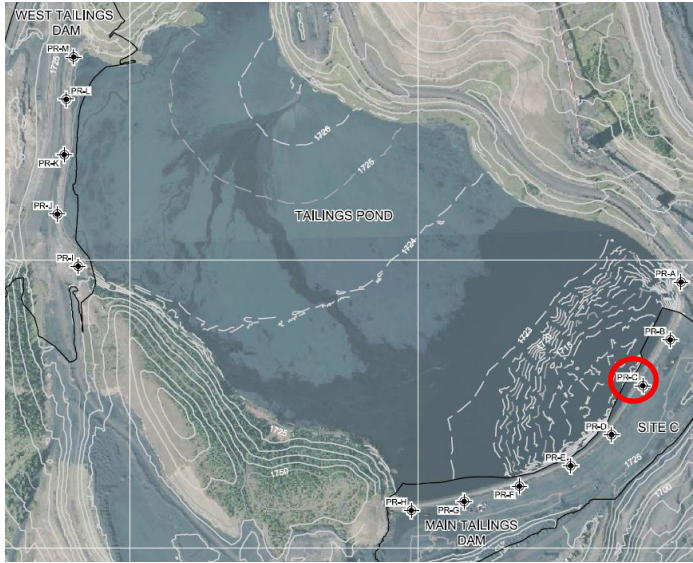
FIGURE
C-2

CRD = Cumulative Relative Displacement
 Note: No readings taken during 2018 reporting period.

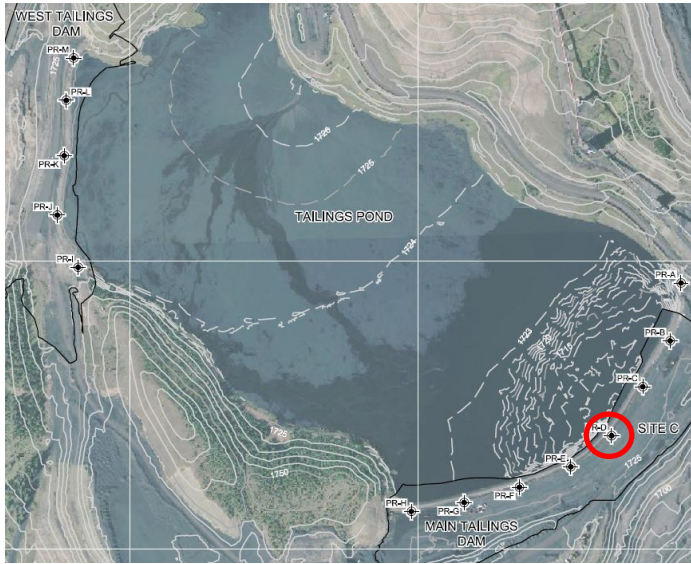
FIGURE **C-3**

CRD = Cumulative Relative Displacement
 Note: No readings taken during 2018 reporting period.

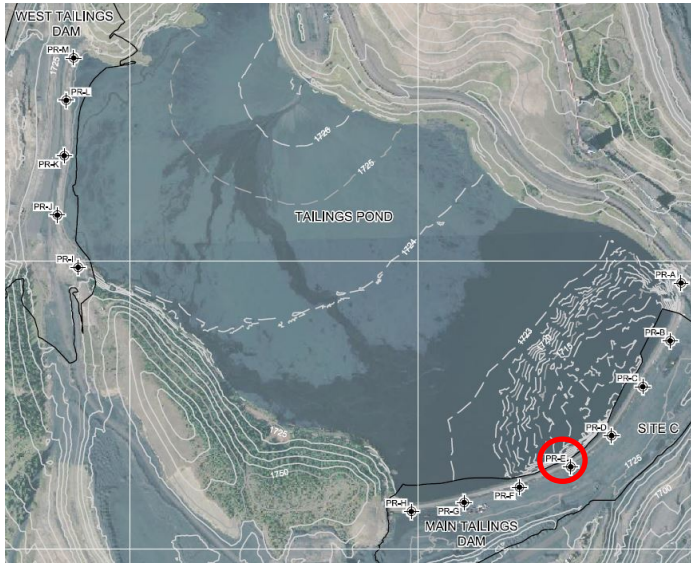
FIGURE
C-4

CRD = Cumulative Relative Displacement
 Note: No readings taken during 2018 reporting period.

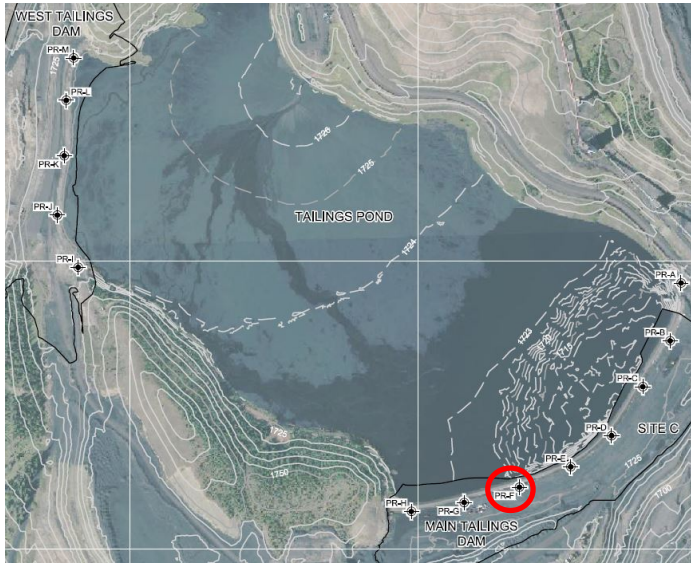
FIGURE
C-5

CRD = Cumulative Relative Displacement
 Note: No readings taken during 2018 reporting period.

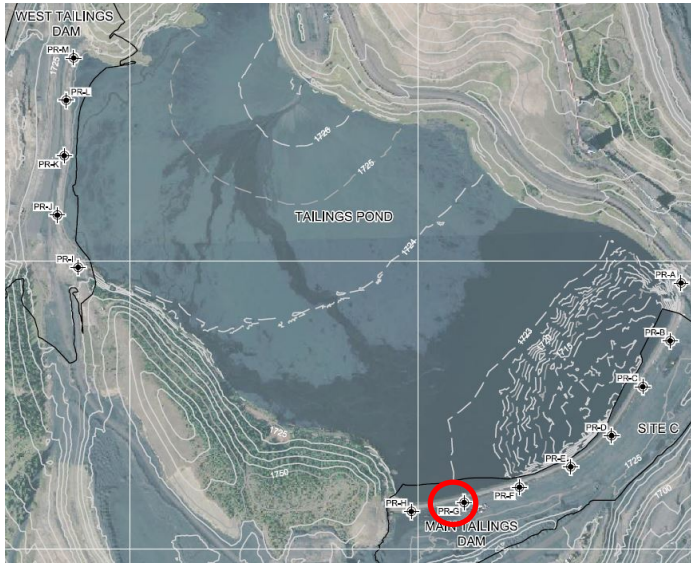
FIGURE **C-6**

CRD = Cumulative Relative Displacement
 Note: No readings taken during 2018 reporting period.

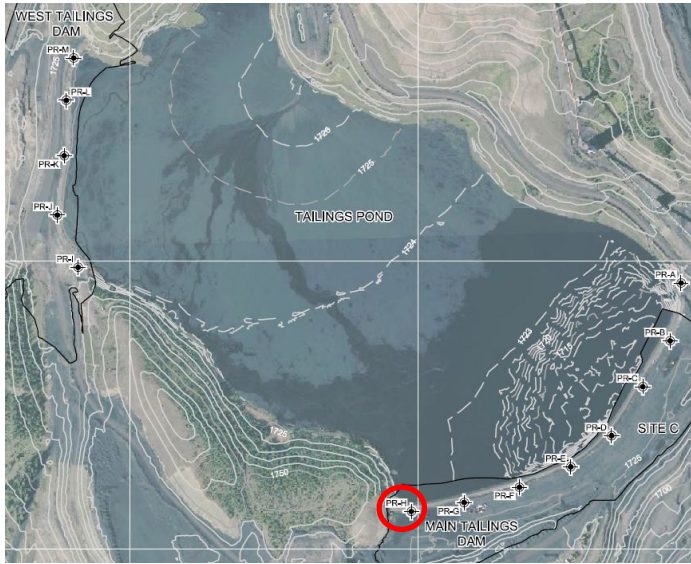
FIGURE
C-7

CRD = Cumulative Relative Displacement
 Note: No readings taken during 2018 reporting period.

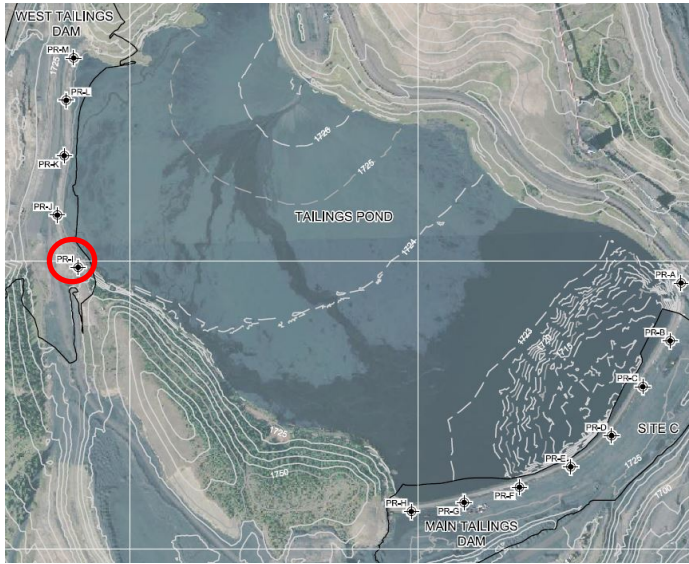
FIGURE **C-8**

CRD = Cumulative Relative Displacement
 Note: No readings taken during 2018 reporting period.

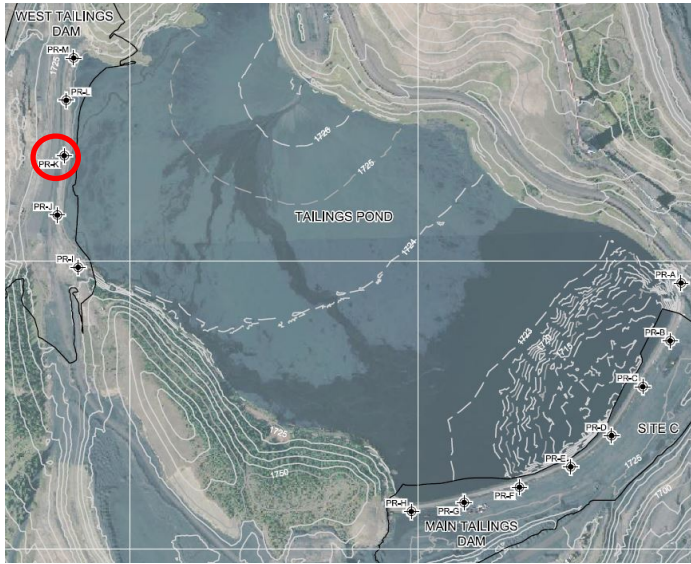
FIGURE **C-10**

CRD = Cumulative Relative Displacement
 Note: No readings taken during 2018 reporting period.

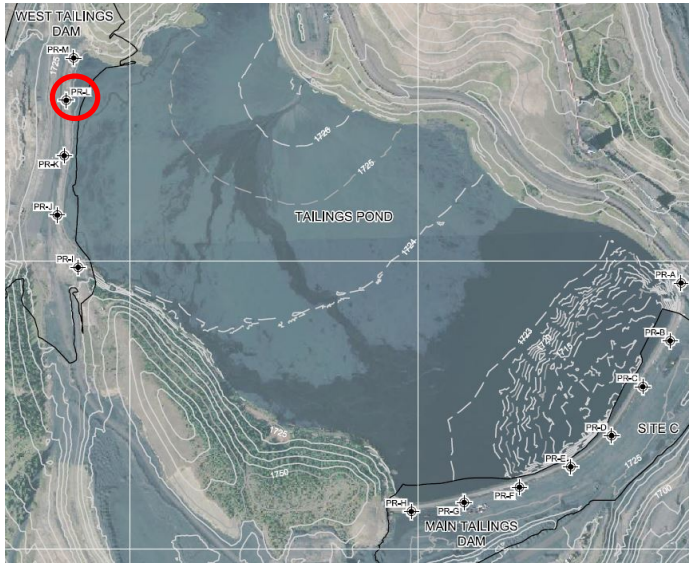
FIGURE **C-11**

CRD = Cumulative Relative Displacement
 Note: No readings taken during 2018 reporting period.

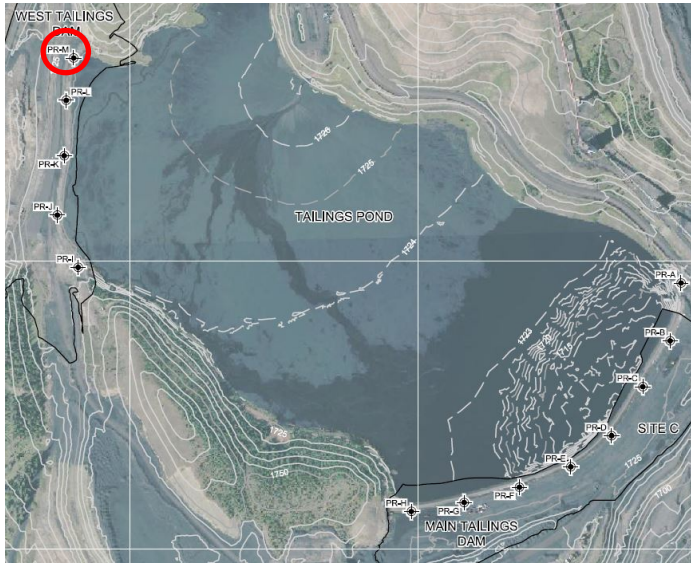
FIGURE
C-12

CRD = Cumulative Relative Displacement
 Note: No readings taken during 2018 reporting period.

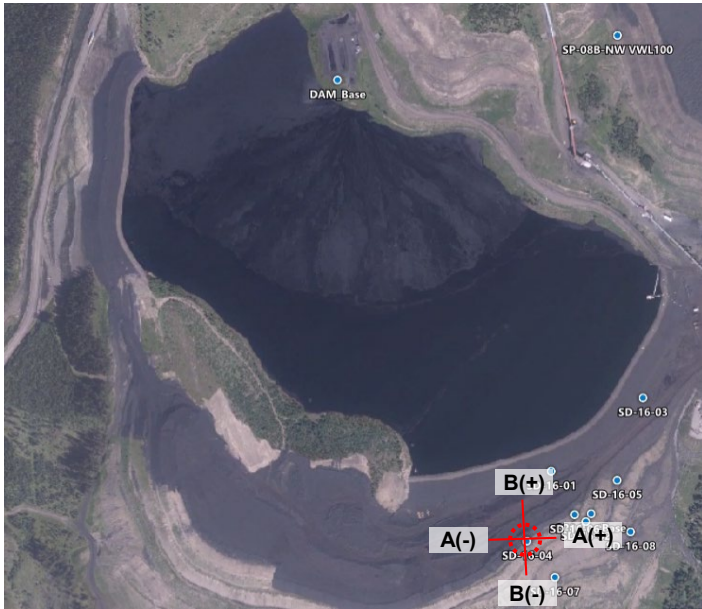
PROJECT No. 1894290	Phase/Task/DOC. 2000/2050/2018-133	Rev. 0	FIGURE C-22
-------------------------------	--	------------------	-----------------------

TITLE
GREENHILLS TAILINGS FACILITY
GPS PLAN VIEW DISPLACEMENTS
