# **Teck Highland Valley Copper Partnership**

## **2018 Dam Safety Inspection Report**

### ***Highmont Tailings Storage Facility***

March 2019

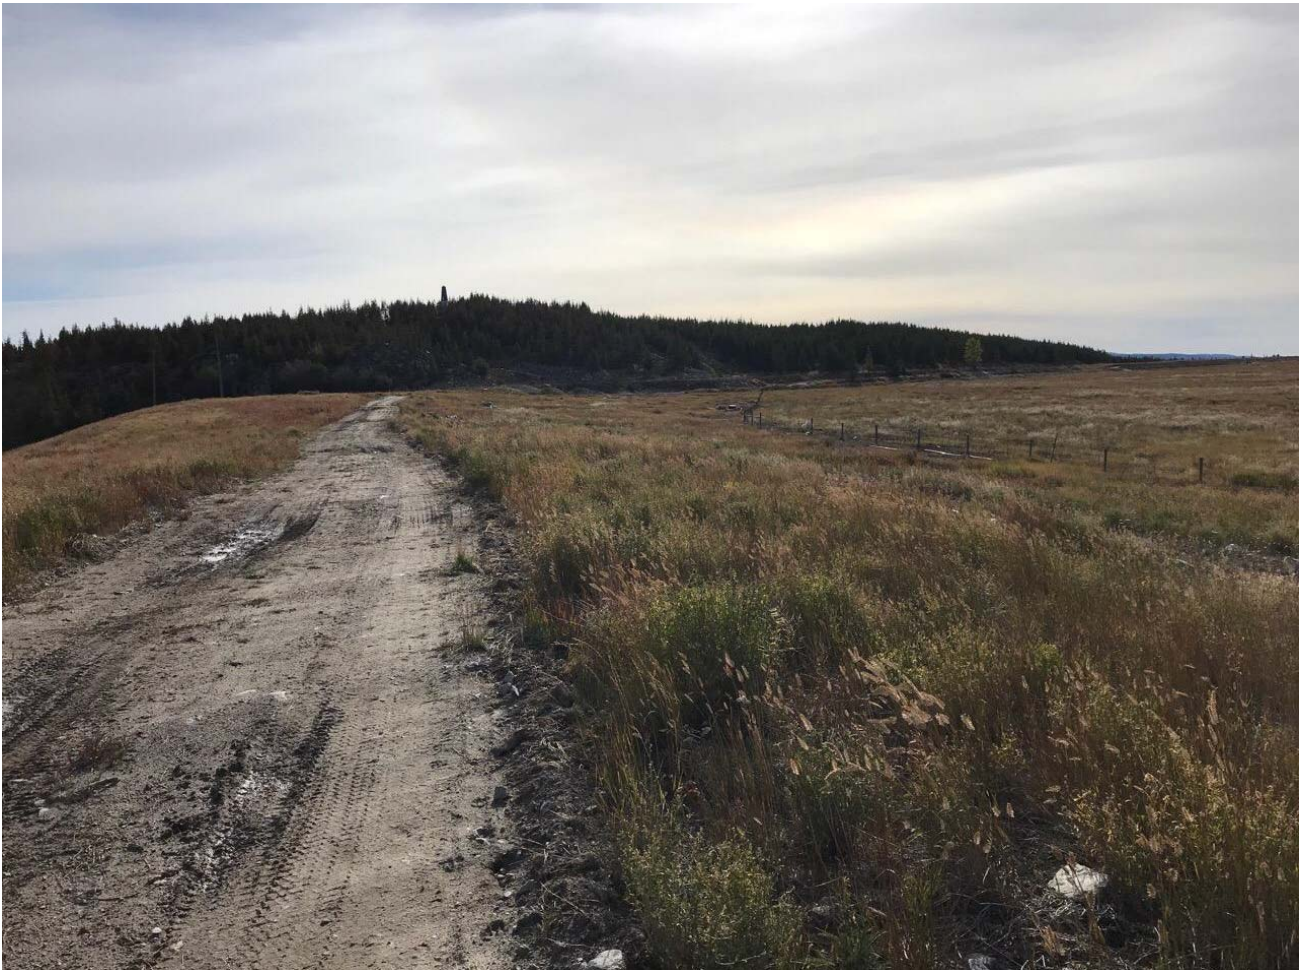
**Photo II-A-1 Overview of North Dam Crest road looking East. There are some low points on the crest but there is no sign of distress (HGH-2018-1)**

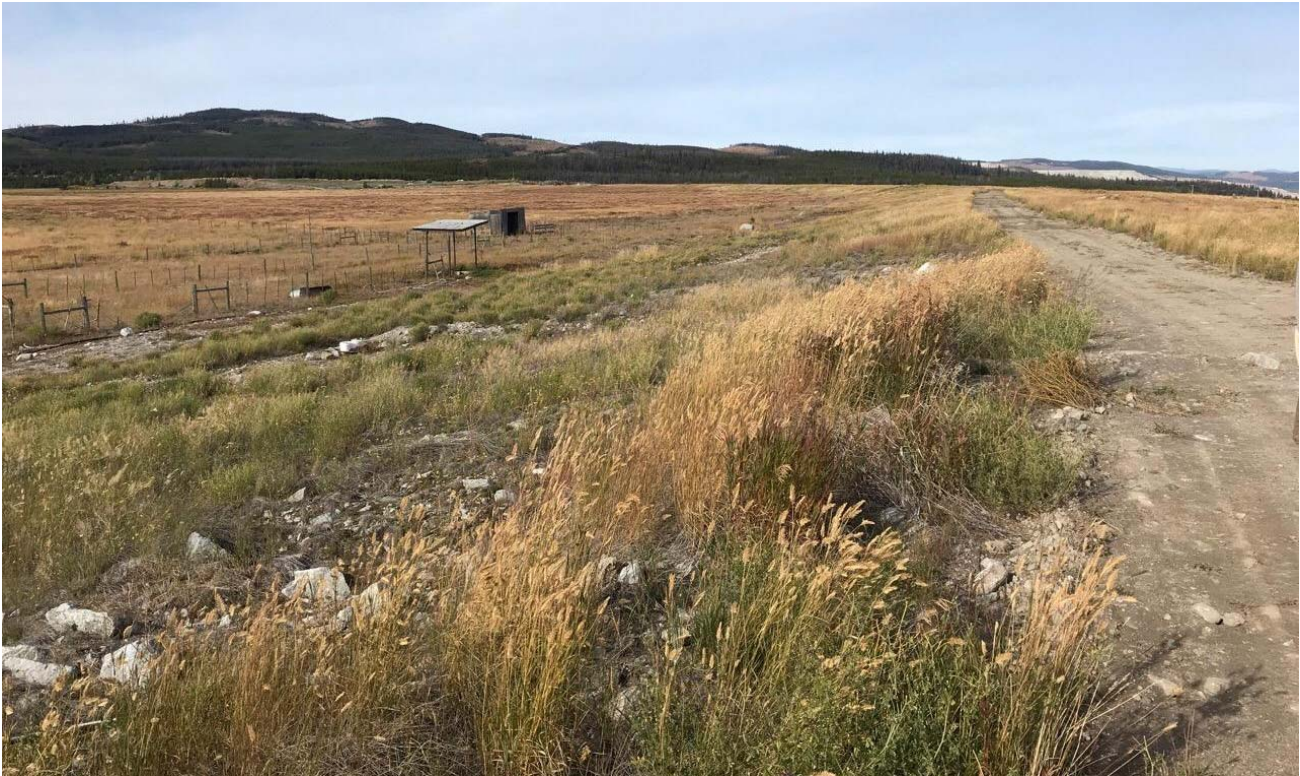
**Photo II-A-2 Overview of North Dam Crest road and impoundment beach looking West.  
(HGH-2018-1)**

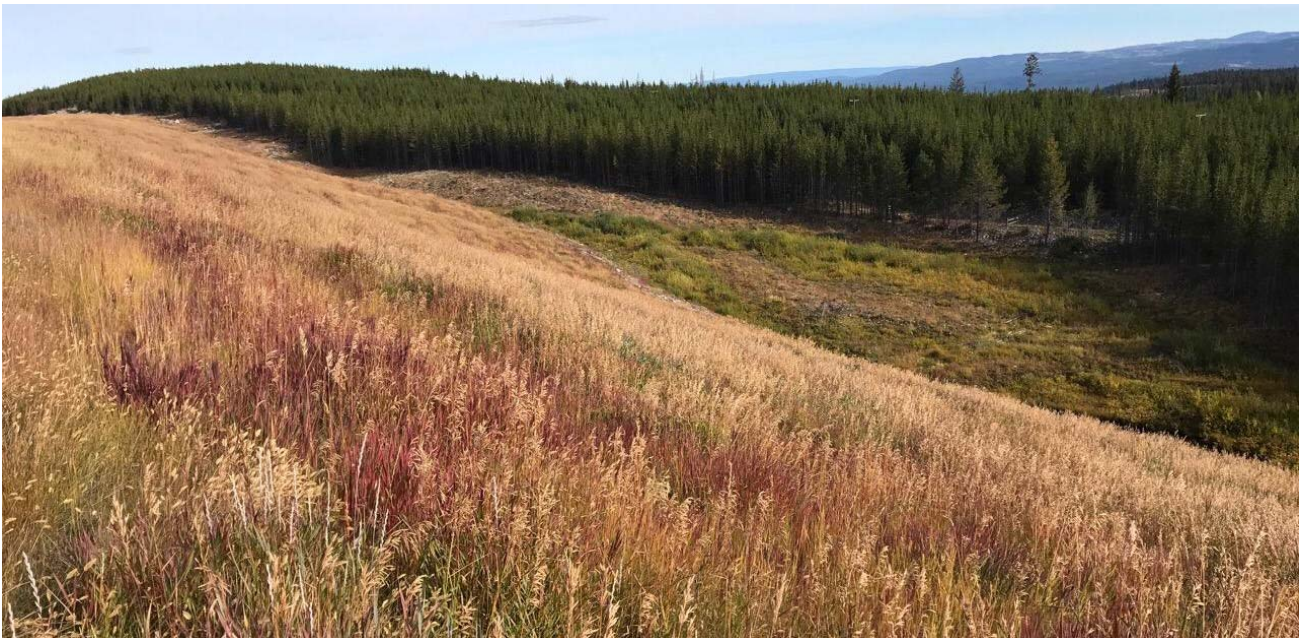
**Photo II-A-3 East Dam downstream overview looking North. Slope covered by vegetation.  
(HGH-2018-2)**

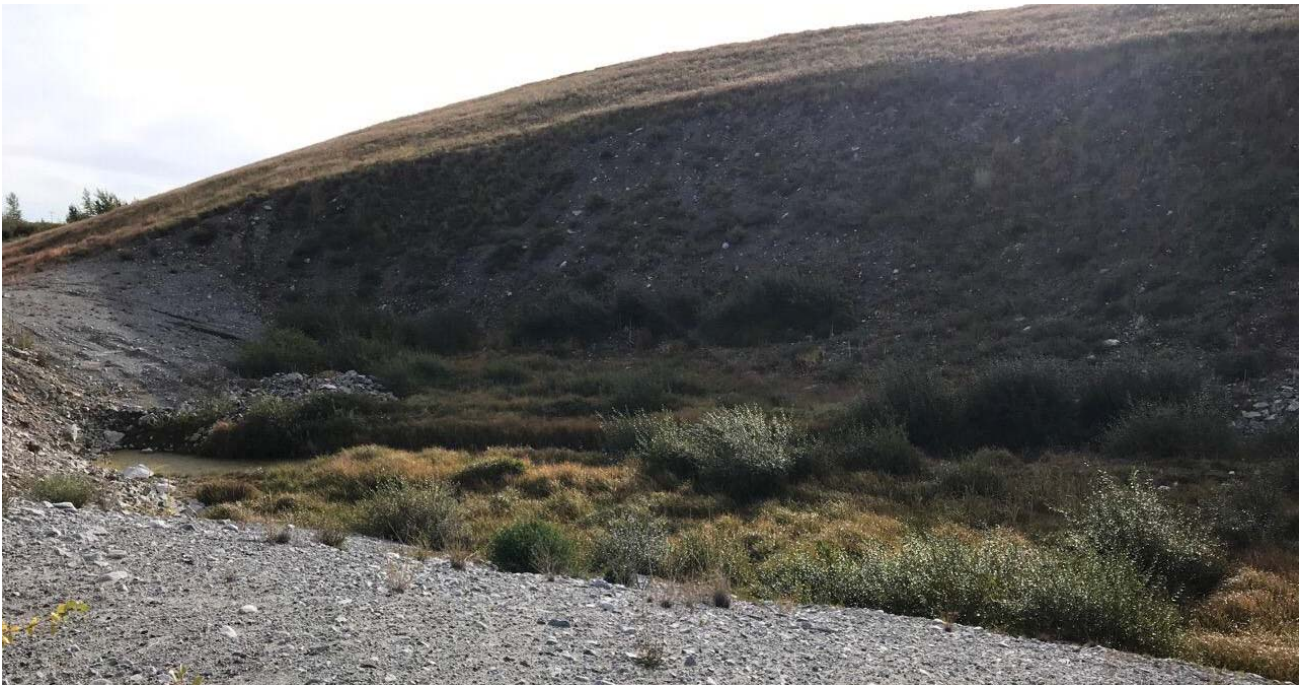
**Photo II-A-7 Steepened section of downstream slope and underdrain flow channel. Underdrain discharge seems similar to 2017 DSI. There is no evidence of excessive ponding or high-water level on dam toe. (HGH-2018-5)**

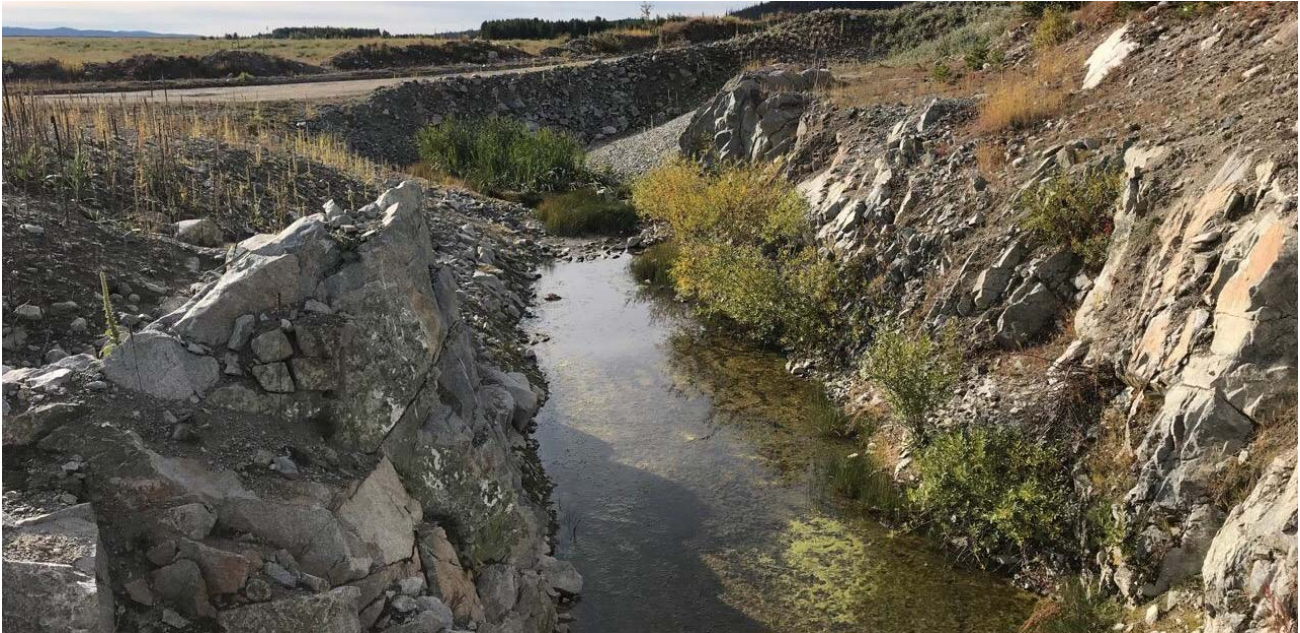
**Photo II-A-11 Spillway channel looking upstream from the flow control gate. (HGH-2018-8)**

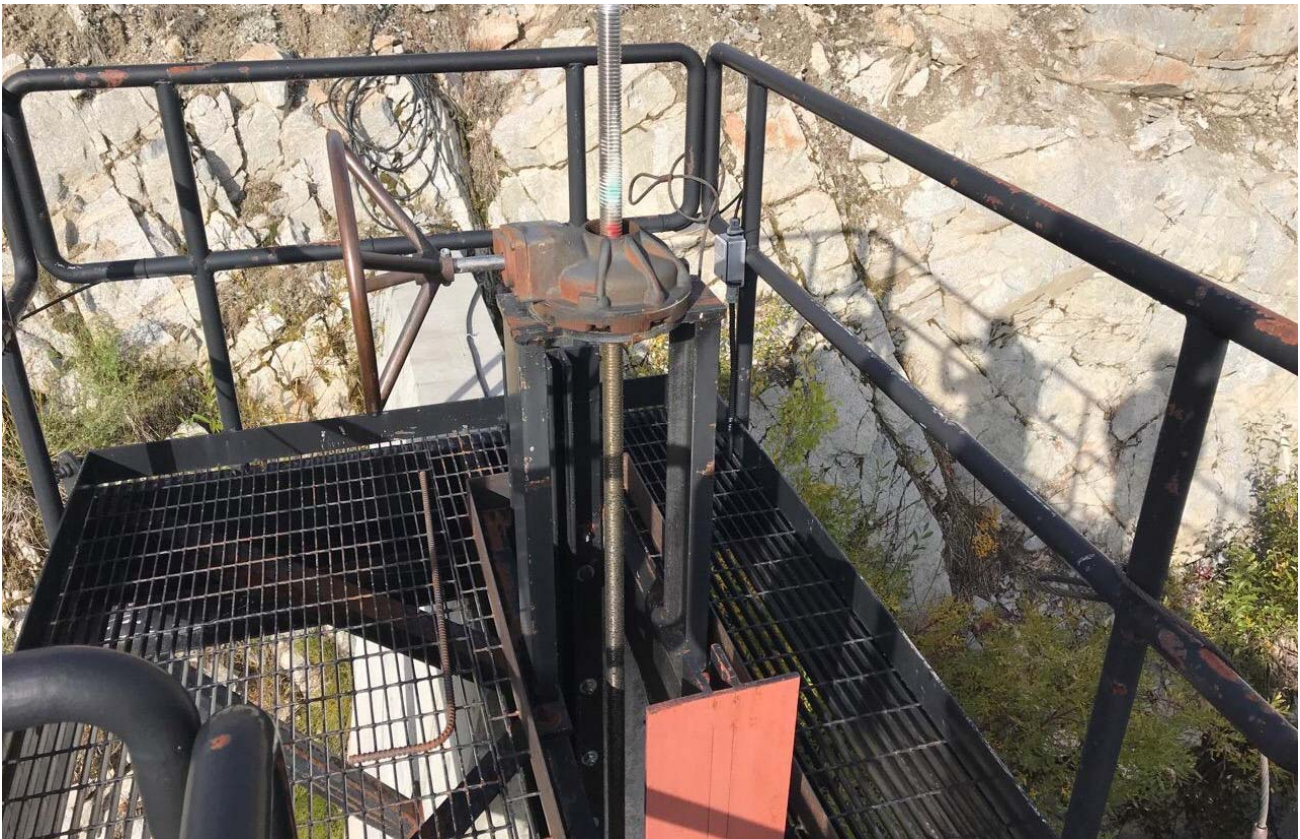
**Photo II-A- 12 Spillway flow control gate (HGH-2018-8)**

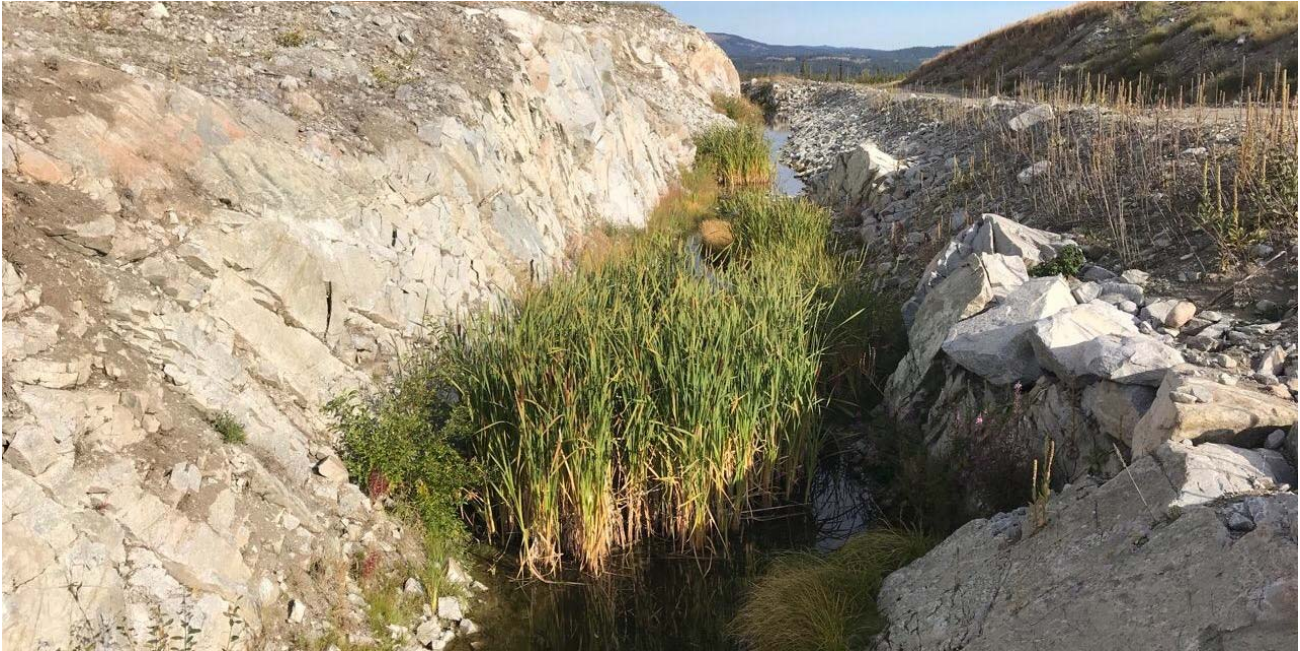
**Photo II-A-13 Spillway channel looking downstream from the flow control gate. Channel is highly vegetated. Water elevation has not changed compared to inspection in 2017(HGH-2018-8)**

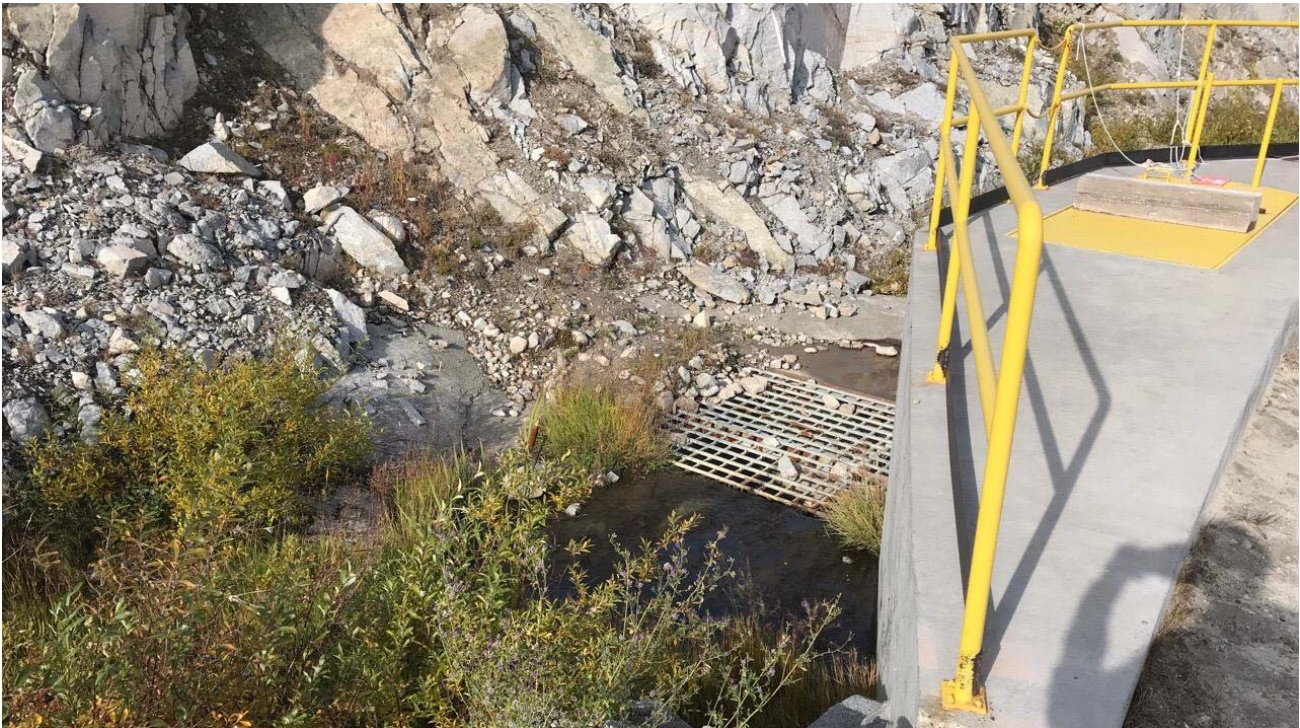
**Photo II-A-14 Spillway channel looking downstream at inlet to Seepage Recovery Pond S1 pipeline division, showing trashrack on invert (HGH-2018-9)**

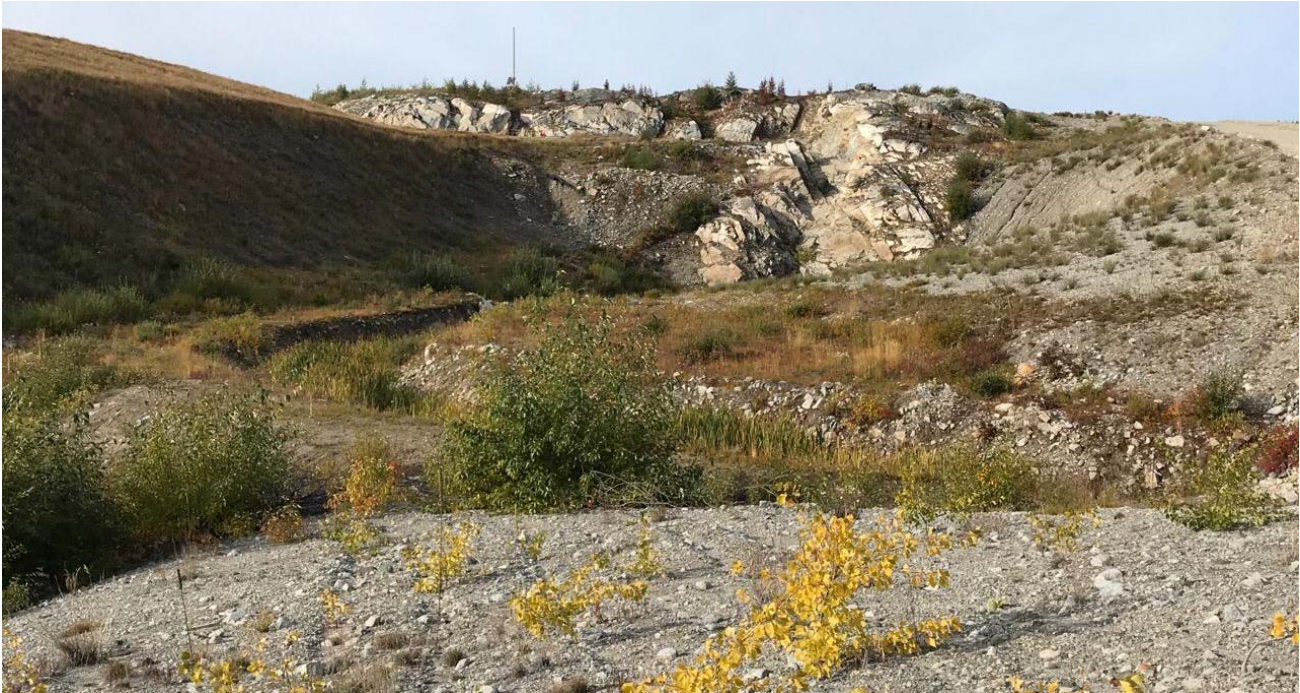
**Photo II-A-15 Overview of spillway channel and rock chute. (HGH-2018-5)**

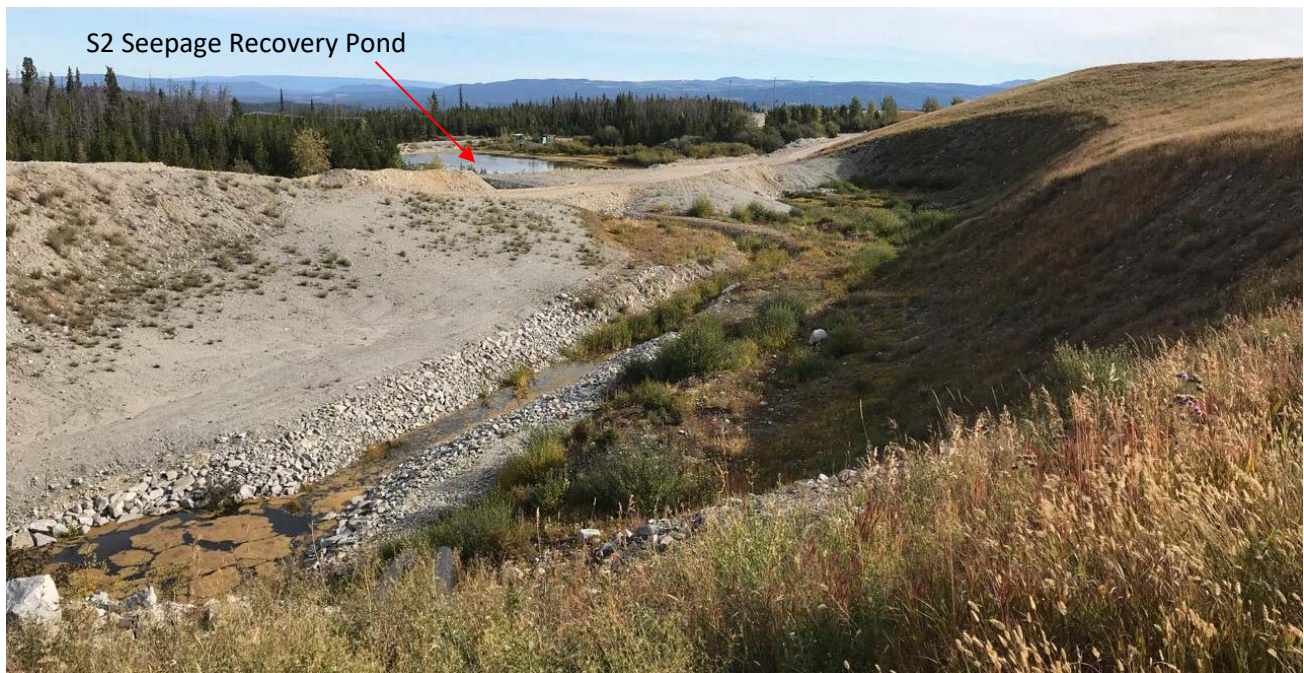
**Photo II-A-16 Overview of spillway channel looking downstream towards S2 Seepage Recovery Pond (HGH-2018-9)**

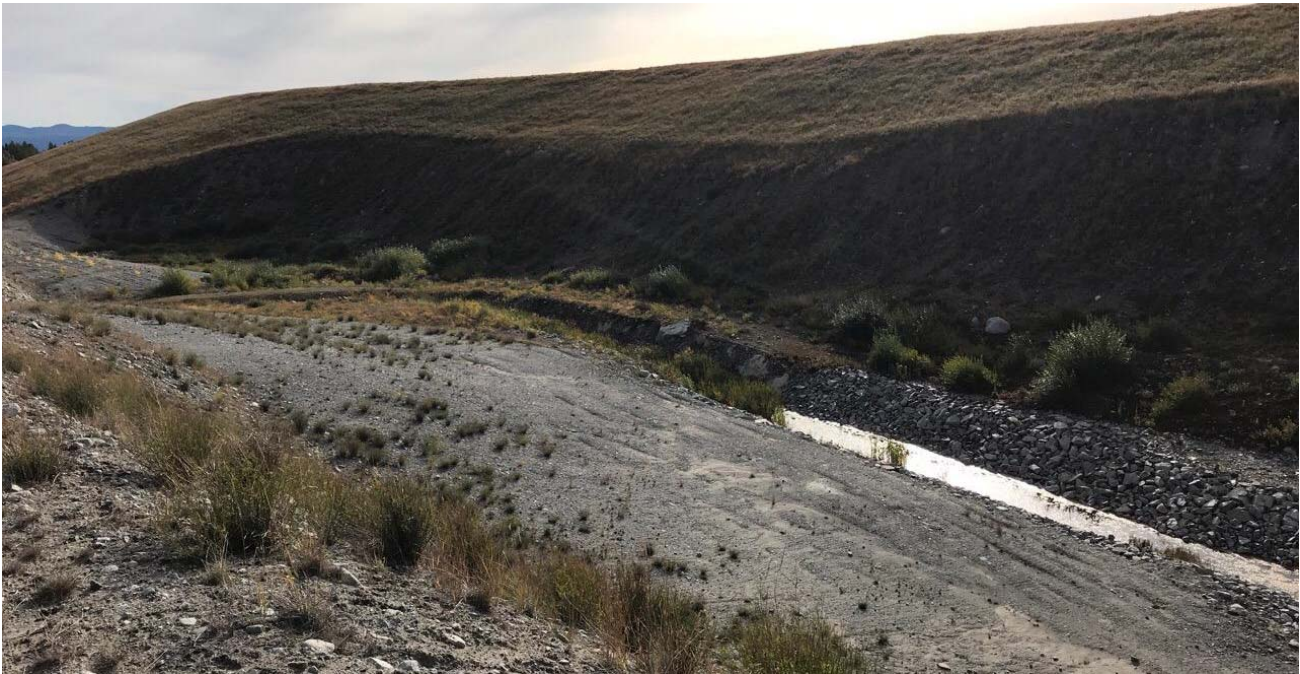
**Photo II-A-17 Overview of spillway area from the road crest looking south. (HGH-2018-10)**

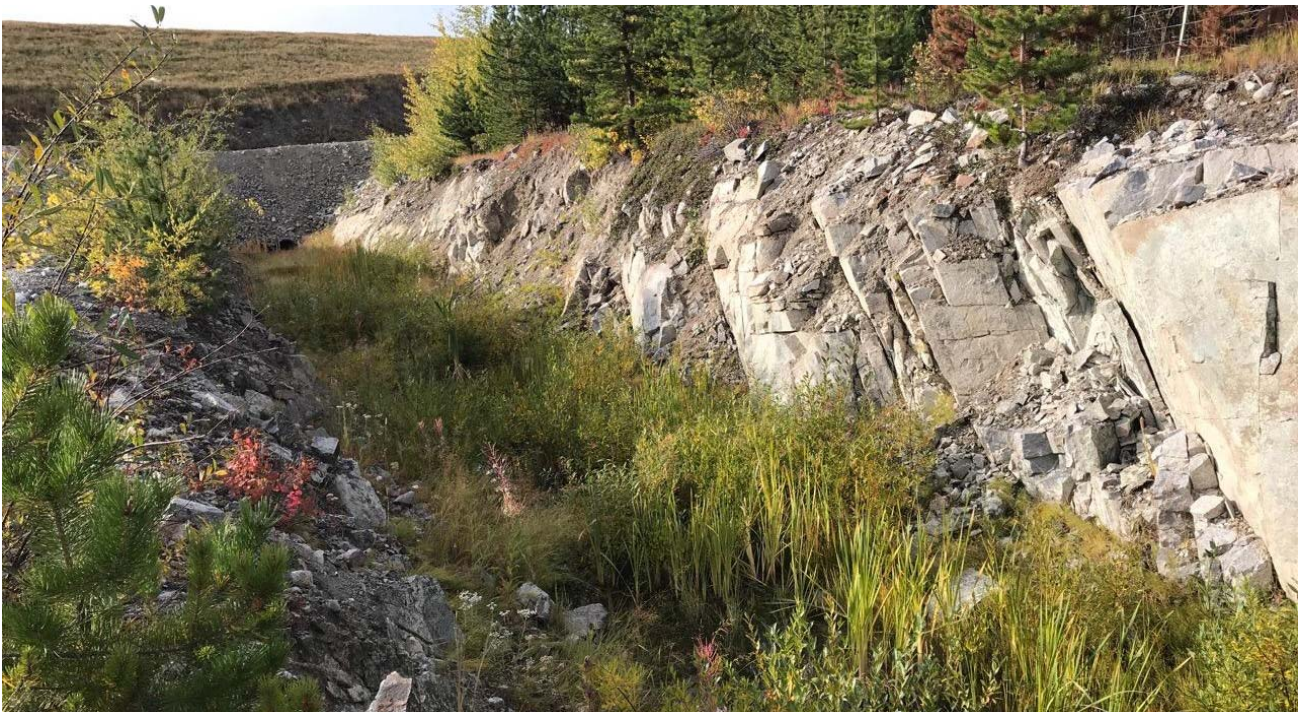
**Photo II-A-20 S2: Highmont spillway; looking south. North dam toe and the road-crossing culverts are visible. There is vegetation growth which will be cleared as part of routine maintenance (HGH-2018-13).**

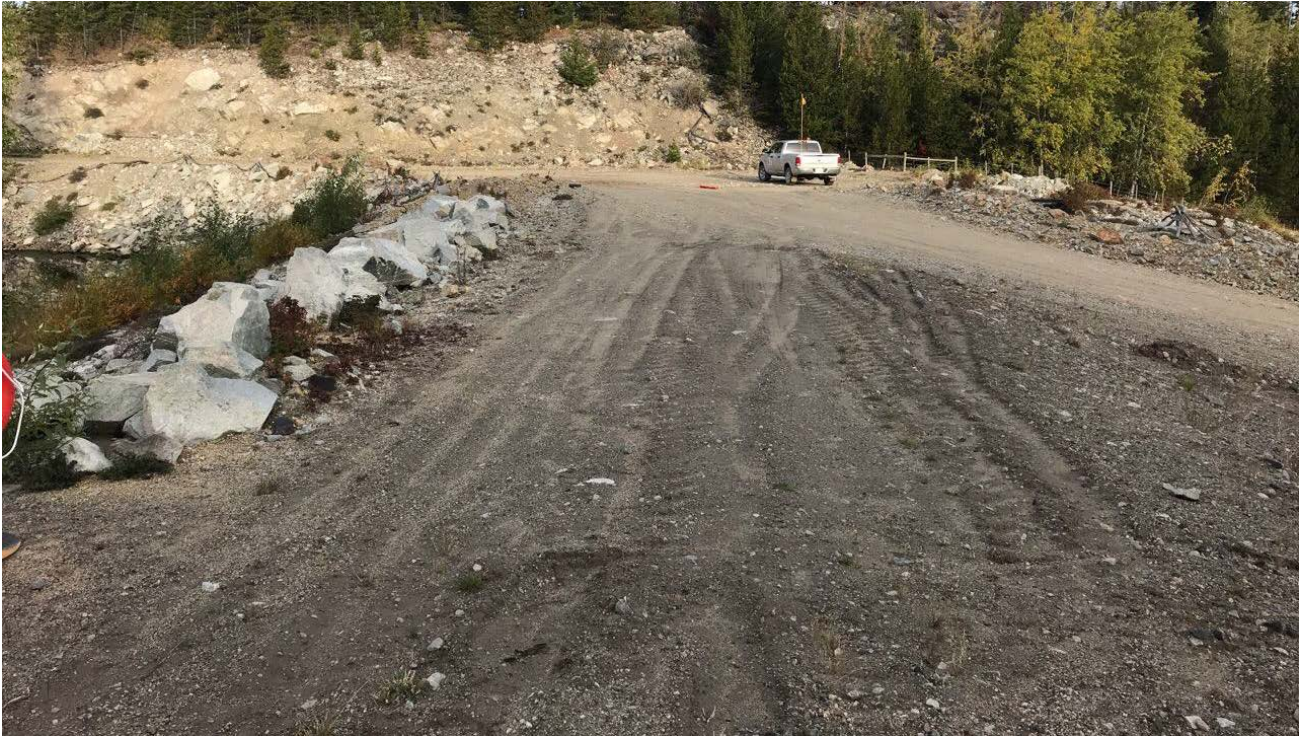
**Photo II-B-2 S1: Dam crest looking West towards left abutment. (HGH-2018-14)**

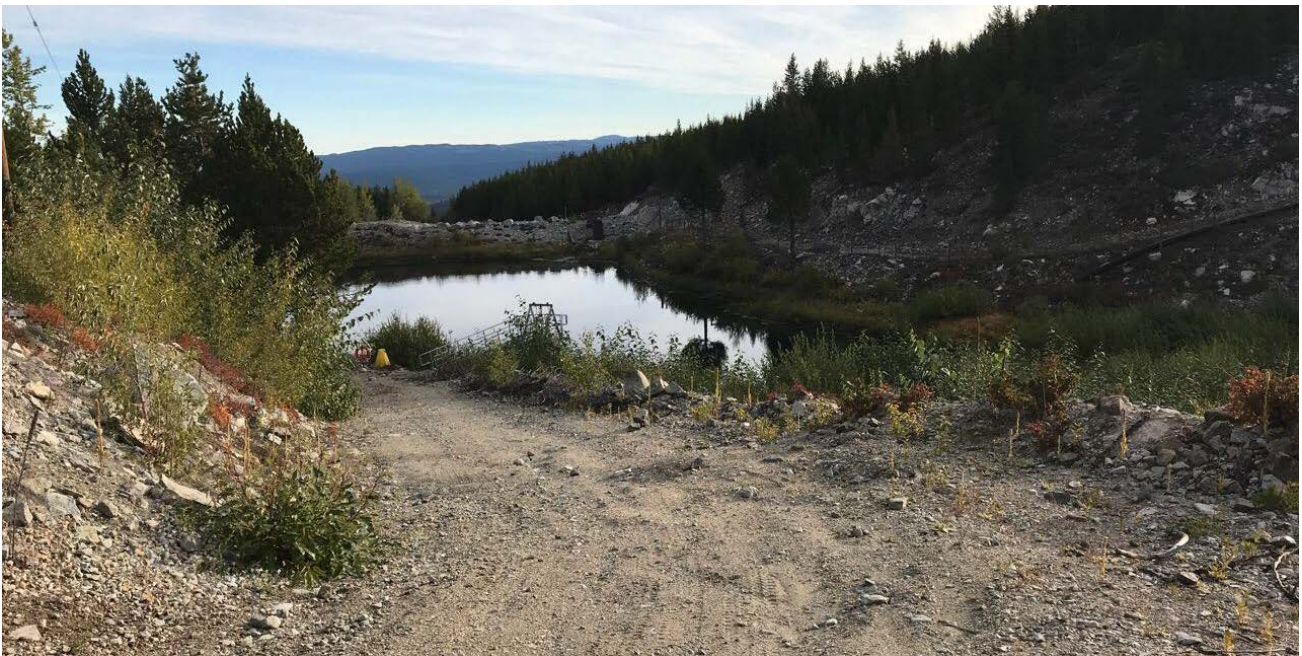
**Photo II-B-3 S1: Overview of pond and upstream slope of dam, looking North. (HGH-2018-15)**

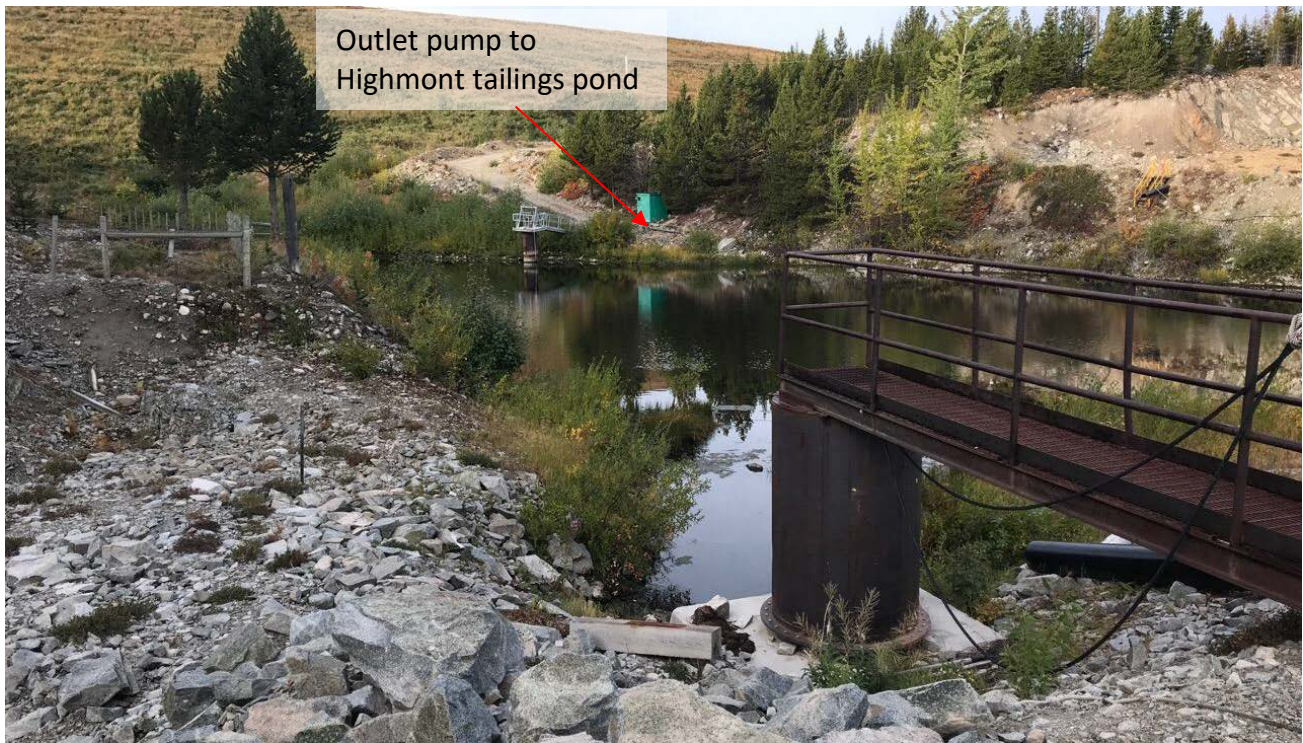
**Photo II-B-4 S1: Spillway inlet (HGH-2018-14)**

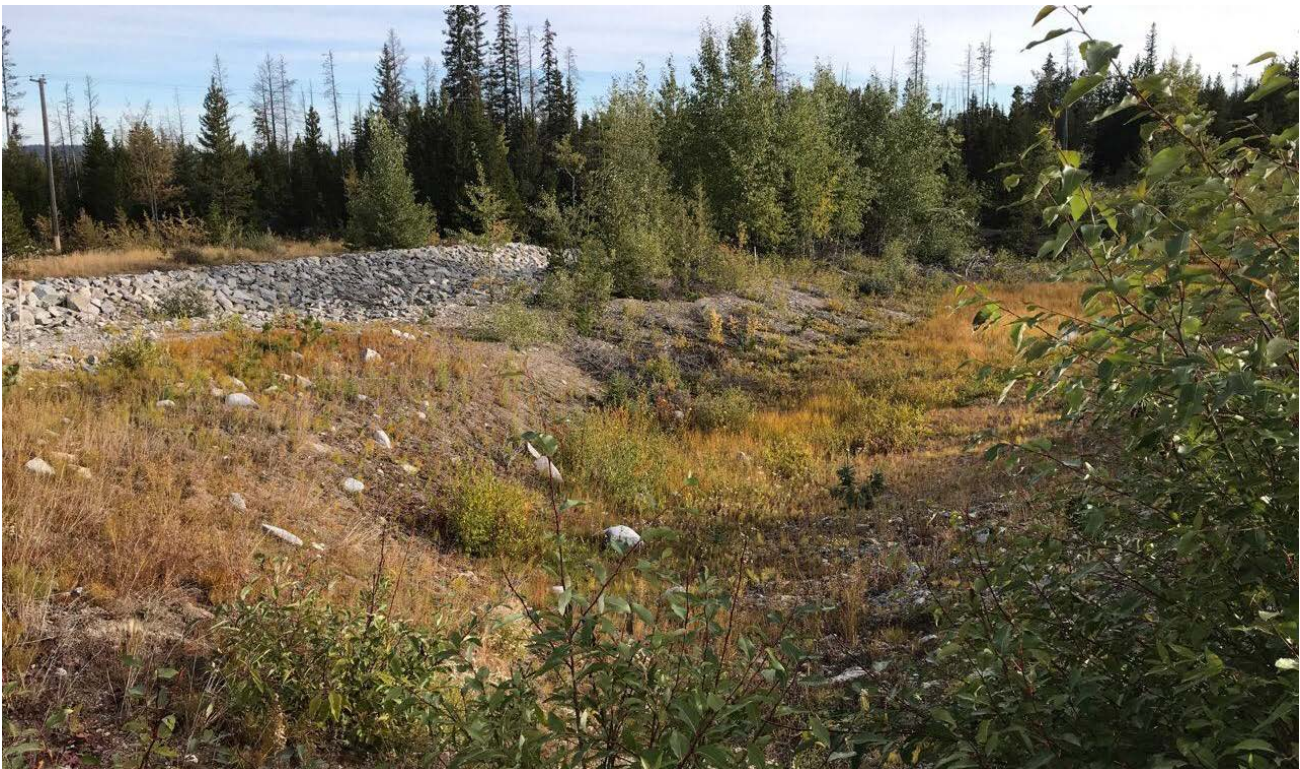
**Photo II-B-9 S2: Spillway invert and channel. Looking downstream to tie-in with Highmont spillway. (HGH-2018-17)**

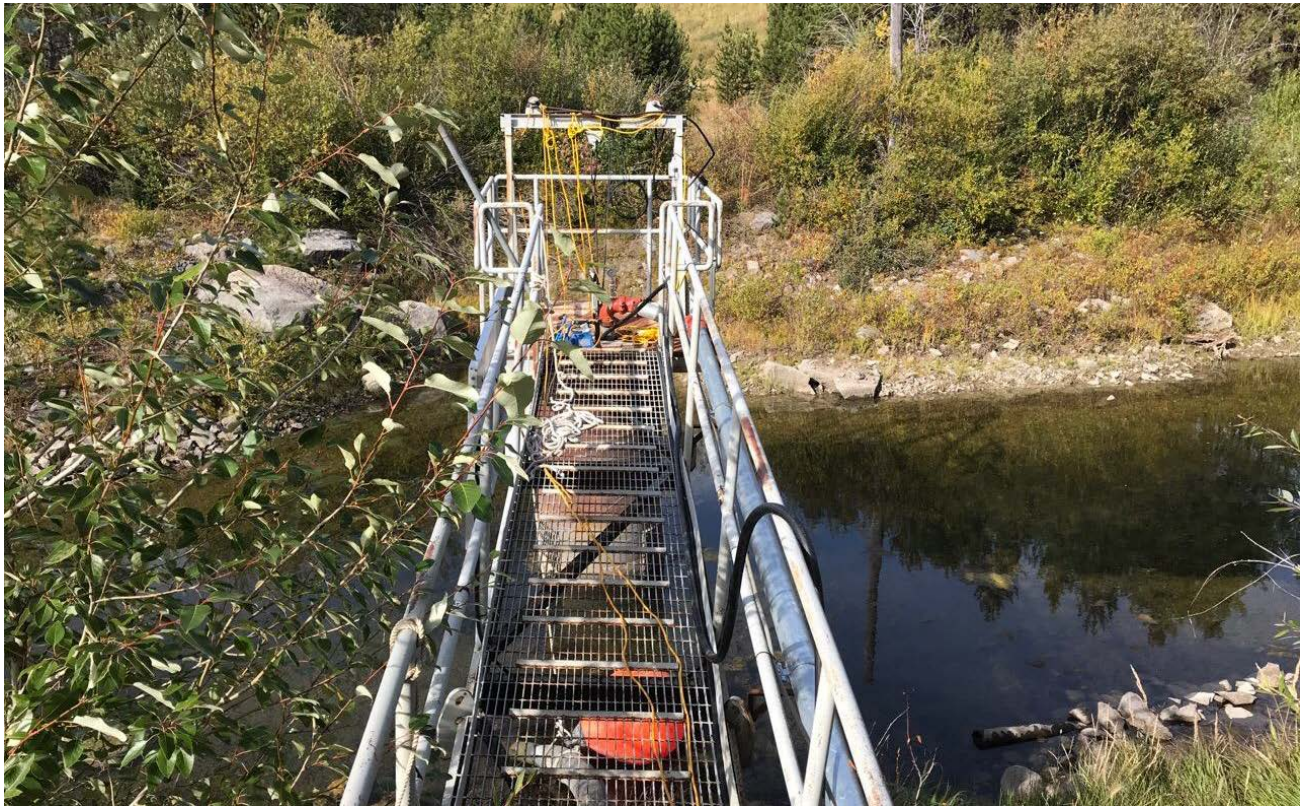
**Photo II-B-17 S3: Catwalk; personal flotation devices are in place. (HGH-2018-4)**

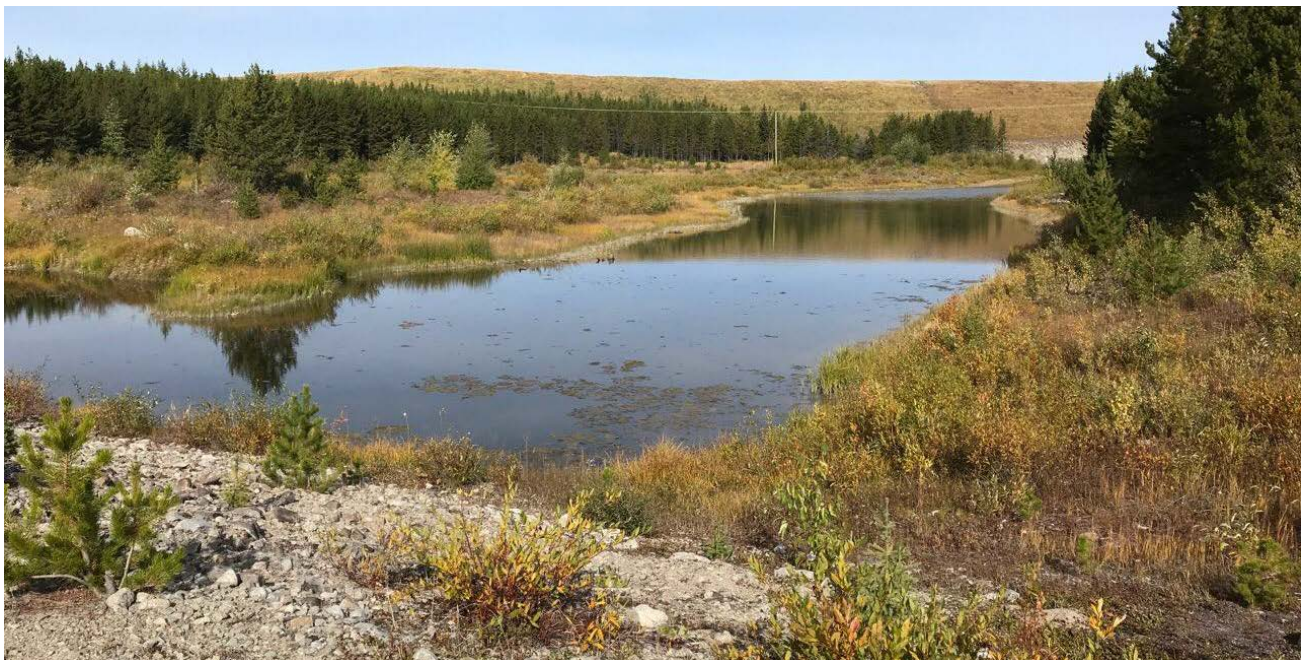
**Photo II-B-18 S3: Pond and South Dam toe view from left abutment, looking Northwest (HGH-2018-19)**

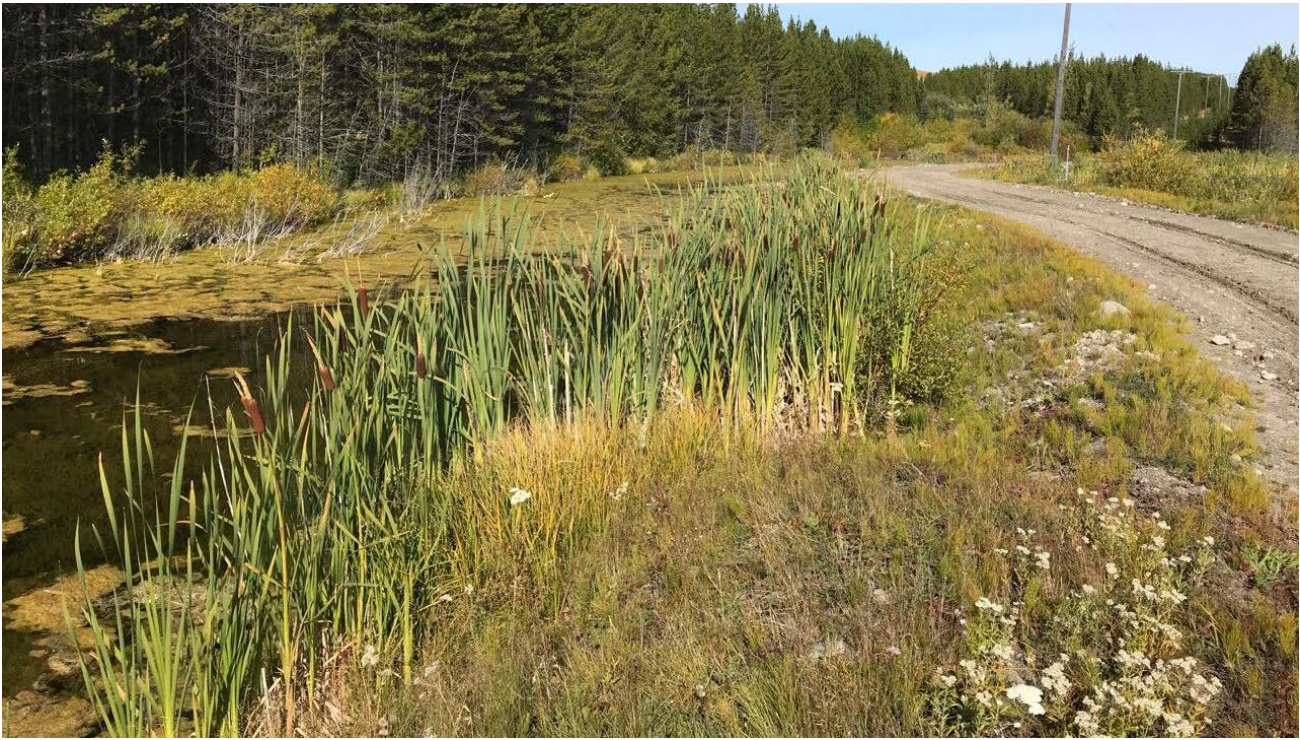
**Photo II-B-28 S5: Inflow pond, looking North. Pond is highly vegetated (HGH-2018-24)**

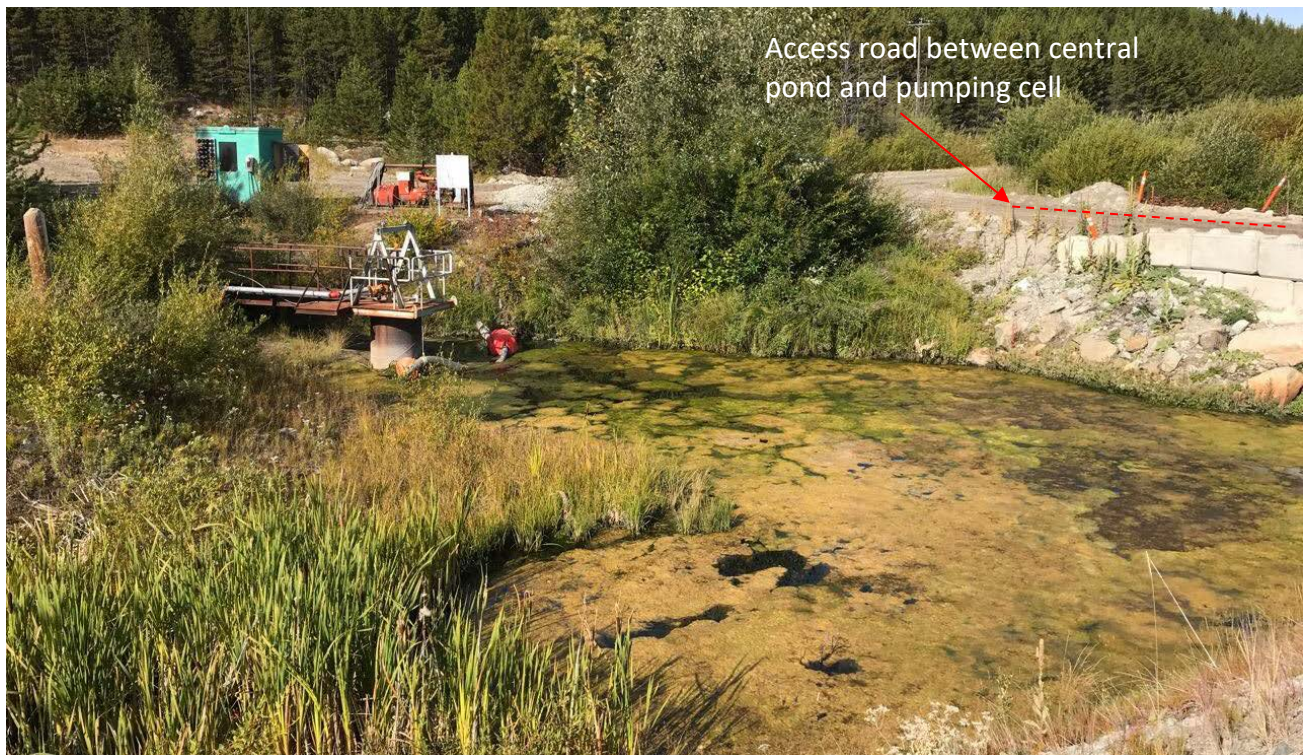
**Photo II-B-29 S5: Pumping cell with outlet pump to S1 pond. (HGH-2018-23)**

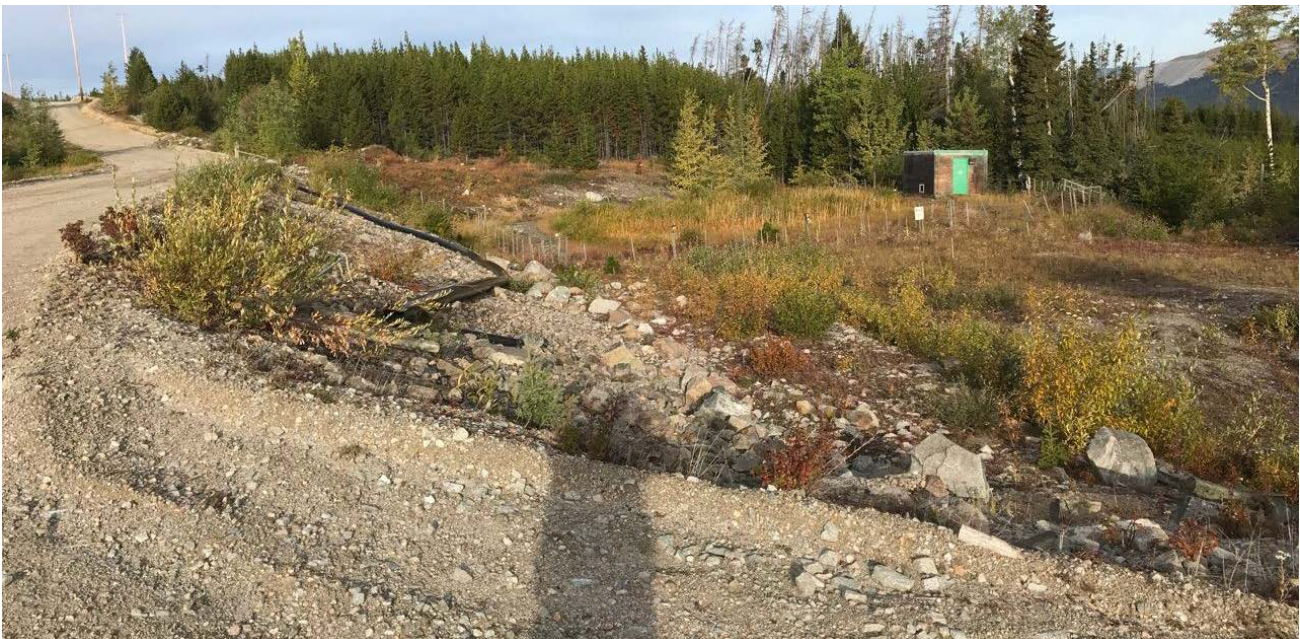
**Photo II-B-33 S8: Downstream slope looking West from right abutment. (HGH-2018-27)**

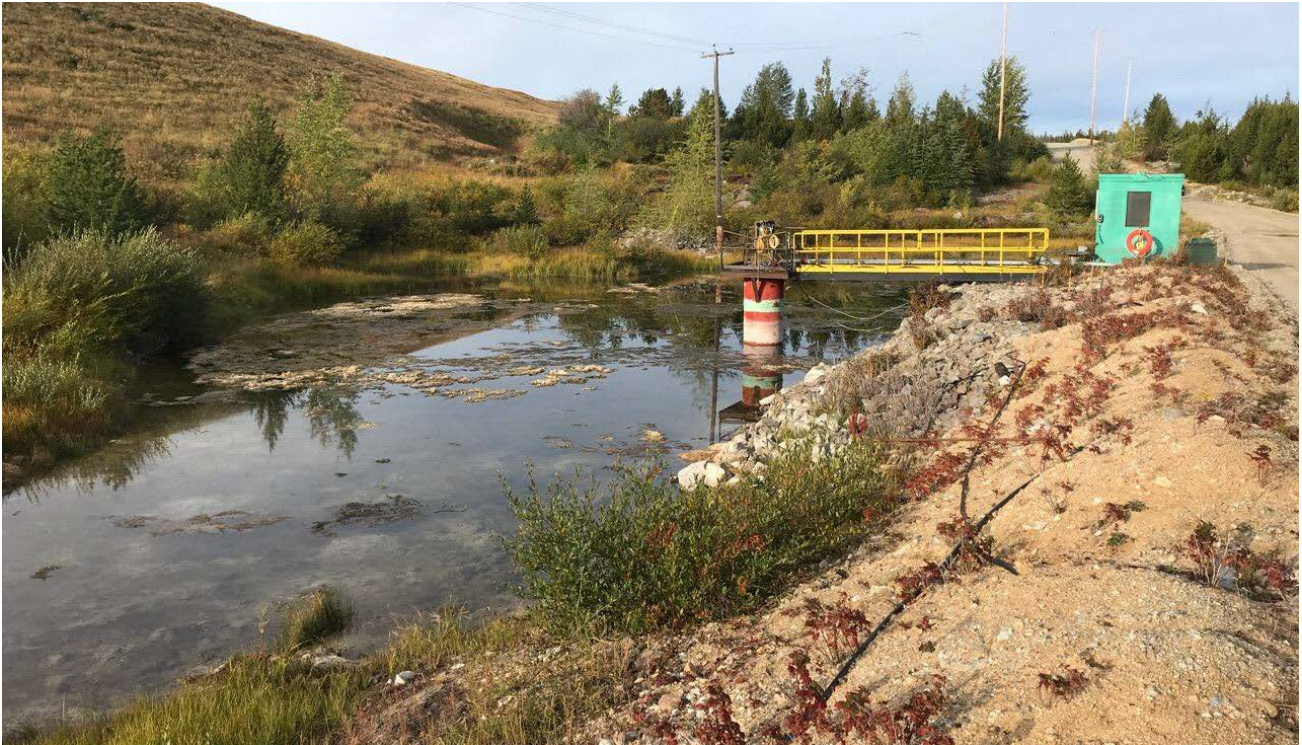
**Photo II-B-34 S8: Pond overview with pumphouse to S1 pond (right of photo) and North Dam downstream slope on left. (HGH-2018-27)**

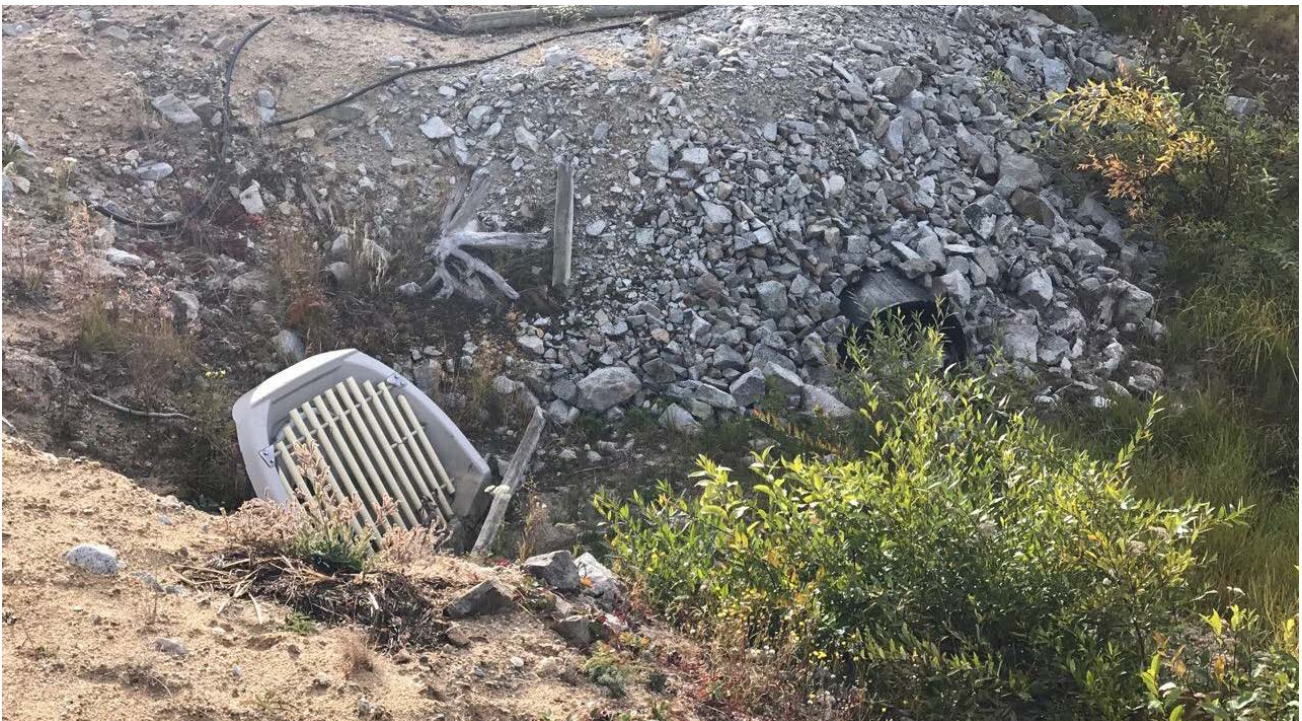
**Photo II-B-35 S8: Trash rack for overflow pipe is clear of debris. (HGH-2018-27)**
