# **Teck Metals Ltd.**

## **Pinchi Lake Mine Tailings Storage Facility**

### ***2018 Dam Safety Inspection***

M07728A33.730

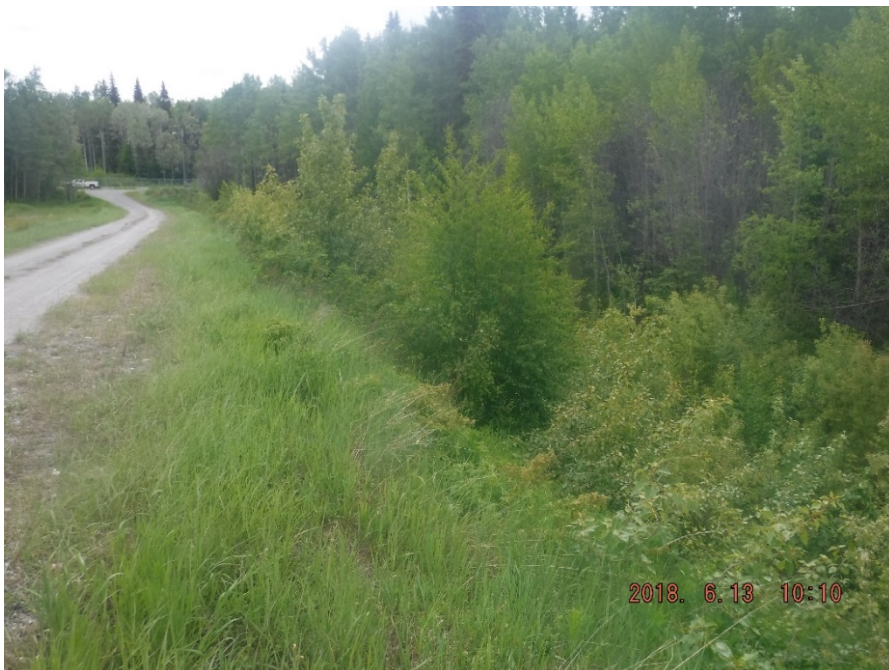
- There is vegetation on the slope of the east leg of the dam, especially on the north section, including trees up to about 3 m tall (Location 8 in Figure 4.1; Photos II-1 to II-4, II-6, and II-8). This vegetation is not currently considered to be a dam safety concern, although it may be prudent to clear it before the trees become more difficult to remove. The vegetation management plan recommends vegetation clearing prior to vegetation exceeding 1.5 m in height (Spectrum 2017).

**Photo II-2 Tailings Dam – east leg, looking north. Note vegetation on dam slope.**

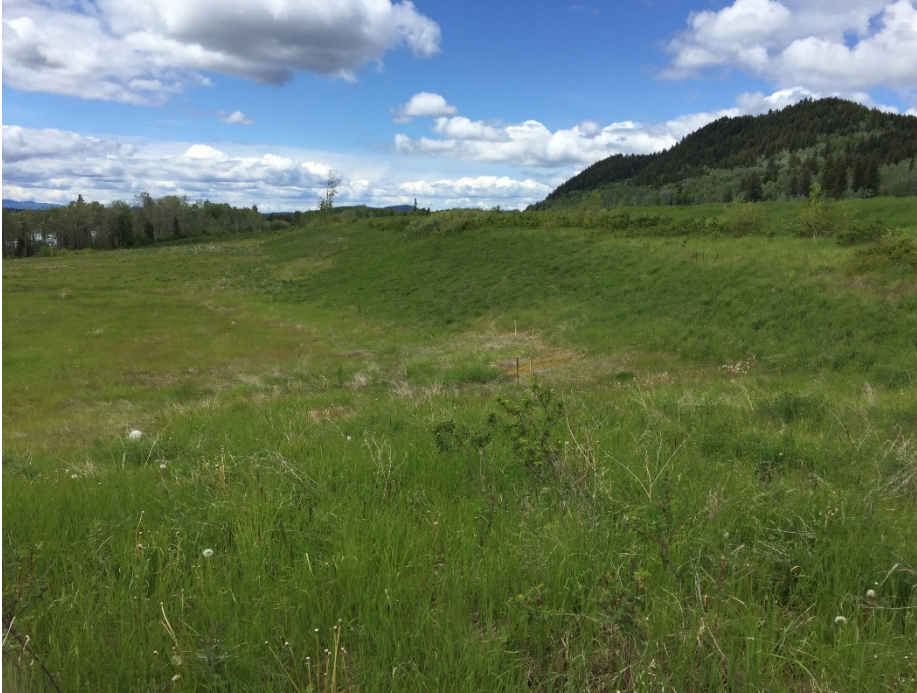
**Photo II-43 Borrow Area A – looking west from access road.**

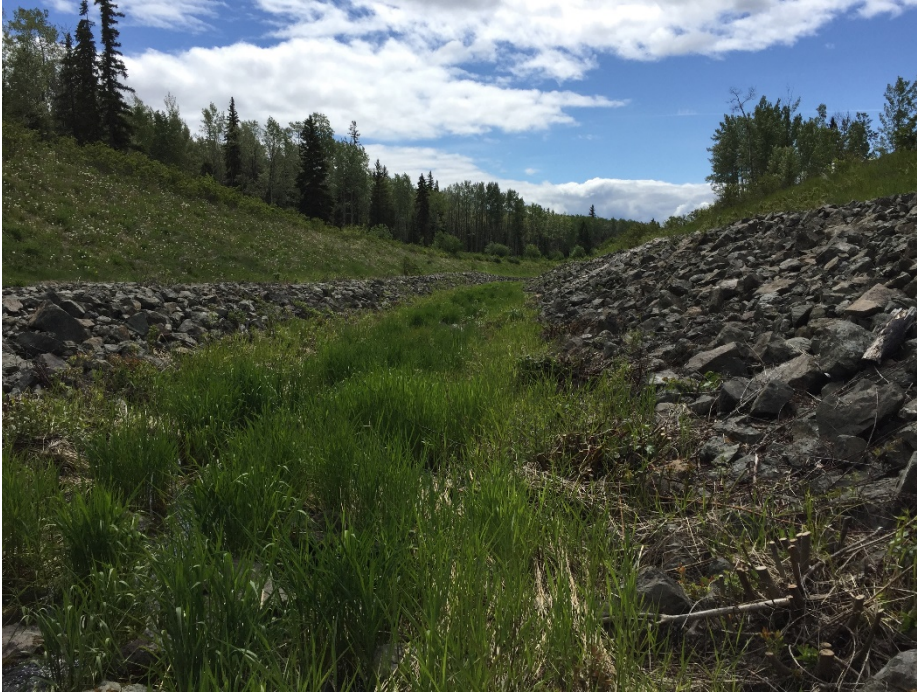
**Photo II-59 Ed Creek Diversion Channel – looking downstream from near first bend.**
