October 01, 2018

Project No. 1895461

2018 ANNUAL PERFORMANCE REPORT FOR TAILINGS BACK DAM, RED DOG MINE, ALASKA

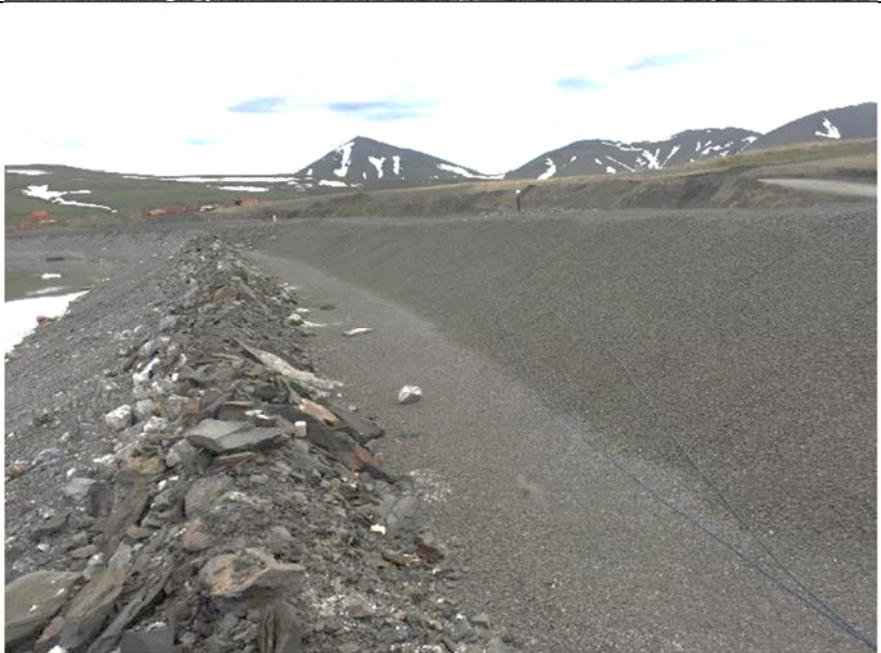
PHOTO 4

INSULATION LAYER
AND
INSTRUMENTATION
CABLES NEAR
STATION 15+00

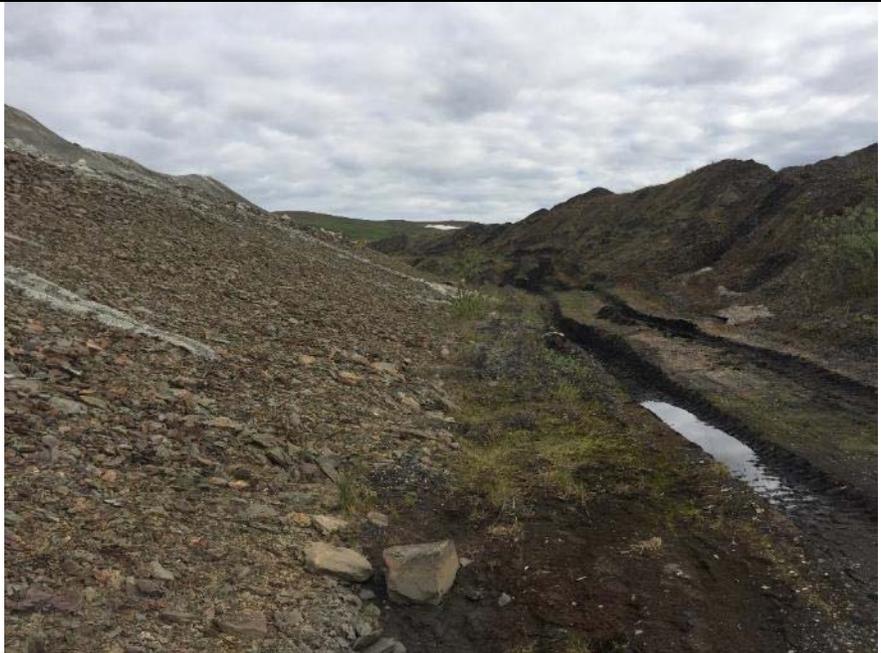
PHOTO 9

DOWNSTREAM
EMBANKMENT SLOPE
AND OVERBURDEN
STOCKPILE NEAR
STATION 19+00

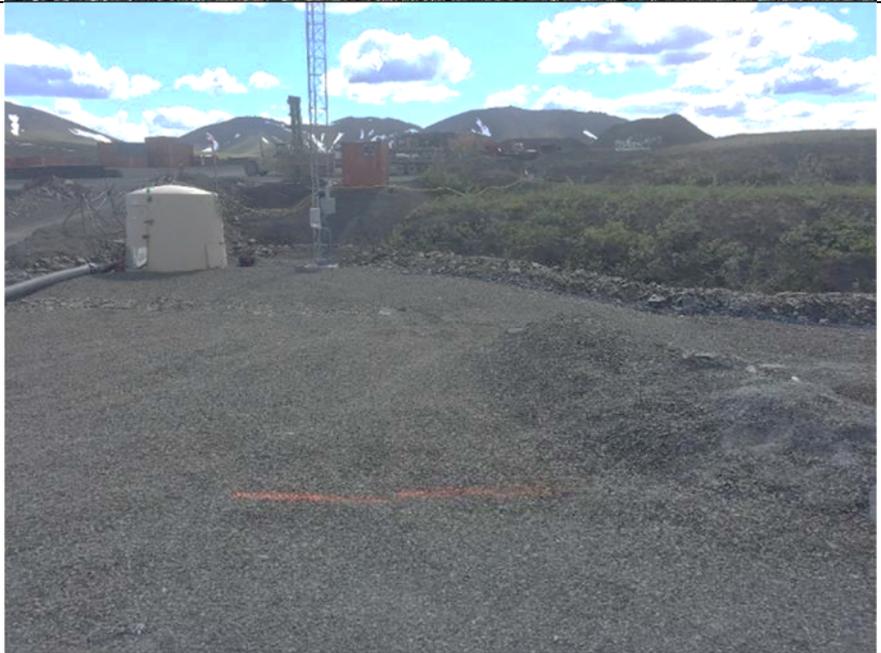
PHOTO 20

SUMP PUMP HOUSE
AND
COMMUNICATIONS
TOWER NEAR
STATION 25+50

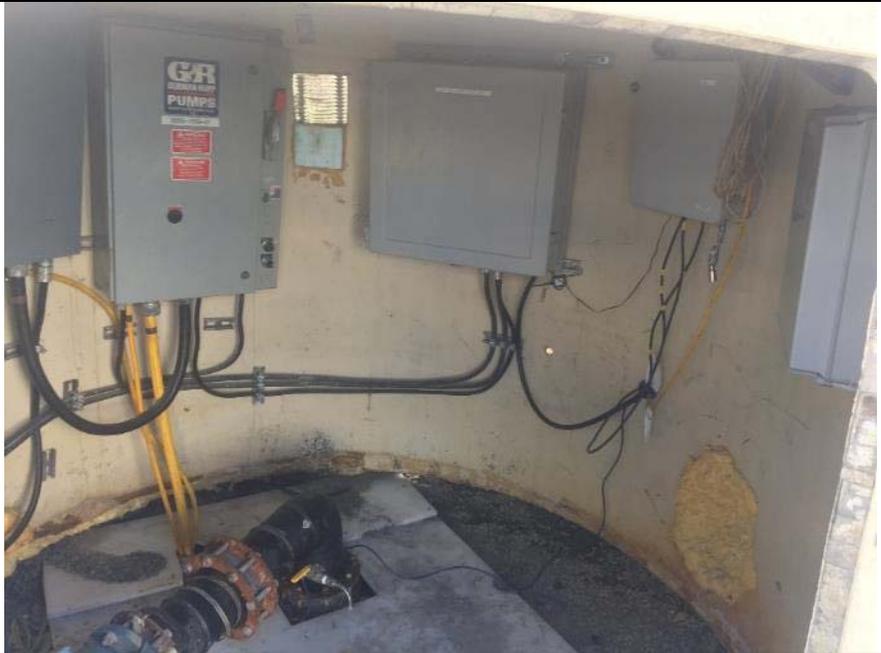
PHOTO 21

INTERIOR OF SUMP
PUMPHOUSE
