**Teck Metals Ltd.**

**Sullivan Mine Tailings Facilities**

***2018 Dam Safety Inspection***

March 2019

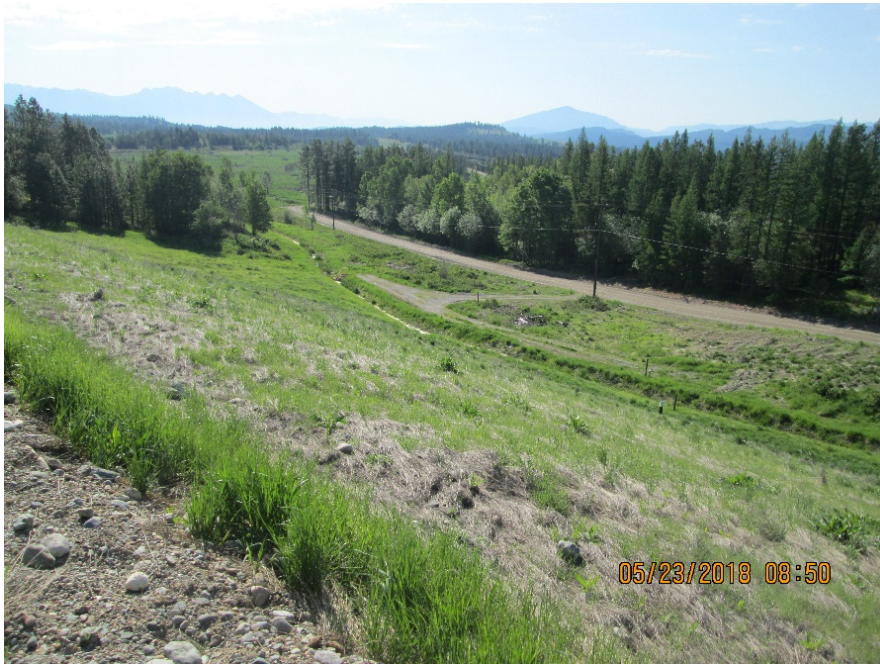
**Photo A.1 Downstream Slope of ARD Pond South Dam**

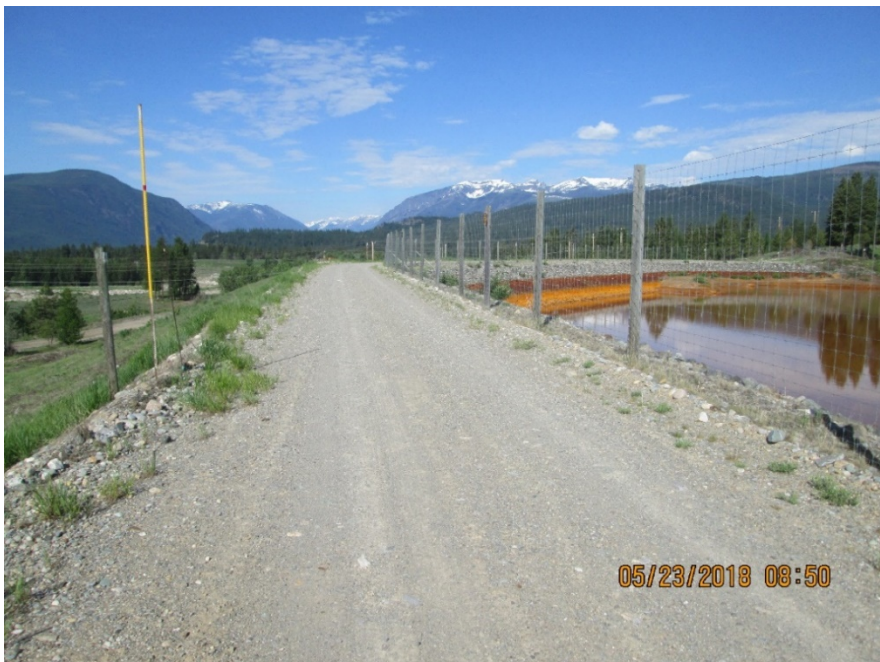
**Photo A.2 Crest and Upstream Slope of ARD Pond South Dam**

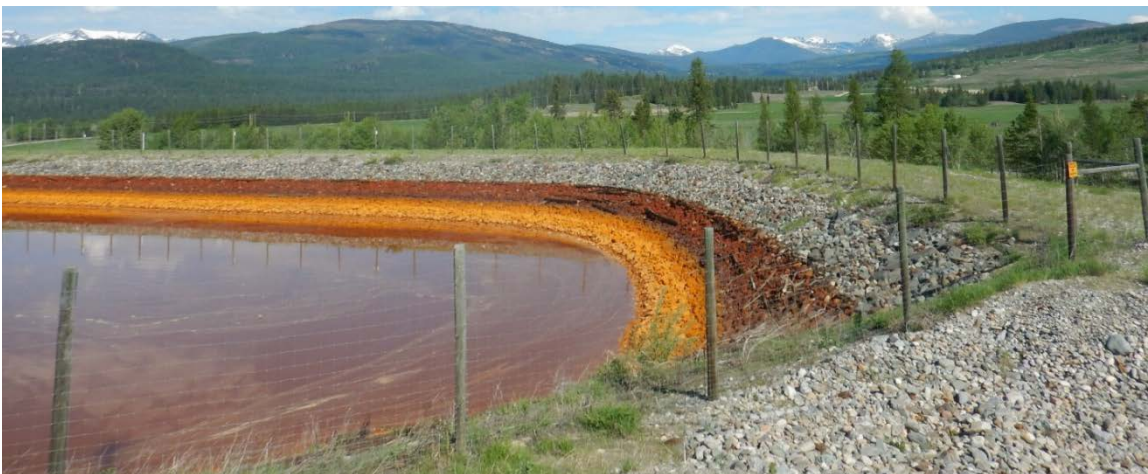
**Photo A.4 Upstream Face of ARD Pond North Dam**

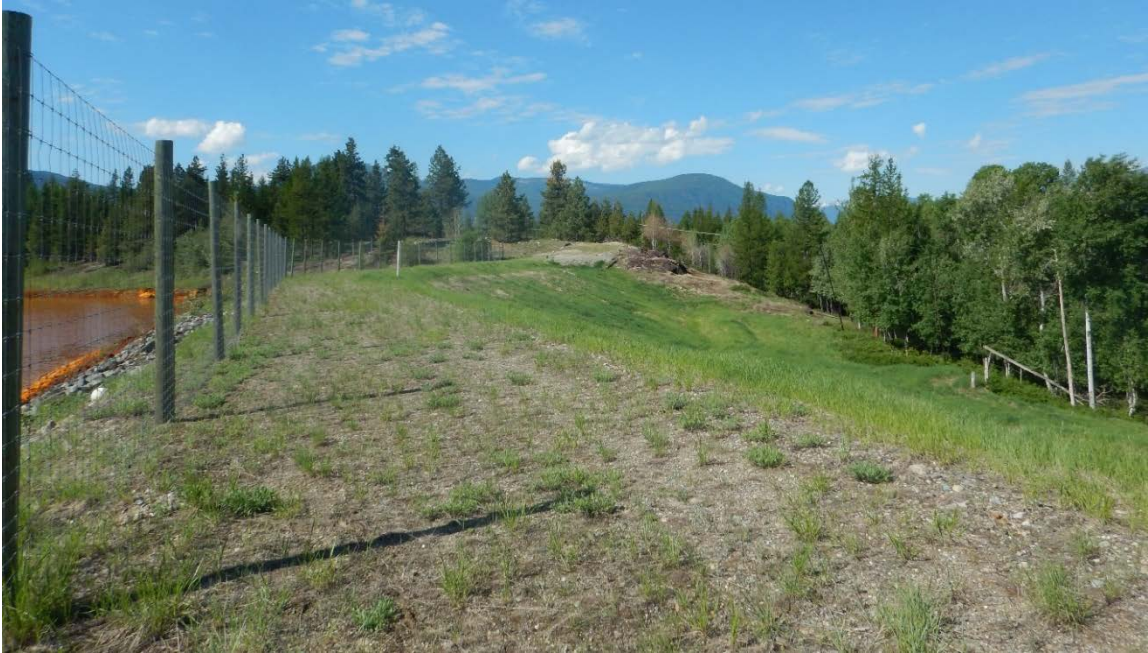
**Photo A.5 Crest and Downstream face of ARD Pond North Dam**

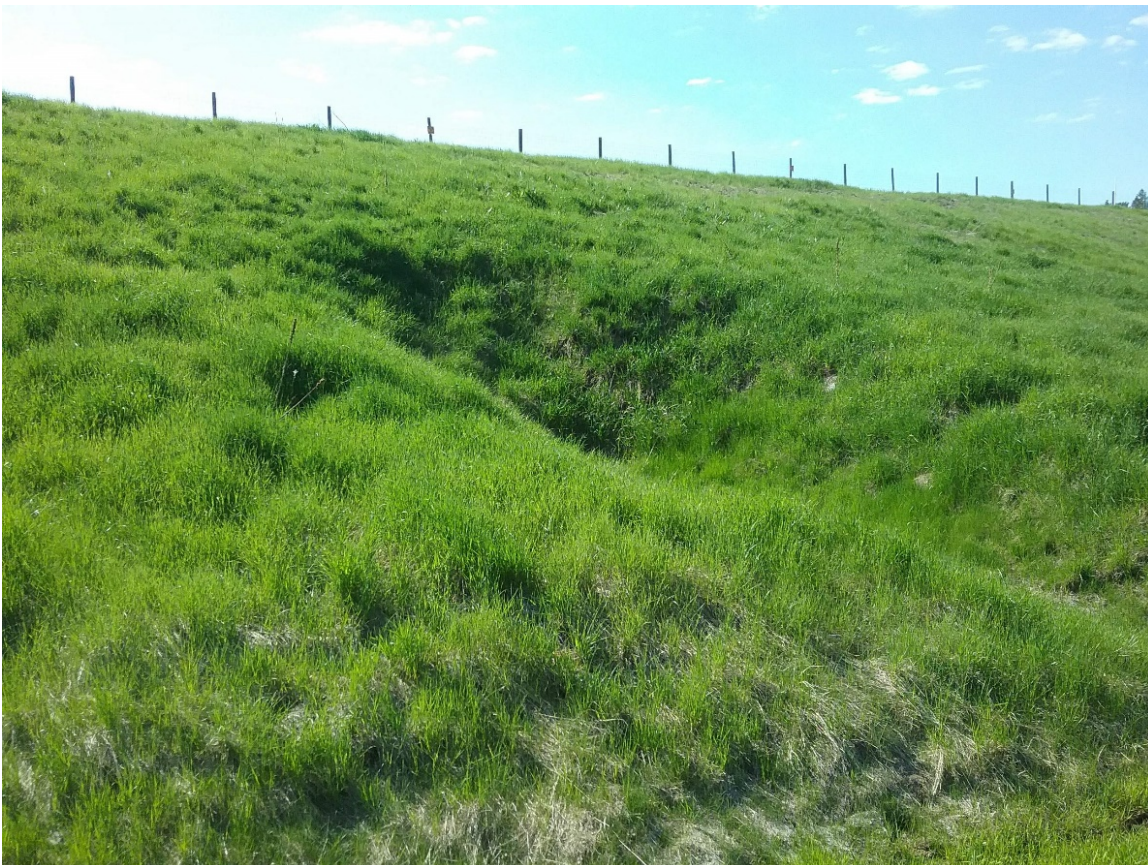
**Photo A.6 Localized Depressions on Downstream Face of ARD Pond North Dam**

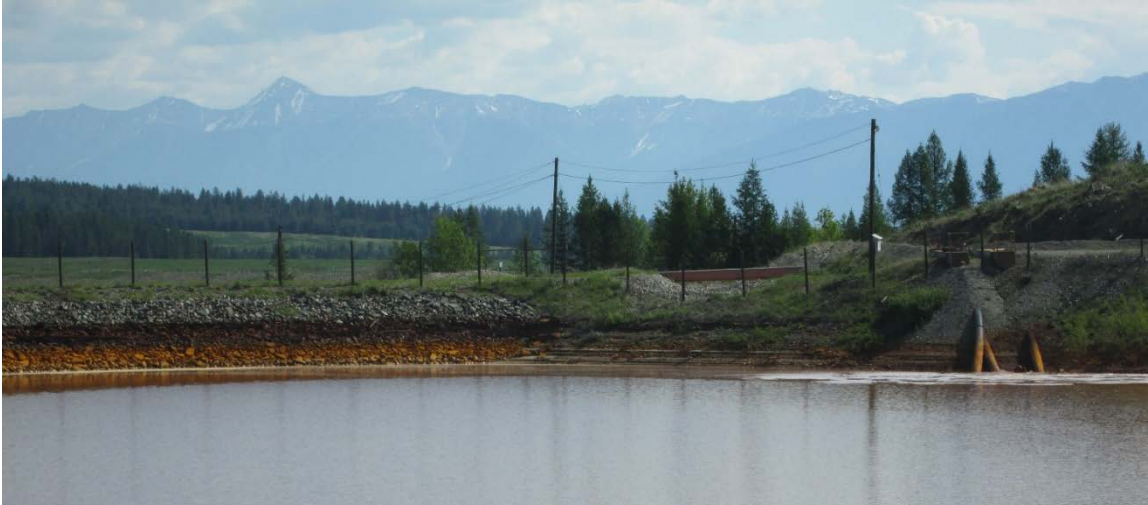
**Photo A.7 Looking across ARD Pond Towards Inlet of ARD Pond**

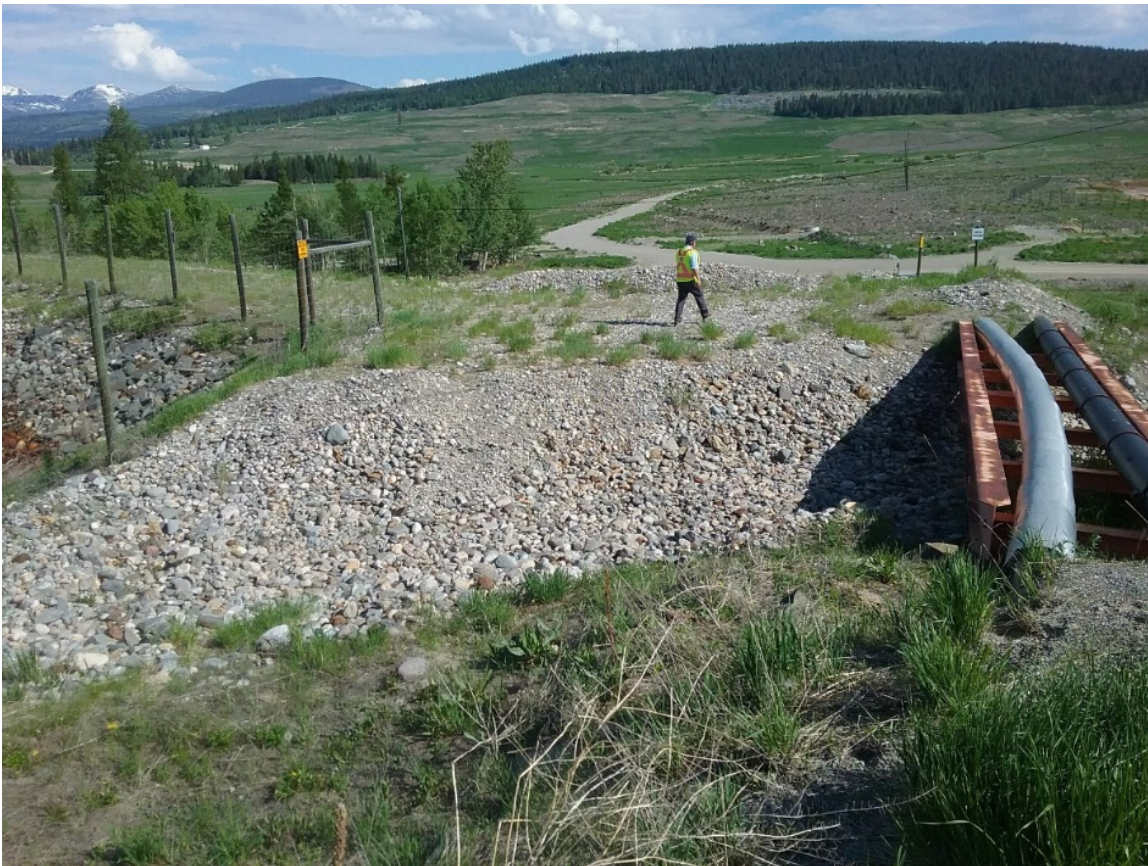
**Photo A.8 ARD Pond Spillway**

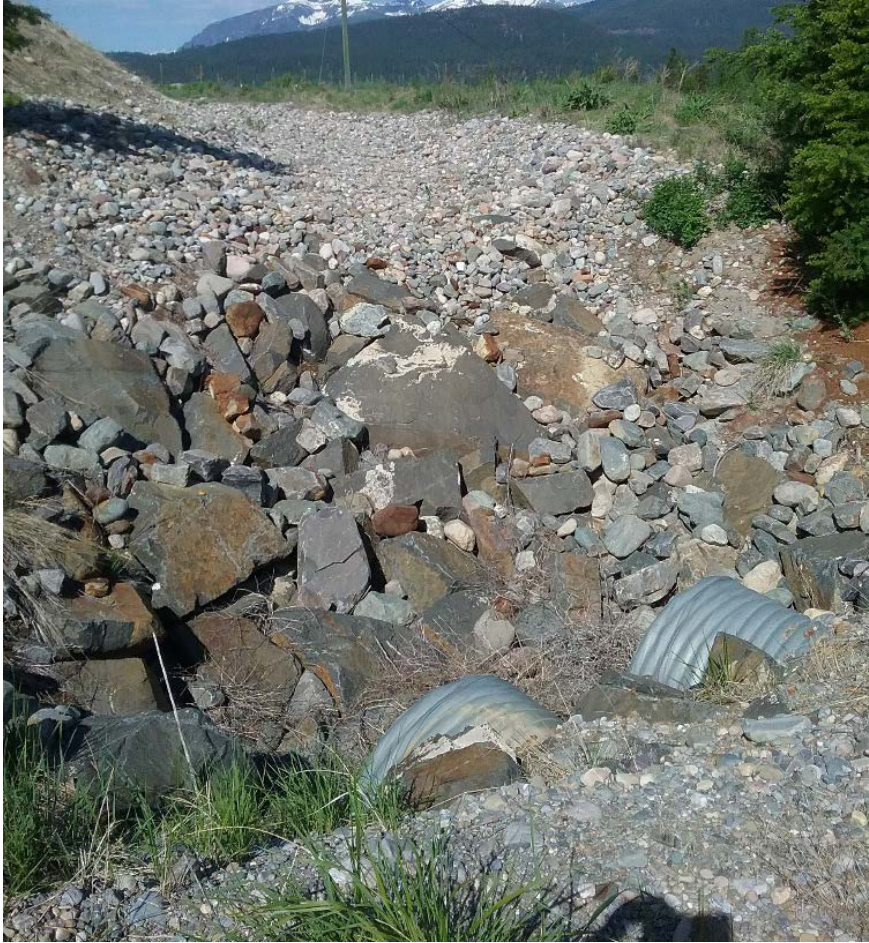
**Photo A.9 ARD Pond Spillway looking towards Iron Pond**

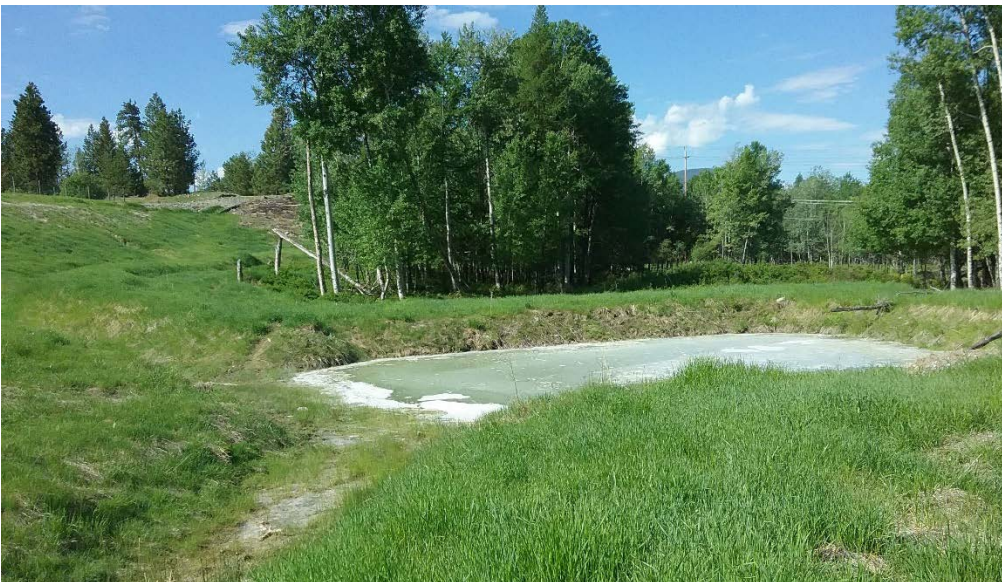
**Photo A.10 Sump downstream of ARD North Dam**

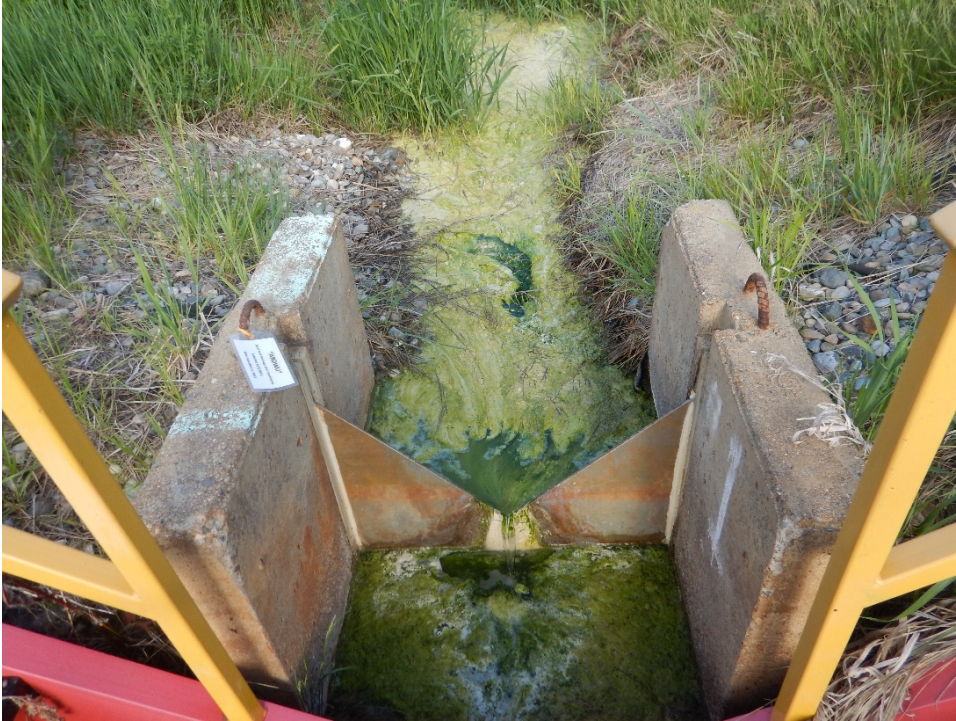
**Photo A.11 Weir #1 Downstream of ARD Pond. Channel requires cleaning**

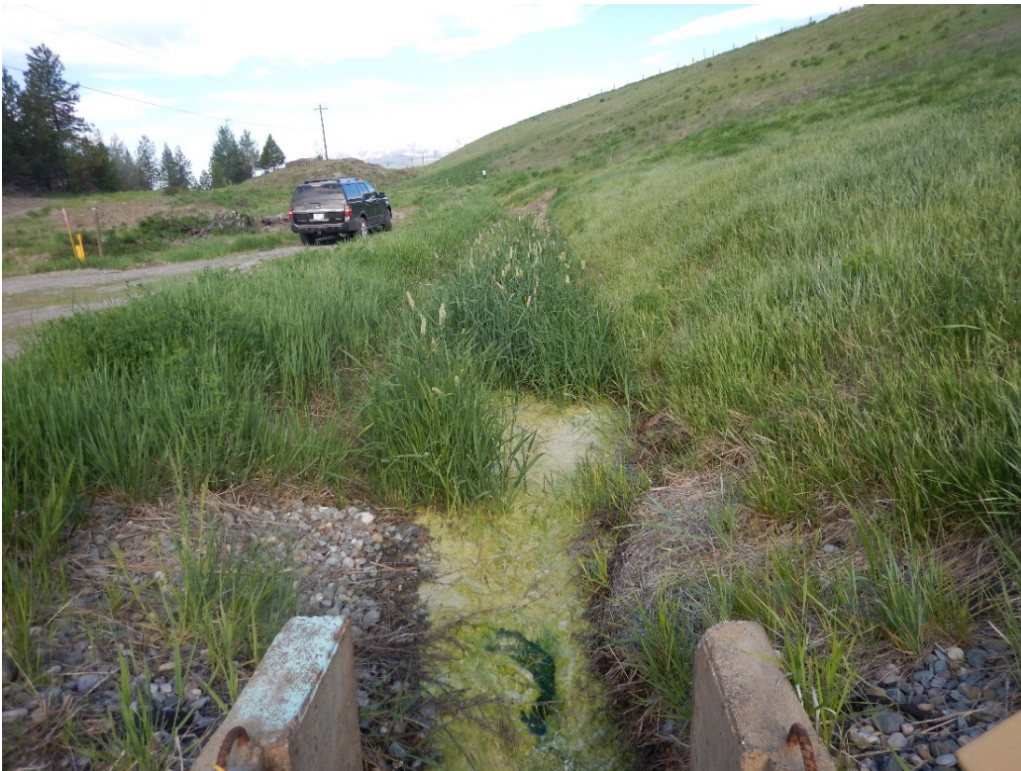
**Photo A.12 Weir #1 Downstream of ARD Pond. Channel requires cleaning**

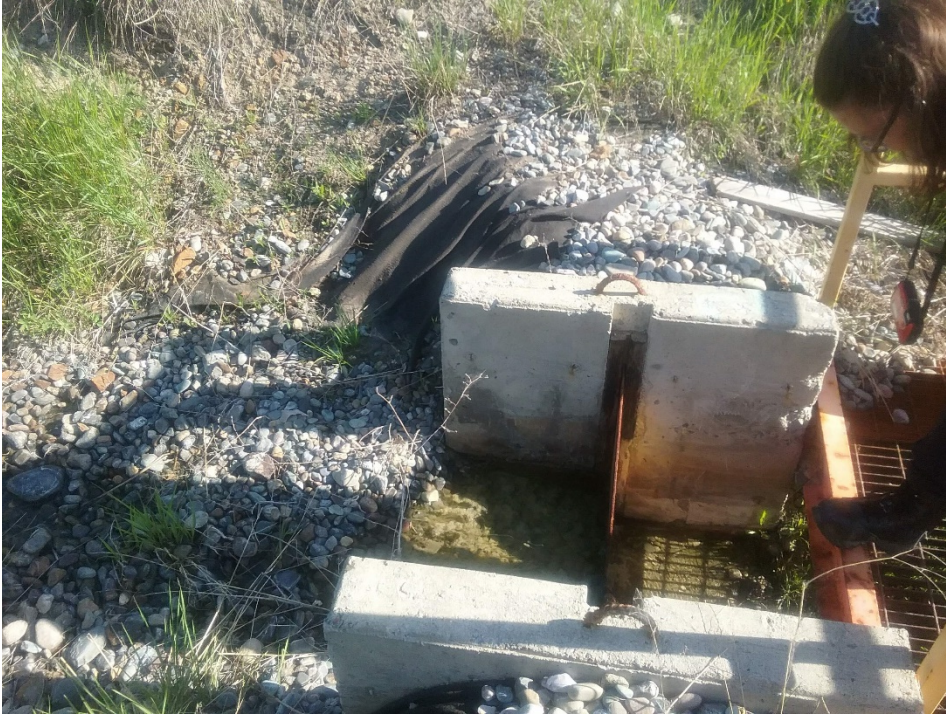
**Photo A.13 Weir #2 Downstream of ARD Pond. Bank requires maintenance**

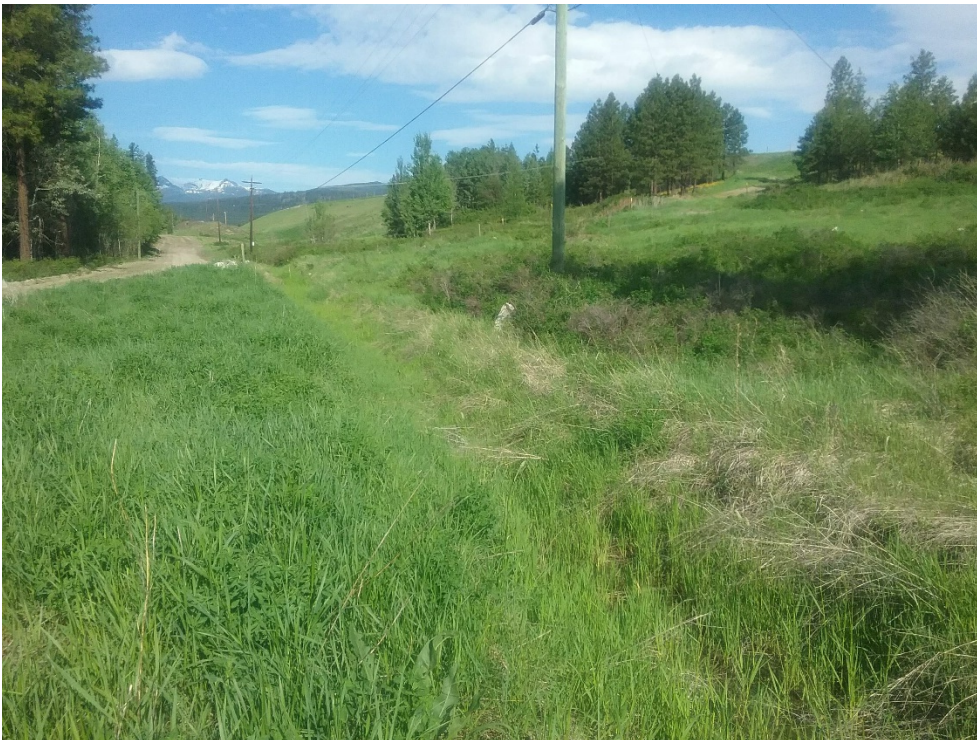
**Photo A.14 Channel approaching Weir #2 Downstream of ARD Pond.**

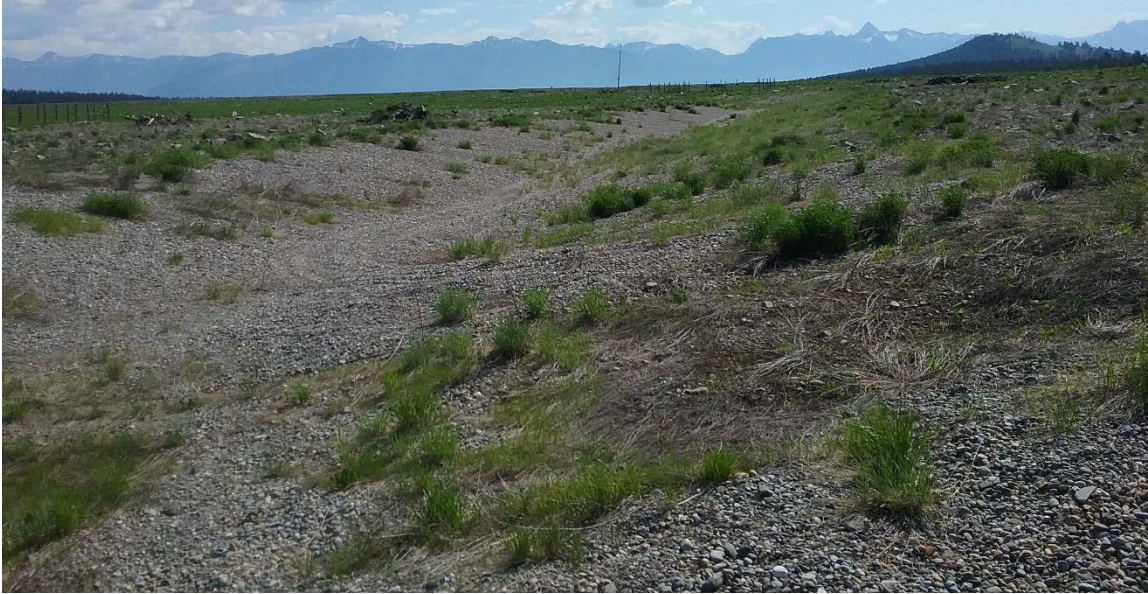
**Photo B.1**      **Approach swale to the Emergency Spillway**

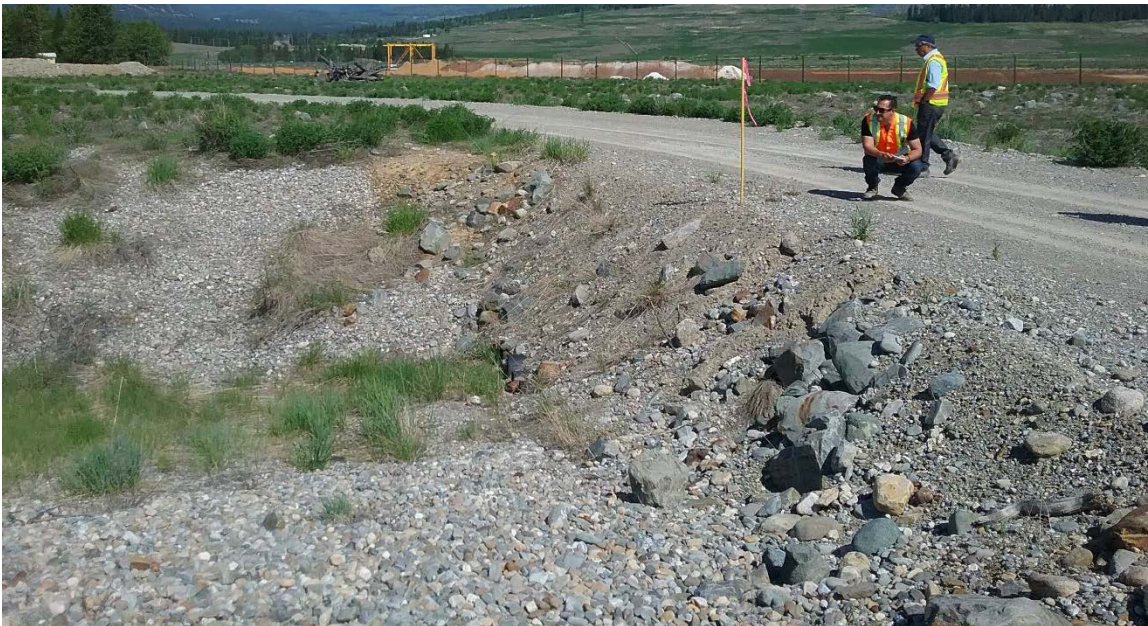
**Photo B.2**      **Access Road Across Approach Swale**

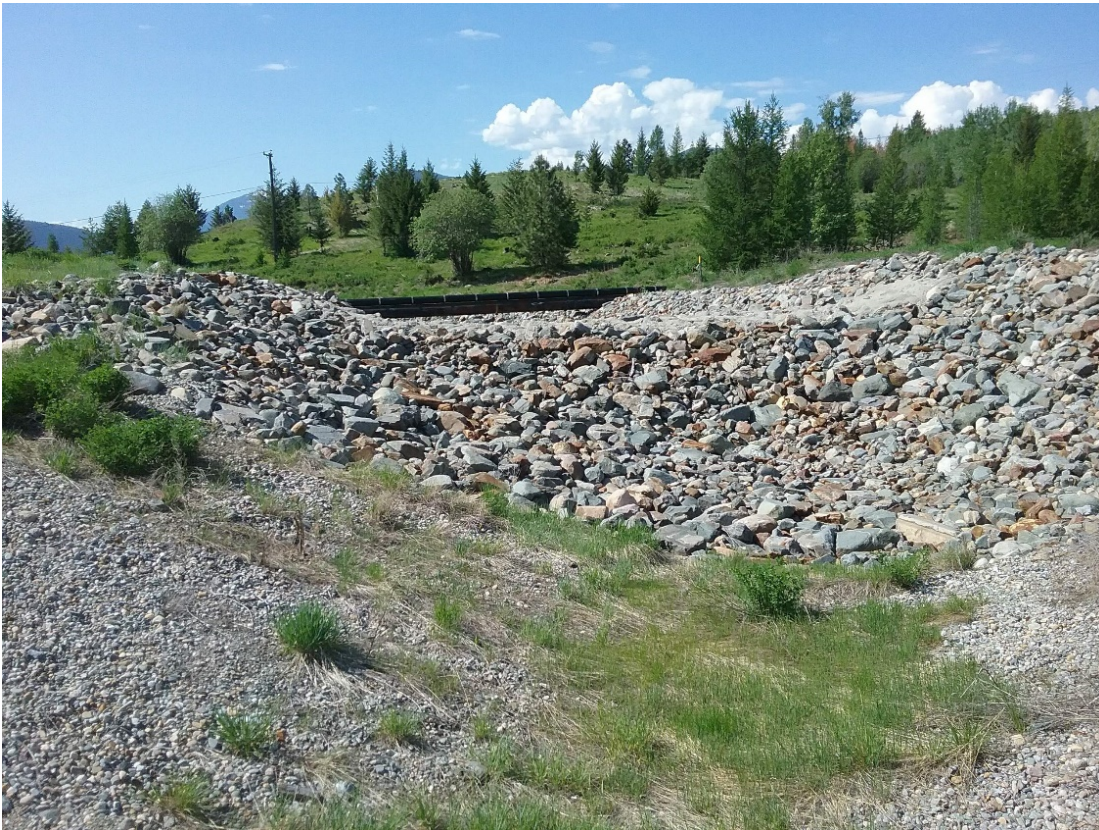
**Photo B.3 Upstream End of the Emergency Spillway looking downstream**

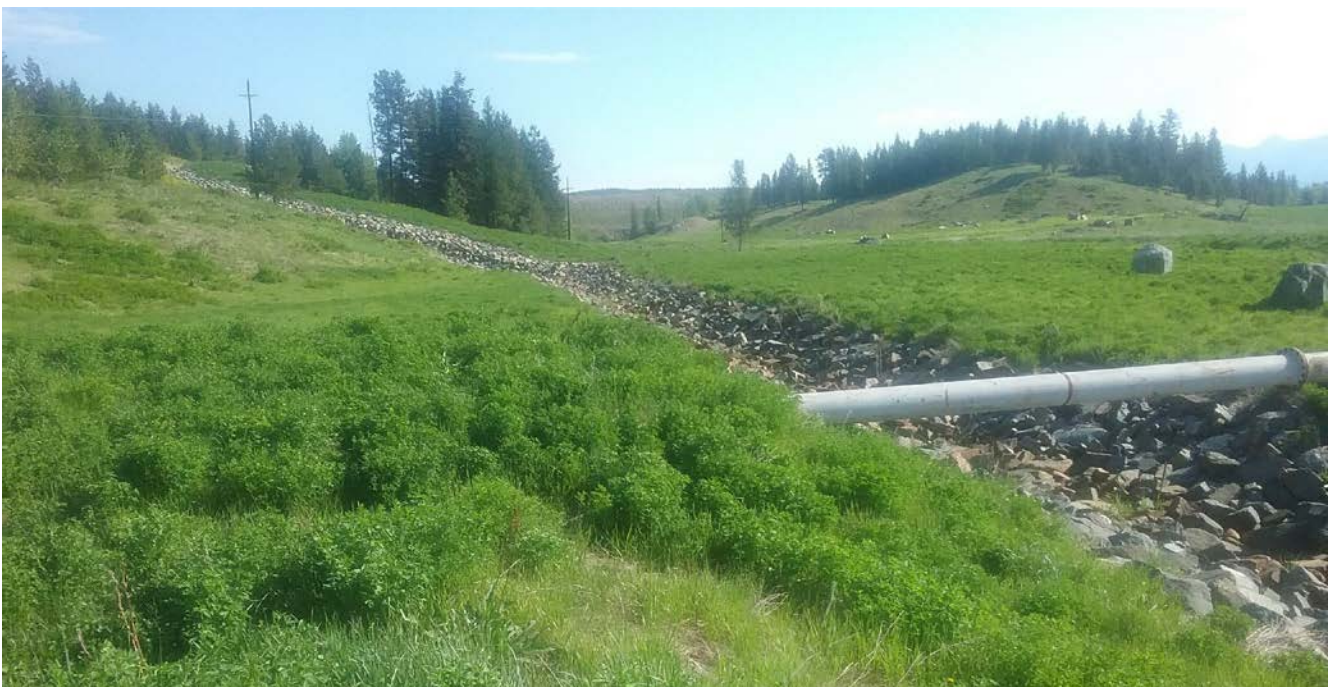
**Photo B.4 Emergency Spillway looking upstream**

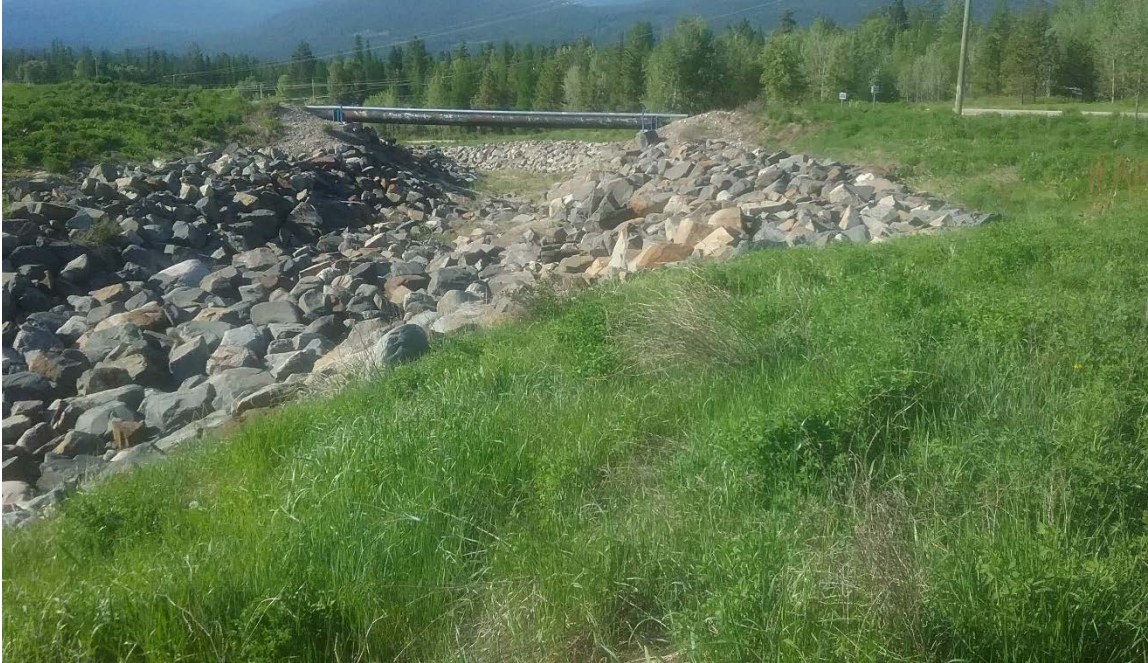
**Photo B.5 Emergency Spillway looking downstream**

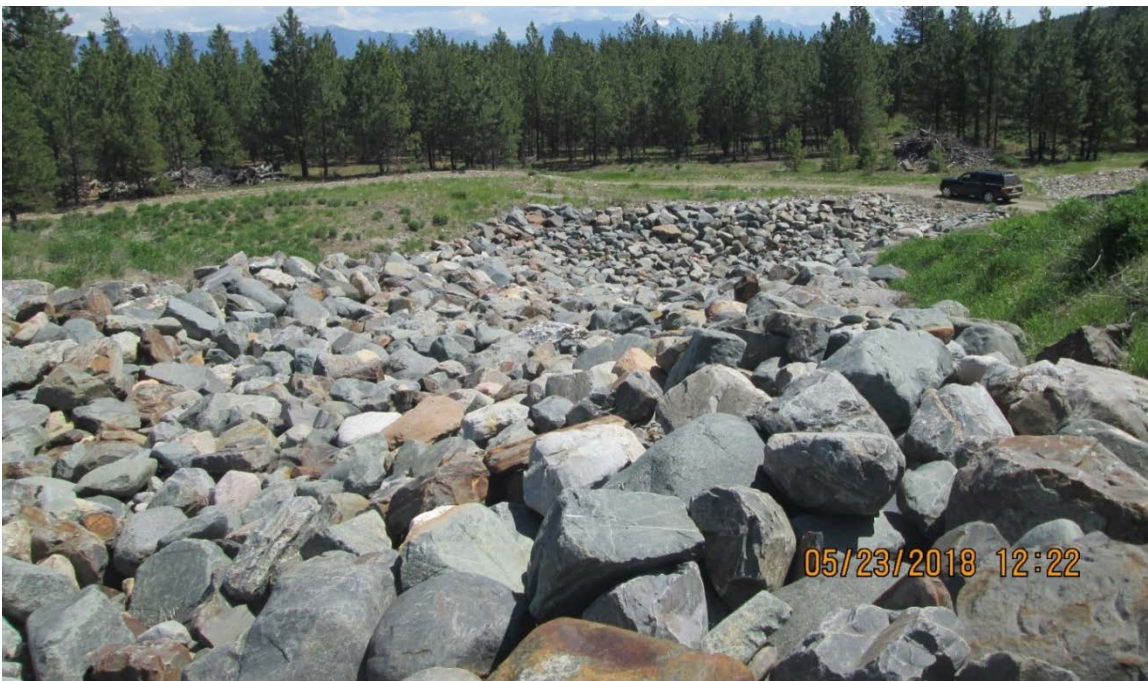
**Photo B.6 Downstream End of the Emergency Spillway**

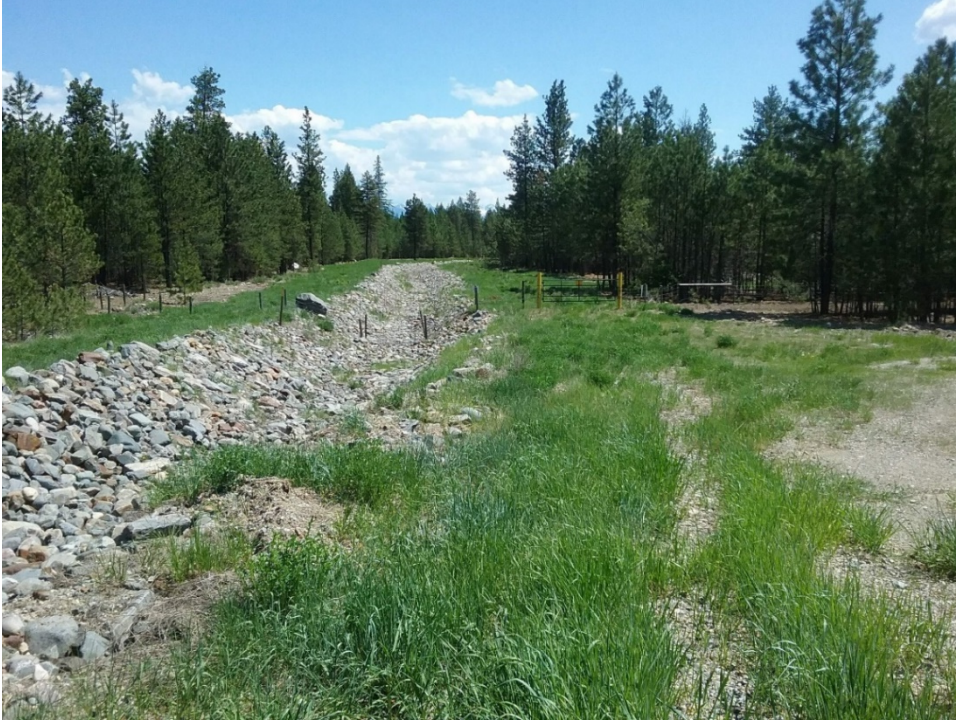
**Photo C.1 Diversion Channel Upstream of Siliceous TSF looking downstream**

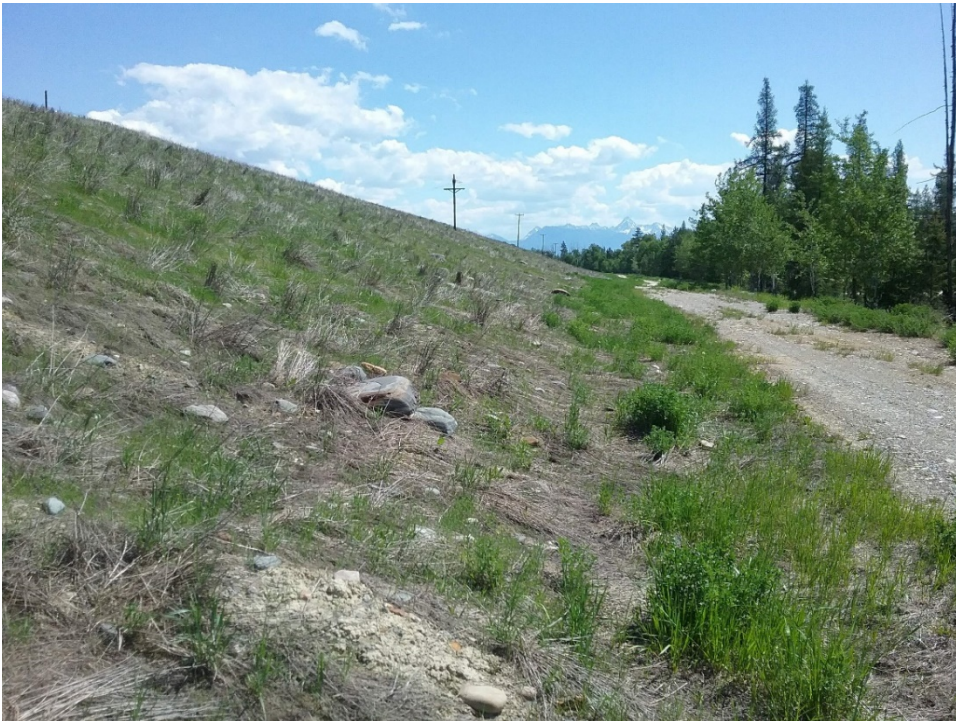
**Photo C.2 Downstream Slope of Siliceous Dike**

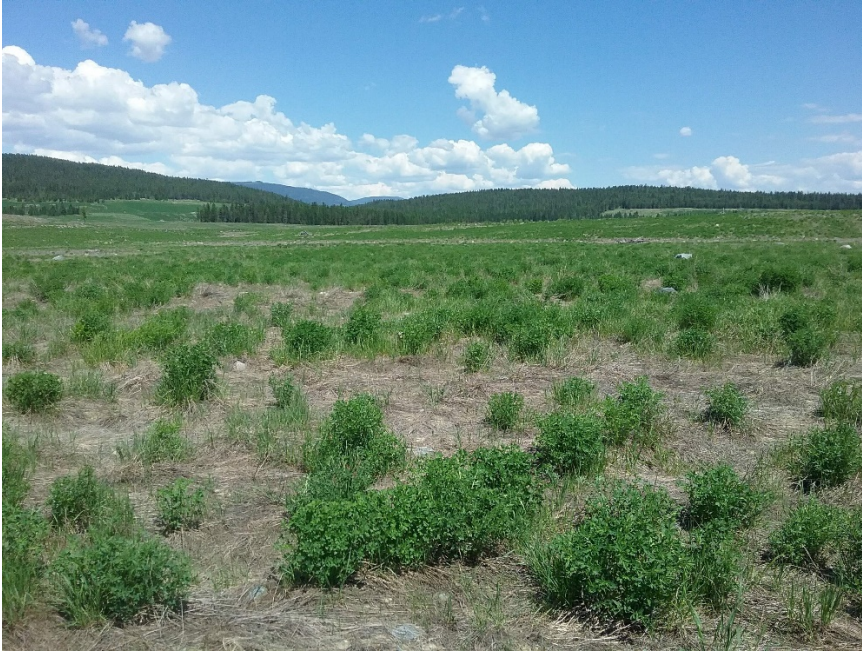
**Photo C.3 Overview of Siliceous TSF**

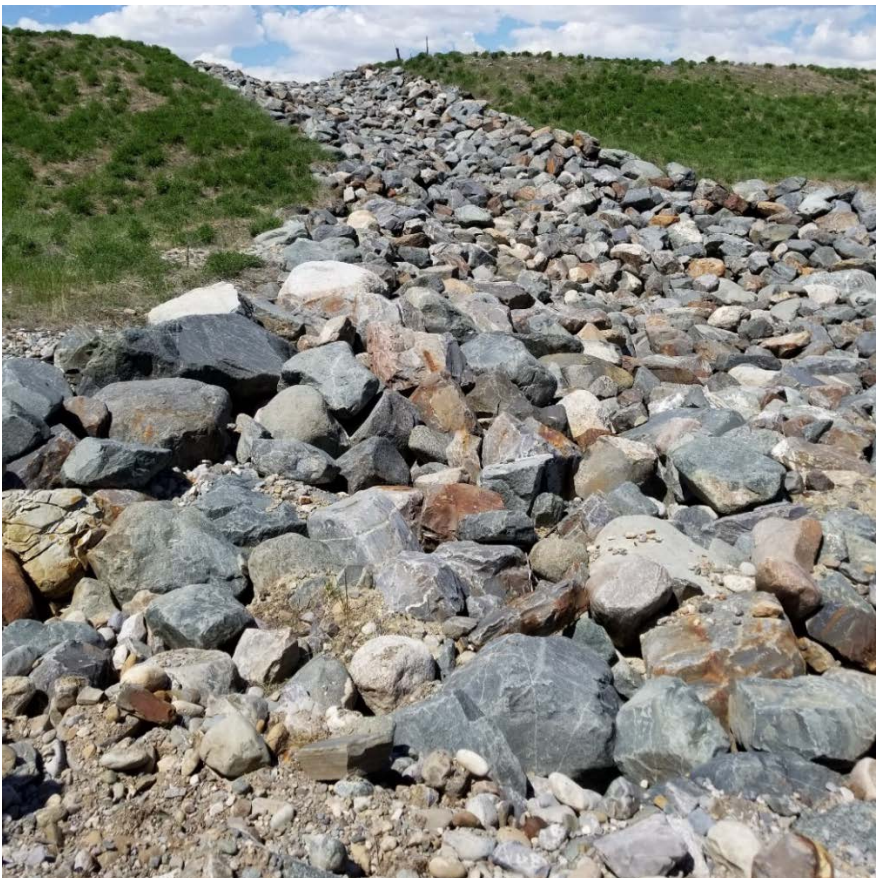
**Photo C.4 Siliceous TSF Emergency Spillway**

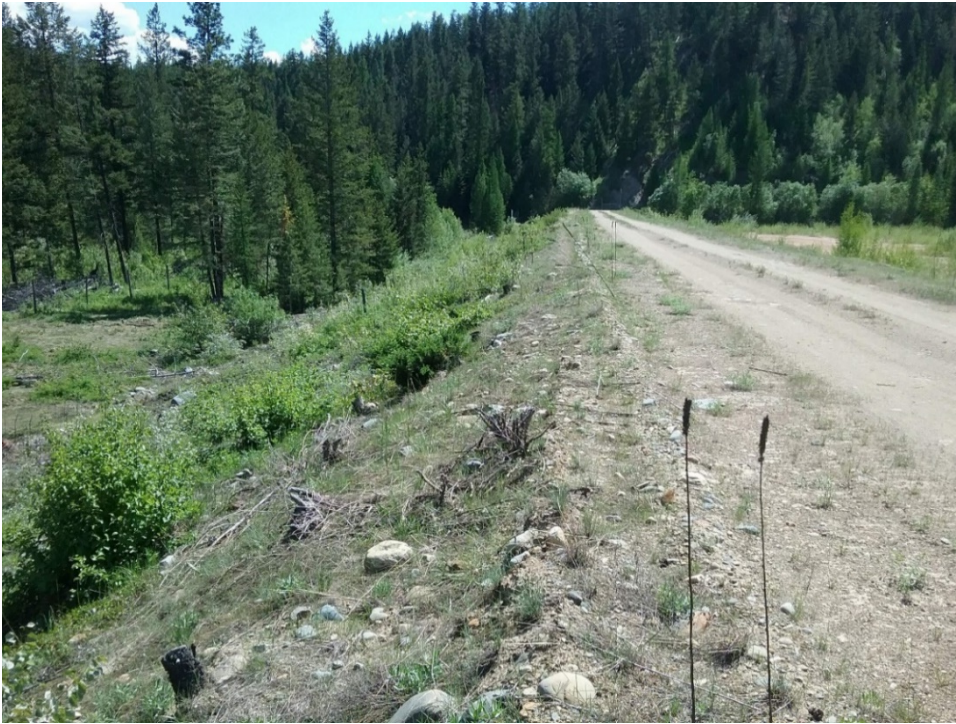
**Photo D.1 Sludge Impoundment South Dike Crest and Downstream Slope**

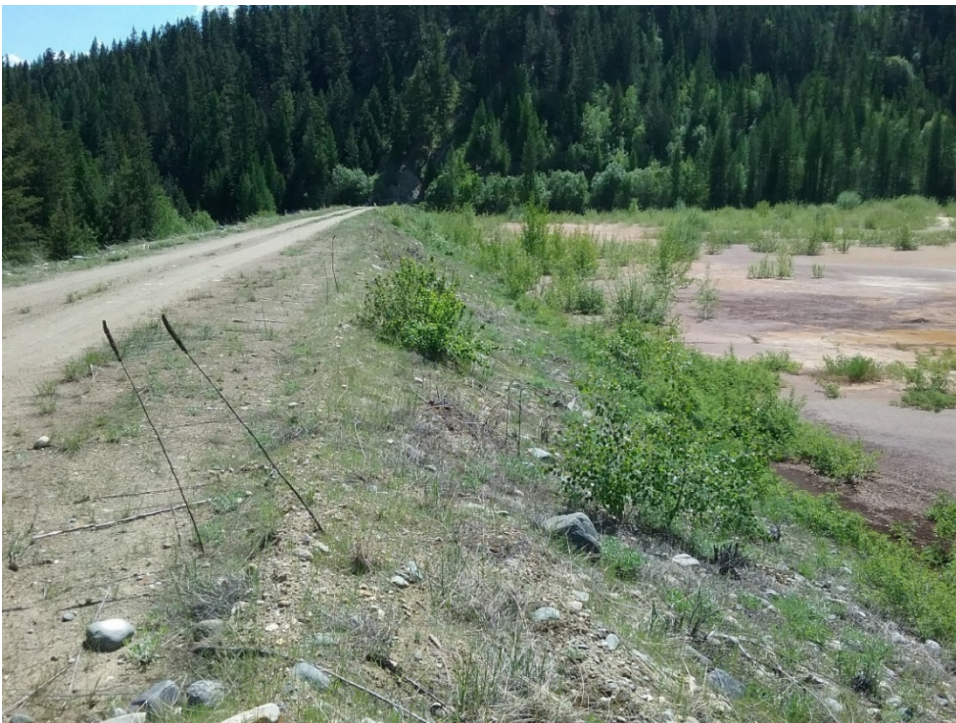
**Photo D.2 Upstream Face of Sludge Impoundment South Dike**

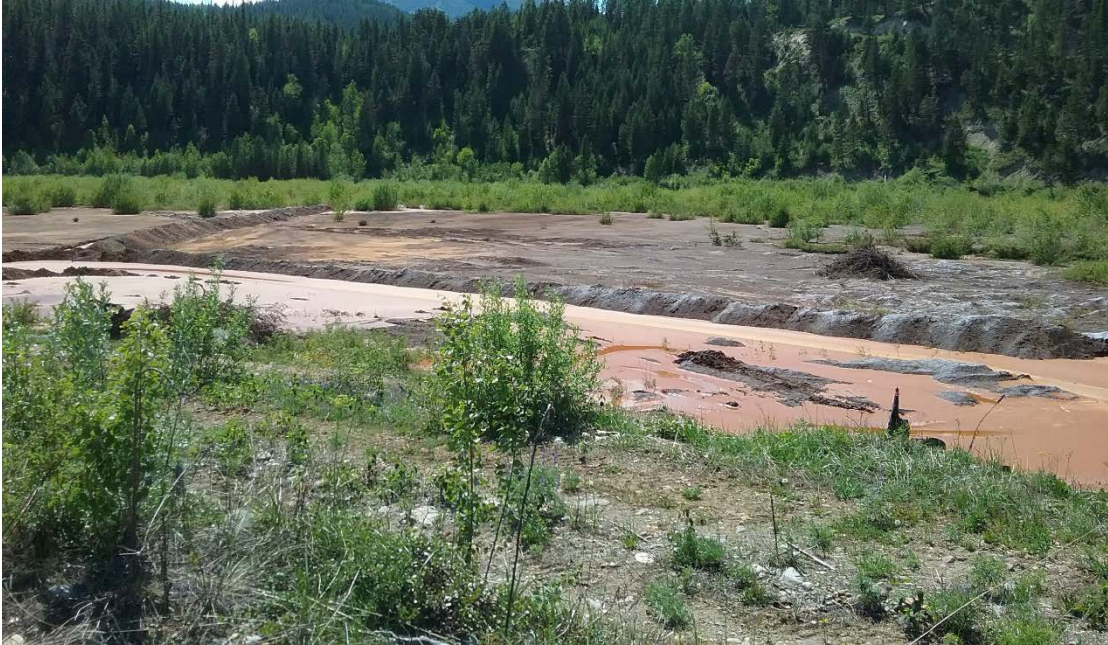
**Photo D.3 Overview of Sludge Impoundment**

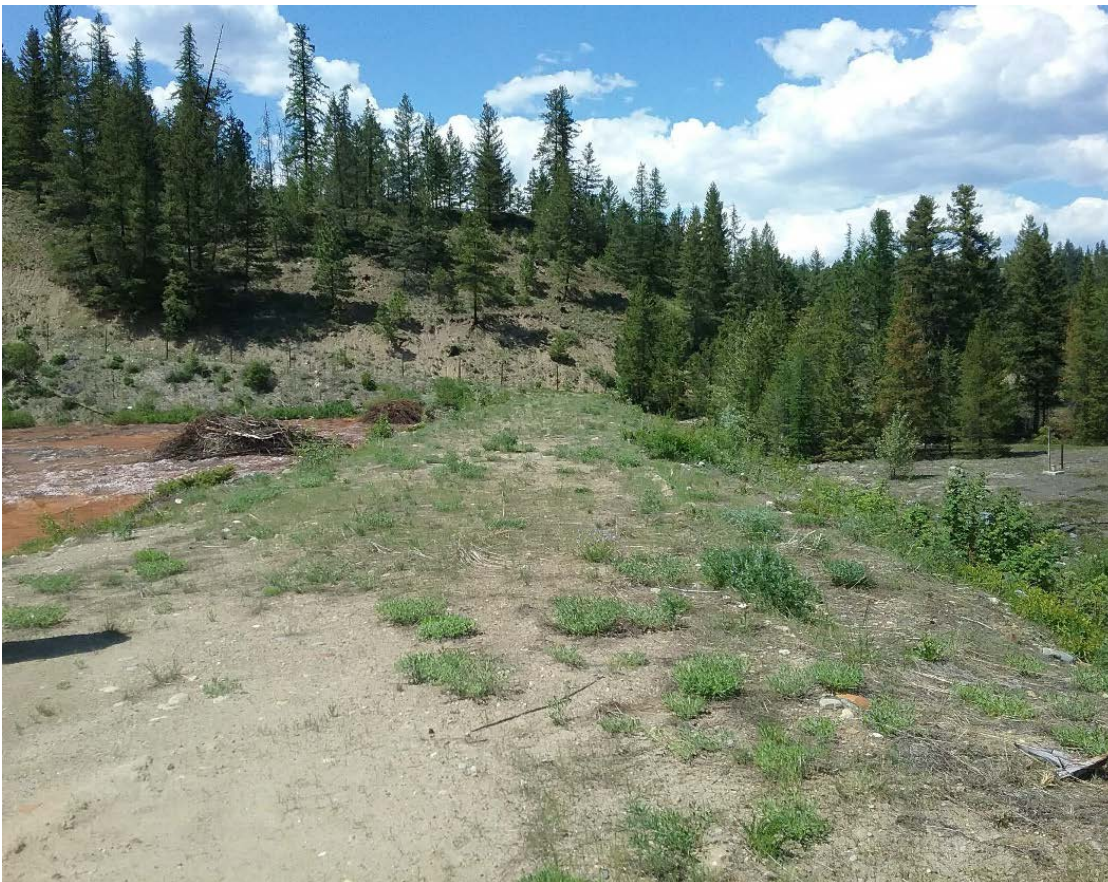
**Photo D.4 Sludge Impoundment North Dike Crest**

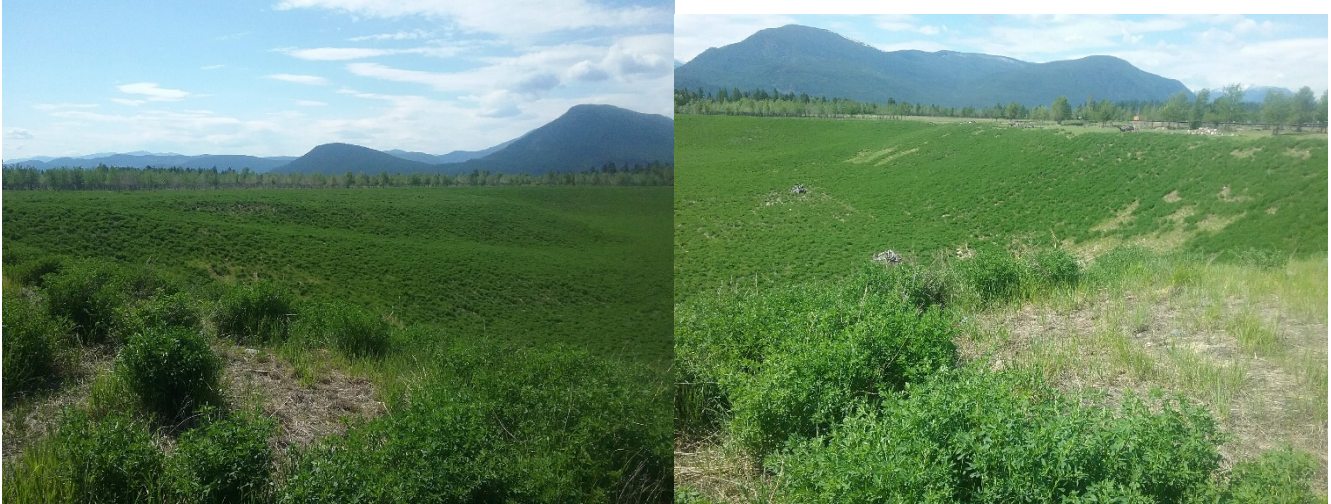
**Photo E.1      Overview of Excavation Area in Calcine TSF looking towards the dam**

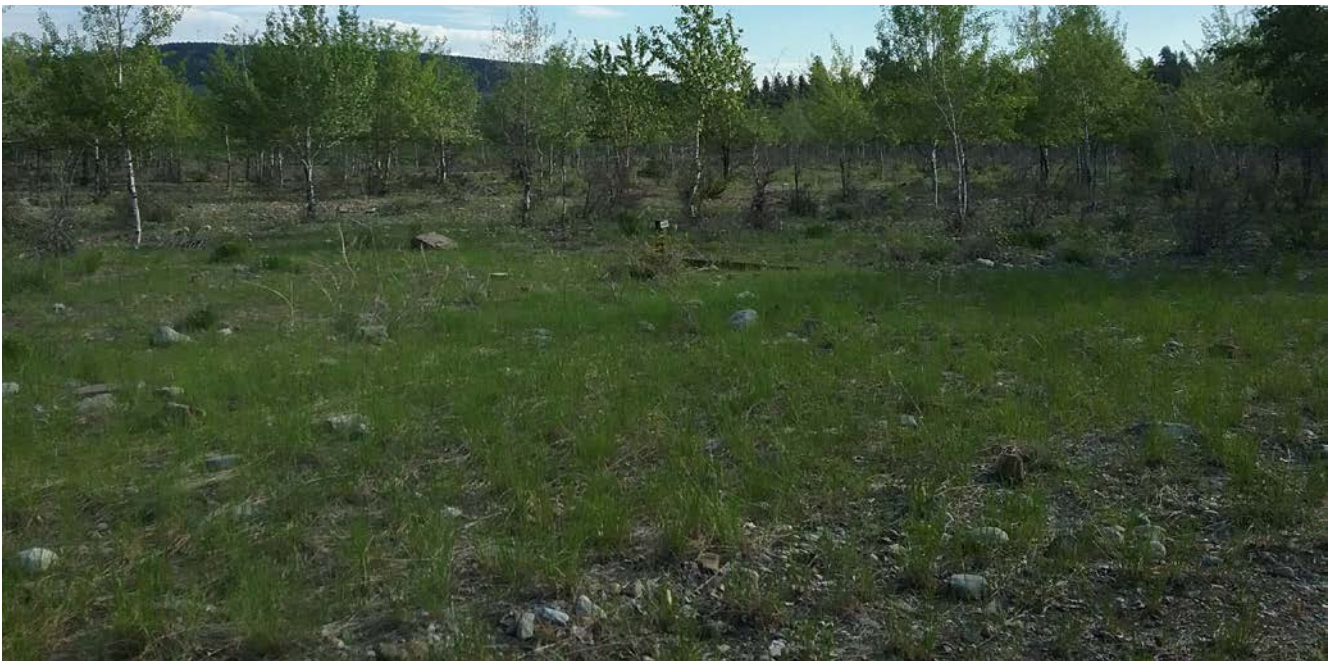
**Photo E.2      Overview of Excavation Area in Calcine TSF Looking Upstream from Dam Crest**

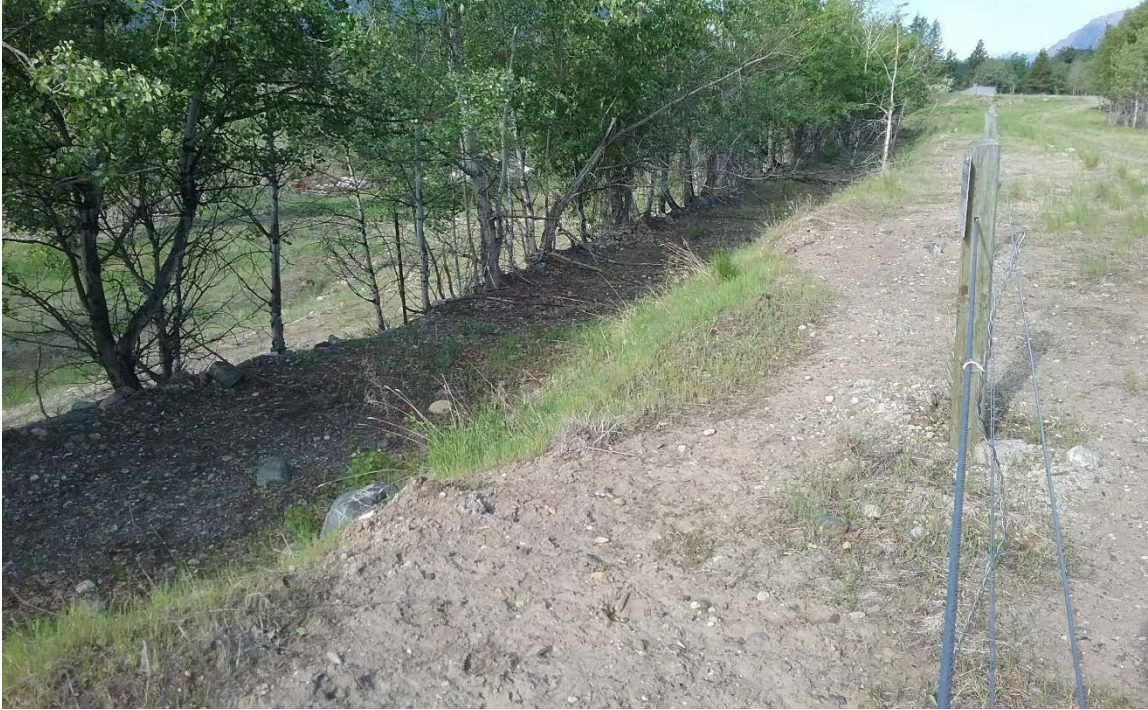
**Photo E.3 Dam Crest and Downstream Slope of Calcine Dike looking west**
