**Teck Metals Ltd.**

**Sullivan Mine Tailings Facilities**

***2018 Dam Safety Inspection***

March 2019

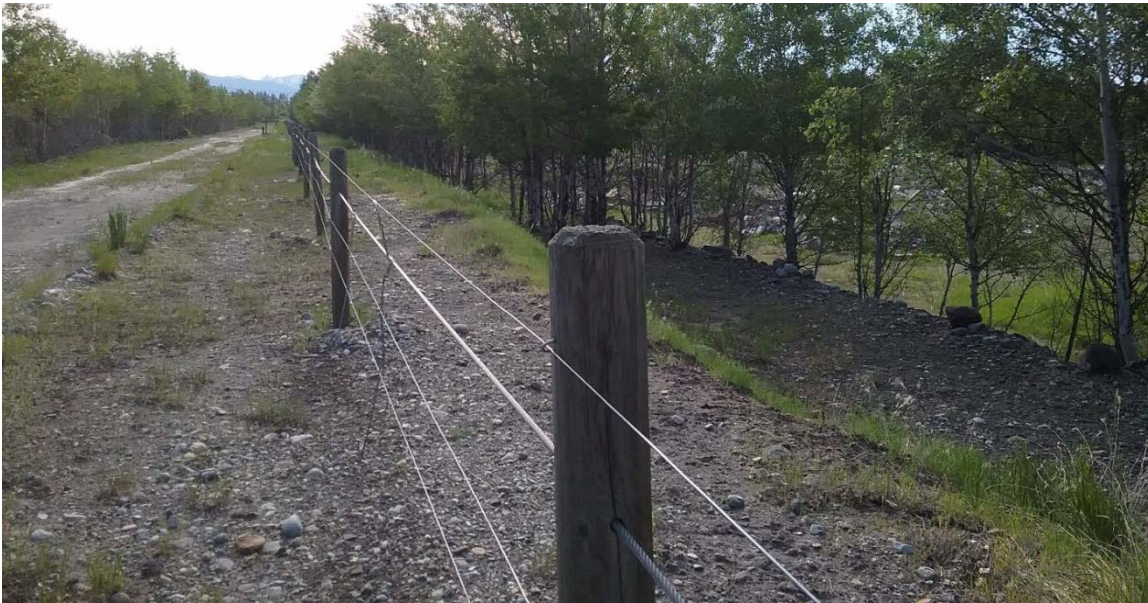
**Photo E.4 Dam Crest and Downstream Slope of Calcine Dike looking east**

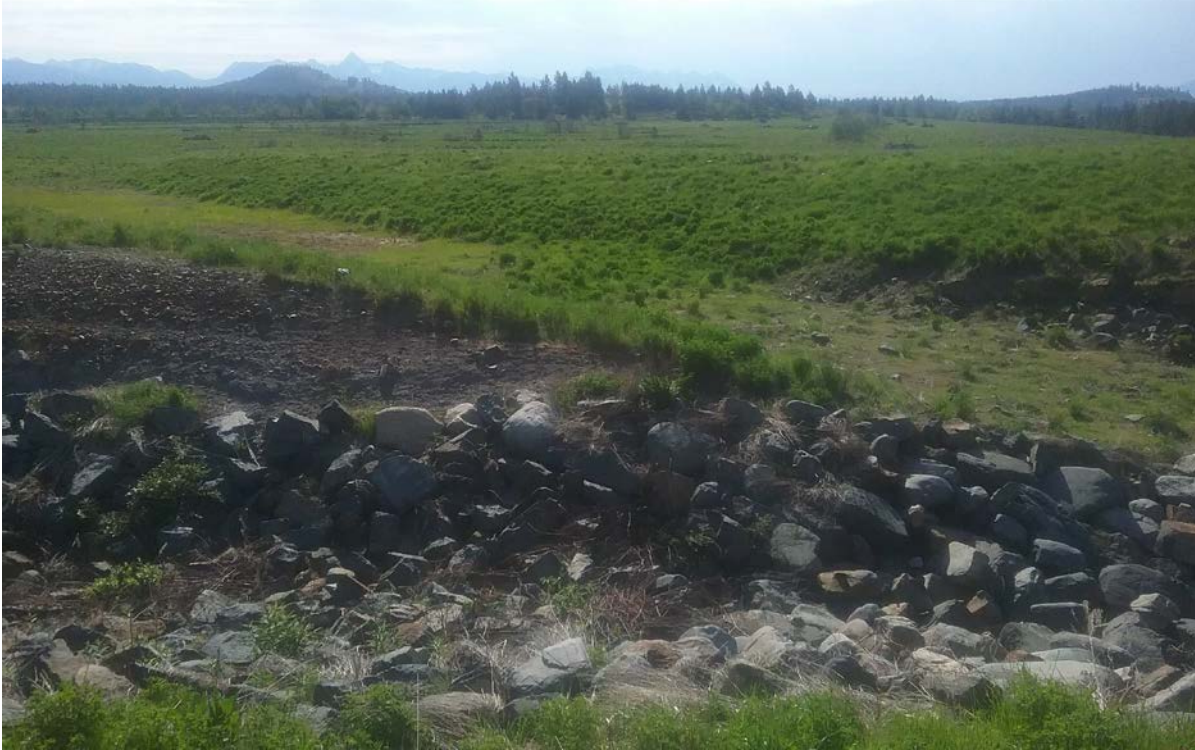
**Photo F.1 Overview of West Gypsum Dike and Spillway**

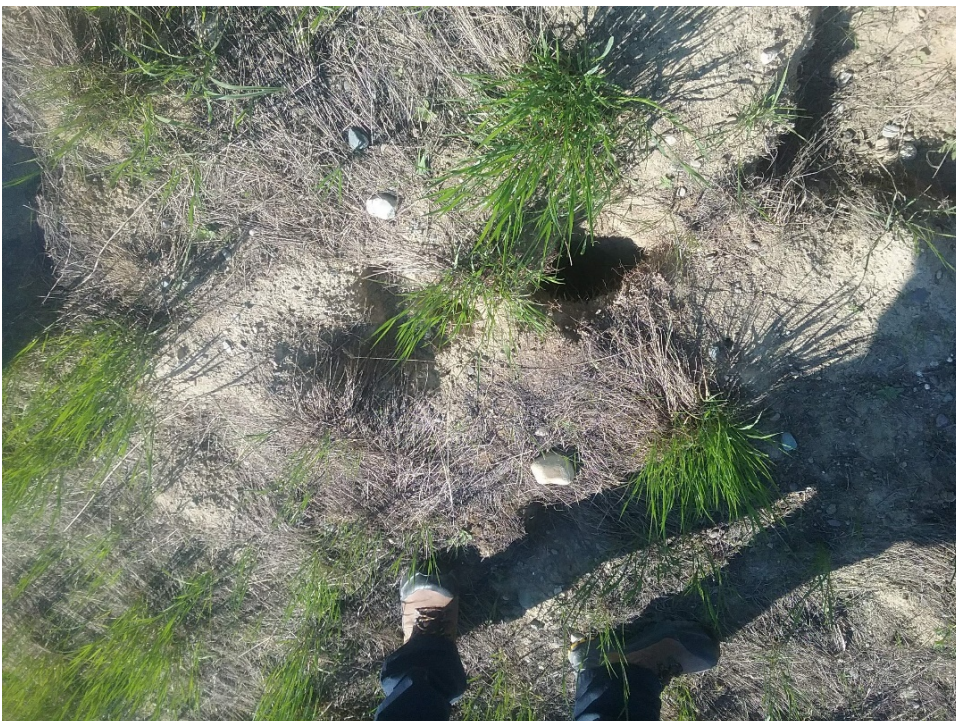
**Photo F.2 Animal Burrows at Toe of West Gypsum Dike**

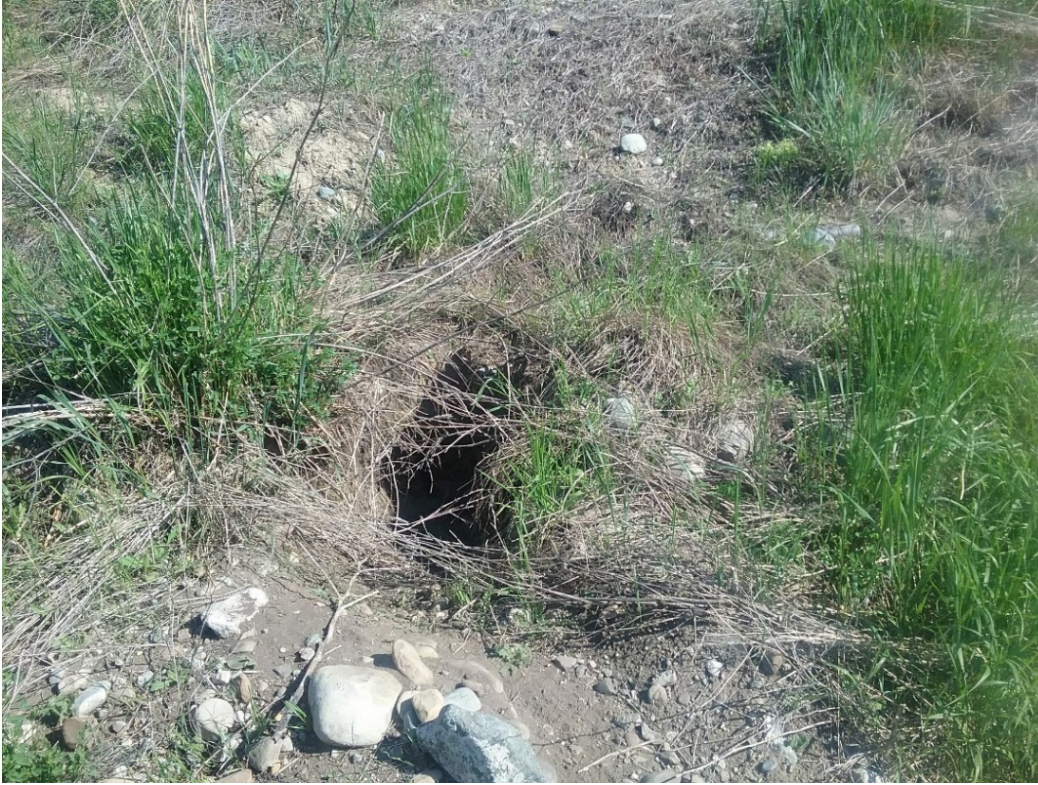
**Photo F.3 Badger Hole near Toe of East Gypsum Dike**

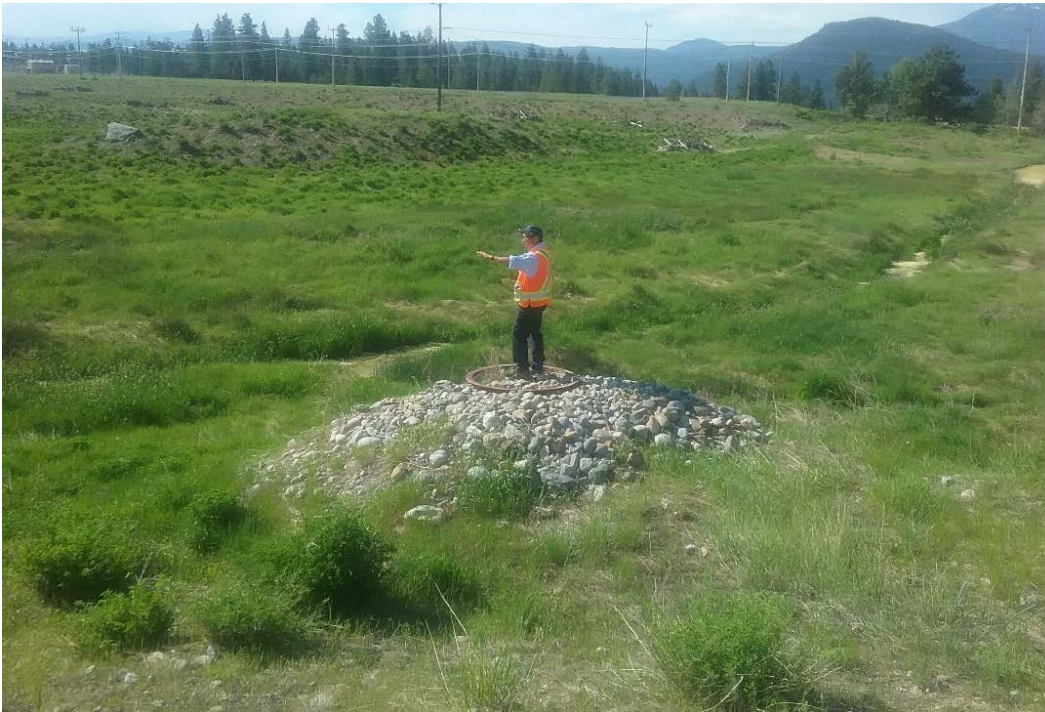
**Photo F.4 Decommissioned Decant Pipe downstream of East Gypsum Dike**

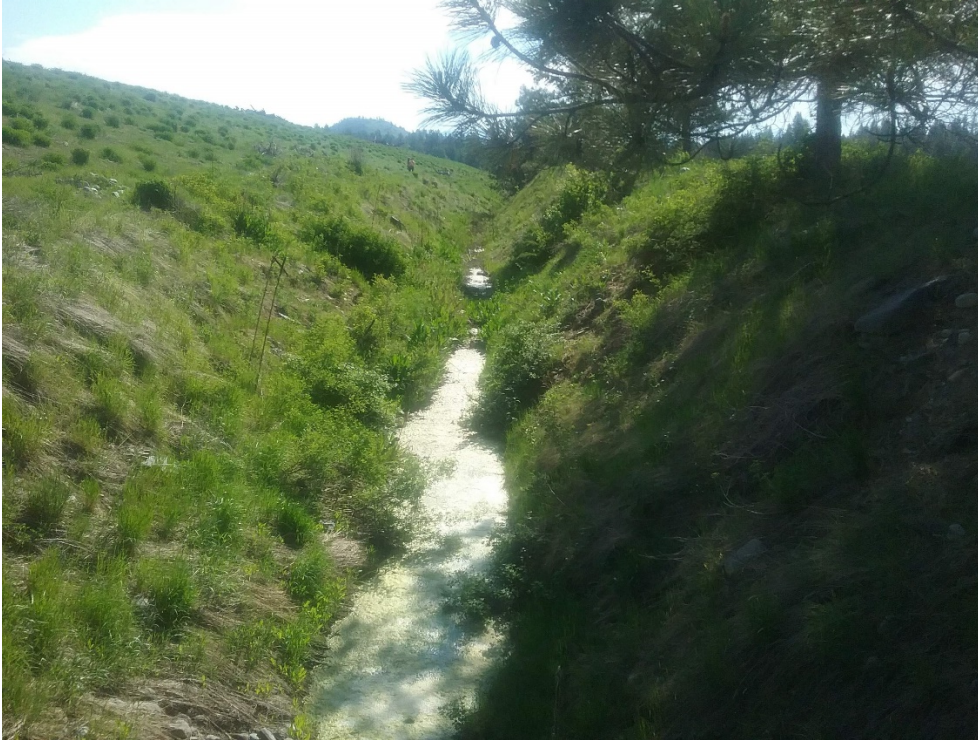
**Photo F.5 Ditch Downstream of East Gypsum Dike**

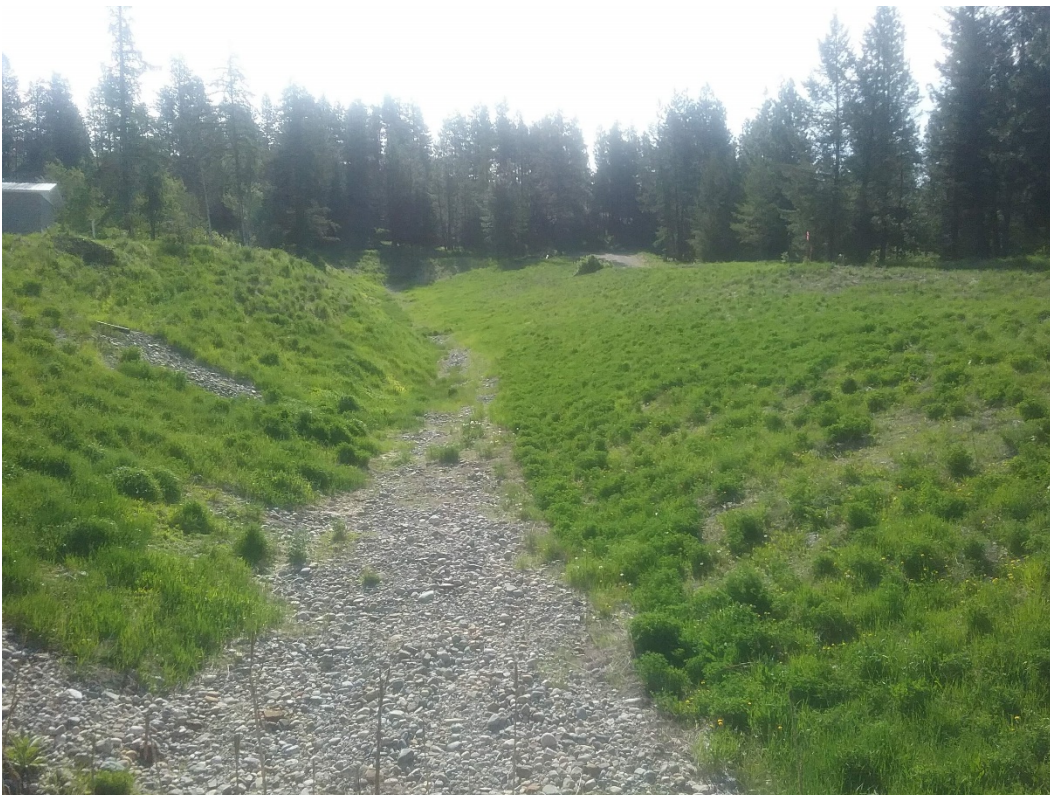
**Photo F.6 Seepage Collection Ditch Downstream of Gypsum Dikes**

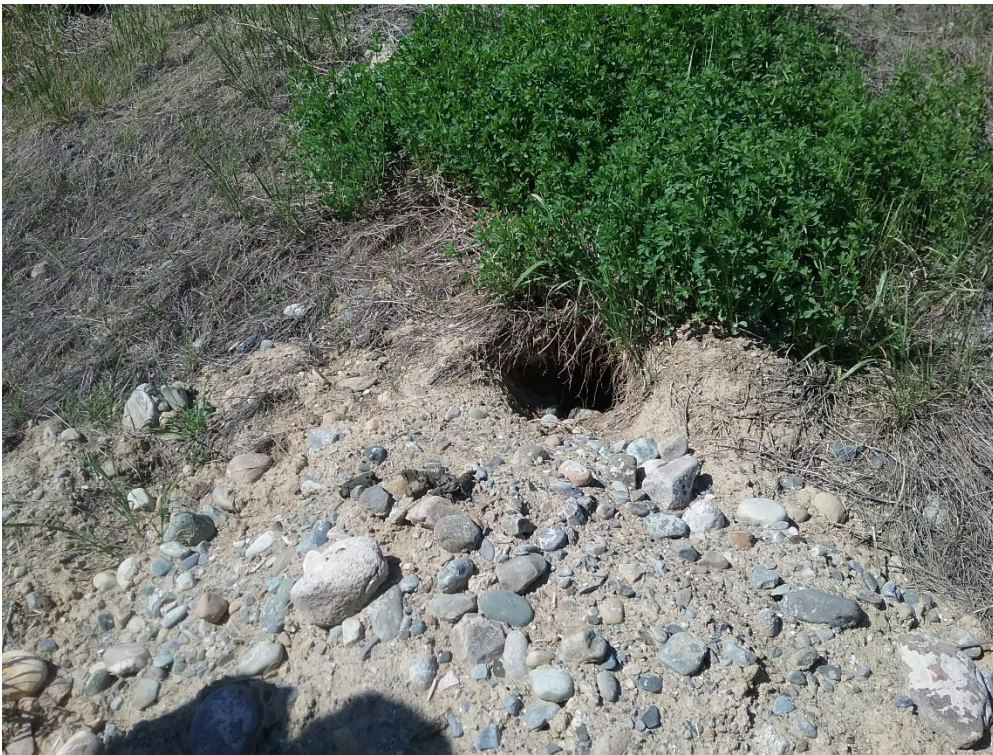
**Photo F.8 Animal Burrow in West Gypsum Dike**

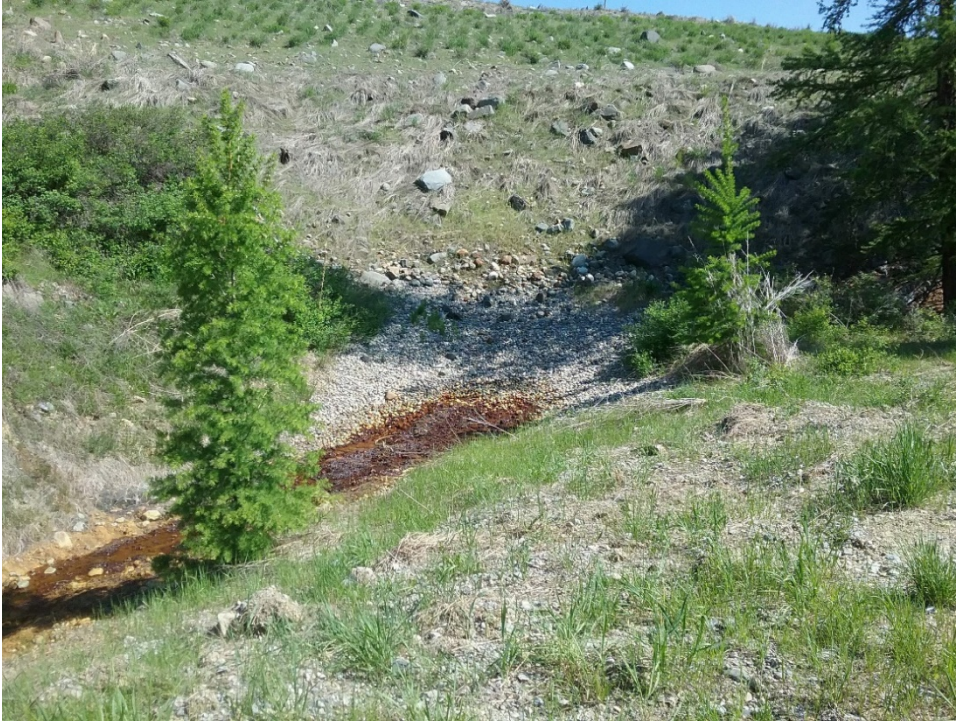
**Photo G.3 Seepage from Toe of Iron Dike**
