Teck Highland Valley Copper Partnership

2018 Dam Safety Inspection Report

Trojan Tailings Storage Facility

March 2019

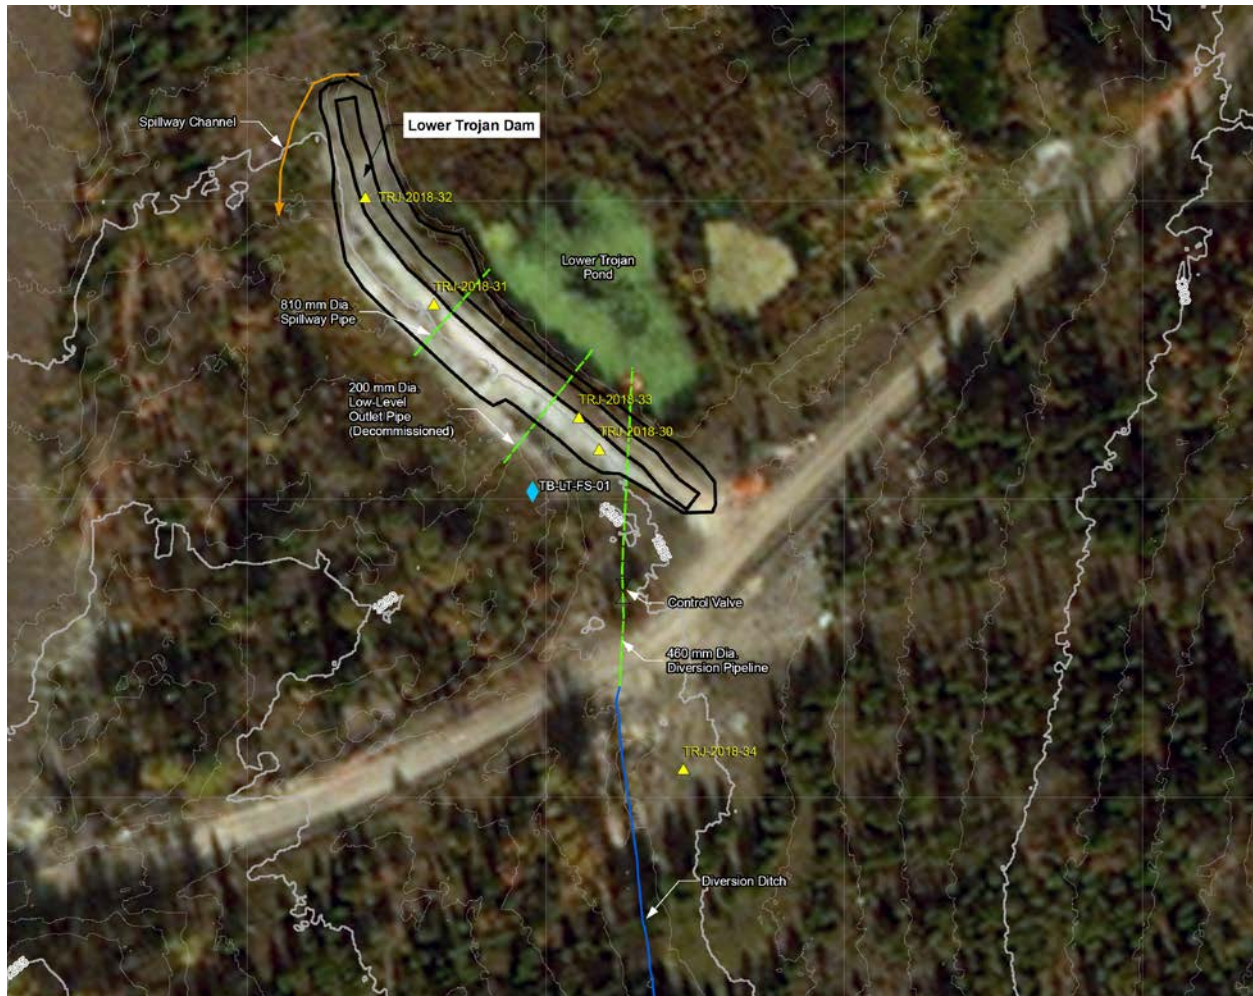
SITE PLAN

1. The impoundment, upstream slope and low-level outlet intake areas were heavily vegetated and full of debris. This should be monitored and cleared as part of the routine maintenance program.

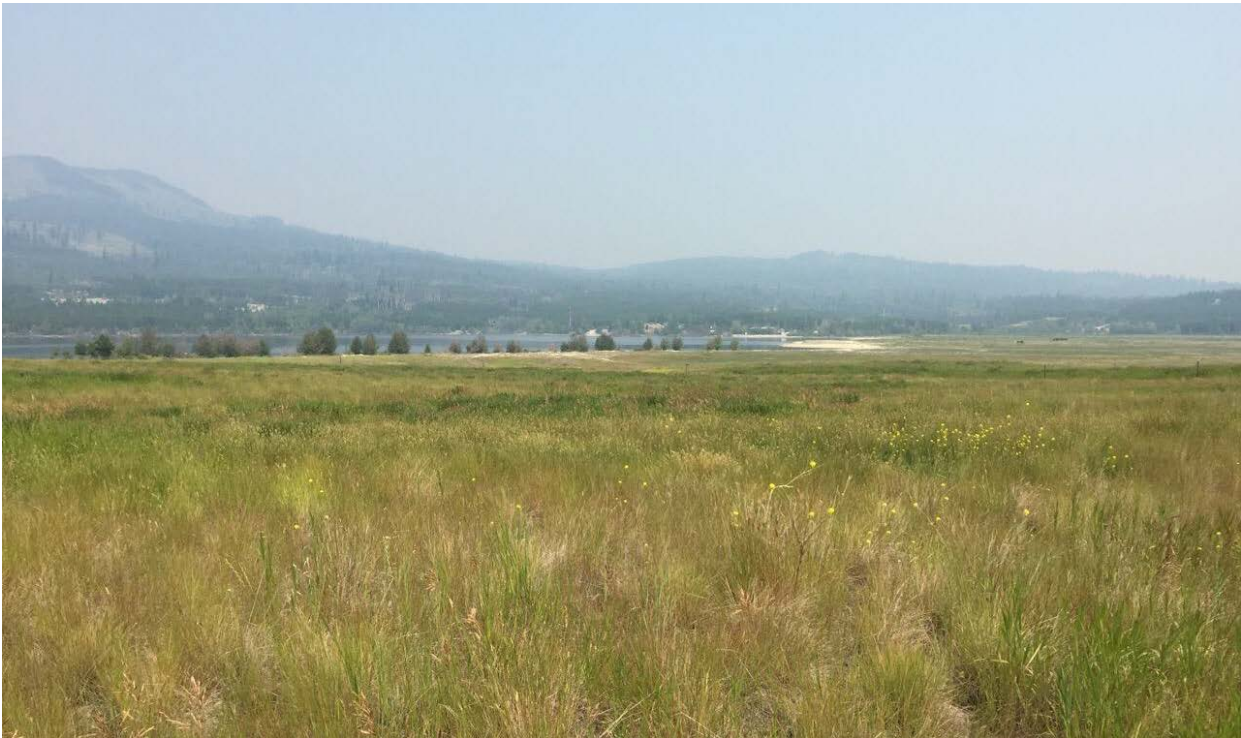
Photo II-A- 2 Trojan impoundment view from crest road (TRJ-2018-02)

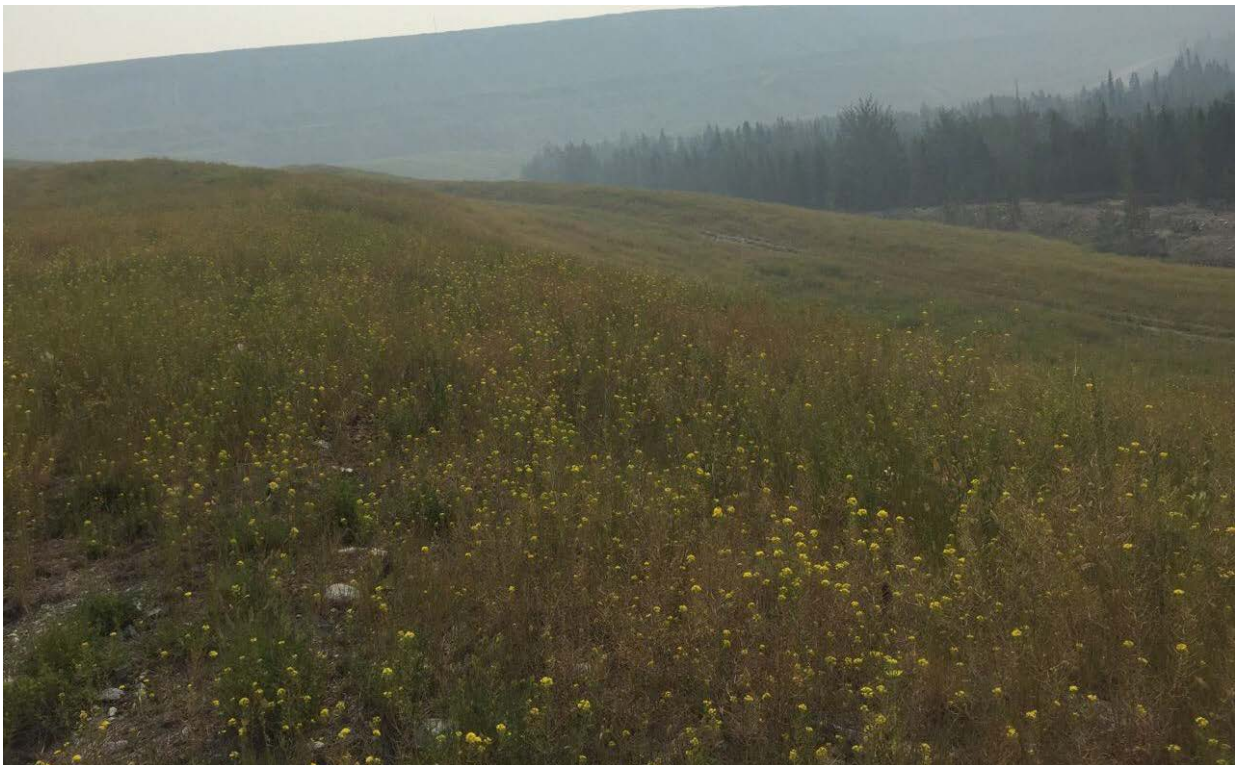
Photo II-A- 3 Trojan Dam crest and starter dam crest (lower bench) (TRJ-2018-03)

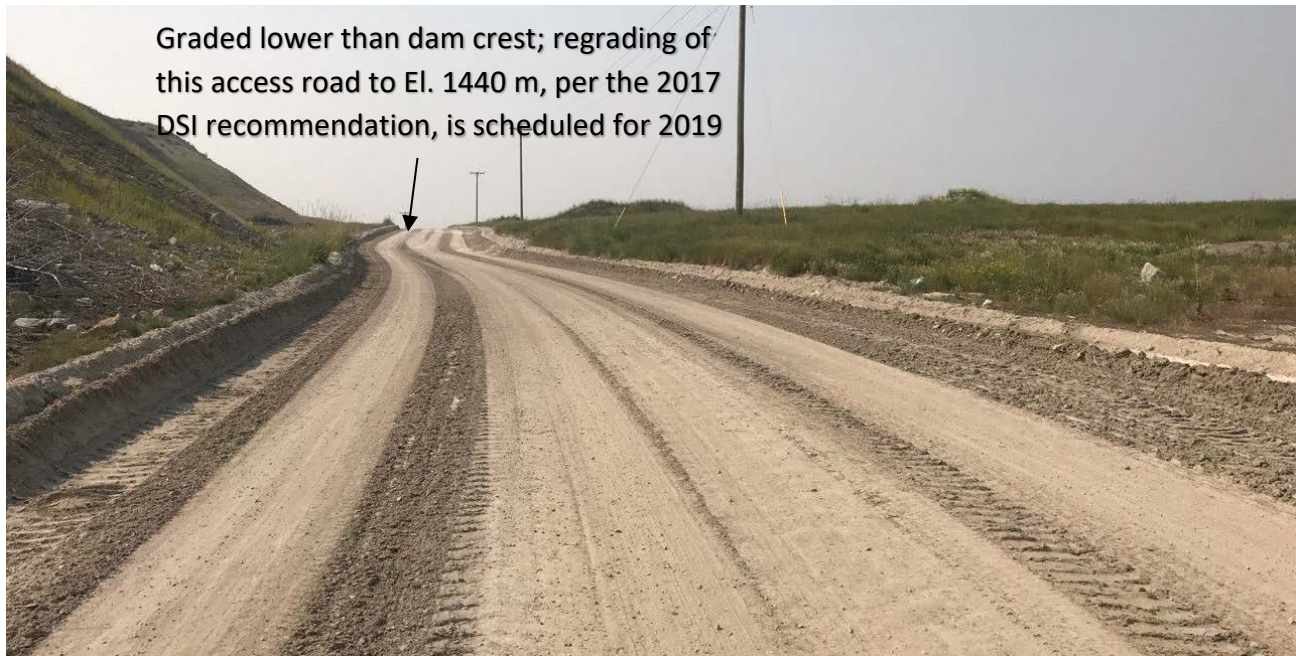
- Trojan Dam meets the freeboard requirement. A 2017 DSI recommendation was to raise the access road near the left abutment which forms part of the impoundment. The raise to El. 1440 m (allows for 0.9 m of buffer above minimum dam crest for grading as part of routine road maintenance) has been deferred to 2019.
- R4 Seepage Pond meets the freeboard requirement.
- As discussed in Section 4.4, upgrades are recommended for the LTD to safely pass the IDF with adequate freeboard.

Photo II-A- 4 Access road at Trojan TSF left abutment (TRJ-2018-04)

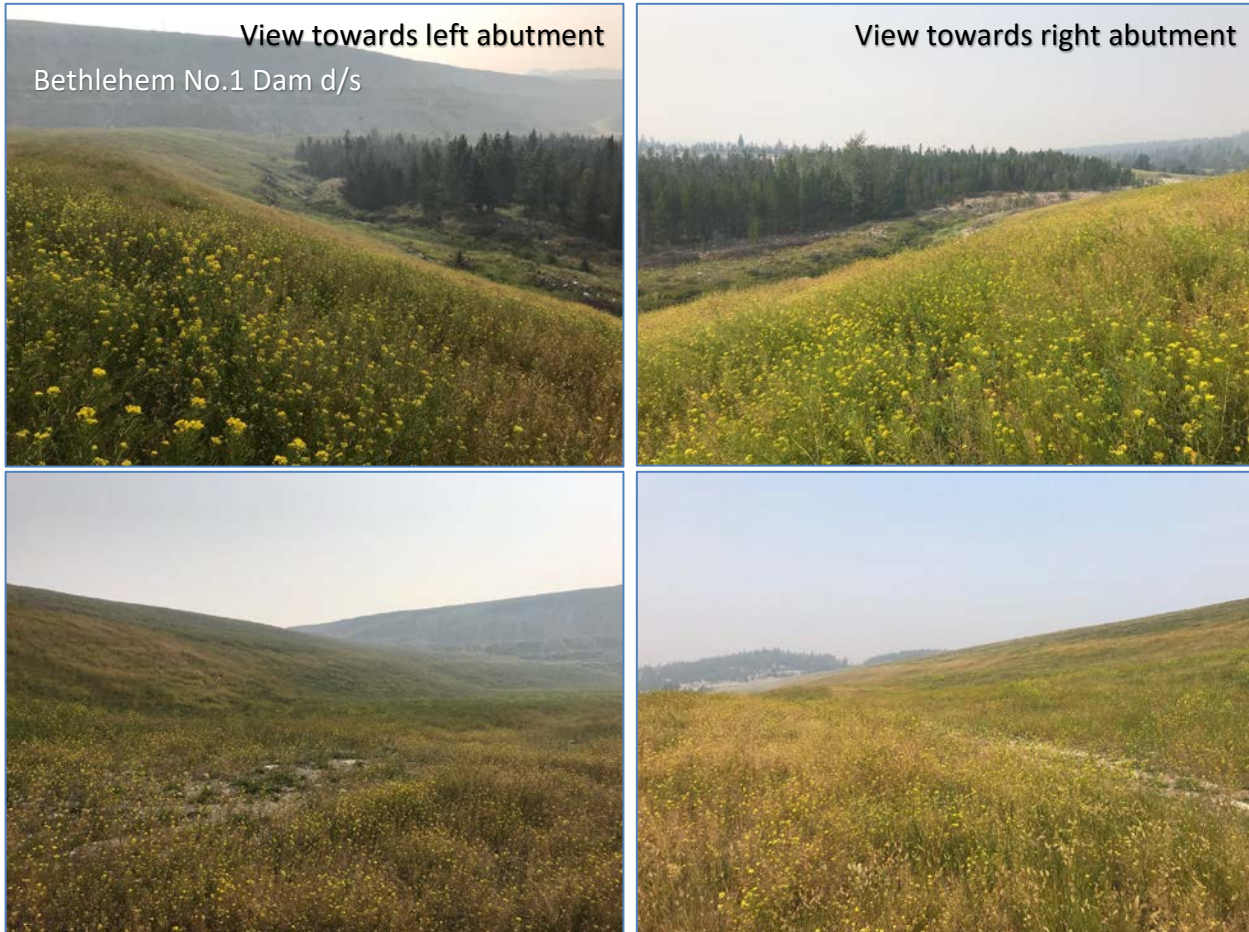
Photo II-A- 5 Trojan Dam downstream slopes (TRJ-2018-05 and TRJ-2018-06)

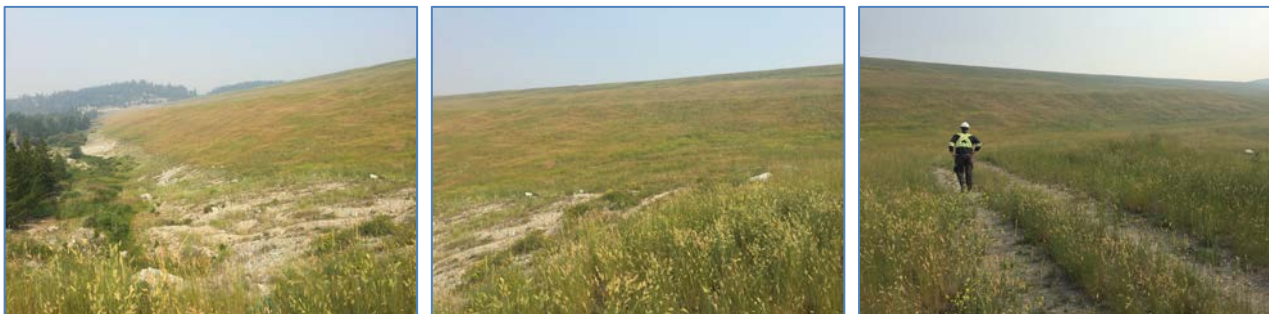
Photo II-A- 6 Trojan Dam downstream slopes (TRJ-2018-07)

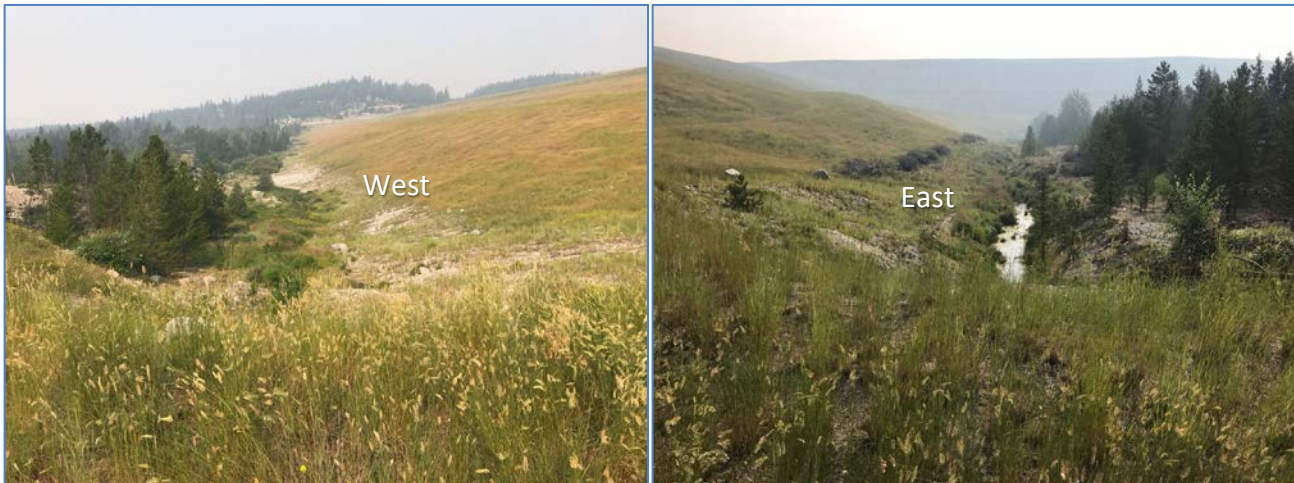
Photo II-A- 8 West and East seepage collection ditches (TRJ-2018-09)

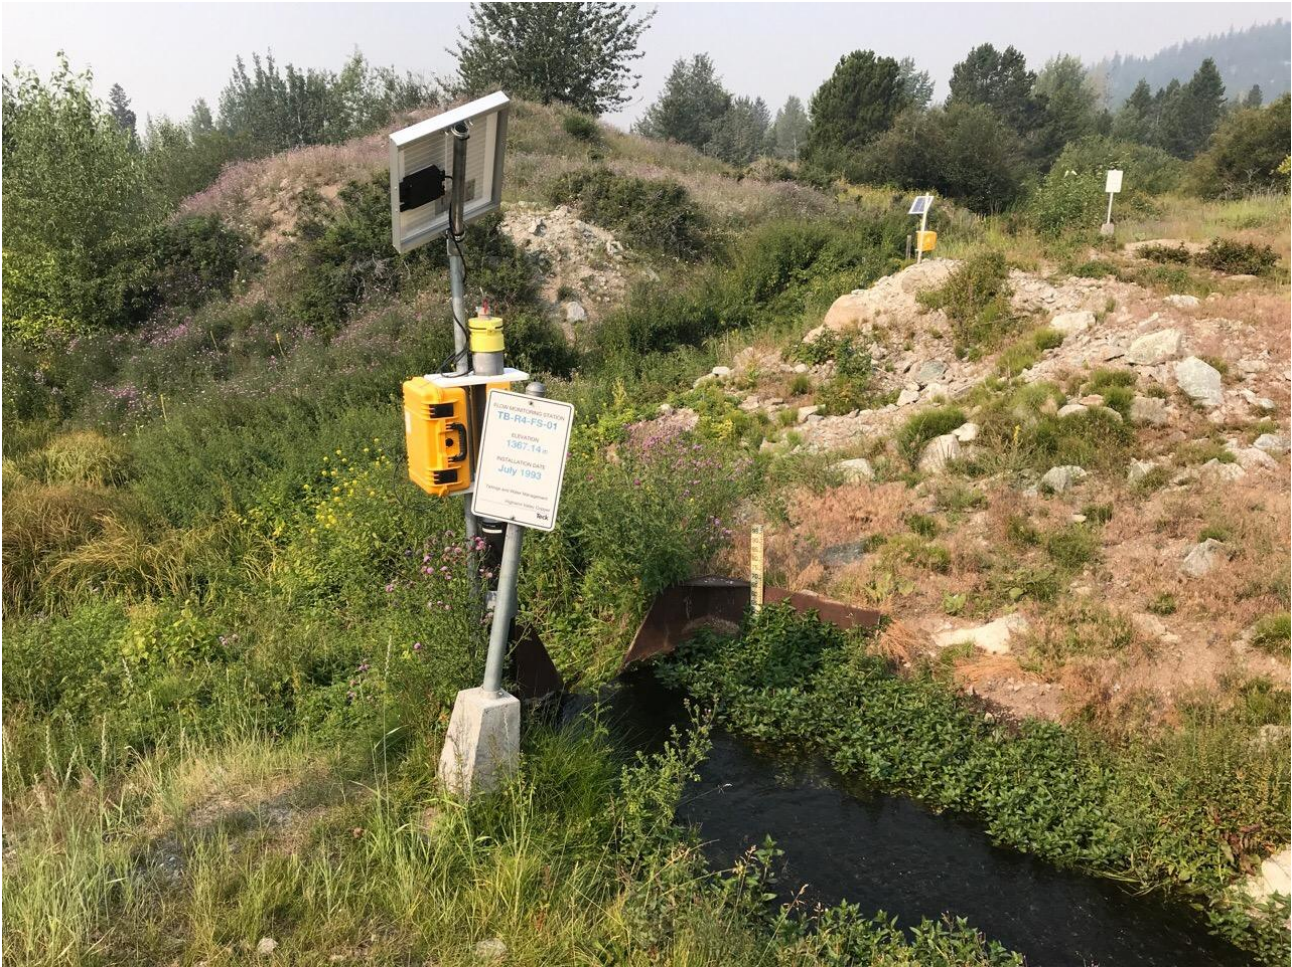
Photo II-A- 9 R4 Seepage Pond inlet at monitoring station TB-R4-FS-01 (TRJ-2018-10)

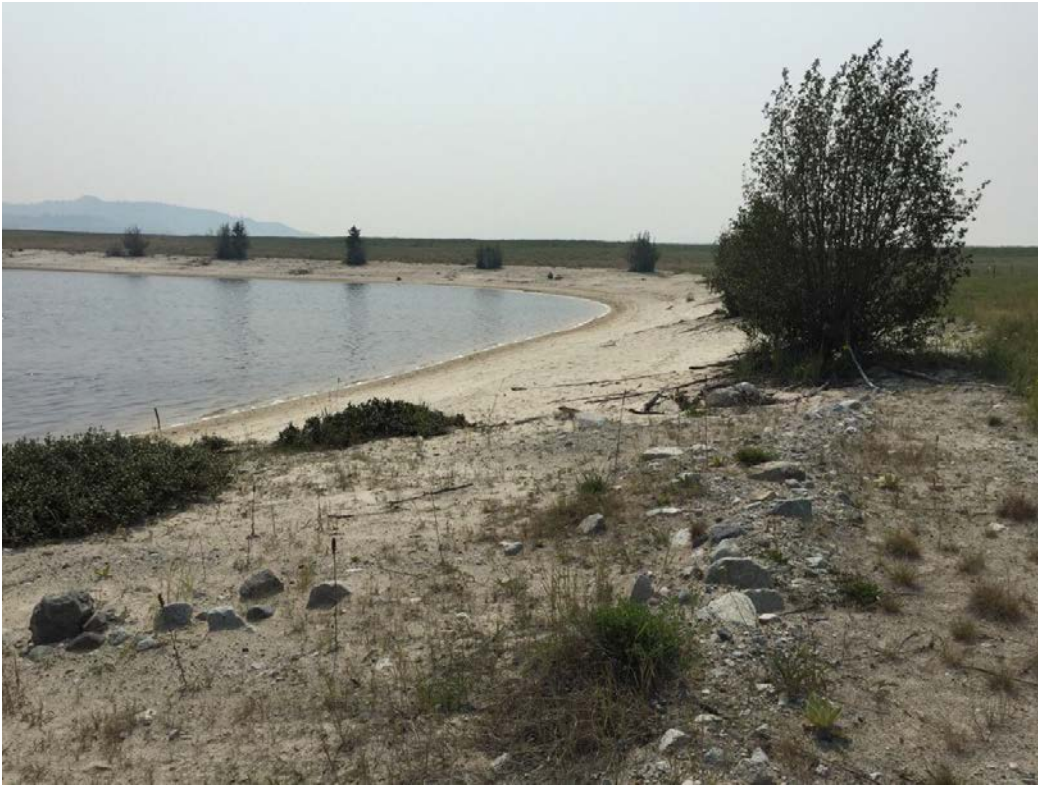
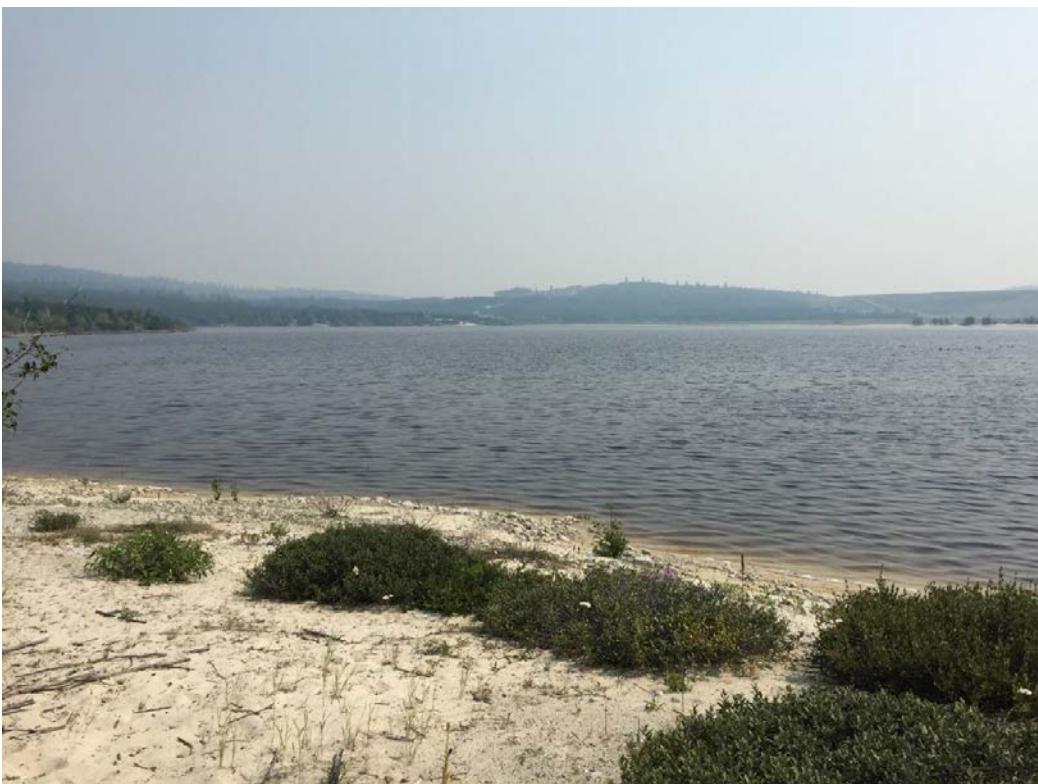
Photo II-A- 11 Trojan pond and beach adjacent to spillway inlet (TRJ-2018-12)

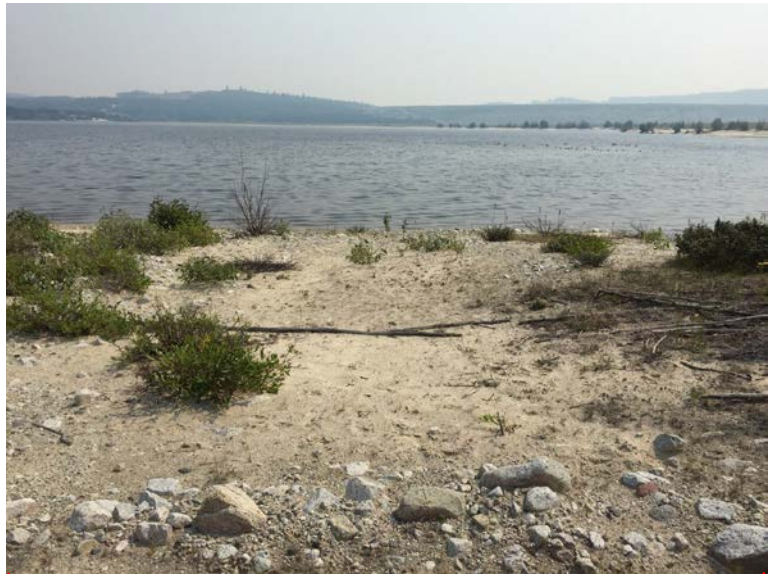
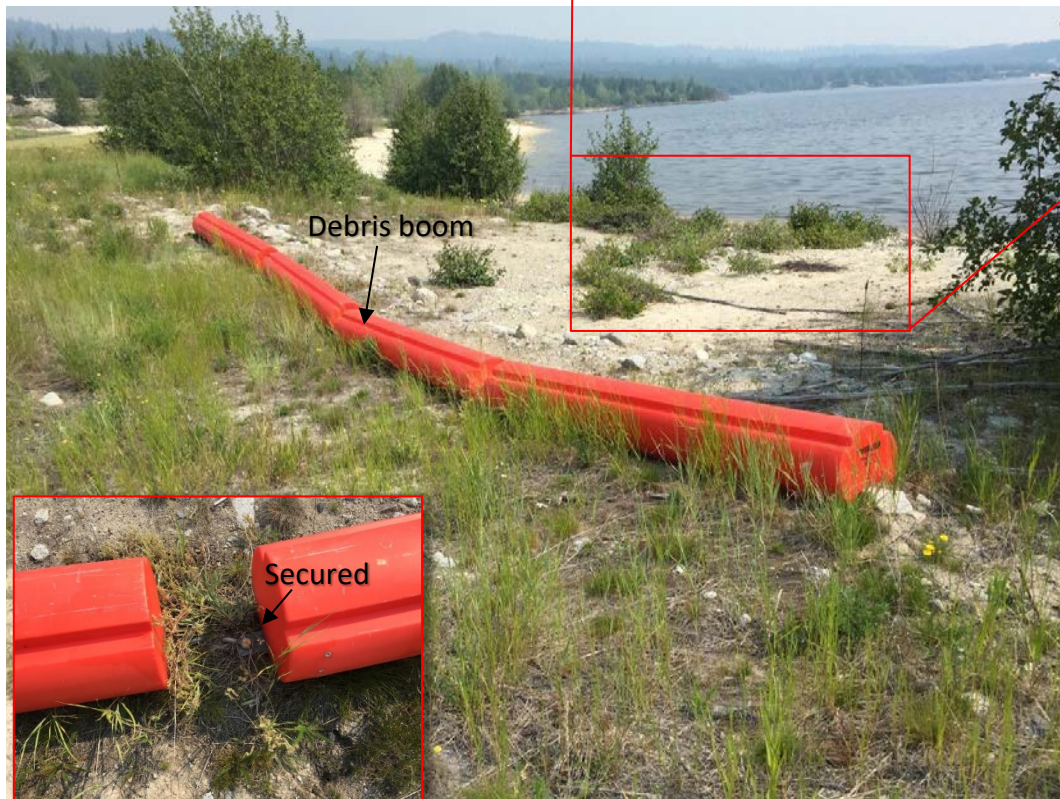
Photo II-A- 12 Trojan spillway inlet (TRJ-2018-13)

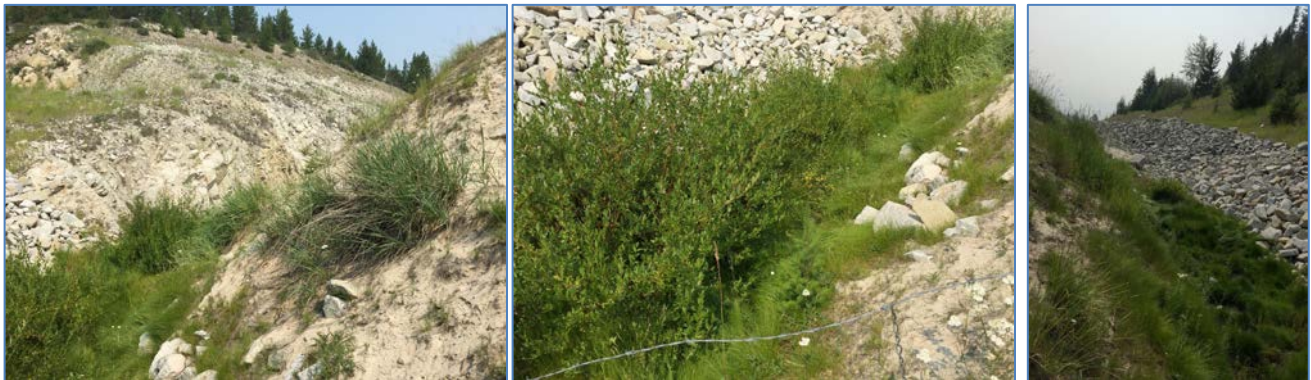
Photo II-A- 14 Spillway channel – transition to riprap lined section (TRJ-2018-16)

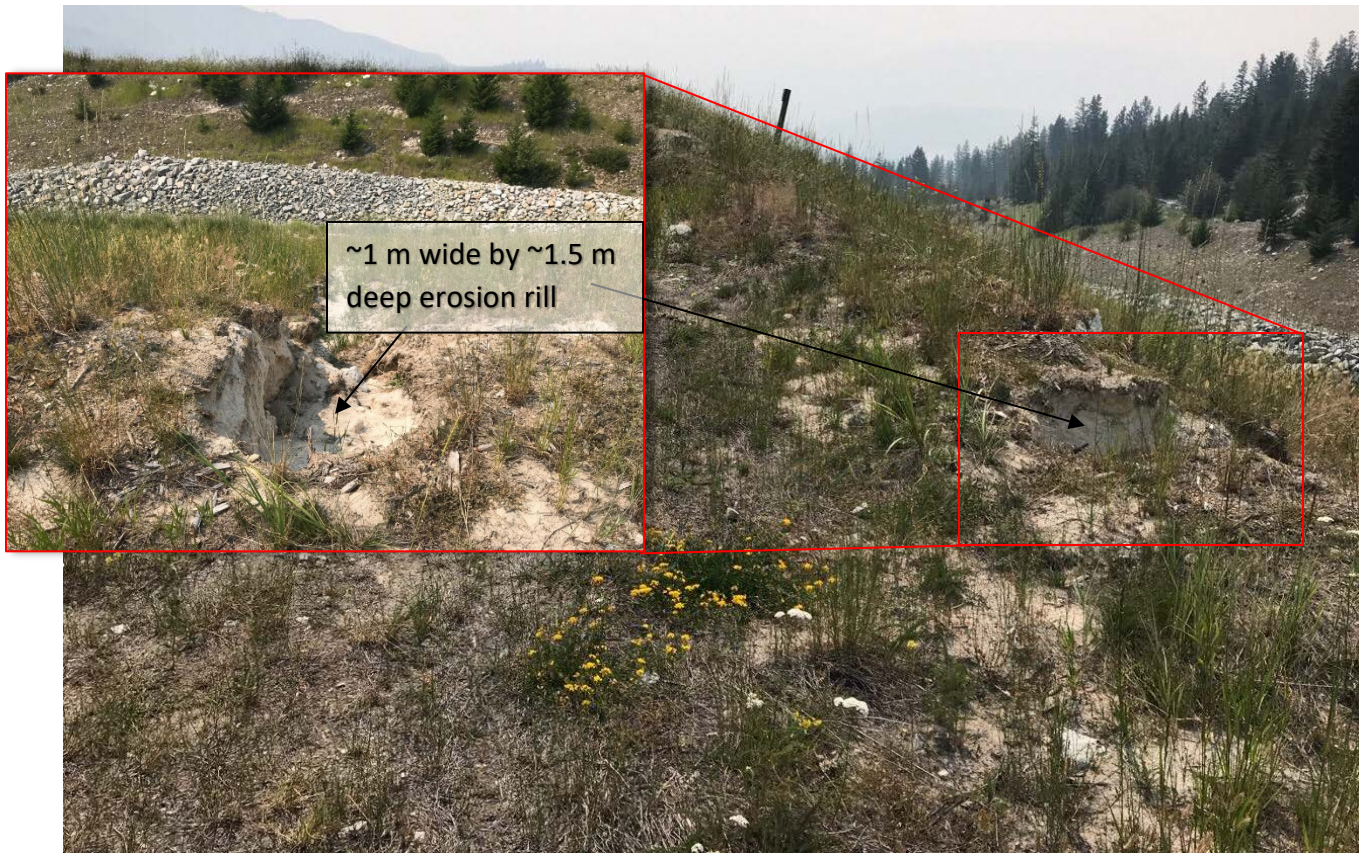
Photo II-A- 15 Spillway channel – left bank dam slope erosion feature (TRJ-2018-17)

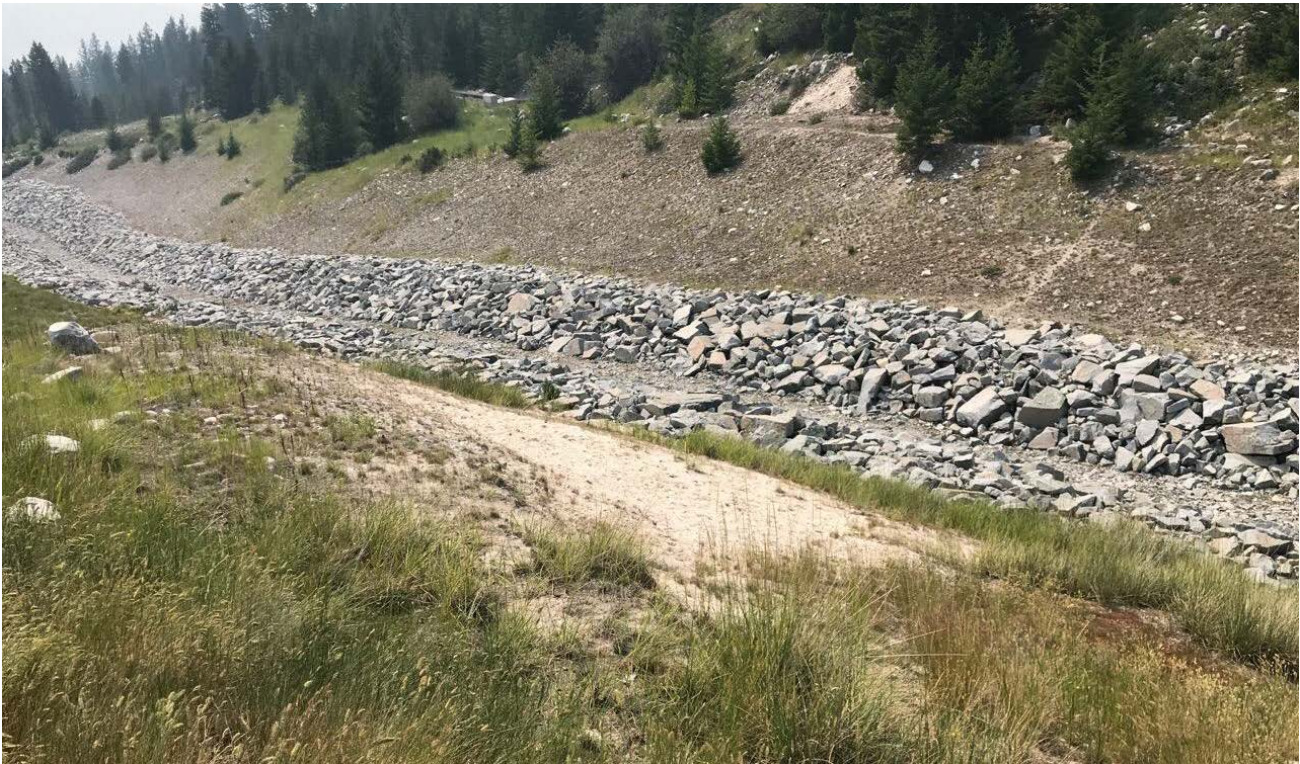
- **Modification #1:** Raise the left bank of the final (i.e. most downstream) 80 m of existing riprap lined spillway channel to meet the 2 m design depth (AmecFW 2017, KC 2002).
 - ◆ The Wood record drawing (Appendix III), labelled as Figure 1, shows the raise was completed to the design depth.
- **Modification #2:** Downstream extension of channel section with erosion protection (riprap).
 - ◆ Based on cross sections provided by THVCP and appended in the Wood as-built report, the left bank riprap thickness appears thinner than the 1.2 m required by design in the final 70 m of extension.
 - ◆ KCB recommend that THVCP confirm the thickness of riprap and information captured by the as-built survey.

Photo II-A- 17 Spillway channel – extension of riprap section (TRJ-2018-20)

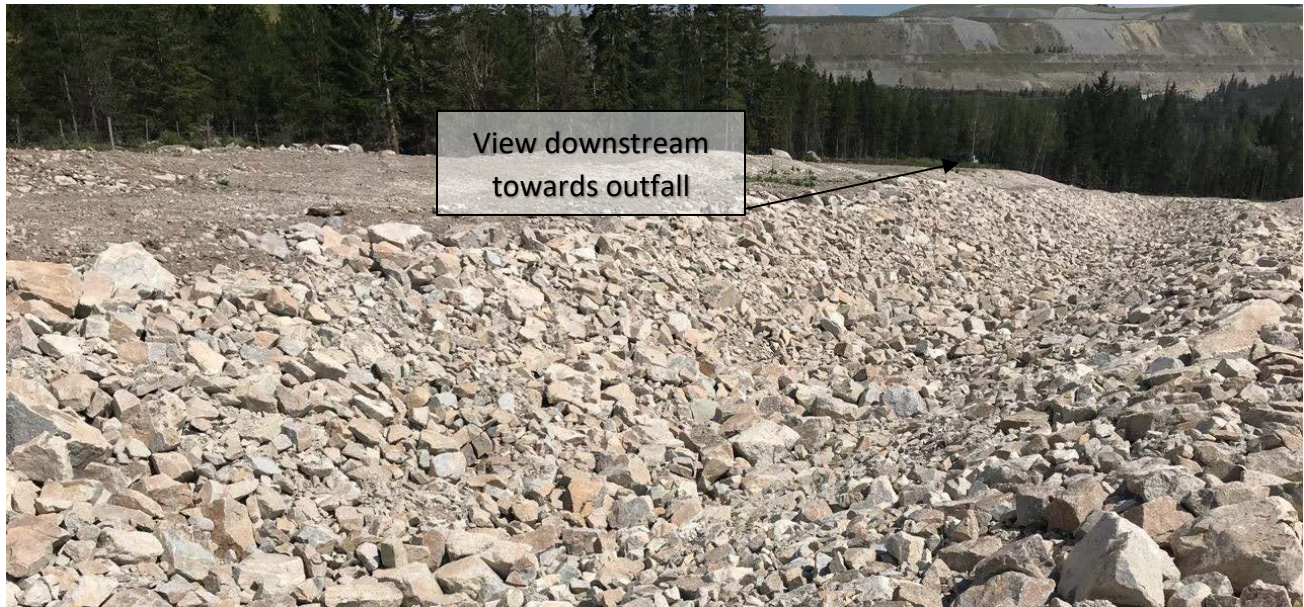
Photo II-A- 18 Spillway channel – extension of riprap section (TRJ-2018-21)

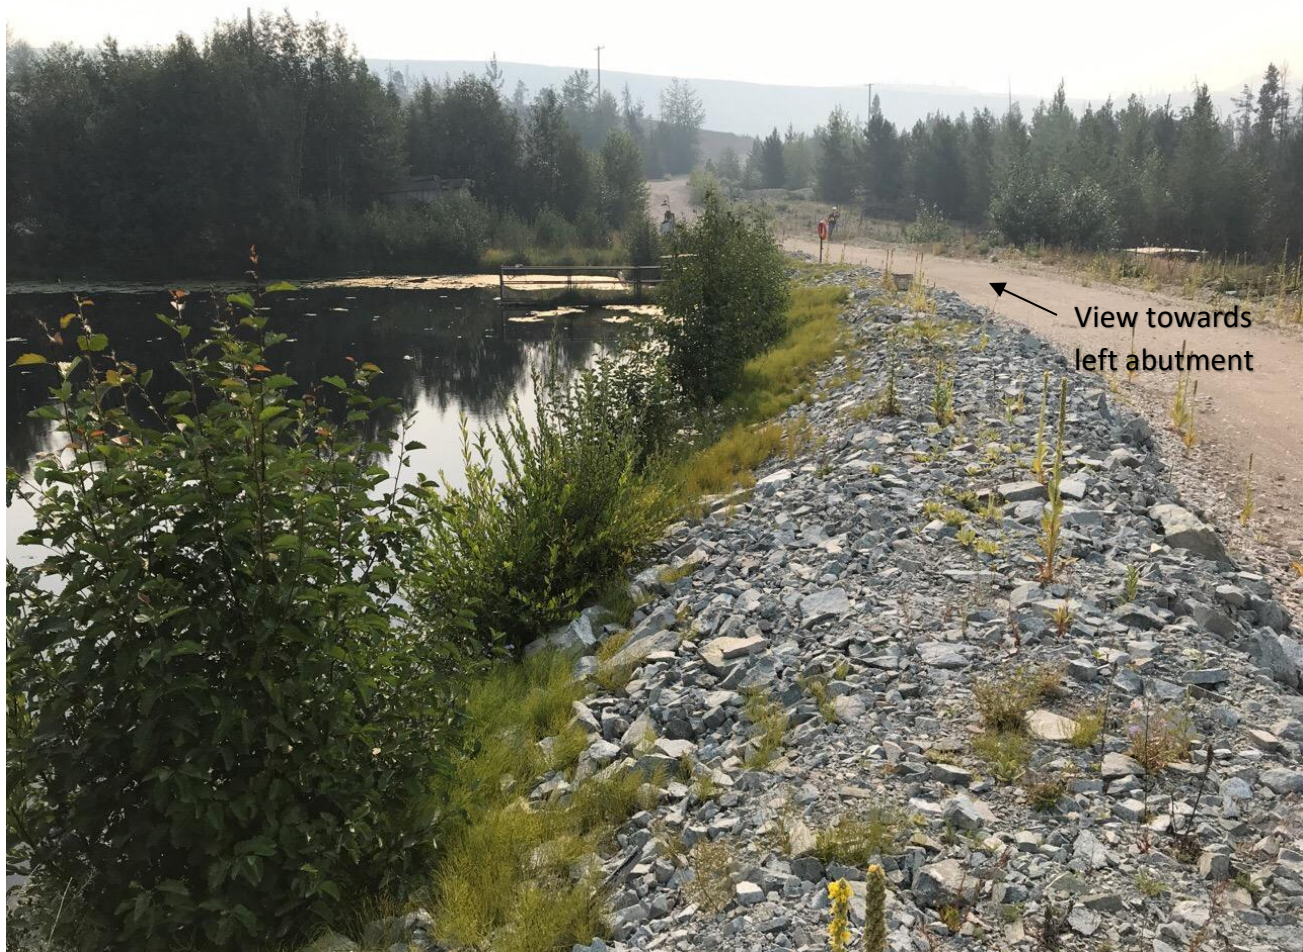
Photo II-B- 1 Dam Crest and upstream slope (TRJ-2018-23)

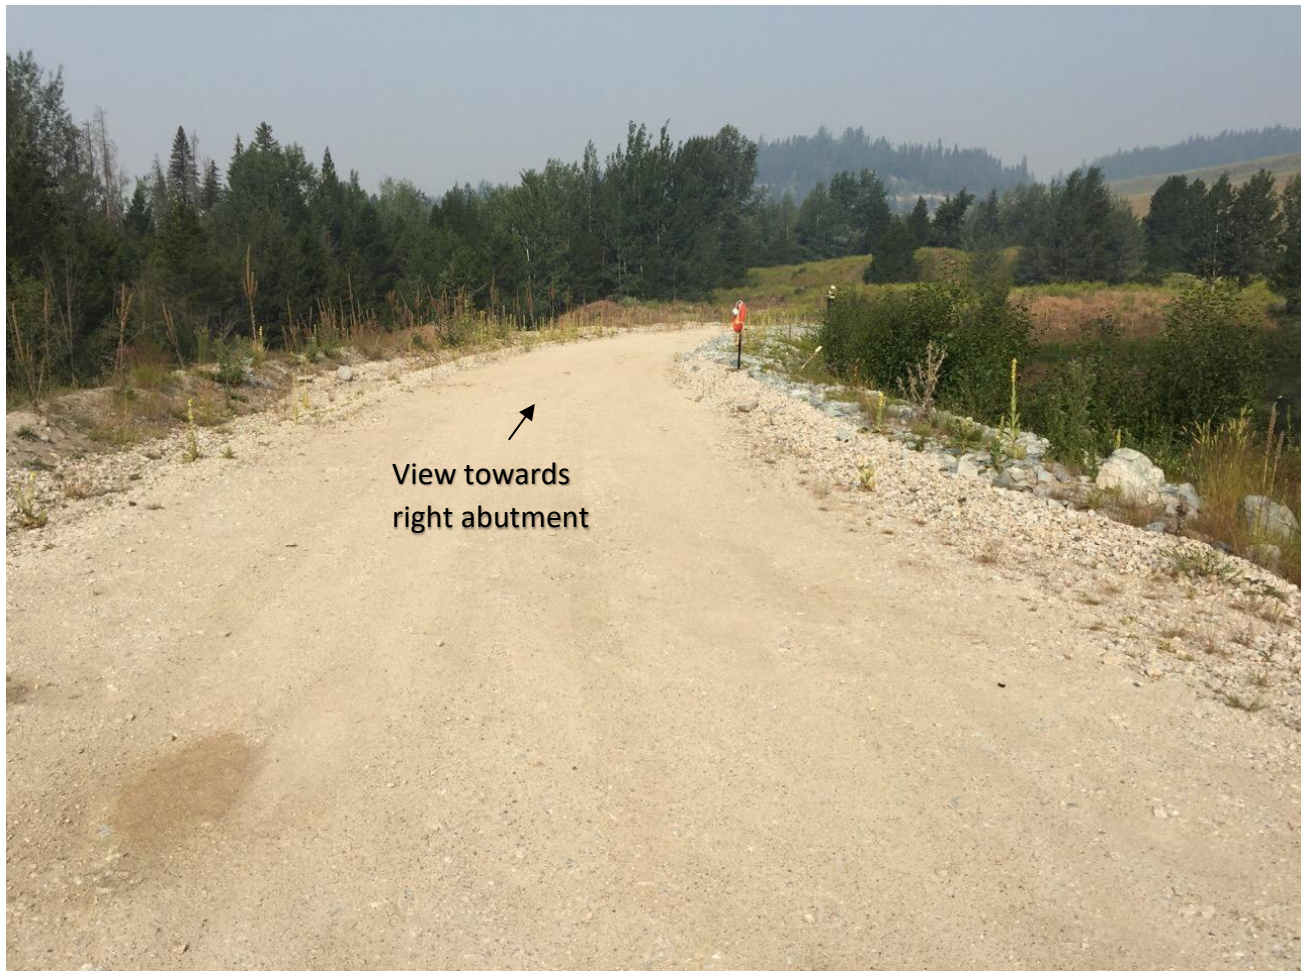
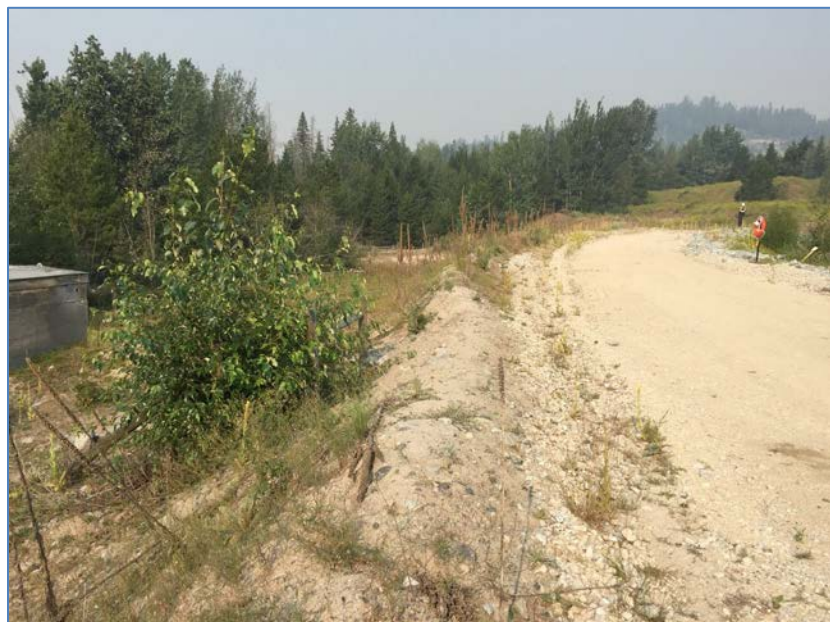
Photo II-B- 2 Dam crest and downstream slope (TRJ-2018-23)

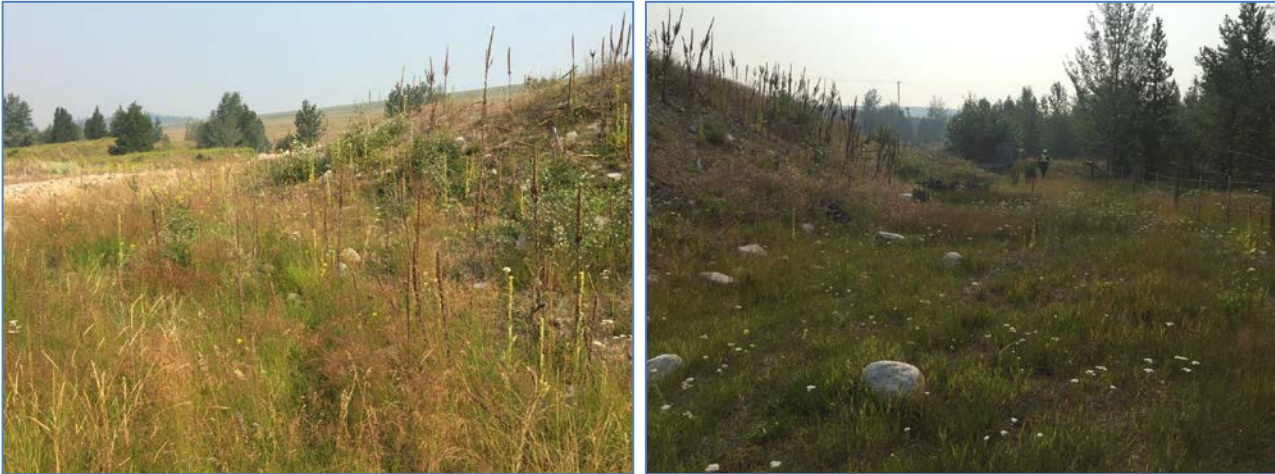
Photo II-B- 3 Downstream slope and toe (TRJ-2018-24)

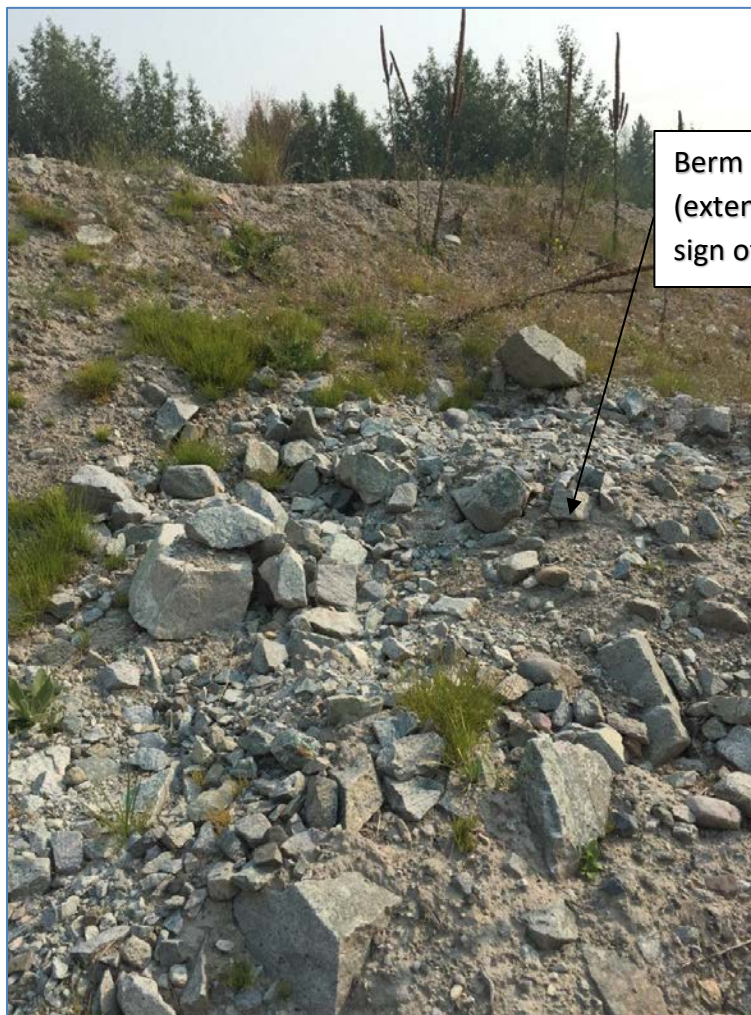
Photo II-B- 4 Downstream slope (TRJ-2018-25)

Berm covering pipe
(extent unknown) – no
sign of seepage or erosion

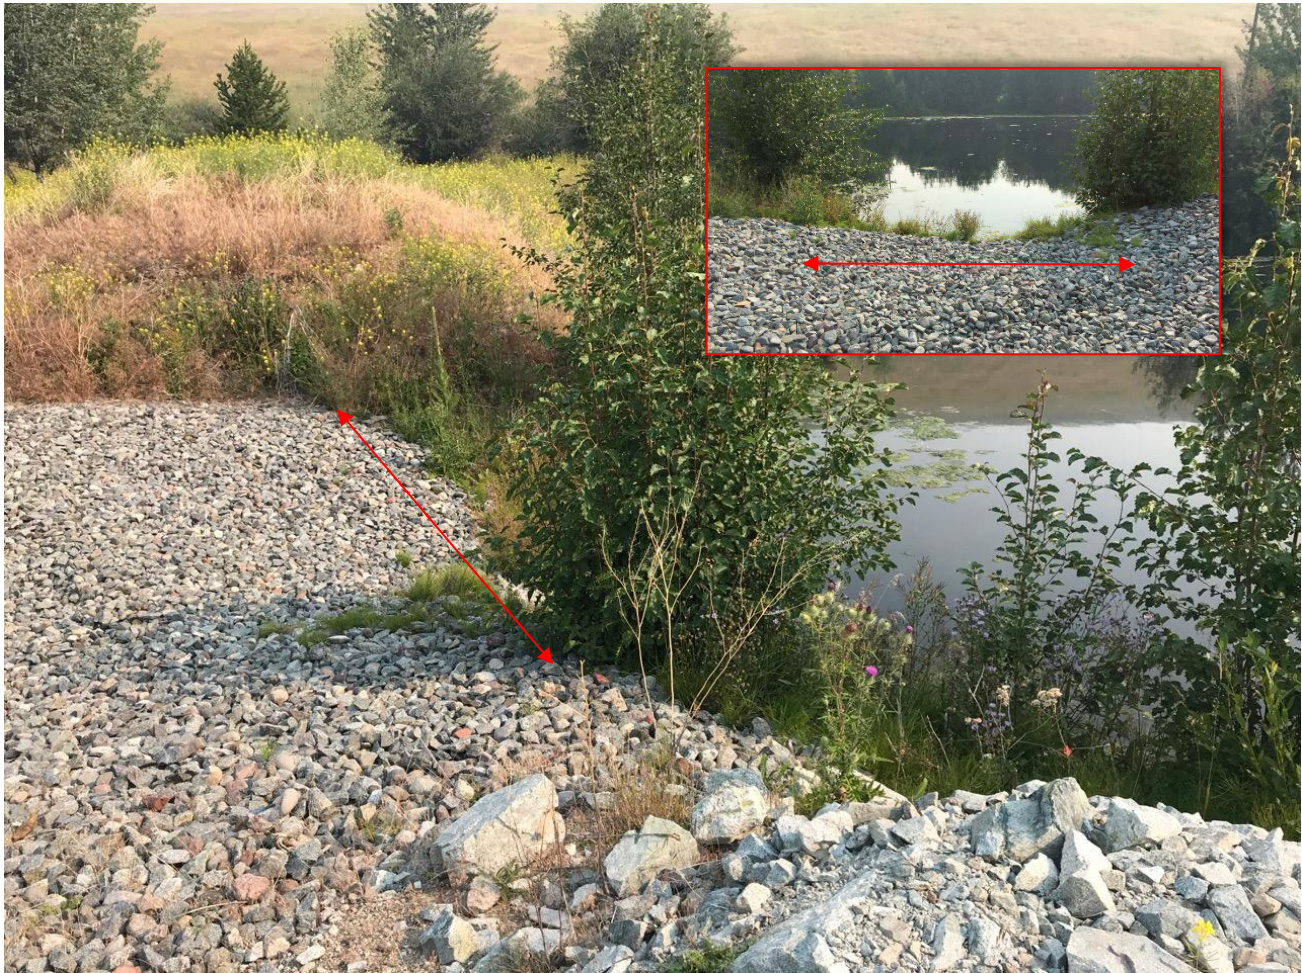
Photo II-B- 6 Spillway Inlet (TRJ-2018-27)

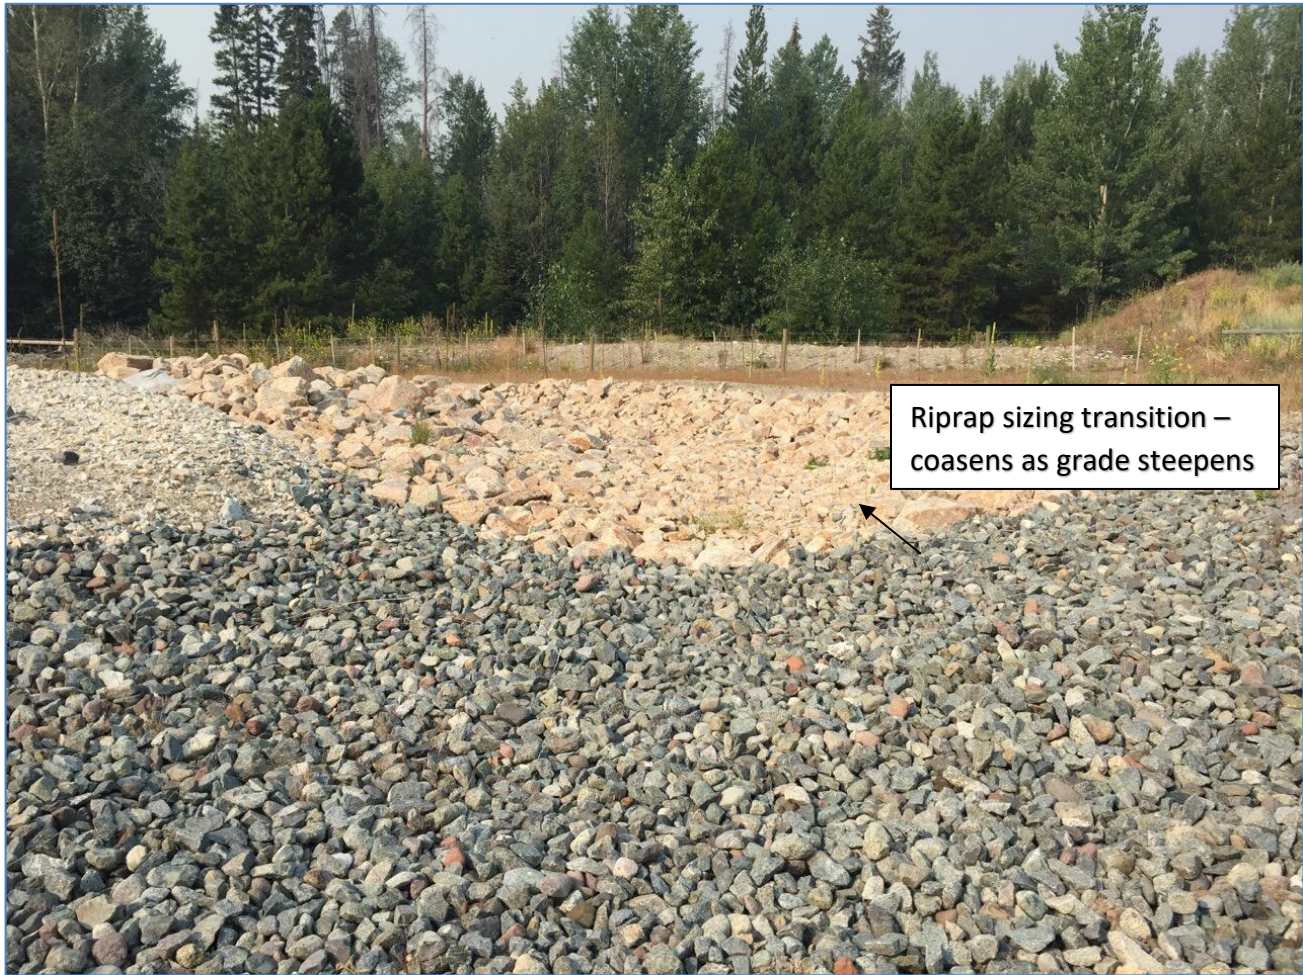
Photo II-B- 7 Spillway channel (TRJ-2018-27)

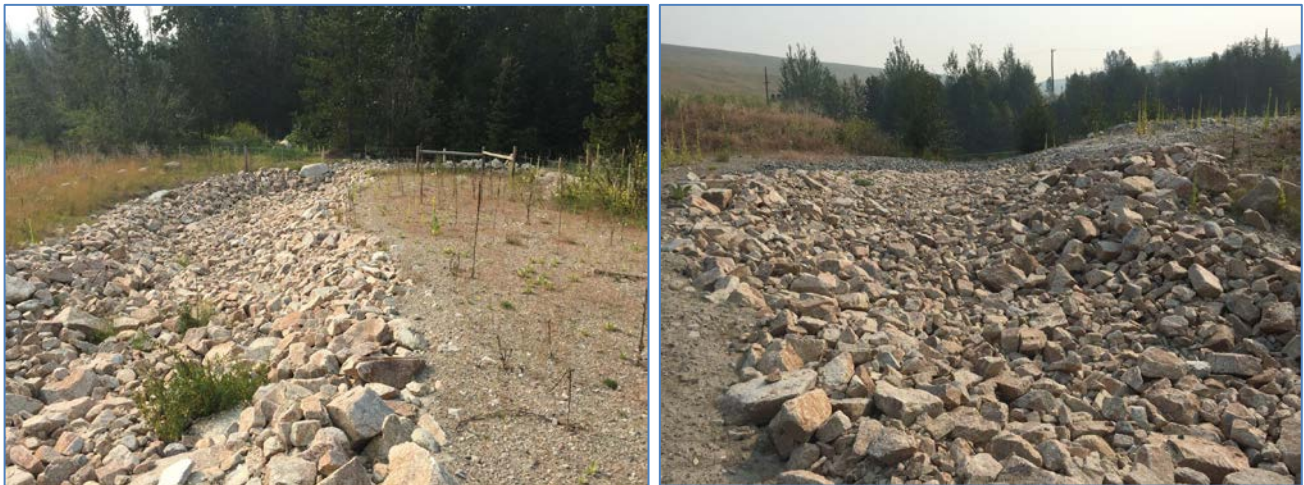
Photo II-B- 8 Spillway channel (TRJ-2018-28)
