Teck Highland Valley Copper Partnership

2018 Dam Safety Inspection Report

Trojan Tailings Storage Facility

March 2019

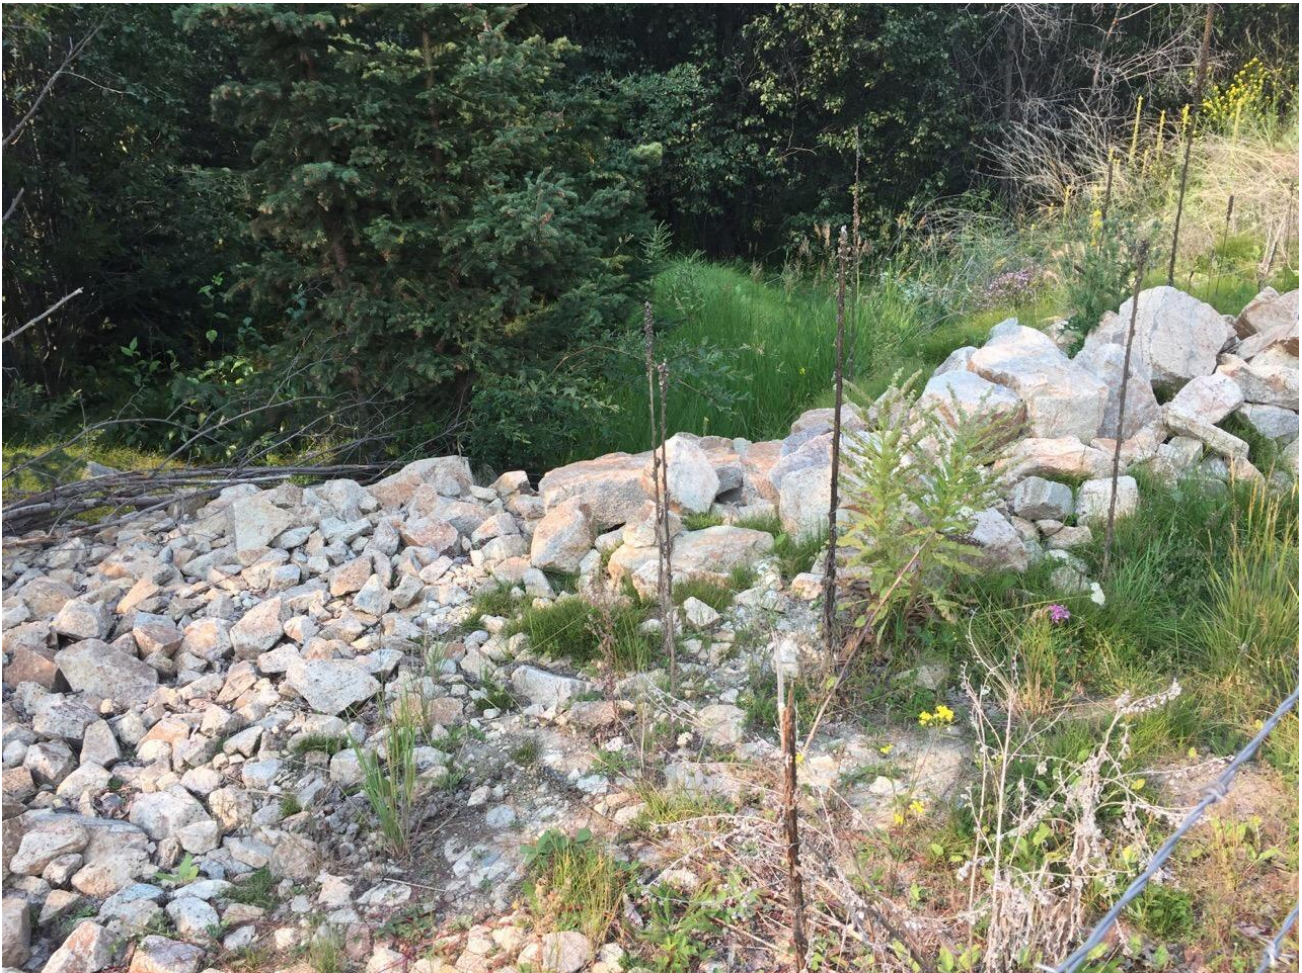
Photo II-B- 9 Spillway channel – transition to grass-lined channel (TRJ-2018-29)

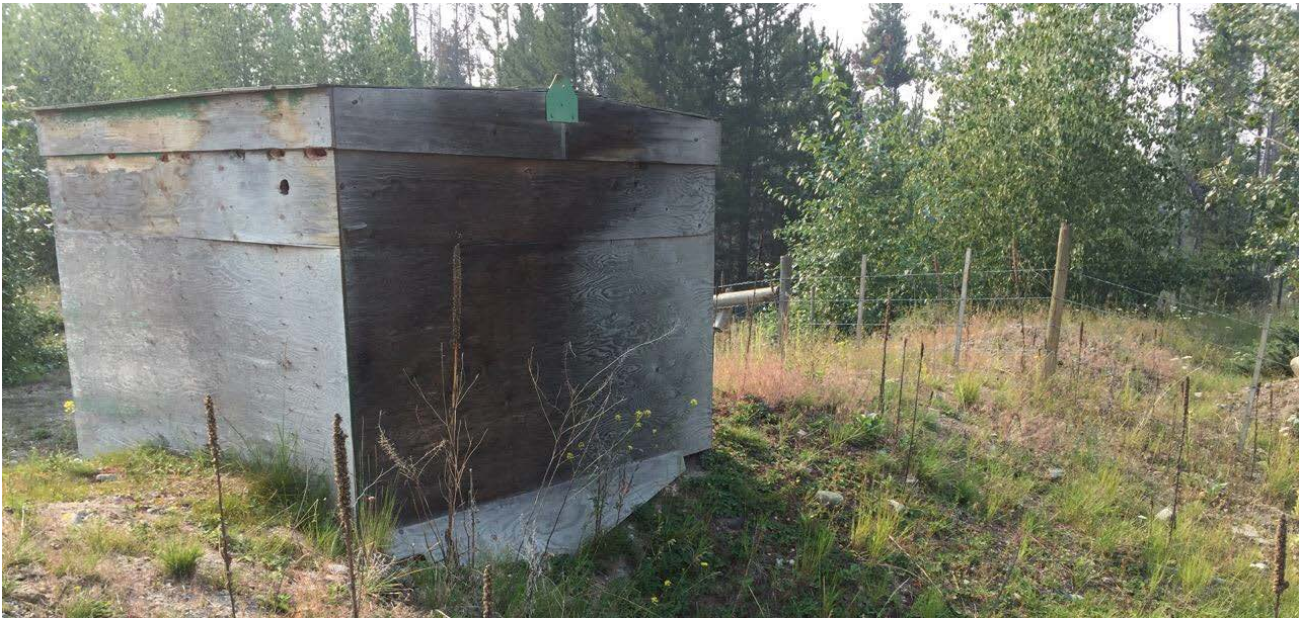
Photo II-B- 10 Box enclosed valve for seepage pipe at downstream of the dam (TRJ-2018-25)

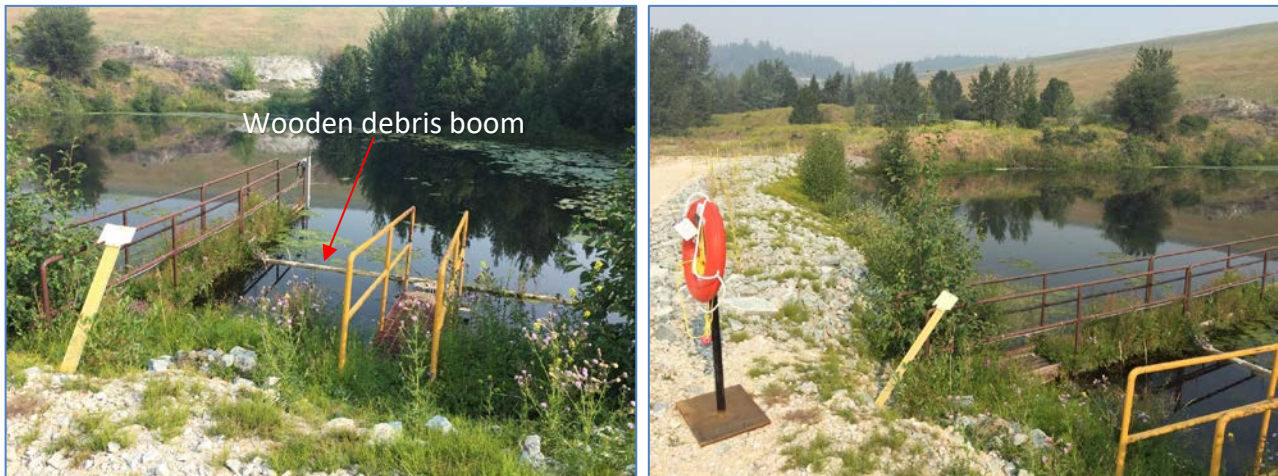
Photo II-B- 11 Low-level outlet to Witches Brook via Lower Trojan Dam (TRJ-2018-26)

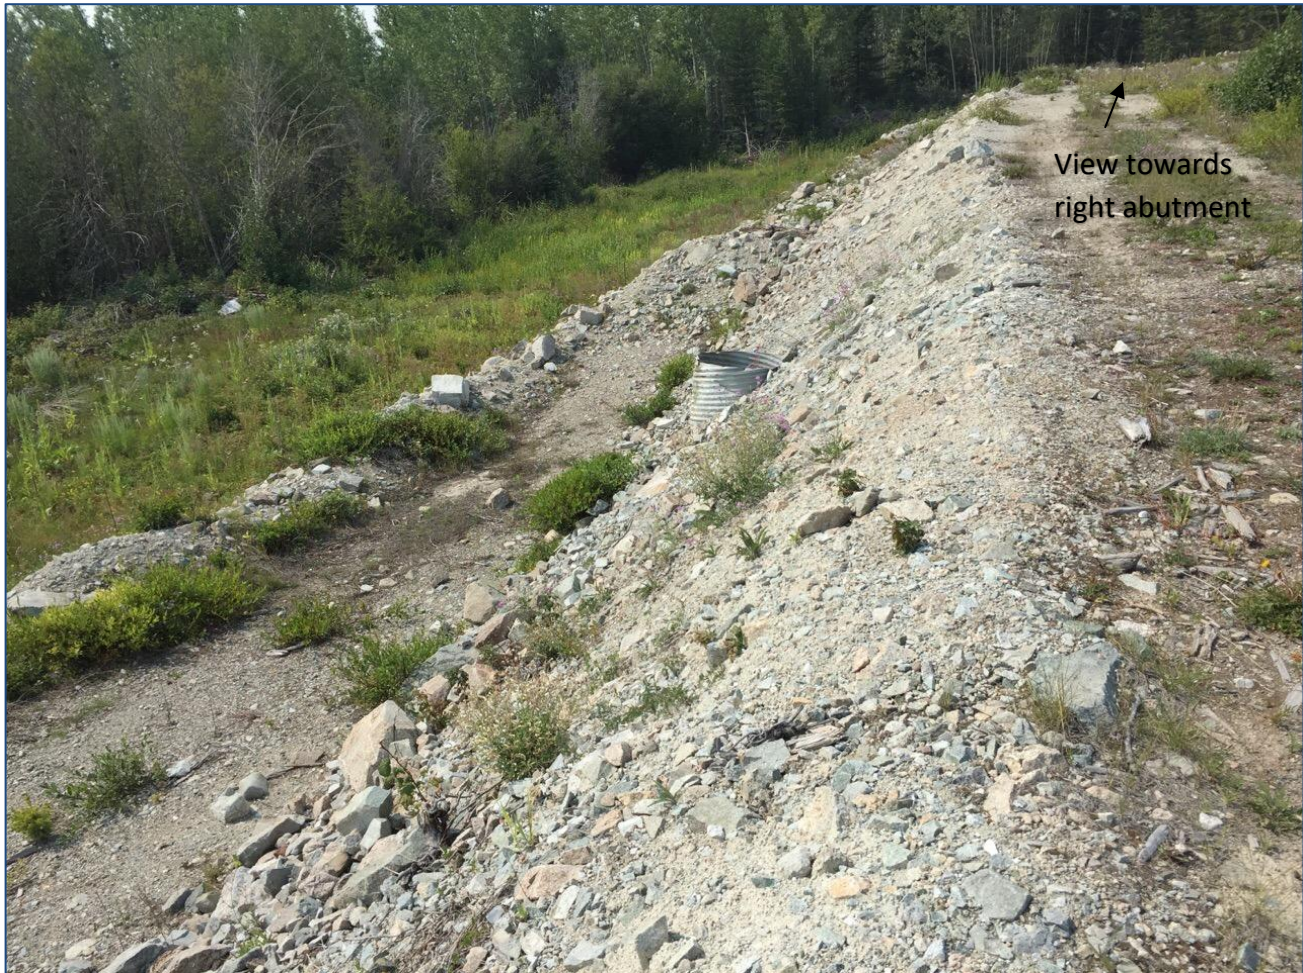
Photo II-C-1 Dam crest and downstream slope (TRJ-2018-30)

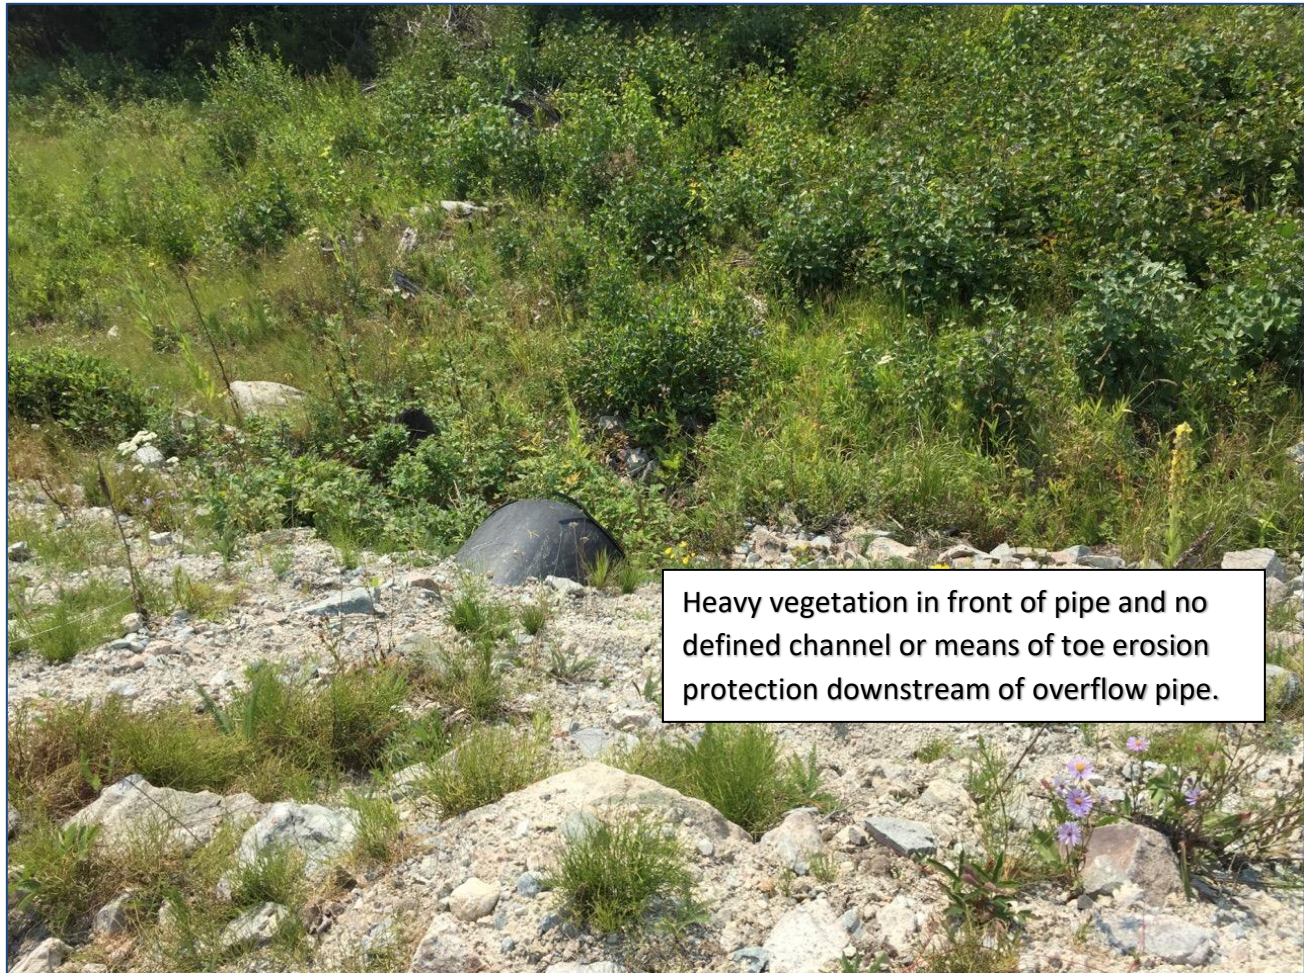
Photo II-C-2 Downstream slope near right abutment with overflow pipe (TRJ-2018-31)

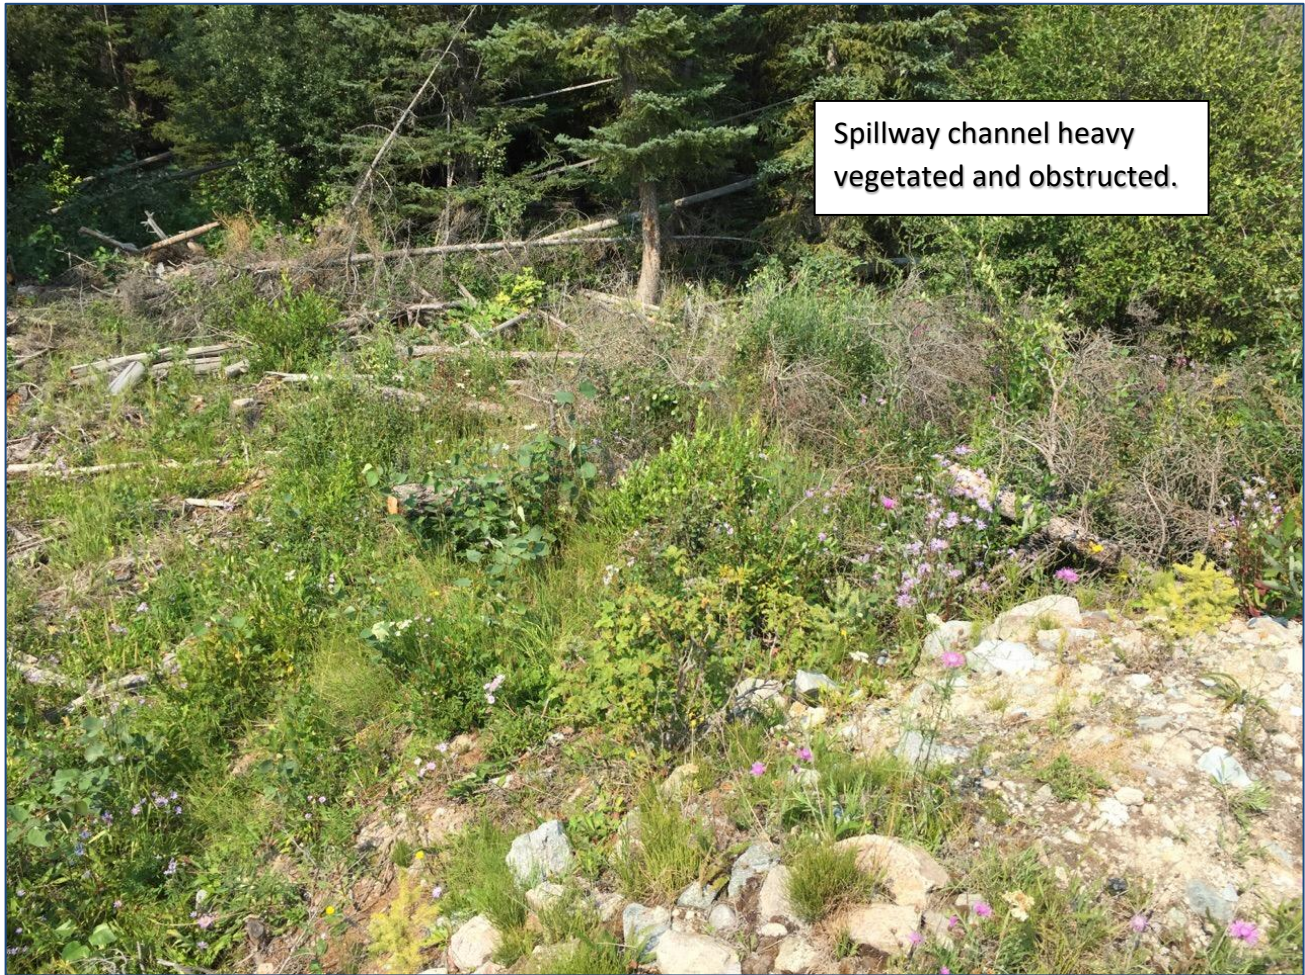
Photo II-C-3 Spillway near right abutment (TRJ-2018-32)

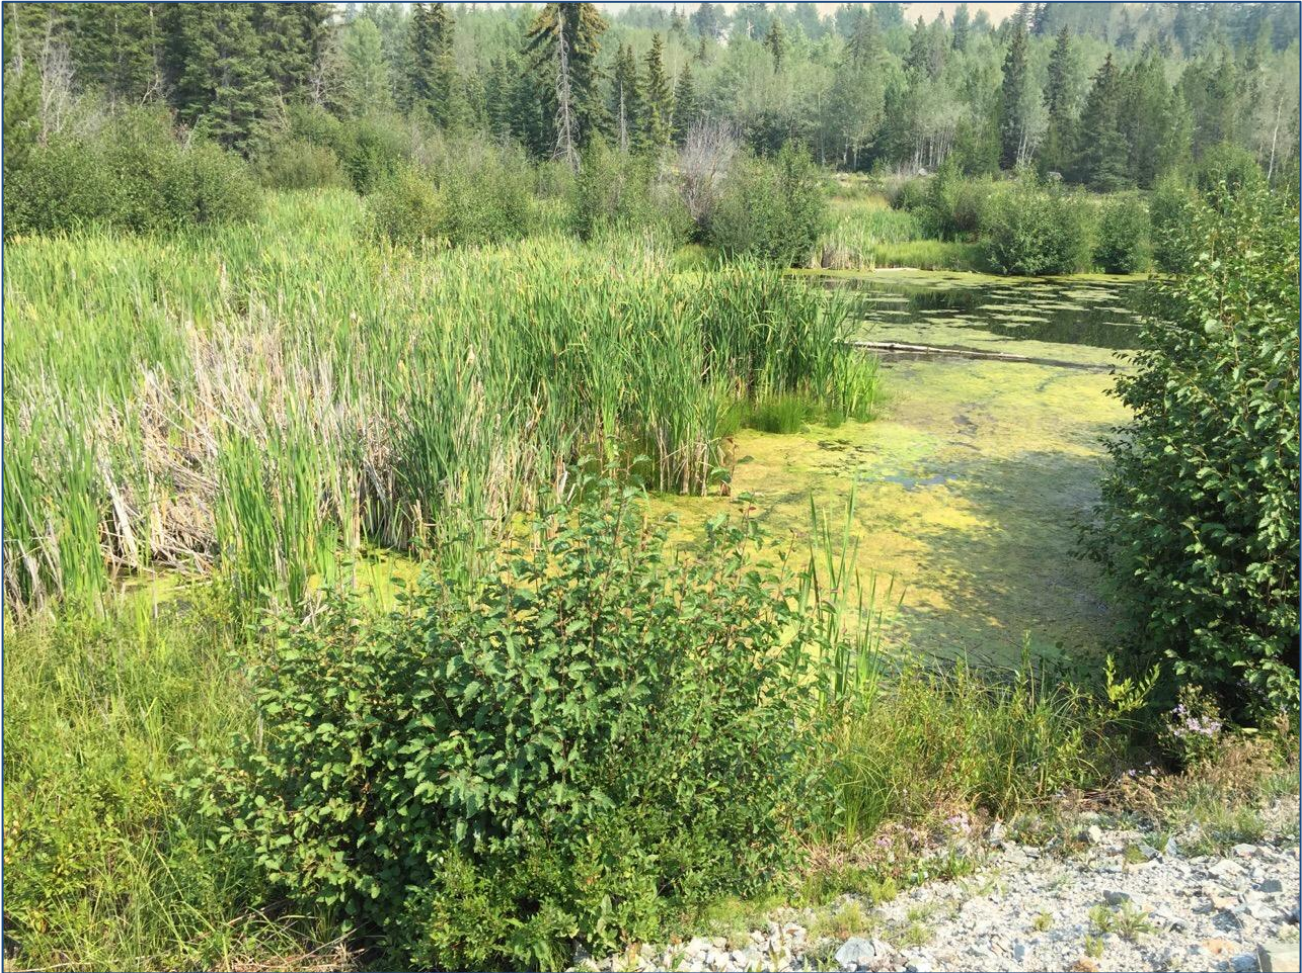
Photo II-C-4 Lower Trojan Dam Pond (TRJ-2018-32)

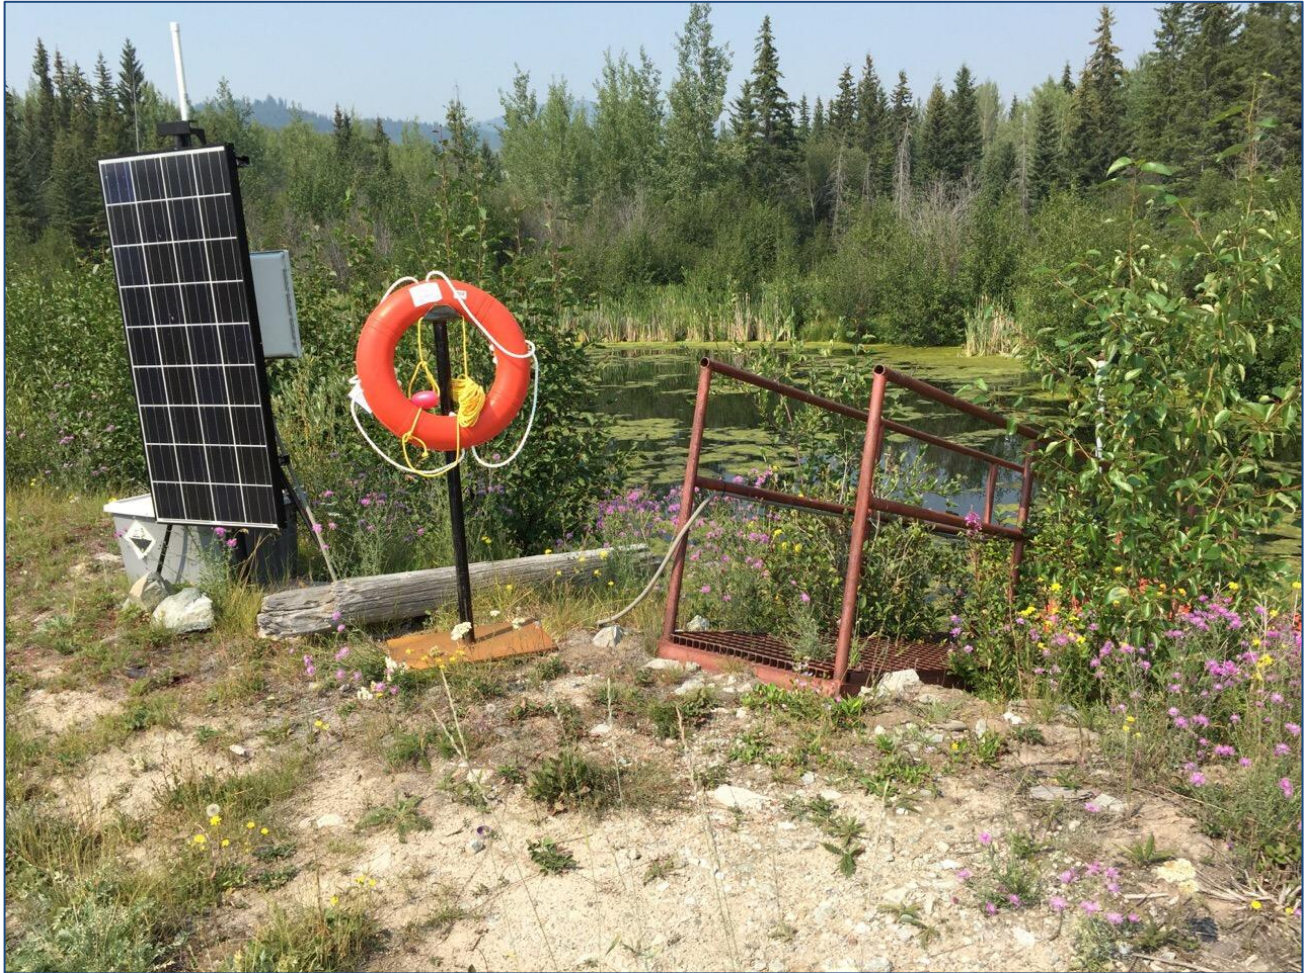
Photo II-C-5 Upstream crest with view of ramp to low level outlet intake (TRJ-2018-33)

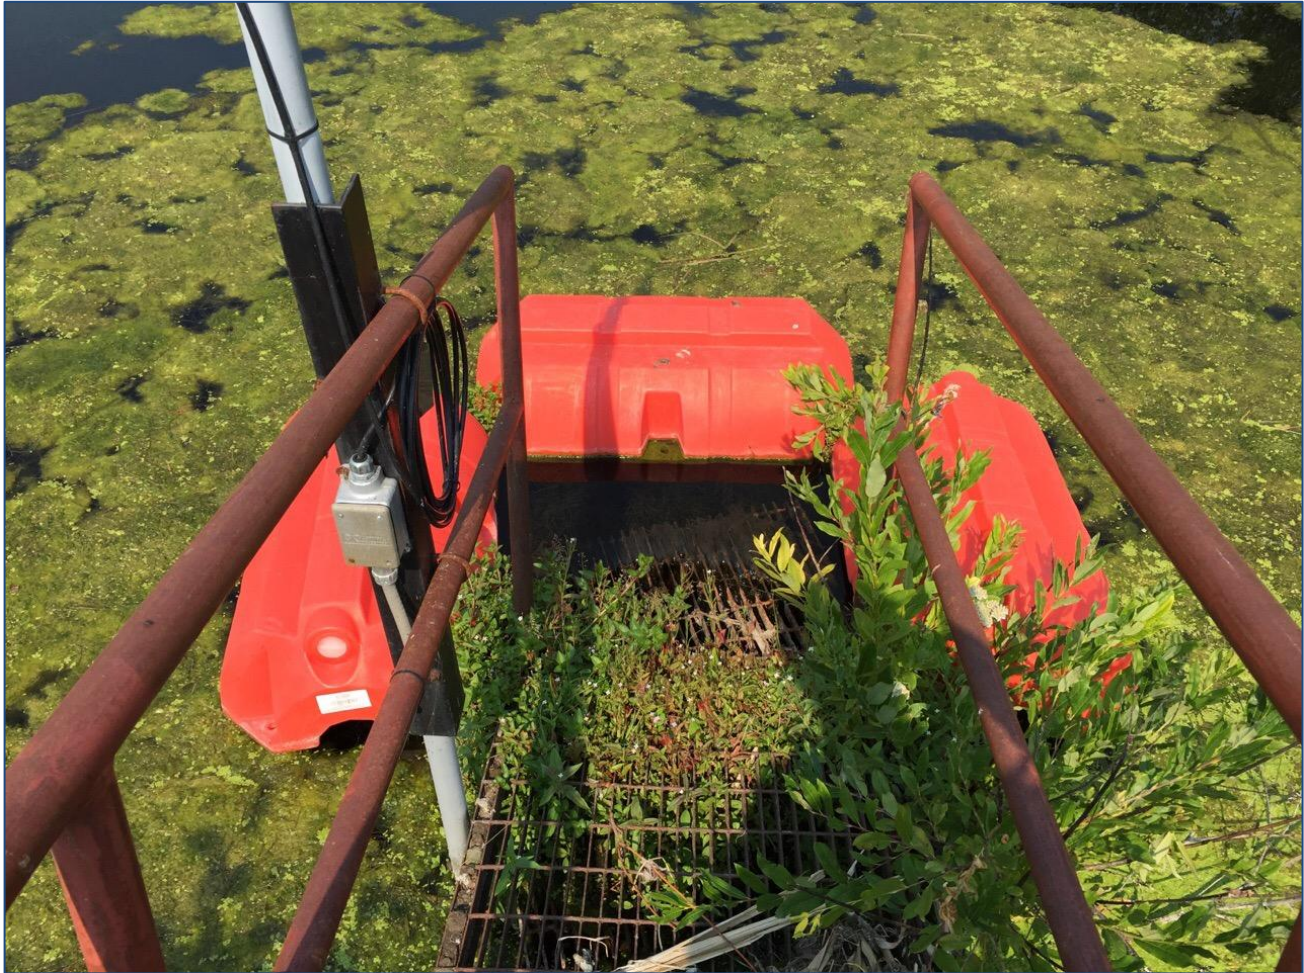
Photo II-C-6 Low-level outlet intake and secured debris booms (TRJ-2018-33)

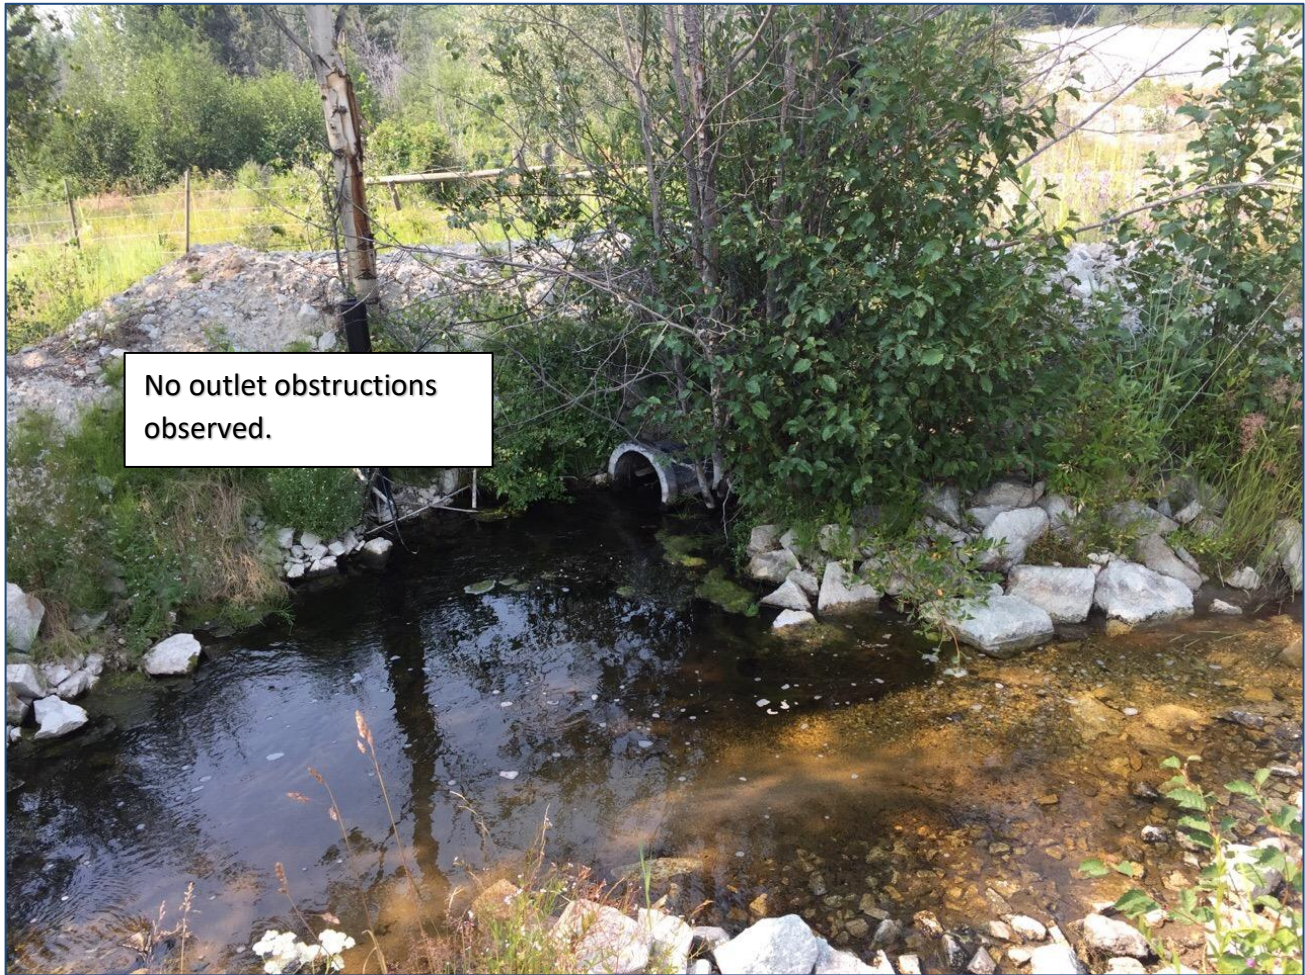
Photo II-C-7 Low-level outlet discharge pipe (TRJ-2018-34)

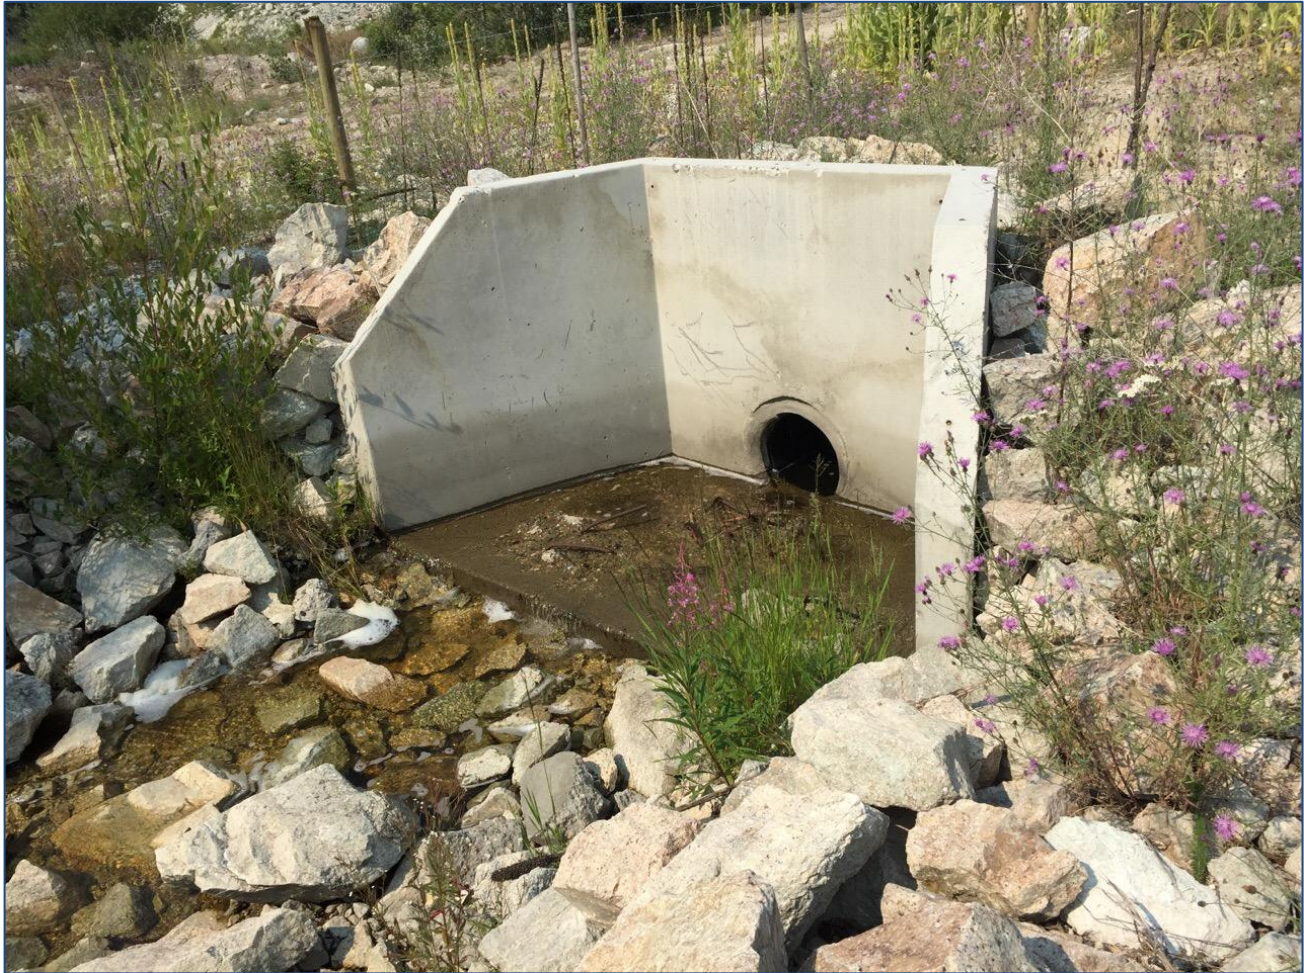
Photo II-C-8 Inflow culvert from Trojan Diversion Ditch (TRJ-2018-34)

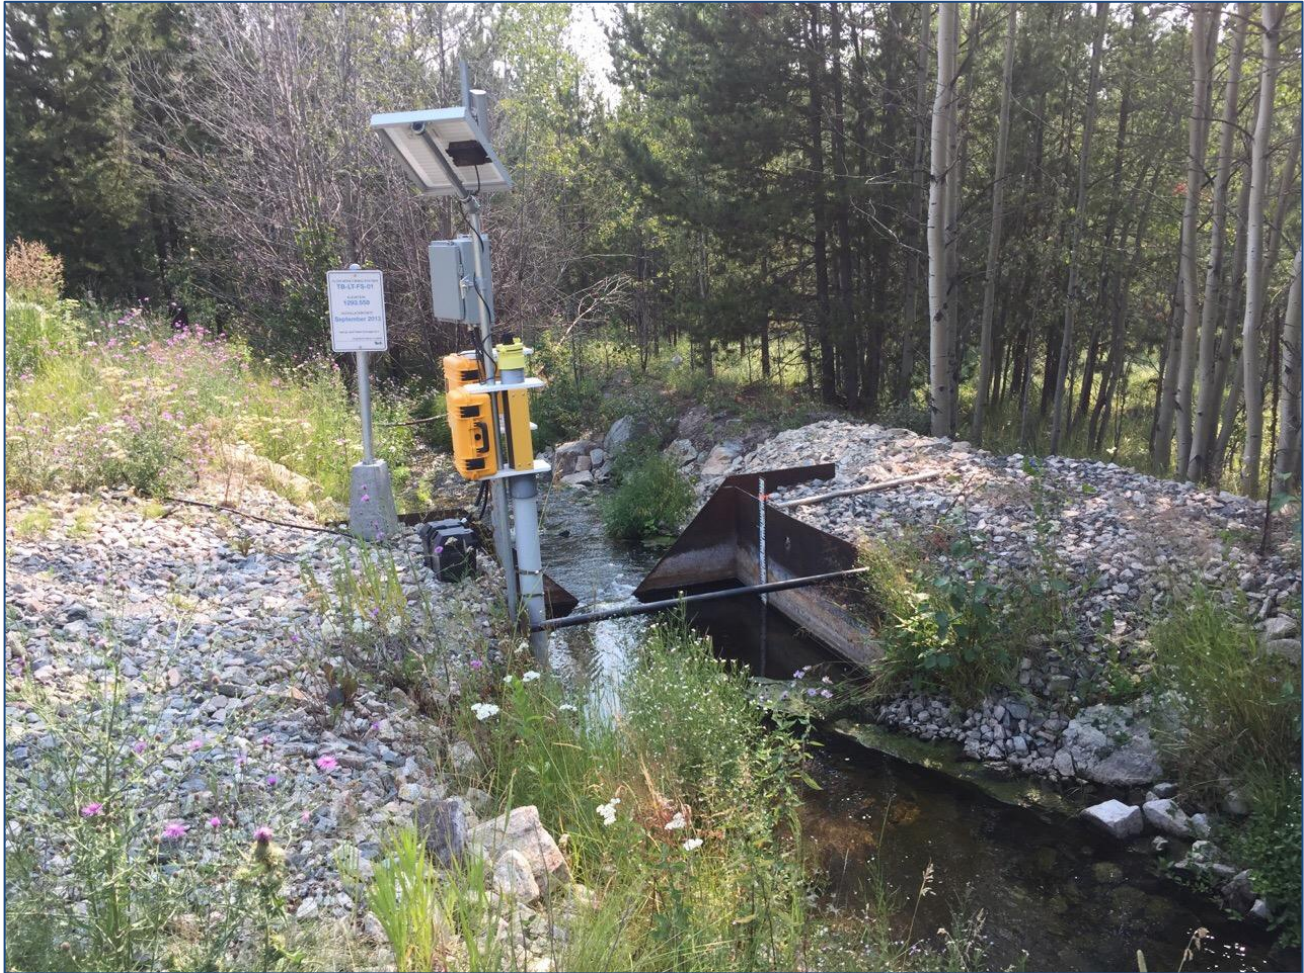
Photo II-C-9 Discharge channel to weir TB-LT-FS-01 (TRJ-2018-34)
