Klohn Crippen Berger

Teck Coal Limited Elkview Operations

West Fork Tailings Facility and Lagoons A, B, C, and D

2019 Dam Safety Inspection

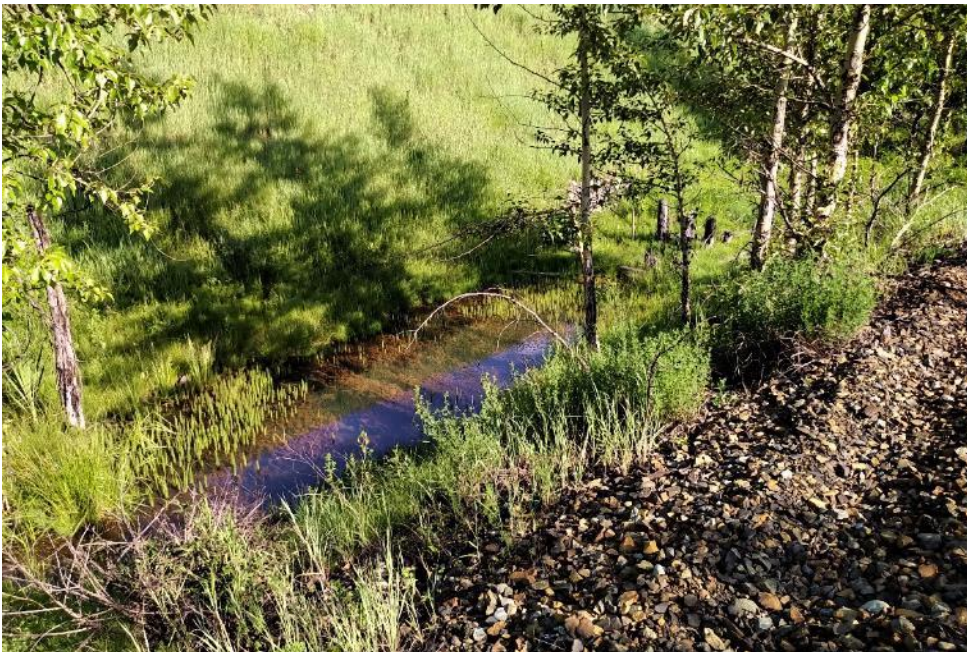
Photo IC-10 Ponding between the toe of Lagoon C and the railroad tracks. (looking west)

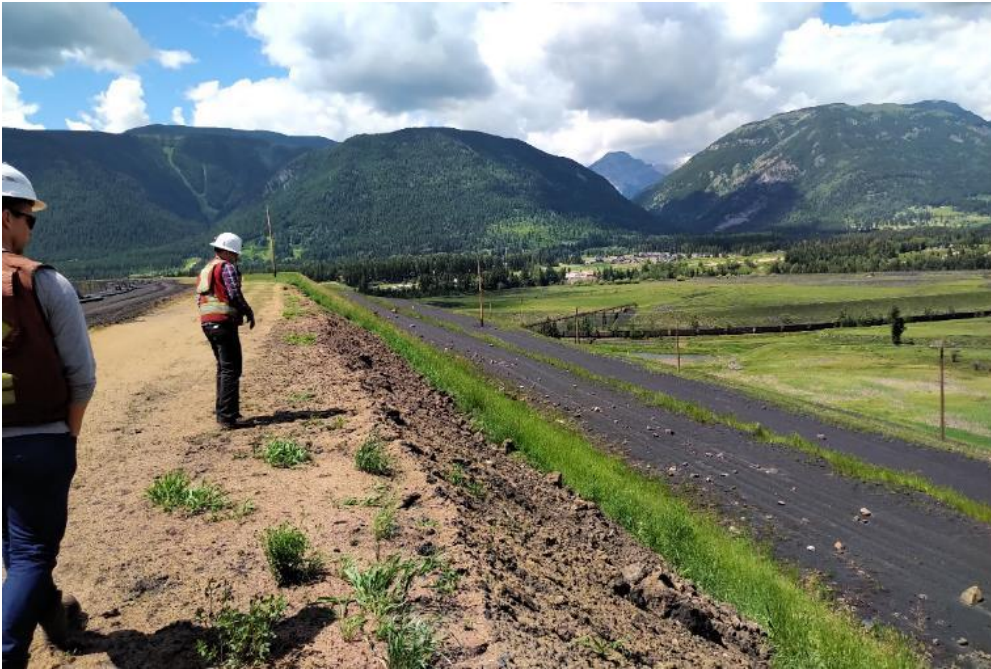
Photo ID-7 Minor rockfall from the crest onto the second bench and application of tackifier to vegetate slopes. (looking west)

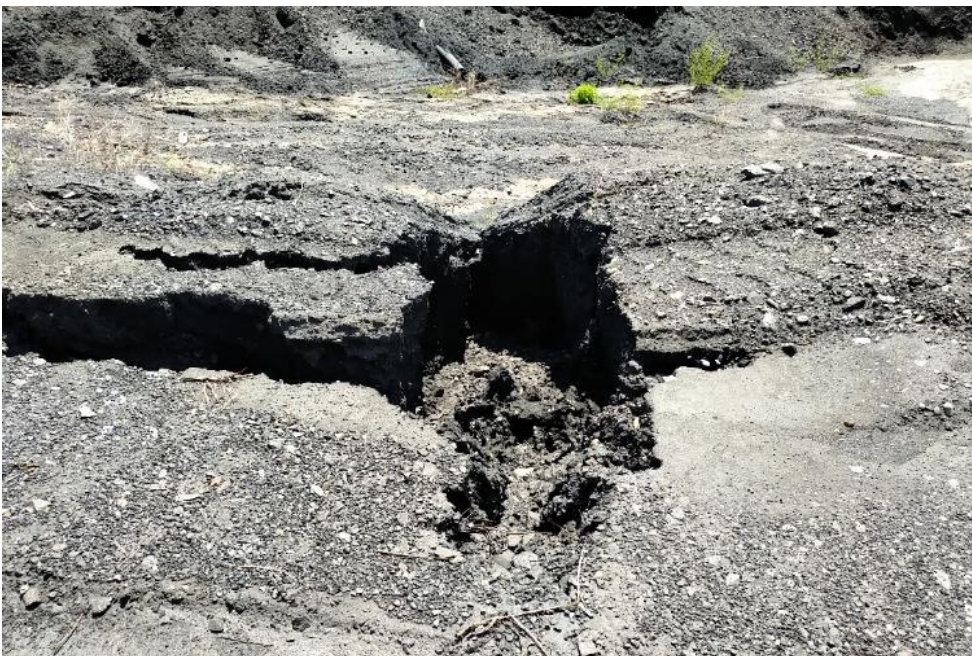
Photo ID-8 Upstream crest erosion 1. (looking west)
