2019 Dam Safety Inspection for South Tailings Pond and North Tailings Pond

Teck Coal Limited, Fording River Operations

Reference No. 18110785-2019-159-R-Rev0-1000

4 March 2020

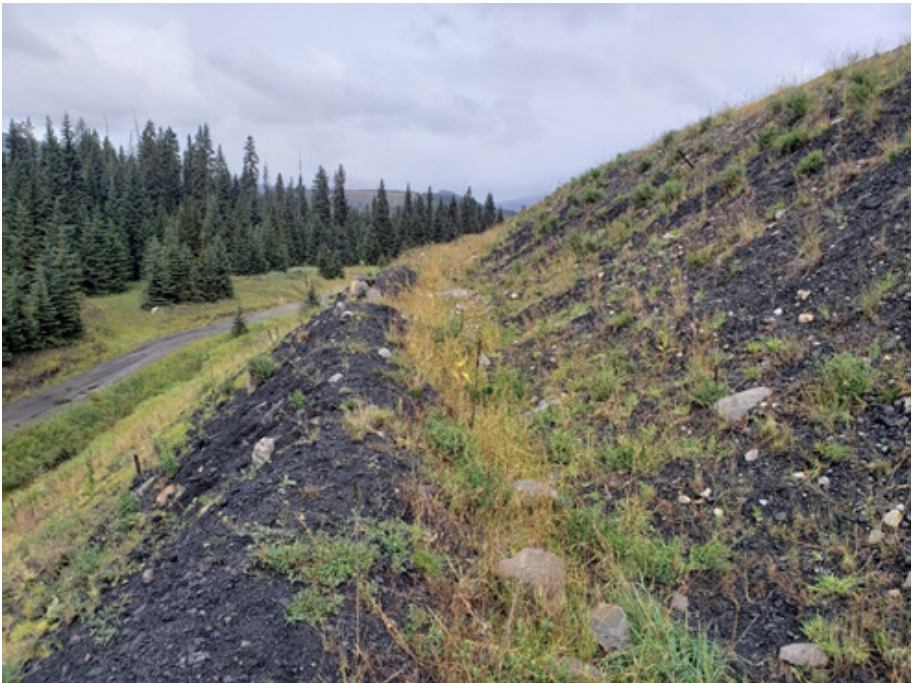
Photograph A-4: STP West Dam Downstream Slope Looking North along mid slope bench Near Station 0+200, 10 September 2019

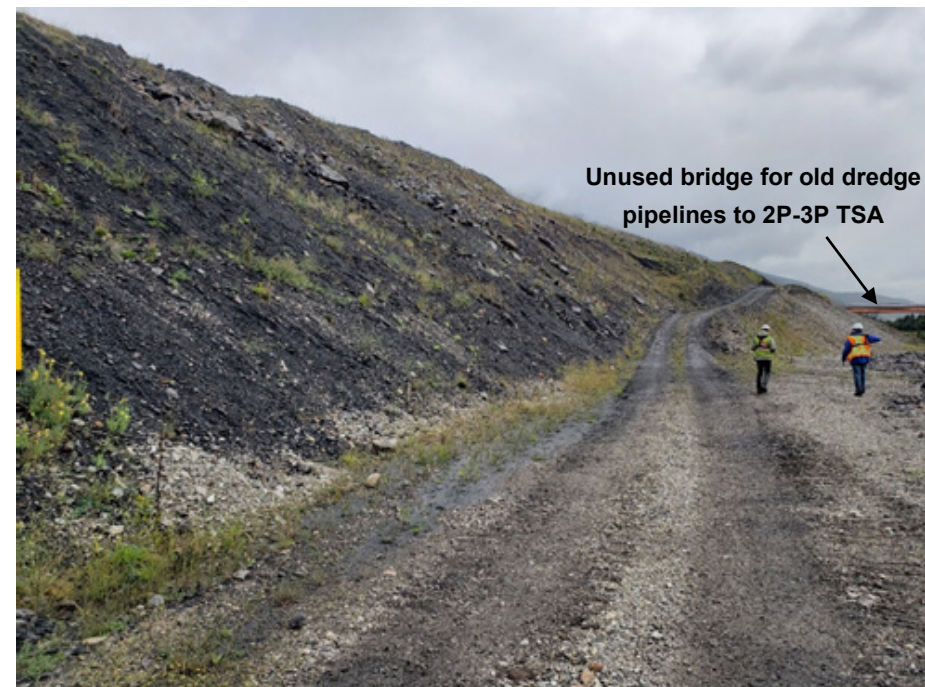
Photograph A-7: STP West Dam Downstream Slope, on Access Road near Station 0+550, looking Southeast toward Pipeline Ridge for old Dredge Pipelines to 2P-3P TSA, 10 September 2019

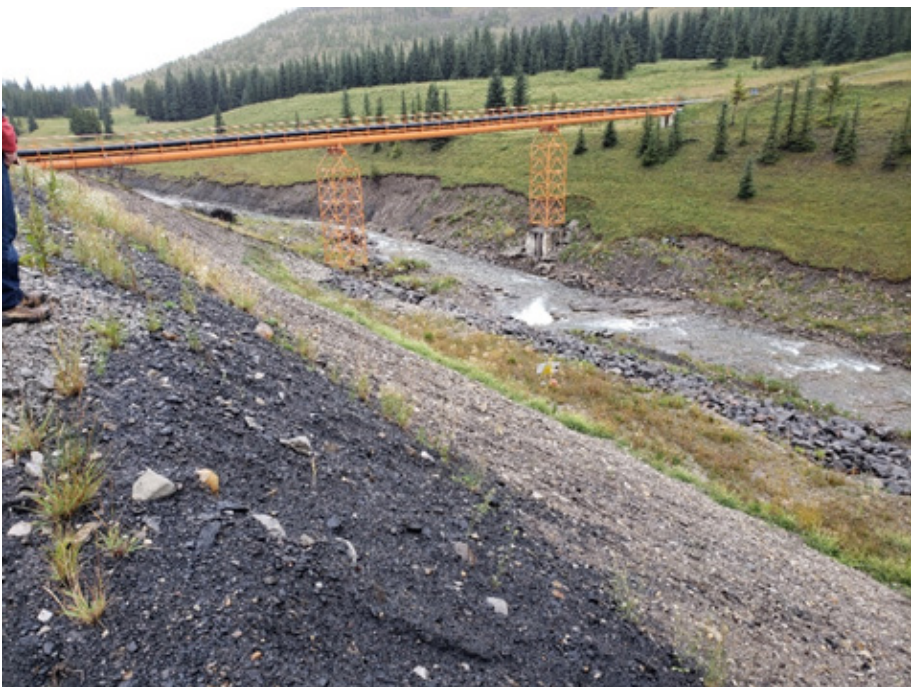
Photograph A-8: STP West Dam Downstream Slope, Looking Southeast at the Pipeline Bridge at Station 0+650, 10 September 2019

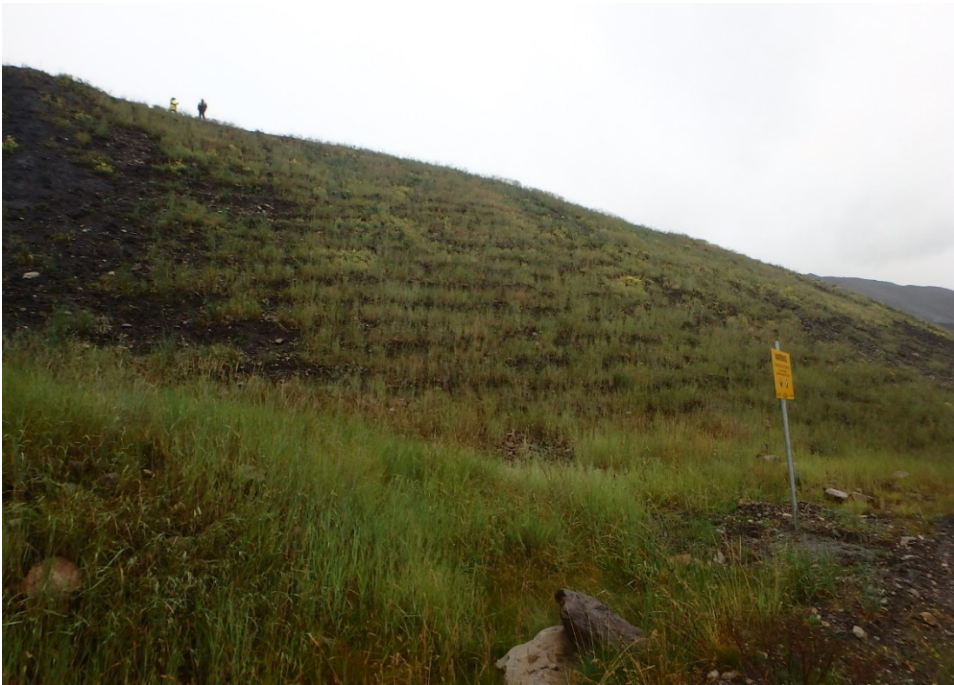
Photograph A-11: STP Downstream Slope at Transition Between West and Main Dam, Looking Northeast Toward the Crest from the Toe Near Station 1+150, 10 September 2019

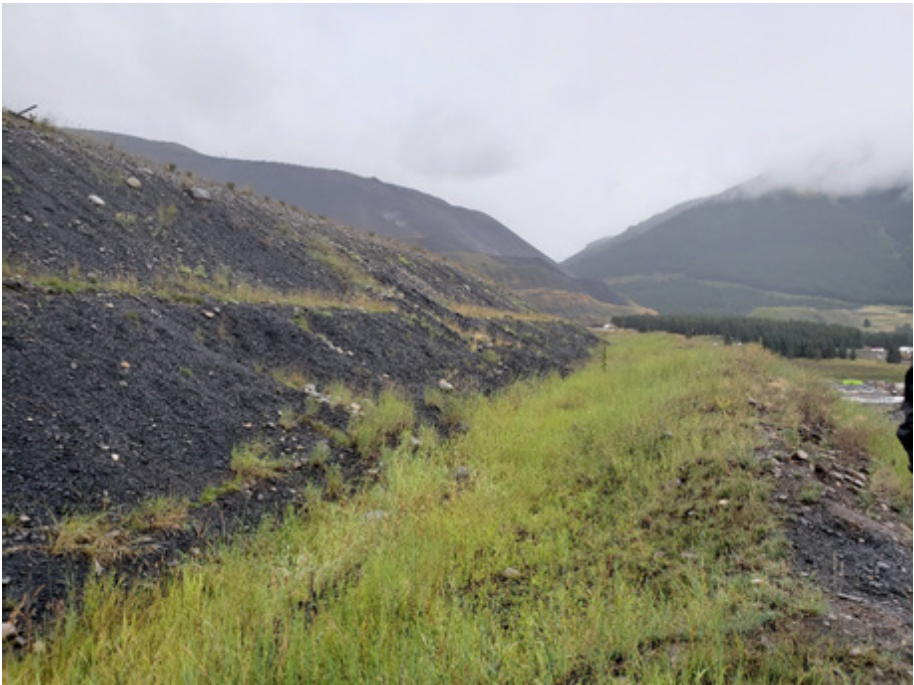
Photograph A-12: STP Main Dam Downstream Slope, looking Northeast, 10 September 2019

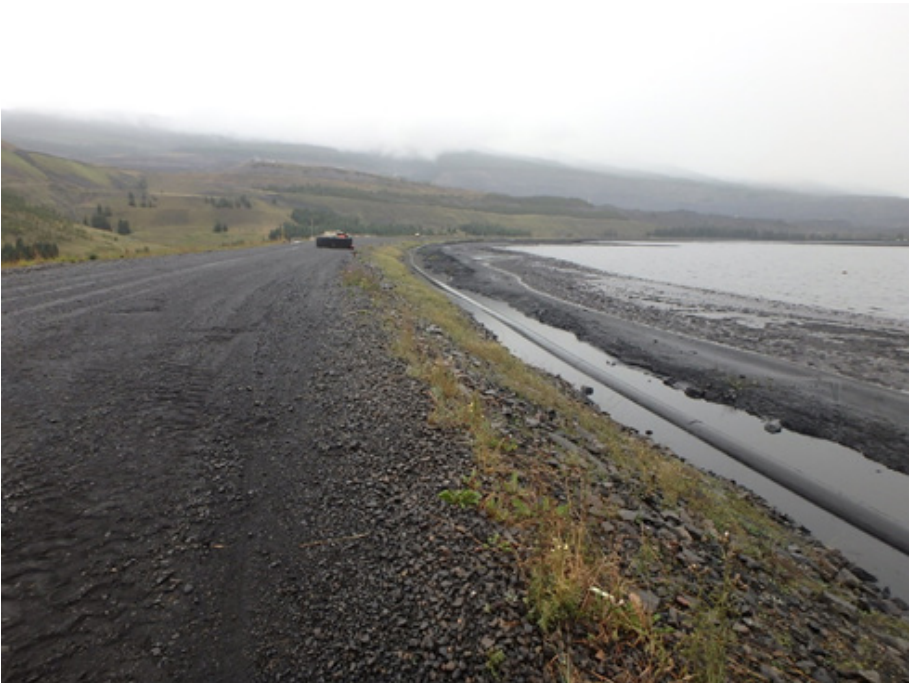
Photograph A-15: STP Main Dam Crest, Looking Southwest, near Station 1+500, 10 September 2019

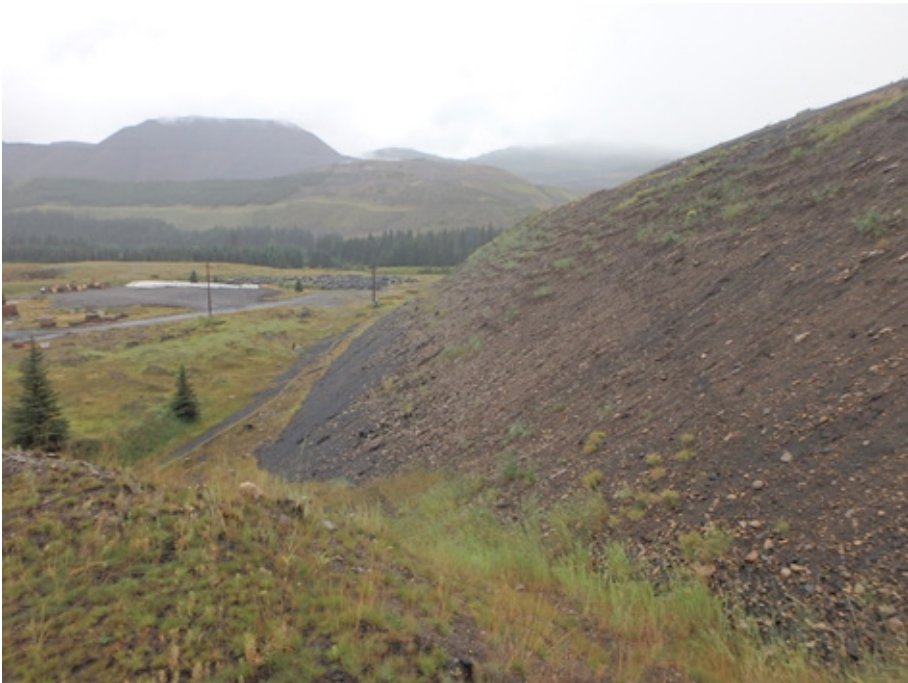
Photograph A-16: STP Main Dam Downstream Slope, looking Southwest from Station 1+600 Across Dam Slope, 10 September 2019

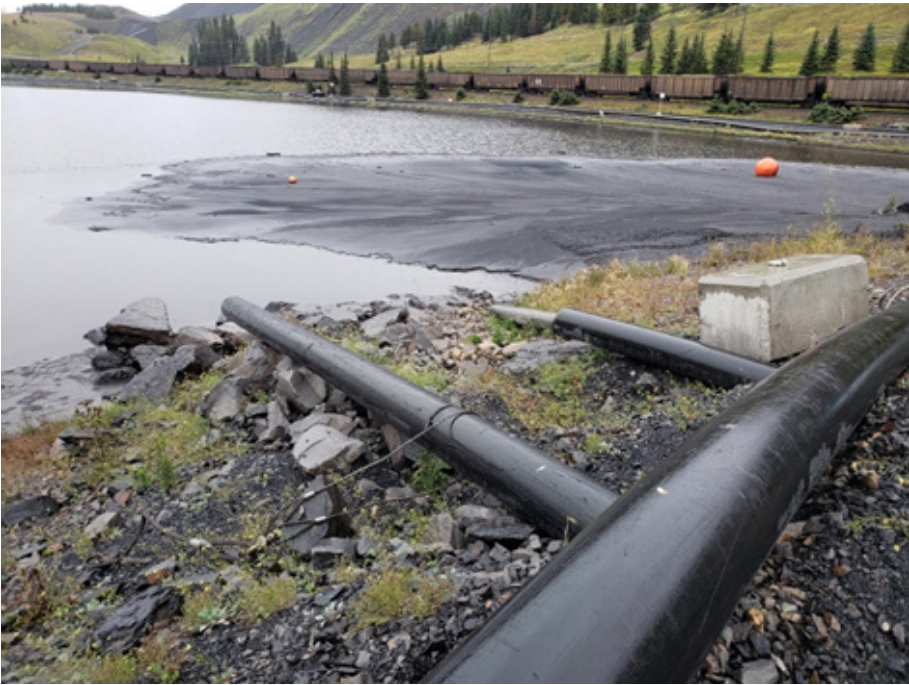
Photograph A-21: STP South Abutment Till Blanket Area, Makeup Water Pipelines from Kilmarnock Ponds with Rip Rap Protection on Blanket, Looking Northeast, 10 September 2019

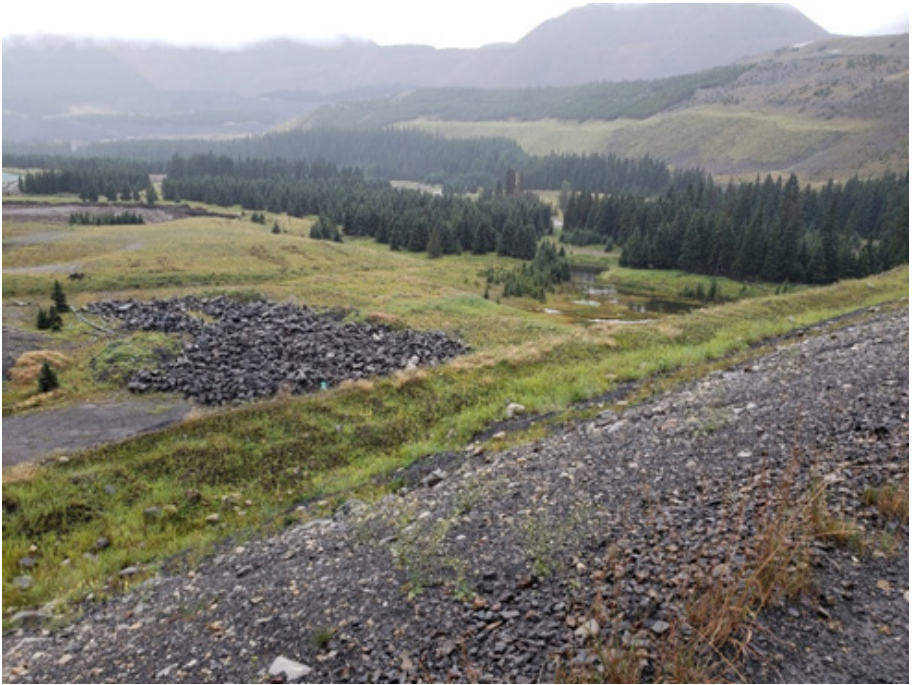
Photograph A-22: STP Main Dam Downstream Slope, looking Southwest at Rip Rap Stockpile From the Dam Crest near Station 1+450, 10 September 2019

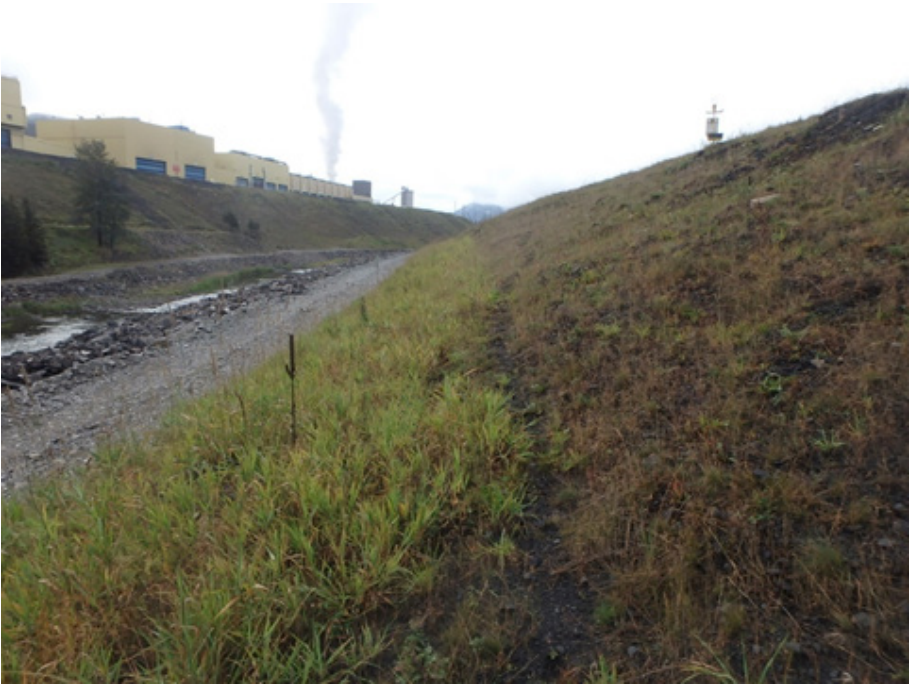
Photograph A-27: NTP, looking South Along the Downstream Slope and Toe of the Dam near Station 0+300, 11 September 2019

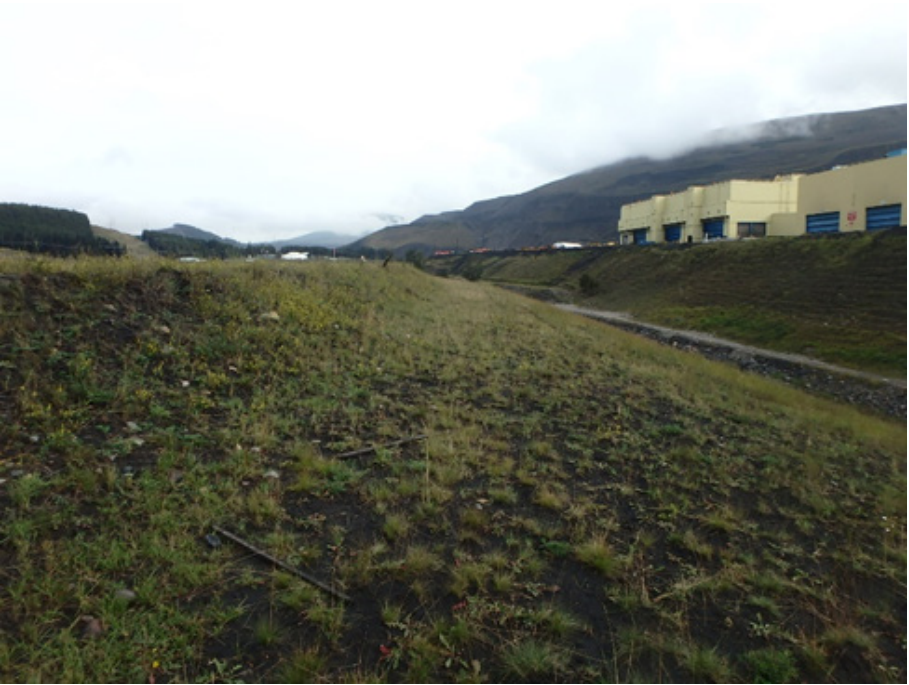
Photograph A-28: NTP, Looking North Along the Downstream Slope of the Dam near Station 0+550, 11 September 2019

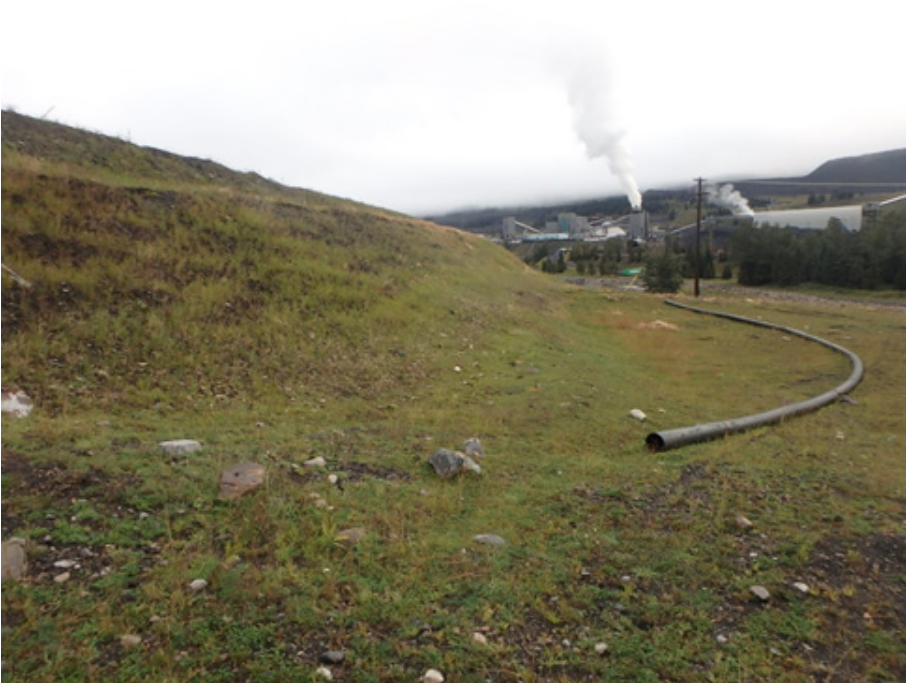
Photograph A-29: NTP looking North along Downstream Slope and Toe near Station 1+300, 1 September 2019

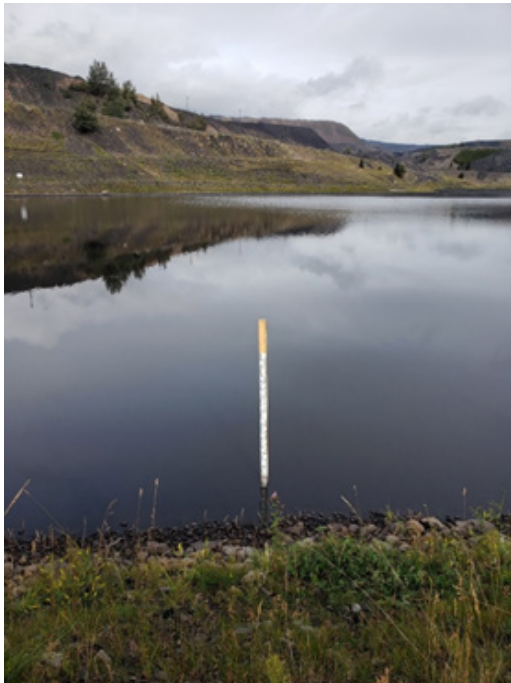
Photograph A-30: NTP Looking Northwest at Water Level Staff Gauge near Station 1+360, 11 September 2019

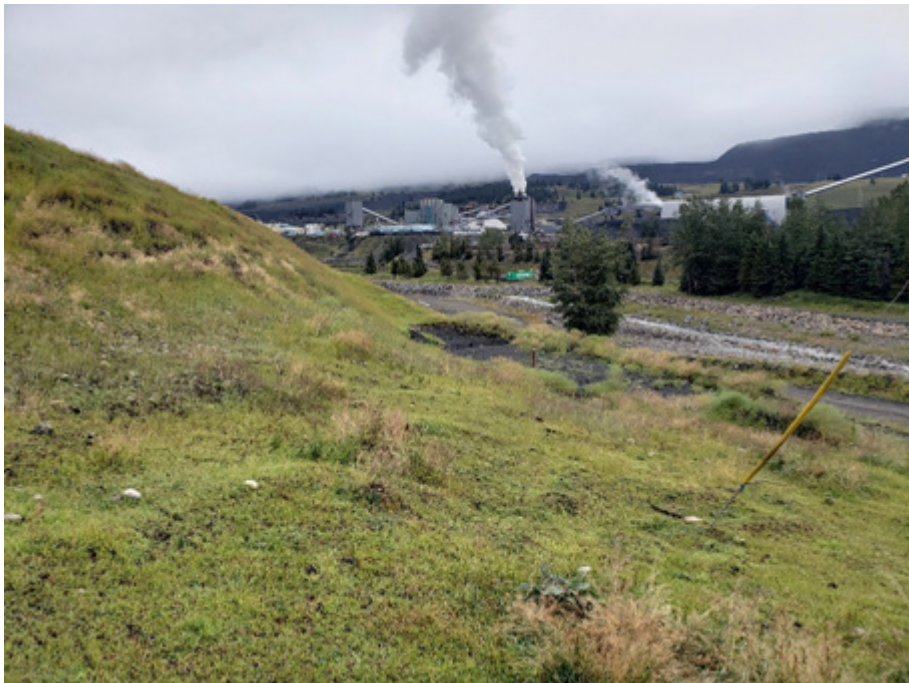
Photograph A-32: NTP Dam Downstream Slope and Toe and Stepped Erosion and Area of Ponding Water, at Station 1+200, 11 September 2019

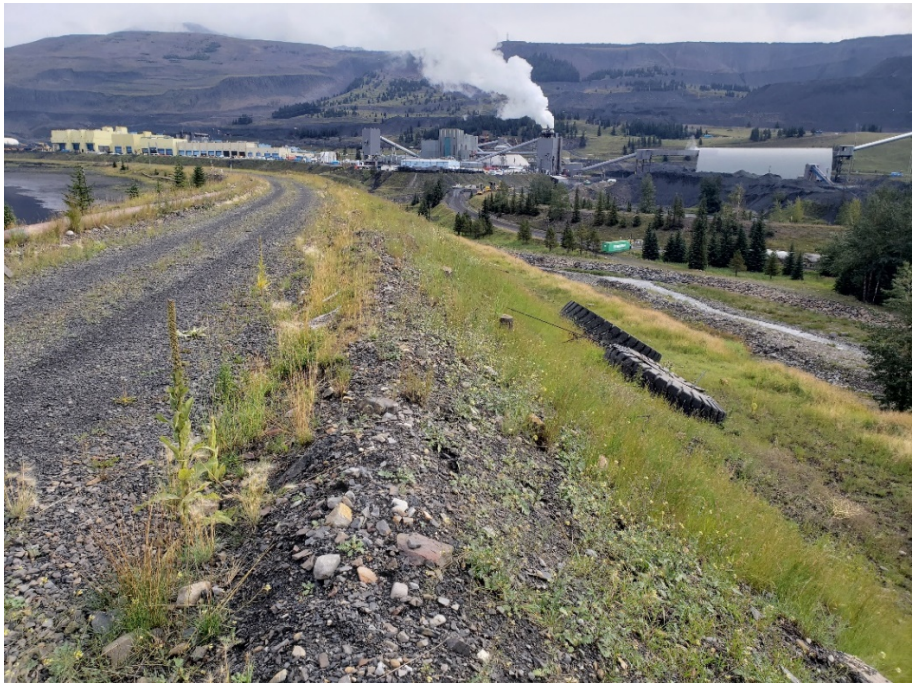
Photograph A-36: NTP looking Northeast along Dam Crest, Road to South Access Ramp to the Right, at Station 1+400, 11 September 2019

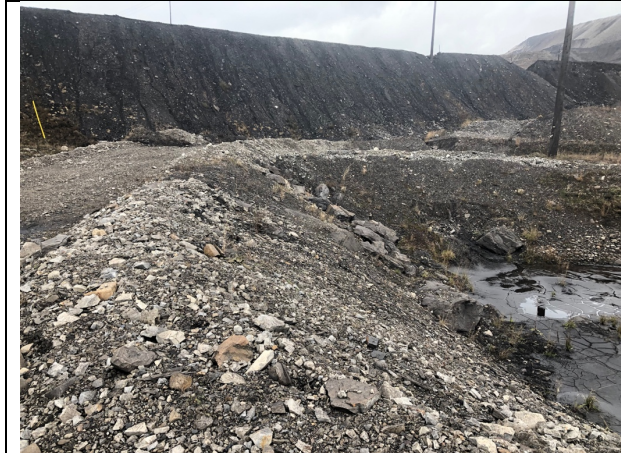
Photo 1: Looking upstream along alignment of NTP riprap that is buried (approx. Sta. 0+100)

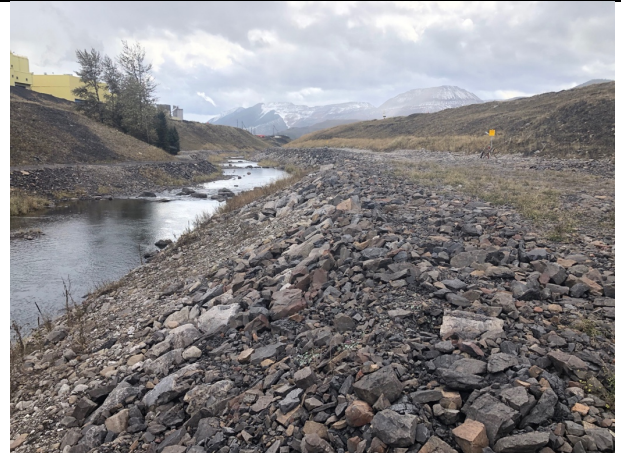
Riprap extends from upstream of the NTP to about Sta. 1+075 of the Golder NTP dam baseline as shown on Figure 1. Visual inspection of the lower riprap slope was impeded by gravel placed over the riprap during 2013 construction. The upper riprap slope placed during 2016/2017 was visible and appears to be well-interlocked. The exposed toe of the revetment was also observed and appears to be in good condition with no visual signs of scour or displacement. Riprap was visible on the entire slope in one short section approximately between Sta. 0+750 and Sta. 0+830. The exposed riprap is in good condition and appears to remain well interlocked. The slope of the exposed riprap is about 1.5H:1V.

Photo 2: Looking downstream at NTP riprap covered by gravel (approx. Sta. 0+180)

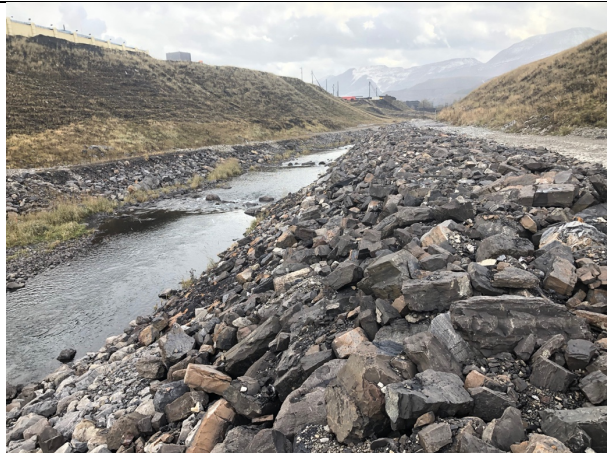
Photo 3: Looking downstream at NTP riprap (approx. Sta. 0+450)

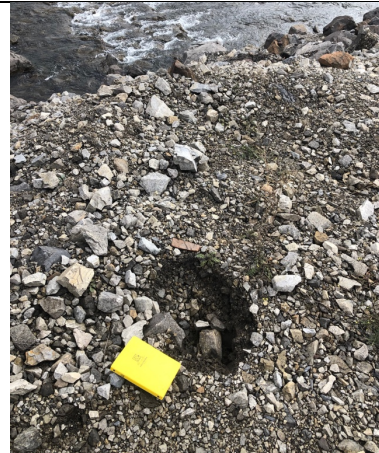
Photo 4: Small sinkhole about 1.5 m from top of bank on running surface of riprap along the NTP riprap (approx. Sta. 0+710)

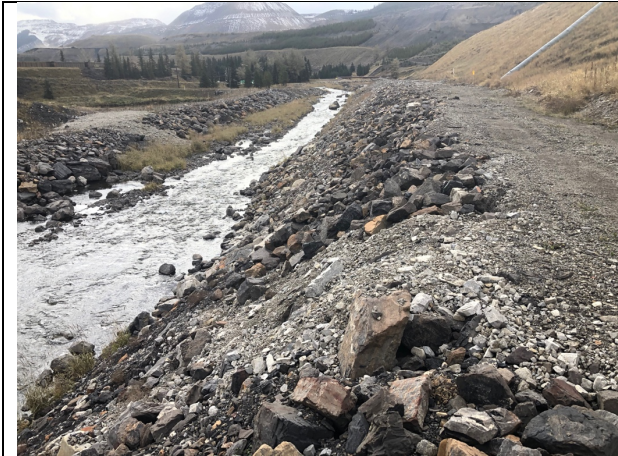
Photo 5: Looking downstream at NTP riprap
(approx. Sta. 0+860)

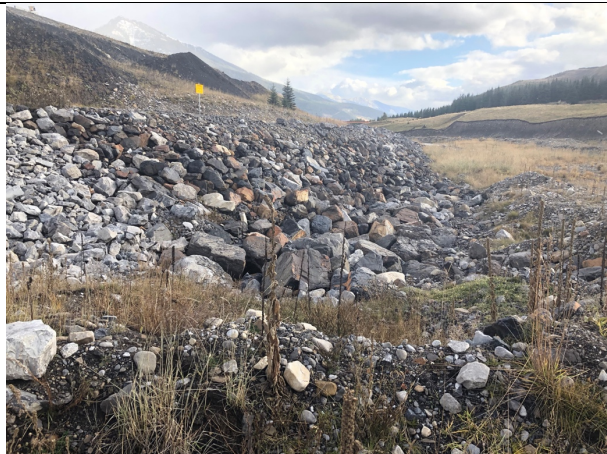
A riprap revetment protects the STP embankment toe from Sta. 0+240 to 0+685 of the Golder STP dam baseline (refer to Figure 2). Most of the riprap slope is exposed and visible along the length of the revetment, with the exception of a 20 m length at the upstream end which is covered in finer rock (200 mm minus rock). The riprap is well interlocked with smaller riprap filling the voids of the larger riprap. The riprap slope is about 2H:1V.

Photo 7: Looking downstream at STP riprap
(approx. Sta. 0+275)

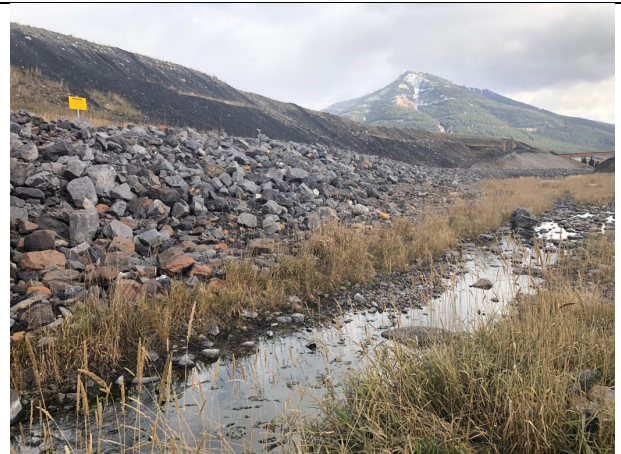
Photo 8: Looking downstream at STP riprap
(approx. Sta. 0+330)

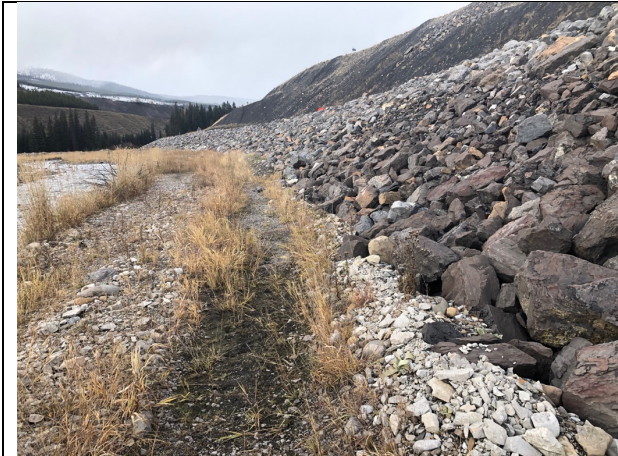
Photo 9: Looking upstream at STP riprap (approx. Sta. 0+580)

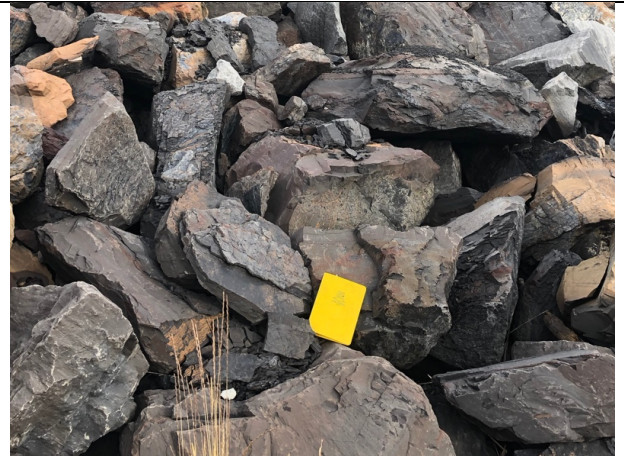
Photo 10: Riprap degradation due to weathering on several pieces of riprap

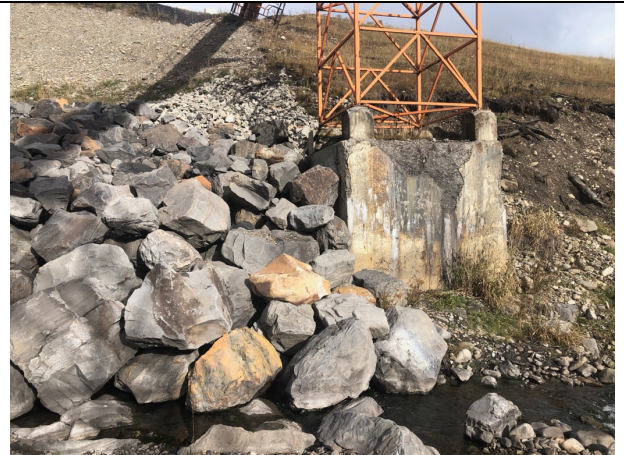
Photo 12: STP riprap tie-in to pipe bridge abutment (approx. Sta. 0+685)

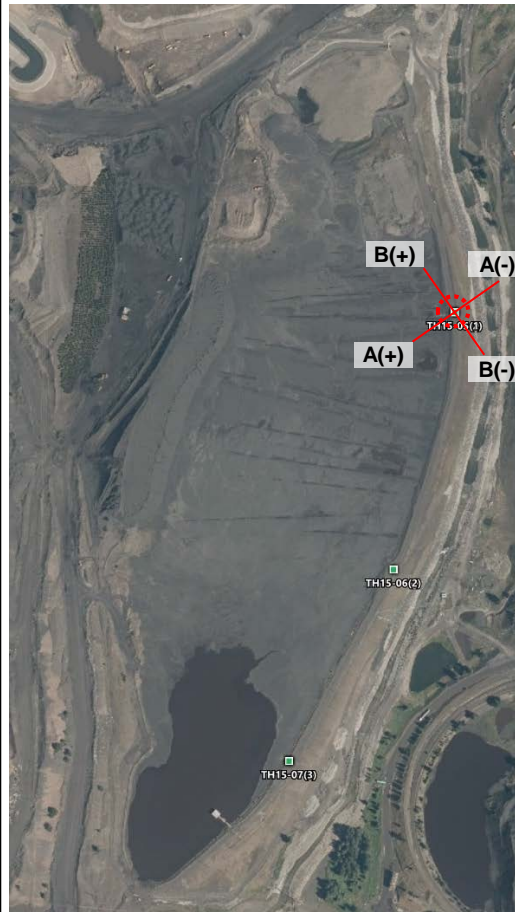
FIGURE
I-5

North Tailings Pond, Inclinator TH15-05
Fording River Operations

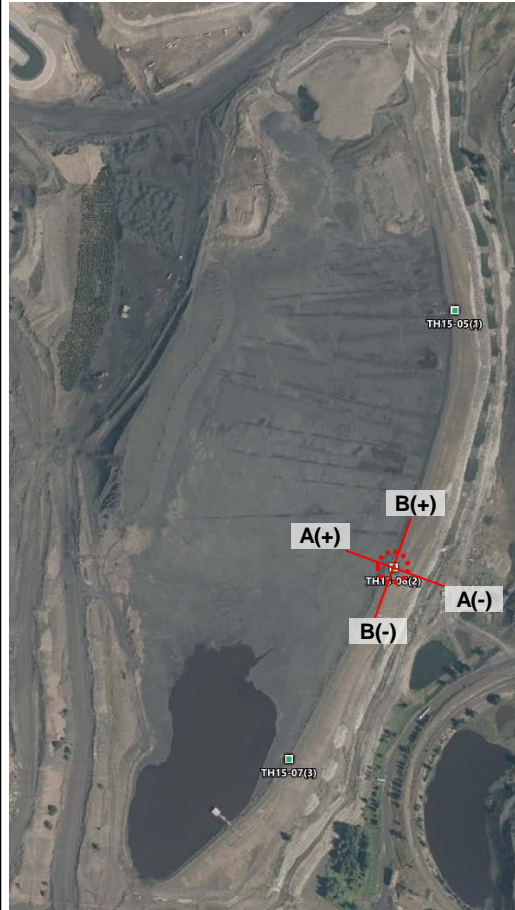
FIGURE
I-6

North Tailings Pond, Inclinator TH15-06
Fording River Operations
