2019 Dam Safety Inspection

Greenhills Operations Tailings Storage Facility

Teck Coal Limited

Reference No. 18110798-2019-148-R-Rev0-3000

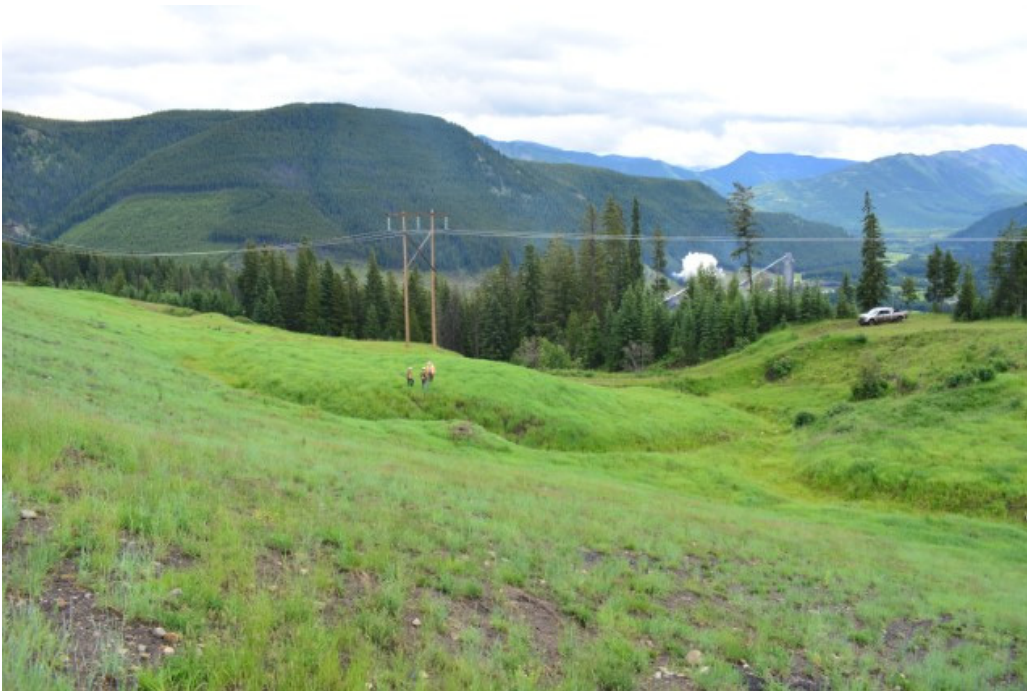
Photograph 12: Site D Coarse Coal Refuse Spoil– Downstream Toe Area; looking Southeast, 17 July 2019

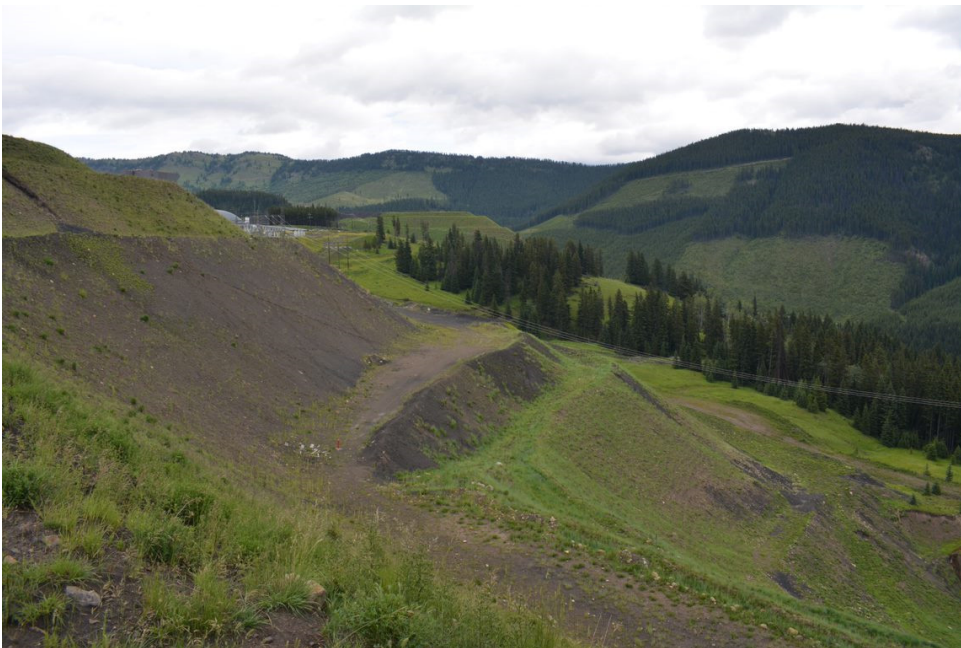
Photograph 18: Site C Coarse Coal Refuse Spoil – looking East, 17 July 2019
