# 2019 Dam Safety Inspection

*Pine Point Tailings Impoundment Area, Pine Point, NT*

**Golder Associates Ltd.**

8 November 2019

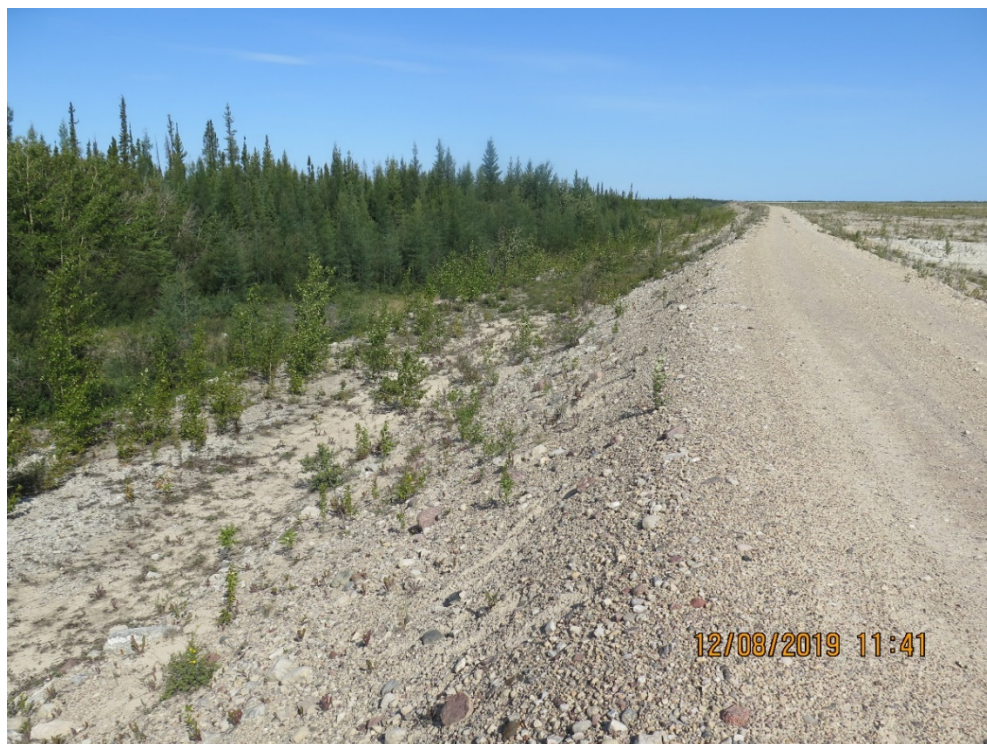
**Photograph 4: West Dyke – Downstream Slope and Toe Area Near South End, Looking North, 12 August 2019**

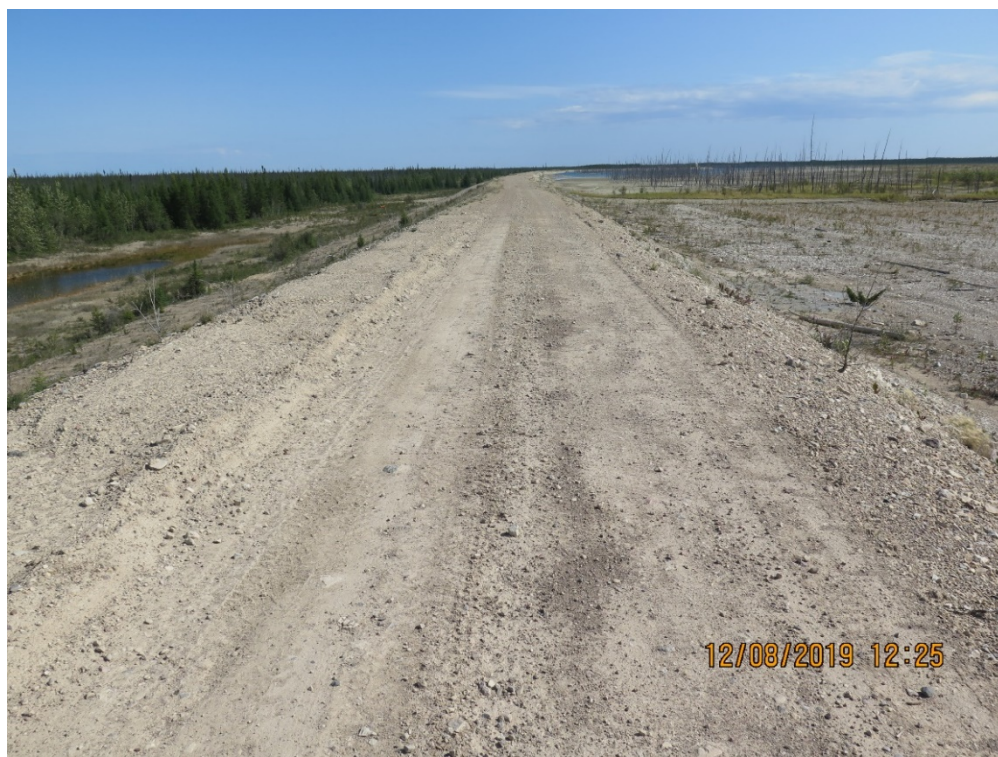
**Photograph 10: North Dyke – Crest Near West End, Looking Northeast, 12 August 2019**

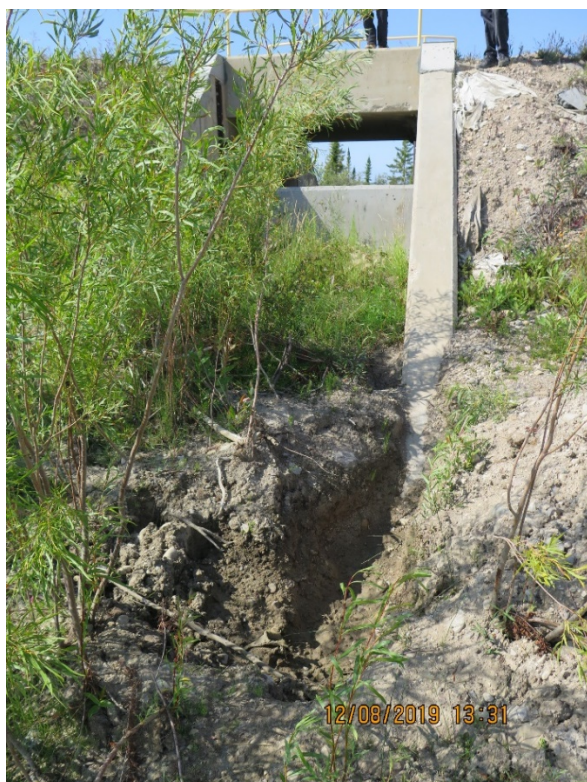
**Photograph 16: Main Pond Spillway – Excavation Near Toe of Wall on Upstream Side, Looking East, 12 August 2019**

Main Pond Spillway	<input checked="" type="checkbox"/>	New excavation up to 50 cm depth around the base of the concrete wing wall on the upstream side of the spillway
Treatment Spillway	<input checked="" type="checkbox"/>	Siphons in place
Other -(photos)	N/A	Photographs – 8 to 19 (Attachment 1)
Notes:		Seepage with red staining in area downstream of dogleg
<b>East Dyke</b>		
Ponded Water	<input checked="" type="checkbox"/>	Dyke not retaining water Tailings upstream of dyke in non-vegetated area
Erosion	<input checked="" type="checkbox"/>	Minor rilling on upstream and downstream slopes up to 10 cm deep
Settlement/Depressions	<input checked="" type="checkbox"/>	None
Sinkholes	<input checked="" type="checkbox"/>	None
Cracks/Movement	<input checked="" type="checkbox"/>	None
Debris	<input checked="" type="checkbox"/>	None
Vegetation	<input checked="" type="checkbox"/>	On upstream and downstream slopes
Other -(photos)	N/A	Photograph 20 (Attachment 1)

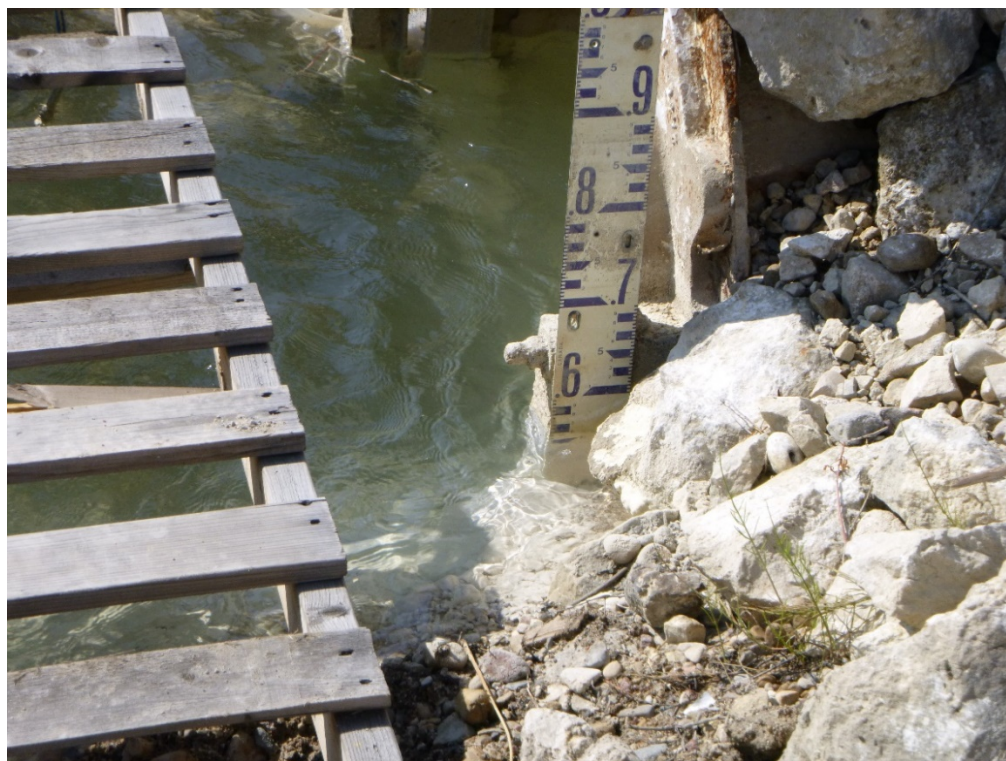
- The impoundment water level was 0.558 m at the staff gauge at the culvert through the polishing pond dyke (Photograph 19), interpreted to be elevation 200.558 m.

**Photograph 19: Main Pond Water Level Gauge at Culvert Intake to Polishing Pond (Elevation 200.558 m),  
12 August 2019**

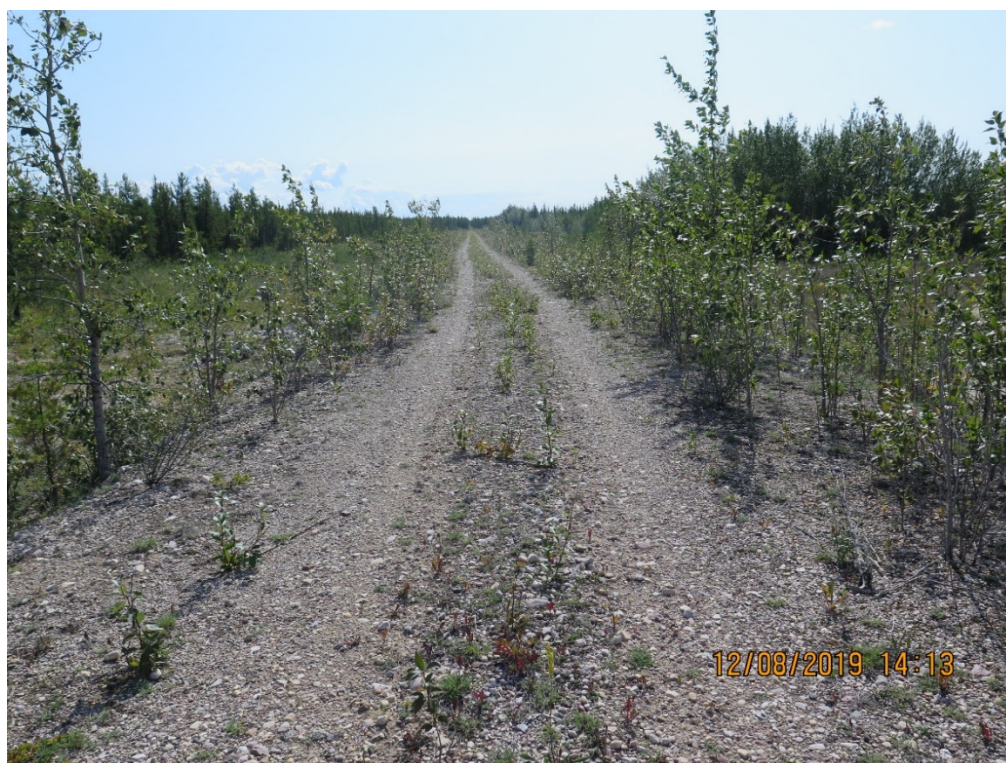
**Photograph 20: East Dyke – Crest, looking South, 12 August 2019**
