October 24, 2019

Reference No. 18113464-004-L-Rev1-3000-TBD

## **Red Dog Tailings and Water Department**

## **2019 ANNUAL PERFORMANCE REPORT FOR TAILINGS BACK DAM, RED DOG MINE, ALASKA**

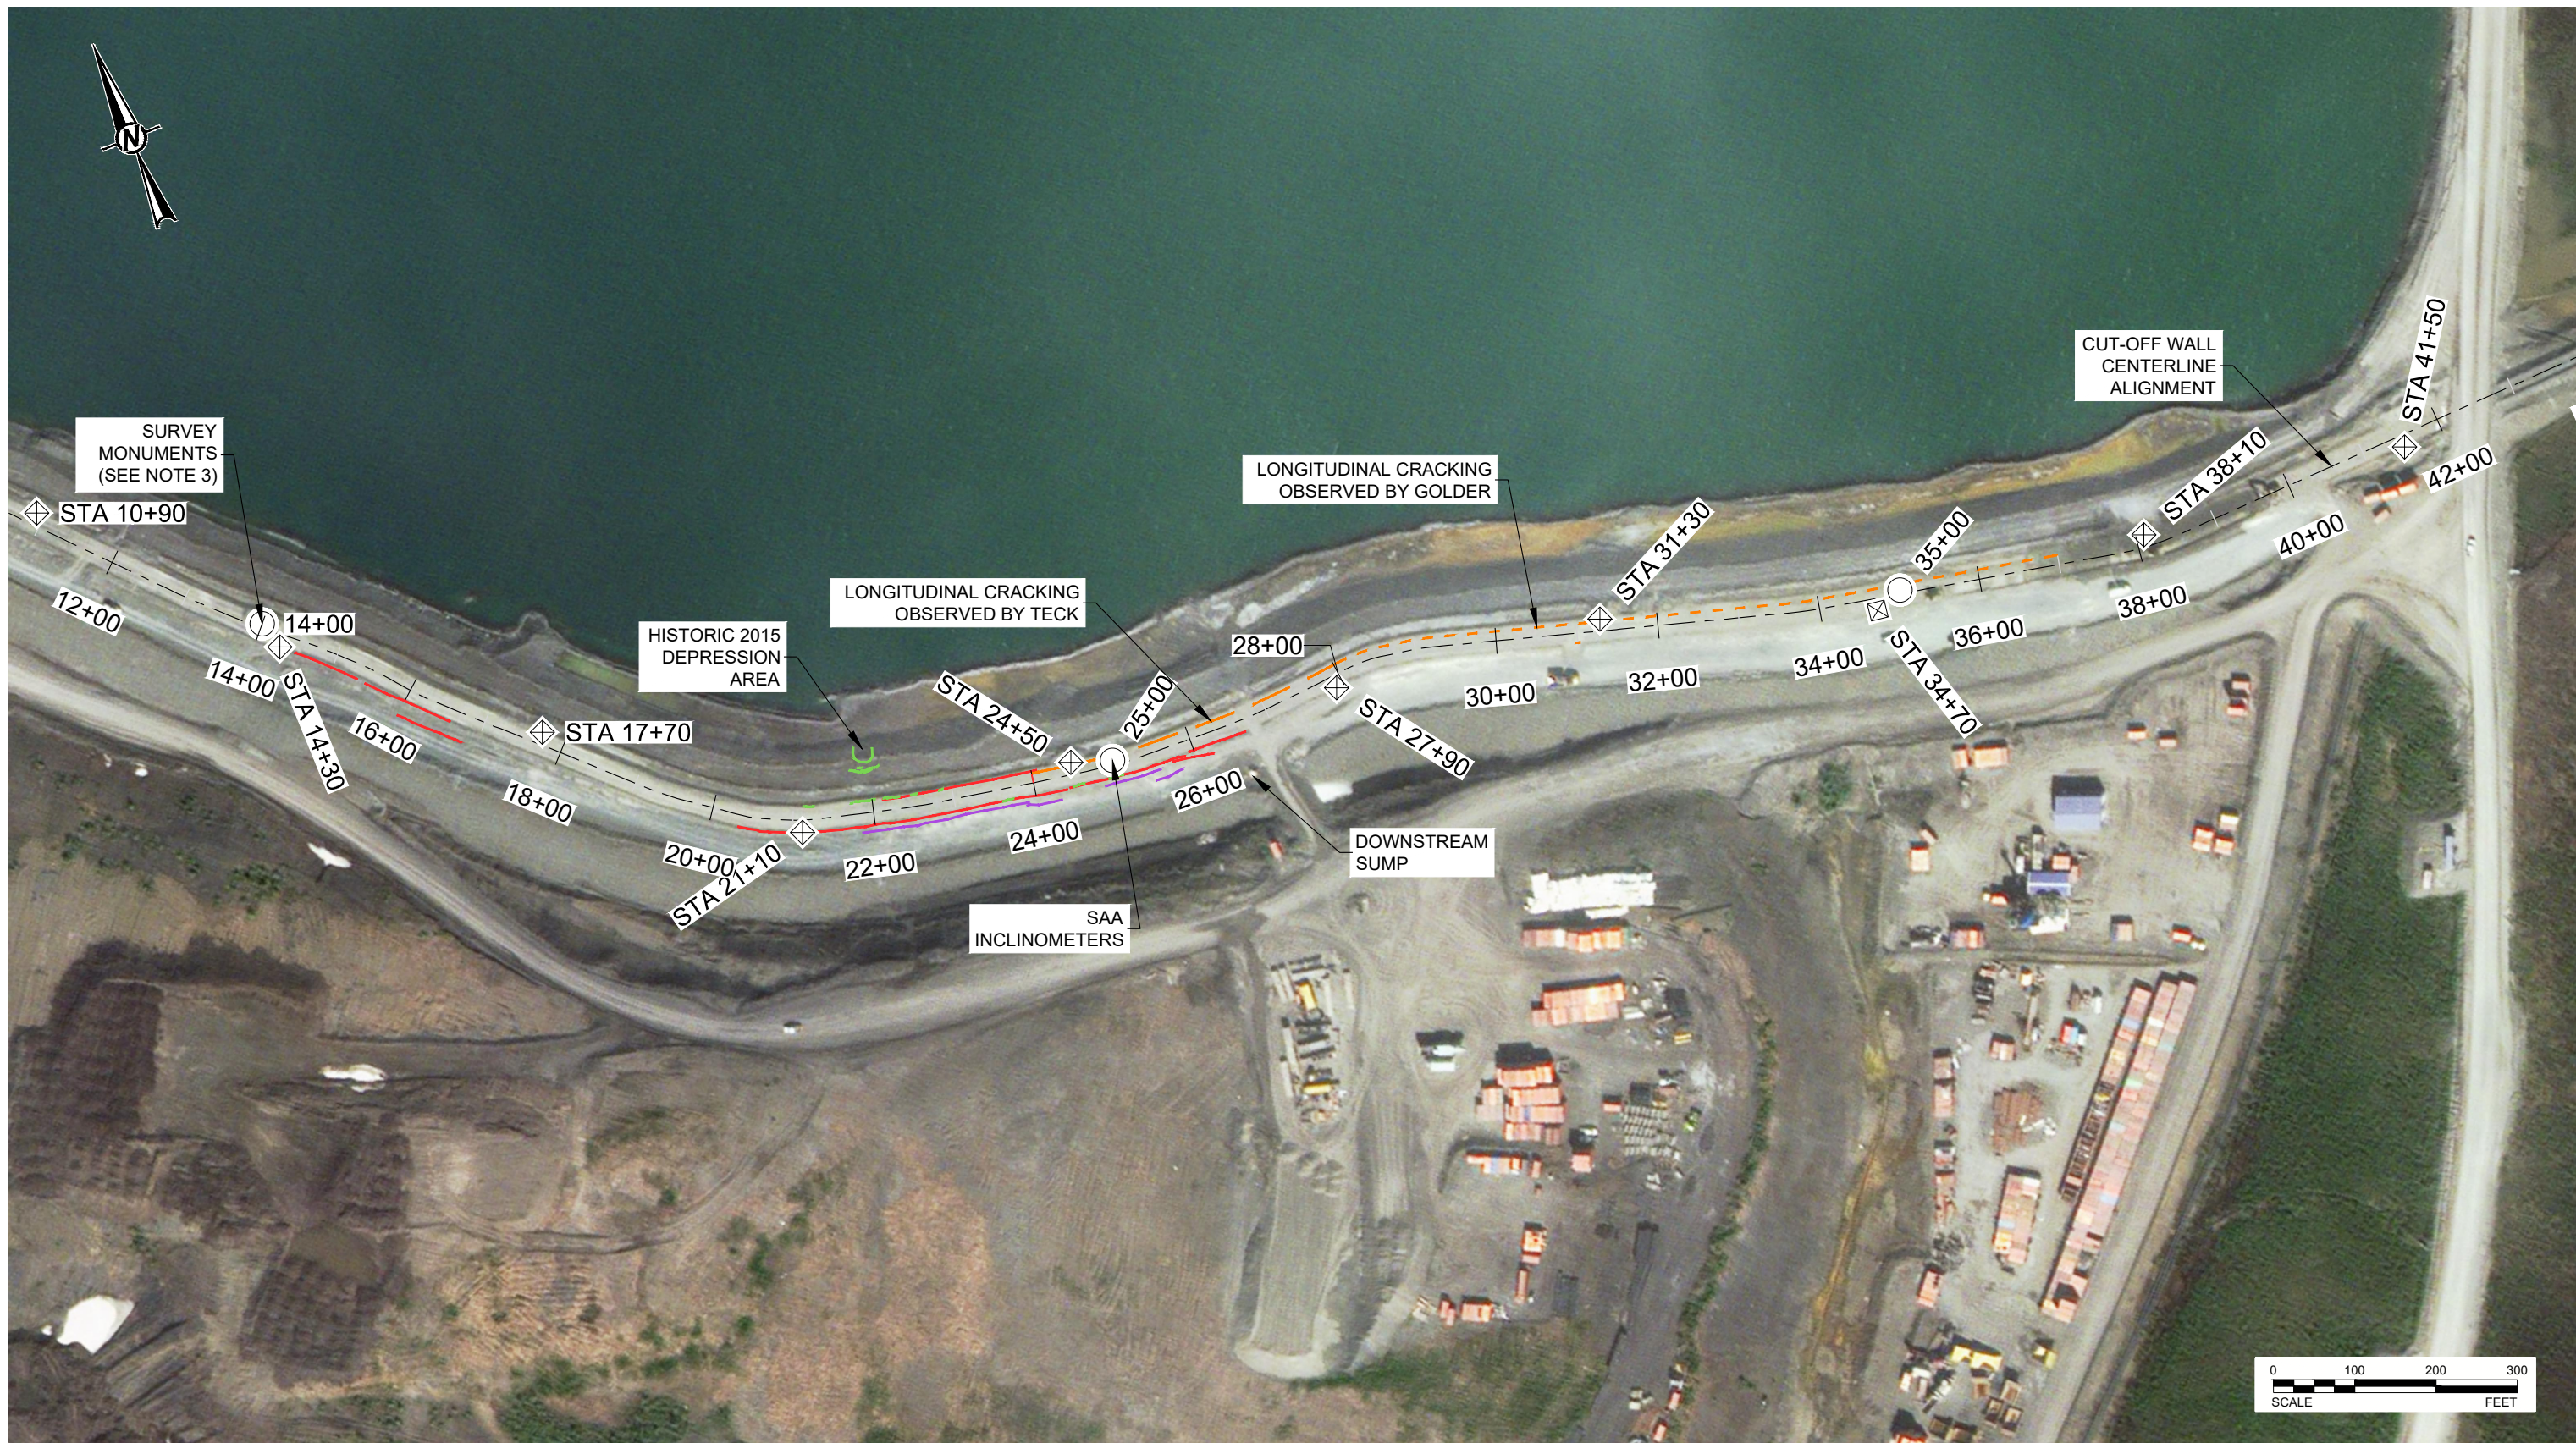
TITLE  
HISTORIC CRACKING ALONG DAM ALIGNMENT

Most of the cracks observed in 2018 were surveyed at the locations shown in Figure 5; however, those observed in September 2018 and those in 2019 were not.

- Historic longitudinal cracking between Stations 20+00 and 27+00 near the interface of the select fill and rockfill materials was not visible during inspection due to the Stage IV embankment raise construction. However, Teck and Golder CQA personnel observed and documented longitudinal cracking at the select fill and mineralized rockfill interface from Station 23+75 to 37+00, which is within the area where ice-rich materials were encountered during historic investigations (see Figure 2). Per design, this cracking is understood to be related to consolidation of thawed foundation materials below the rockfill and is not considered to be a concern for the performance of the COW or the stability of the embankment. Movement monitoring data in this area via SAA inclinometers and survey monuments also reflect these observed deformations, but the movements are within the design tolerance and have not hindered the performance of the COW.

- Install two additional SAA inclinometers, one upstream and one downstream of the COW, where cracks have been observed in the TBD crest (such as near survey monument Mon-15-05) to better characterize movements and compare with the numerical model (PSI-R-04, -10). Installation of these two additional SAA inclinometers is currently planned likely in the vicinity of Station 22+00 following completion of Stage VI raise construction.

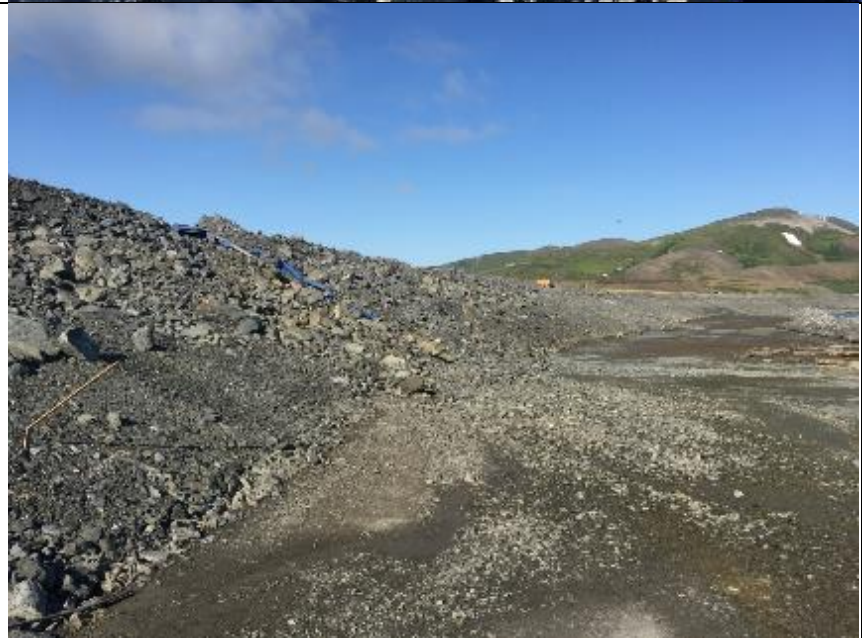
**PHOTO 14**

- Erosion of the upstream embankment face was observed in areas where seepage pumpback was discharged onto the slope near Station 26+50 (Photo 14) and Station 34+00 (Photo 17).
- Undocumented fill was placed on the crest of the east abutment to form an access road (Photo 21).

SUMP PUMPHOUSE  
DISCHARGE EROSION ON  
UPSTREAM FACE NEAR  
STATION 26+50, LOOKING  
WEST

- Repair the erosion observed at the two discharge locations near Station 26+50 and Station 34+00 and extend the discharge pipes into the impoundment or provide rip rap to prevent erosion from occurring in the future.

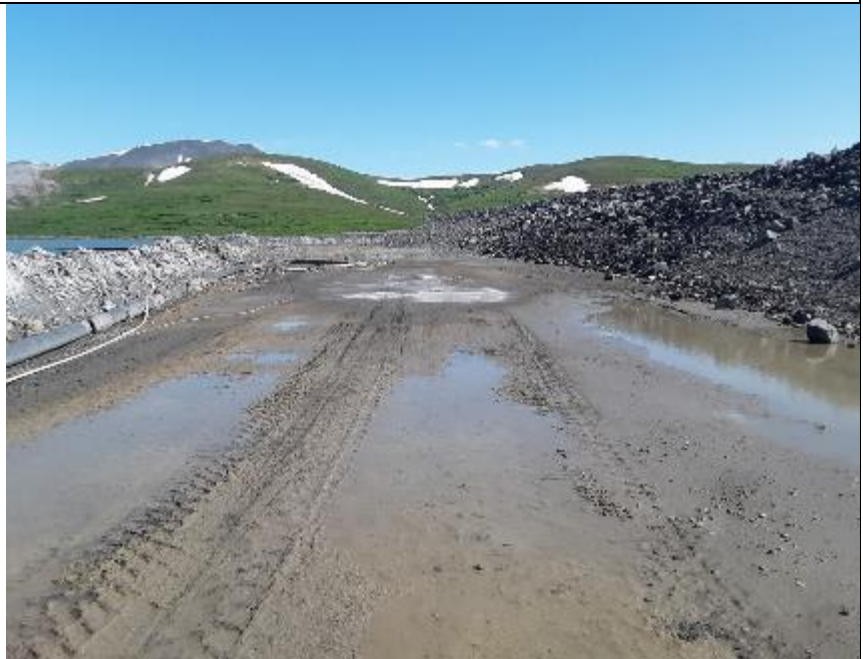
**PHOTO 16**

DAM CREST AND SAA  
35+00 NEAR STATION  
33+00, LOOKING EAST

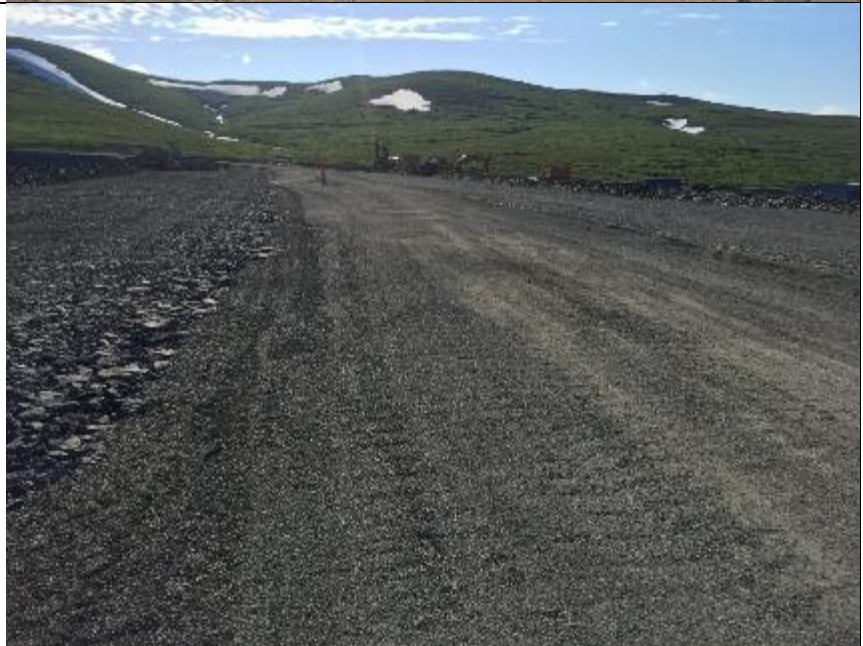
**PHOTO 18**

DOWNSTREAM  
EMBANKMENT SLOPE  
NEAR STATION 36+50,  
LOOKING WEST

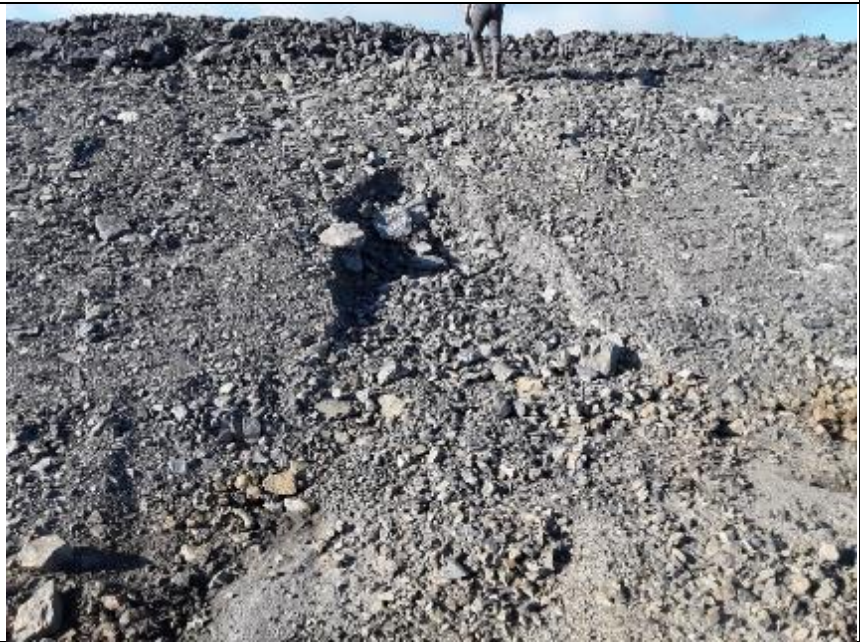
**Appendix A: Photographs****PHOTO 17**

OVERBURDEN STOCKPILE  
PUMPBACK DISCHARGE  
EROSION ON UPSTREAM  
FACE NEAR STATION 34+00,  
LOOKING SOUTH

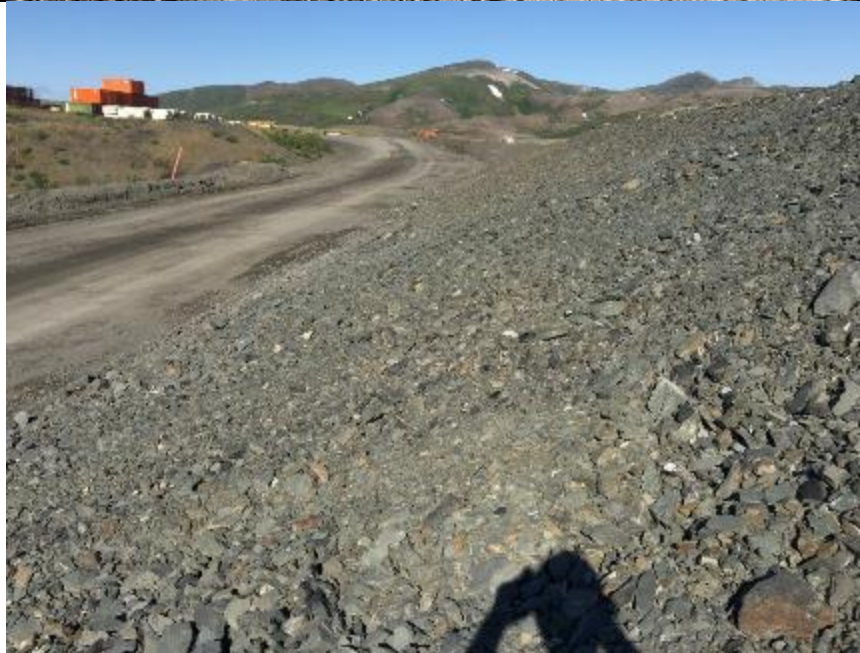
**Appendix A: Photographs****PHOTO 19**

DOWNSTREAM  
EMBANKMENT SLOPE  
NEAR STATION 39+50,  
LOOKING WEST

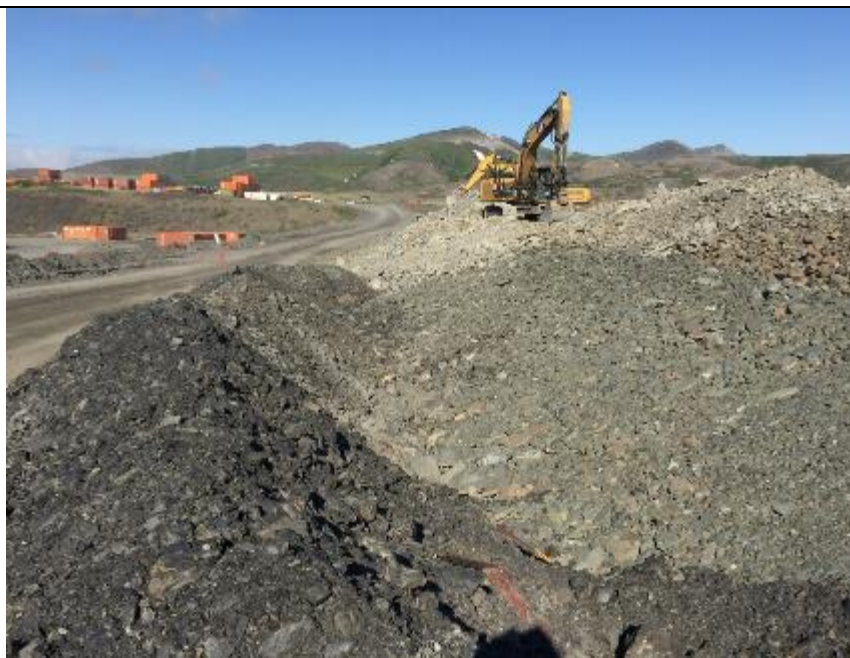
**PHOTO 20**

UPSTREAM SLOPE AND  
COFFERDAM ROAD NEAR  
STATION 41+00, LOOKING  
WEST

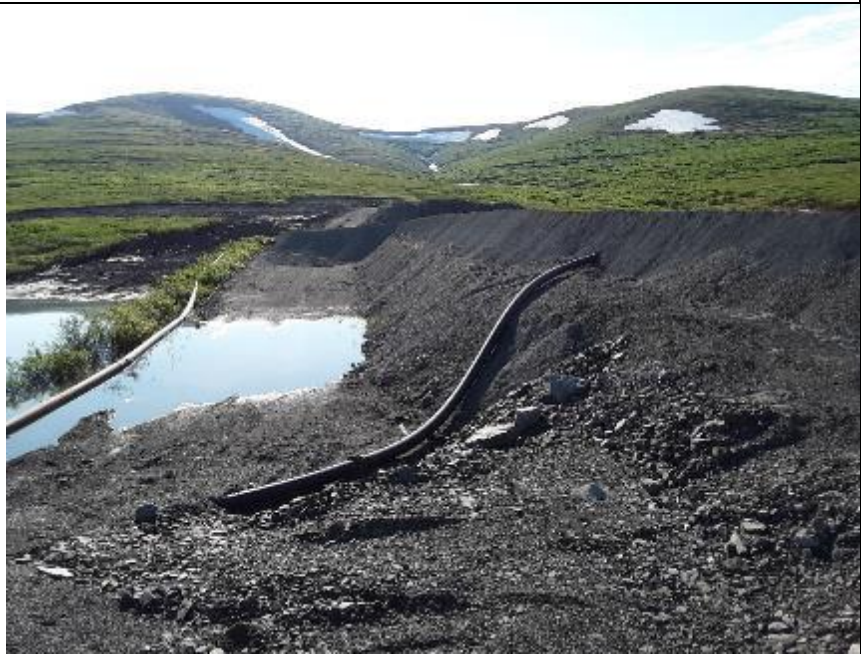
**Appendix A: Photographs****PHOTO 21**

PIPE CROSSING AND  
UPSTREAM SLOPE NEAR  
STATION 43+00, LOOKING  
EAST

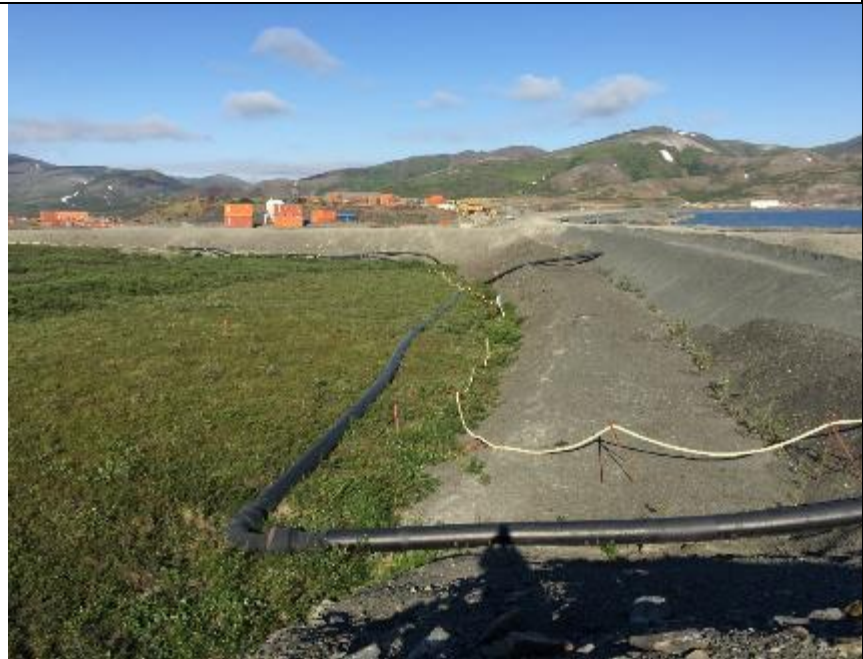
**PHOTO 24**

- Similar to previous inspections, longitudinal cracking was observed along the downstream crest of the east abutment near Station 49+00 (Photo 24) and within the downstream rockfill about 8 feet from the crest near Station 45+00 (Photo 22). This cracking was observed during previous inspections and initially observed during the 2014 periodic safety inspection (PSI). The length and width of the cracking appeared to be similar to what has been previously observed. As described in previous reports, this cracking is not a stability concern and poses no risk to the COW.

HISTORIC CRACKING AT  
DOWNSTREAM  
EMBANKMENT CREST  
NEAR STATION 49+00,  
LOOKING WEST

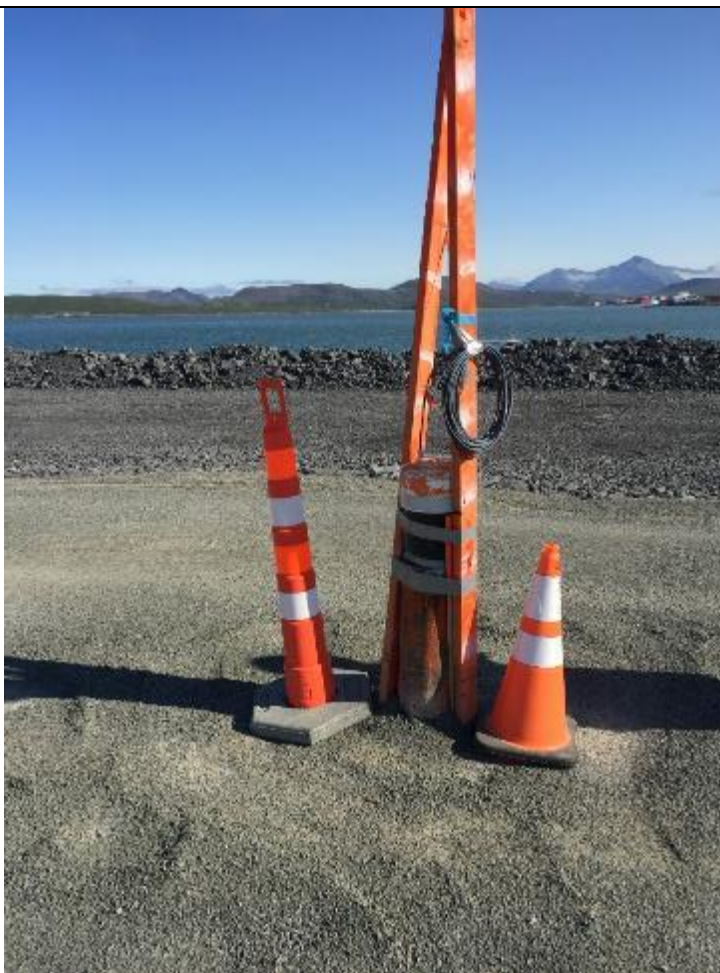
**PHOTO 30**

UPSTREAM PIEZOMETER  
P-15-137 CABLE  
EXTENSION NEAR STATION  
32+00, LOOKING  
SOUTHWEST
