October 24, 2019

Reference No. 18113464-005-L-Rev0

2019 ANNUAL PERFORMANCE REPORT FOR TAILINGS MAIN DAM, RED DOG MINE, ALASKA**Tailings and Water Team:**

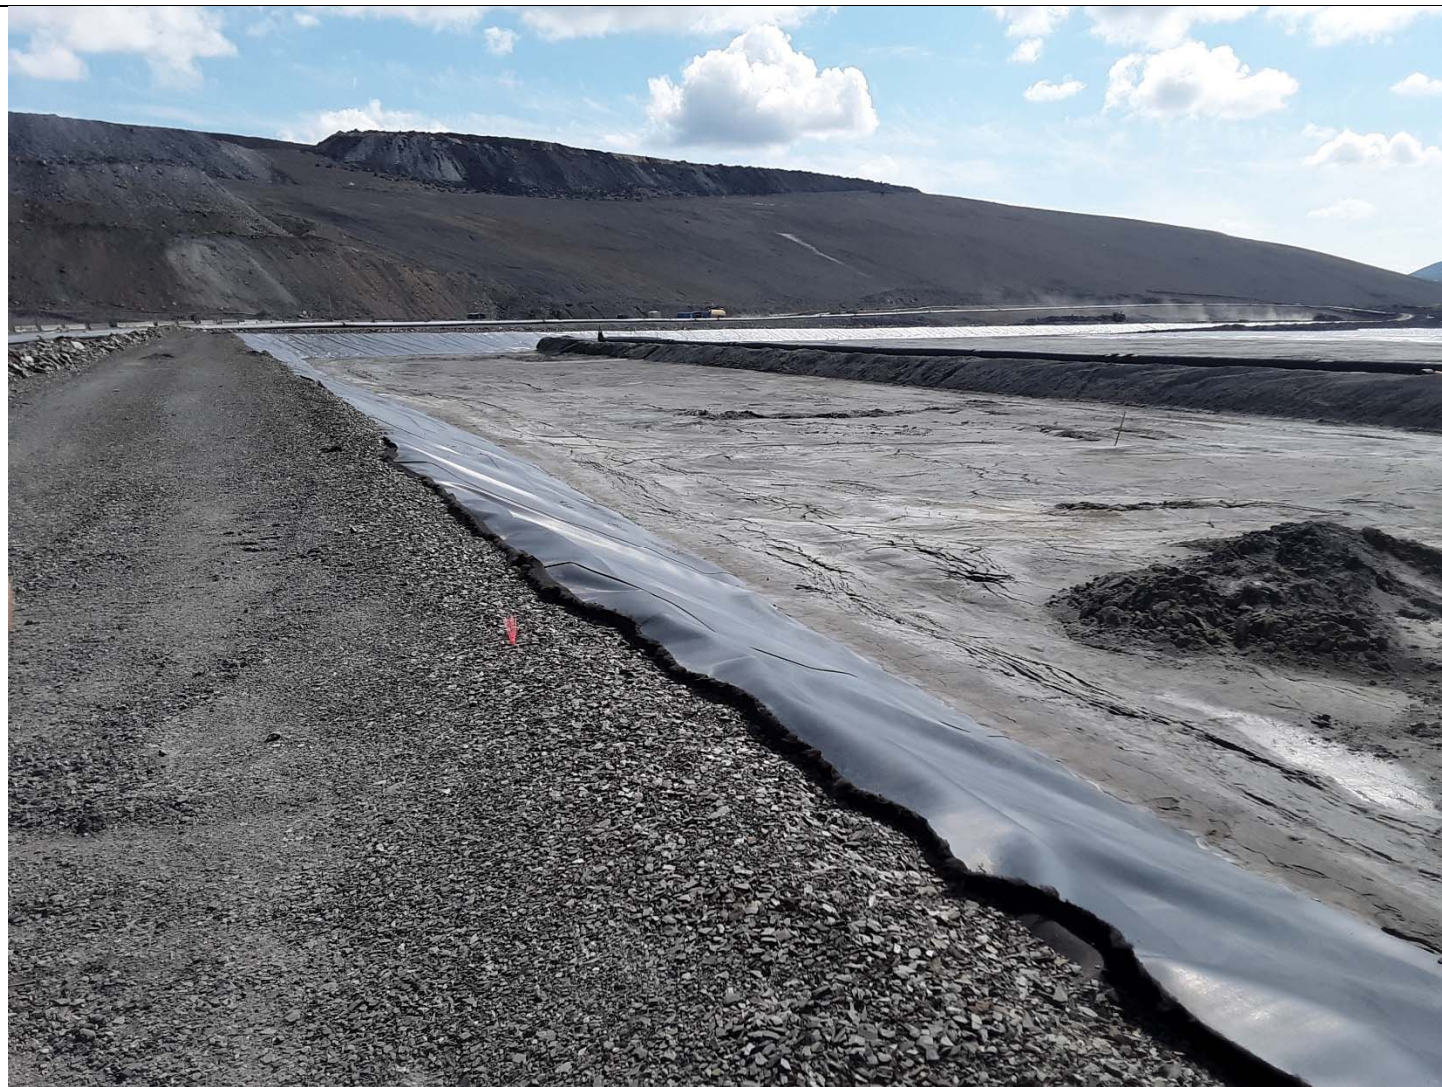
PHOTO 2

UPSTREAM LINER AT TMD
EMBANKMENT, LOOKING
SW FROM PIPELINE
CORRIDOR

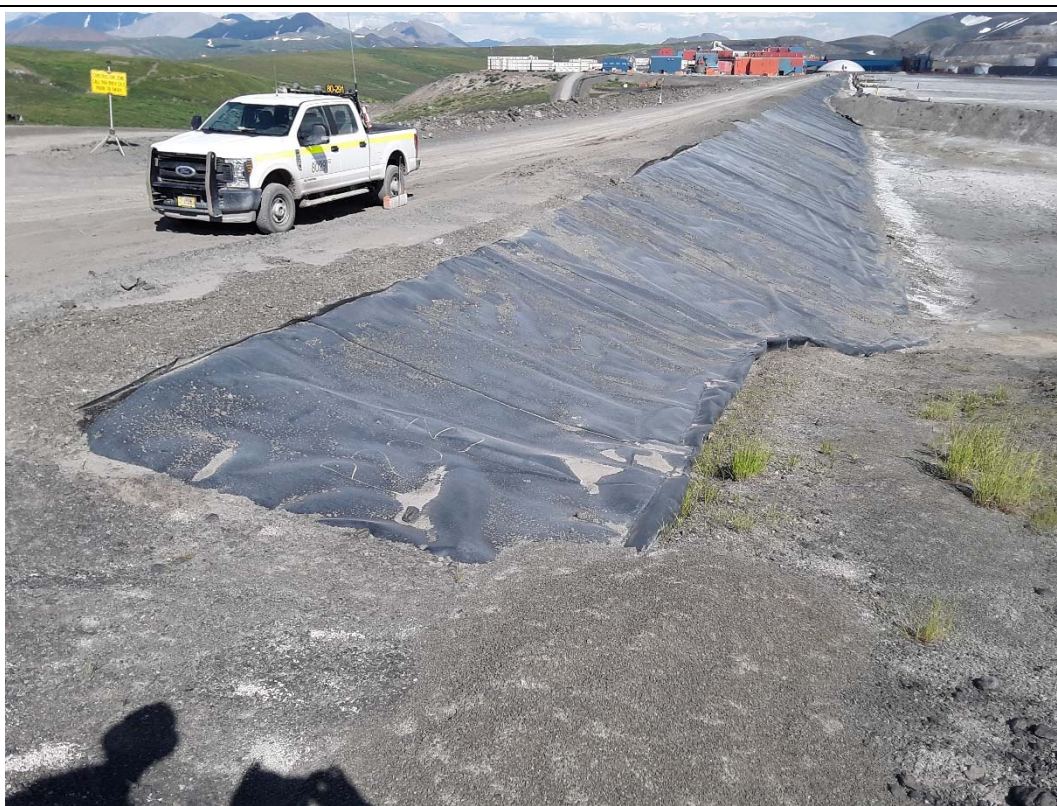
**PHOTO 4**

TMD
EMBANKMENT
WEST ABUTMENT,
LOOKING W

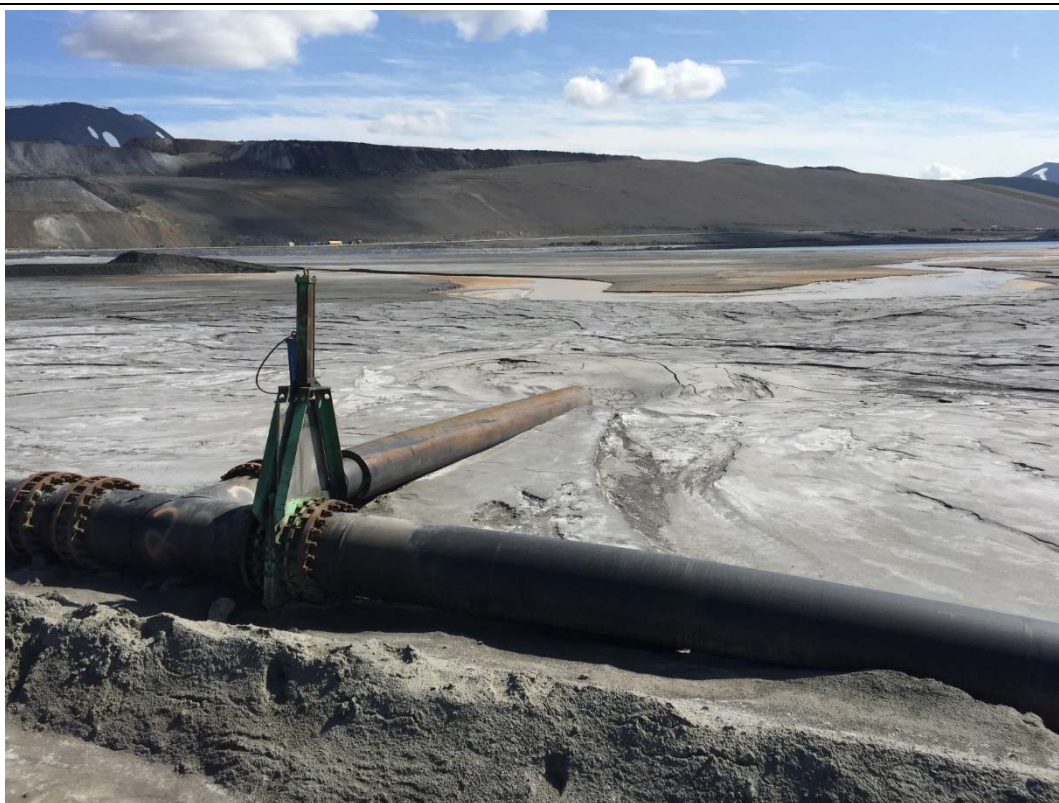
**PHOTO 8**

- The tailings beach appeared to be flatter and smoother as compared to observations during previous inspections (Photos 2, 5, and 7 to 9). An area where the tailings pipe bench had been washed out was observed near Piezometer P-11 (Photo 8).

PIPE BENCH
WASHOUT NEAR
PIEZOMETER
P-11, LOOKING
SW

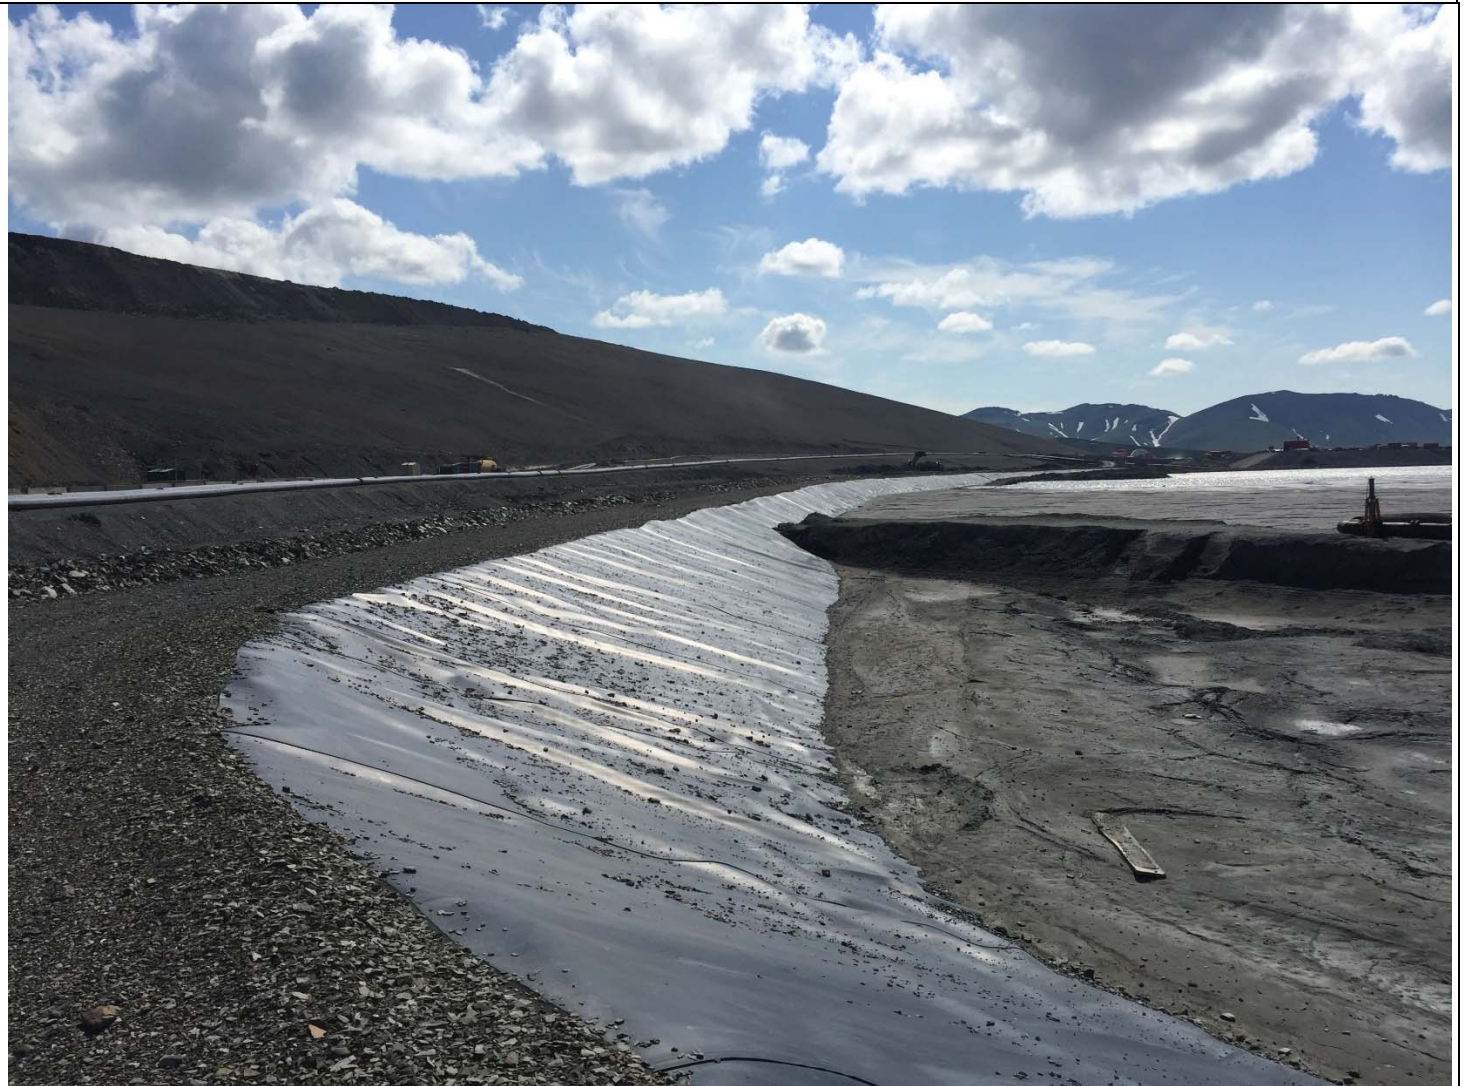
Appendix A: Photographs**PHOTO 10**

WING WALL
DOWNSTREAM
SLOPE NEAR
POWER HOUSE,
LOOKING NE

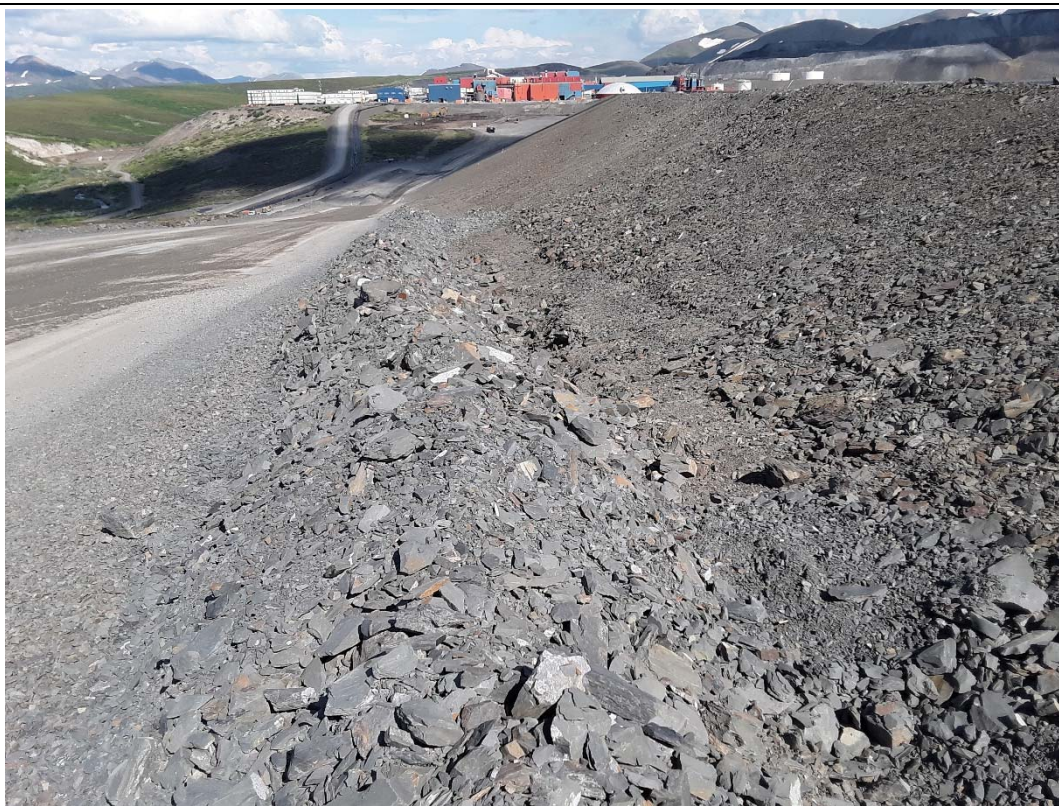
**PHOTO 19**

- The downstream abutments of the TMD Main Embankment were observed (Photos 18 to 20) with no signs of instability or seepage. We also did not observe any signs of instability for the TMD Main Embankment buttress, such as cracking, slumps, or indications of lateral movement.

TMD
EMBANKMENT
WEST ABUTMENT,
LOOKING UP
SLOPE FROM
BUTTRESS

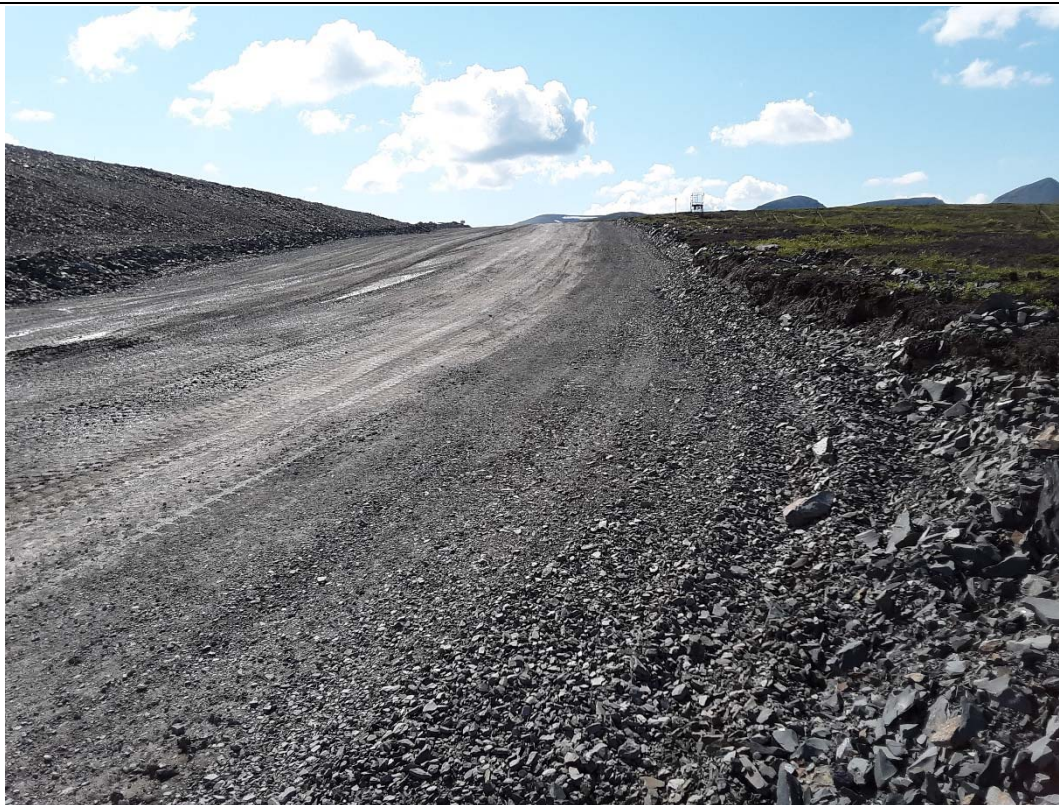
Appendix A: Photographs**PHOTO 20**

TMD
EMBANKMENT
EAST ABUTMENT,
LOOKING NW
DOWN SLOPE

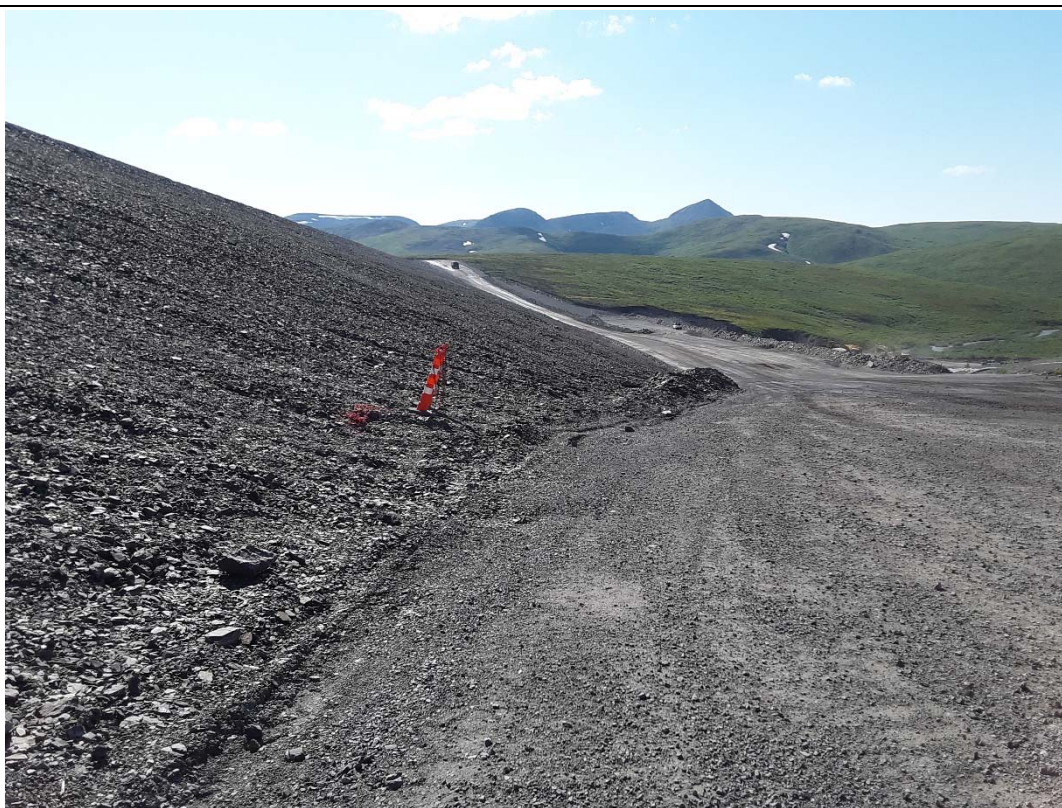
**PHOTO 21**

TMD
EMBANKMENT
DOWNSTREAM
SLOPE FACE,
LOOKING W

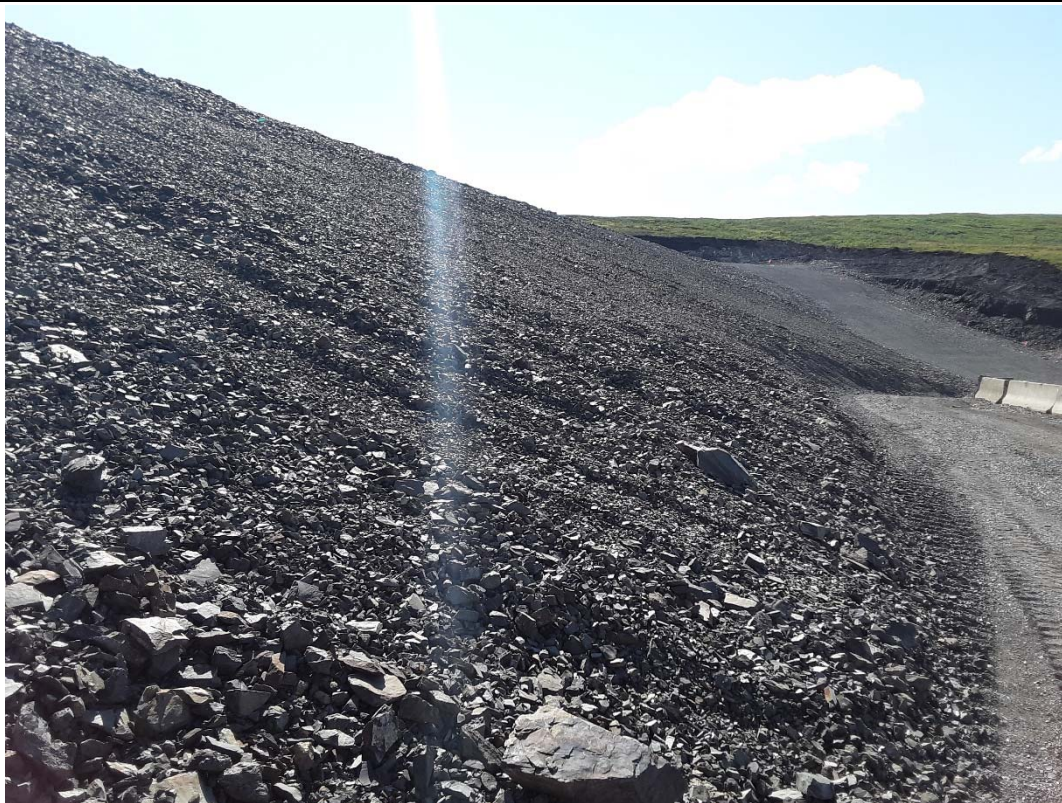
Appendix A: Photographs**PHOTO 22**

TMD EMBANKMENT
DOWNSTREAM
SLOPE AND EAST
ABUTMENT, LOOKING
SE FROM BUTRESS

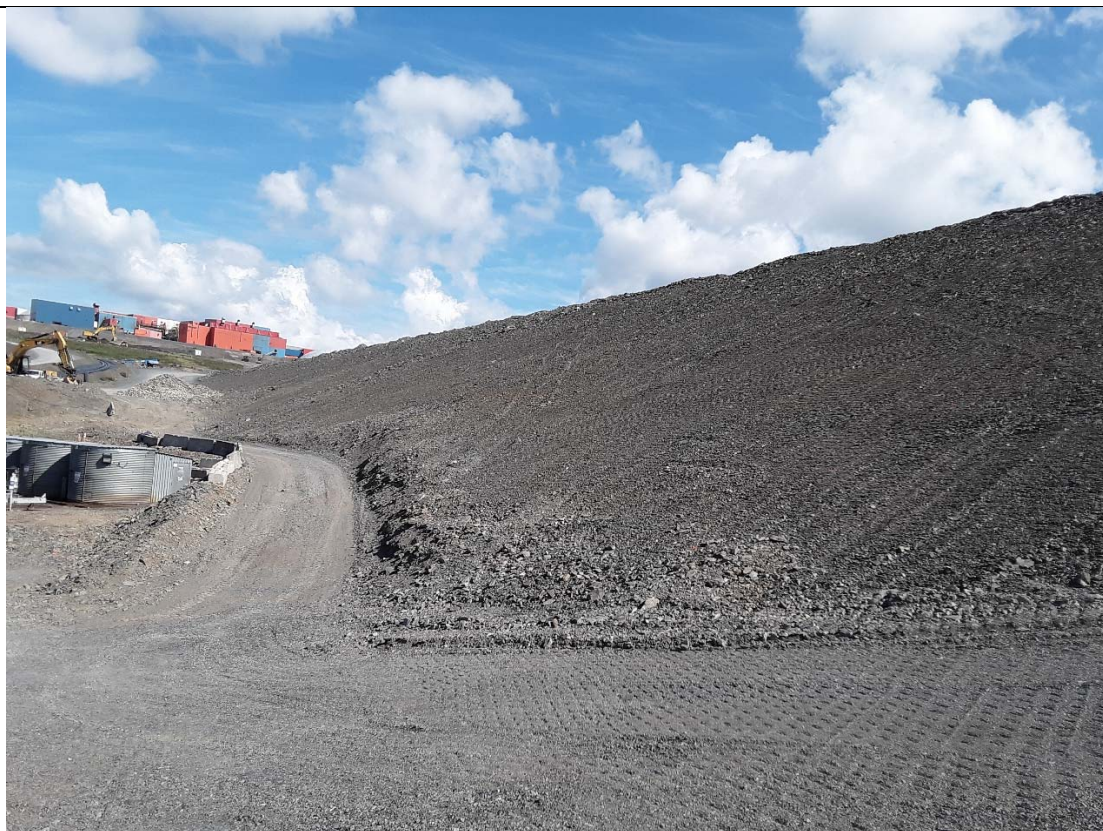
**PHOTO 23**

TMD EMBANKMENT
DOWNSTREAM
SLOPE AND WEST
ABUTMENT, LOOKING
W FROM BUTRESS

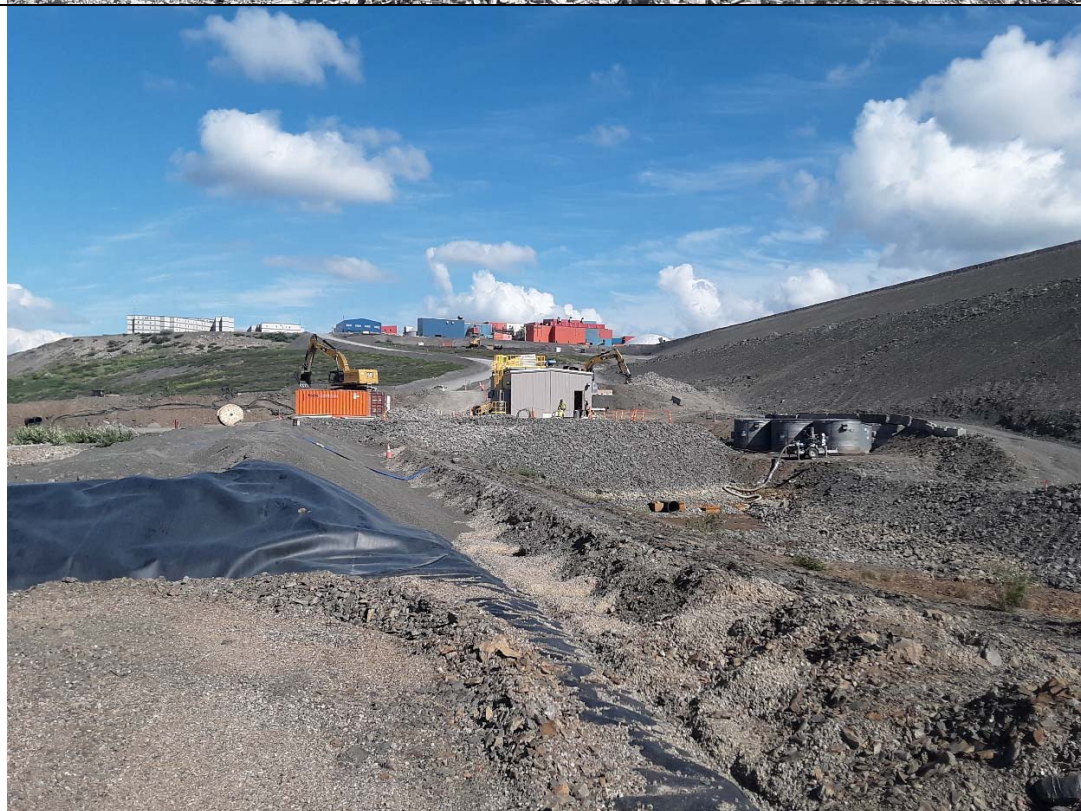
Appendix A: Photographs**PHOTO 26**

- The SCP was at an elevation of about 789 feet and the seepage collection pump station was being switched over to the newly constructed system (see Photo 25). Some iron staining was observed near the toe of the buttress and around the SCP (see Photo 26). A seep entering the SCP that appeared to be near where the underdrain connects into it, which was noted in previous inspections, was not visible during this inspection due to the dam embankment construction.

- The Seepage Collection Dam appeared to be in satisfactory condition with no indications of instability (Photos 25 and 26). The Seepage Seepage Pumpback located downstream of the Seepage Collection Dam was also observed (Photo 27) and did not appear to be actively pumping at that time.

SEEPAGE
COLLECTION DAM
AND POND, LOOKING
NE
