Beaverdell Tailings Storage Facilities

2020 Annual Facility Inspection Report

Golder Associates Ltd.

Reference No. 20140466-275-R-Rev0-1000

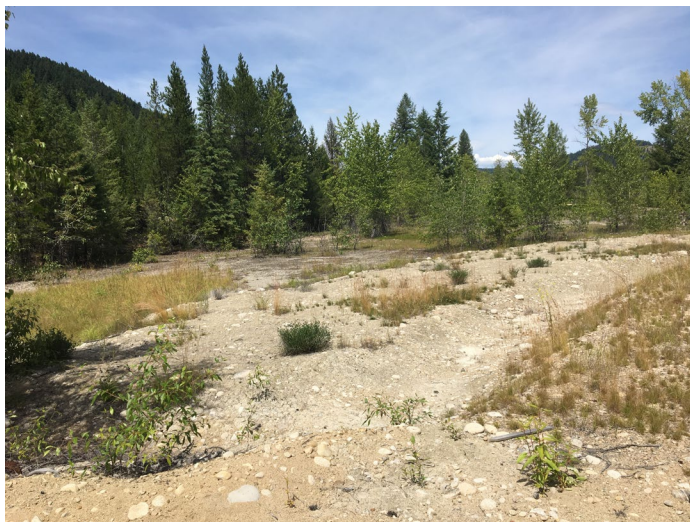
Photograph 1: South TSF Cell 1, tailings surface, looking northeast. 21 July 2020.

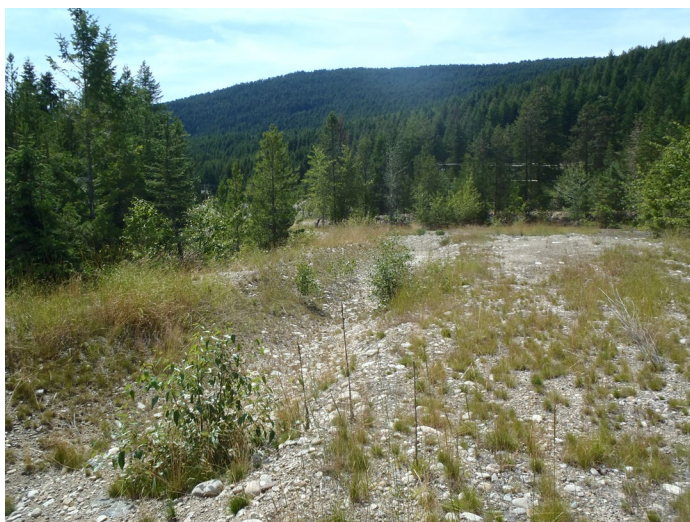
Photograph 3: South TSF, Cell 1, crest and upstream ditch, looking southwest. 21 July 2020.

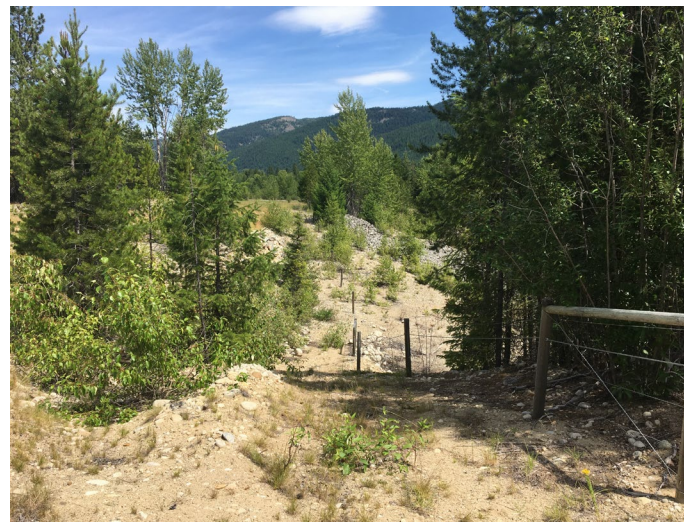
Photograph 4: South TSF, Cell 1, downstream slope, looking northeast. 21 July 2020.

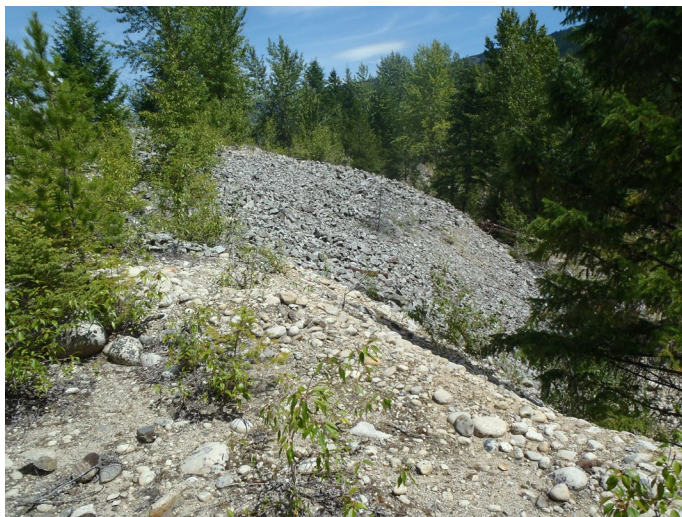
Photograph 5: South TSF, Cell 5, downstream slope waste rock, looking east.
21 July 2020.

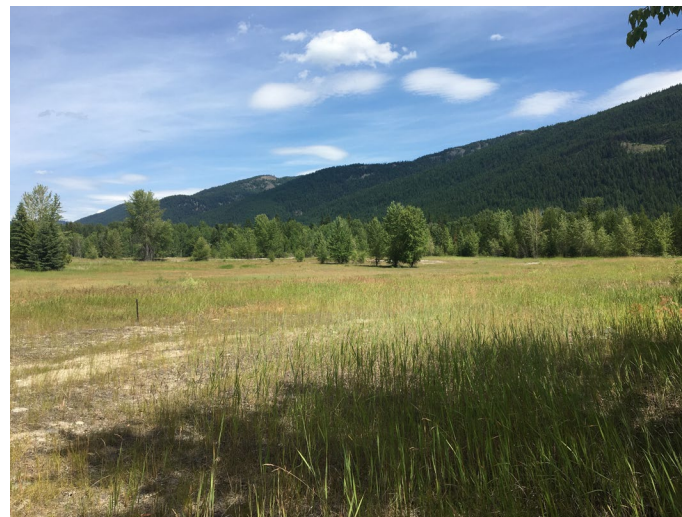
Photograph 6: South TSF, Cell 5, tailings surface, looking northeast. 21 July 2020.

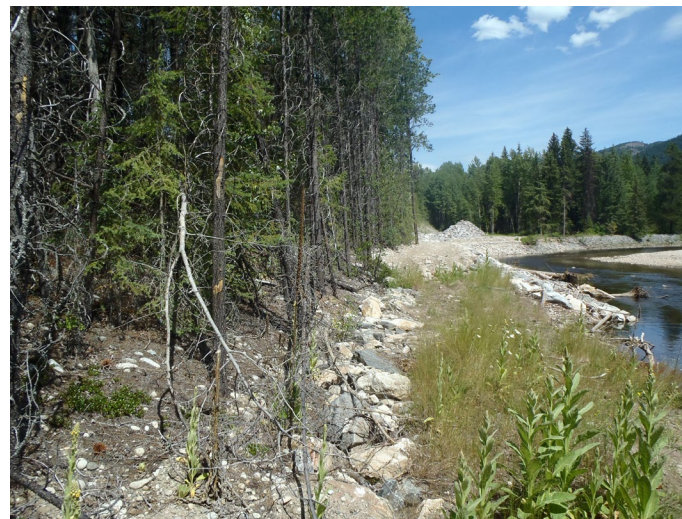
Photograph 8: South TSF, Cell 5, downstream dam slope, looking northeast.
21 July 2020.

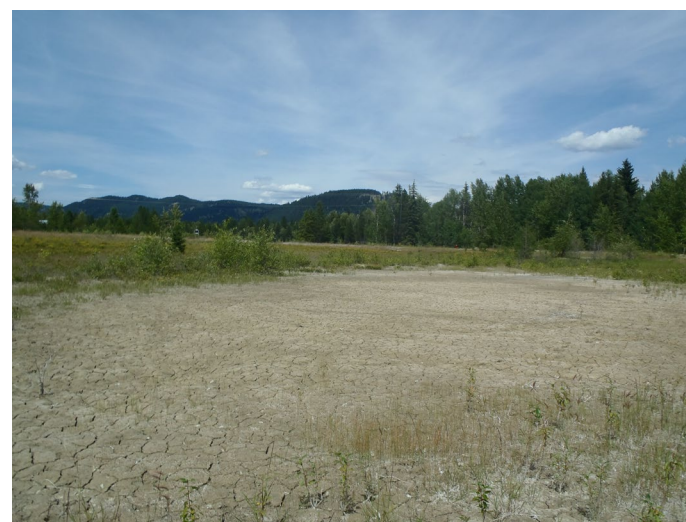
Photograph 11: South TSF, Cell 4, tailings surface, looking northwest.
21 July 2020.

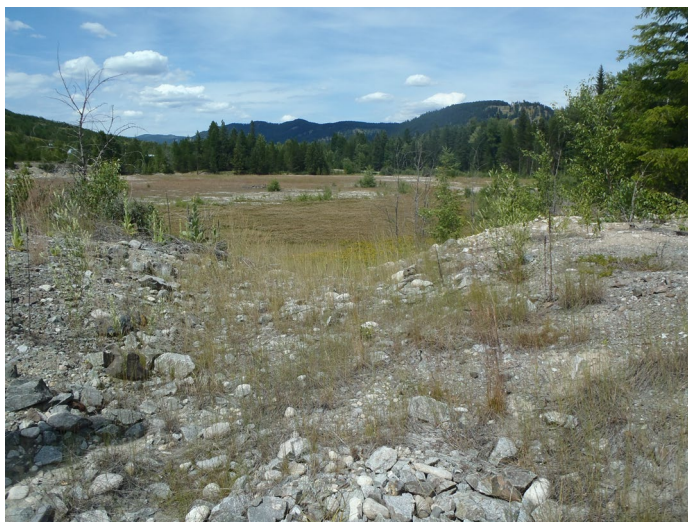
Dimensions of the internal spillways through the cells have been determined based on the 2018 LiDAR survey data and observations made during site inspections. The spillway through the Cell 3/4 divider dyke has a base width of 3 m, a minimum depth of 1 m, lateral slopes of 2H:1V, and an invert elevation of approximately 784.5 m. It is trapezoidal in shape, partially riprap-armoured, and allows the conveyance of surface water from Cell 4 to Cell 3 (Photograph 14, Appendix B).

Photograph 14: South TSF, spillway between Cell 4 and Cell 3, looking northwest. 21 July 2020.

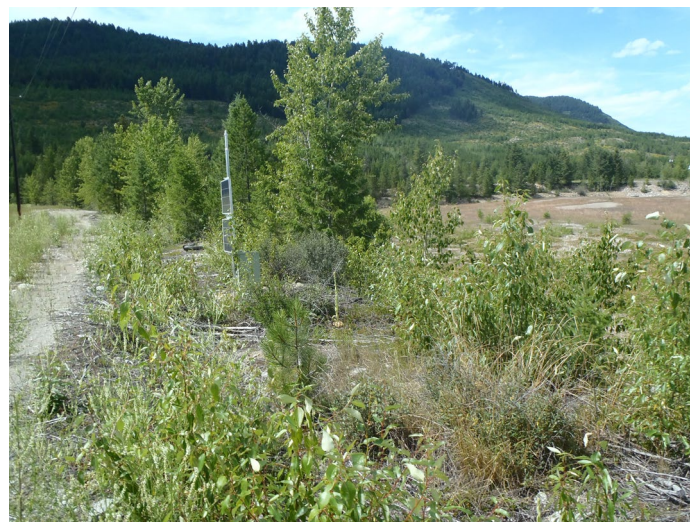
Photograph 15: South TSF, Cell 3, tailings surface and instrumentation gateway, looking west. 21 July 2020.

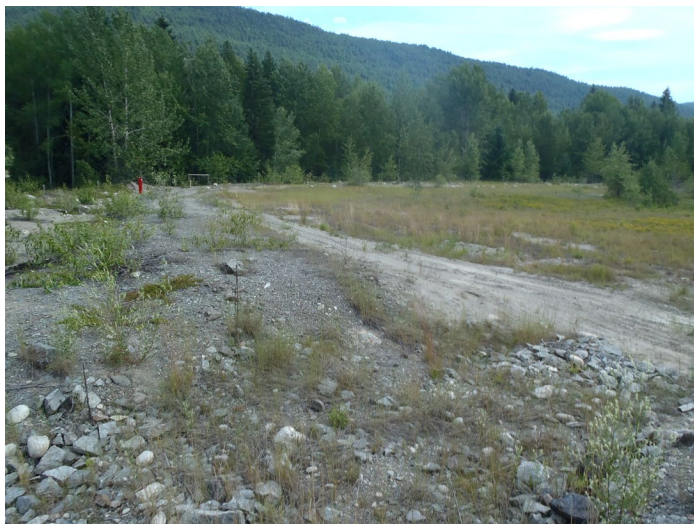
Photograph 16: South TSF, Cell 4, tailings surface and crest, looking southeast. 21 July 2020.

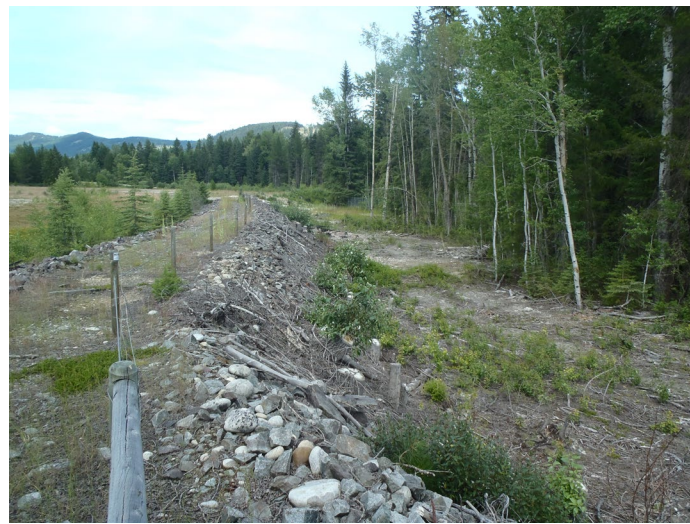
Photograph 17: South TSF, Cell 3, crest, downstream slope and toe, looking northeast. 21 July 2020.

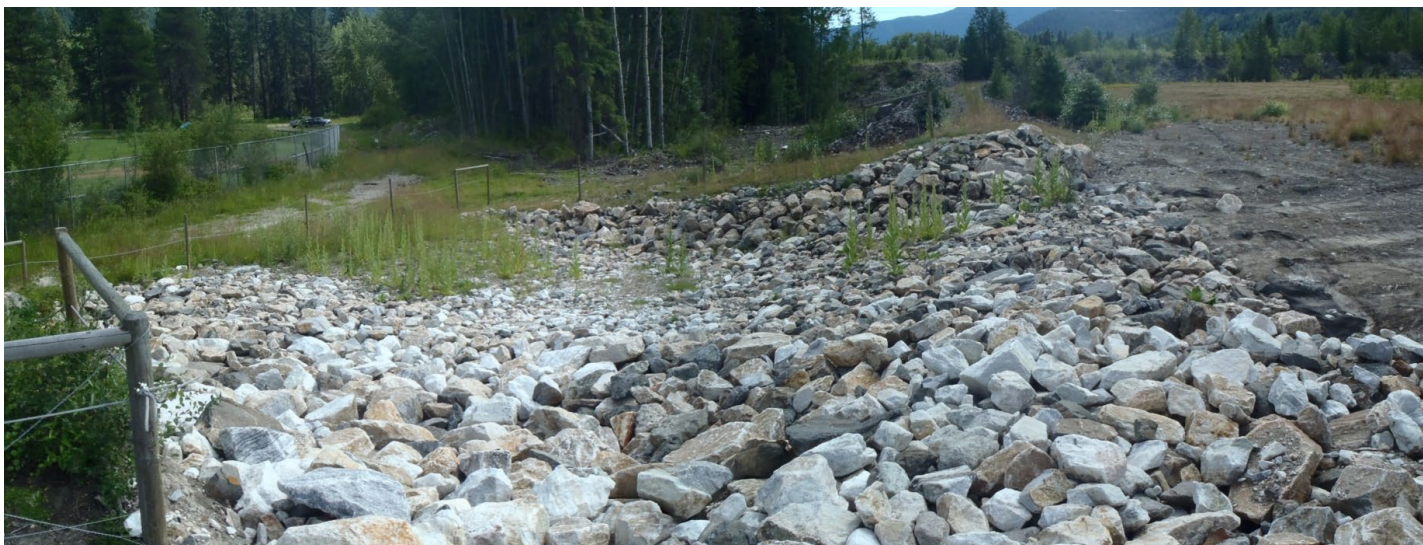
The Cell 3 external spillway, which conveys surface water from the South TSF, was upgraded on 4 July 2019. (Photograph 18, Appendix B). Based on the construction record (Golder 2019e) the Cell 3 spillway has a minimum base width of 13.6 m at the invert, a longitudinal slope of 5H:1V, and an invert elevation of 780.4 m. It is trapezoidal in shape and armoured with Class 50 riprap, minimum 0.66 m thick. The spillway is capable of conveying the 24-hour probable maximum flood (PMF).

Photograph 18: South TSF, Cell 3, spillway downstream, looking southeast. 21 July 2020.

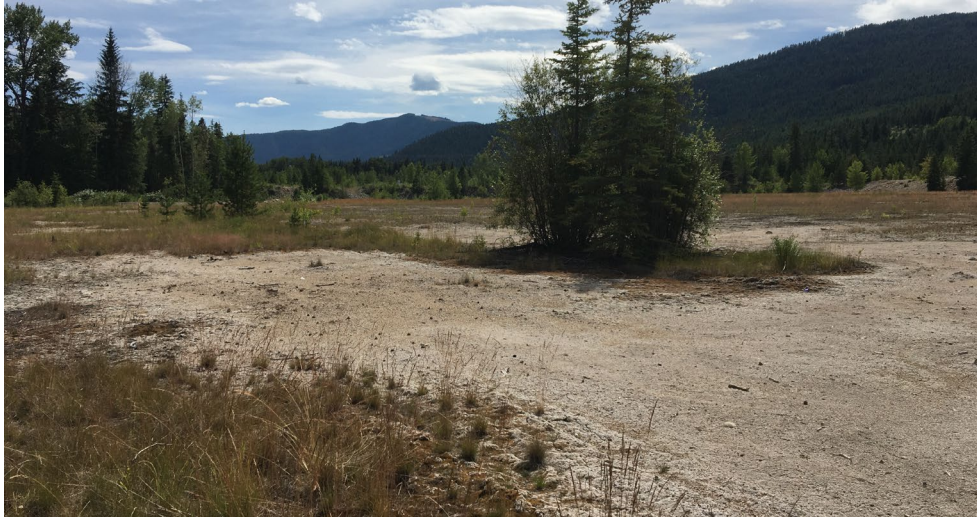
Photograph 19: South TSF, Cell 3, tailings surface, looking south. 21 July 2020.

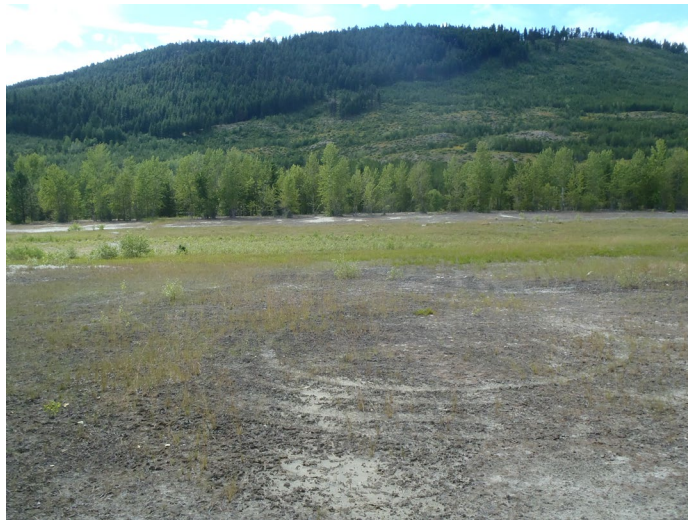
Photograph 21: North TSF, Cell 6, tailings surface, looking west. 21 July 2020.

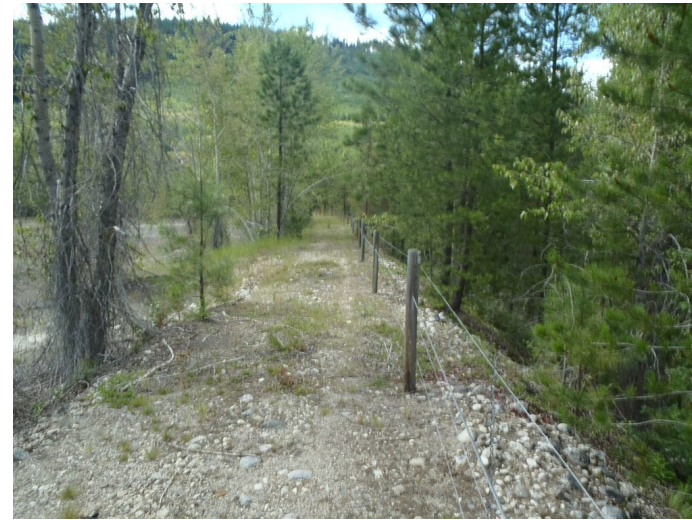
Photograph 22: North TSF, Cell 6, east crest, looking north. 21 July 2020.

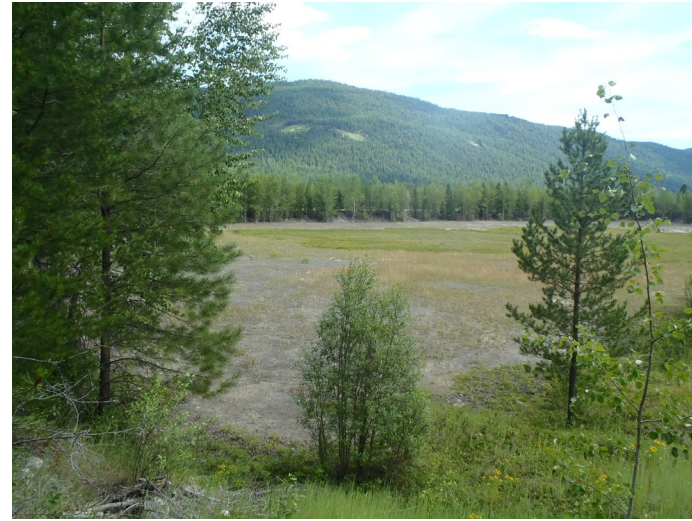
Photograph 24: North TSF, Cell 6, tailings surface from divider dyke between Cell 6 and Cell 7, looking southeast. 21 July 2020.

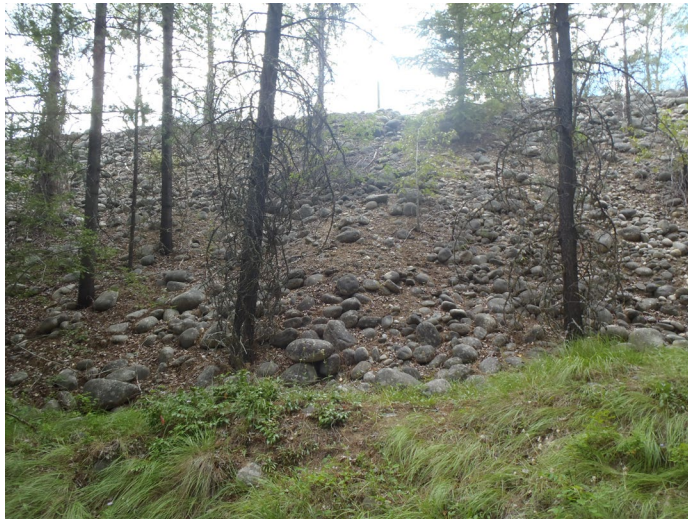
Photograph 25: North TSF, Cell 6, east downstream slope, looking west. 21 July 2020.

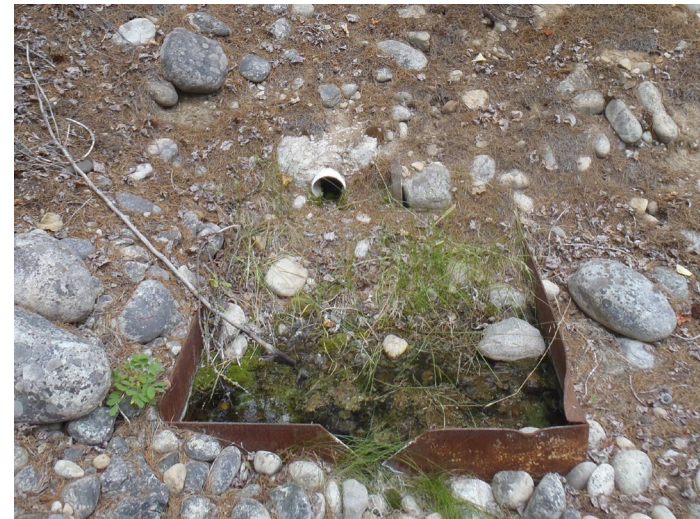
Photograph 26: North TSF, Cell 6, decant outlet, looking north. 21 July 2020.

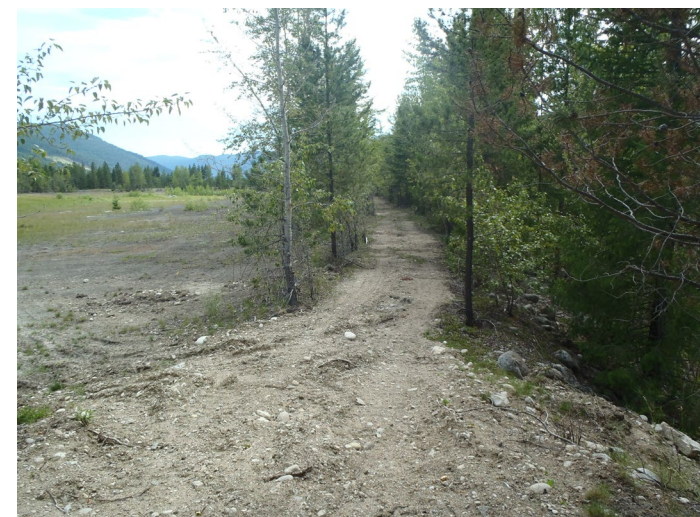
Photograph 28: North TSF, Cell 6/7 divider dyke looking south. 21 July 2020.

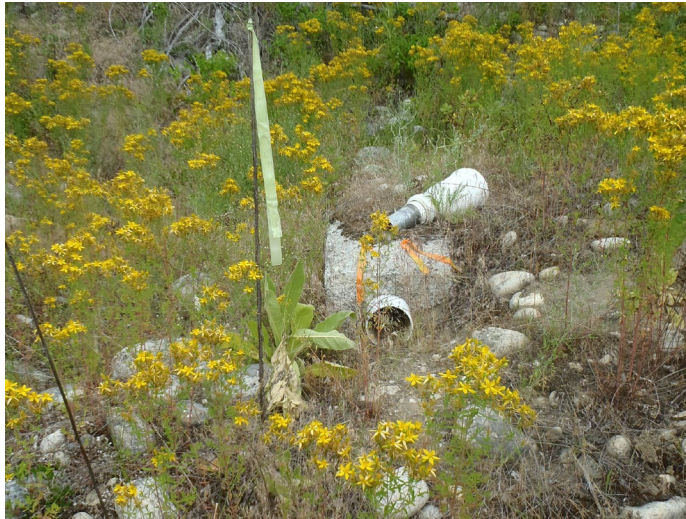
Photograph 29: North TSF, Cell 7 decant outlet, looking north. 21 July 2020.

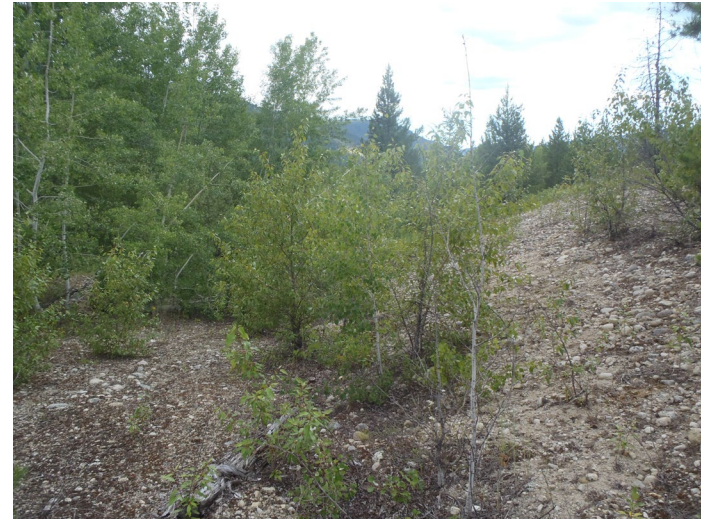
As a result, the catchment area of the North TSF, in an IDF event, consists of the surface area of the facility plus a 90,000 m² area of external catchment. Cell 7 has the storage capacity to store the IDF event. Water can also discharge via the Cell 7 spillway south of the TSF (Photographs 30, Appendix B).

Photograph 30: North TSF, Cell 7, spillway at southwest corner, looking northeast. 21 July 2020.

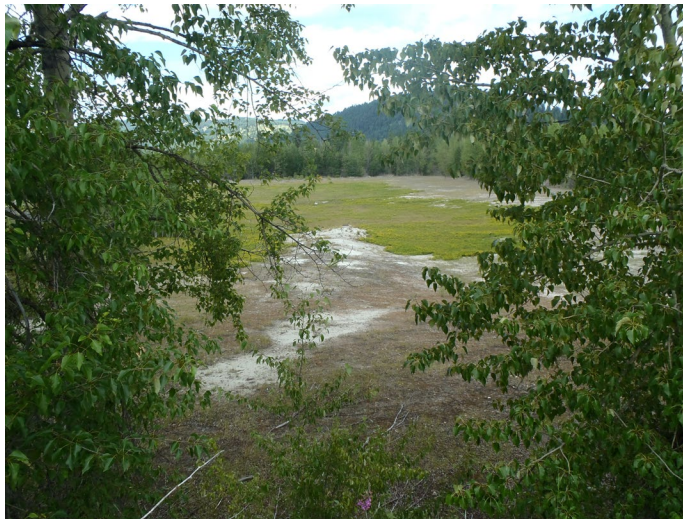
Photograph 31: North TSF, Cell 7, tailings surface looking north. 21 July 2020.

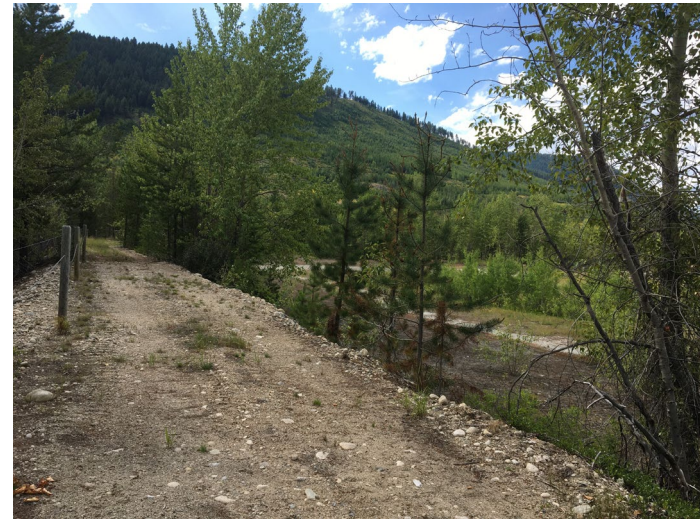
Photograph 32: North TSF, Cell 7 crest, looking west. 21 July 2020.

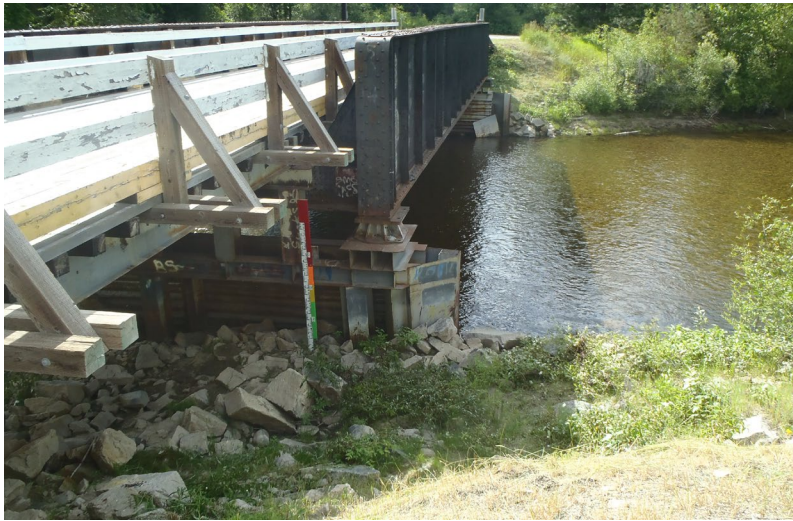
A staff gauge was installed on the east (town side) of the Beavardell Station Road bridge (Photograph 33, Appendix B) on 29 May 2020 to allow visual assessment of conditions in the WKR by site personnel prior to crossing the river. In addition to the graduated measurements on the staff gauge, colour-coded tape was installed corresponding to the levels identified in the draft flood response protocol and TARP.

Photograph 33: West Kettle River bridge crossing with staff gauge looking west.
21 July 2020.
