Teck Coal Limited

Elkview Operations

Coarse Coal Refuse Dump

2020 Annual Summary of Facility Performance Report

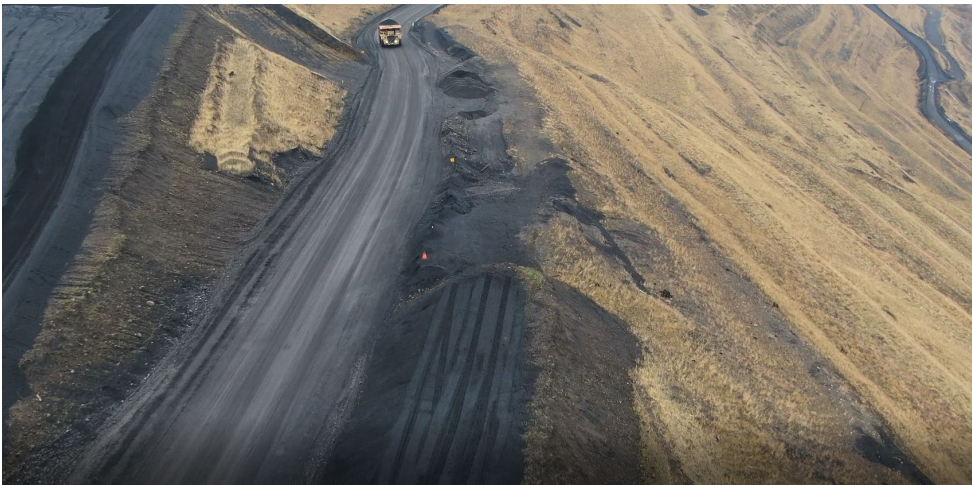
Photo I-1 CCR upper benches. (looking south, photo taken from drone flight)

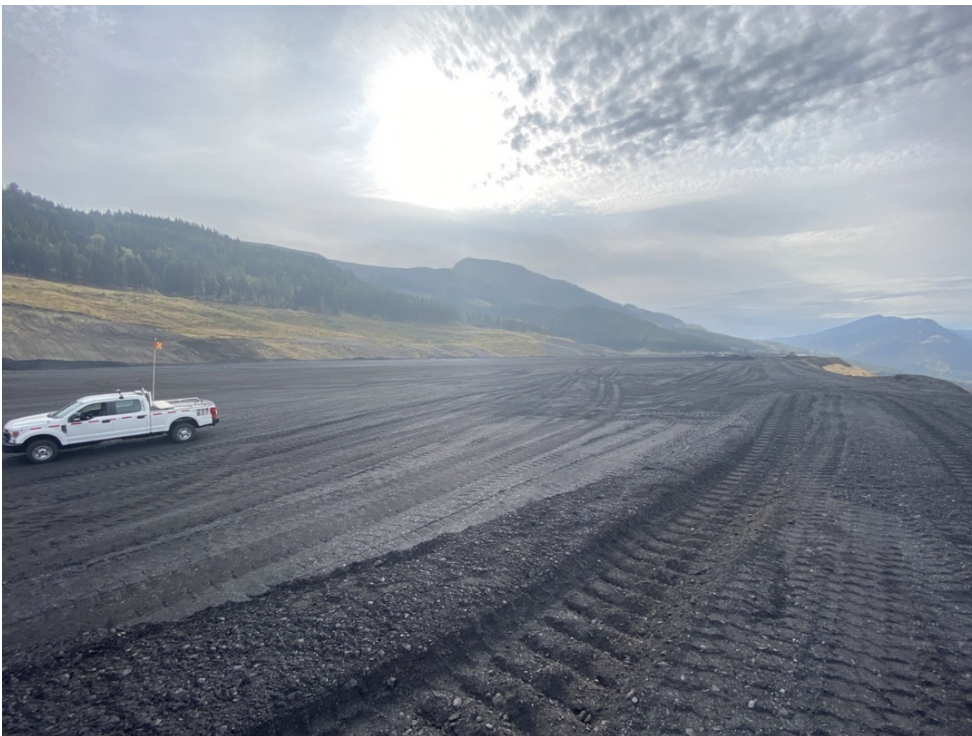
Photo I-2 CCR Dump crest typical conditions. (looking south)

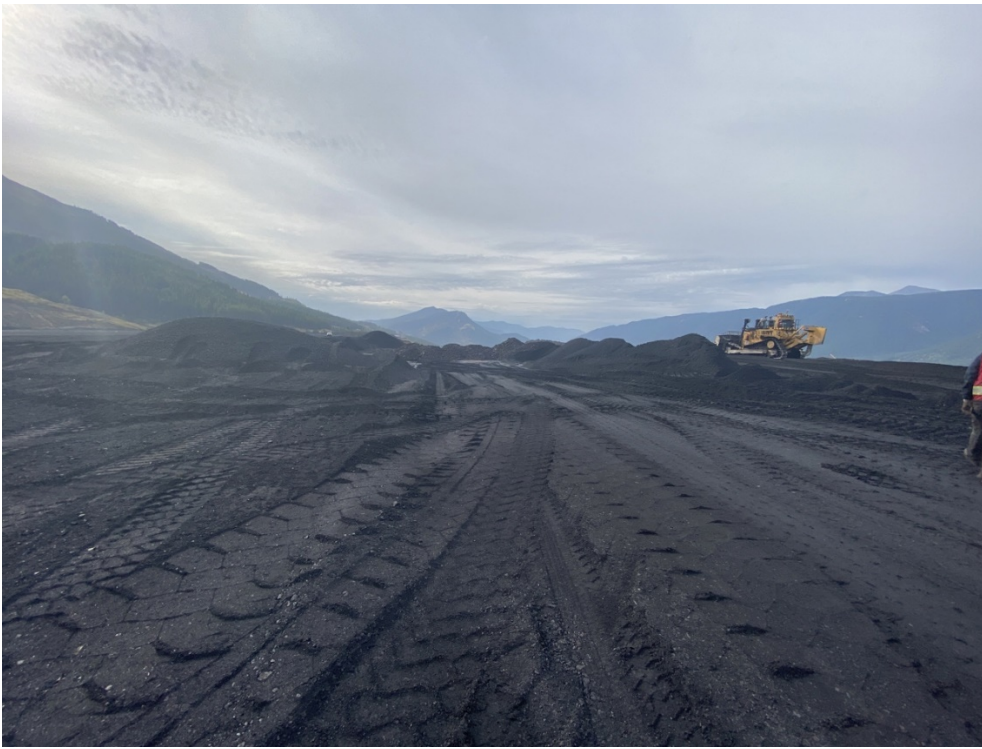
Photo I-3 CCR Dump crest construction in progress. (looking south)

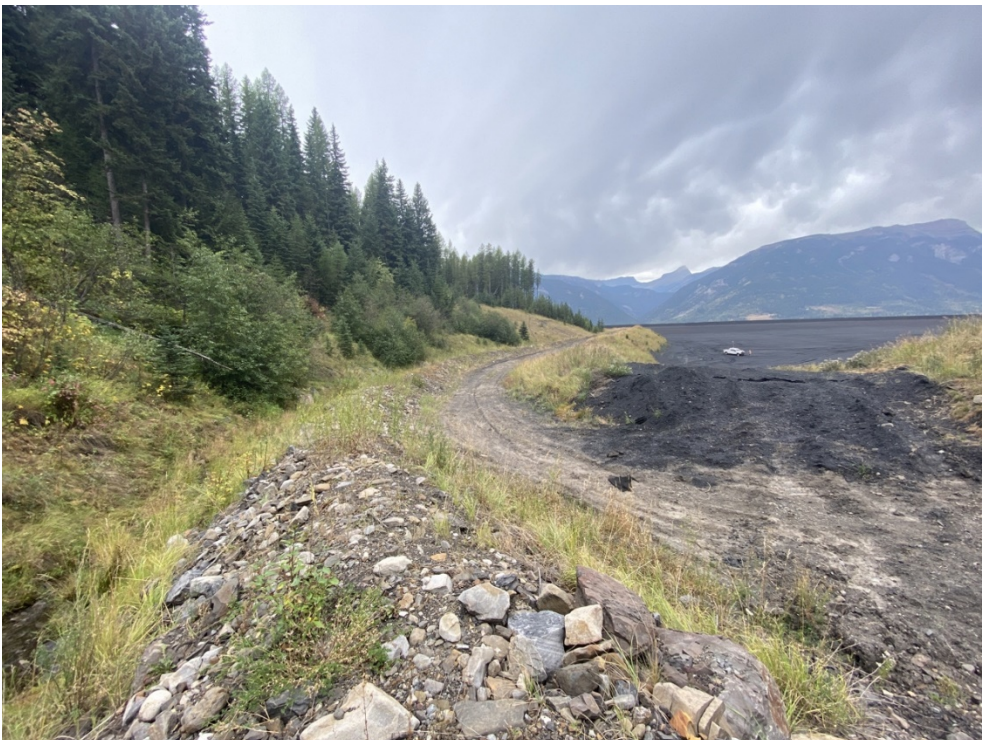
Photo I-4 CCR Dump diversion ditch and Lindsay Drain extension. (looking west)

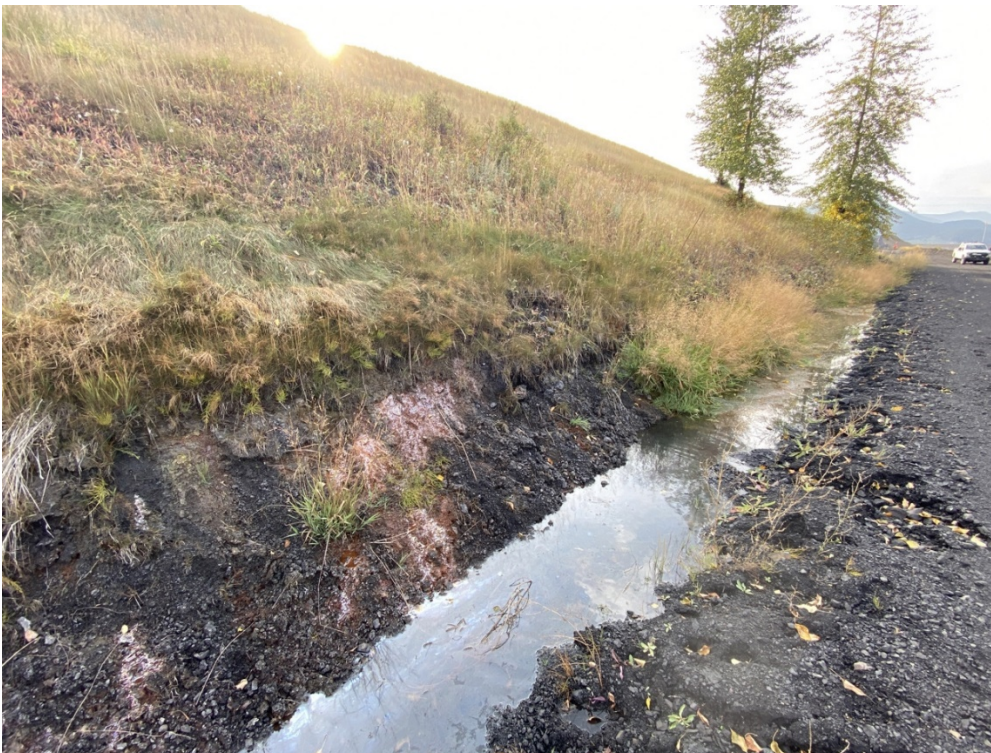
Seepage was observed at several interbench slopes of the CCR Dump in the locations consistent with those observed during the 2019 annual inspection (KCB 2019). Some ditch drains on CCR benches were observed to contain an orange colouration, indicating the presence of seepage from the CCR Dump in the drains. The observed seepage is not considered to be of concern to the stability of the CCR Dump.

Photo I-6 CCR Dump seepage at bench ditches. (looking south)

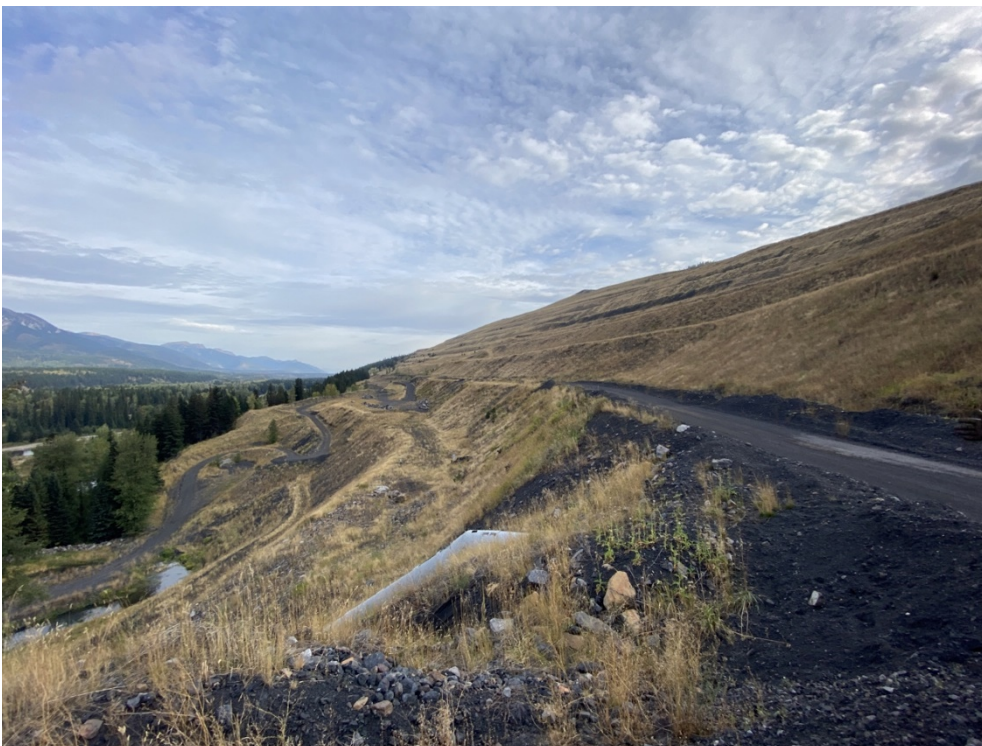
Photo I-8 CCR Dump bench typical condition. (looking north)

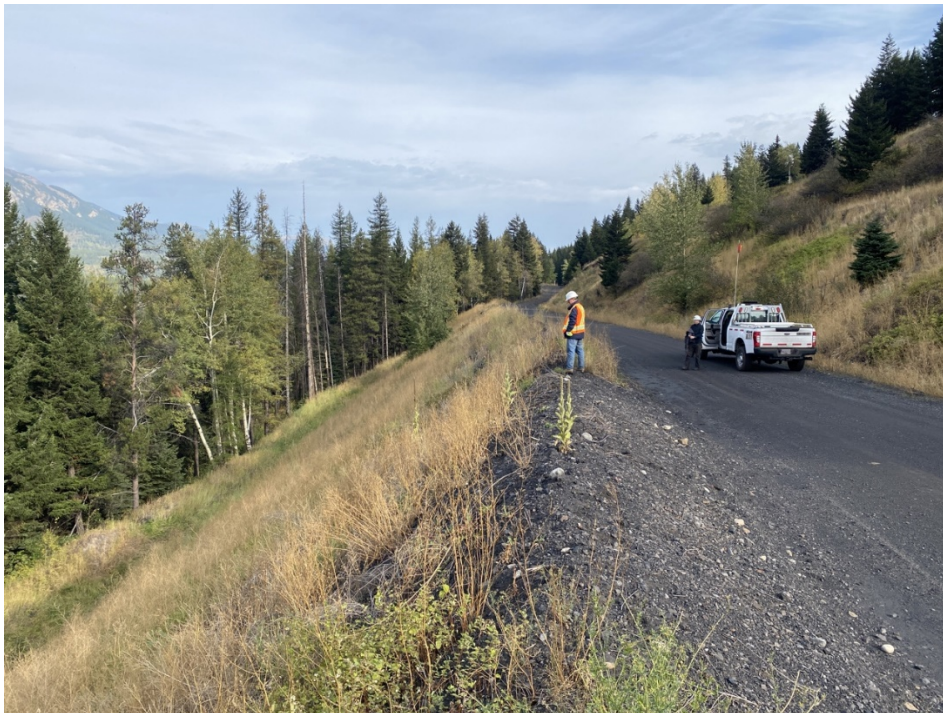
Photo I-11 CCR Dump bench typical conditions. (looking north)

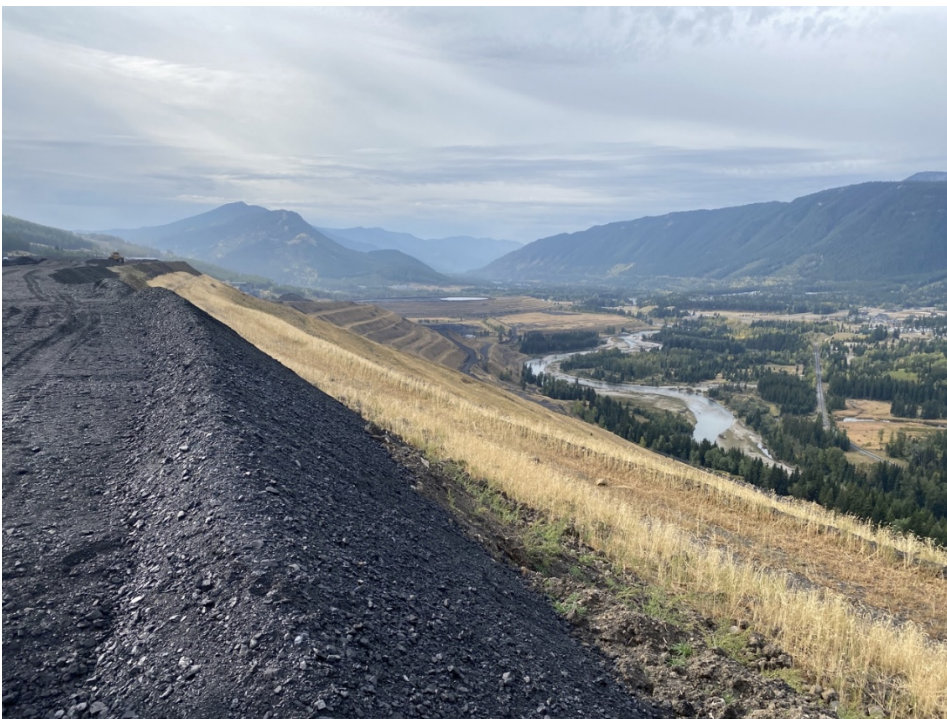
Photo I-12 CCR Dump crest and slope typical conditions. (looking south)

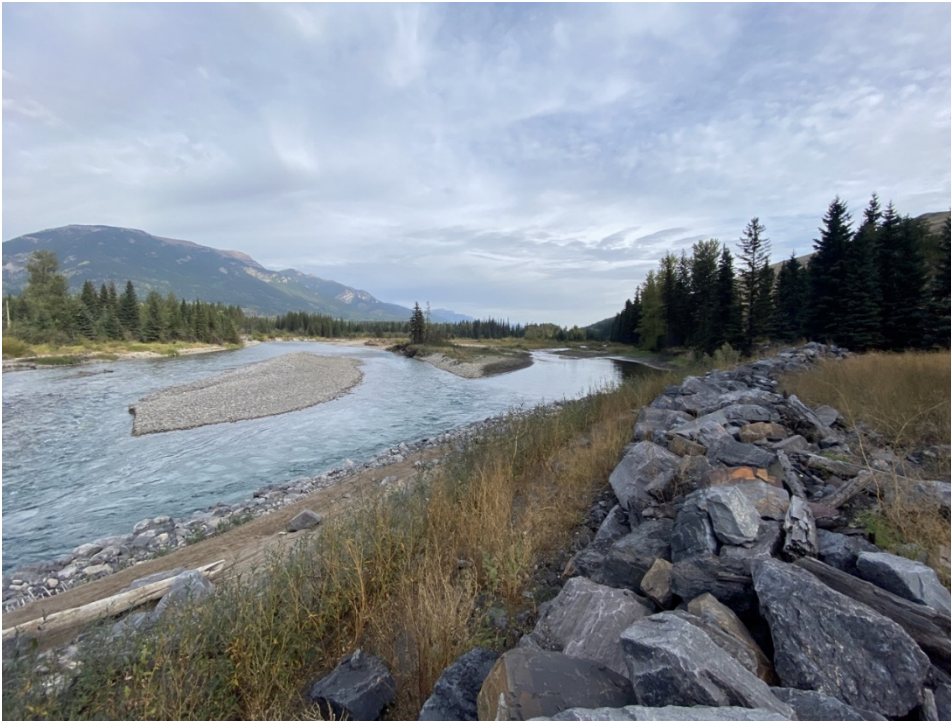
Photo I-15 CCR Dump toe riprap adjacent to the Elk River (looking north).
