2020 ANNUAL DUCK POND OPERATIONS TAILINGS MANAGEMENT FACILITY INSPECTION REPORT

2020 Annual Facility Inspection Report
Duck Pond Operations Tailings Management Facility

20139279 (1000)

April 9, 2021

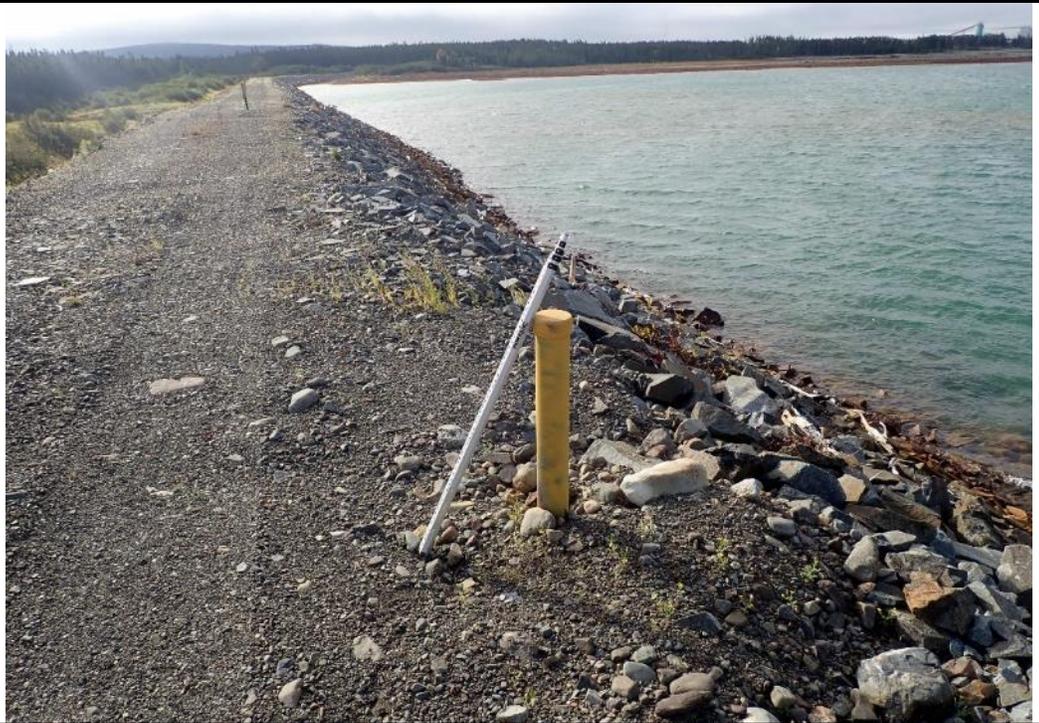
Photograph 4

View of piezometer locations, looking southeast; note small ditches to channel surface water away from the wells.

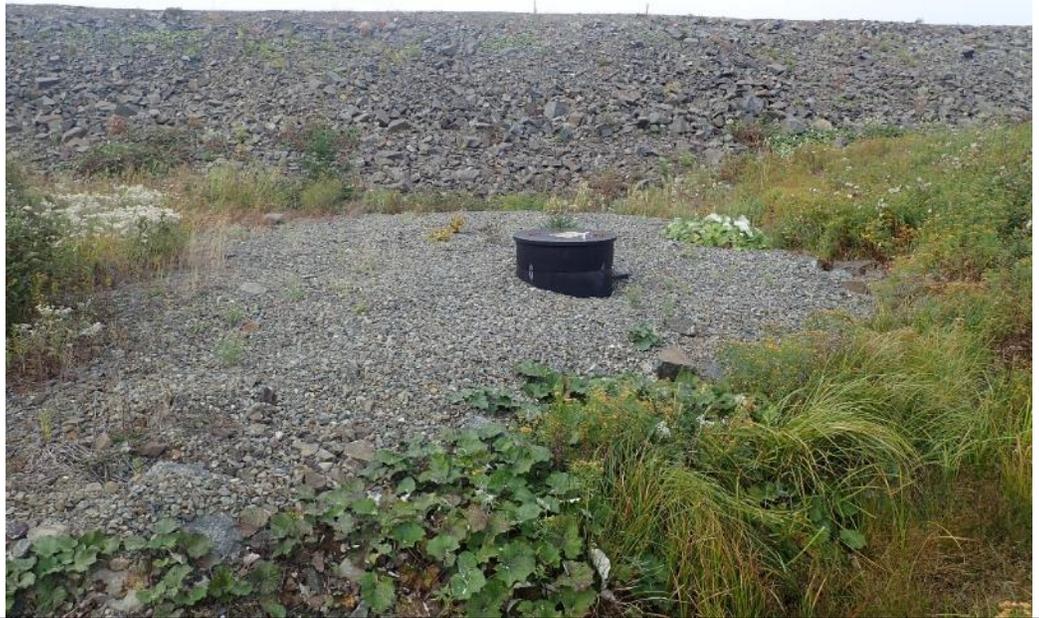
Photograph 10

Outlet of HDPE culvert in the access road; culvert associated with the seepage collection sump. Note minor bending visible along the soffit.

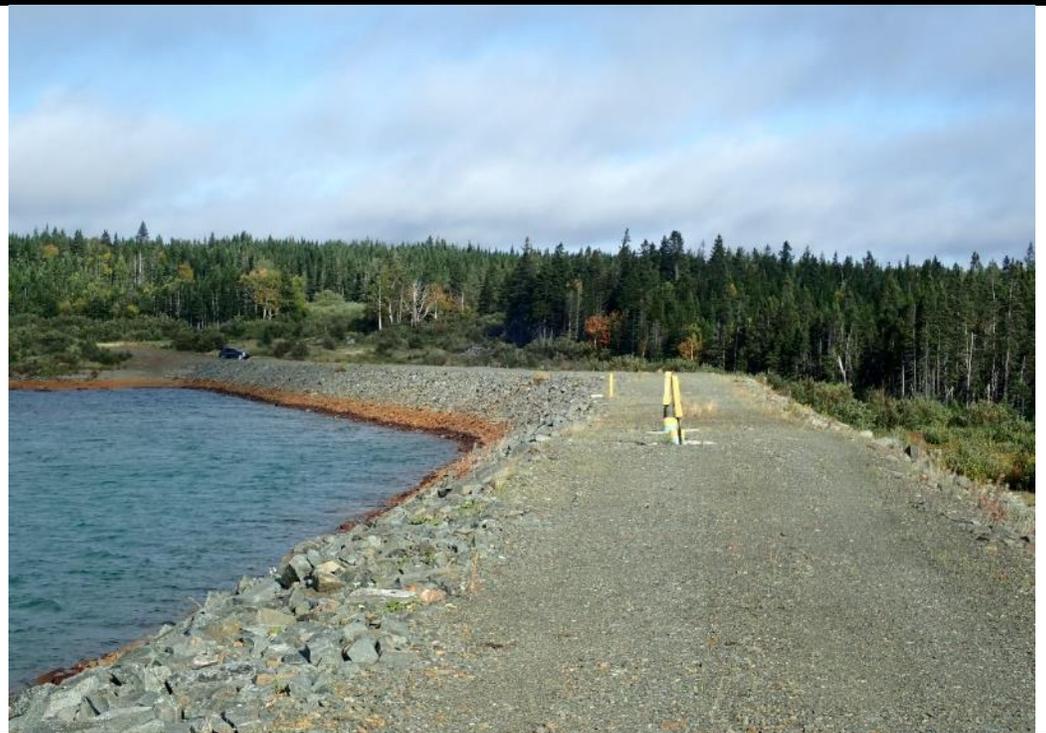
Photograph 12

View of crest and upstream slope, looking northwest. Note the normal high-water mark (staining) visible on the upstream slope.

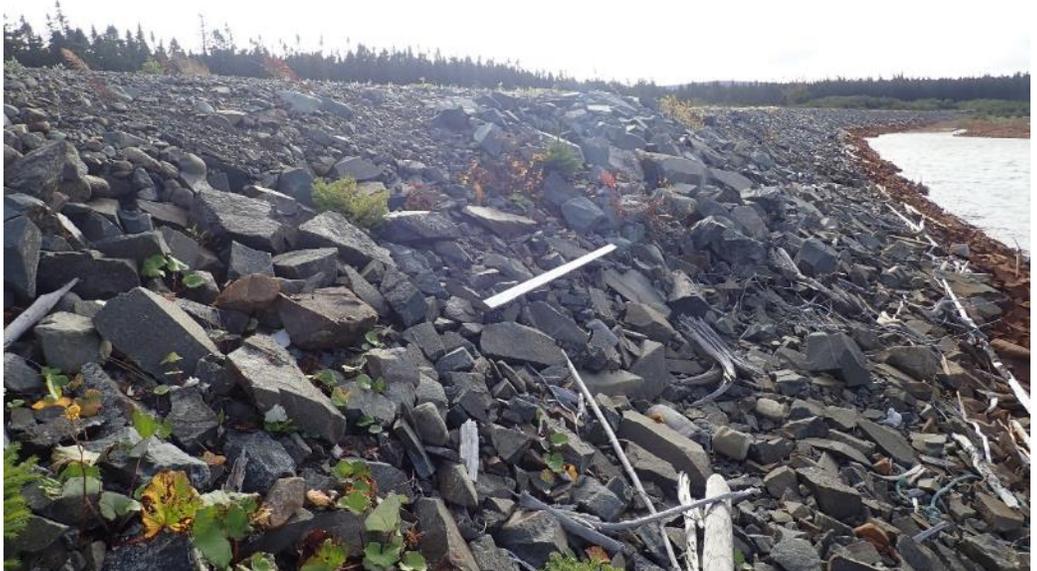
Photograph 13

View of upstream slope.

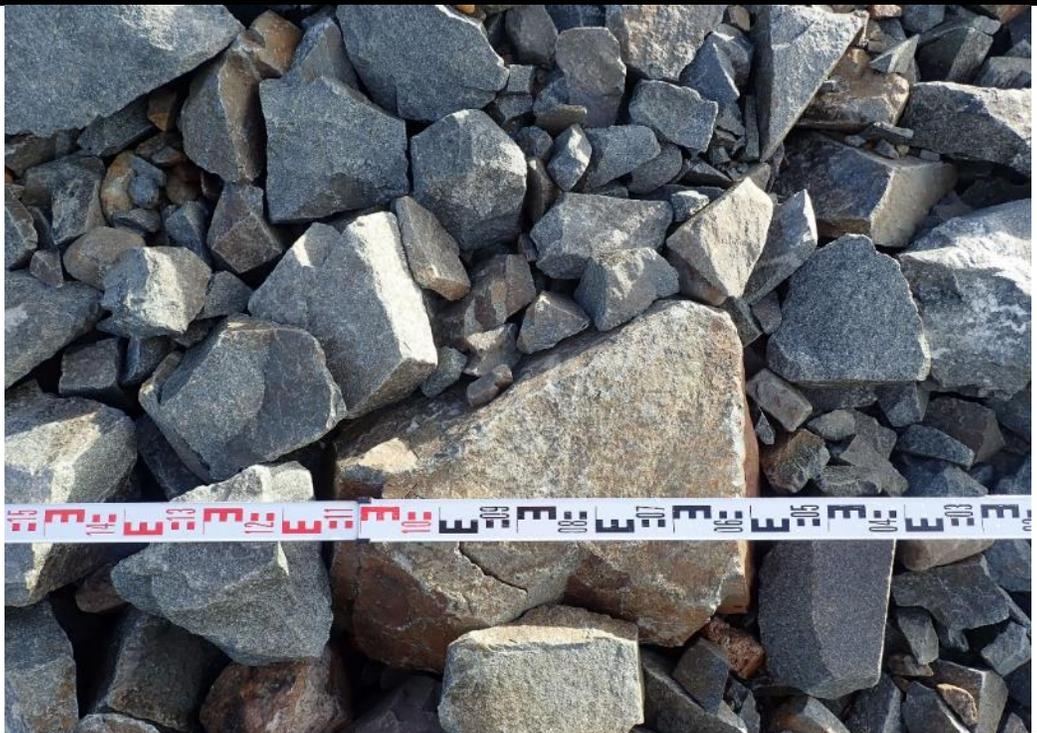
Photograph 14

Closeup view of rip rap along the upstream slope; note range of particle sizes.

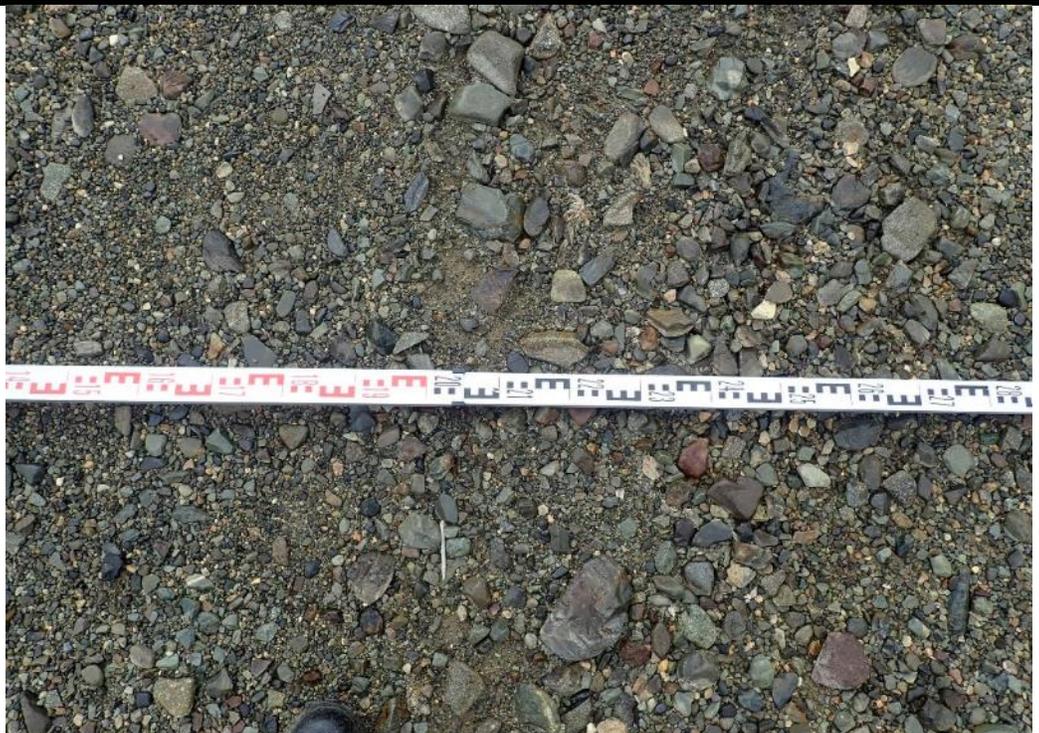
Photograph 2

Closeup view of crest material.

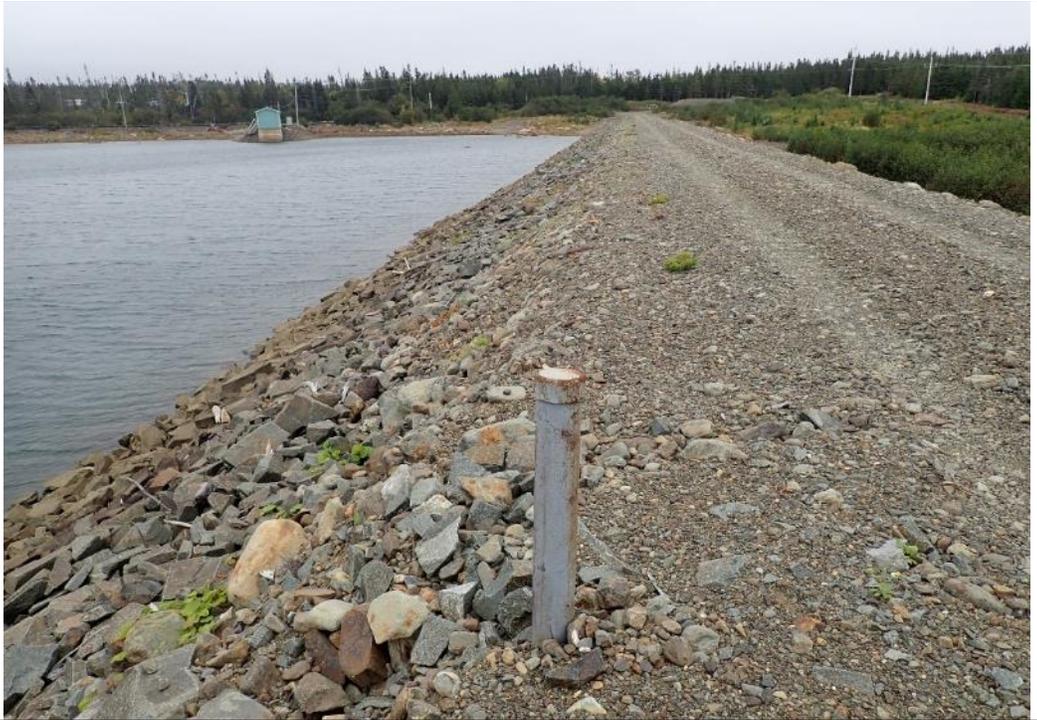
Photograph 3

View of settlement plate location along upstream shoulder, looking south.

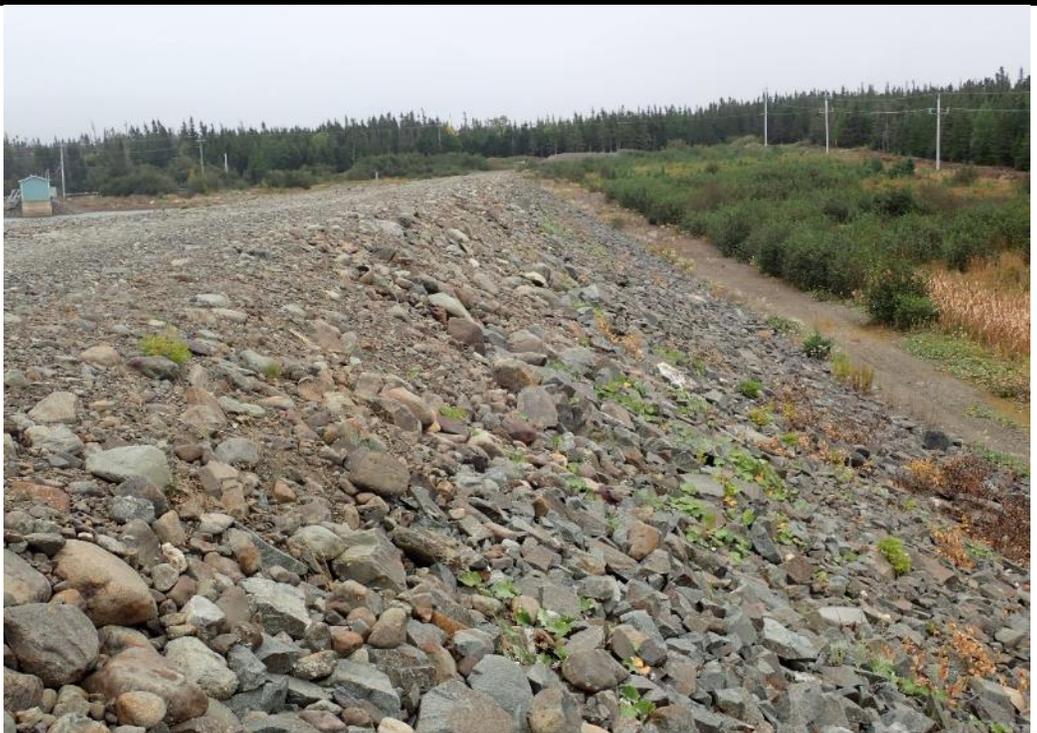
Photograph 4

View of downstream slope looking south, note general lack of vegetation along the slope. Small access road visible along the toe.

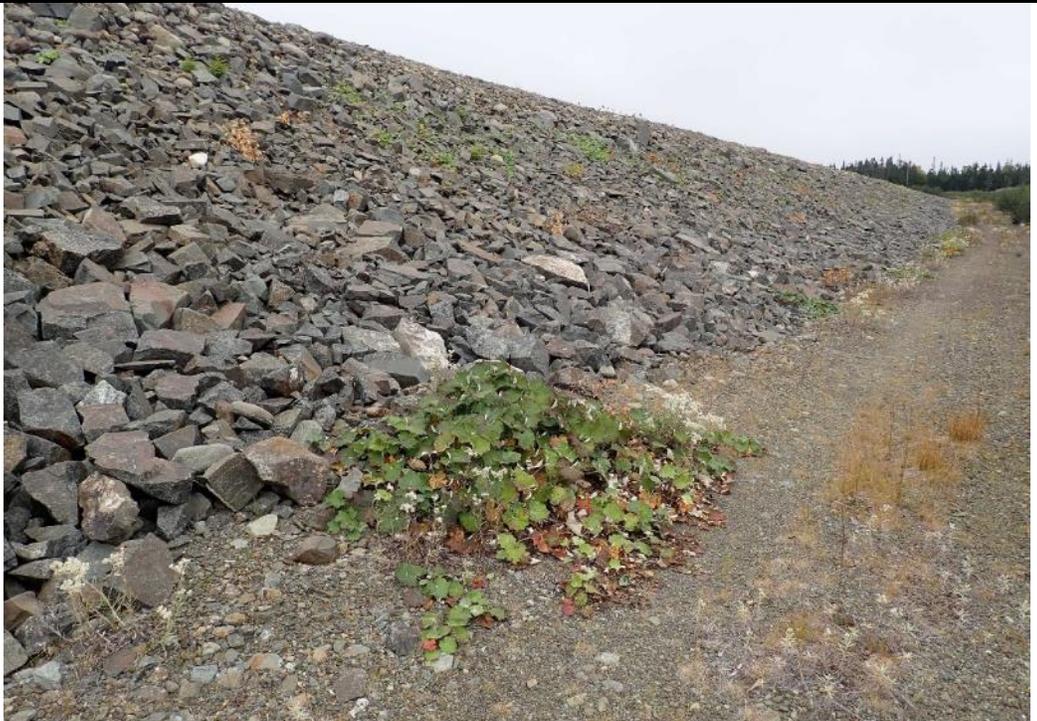
Photograph 5

View along downstream slope, looking south. Note isolated patch of lush vegetation, marking potential seepage location.

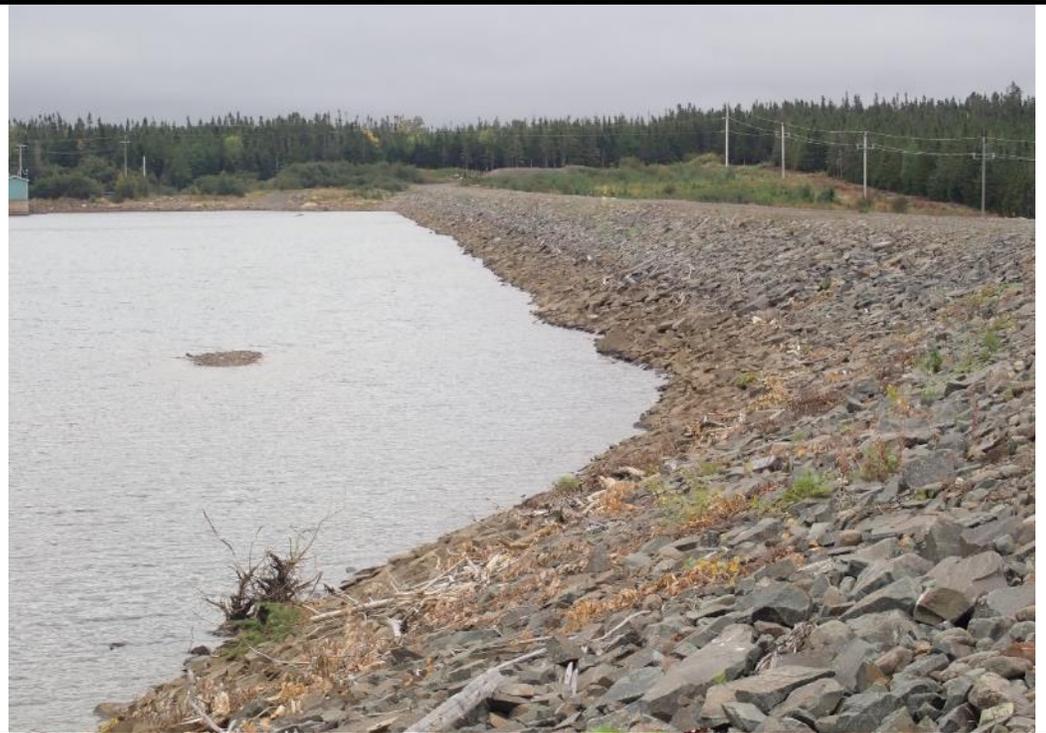
Photograph 8

View of upstream slope, looking south. Note the normal high-water mark (staining) visible on the upstream slope.

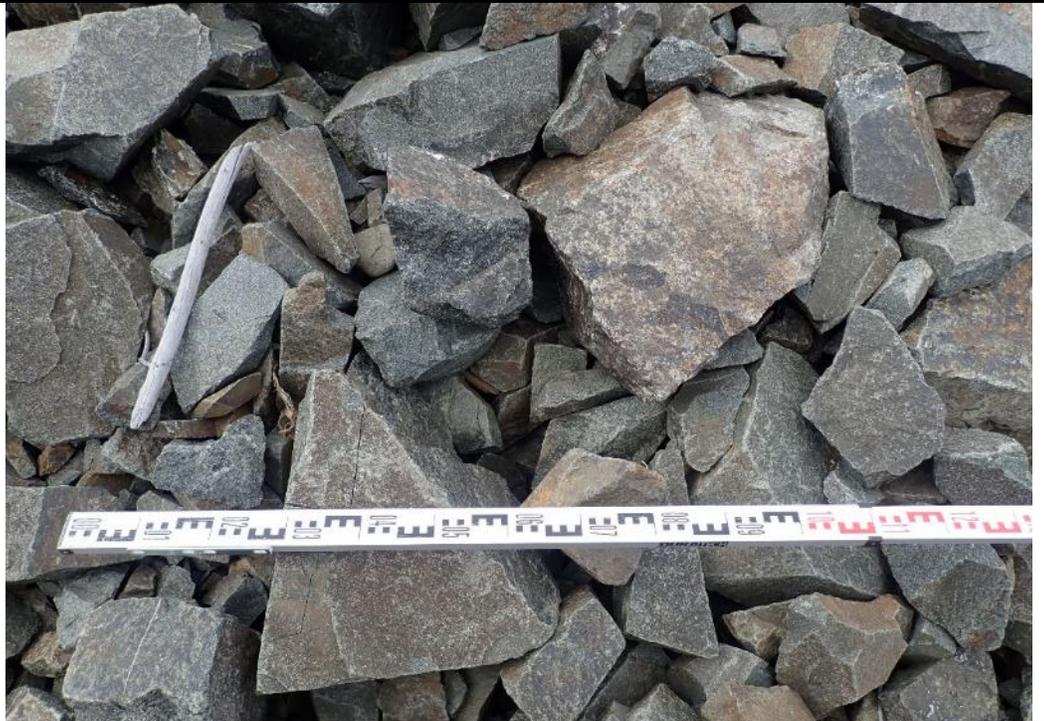
Photograph 9

Closeup view of riprap along the upstream slope, note range of particle sizes.

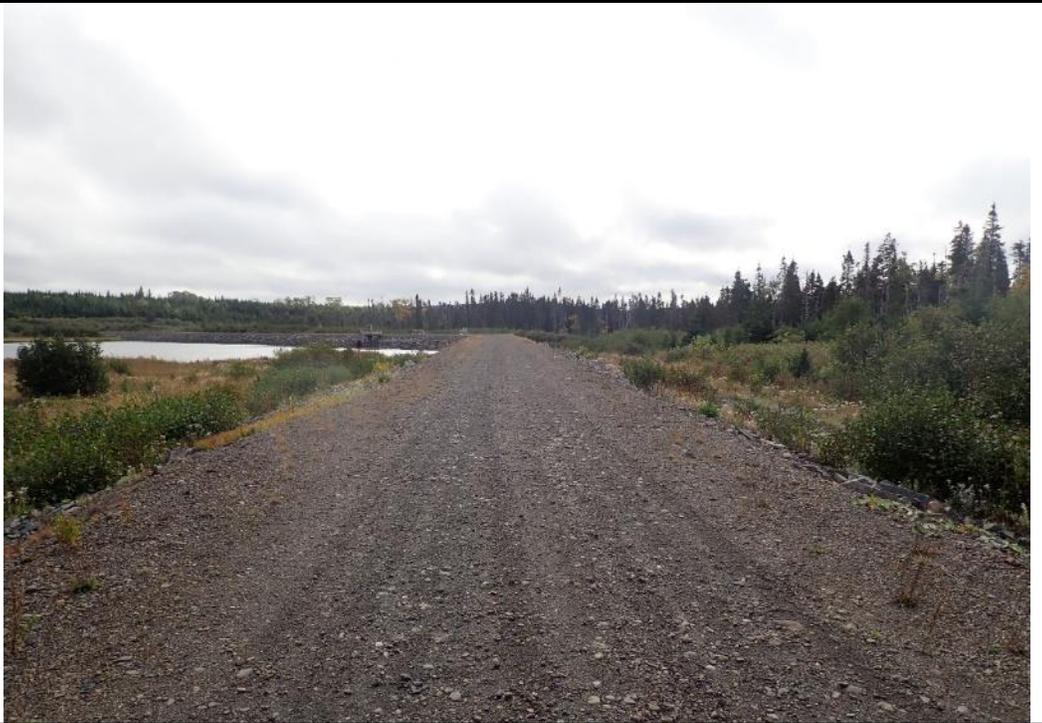
Photograph 1

View of crest looking south; no crossfall noted (not included as part of design), tire tracks from light vehicles visible.

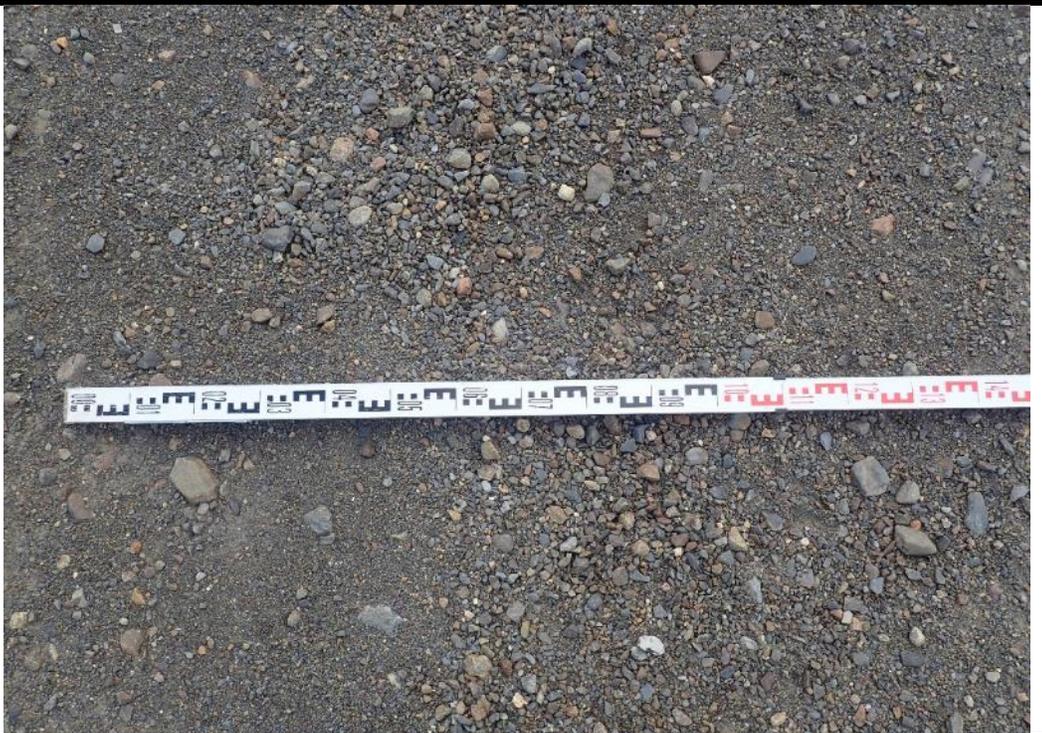
Photograph 2

Closeup view of crest material.

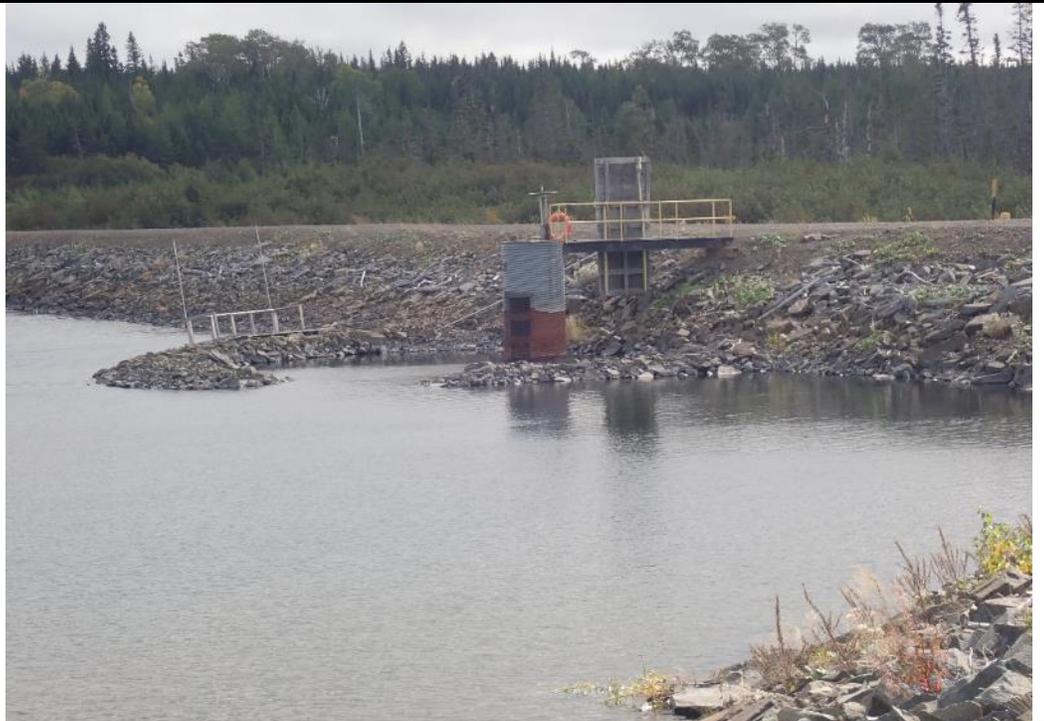
Photograph 3

View of decant structure along upstream slope.

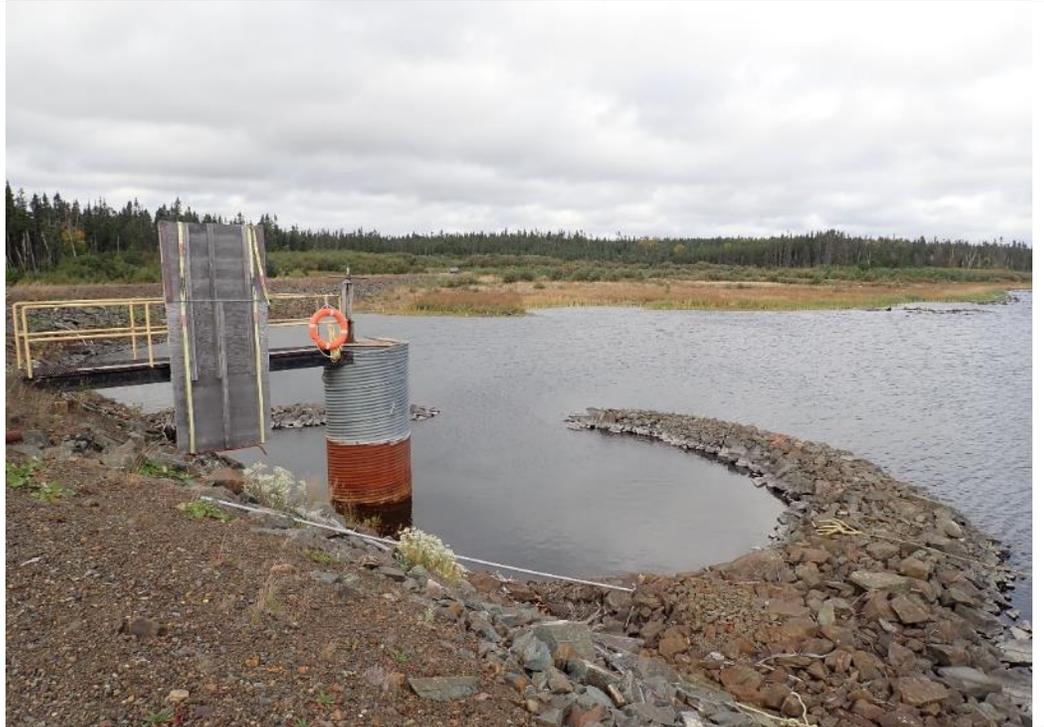
Photograph 4

Closer view of decant structure showing high-water mark. Small breakwater also visible in the Polishing Pond for protection.

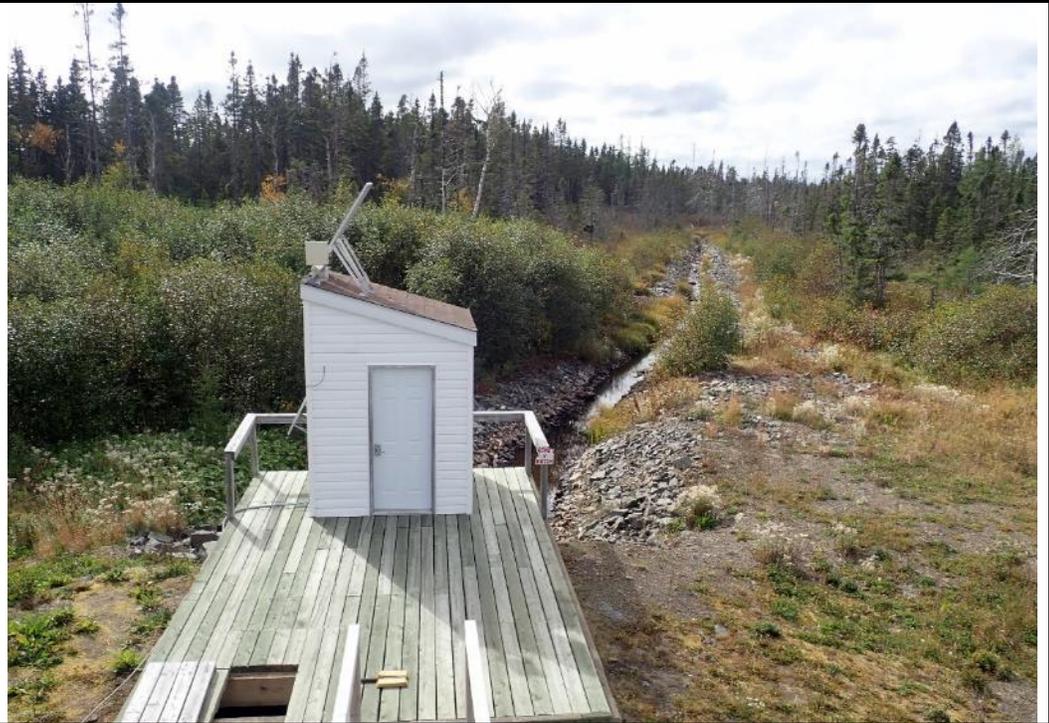
Photograph 7

View of hydraulic discharge structure looking southwest. Outflow channel visible in the background.

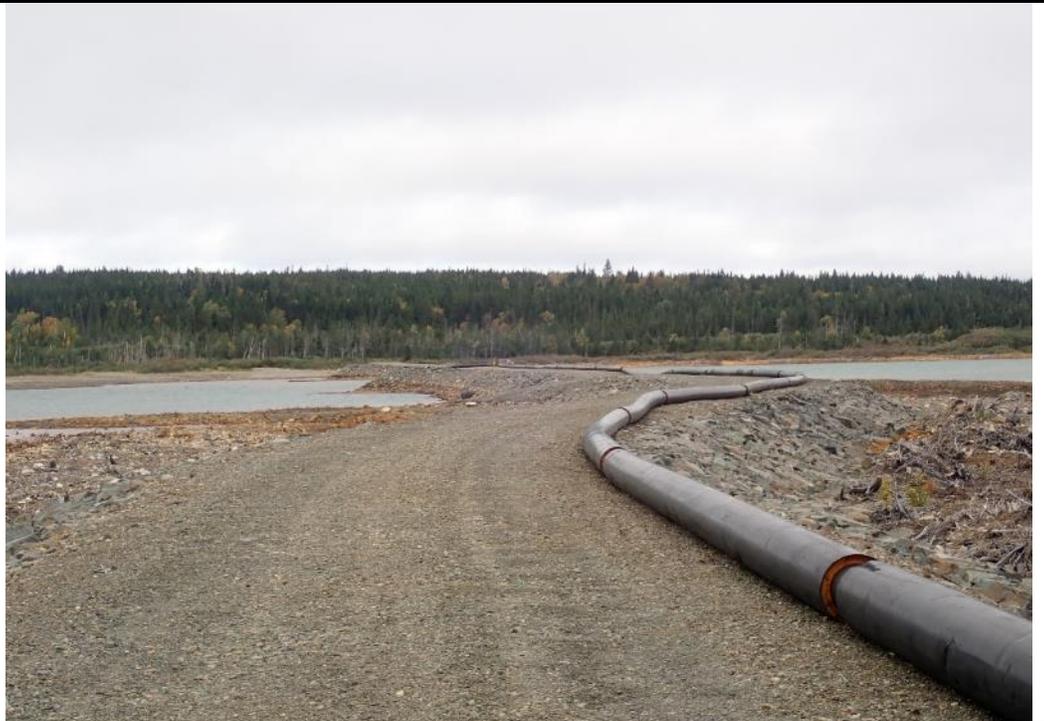
Photograph 1

View of Internal Berm 1 crest looking northwest.

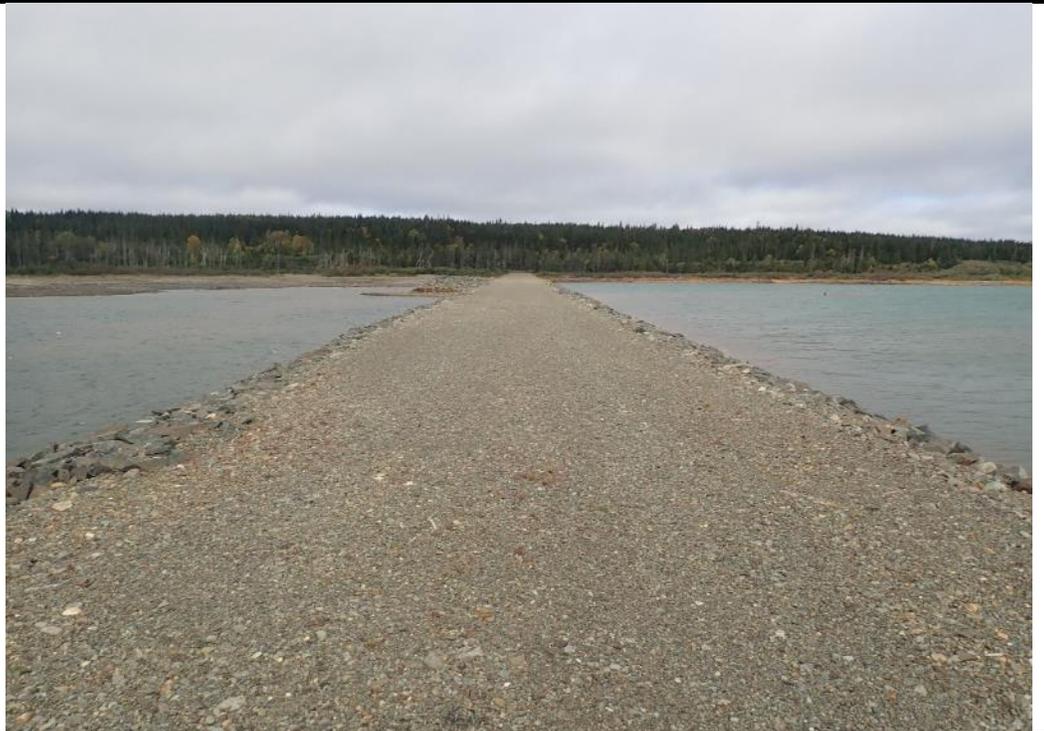
Photograph 2

View of Internal Berm 1 crest looking northwest.

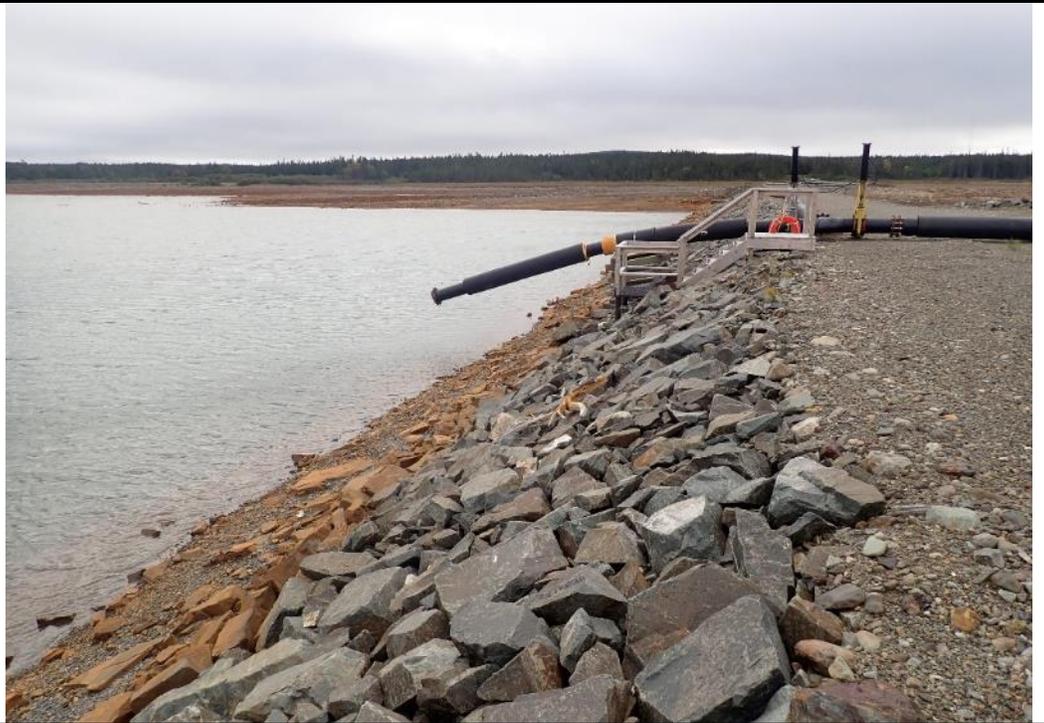
Photograph 3

View of Internal Berm 1 slope looking southeast showing normal high-water mark (staining).

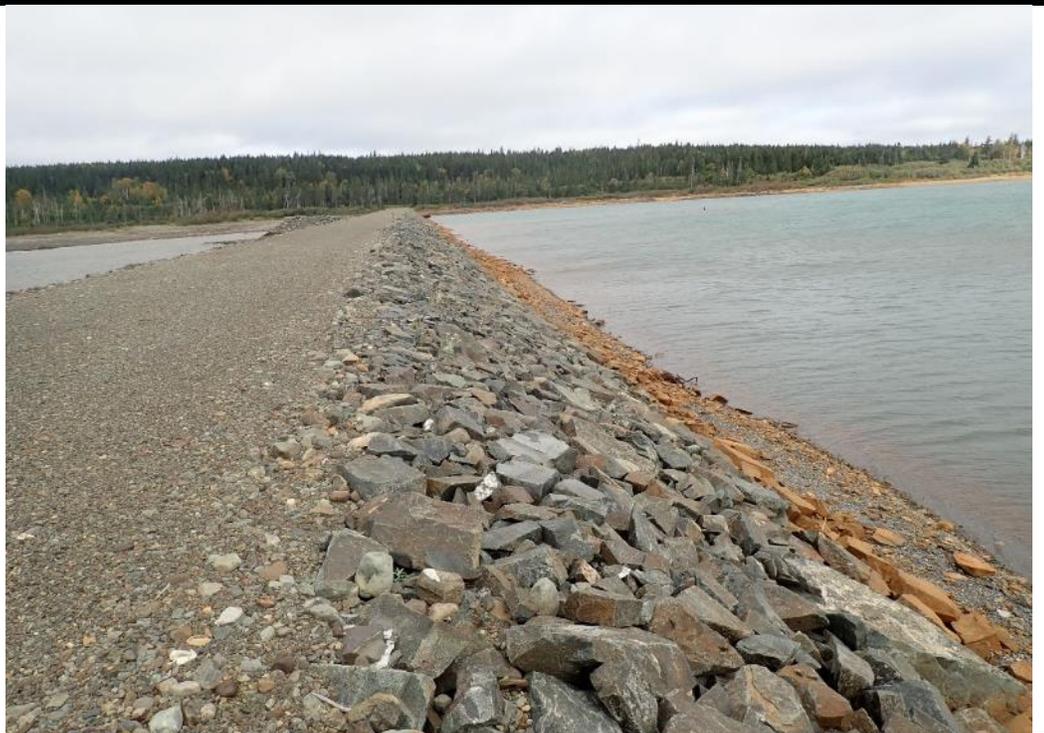
Photograph 4

View of Internal Berm 1 slope looking northwest showing normal high-water mark (staining).

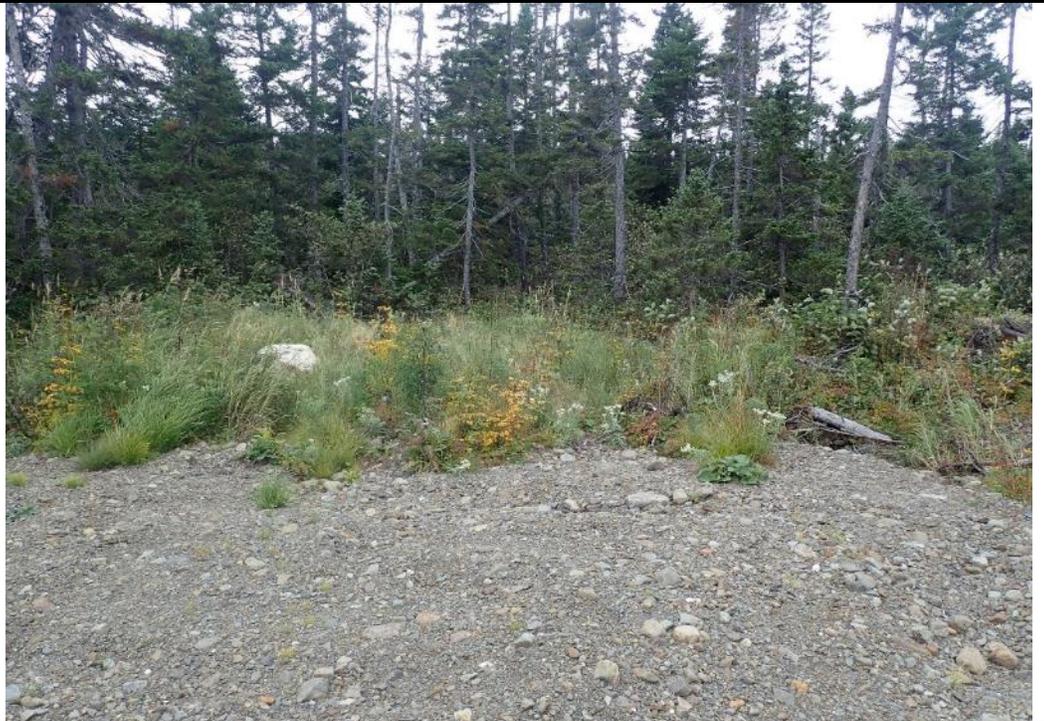
Photograph 5

View of northwest abutment of Internal Berm 1 showing level grade with existing ground.

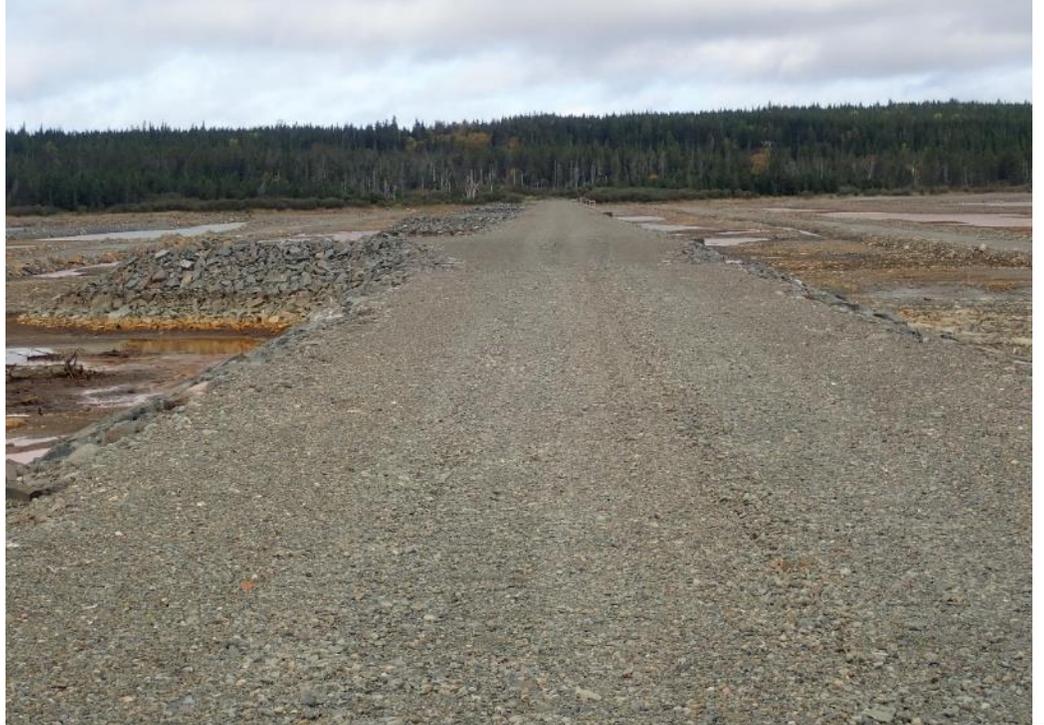
Photograph 6

View of Internal Berm 2 crest looking northwest. Finger dikes visible on left and right.

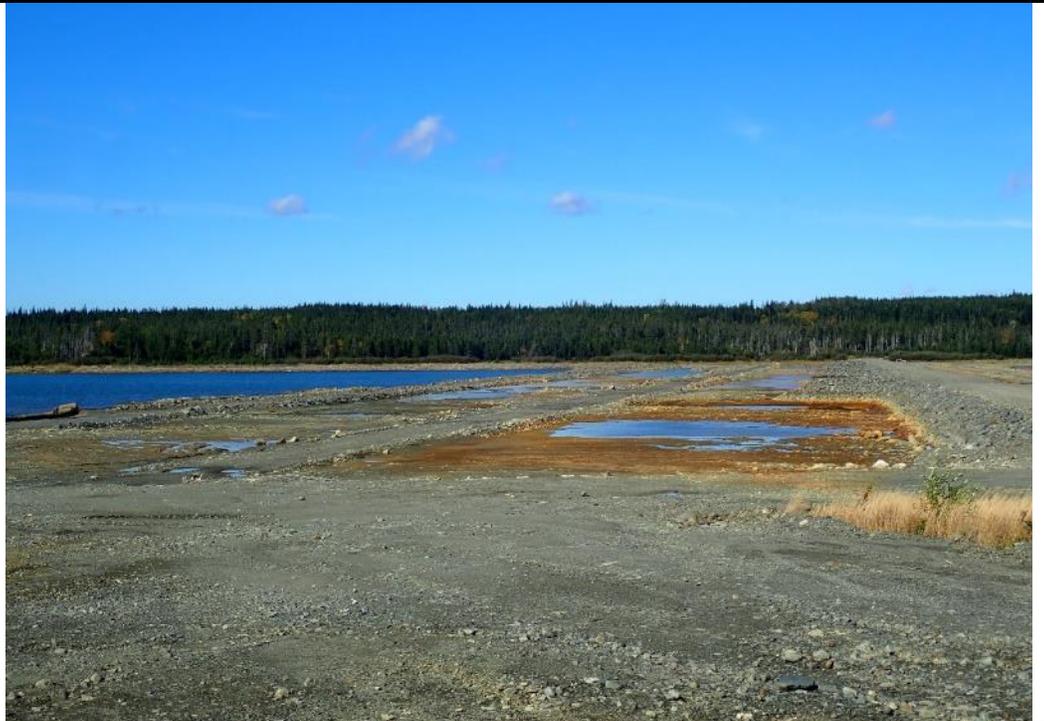
Photograph 7

View of Finger Dikes 2 & 4 adjacent to Internal Berm 2, looking northwest.

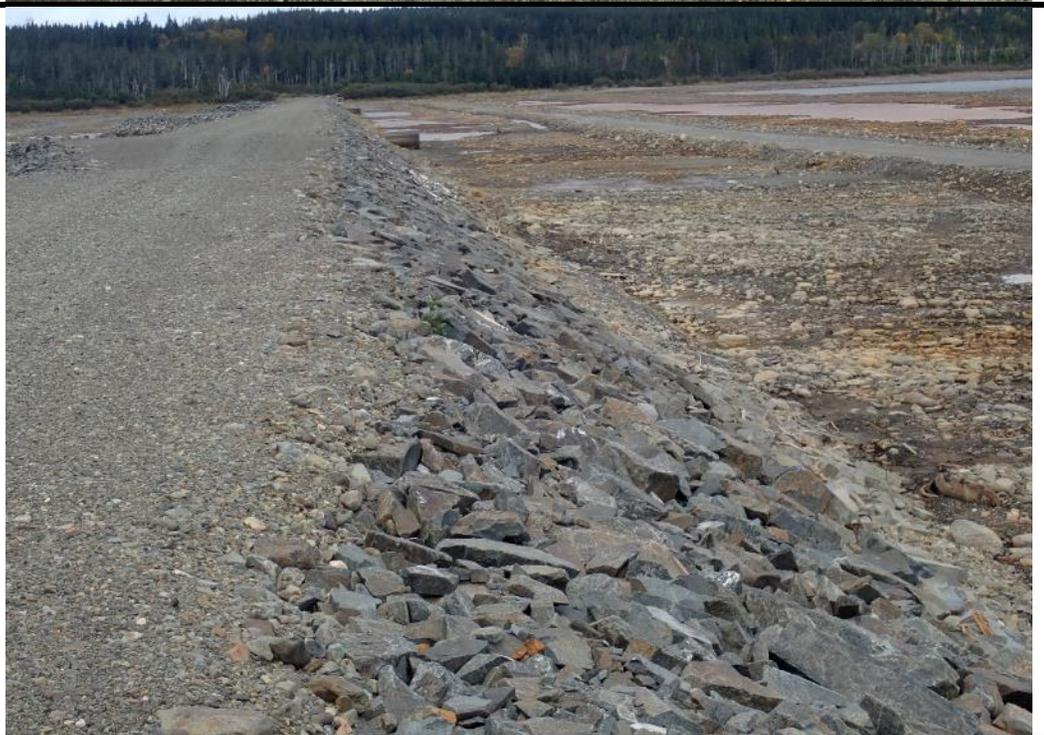
Photograph 8

View of Internal Berm 2 slope looking northwest.

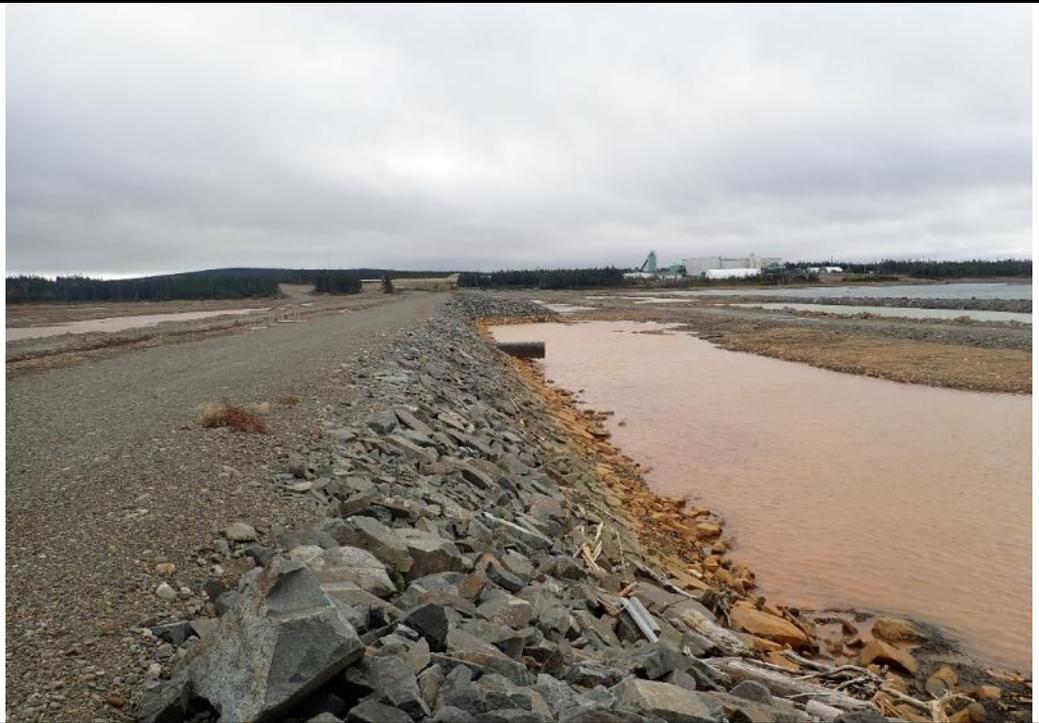
Photograph 9

View of Internal Berm 2 slope looking southeast, showing normal high-water mark (staining).

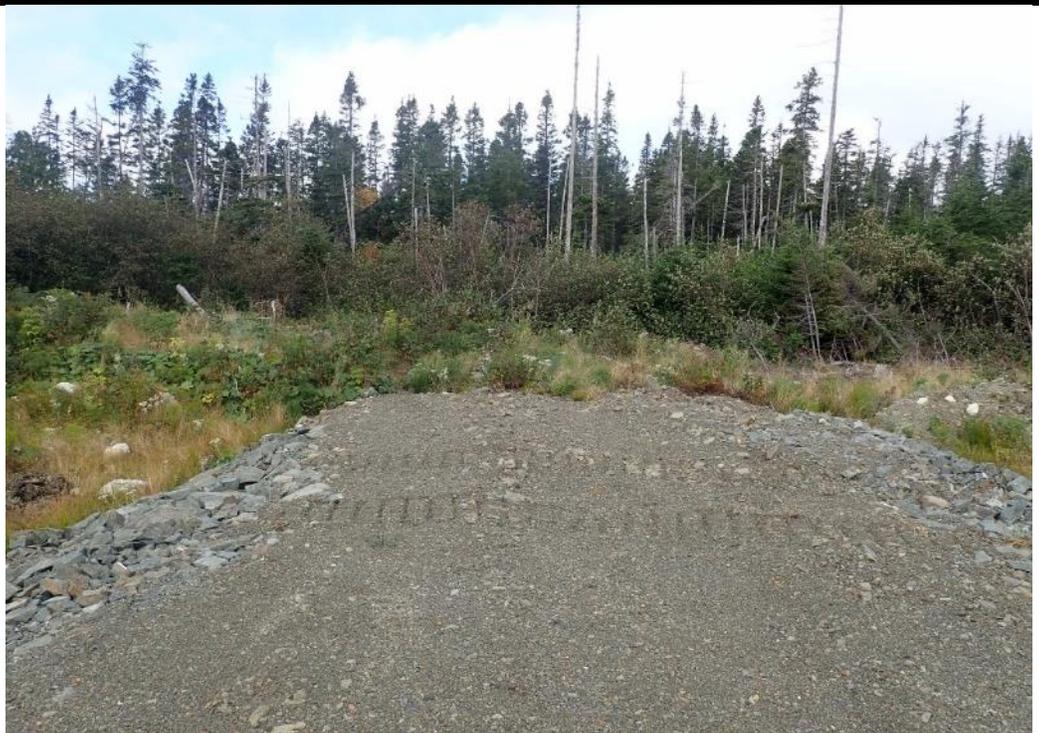
Photograph 10

View of northwest abutment of Internal Berm 2 showing level grade with existing ground.

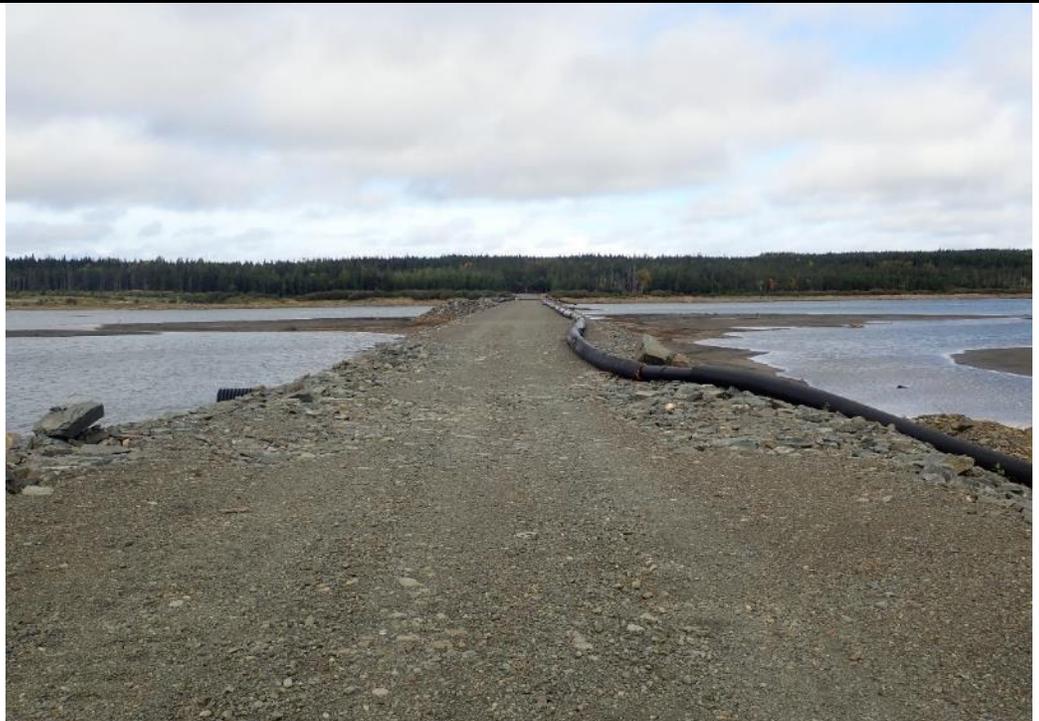
Photograph 11

View of Internal Berm 3 crest looking northwest.

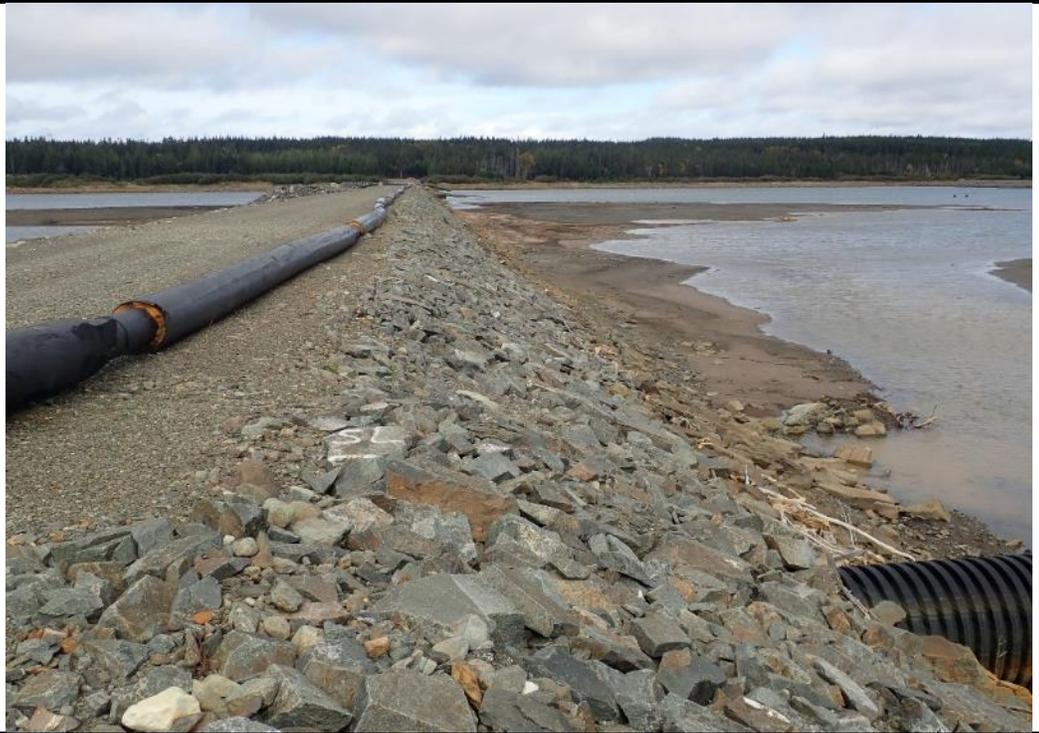
Photograph 12

View of Internal Berm 3 slope looking northwest.

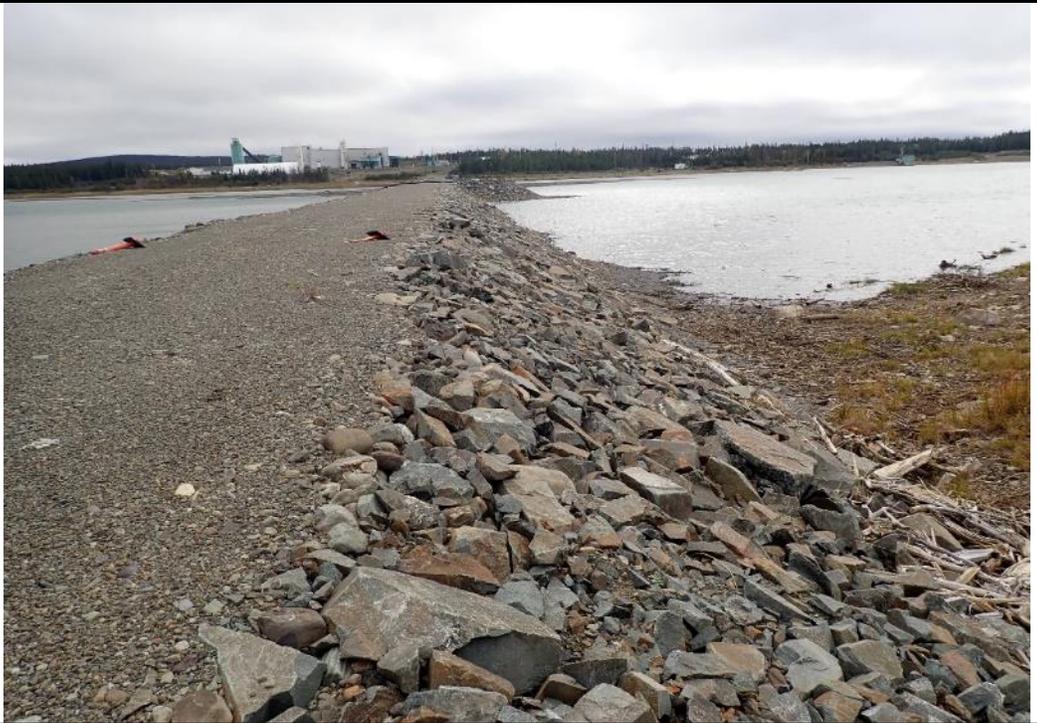
Photograph 13

View of Internal Berm 3 slope looking southeast.

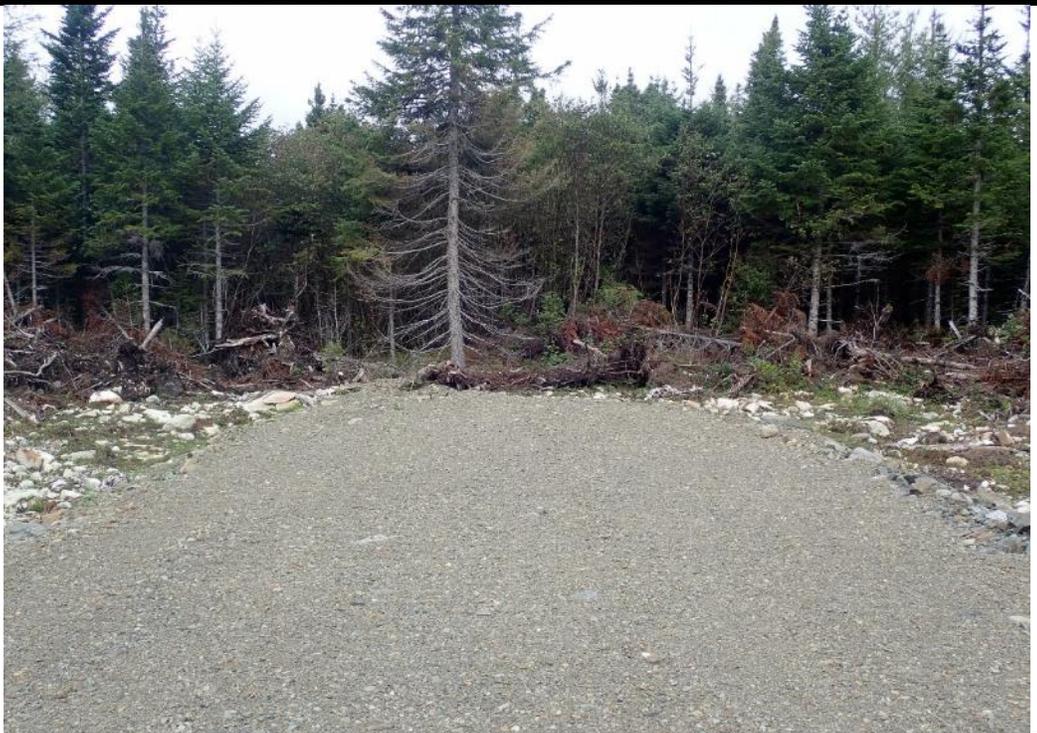
Photograph 14

View of northwest abutment of Internal Berm 3 showing level grade with existing ground.
