2020 ANNUAL DUCK POND OPERATIONS TAILINGS MANAGEMENT FACILITY INSPECTION REPORT

2020 Annual Facility Inspection Report
Duck Pond Operations Tailings Management Facility

20139279 (1000)

April 9, 2021

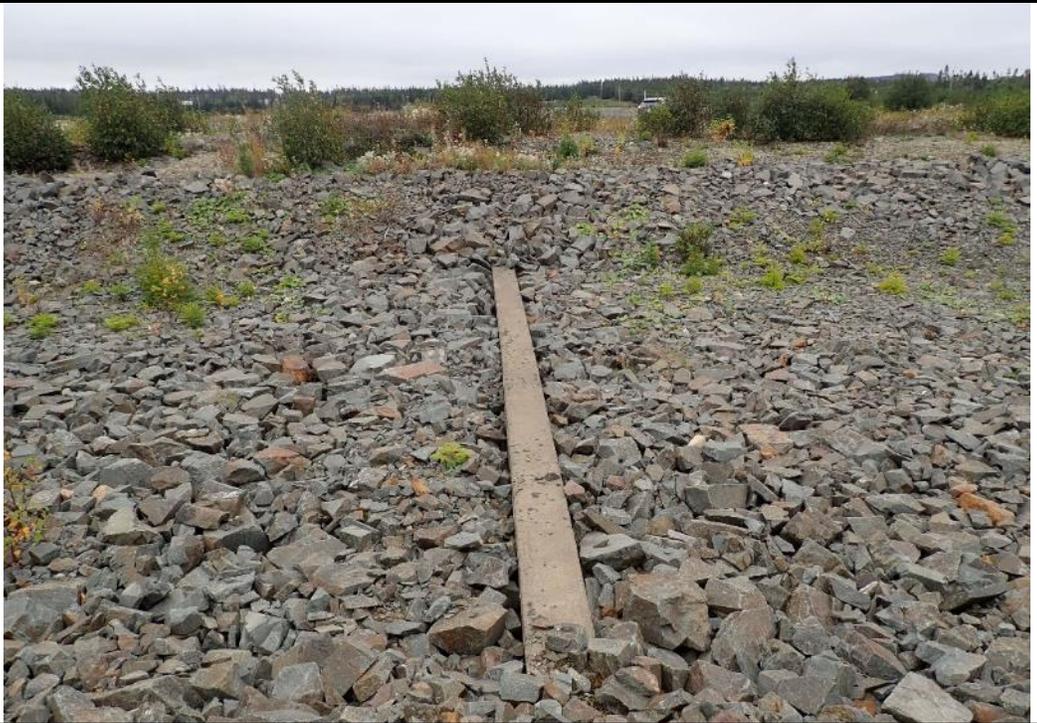
Photograph 4

View along Dam B Spillway looking south, note minor vegetation growth in channel.

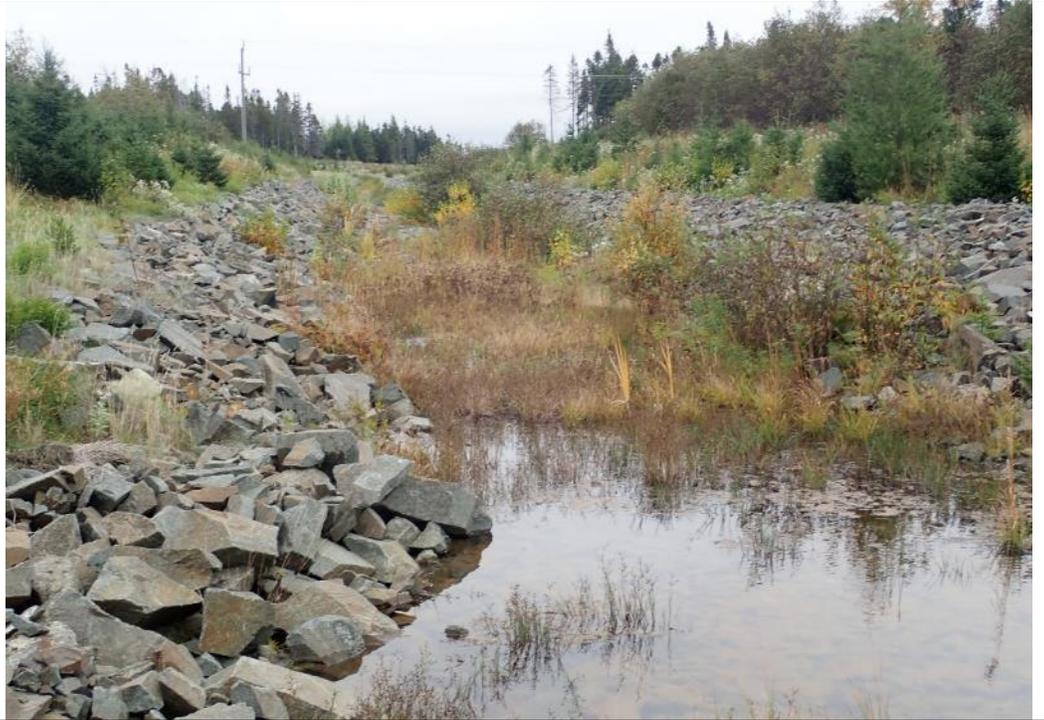
Photograph 6

View along Dam B Spillway after ponded area; Mine Access Road visible in the background.

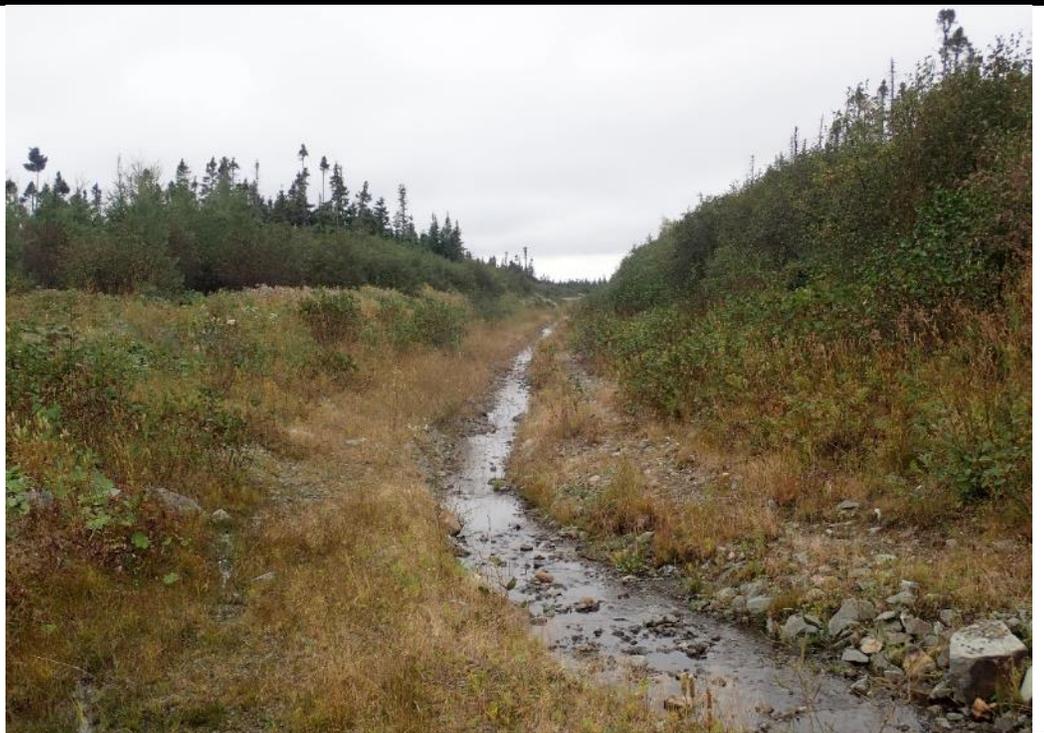
Photograph 7

View of Dam B Spillway channel looking northeast from culverts along Mine Access Road.

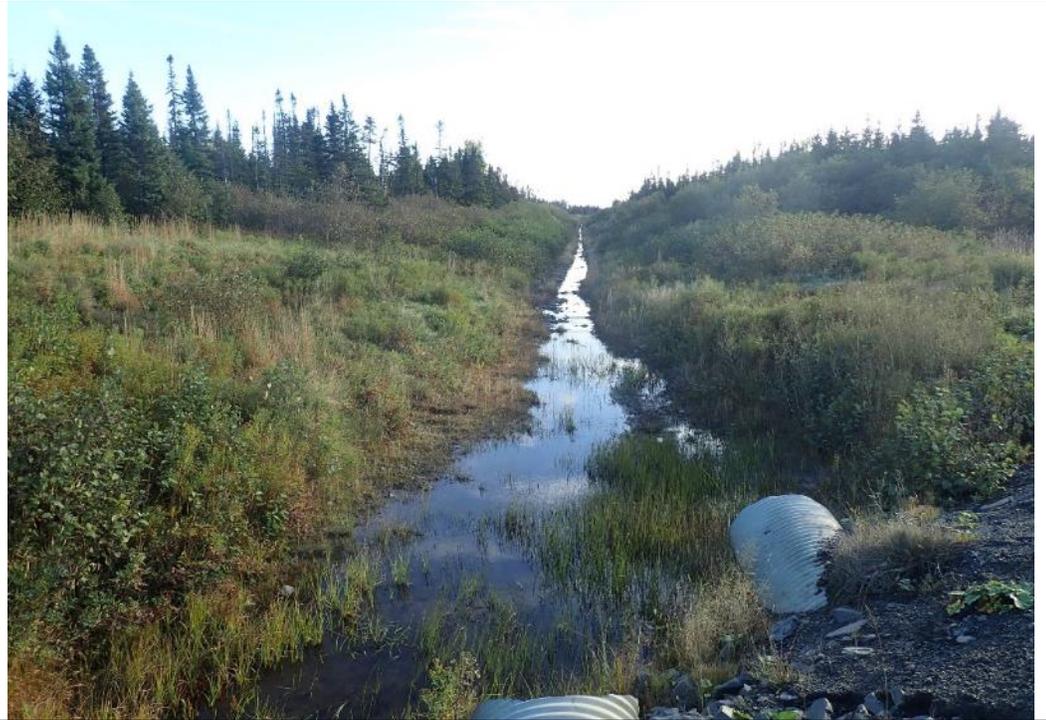
Photograph 8

View of inlets of three CSP culverts along Dam B Spillway at Mine Access Road.

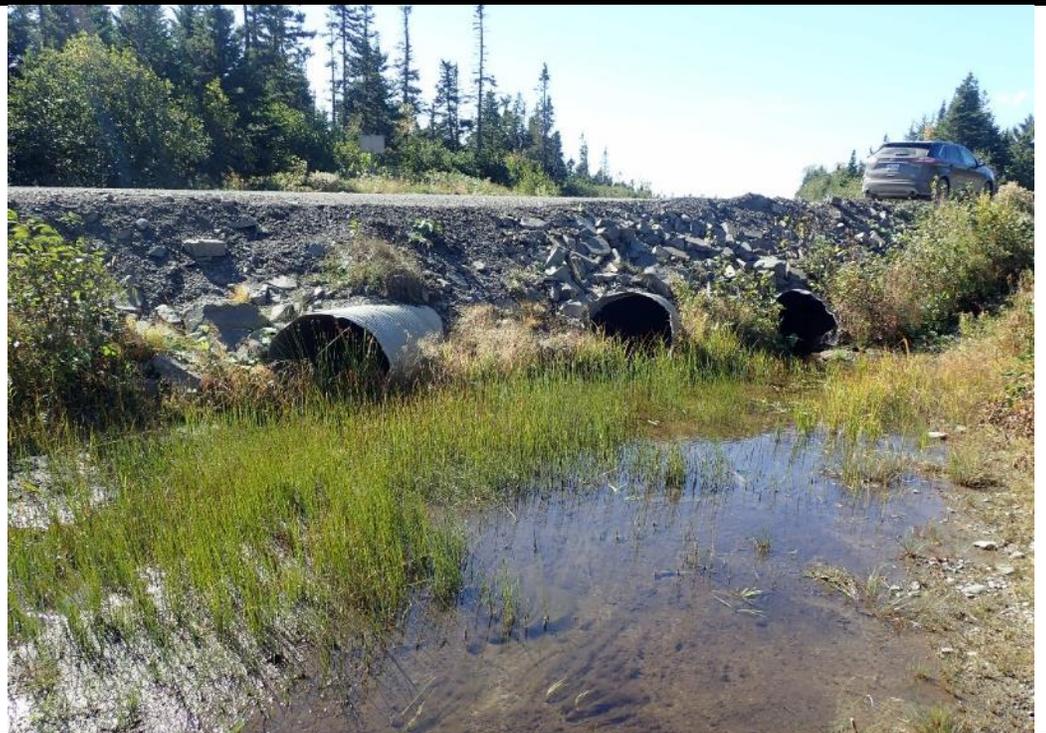
Photograph 9

View of outlets of three CSP culverts along Dam B Spillway at Mine Access Road.

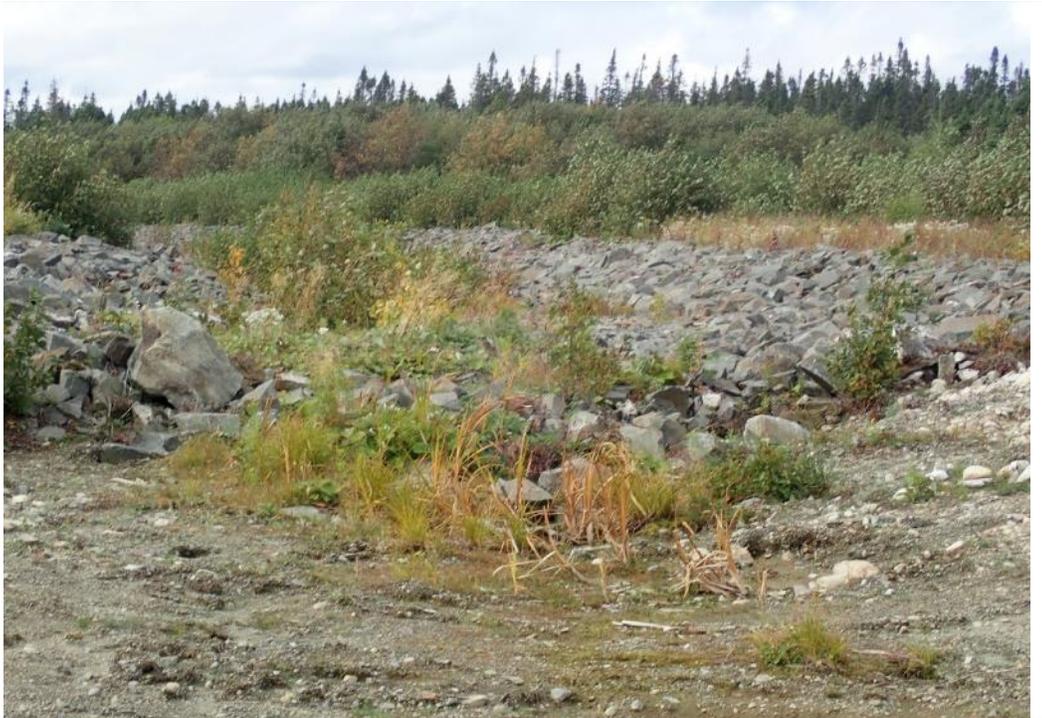
Photograph 1

View of Dam C spillway inlet, note minor vegetation growth.

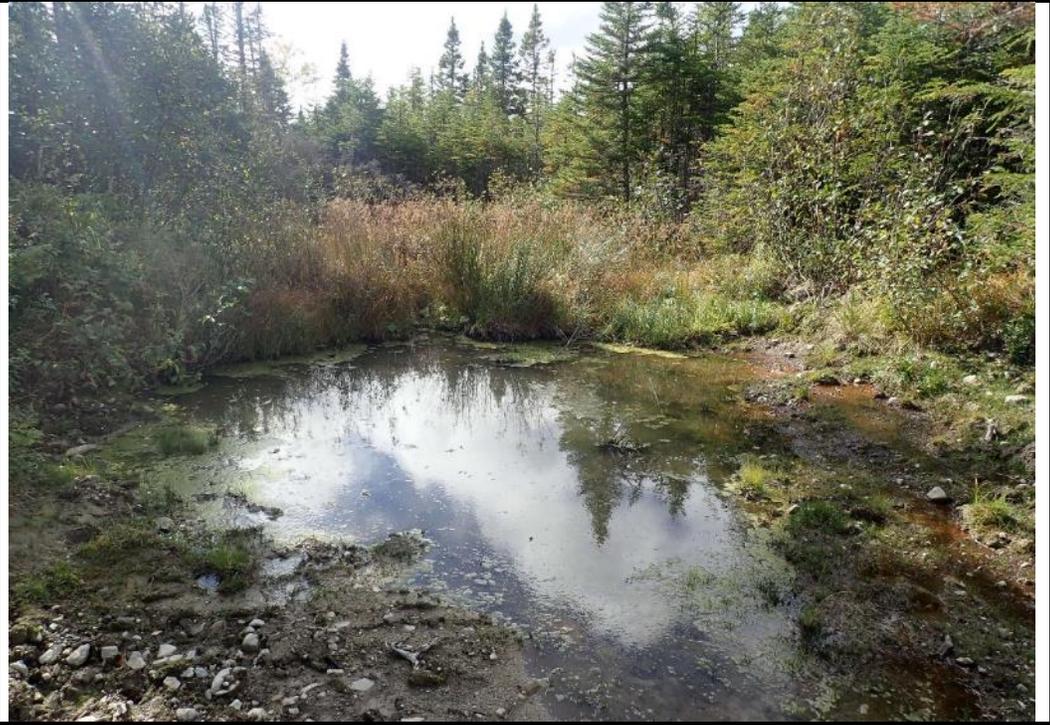
Photograph 5

View of ponded water at the end of the Dam C spillway.

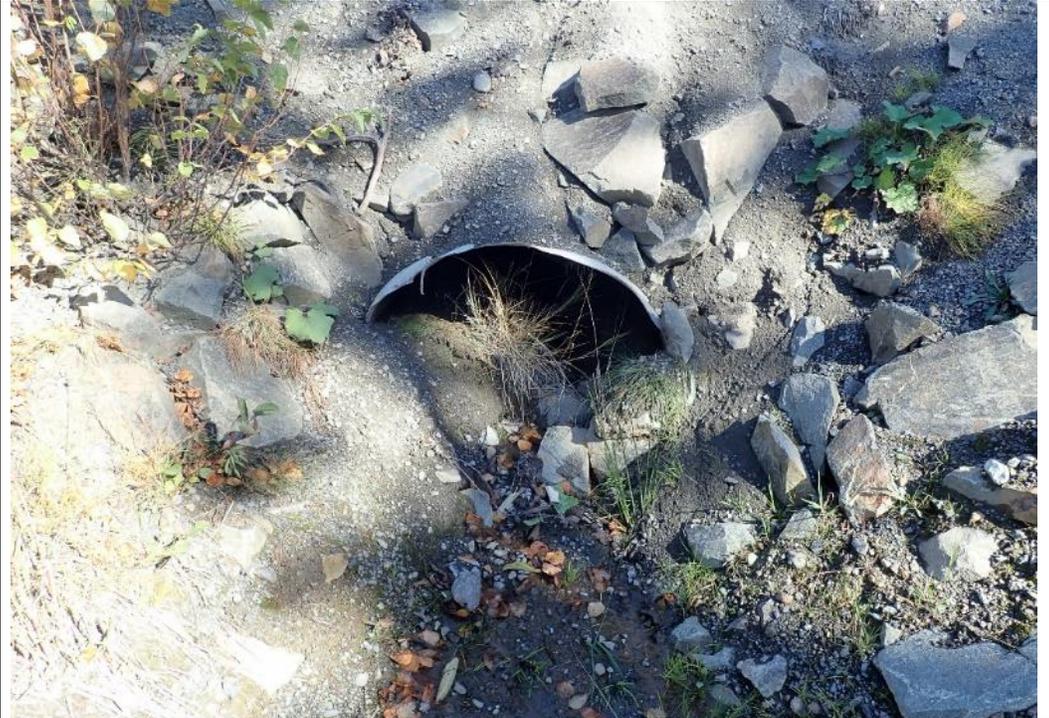
Photograph 13

View of Diversion Ditch C1 culvert (outlet) along Mine Access Road. Outlet is partially blocked.

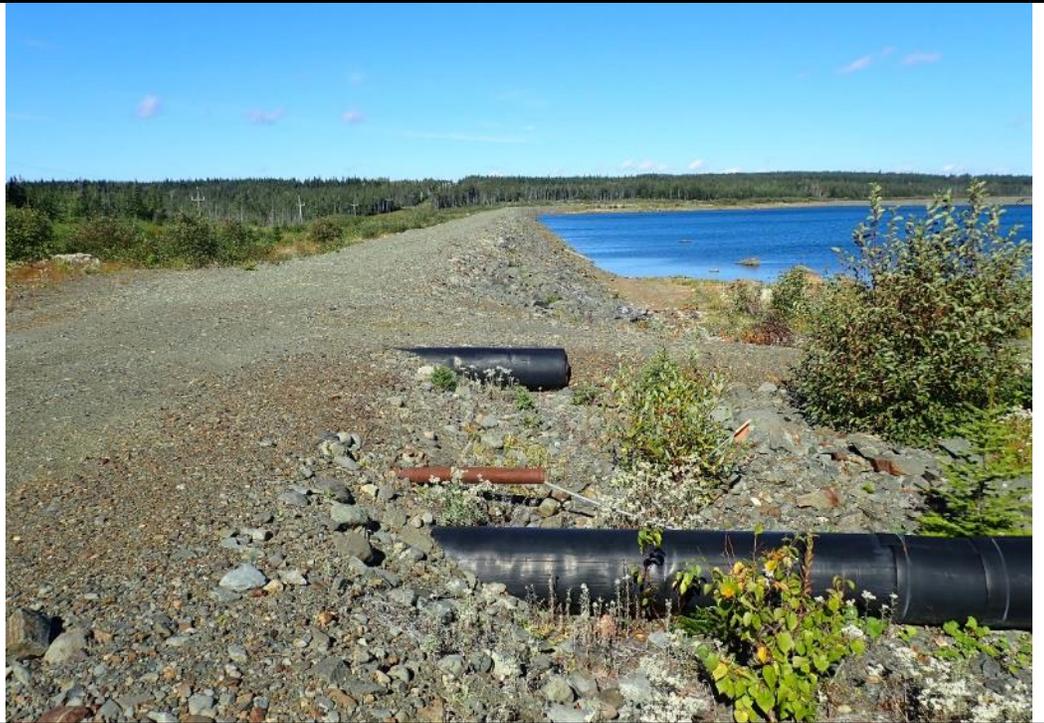
Photograph 1

View of water transfer pipeline near south abutment of Dam B. Water transfer pipeline empties into Discharge Ditch.

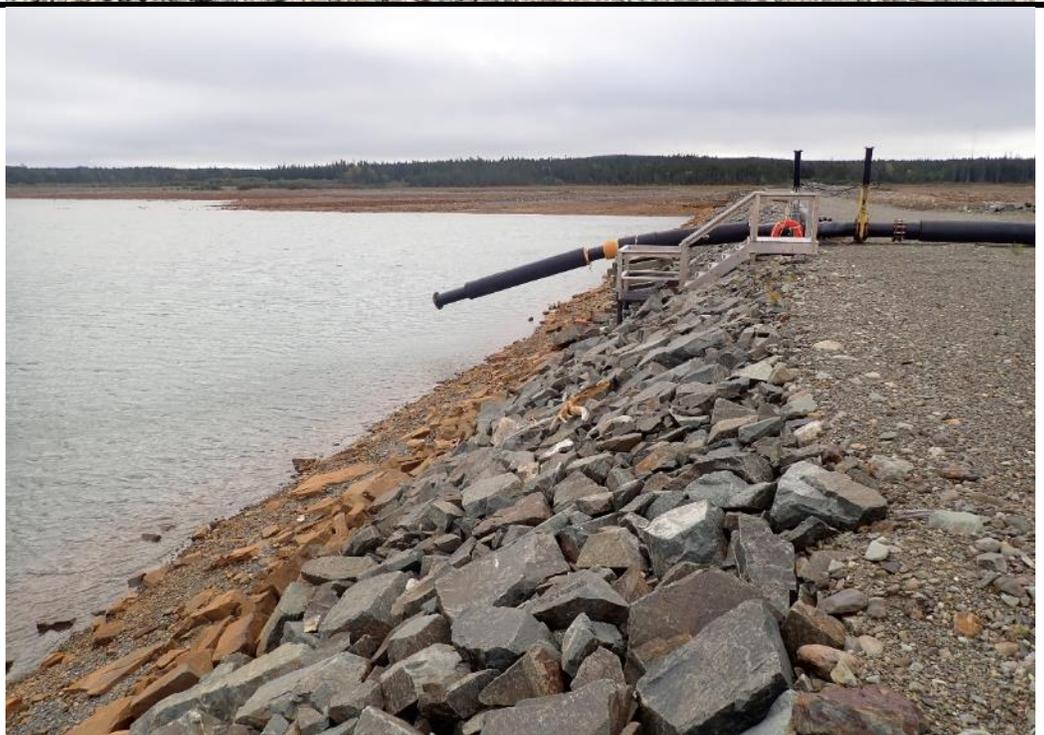
Photograph 4

In 2017 two new pipelines were installed from the water treatment plant to Berms 1 and 3. The pipelines appear to be a combination of 10", 12", and 14" HDPE pipelines with tee valve at the discharge locations to allow flow into all 4 cells (see Photo 4). Teck reports that the pipelines are functioning as required.

Water treatment plant discharge pipeline on Berm 1.

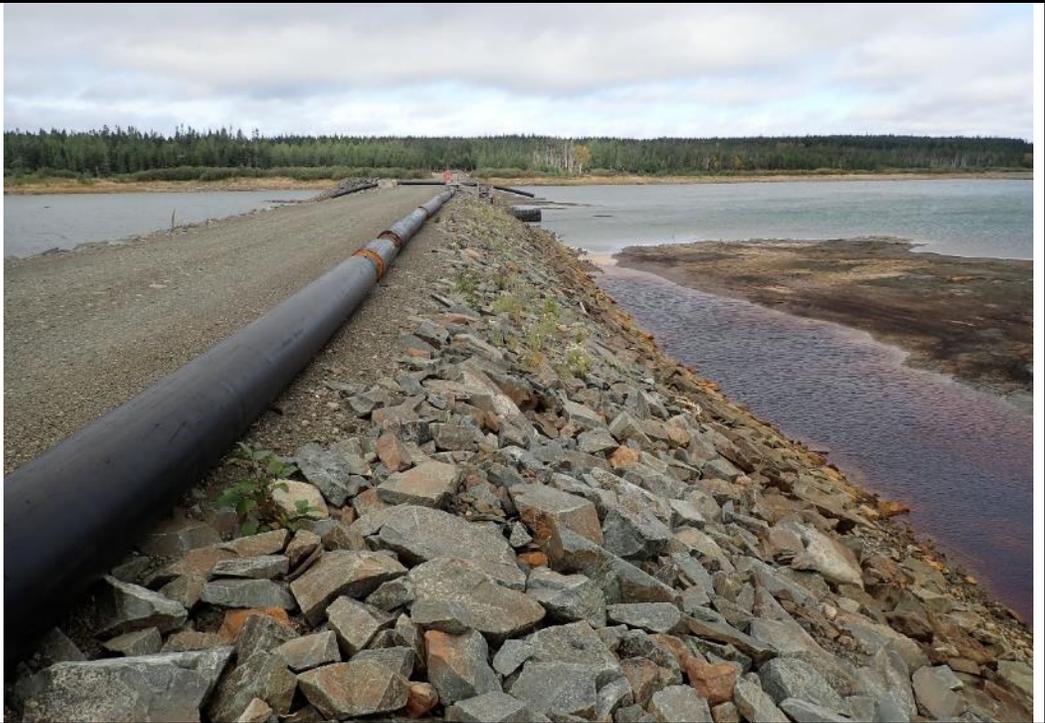
Photograph 5

Water treatment plant
discharge pipeline on Berm 3.
