Teck Coal Limited Elkview Operations

West Fork Tailings Facility and Lagoons A, B, C, and D

2020 Annual Summary of Facility Performance

March 31, 2021

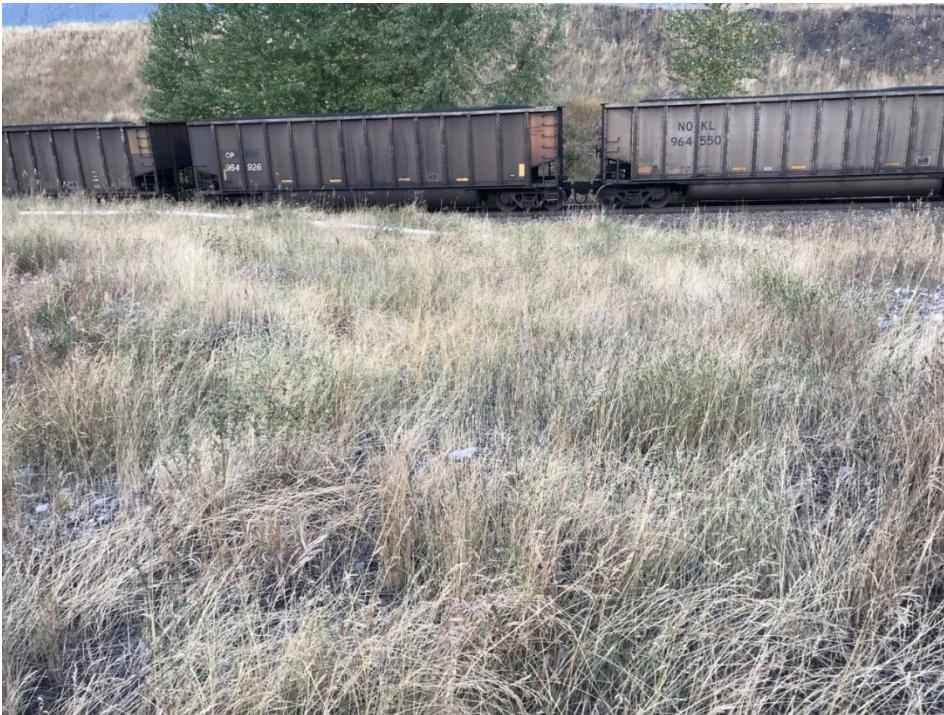
LB-1	A portion of the crest was observed to be narrow, and may possibly be a low spot.	No	No	IB-3
LB-2	A minor erosion gully was observed from the crest of Lagoon B.	No	No	IB-5
Lagoon C				
LC-1	A local low spot on the crest near the trestle was observed.	No	No	IC-9
LC-2	Erosion on the upstream side of the crest was observed at the north section of the Lagoon near the pumphouse. It is not expected that this erosion could propagate though the crest of the dam, causing a significant dam failure.	No	No	IC-3, IC-4

Photo IB-3 Lagoon B potential low spot in crest. (looking west)

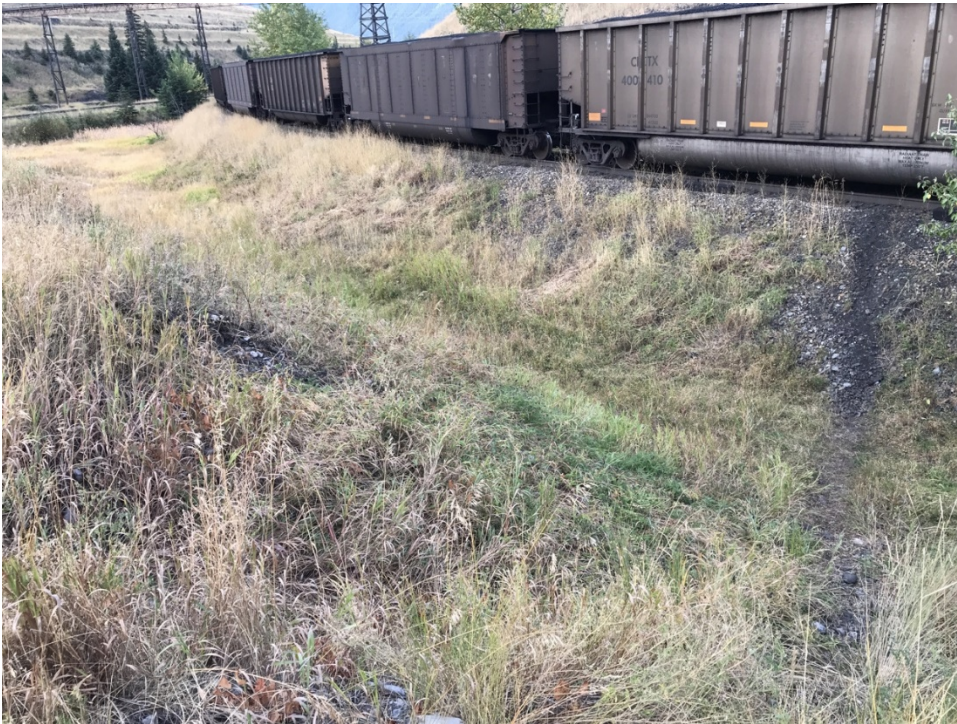
Photo IB-5 Lagoon B minor erosion gully. (looking southwest)

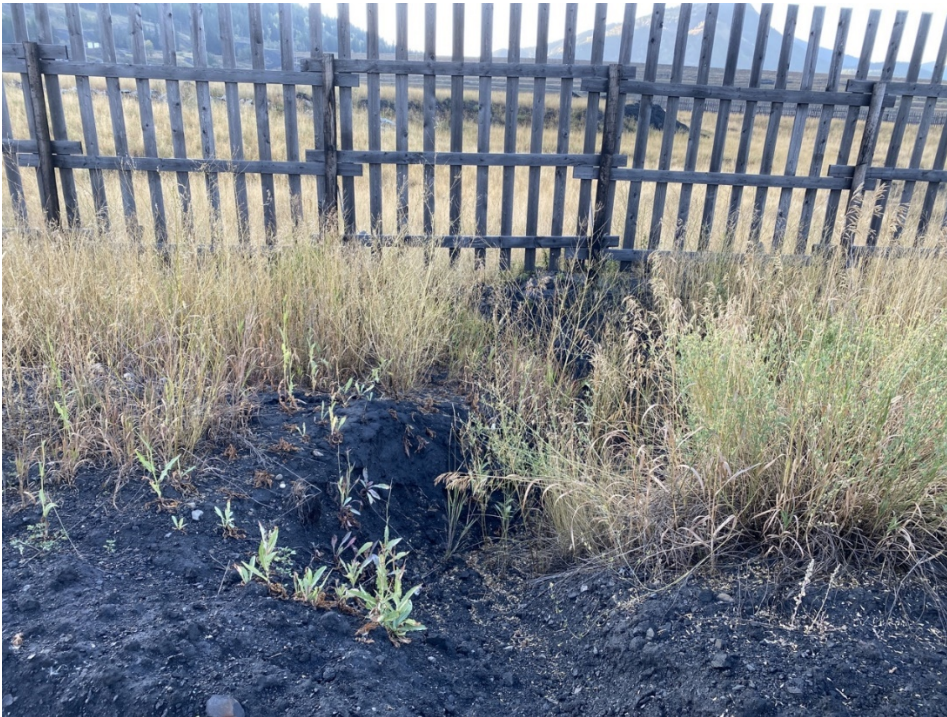
Photo IC-3 Lagoon C minor erosion upstream of crest near pumphouse. (looking southeast)

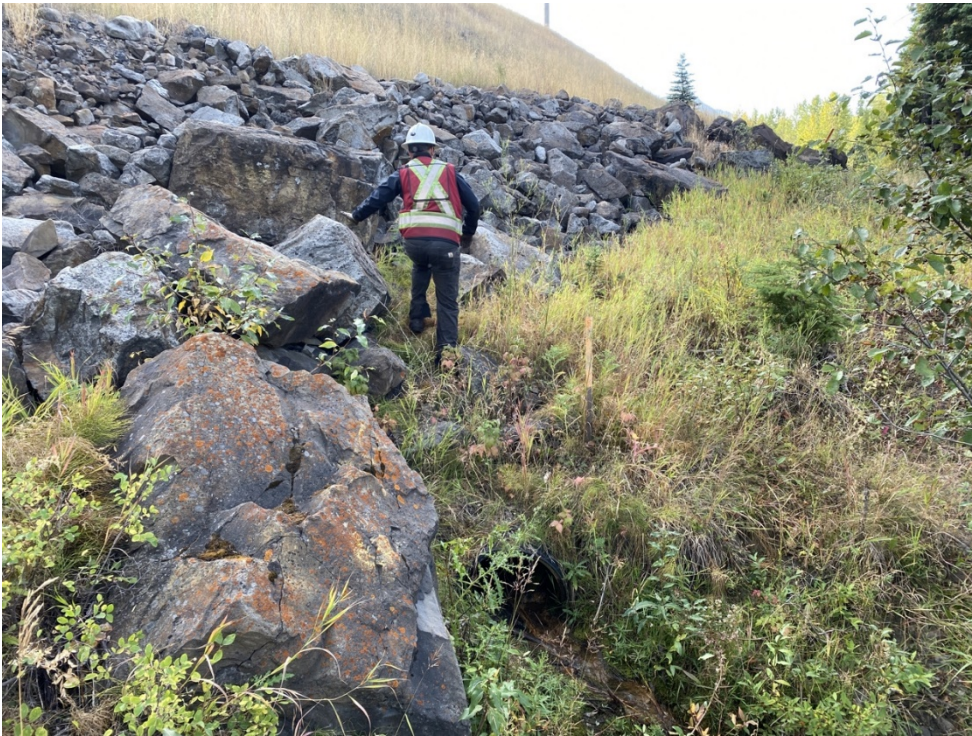
Photo IC-11 Lagoon C toe riprap and buried pipe. (looking south)

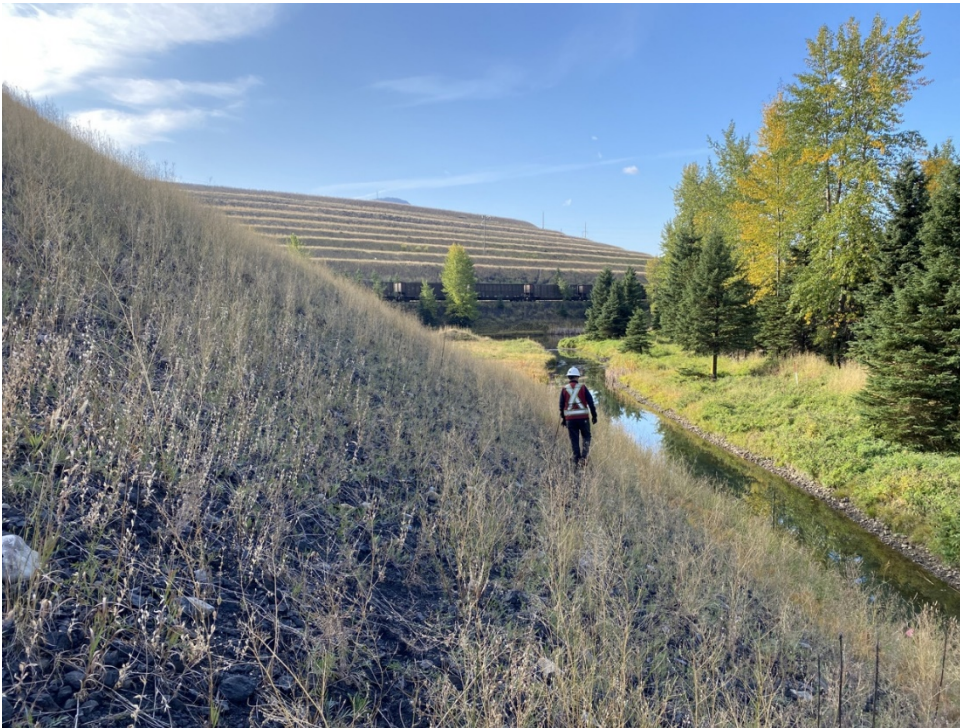
Photo IC-13 Lagoon C ponding between toe and rail line. (looking south)

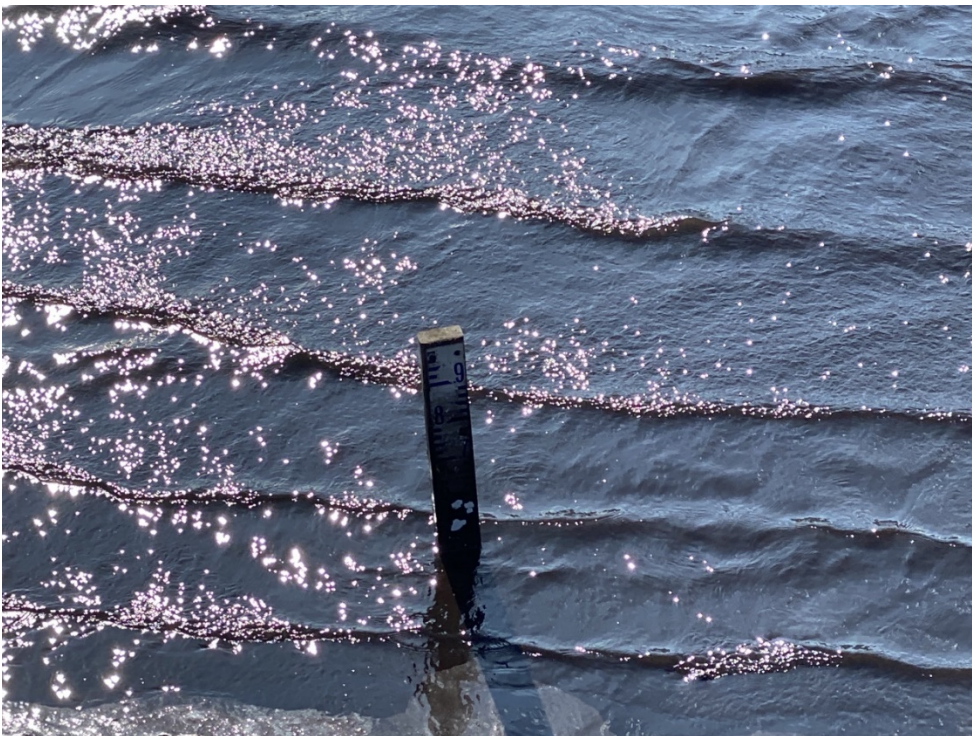
No.	(Anomalous) Observations	Change from 2019 DSI?	Dam Safety Concern?	Photo Reference
LC-3	The buried pipe at the western toe of Lagoon C was flowing at the time of inspection. This pipe drains the fill material at the western toe of Lagoon C, adjacent to the buried gas pipeline.	No	No	IC-11
Lagoon D				
LD-1	Minor downstream erosion was observed at several locations around the Lagoon D dam.	No	No	ID-12, ID-14
LD-2	The staff gauge used to measure the depth of the decant pond was observed to be covered with tailings sediment, obscuring the depth marks. EVO personnel should clean or replace staff gauges as required, and the OMS Manual should be updated to include this maintenance practice.	Yes	No	ID-10

Photo ID-10 Lagoon D decant pond staff gauge unreadable (looking south).

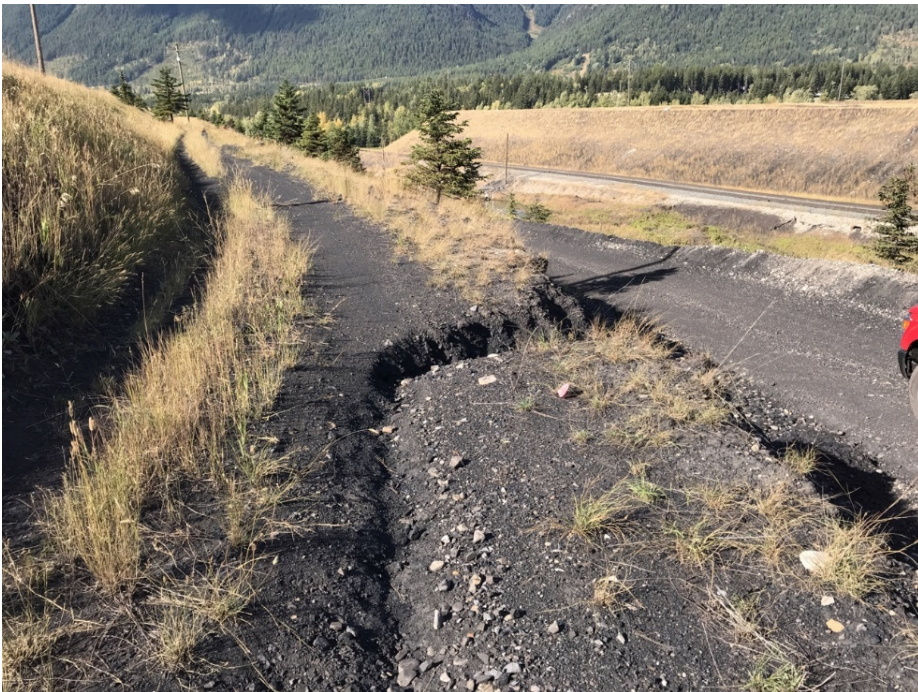
Photo ID-14 Lagoon D bench minor erosion. (looking west)

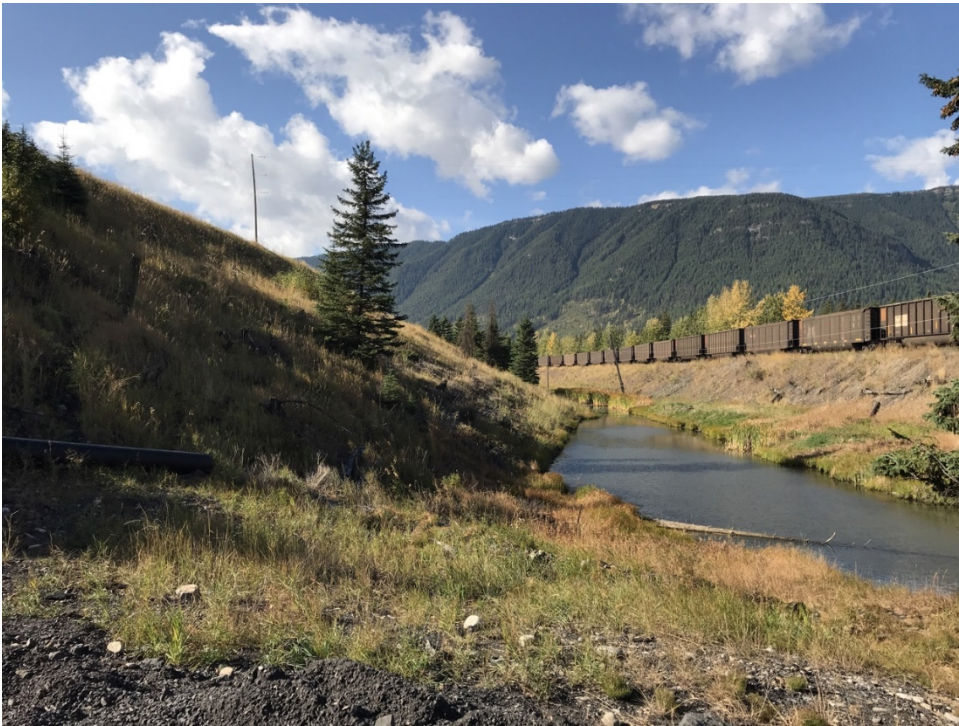
Photo ID-15 Lagoon D ponding at the toe (Otto Ponds) adjacent to the rail line. (looking west)

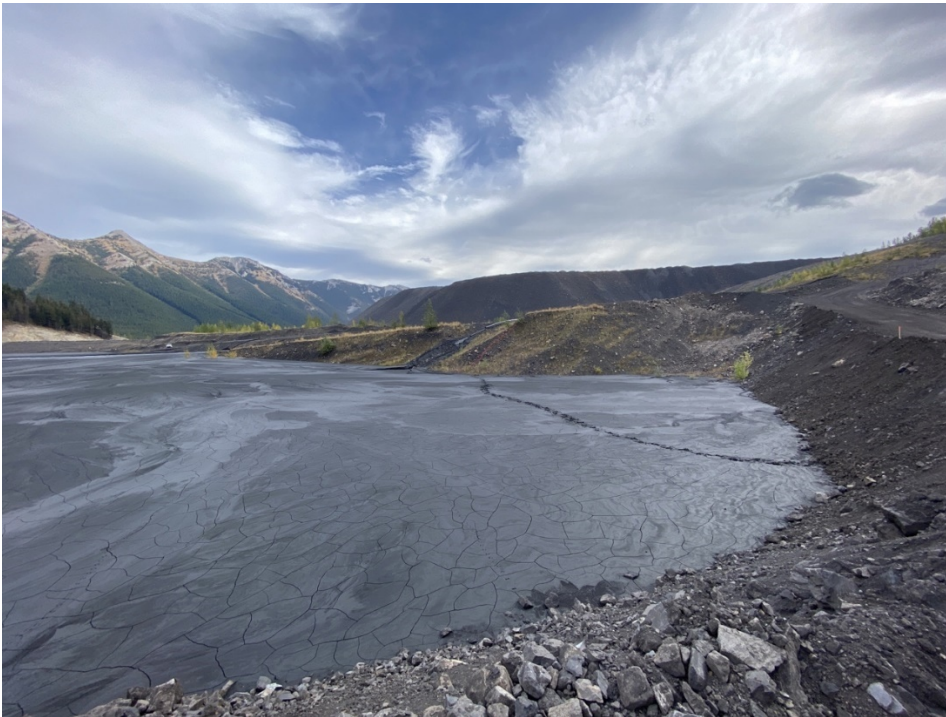
Photo IW-1 WFTF embankment overview. (looking southeast)

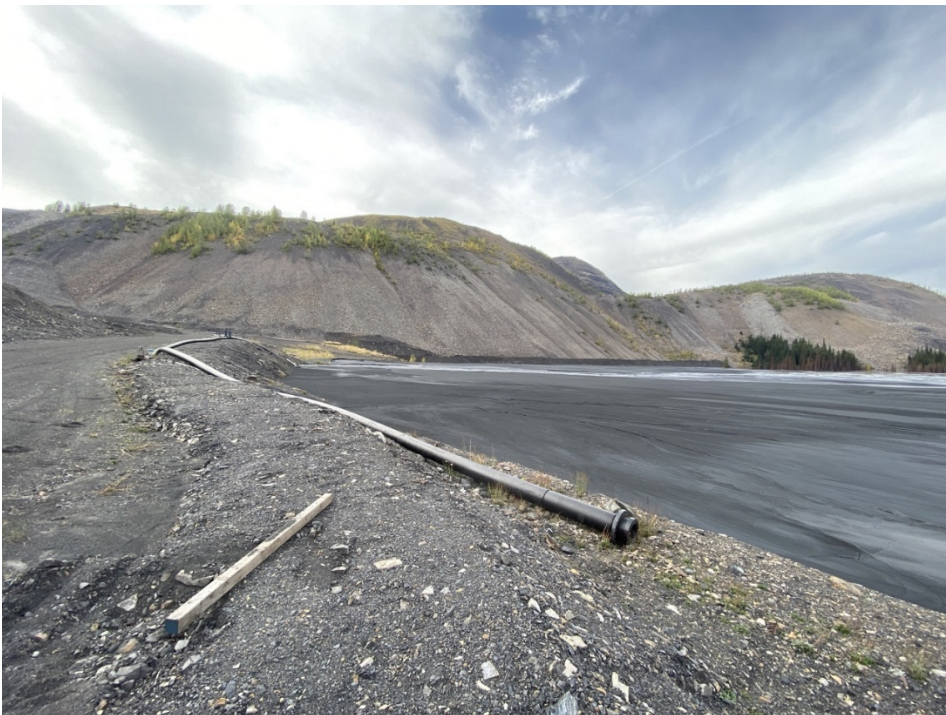
Photo IW-2 WFTF embankment. (looking west)

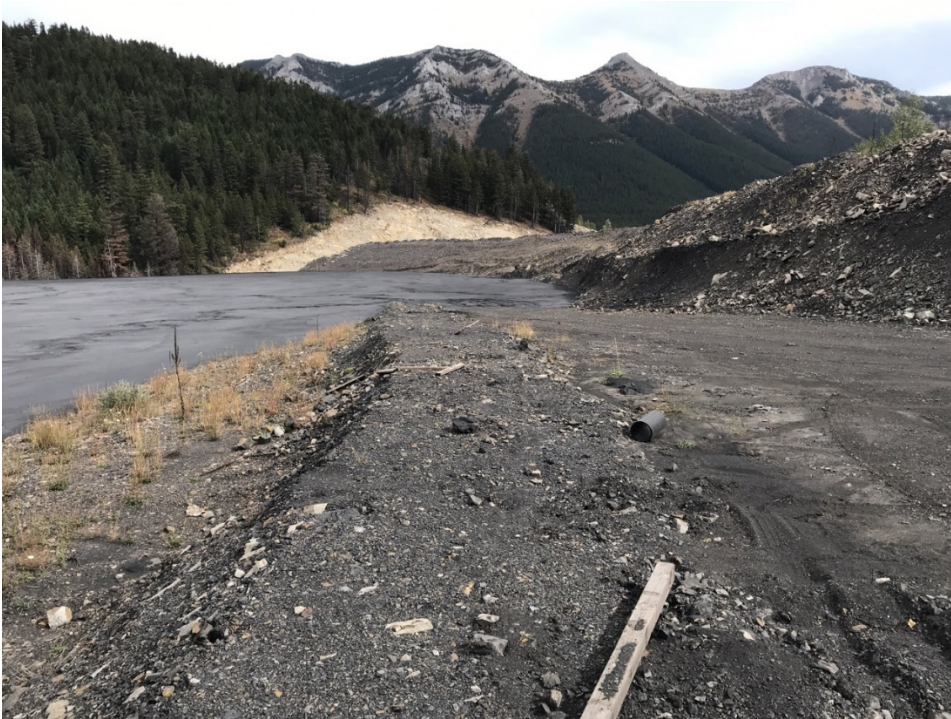
Photo IW-3 WFTF embankment. (looking east)

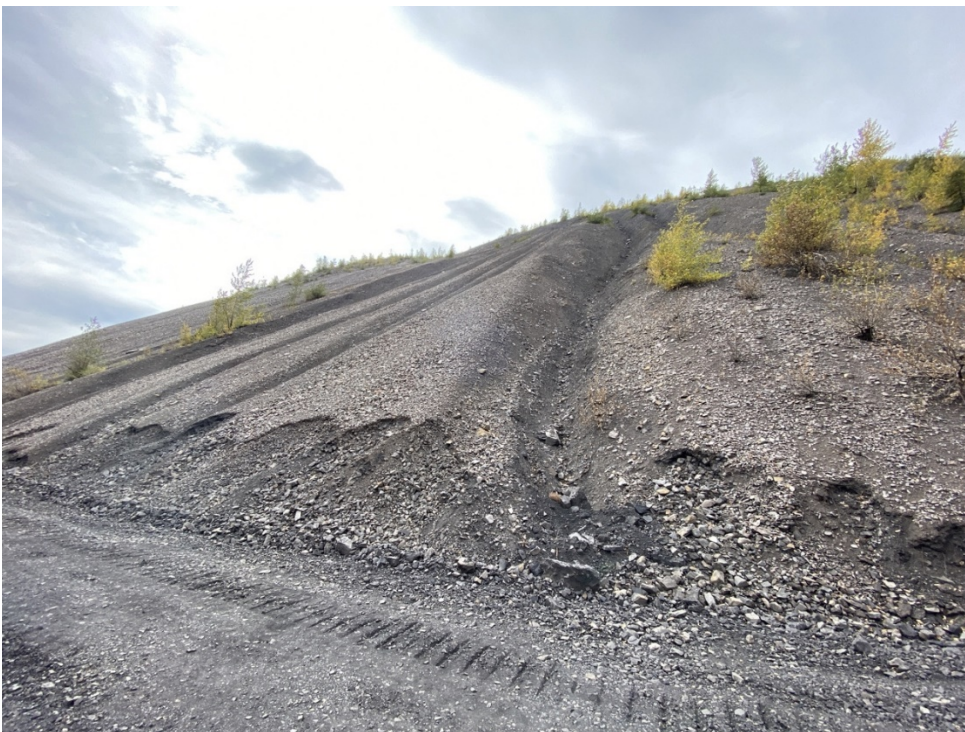
Photo IW-8 WFTF Adit Dump erosion above Adit Toe Berm. (looking west)

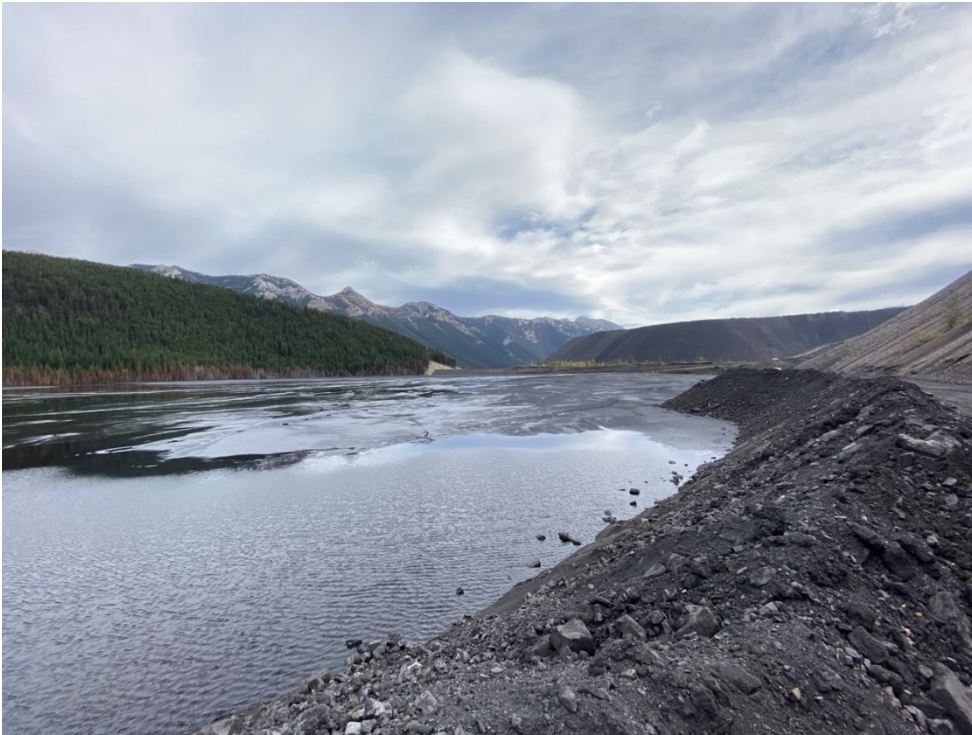
Photo IW-9 WFTF tailings beach and pond. (looking south)
