REPORT 2020 Annual Inspection

Pine Point Tailings Impoundment Area, Pine Point, NT

Reference No. 20140895-279-R-Rev0-1000

16 December 2020

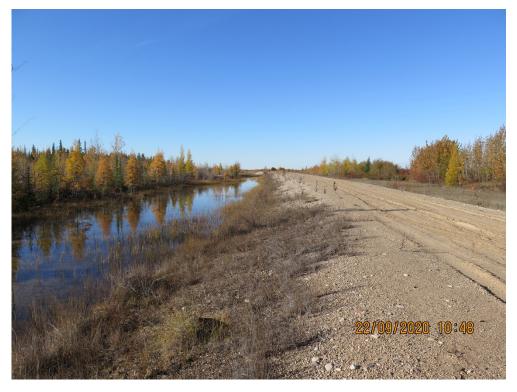
Photograph 1: South Dyke - East End – Dam Crest and Downstream Slope and Toe Area, Looking West, 22 September 2020

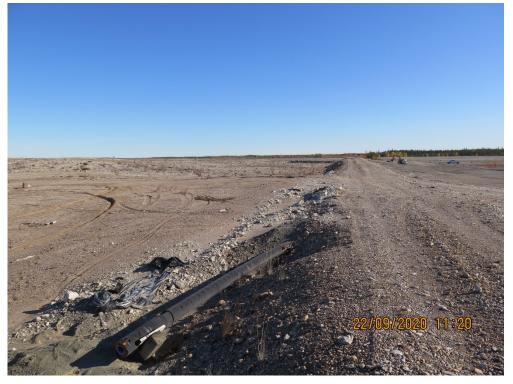
Photograph 3: South Dyke - Central Portion – Upstream Slope and Crest, and Debris in Impoundment Area, Looking East, 22 September 2020

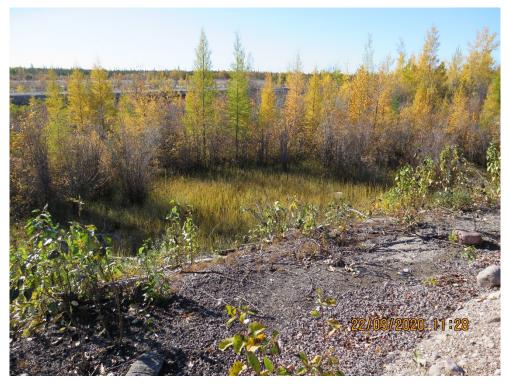
Photograph 6: South Dyke – West End - Downstream Slope Cleared of Vegetation and Toe Area with Wet Ground, Looking Southwest, 22 September 2020

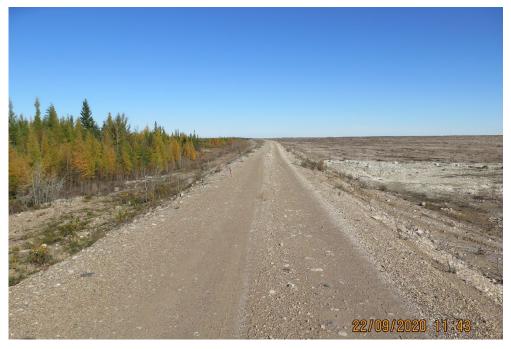
Photograph 7: West Dyke – South End – Crest, Upstream Slope and Toe Area, Looking North, 22 September 2020

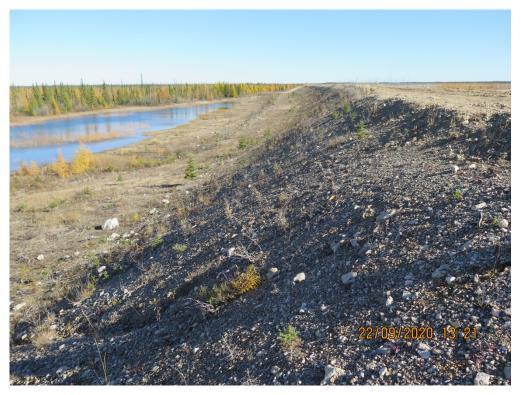
Photograph 12: North Dyke – West End - Downstream Slope, Looking East, 22 September 2020

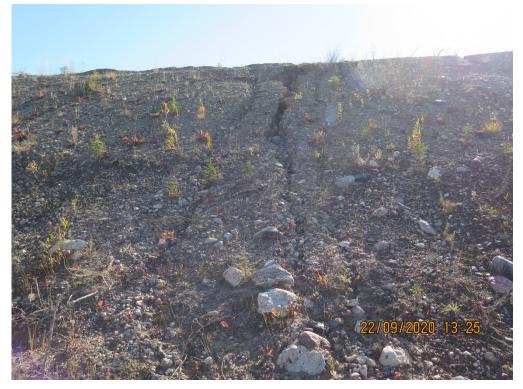
Photograph 13: North Dyke – West End - Erosion Rills on Downstream Slope, Looking South, 22 September 2020

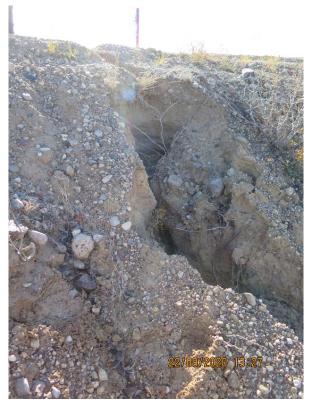
Photograph 14: North Dyke - West End - Erosion Rill on Downstream Slope, Detail, 22 September 2020

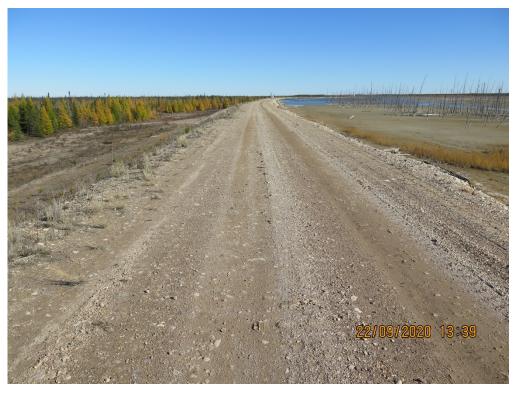
Photograph 15: North Dyke – West End – Crest, Looking Northeast, 22 September 2020

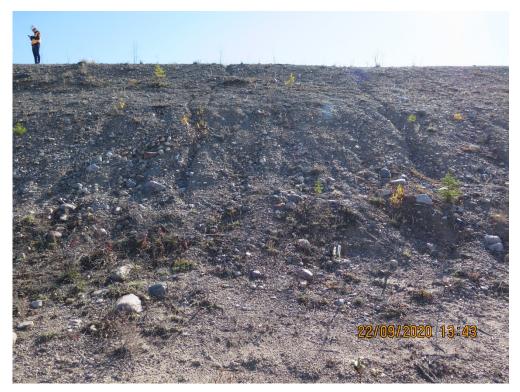
Photograph 16: North Dyke – Central Portion - Downstream Slope with Erosion Rills, Looking South, 22 September 2020

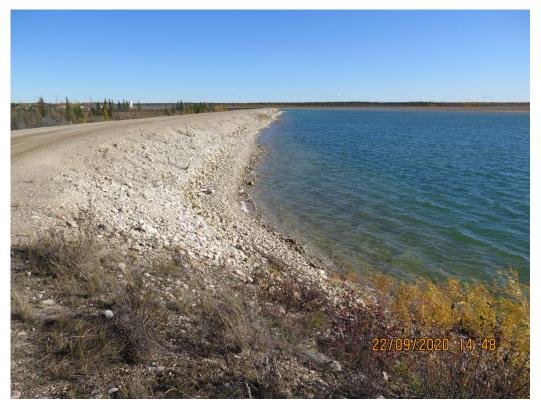
Photograph 18: North Dyke – Upstream Slope of Dogleg, Looking East, 22 September 2020

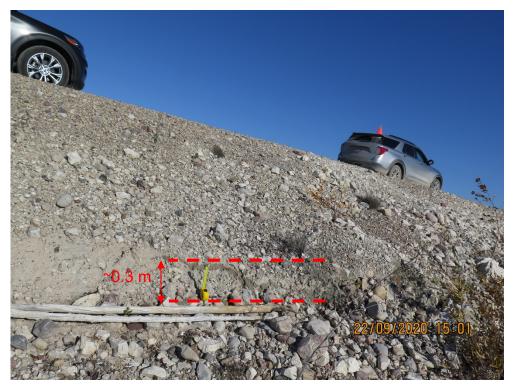
Photograph 19: North Dyke – Upstream Slope West of Dogleg, ~0.3 m Scarp with Exposed Core, Looking Northeast, 22 September 2020

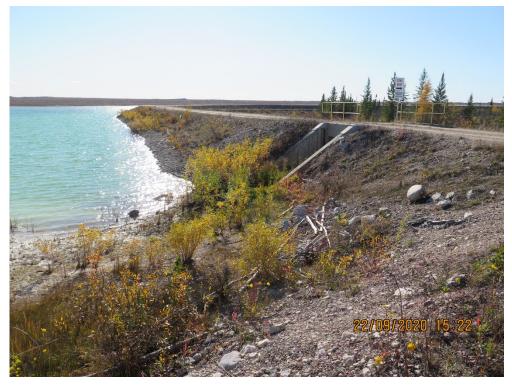
Photograph 21: Main Pond Spillway (Spillway No. 1) - Inlet, Looking Southwest, 22 September 2020

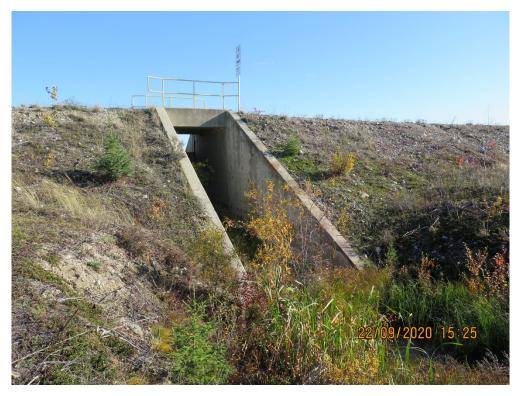
Photograph 22: Main Pond Spillway (Spillway No. 1) - Outlet, Looking Southeast, 22 September 2020

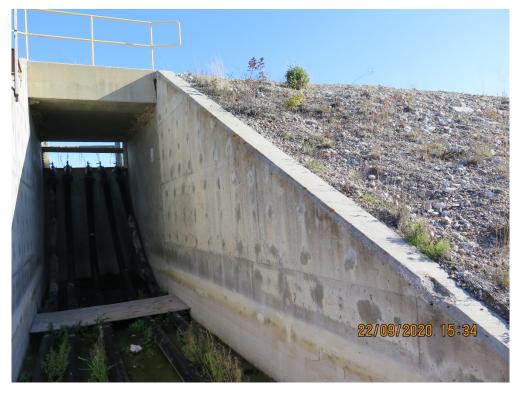
Photograph 23: Polishing Pond Spillway (Spillway No. 2) – Outlet, Syphons in Place, Looking East, 22 September 2020

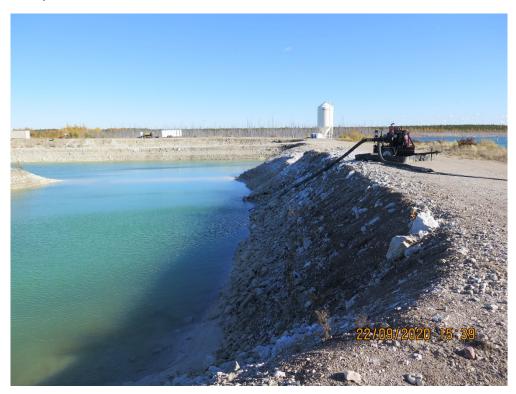
Photograph 24: Polishing Pond – Crest and Slope of Dyke (Polishing Pond on left), Looking East, 22 September 2020

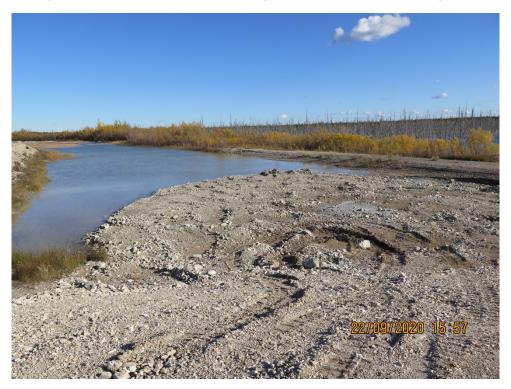
Photograph 26: North Dyke – Impoundment from Polishing Pond, looking East, 22 September 2020

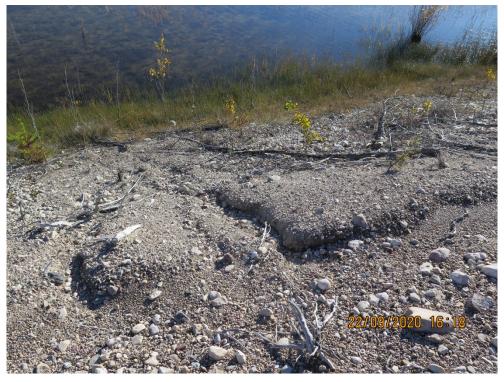
Photograph 27: North Dyke – East End - Upstream Slope with Erosion Rill, looking South, 22 September 2020

Vegetation		Minor vegetation on upstream and downstream slopes
Other -(photos)	N/A	Photographs 7 to 11 (Attachment 1)
Notes:		Erosion on upstream slope with dried grout near borehole drilled in 2020. No grout observed on downstream slope.
North Dyke		•
Ponded Water	Ŋ	Freeboard approximately 2.0 to 2.5 m Pond water level higher than in previous inspections Ponded water north of dyke in downstream toe area Ponded water upstream area of north dyke in area east of polishing pond
Erosion	V	 Rilling on upstream and downstream slopes up to 30 cm deep. Rills requiring repair: 25 m from northwest corner, downstream slope, 80 cm depth (11 V 638,317 6,753,169) East of polishing pond, cutting into crest, upstream side requires repair (11 V 640,451 6,753,933) Location of rill repairs in 2018 in good condition. Riprap placed on upstream slope of dam in good condition, some exposed geotextile. Minor deformation and stepping in lower upstream slope toe around dogleg with a scarp of up to 30 cm and exposed till core, similar to previous inspection. Minor rilling on upstream slope of north dyke, east of polishing pond, requires maintenance for vehicle safety

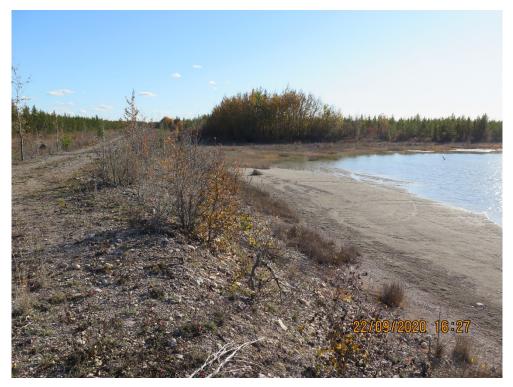
Photograph 28: East Dyke – Crest and Upstream Slope with Ponded Water, looking South, 22 September 2020

East Dyke		
Ponded Water	\checkmark	Tailings and ponded water upstream of dyke in non-
		vegetated area
Erosion	\checkmark	Minor rilling on upstream and downstream slopes up to 10
		cm deep
Settlement/Depressions	\checkmark	None
Sinkholes	\checkmark	None
Cracks/Movement	\checkmark	None
Debris	\checkmark	None
Vegetation	\checkmark	On upstream and downstream slopes
Other -(photos)	N/A	Photograph 28 (Attachment 1)
		NT
Notes:		None
