Quintette Coal Operations

2020 Annual Summary of Tailings Facility Performance

Plantsite Tailings Dam and Plantsite Seepage Collection Pond Dam

March 2021

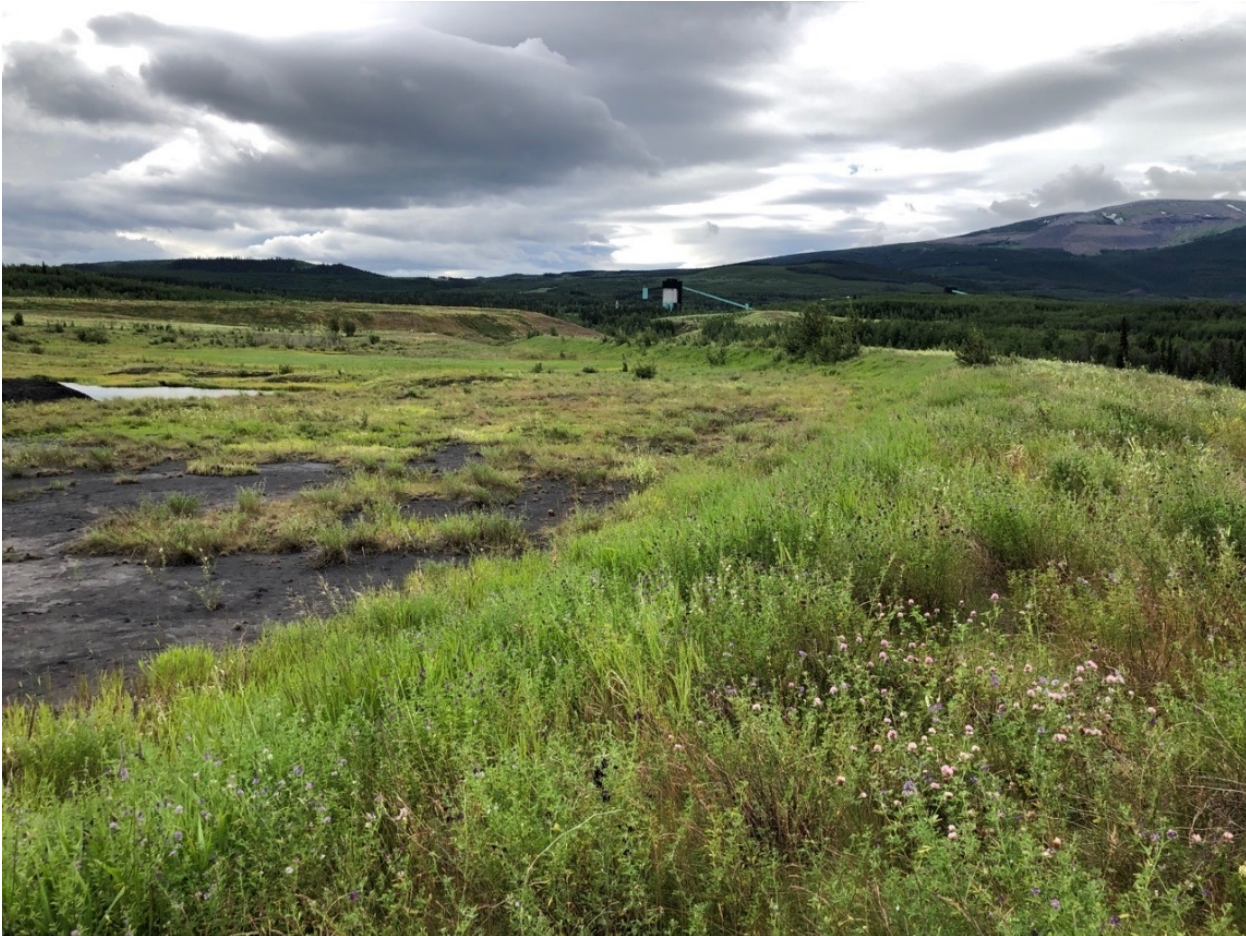
Photo I-1 PTD Impoundment – looking south (PTD-2020-01)

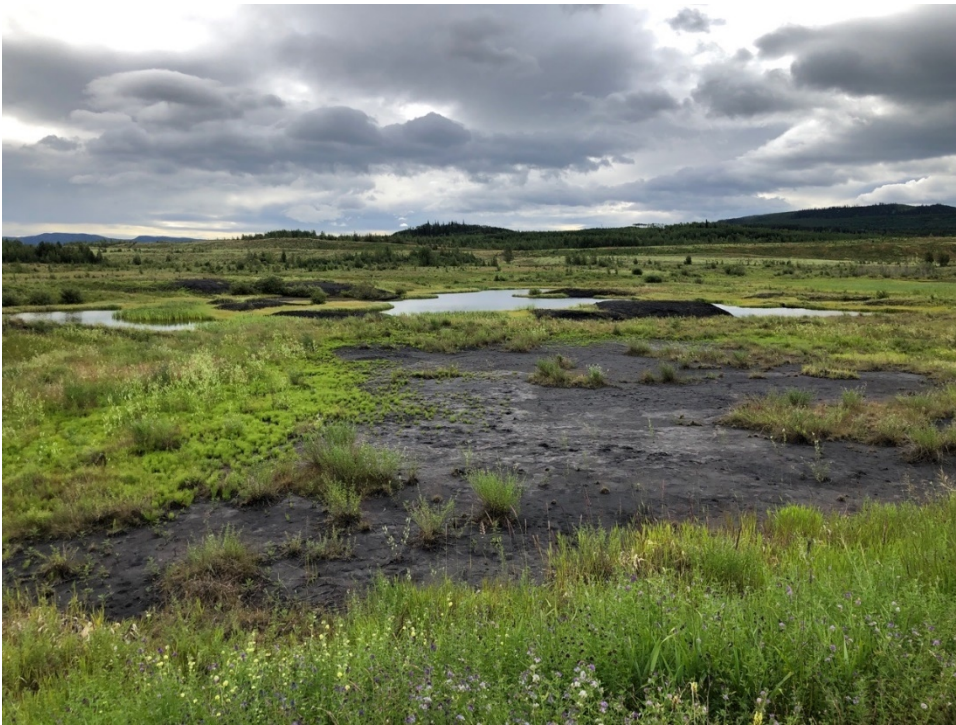
Photo I-2 Ponded Area 2 – looking east (PTD-2020-01)

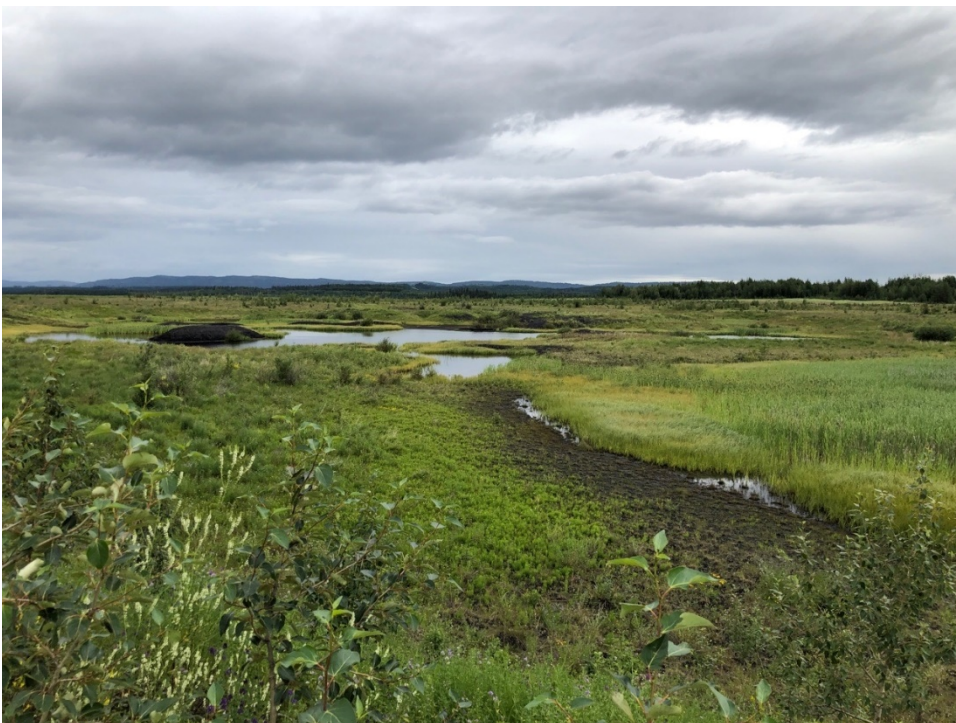
Photo I-4 PTD upstream slope– looking south (PTD-2020-03)

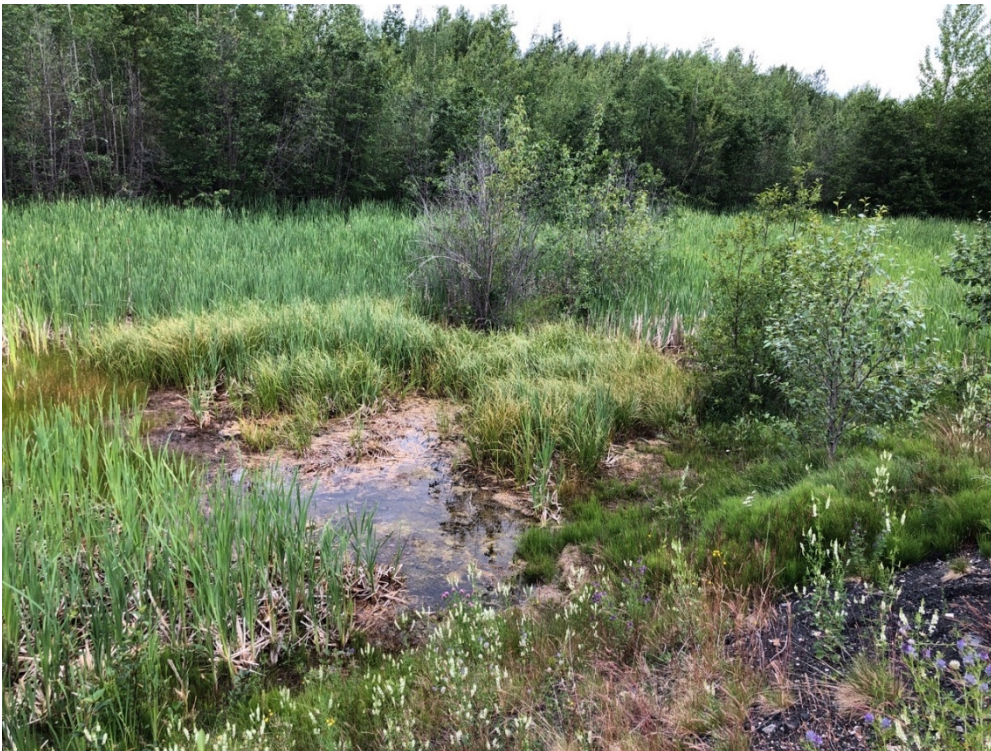
Photo I-33 Ponded water in low spot at toe of dam (PTD-2020-14)

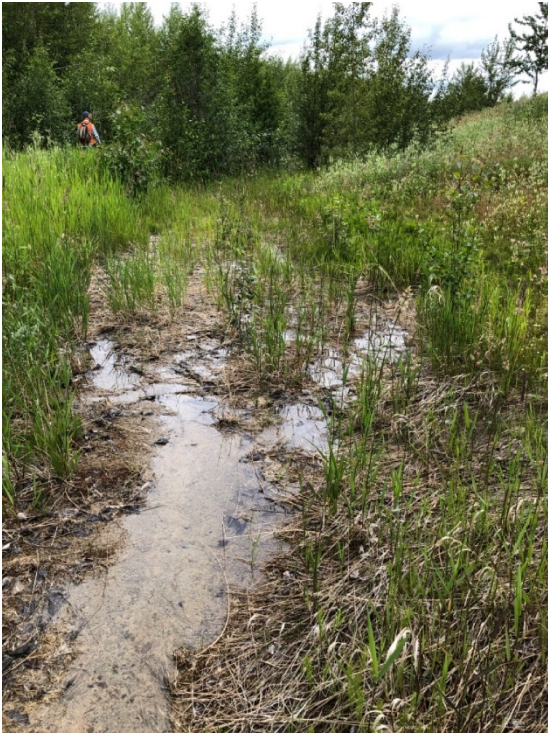
Photo I-36 Some flow along dam toe (PTD-2020-16)

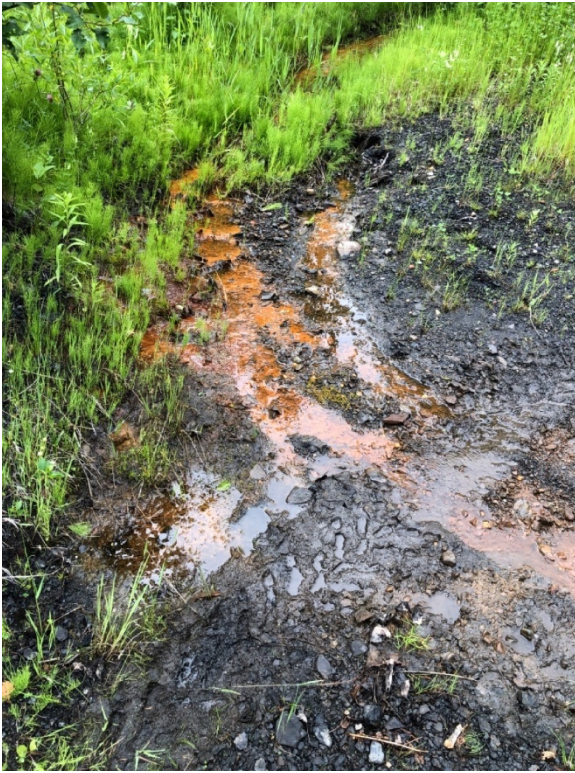
Photo I-38 Flow along dam toe (PTD-2020-18)

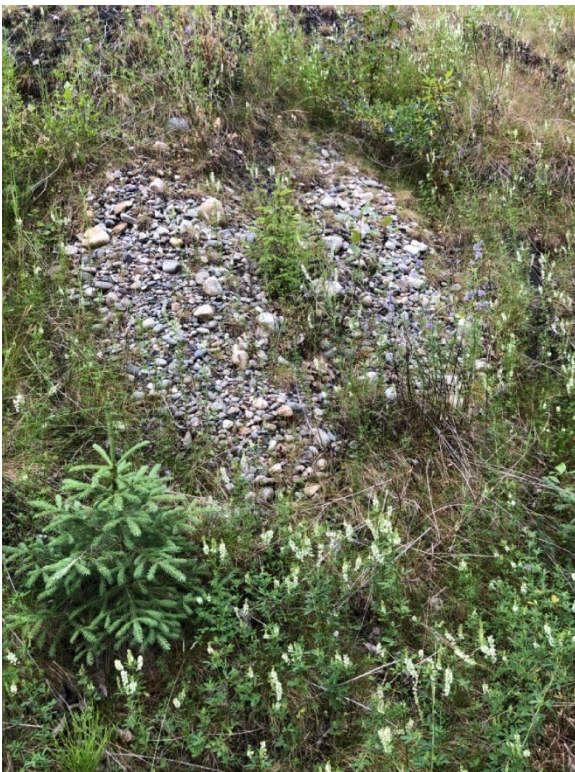
Photo I-41 Finger drain, no flow (PTD-DRAIN-05)

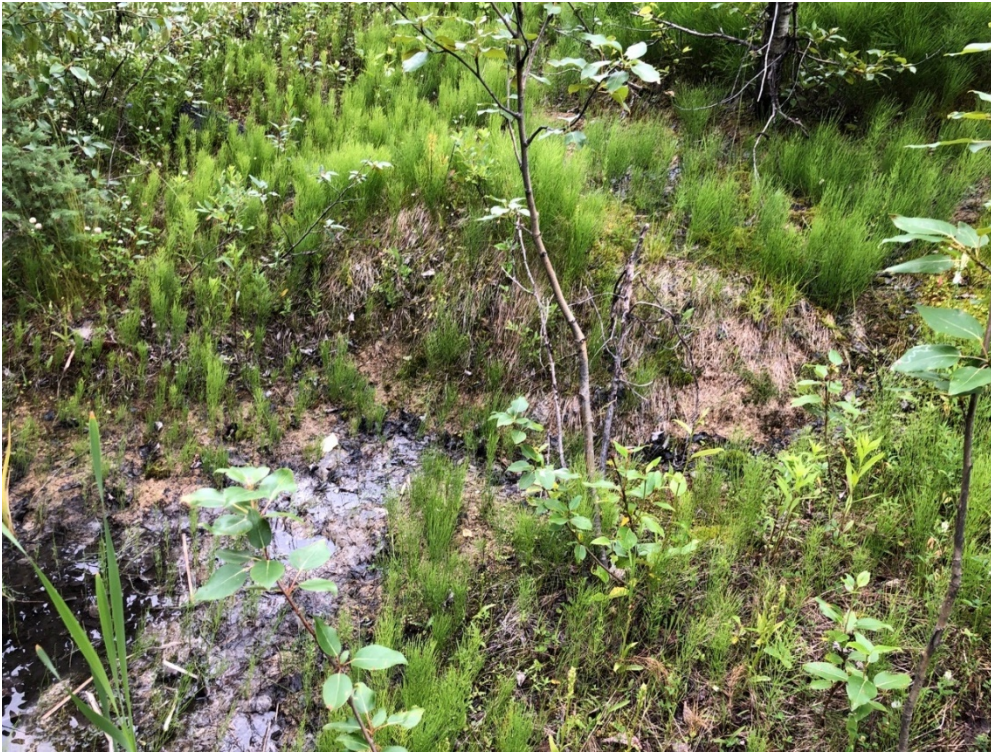
Photo I-42 Finger drain, ponded water, but no flow (PTD-DRAIN-06)

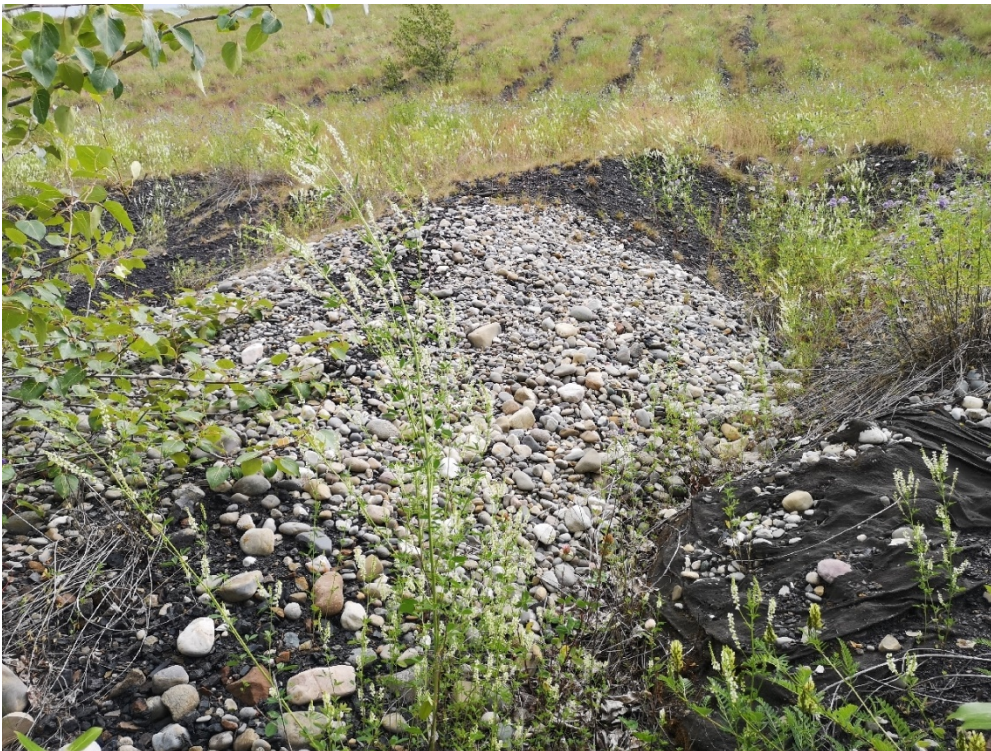
Photo I-43 Finger drain, no flow (PTD-DRAIN-10)

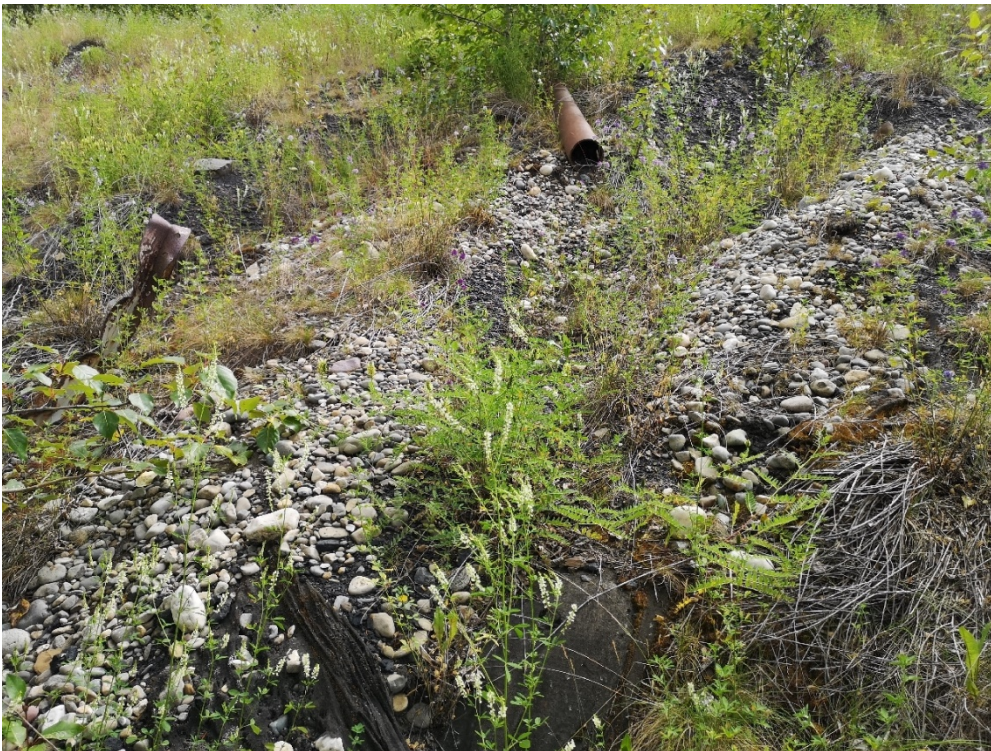
Photo I-47 Finger drain, no seepage (PTD-DRAIN-12)

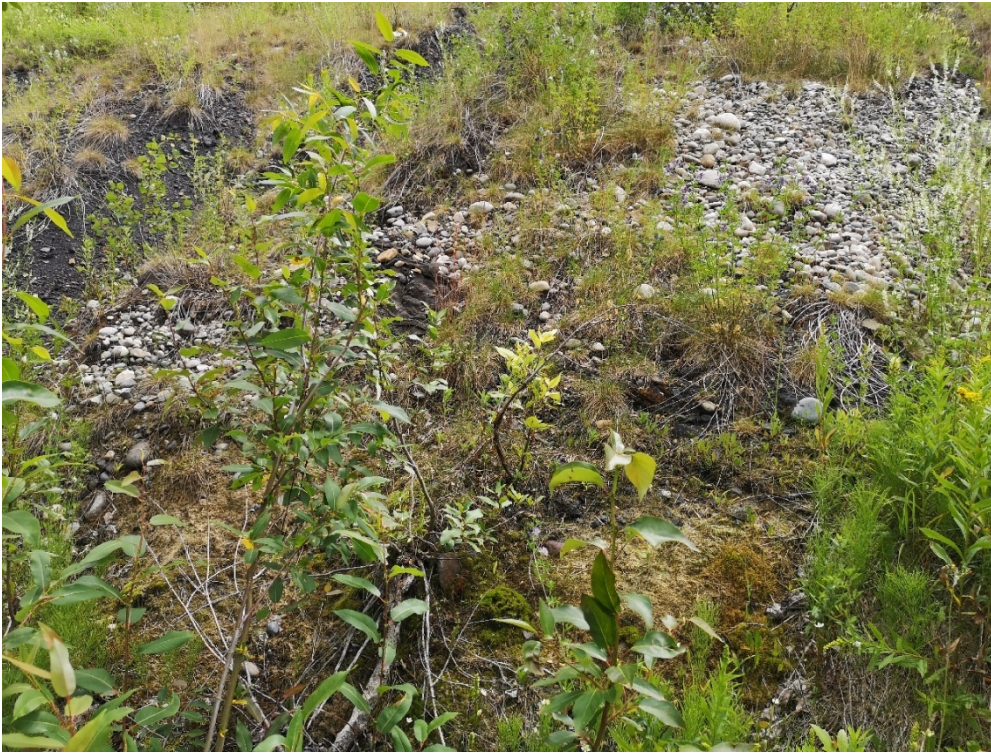
Photo I-48 Finger drain, wet, but no flow (PTD-DRAIN-13)

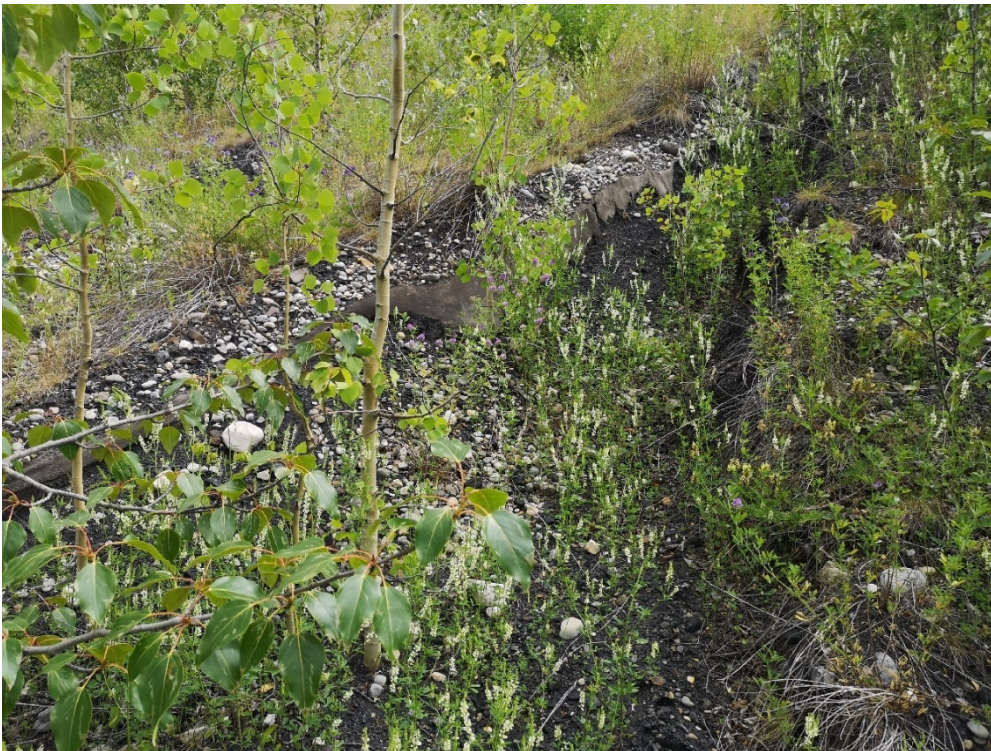
Photo I-49 Finger drain, dry (PTD-DRAIN-14)

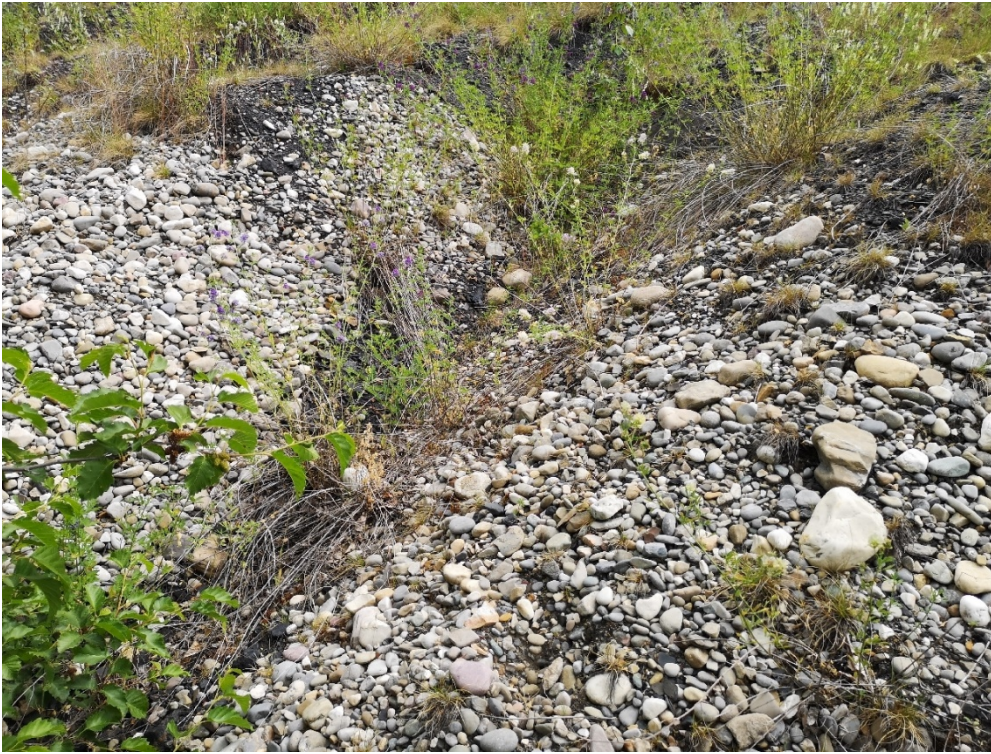
Photo I-50 Finger drain, dry (PTD-DRAIN-15)

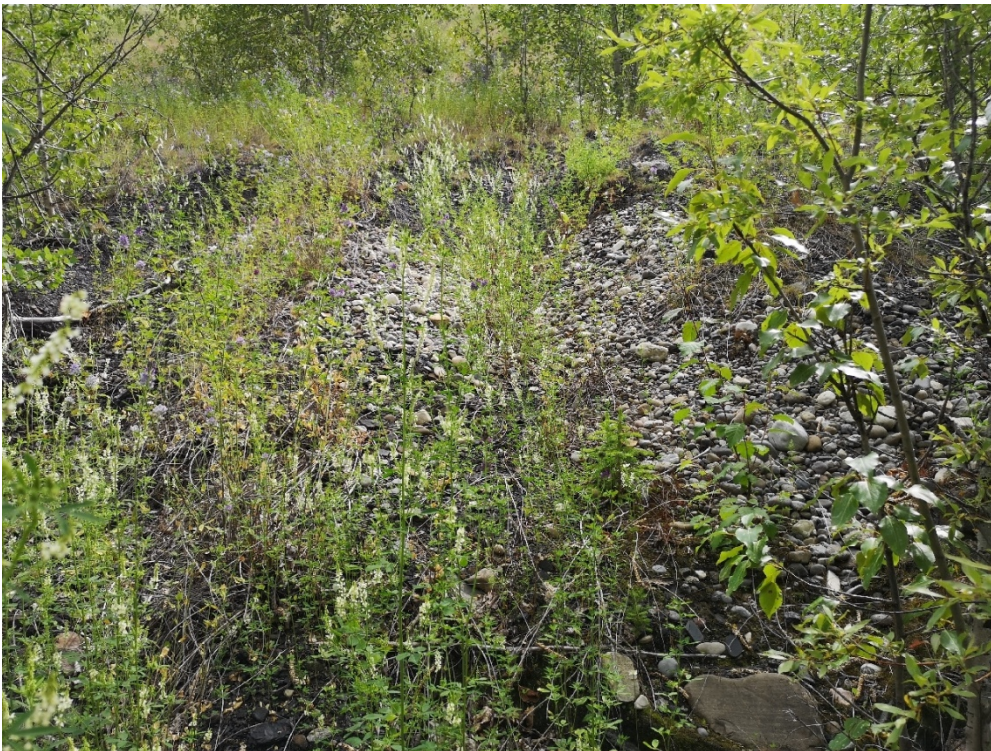
Photo I-51 Finger drain, dry (PTD-DRAIN-16)

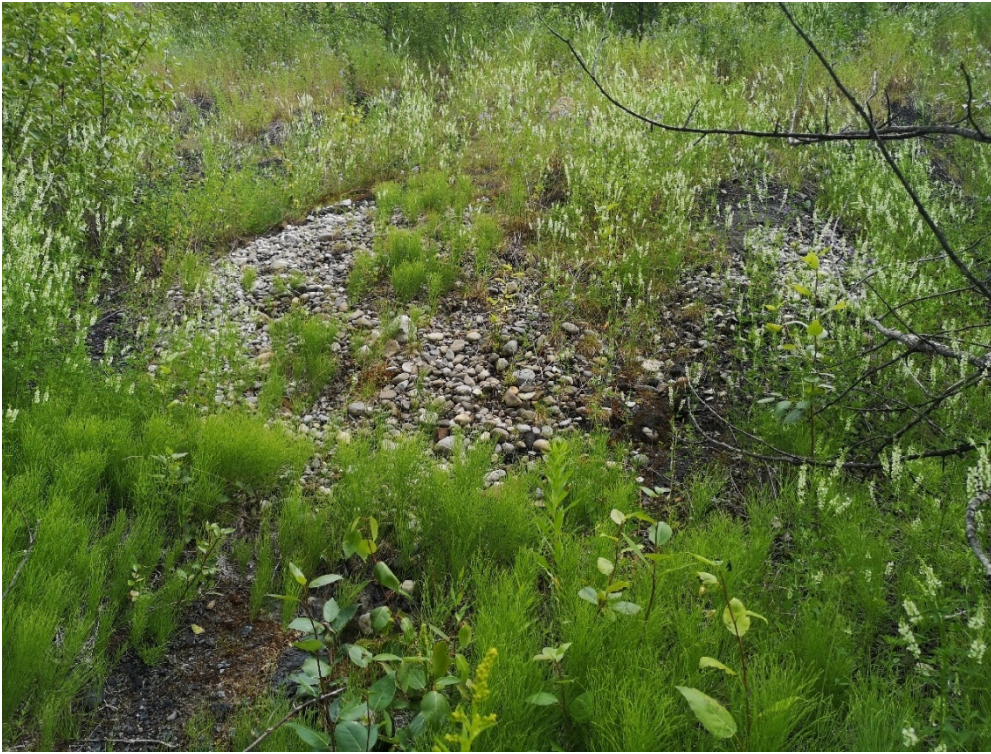
Photo I-52 Finger drain, some seepage (PTD-DRAIN-17)

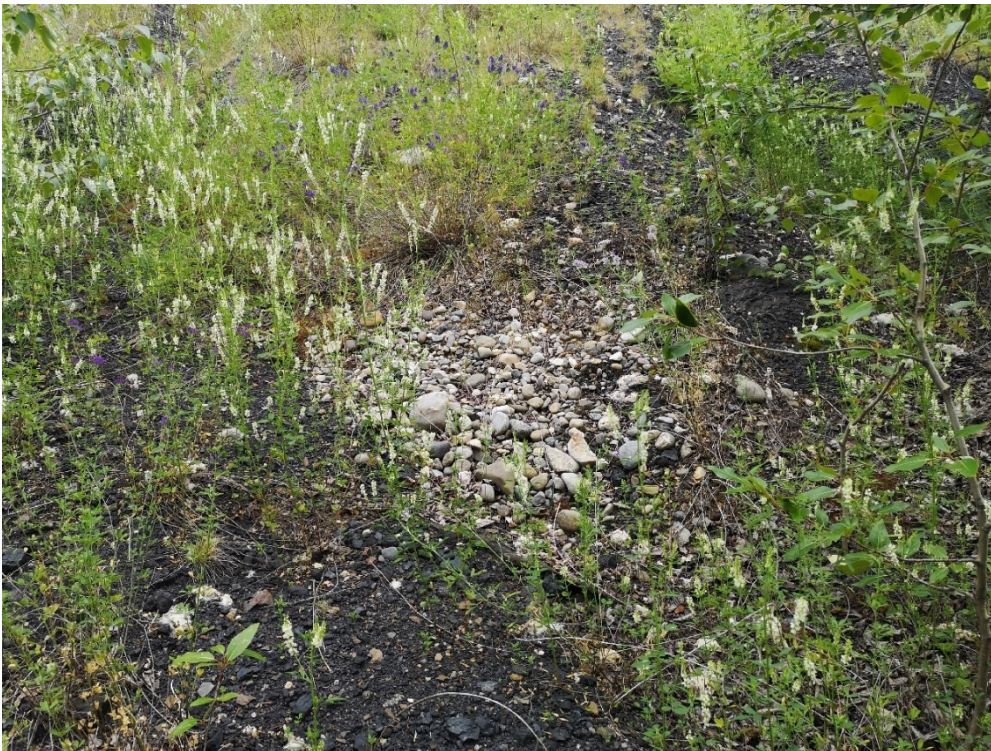
Photo I-53 Finger drain, dry (PTD-DRAIN-18)

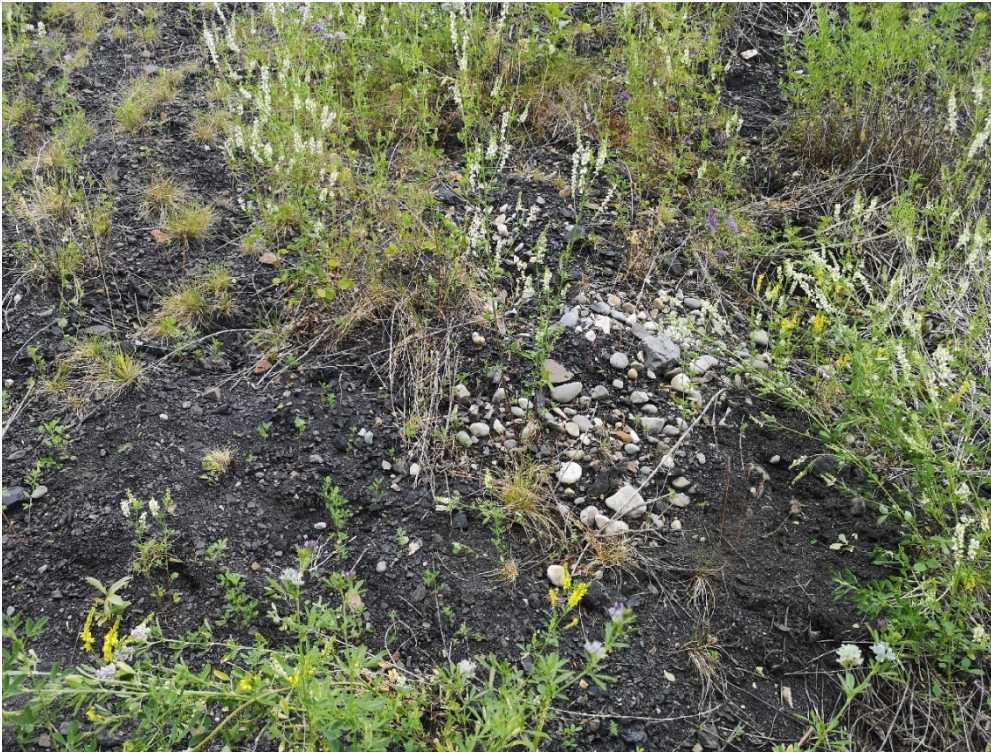
Photo I-54 Finger drain, dry (PTD-DRAIN-19)

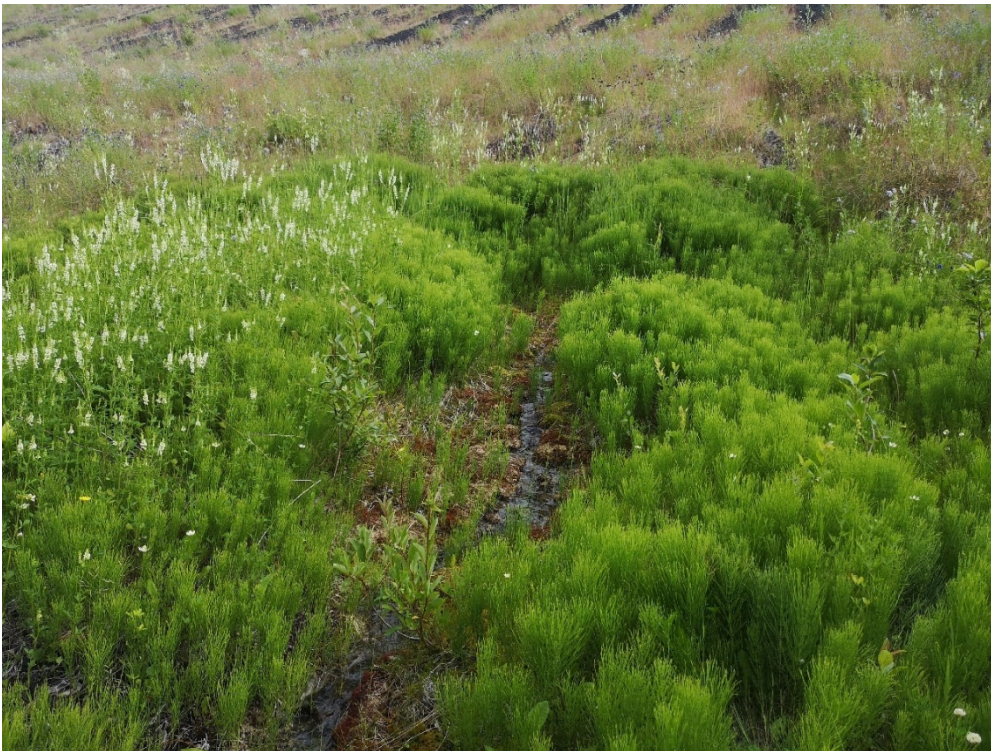
Photo I-55 Finger drain, flowing into two channels (PTD-DRAIN-19)

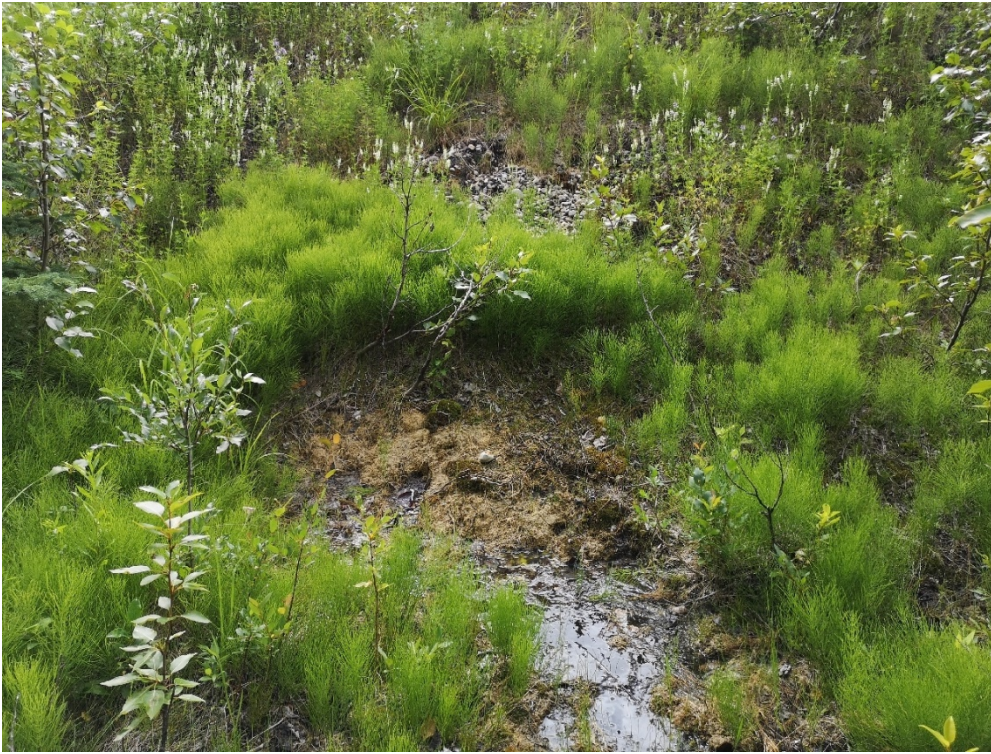
Photo I-58 Finger drain, some seepage (PTD-DRAIN-20)

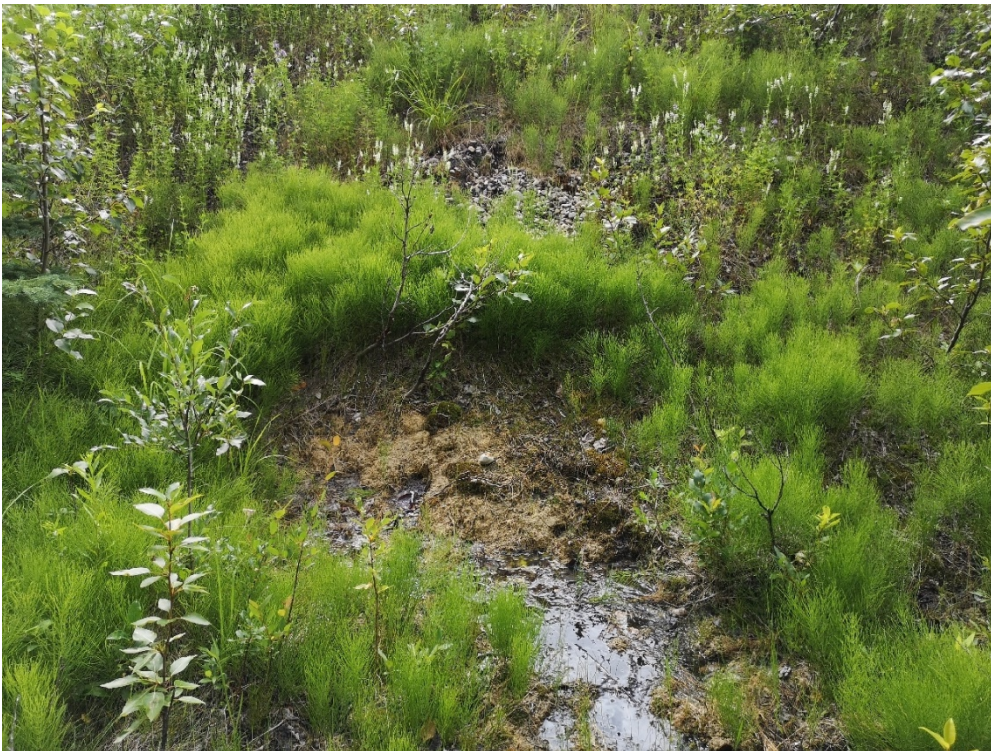
Photo I-63 Finger drain, some seepage (PTD-DRAIN-21)

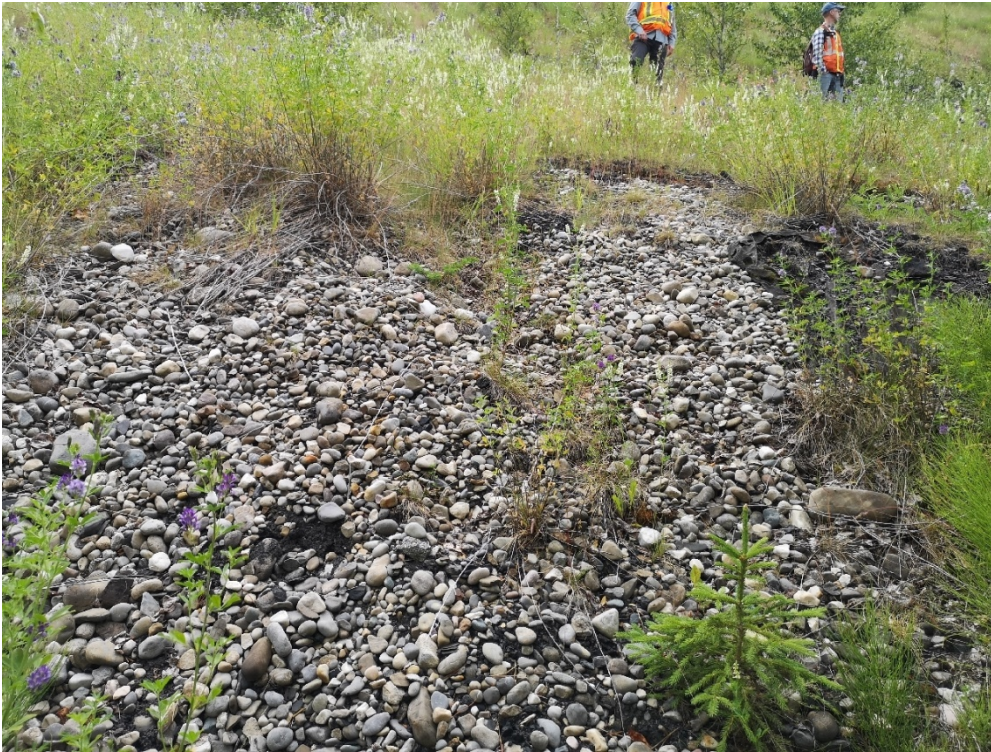
Photo I-64 Finger drain, downstream area is wet, no seepage visible (PTD-DRAIN-22)

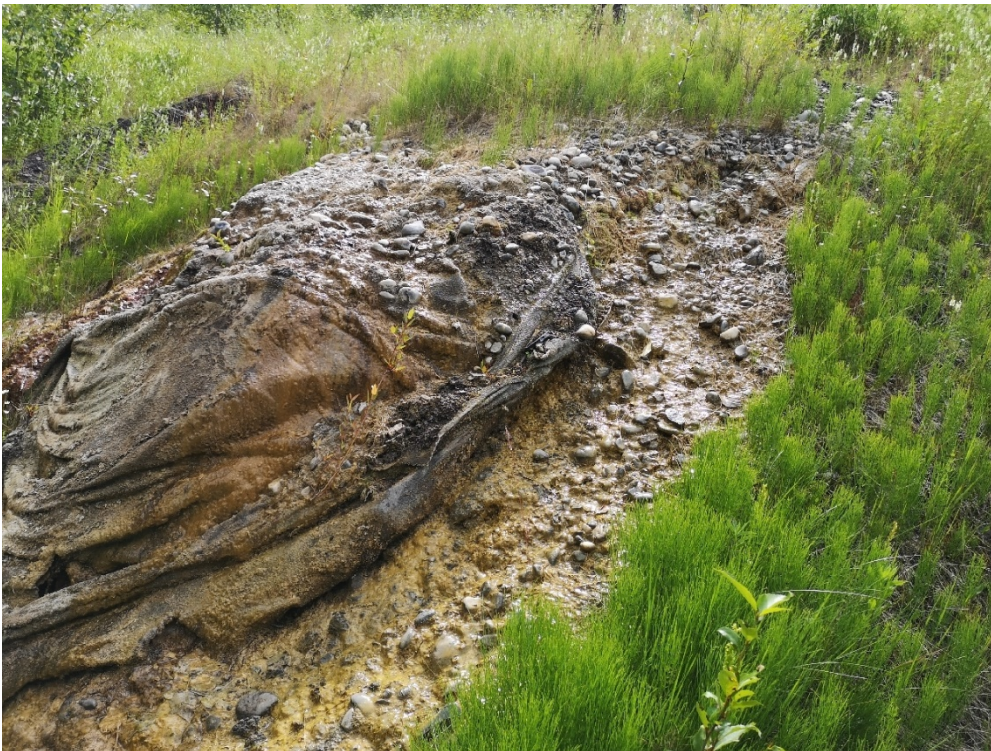
Photo I-65 Finger drain, some seepage (PTD-DRAIN-23)

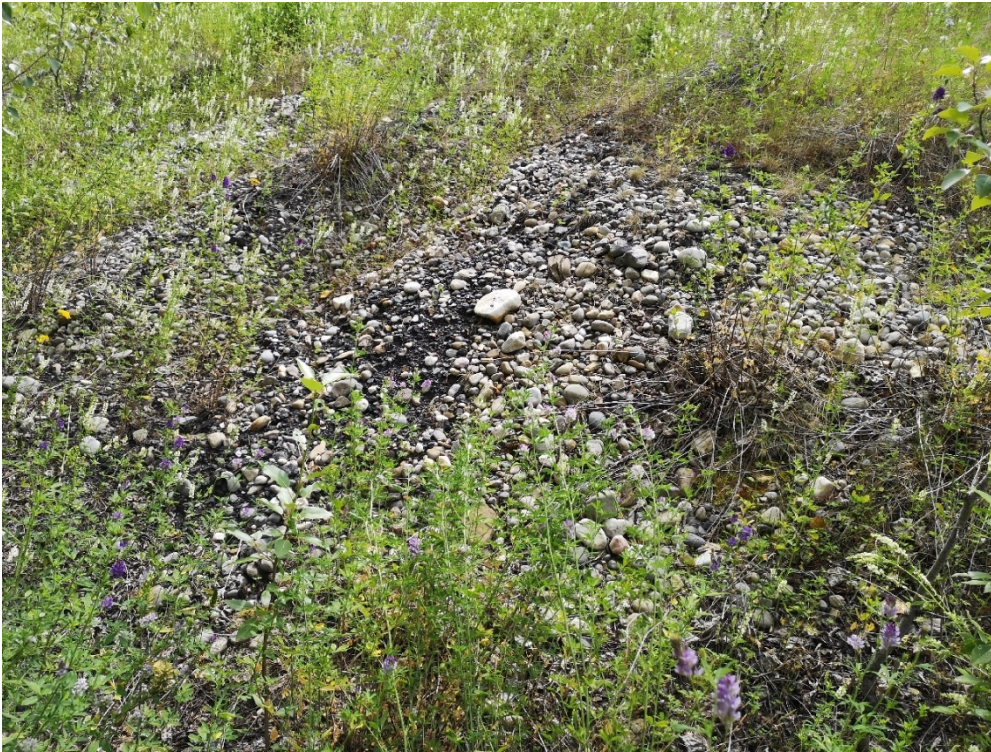
Photo I-66 Finger drain, dry (PTD-DRAIN-24)

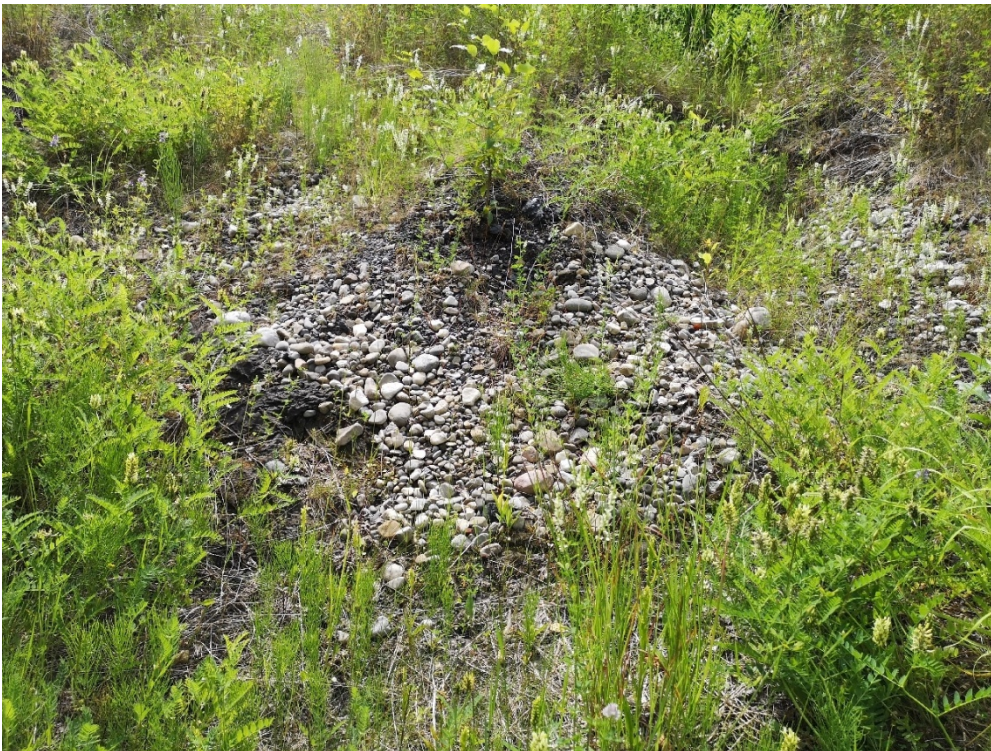
Photo I-67 Finger drain, dry (PTD-DRAIN-25)

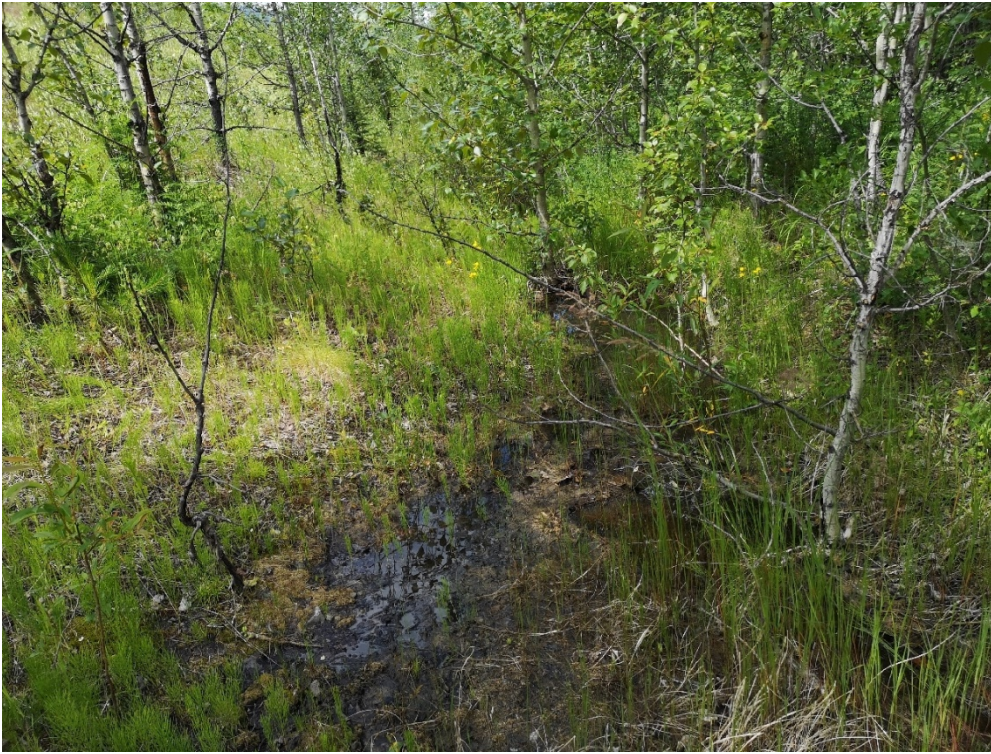
Photo I-68 Seepage channel along toe of dam (PTD-DRAIN-25)

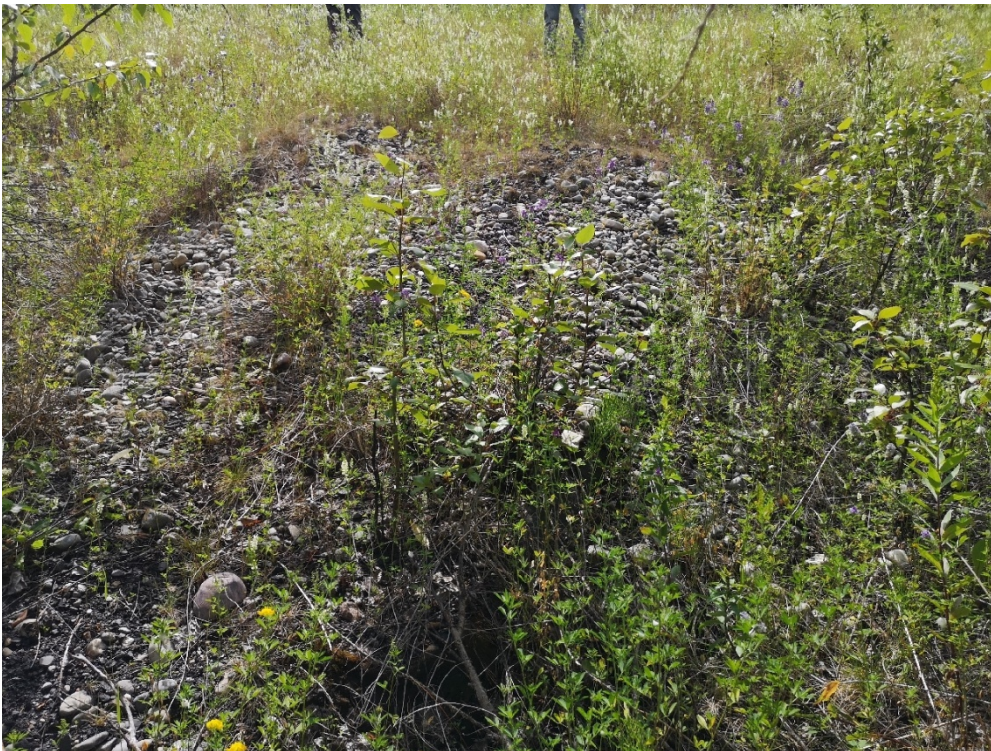
Photo I-69 Finger drain, dry (PTD-DRAIN-26)

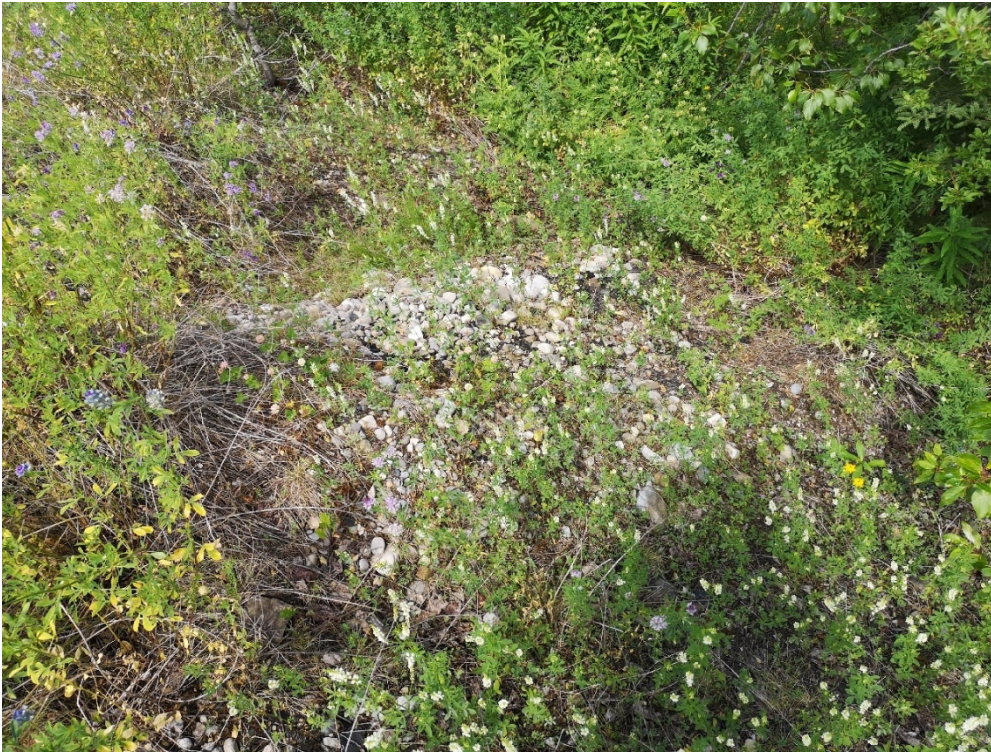
Photo I-70 Finger drain, dry (PTD-DRAIN-27)

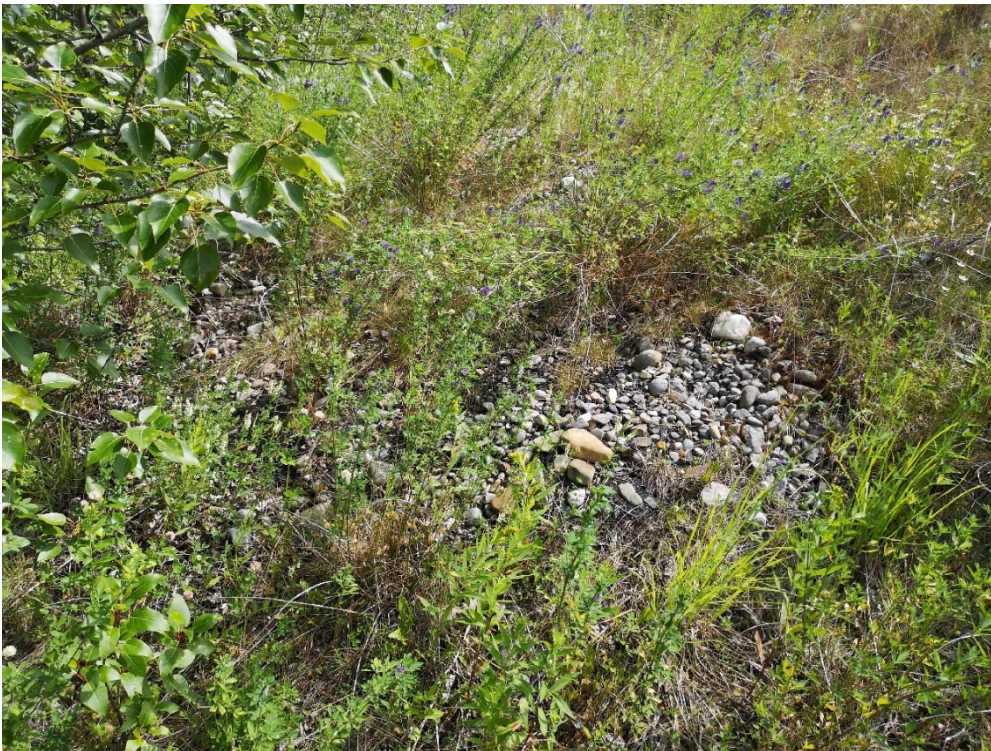
Photo I-71 Finger drain, dry (PTD-DRAIN-29)

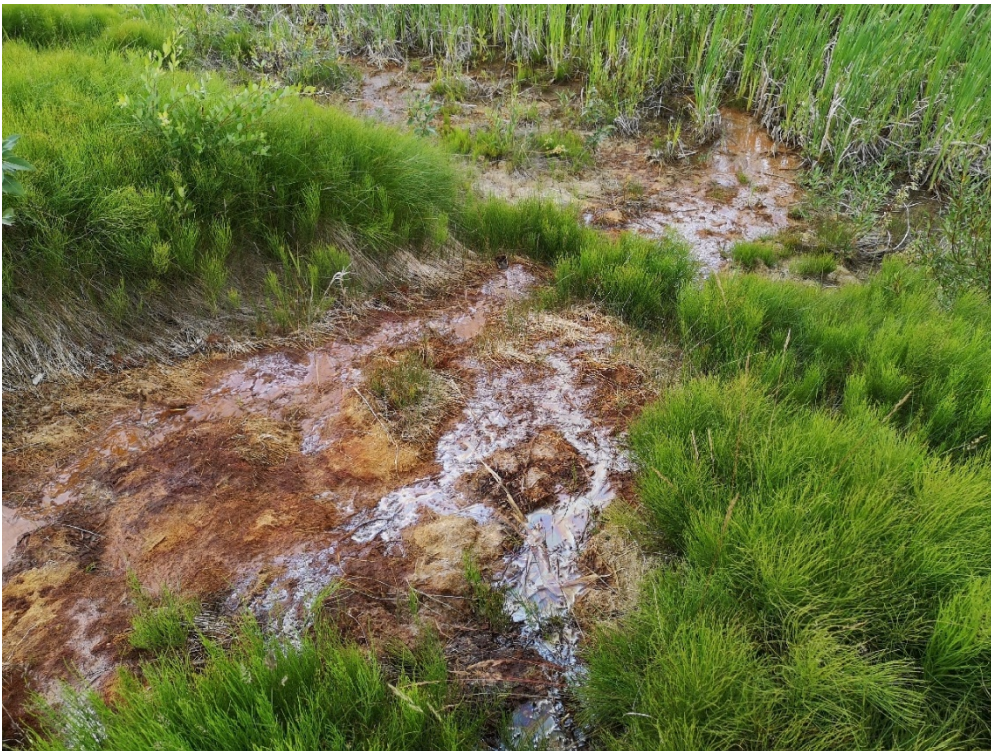
Photo I-81 Closure Spillway channel, some seepage (PTD-2020-28)

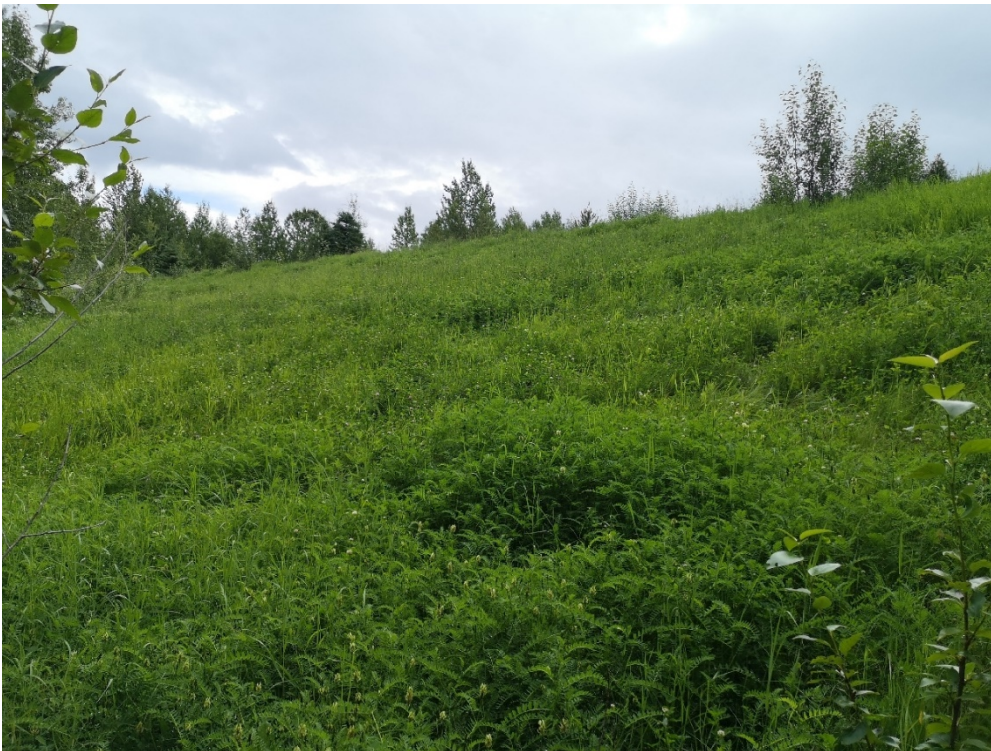
**Photo I-92 Plantsite Seepage Collection Pond, downstream slope, small channel, dry
(PSCP-2020-04)**

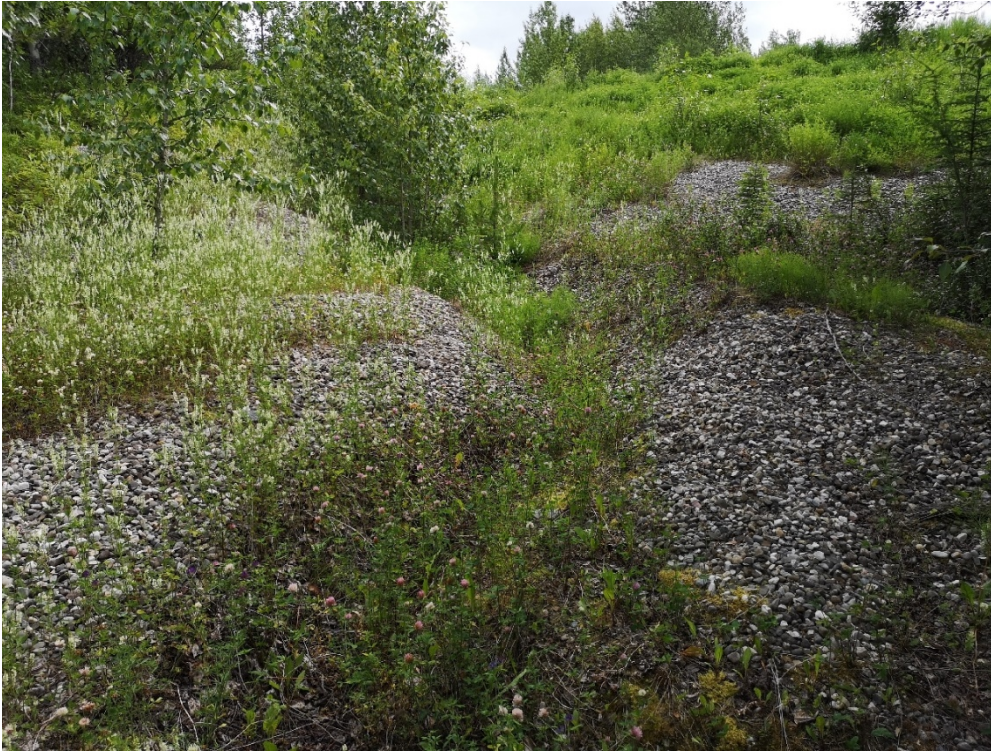
Photo I-93 Plantsite Seepage Collection Pond right abutment (PSCP-2020-05)
