Quintette Coal Operations

2020 Annual Summary of Tailings Facility Performance

Plantsite Tailings Dam and Plantsite Seepage Collection Pond Dam

March 2021

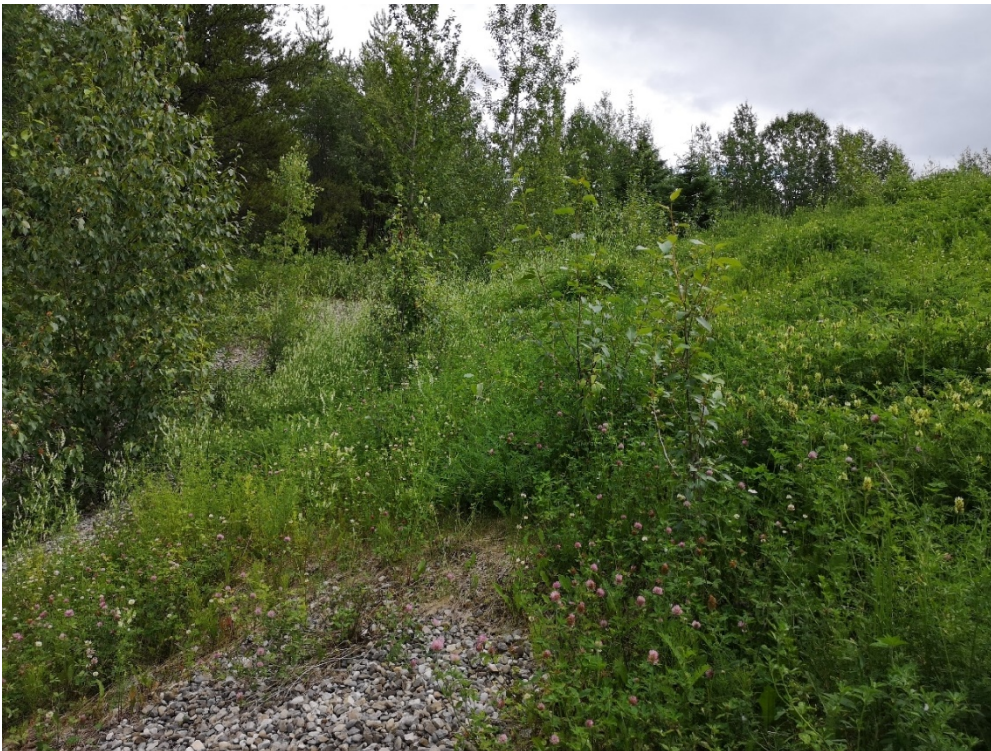
Photo I-94 Plantsite Seepage Collection Pond downstream slope – looking west (PSCP-2020-06)

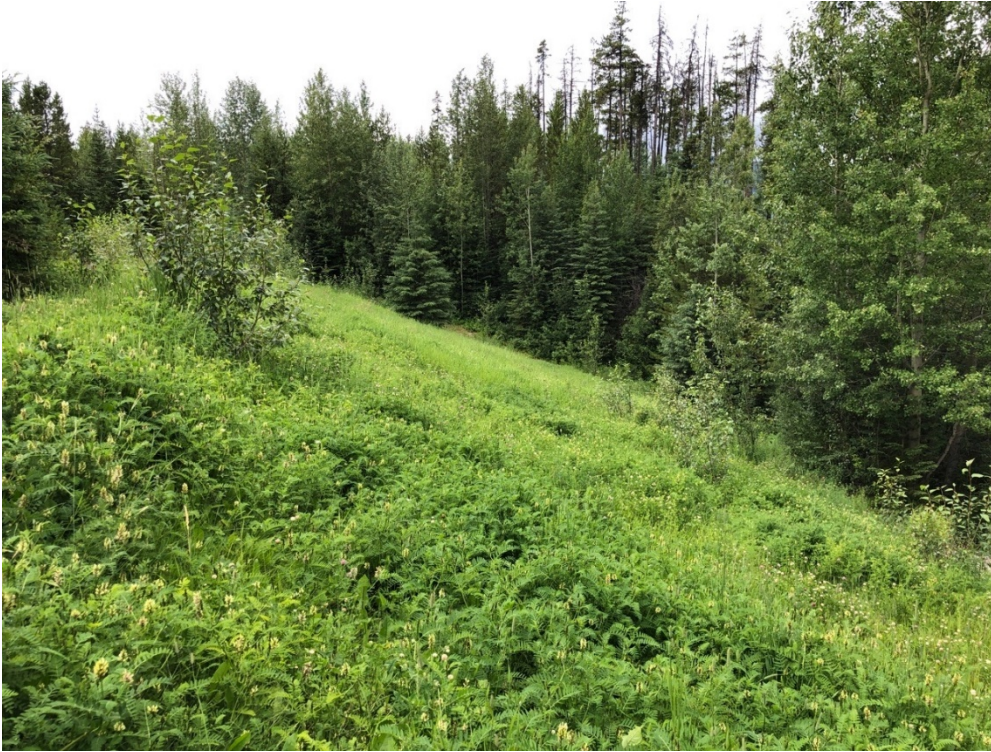
Photo I-95 Plantsite Seepage Collection Pond downstream slope – looking south (PSCP-2020-06)

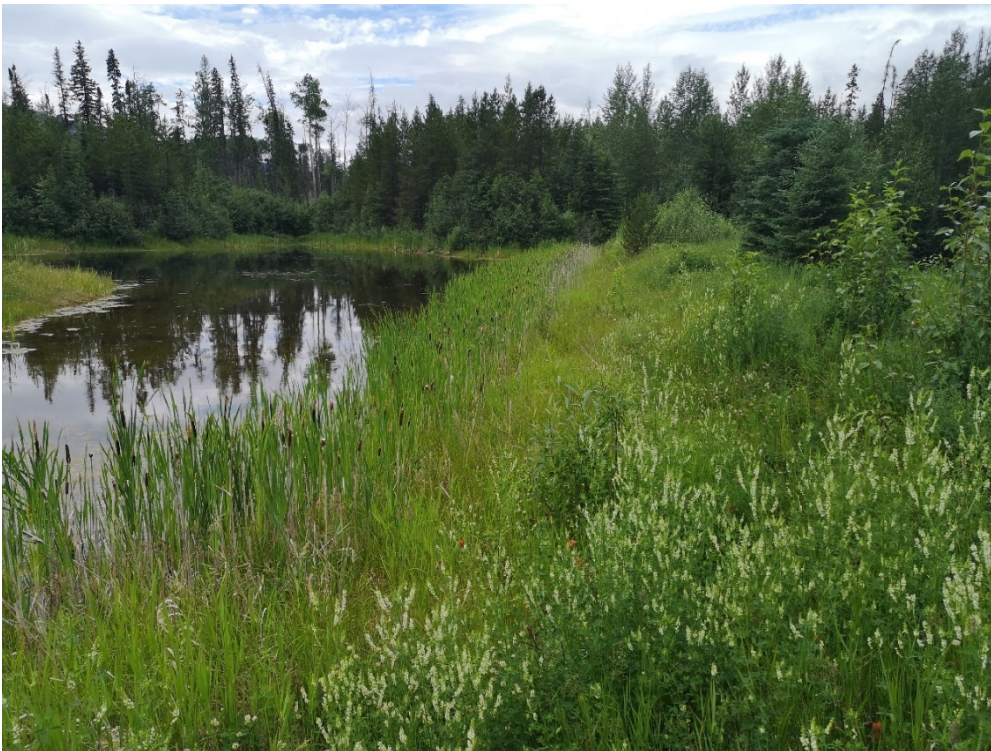
**Photo I-96 Plantsite Seepage Collection Pond outlet channel, no beaver dams, heavily vegetated
– looking upstream (west) (PSCP-2020-07)**

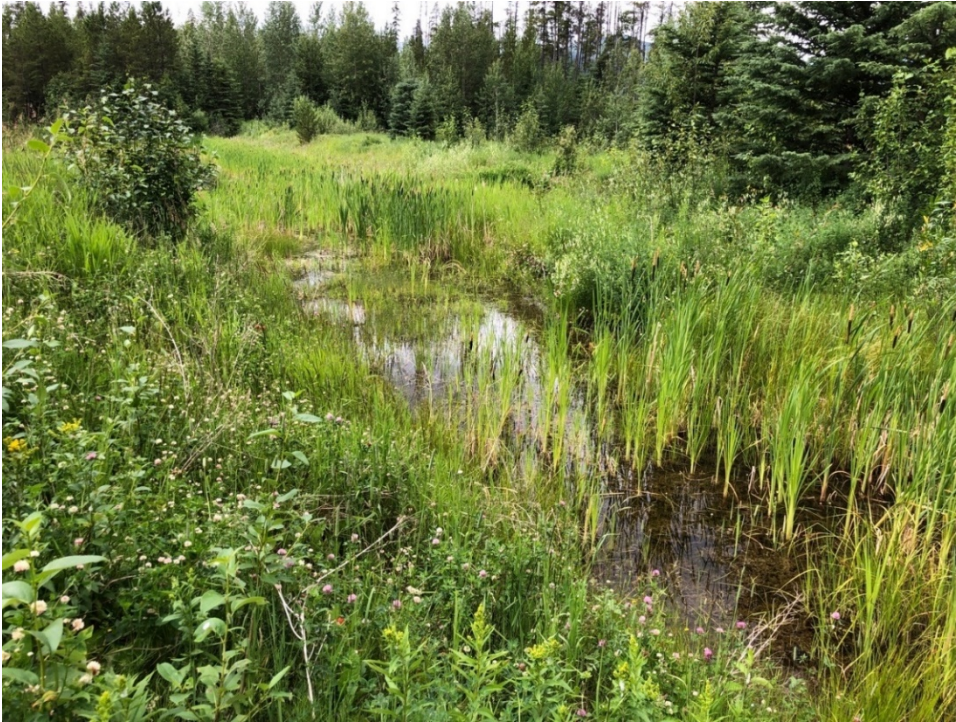
**Photo I-97 Plantsite Seepage Collection Pond outlet channel, no beaver dams, heavily vegetated
– looking downstream (east) (PSCP-2020-07)**

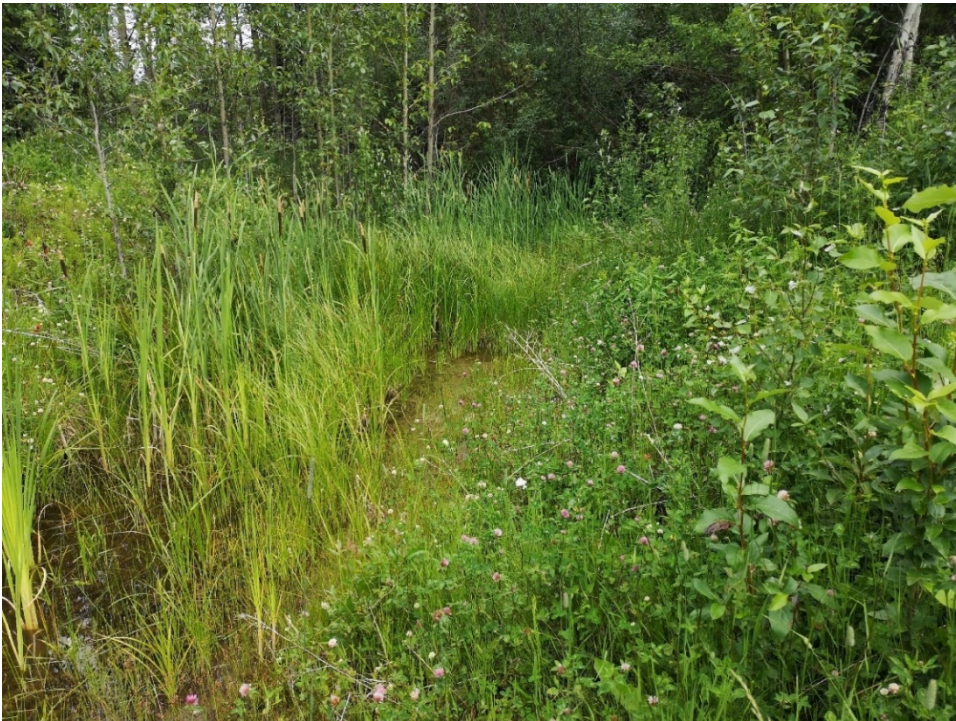
Photo I-98 Plantsite Seepage Collection Pond outlet channel – looking northeast (PSCP-2020-08)

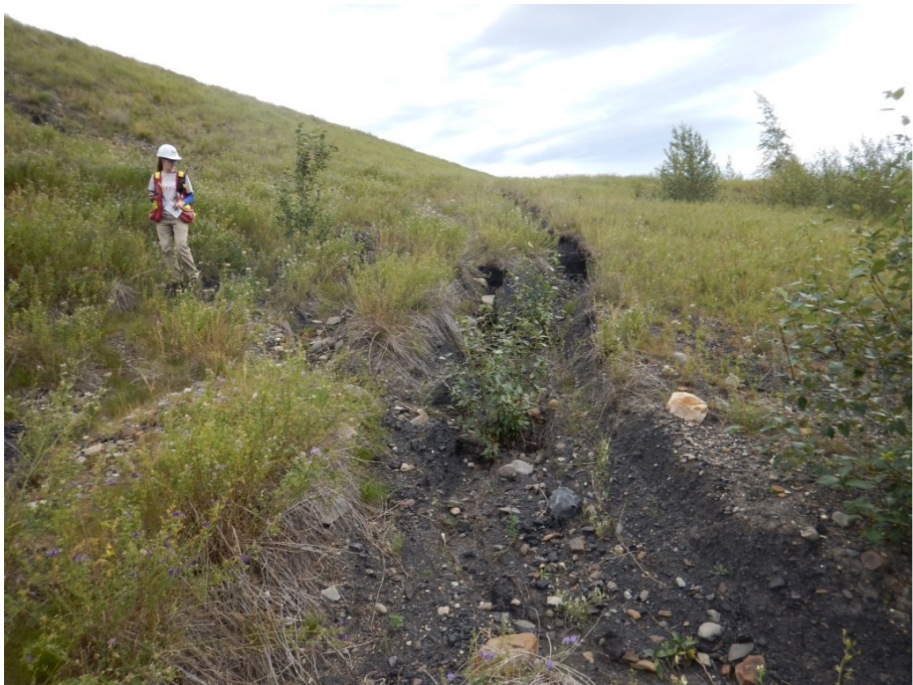
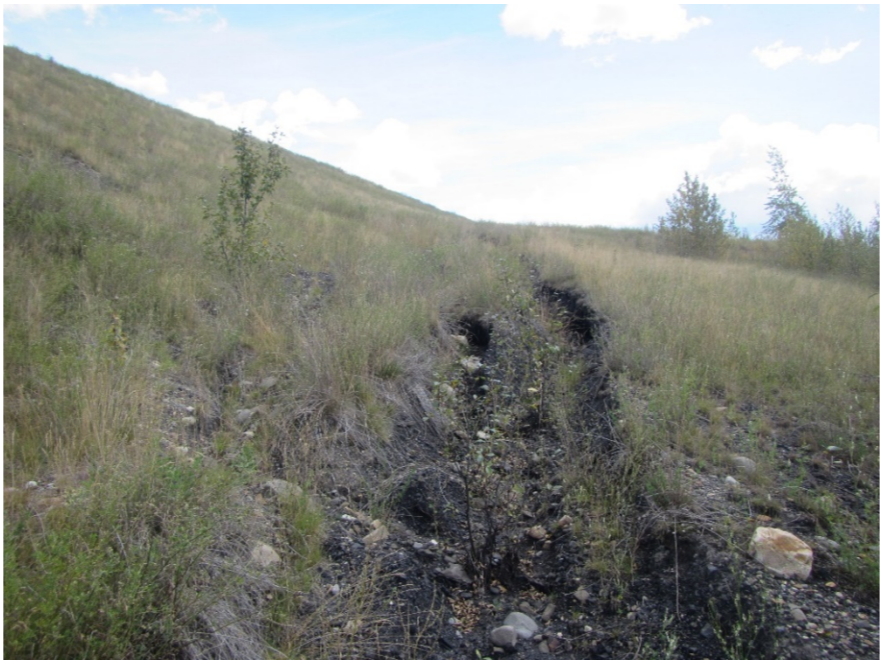
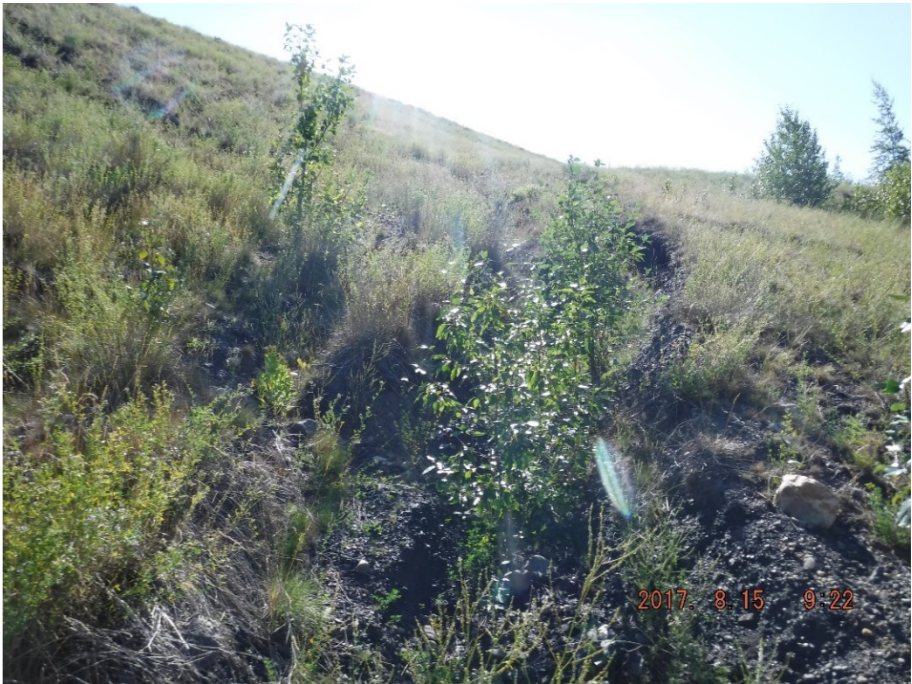
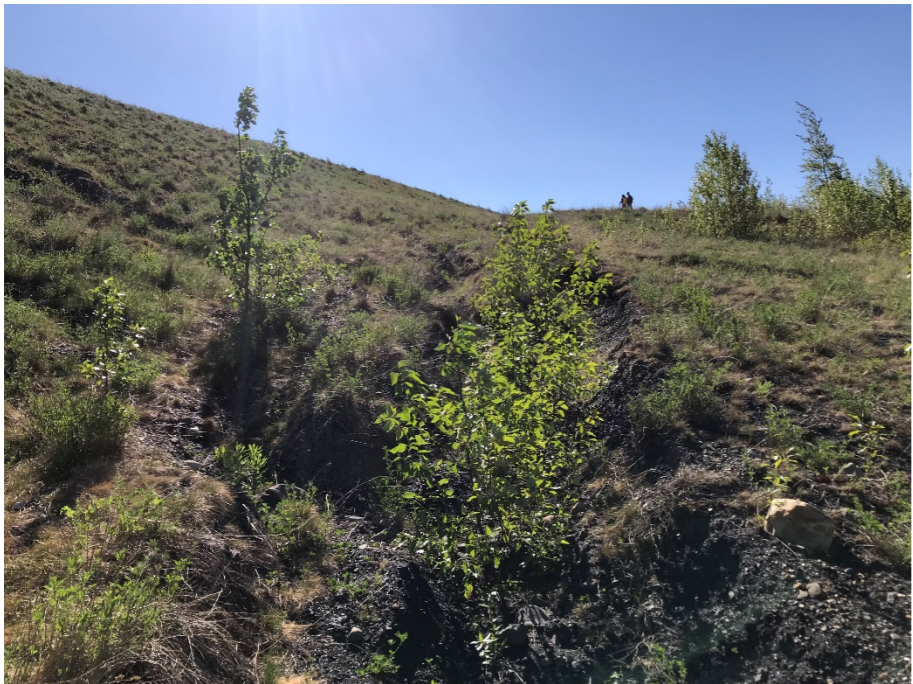
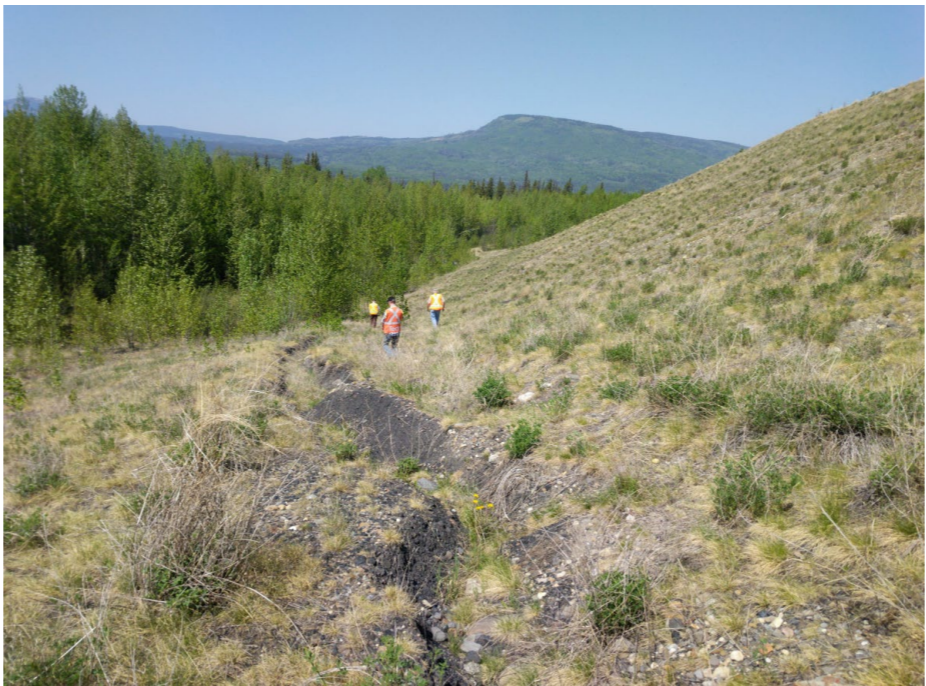
II-2 PTD-RILL-02

2019 (looking at the opposite direction from previous inspections)
