Teck Metals Ltd.

Annual Summary of Tailings Facility Performance Report

Sullivan TSF 2020

March 30, 2021

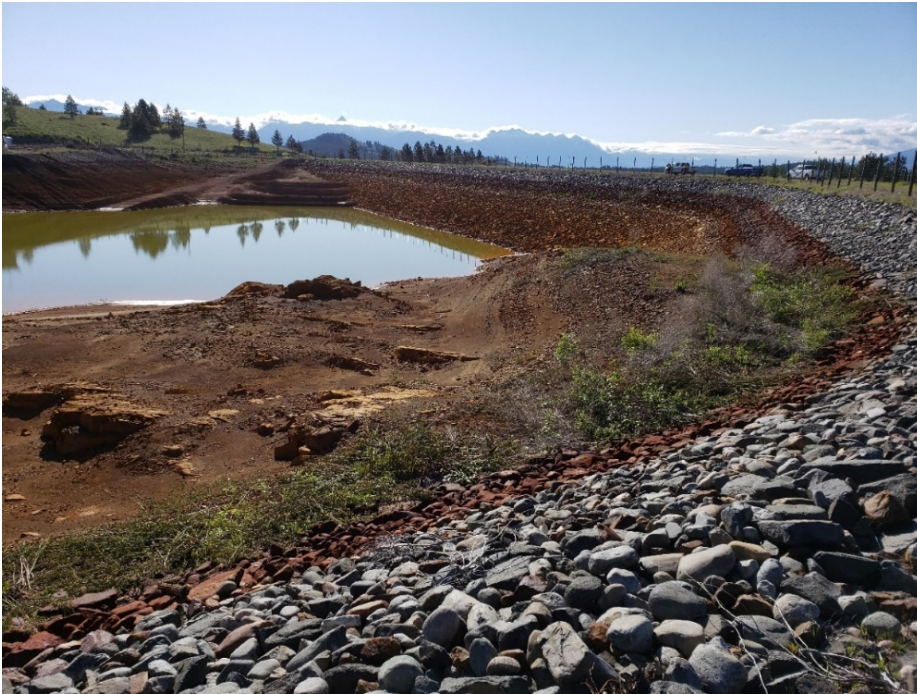
Photo I.1 **ARD South Dam Upstream Slope**

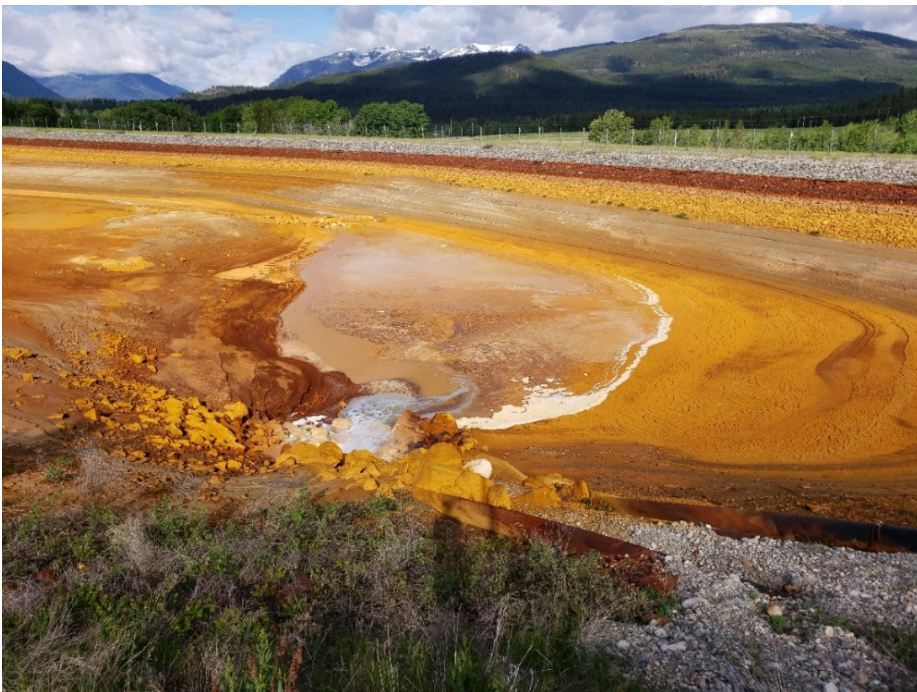
Photo II.2 **North Dam Upstream Slope**

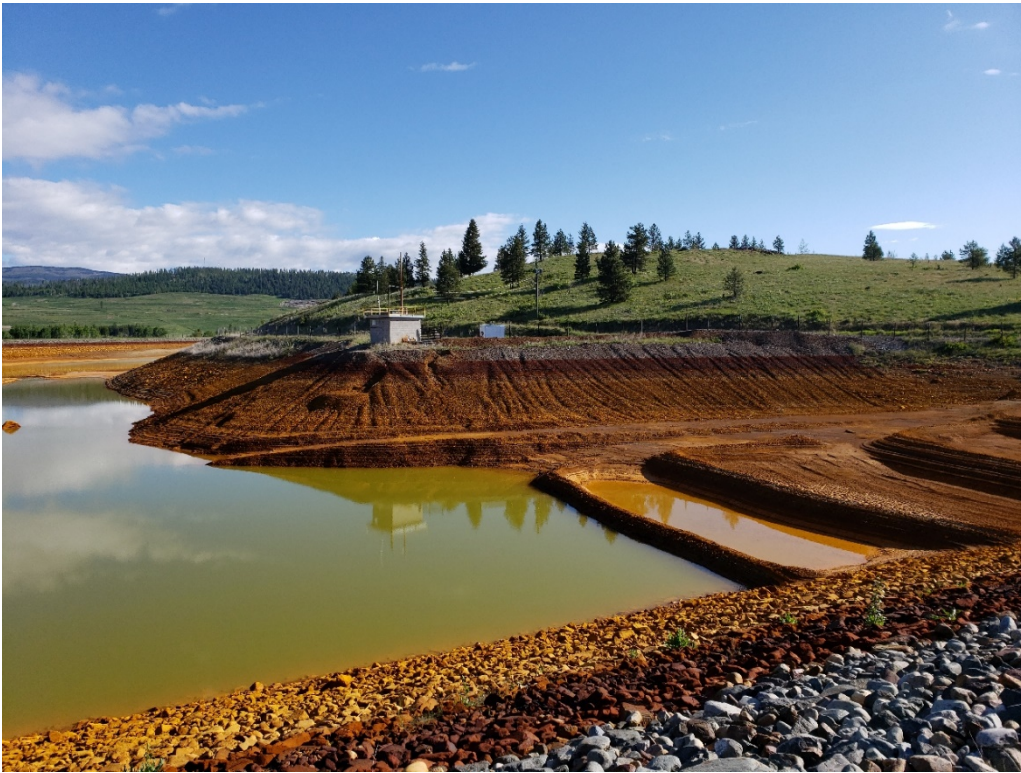
Photo II.3 Erosion adjacent to pumphouse

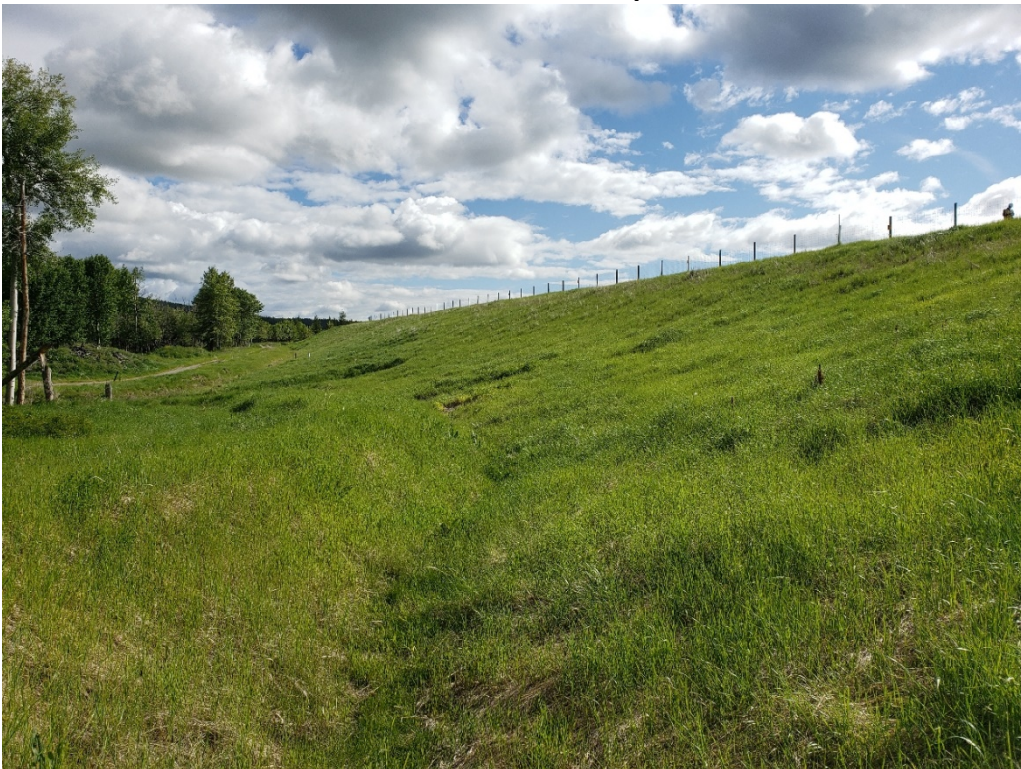
Photo II.4 ARD North Dam Downstream Slope

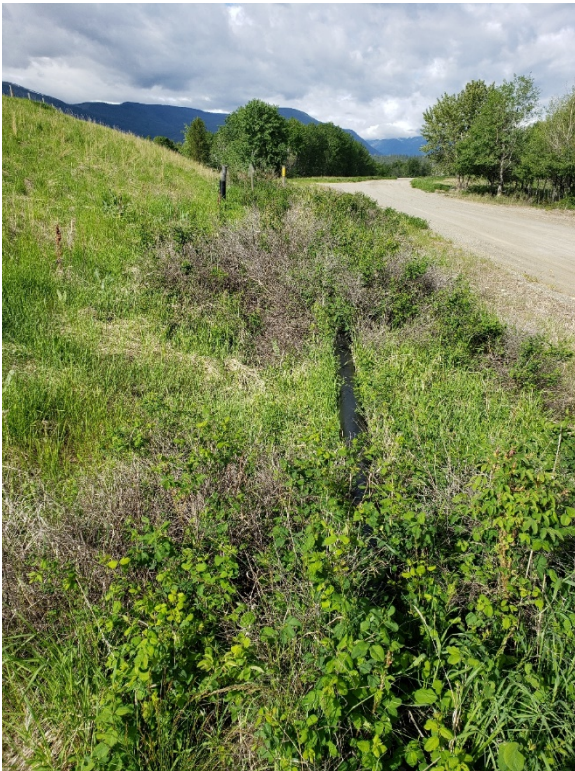
Photo II.5 Vegetation at toe of North Dam

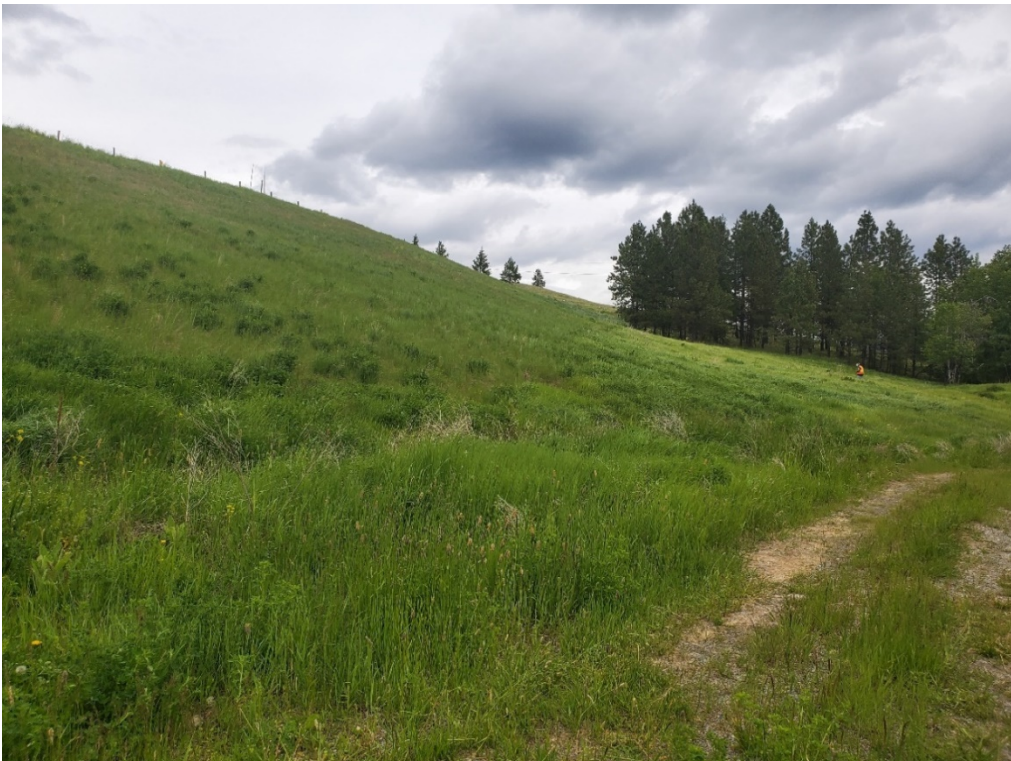
Photo II.6 South Dam Downstream Slope

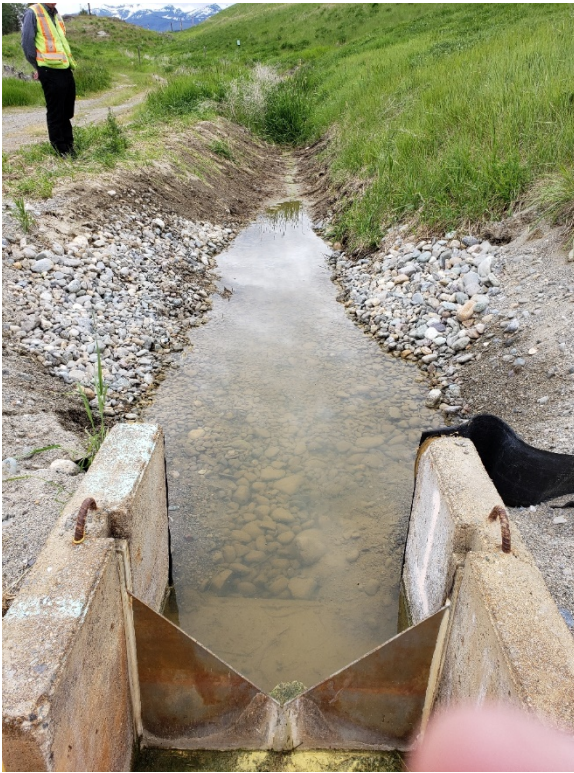
Photo II.7 Weir 1 upstream ditch

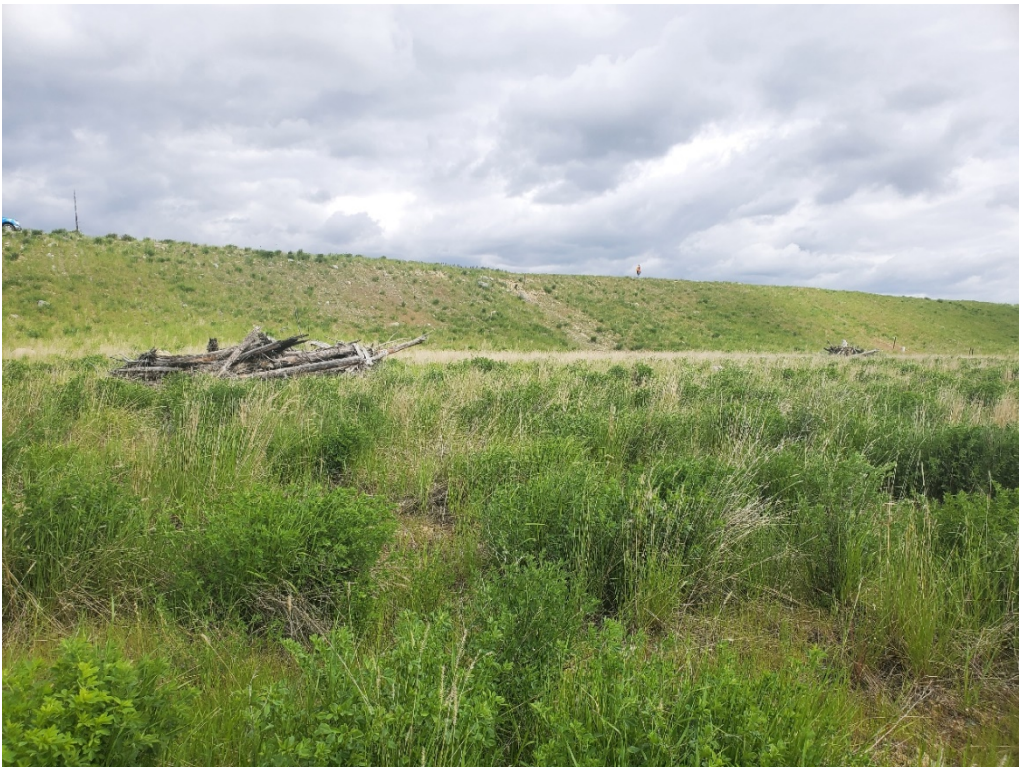
Photo II.8 Iron Dike Downstream Slope

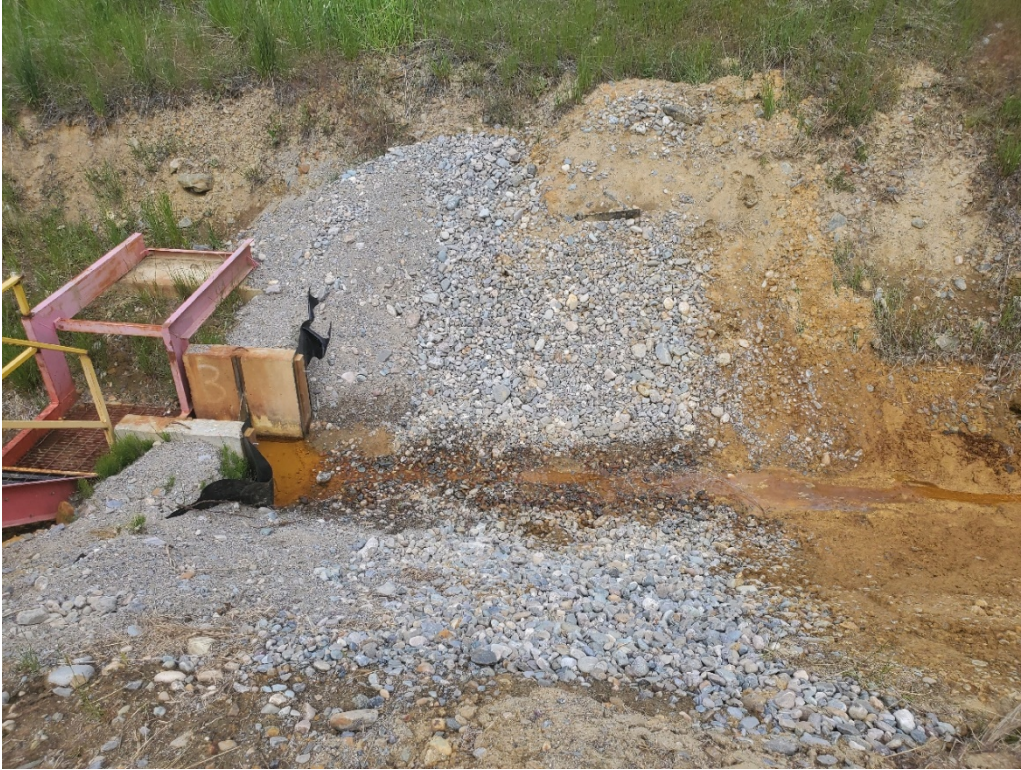
Photo II.9 Weir 3 – AIPWU

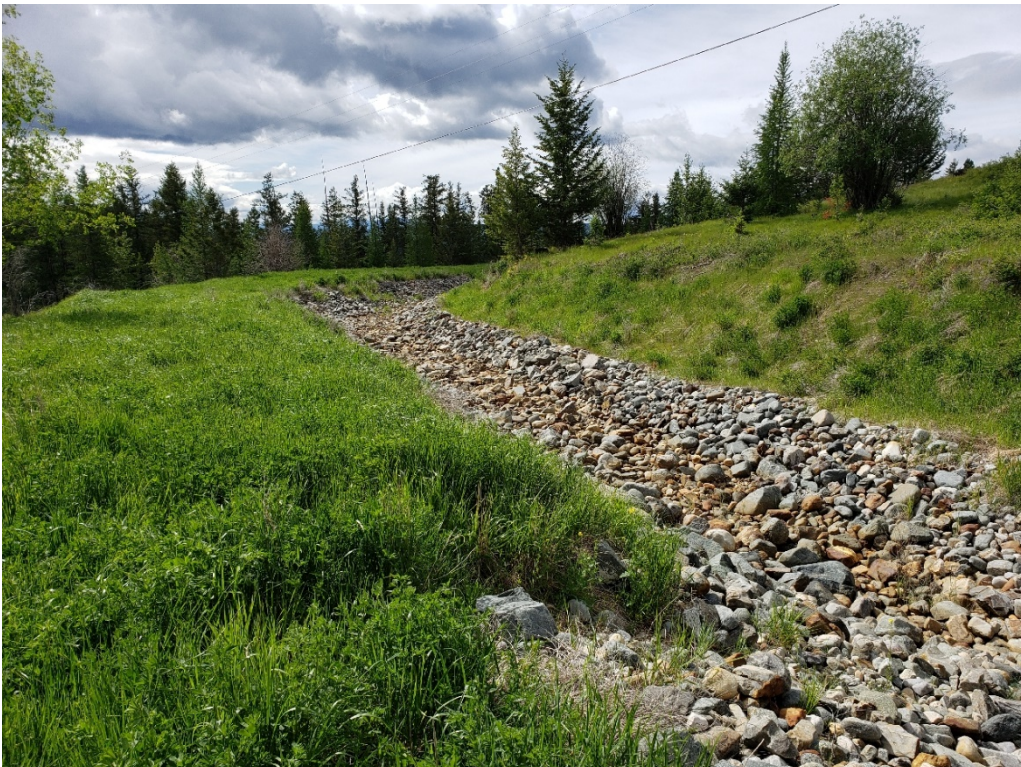
Photo II.12 Emergency Spillway Channel

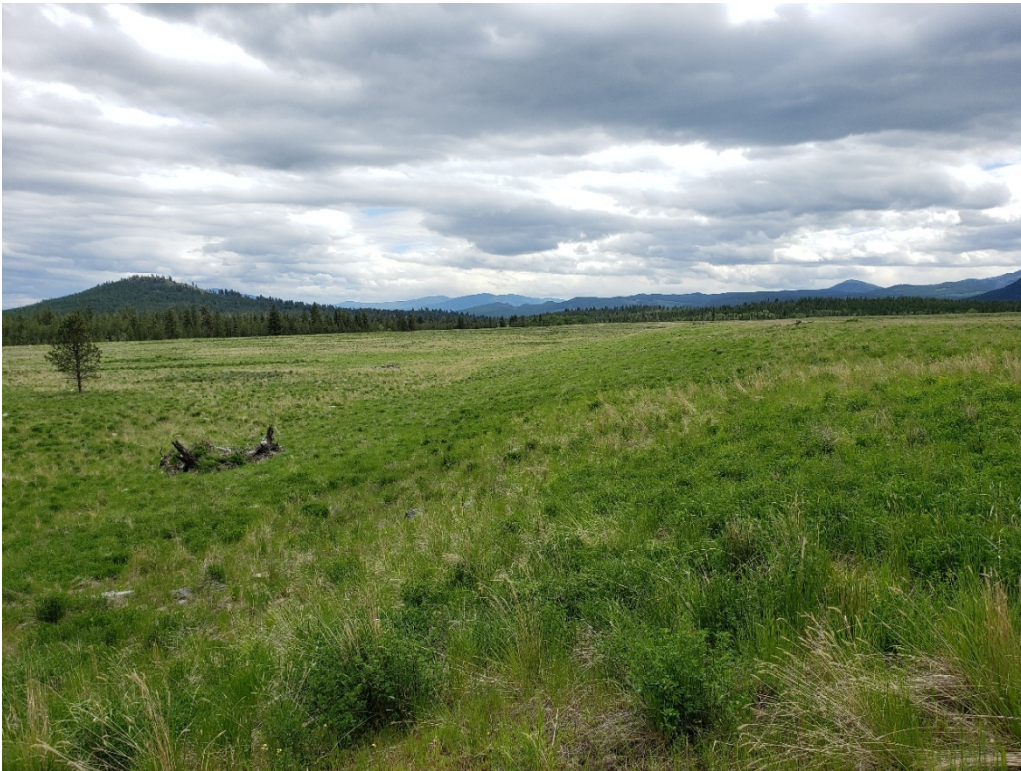
Photo II.13 No. 1 Siliceous Dike

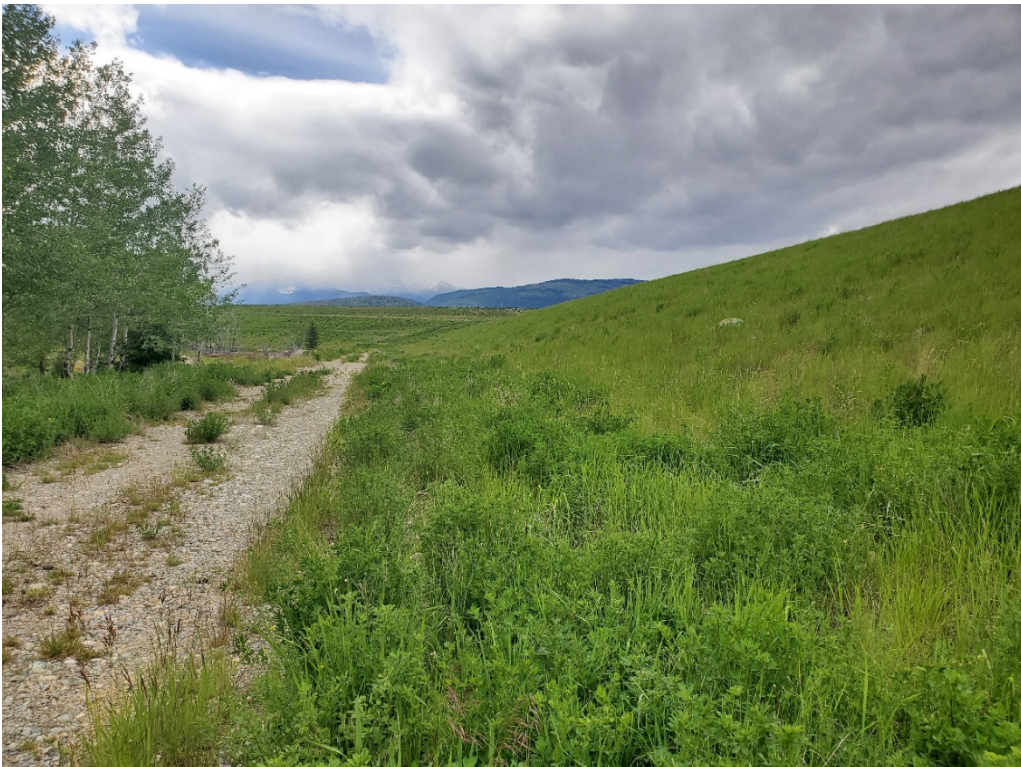
Photo II.14 No. 2 Siliceous Dike

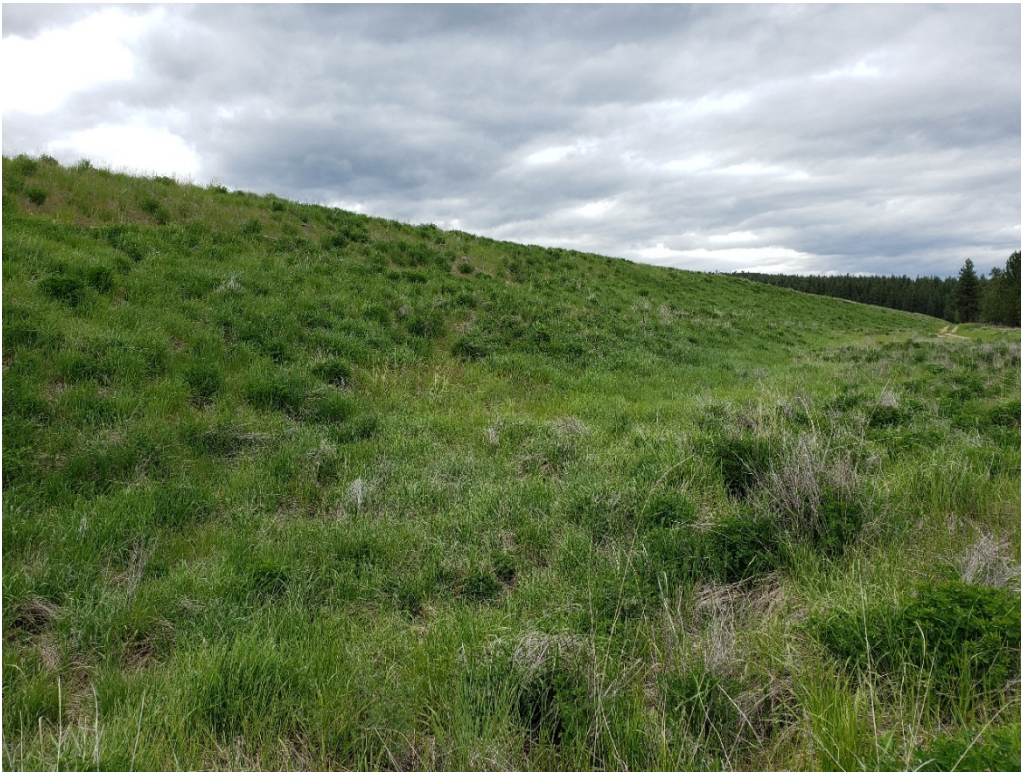
Photo II.15 No. 3 Siliceous Dike

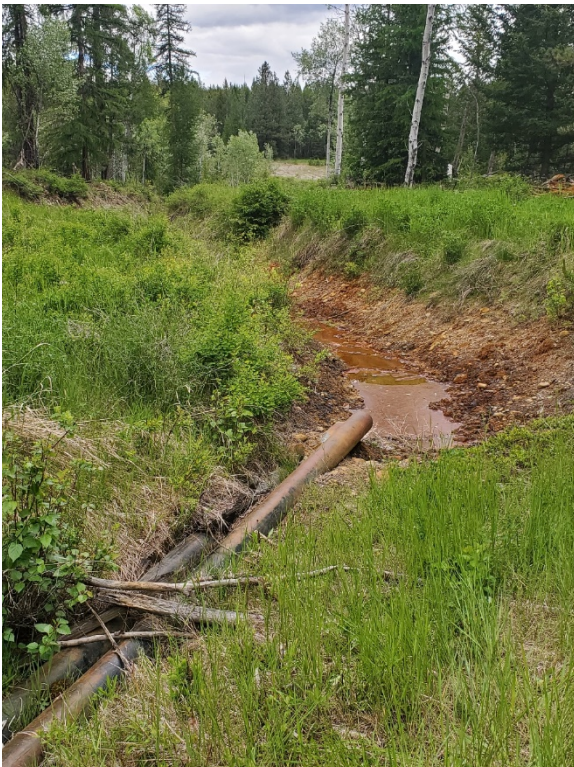
Photo II.16 Decants downstream of No. 3 Siliceous

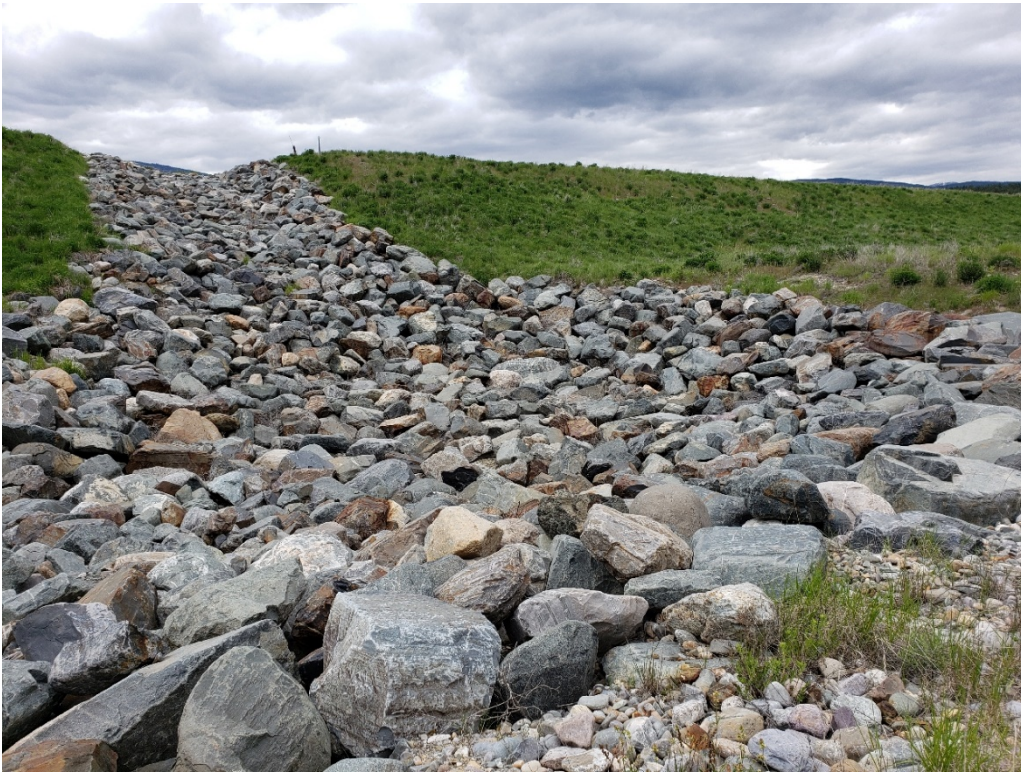
Photo II.17 Siliceous TSF Spillway

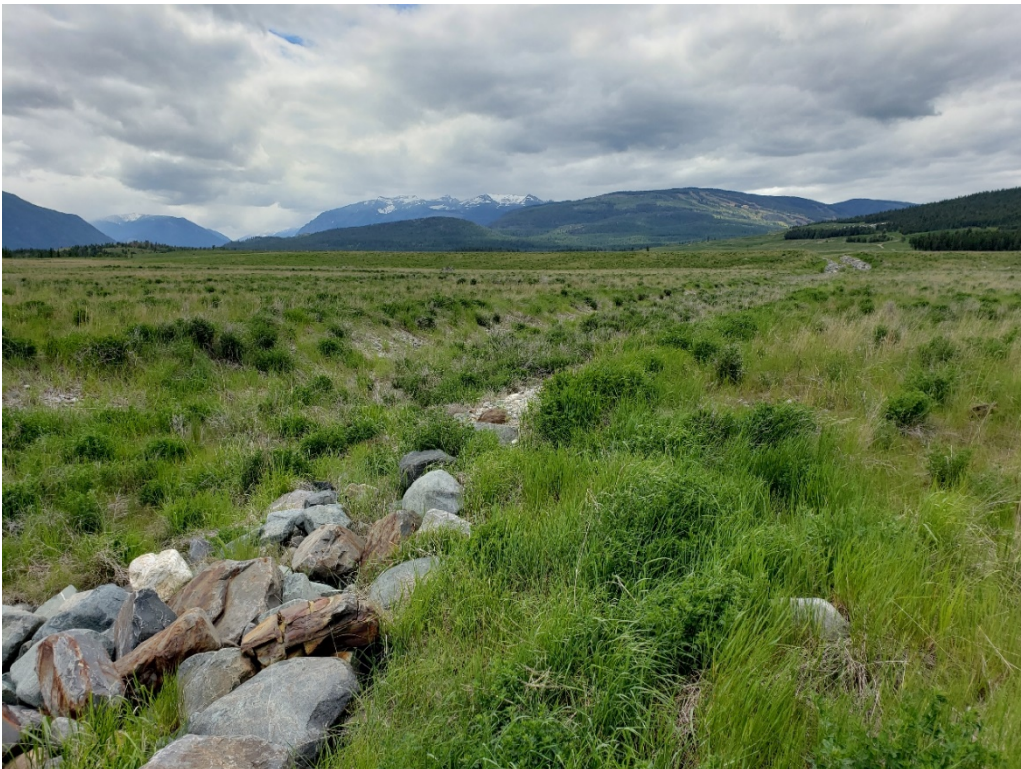
Photo II.18 Siliceous TSF Spillway on No. 3 Siliceous TSF

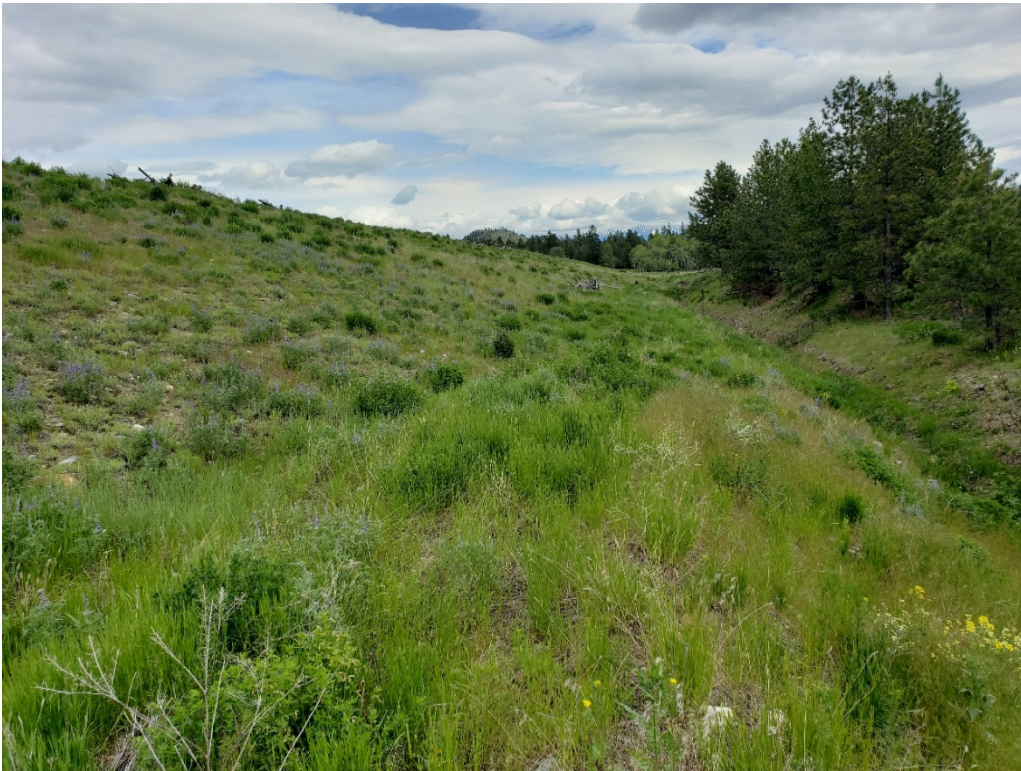
Photo II.19 East Gypsum Dike downstream slope

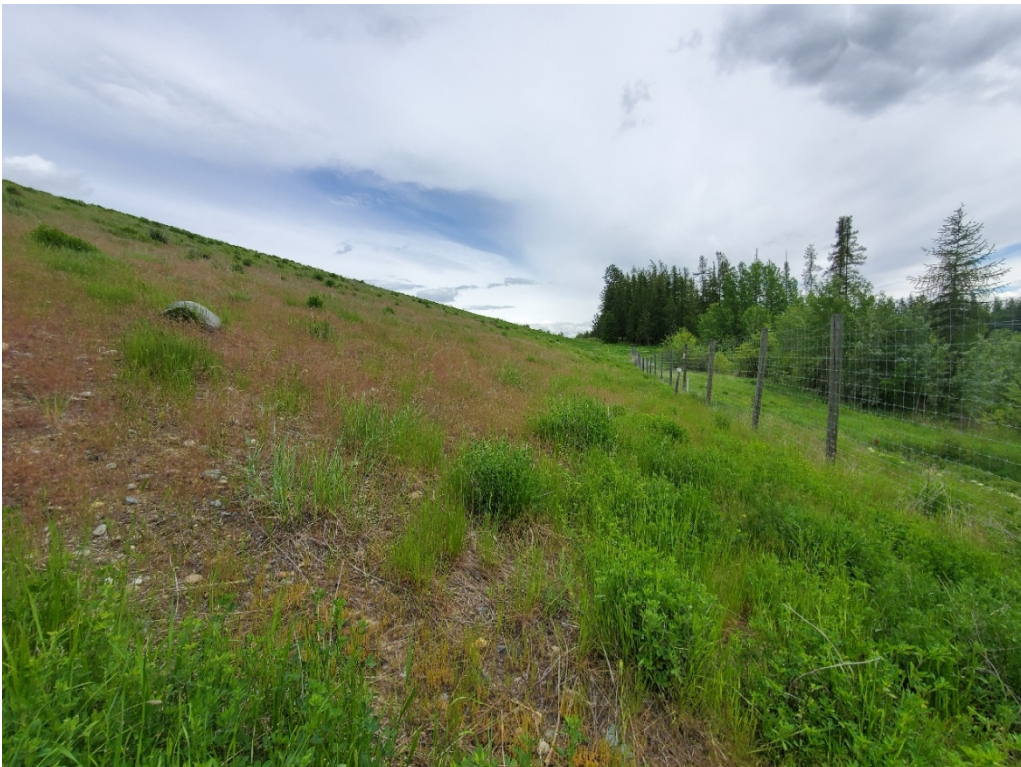
Photo II.20 West Gypsum Dike downstream slope

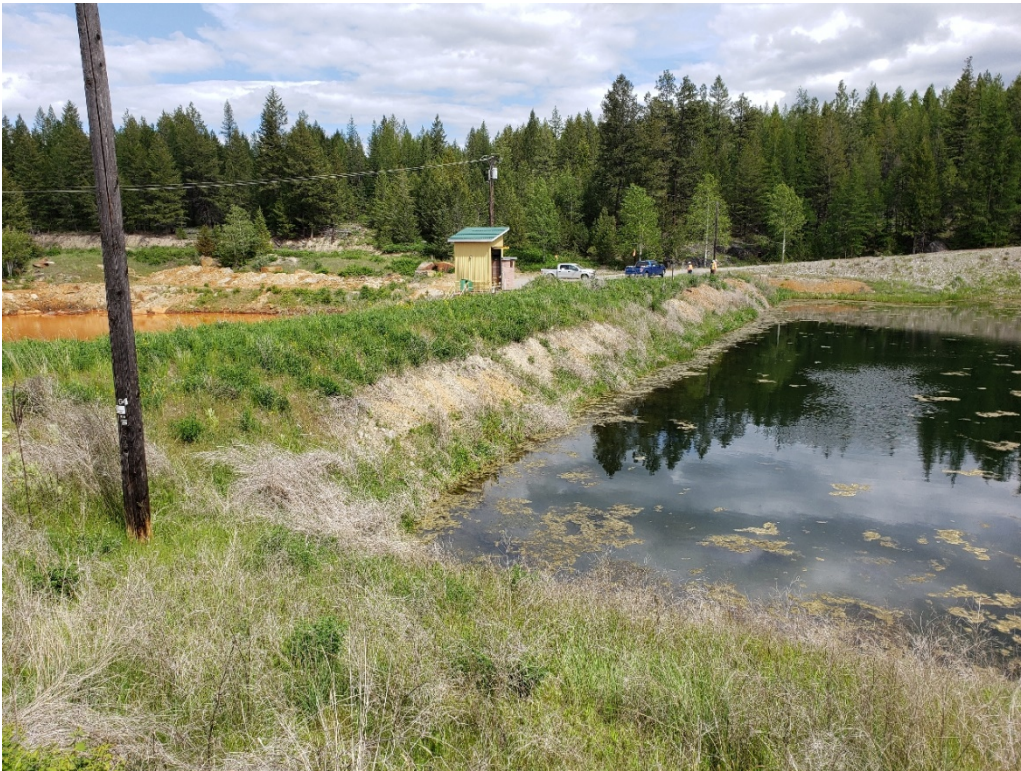
Photo II.21 Recycle Dam downstream slope

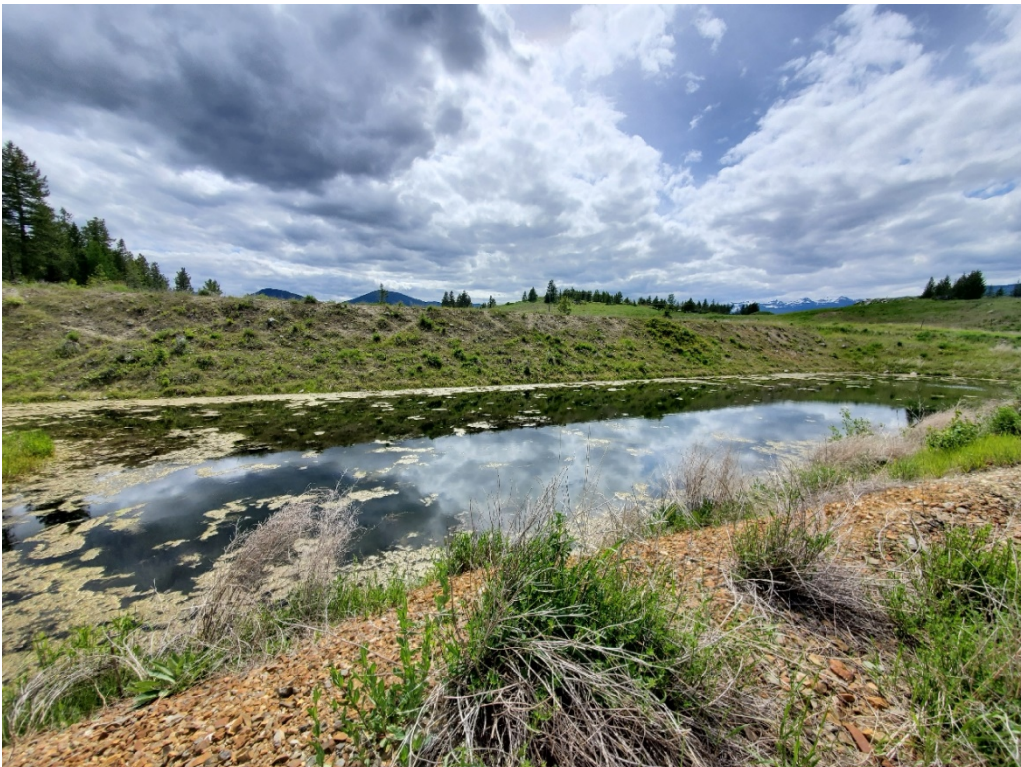
Photo II.22 Northeast Gypsum Dike Downstream Side

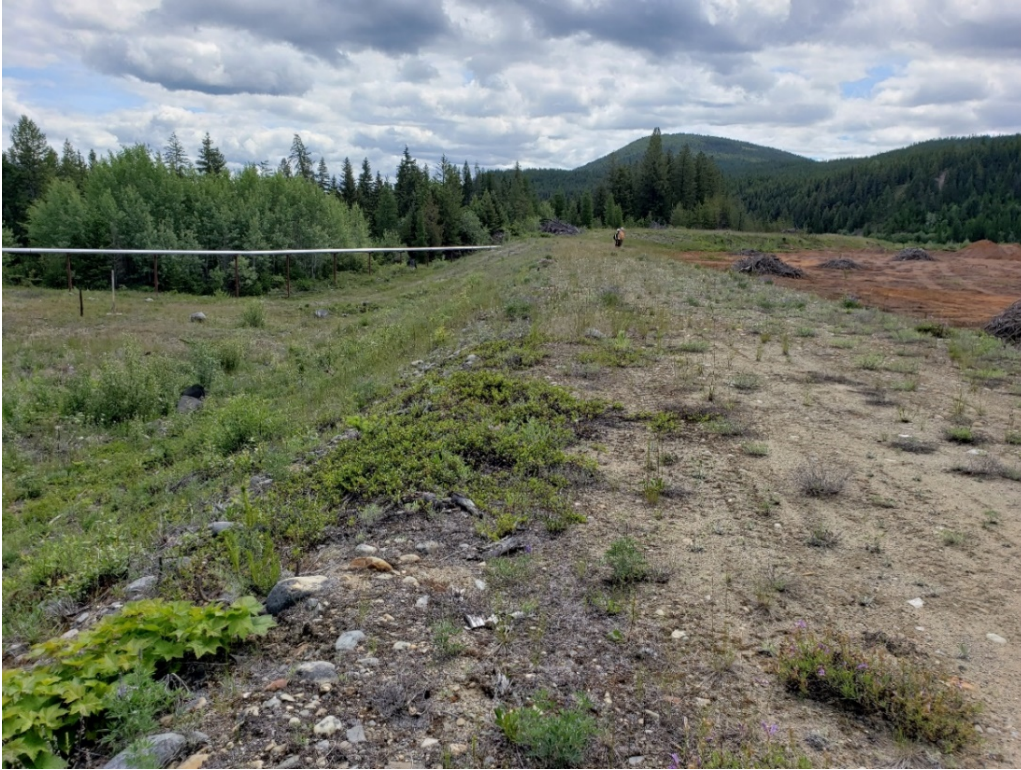
Photo II.23 Sludge Impoundment North Dike crest and downstream slope

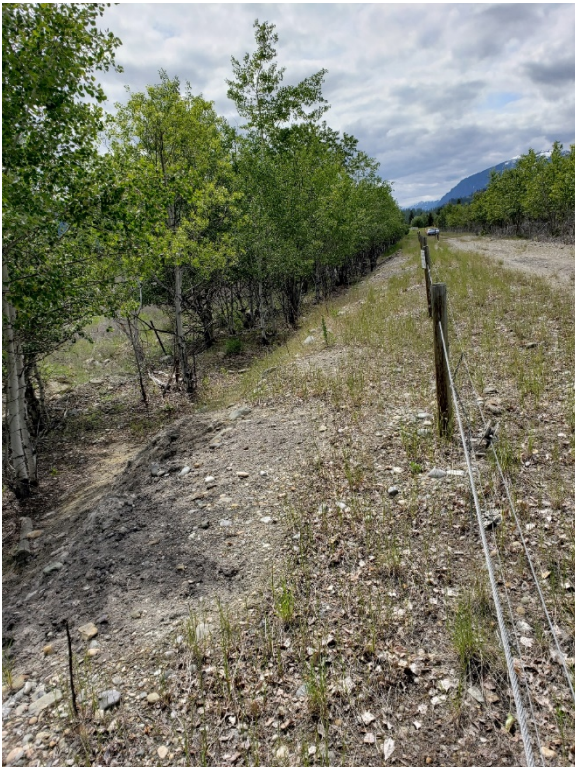
Photo II.24 Calcine Dike downstream slope

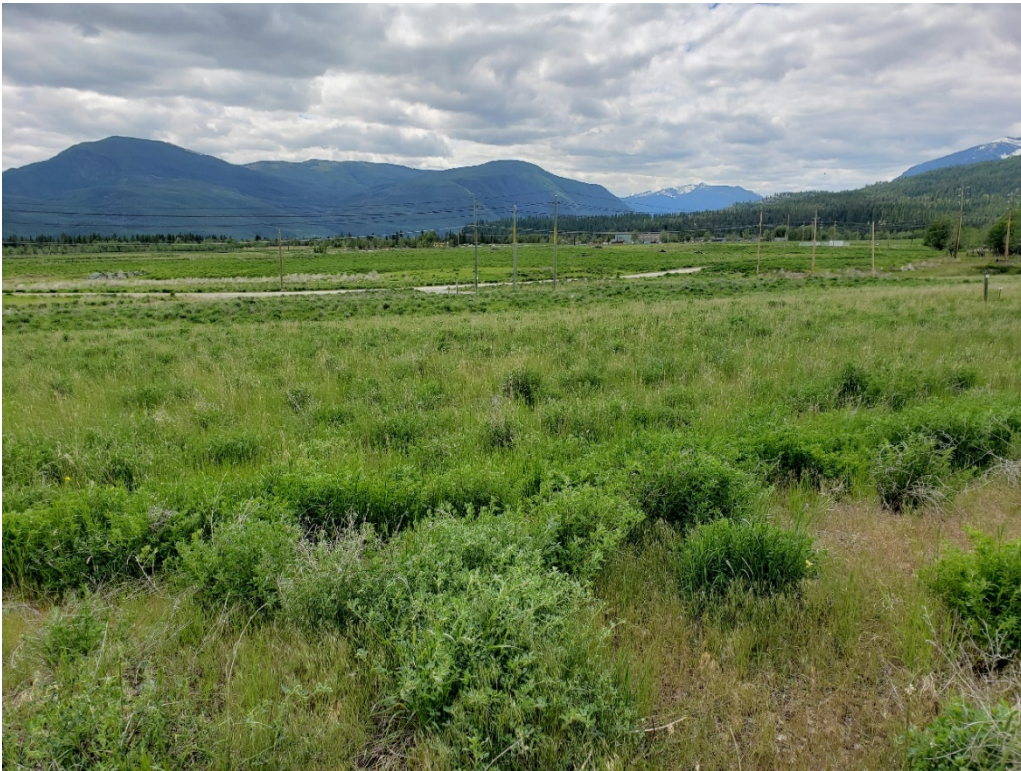
Photo II.25 Old Iron Dike downstream slope

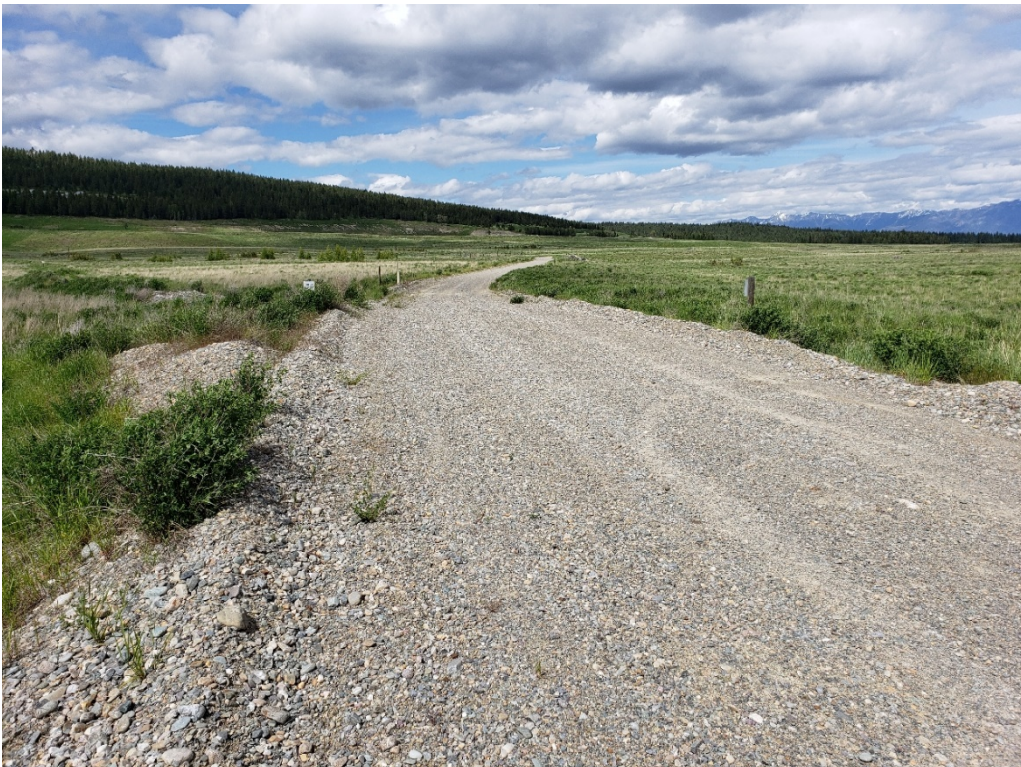
Photo II.26 Iron TSF Divider Dike
