Teck Highland Valley Copper Partnership

2020 Annual Facility Performance Report

Trojan Tailings Storage Facility

March 2021

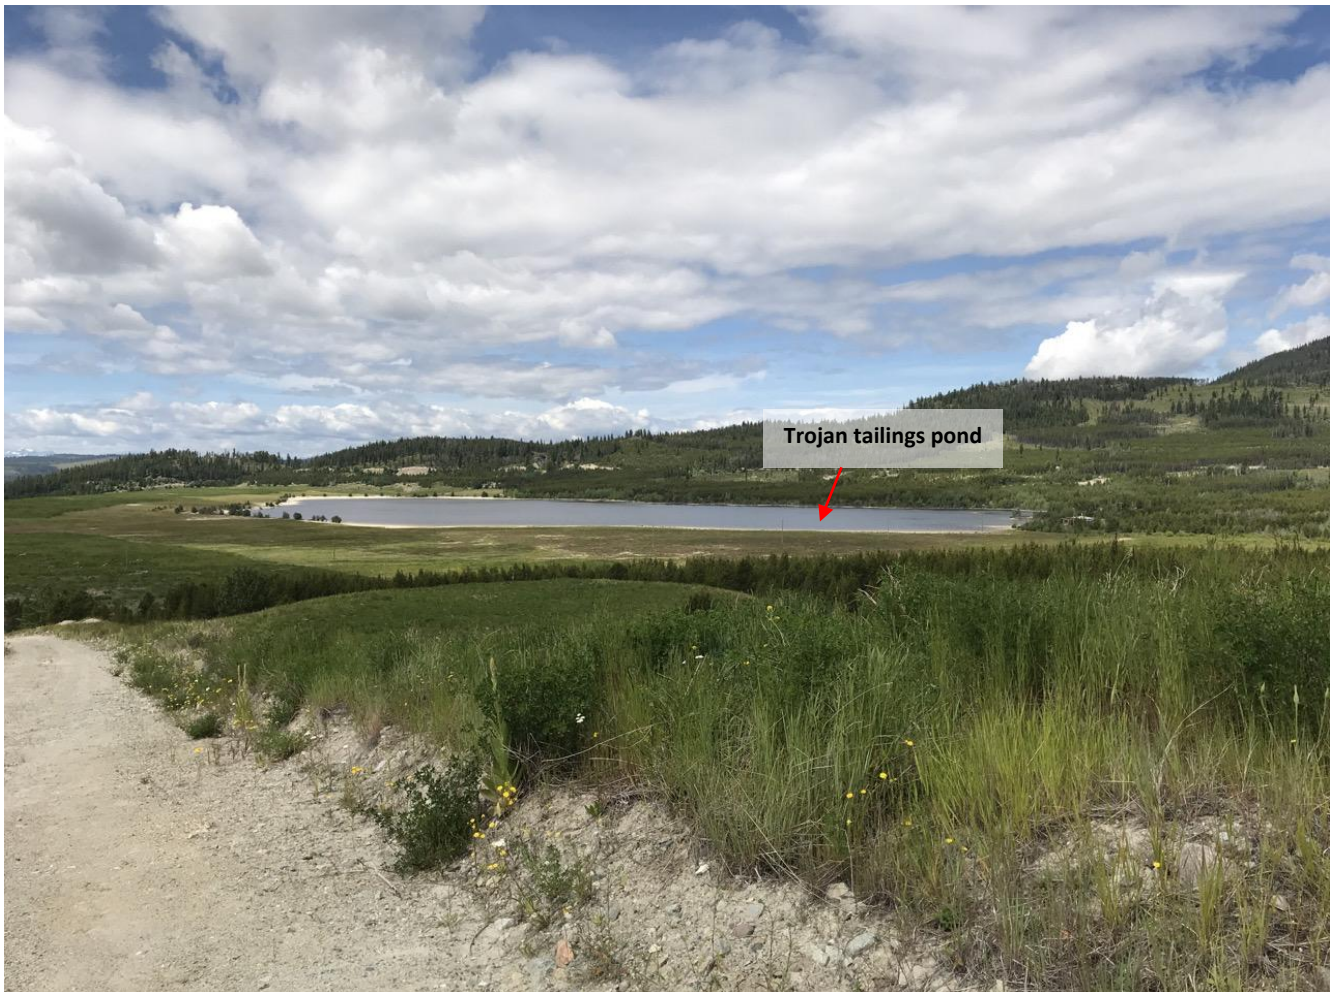
Photo I-A-1 Overview of Trojan Tailings Storage Facility (TSF) from access road between Trojan TSF and Bethlehem TSF (TRJ-2020-01)

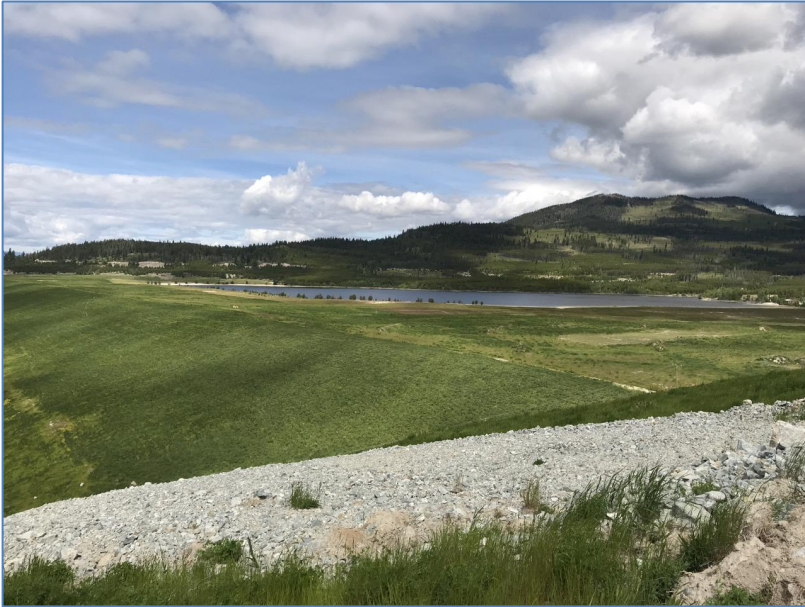
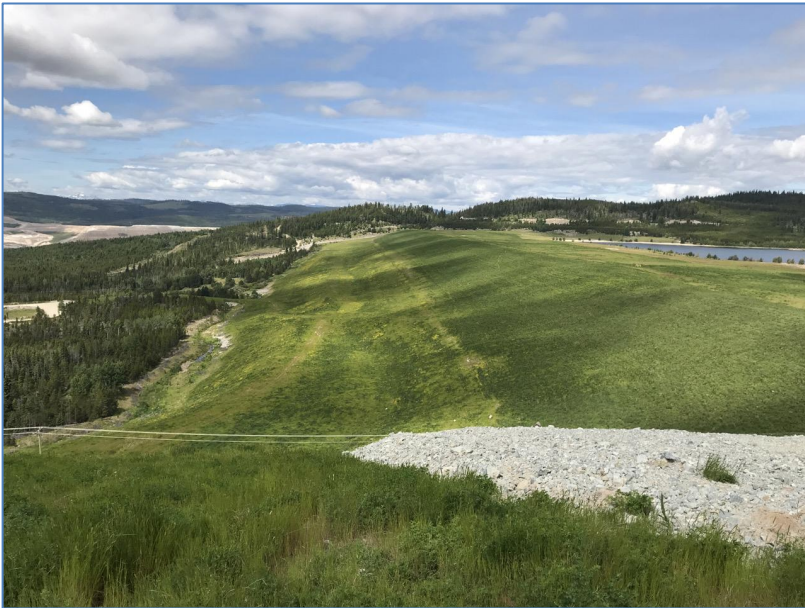
Photo I-A-3 Overview of Trojan Tailings Pond and Trojan Dam downstream slopes from left abutment. No visible erosion or scour (TRJ-2020-03)

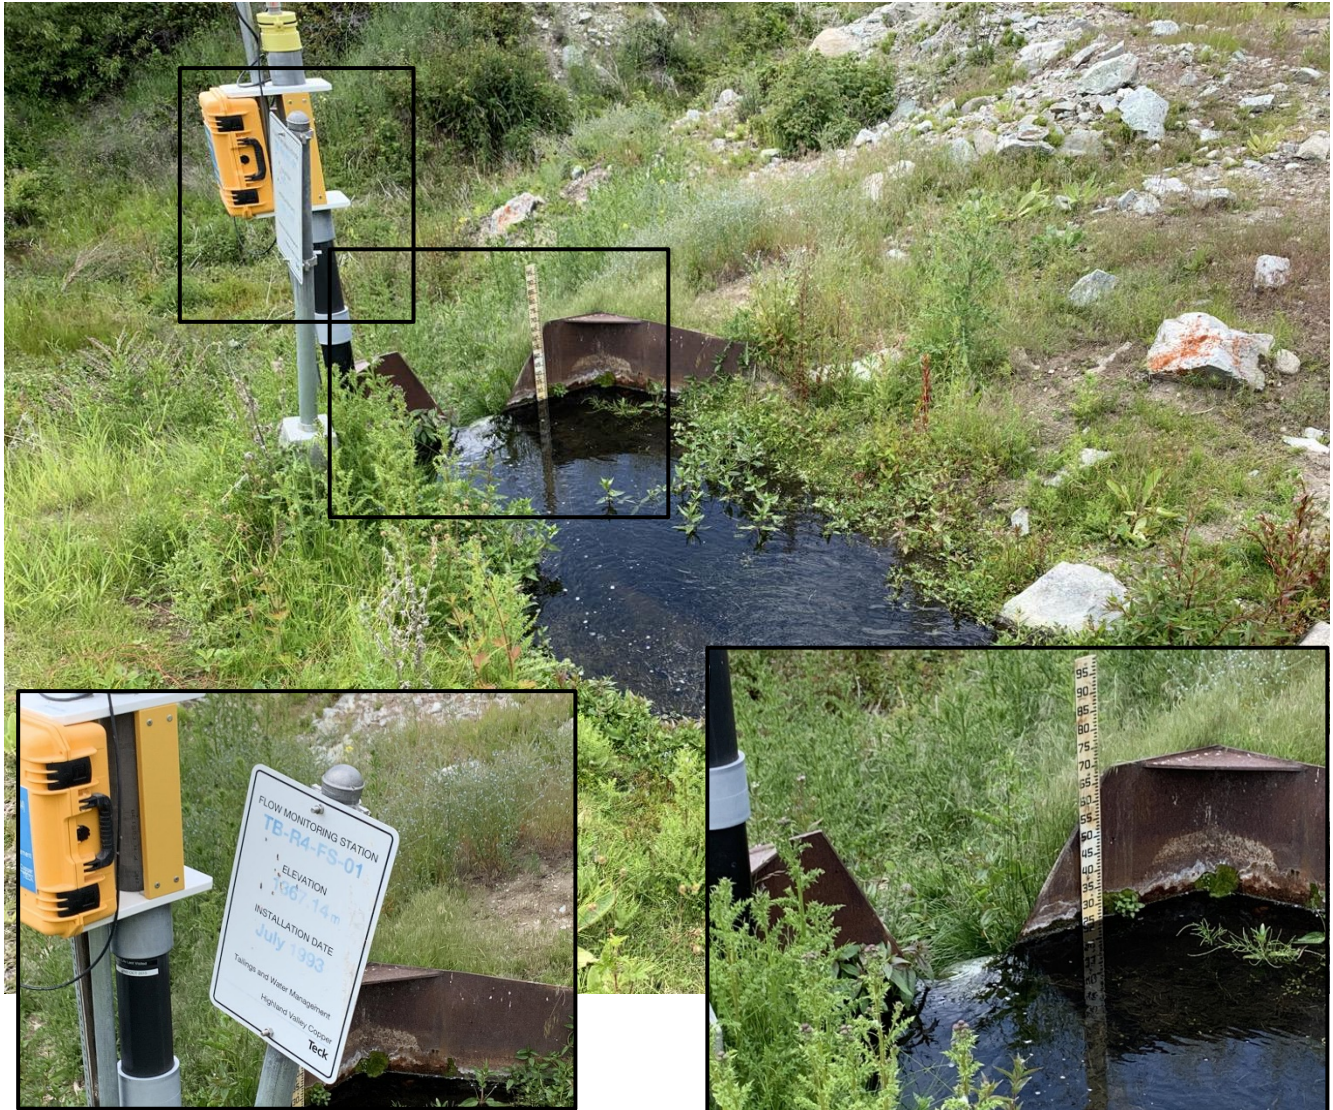
Photo I-A-4 Overview of weir TD-R4-SF01 downstream of East and West Seepage Collection Ditches (TRJ-2020-04)

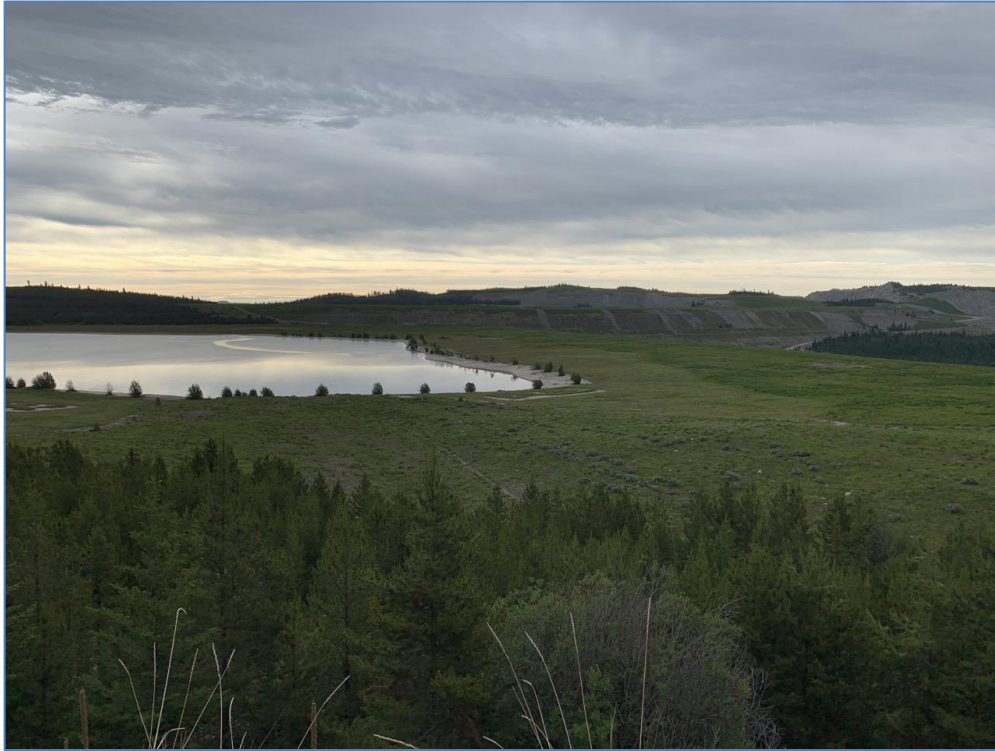
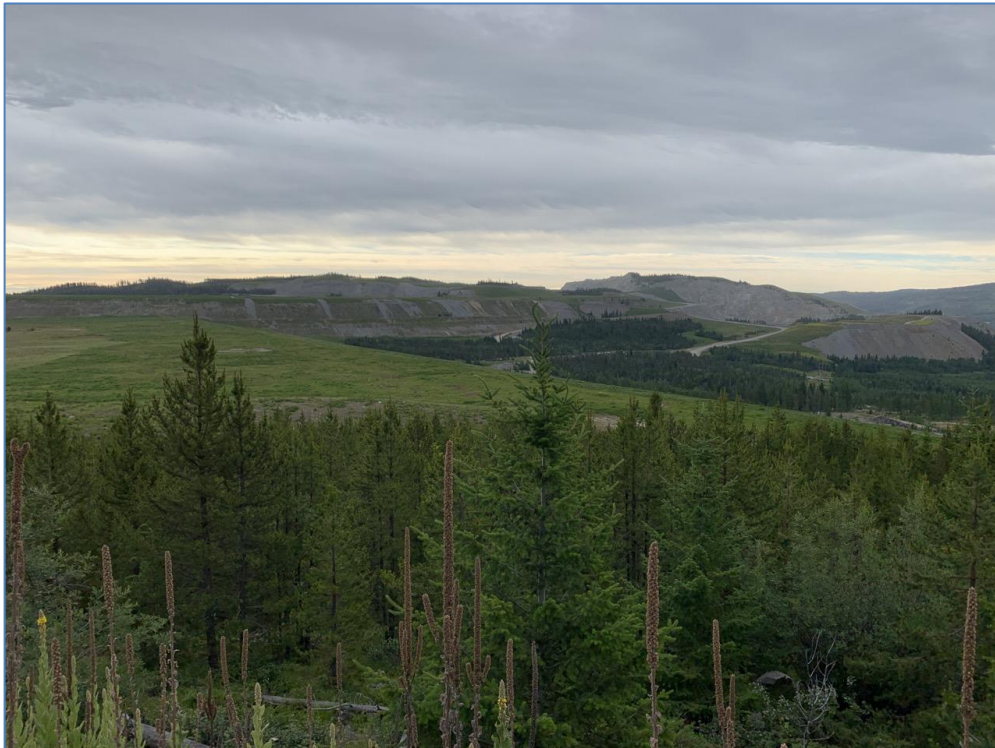
Photo I-A-5 Overview of Trojan Tailings Pond and tailings beach from Trojan Diversion Channel (TRJ-2020-05 and TRJ-2020-06)

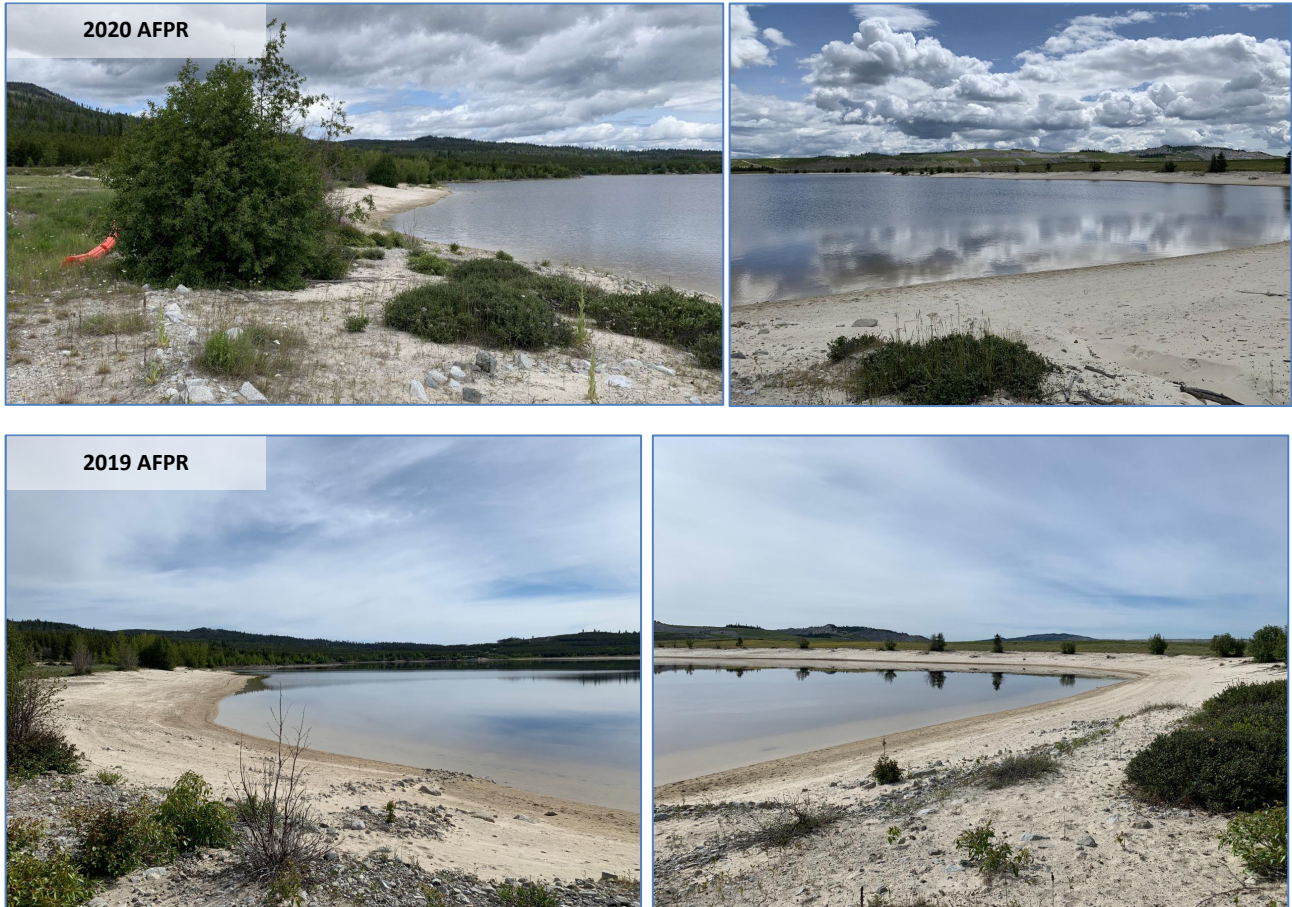
Photo I-A-6 Overview of Trojan Tailings Pond. Sand beach is exposed. Spillway inlet is visible. Debris boom is secured (TRJ-2020-07)

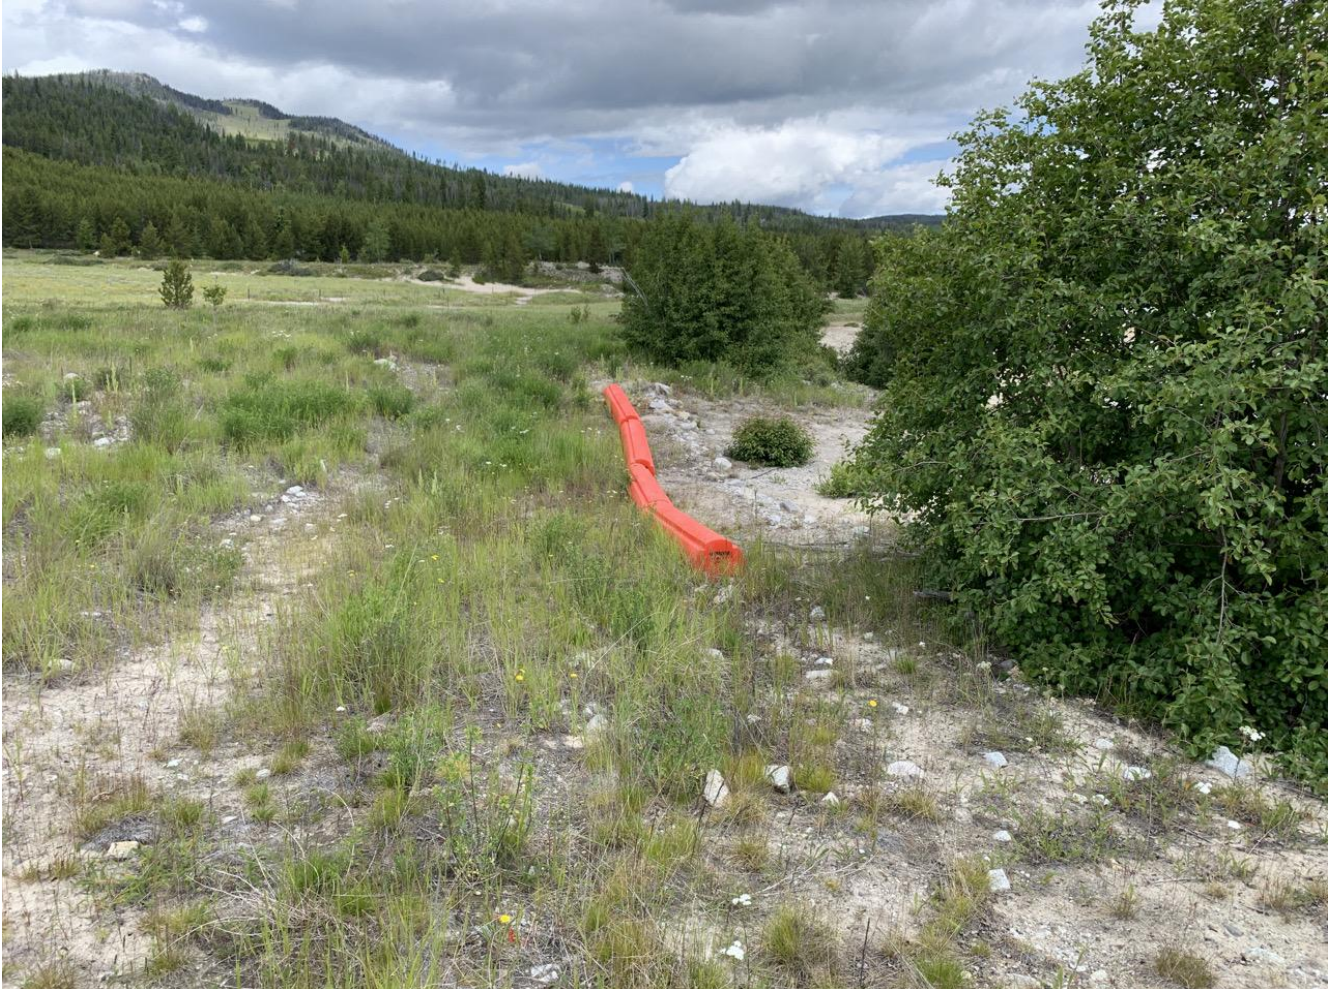
Photo I-A-7 Trojan spillway inlet. Approach channel is clear and debris boom is secured.
(TRJ-2020-07)

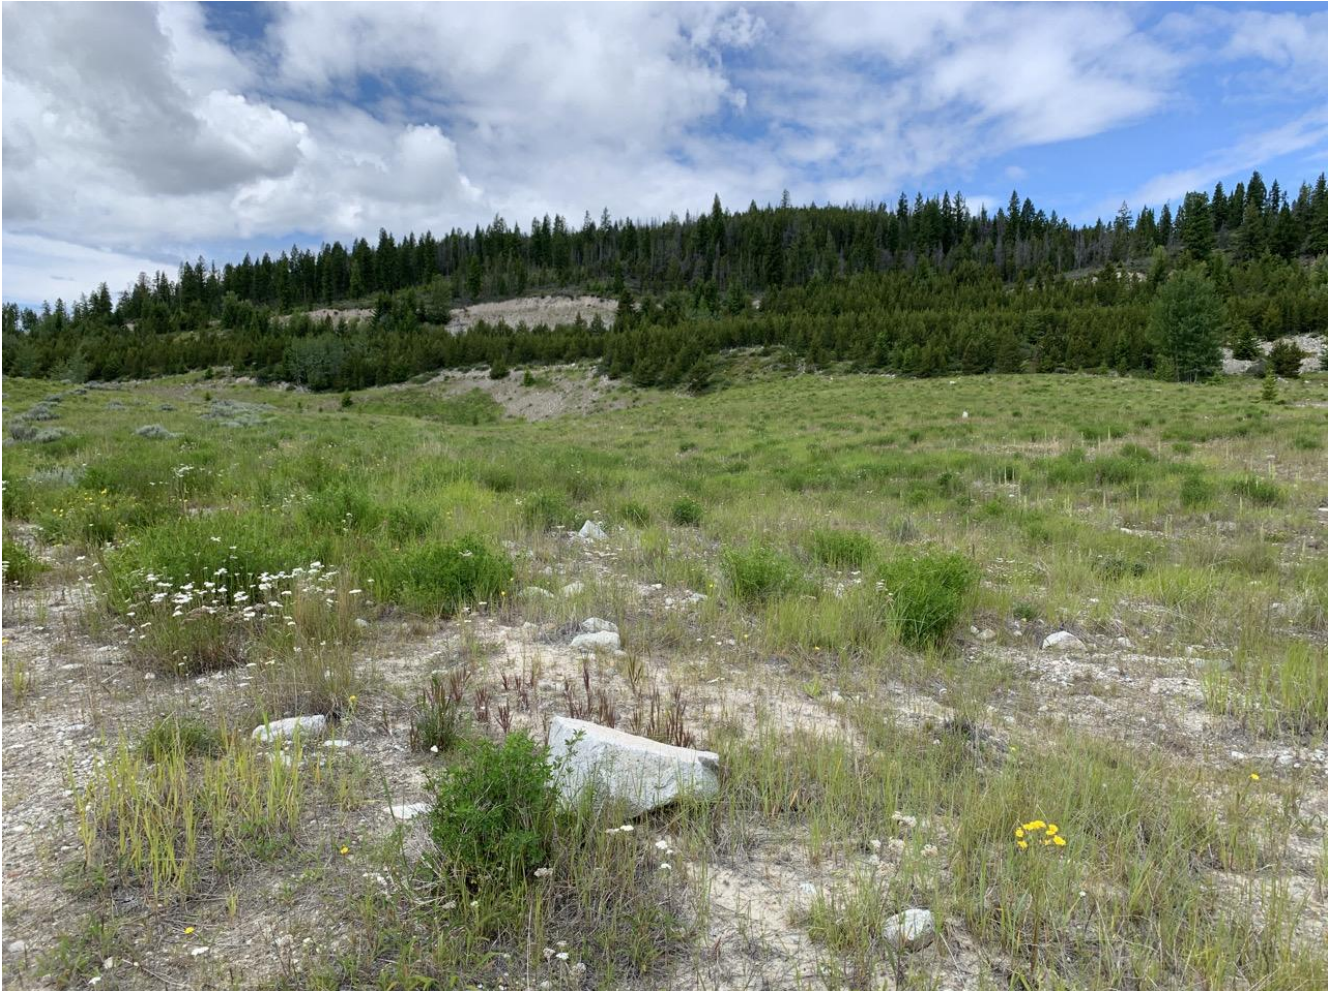
Photo I-A-8 Trojan spillway approach channel (TRJ-2020-07)

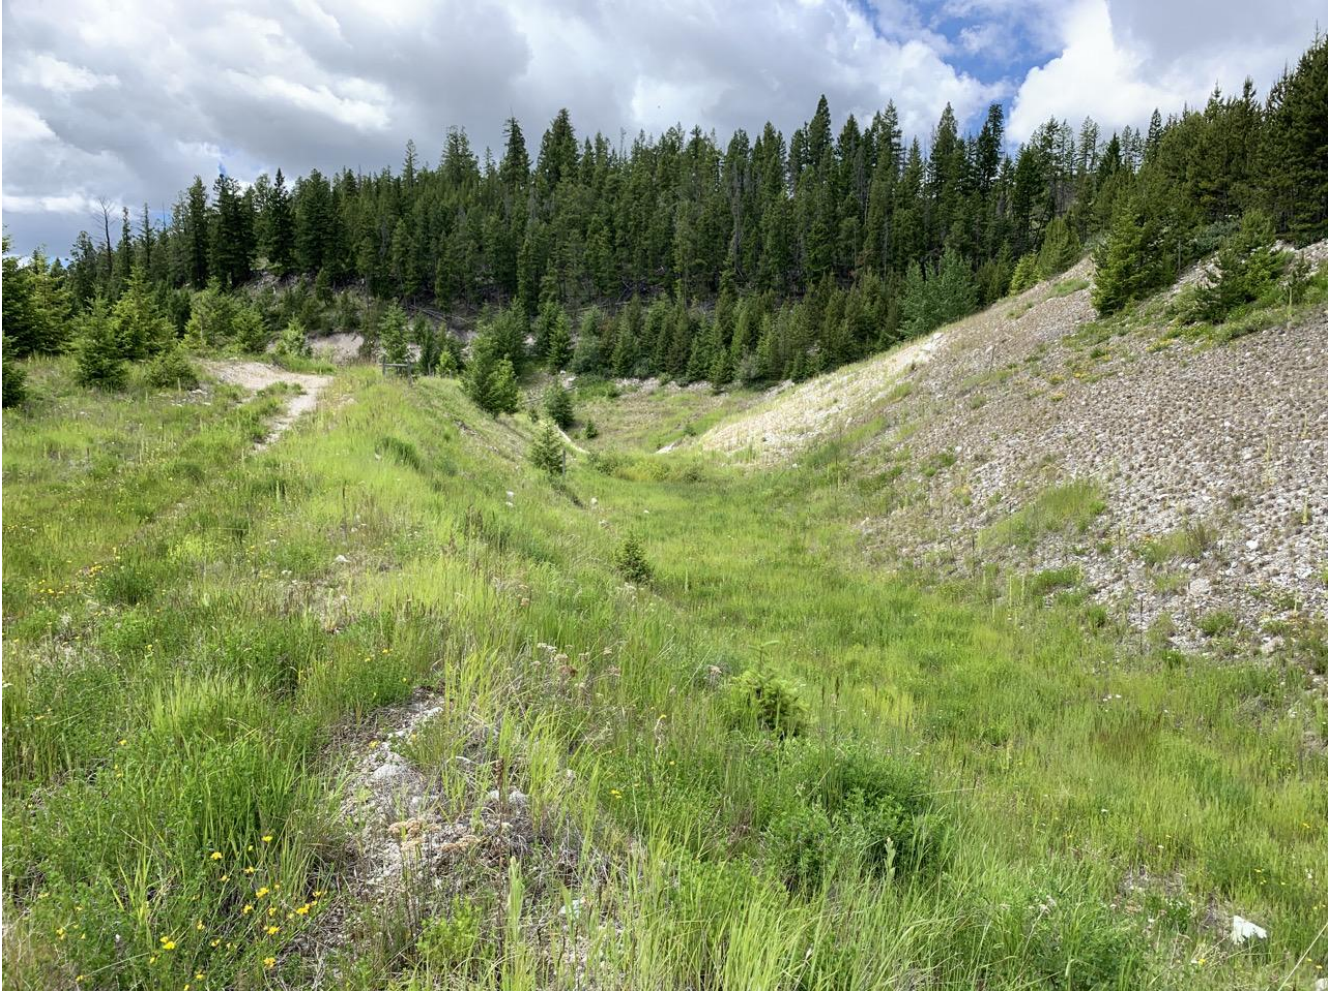
Photo I-A-10 Overview of spillway channel, downstream of chute. Slopes are in good condition. Channel is vegetated (TRJ-2020-09)

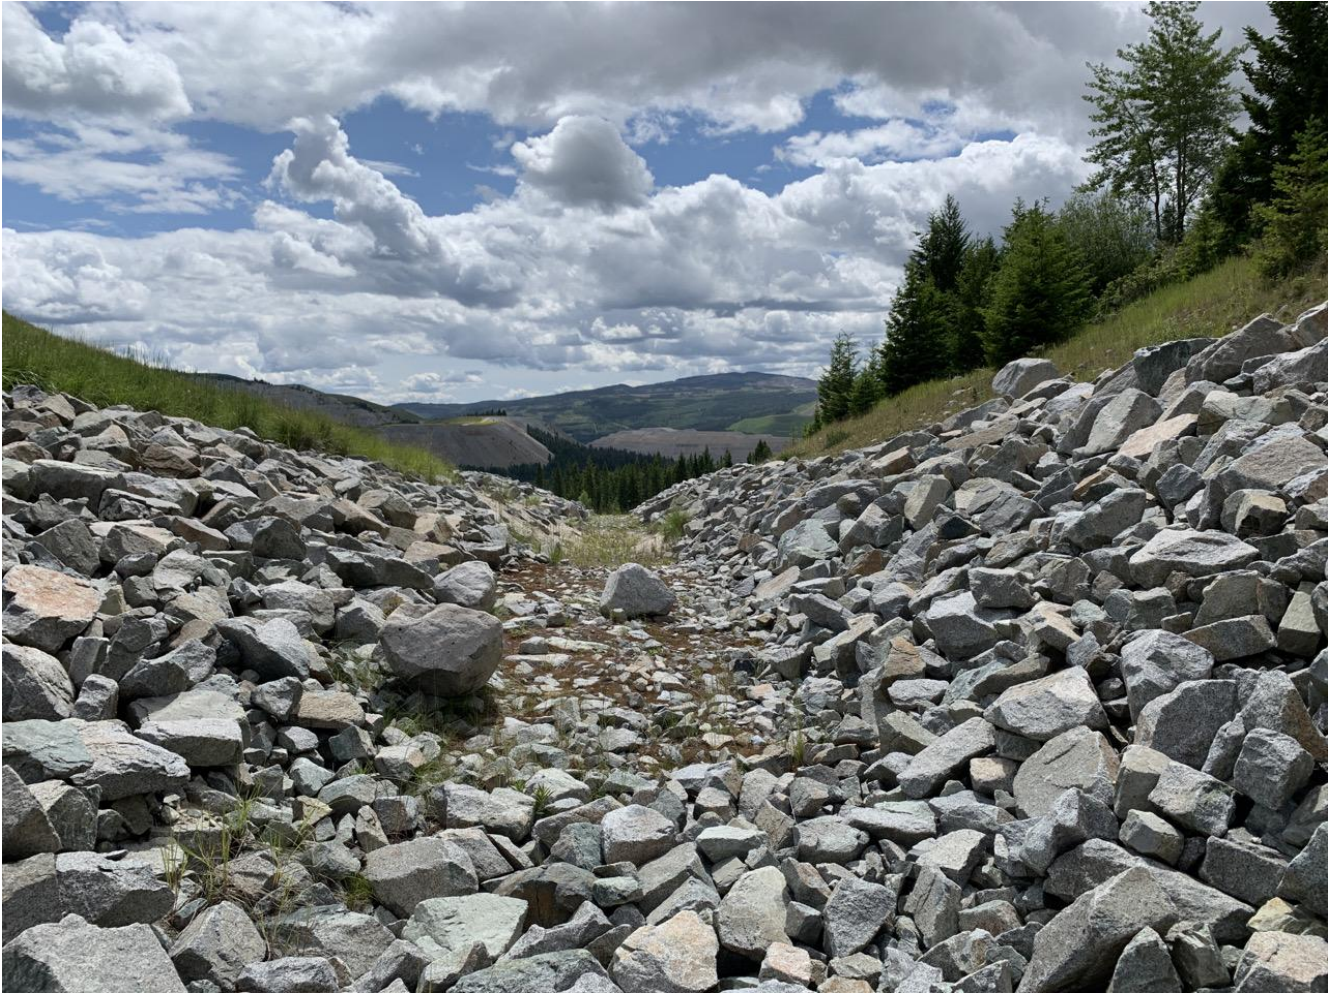
Photo I-A-11 Overview of riprap segment of spillway channel, looking toward south (TRJ-2020-10)

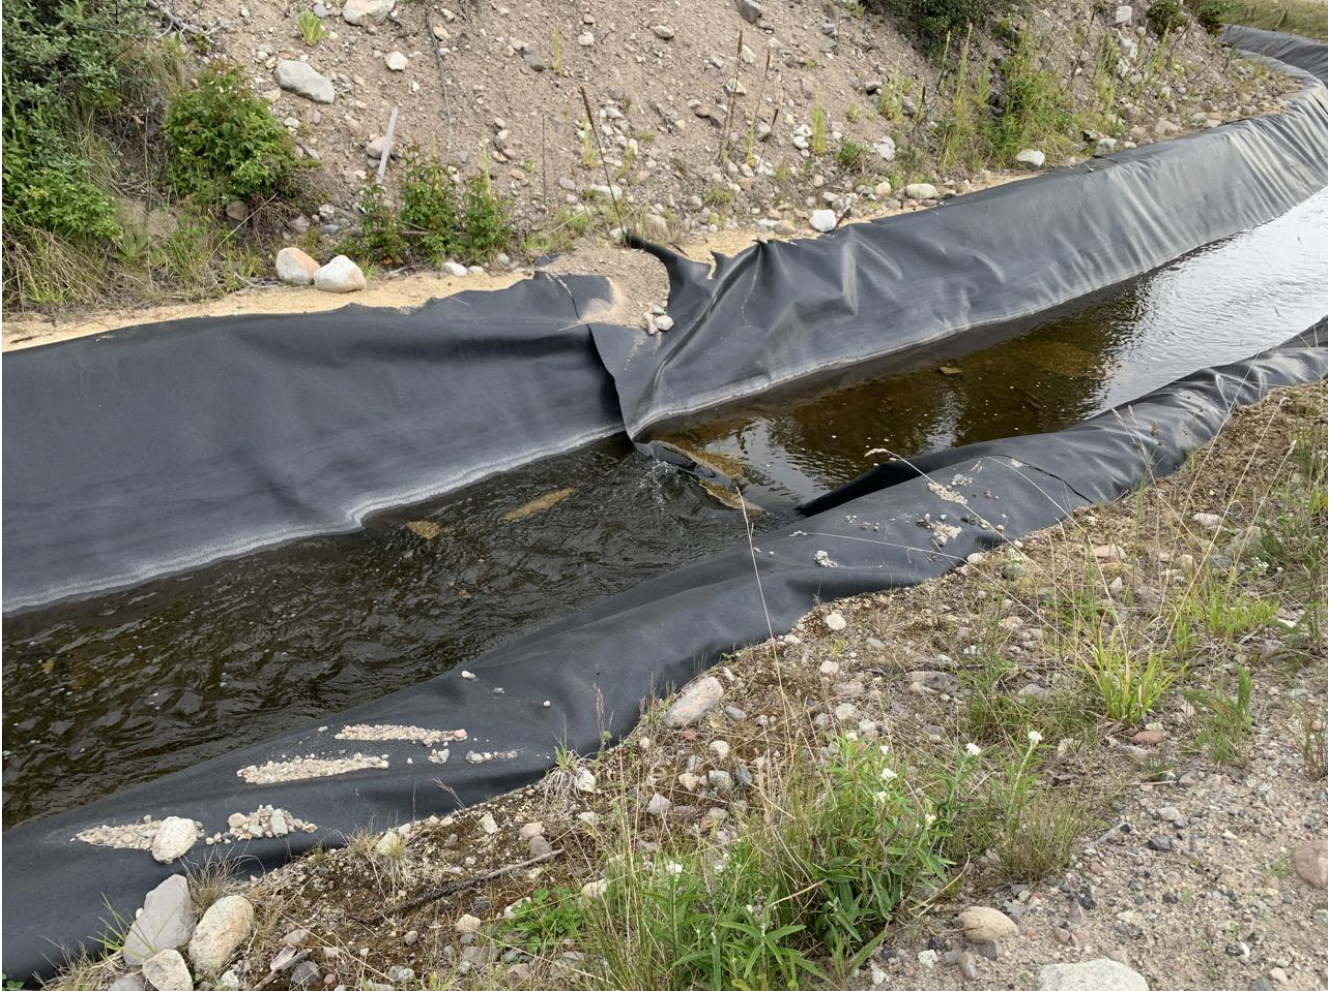
Photo I-A-17 Example of liner overlap point. No seepage faces observed on slope downstream of this area (TRJ-2020-16)

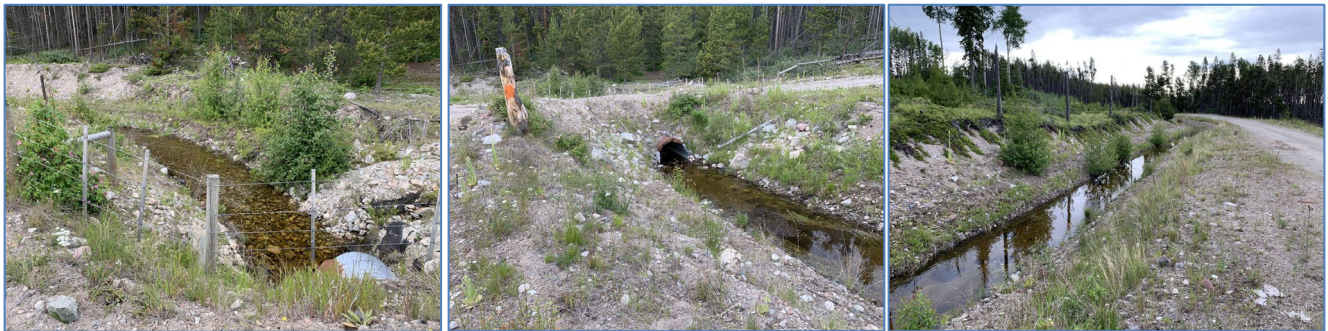
Photo I-A-22 Trojan Diversion (road junction). Culvert is clear. Low velocity flow of clear water into the unlined channel. (TRJ-2020-20)

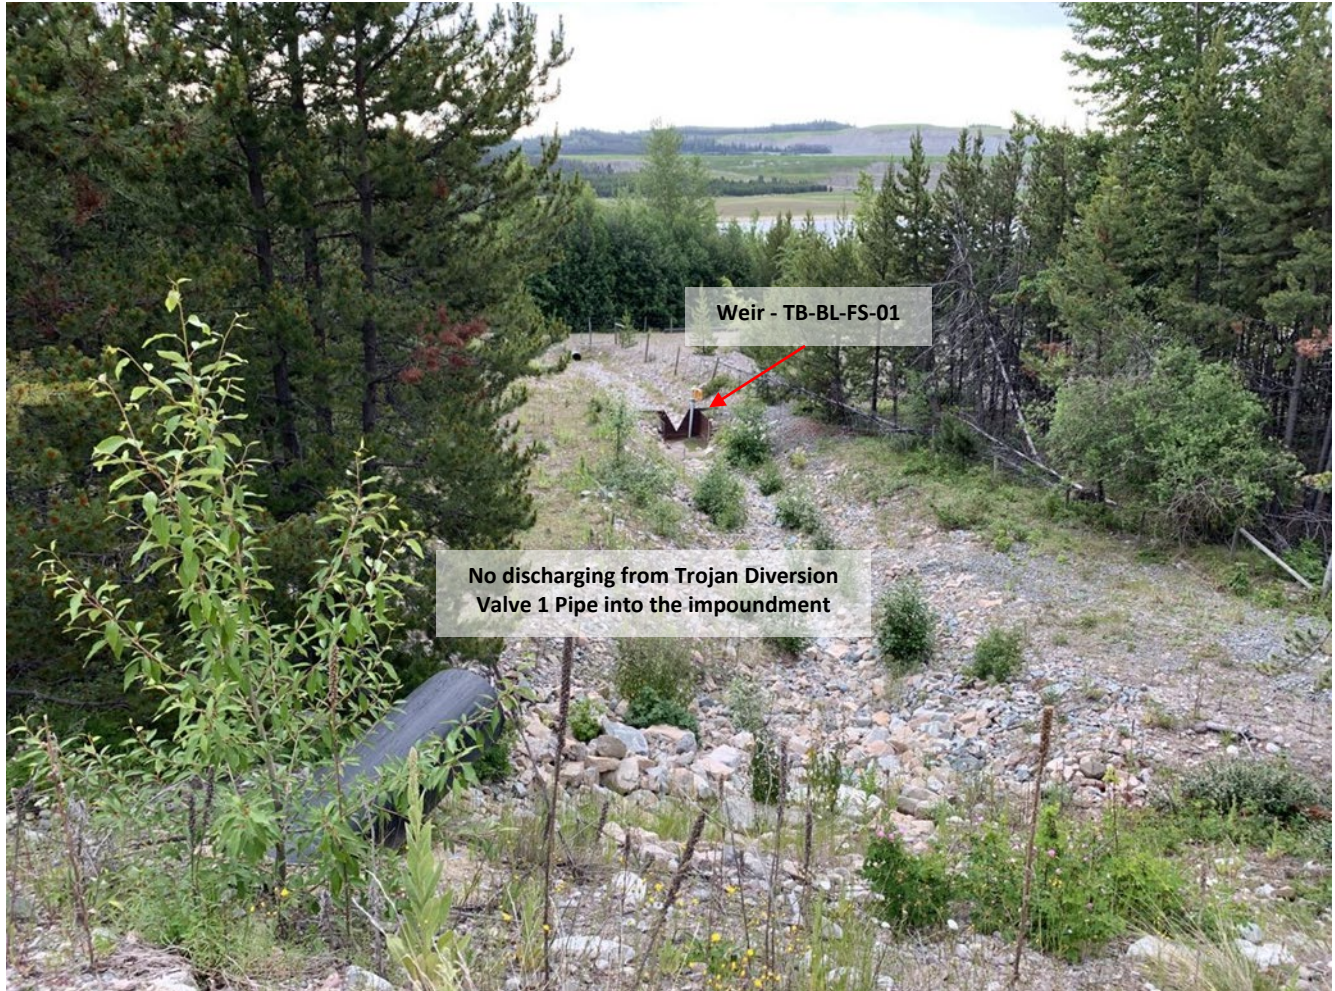
Photo I-A-23 No scour was observed at Trojan Diversion Valve 1 pipe discharge point (TRJ-2020-18)

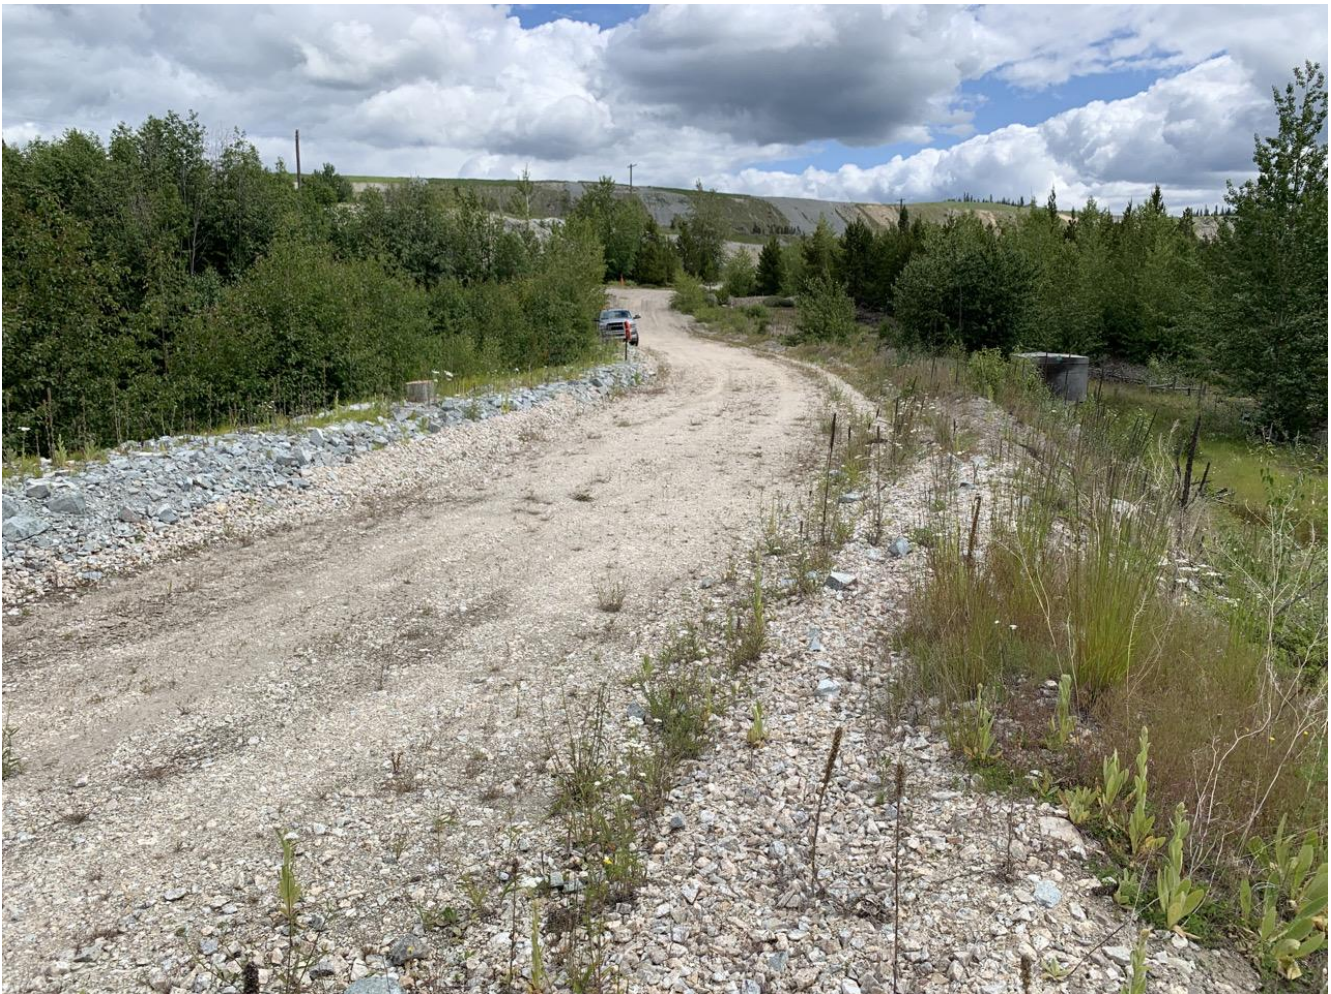
Photo I-B-1 Overview of crest and downstream slope looking towards left abutment (TRJ-2020-21)

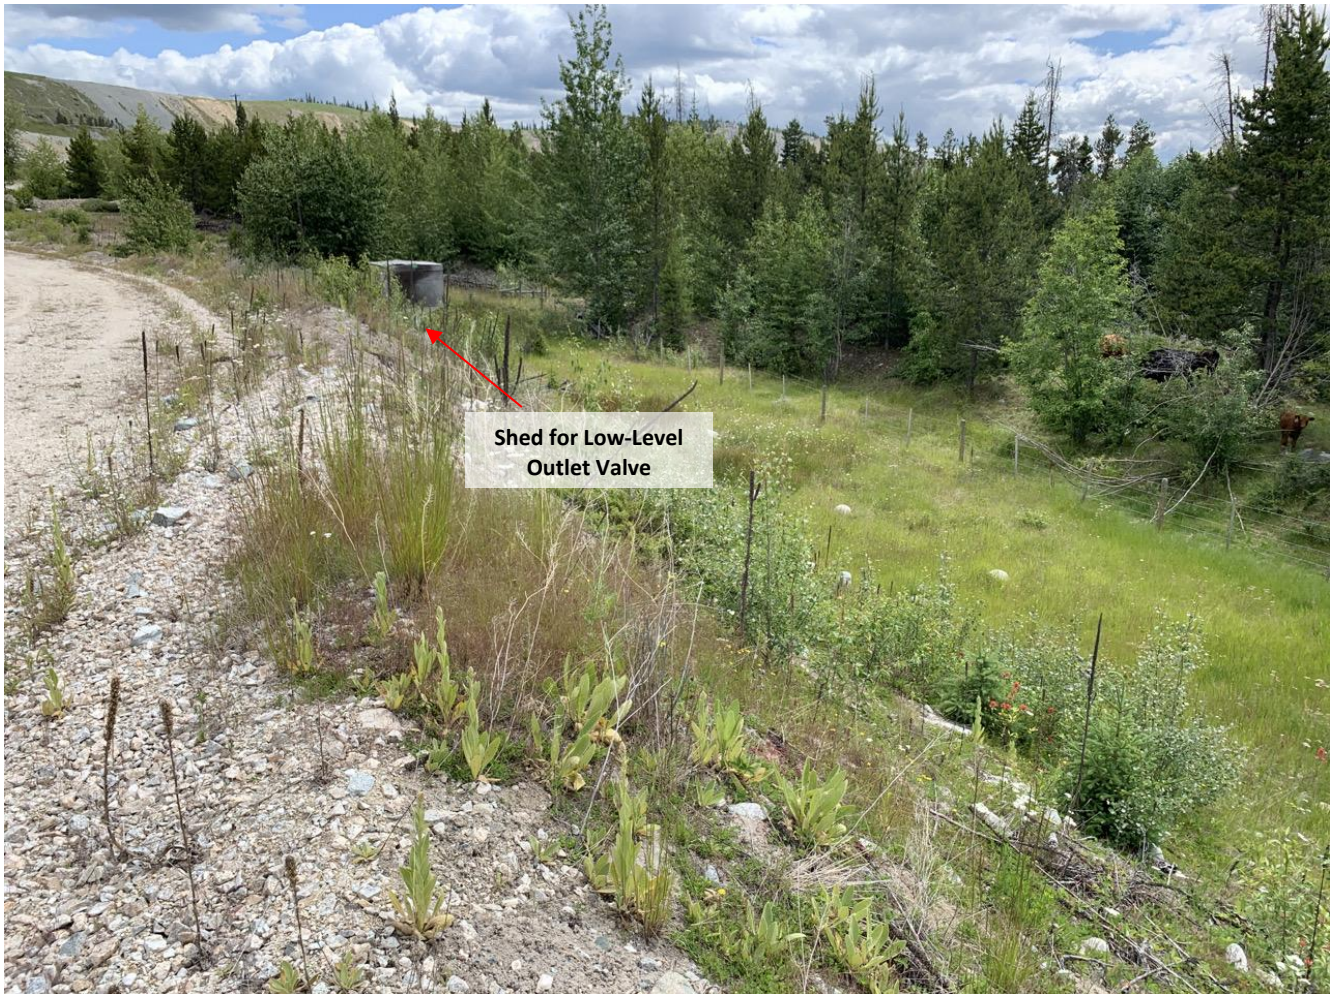
Photo I-B-2 Overview of downstream slope looking towards left abutment (TRJ-2020-21)

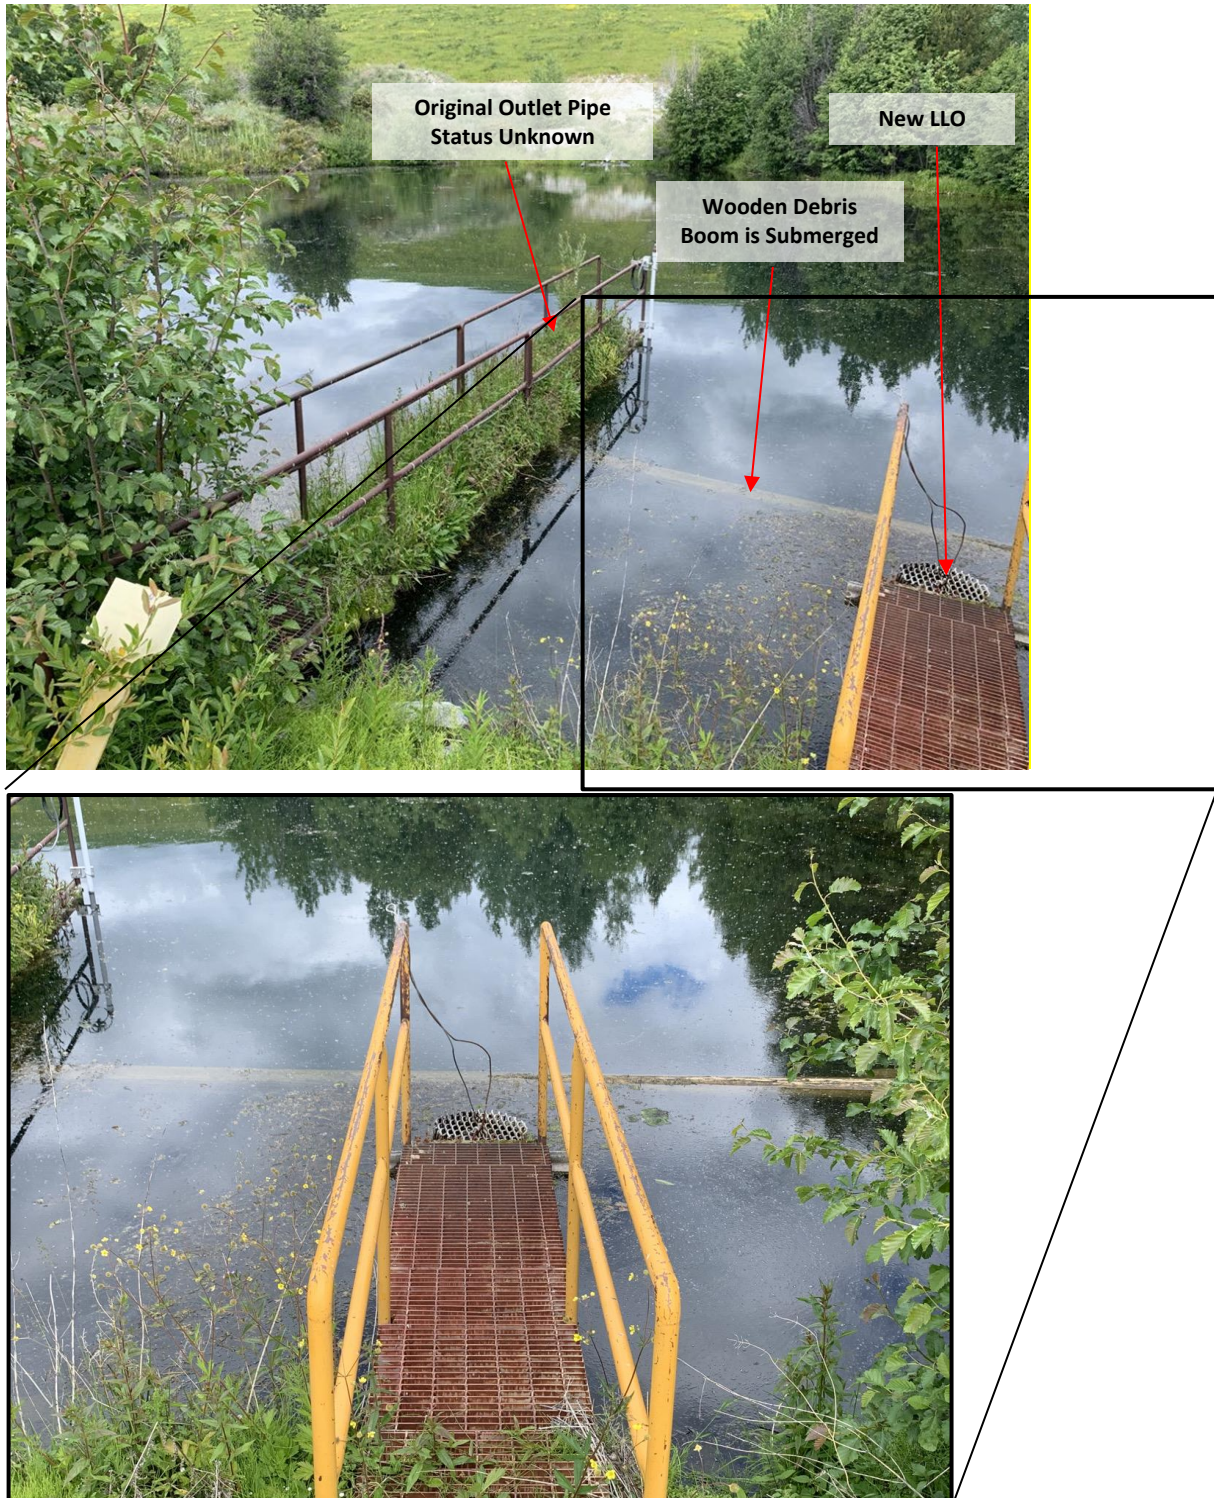
Photo I-B-3 Overview of the pond and low-level outlet to Witches Brook via Lower Trojan Dam with view of Trojan Dam downstream slope (TRJ-2020-22)

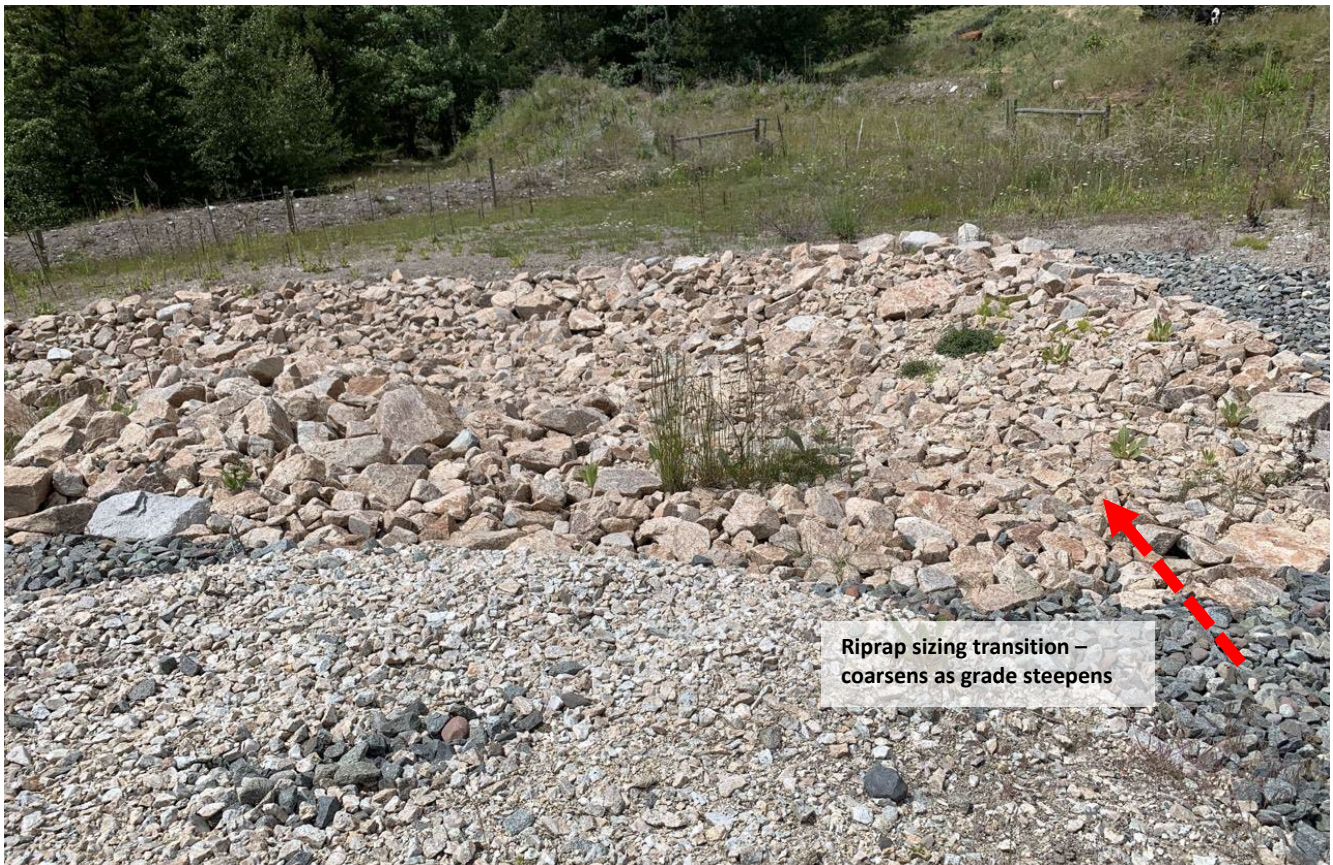
Photo I-B-6 Spillway Channel (TRJ-2020-24)

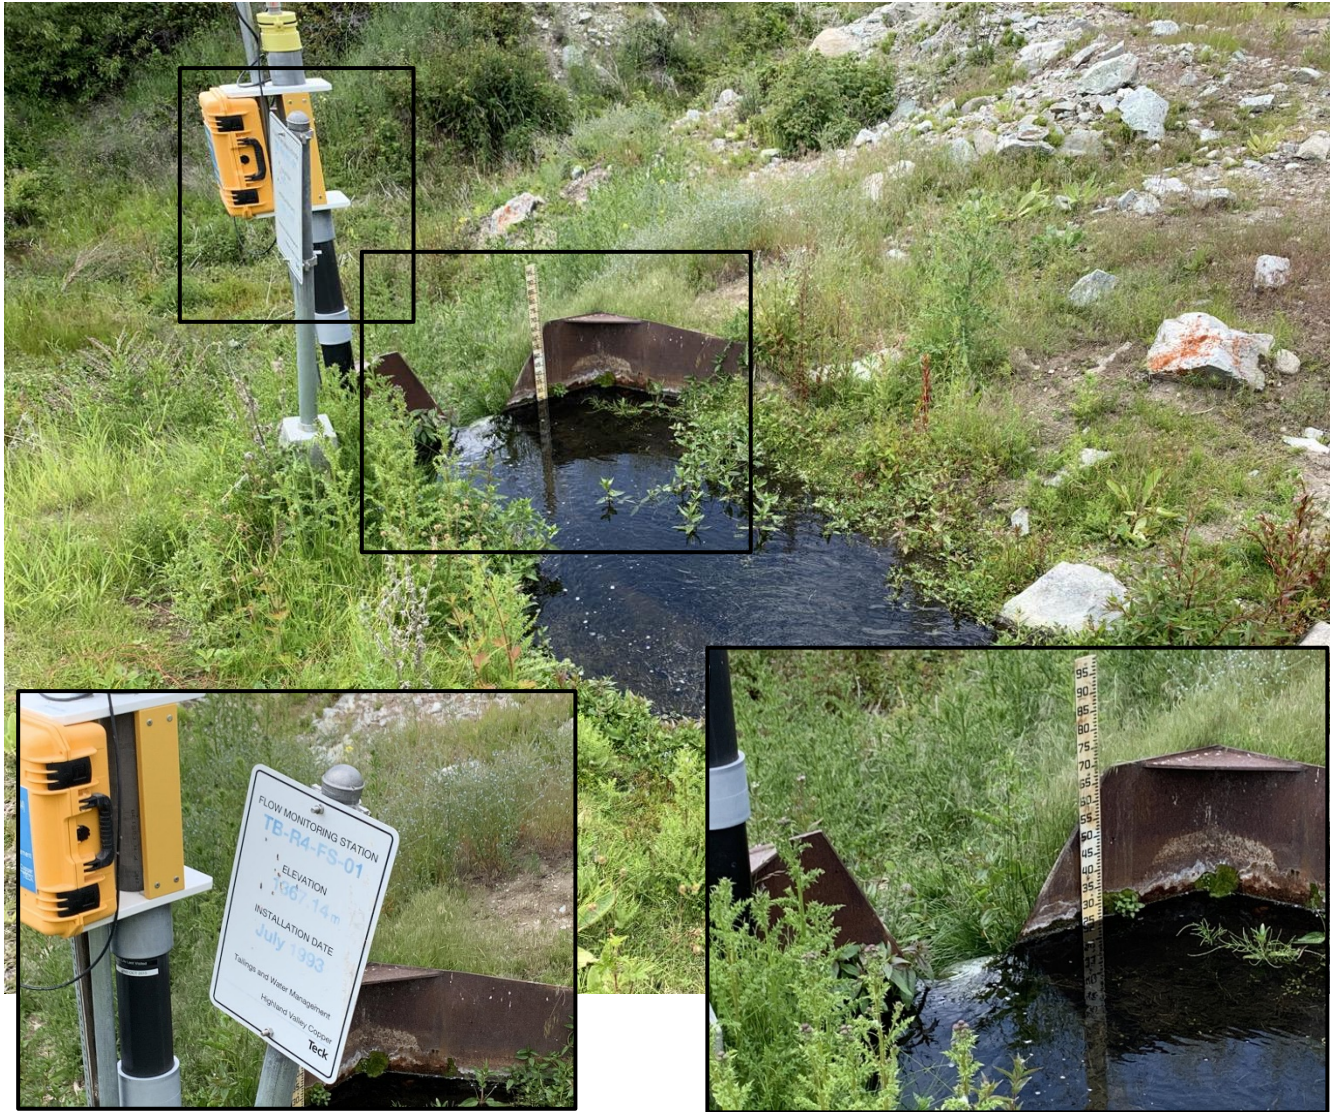
Photo I-B-7 Overview of weir TD-R4-SF01 downstream of East and West Seepage Collection Ditches (TRJ-2020-04)
