Teck Highland Valley Copper Partnership

2020 Annual Facility Performance Report

Trojan Tailings Storage Facility

March 2021

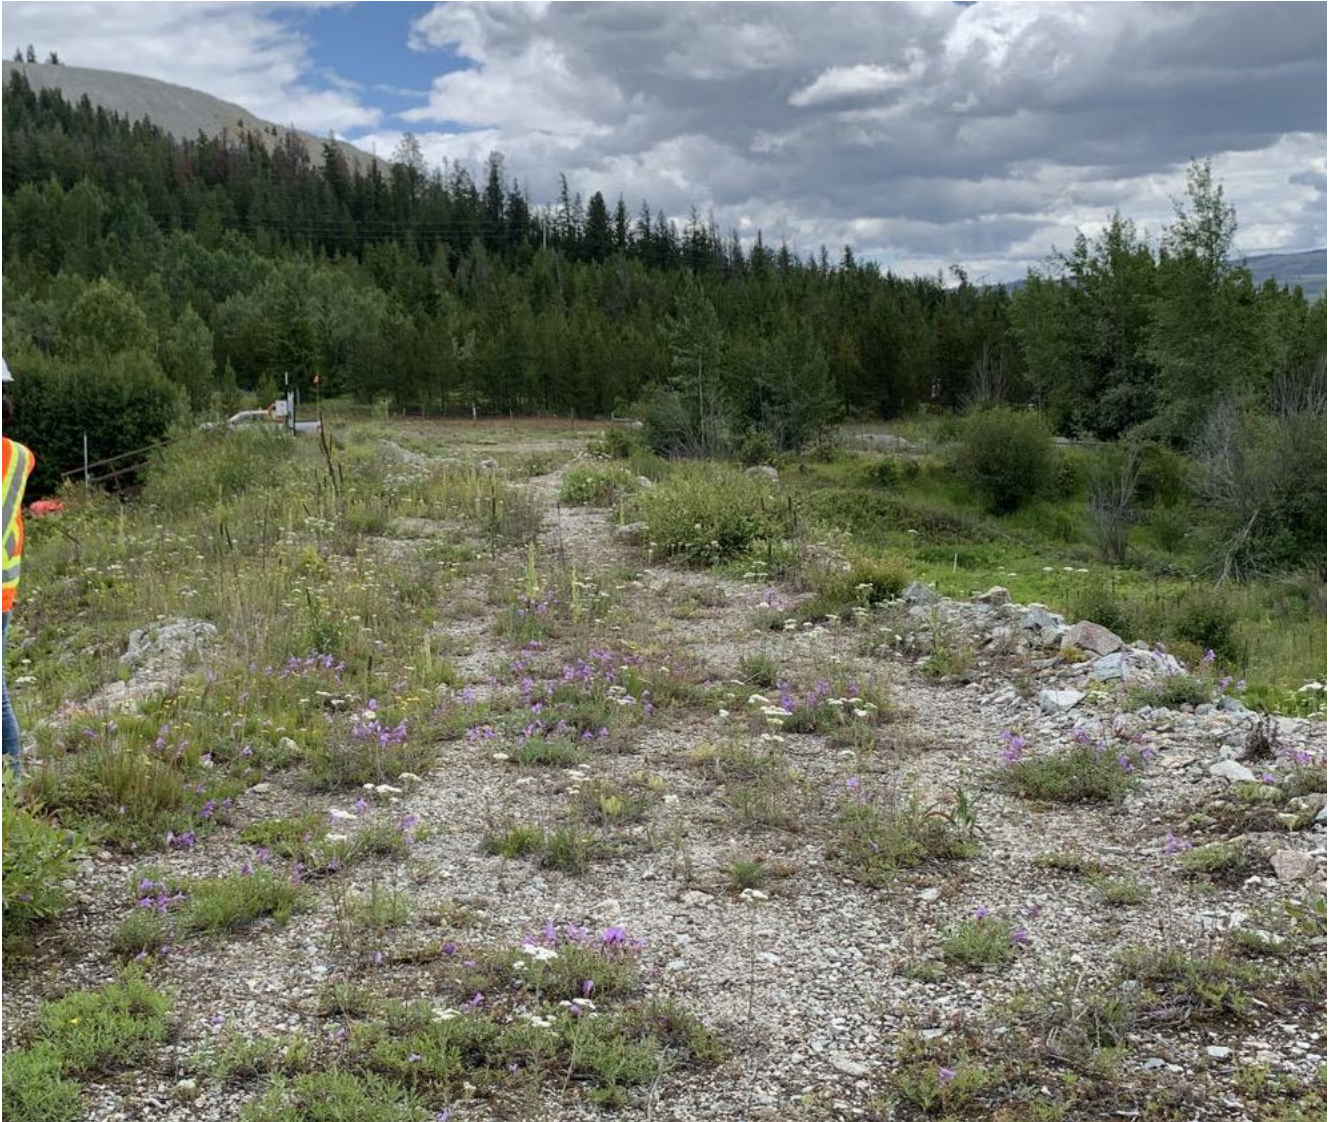
Photo I-C-2 Overview of crest looking toward left abutment (TRJ-2020-26)

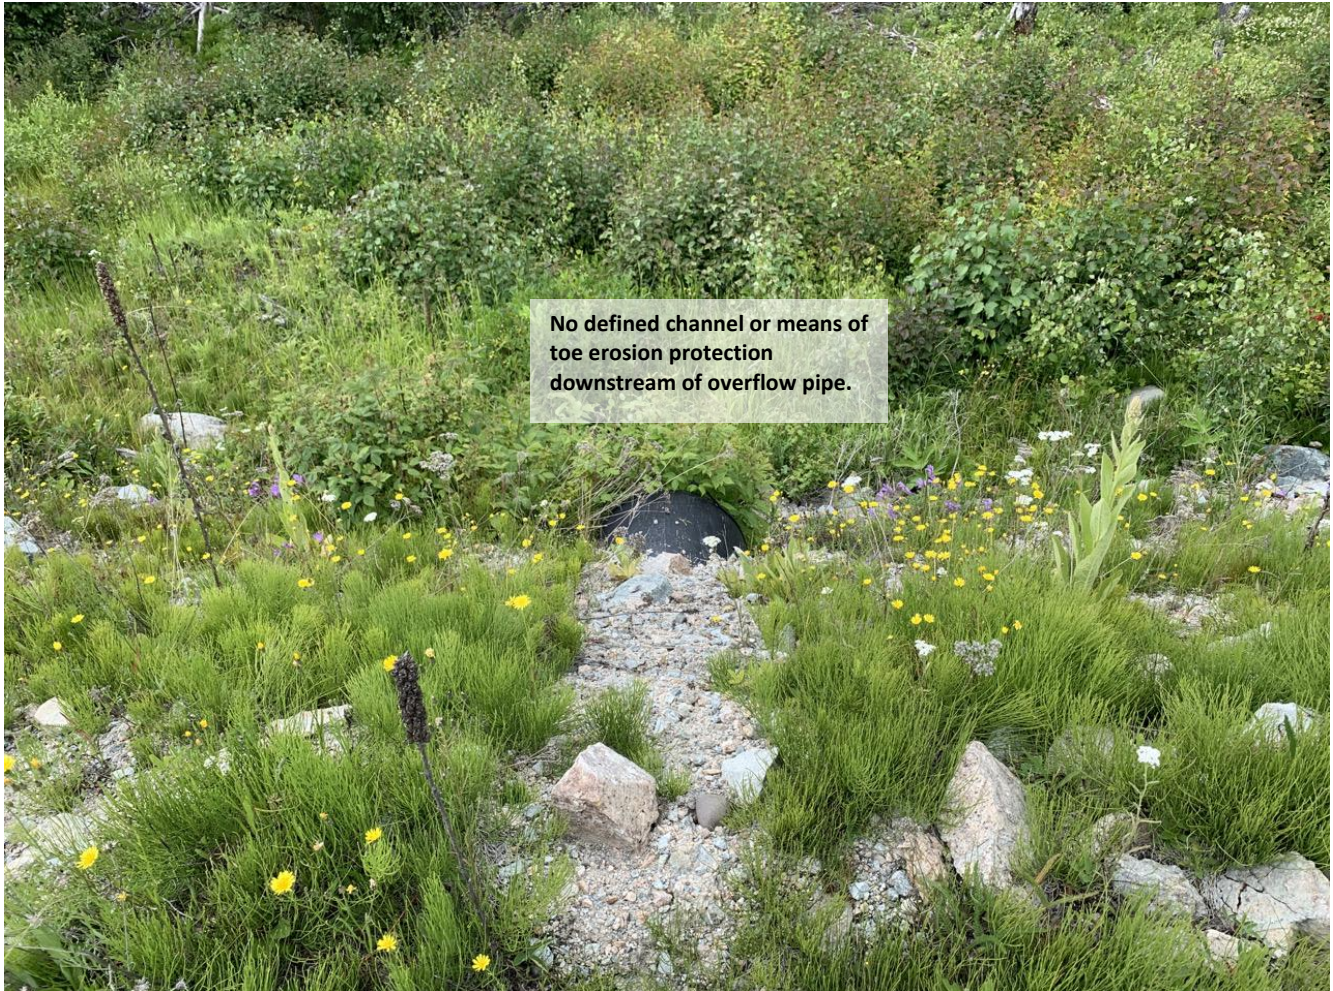
**Photo I-C-3 Downstream slope near right abutment with overflow pipe through the dam.
(TRJ-2020-26)**

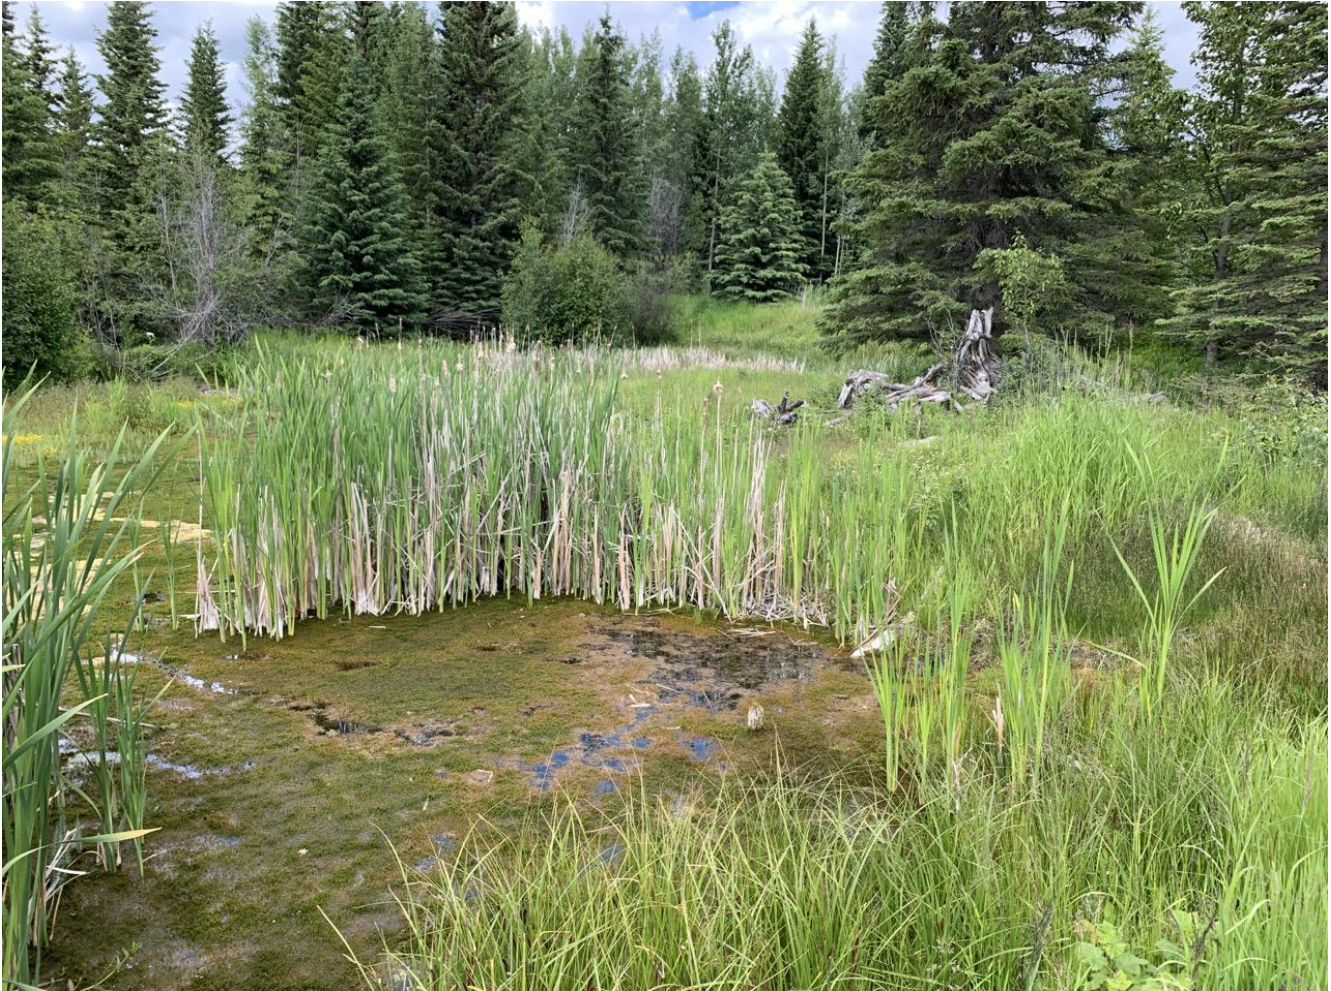
Photo I-C-4 Lower Trojan Dam Pond (TRJ-2020-27)

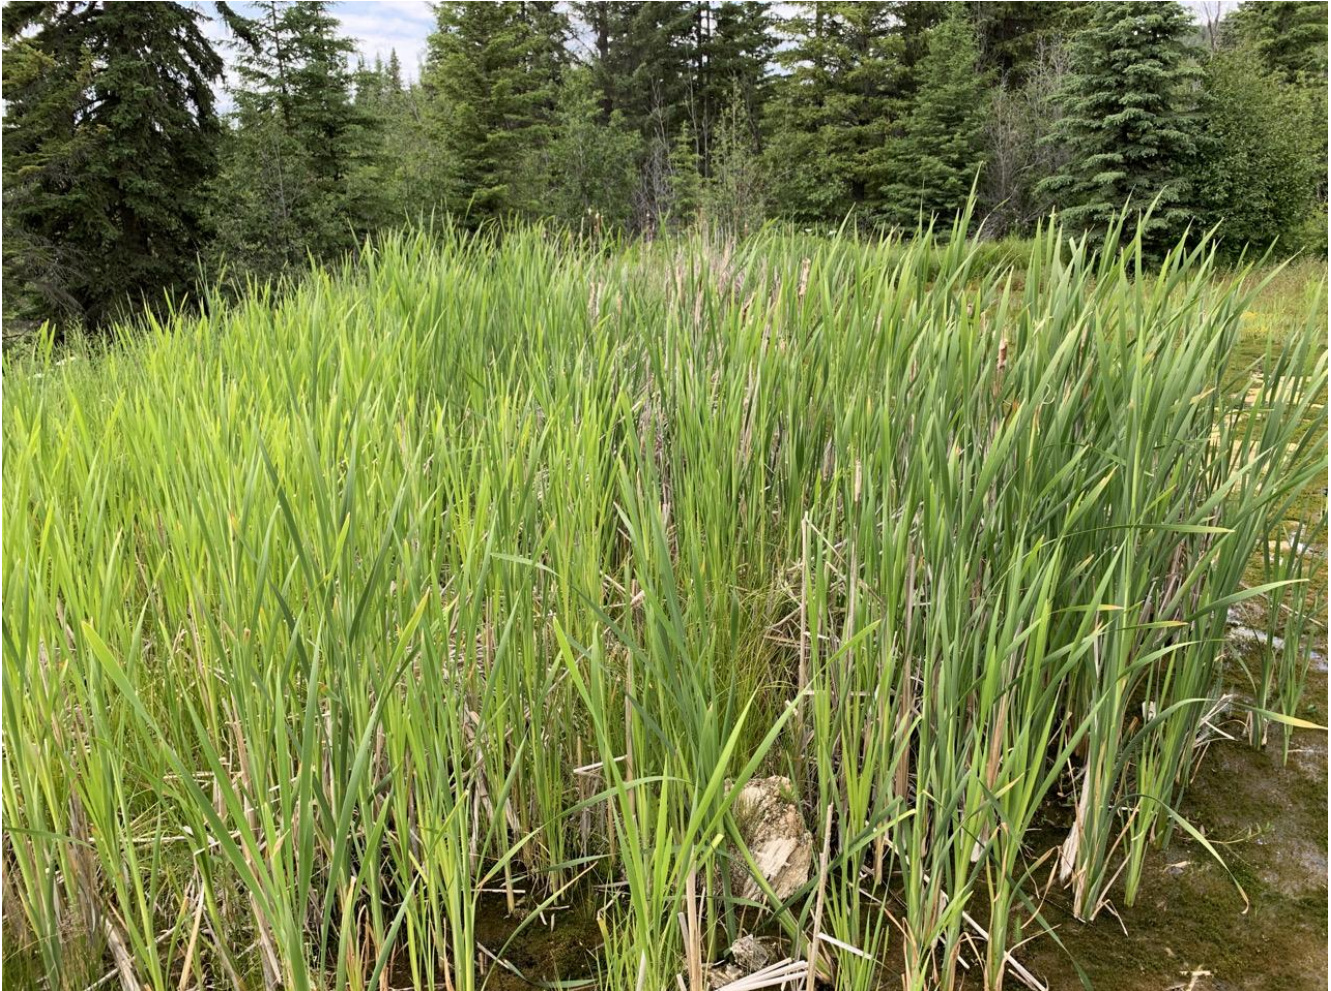
Photo I-C-5 Lower Trojan upper basin. (TRJ-2020-27)

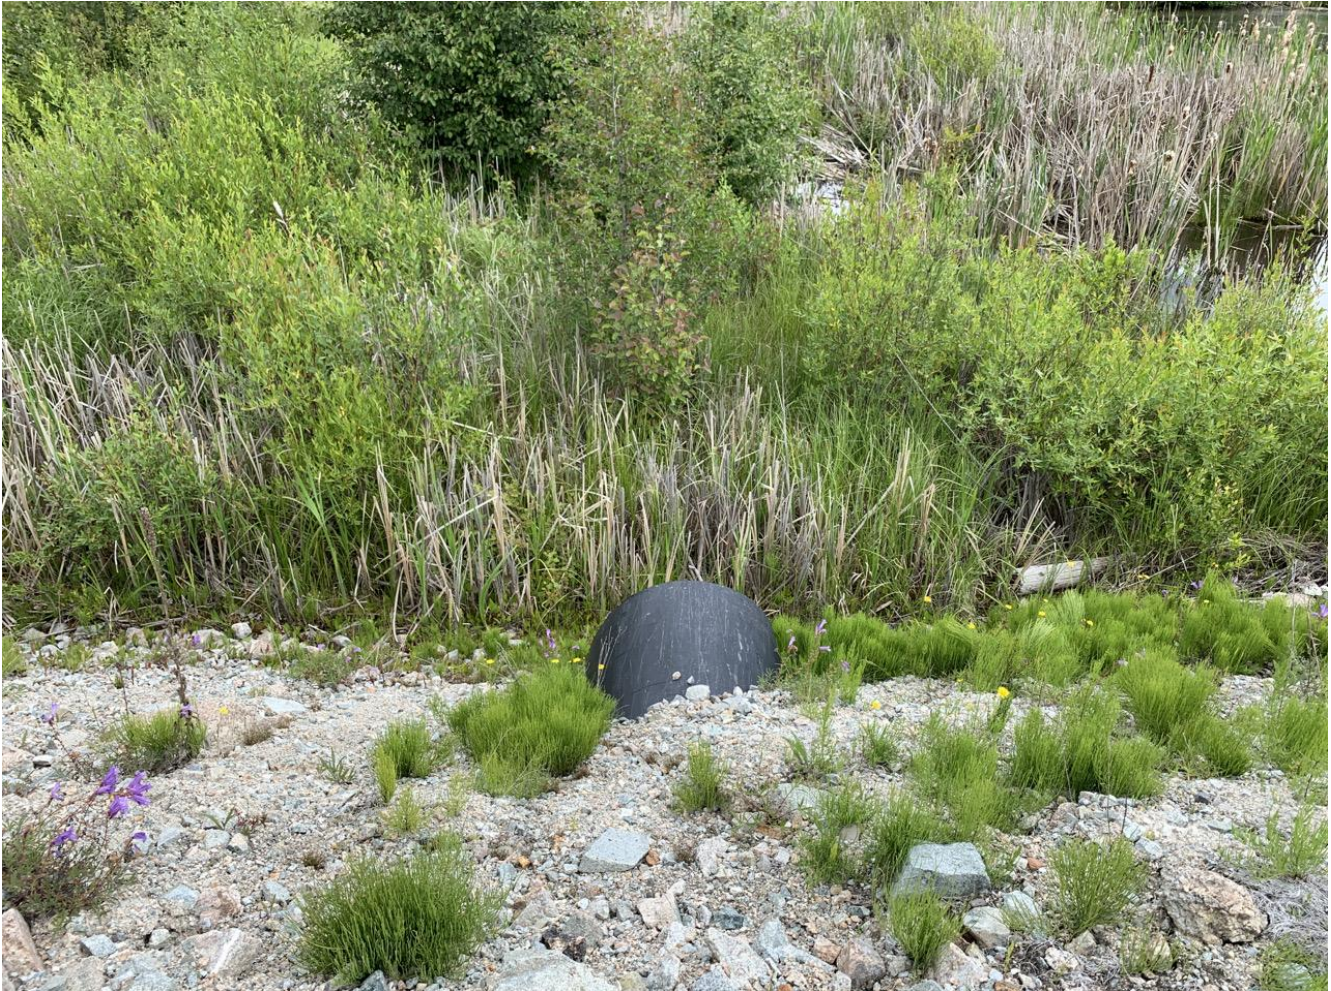
Photo I-C-7 Upstream Overflow Pipe (TRJ-2020-26)

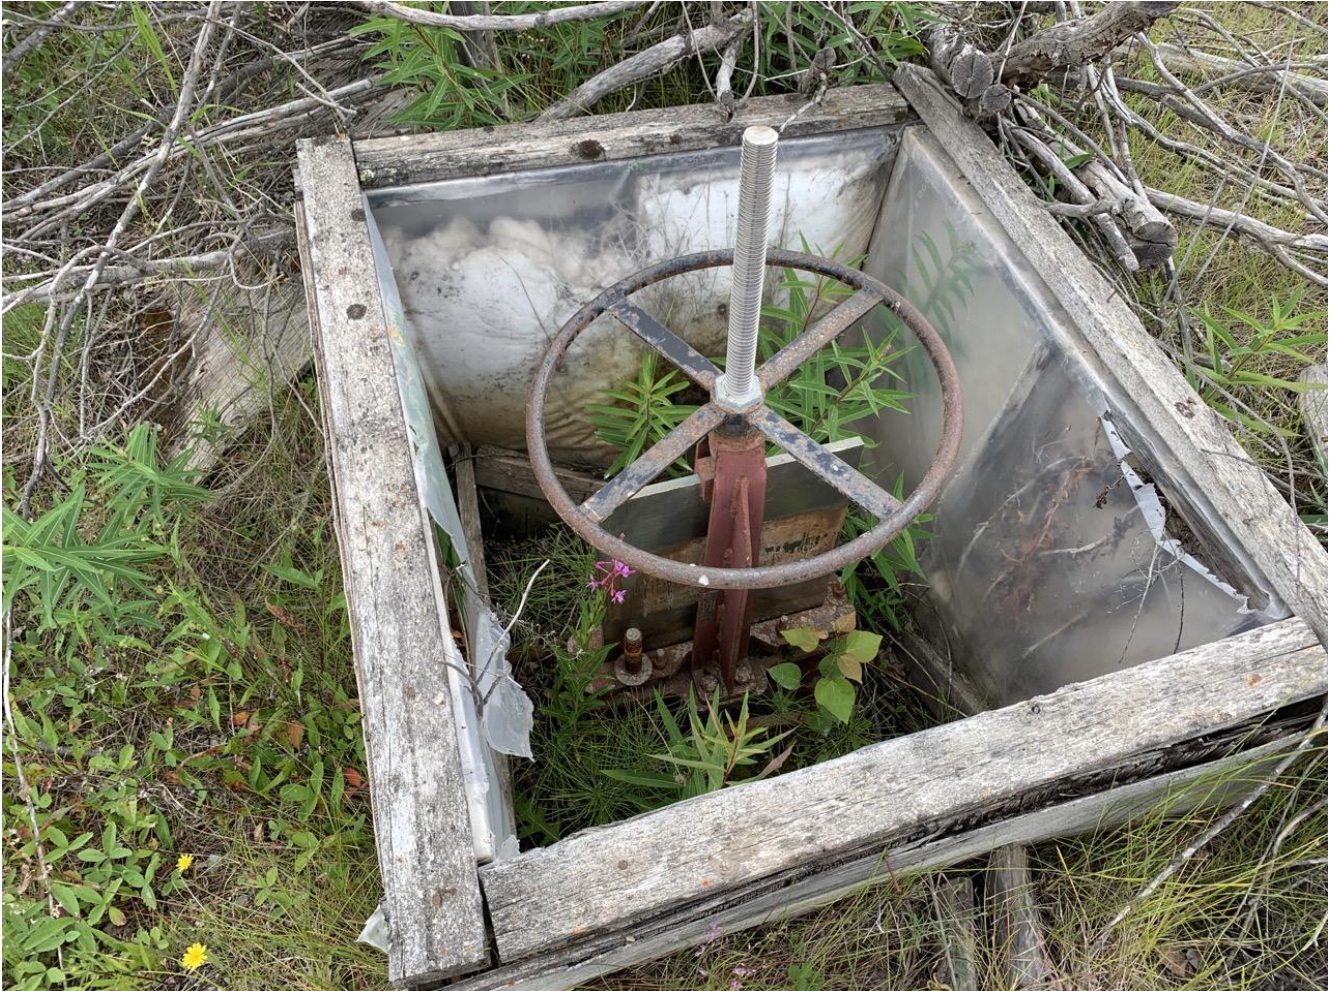
Photo I-C-11 Low-Level Outlet (LLO) valve can be hand operated to open and close (TRJ-2020-30)
