Teck Coal Limited - Elkview Operations

West Fork Tailings Facility and Lagoons A, B, C, and D

2021 Annual Facility Performance Report

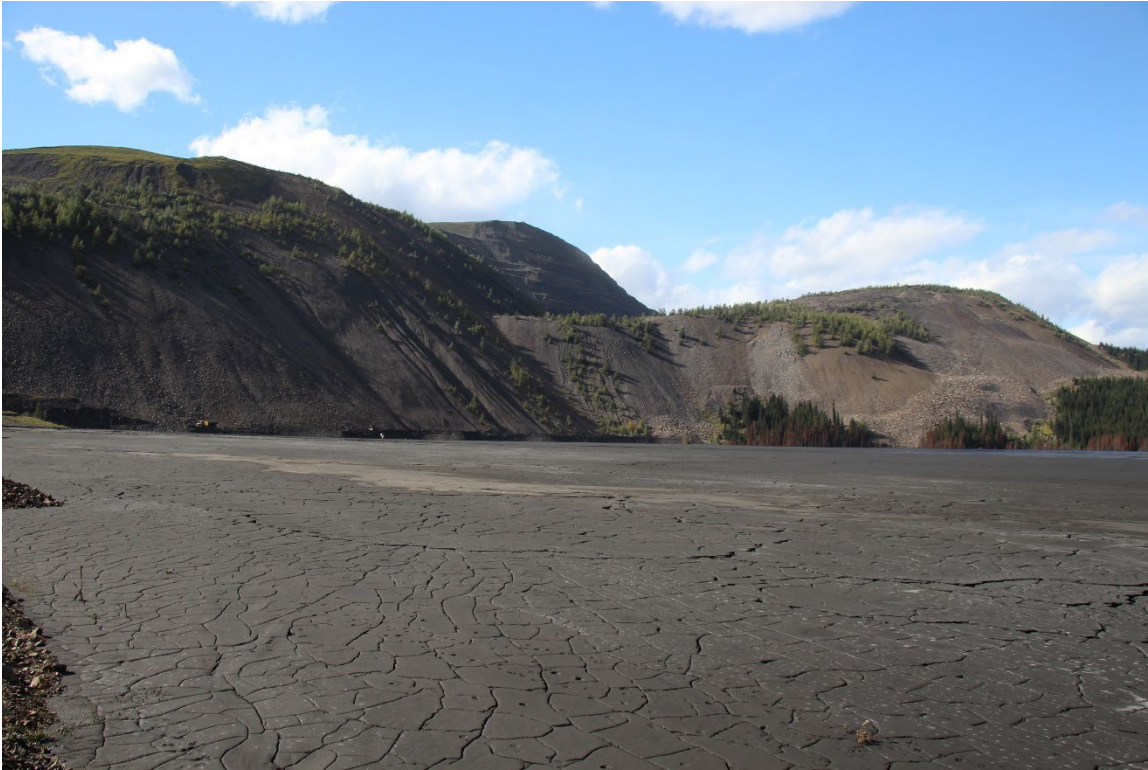
Photo IW-1 WFTF tailings beach overview. (Looking NW – Taken 15 September 2021)

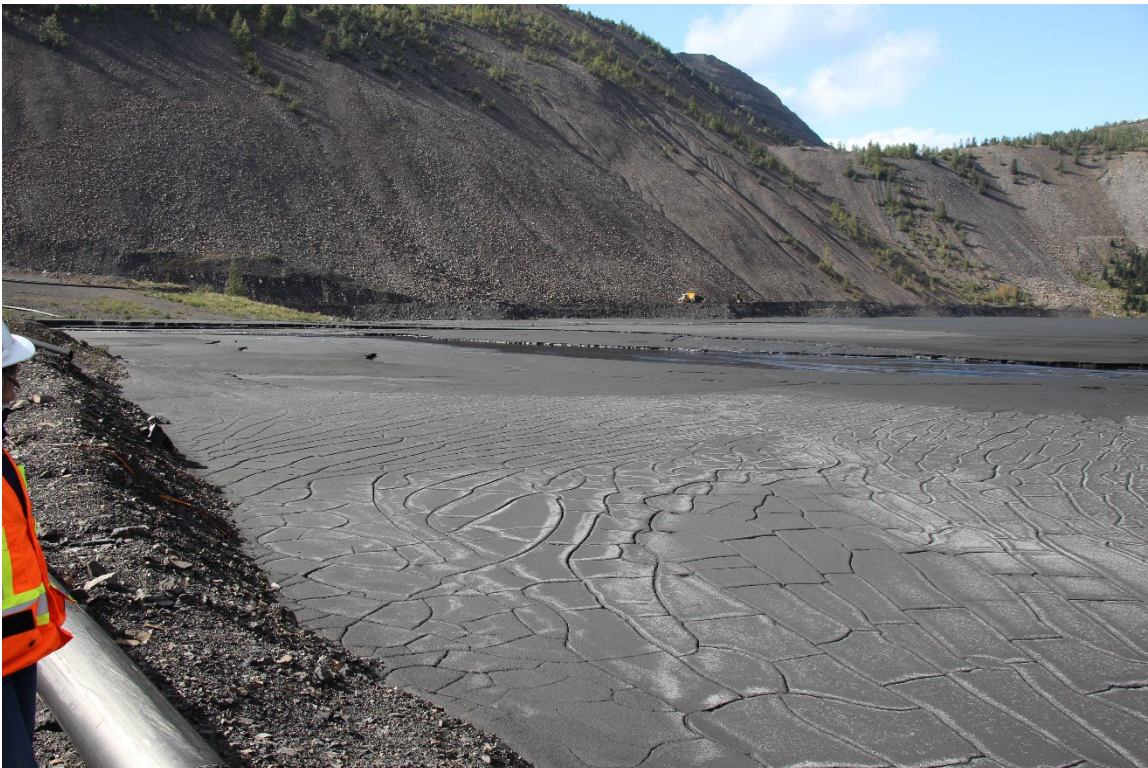
Photo IW-2 WFTF tailings beach. (Looking West – Taken 15 September 2021)

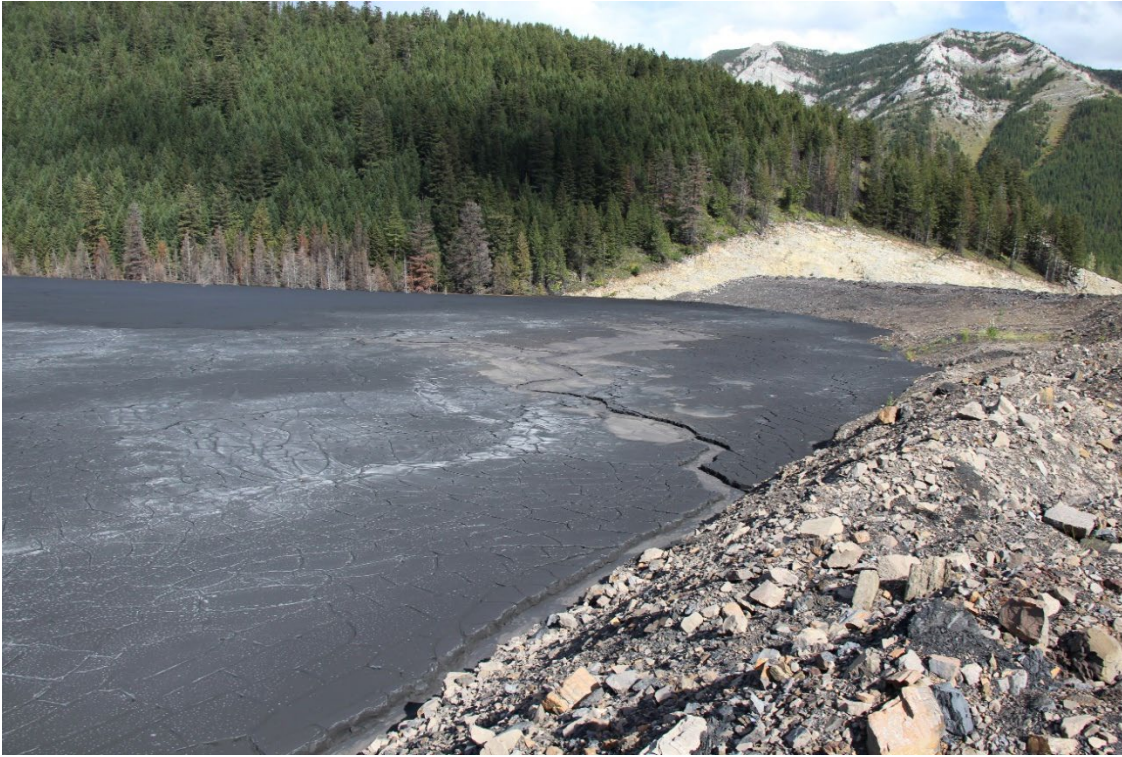
Photo IW-3 WFTF embankment. (Looking East – Taken 15 September 2021)

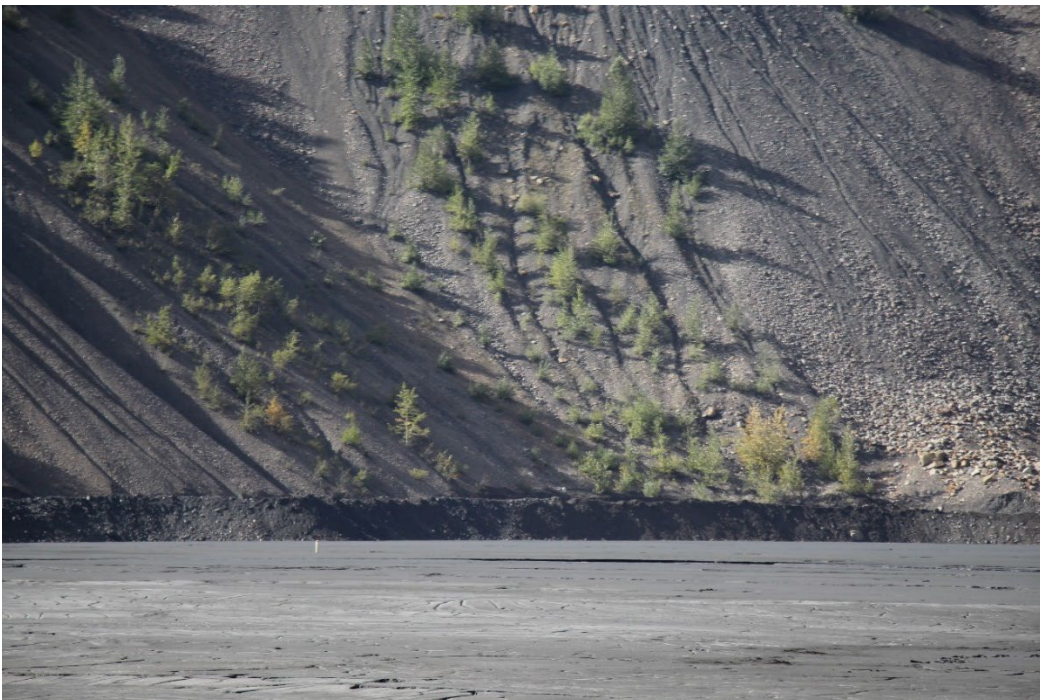
Photo IW-8 WFTF Adit Dump erosion above Adit Filter Berm. (looking west – Taken 15 September 2021)

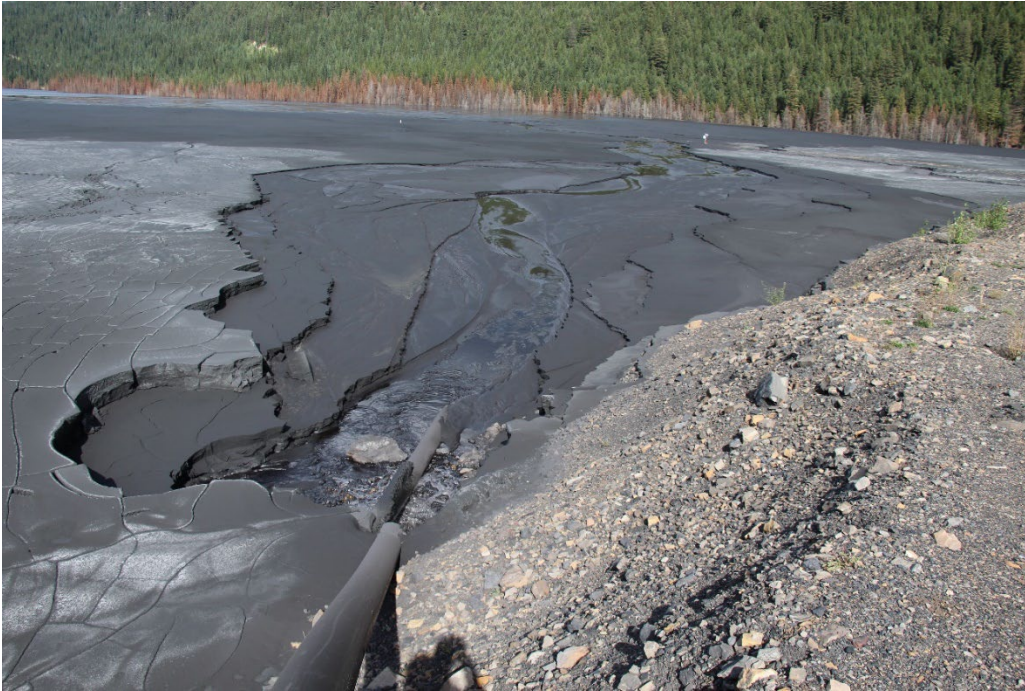
Photo IW-9 WFTF tailings beach and spigot. (Looking NE – Taken 15 September 2021)

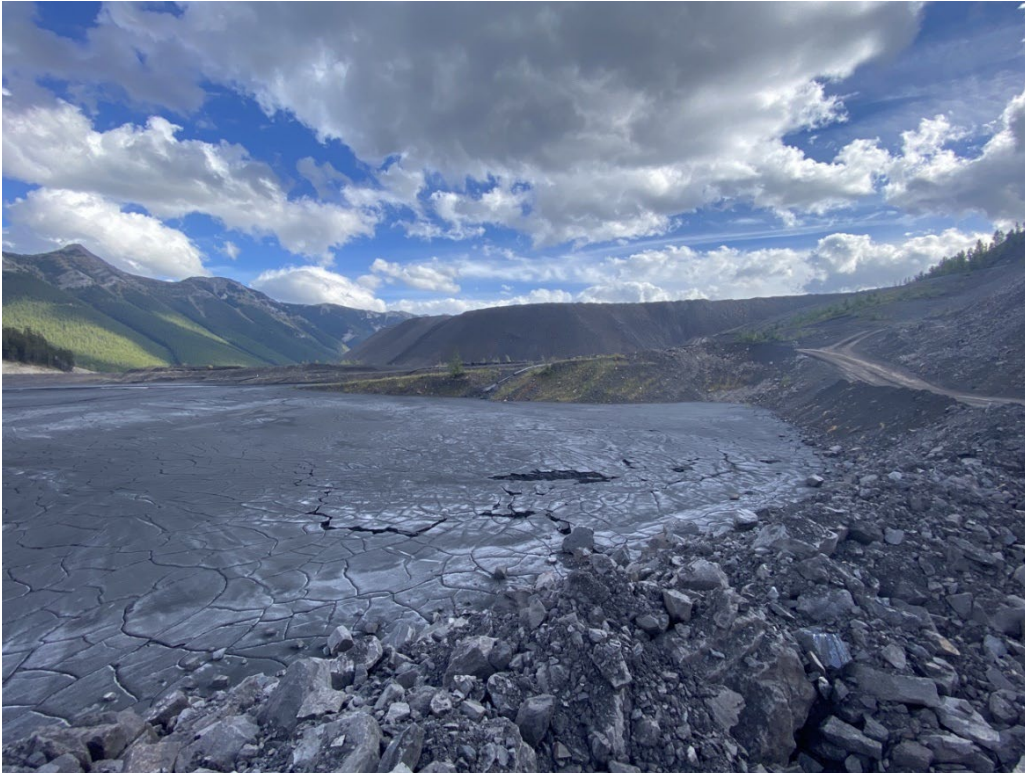
Photo IW-10 WFTF embankment at west abutment. (Looking South – Taken 15 September 2021)

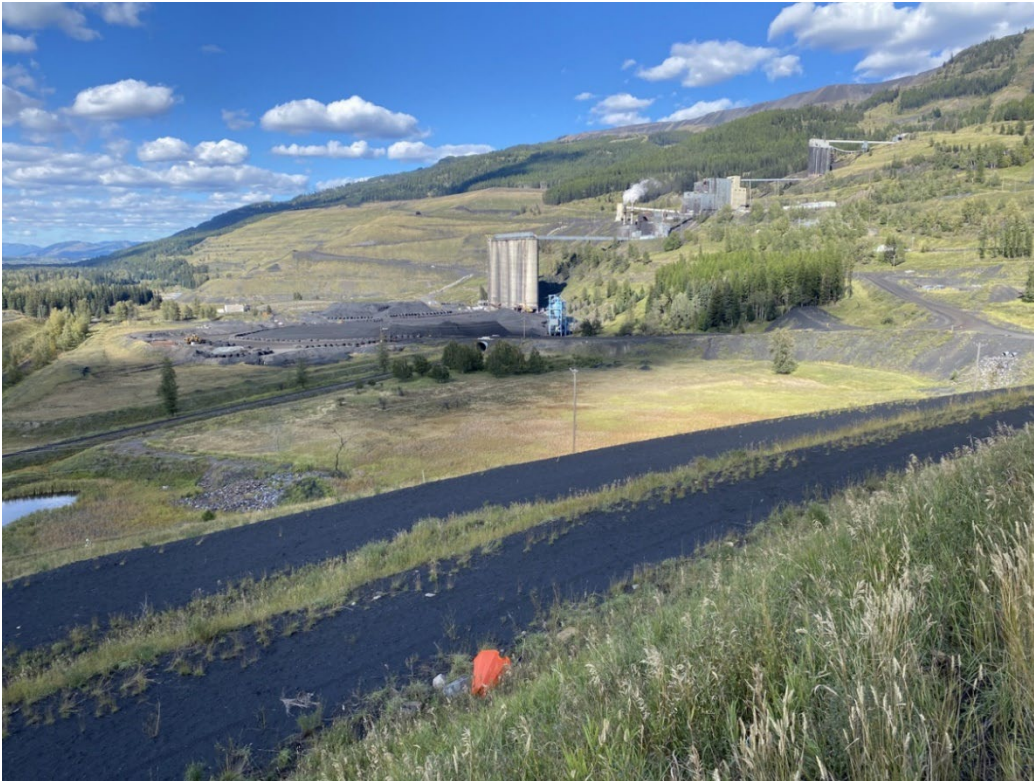
Photo IA-1 Lagoon A general conditions and overview. (from Lagoon D looking northeast – Taken 16 September 2021)

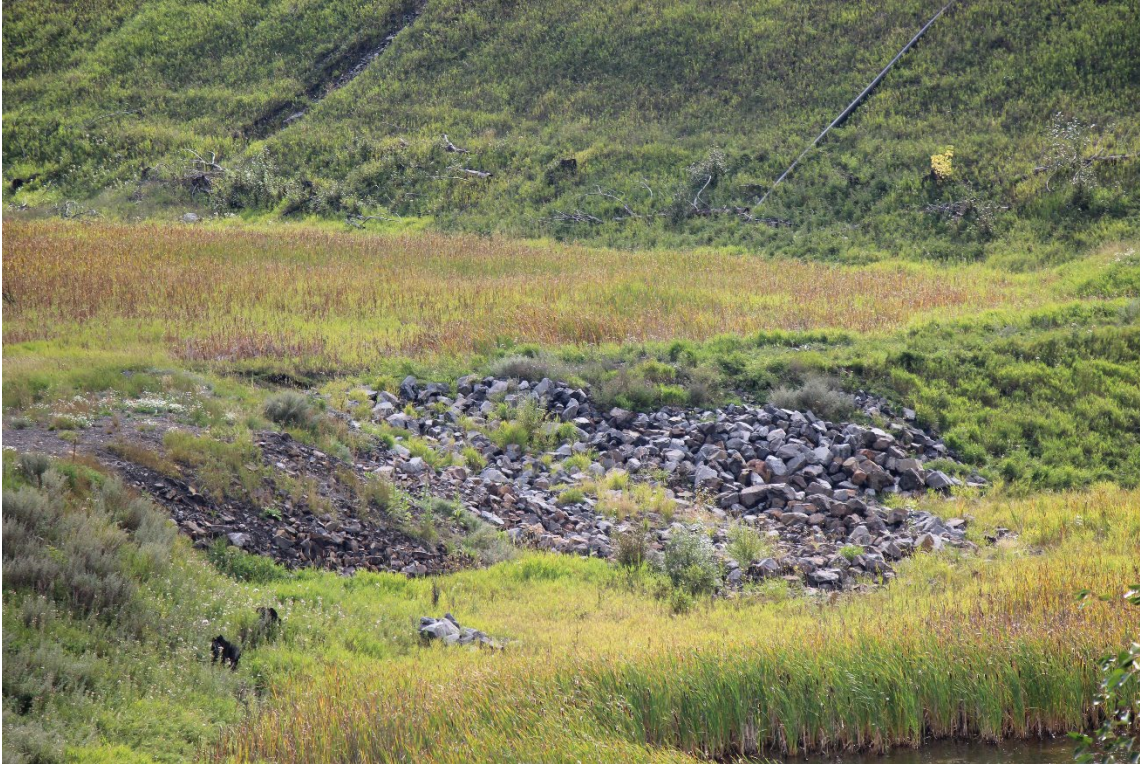
Photo IA-3 Lagoon A crest and spillway riprap. (Looking SE – Taken 15 September 2021)

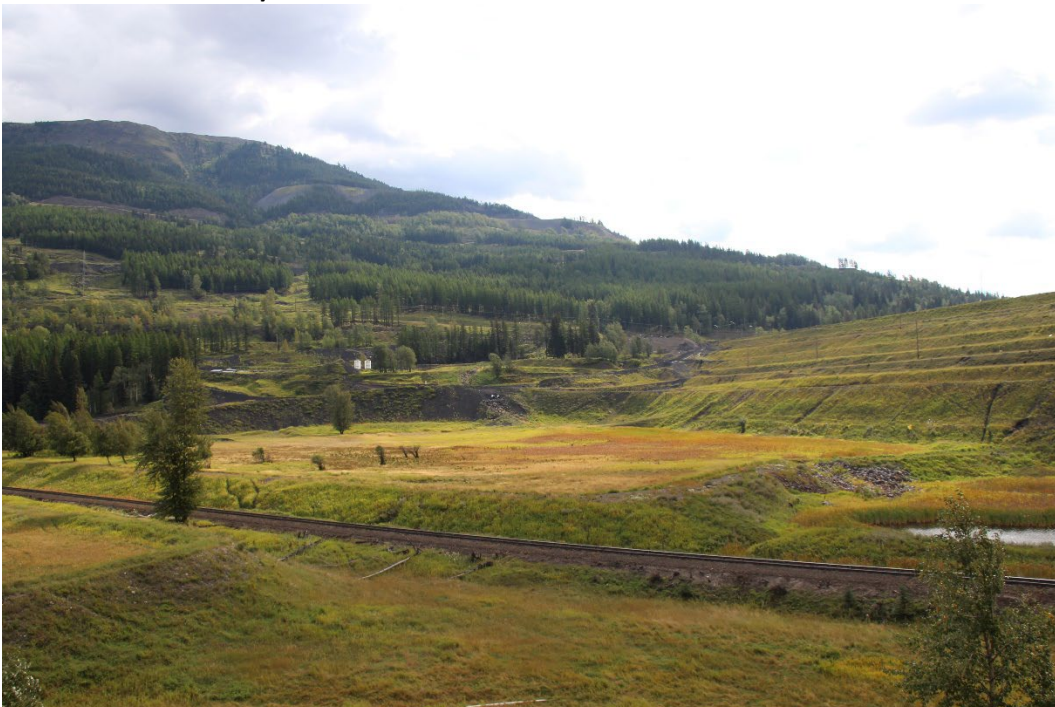
Photo IA-6 Lagoon A typical conditions. (Looking East from Lagoon C crest – Taken 15 September 2021)

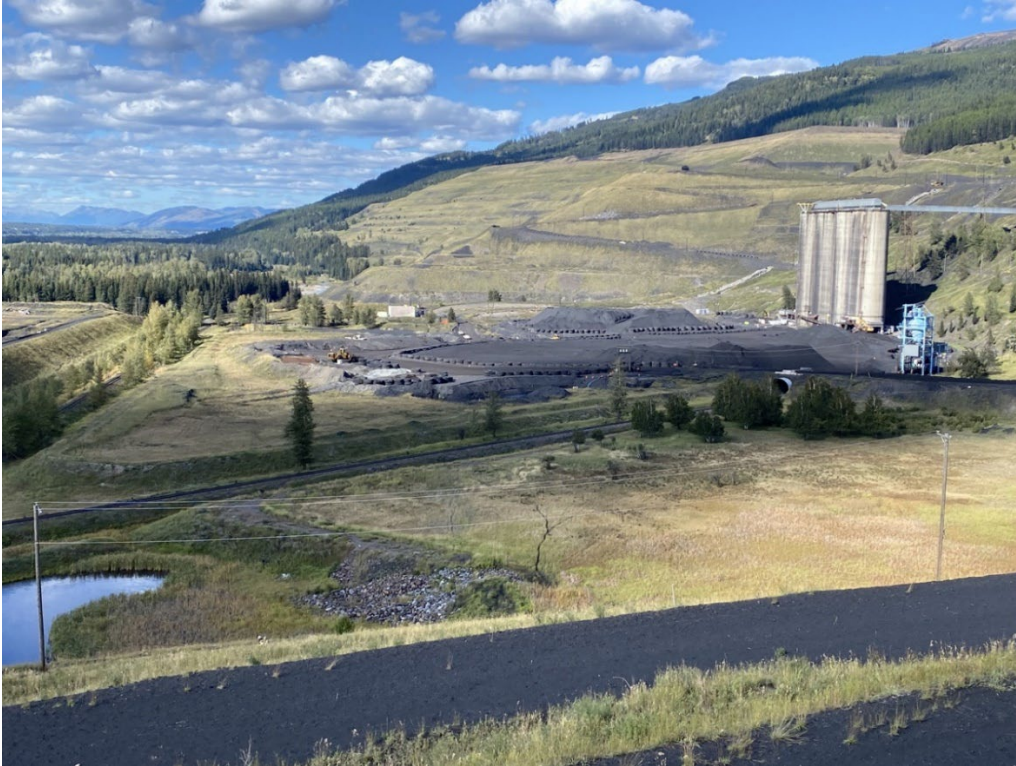
Photo IB-1 Lagoon B overview. (Looking North from Lagoon D crest – Taken 16 September 2021)

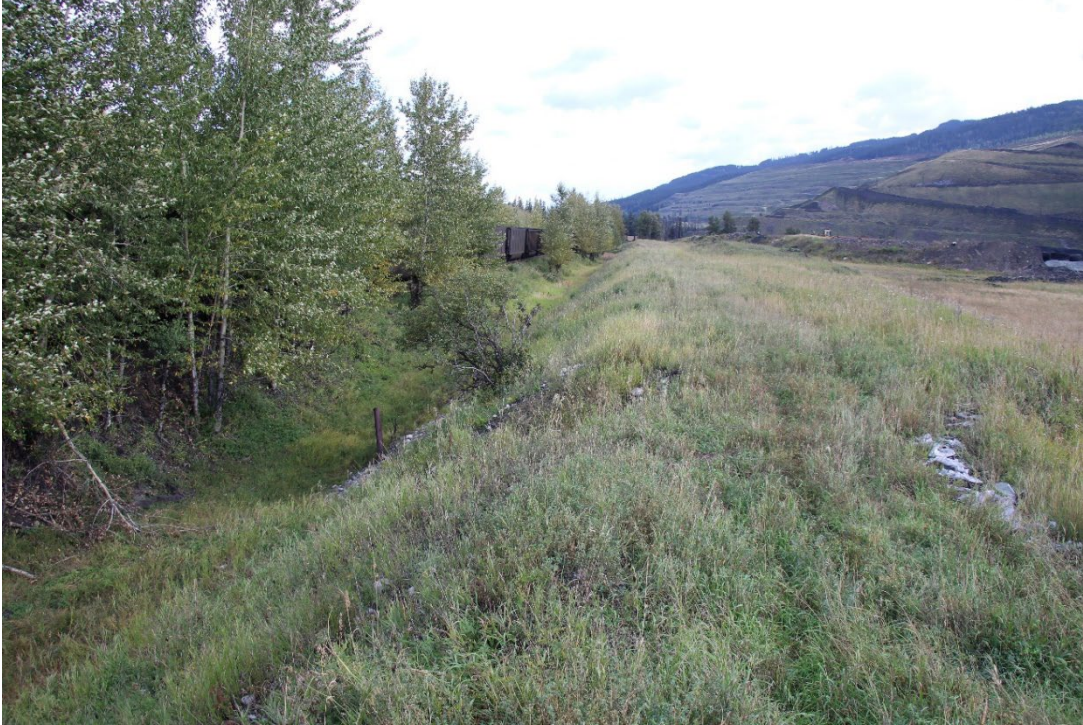
Photo IB-3 Lagoon B crest typical condition. (Looking North – Taken 15 September 2021)

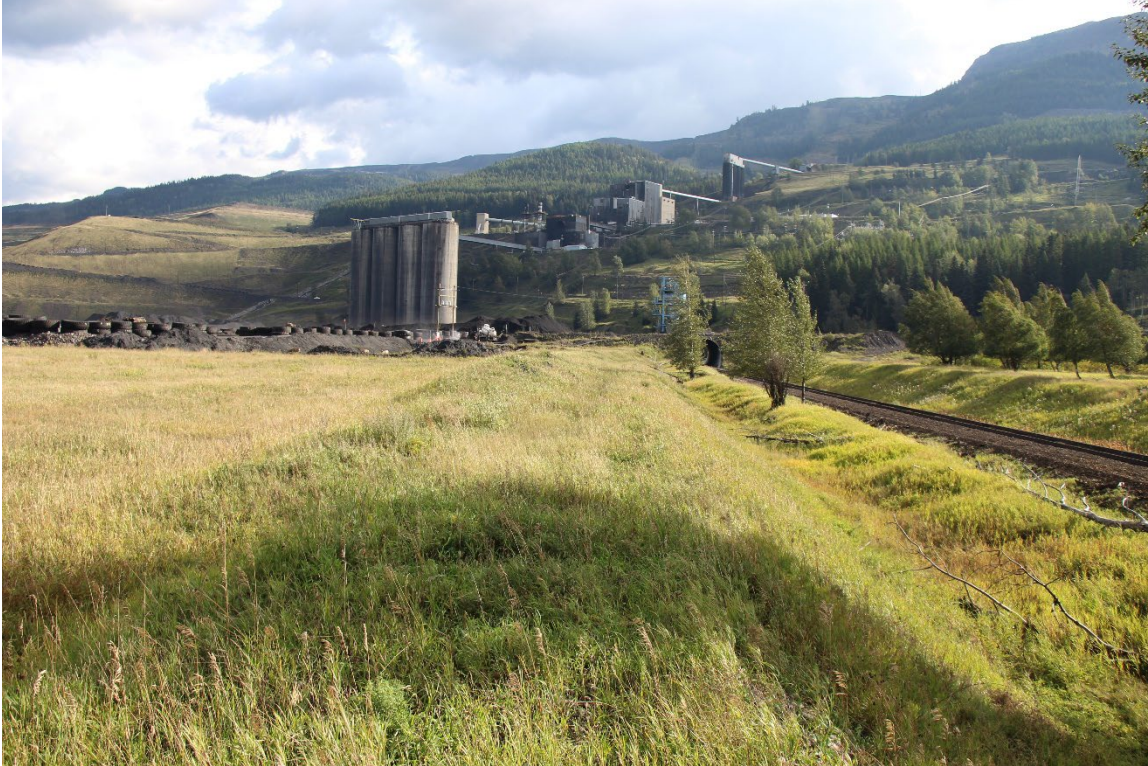
Photo IB-5 Lagoon B crest typical condition. (Looking NE – Taken 15 September 2021)

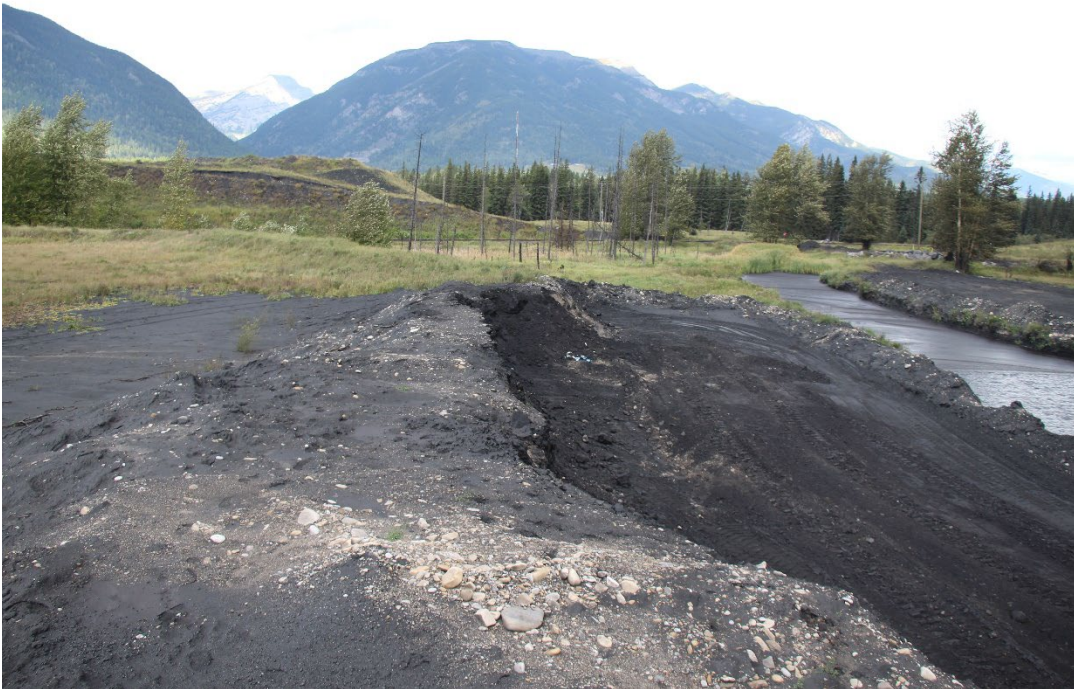
LB-3	A portion of the embankment on the northwest side of the facility was excavated by EVO personnel to make a turnaround area for the Goddard Pond hydrovac trucks. The edge of the excavation created an unsupported cut slope in exposed, unsaturated tailings, approximately 4 m high. The tailings slope did not appear to have deformed.	Yes (feature may have existed in 2020 as well)	Yes	IB-7, IB-8
Lagoon C				
LC-1	A local low spot on the crest near the trestle was observed, and survey confirms the low spot elevation is 1126.6 m.	No	Yes	IC-7

Photo IB-7 Lagoon B embankment excavation. (Looking West – Taken 15 September 2021)

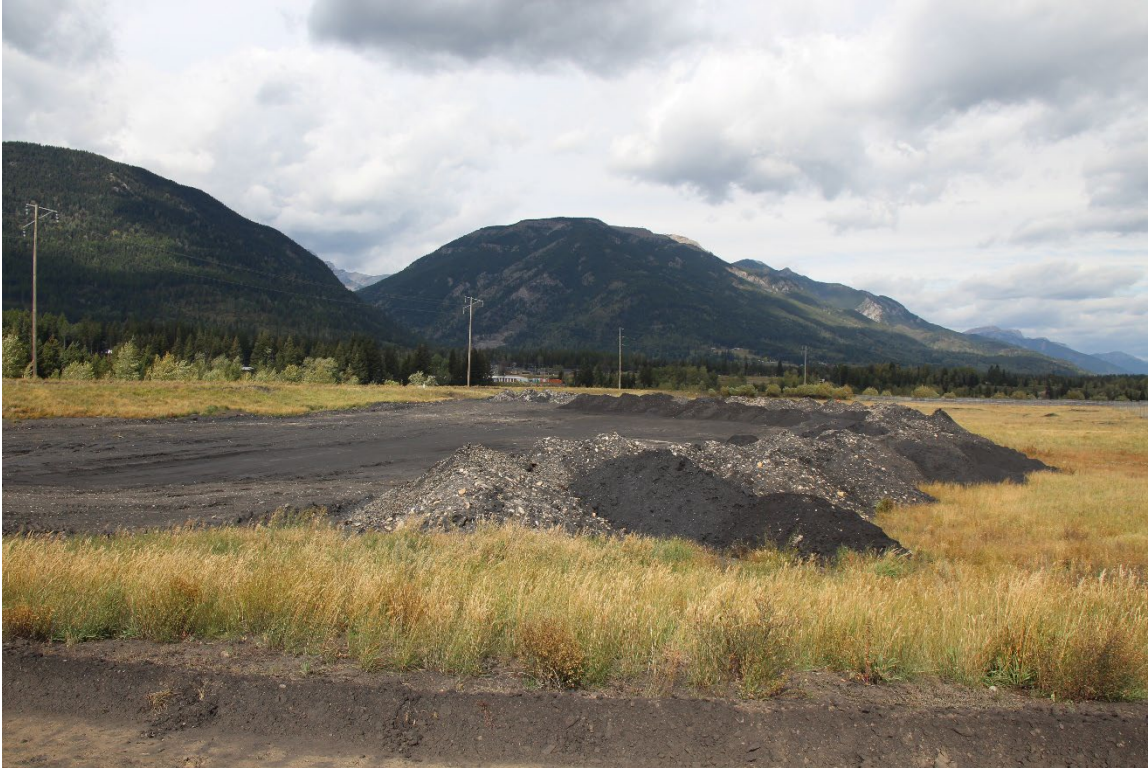
Photo IC-5 Lagoon C sediment placement. (Looking North – Taken 15 September 2021)

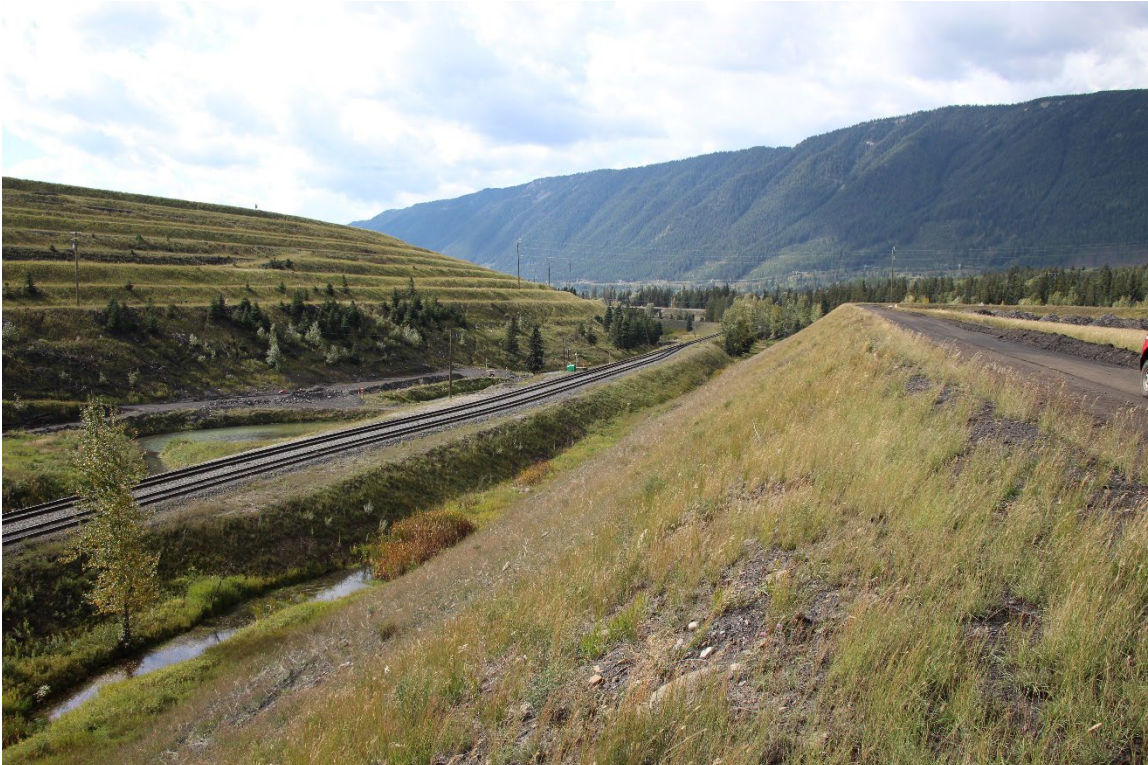
Photo IC-6 Lagoon C crest and downstream slope. (Looking SW – Taken 15 September 2021)

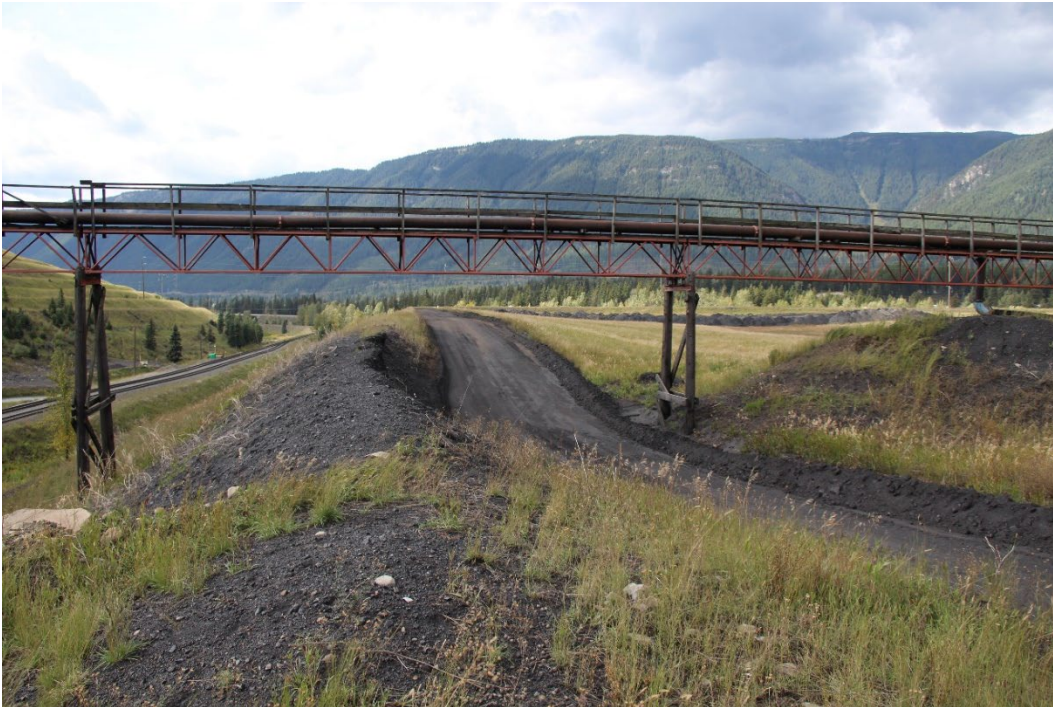
Lagoon C has sufficient capacity to store the 24-hr IDF, however due to the low spot in the crest at the trestle, it has less than the recommended freeboard during this event (KCB 2021c). Lagoon C would overtop at the low spot near the trestle during the 72-hour IDF. Ponded water infiltrates through the tailings to the natural ground.

Photo IC-7 Lagoon C crest low spot and trestle structure. (Looking SW – Taken 15 September 2021)

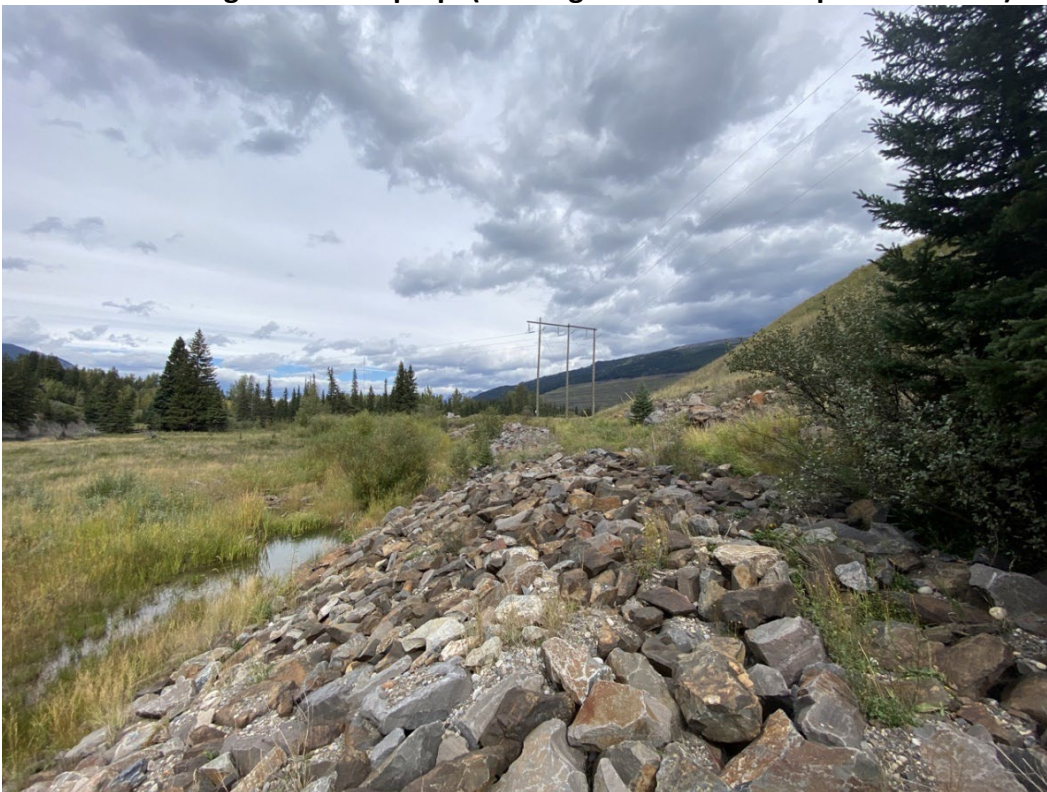
Photo IC-8 Lagoon C toe riprap. (Looking NE – Taken 15 September 2021)

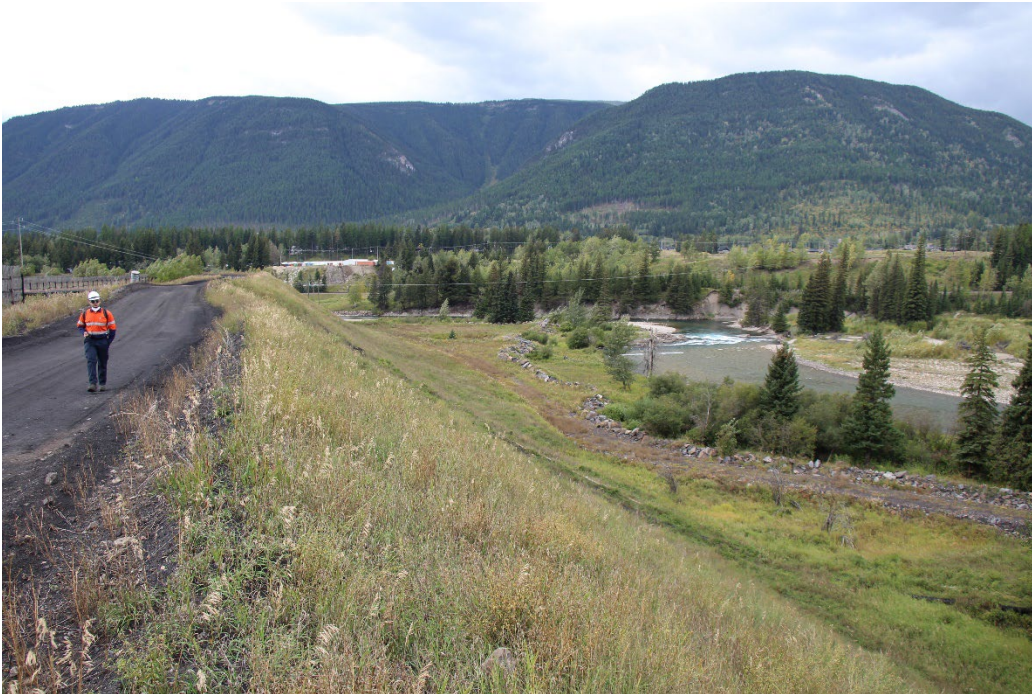
Photo IC-9 Lagoon C downstream slope and toe riprap. (Looking West – Taken 15 September 2021)

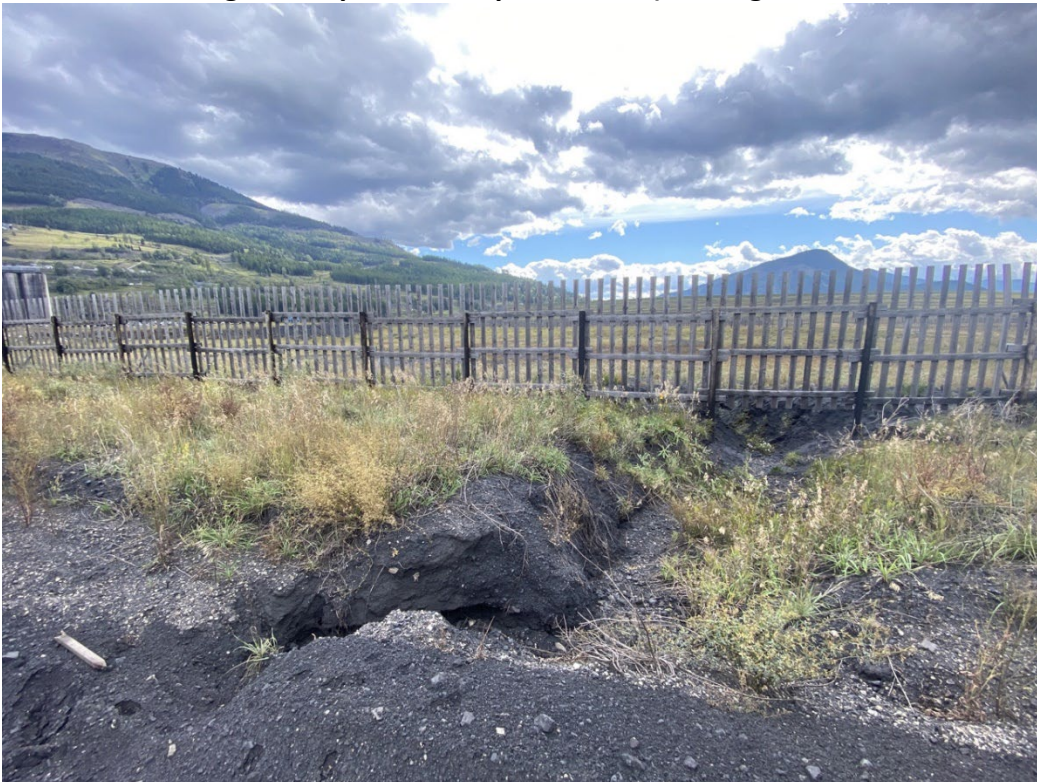
Photo IC-10 Lagoon C upstream slope erosion. (Looking South – Taken 15 September 2021)

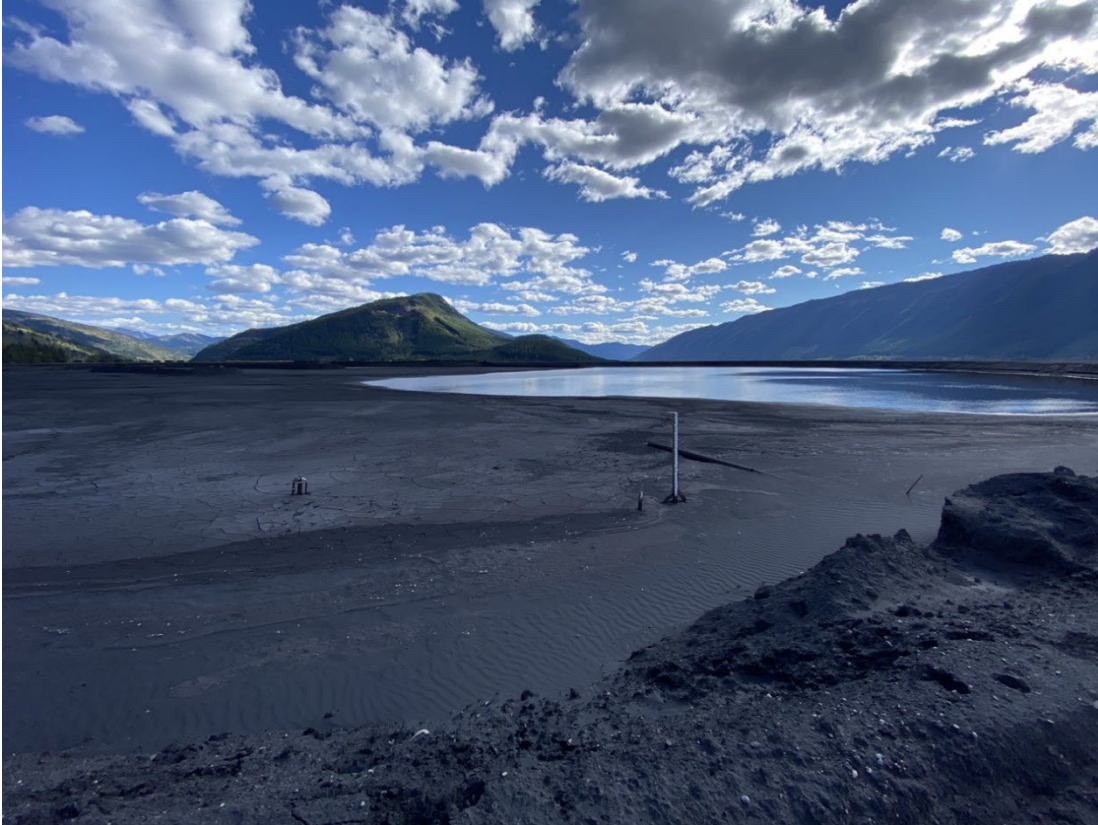
Photo ID-1 Lagoon D tailings beach. (Looking South – Taken 16 September 2021)

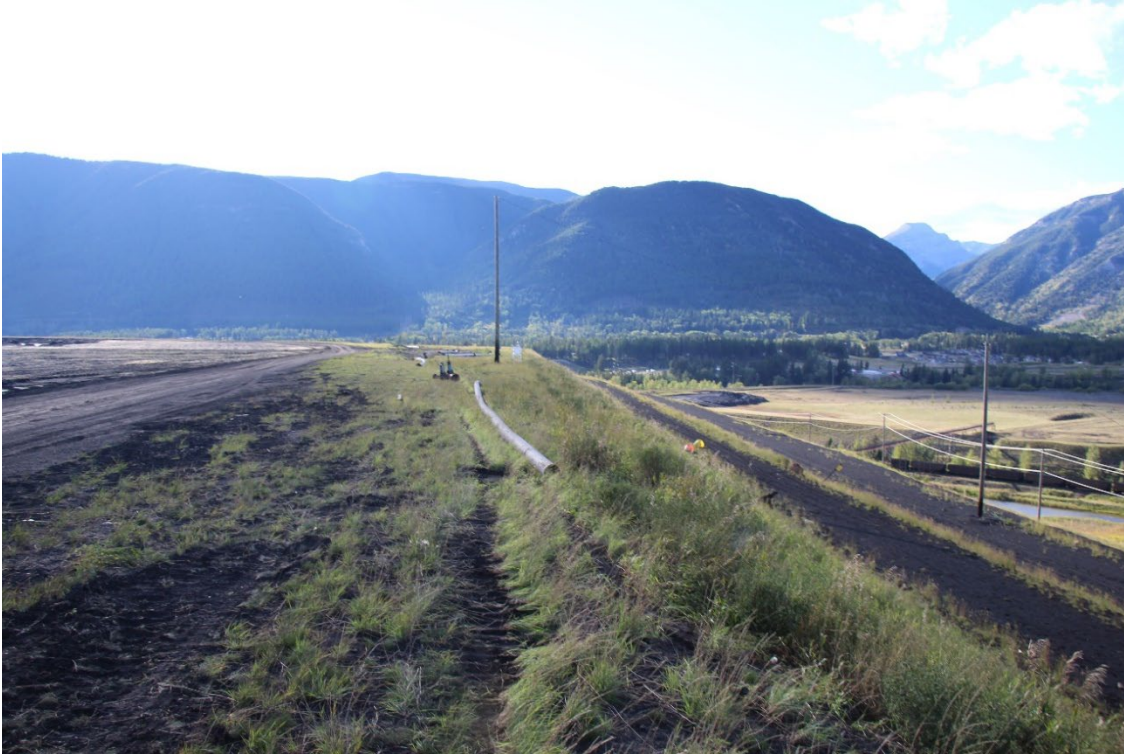
Photo ID-3 Lagoon D crest typical condition. (Looking West – Taken 16 September 2021)

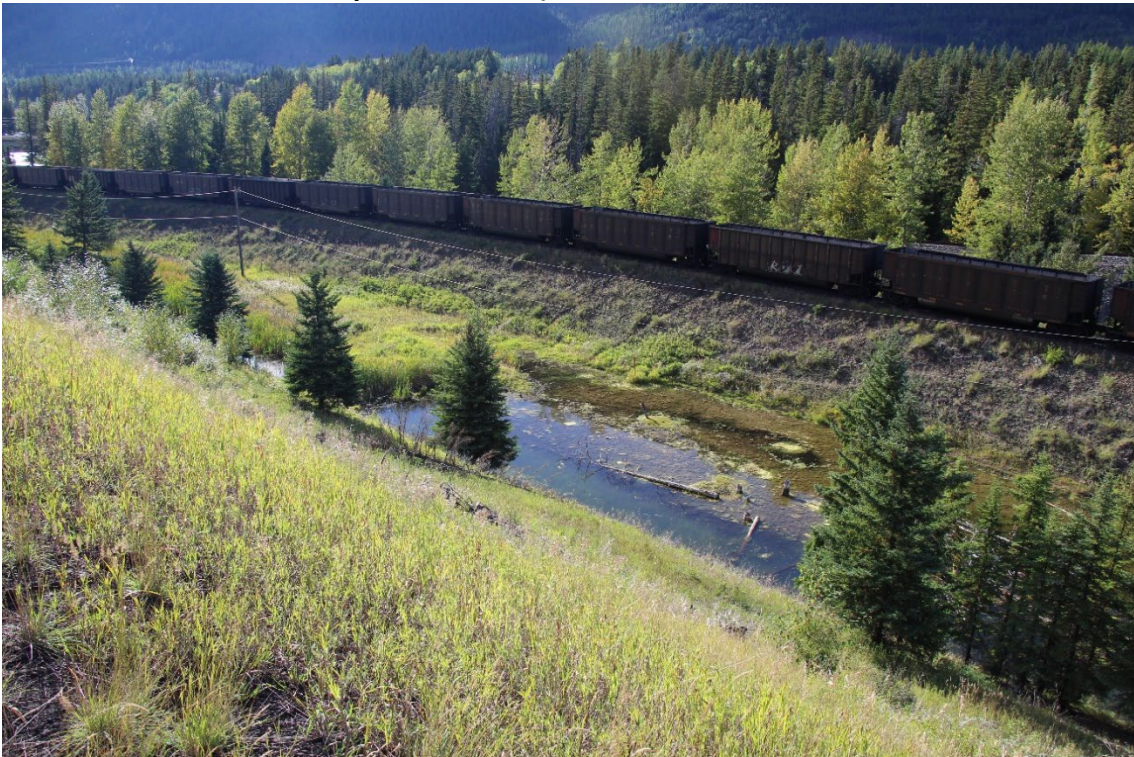
Photo ID-4 Lagoon D ponding at the toe (Otto Ponds) adjacent to the rail line. (Looking West – Taken 16 September 2021)

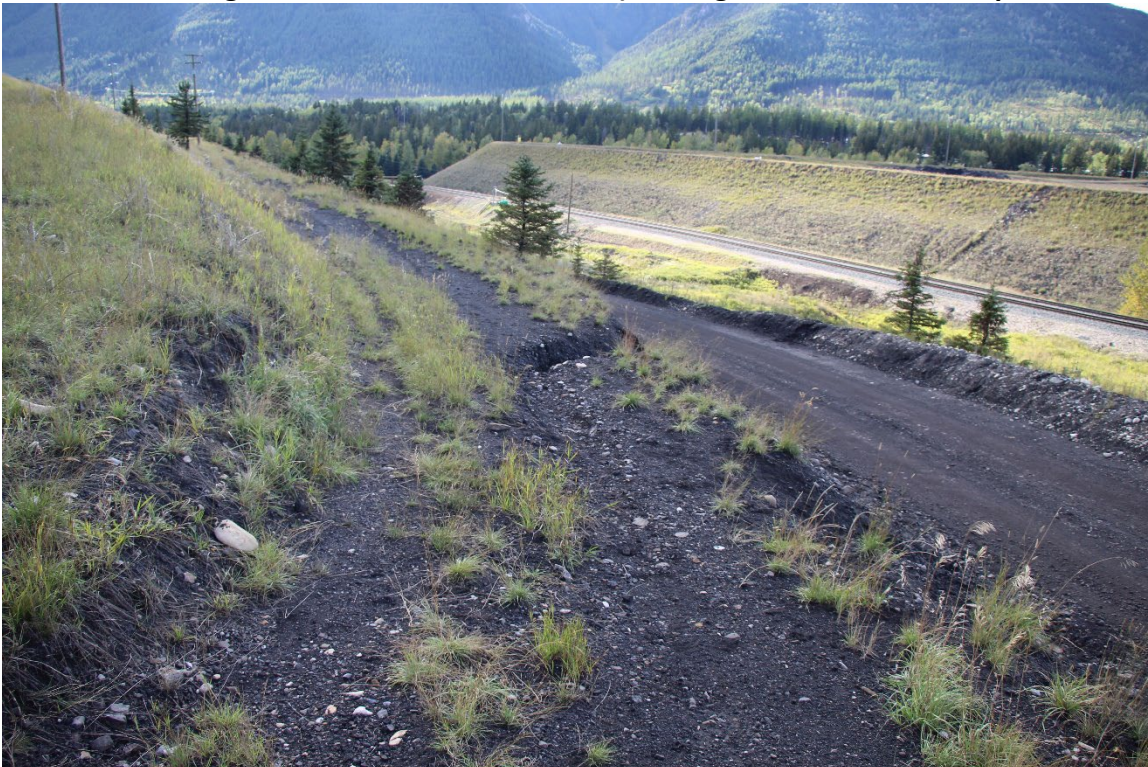
Photo ID-10 Lagoon D bench minor erosion. (Looking West – Taken 16 September 2021)

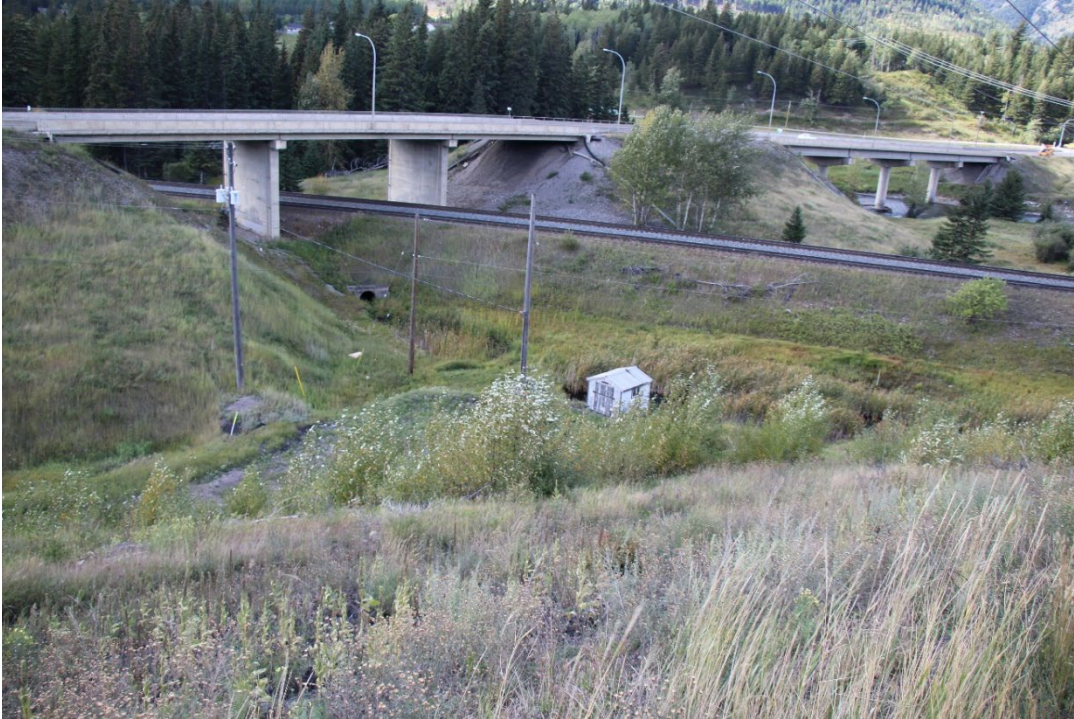
Photo ID-11 Lagoon D toe and pumphouse. (Looking West – Taken 16 September 2021)

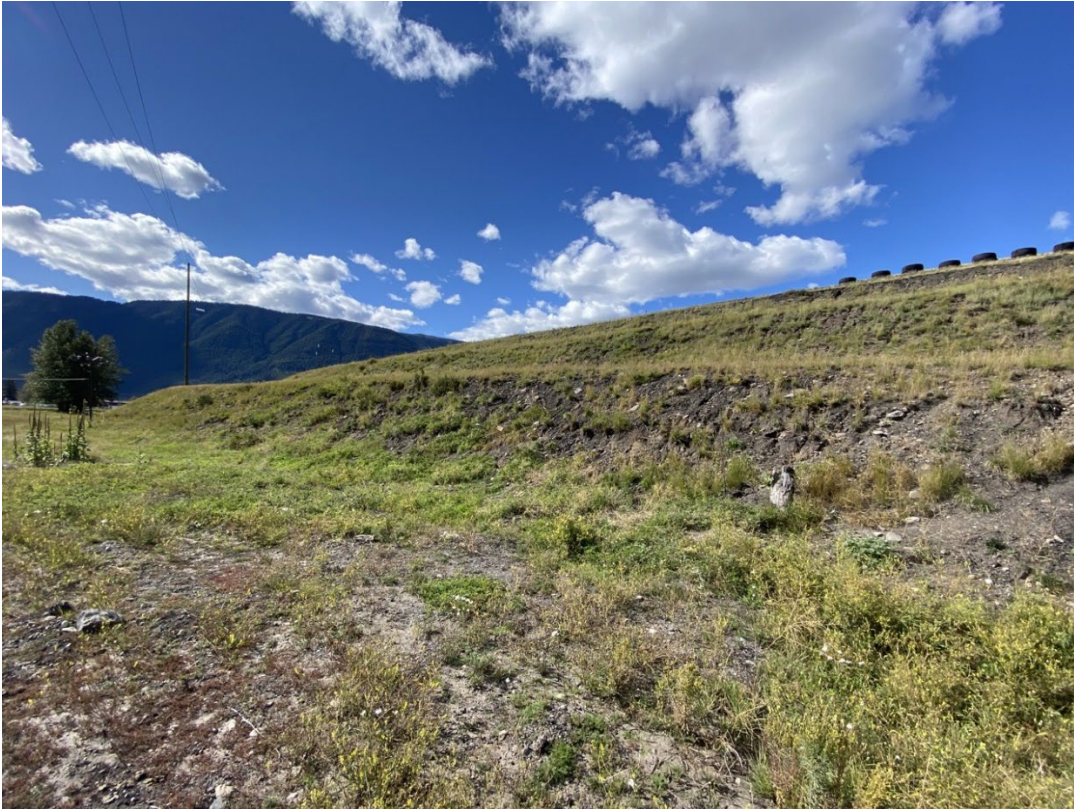
Photo ID-12 Lagoon D embankment. (Looking NW – Taken 16 September 2021)

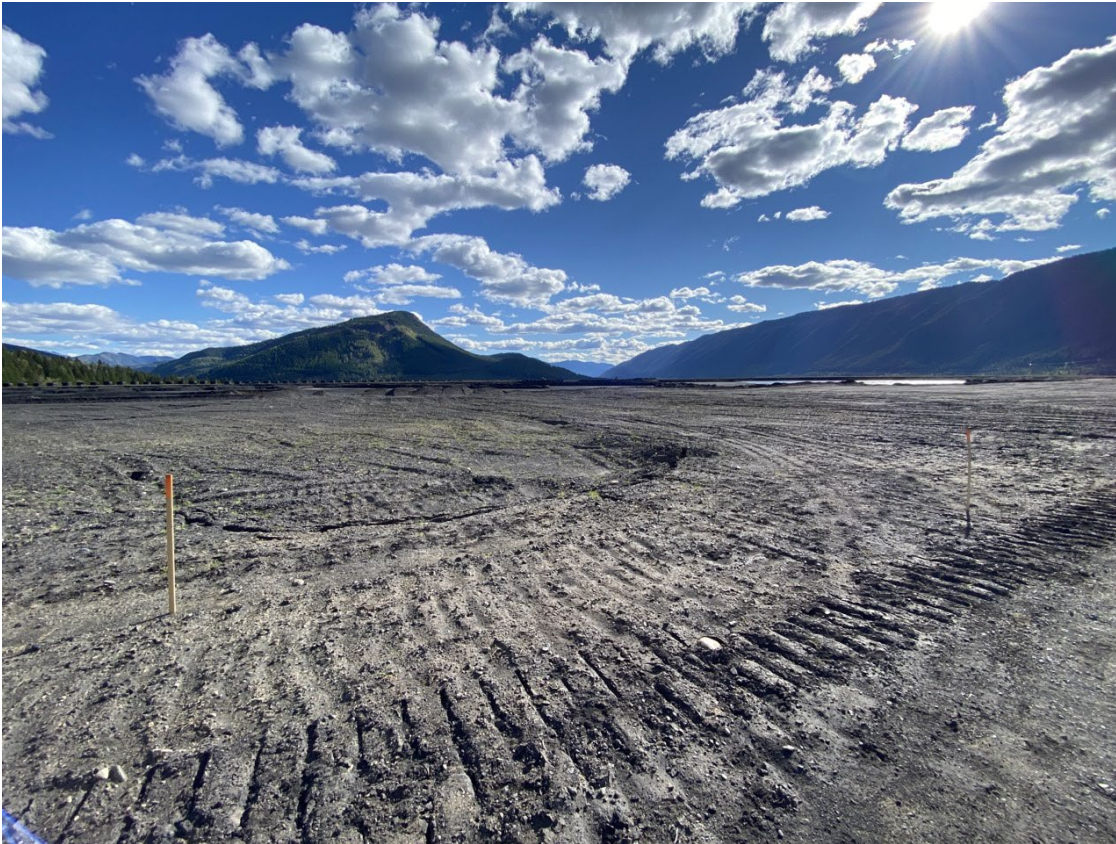
No.	Notable Observations	Change from 2020 AFPR?	Recommendation provided?	Photo Reference
LC-2	Erosion on the upstream side of the crest was observed at the north section of the Lagoon near the pumphouse. It is not expected that this erosion could propagate through the crest of the embankment and is therefore not an embankment safety concern.	No	No	IC-10
Lagoon D				
LD-1	Minor erosion of the downstream slope was observed at several locations around Lagoon D.	No	No	ID-10
LD-2	Minor subsidence was observed at the surface of the backfilled northern tailings cells.	Yes	No	ID-13

Photo ID-13 Lagoon D minor subsidence of backfilled north tailings cell. (Looking SW – Taken 16 September 2021)
