2021 Annual Facility Performance Report for South Tailings Pond and North Tailings Pond

Teck Coal Limited, Fording River Operations

Golder Associates Ltd.

25 March 2022

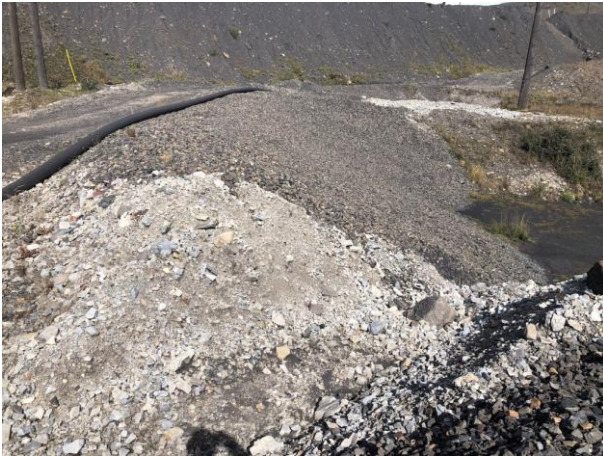
Photo 1: Looking upstream along alignment of NTP riprap that is buried (approx. Sta. 0+125)

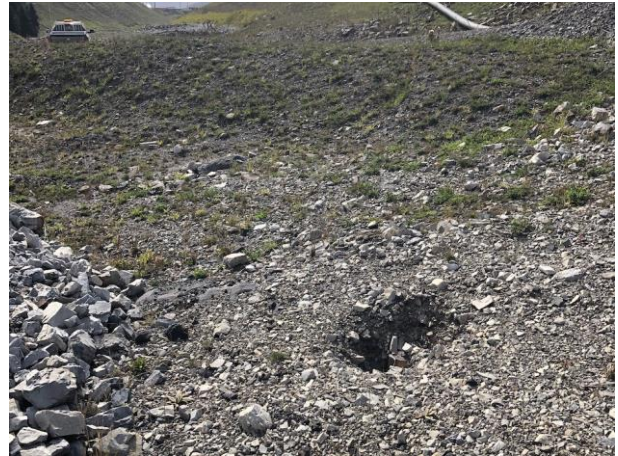
Photo 2: Small sinkhole about 0.9 by 0.6 m at approx. Sta. 0+140. This is along the alignment of the buried setback riprap

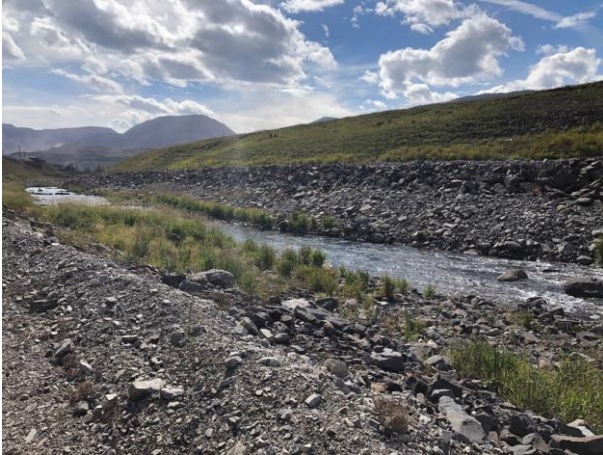
**Photo 5: Looking downstream at NTP riprap
(from approx. Sta. 0+350)**

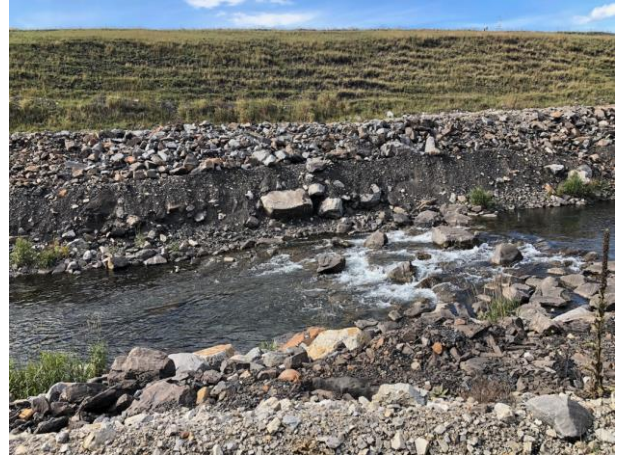
**Photo 6: Looking at erosion of the gravel material
placed on top of the riprap at one of the riffle
crest bank tie-ins on the NTP (approx. Sta. 0+550)**

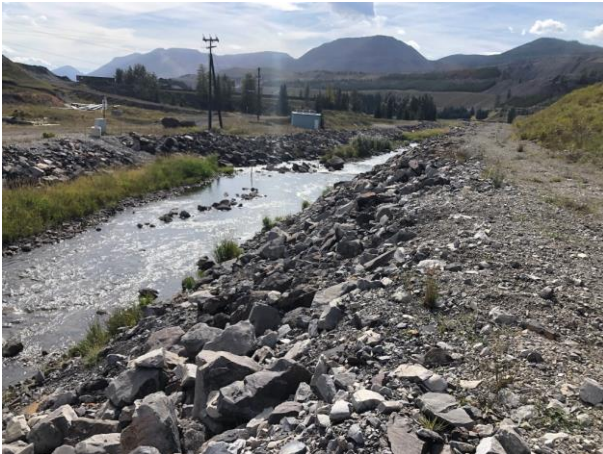
**Photo 7: Looking downstream at NTP riprap
(from approx. Sta. 0+705)**

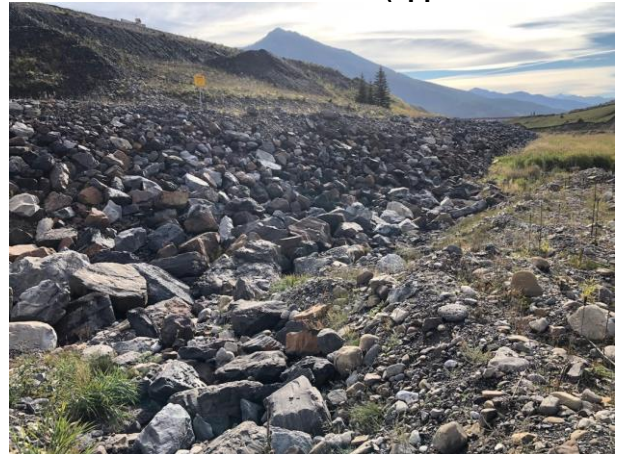
**Photo 8: Looking downstream at STP riprap that
is over-steepened (1.5H:1V) (from approx.
Sta. 0+270)**

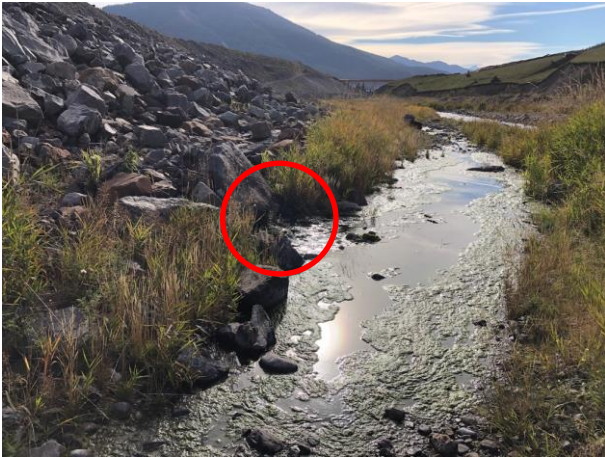
Photo 9: Looking downstream at STP riprap and where water is flowing out of riprap apron (approx. Sta. 0+365)

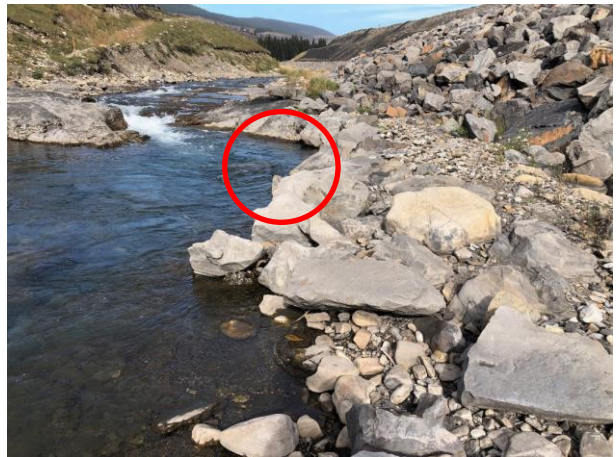
Photo 12: Erosion along the toe apron of the STP riprap at Sta. 0+670

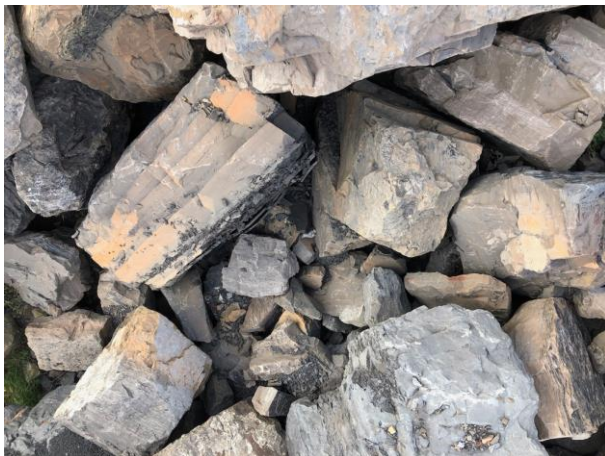
Photo 14: Weathering riprap at the emergency riprap stockpile

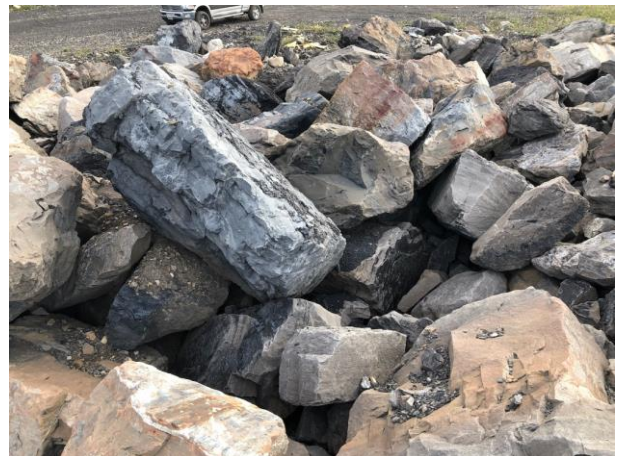
Photo 15: Riprap at emergency riprap stockpile
