Teck Resources Limited

Quintette Coal Operations

2021 Annual Facility Performance Review

Plantsite Tailings Storage Facility and Plantsite Seepage Collection Pond Dam

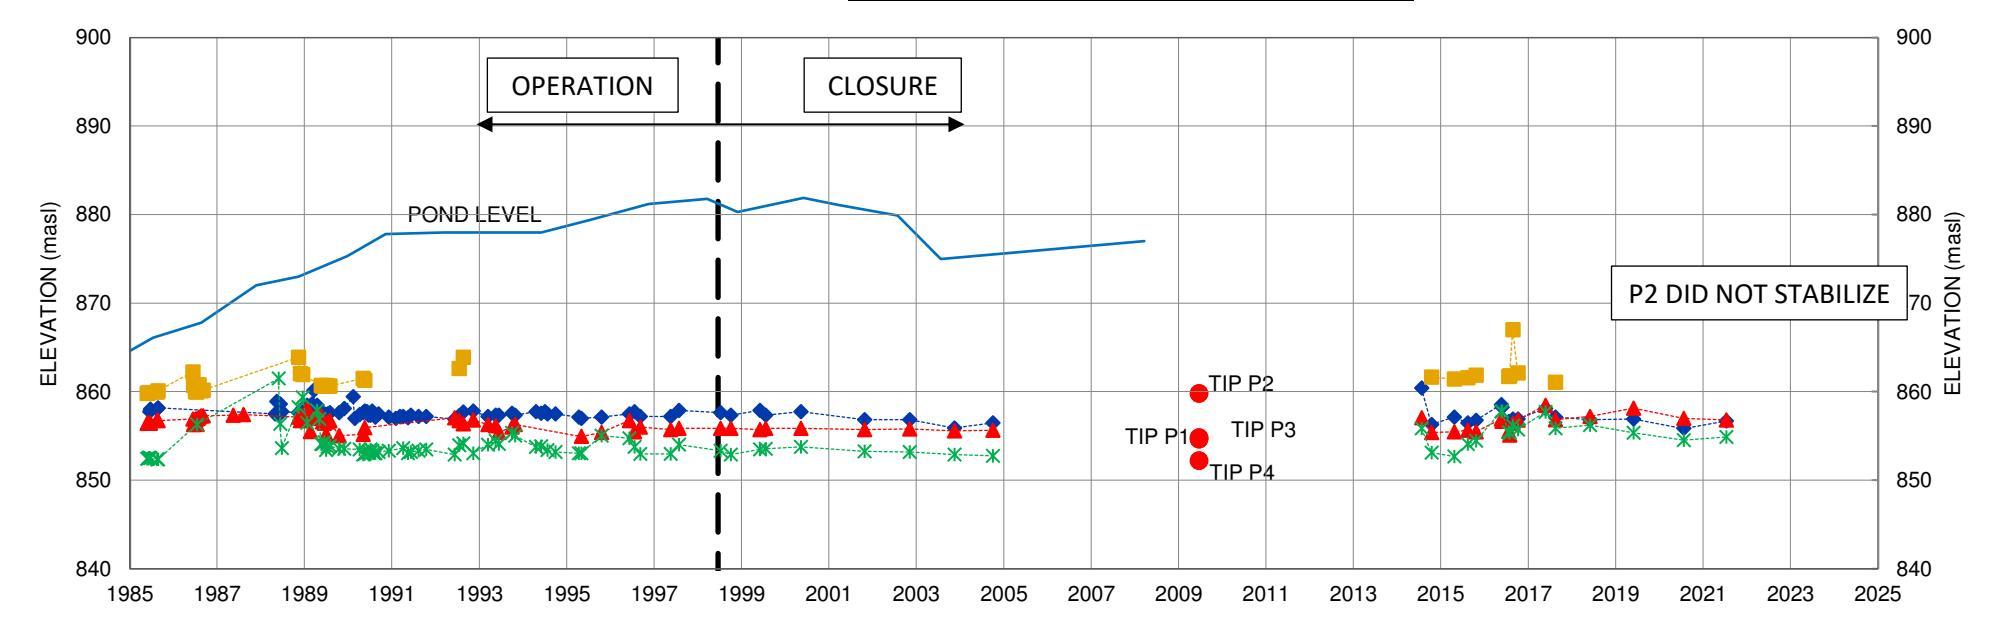
STATION		PIEZOMETER TYPE	TIP ELEVATION (masl)		PIEZOMETRIC LEVELS	
	DATE		PIEZOMETER F ID.			PRESSURE READING (psi)	HEAD (m)	ELEVATION (masl)
		0+300	P1	PNEUMATIC	854.8	2.7	1.9	856.7
	2021 07 12		P2	PNEUMATIC	859.8	SEE NOTE 5	-	-
	2021-07-13		P3	PNEUMATIC	854.6	3.1	2.2	856.8
			P4	PNEUMATIC	852.2	3.8	2.7	854.9

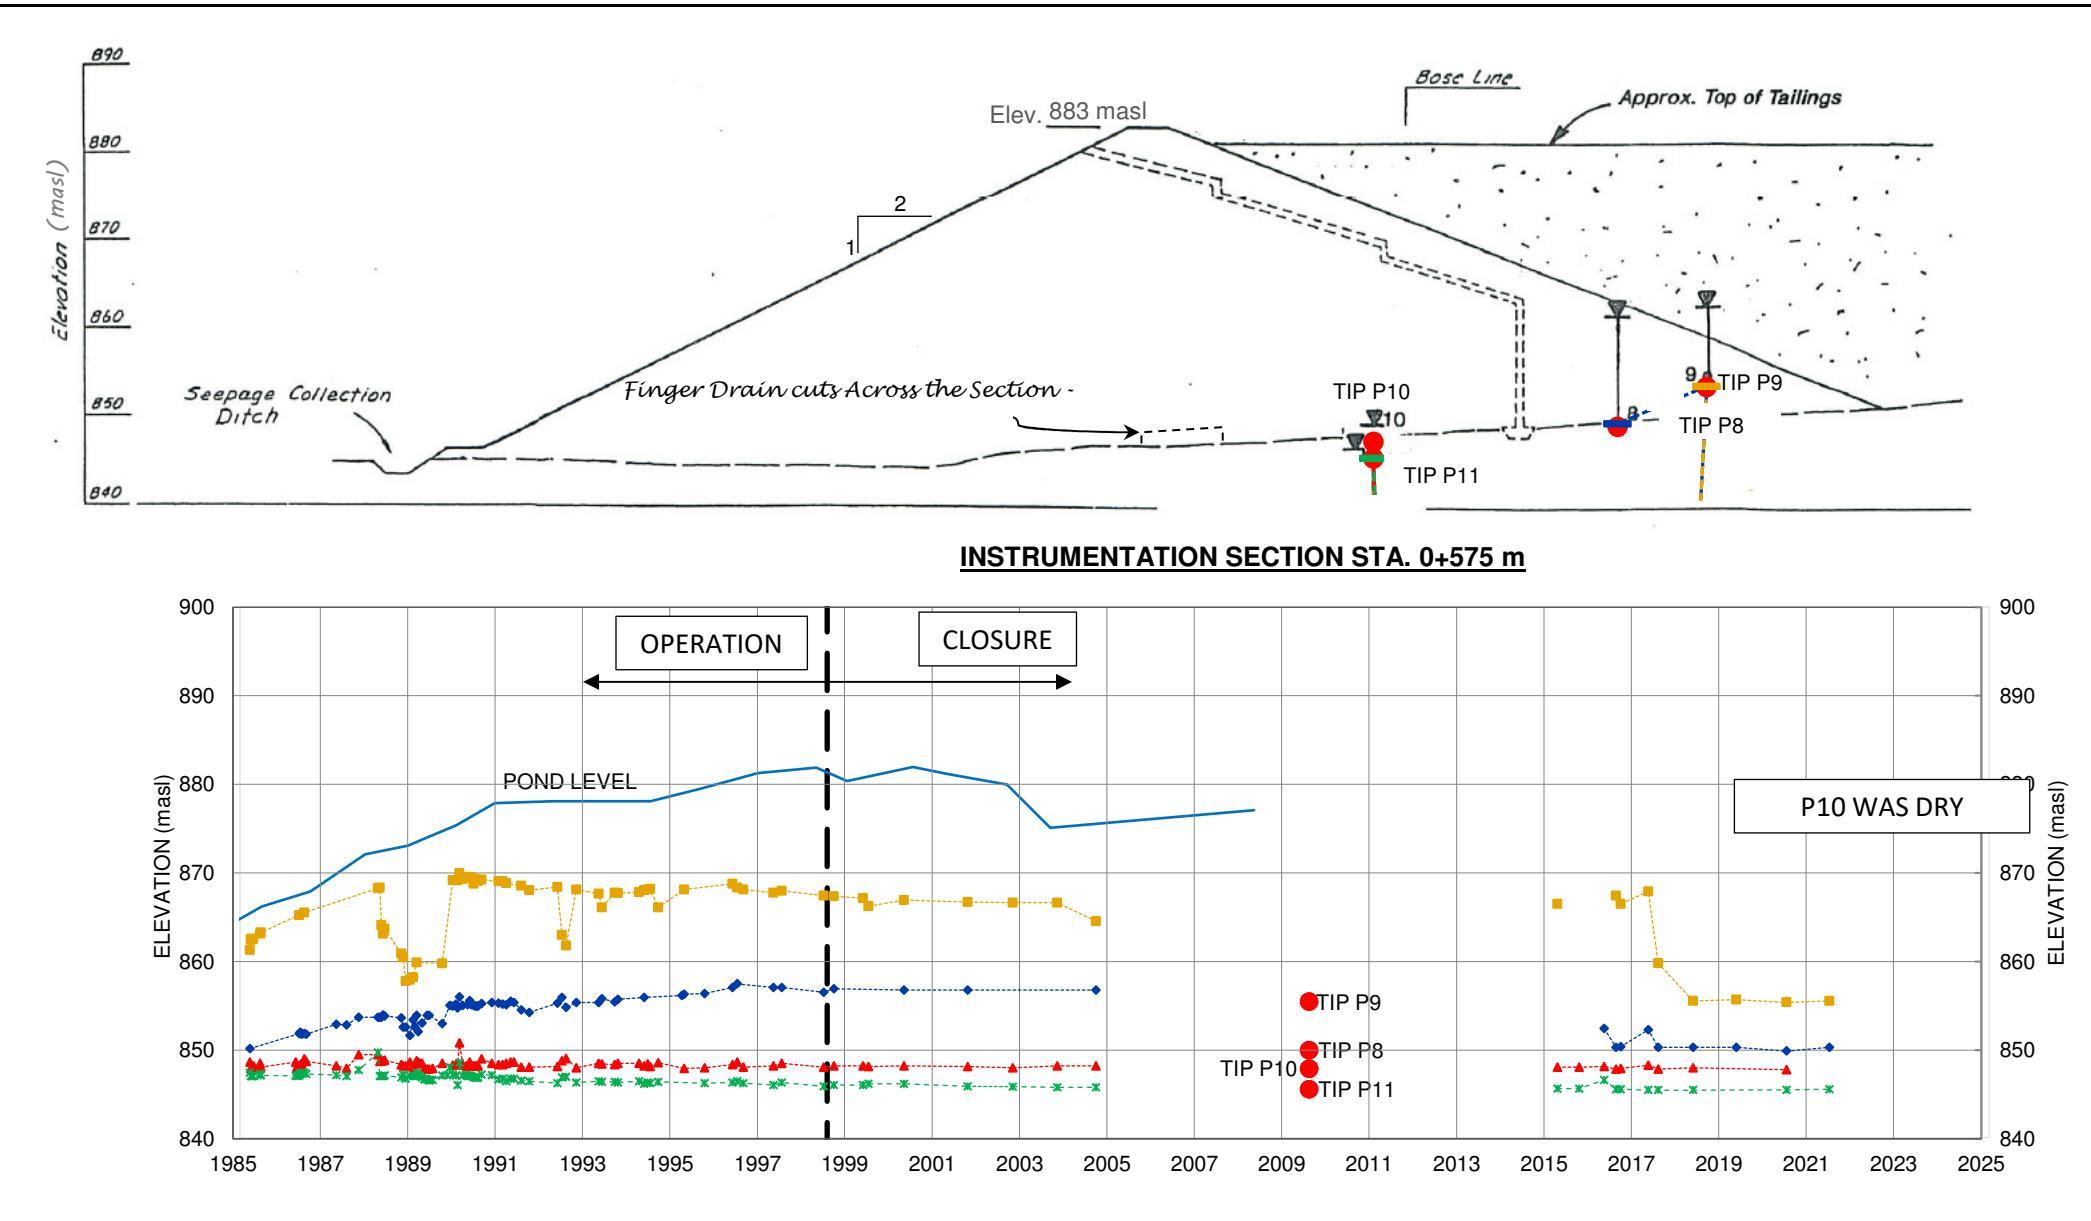
DATE	STATION	PIEZOMETER ID.	PIEZOMETER TYPE	TIP ELEVATION (masl)	PRESSURE READING (psi)	PIEZOMETRIC LEVELS	
							HEAD (m)	ELEVATION (masl)
		0+575	P8	PNEUMATIC	849.9	0.6	0.4	850.3
	2021 07 12		P9	PNEUMATIC	855.4	0.2	0.1	855.5
	2021-07-13		P10	PNEUMATIC	847.8	DRY	DRY	
			P11	PNEUMATIC	845.5	0.1	0.1	845.6

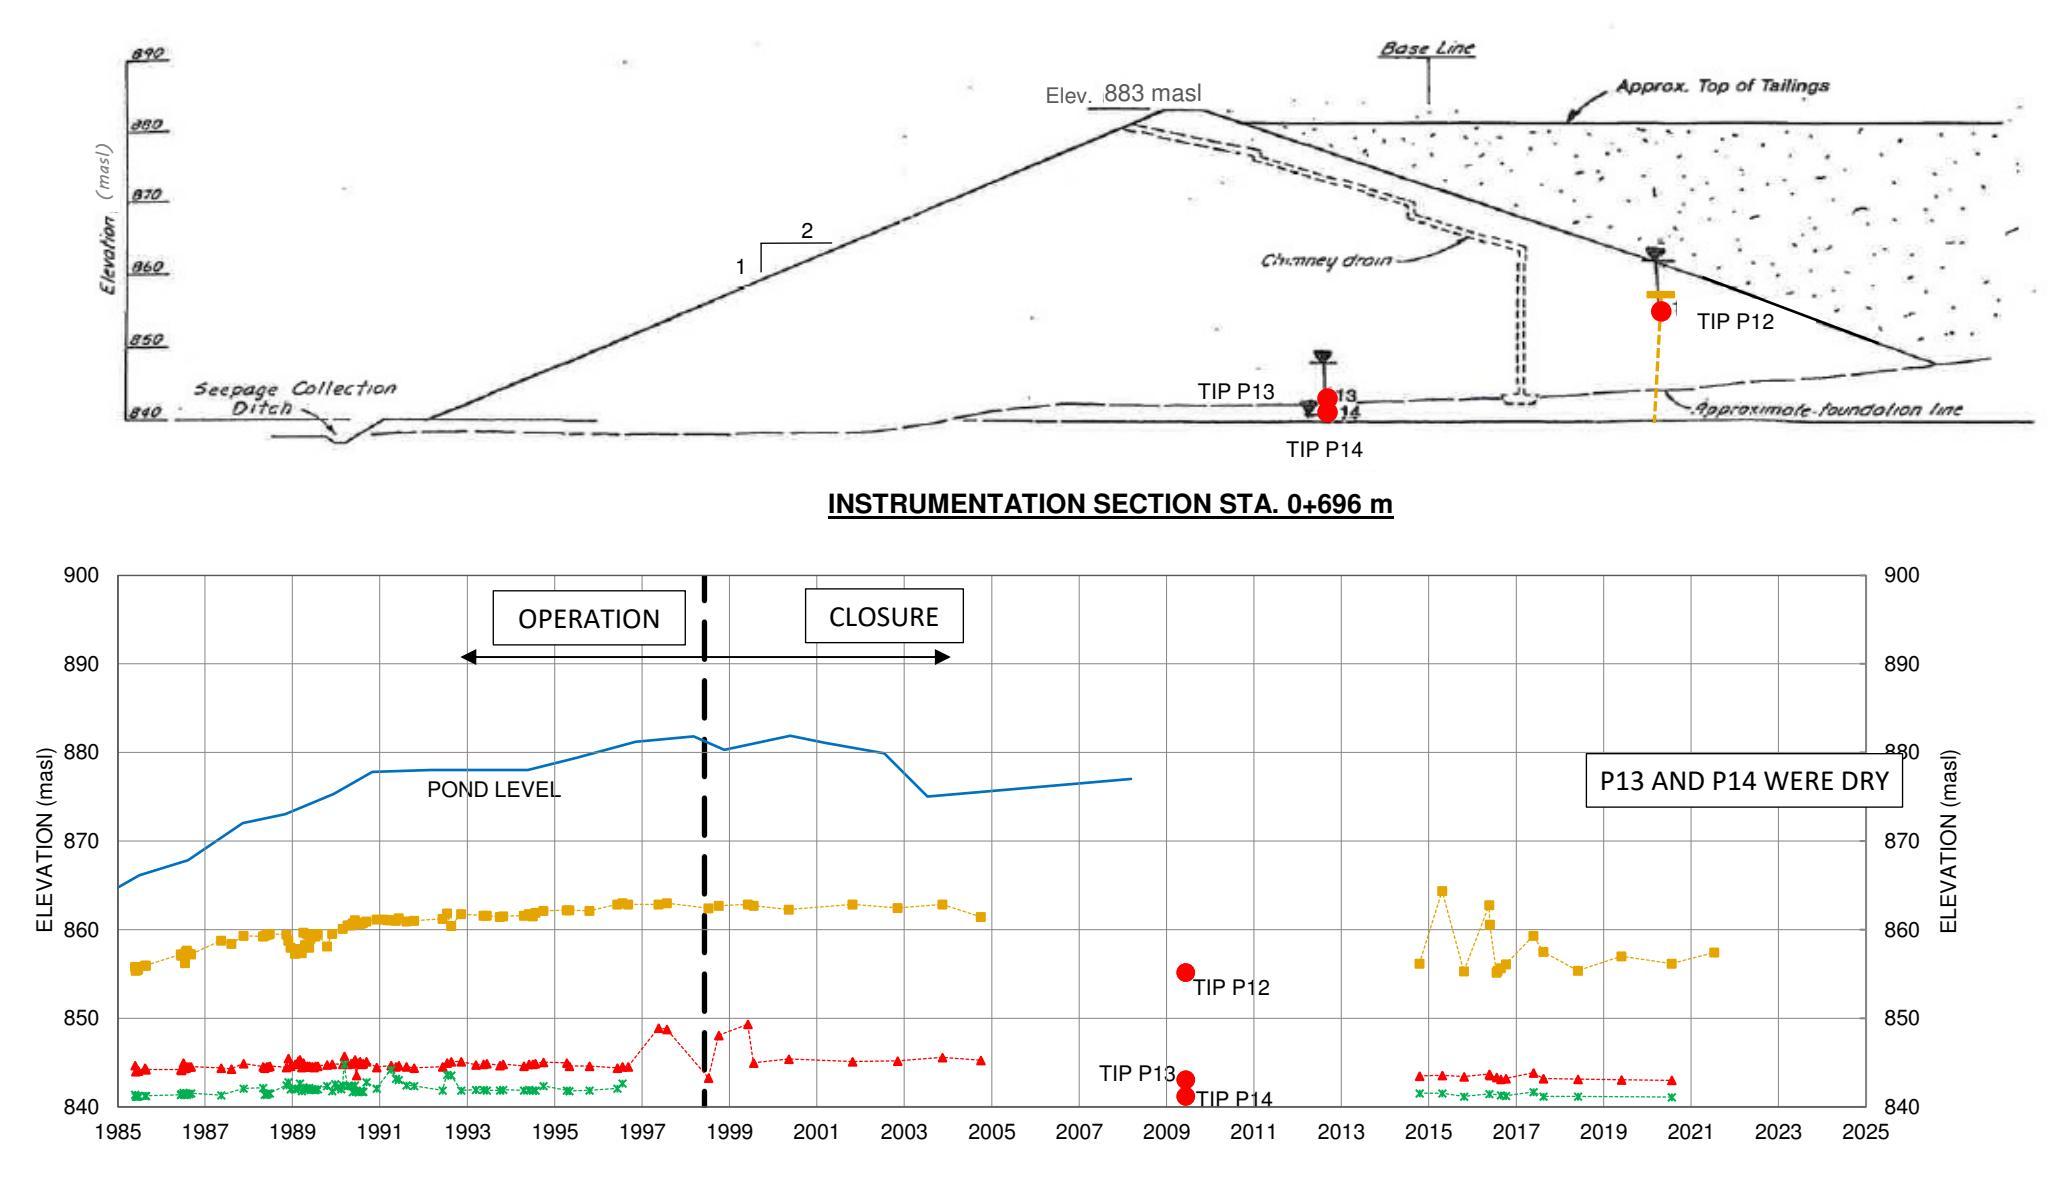
PIEZOMETRIC LEVELS	
DATE	STATION	PIEZOMETER ID.	PIEZOMETER TYPE	TIP ELEVATION (masl)	PRESSURE READING (psi)	HEAD (m)	ELEVATION (masl)
		P12	PNEUMATIC	855.1	3.3	2.3	857.4
2021-07-13	0+696	P13	PNEUMATIC	843.0	DRY	DRY	
		P14	PNEUMATIC	841.1	DRY	DRY

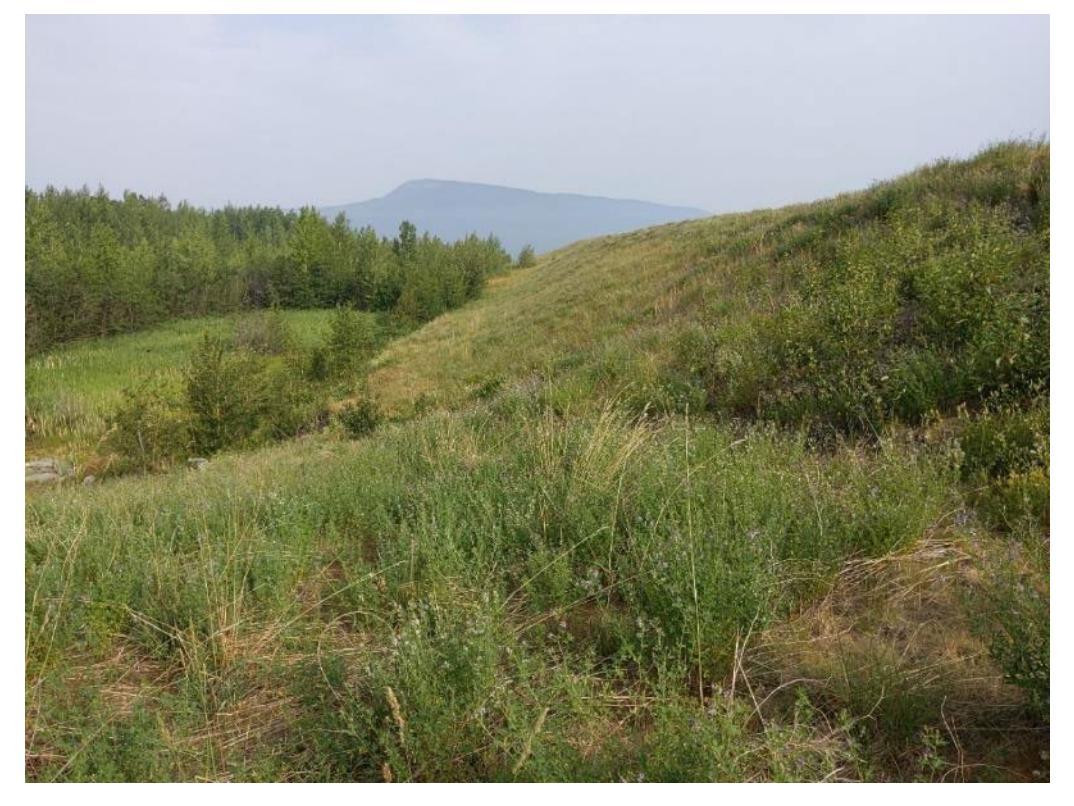
Photo I-18 Piezometer at downstream toe missing tip (PTD-2021-08)

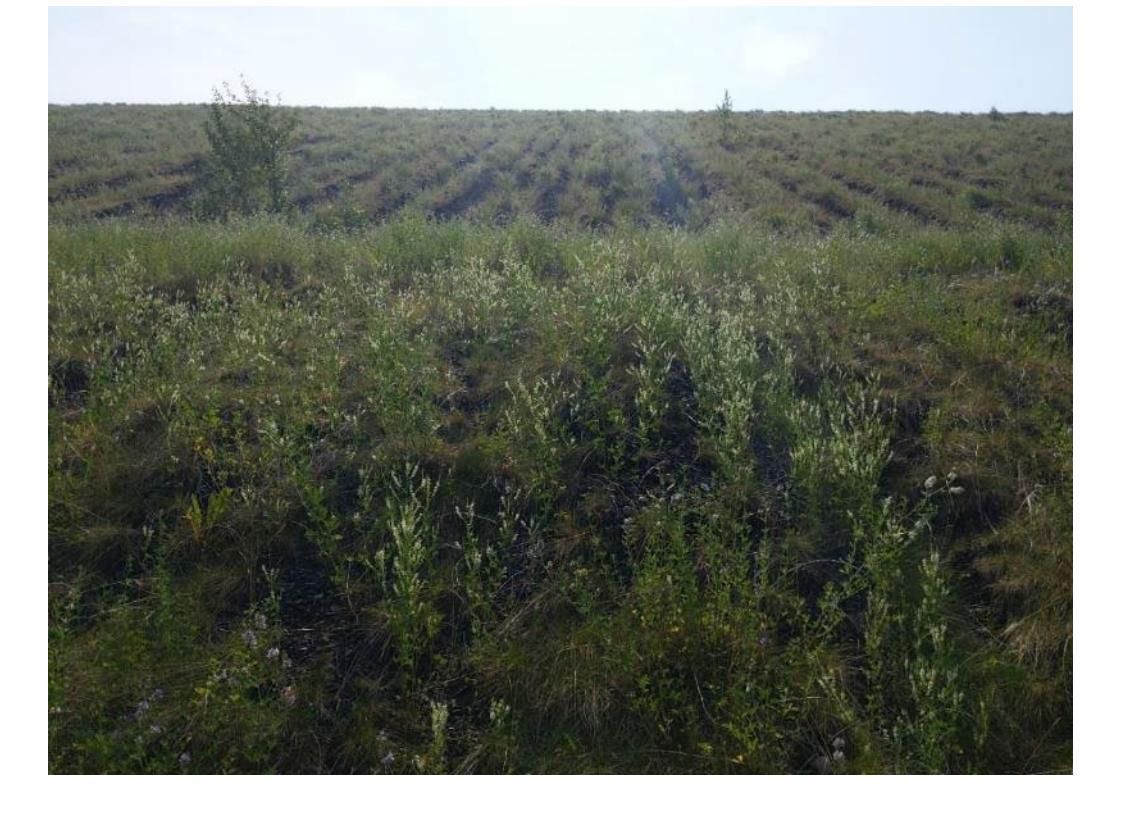
Photo I-21 PTD Downstream Slope – looking east (PTD-2021-12)

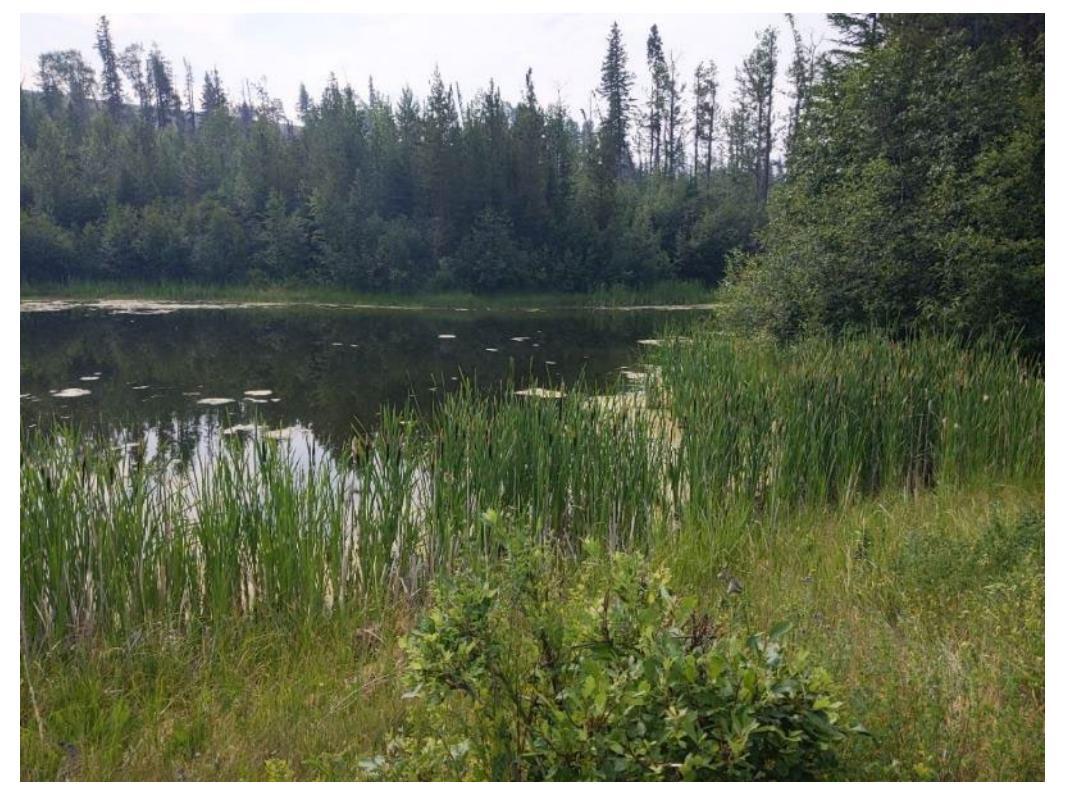
Photo I-23 PSCP Embankment – looking southeast (PSCP-2021-02)

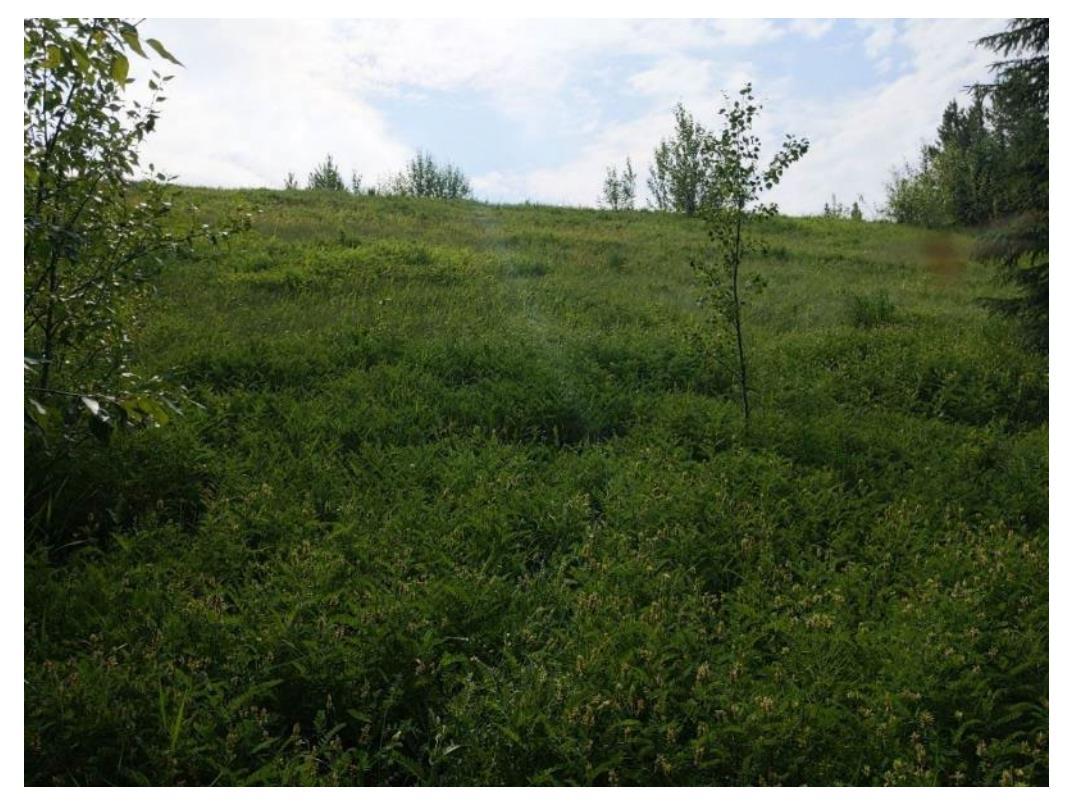
Photo I-24 PSCP Embankment gravel drainage blanket – looking east (PSCP-2021-03)

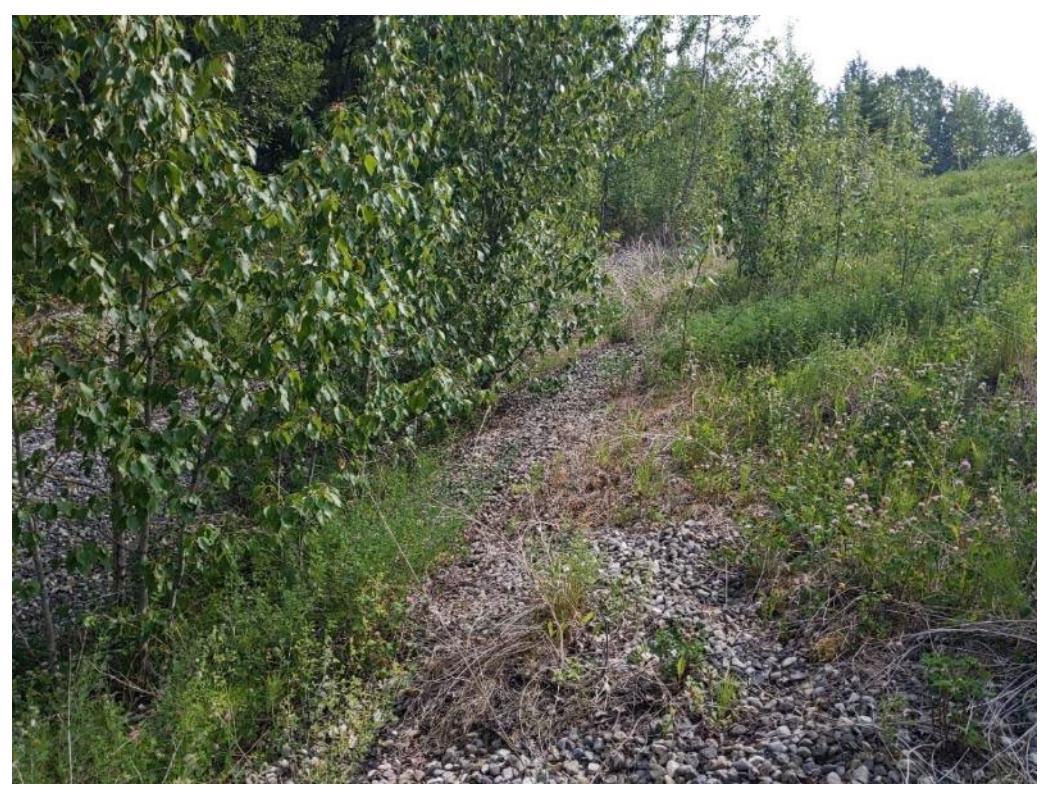
Photo I-25 PSCP Spillway – looking north (PSCP-2021-04)

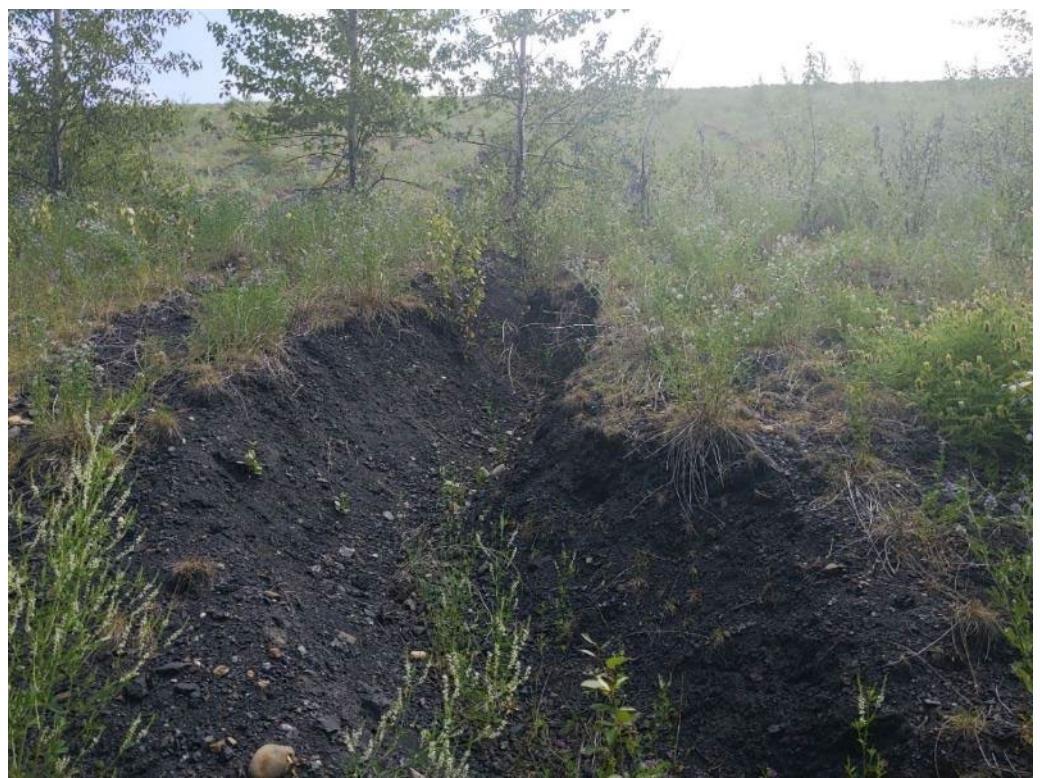
Photo I-28 PTD Downstream Slope erosion rills – looking east (PTD-2021-16)

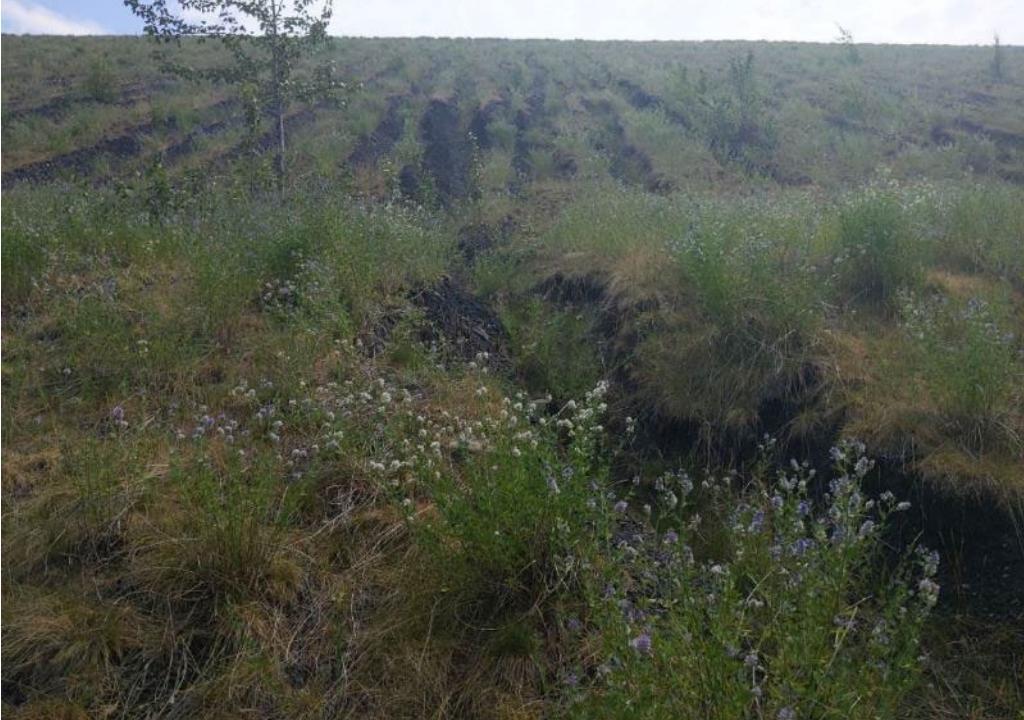
Photo I-29 PTD Downstream Slope erosion rills – looking east (PTD-2021-18)

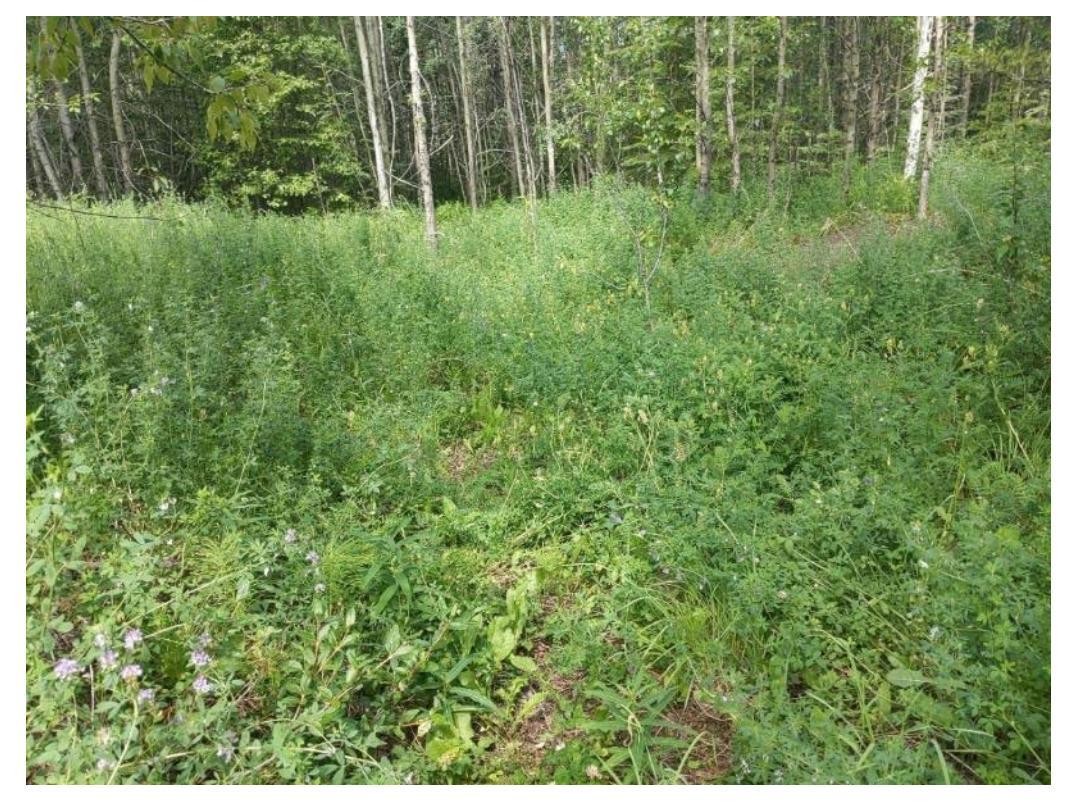
Photo I-31 Outlet of Seepage Collection Ditch along north wingwall (PTD-2021-20)

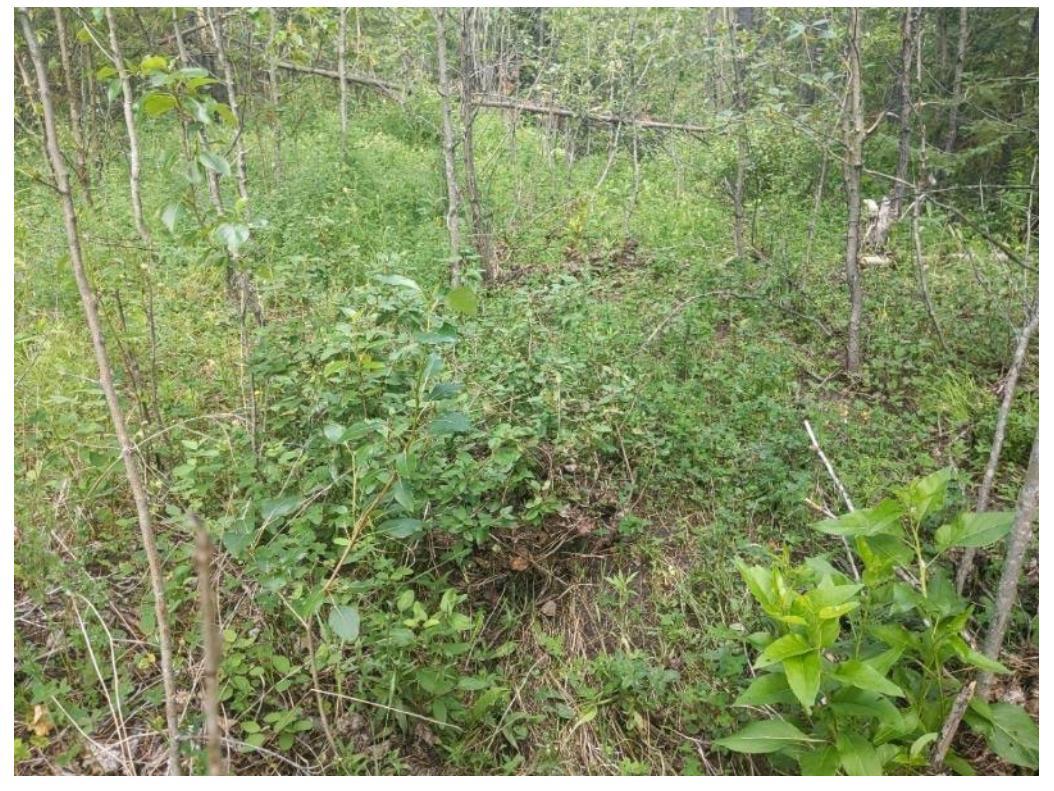
Photo I-39 Seepage Collection Ditch – looking north (PTD-2021-28)

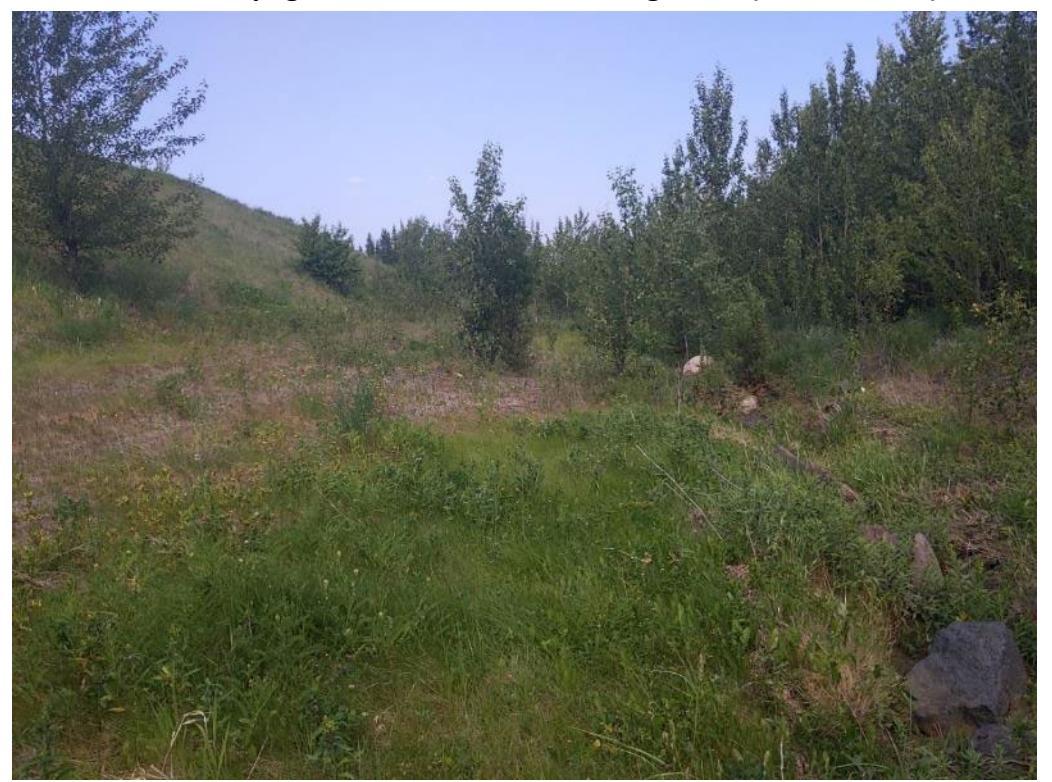
Photo I-40 Depressions on Embankment Slope, presence of a spoil pile adjacent to the depressions suggests that these were caused by animal activity (PTD-2021-29)

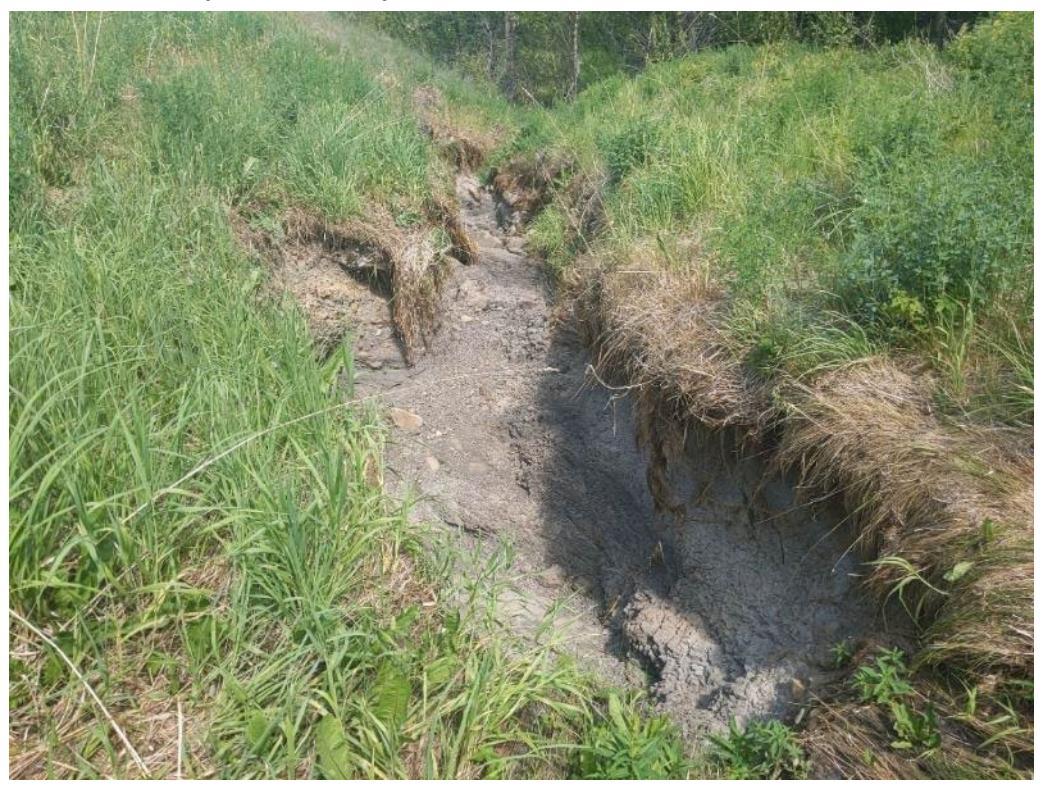
Photo I-42 Seepage Collection Ditch with weathered rock exposed at base – looking south (PTD-2021-32)
