# 2021 Annual Facility Performance Report

Sä Dena Hes Mine, Yukon Territory

Teck Resources Limited

SRK Consulting (Canada) Inc. ■ 1CT008.075 ■ December 2021

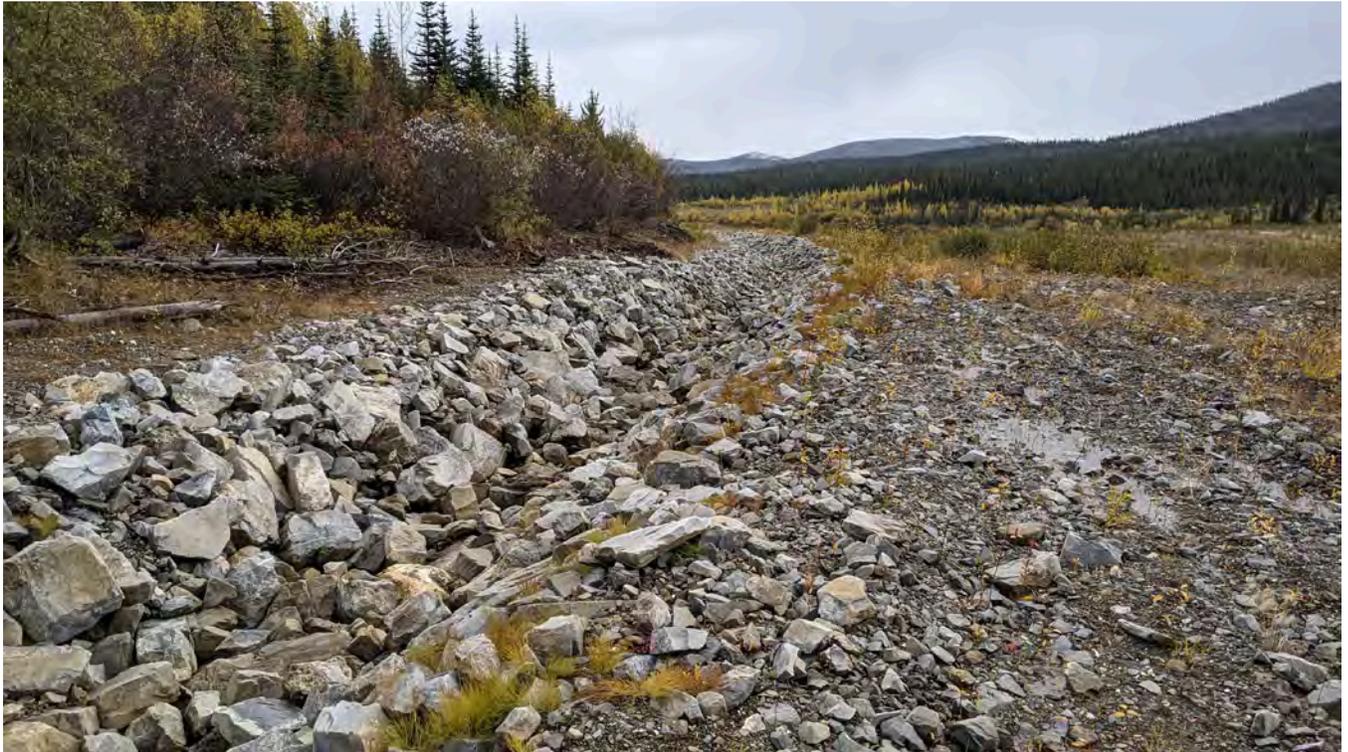
Photo DC-01: North Diversion Channel looking south

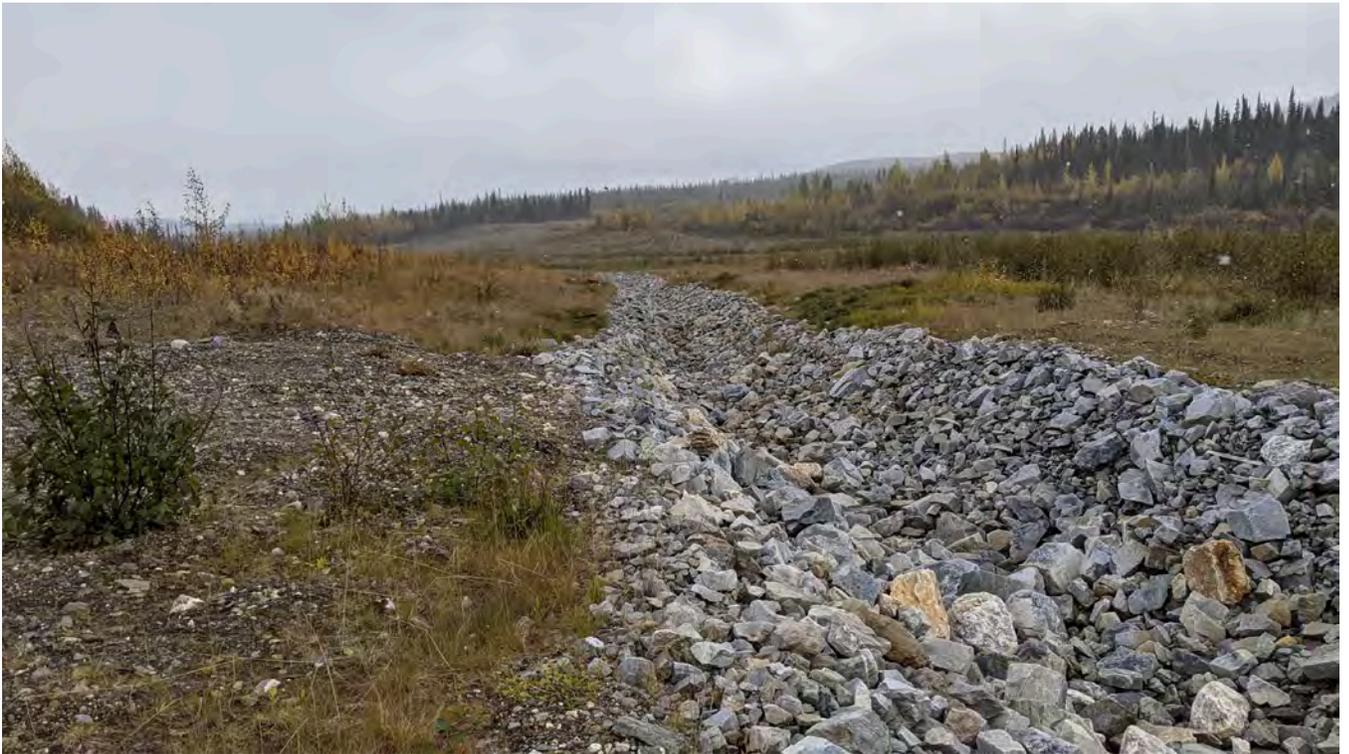
Photo DC-04: South Drainage Channel looking south (downstream).

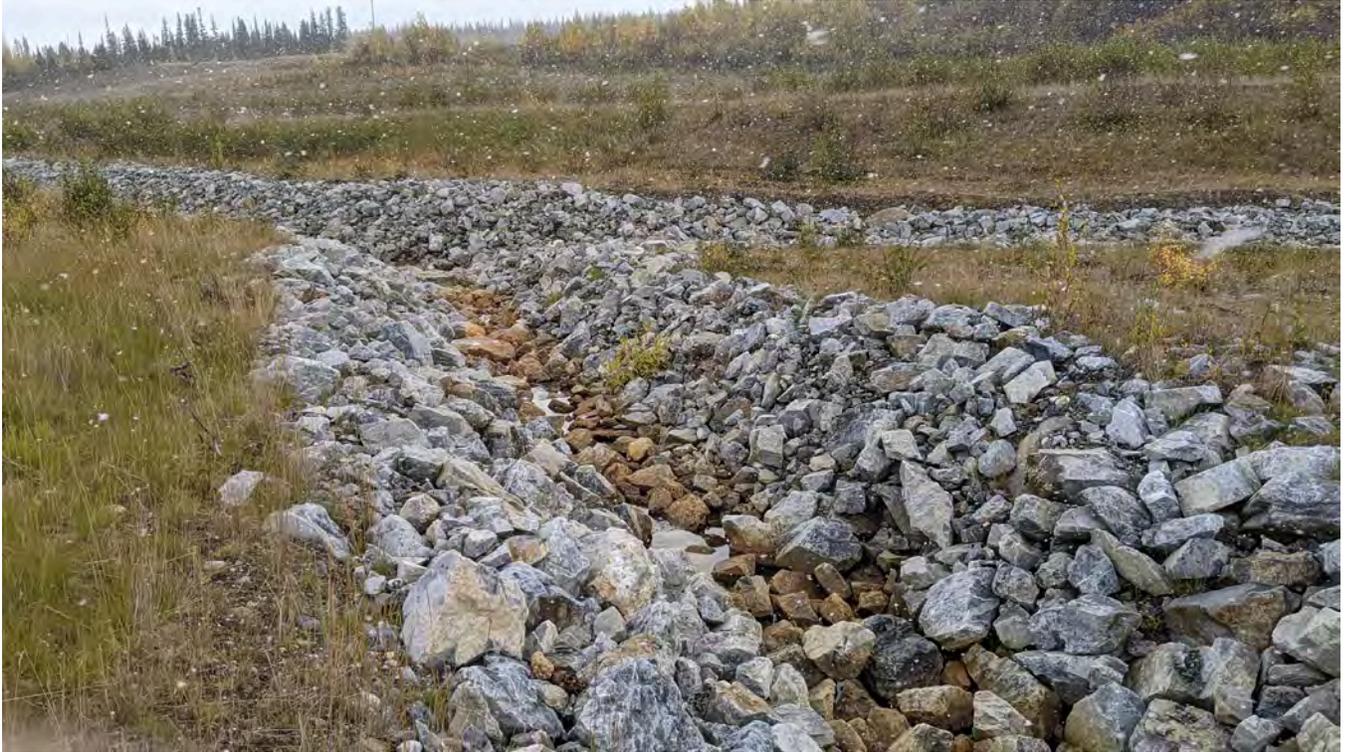
Photo DC-05: South Drainage Channel looking south towards the confluence with Camp Creek.

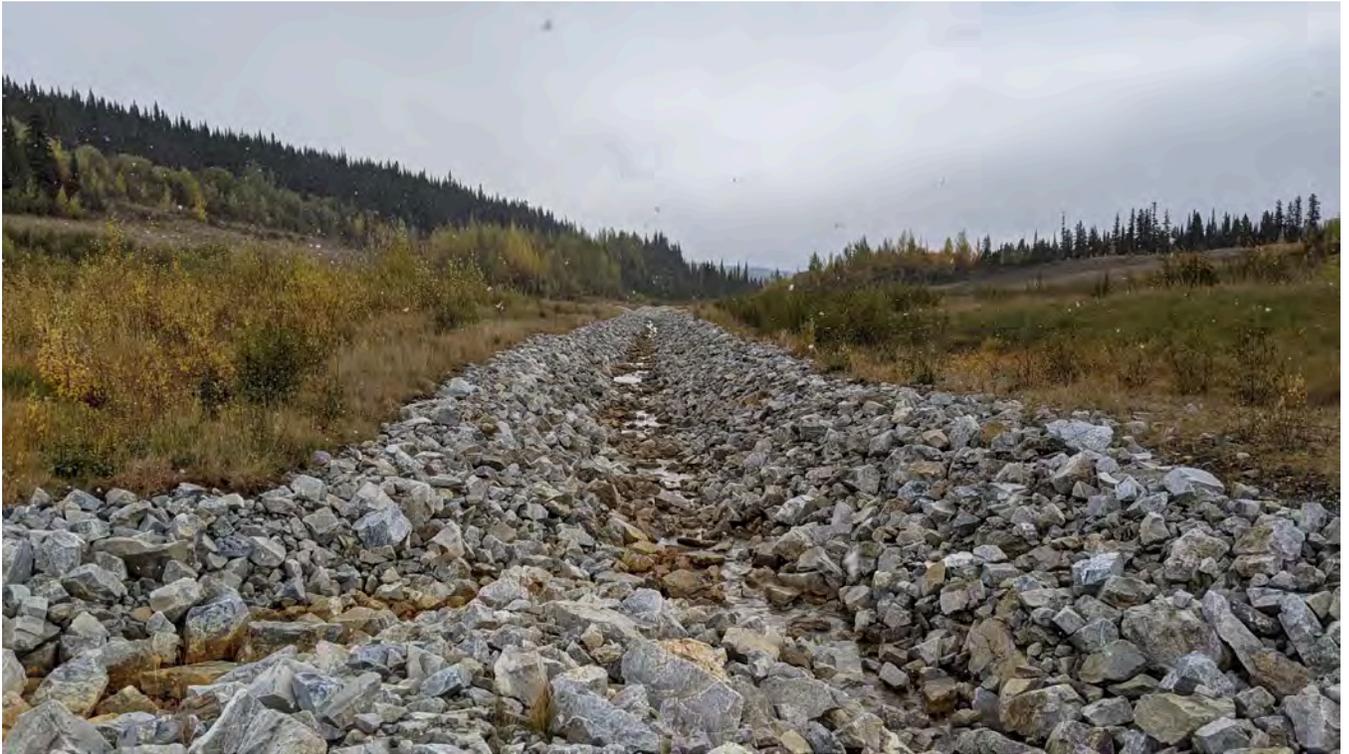
Photo DC-07: Camp Creek looking downstream from the confluence with the South Drainage Channel.

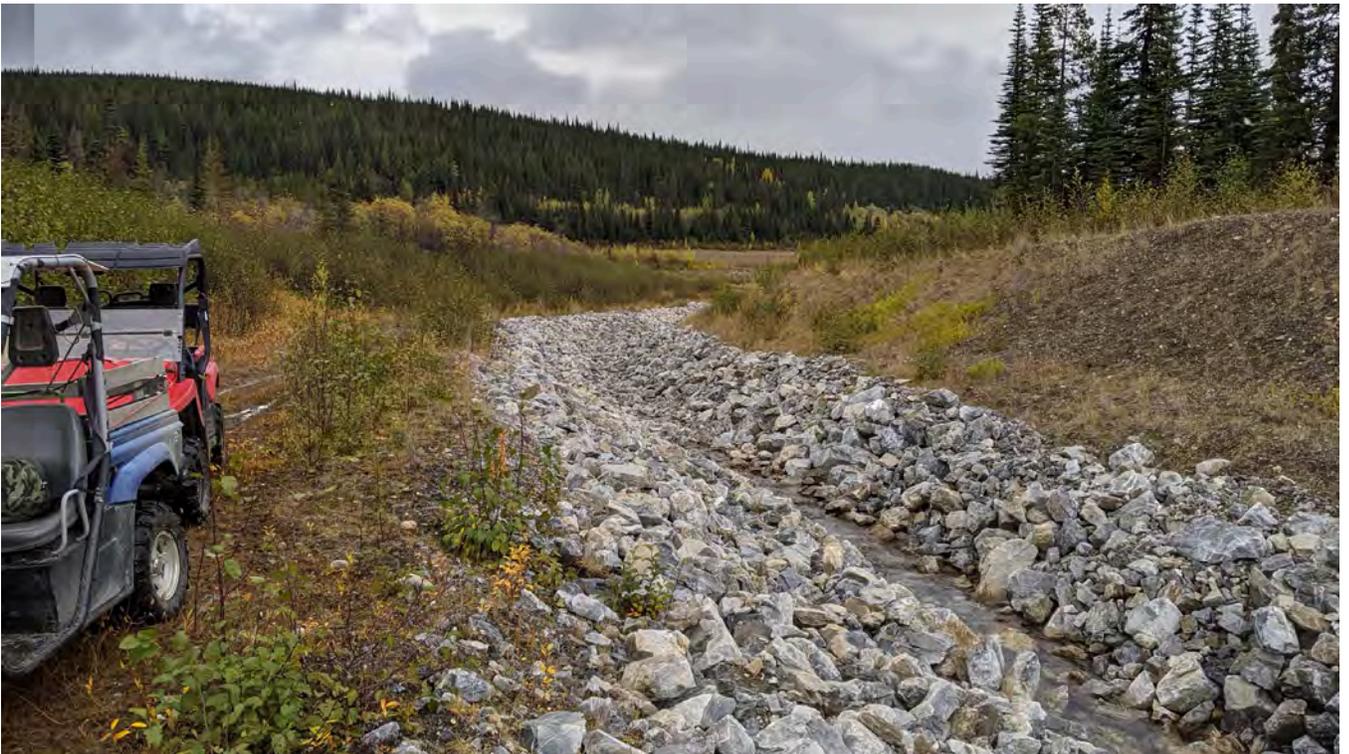
Photo DC-08: Camp Creek upstream of the South Drainage Channel confluence looking downstream.

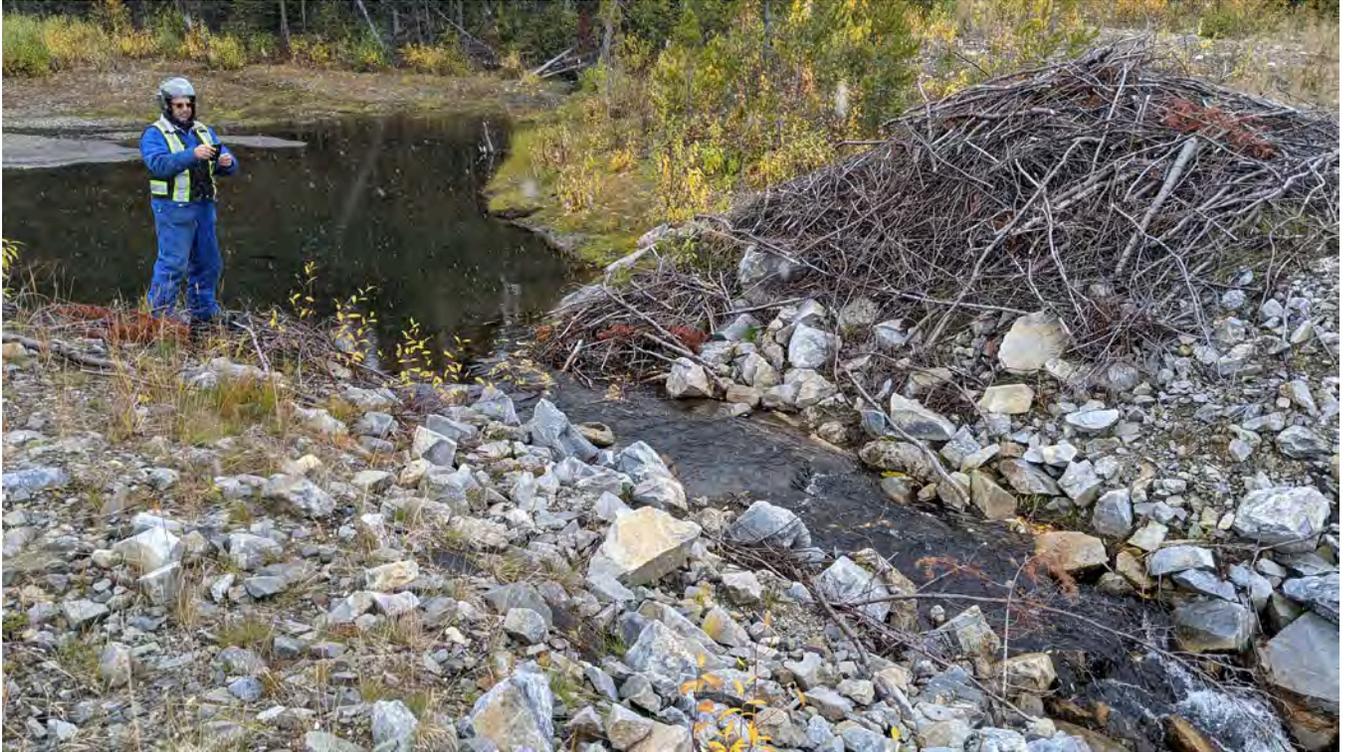
- A beaver dam was removed at the inlet of the decommissioned upper access road crossing of the North Creek Channel.
- Repairs were made to the MH-02 monitoring station located downstream of the North Dam that is used to estimate seepage flow. The monitoring station consists of a 6-inch diameter steel pipe that is embedded in sandbags. The pipe was reinstalled in a horizontal position so that water flows through the pipe.

Photo NC-01: Beaver dam removed from the inlet of the upper decommissioned access road crossing of North Creek to the landfill area.

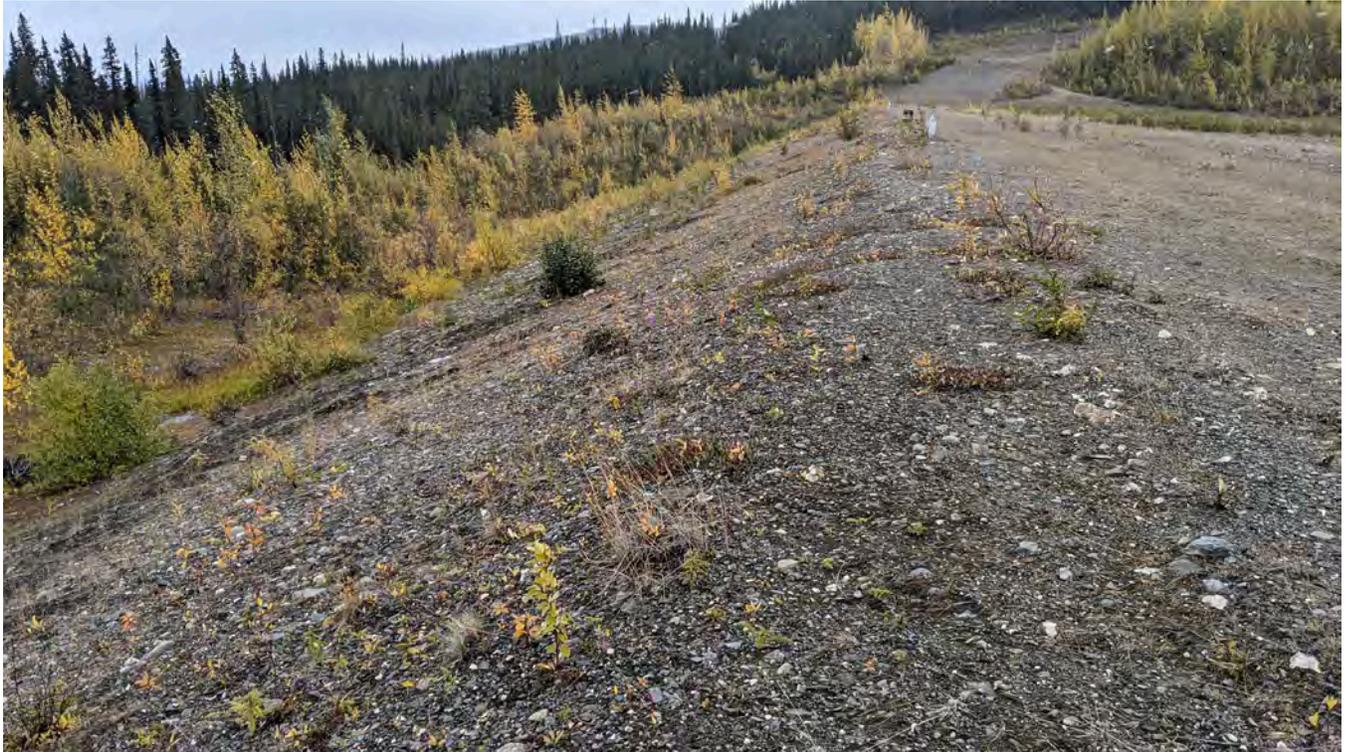
The North Dam is in good condition and shows no signs of deformation or abnormal settling. Sheet and rill erosion of the wind-blown tailings and fine-grained was observed on the downstream slope of the dam that is believed to be caused by a rain event that occurred soon after the spring thaw when the surficial soils may have been saturated and loosened from the thawing process. No remedial action is required as the downstream embankment consists of sand and gravel material that are expected to self-armour as the fine-grained material erodes.

Photo ND-03: Downstream slope of the North Dam looking east from the near the west abutment. Minor sheet and rill erosion present

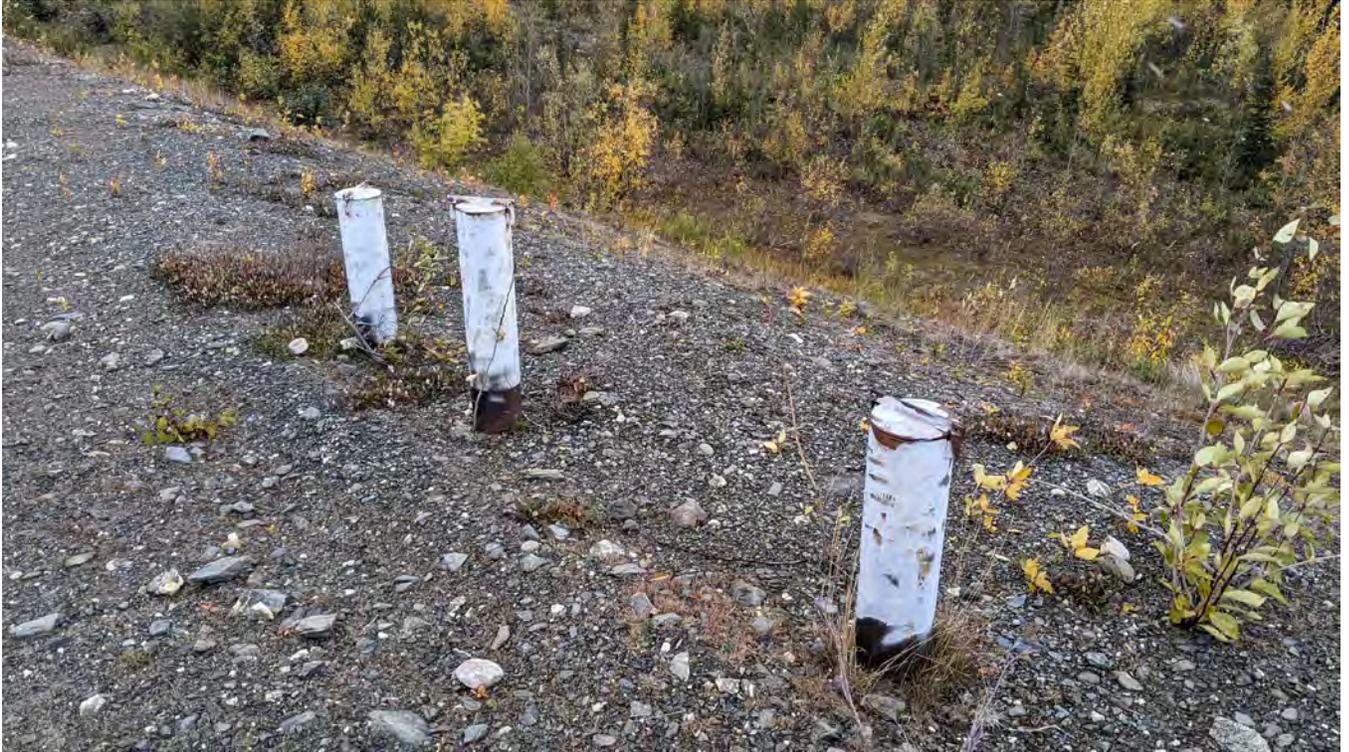
The piezometers are in good condition and continue to function as designed. The seasonal fluctuations recorded in the latter part of 2020 and 2021 in the piezometers are consistent with those in previous

Photo ND-05: Piezometer protective casings on the North Dam crest.

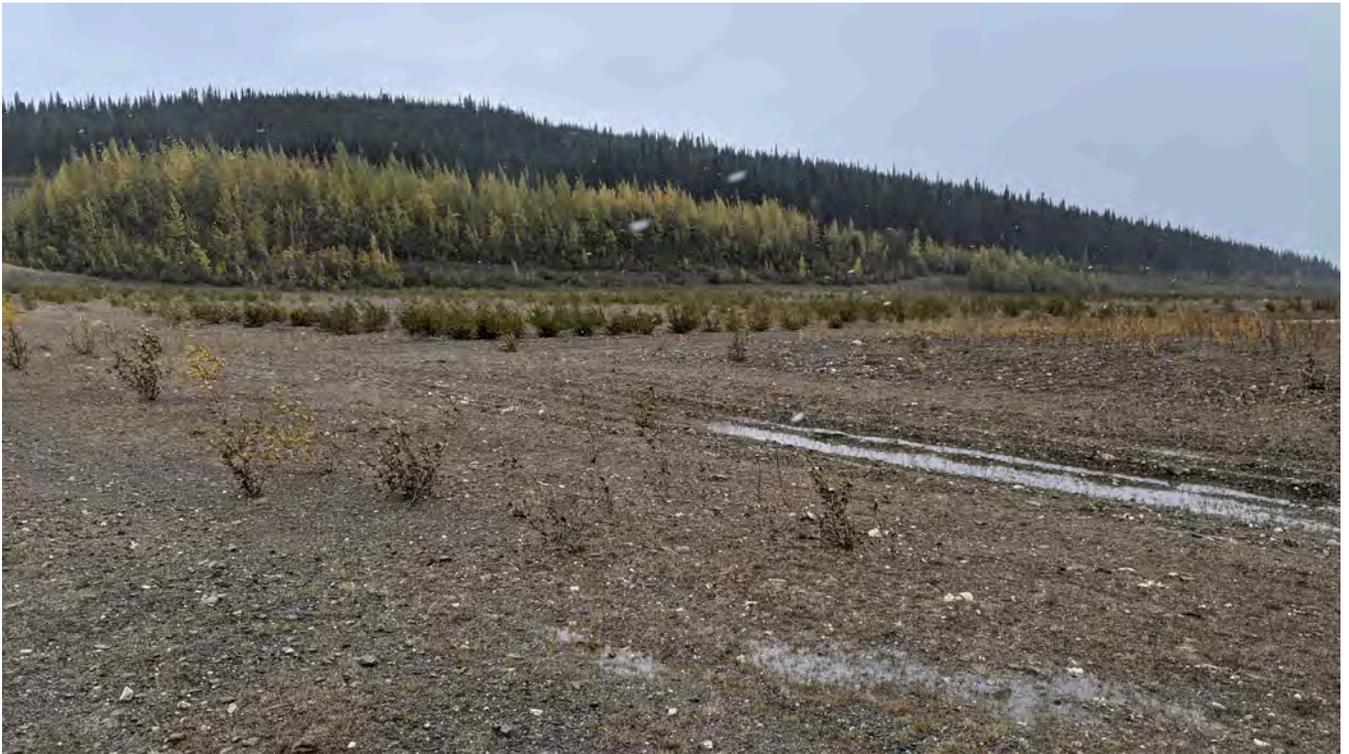
Photo ND-06: Tailings cover immediately upstream of the North Dam.

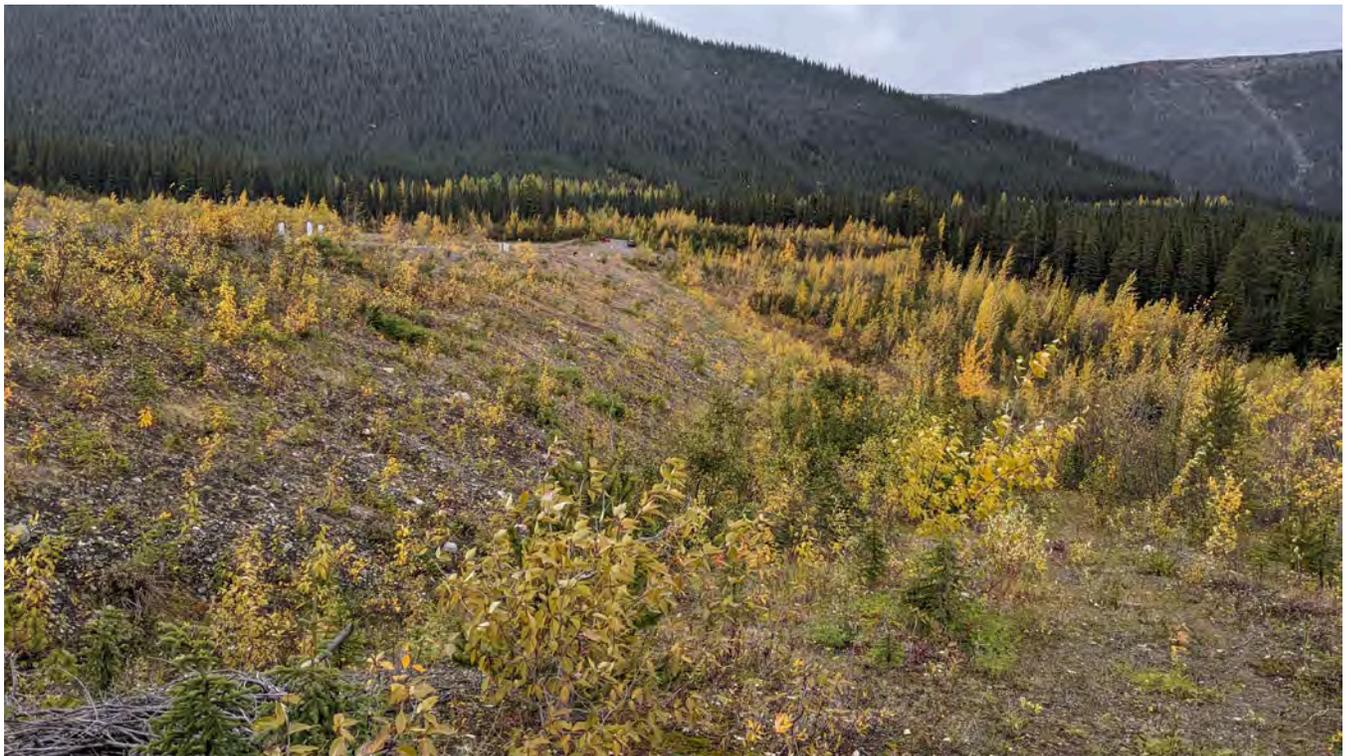
Photo ND-08: Downstream face of the dam looking west.

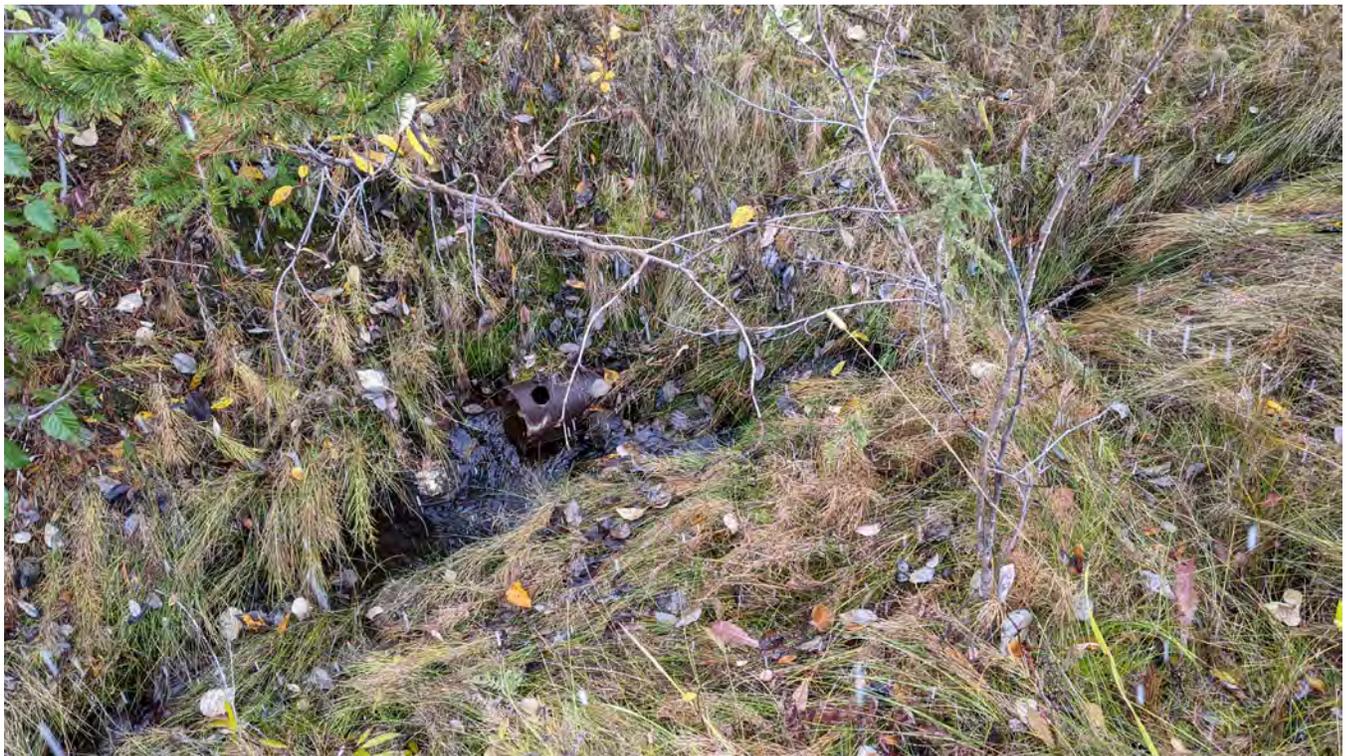
Photo ND-10: MH02 Flow monitoring pipe.

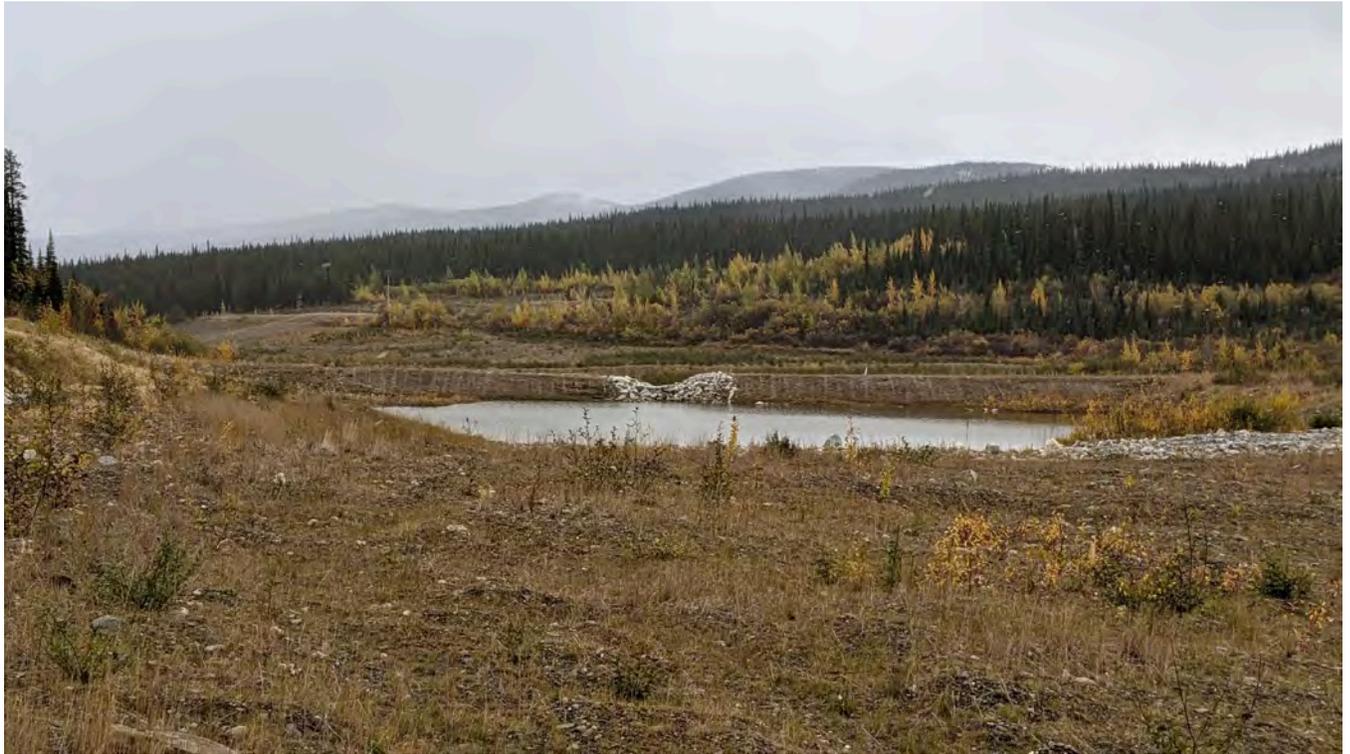
Photo SRS-01: SRS and pond looking south.

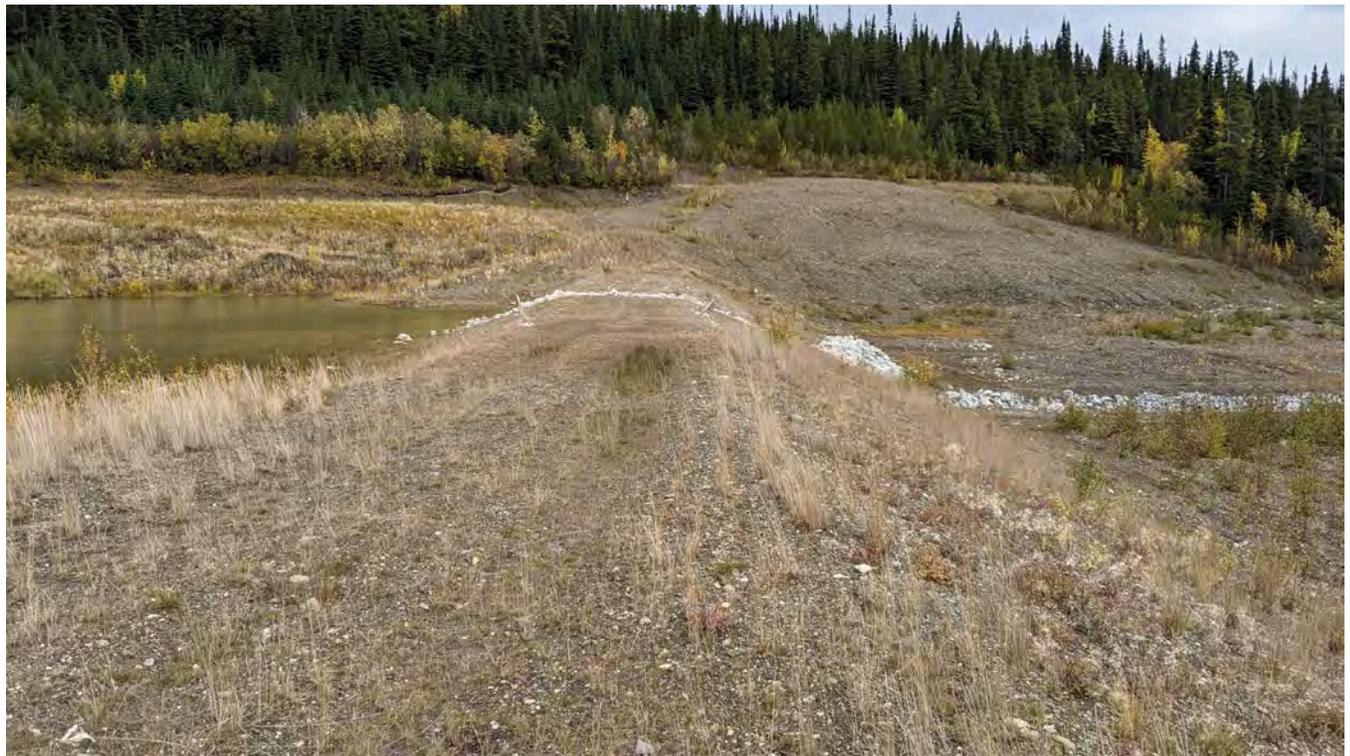
Photo SRS-02: SRS crest looking east from the west abutment.

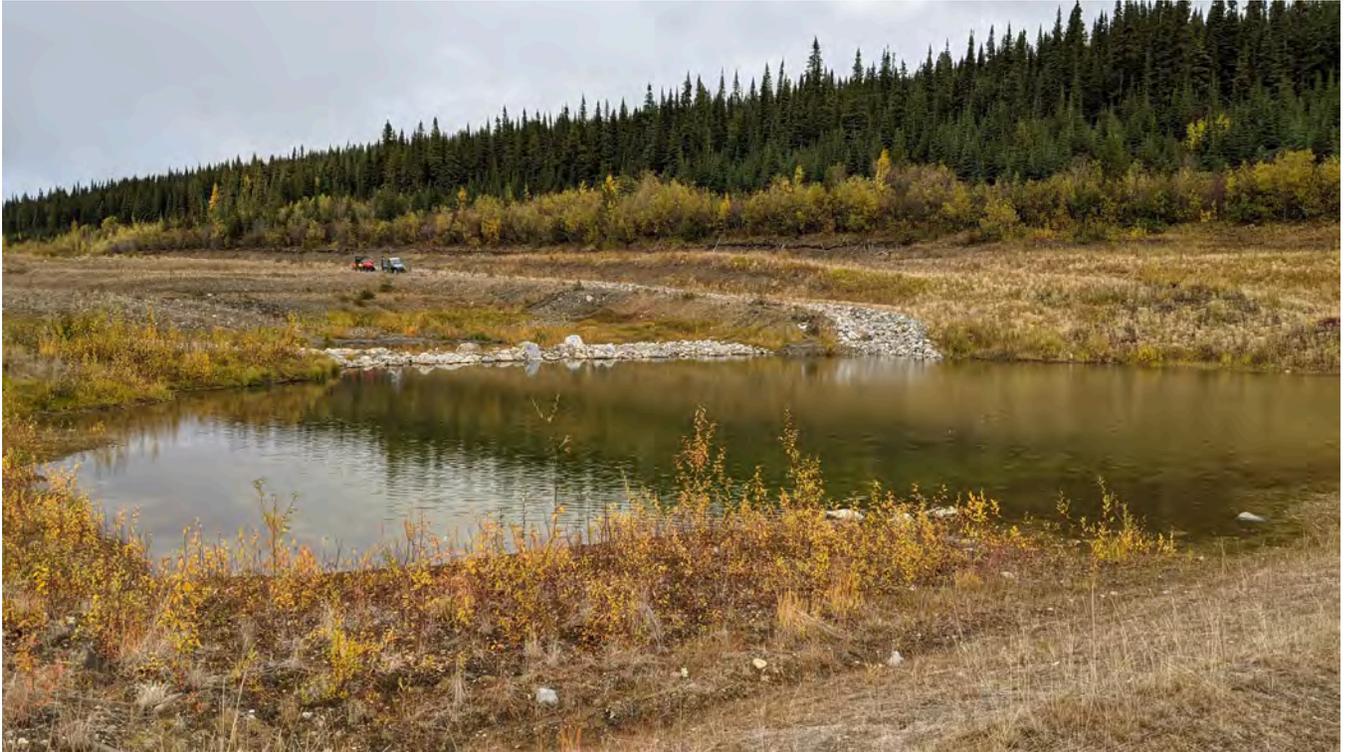
Photo SRS-03: SRS Pond taken from the SRS, also showing the outlet of the North Diversion Channel.

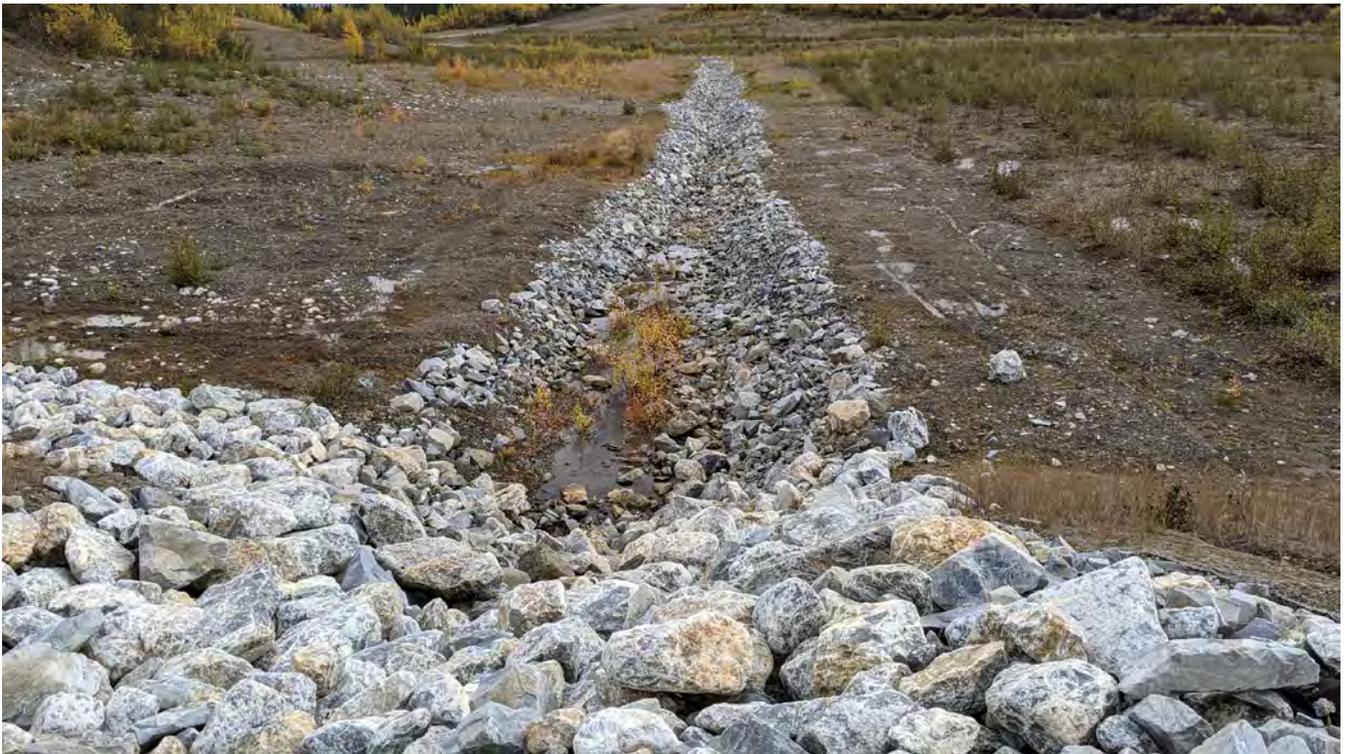
Photo SRS-04: Downstream slope of the SRS spillway and upstream end of the South Drainage Channel.

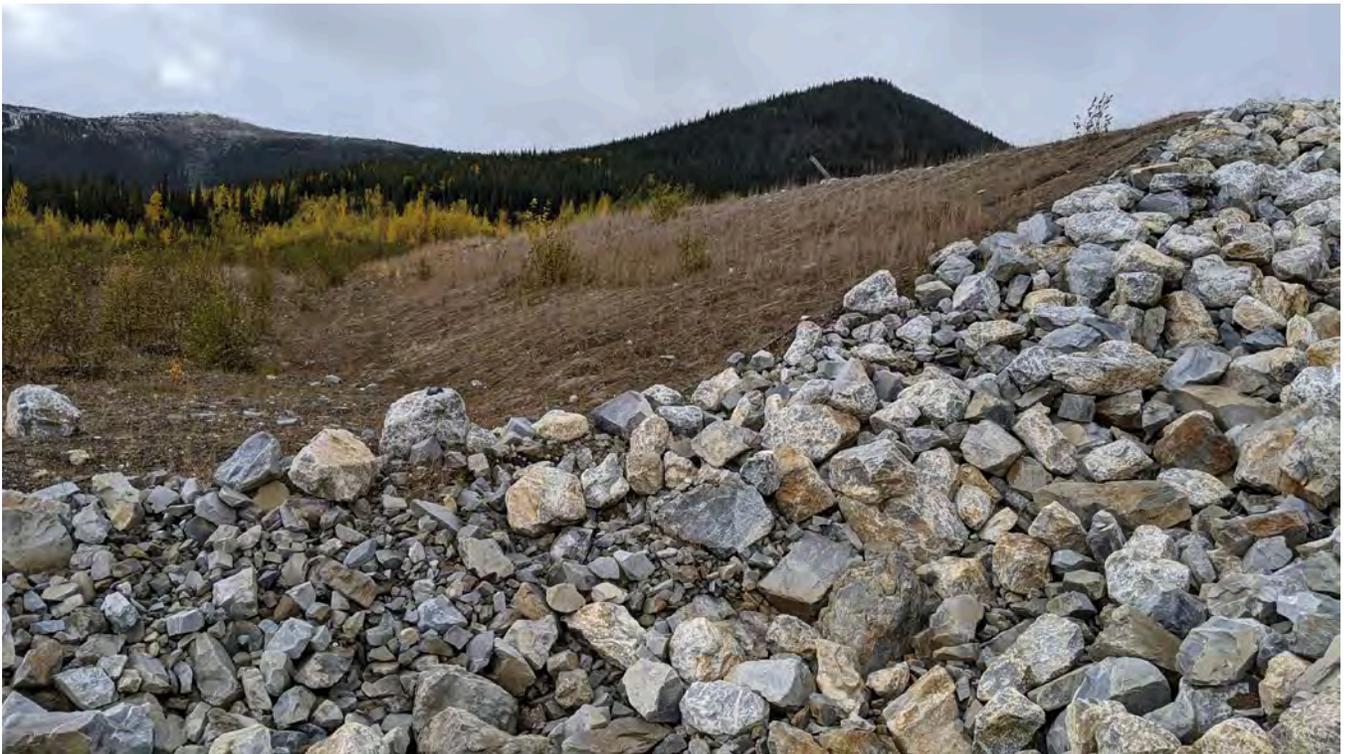
Photo SRS-06: Downstream face of the SRS looking west from the east side of the spillway.

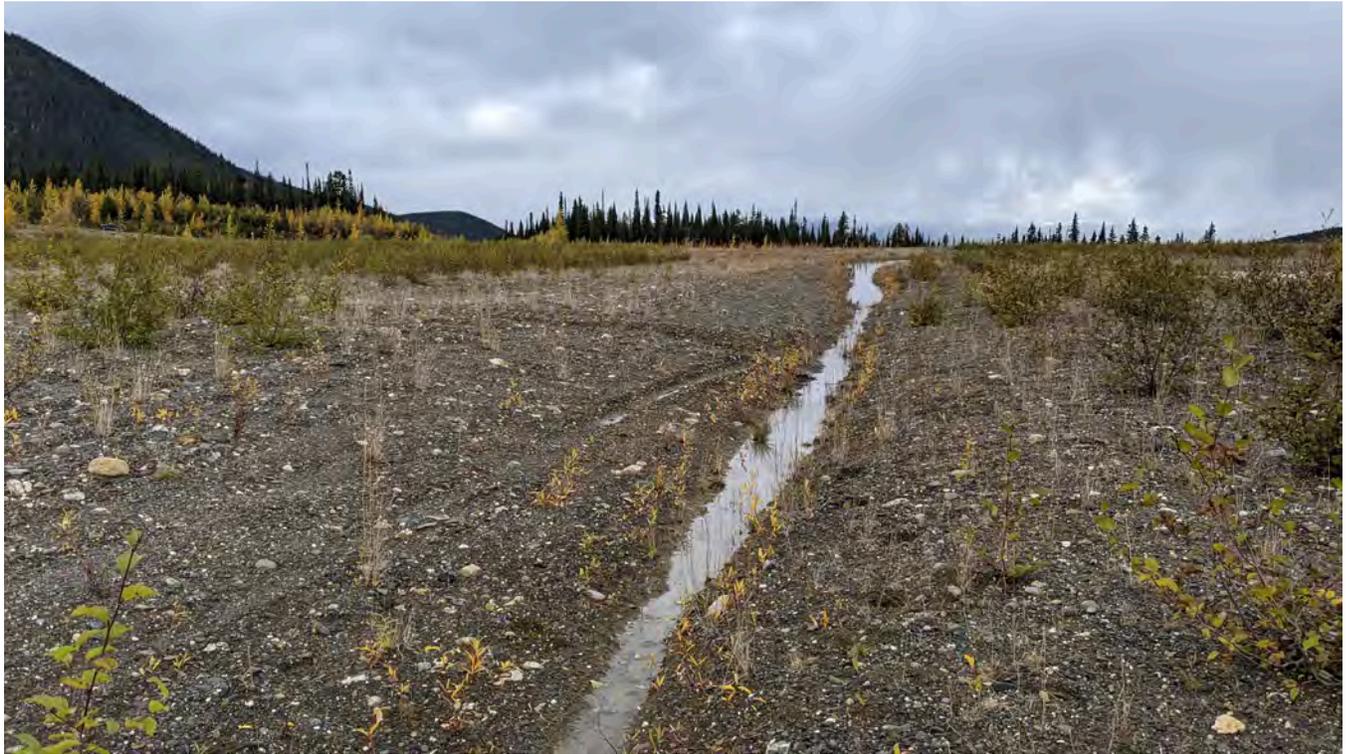
Photo TC-01: Drainage Swale that flows south through the middle of the tailings cover.

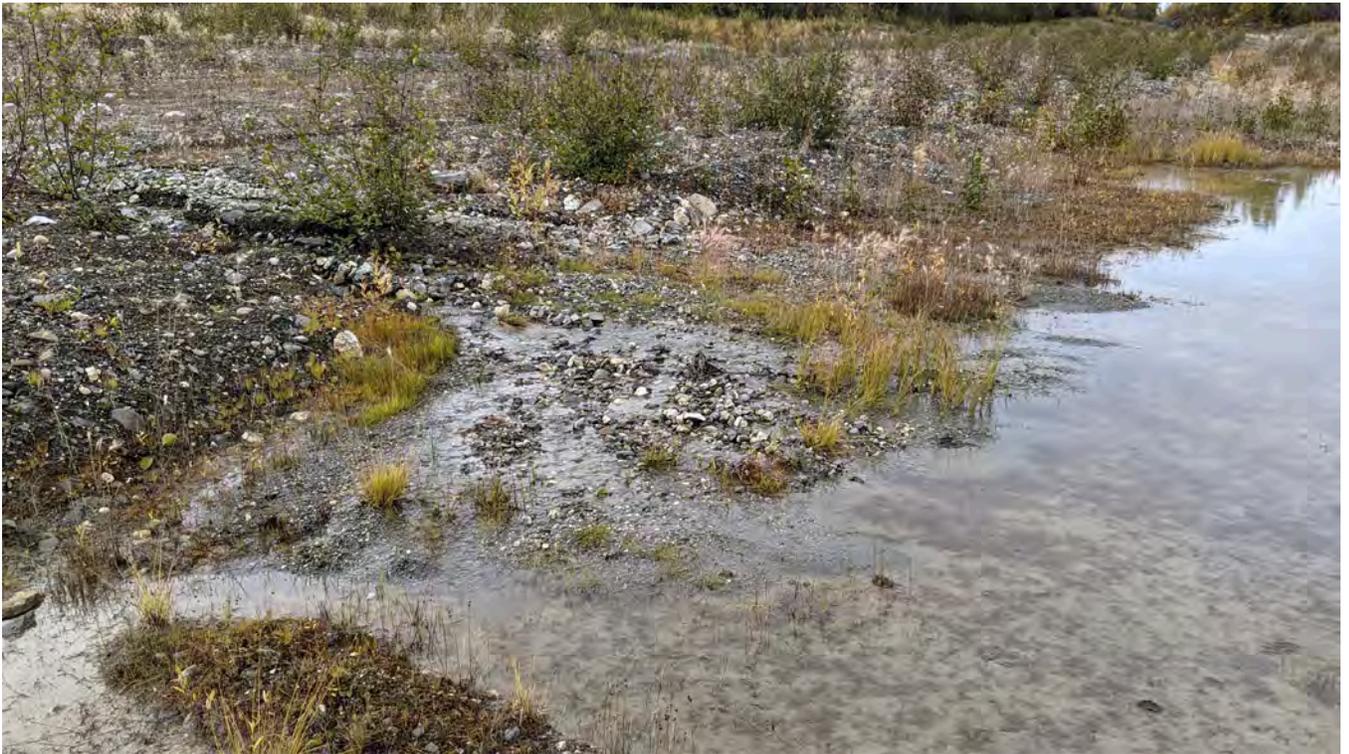
Photo TC-04: Outlet of a small ephemeral stream and pond northwest of the SRS Pond that acts a small sediment pond.

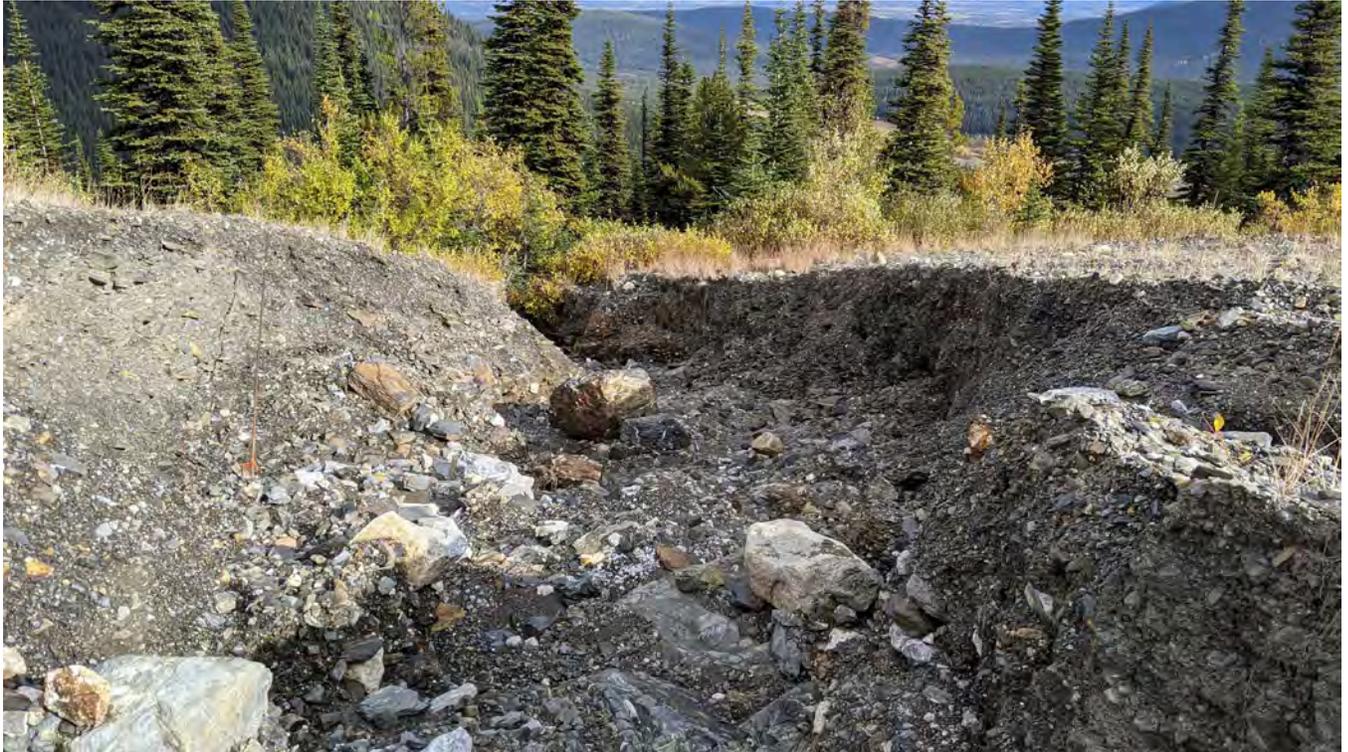
Photo WR-01: Erosion gully at the base of Jewelbox Waste Rock Dump looking downslope. The gully has eroded down to bedrock.

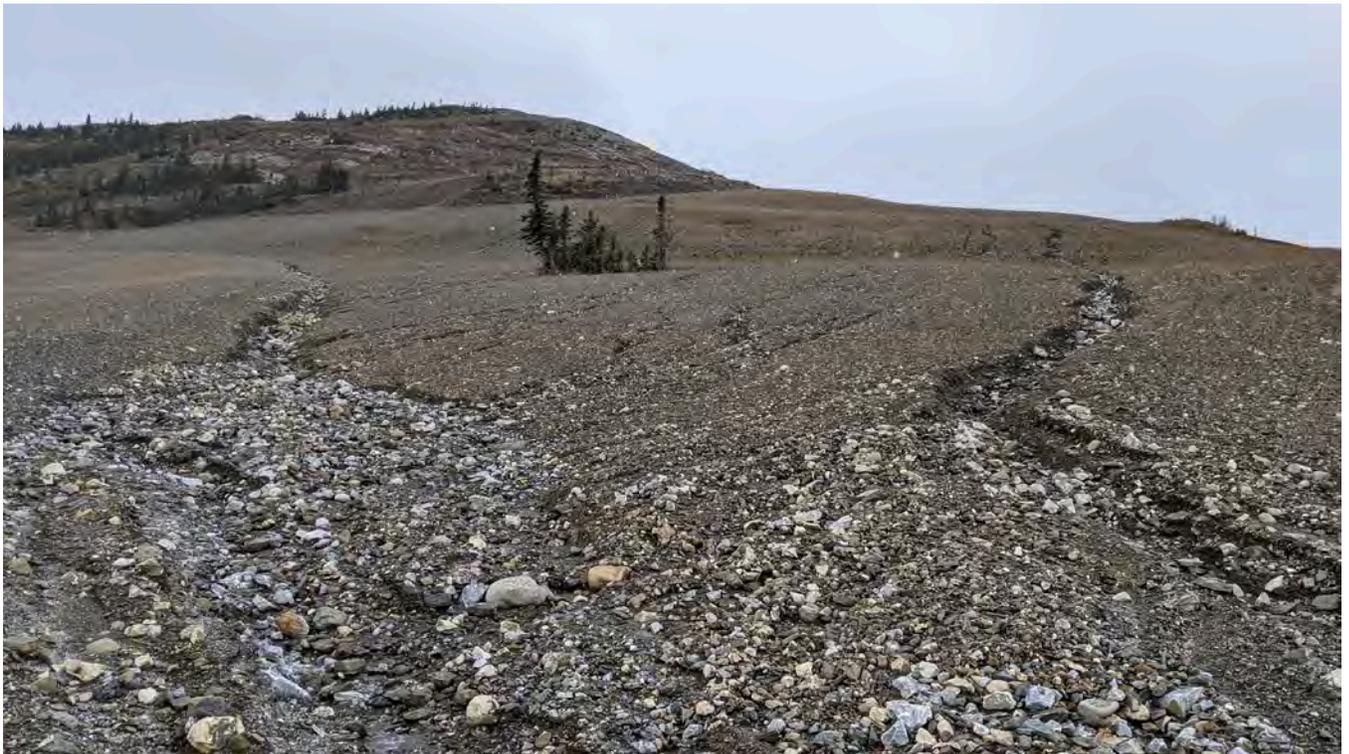
Photo WR-04: Jewelbox Waste Dump – confluence of erosion channel upstream of the gully shown in Photos WR-01 to WR-03.

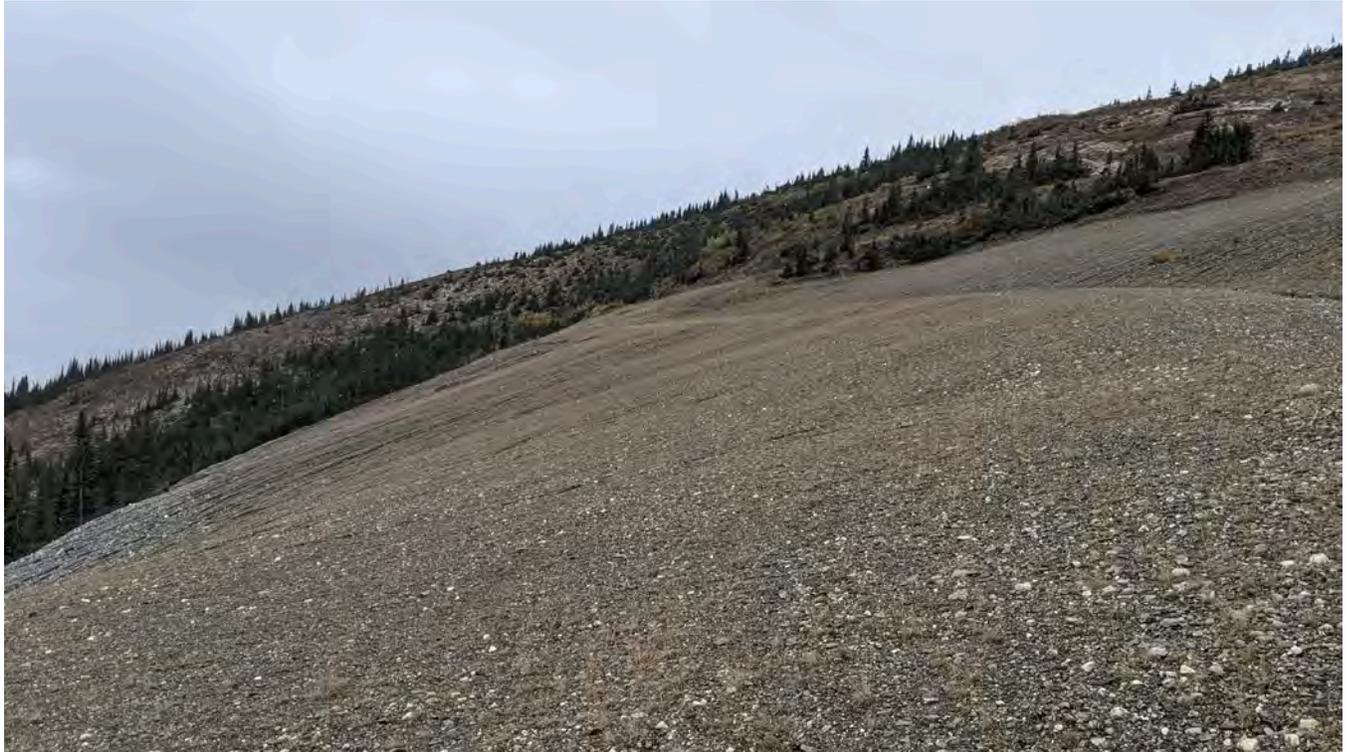
Photo WR-05: Reggraded 1408 Portal Waste Dump looking south towards the 1408 Portal.

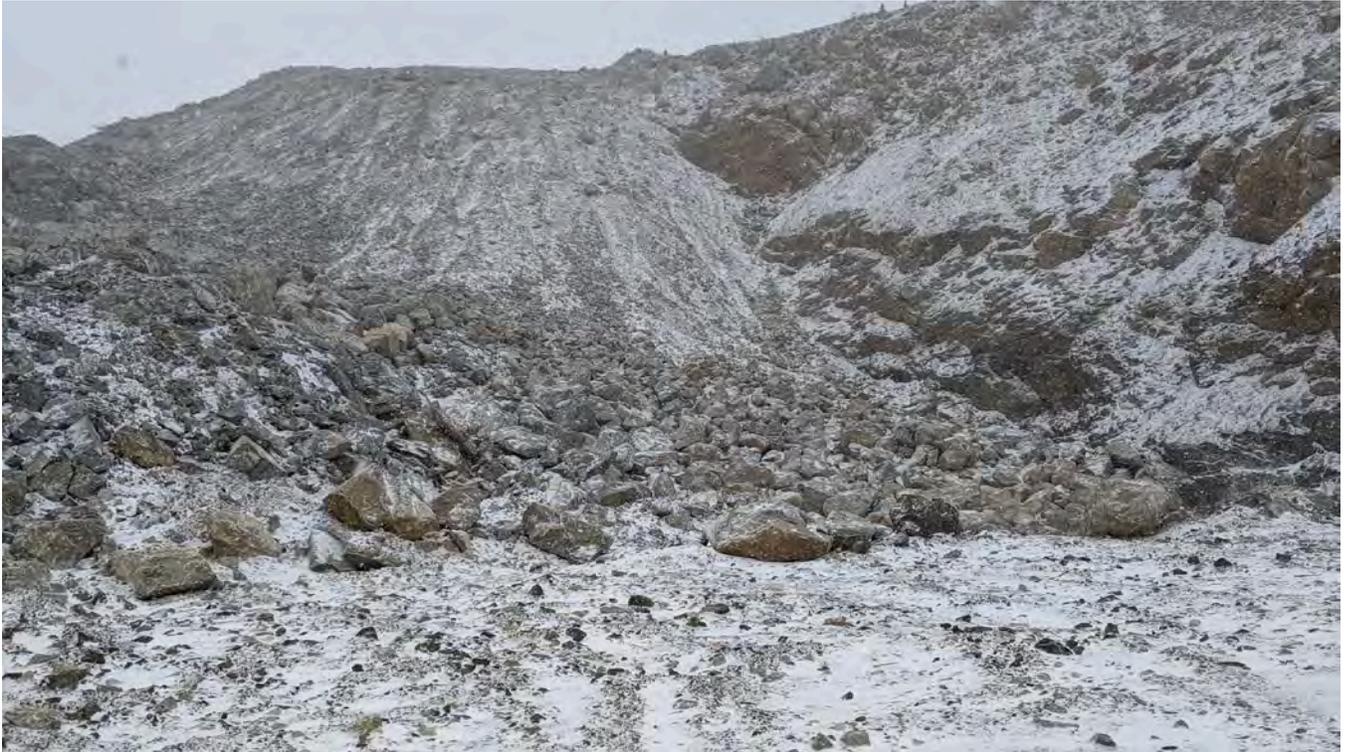
Photo WR-09: Backfill at the 1380 Portal below Main Zone Waste Rock Dump
