# 2021 Annual Facility Performance Report

Sä Dena Hes Mine, Yukon Territory

Teck Resources Limited

SRK Consulting (Canada) Inc. ■ 1CT008.075 ■ December 2021

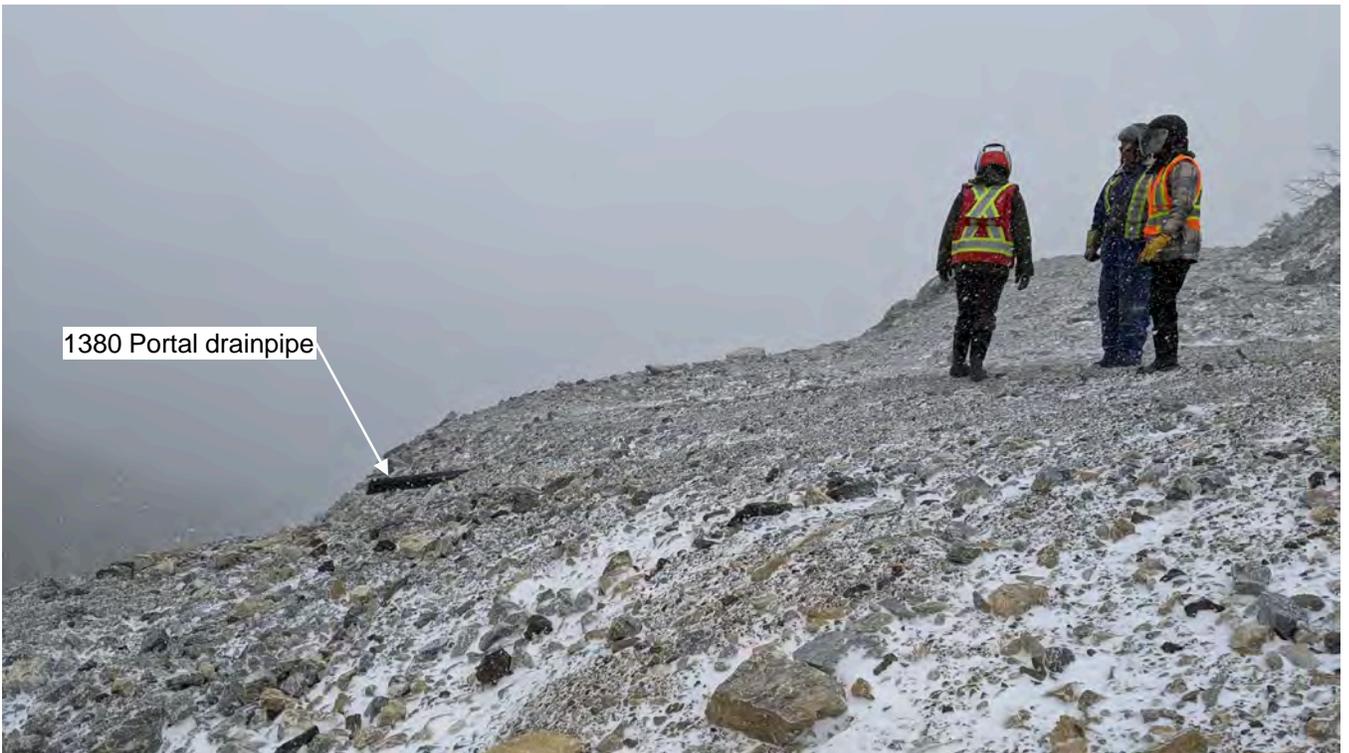
1380 Portal drainpipe

Photo WR-10: 1380 Portal drainpipe.

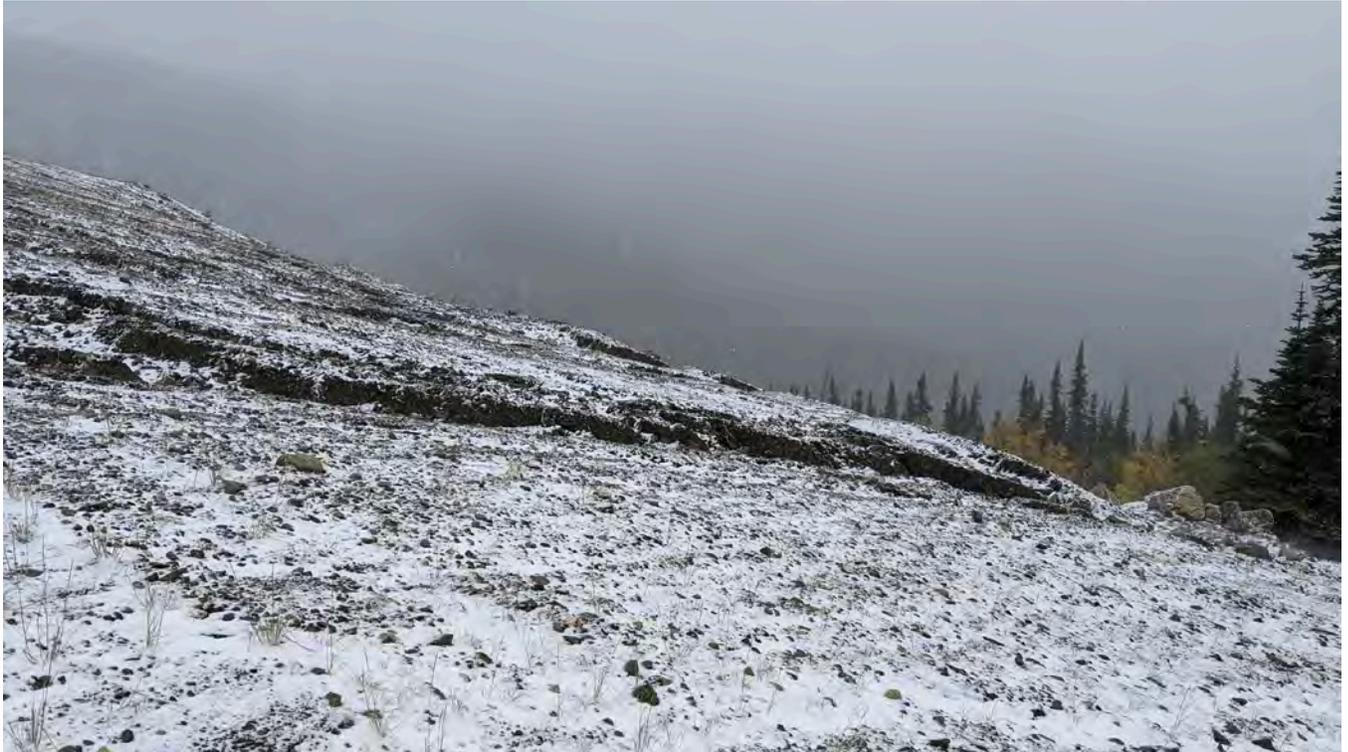
Photo WR-11: Erosion gully down the slope of the Jewelbox North Waste Rock Dump

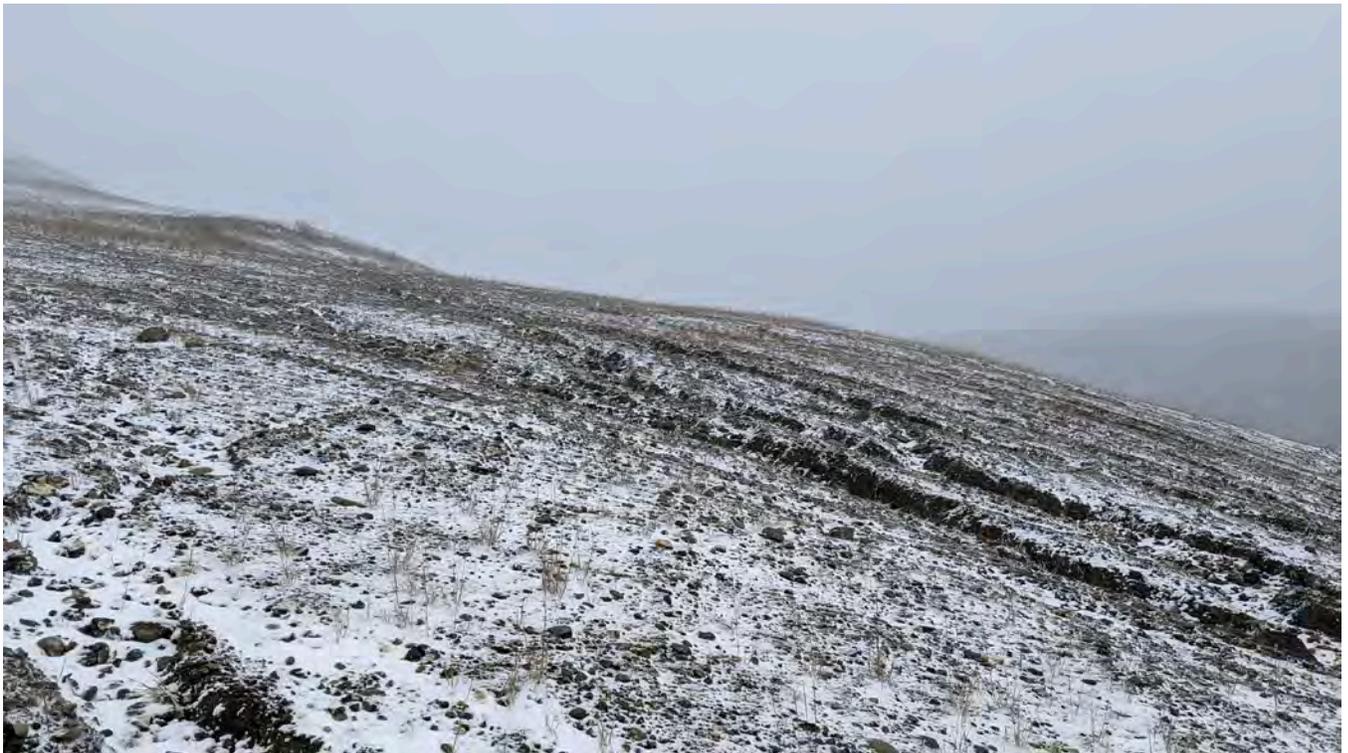
Photo WR-12: Jewelbox North Waste Rock Dump.

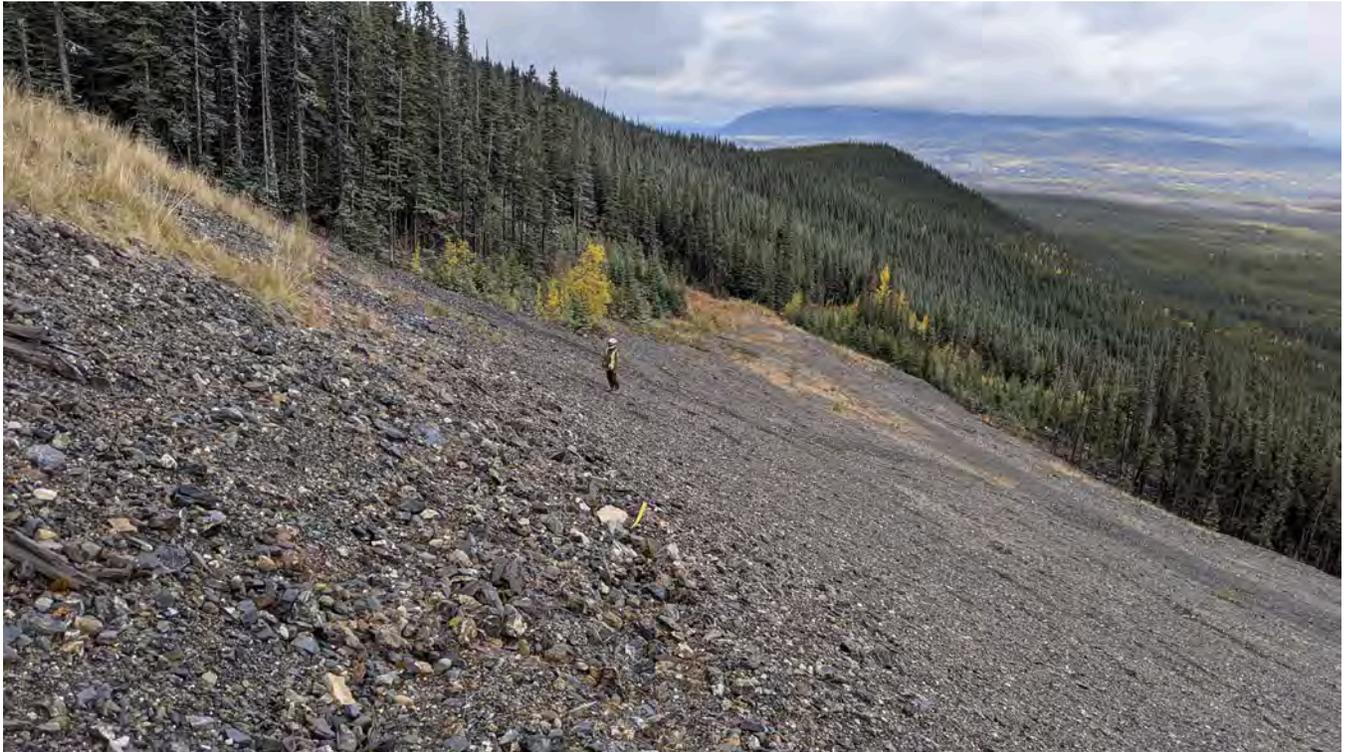
Photo WR-15: Regraded Burnick Waste Dump and 1200 Portal Area looking north.

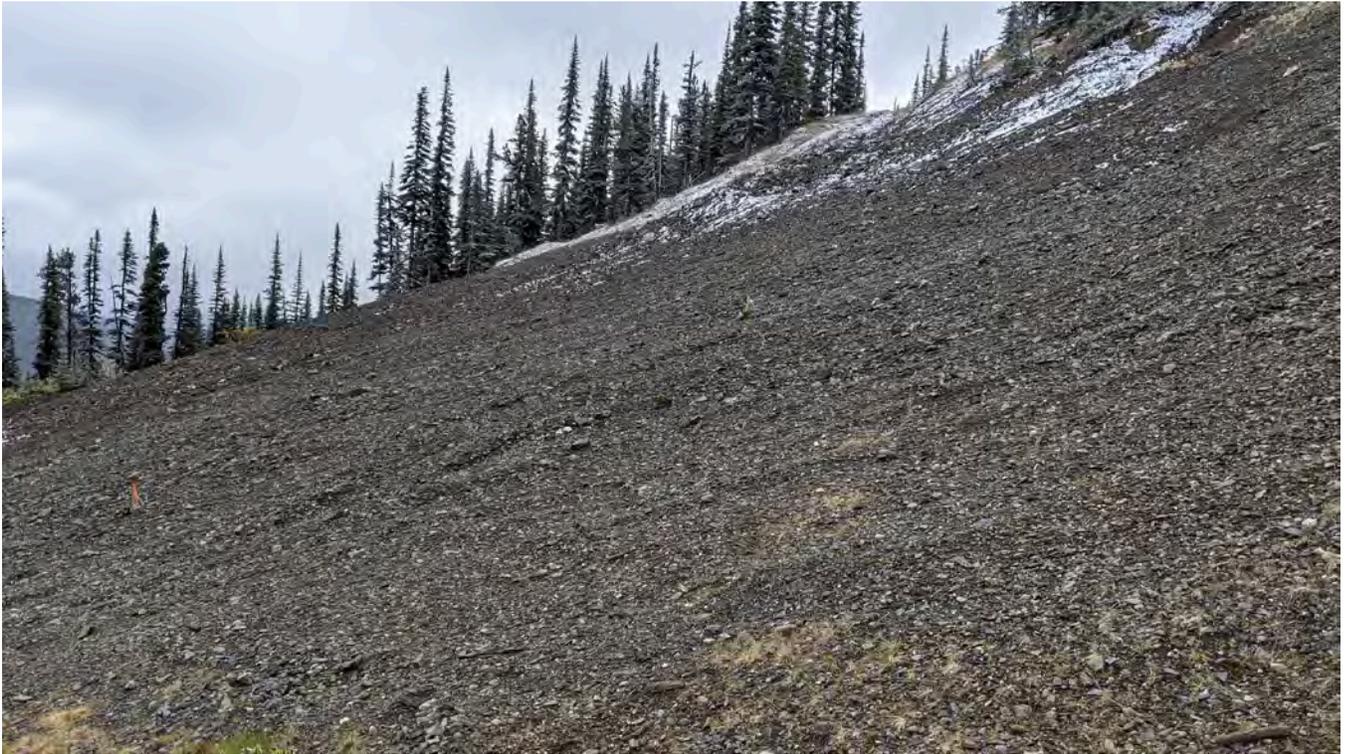
Photo WR-17: Regraded 1300 Portal Waste Rock Dump and 1300 Portal area.

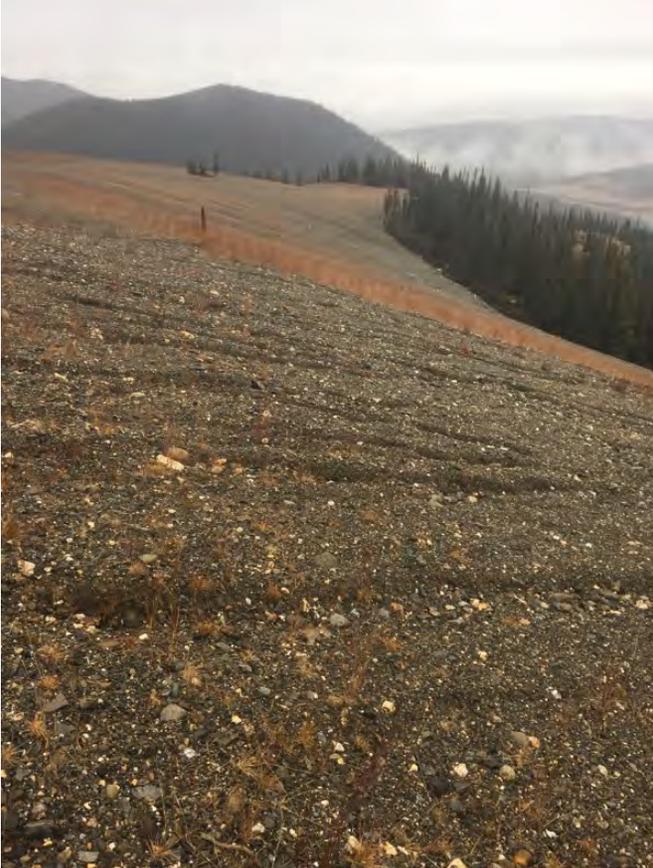
Photo Discription	Photo	Photo Location
Jewelbox rills

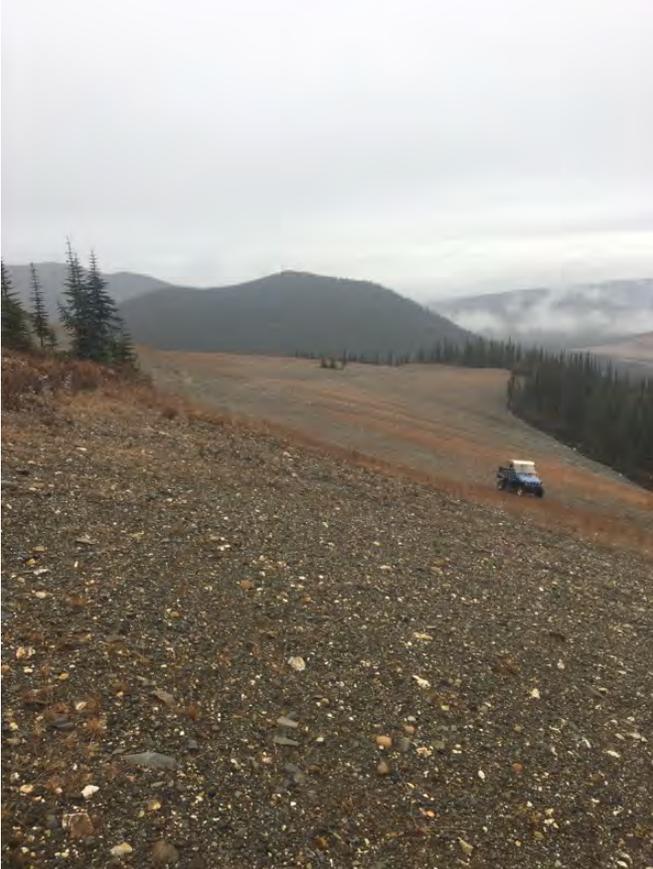
Photo Discription	Photo	Photo Location
Jewelbox vegetation

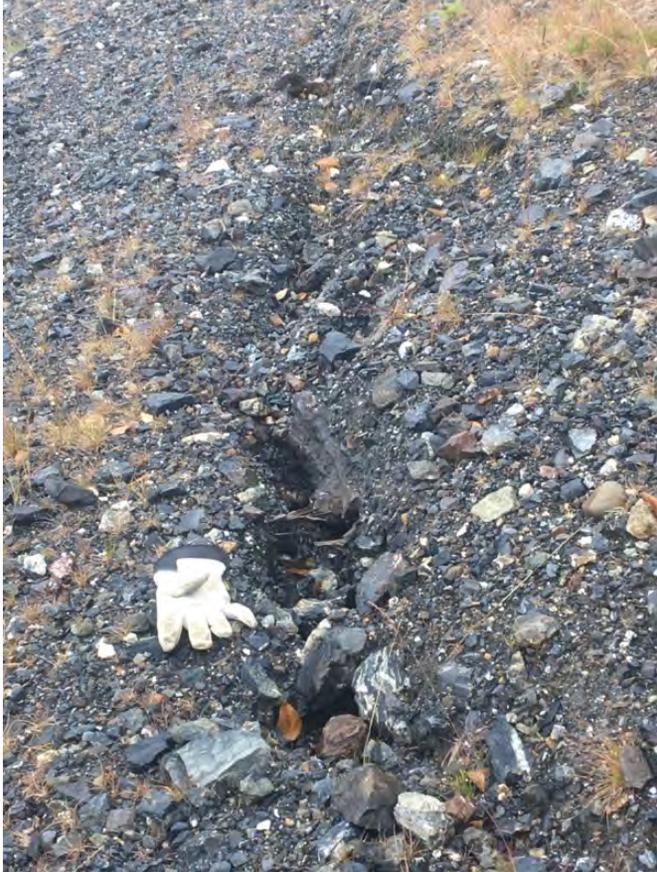
Burnick 1200 Waste Rock Dump  
**Cracks/Scarps**  
Small settlement crack along old portal area

Photo Discription	Photo	Photo Location
1200 portal crack

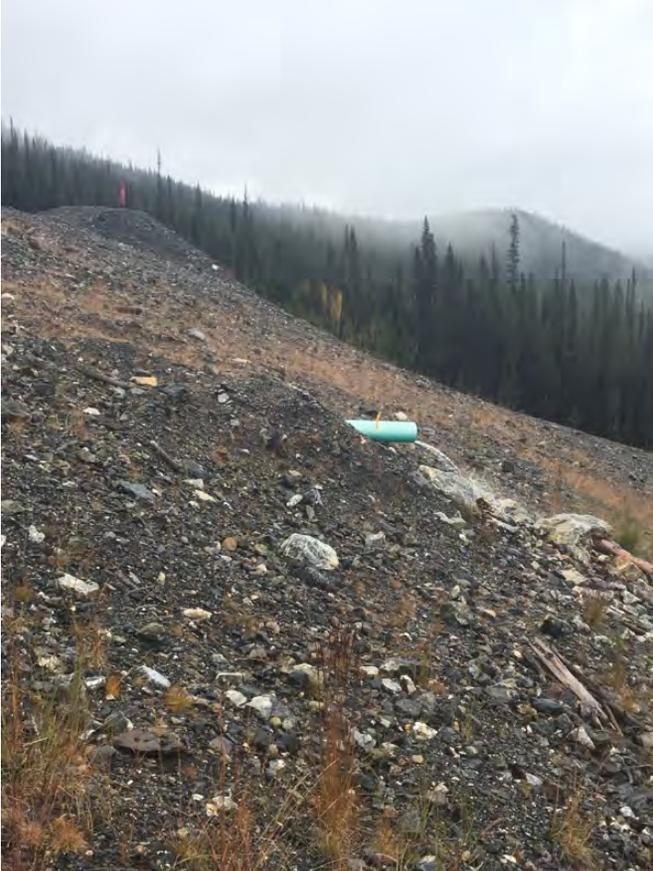
Photo Discription	Photo	Photo Location
1200 Burnick waste rock dump, portal drains

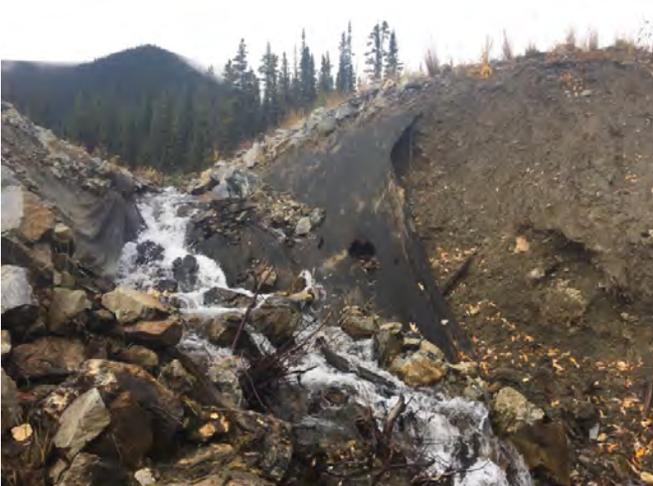
Photo Discription	Photo	Photo Location
Downstream erosion and exposed filter cloth

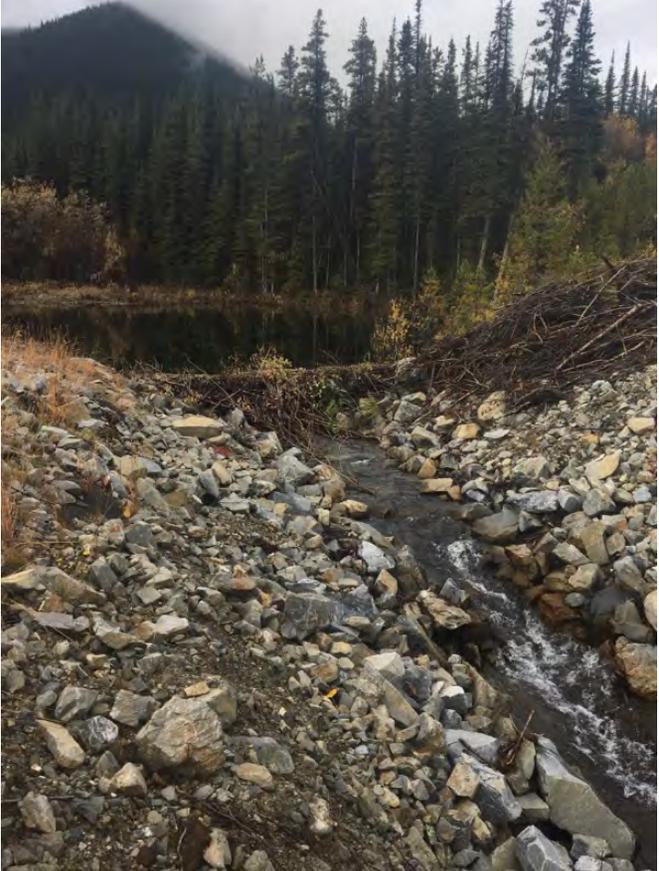
Photo Discription	Photo	Photo Location
Beaver blockage

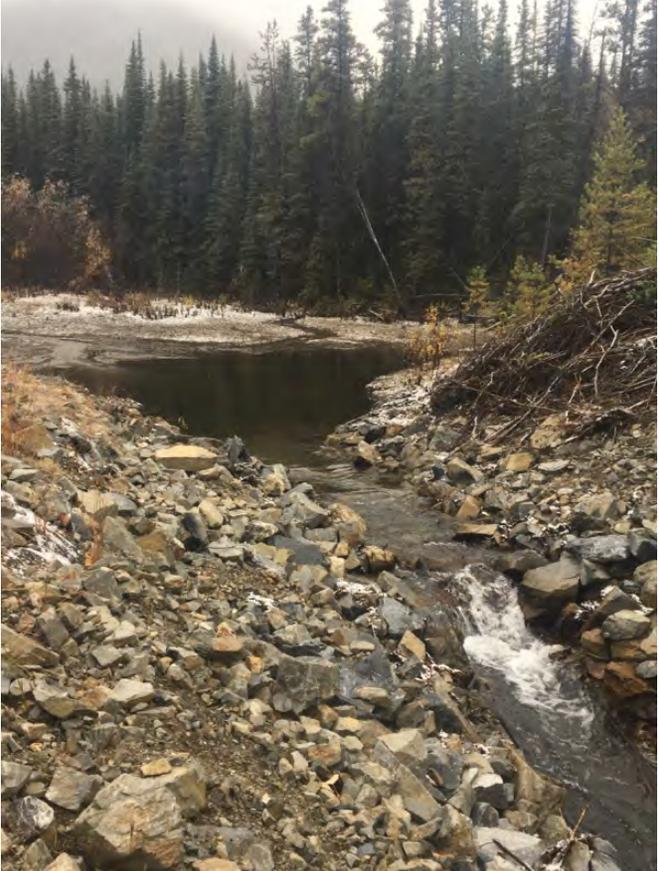
Photo Discription	Photo	Photo Location
Beaver blockage removed

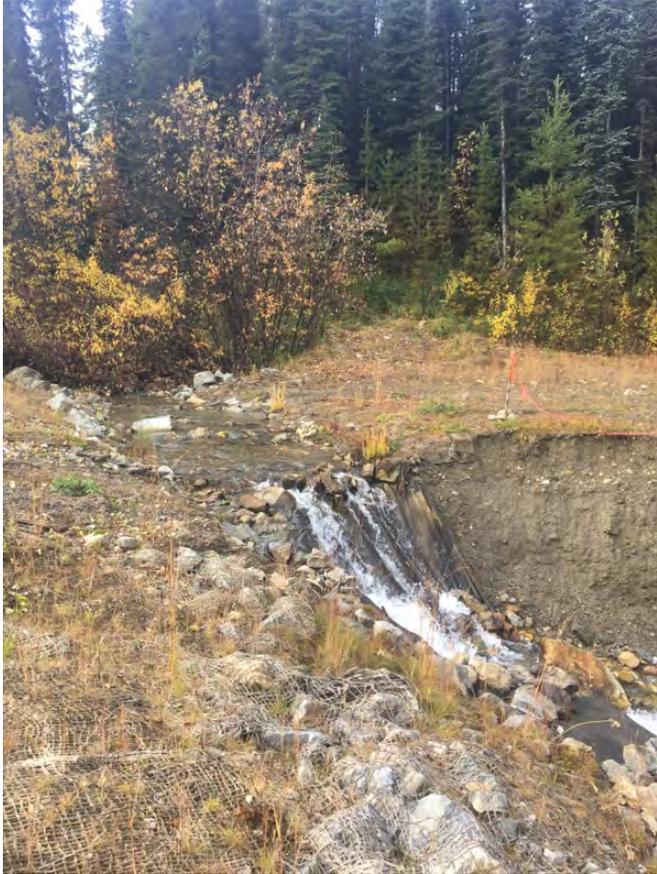
Photo Discription	Photo	Photo Location
<p>Discharge washed out from halfway point of crossing</p>

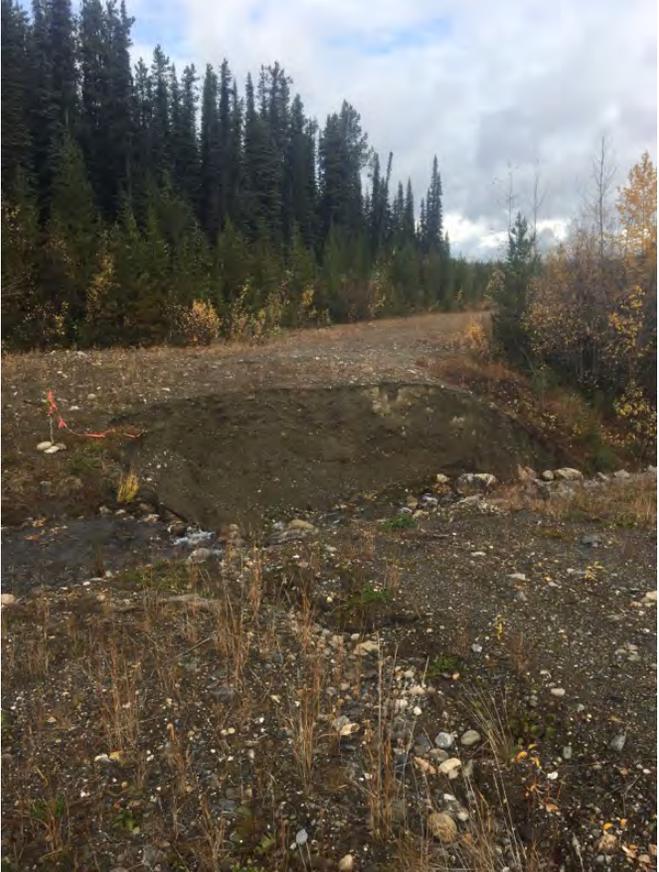
Photo Discription	Photo	Photo Location
Wash out expanding

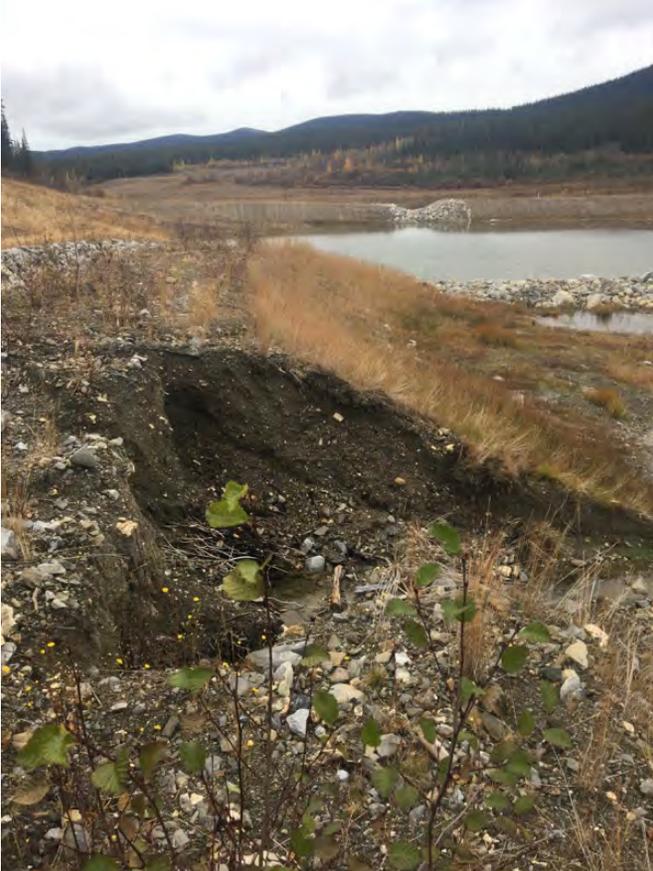
**Date:**  
27/09/2020  
**Slideslopes**  
Washout near SRS

Photo Discription	Photo	Photo Location
Washout to repair

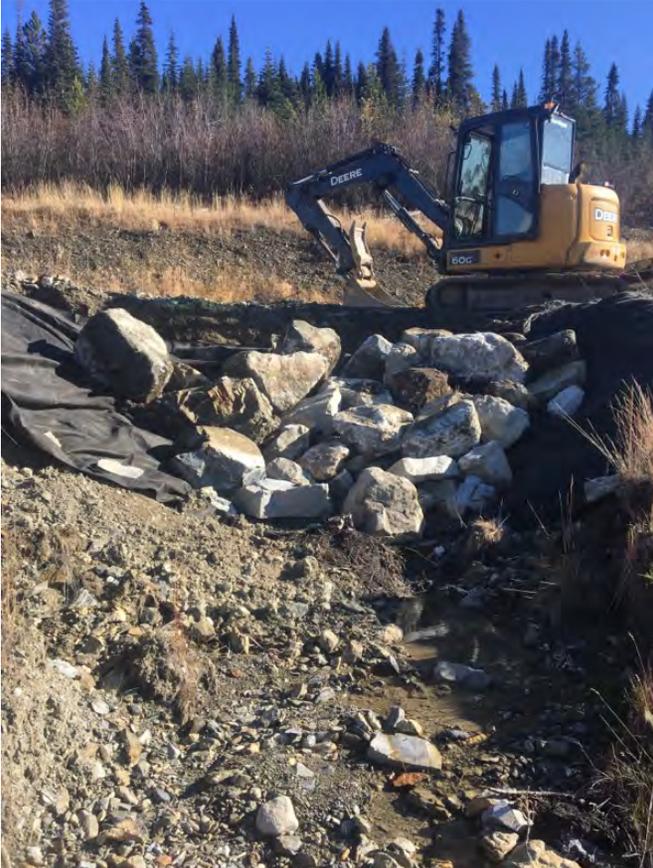
Photo Discription	Photo	Photo Location
Rip raping washout 1

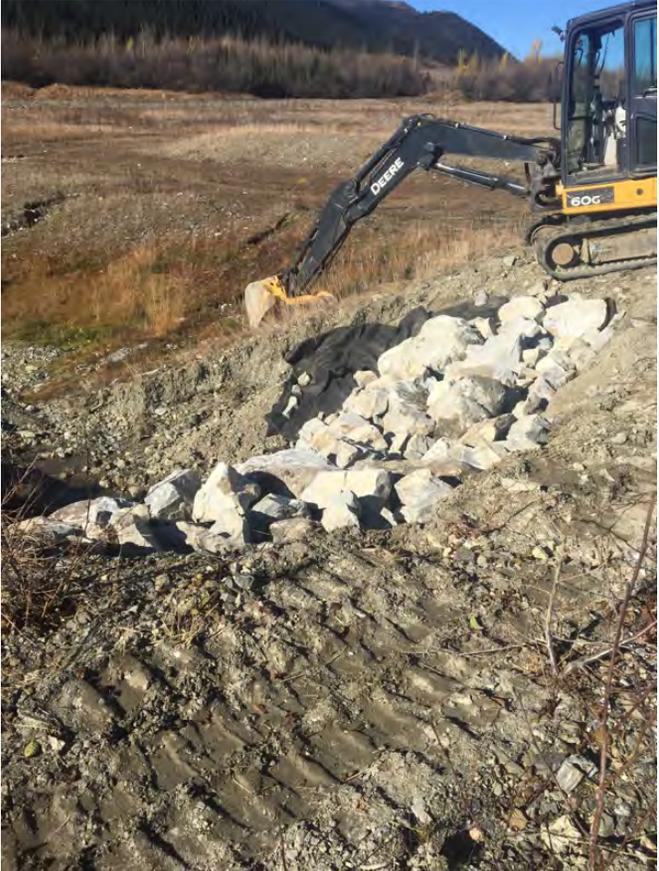
Photo Discription	Photo	Photo Location
Rip rap washout 2

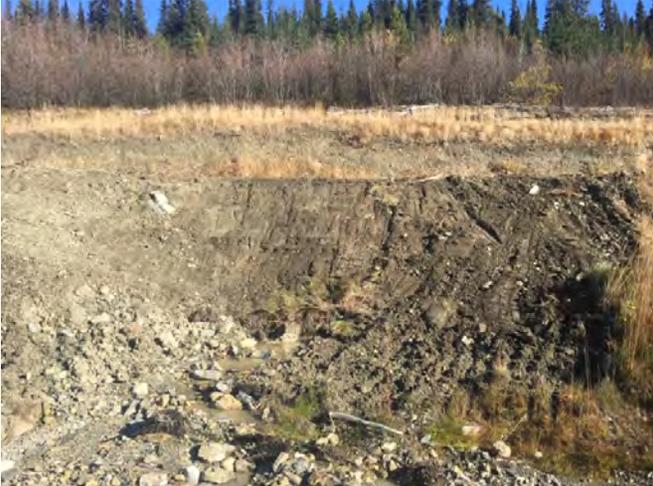
Photo Discription	Photo	Photo Location
Rip rap washout 3

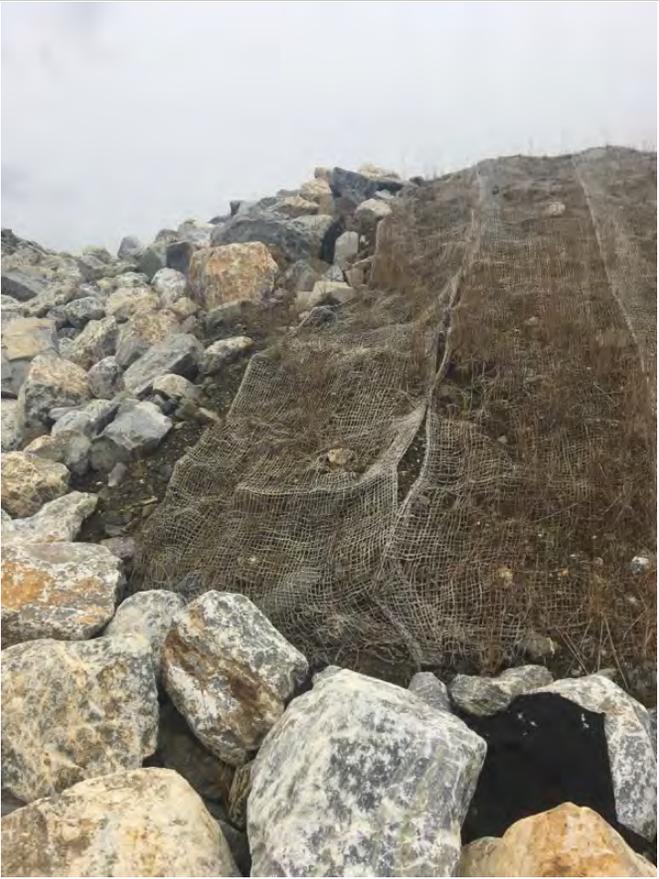
**Cracks/Movement**  
settlement cracks downstream side

Photo Discription	Photo	Photo Location
Cracking downstream slope

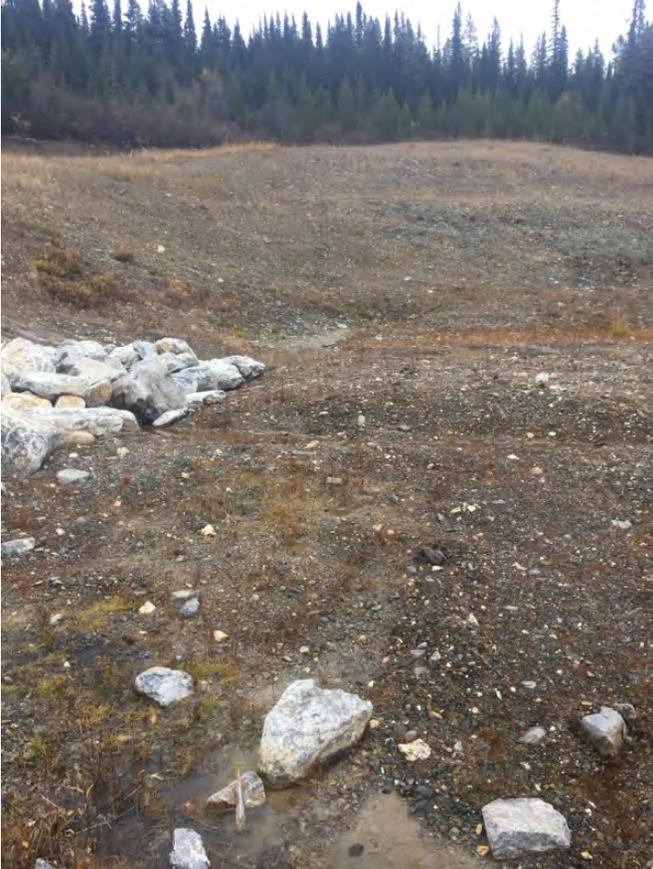
Photo Discription	Photo	Photo Location
Sidehill seepage

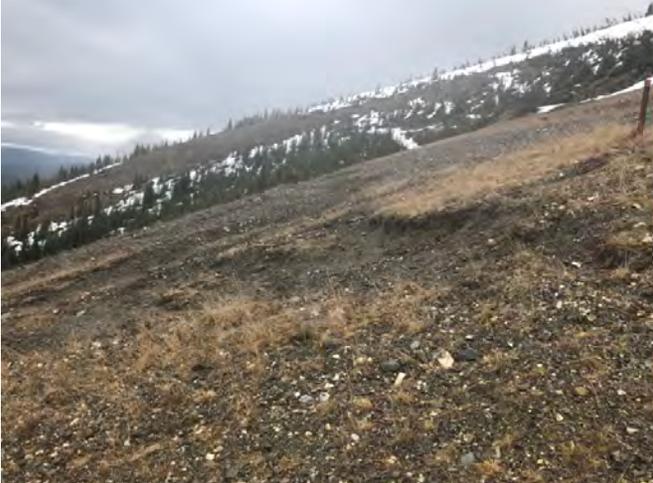
Photo Discription	Photo	Photo Location
Sloughing and settlements

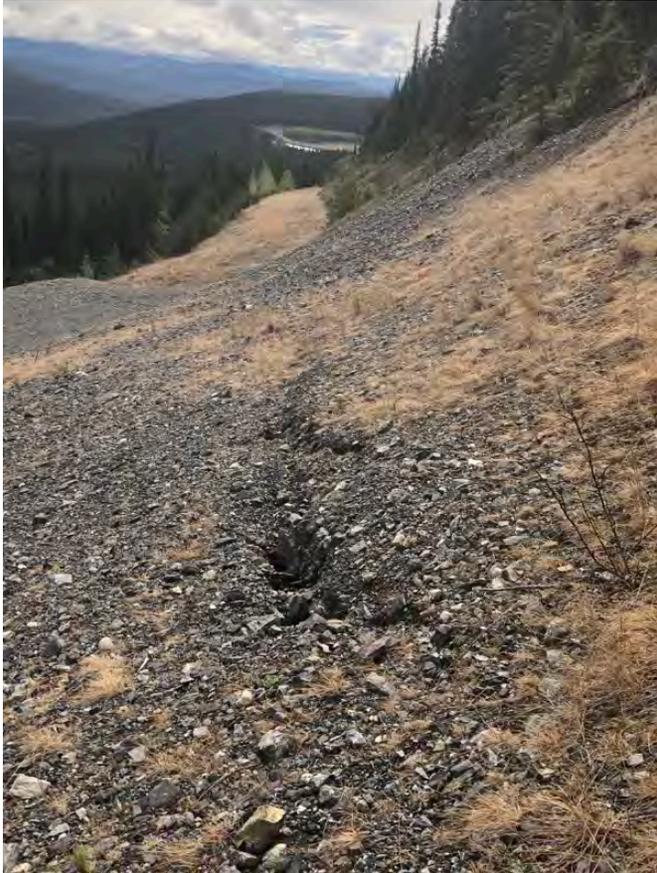
Minor horizontal settlement crack around old portal area

Photo Discription	Photo	Photo Location
<p>Minor crack-will likely silt in</p>

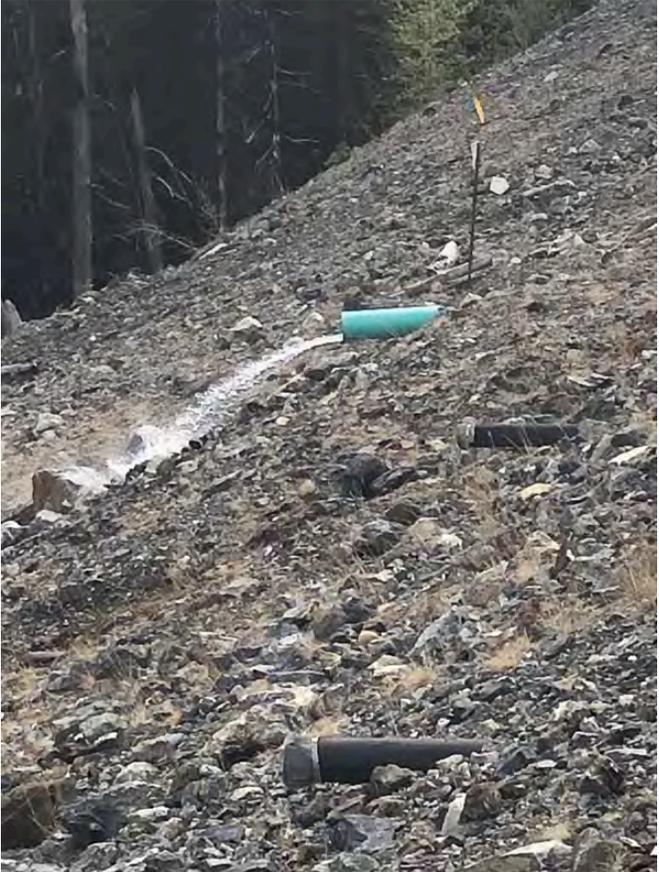
Heavy water flow from main portal drain and approx. 5 litres per min from one secondary drain  
Burnick 1300 Waste Rock Dump

Photo Discription	Photo	Photo Location
<p>Water flow from main portal drain and 1st overflow pipe</p>

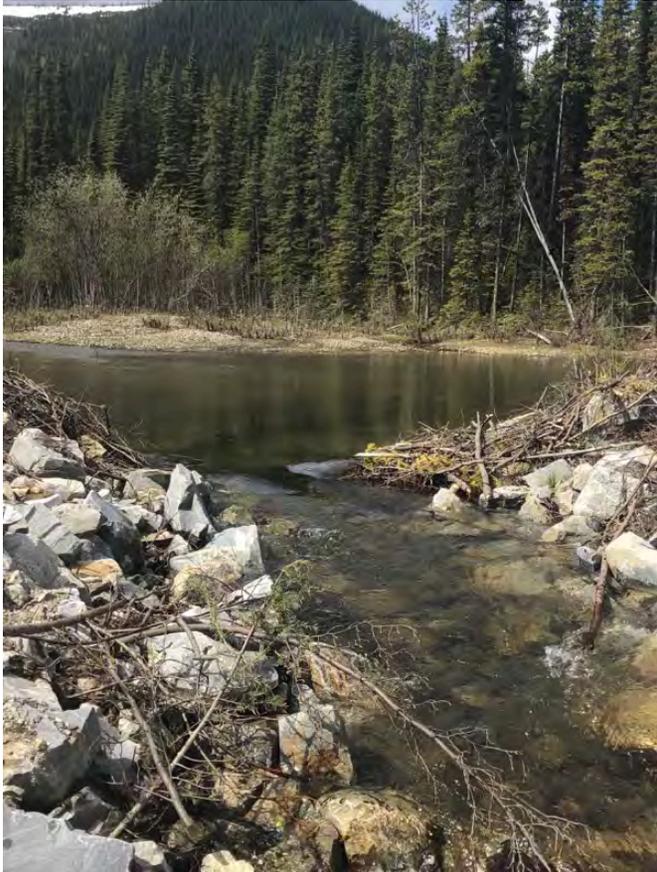
Photo Discription	Photo	Photo Location
Remove beaver debris

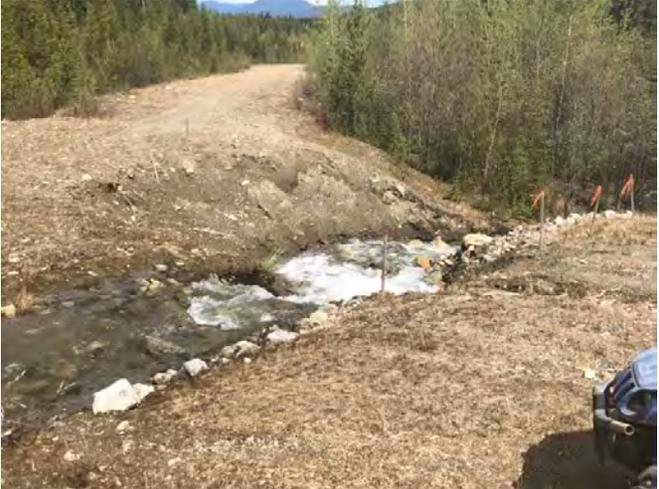
Photo Discription	Photo	Photo Location
Erosion at 2 nd crossing

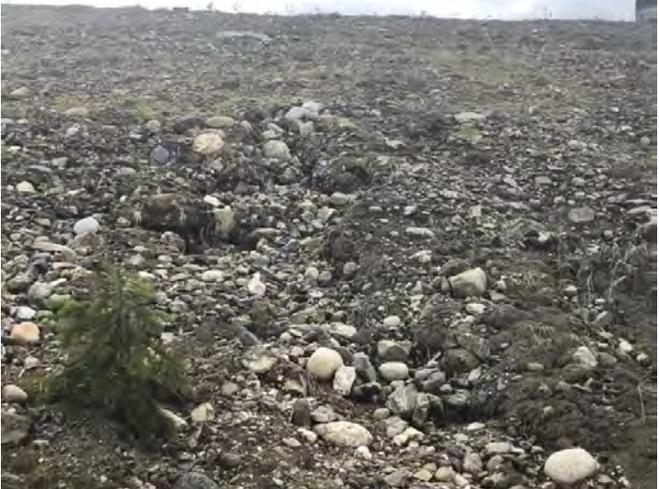
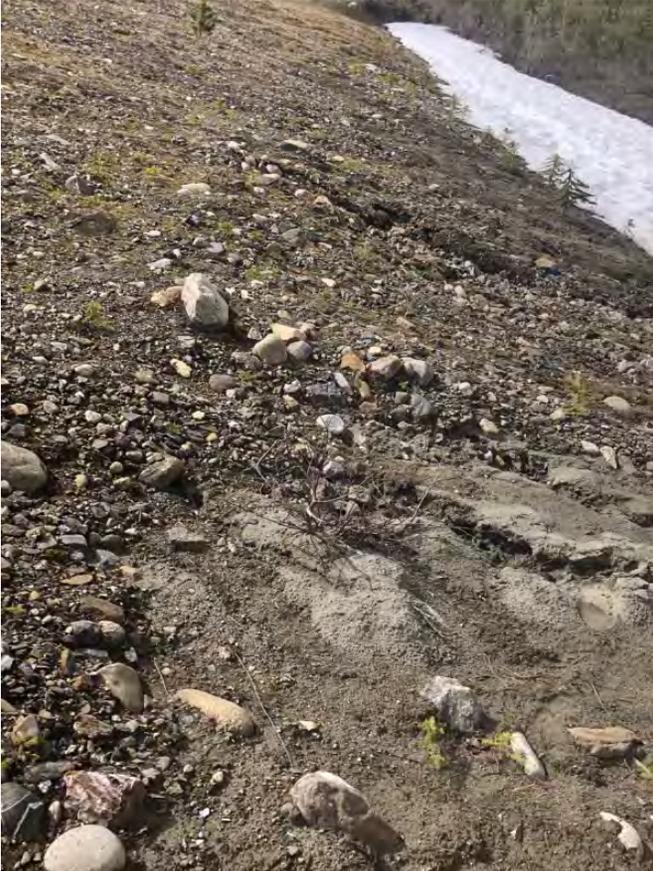
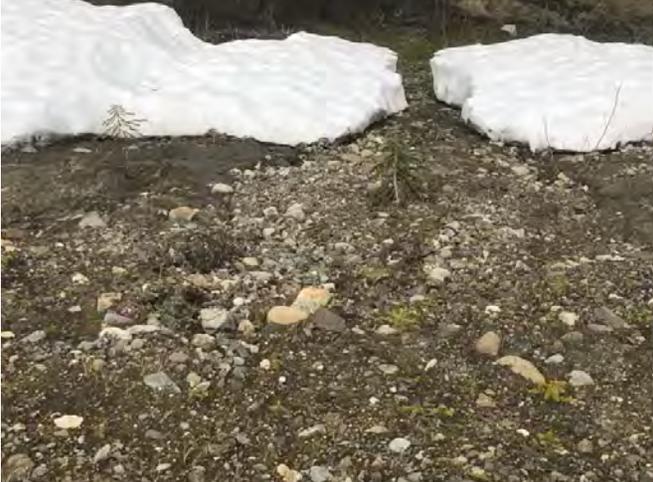
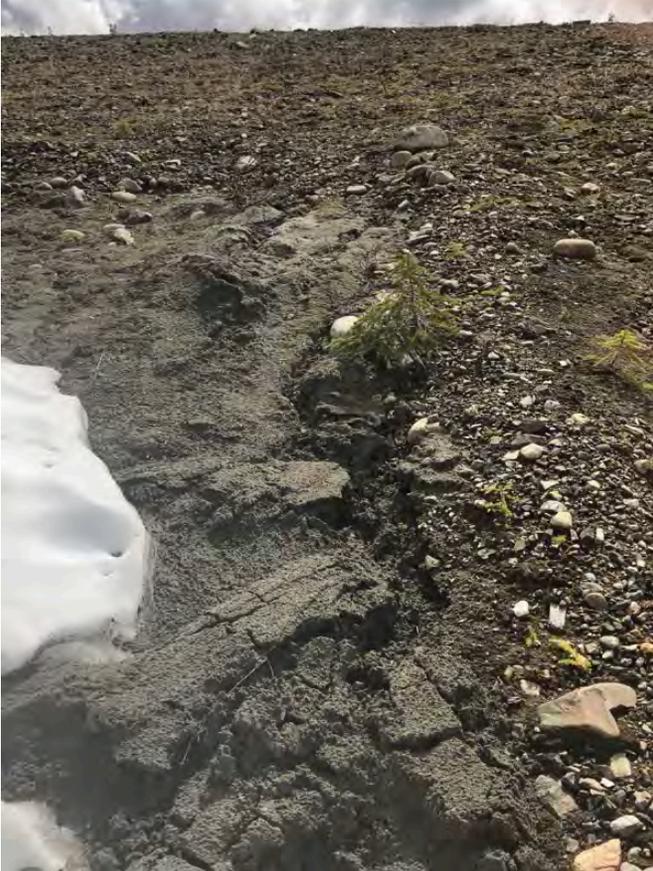
sand that was previously vegetated but now has a rill starting and vegetation washed off. Pics attached. Upon further probing and inspecting determined it was caused by water runoff flowing between the layer of 5-10cm thick organic mat but on top of the dam fill materials washing the rocks off to give the appearance. Probed with a bar and found no signs of holes or depressions deeper than the washed off surface materials or any indication seeps.

Photo Discription	Photo	Photo Location
Unusual erosion

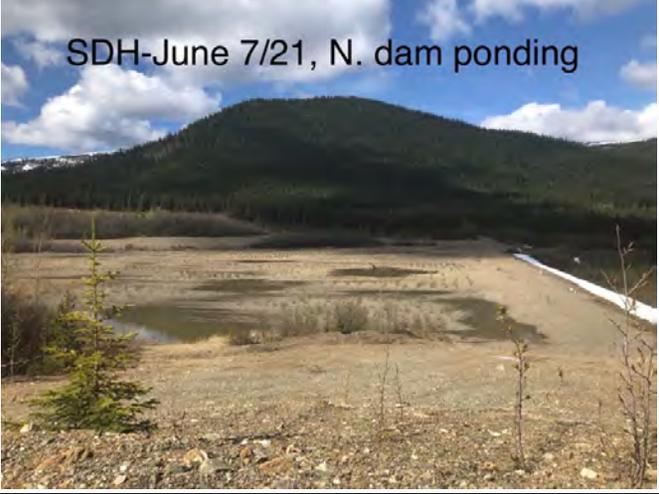
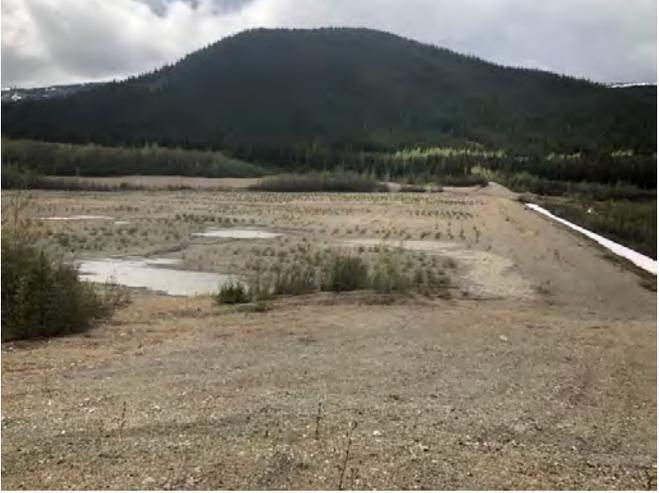
Some shallow ponding in N/E corner of soil cap 30 m from dam crest, slowly draining away from crest. Cleaned center swail and diverted water away from crest and made new drainage ditches by hand to speed up drainage. Sediment buildup, leaves and heaving are the cause.

Photo Discription	Photo	Photo Location
Ponded water before draining

<p>SDH-June 7/21, N. dam ponding</p>	
Ponded water after draining

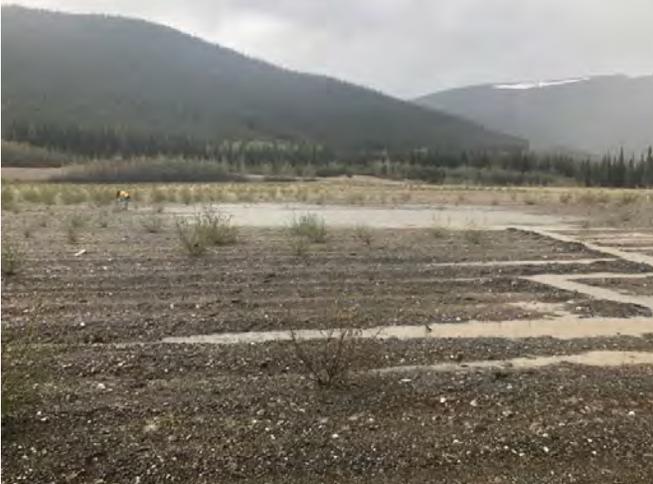
Photo Discription	Photo	Photo Location
Assist drainages

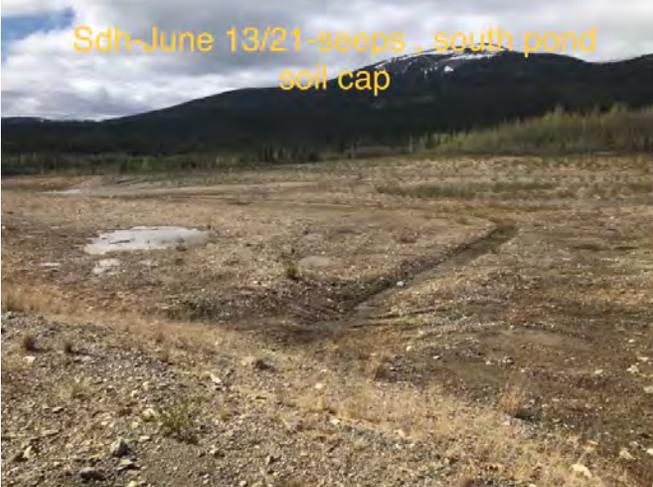
<p>Erosion No Issues</p>	<p>remove sediment build ups with shovels as needed Evaporite Salts No Issues</p>	<p>Hillside seepage appears to be migrating underneath the diversion channel where rip rap was repaired</p>
------------------------------	---	---

Hillside seeps

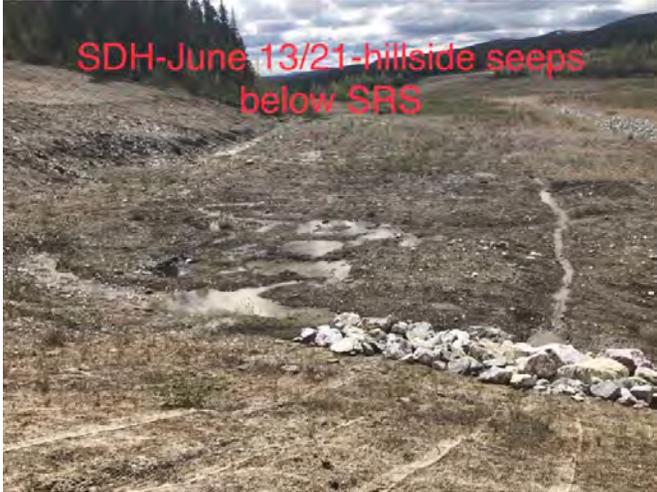
Photo Discription	Photo	Photo Location
Below SRS hillside seepage

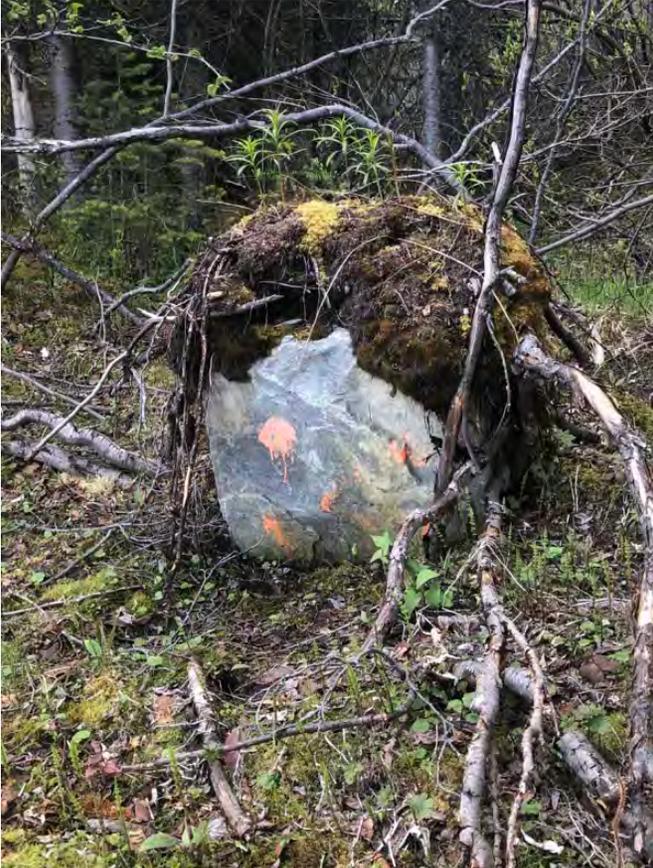
Photo Discription	Photo	Photo Location
Smiley face getting a little faded

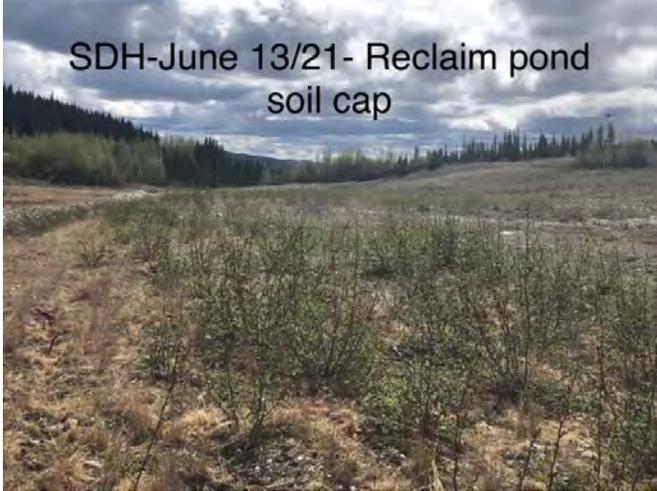
Photo Discription	Photo	Photo Location
Reclaim soil cap
