Teck Metals Ltd.

Sullivan TSF 2021

Annual Summary of Tailings Facility Performance Report

March 25, 2022

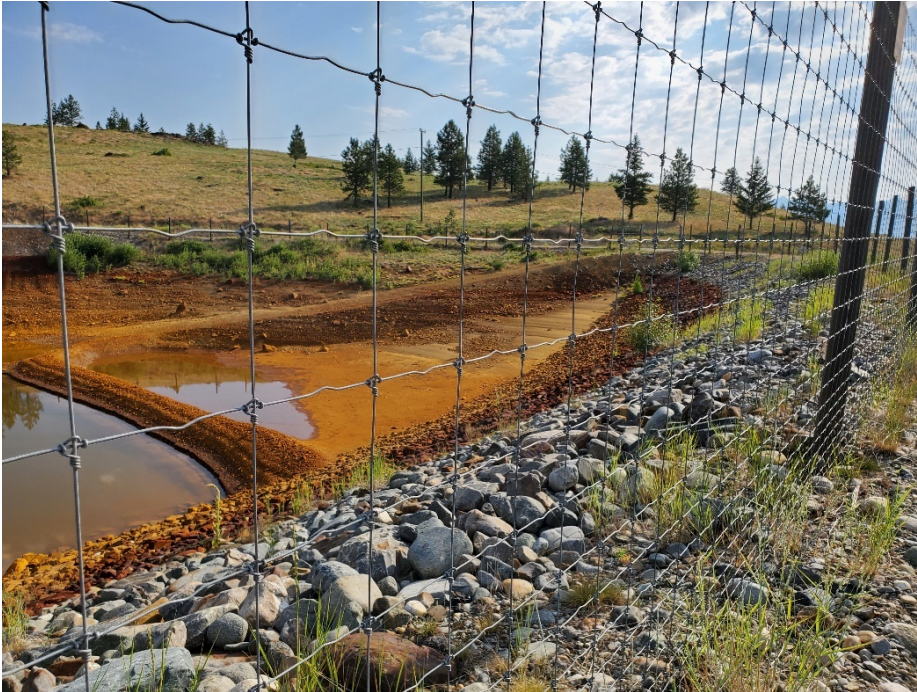
Photo II.1 ARD South Dam Upstream Slope

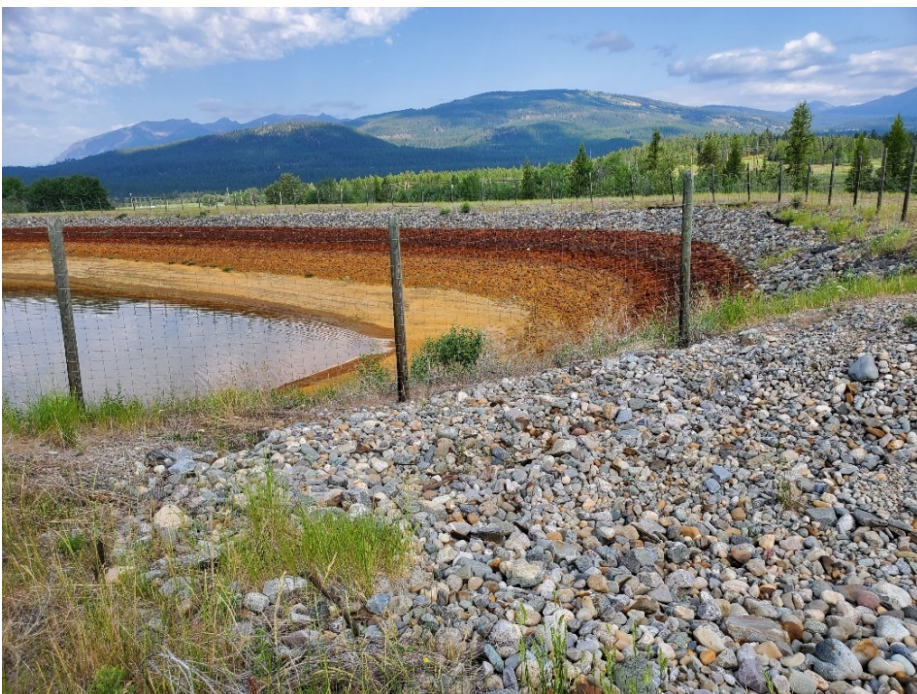
Photo II.2 North Dam Upstream Slope

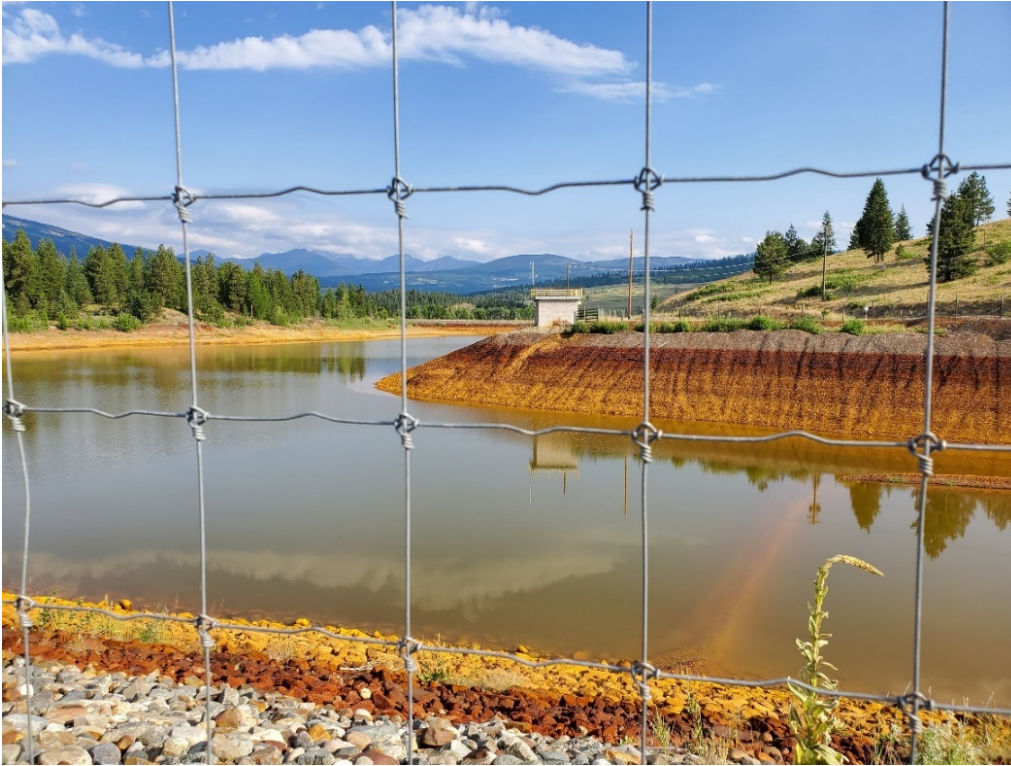
Photo II.3 Erosion adjacent to pumphouse

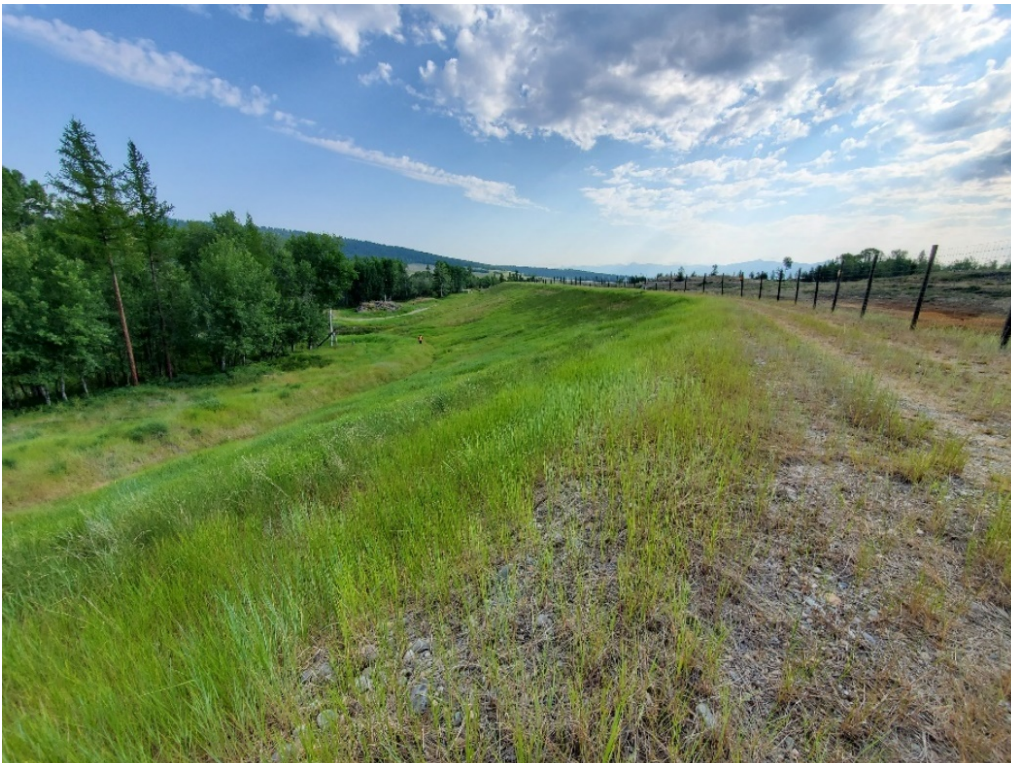
Photo II.4 ARD North Dam Downstream Slope

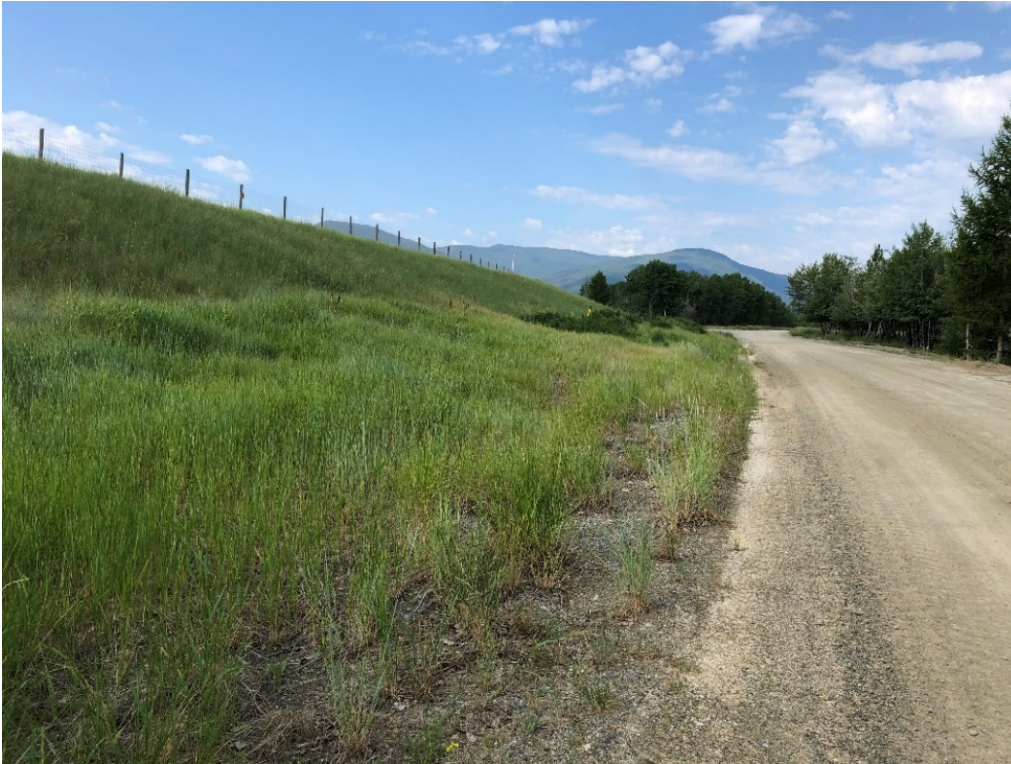
Photo II.5 **Vegetation at toe of North Dam**

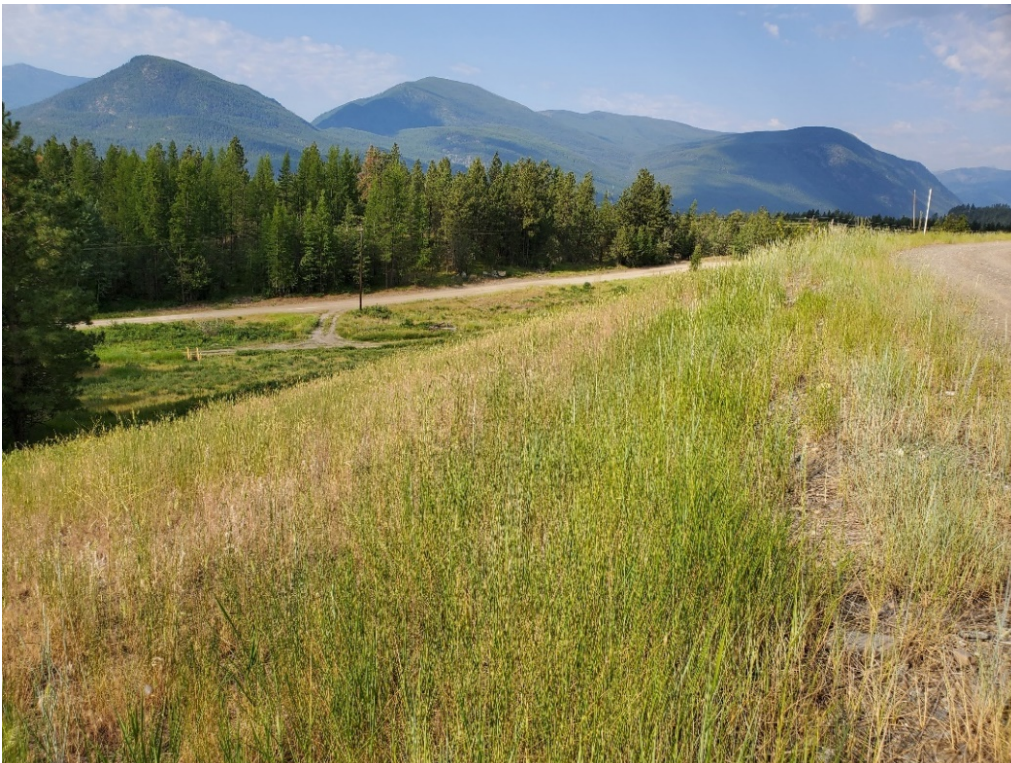
Photo II.6 **South Dam Downstream Slope**

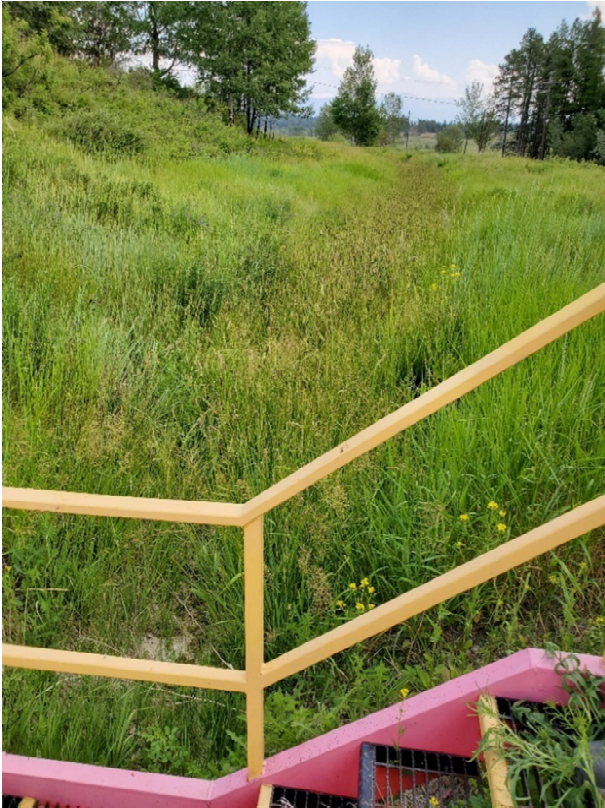
Photo II.7 Weir 1 downstream ditch

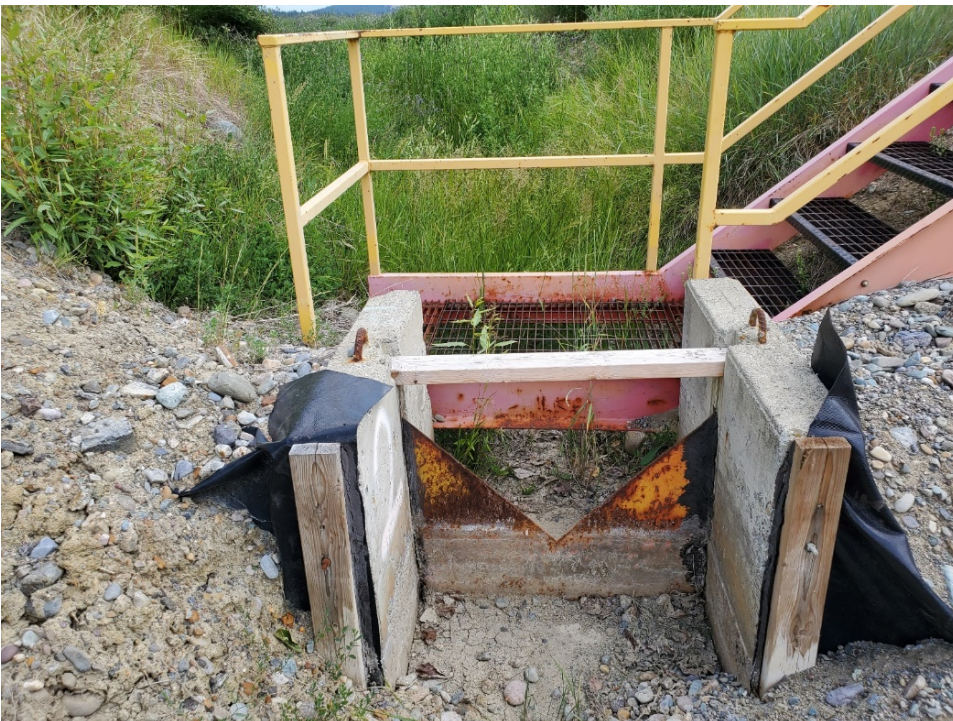
Photo II.8 Weir 2 – AIPWU

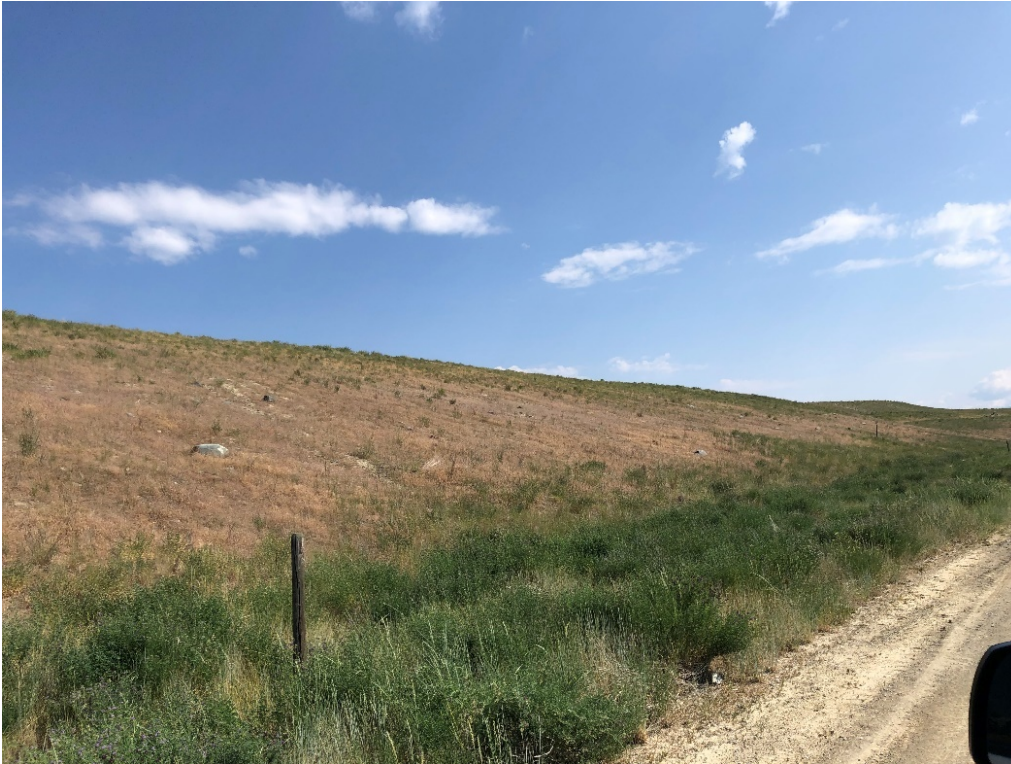
Photo II.9 Iron Dike Downstream Slope

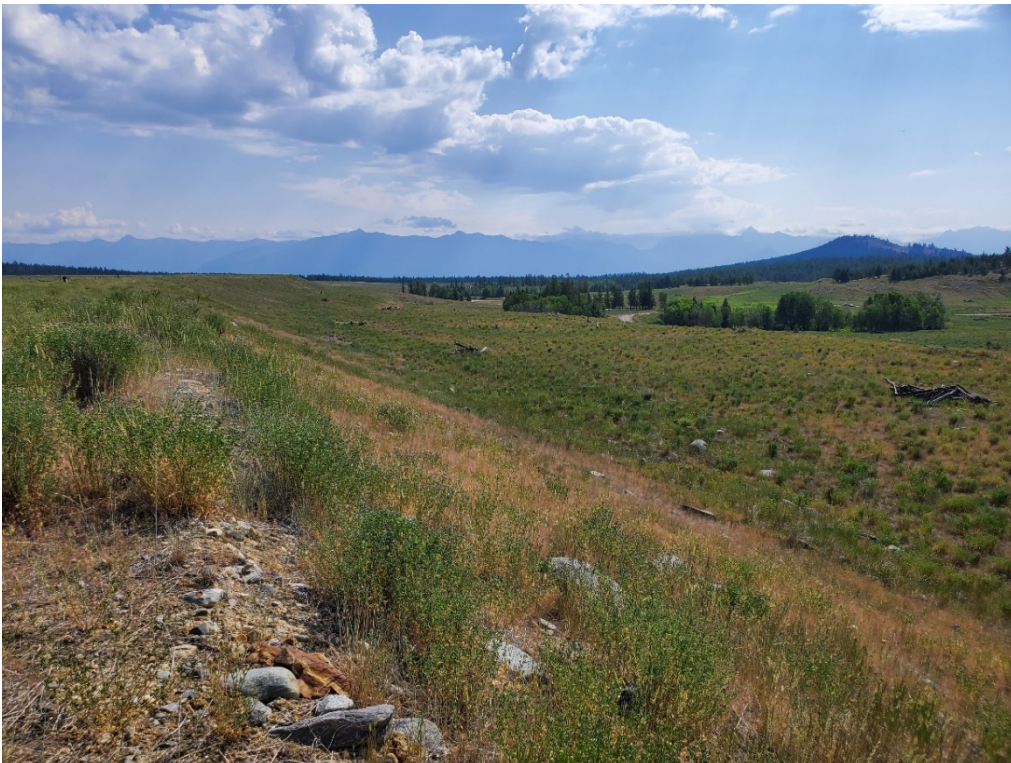
Photo II.10 Iron Dike Crest and Crest of Toe Berm

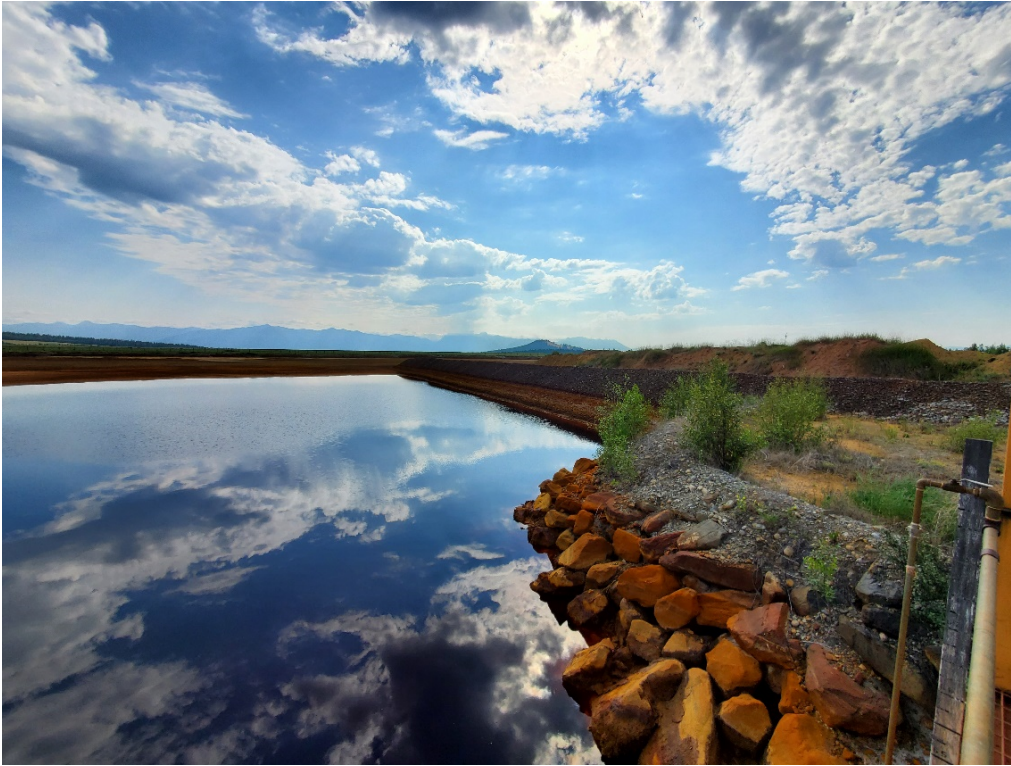
Photo II.11 Overview of Iron Pond

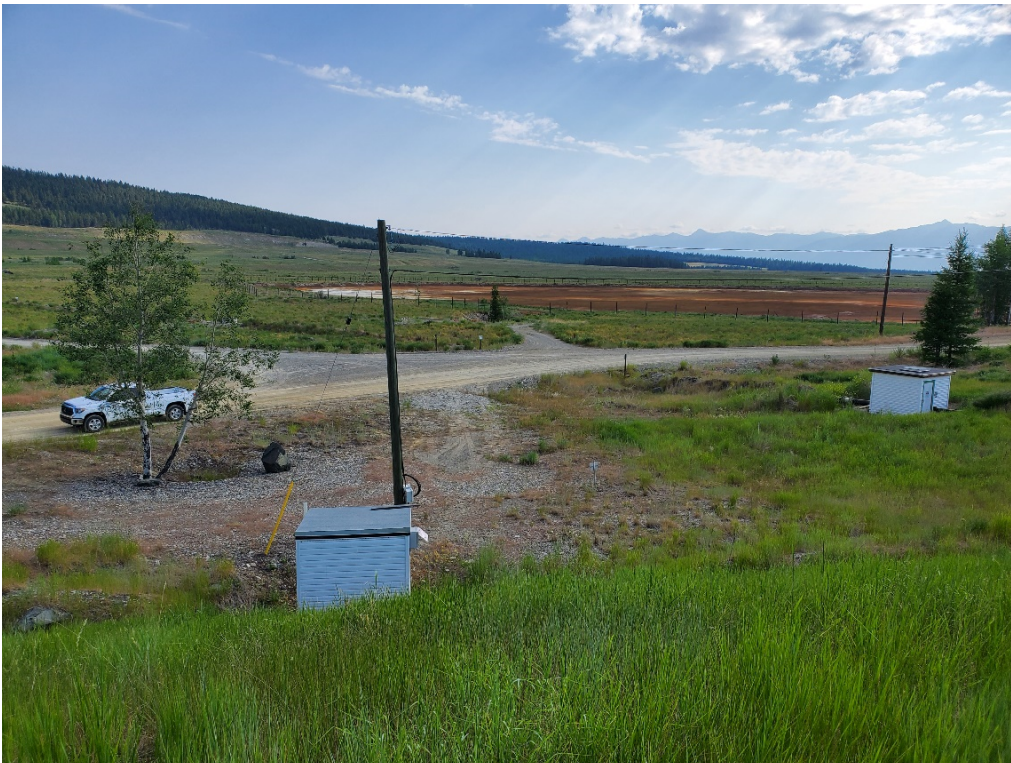
Photo II.12 Overview of Iron TSF looking towards Iron Pond

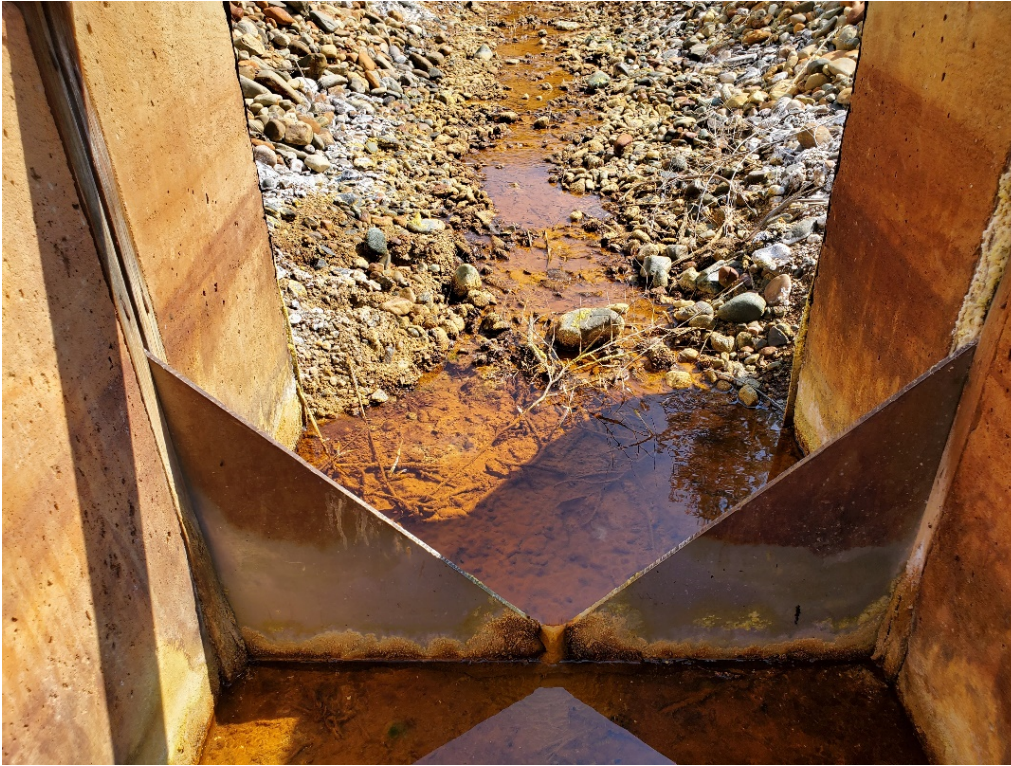
Photo II.13 Weir #3

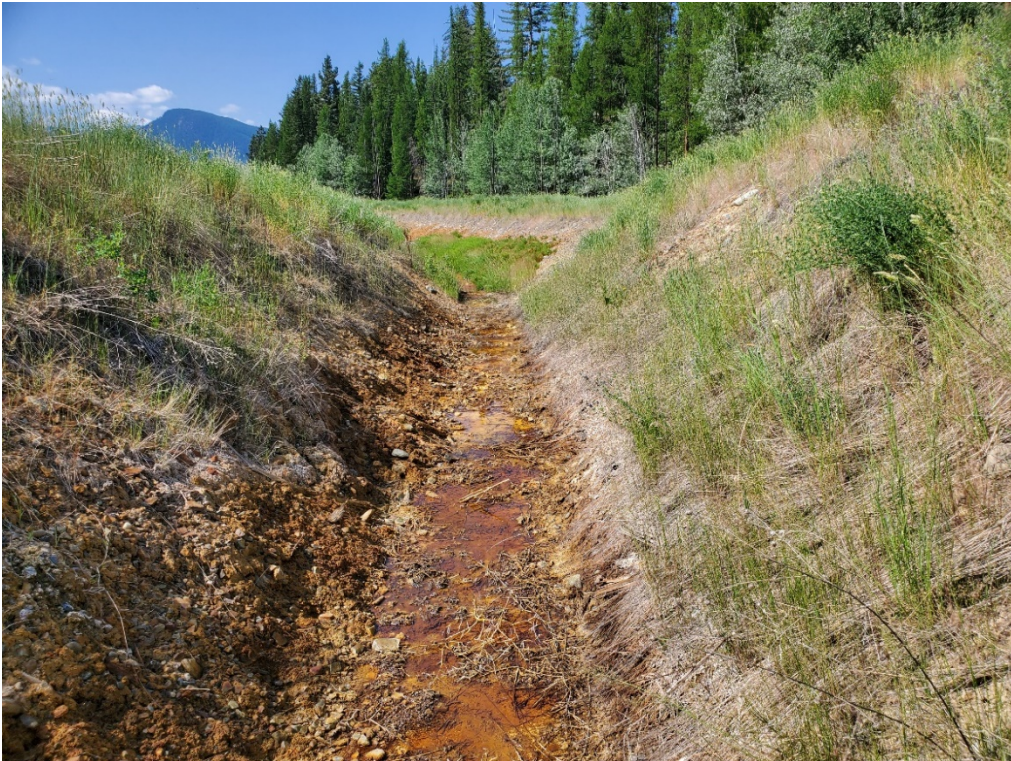
Photo II.14 Channel Downstream of Weir #3

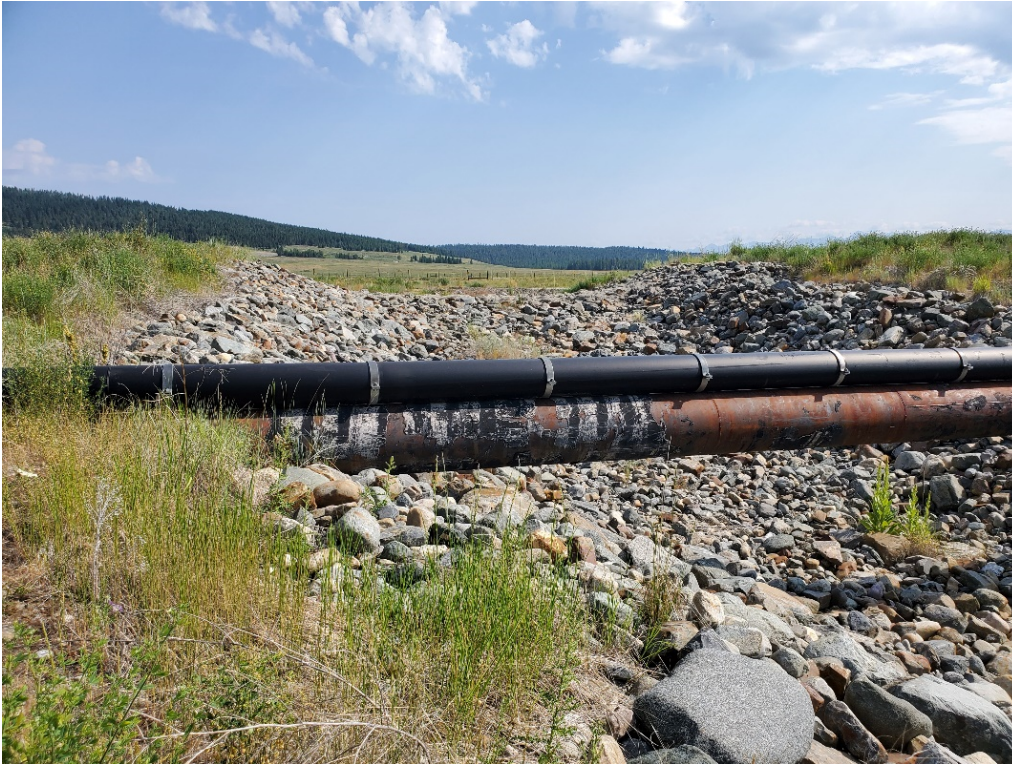
Photo II.17 Emergency Spillway Channel Inlet

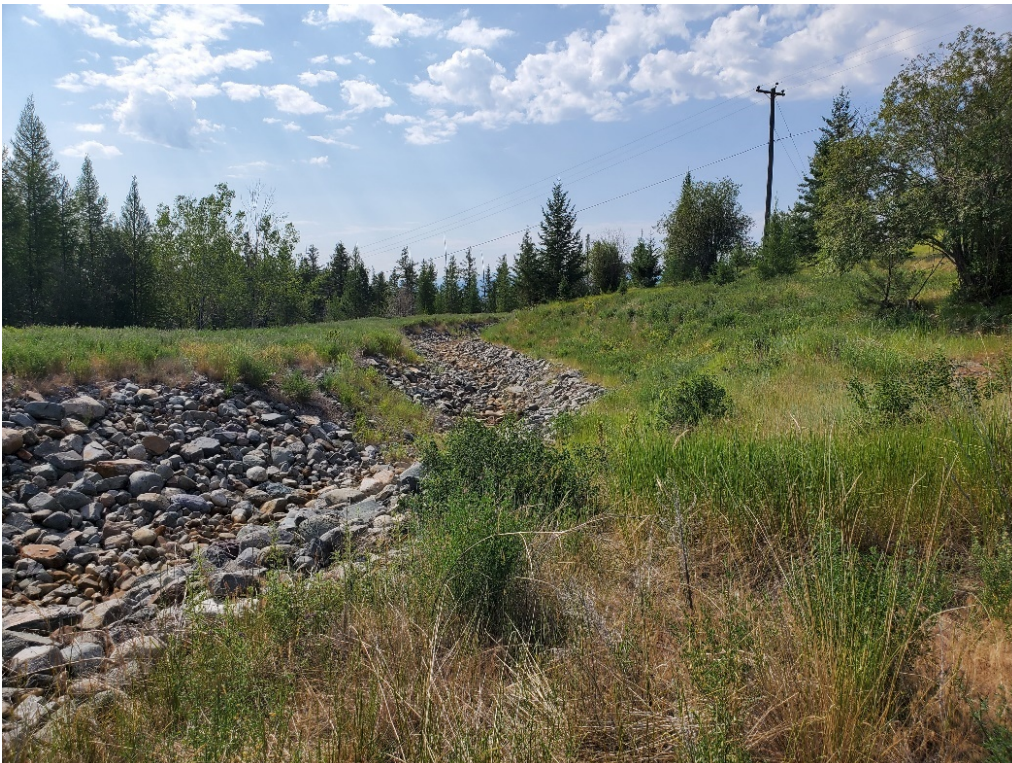
Photo II.18 Emergency Spillway Channel upper section looking downstream from inlet

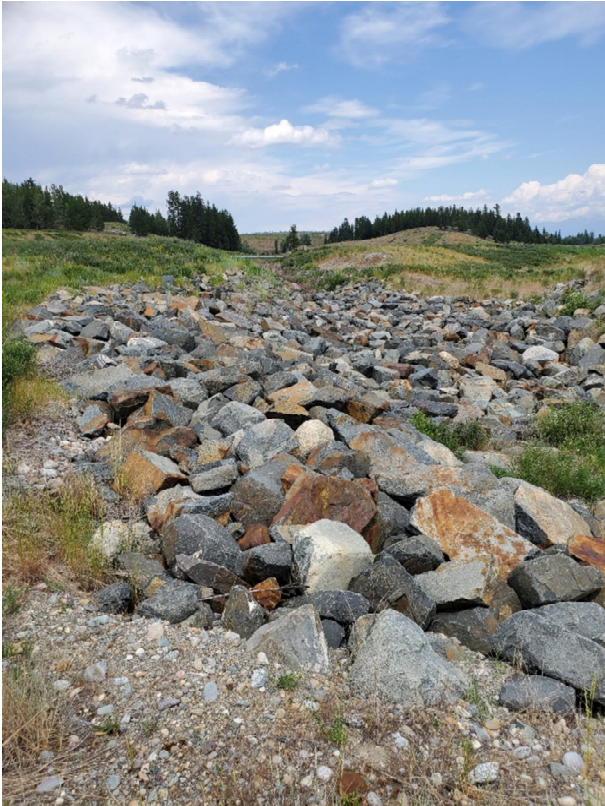
Photo II.19 Emergency Spillway Channel looking upstream from connection to West Gypsum TSF

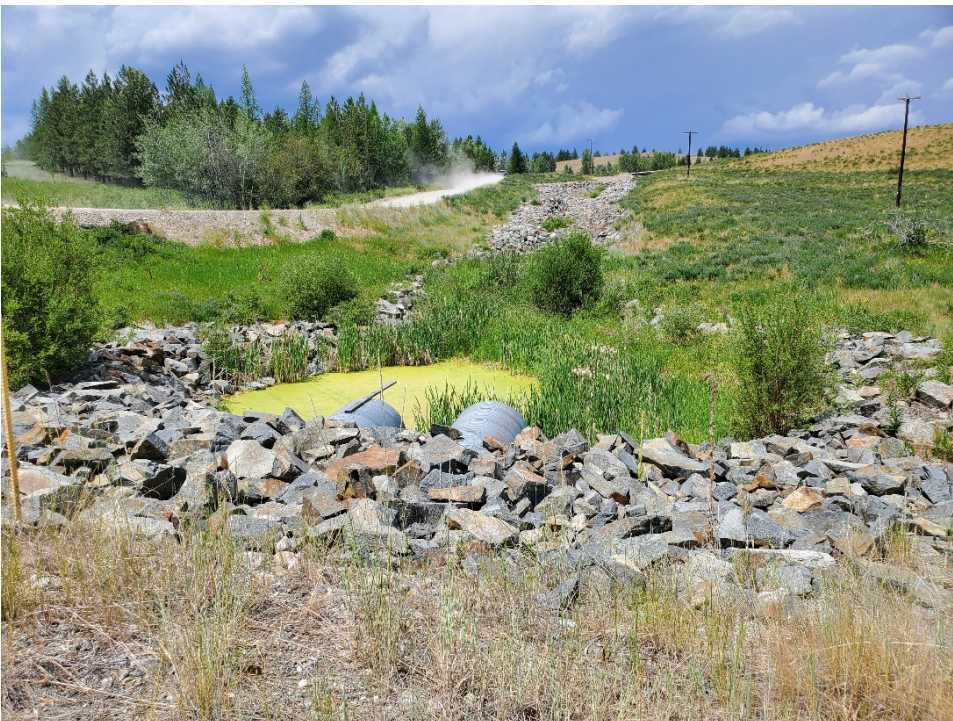
Photo II.20 Emergency Spillway Channel outlet to Cow Creek

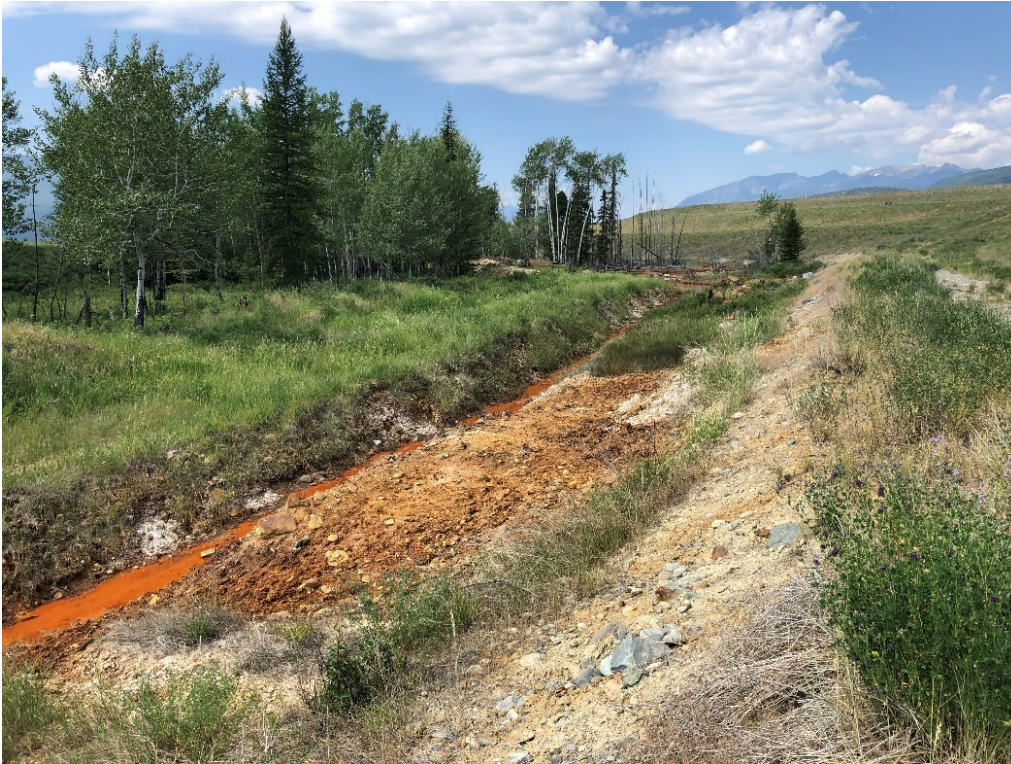
Photo II.21 No. 1 Siliceous Dike

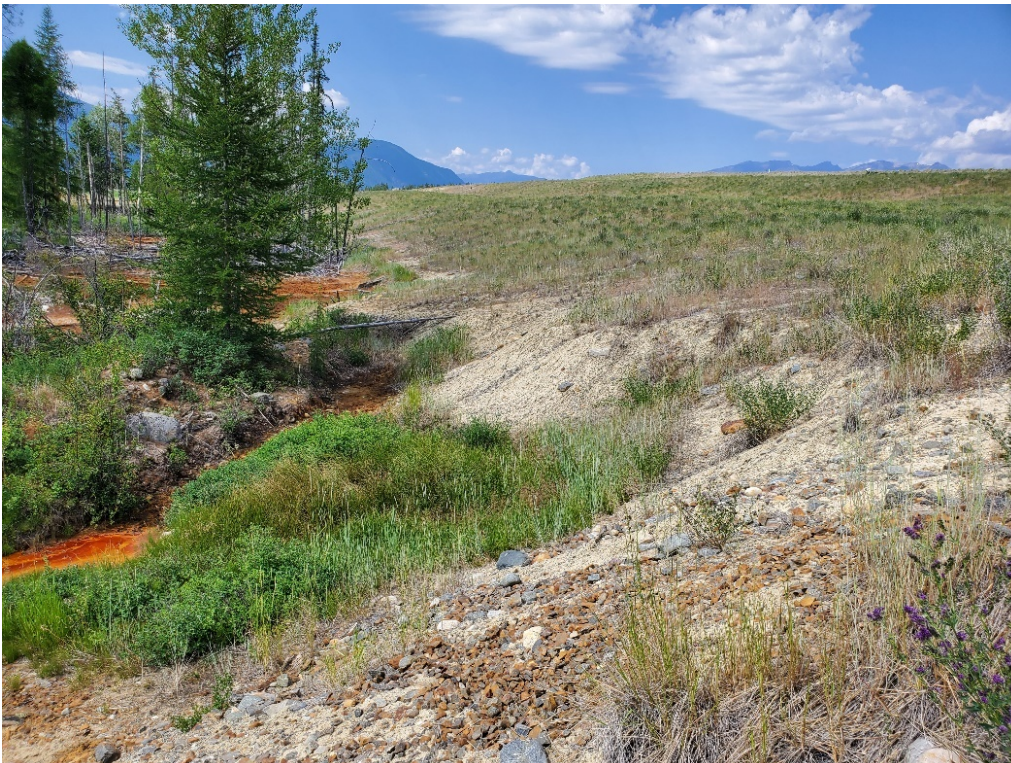
Photo II.22 No. 2 Siliceous Dike

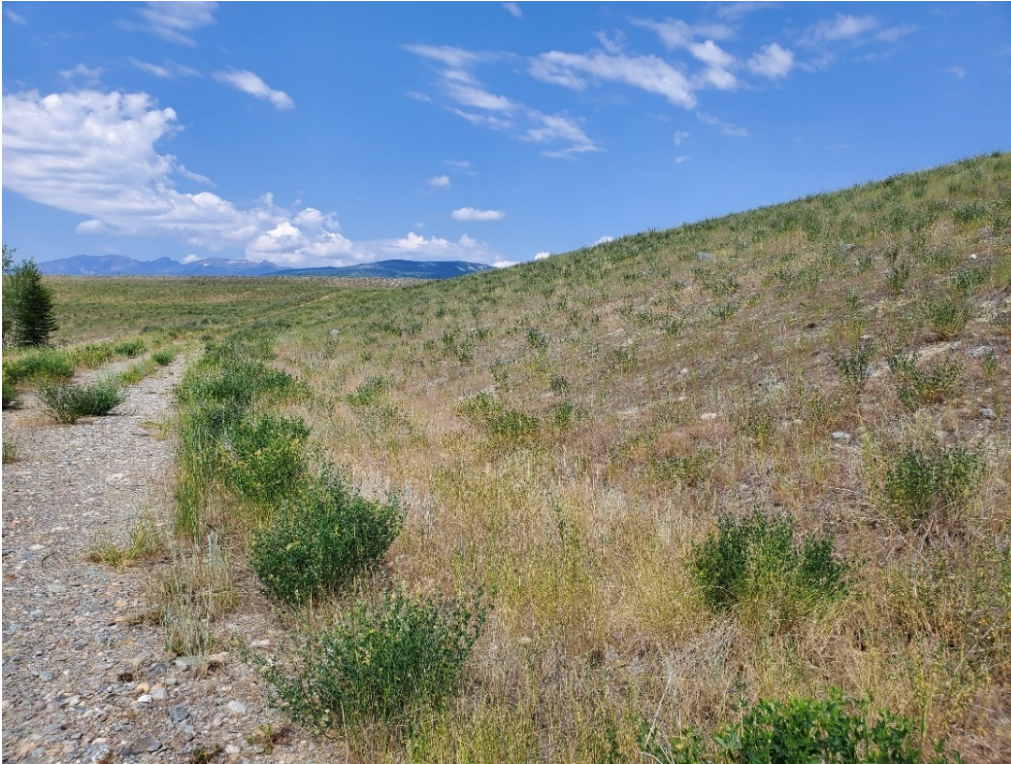
Photo II.23 No. 3 Siliceous Dike

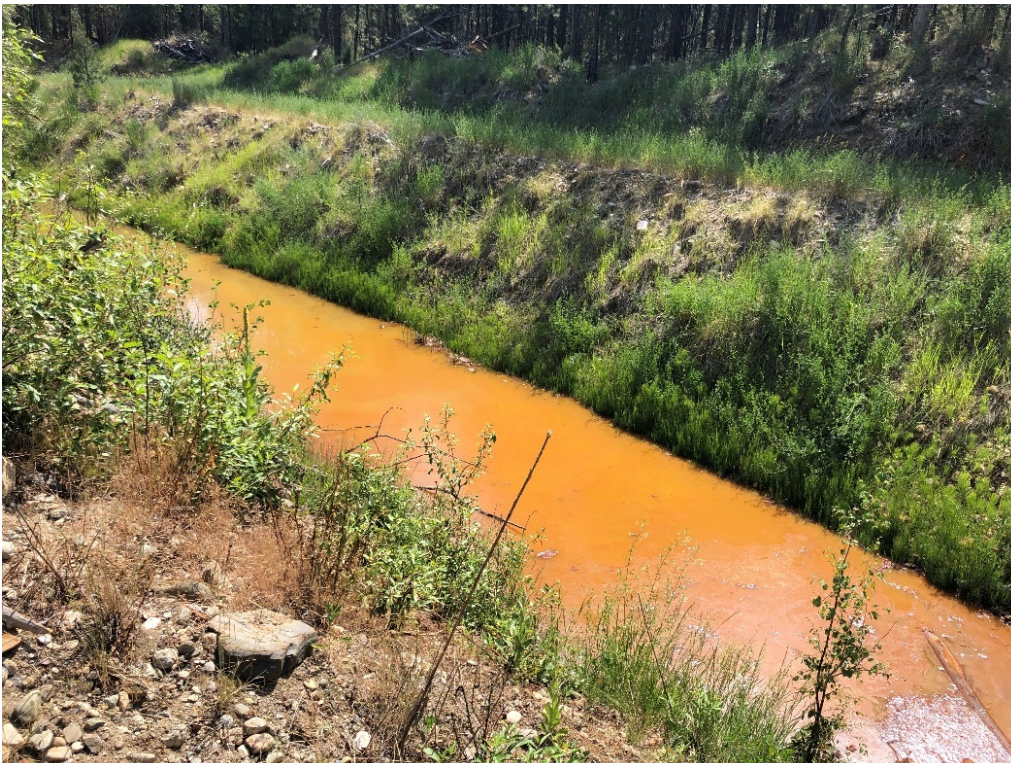
Photo II.24 Seepage downstream of No. 3 Siliceous Dike

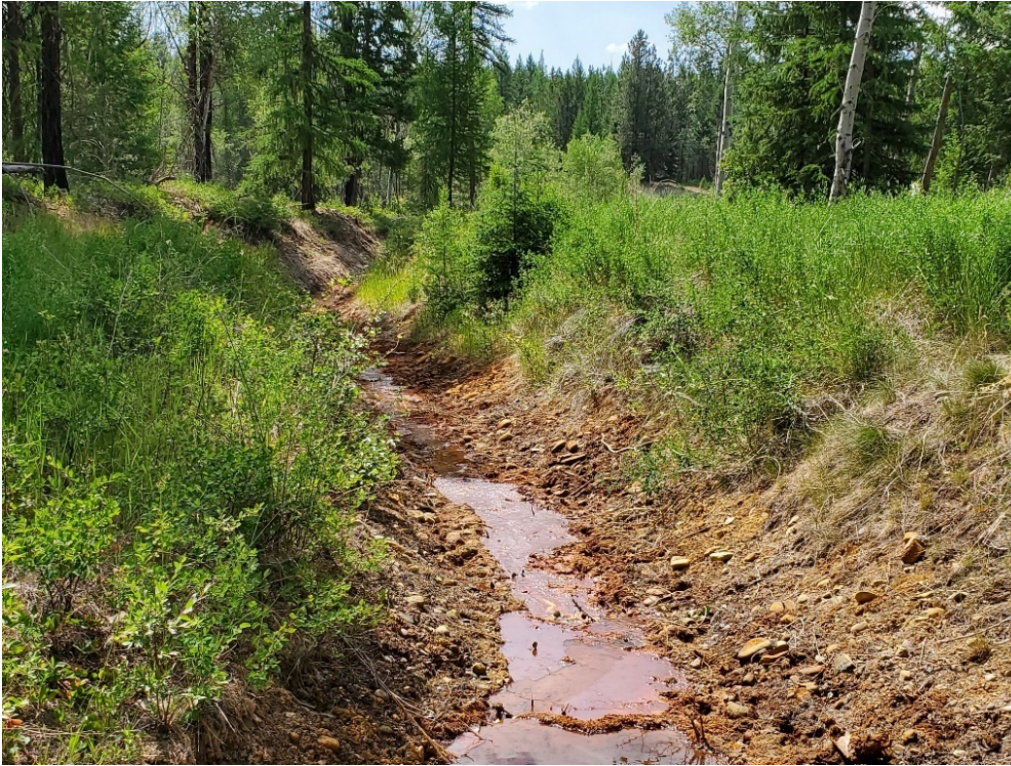
Photo II.25 Decant outlet channel downstream of No. 3 Siliceous

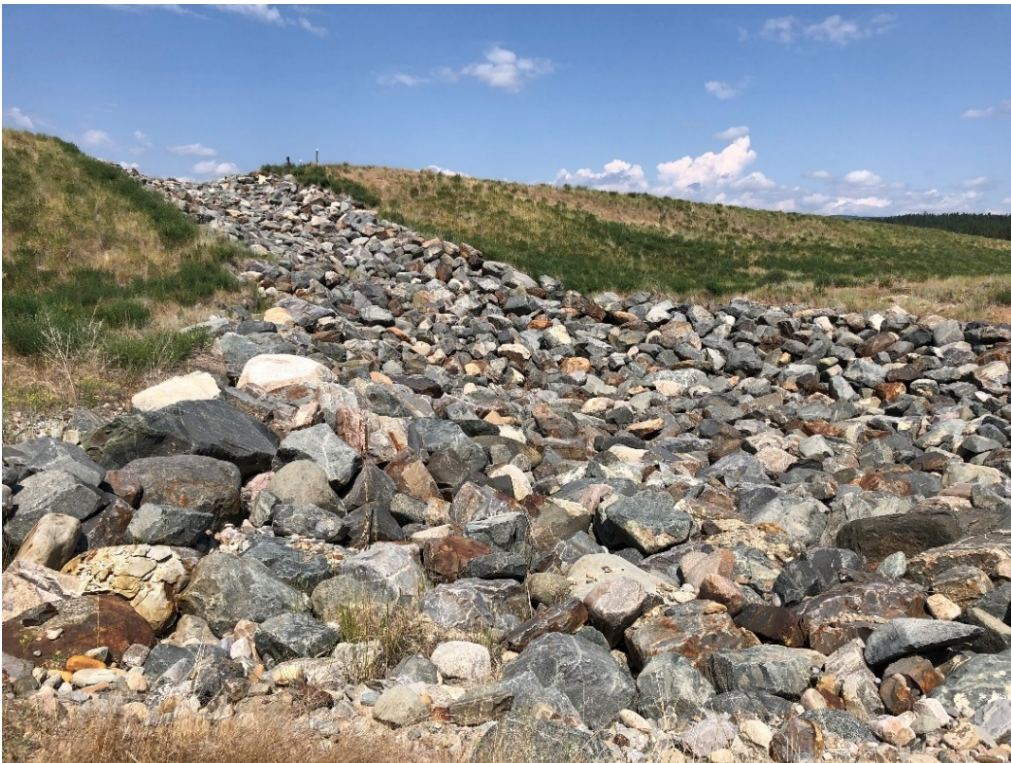
Photo II.26 Siliceous TSF Spillway

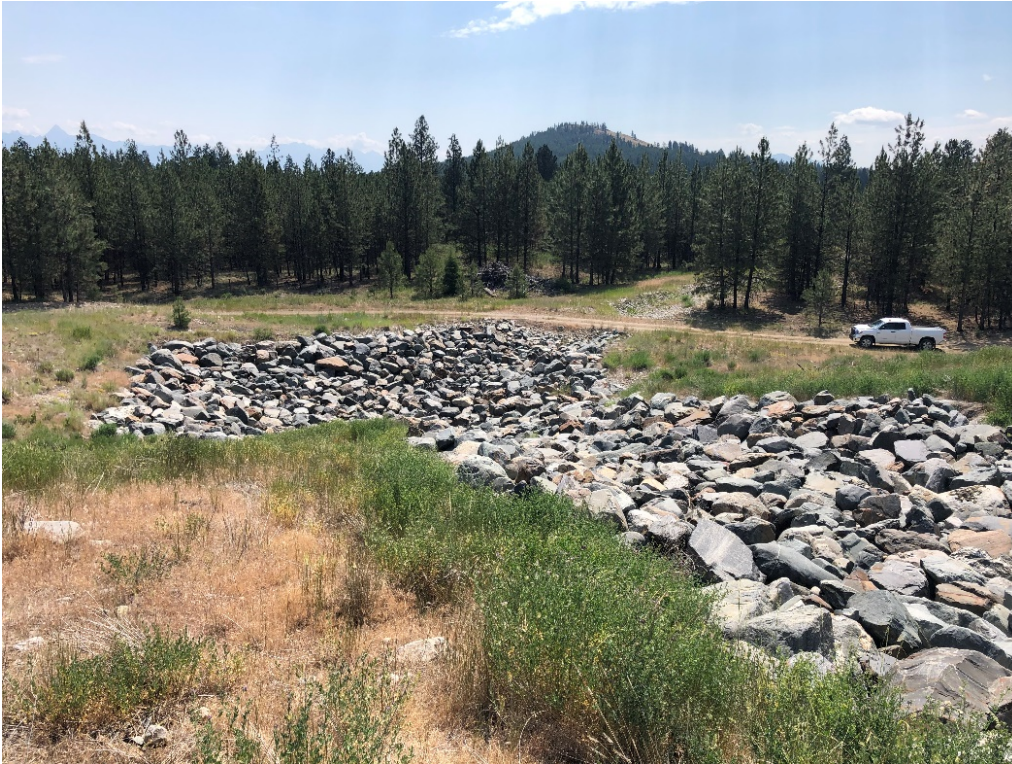
Photo II.27 Siliceous TSF Spillway on No. 3 Siliceous TSF

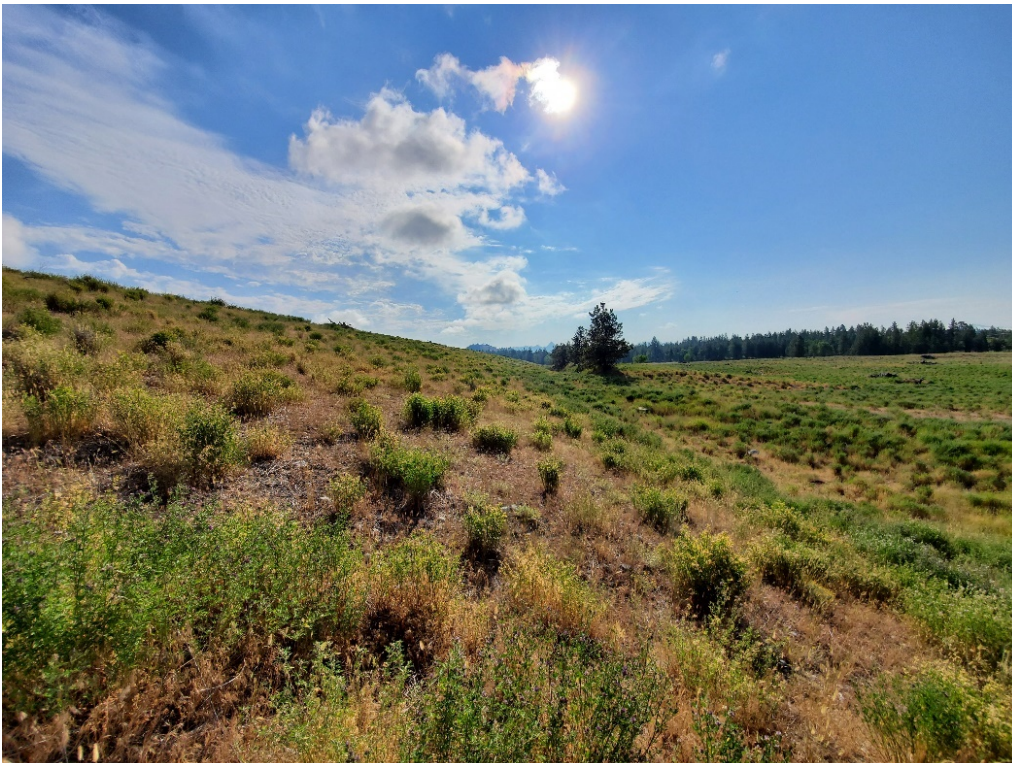
Photo II.28 East Gypsum Dike downstream slope

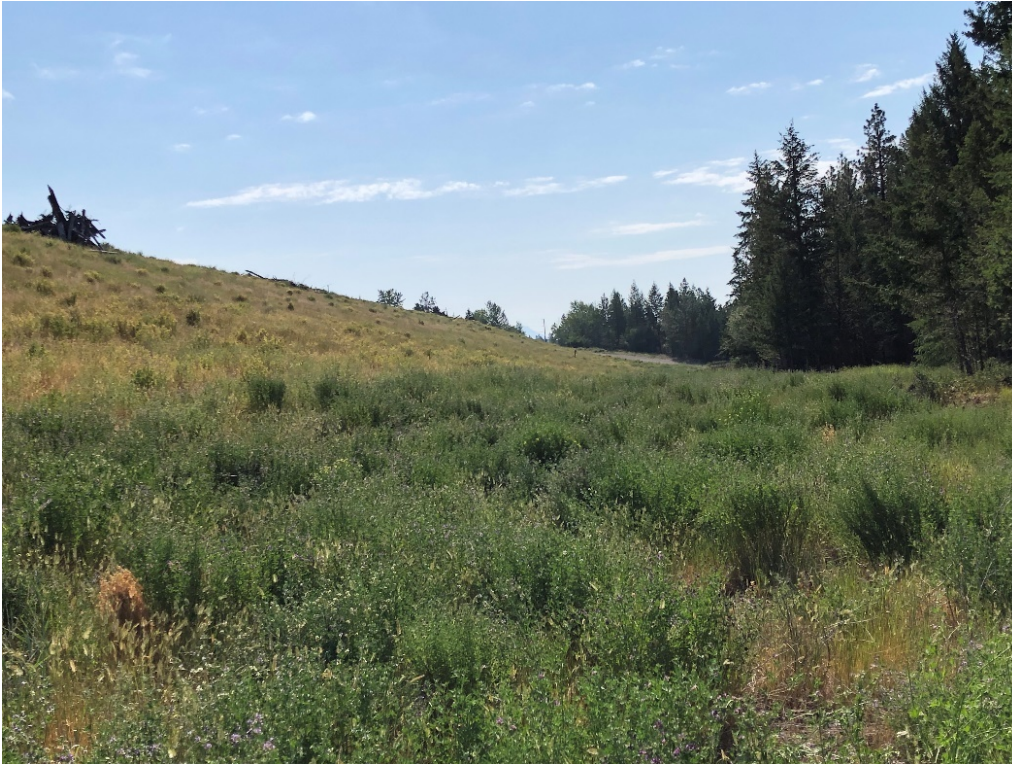
Photo II.29 West Gypsum Dike downstream slope

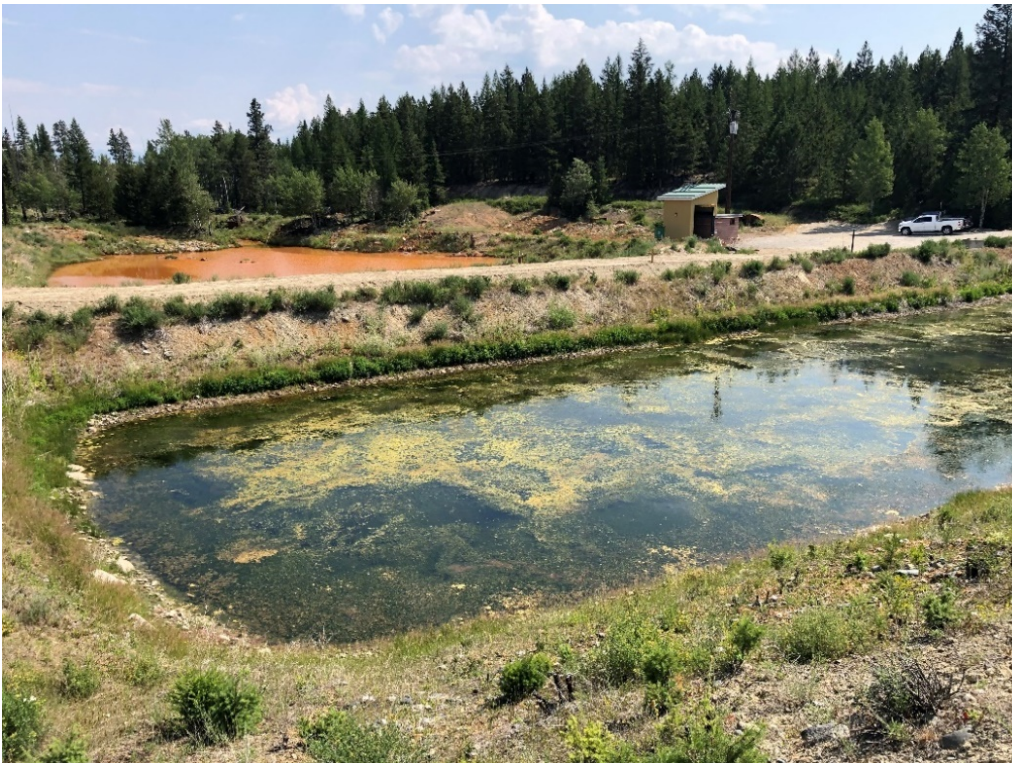
Photo II.30 Recycle Dam downstream slope

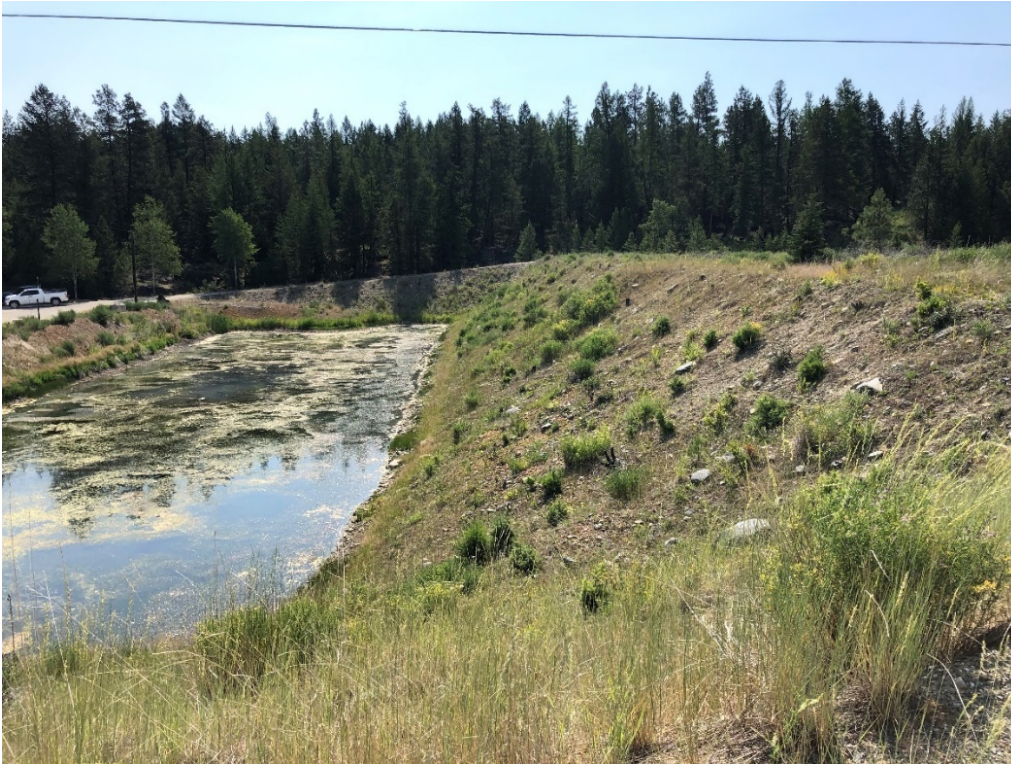
Photo II.31 Northeast Gypsum Dike Downstream Side

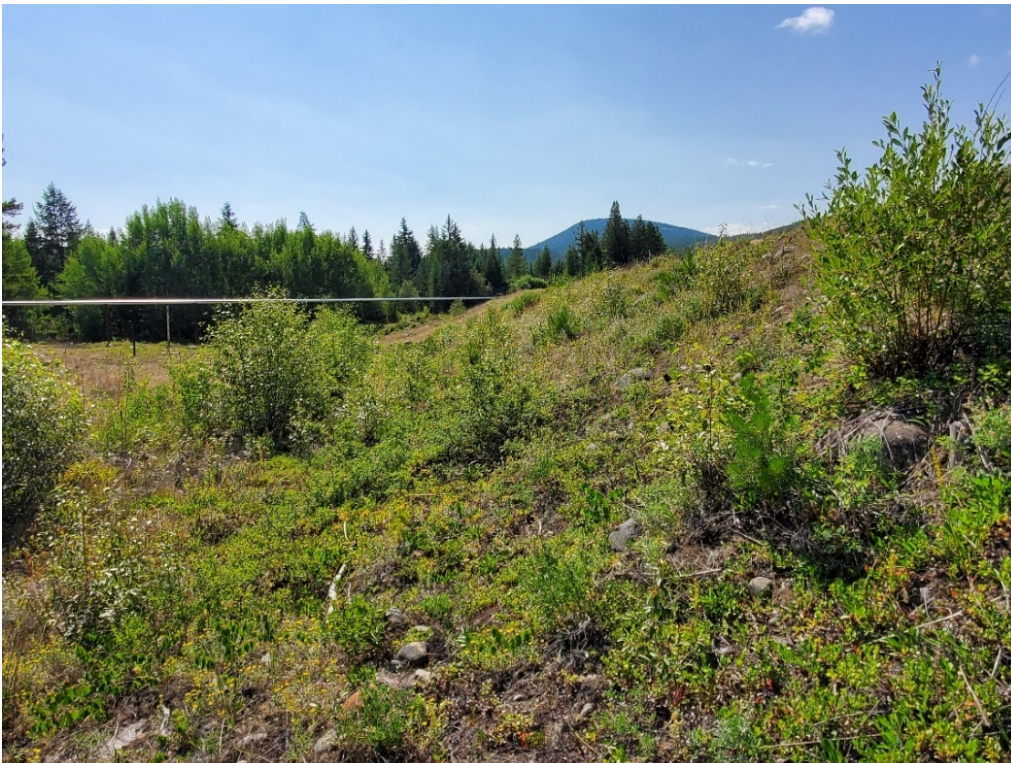
Photo II.32 Sludge Impoundment North Dike downstream slope

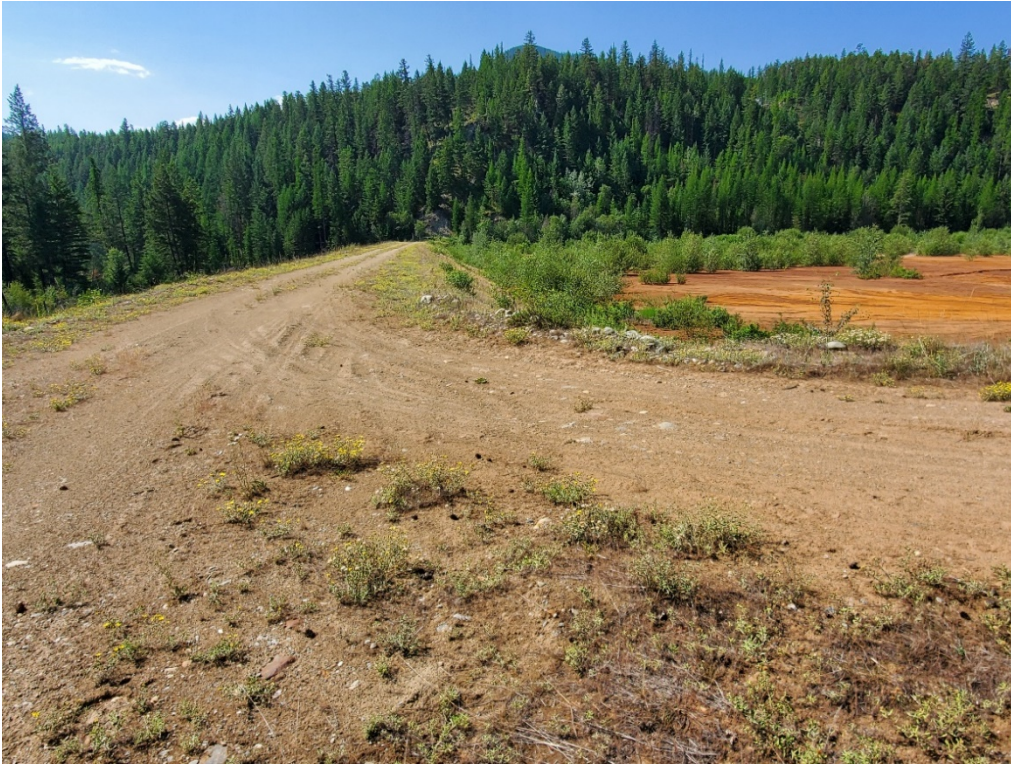
Photo II.33 Sludge Impoundment South Dike Crest and Upstream Slope
