Teck Metals Ltd.

Sullivan TSF 2021

Annual Summary of Tailings Facility Performance Report

March 25, 2022

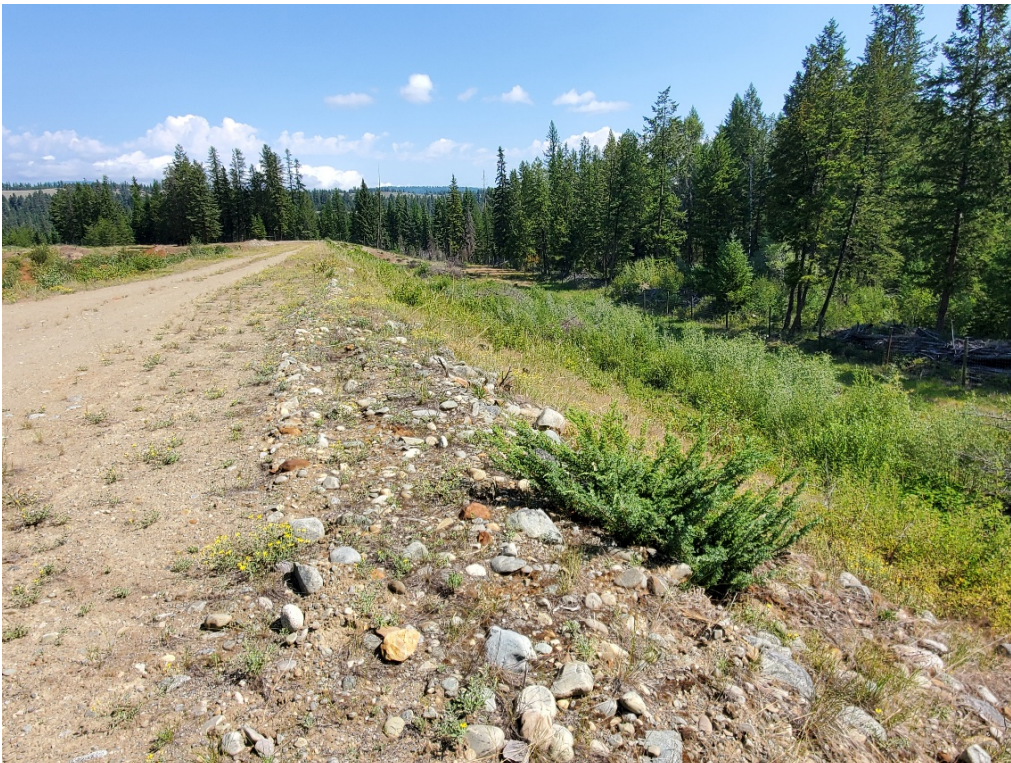
Photo II.34 Sludge Impoundment South Dike Downstream Slope

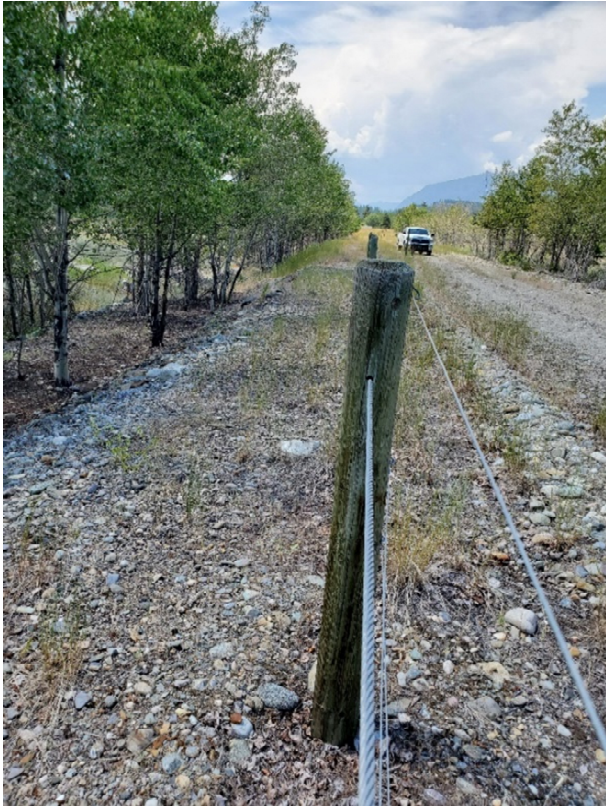
Photo II.35 Calcine Dike Crest and Downstream Slope

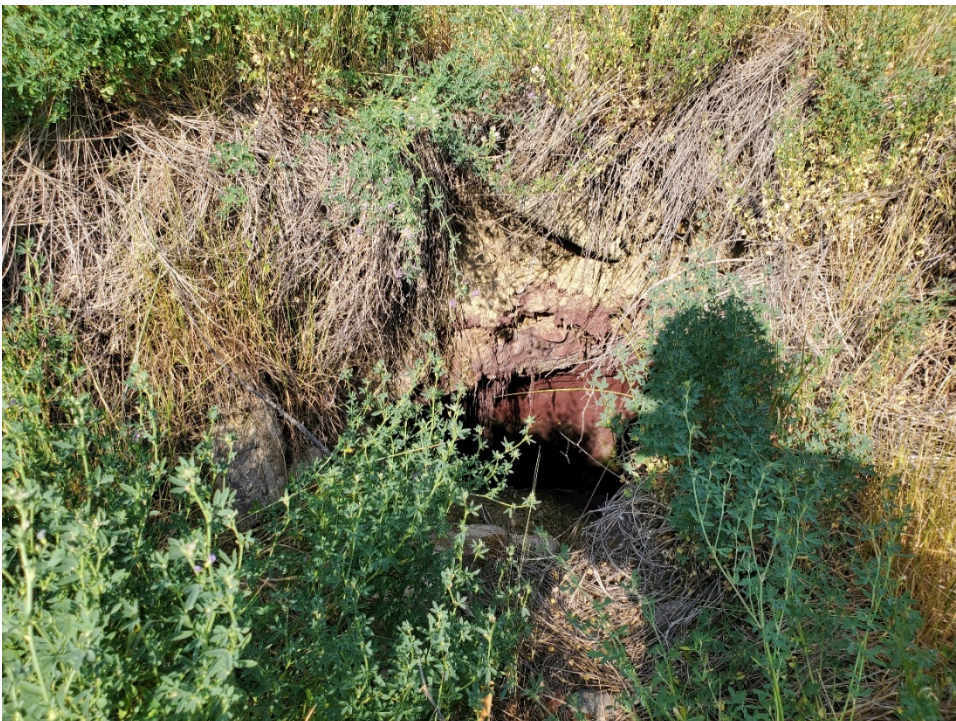
Photo II.36 Void from Collapse of Disused Pipe in Calcine

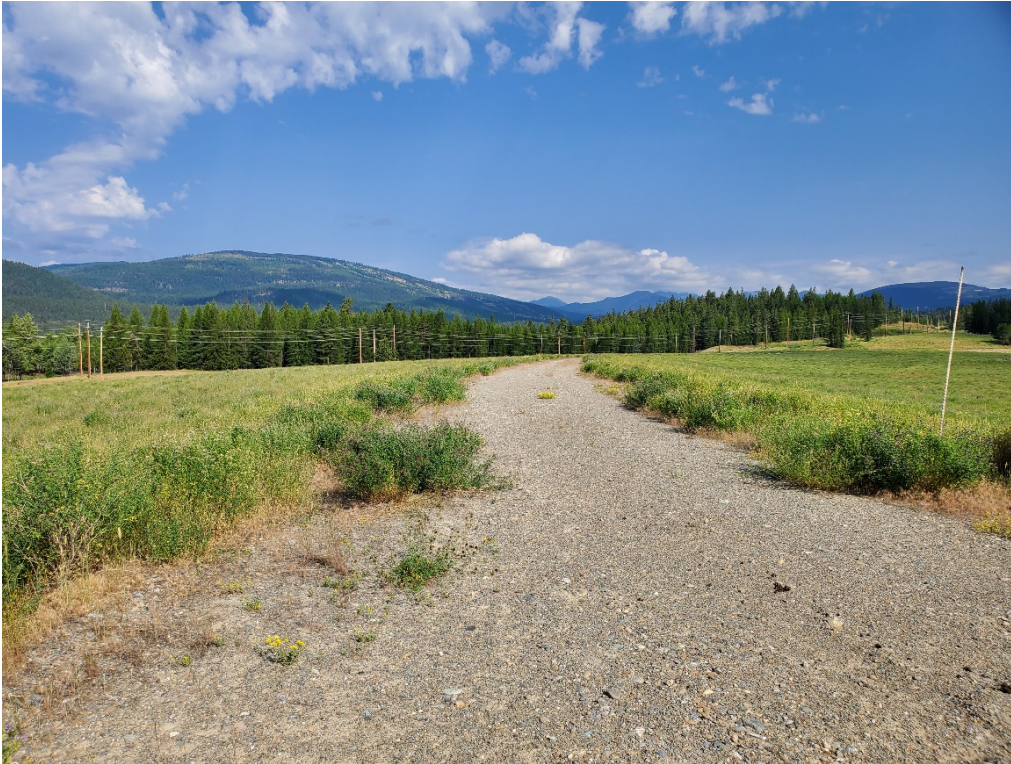
Photo II.37 Old Iron Dike Crest and Upstream Slope

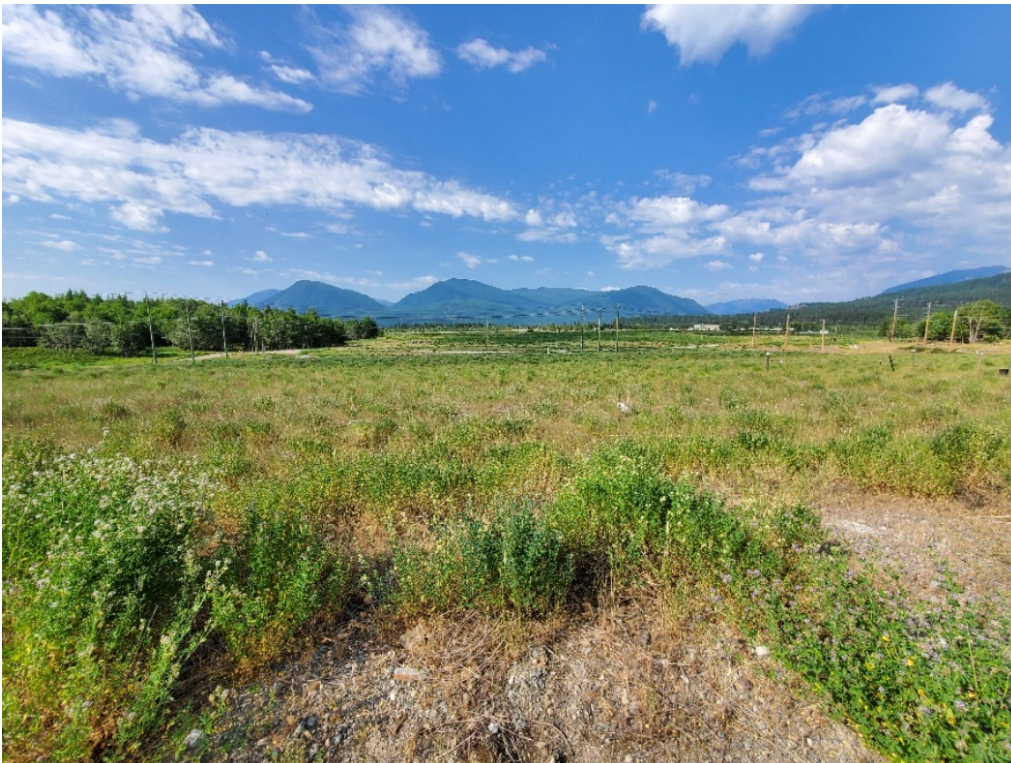
Photo II.38 Old Iron Dike downstream slope

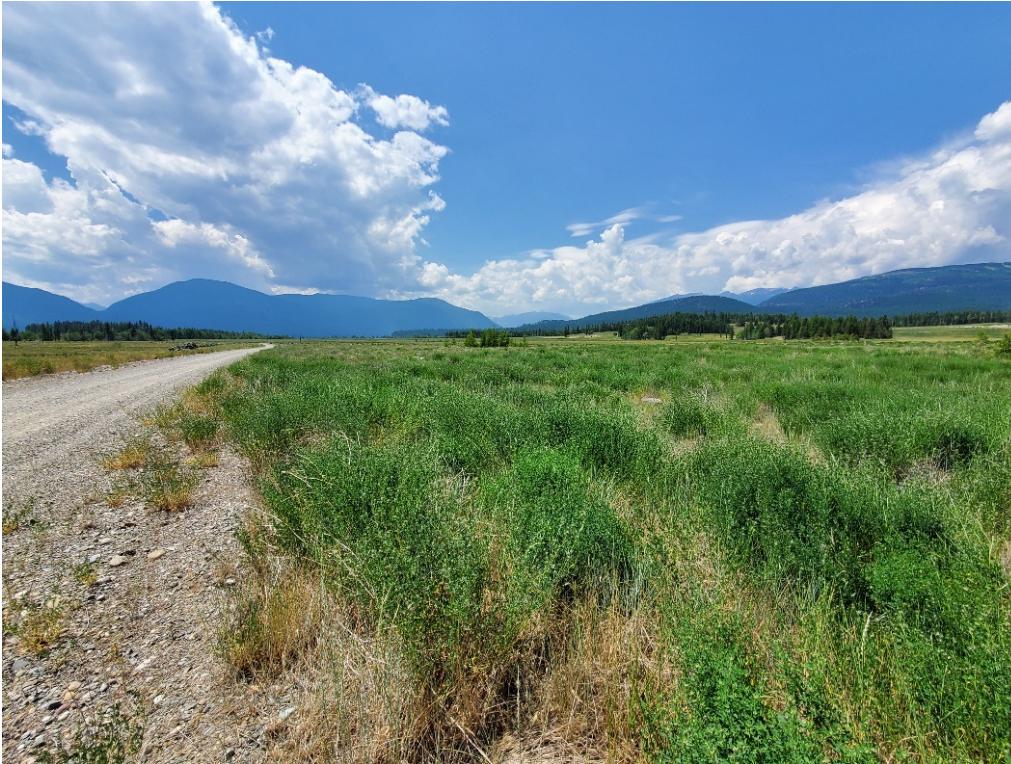
Photo II.39 Iron TSF Divider Dike
