TECK RESOURCES LIMITED BEAVERDELL MINE

Beaverdell Tailings Storage Facilities 2017 Annual Dam Safety Inspection

Reference Number: 1778313-052-R-Rev0-1000

This report presents the 2017 annual dam safety inspection (DSI) for the embankments of the tailings storage facilities (TSF) at the closed Beaverdell Mine. The facilities consist of the South TSF and North TSF.

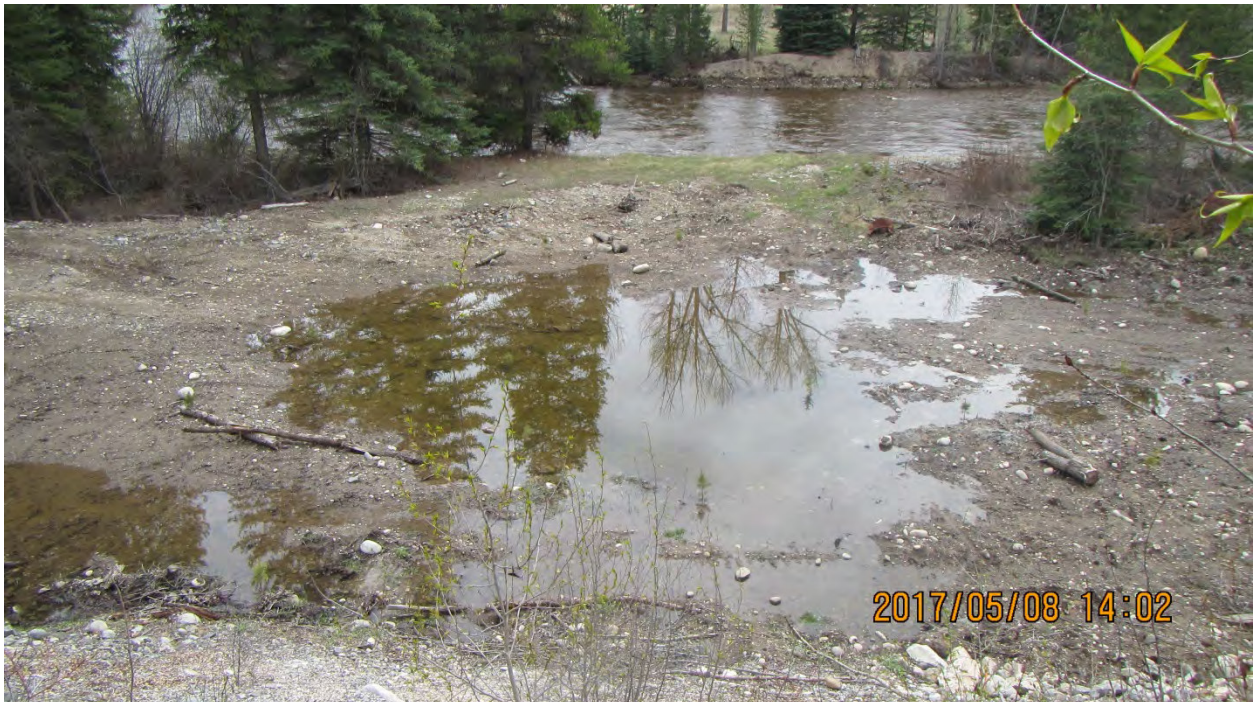
Photo 4
Standing water between WKR and cell 4/5

The ponded water just to the east of cell 5 migrated through the sand and gravel material in the berm between the WKR and Cell 5 (photo 4). This area was riprapped in the distant past and in some sections the riprap is deteriorated or missing. There is evidence of deterioration of the riverbank in two locations on west side of the WKR near cell 5 (photos 1 & 2). Once this water reached the top of this low area it flowed south through the area we used to construct the new riprap system in 2016. The flow did not disturb the newly planted trees or old wooden debris we add to this area. There was no indication of an outflow to this water; it's believed to have drained into the sand gravel layer. During the excavation for the riprap installation in 2016 we encountered water in the sand and gravel layers at the same elevation as the WKR.

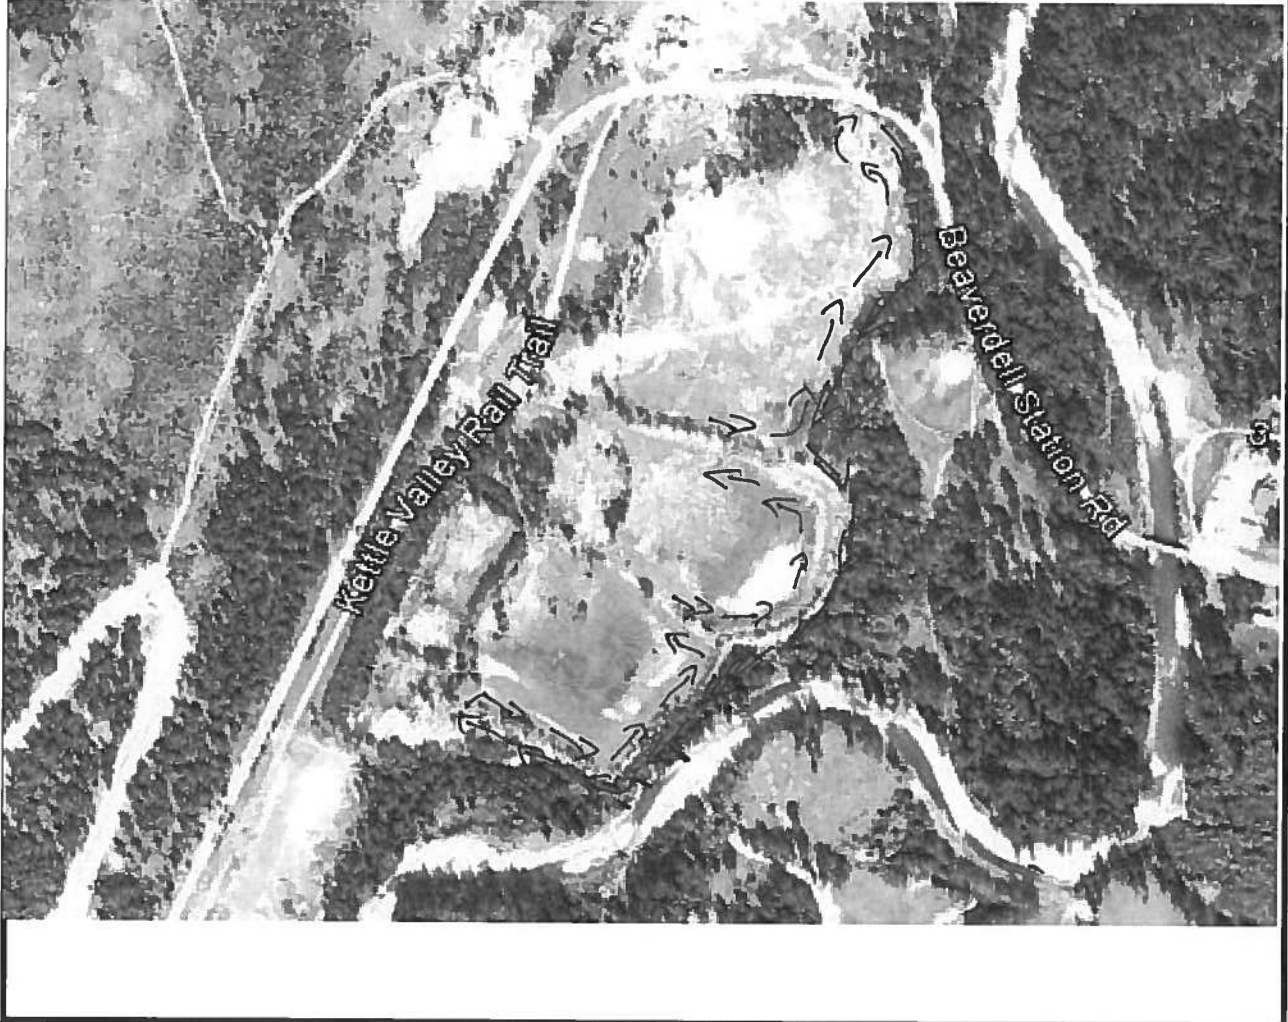
- ① PONDING WATER ALONG EAST TOE OF CELLS 3,4:5
AND PONDING WATER ALONG SOUTH TOE OF CELL 5
- ② TREE ACROSS CELL 3 SPILLWAY.
TREE WAS REMOVED.
- ③ RIVER BANK - SE CORNER CELL 5 IS ERODING.

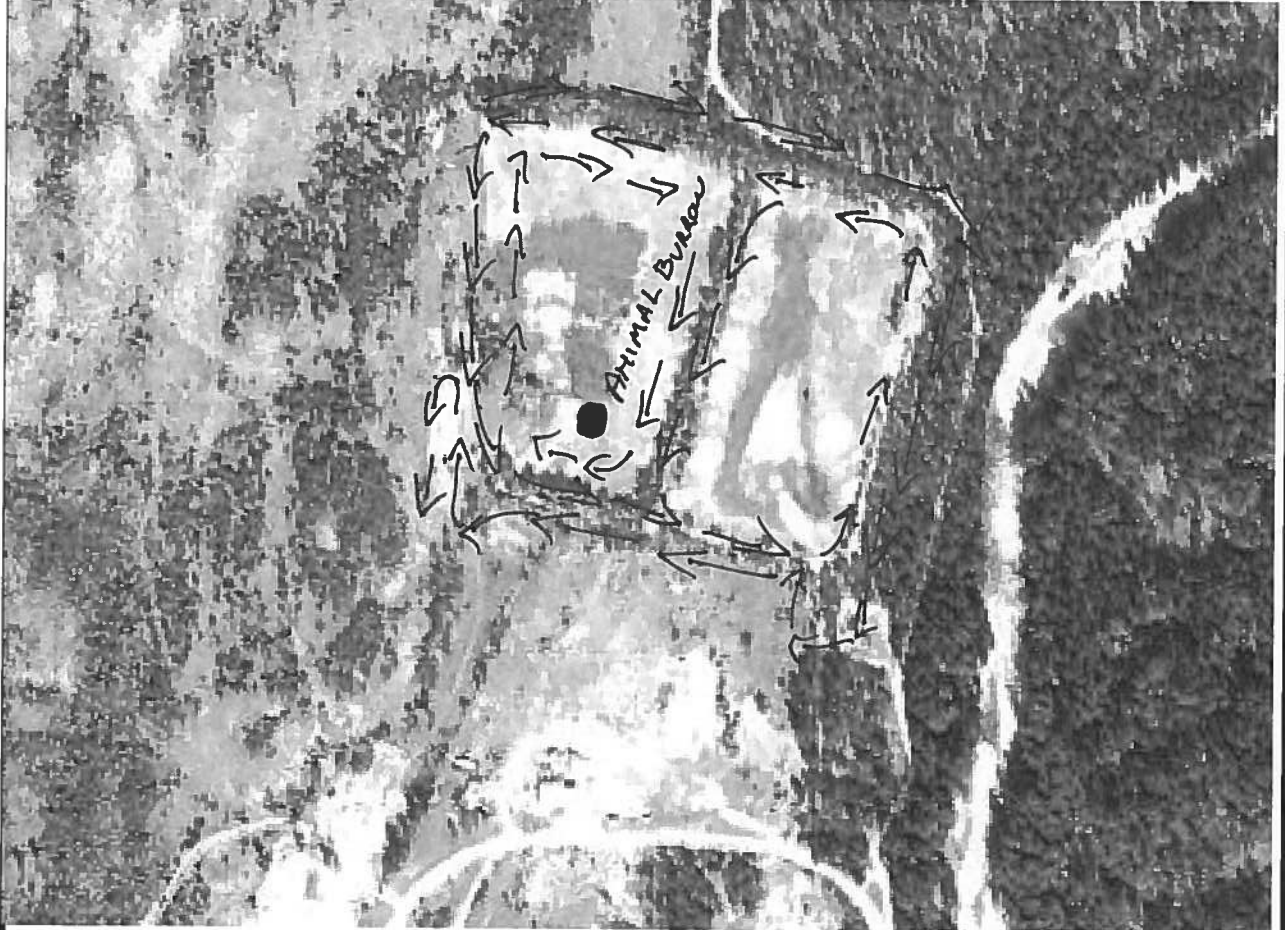
- ① ANIMAL BURROW IN POND OF CELL 7.
- ② DECANT PIPE ON CELL 6 - VERY SMALL TRICKLE OF WATER

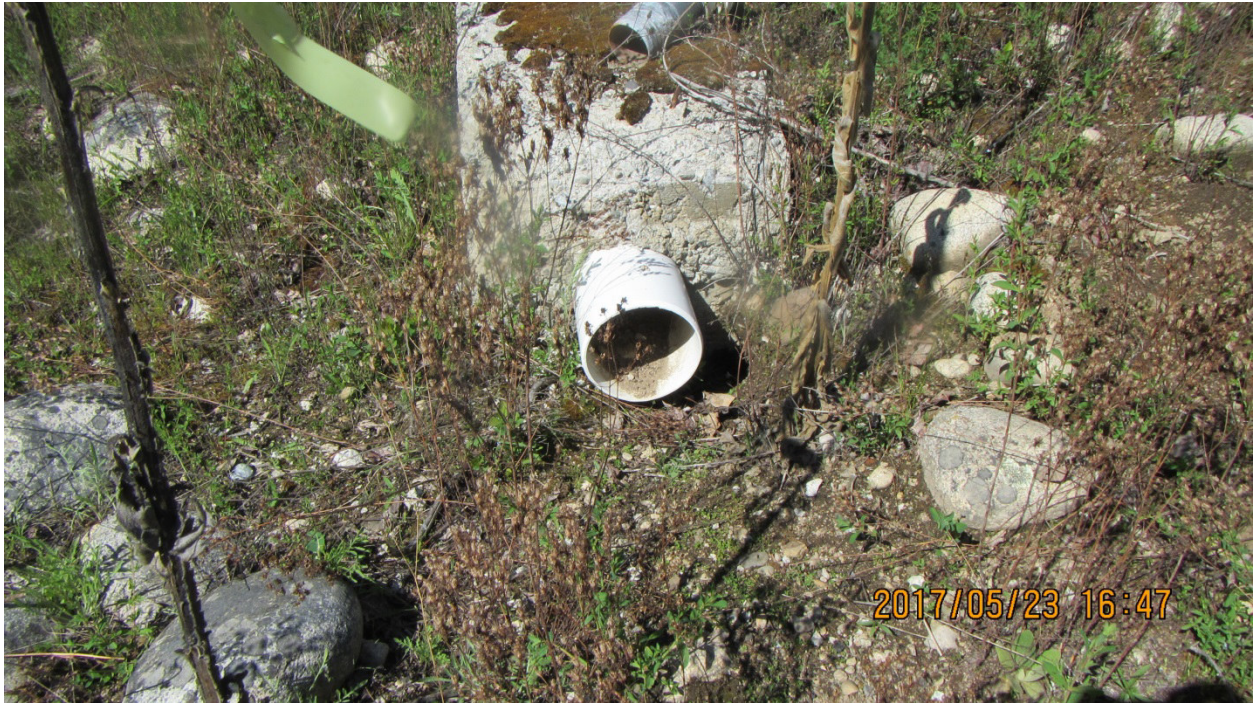
Weir at Decant Outlet Cell 6

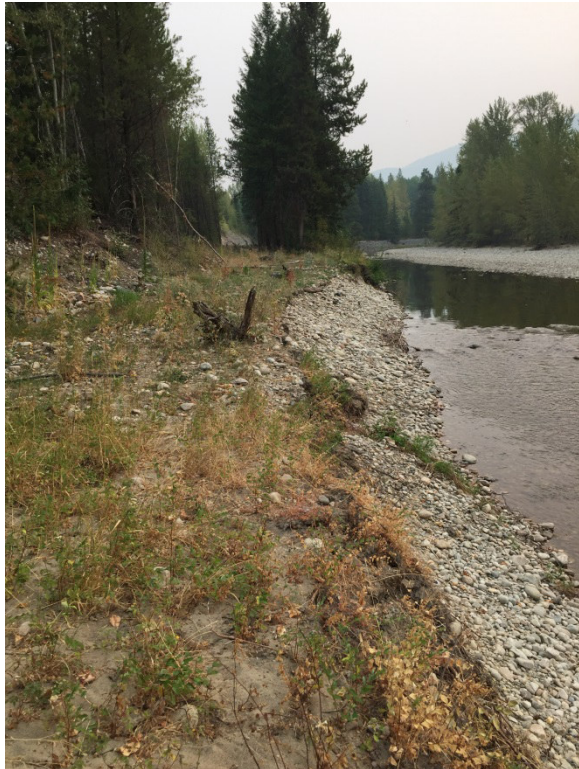
Riprap Cell 5

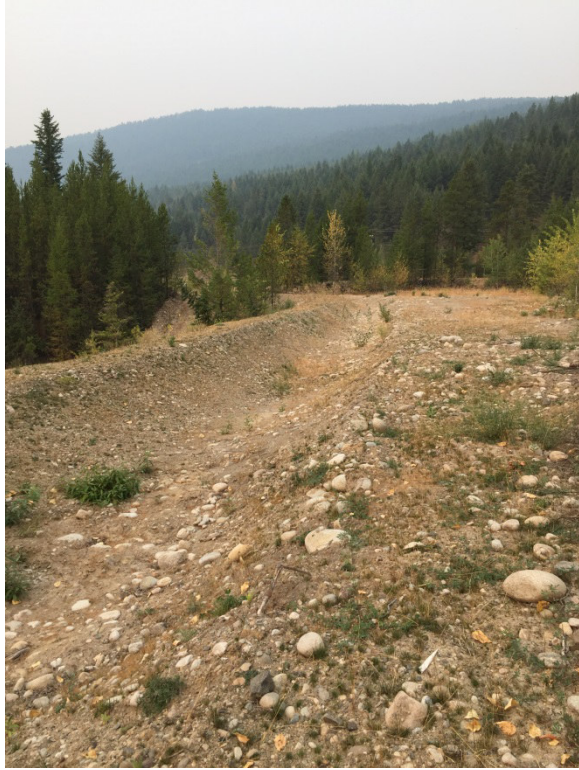
SE Corner of Cell 5

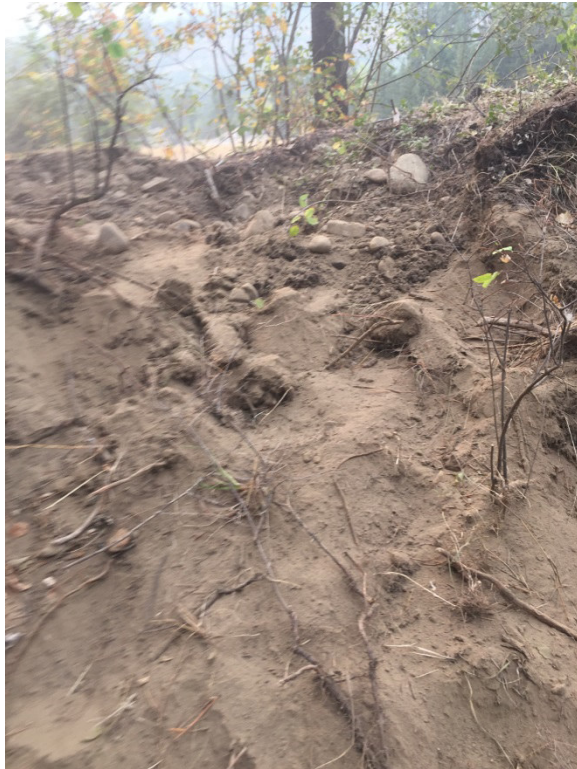
ANIMAL BURROW IN POND 3, DOWNSTREAM SIDE. REPAIRED

Animal Burrow in Cell 3 Dike

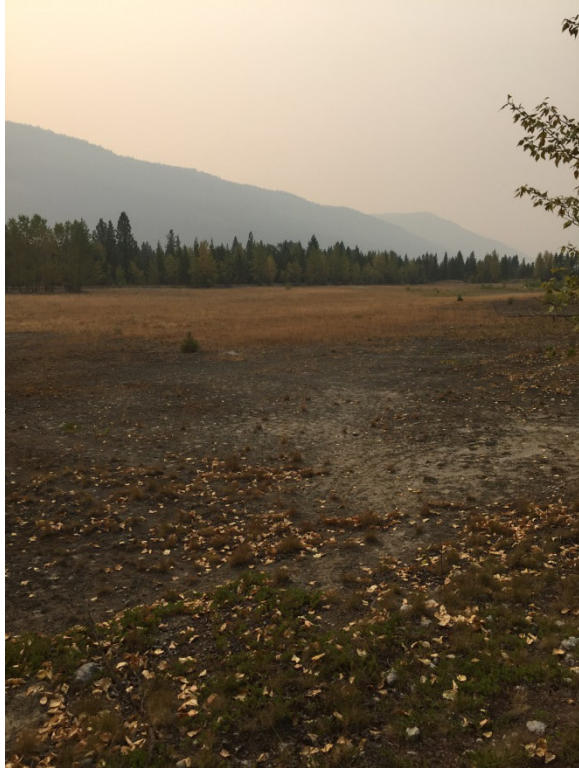
ANIMAL DEN BESIDE DECANT INTAKE IN POND 7

Animal Den in Cell 7

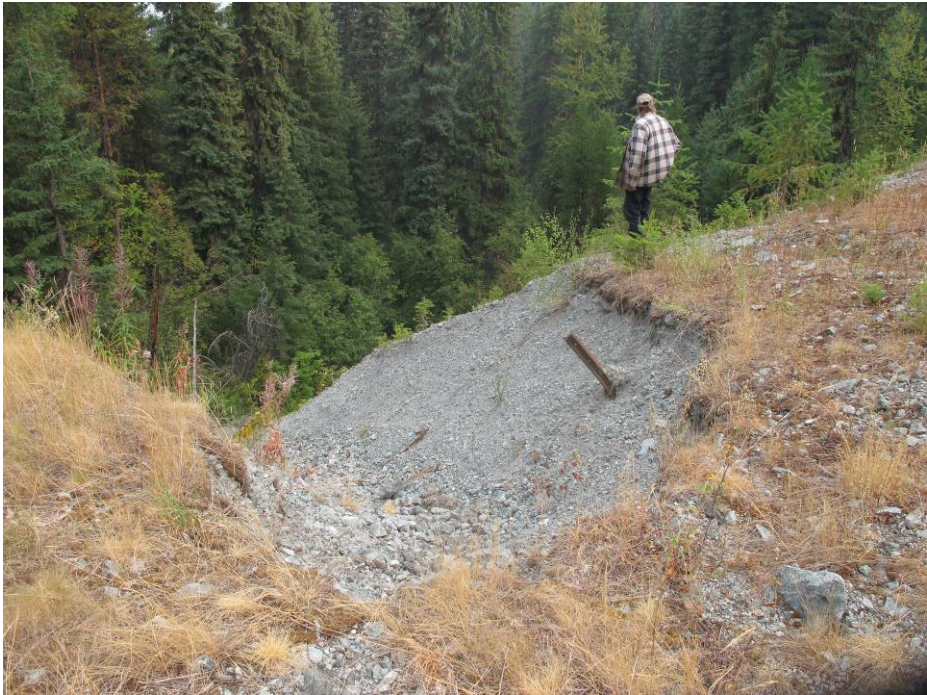
In comparison to the major dumps, Photo 5 shows a typical waste rock dump that is associated with an adit that ‘chased’ a surface exposure. The height was approximately 20 m high and was end dumped from an old mine entrance. The waste rock dumps pose a risk as the construction methods of the dump and volume of the dump is unknown. In addition, waste rock dumps at the main portal sites are within a mountain drainage and erosion of the waste rock dumps were noted (shown in Photo 6).

Photo 6: Erosional feature in waste rock dump above 3550 Portal

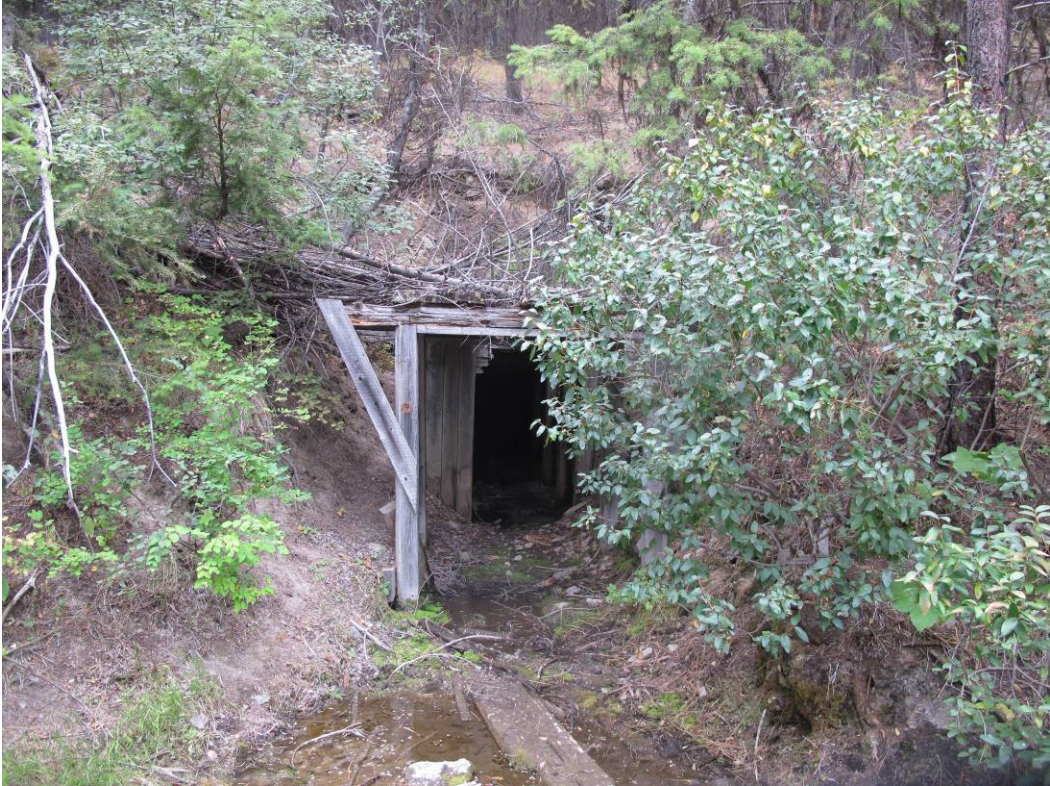
During the inspection, Teck representatives showed the Inspector two portals that are open to the public and no closure has been performed by the Mine Permit holder. Photo 8 and 9 show the

Photo 8: Abandoned portal outside of Beaverdell Mine Property
