2023 Annual Facility Performance Review Report

Duck Pond Operations Tailings Management Facility

Teck Resources Limited

Reference No. 23595269-001-R-Rev0-4100

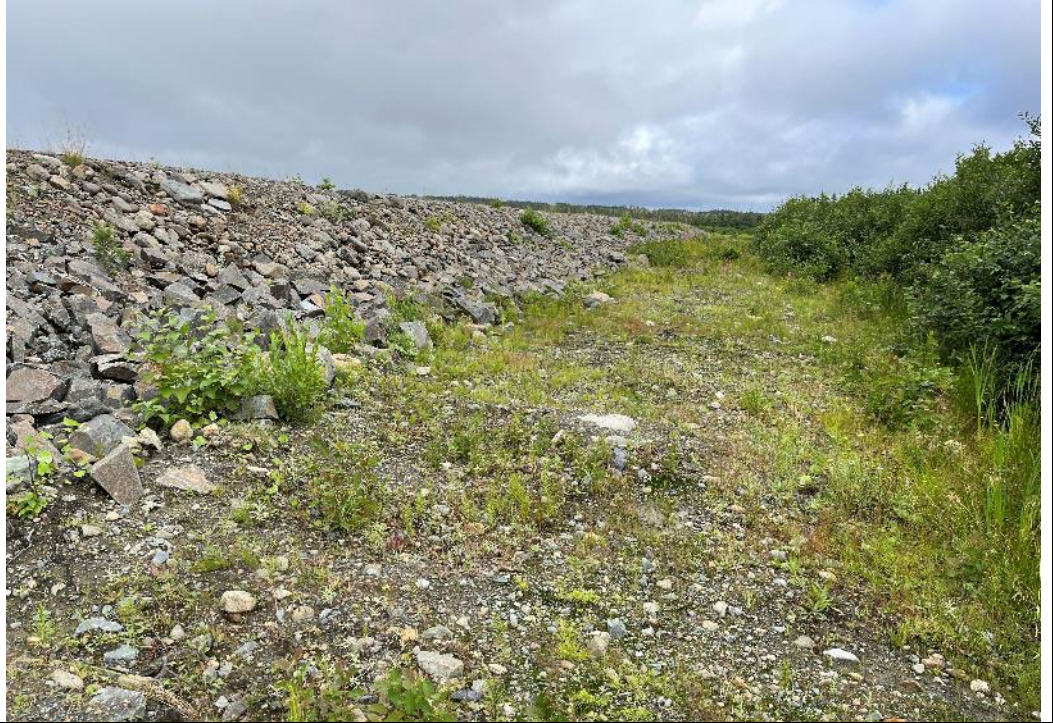
Photograph 2

Dam A upstream slope and
crest looking south from Sta.
0+800.

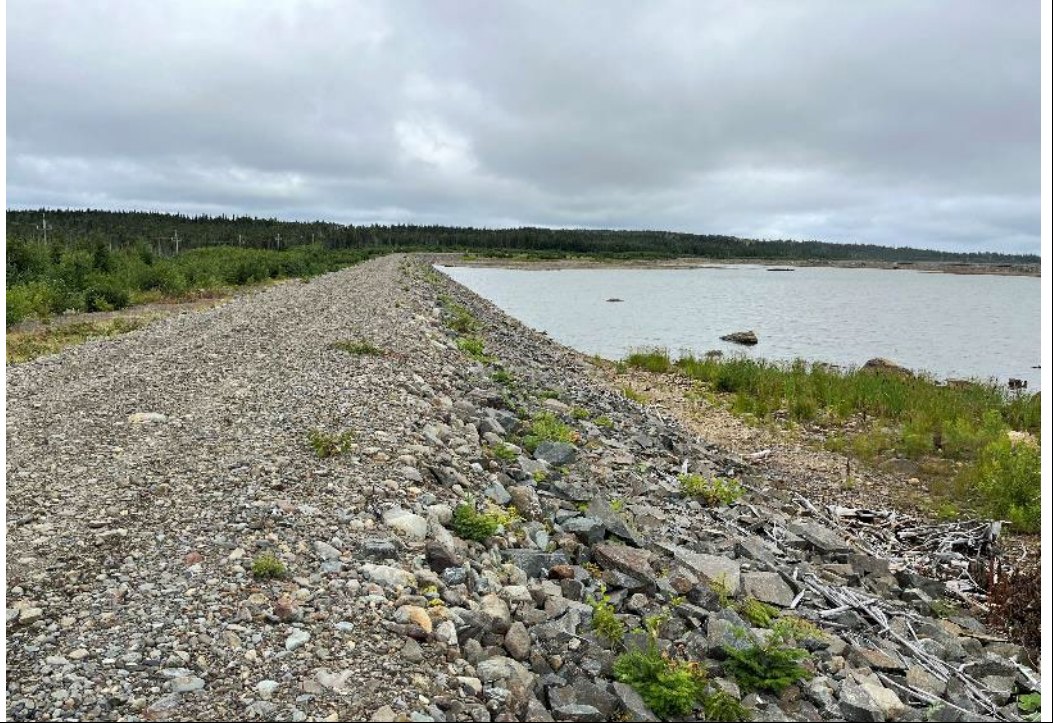
Photograph 2

Dam B upstream slope looking south from north abutment.

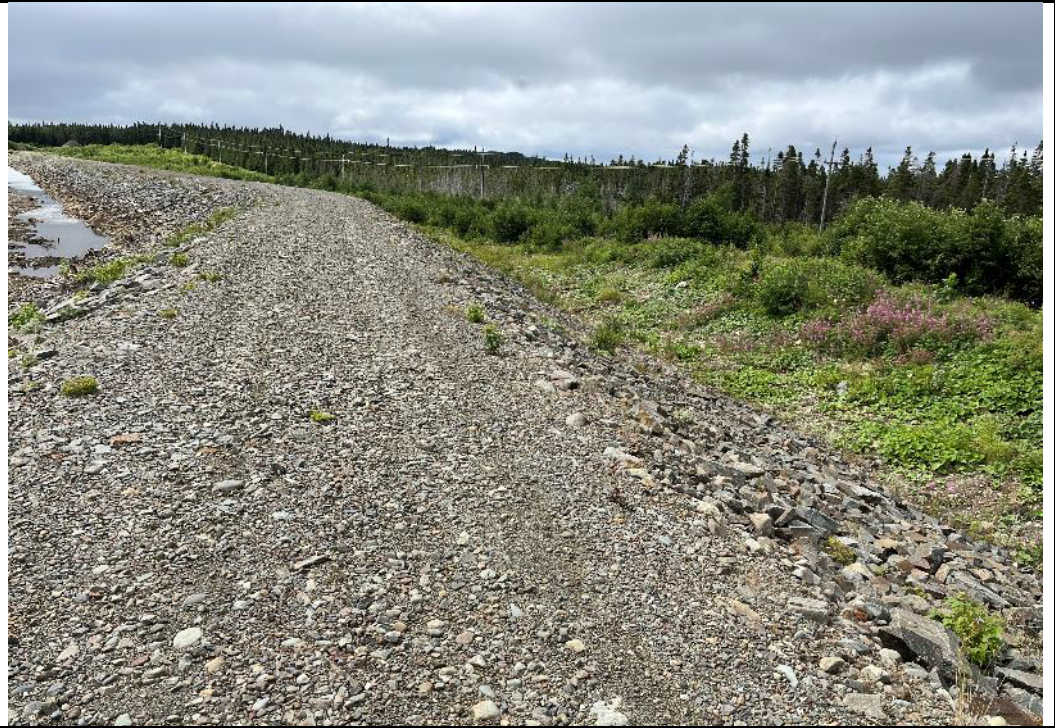
Photograph 8

Downstream slope of Dam B at Sta. 0+250 looking south.

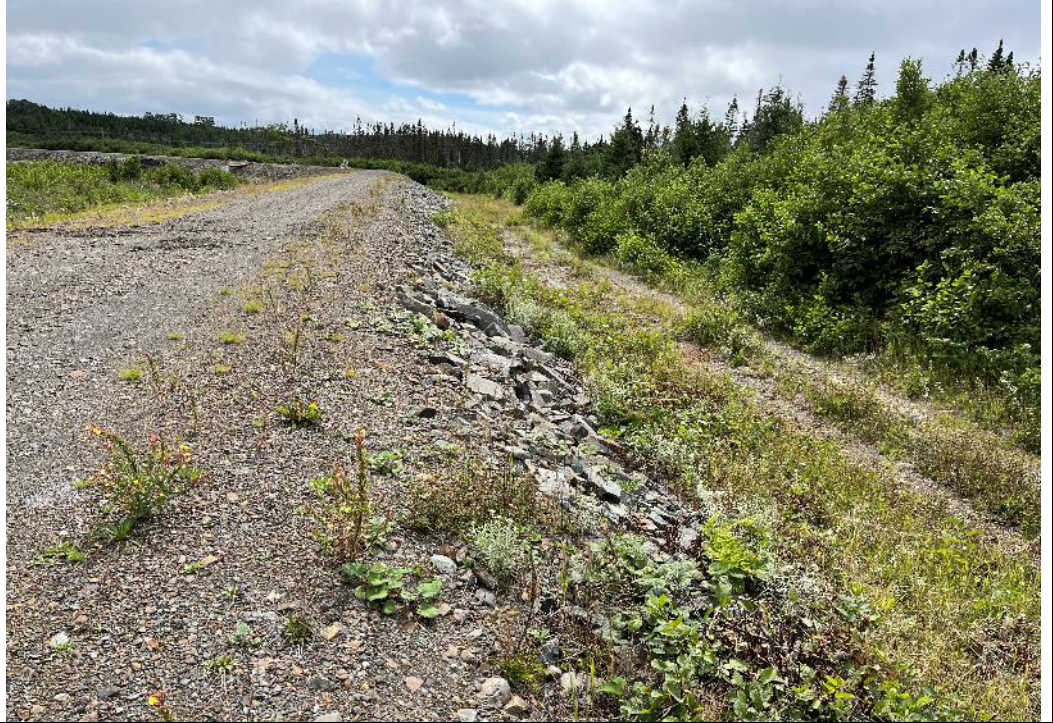
Photograph 2

Dam C crest and upstream slope looking north from south abutment.

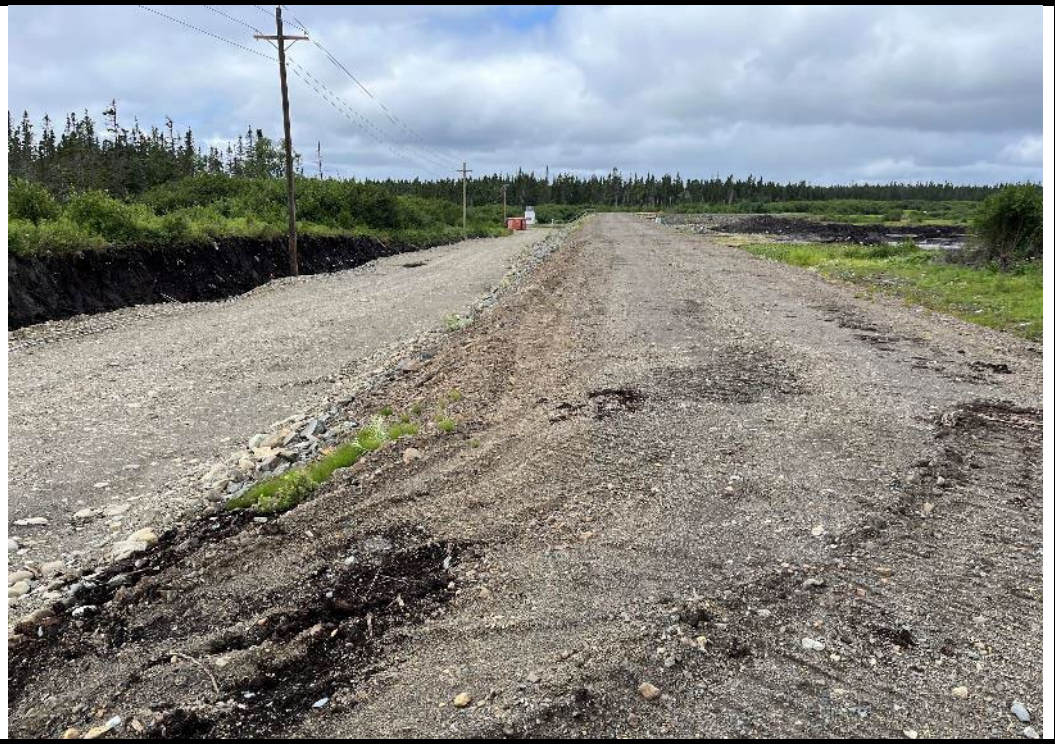
Photograph 6

Downstream slope of Dam C and Sta. 0+450, looking north. New toe access road and hydro line installed in 2023.

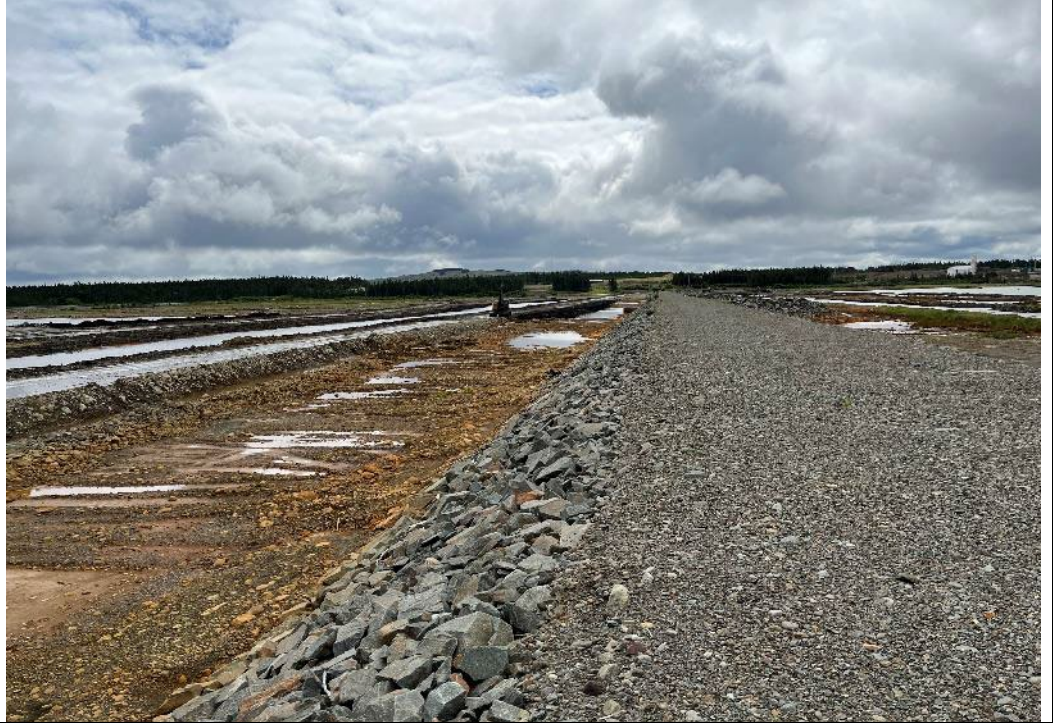
Photograph 4

Berm 2 looking north from south abutment. HDPE culvert connecting Cells 2 and 3 is observed through the berm in the background.

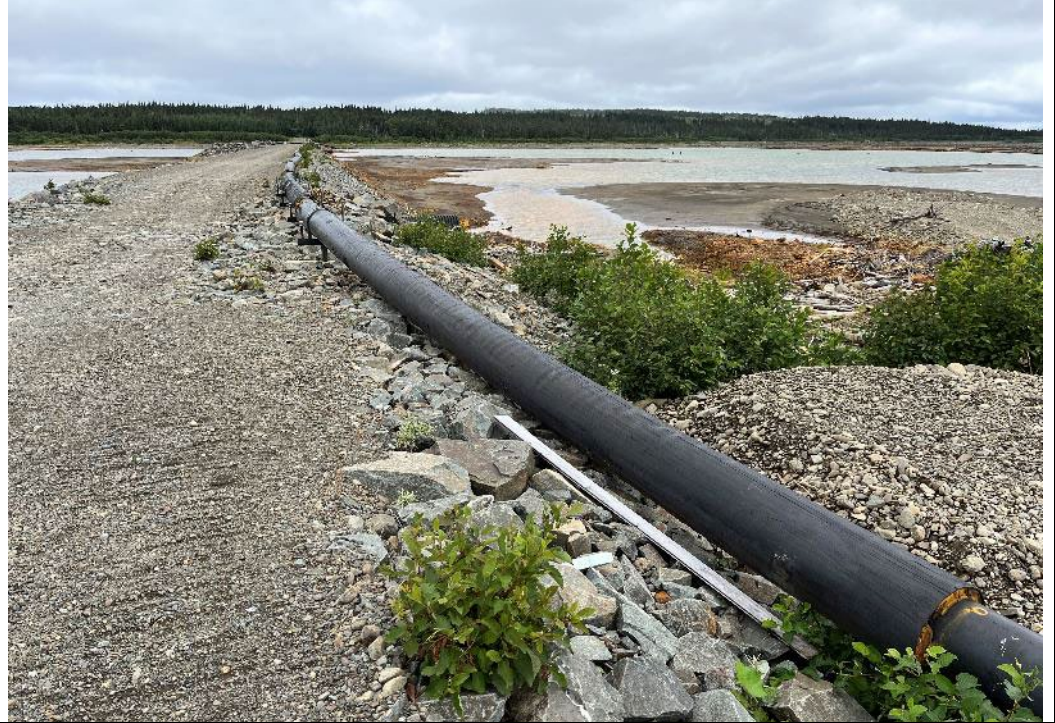
Photograph 6

Berm 3 west slope looking south. Lime addition pipeline and T-valve to control treatment in Cells 3 and 4.

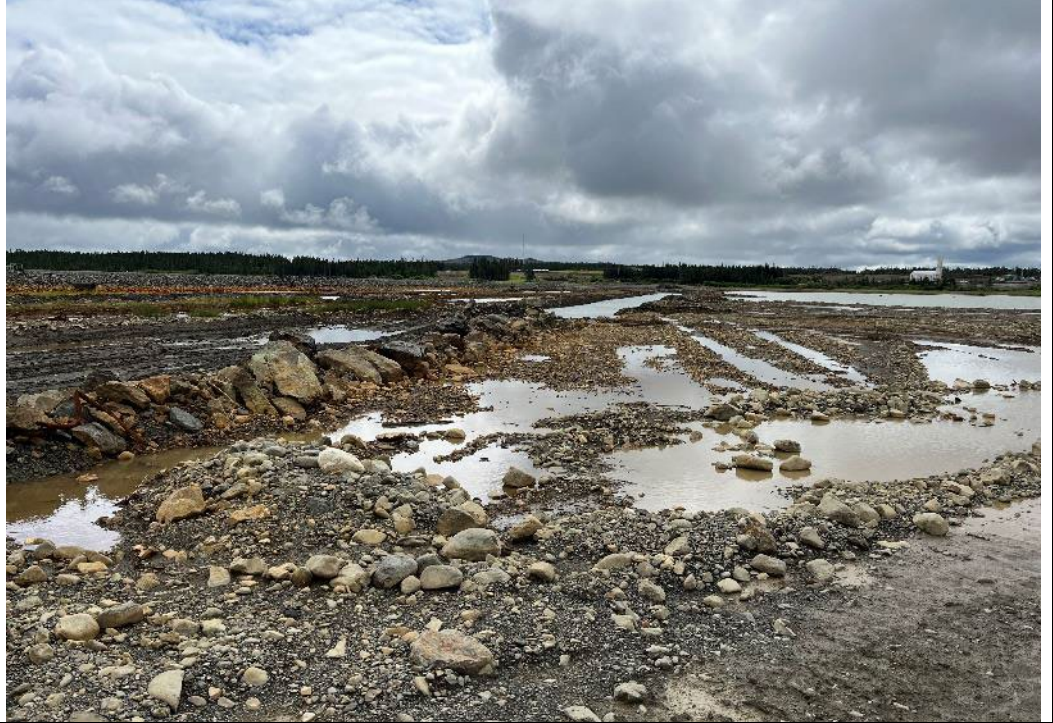
Photograph 8

Remaining portion of Finger Dyke 2, looking south.

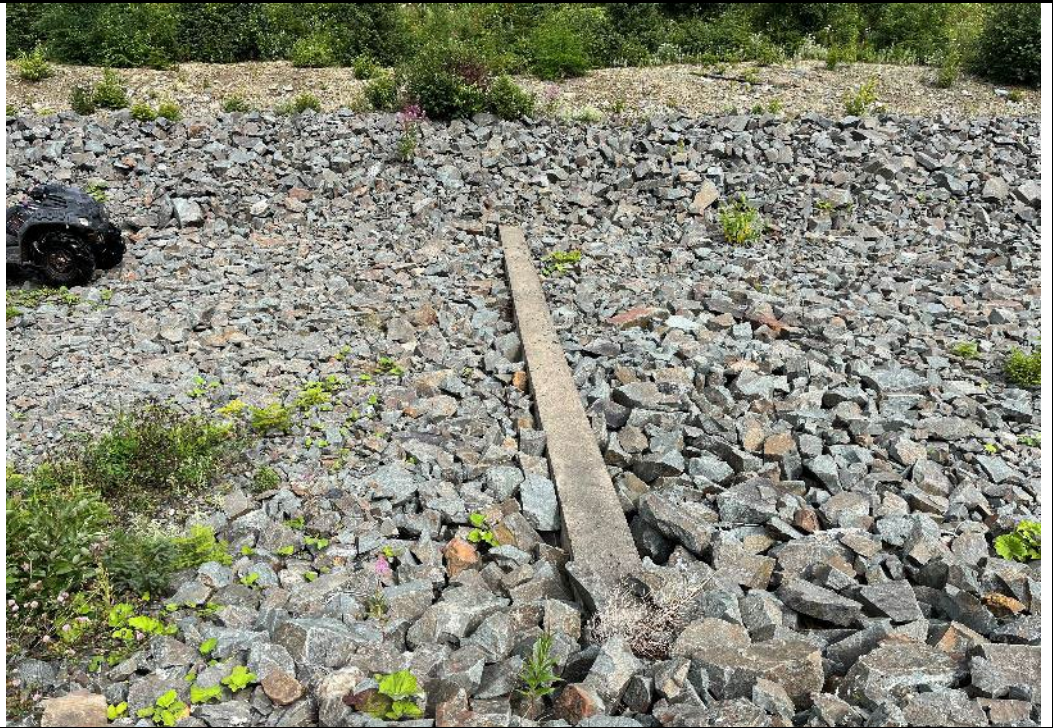
Photograph 2

Dam B Emergency Spillway
inlet channel looking towards
the TMA.

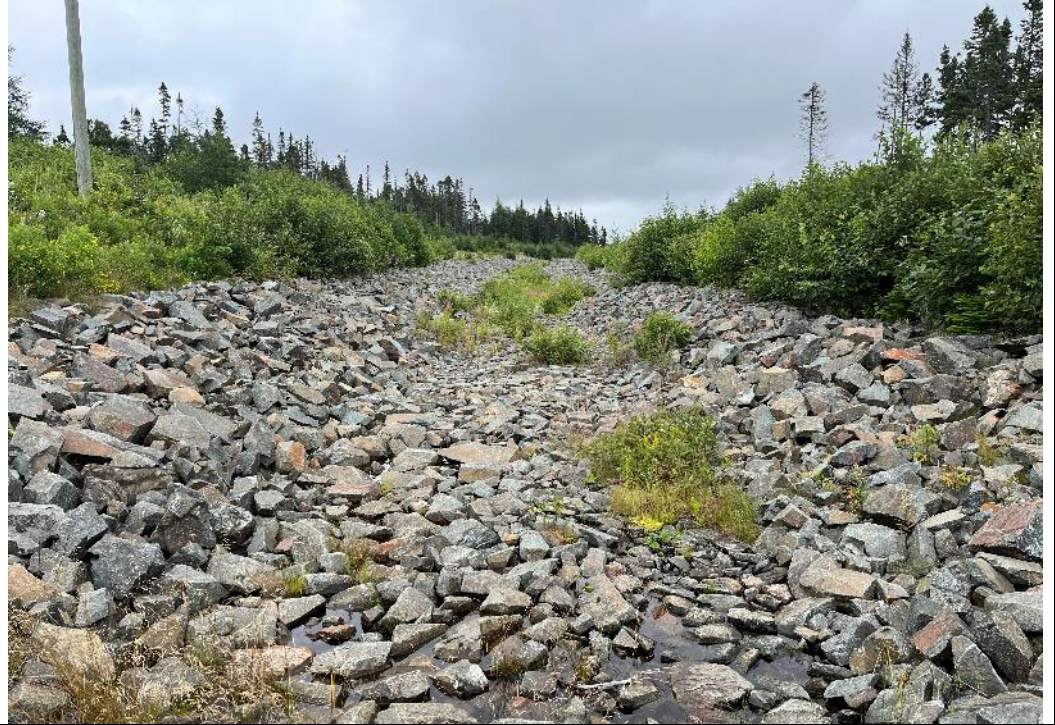
Photograph 4

Dam B spillway channel at confluence with Diversion Ditch B1, looking west towards the mine site access road.

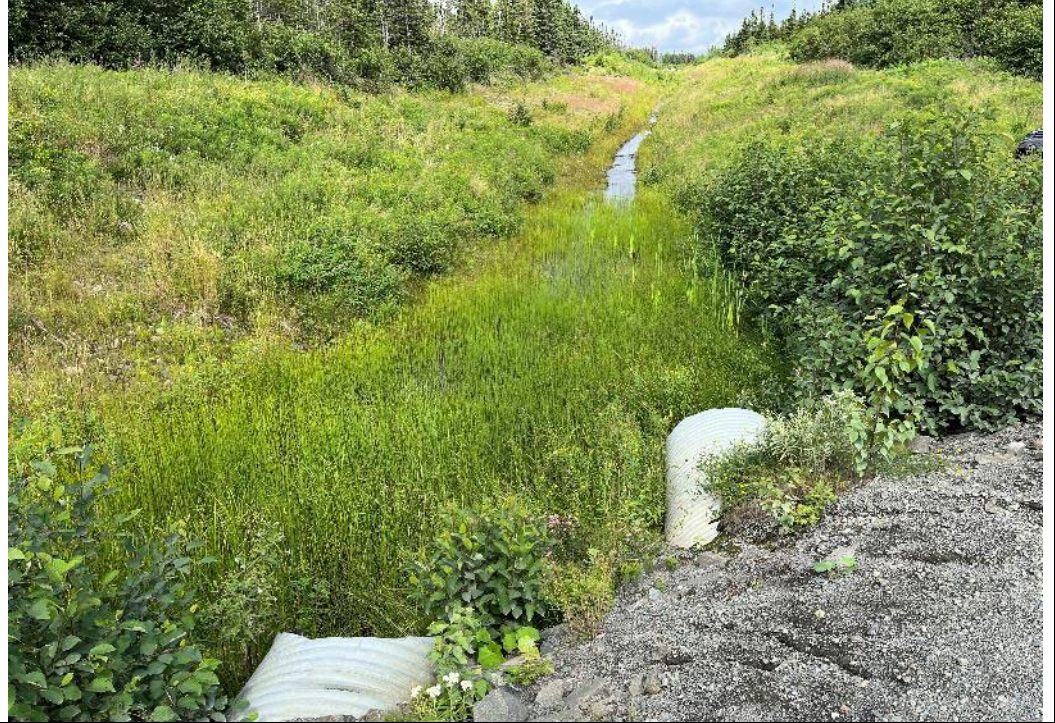
Photograph 6

1. The spillway is in good condition and generally clear of debris.
2. Vegetation in the form of large alders was cleared from the spillway and channel in 2023 to maintain it flow capacity and permit visual surveillance.
3. 3 culverts beneath the main access road at Sta 0+700 are partially blocked with debris and vegetation at the inlet (see photo 6). The culverts should be cleared as part of routine maintenance.

Inlet of culverts beneath the Mine Site Access Road at Sta 0+700.

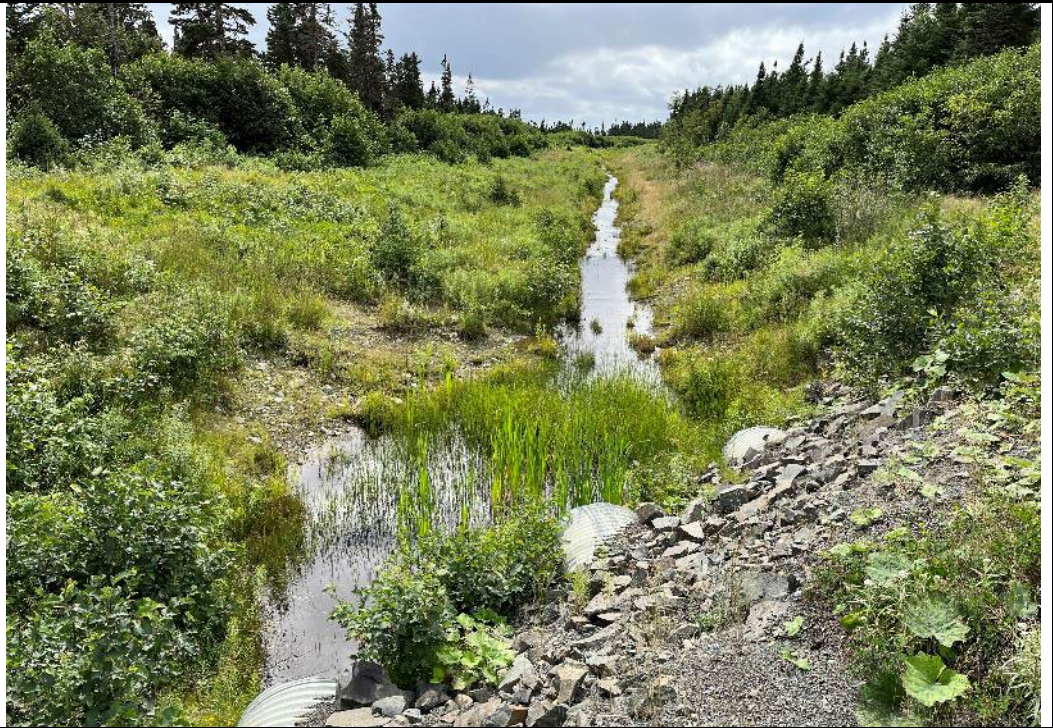
Photograph 7

Dam B Emergency Spillway
Channel looking west from Sta.
0+700.

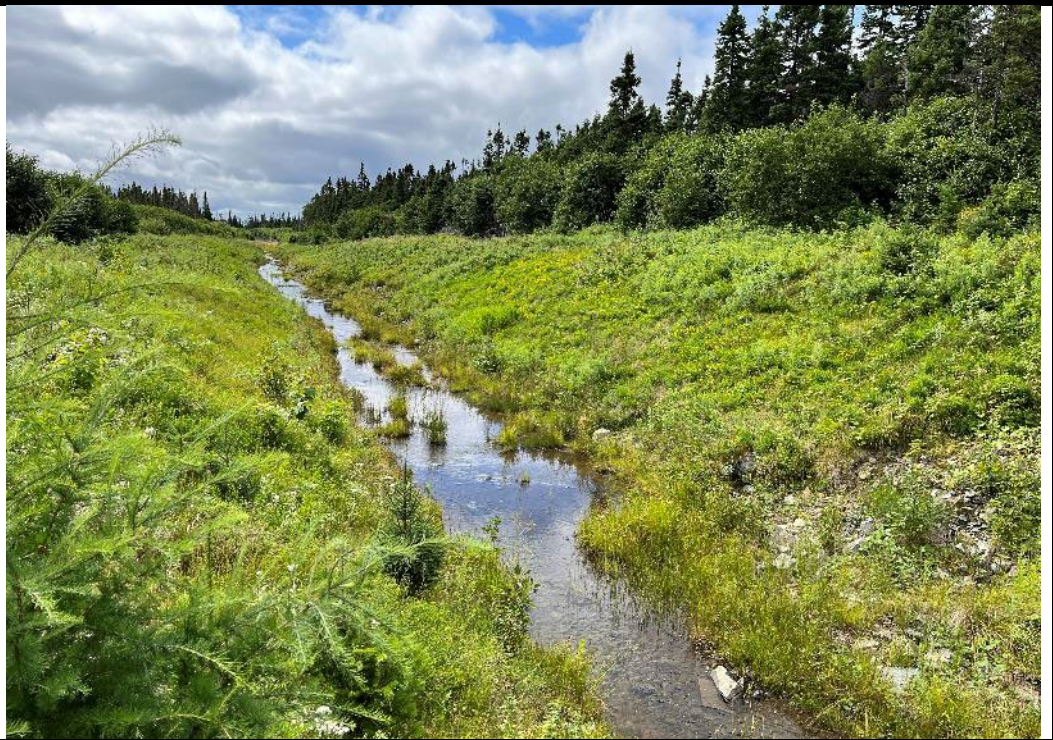
Photograph 8

Dam B Emergency Spillway
Channel at 1+000 looking west
towards its outlet location.

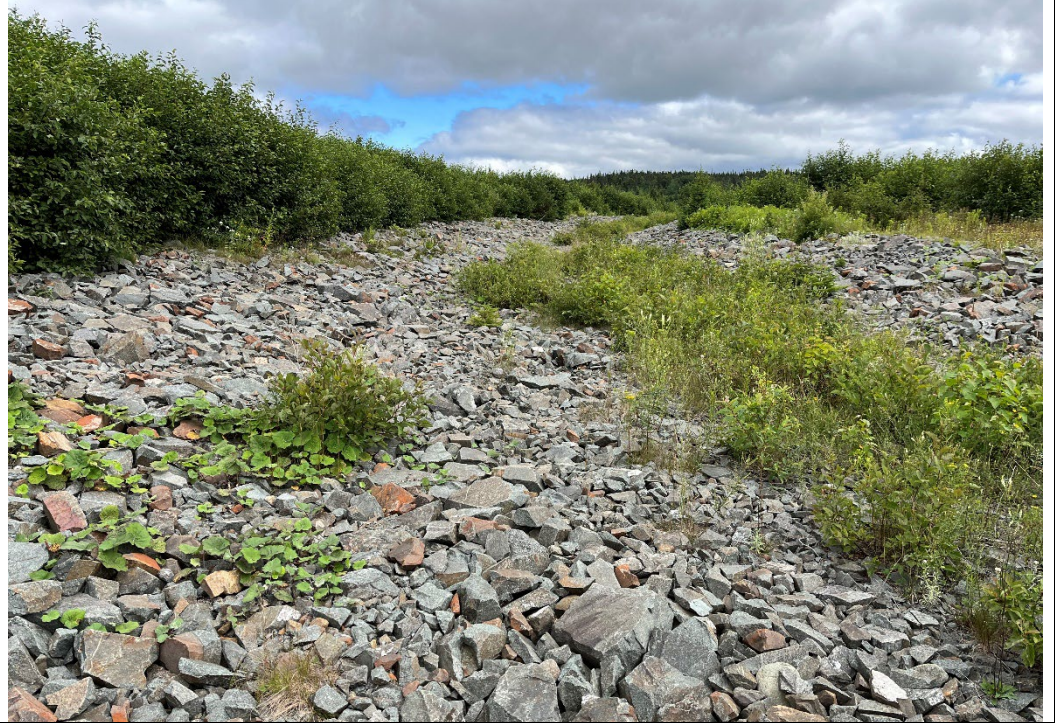
Photograph 1

Dam C Emergency Spillway inlet channel with the Polishing Pond in the background.

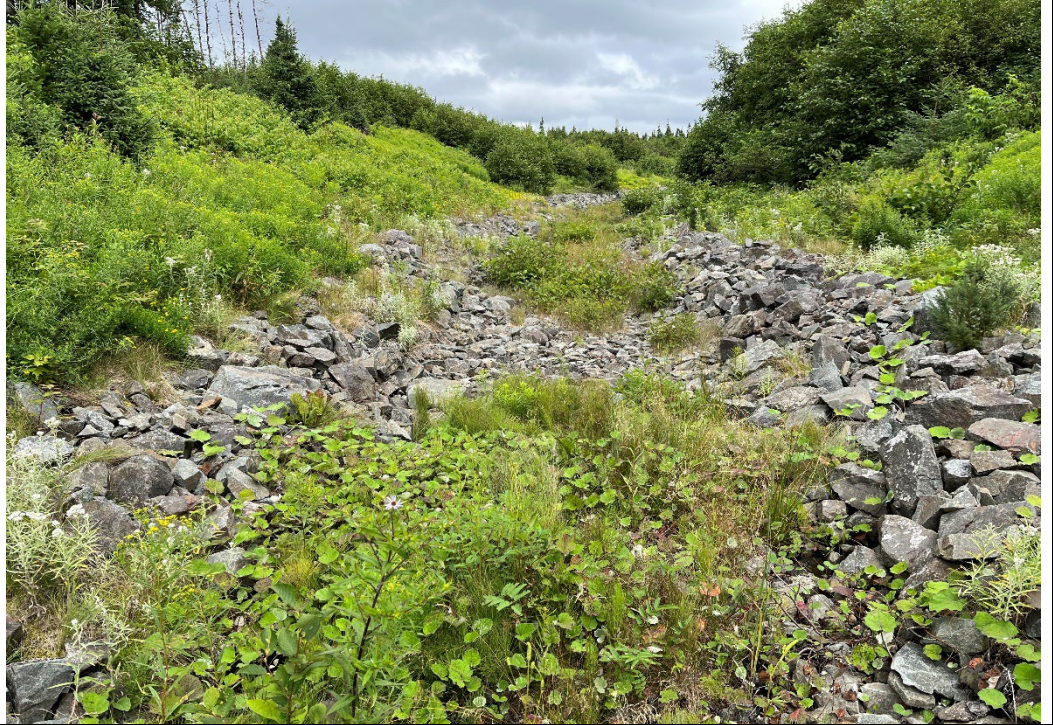
Photograph 3

Dam C Emergency Spillway channel looking east from Sta 0+200.

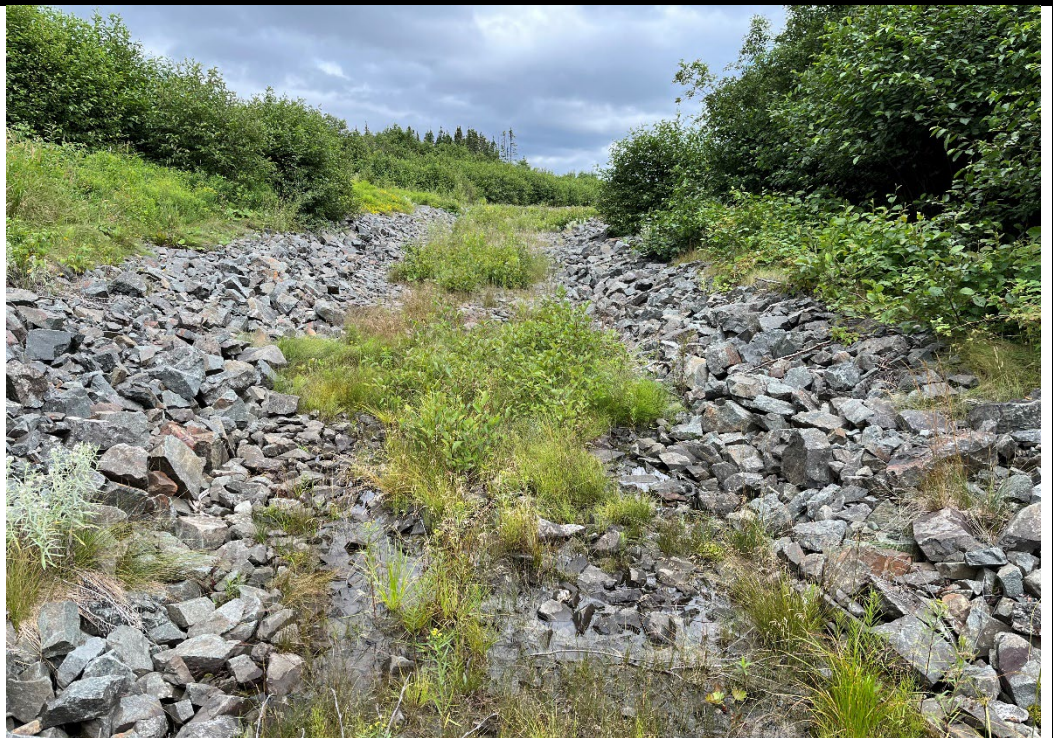
Photograph 4

Dam C Emergency Spillway outlet channel, looking downstream from the end of the rip rap lined section.

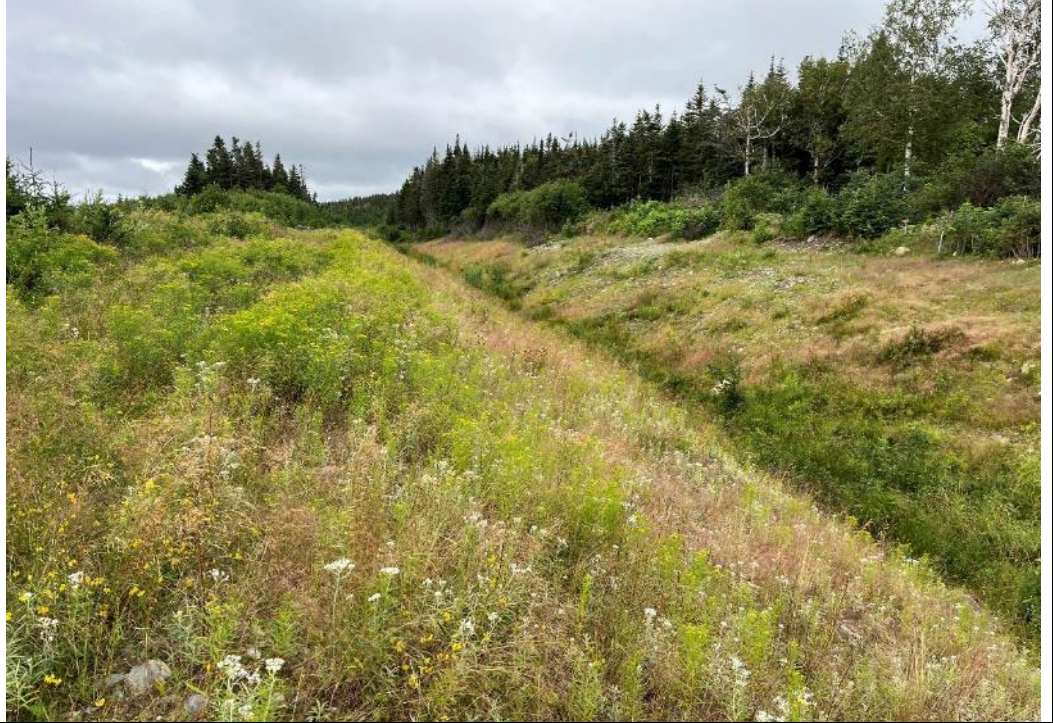
Photograph 1

Diversion Ditch A1 looking west from Sta. 0+800.

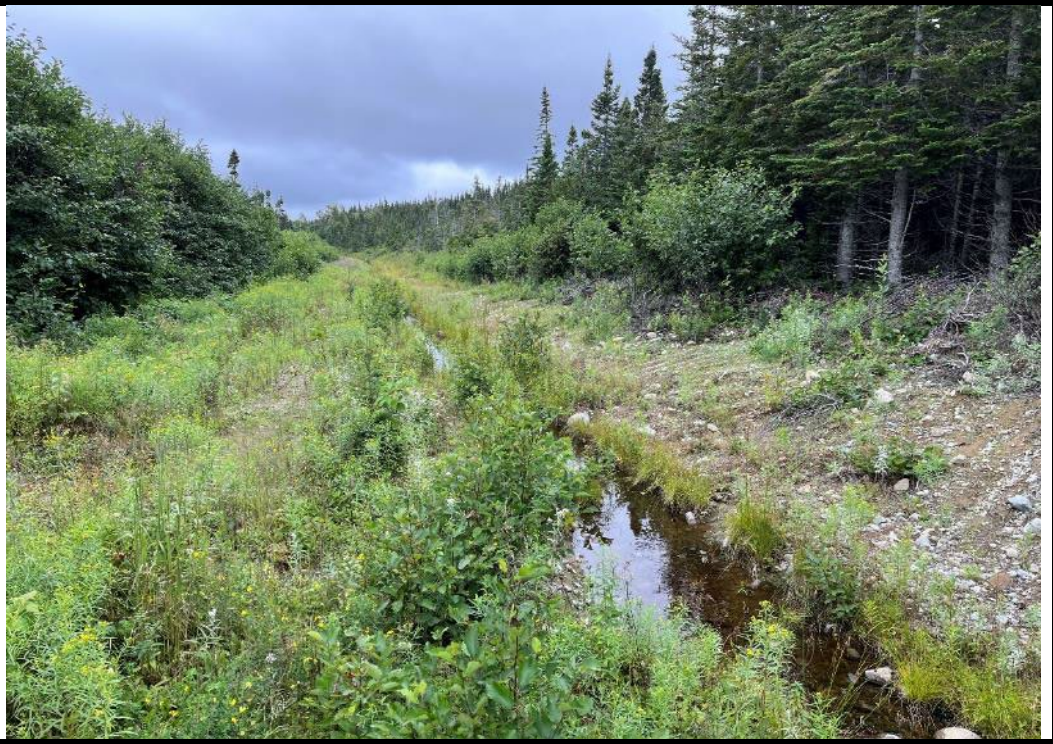
Photograph 2

Diversion Ditch A1 looking west from Sta. 0+400.

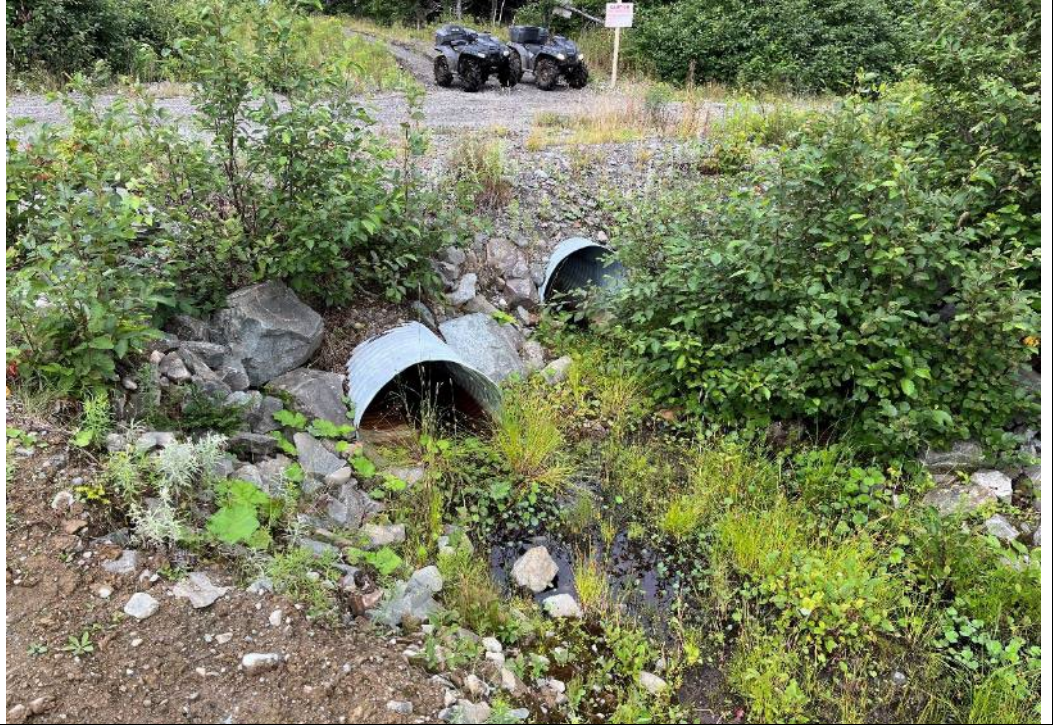
Photograph 3

Diversion Ditch A2 culvert outlets at the access road crossing.

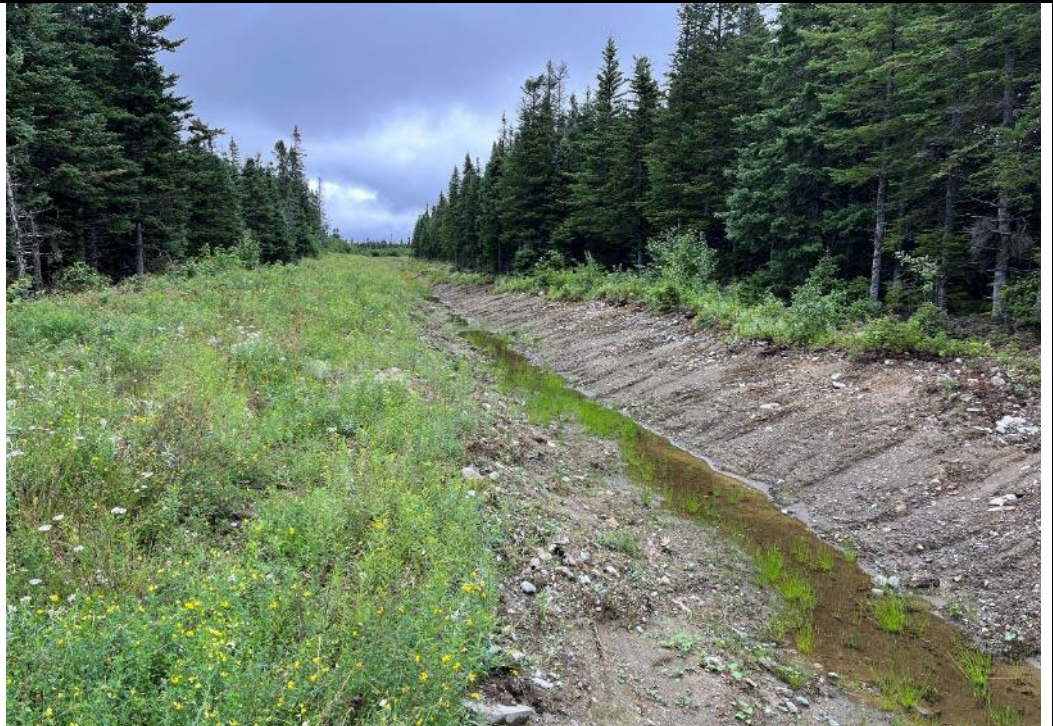
Photograph 5

Diversion Ditch A2 looking east from Sta. 0+100.

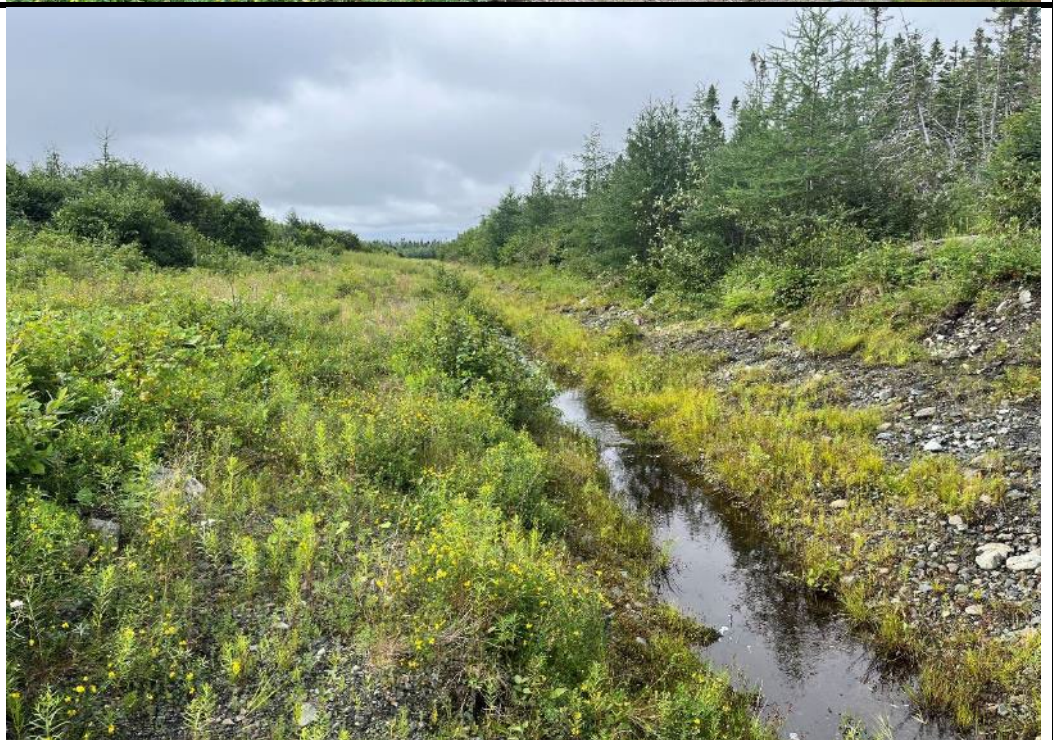
Photograph 6

Diversion Ditch B1 looking west from Sta. 0+200.

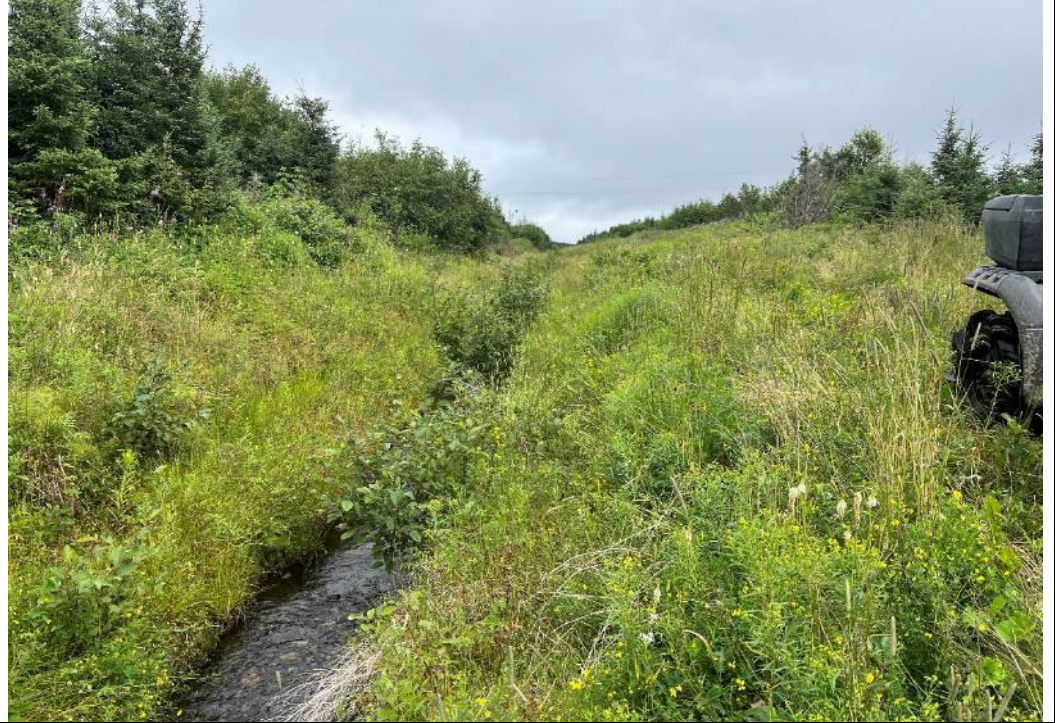
Photograph 7

Diversion Ditch B1 looking east from Sta. 0+700 and the intersection with Dam B Emergency Spillway Channel.

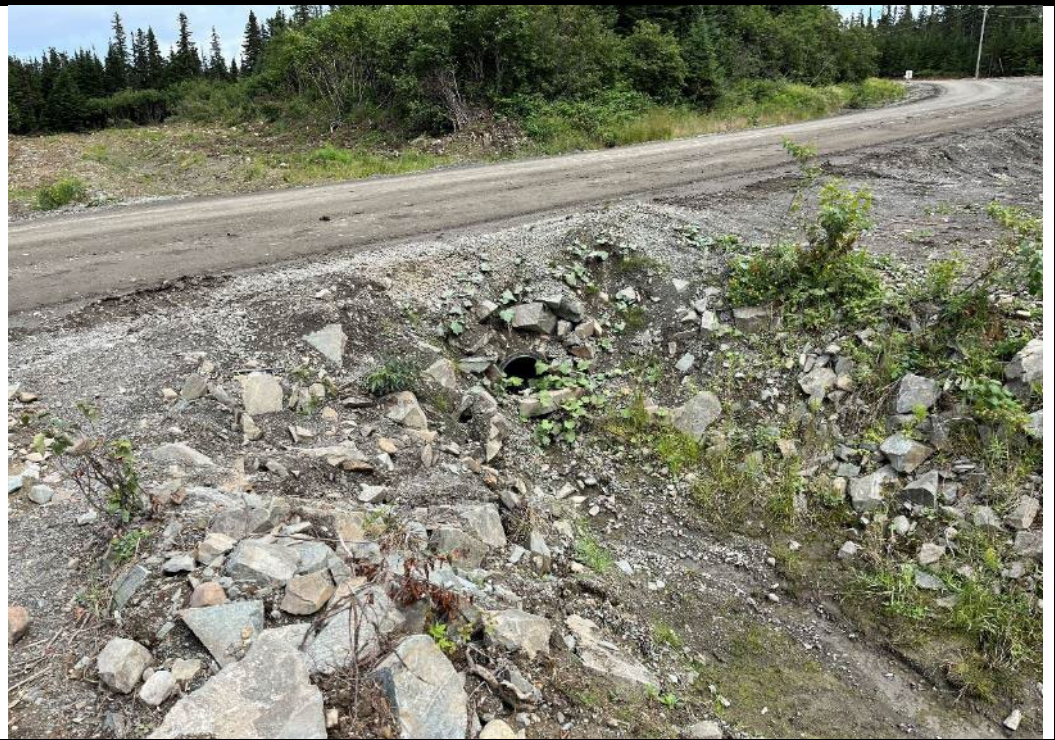
Photograph 8

Diversion Ditch C1 looking at HDPE culvert outlet beneath the Site Access Road.

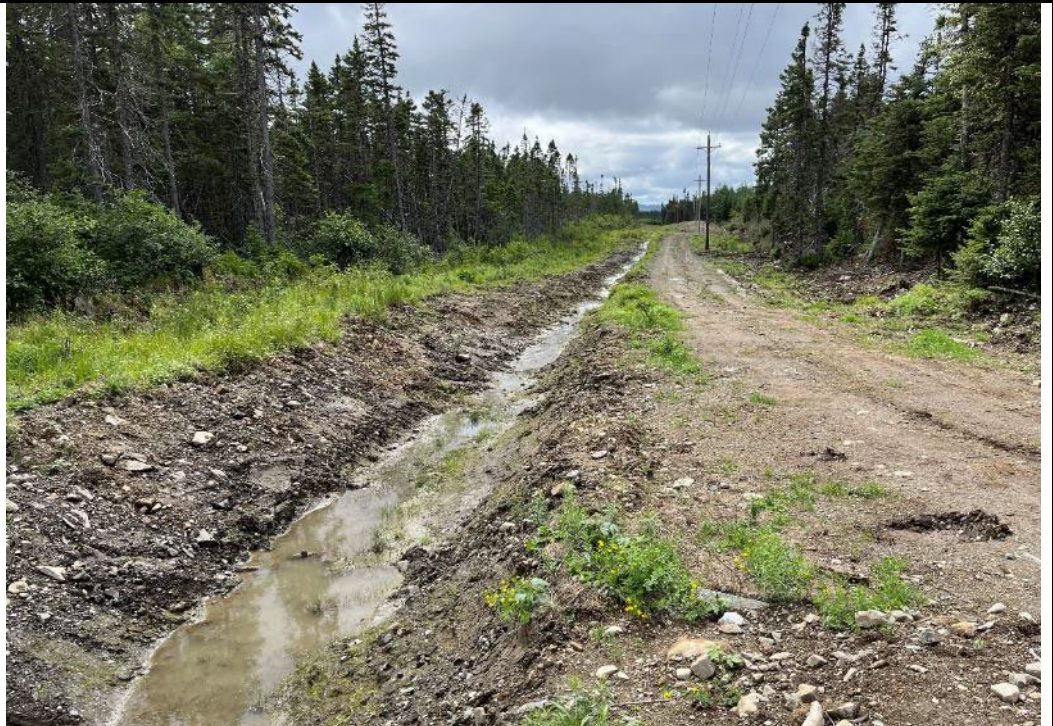
Photograph 9

Diversion Ditch C1 looking west from Sta. 0+150 with new hydro line installed in 2023.

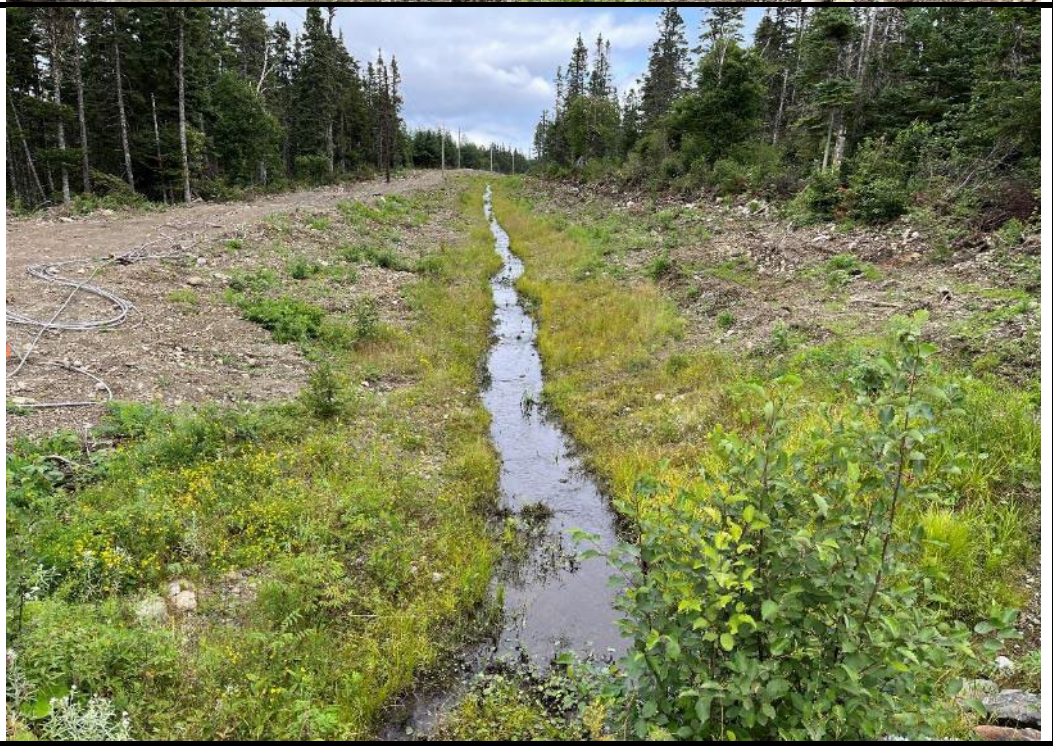
Photograph 10

Diversion Ditch C1, looking east from access road crossing at Sta. 0+750.

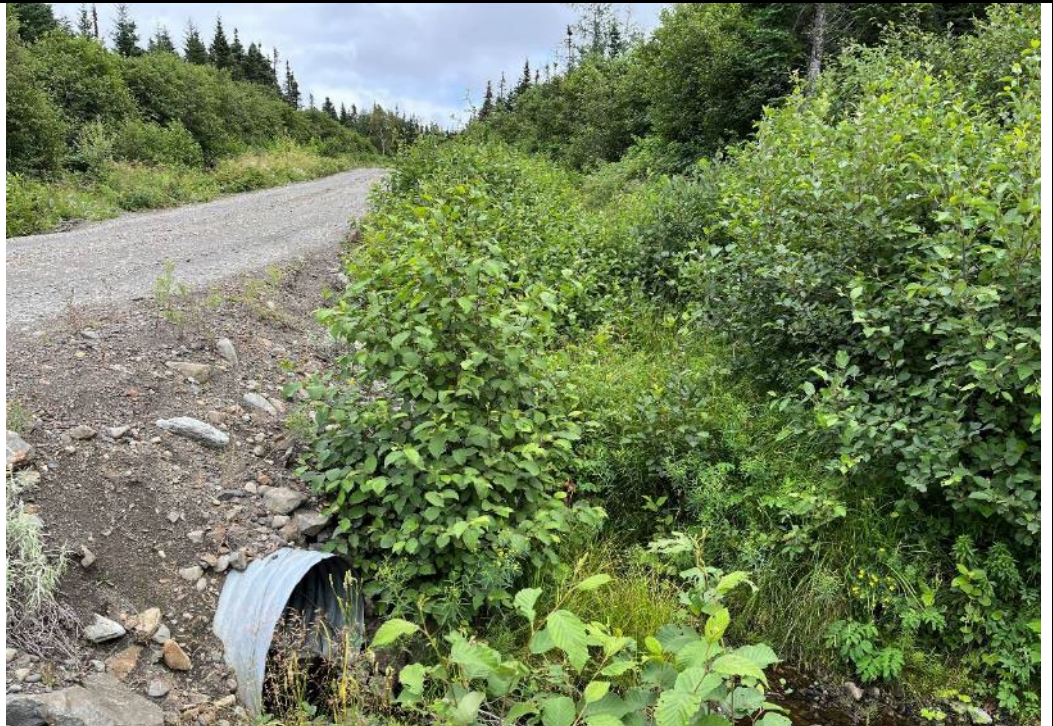
Photograph 11

View of Diversion Ditch C1 culvert (outlet) at the access road crossing at Sta. 0+750.

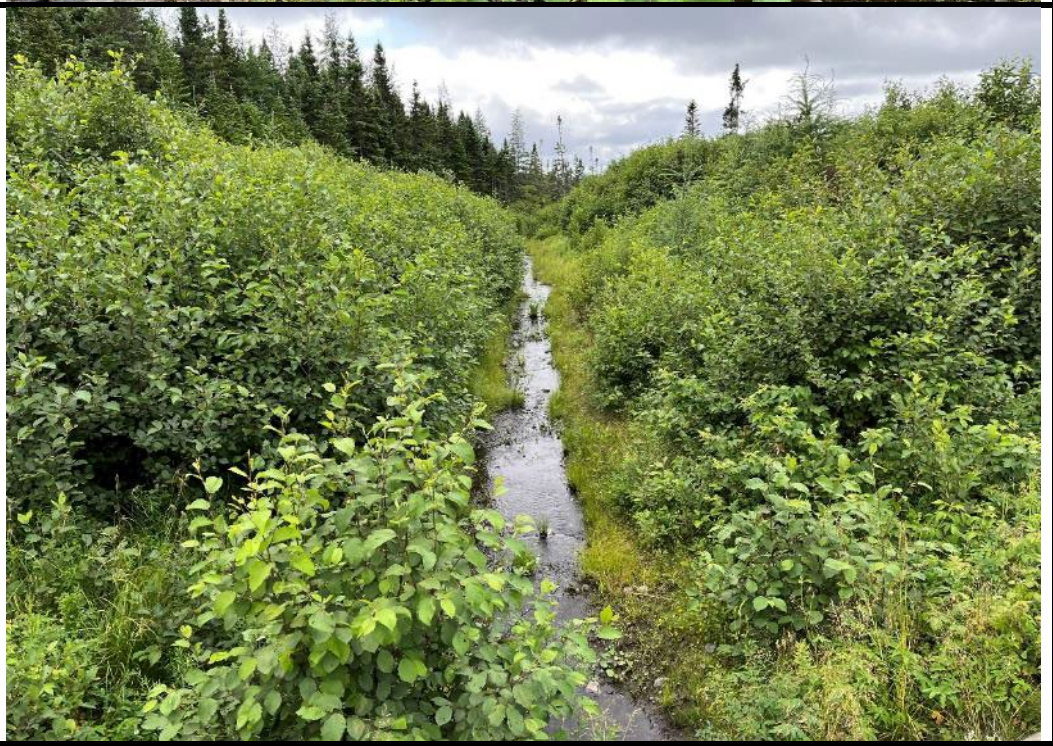
Photograph 12

Diversion Ditch C1 at Sta. 0+750, looking southwest.

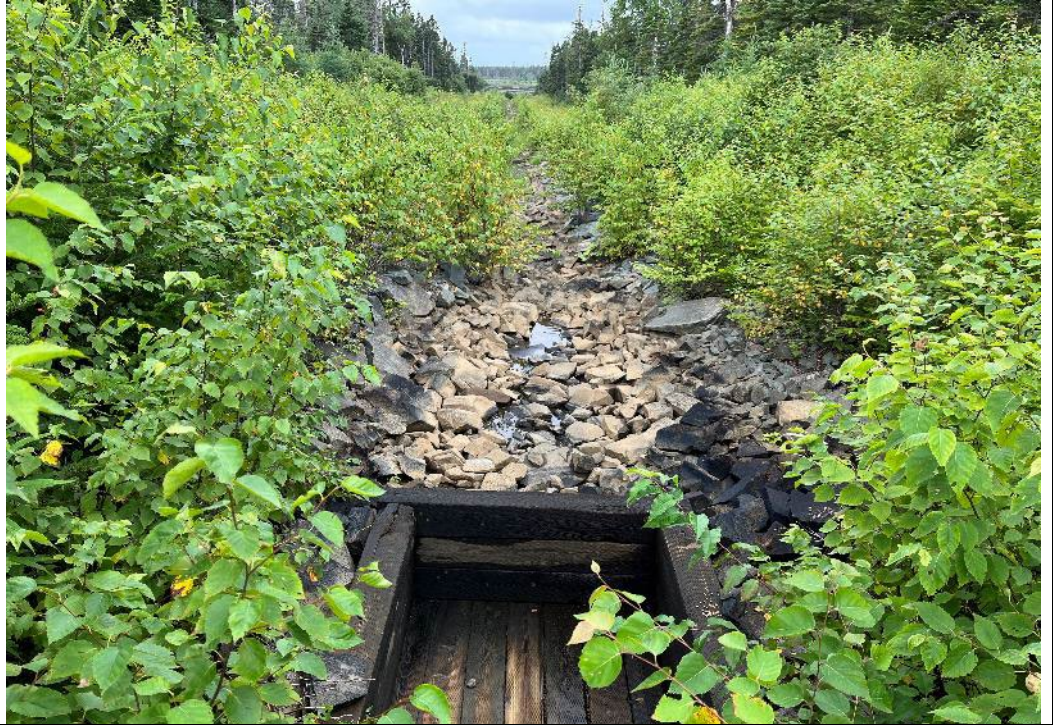
Photograph 1

Discharge Ditch Sta. 0+000 looking downstream towards the Polishing Pond.

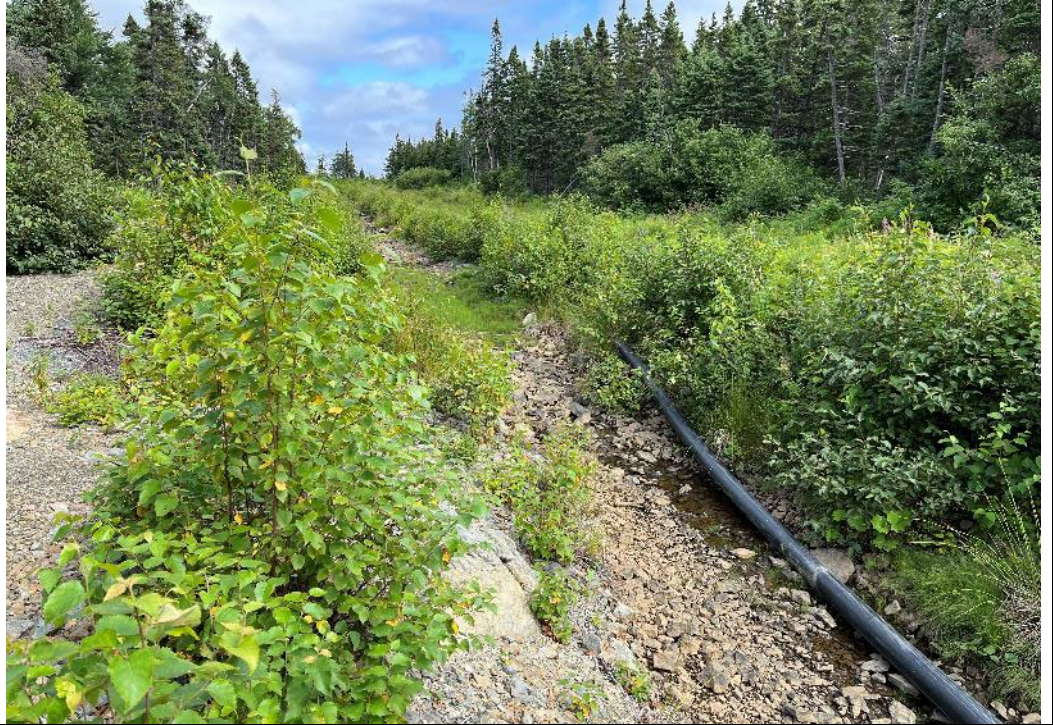
Photograph 3

Discharge Ditch at Sta. 0+220
looking east.
